Unreinforced Masonry and Selected Modern Buildings and Port Facilities

in the Darfield, NZ Earthquake 9-4-2010

Fred Turner, SE

CA Seismic Safety Commission

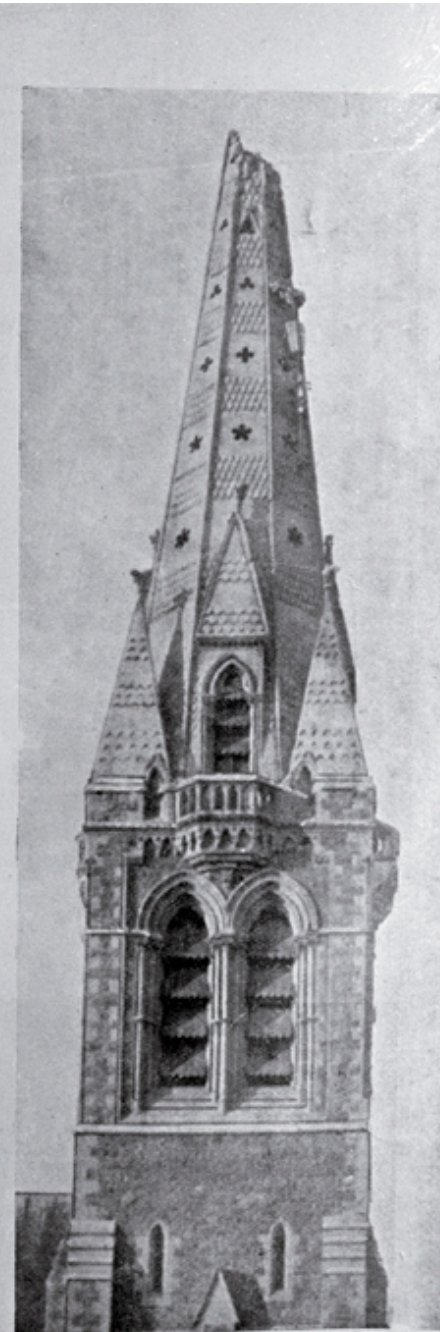
THE 1888 EARTHQUAKE.
Showing the damage done to the Cathedral spire.
Wheeler, photo

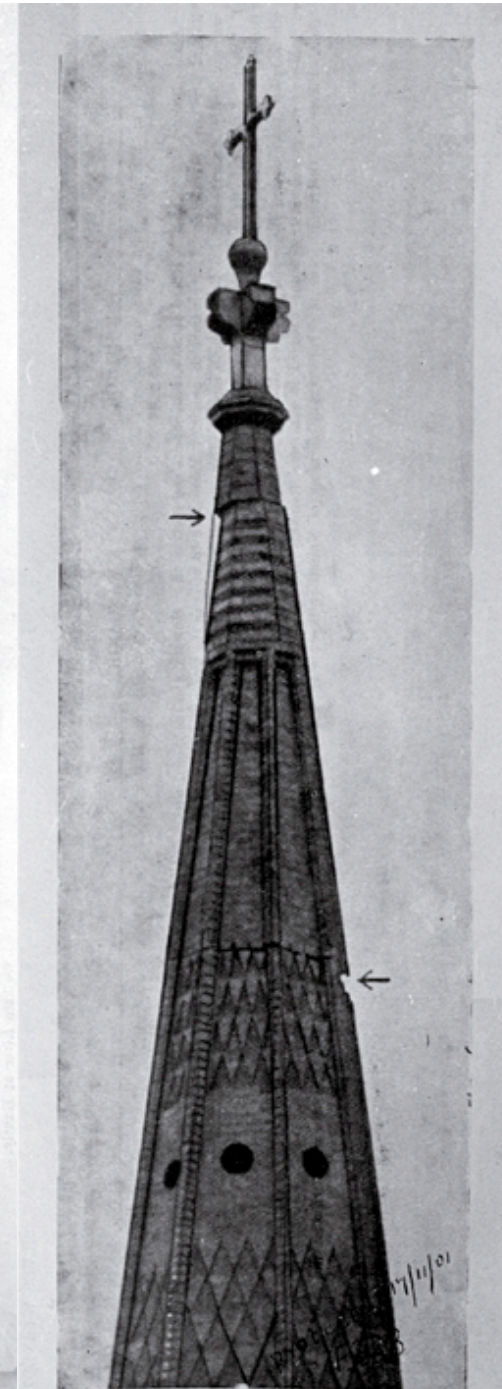
THE EARTHQUAKE IN CHRISTCHURCH.
Showing the damage done to the Cathedral spire on Saturday.
Photo by F. C. Bishop (protected.)

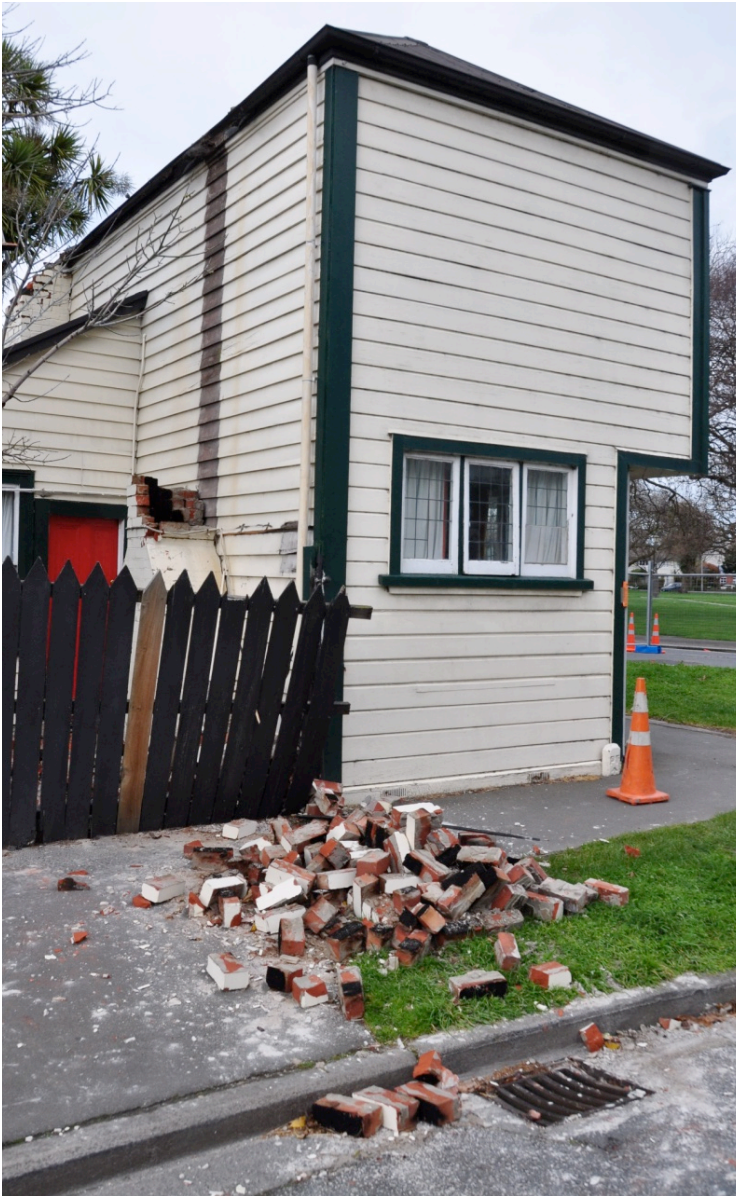
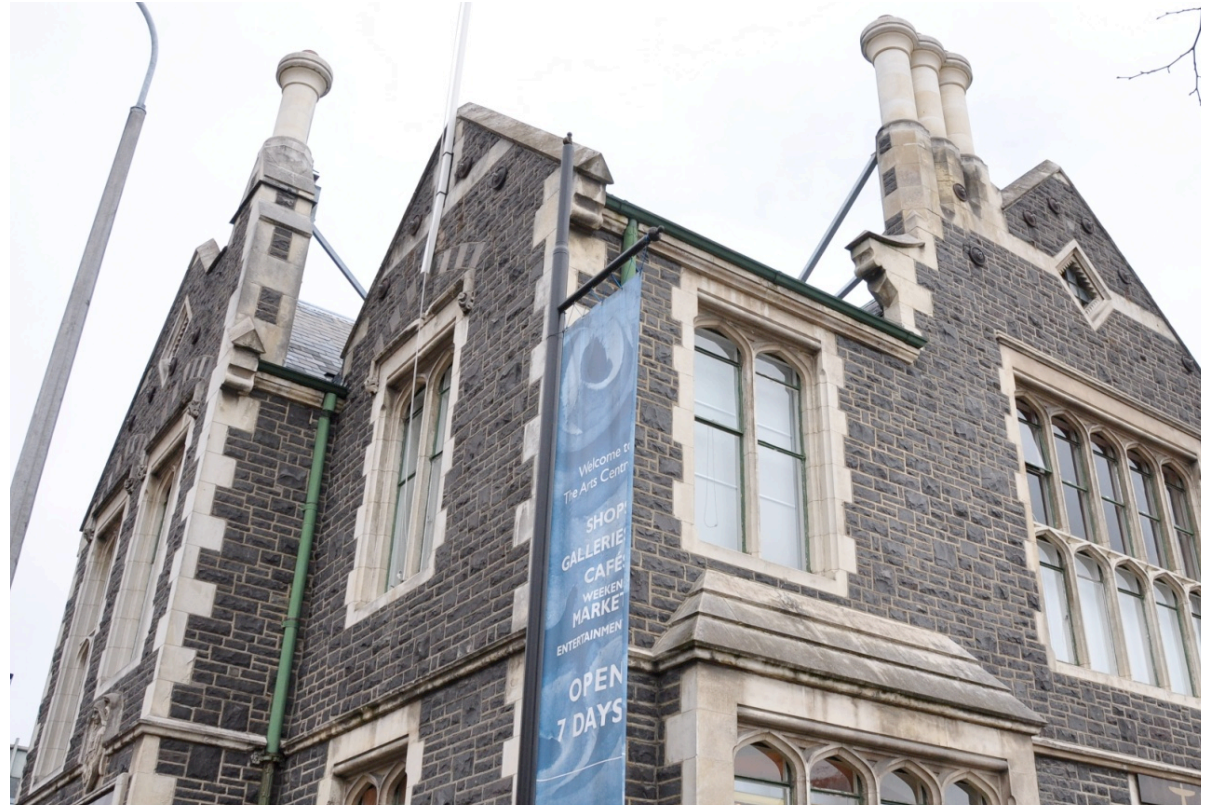
Types of Unreinforced Masonry (URM): Chimneys

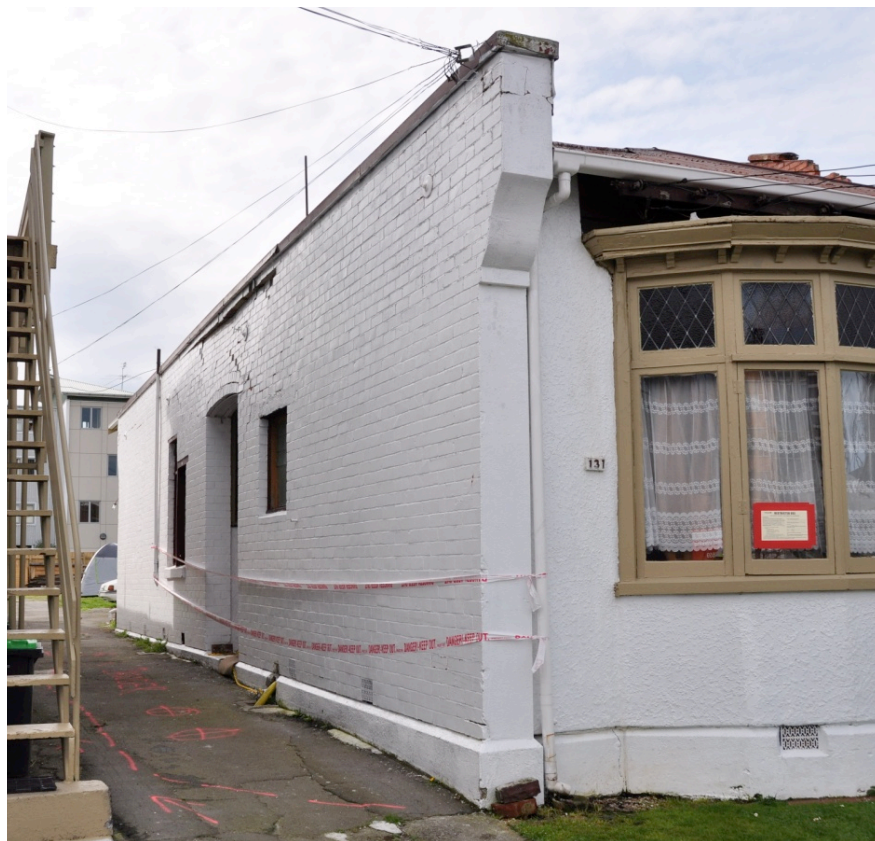
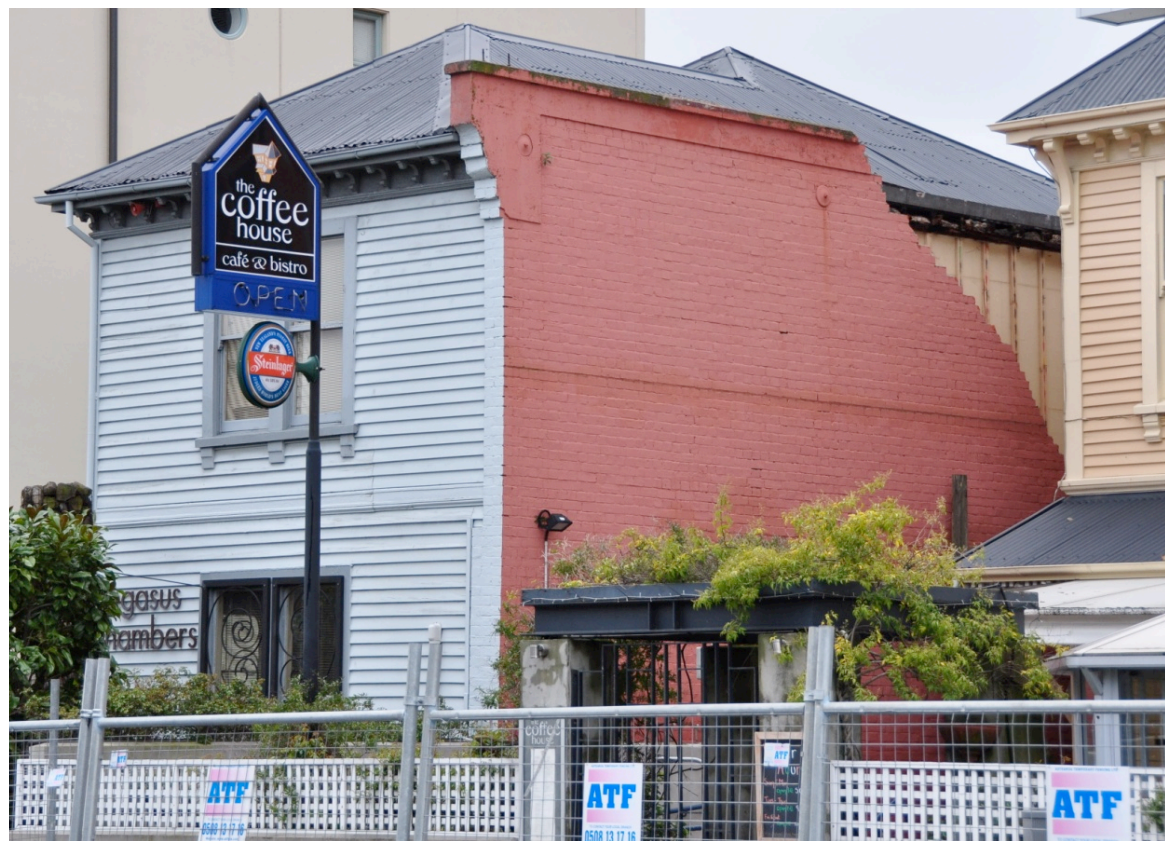
URM Type: Fire Separation Walls

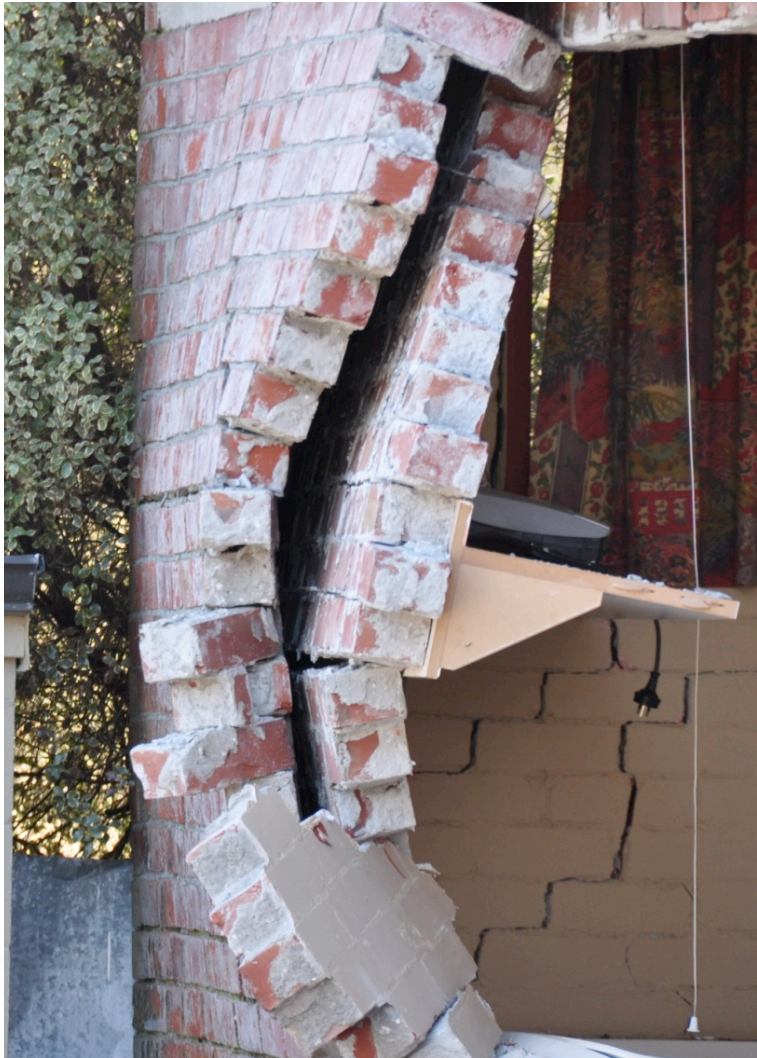
URM Type: Cavity Walls

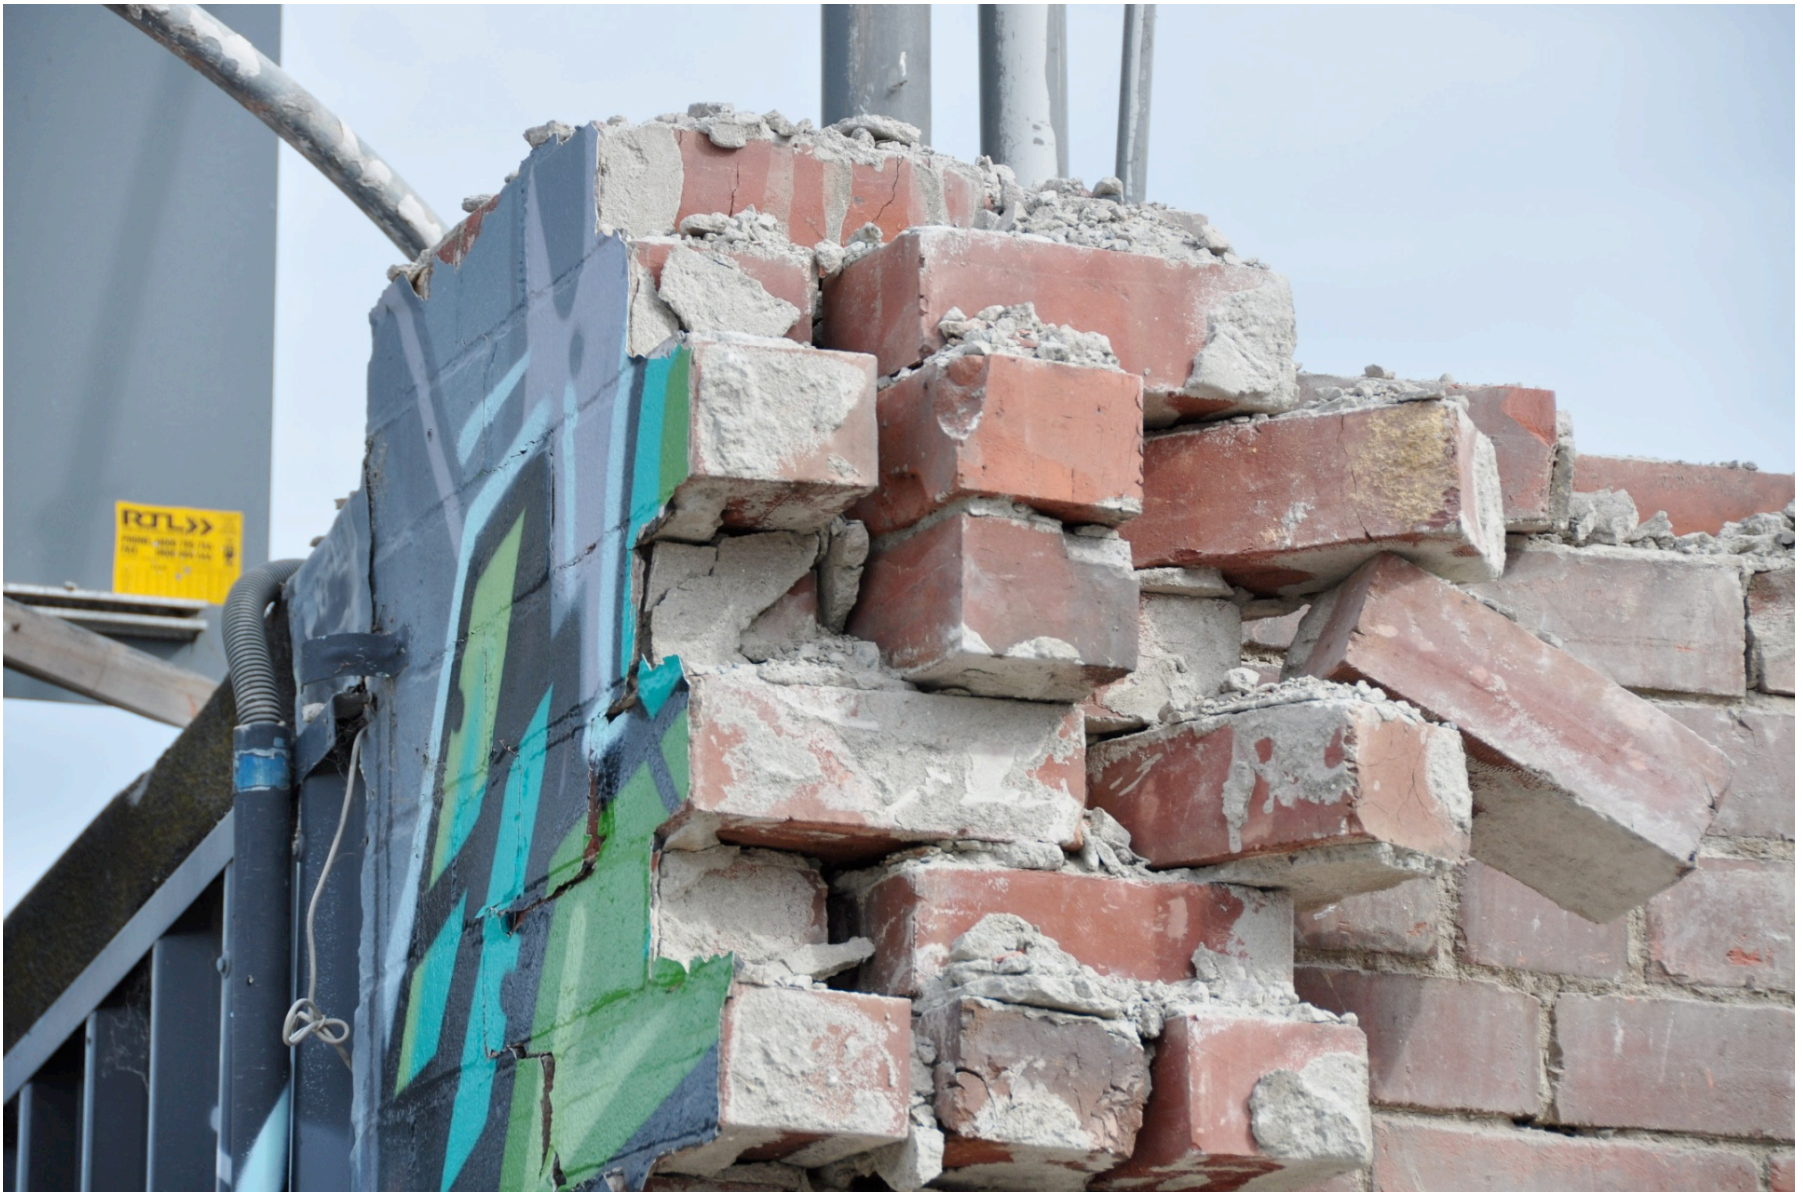
URM Type: Multi-wythe Walls

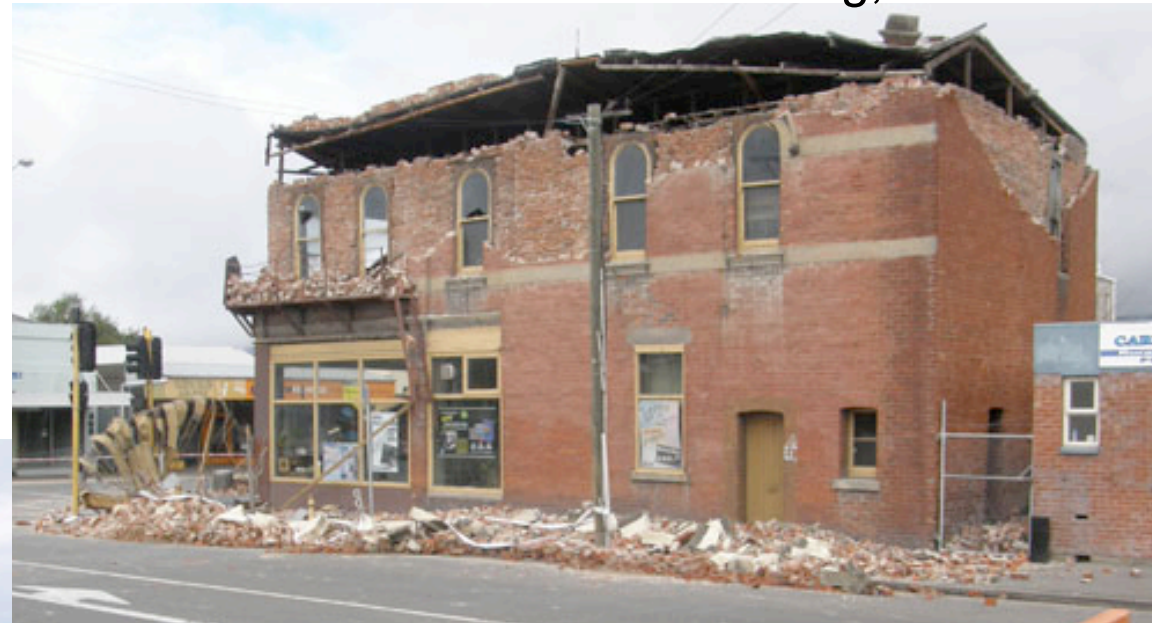
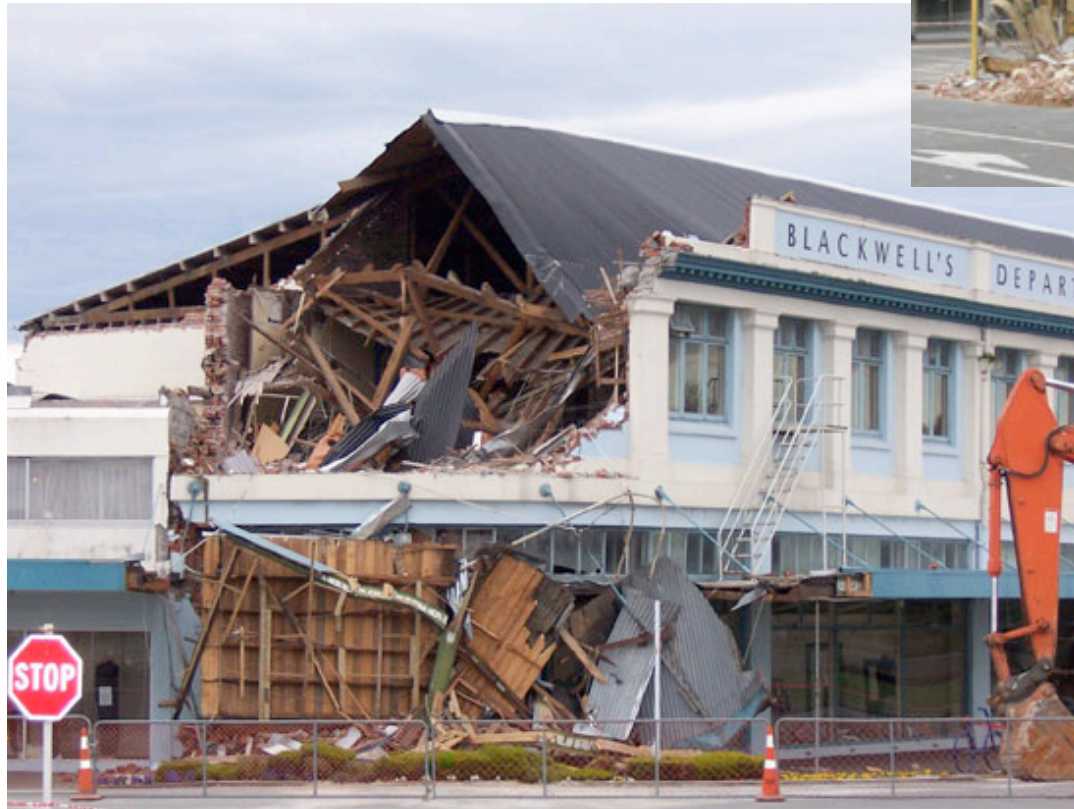
URM Parapet & Upper Wall Collapses

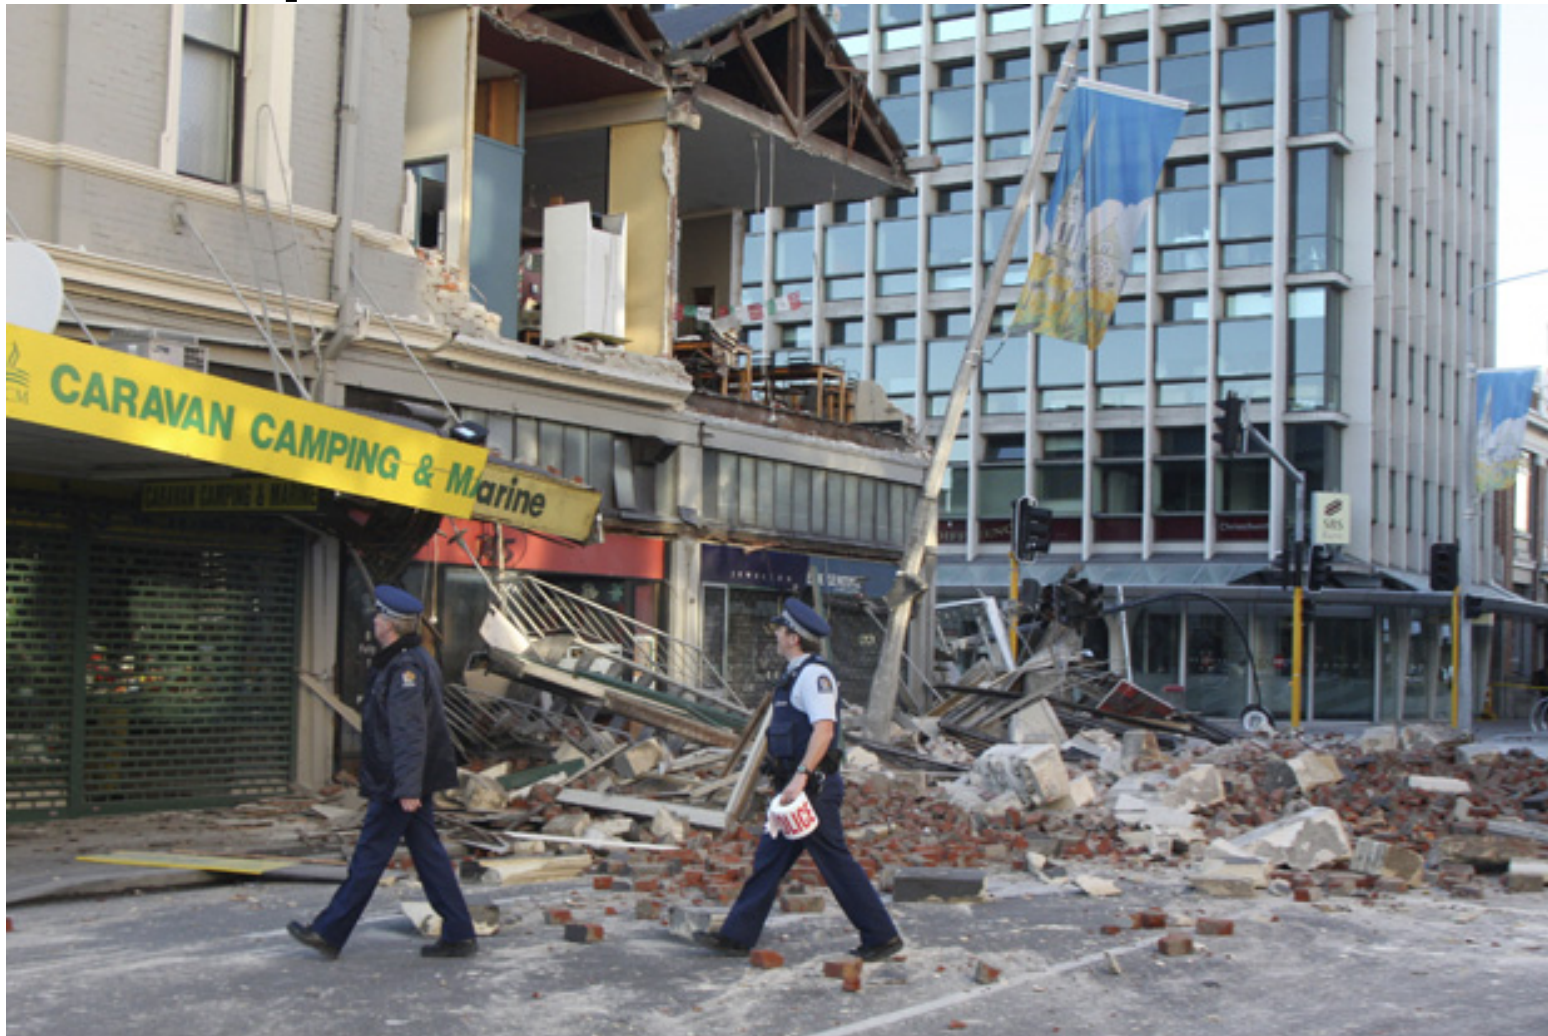
URM Parapet & Upper Wall Collapses

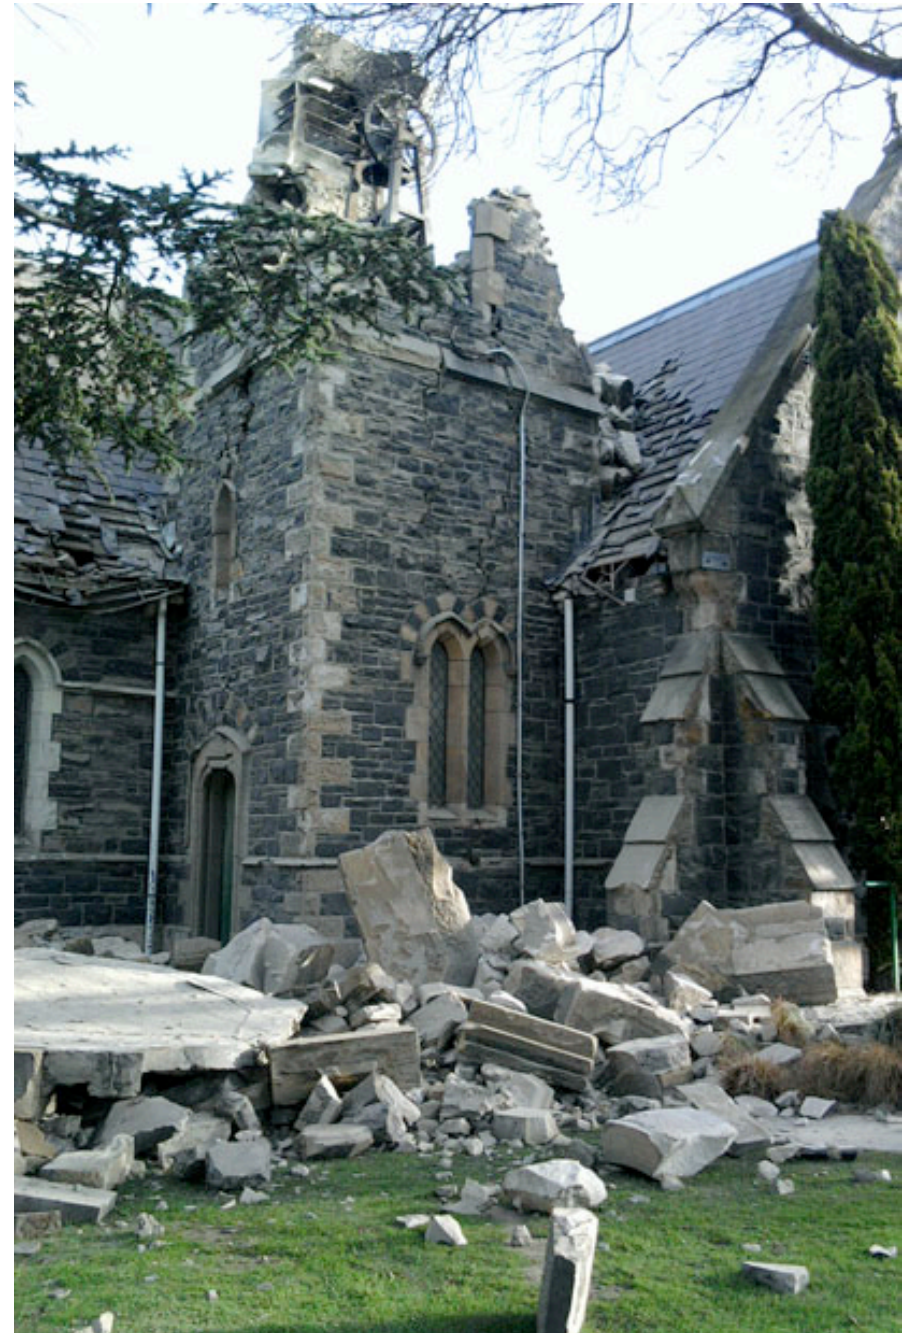
Stone Bell Tower Collapse St. John's Latimer Square

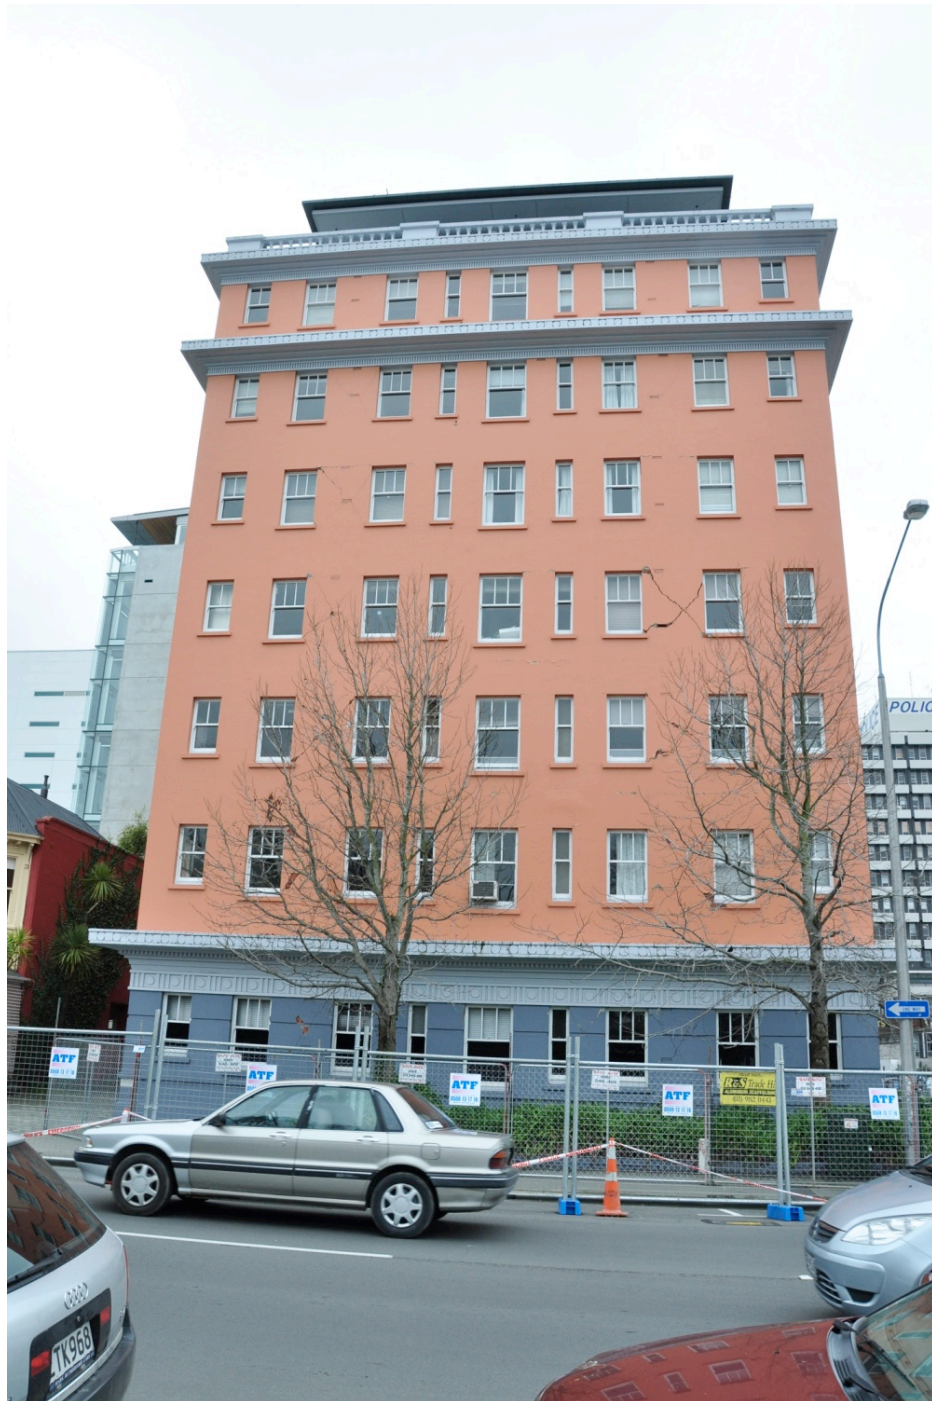
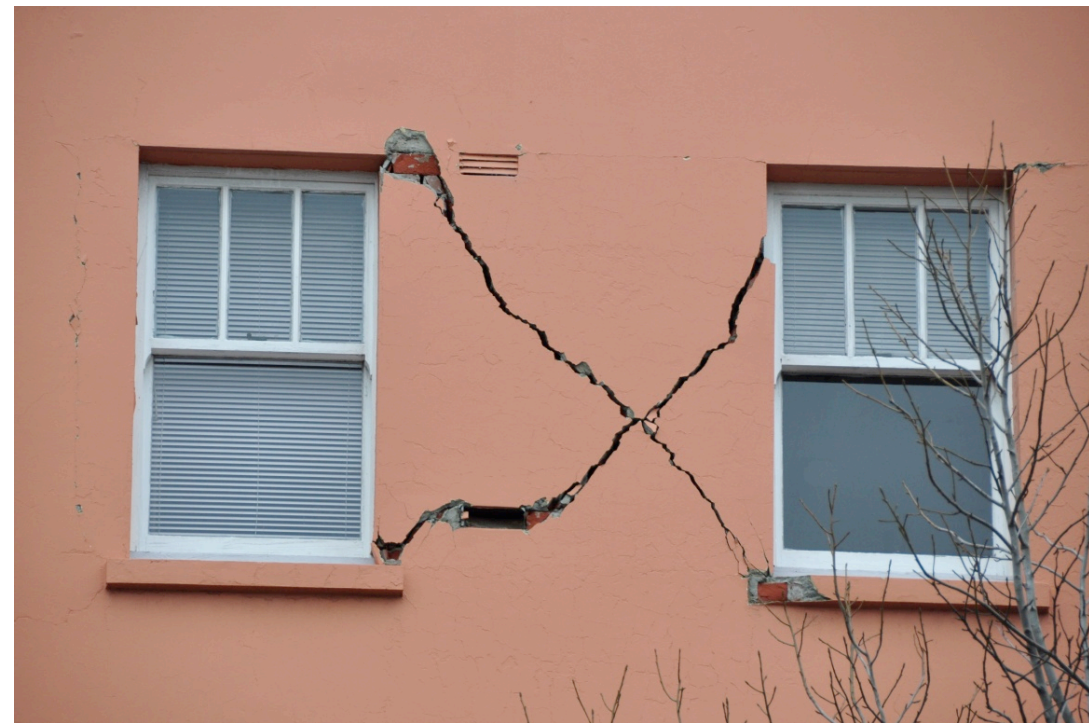
Taller URM Buildings

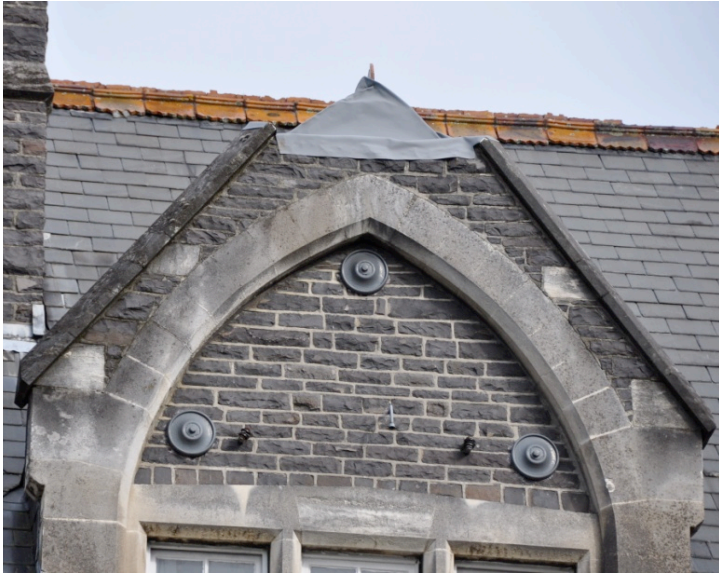
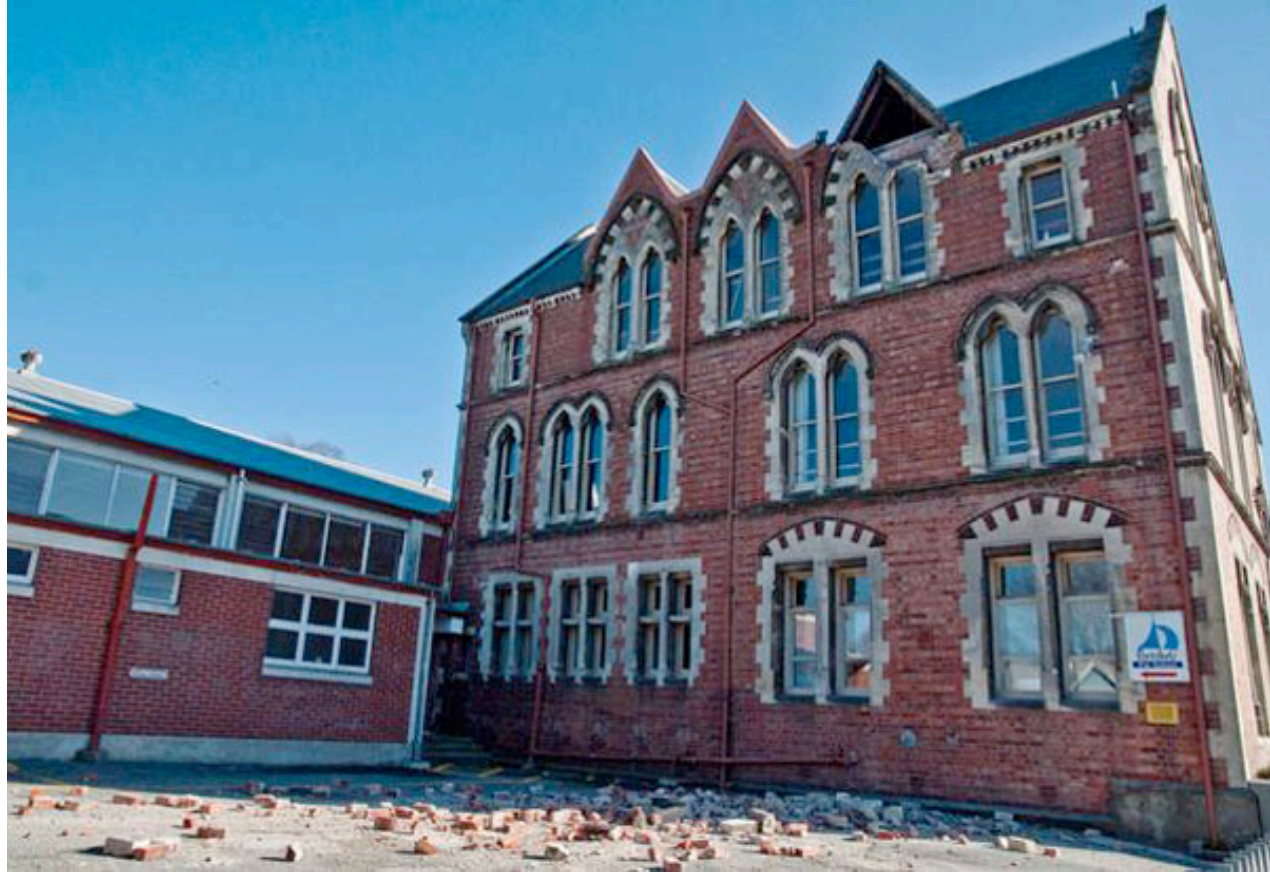
URM Gable Walls

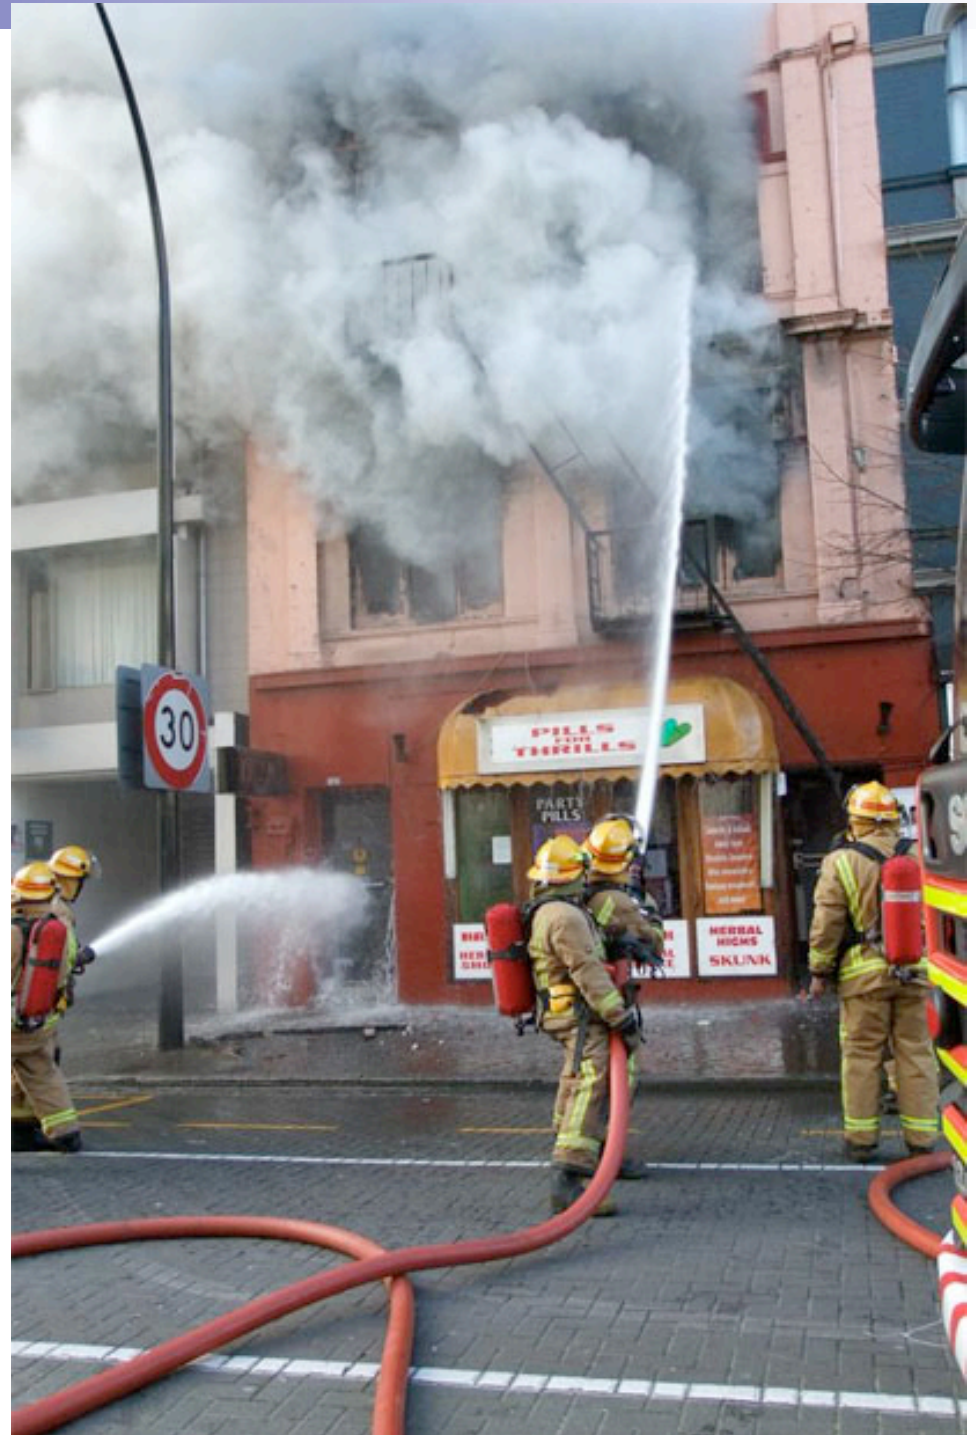
Fire Following Restoration of Electricity

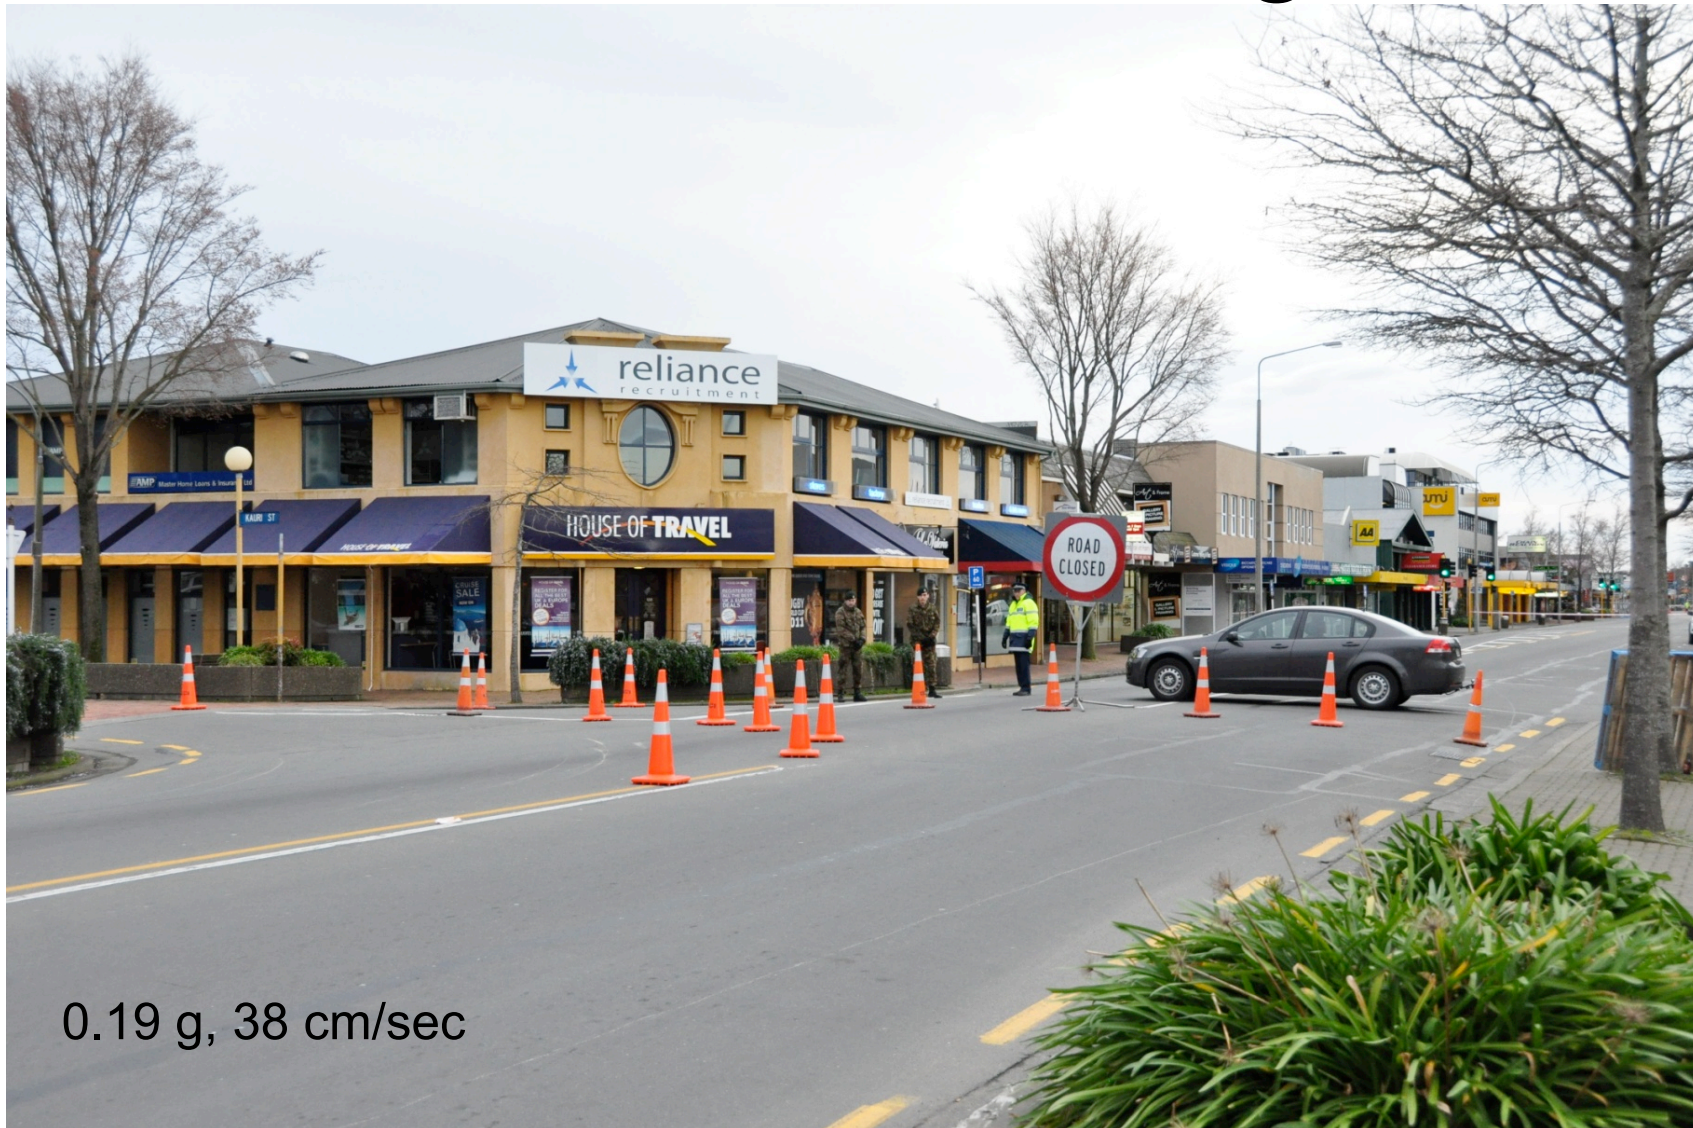
Indirect Impacts of Collapsed URM Buildings

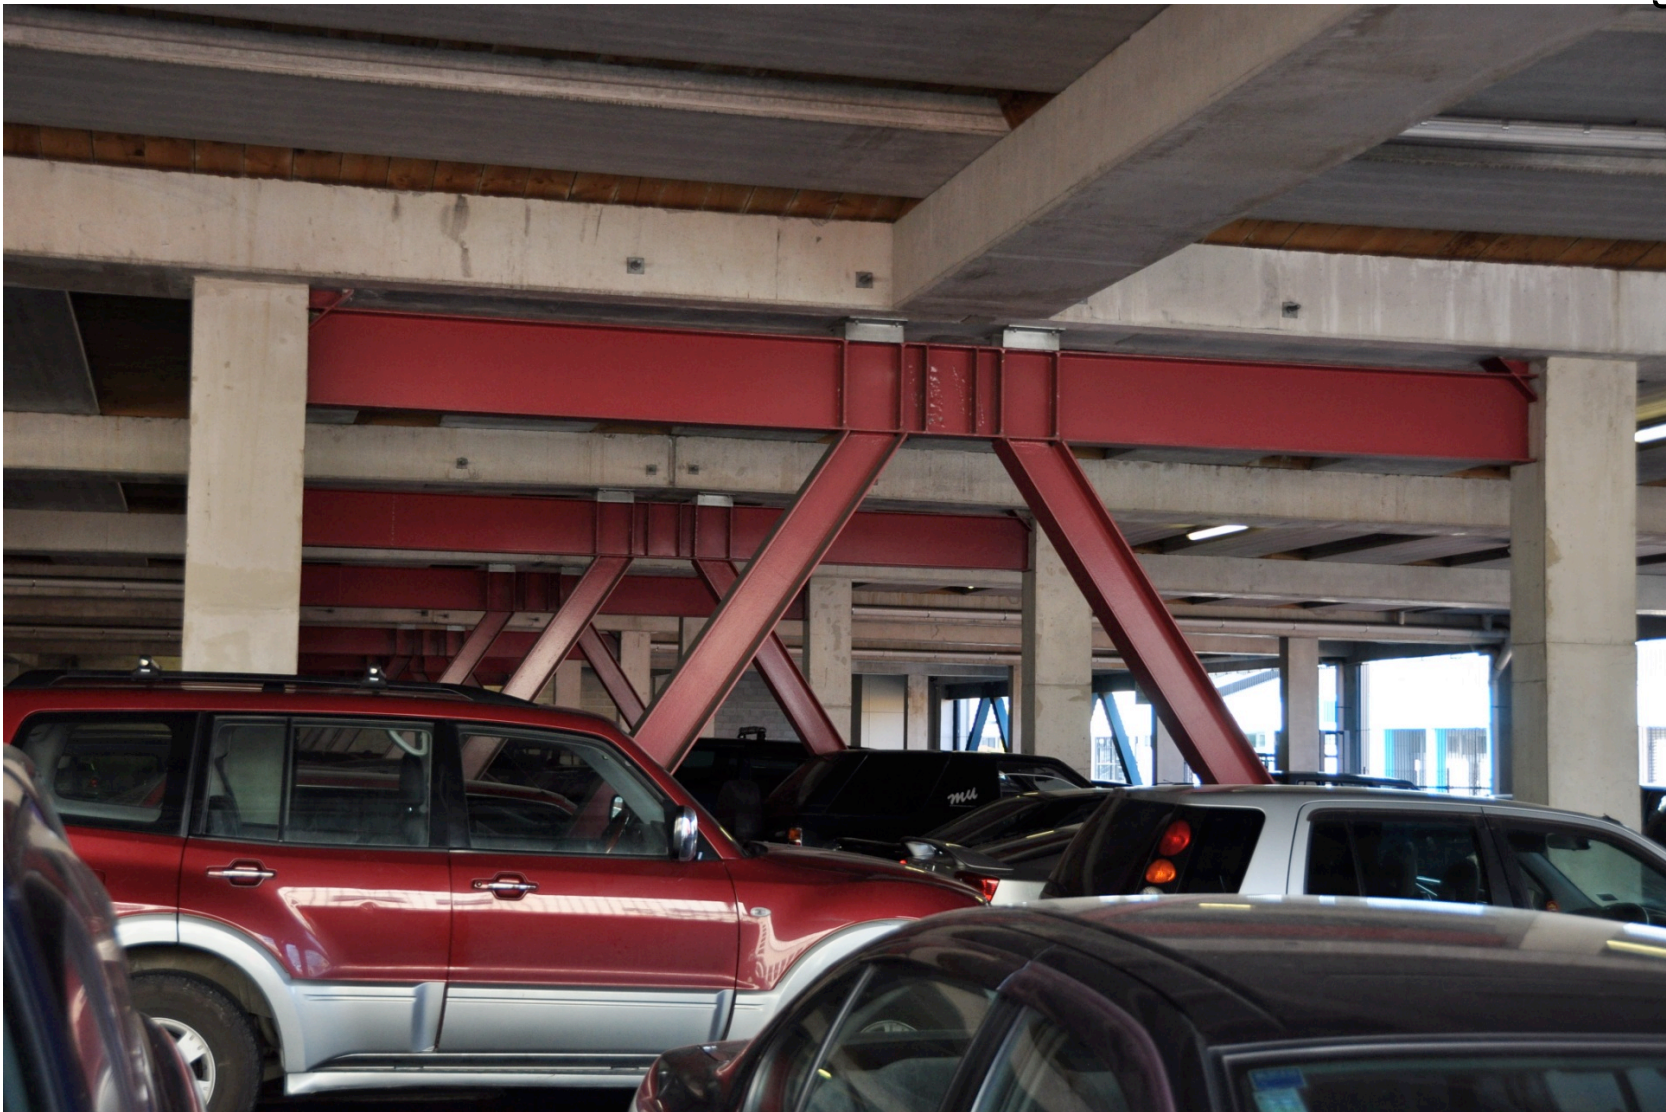
Parking Garage EB Frame

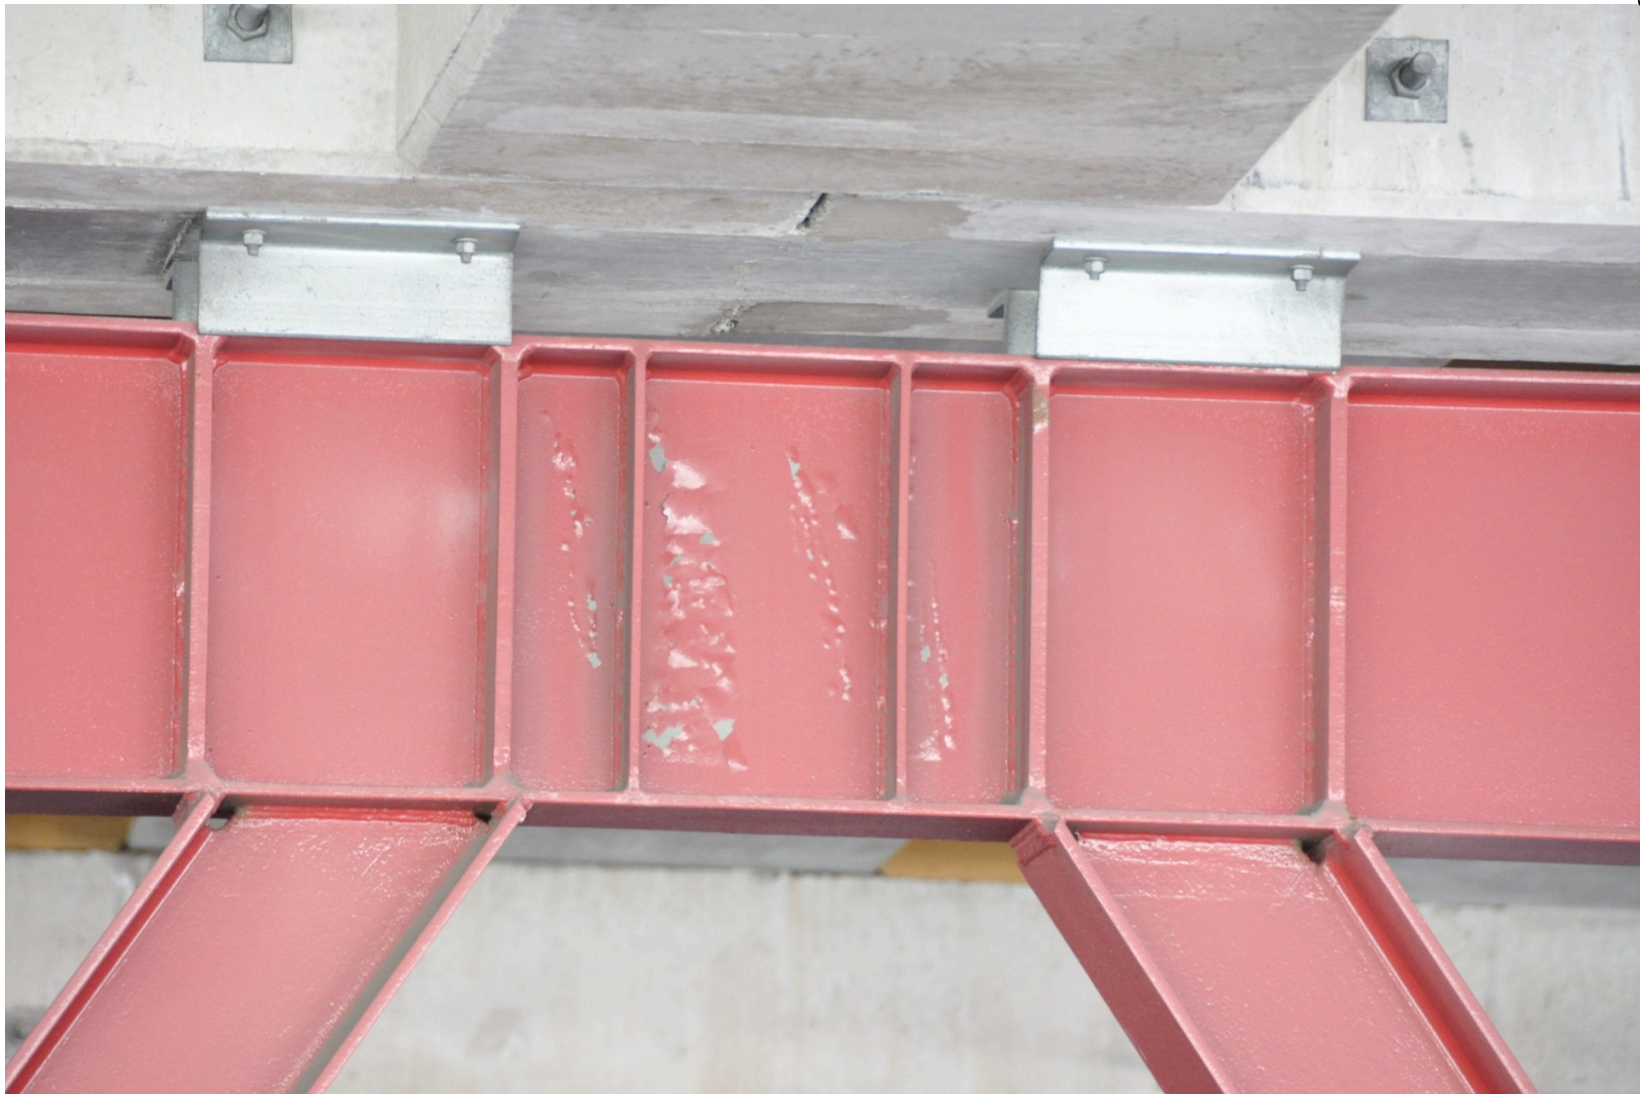
Parking Garage EB Frame
