Unreinforced Masonry and Selected Modern Buildings and Port Facilities

in the Darfield, NZ Earthquake 9-4-2010

Fred Turner, SE

CA Seismic Safety Commission

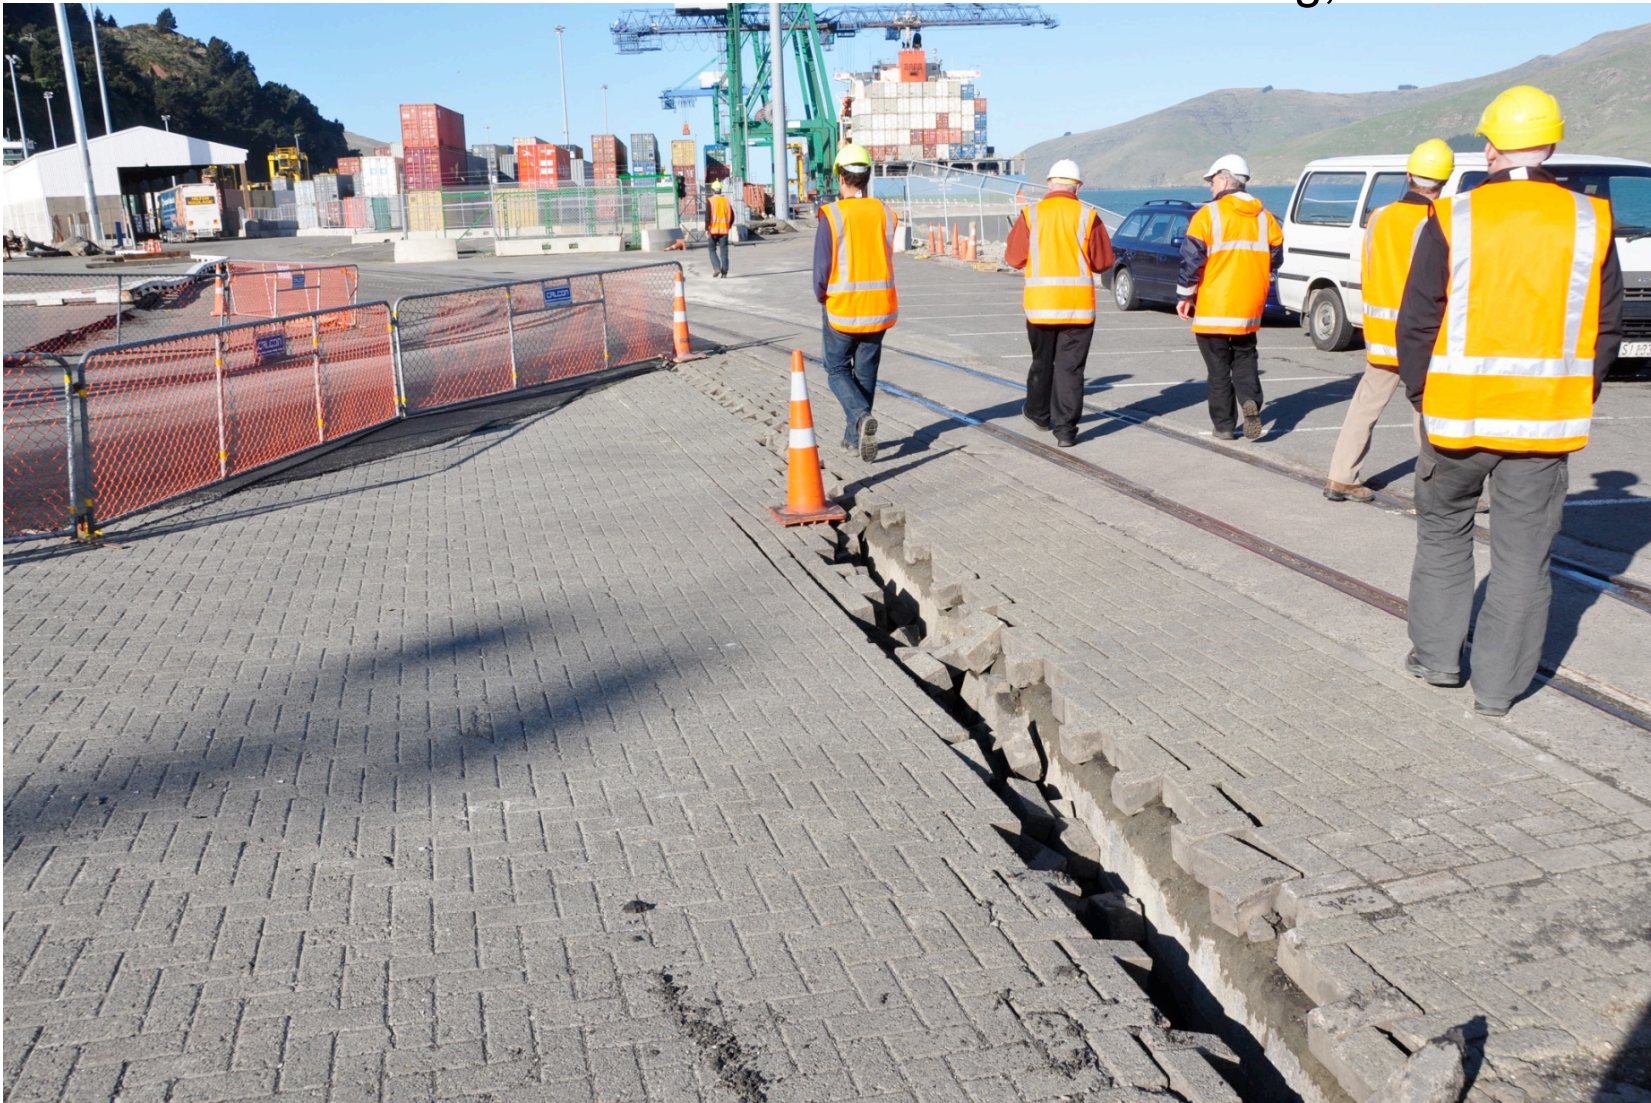
Port Lateral Spreading

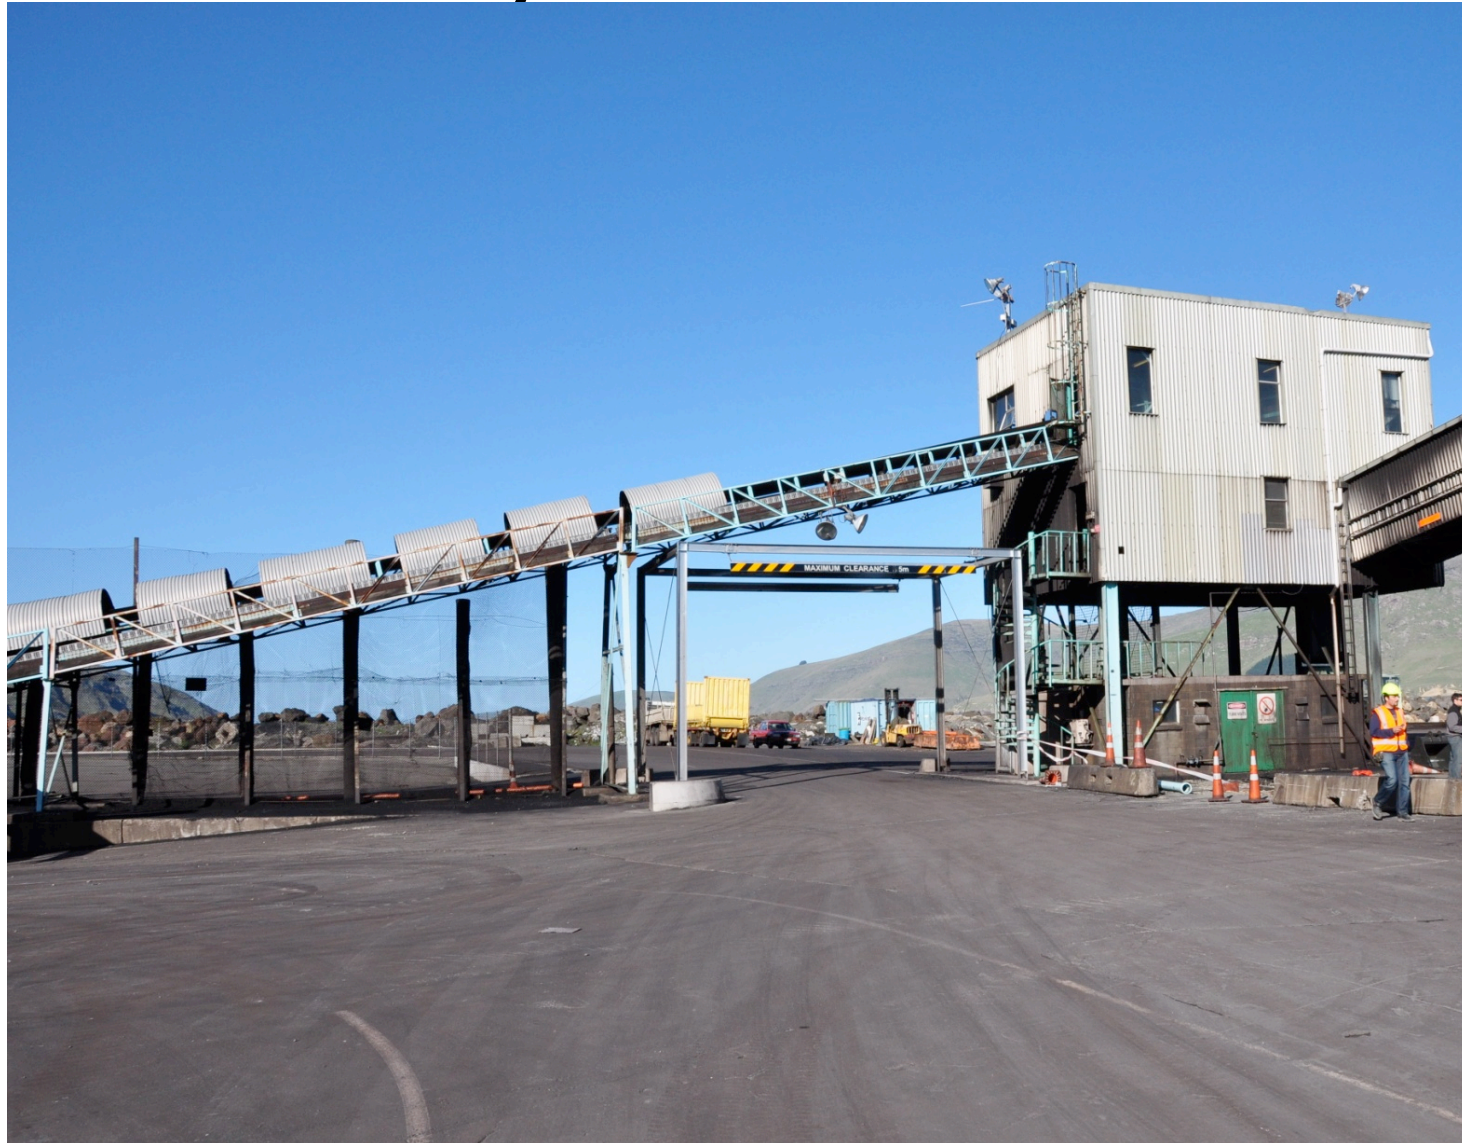
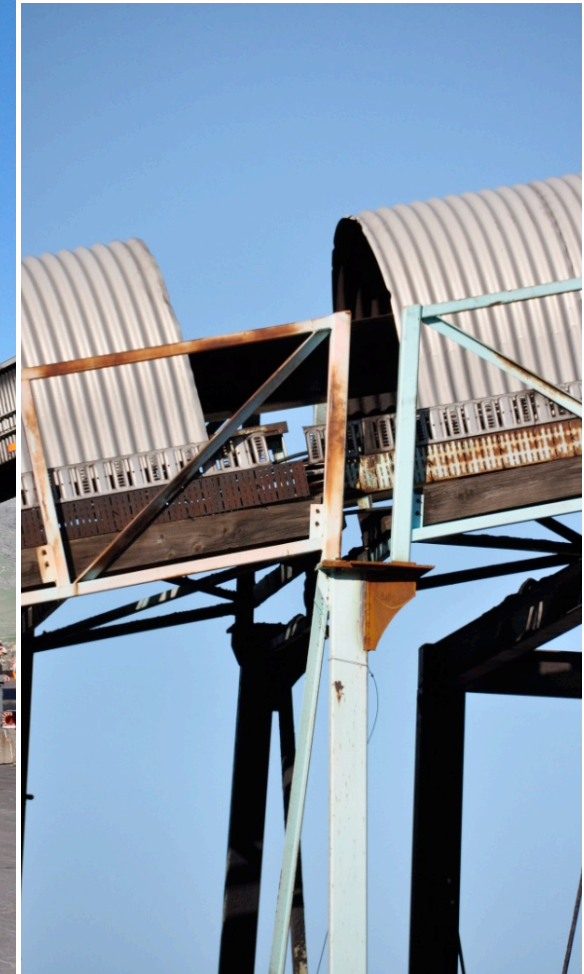
Port Damage to Bulk Coal Conveyor
