# Performance of Nonstructural Components in Critical Facilities

*2012 PEER Annual Meeting*

**Gilberto Mosqueda**

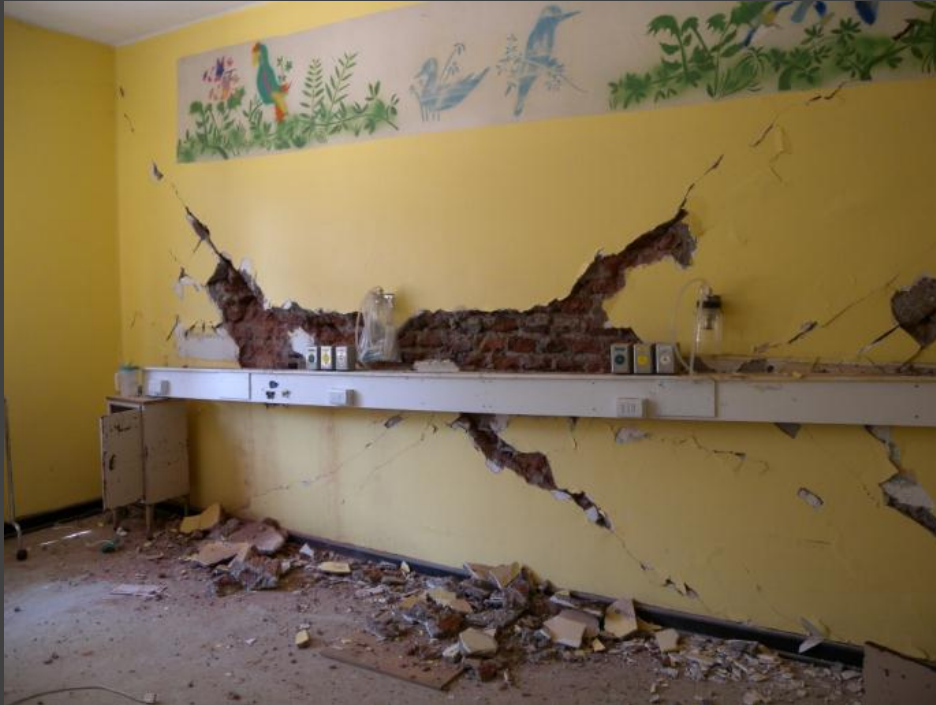
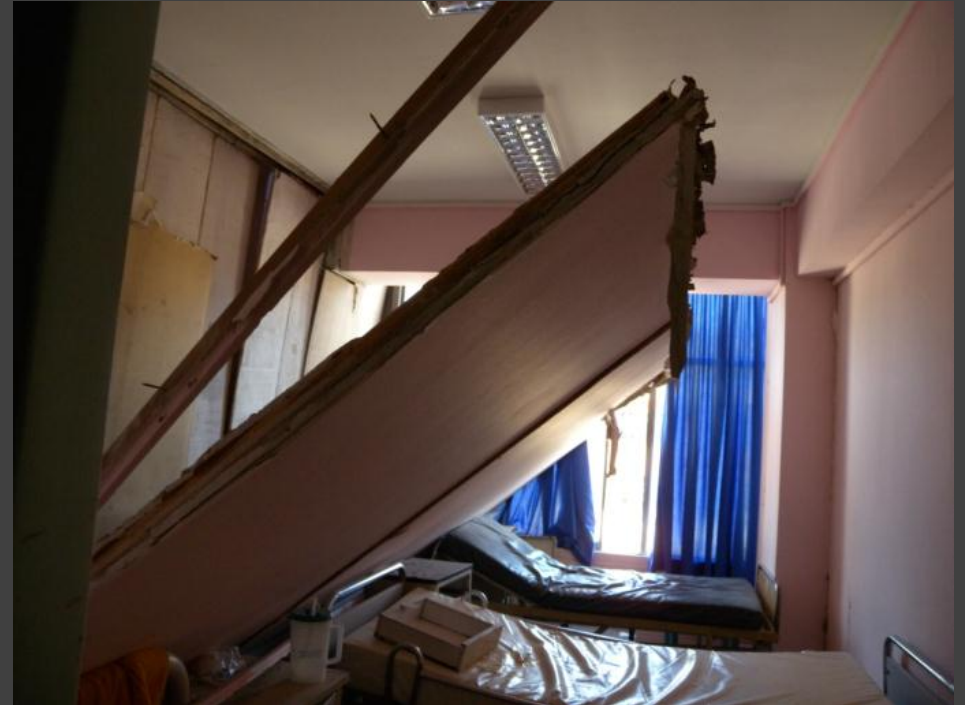
Felix Bulne Hospital in Santiago shut down primarily due to nonstructural damage

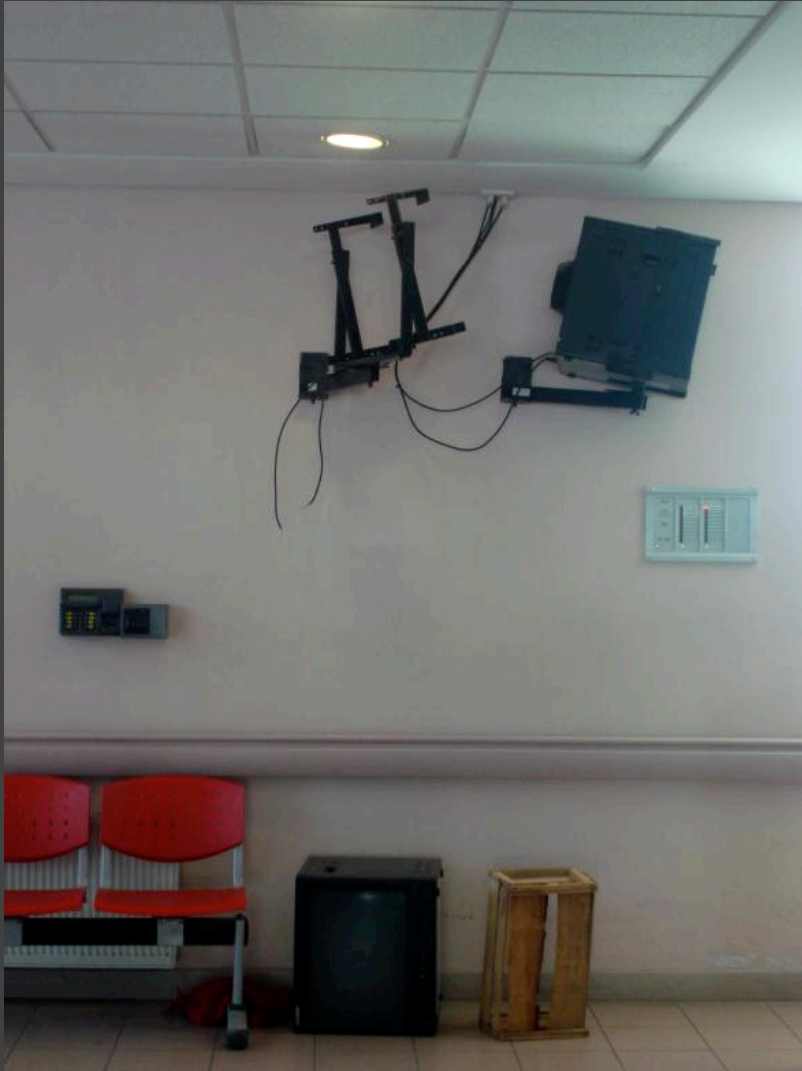
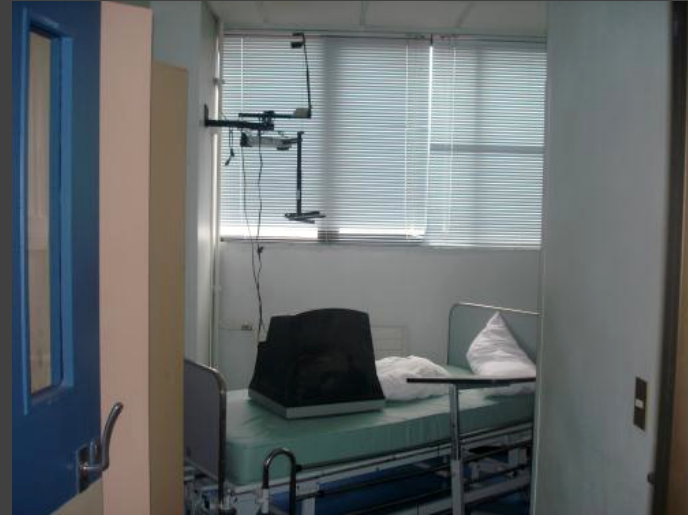
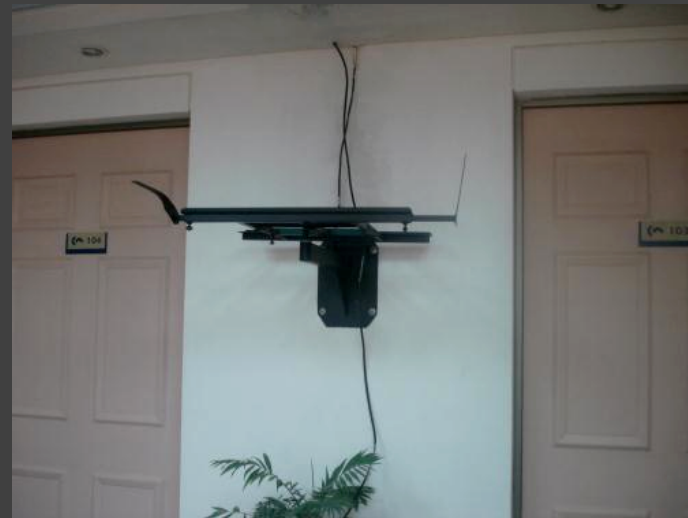
Damage to wall-mounted monitors at Talcahuano and San Carlos Hospitals

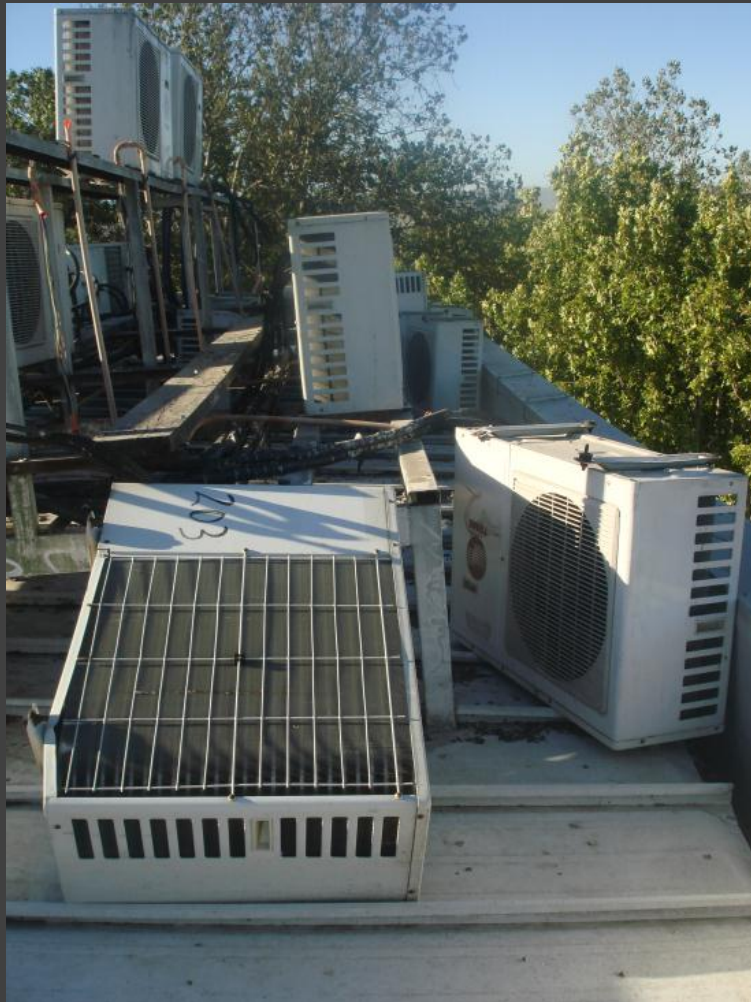
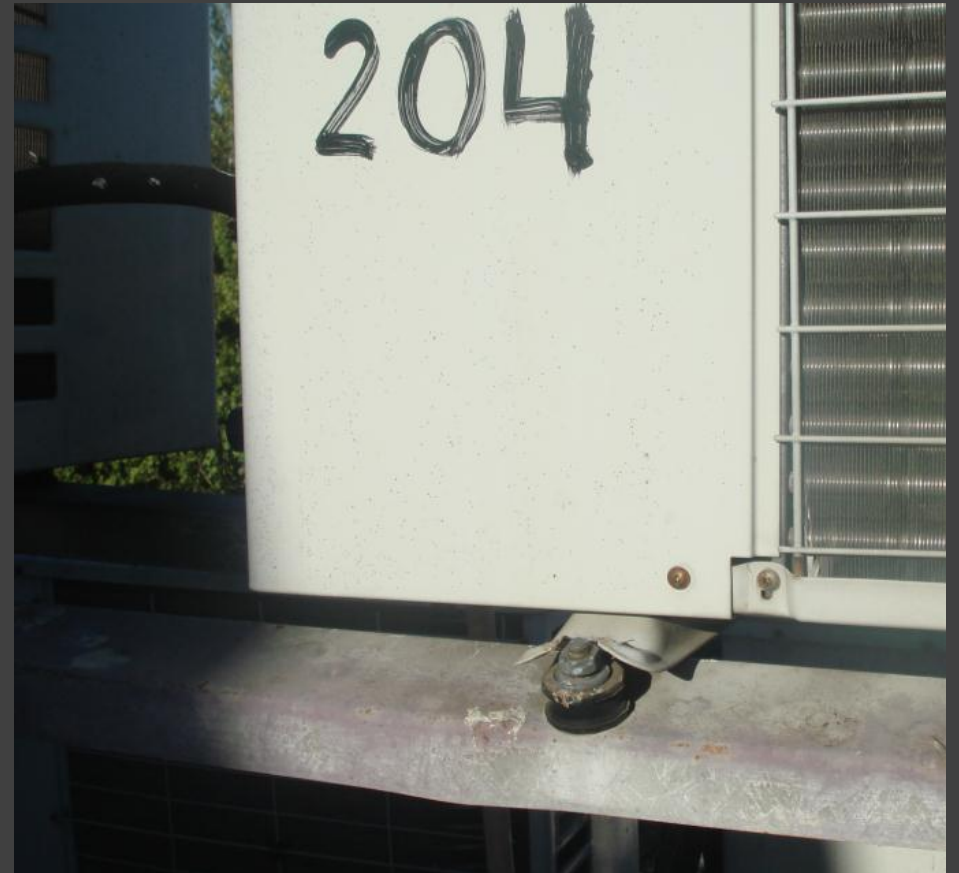
Roof-mounted small AC units at the Clínica del Maule in Talca

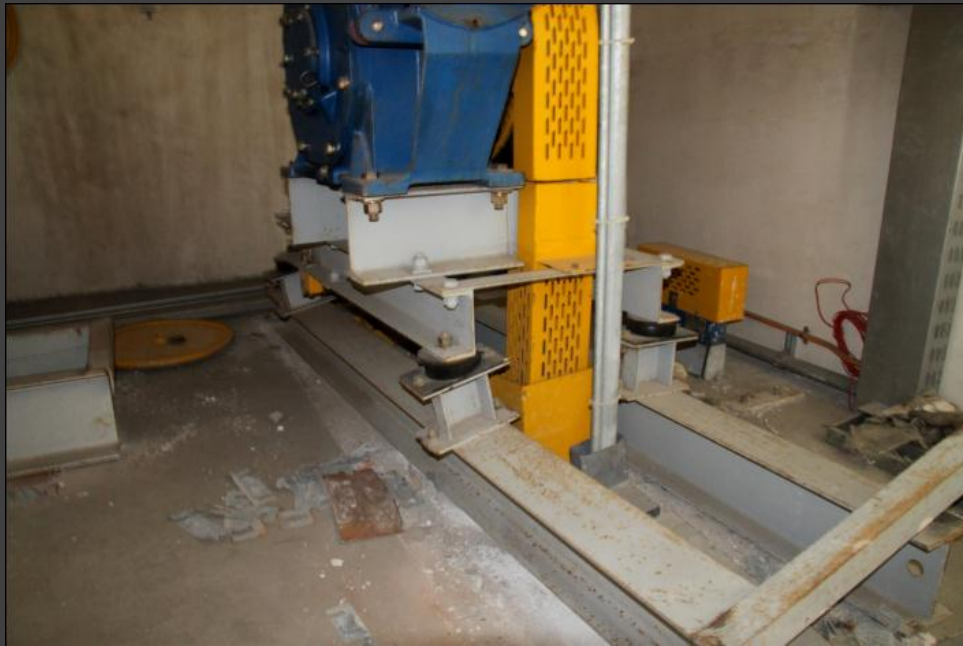
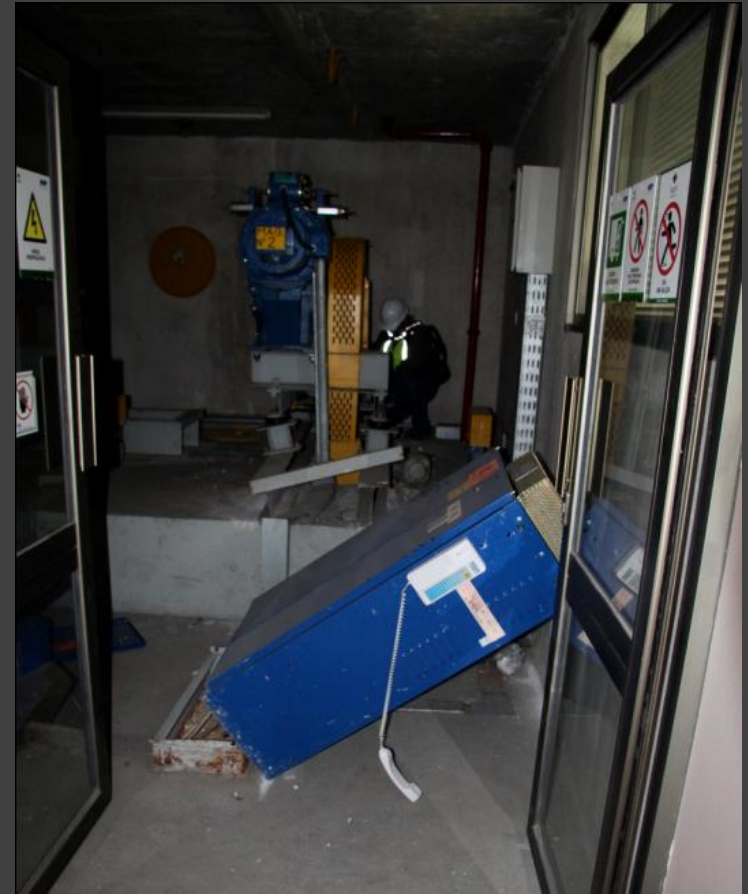
## Damage to elevator equipment

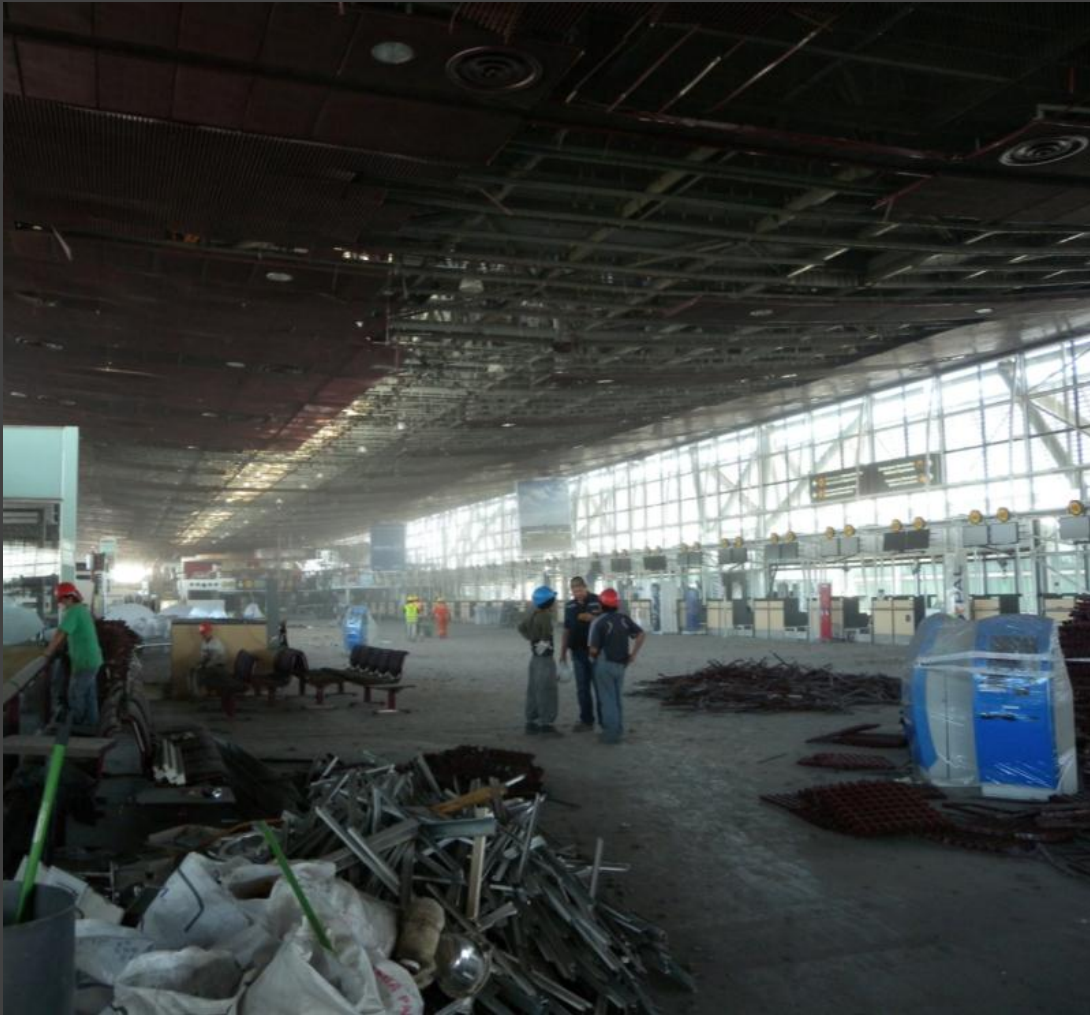
Airport terminal at Santiago shut down mainly due to nonstructural damage

Many suspended air handling units like this fell to the ground

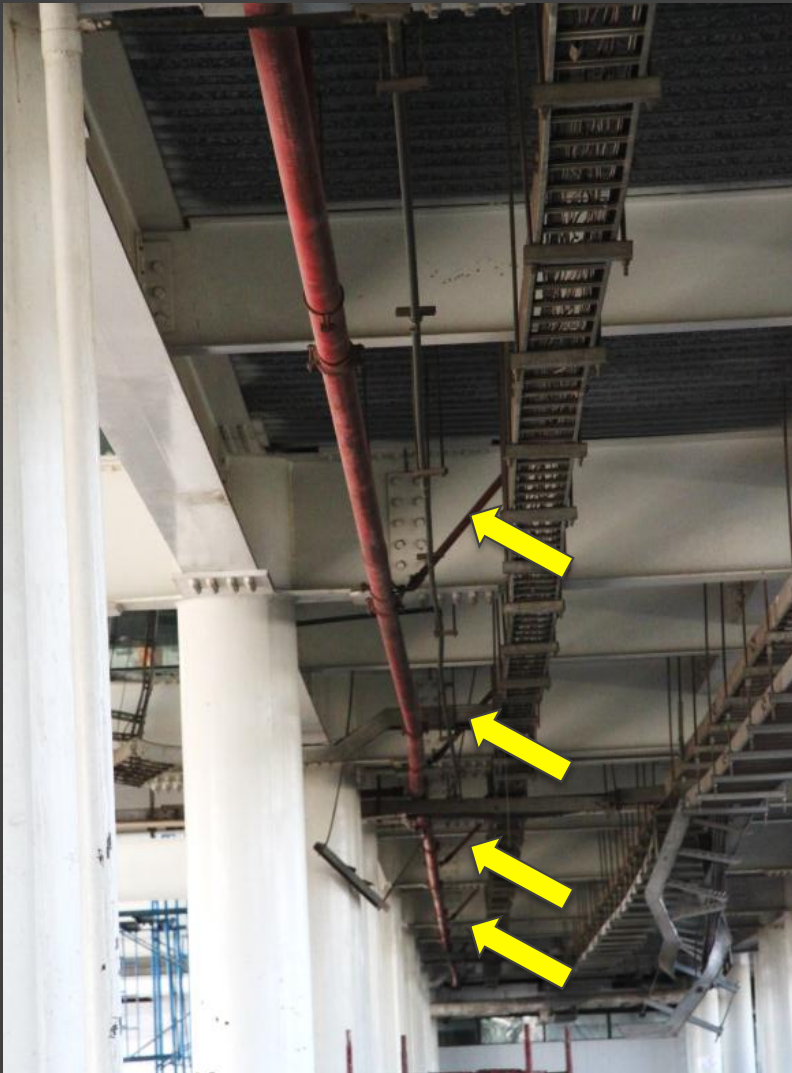
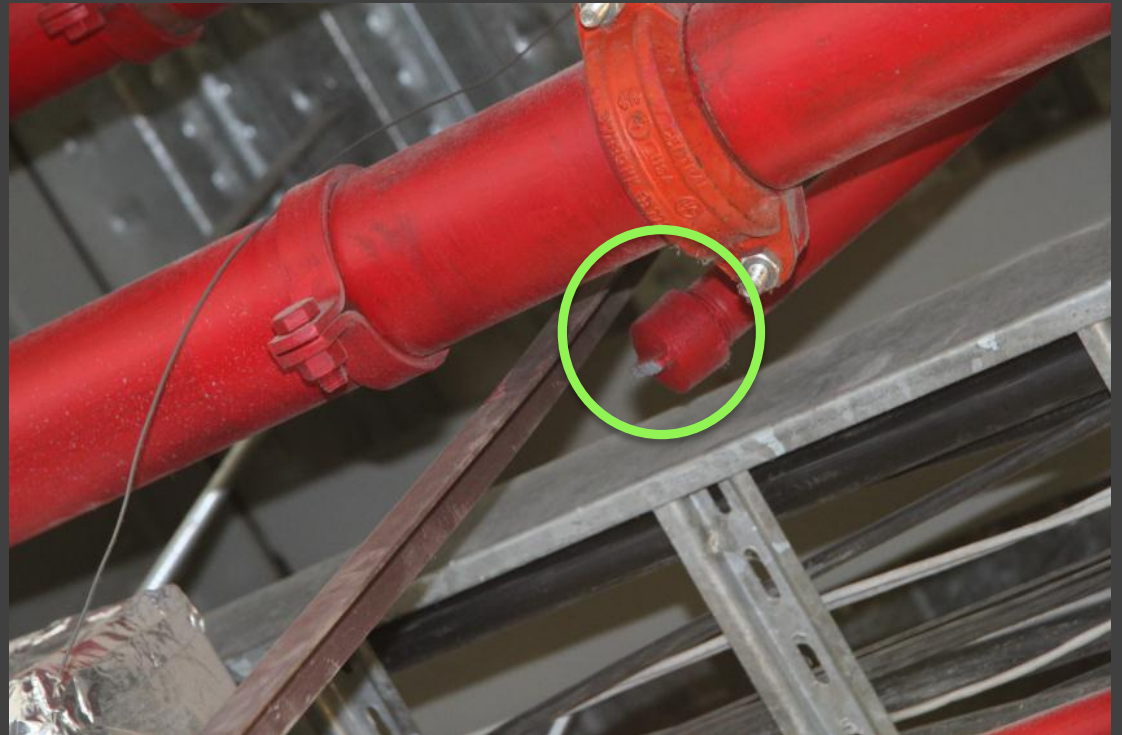
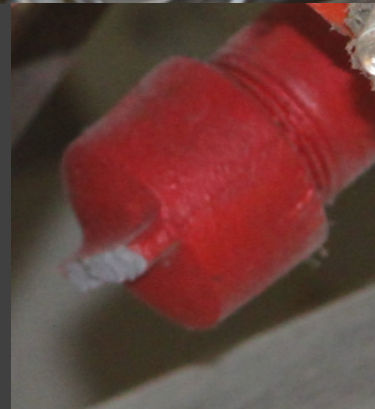
# Damage to sprinkler bracings

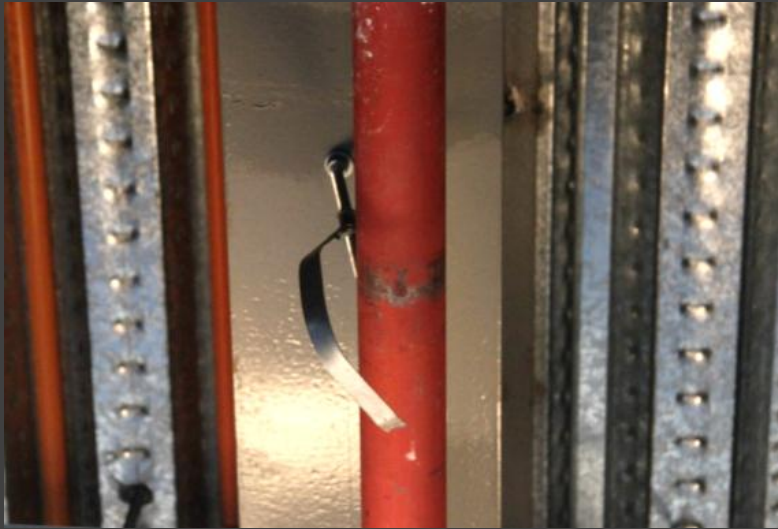
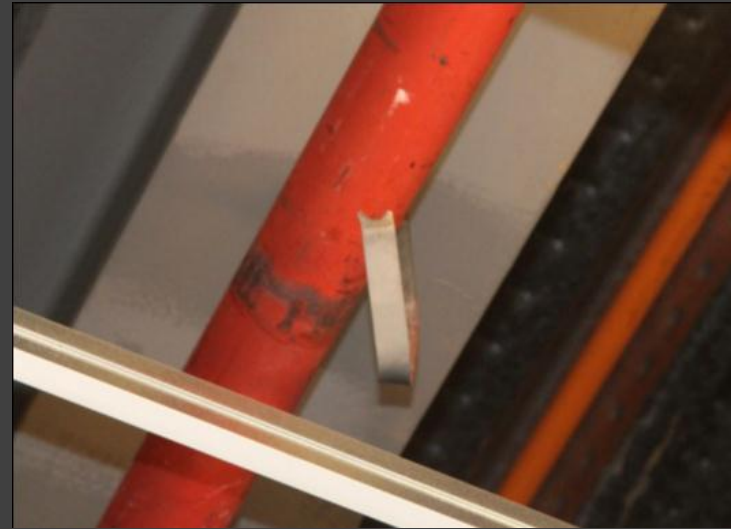
# Damage to piping hangers

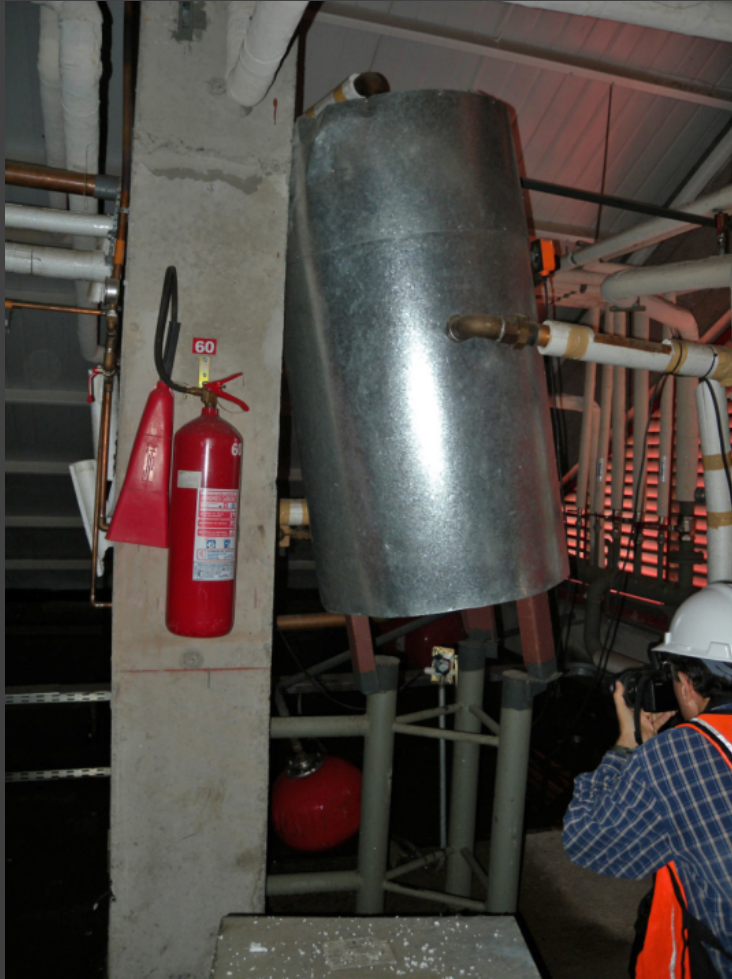
Example of broken water pipes in San Carlos Hospital

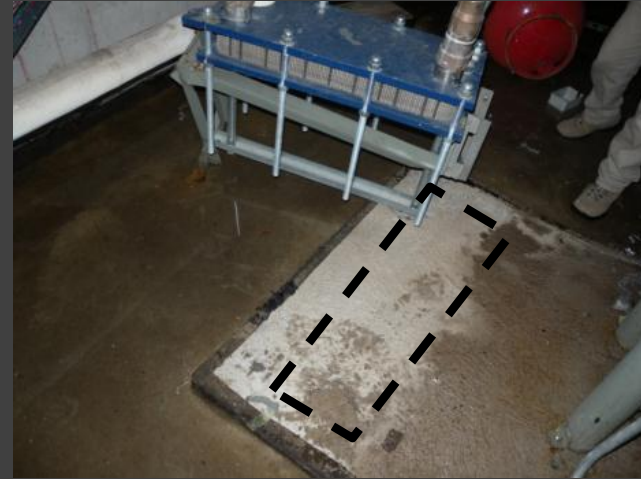
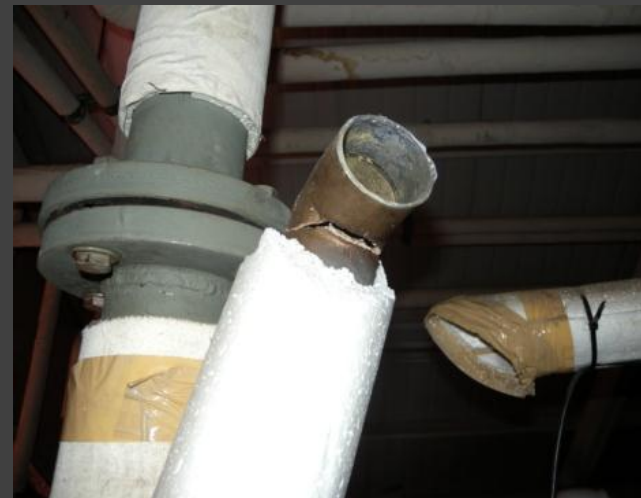
Broken copper water pipe of hot water caused by lack of lateral bracing of the boiler

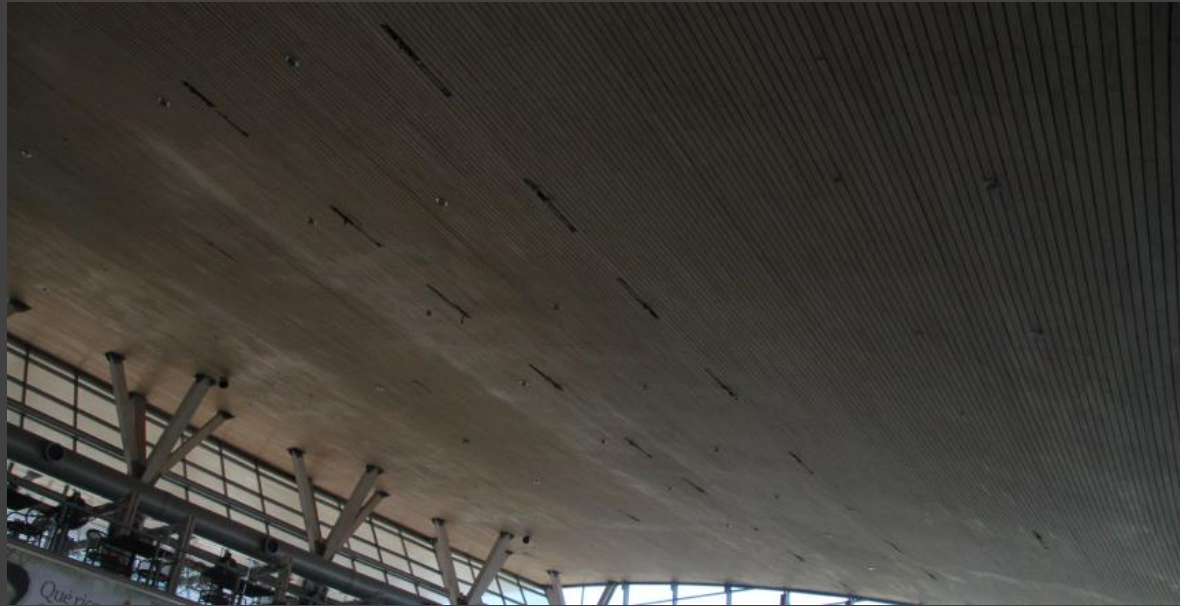
Overall view of wood ceiling

Closeup view of some sprinkler heads sheared off

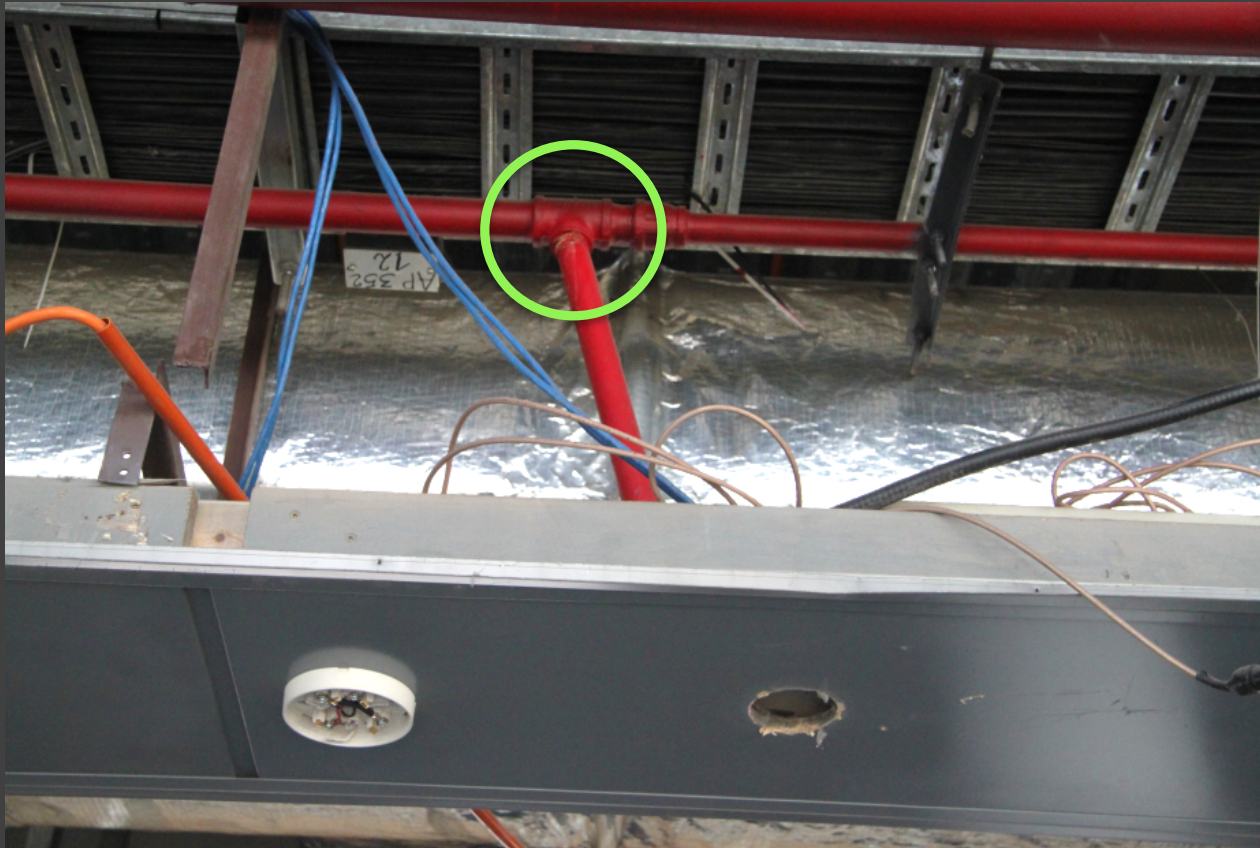
Broken sprinkler piping at the Santiago Airport

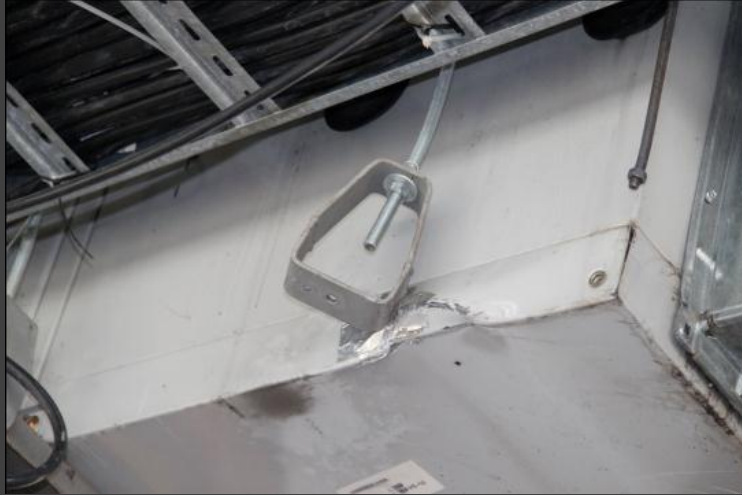
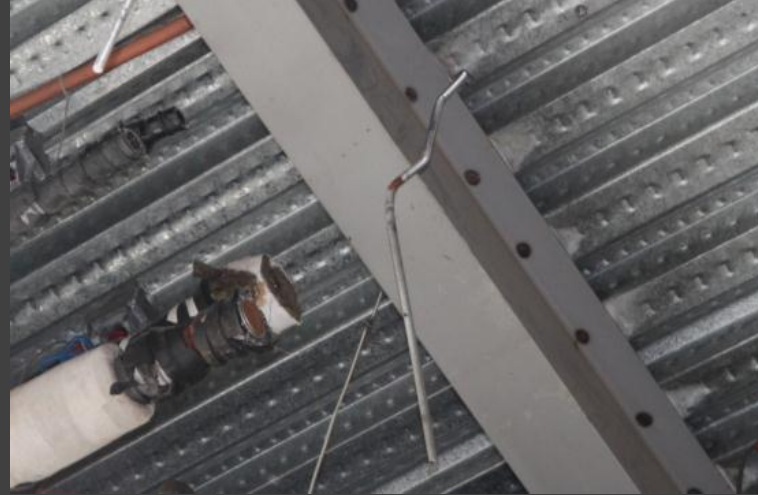
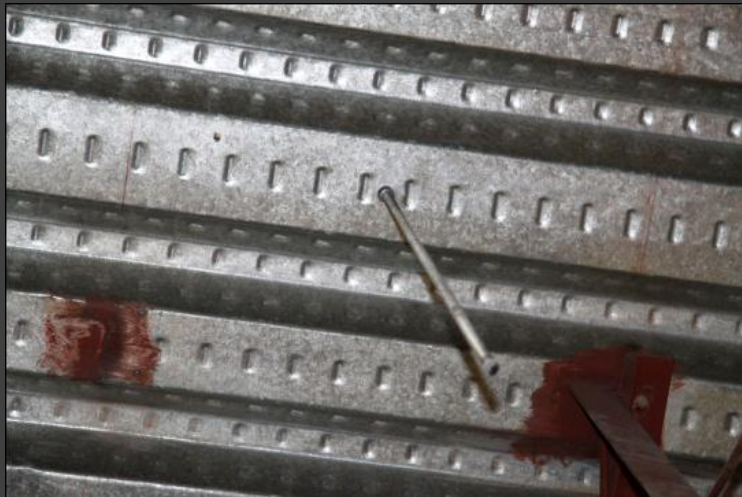
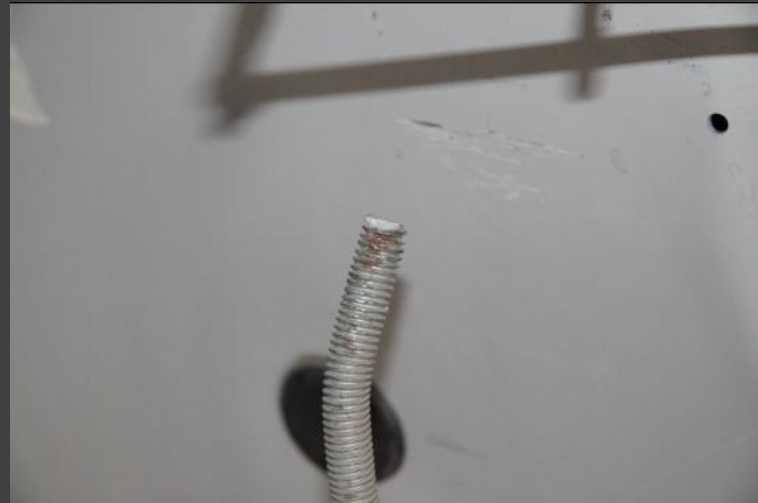
# Damage to threaded rods

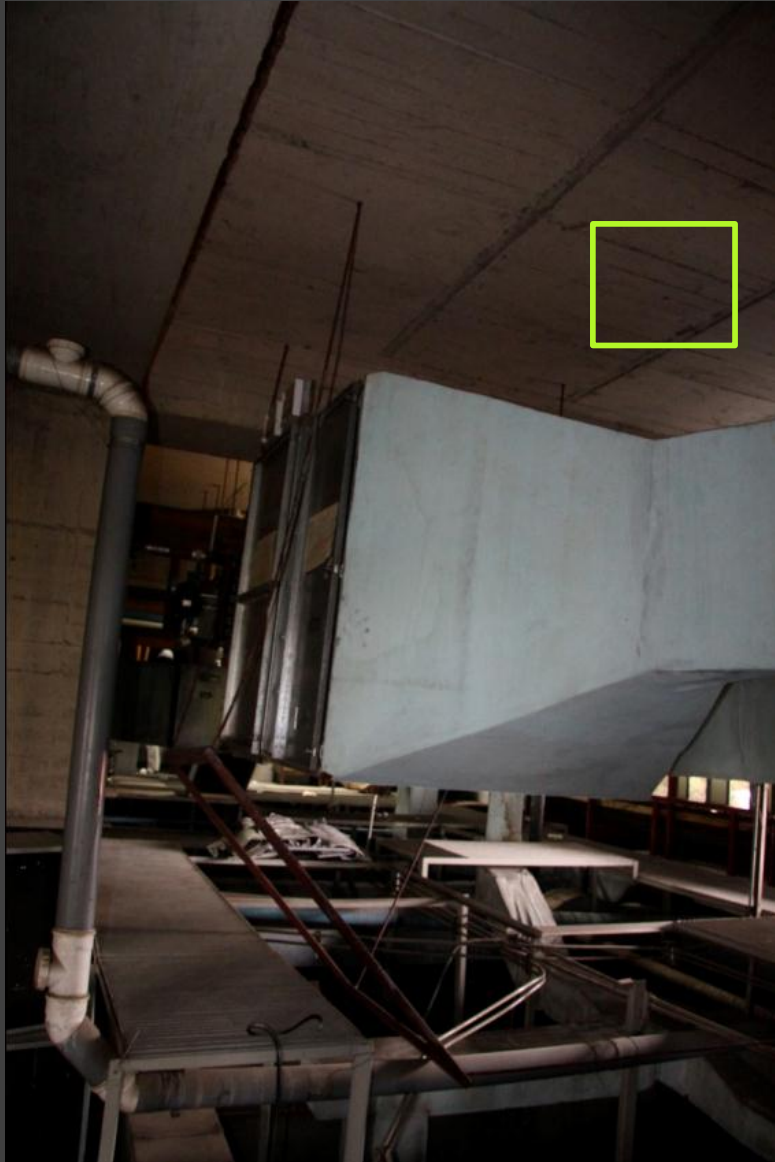
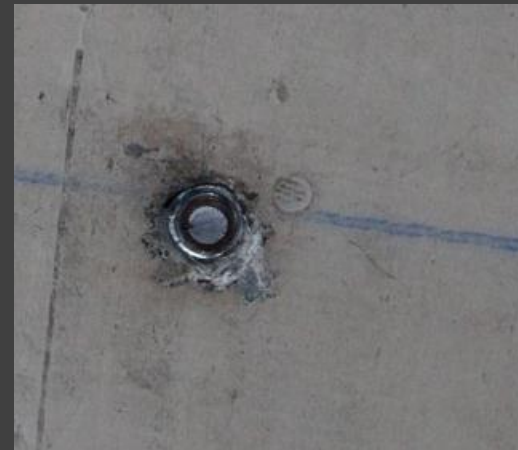
# Damage to anchors

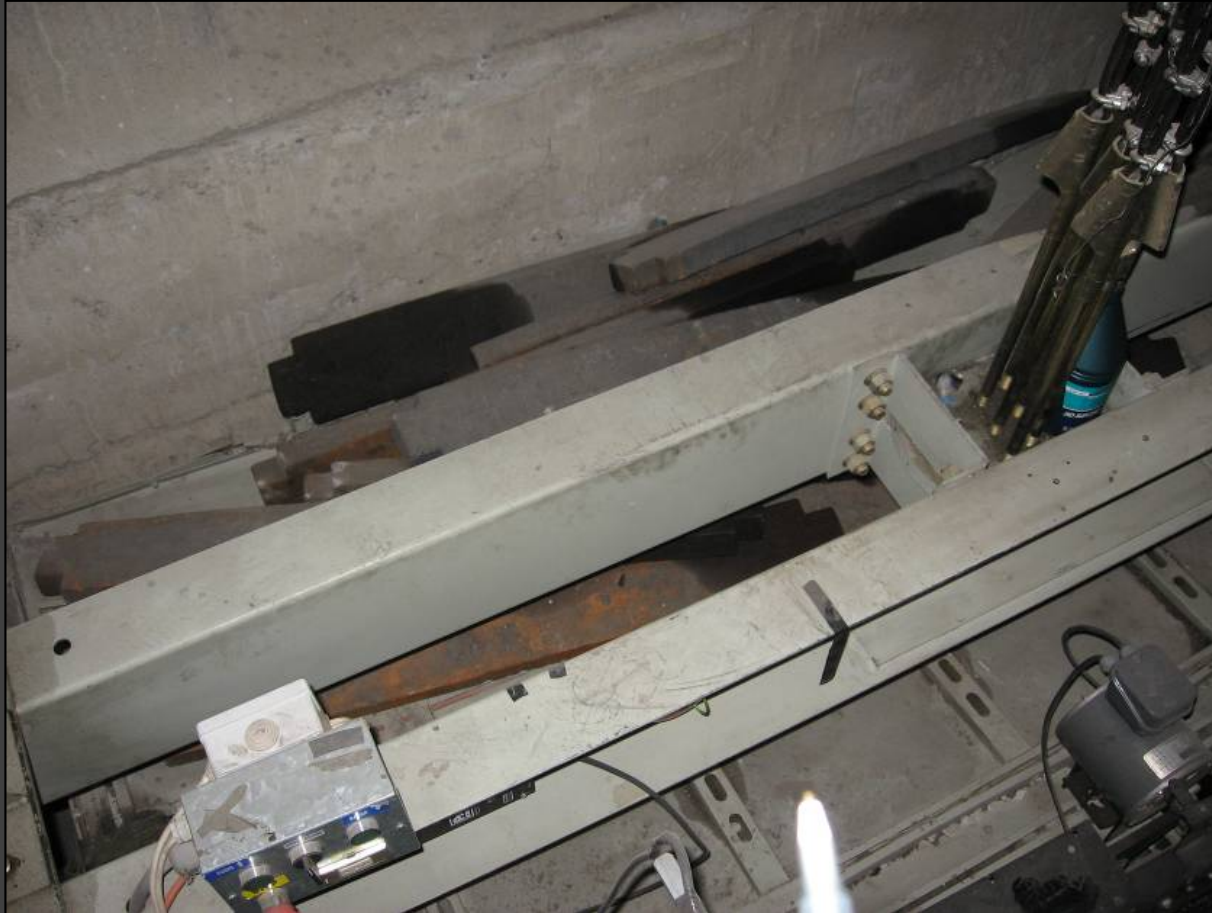
Derailed and disassembled counterweight

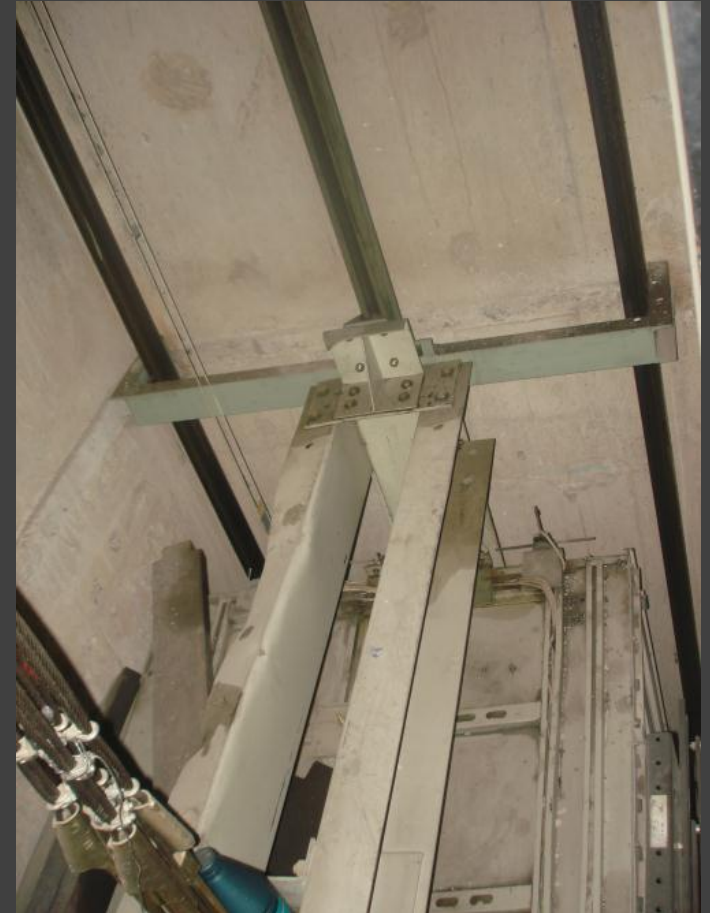
Elevator cabin hit by derailed counterweight

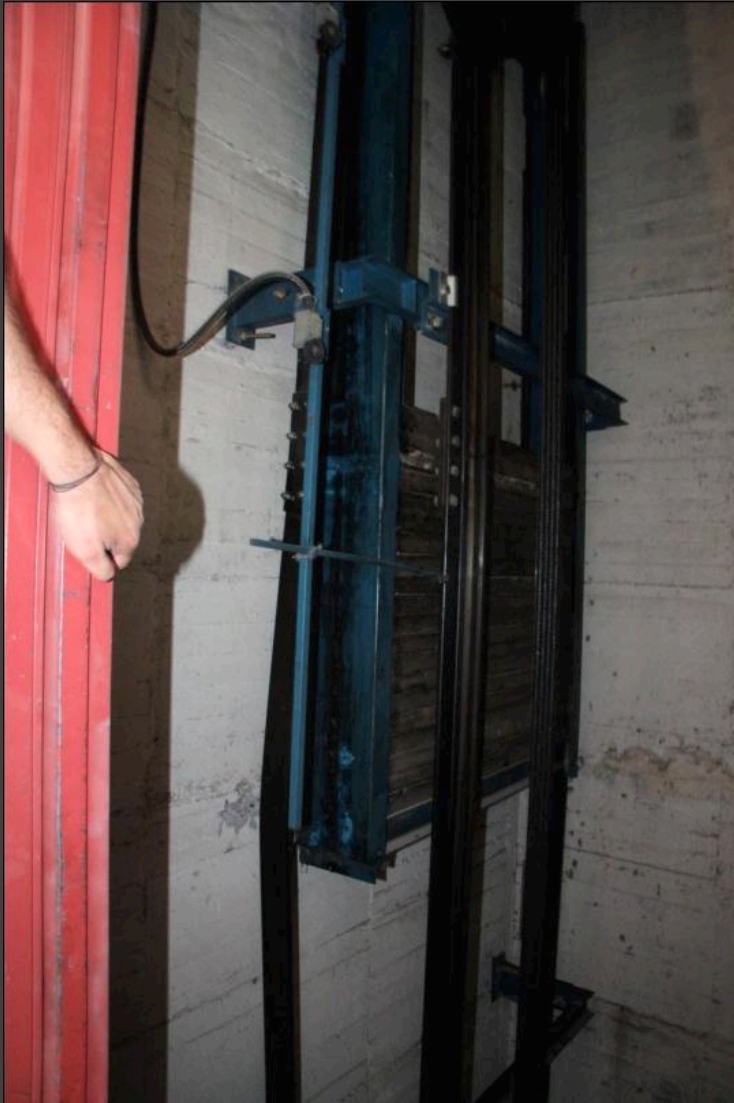
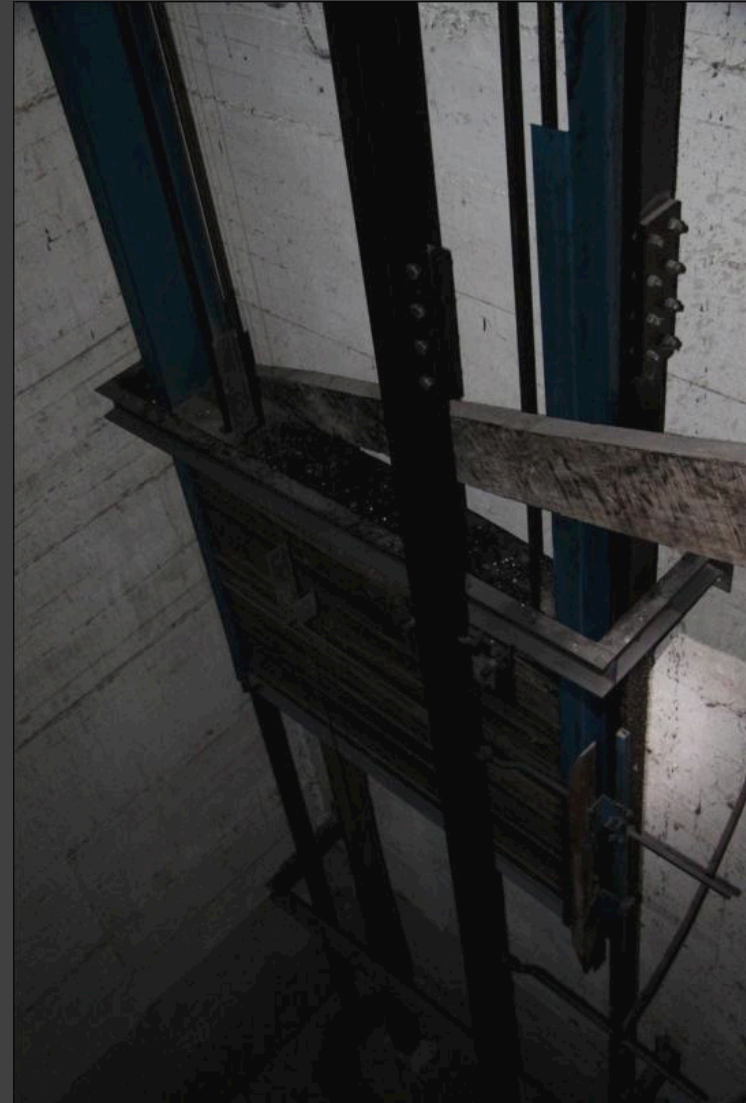
# Damage to Elevators

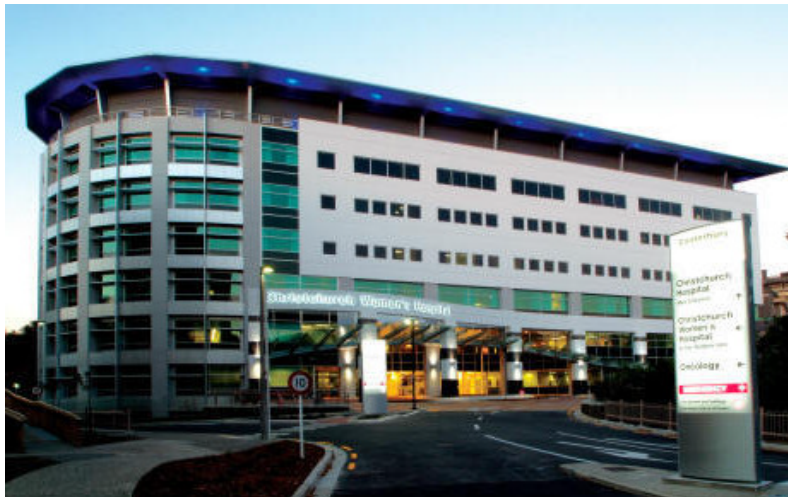
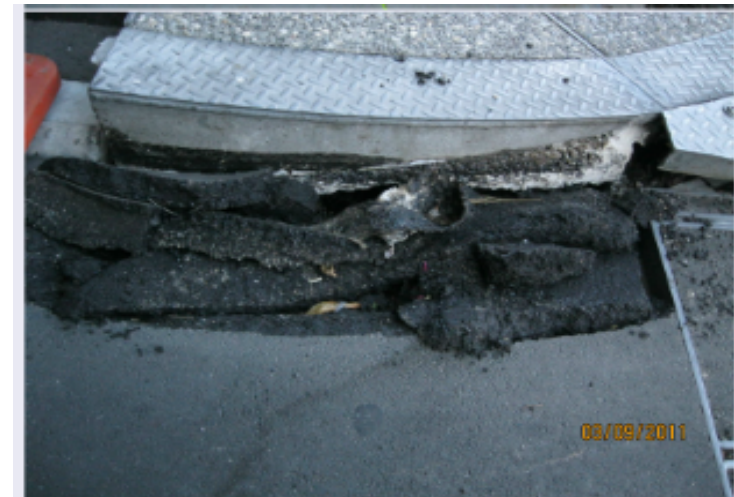
- **Only base isolated building in region of strong shaking**
  - Damage mainly to sacrificial nonstructural components at the seismic gap
  - Other damage reported included overturned small contents and water sloshing from birthing tub

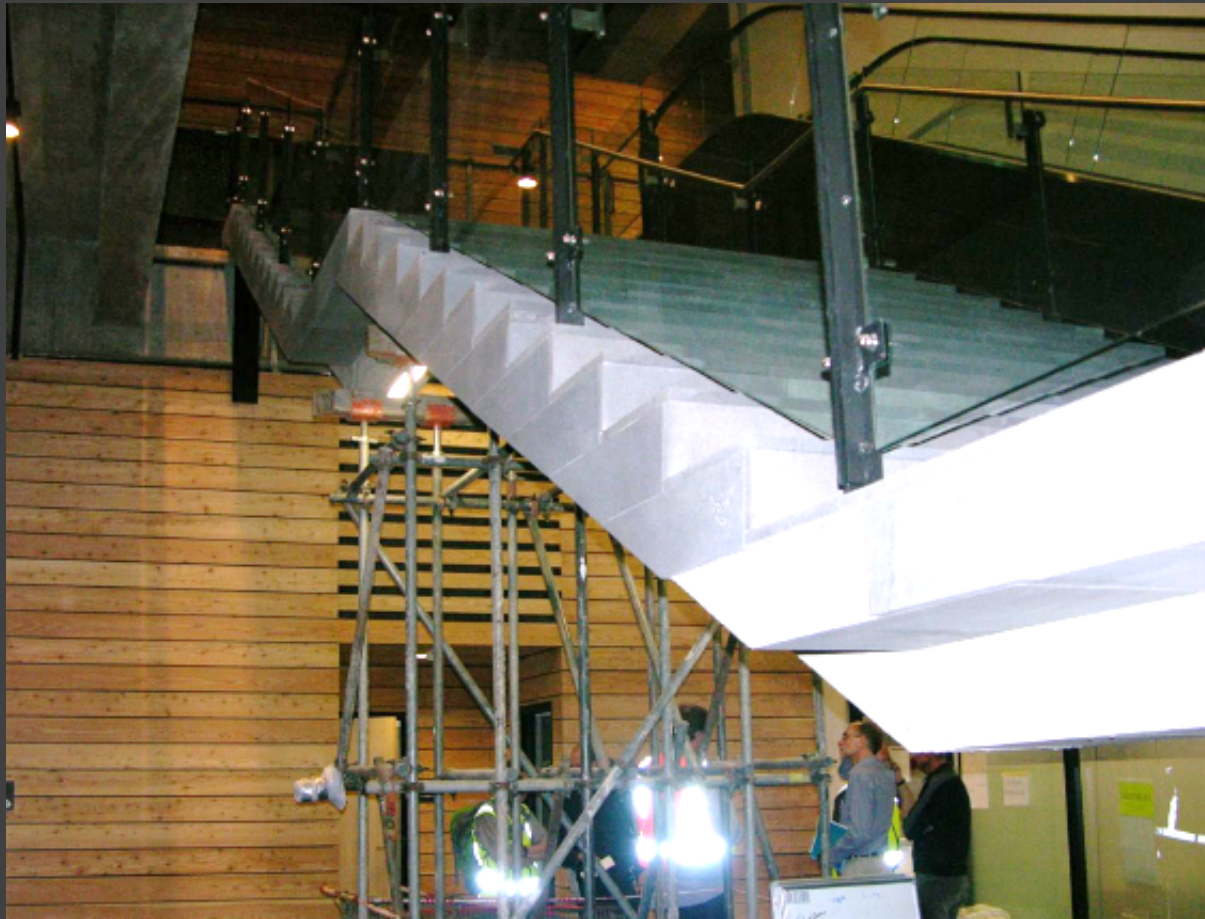
Damage in the main stairs inside the Christchurch City Council building in the Sept. 2010 earthquake

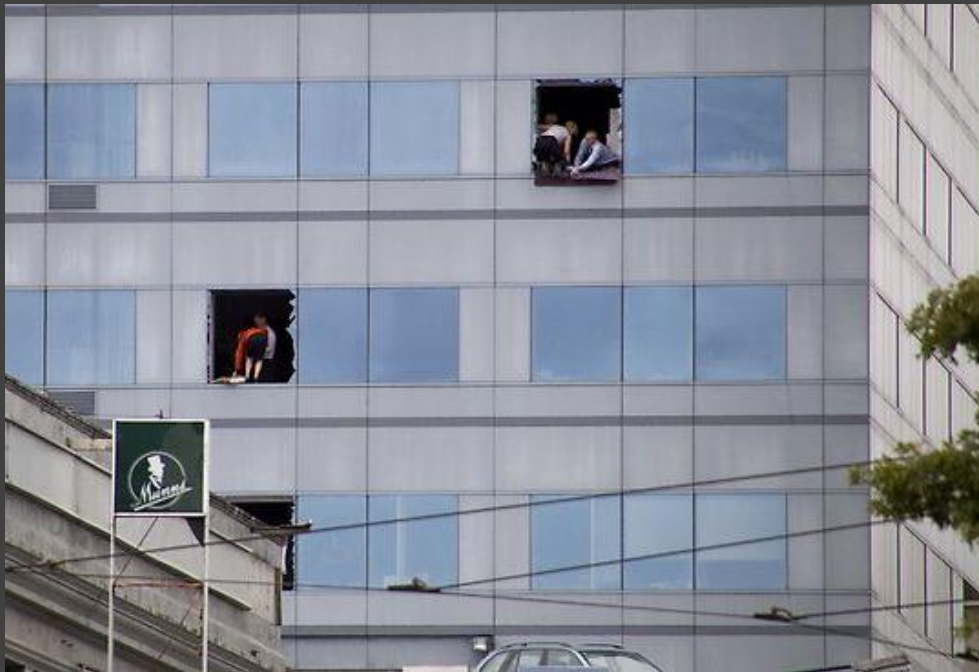
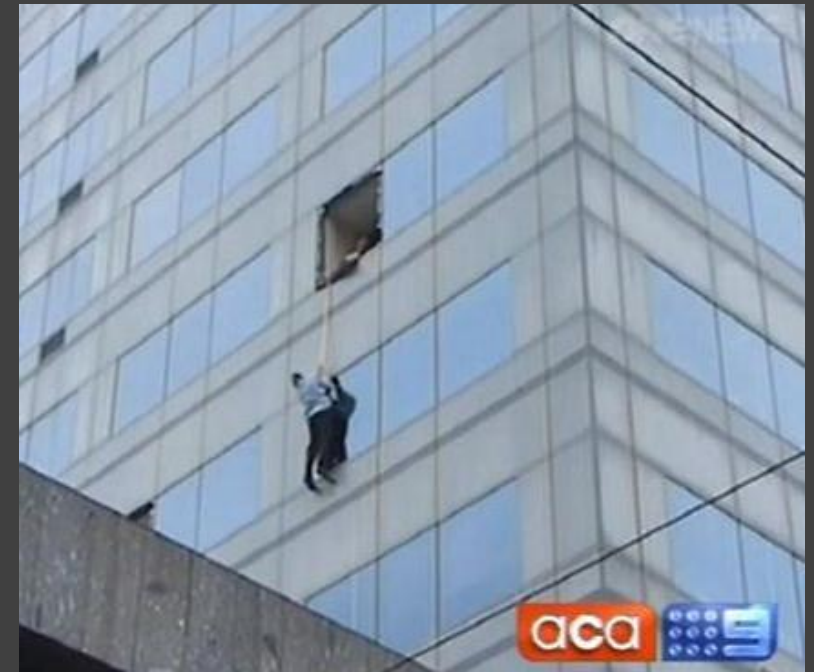
People being lowered through the windows in the 17-storey Forsyth Barr building due to failure of the stairs in the February 2011 earthquake

Hotel Grand Chancellor's stairwells also disintegrated into rubble

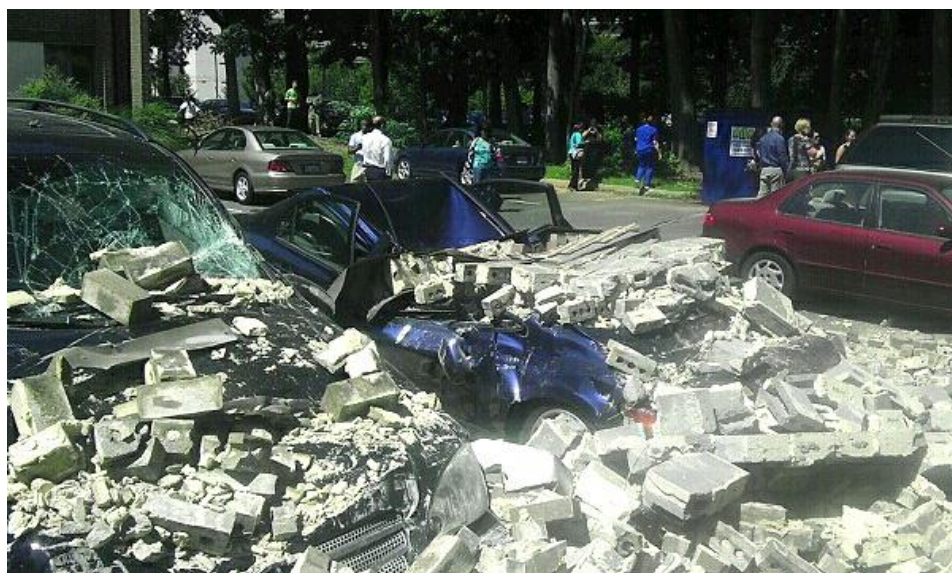
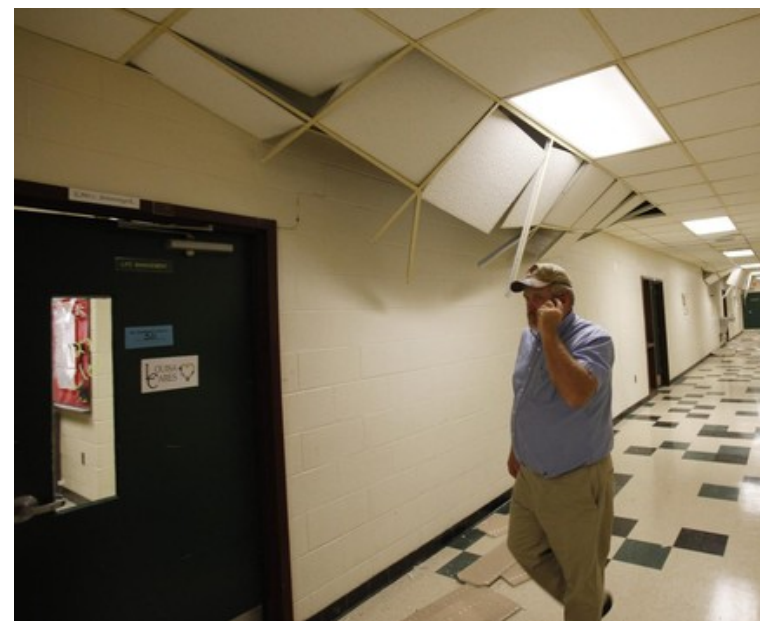
- Damage to suspended ceilings, masonry chimneys, masonry veneer, masonry infills was widespread
- Damage to contents in residential and commercial buildings
- Reports of pipe burst in Pentagon causing minor flooding
- Damage resulted in closure and reduced functionality of some buildings including schools
