# Performance of Nonstructural Components in Critical Facilities

*2012 PEER Annual Meeting*

**Gilberto Mosqueda**

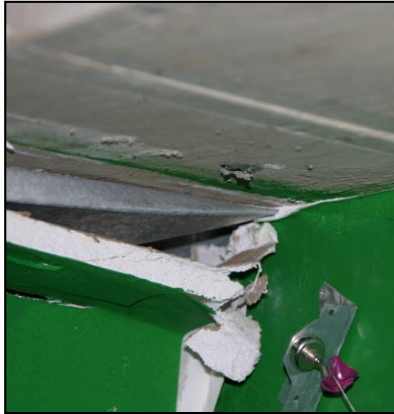
Damage in transverse wall top track

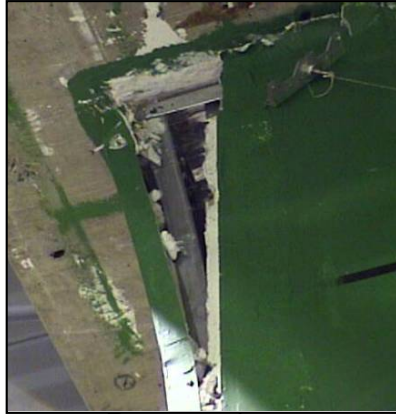
Damage along cornerbeads and boundary studs

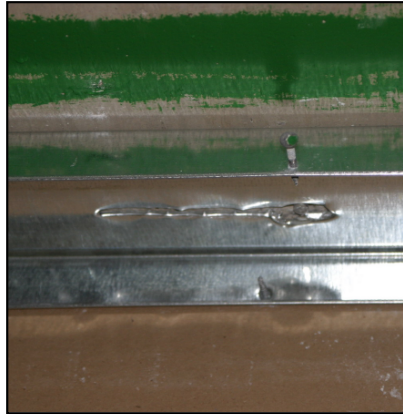
Tearing along top track fastener

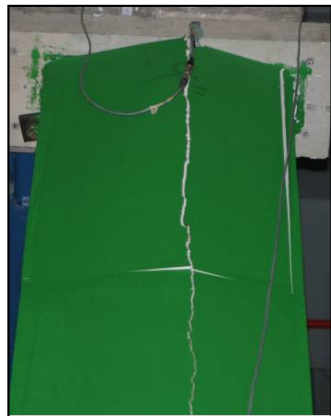
Damage in transverse walls

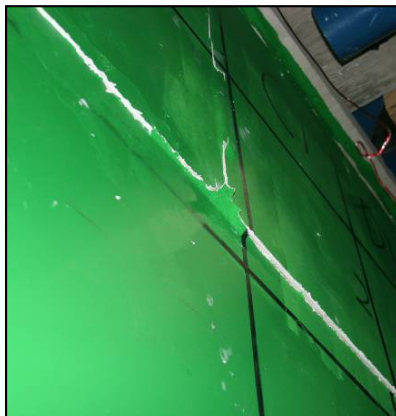
Damage of joints between gypsum panels

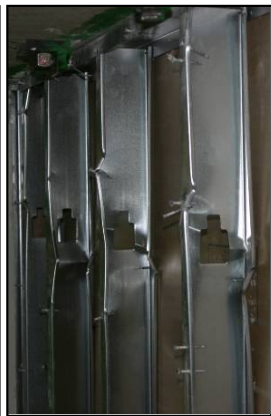
Hinges forming in studs (institutional construction)

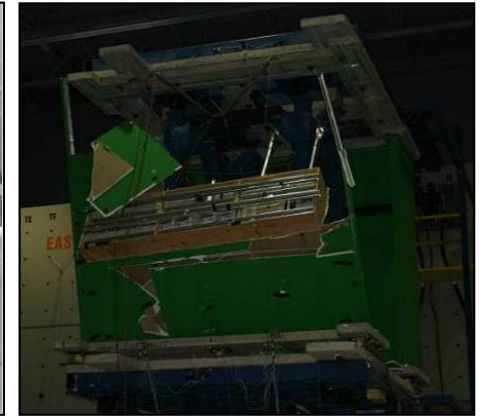
Collapse of partition wall

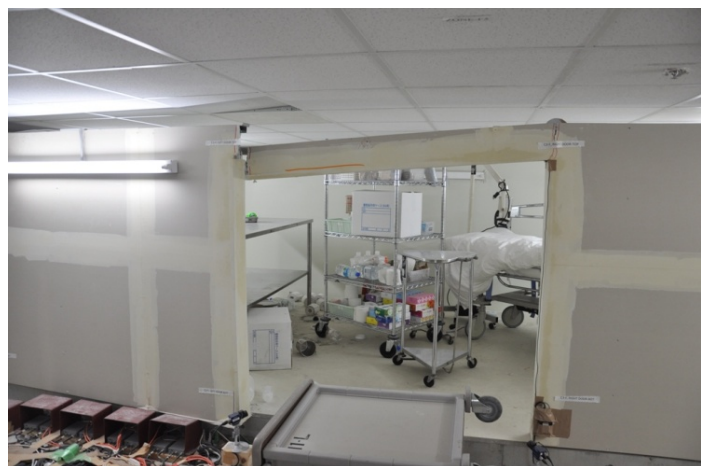
## 5<sup>th</sup> floor partial height wall failure

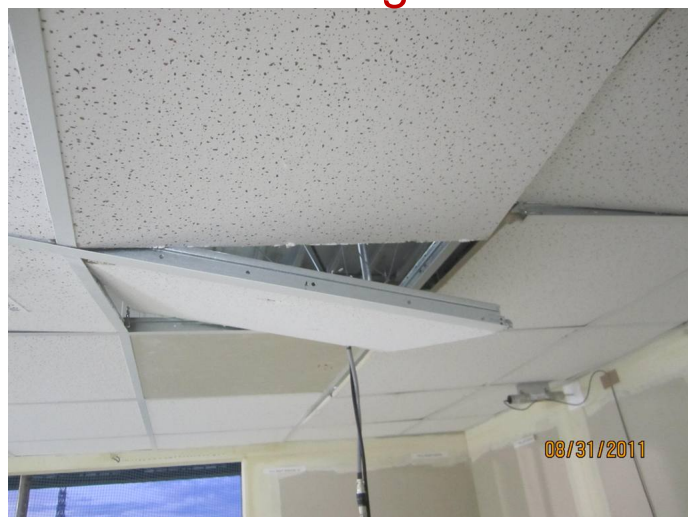
## 5<sup>th</sup> floor ceiling failure

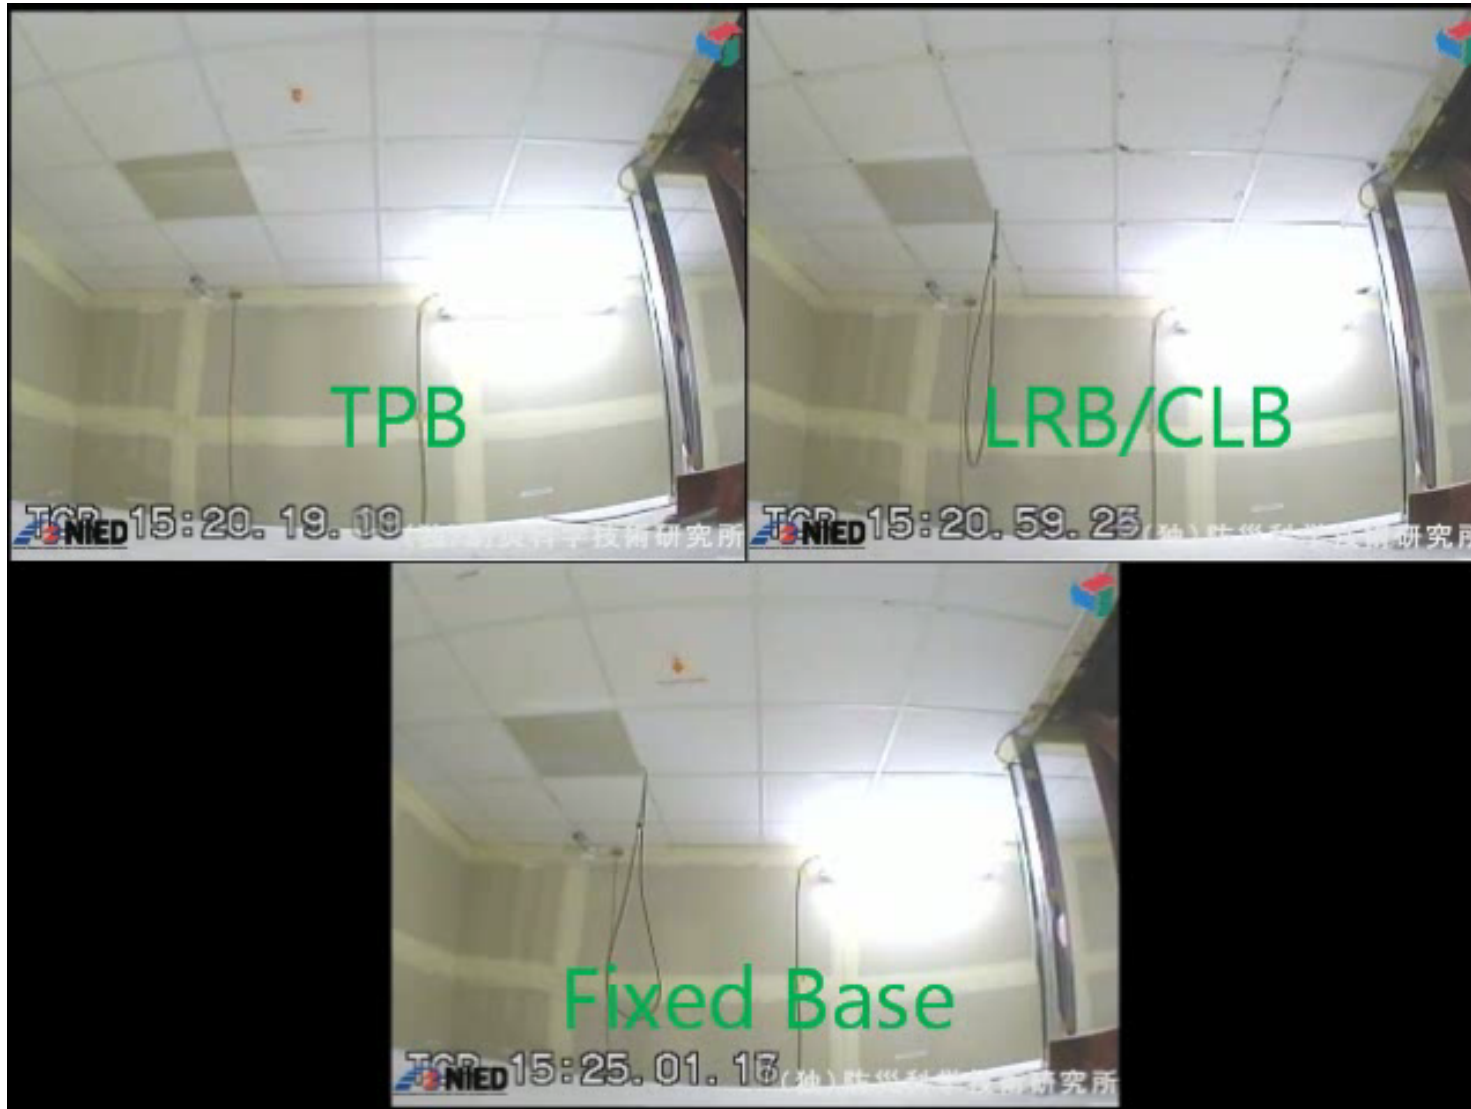
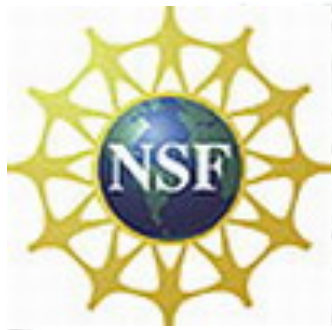
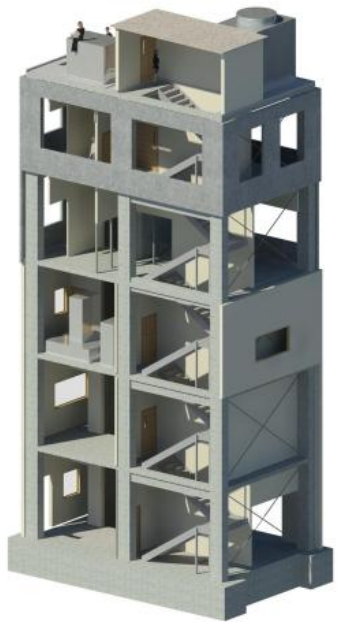
*Similar damage was observed in all three systems, induced by vertical excitations.*
