Seismic performance of RC low-rise building structures having irregularities at the ground story during the 15 November 2017 Korea earthquake

Kyung-Ran Hwang and Han-Seon Lee School of Civil, Environmental, and Architectural Engineering, Korea University

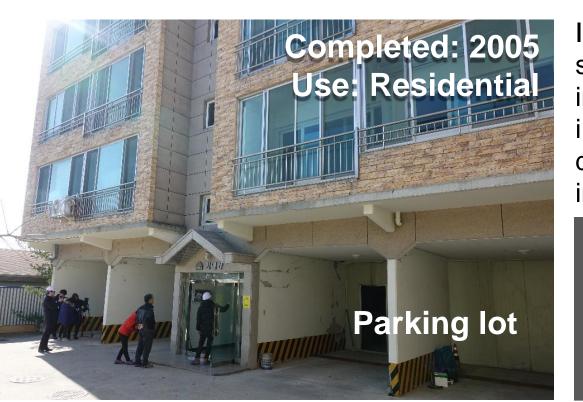
In a shear wall in the horizontal direction, serious shear failure occurred. The wall is not placed in the center of the plan. Because of this torsional irregularity, many cracks in the wall in the transverse direction are observed, despite a large amount of wall in the transverse direction.
