Geotechnical Aspects of the September 4, 2010 Darfield Earthquake

Scott A. Ashford

GEER Reconnaissance

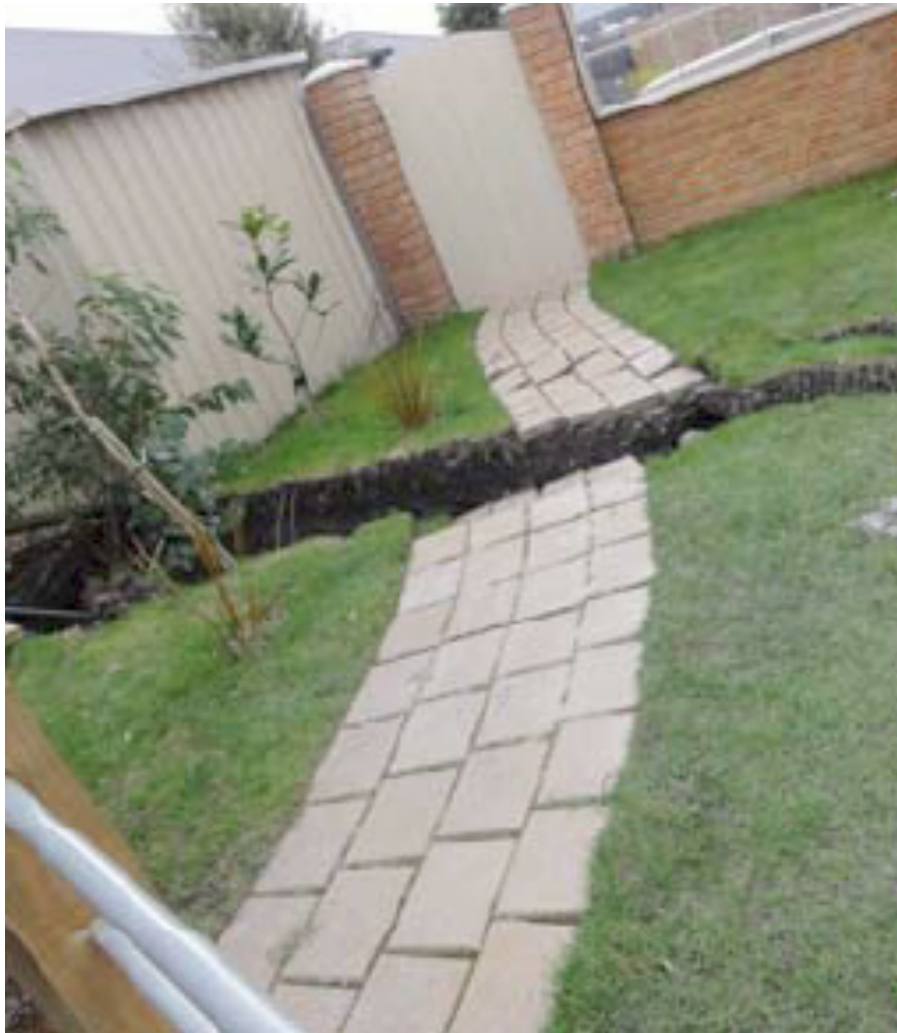
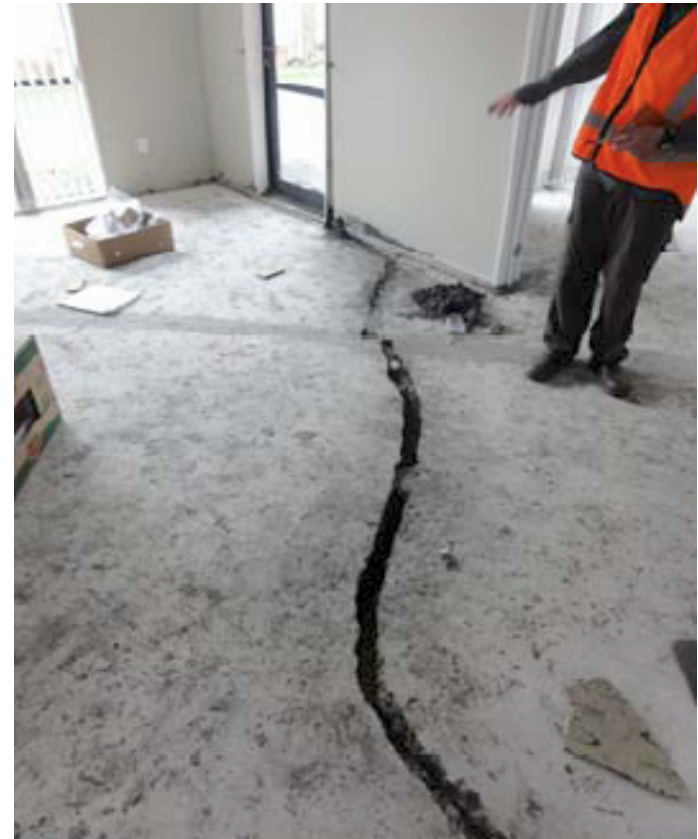
Estimates varied on number of homes damaged from liquefaction

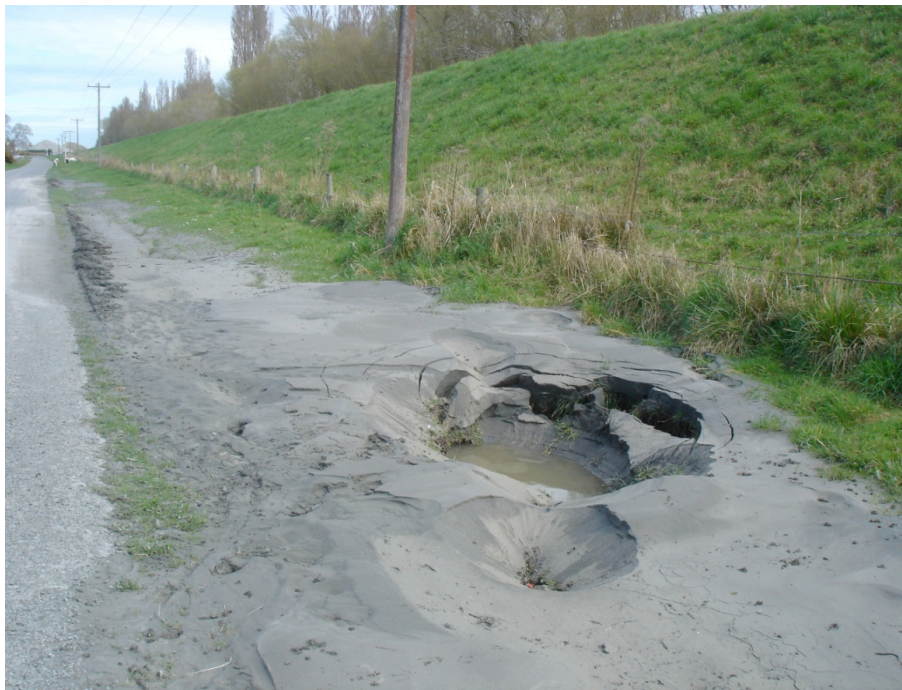
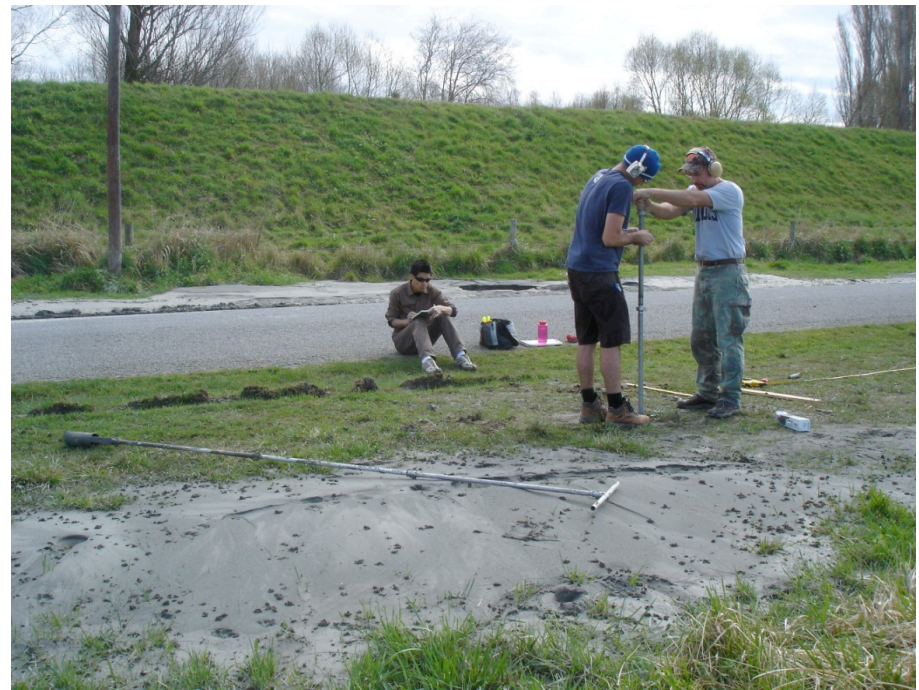
Liquefaction and lateral spreading occurred along stopbanks.
DCPT and SASW profiles obtained.

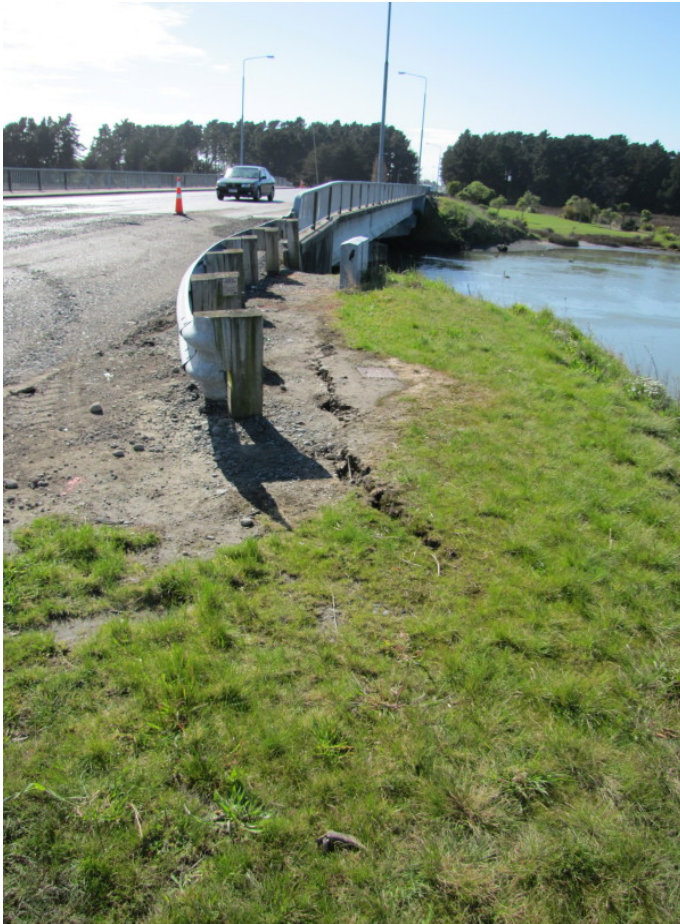
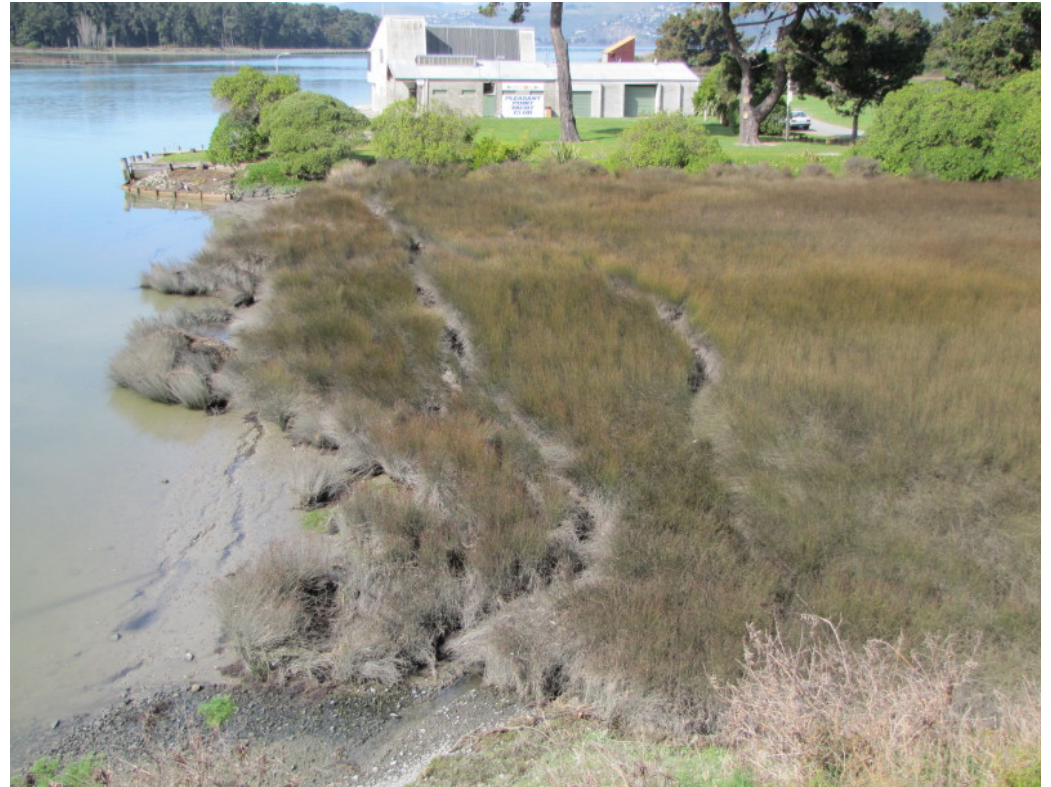
Bridge Street Bridge performed well, with 1m lateral spread

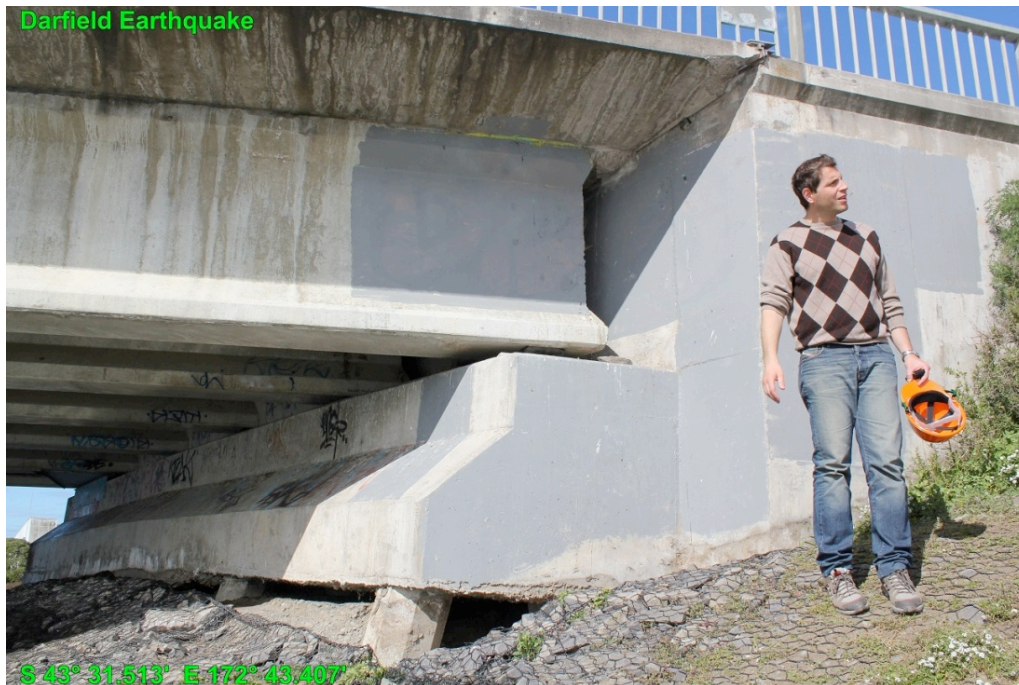
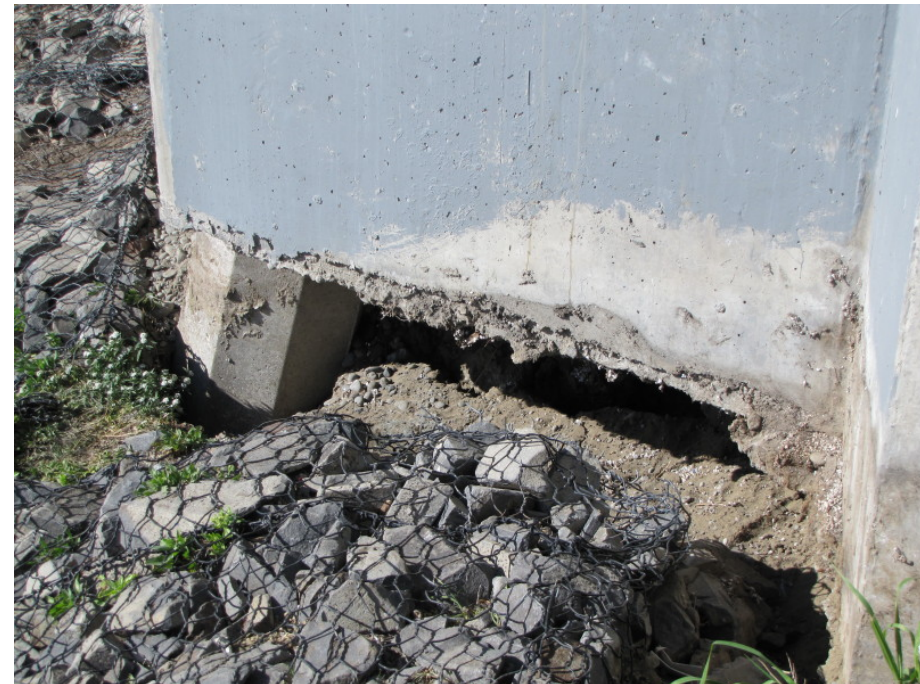
Bridge Street Bridge Abutment

Limited and documented abutment movement

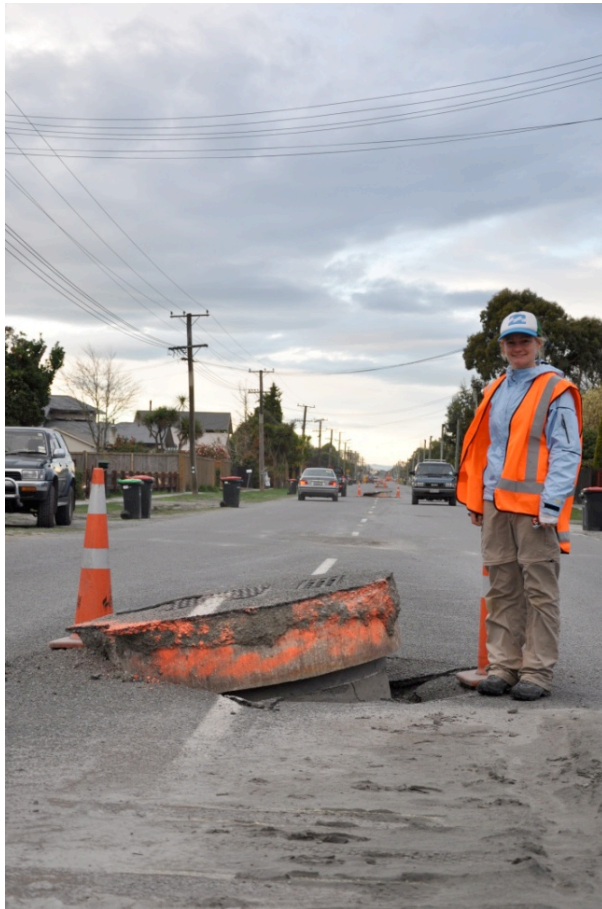
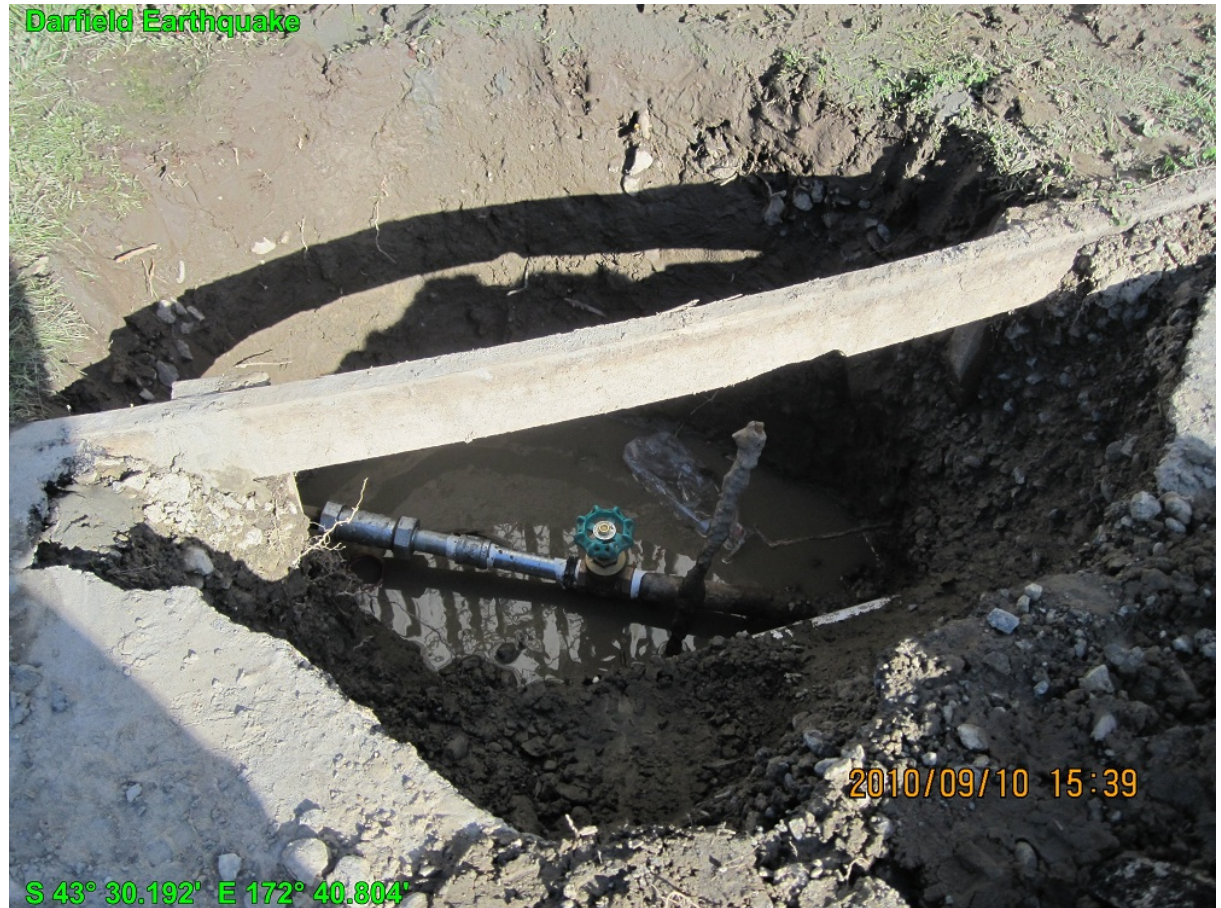
Water and Sewer Mains

- Christchurch City Council
 - 25km of water to be replaced
 - 70km of wastewater lines to be replaced
 - Conducted 1 years worth of repairs in 6 days
 - 11,000 tons of sand ejecta
 - Potentially 9,000 m³ voids created
- Adjacent Waimakariri District Council and Selwyn District Council also hit.
