**Documenting Incidents of Ground Failure Resulting from the  
August 17, 1999 Kocaeli, Turkey Earthquake:  
Data Report Characterizing Subsurface Conditions**

## **1. Introduction**

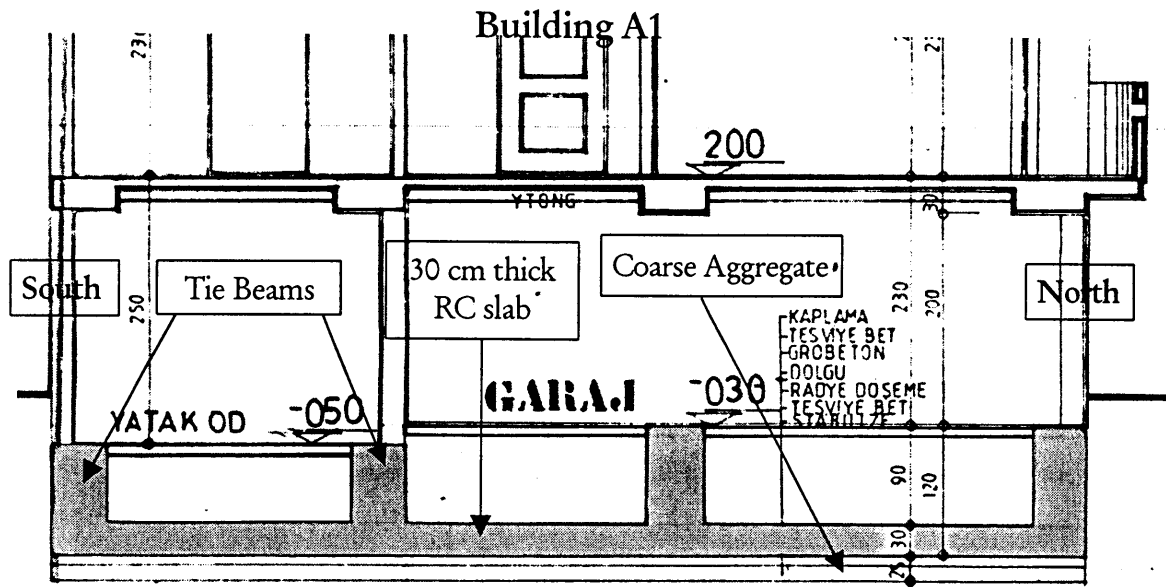
Figure 5-5: North-south cross section across the foundation and ground floor of building A1.

According to the building drawings, both buildings were built with the same design for which the base of the mat foundation is located at 1.5 m below the sidewalk elevation. As is shown in Figure 5-5, the mat consists of 1.2 m-deep reinforced concrete tie beams over a solid, 30 cm-thick slab. The space between the beams was filled and the first floor slab placed over this fill.

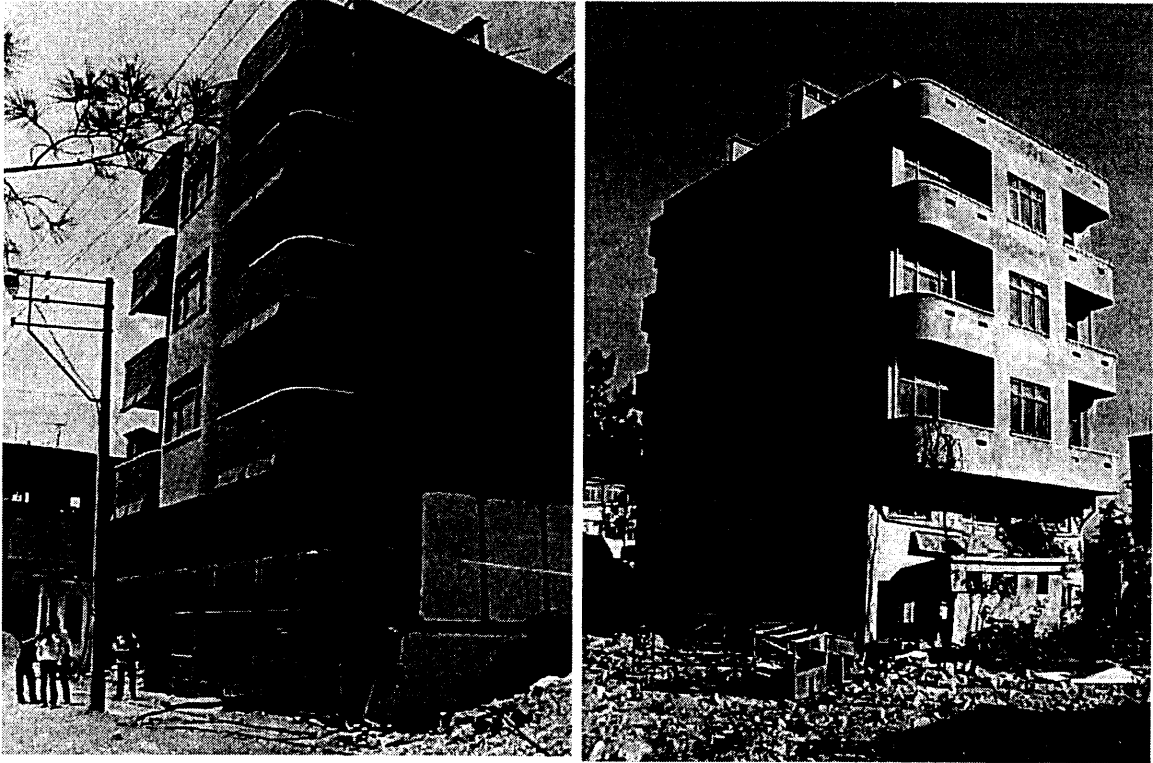
Inspection of the structural components such as beams and columns showed no evidence of cracking or distress. Non-structural components, such as infill walls and hardwood floors, also appeared undamaged.

Figure 5-14: a) View from Meydan street of the north and east sides of the building b) view of the north and west sides of the structure.

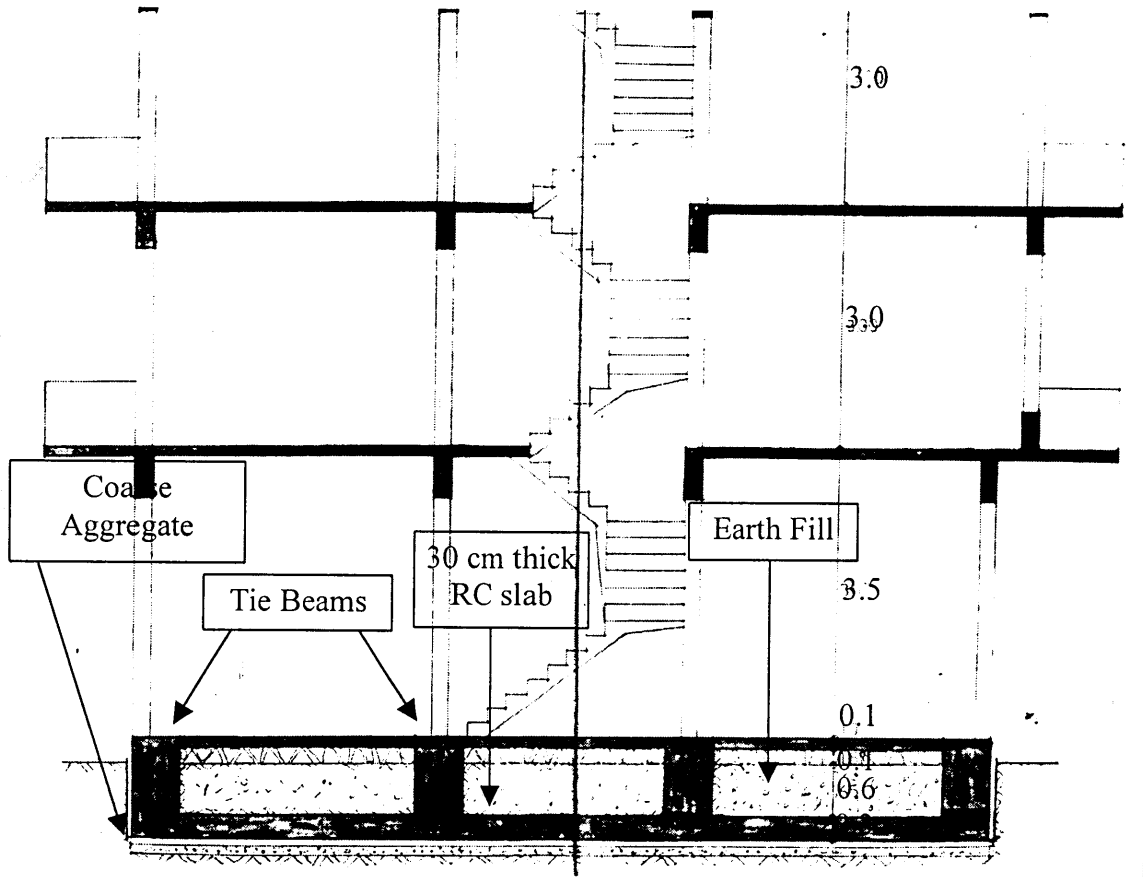
According to the building drawings, the building was built over a mat foundation consisting of 1.2 m-deep reinforced concrete tie beams over a solid, 30 cm-thick slab. It can be noticed in the E-W cross section of the structure and foundation of the building shown in Figure 5-17 that the to first story of the building has a greater height than the other stories as it is used for commercial purposes.

Figure 5-17: East-west cross section across the foundation, ground floor, and first floor of building D1

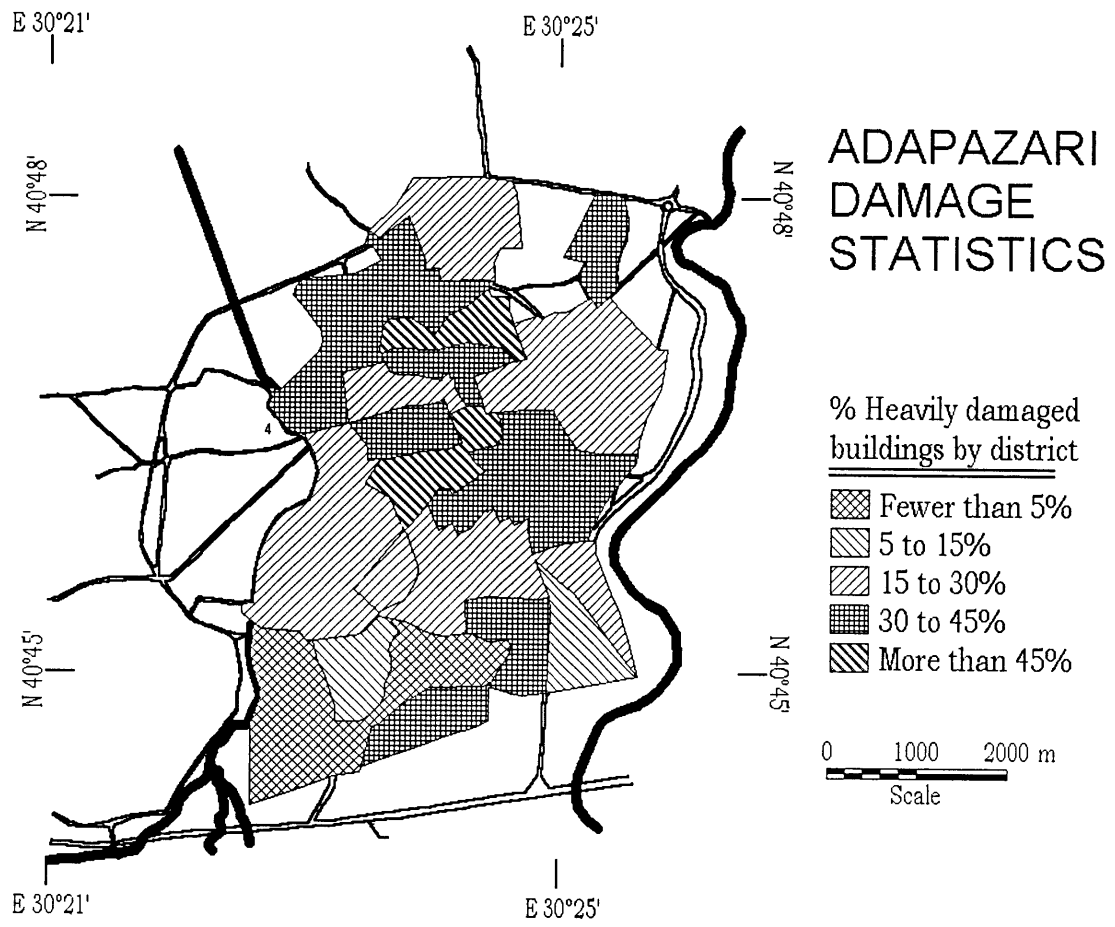
Figure 5-41: Extent of damage in the City of Adapazari during the 1999 Earthquake.

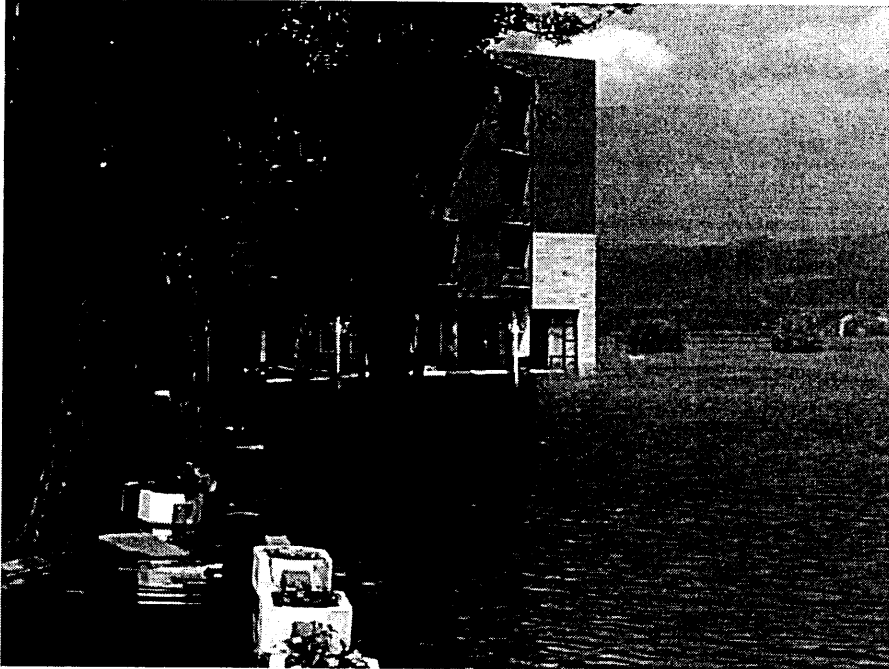
Figure 5-58: Subsidence of the coastline caused Hotel Sapanca to be inundated by the lake, and approximately 10 to 50 m of the coastline became submerged due to subsidence.

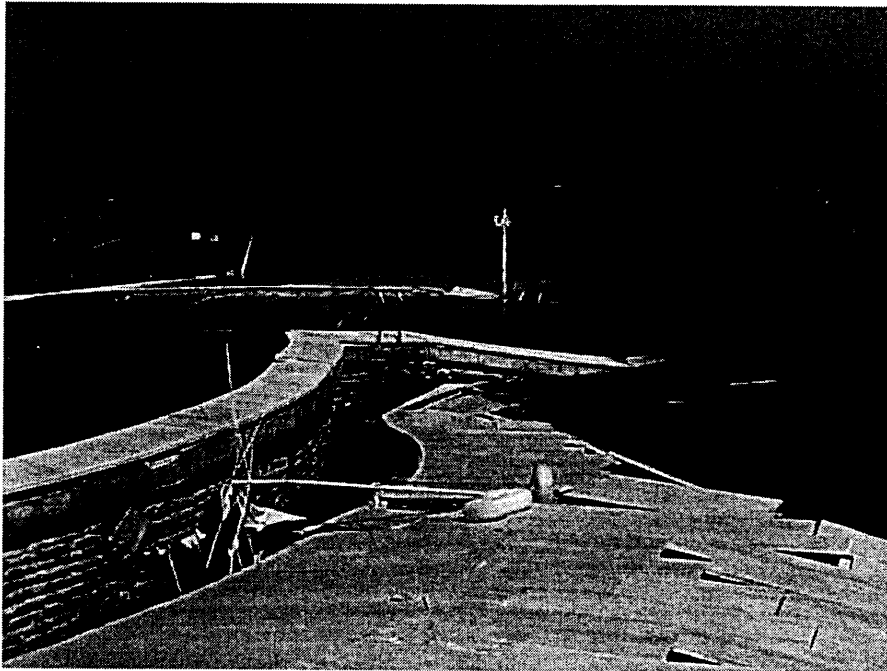
Figure 5-59: A dramatic monoclinal warp or scarp was observed through the swimming pool behind Hotel Sapanca.

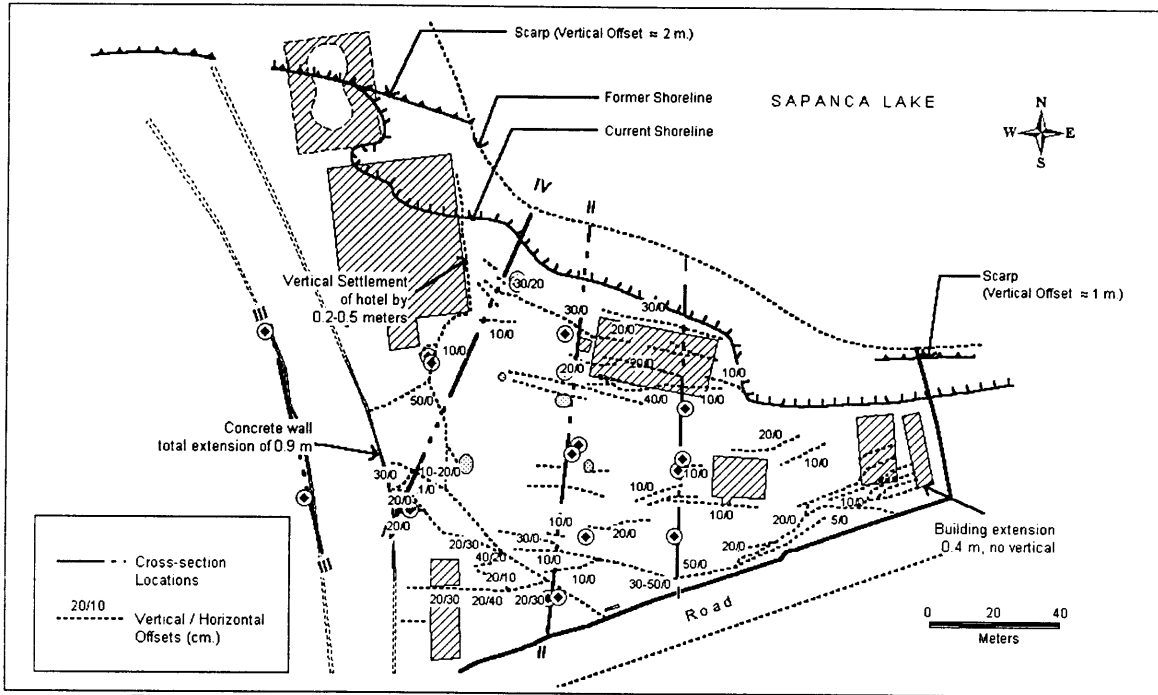
Figure 5-61: Measurements of cracks and fissures on the Sapanca Hotel Site

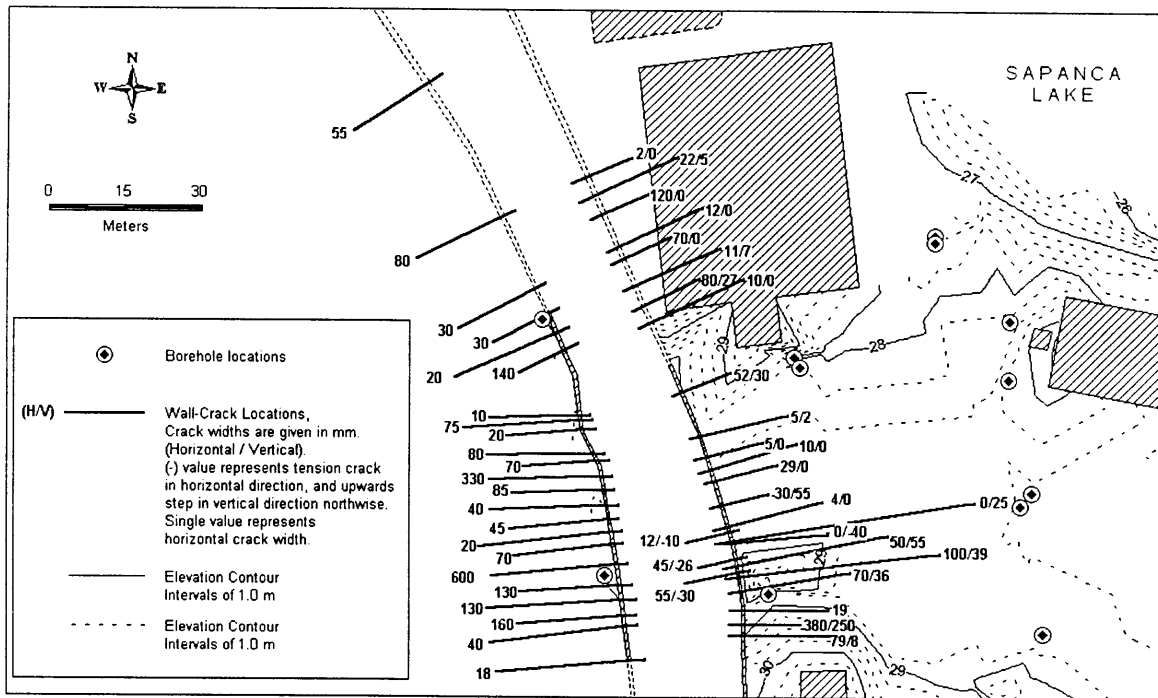
Figure 5-62: Measurements of wall cracks

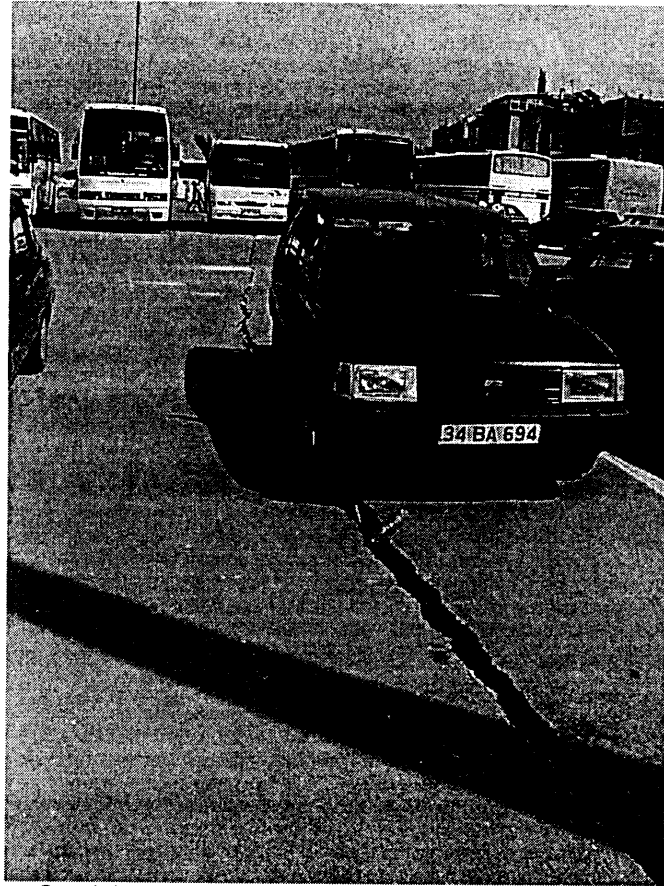
As shown in Figure 5-79, the mapped area near the pier includes three distinct zones. One zone is paved with asphalt concrete. Figure 5-80 shows a representative ground crack in this area. A second zone is a pile-supported waterfront structure. A third zone, located between the asphalt parking lot and

Figure 5-80: Crack in parking lot south of pier for ferry terminal at Yalova Harbor
