Quick reconnaissance report on May 12, 2008 Wenchuan Earthquake

By Yan XIAO

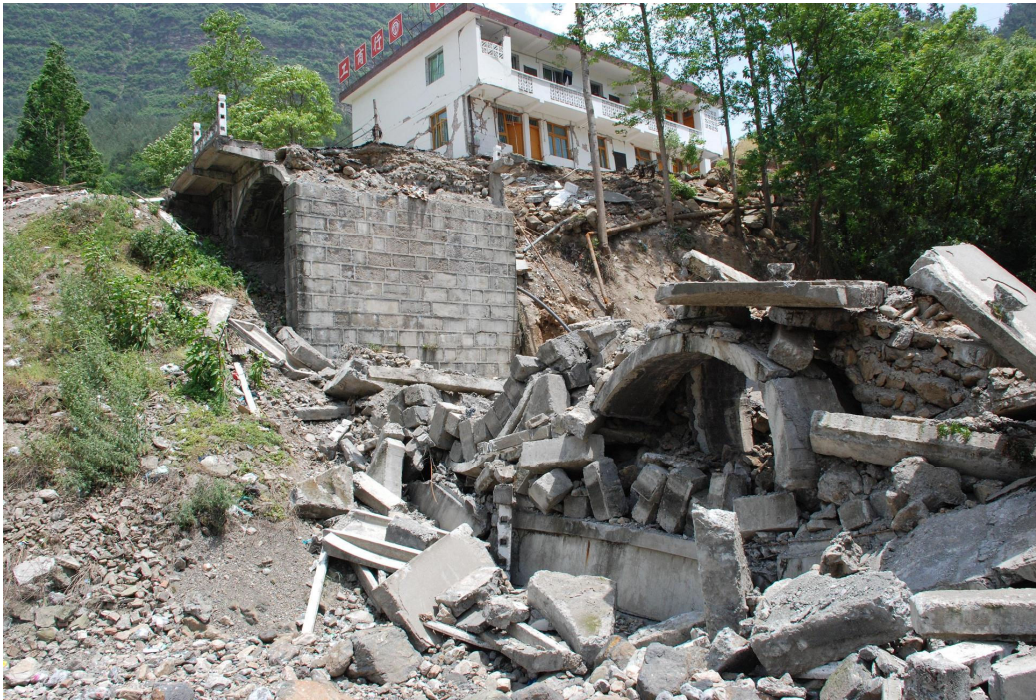
Collapsed arch bridge

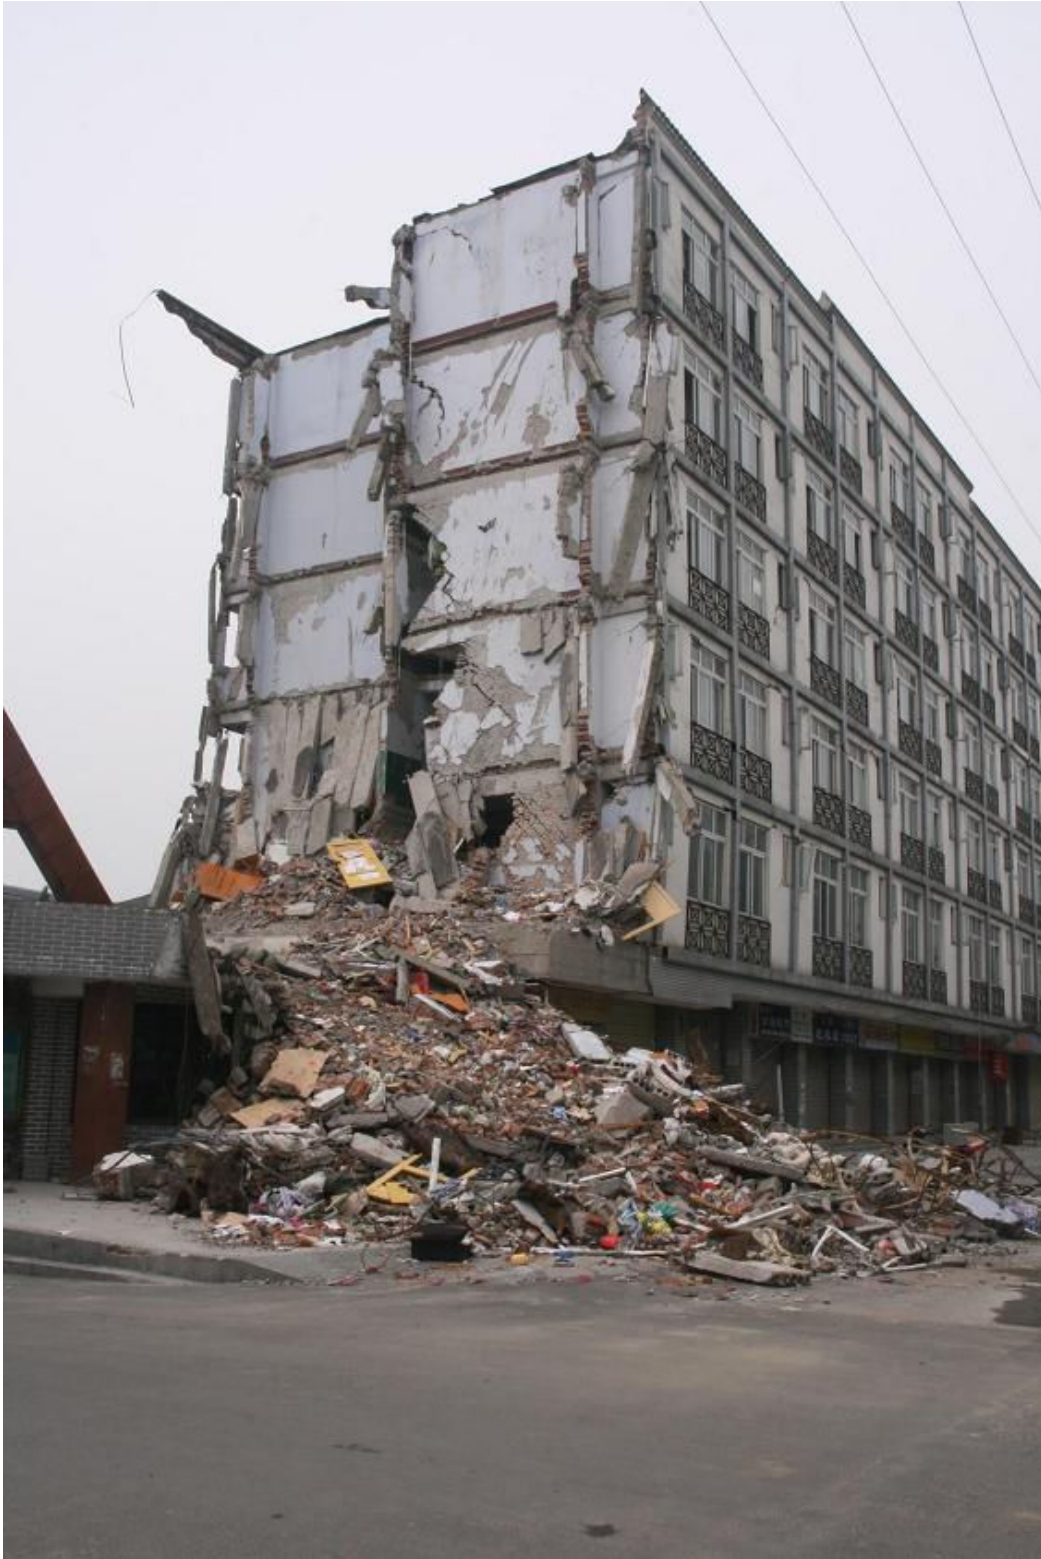
Collapsed building in Dujiangyan

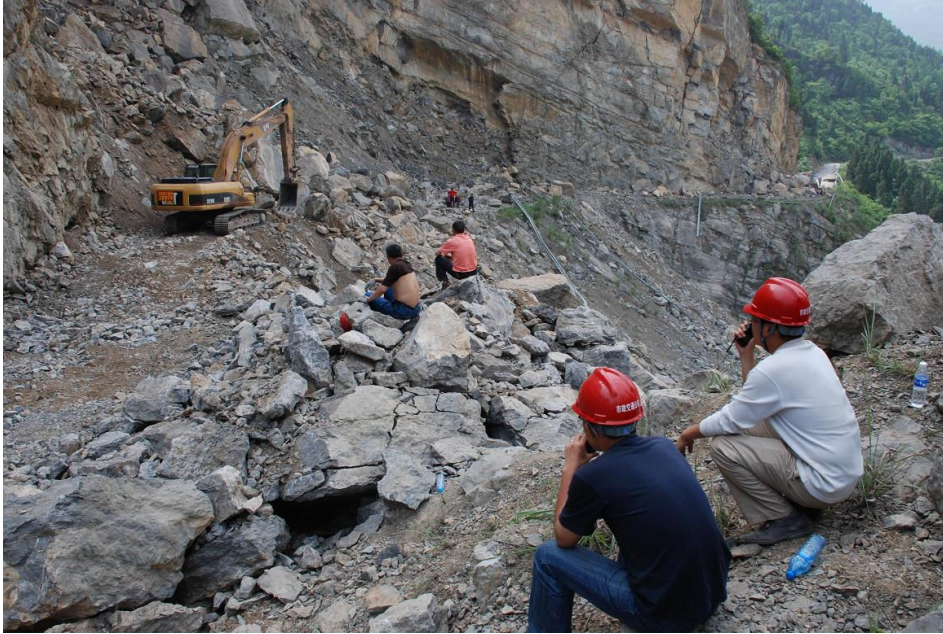
Dangerous and slow process in recovering the damaged mountain highway

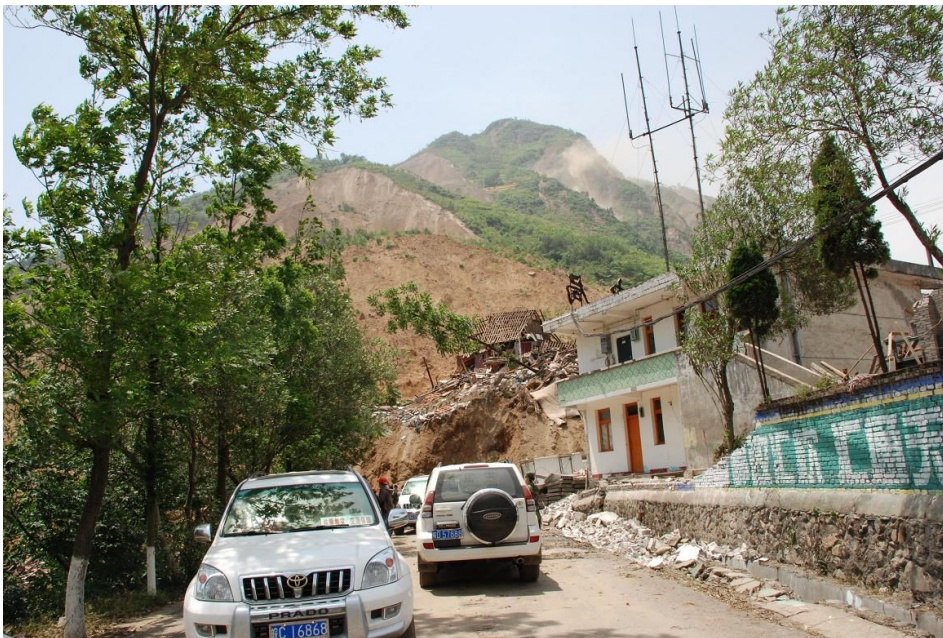
Mountain slope failure in Beichuan

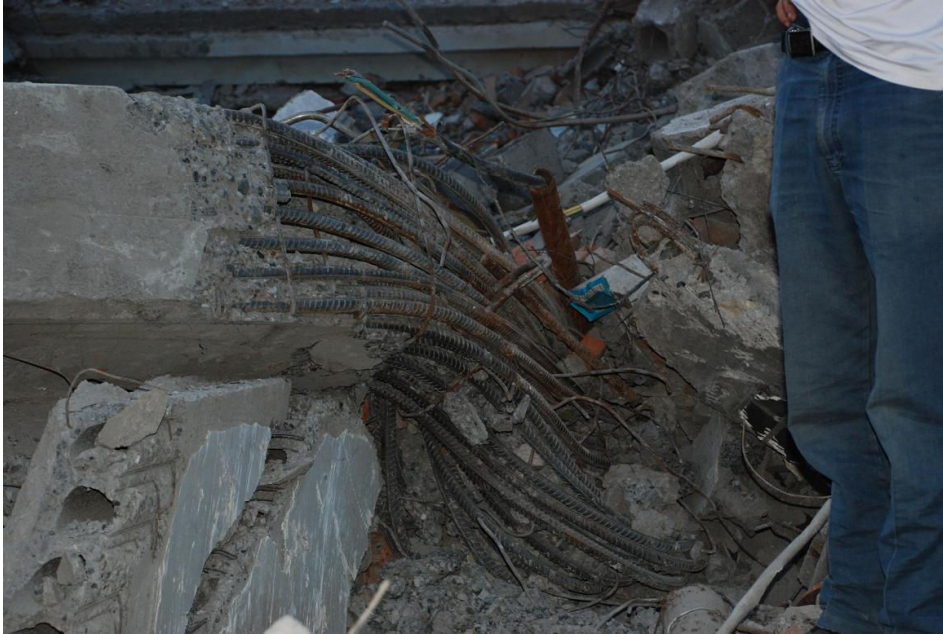
From the reconnaissance of the earthquake damage, it is clear that most of the damaged concrete building columns, and beam to column joints did not have proper transverse reinforcement.

Poor design with too many longitudinal bars but little transverse bars
