Geotechnical Aspects of the M = 8.8 February 27, 2010 Chile Earthquake

*Jonathan Bray, UC Berkeley; David Frost, Georgia Tech;
Ramon Verdugo, Universidad de Chile; Christian Ledezma, Pontificia
Universidad Catolica de Chile; & Terry Eldridge, Golder Assoc.*

NSF-Sponsored GEER Reconnaissance

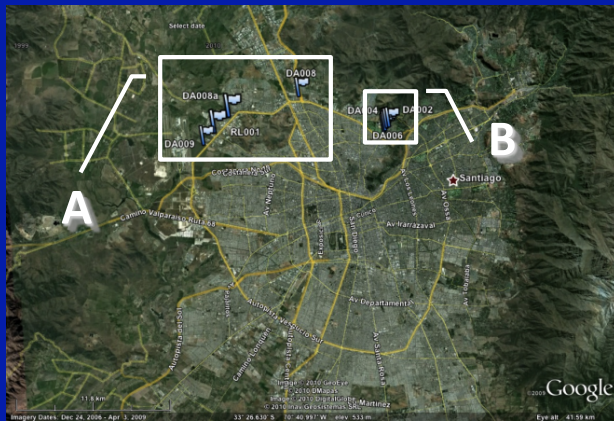
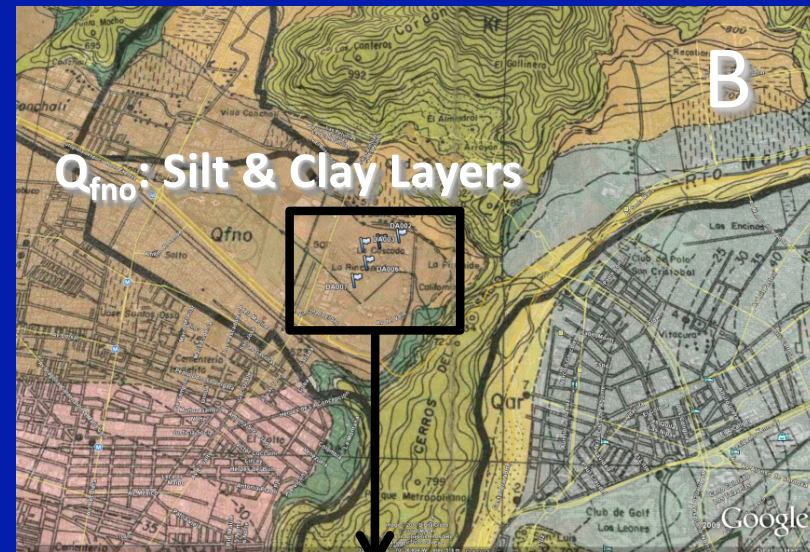
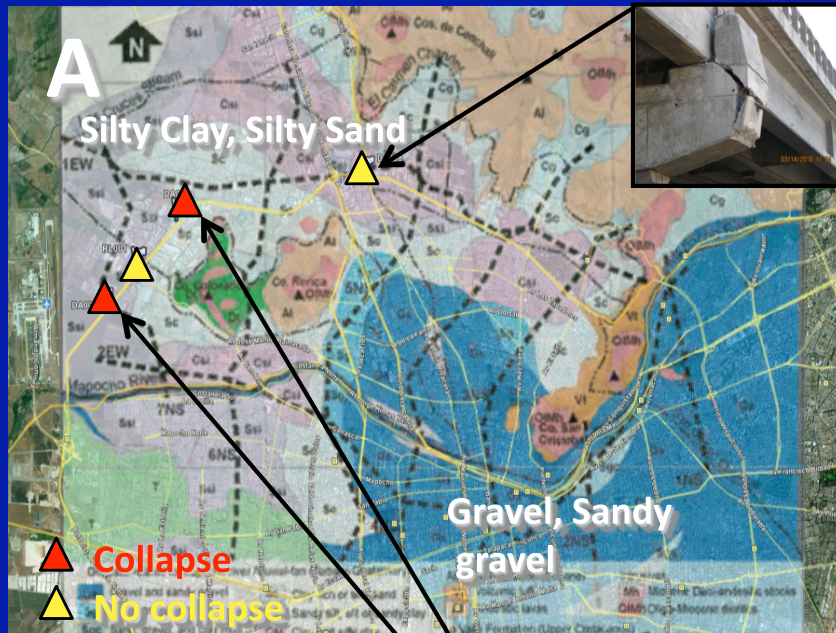
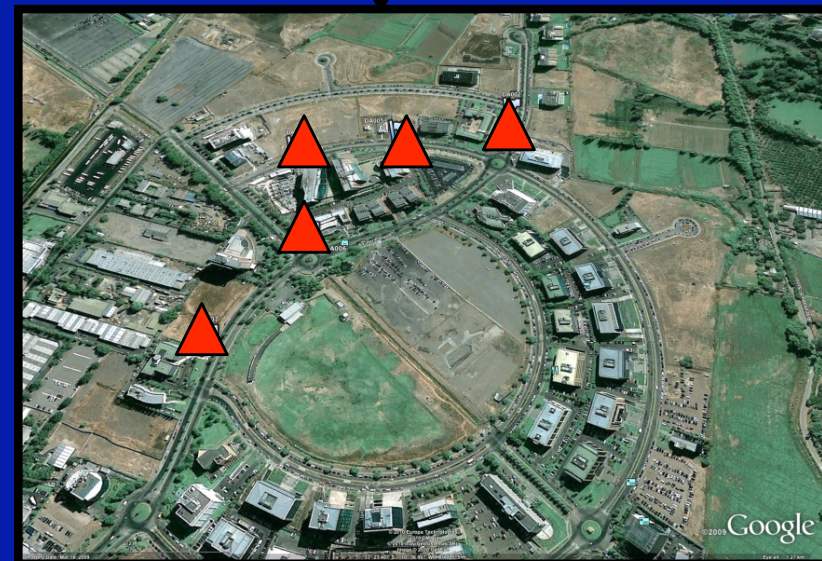
Site Effects: Vespucio Norte & Ciudad Empresarial

Localized Damage – Site Effects?

H/V peaks: 0.5-2sec (Bonney et al, 2008)
Damage to 5 to 20-story buildings

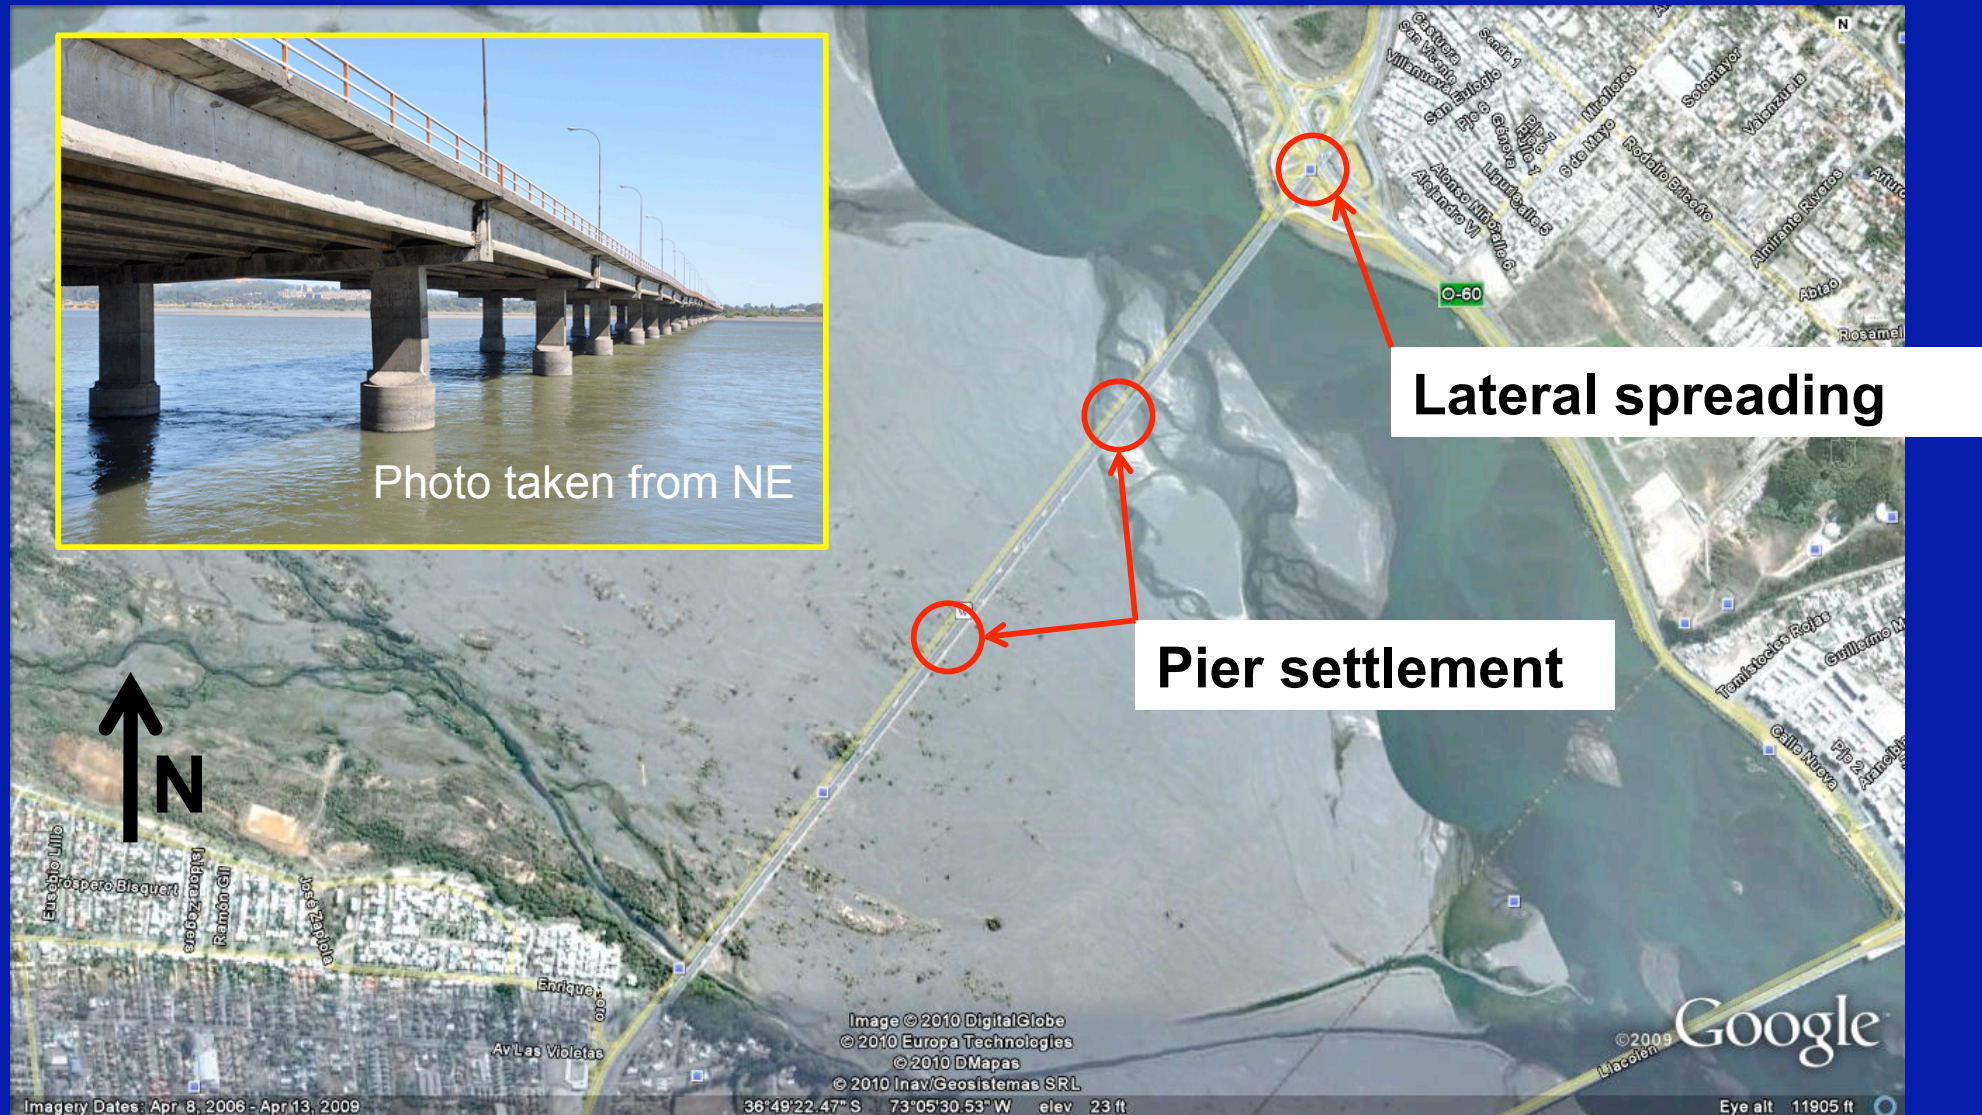
Juan Pablo II Bridge, Concepción

Bent damage due to lateral spreading on NE approach
Liquefaction-induced pier settlements along bridge span

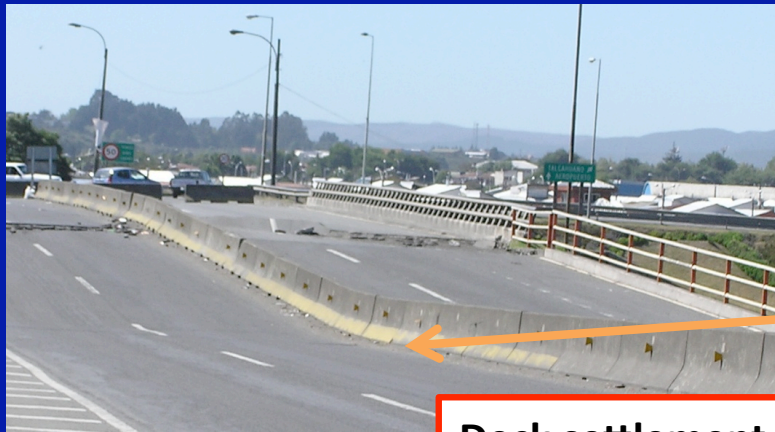
Juan Pablo II Bridge

Lateral spreading and bridge bent damage on NE approach

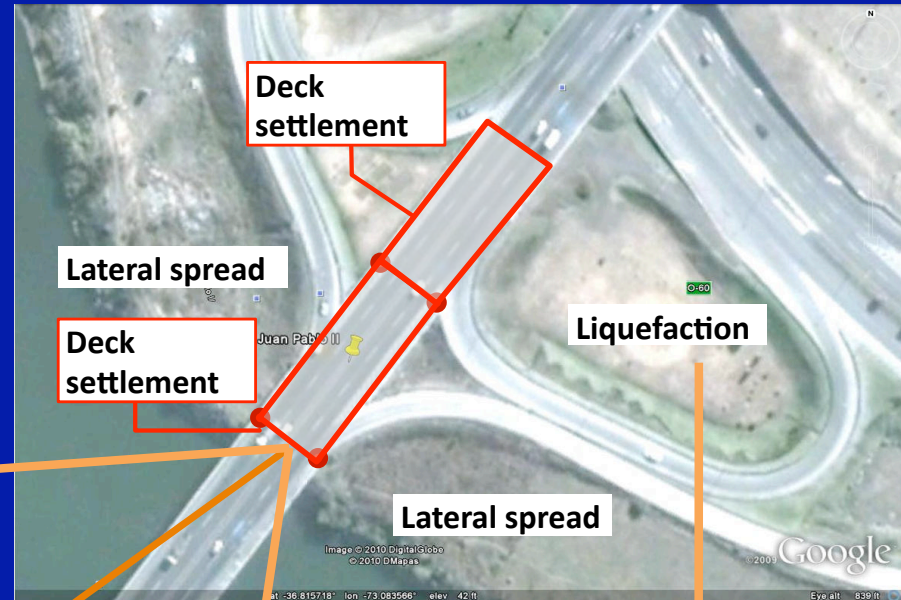
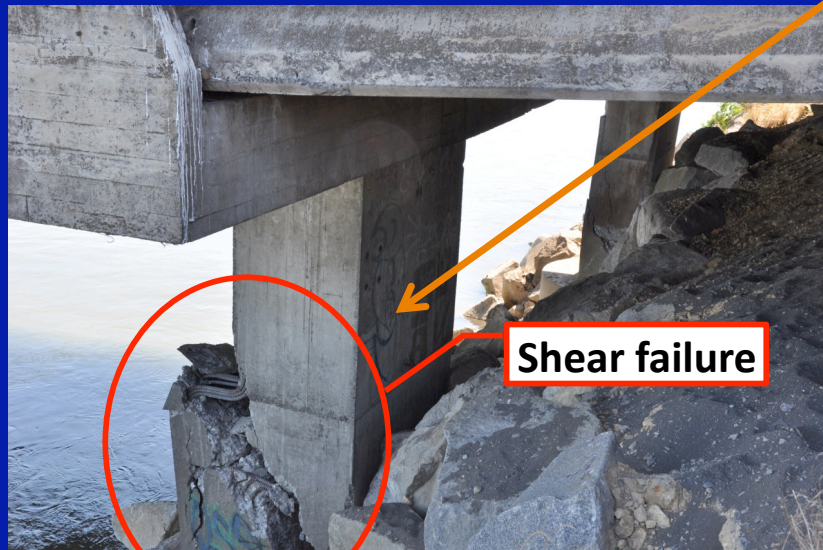
Deck settlement

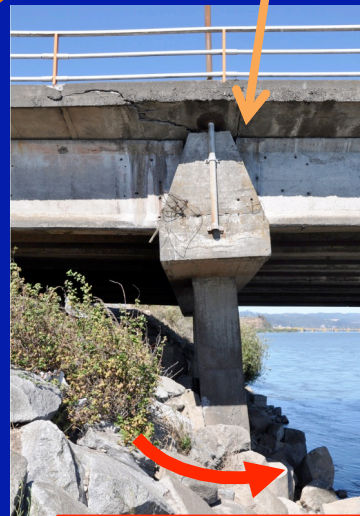
Shear failure

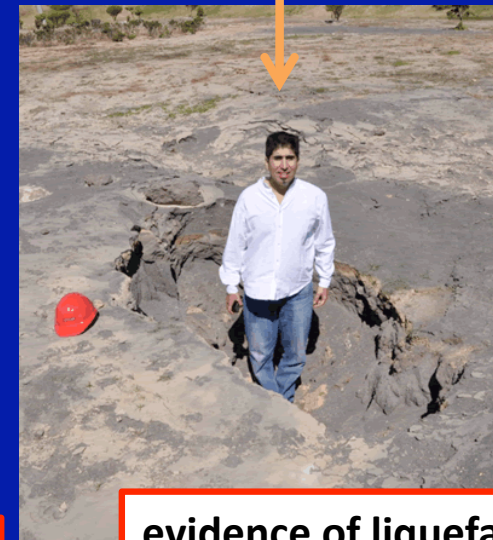
Lateral spread

evidence of liquefaction

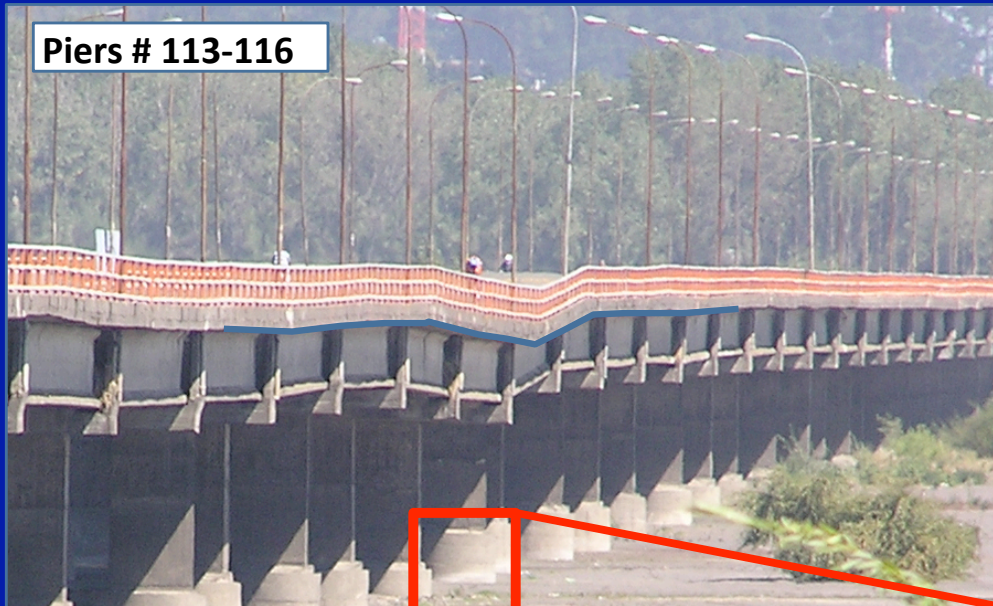
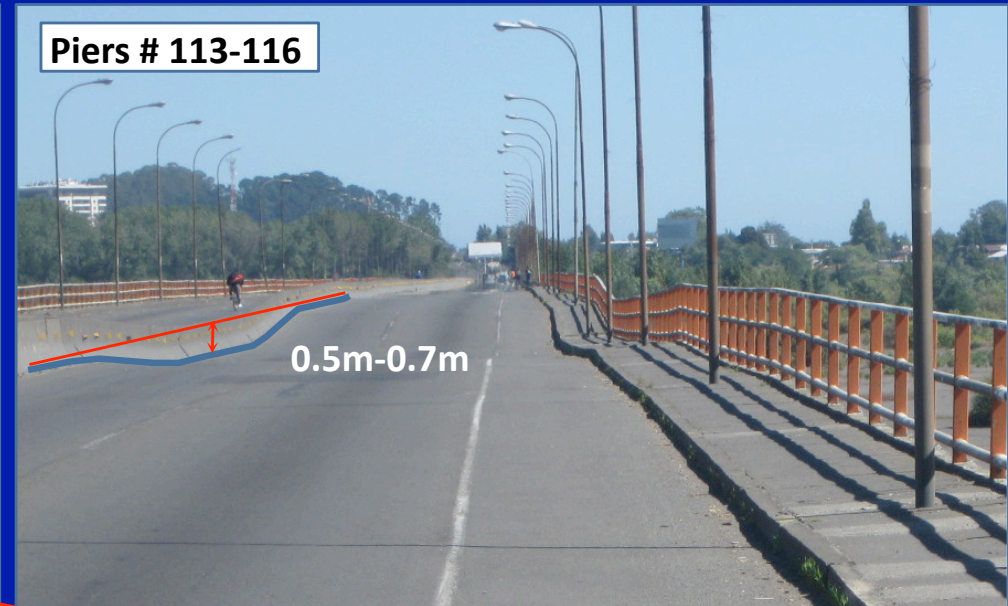
Juan Pablo II Bridge

Liquefaction-induced pier settlements along bridge span

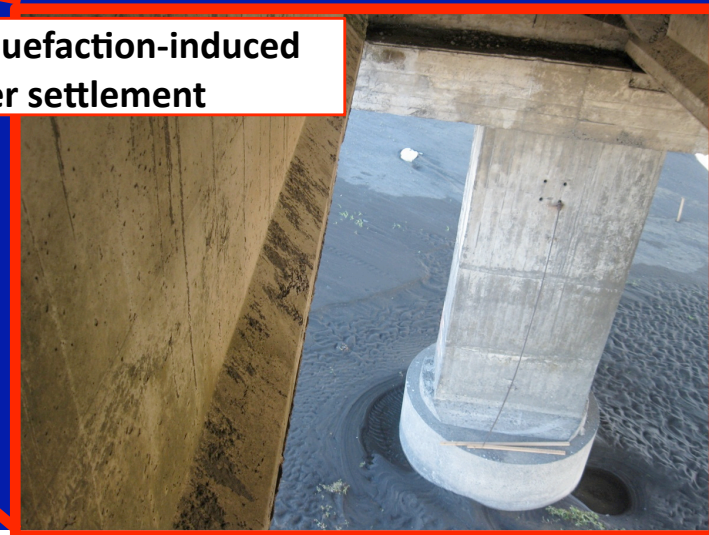
Liquefaction-induced pier settlement

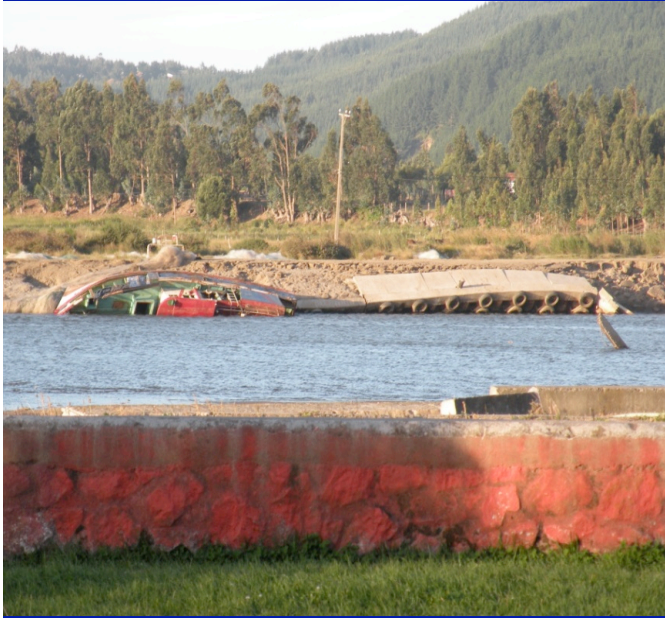
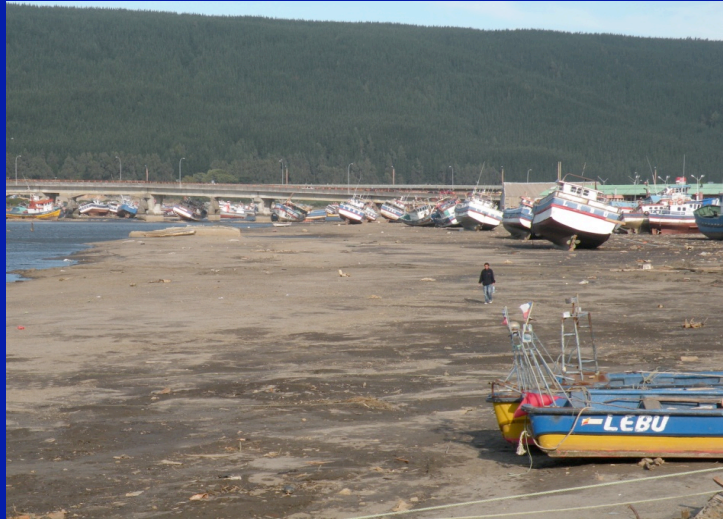
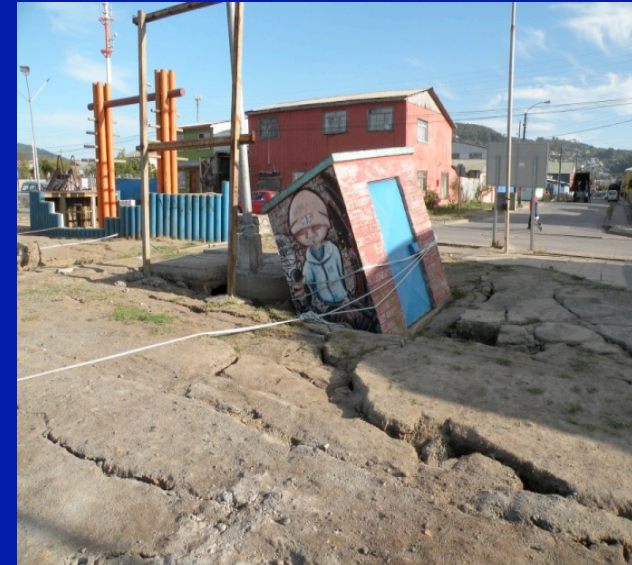
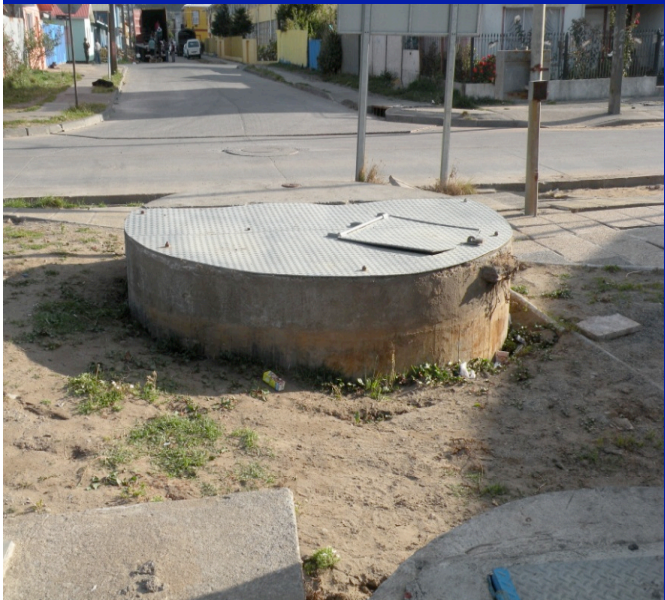
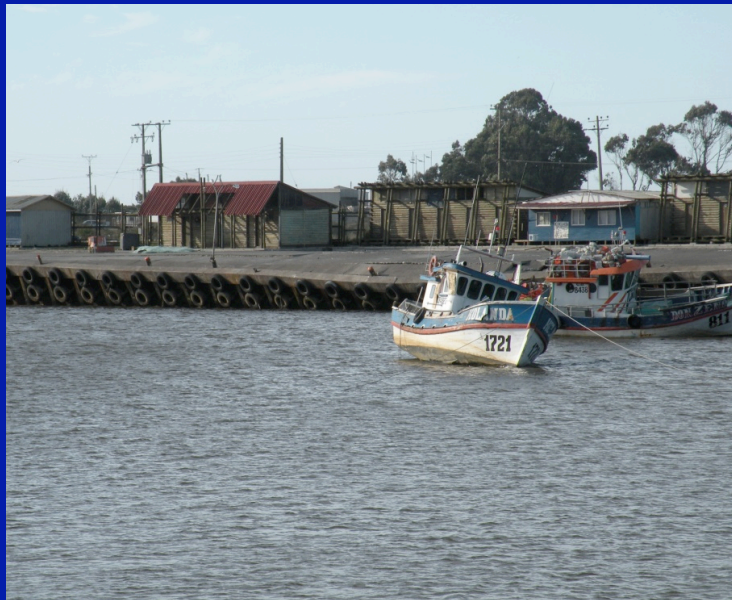
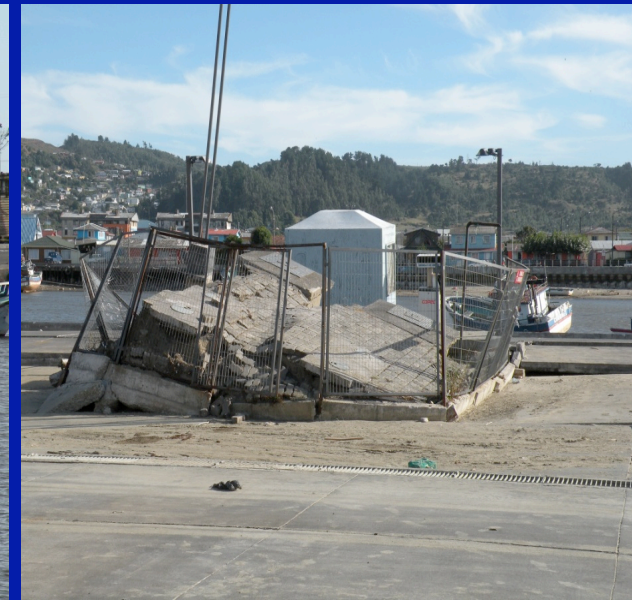
Lebu (Fishing Port & Village)

Uplift (~2m), quay wall failure, liquefaction – fishing industry devastated

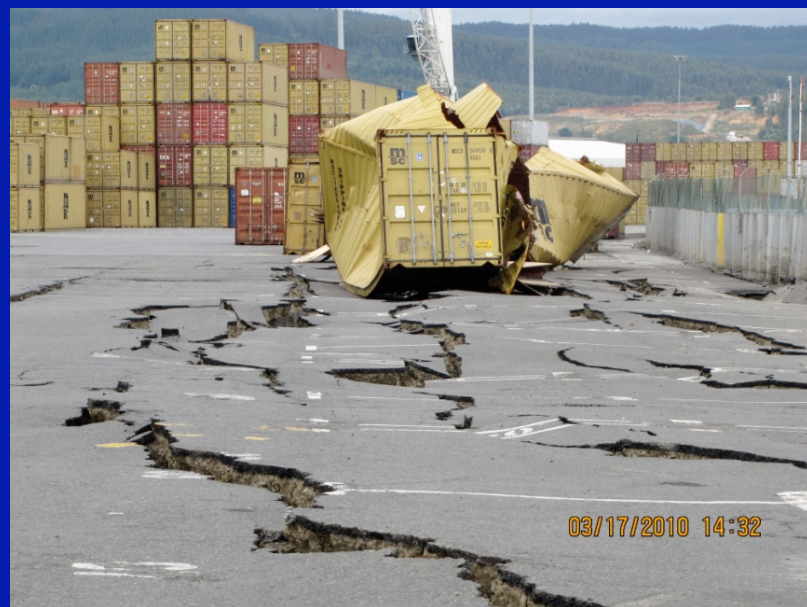
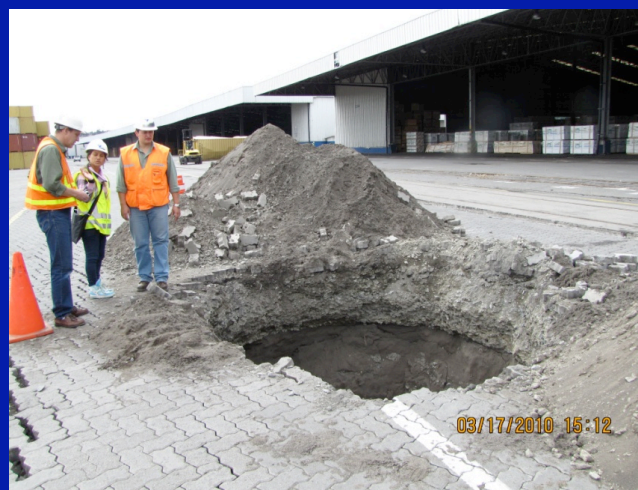
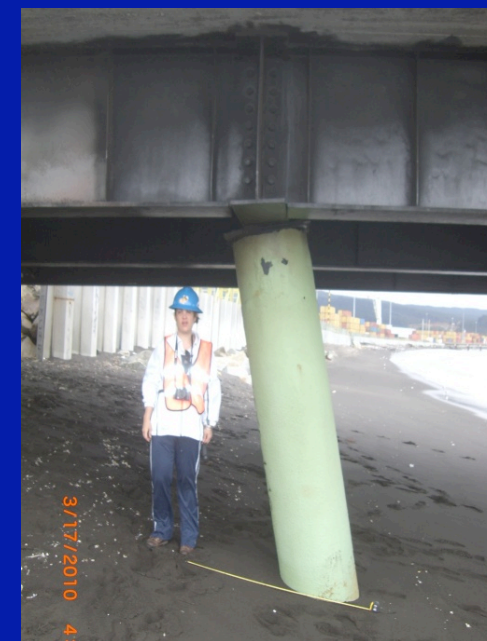
Coronel : a) Lateral Spreading/Settlement, b) Sediment Ejecta/Sinkholes, & c) Pile Damage

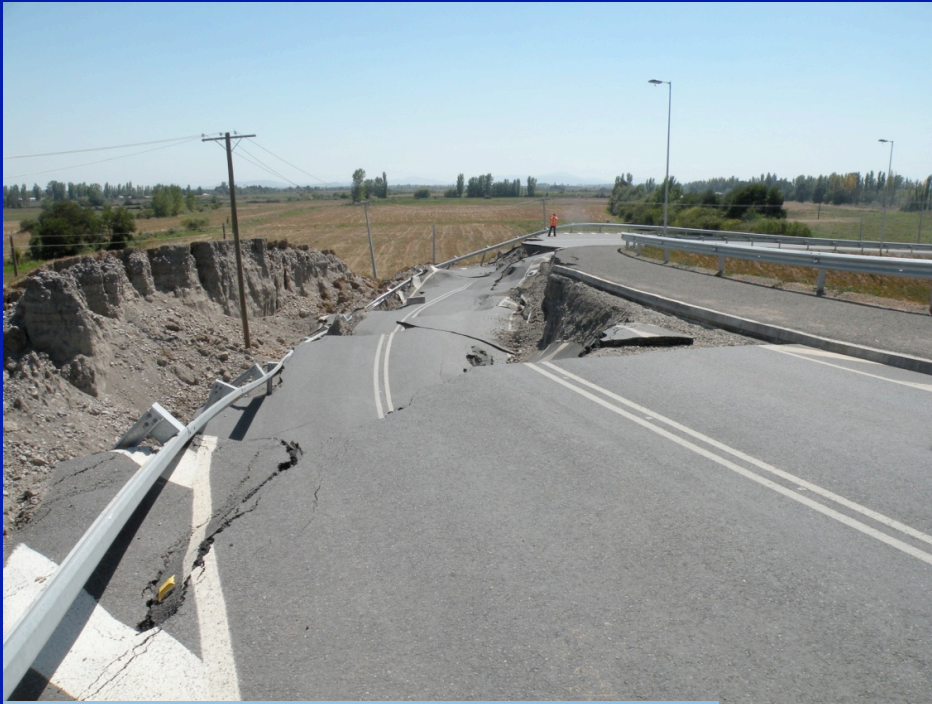
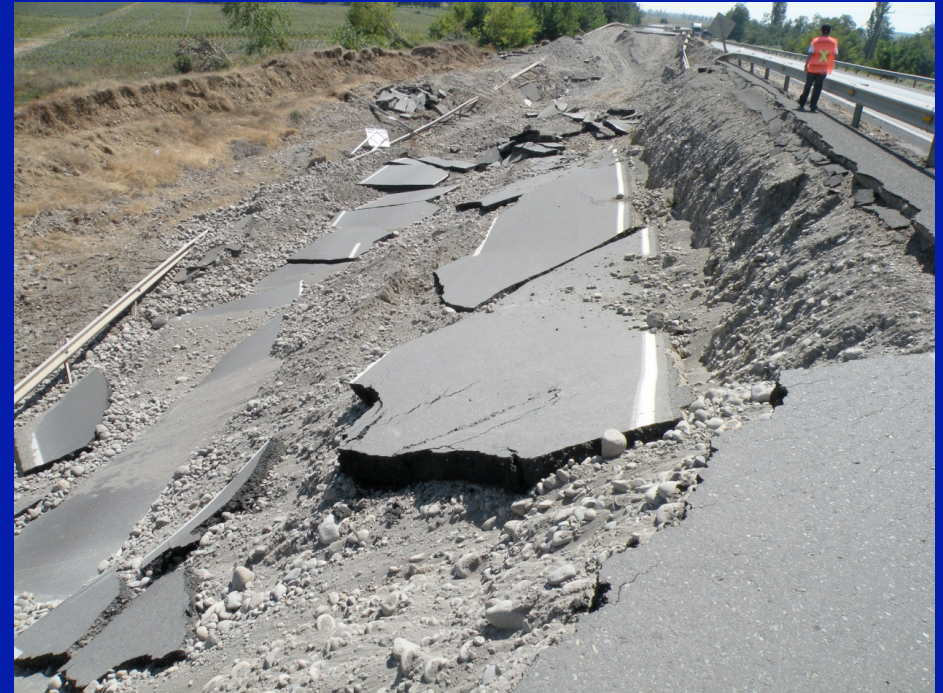
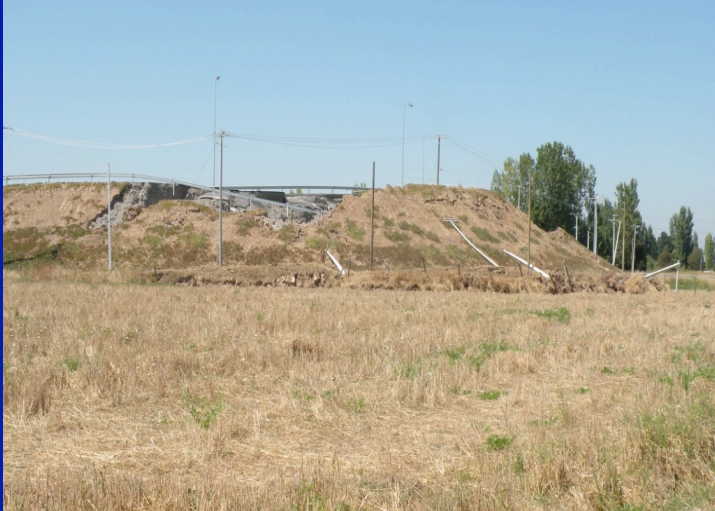
Embankment Failures along Highway 5

Possible liquefaction of thin seams in foundation soils led to translational failures of highway embankments
