27 March 2010 Offshore Maule, Chile Earthquake

2010 Chile earthquake

EERI Learning From Earthquakes Program Reconnaissance Team

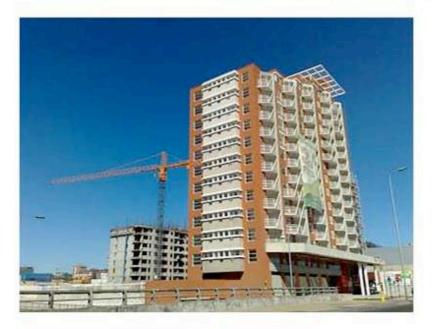
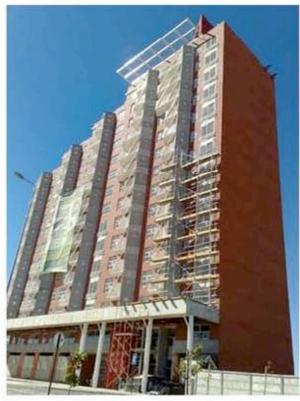
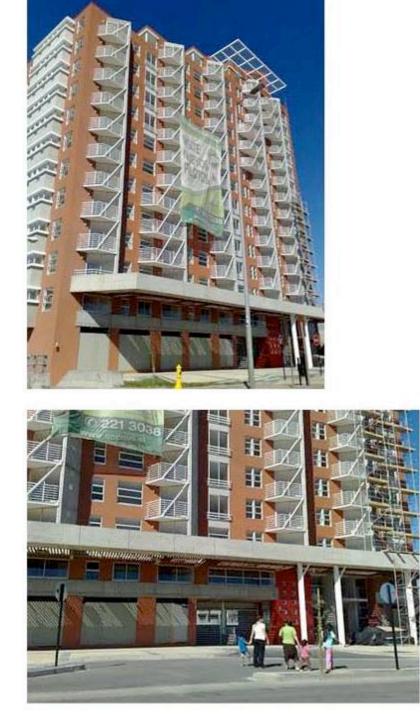
Torre Alto Rio (Rio Alta) Apartment Building in Concepcion, Chile Before

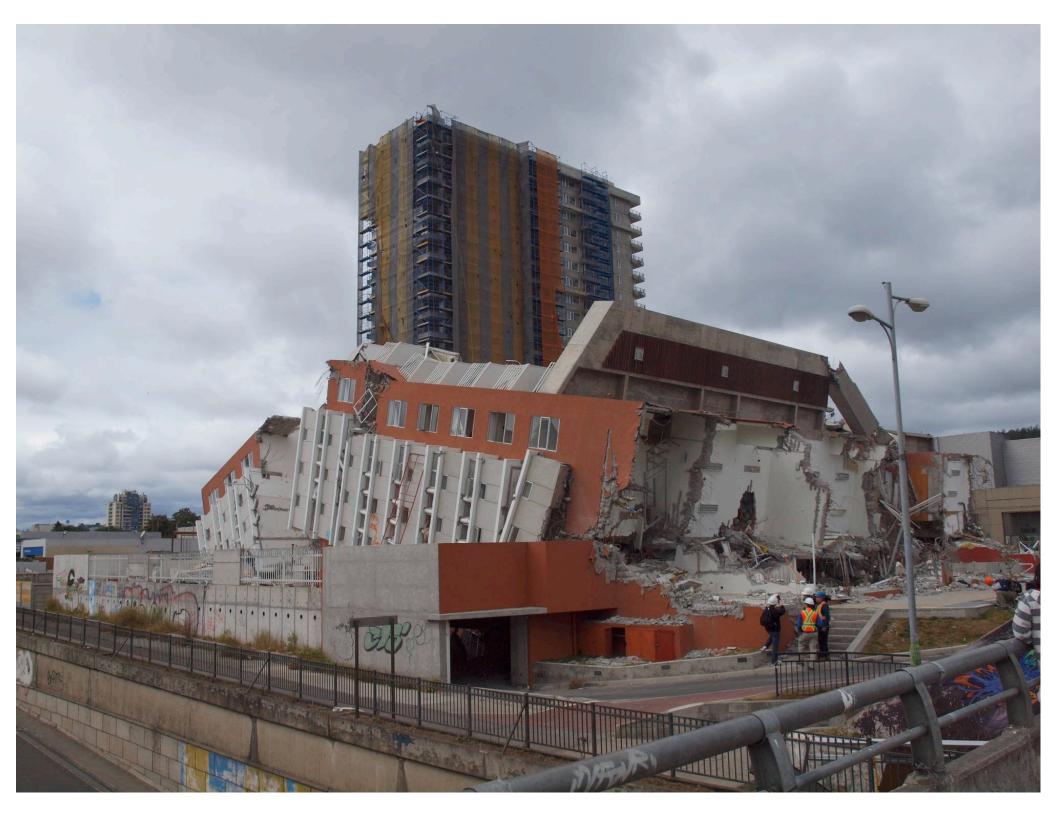
Collapsed building in Concepcion

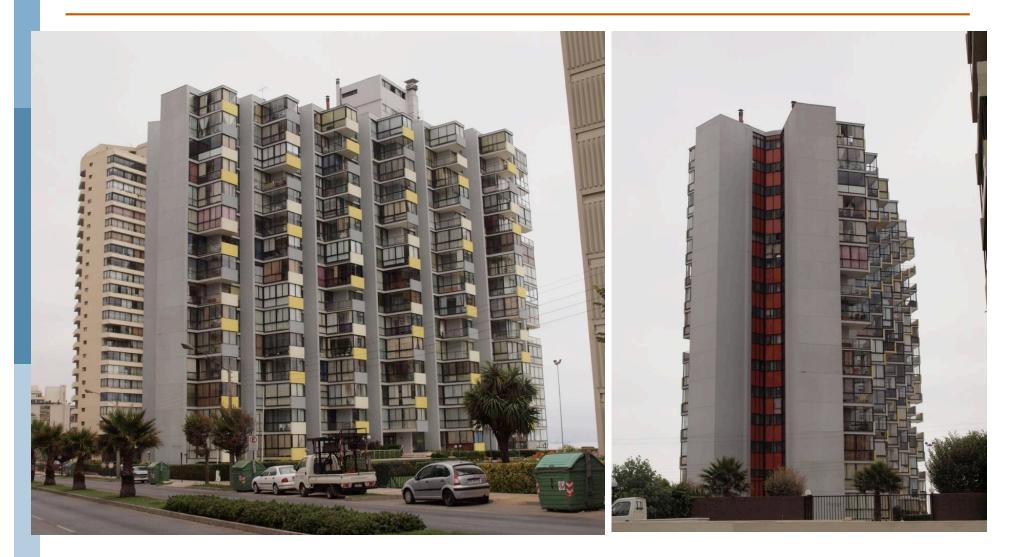
Acapulco – 1985 Damage and retrofit

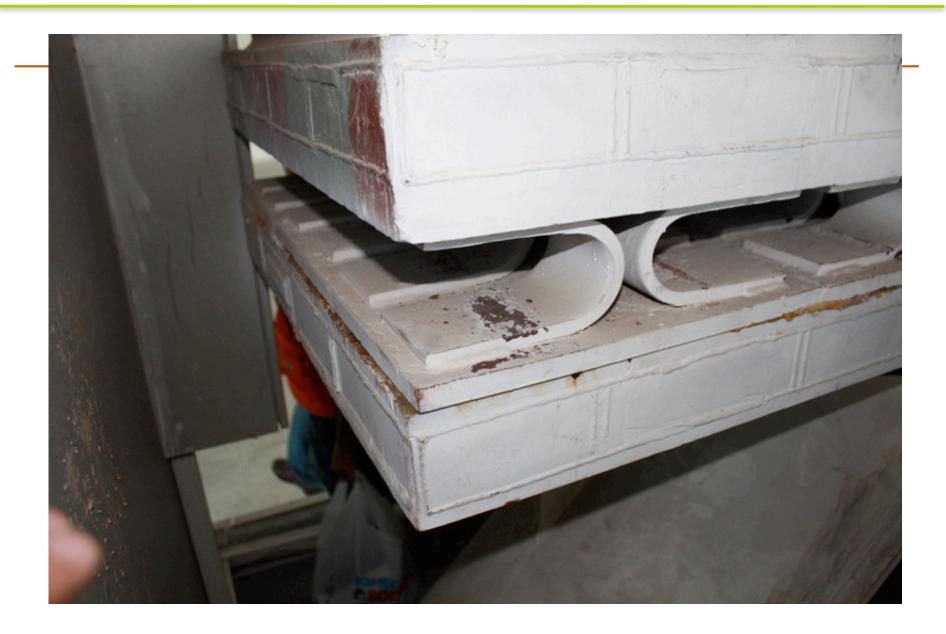
Energy Dissipating Device in Titanium Building
