# February 27, 2010 Chile Earthquake Reconnaissance Team Investigation

## Reinforced Concrete Buildings

Investigate the performance of reinforced concrete buildings (typically 3 – 25 stories) during 8.8 Offshore Maule Earthquake

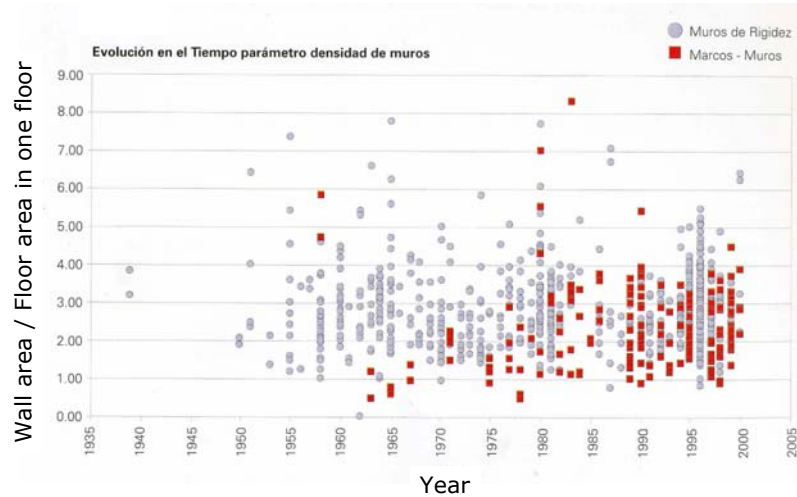
The ratio of wall area to single floor area is relatively large in comparison with US practices. Although the ratio has remained relatively constant, the building heights have increased in later years.

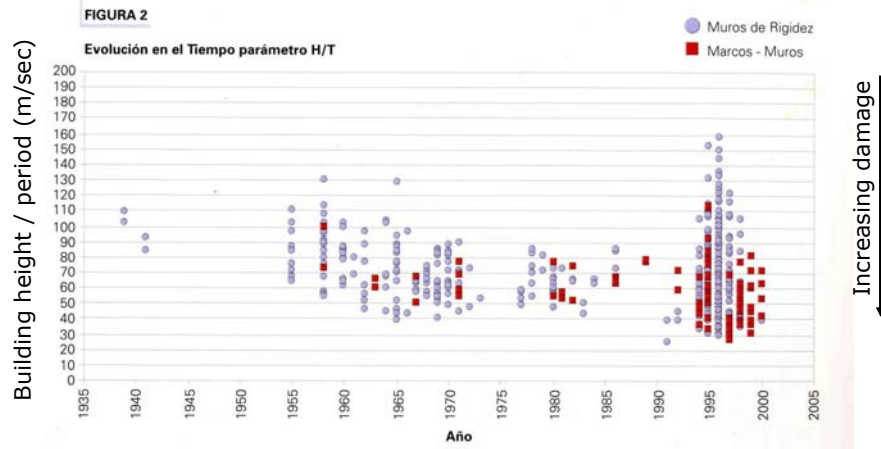
Buildings are becoming more flexible with time. According to Moroni, the damage rate for Chilean buildings increases as the flexibility increases.

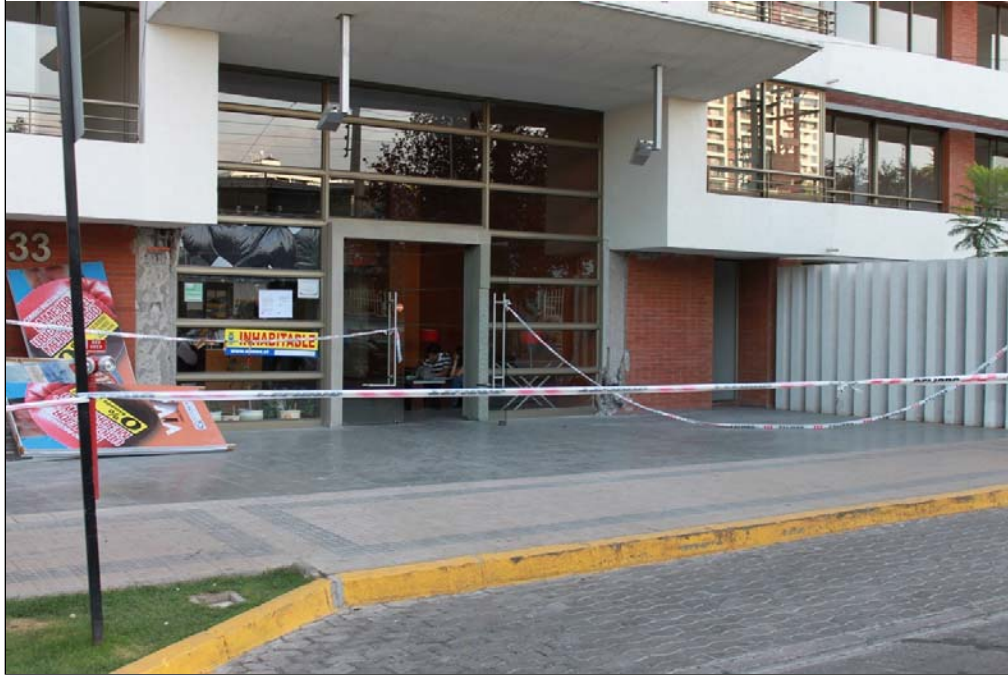
Los Cerezos 33, Ñuñoa, Santiago.

~ 26 story building. Note walls at sides of entry are “clipped.” Wall to left is continuous into subterranean levels and is crushed at the top. Wall to right is supported on column in first subterranean level, resulting in wall crushing at the connection with the column.

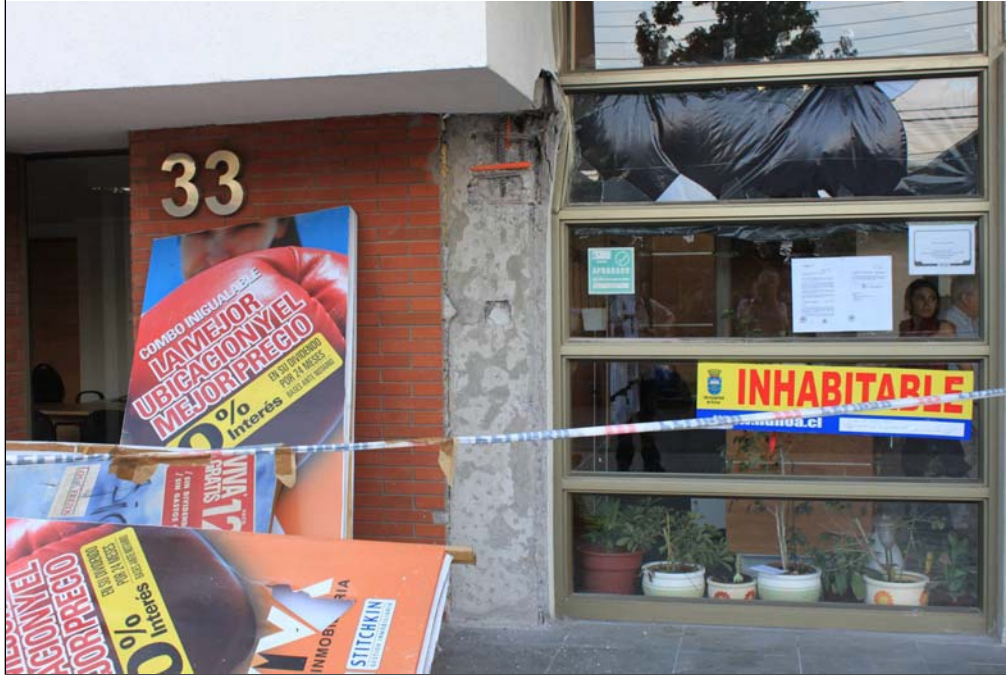
Los Cerezos 33, Ñuñoa, Santiago.

~ 26 story building. Crushing at top of wall to left of entry.

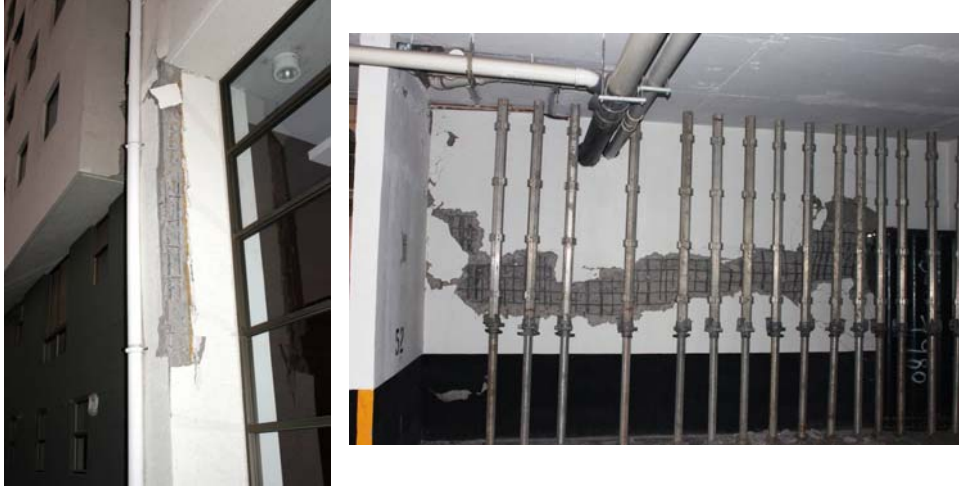
Av. Irarrázaval 2931, Ñuñoa, Santiago.

Photo to left shows damage to lap splice at first story above grade. This half of the building showed signs of being in tension (lap splice damage, tension cracks).

Photo to the right shows crushing of wall below grade on opposite side of building (compression side).

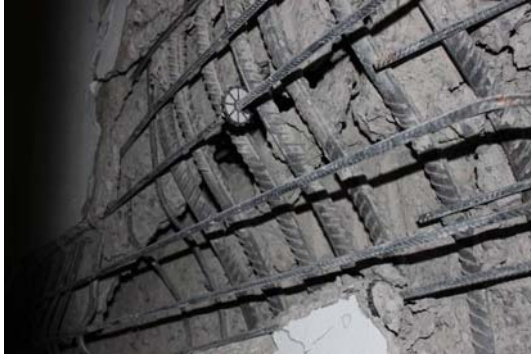
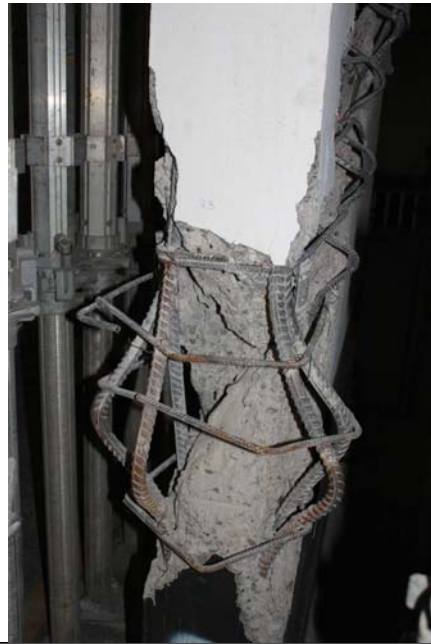
Av. Irarrázaval 2931, Ñuñoa, Santiago.

View of details of reinforcement and failure at one crushed wall boundary. Note lack of cross ties in the field of the wall. Note wide spacing and 90-degree bends on transverse reinforcement in boundary.

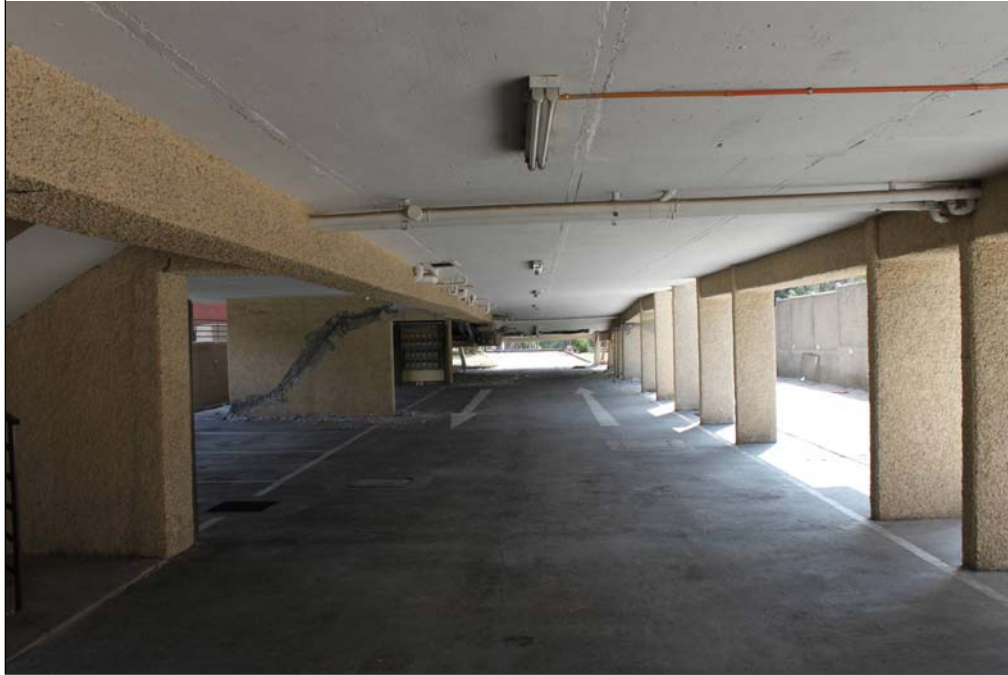
Maipu, Santiago.

Building similar to Building C, located within two blocks. Viewing from road side (relatively undamaged) toward back (collapsed). The wall with the large inclined “crack” showed inclined cracking in both directions.

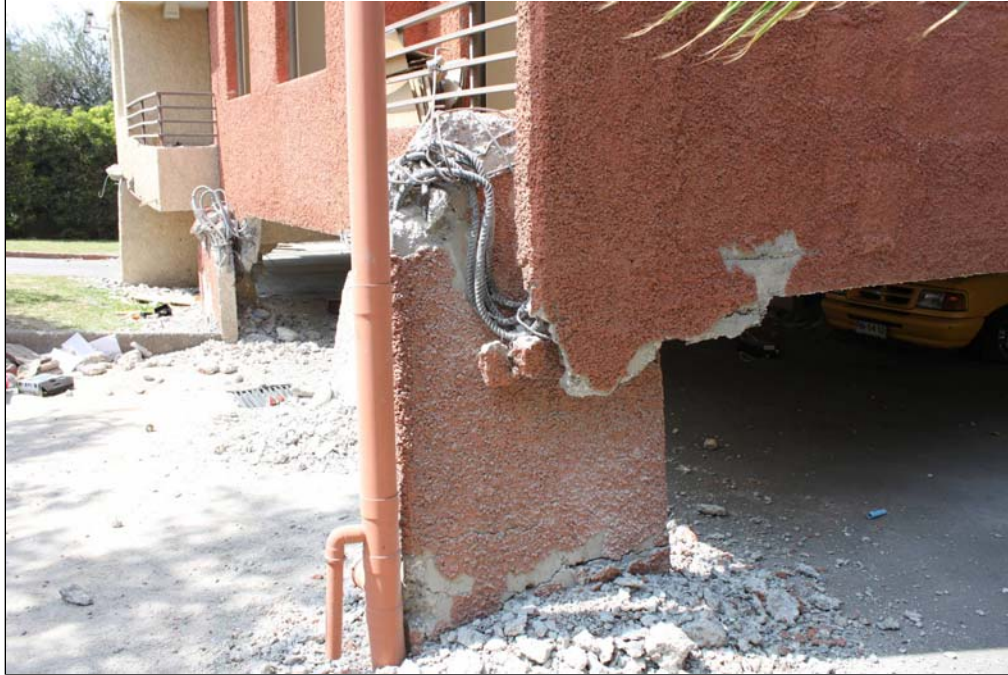
Maipu, Santiago.

Building similar to Building C, located within two blocks. Back end of building collapsed.

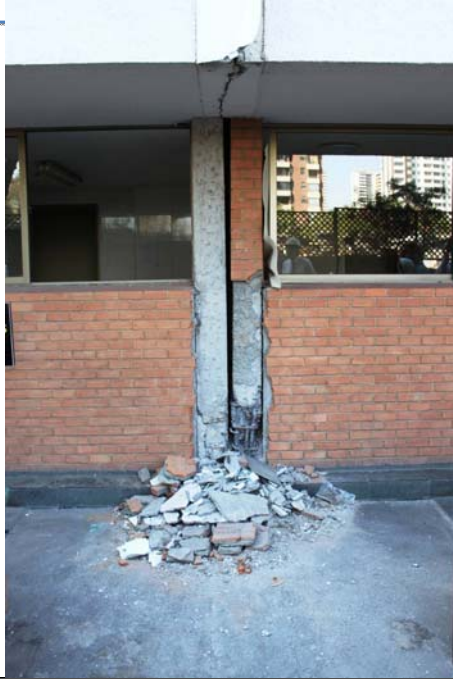
Sol Oriente I and II, Macul, Santiago, Chile.

Joint between two towers showing different damage in each. The roof is leaning 13 cm away from this side of the building.

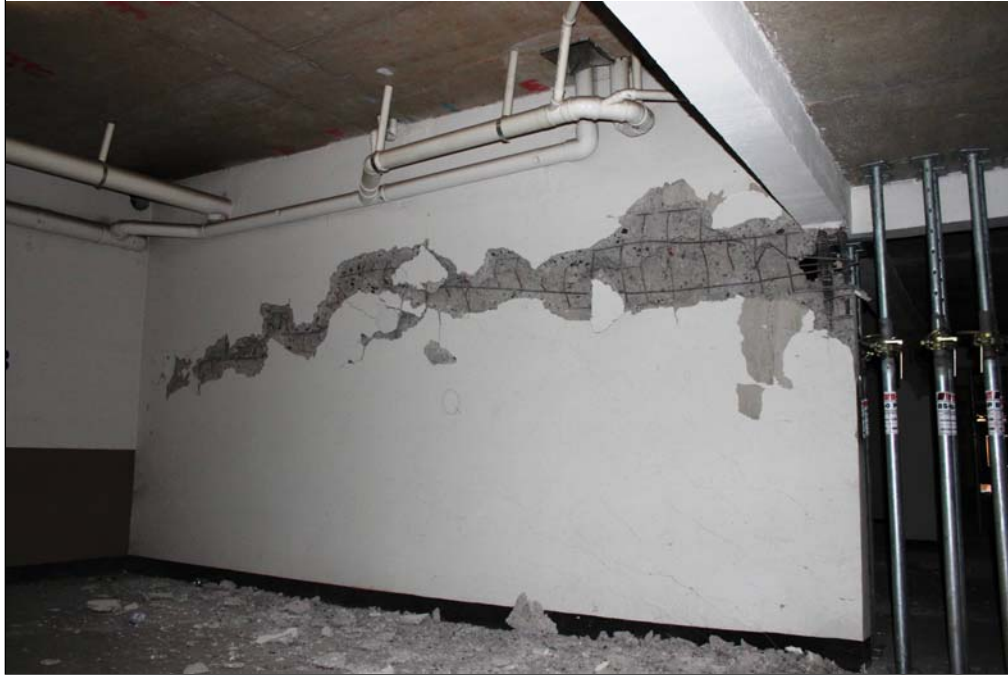
Sol Oriente I and II, Macul, Santiago, Chile.

Complex of highrise condominiums. Typical crushed transverse wall. The longitudinal walls were intact with no appreciable signs of damage.

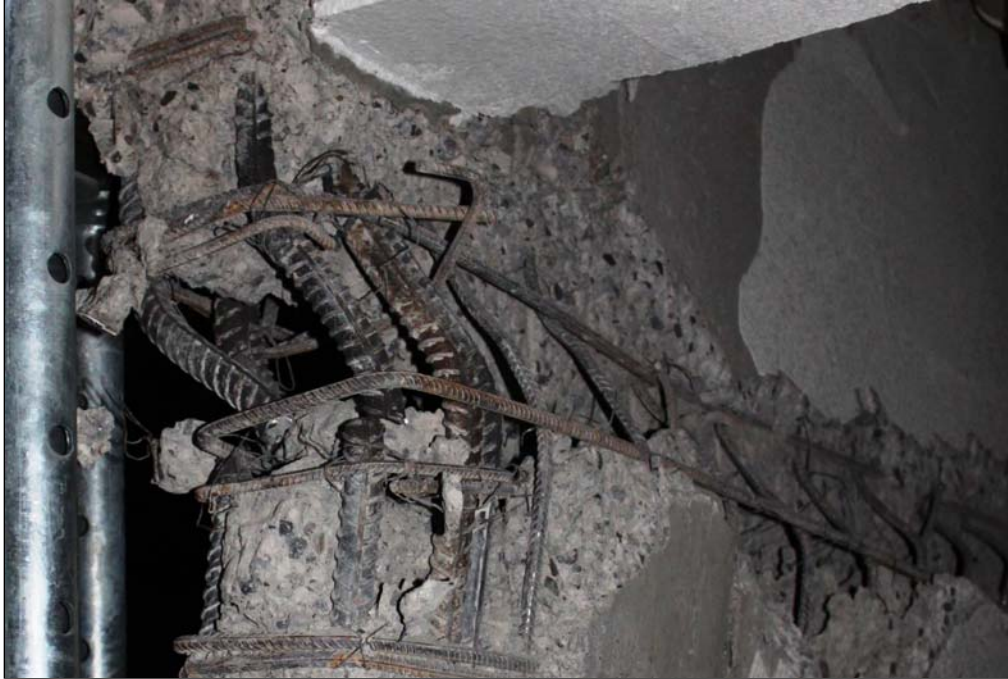
Sol Oriente I and II, Macul, Santiago, Chile.

Complex of highrise condominiums. Fractured boundary element longitudinal bars was not uncommon in buildings of this type.

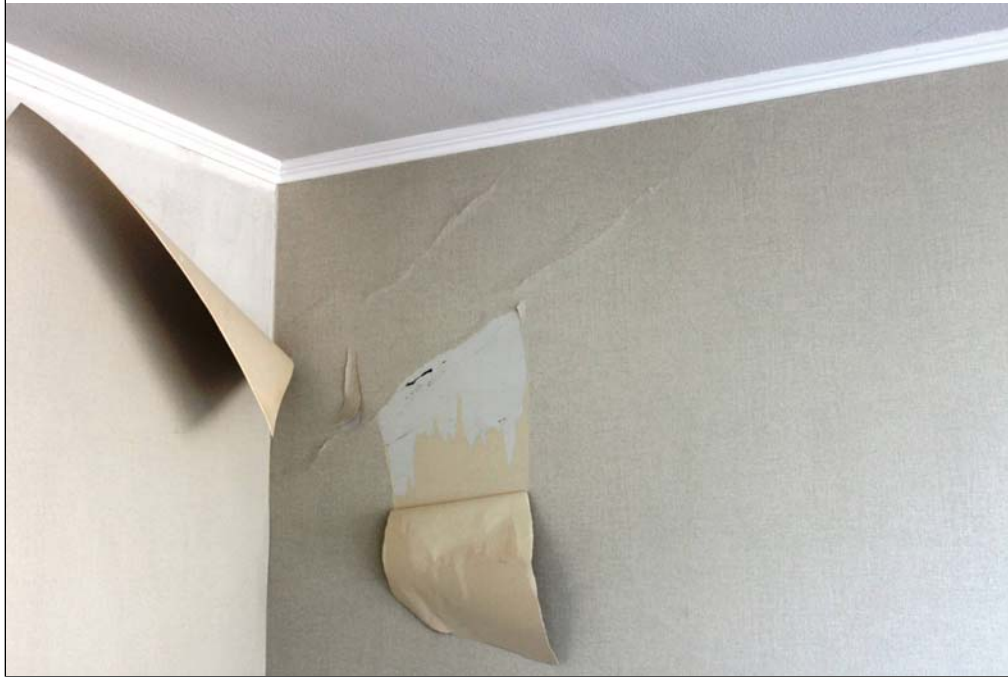
Sol Oriente I and II, Macul, Santiago, Chile.

Crushed transverse walls were all on one side of the longitudinal walls. Photo is from 2<sup>nd</sup> story on side opposite the crushed walls. Note cracks in wall, suggesting tension in the slab toward the left of the photo, consistent with internal forces expected as the slab acted to tie the crushed part of the building back into the other half.

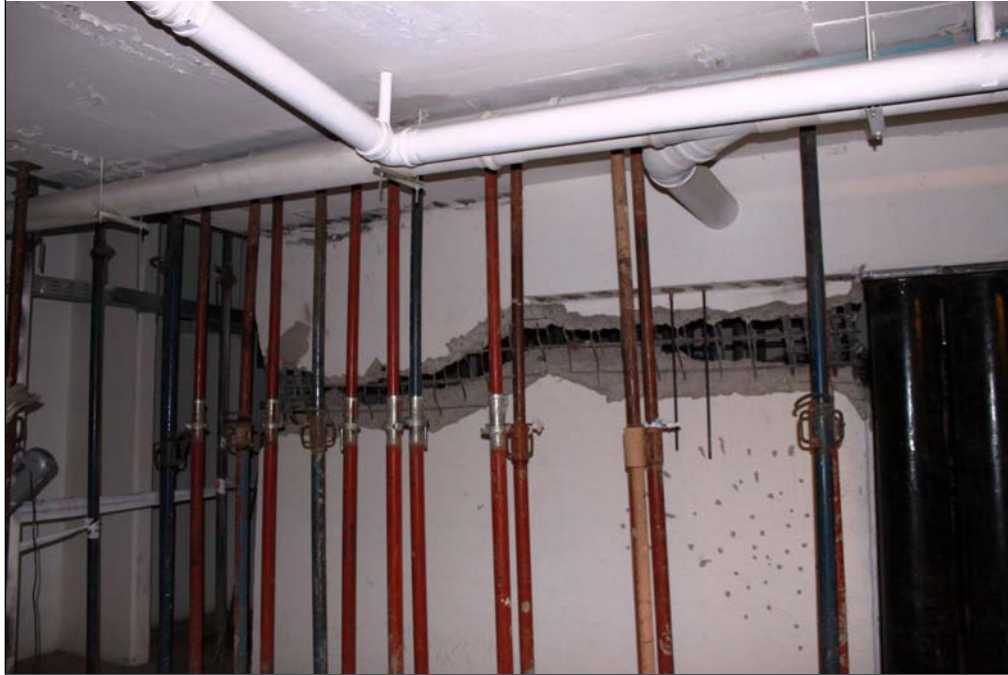
Av Los Leones 1841, Providencia, Santiago, Chile.

One of a few crushed walls in first level below grade.

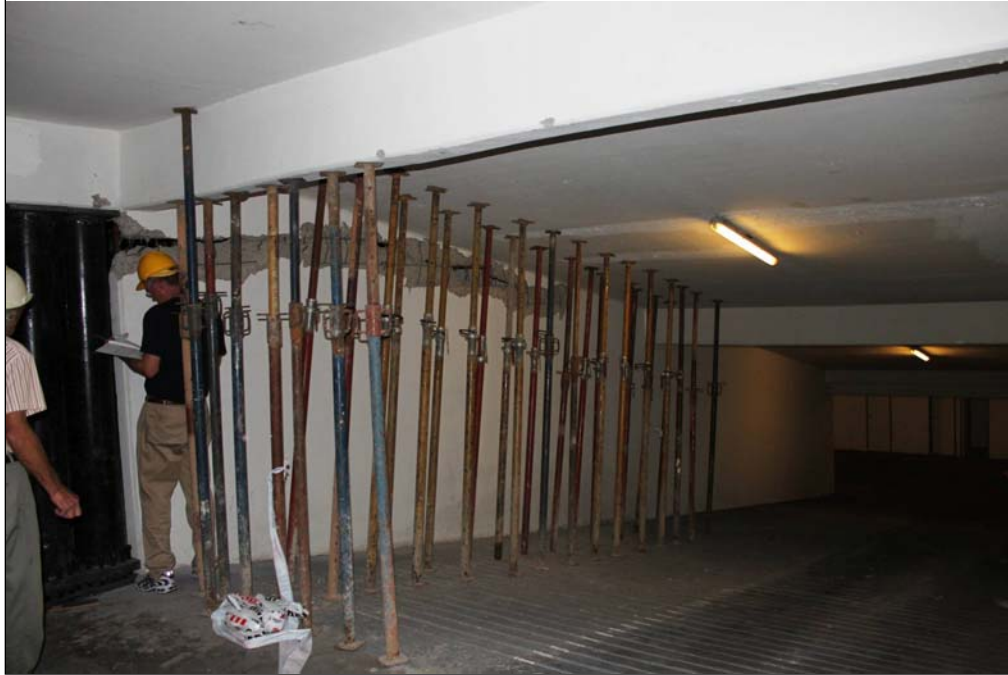
Av Los Leones 1841, Providencia, Santiago, Chile.

One of a few crushed walls in first level below grade.

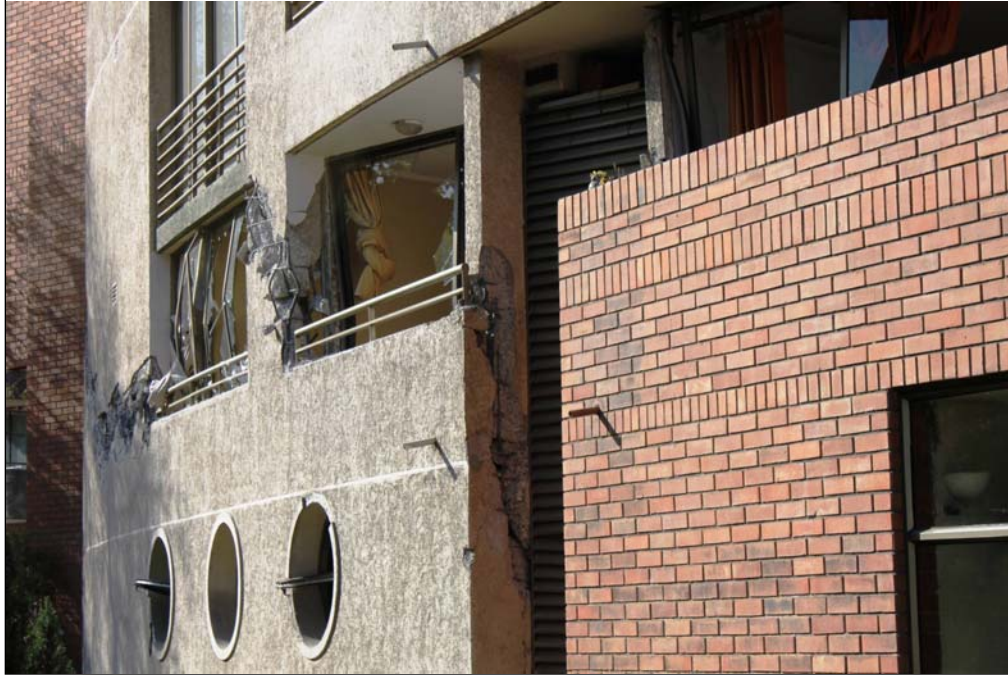
[Av Presidente Balmaceda 2150](#), Providencia, Santiago, Chile.

Failure of structural elements along the east part of the north face at the lower level.

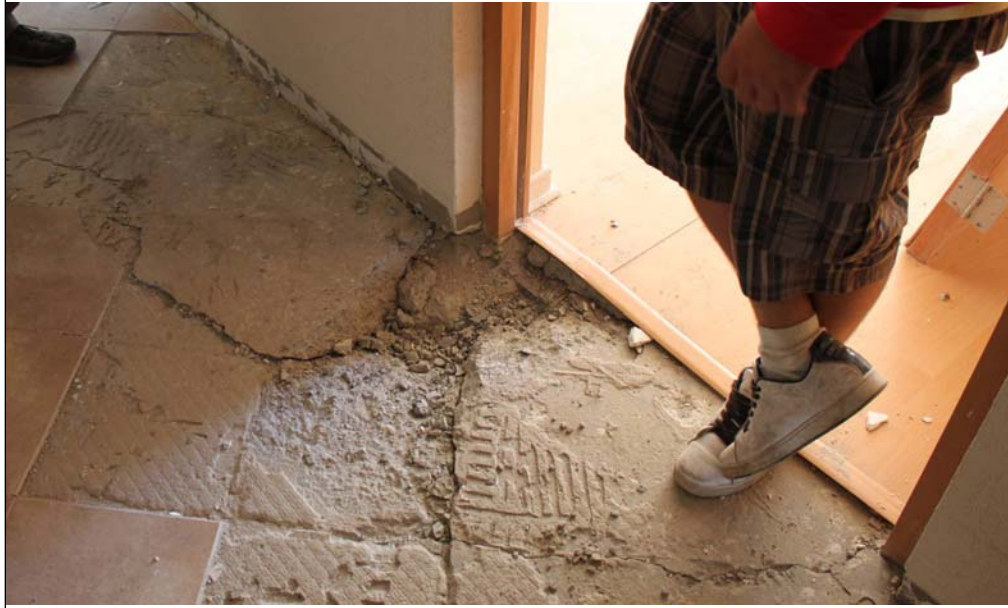
[Av Bernardo O'Higgins 901](#), Talca, Chile

Typical damage to slab coupling two walls either side of doorway. Note there is no beam here.

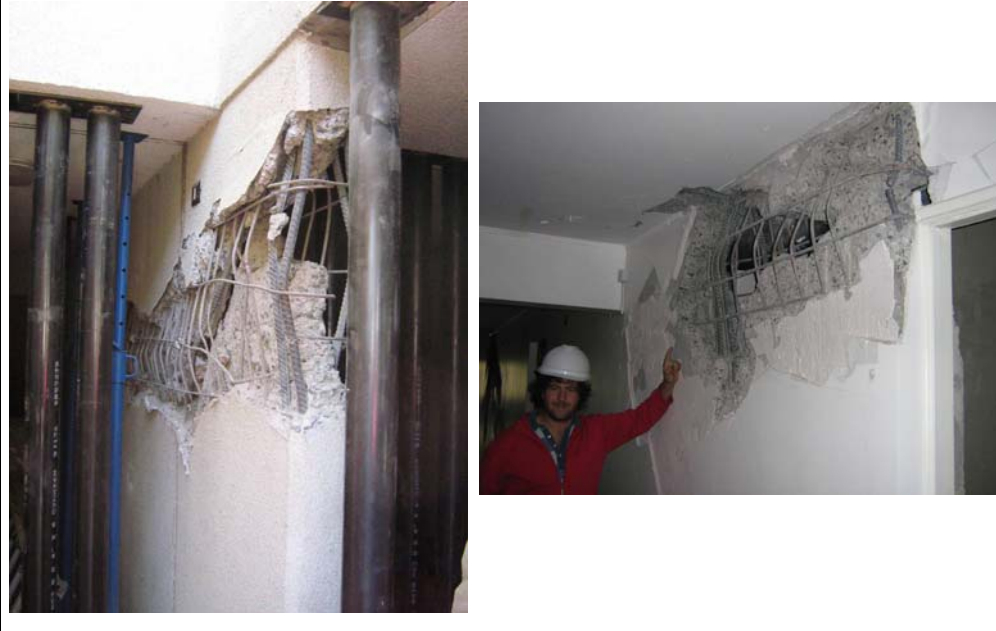
18 de Septiembre 235, Chillan, Chile

Walls showed characteristic damage at two locations.

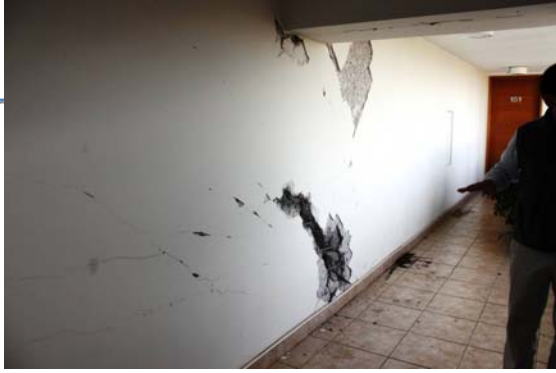
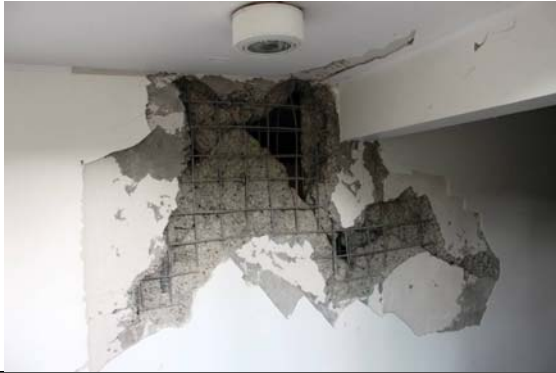
18 de Septiembre 235, Chillan, Chile

Series of door openings aligned over height and ended with solid wall at top story and at bottom story. Top and bottom wall segments were damaged in patterns suggesting strong coupling action at those levels.

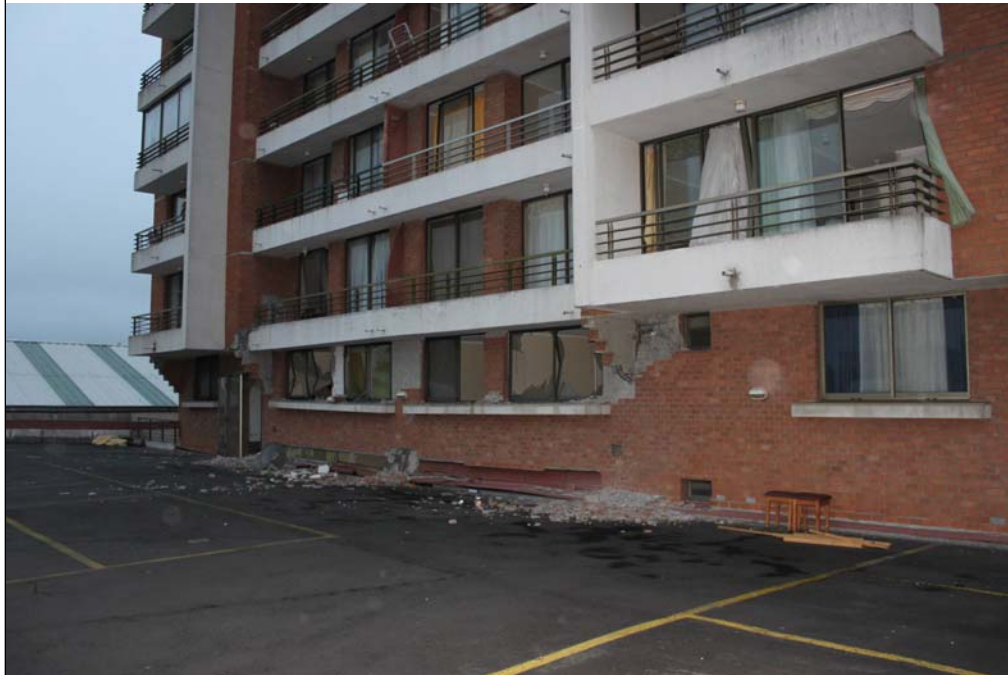
Av Los Carreras 1535, Concepción, Chile

Back view of the building. Walls are clipped gradually. Bent bars at this location spalled cover. Walls crushed adjacent to the start of the clip.

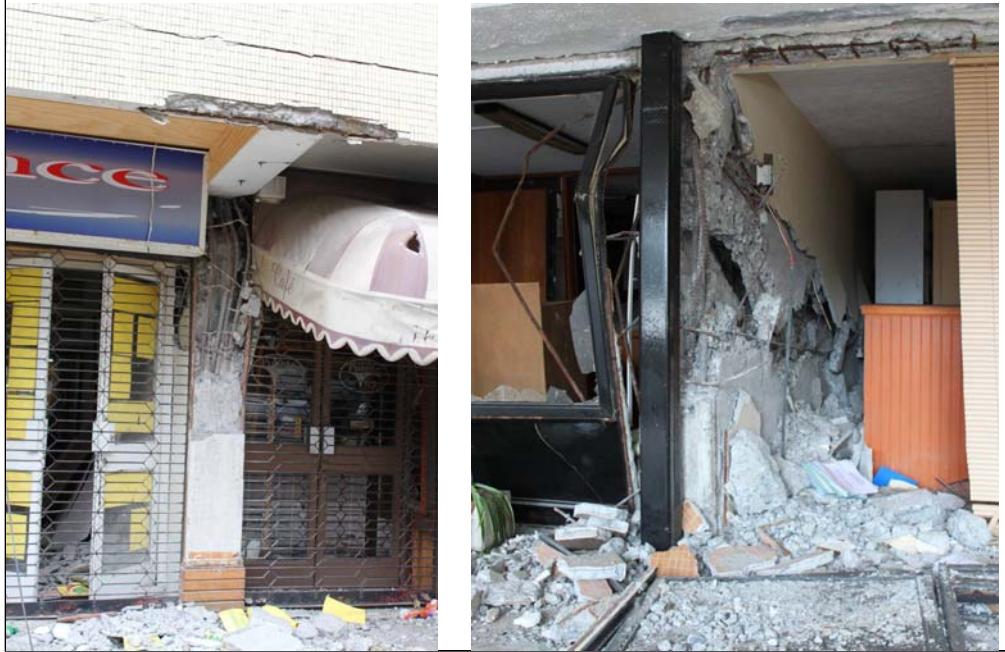
Lincoyan 440, Concepción, Chile

Crushed walls at street level.

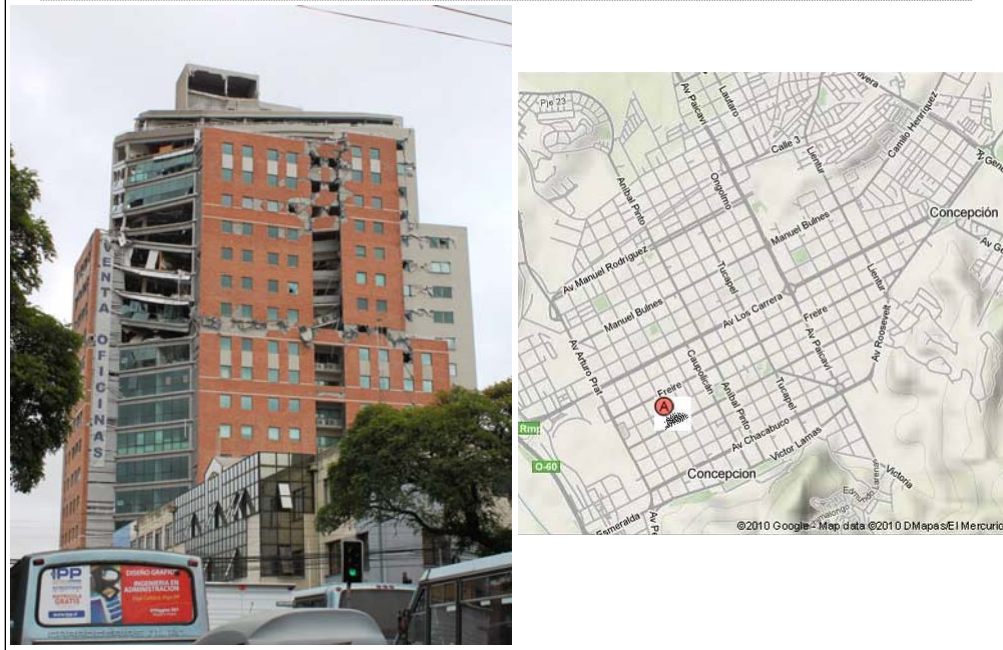
O' Higgins 241, Concepción, Chile

Note story collapse (1) at level of setback of the punched wall/frame in the foreground, (2) just above the punched frame to the left above the “venta” sign, and (3) just above the top of the punched wall/frame in the foreground.

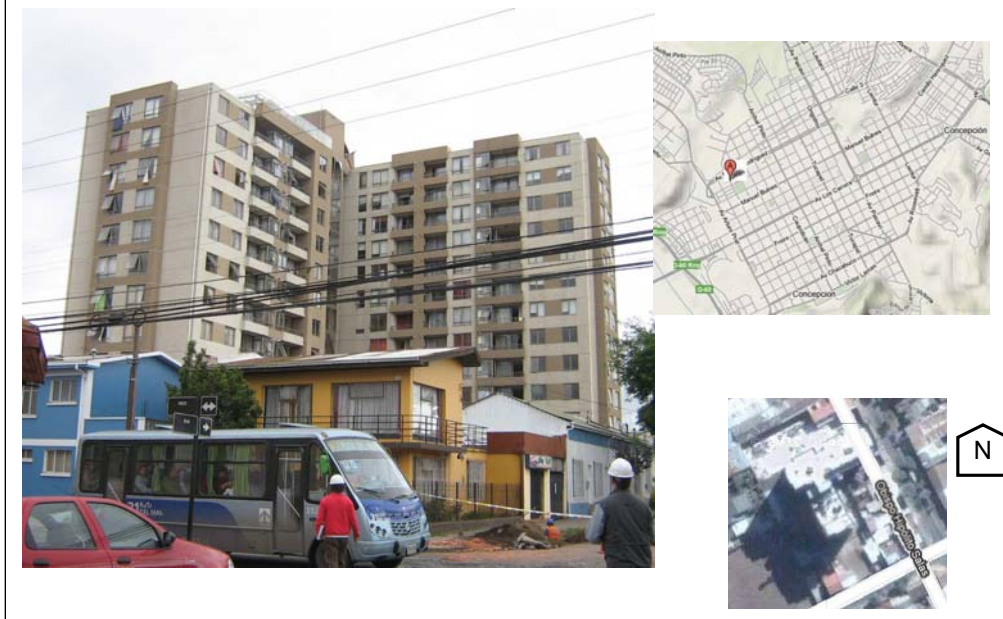
Obispo Hipolito Salas 1243, Concepción, Chile

The North tower was relatively undamaged, with minor cracking. The South tower was heavily damaged, and showed signs of foundation rocking.

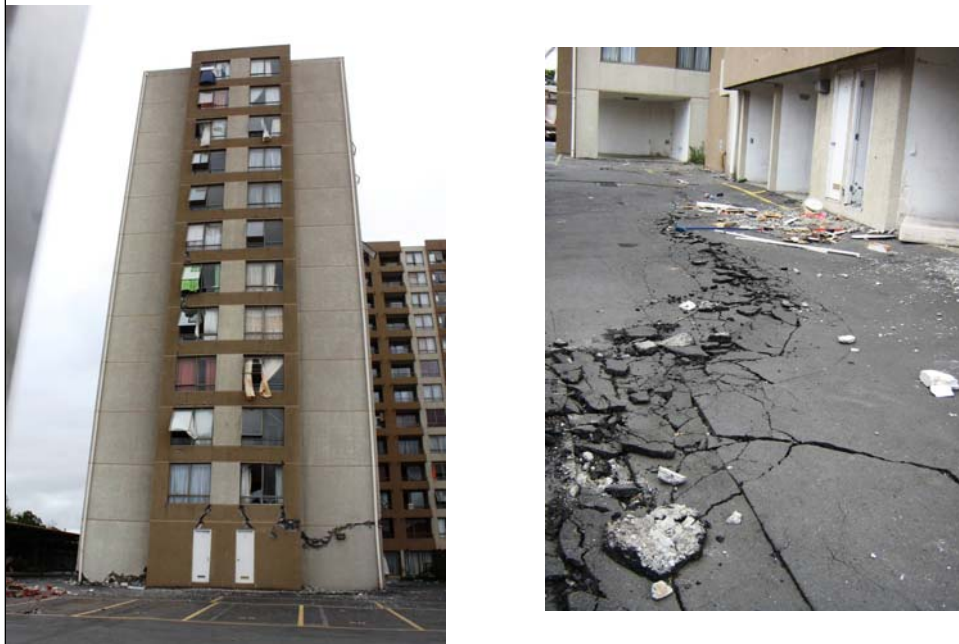
Obispo Hipolito Salas 1243, Concepción, Chile

View of the South tower. Gauging from the adjacent North tower, it appeared that the South tower was leaning about 1 foot at the roof.

Right photo shows damaged pavement around the west side of the South tower.

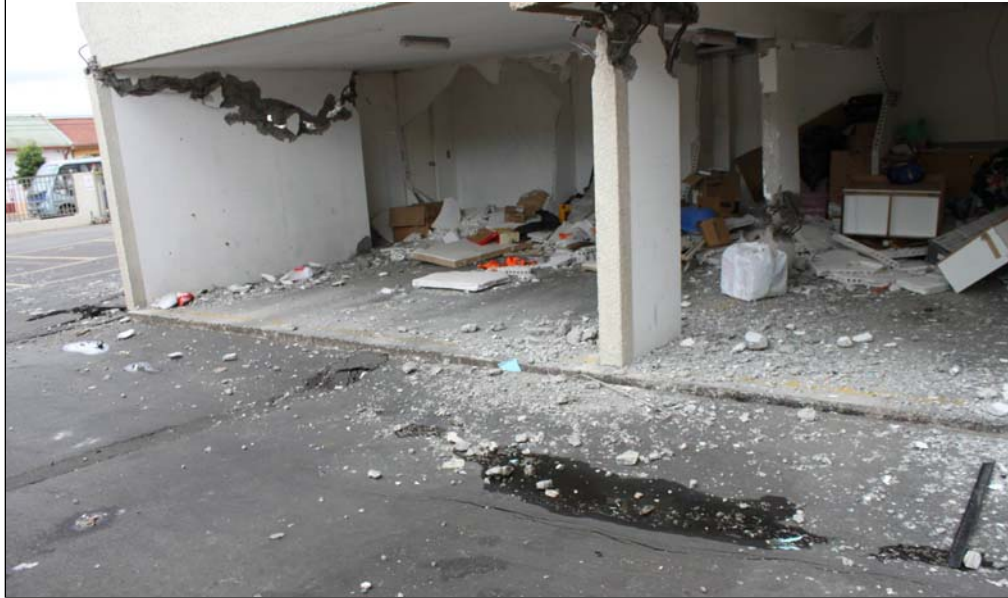
Obispo Hipolito Salas 1243, Concepción, Chile

Some walls were discontinuous and supported on piers, as shown, resulting in tension and compression damage to the piers, and apparent diaphragm transfers, as were evident in diaphragm cracking.

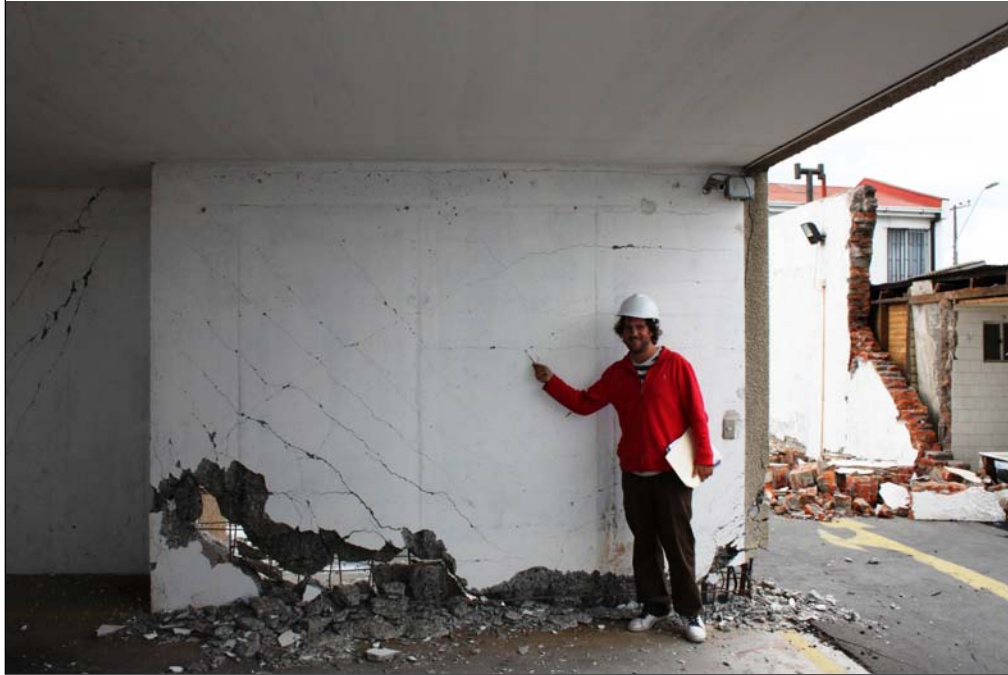
Obispo Hipolito Salas 1243, Concepción, Chile

Some walls showed inclined cracks indicative of damage due to shear.

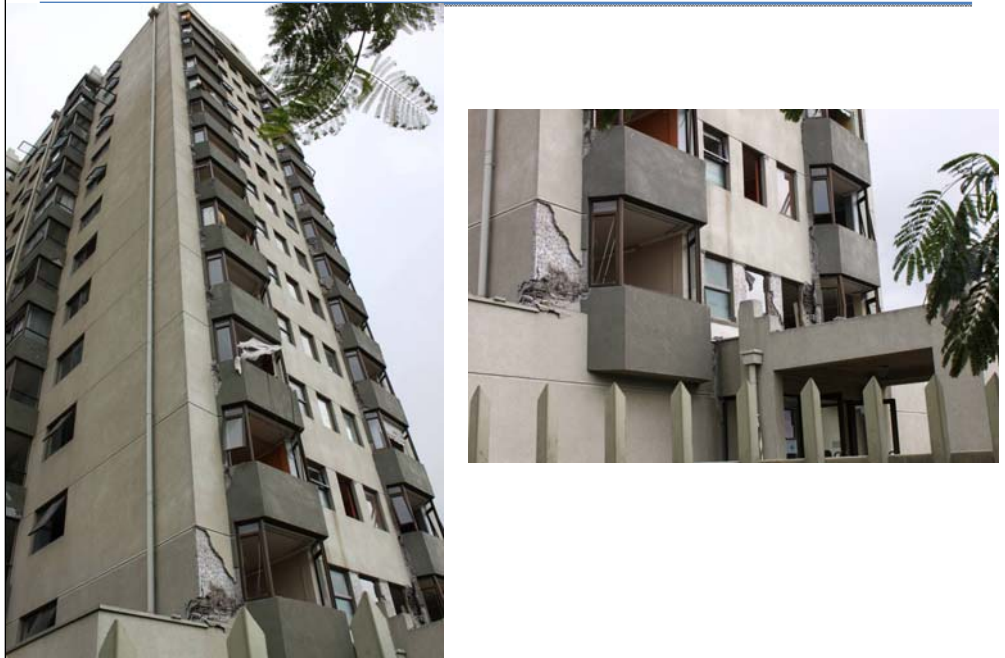
Castellón 1367, Concepción, Chile

Walls damaged above the first floor. Note also the damage to walls at the intersection of the balcony beams with the walls. The appearance is of out-of-plane coupling.

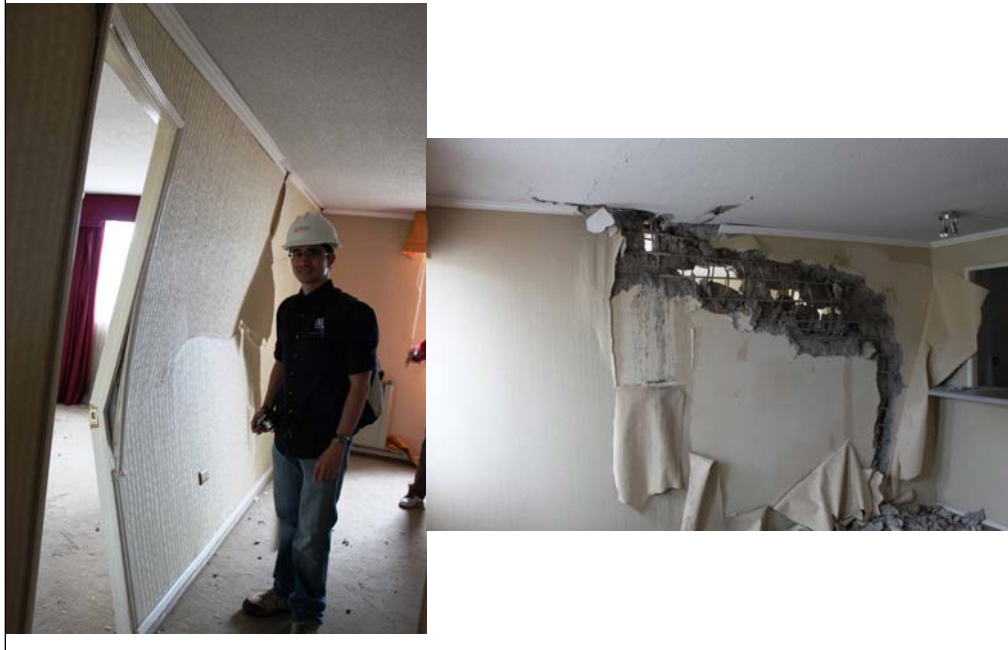
Castellón 1367, Concepción, Chile

In one room, looking to the right wall is a crushed concrete wall, and looking to the left the partition wall has buckled due to shortening of the story.

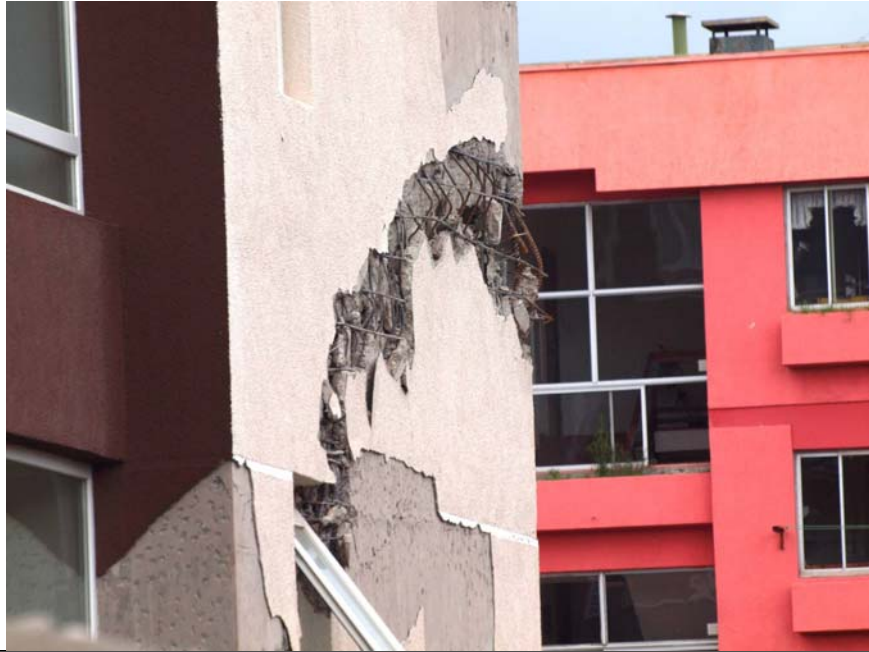
Salas 445, Concepción, Chile

Damage to exterior wall around the right side of the building toward the back.

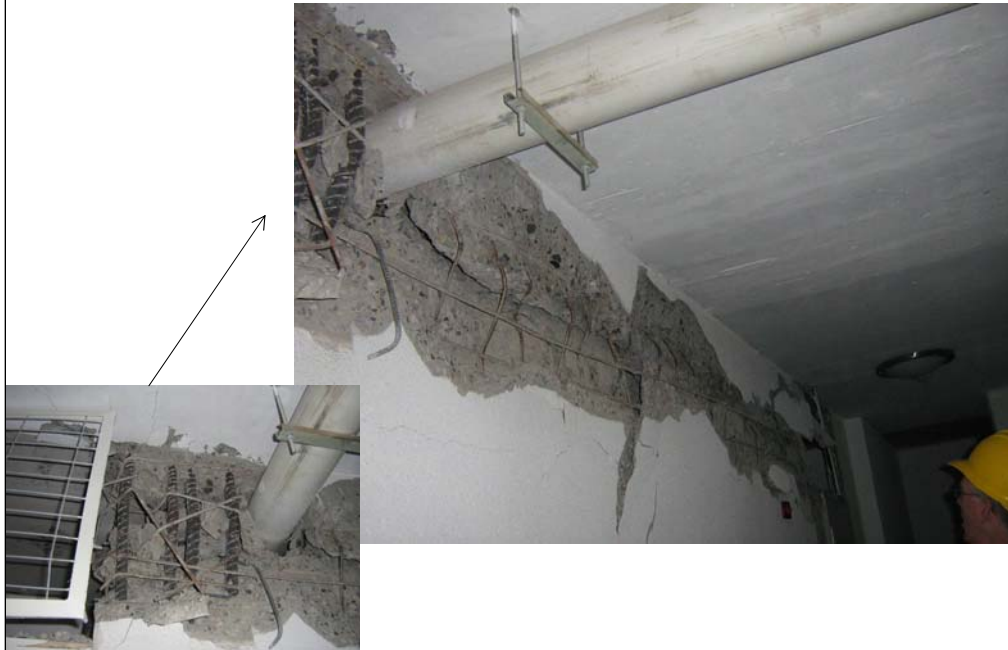
Salas 445, Concepción, Chile

Crushing damage in the first subterranean level.

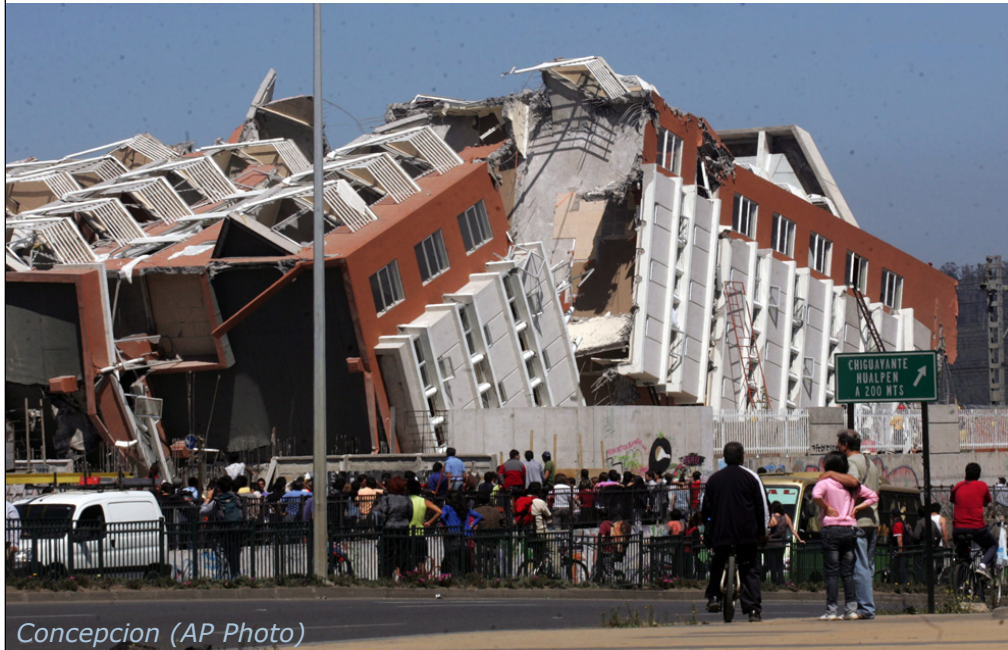
Concepción, Chile

Building fell toward the photographer. Viewing roof.

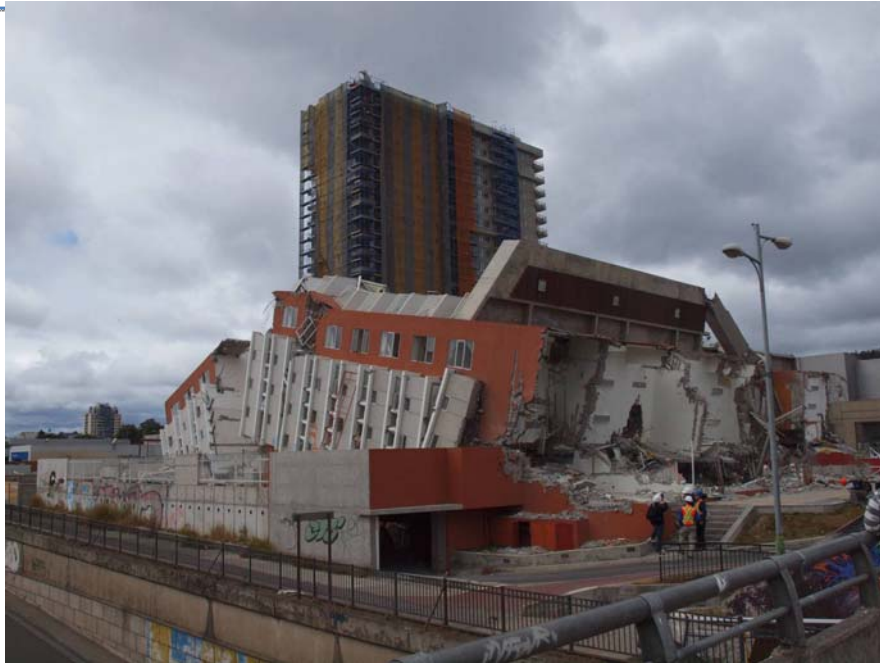
Concepción, Chile

Building fell away from the photographer. Viewing underneath building.
