Repair/Upgrade Procedures for Welded Beam to Column Connections

James C. Anderson

Report No. PEER-98/03
Pacific Earthquake Engineering Research center
College of Engineering
University of California, Berkeley
May 1998

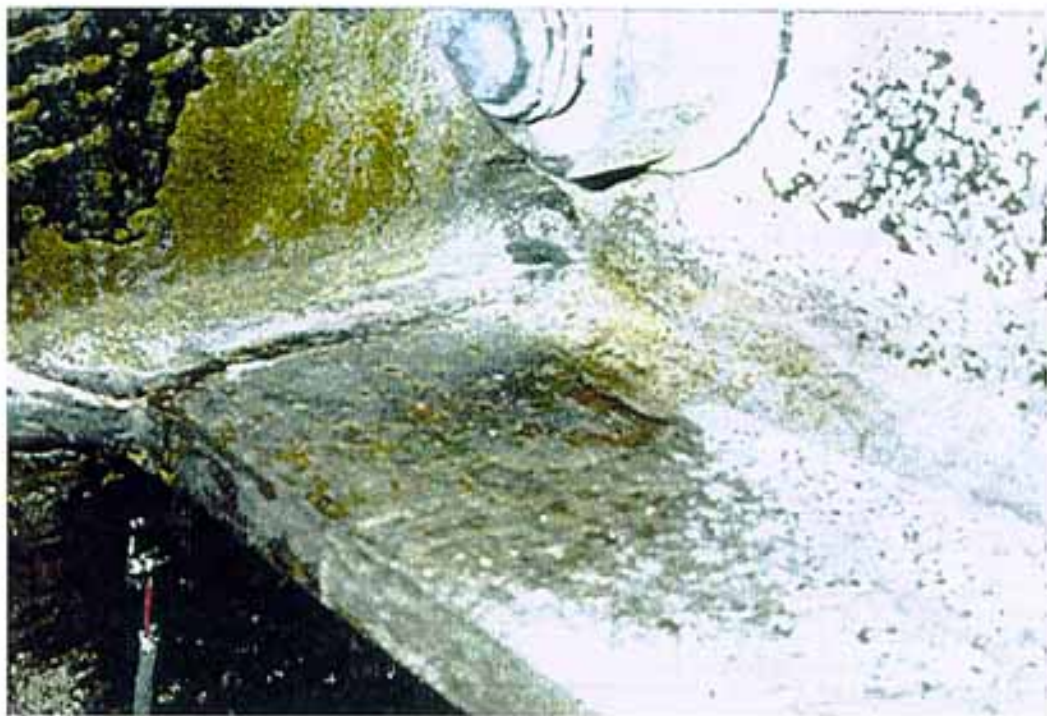
Figure 4.2.2 Repaired Bottom Flange Weld, Spec. 1R

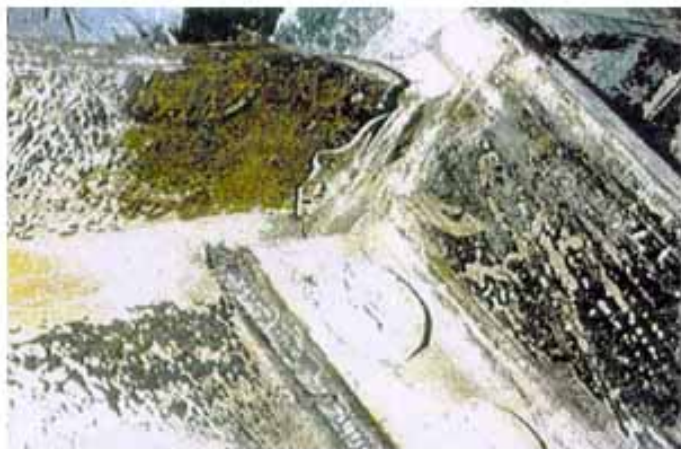
Figure 4.2.4 Crack in Top Flange of Beam, 1R

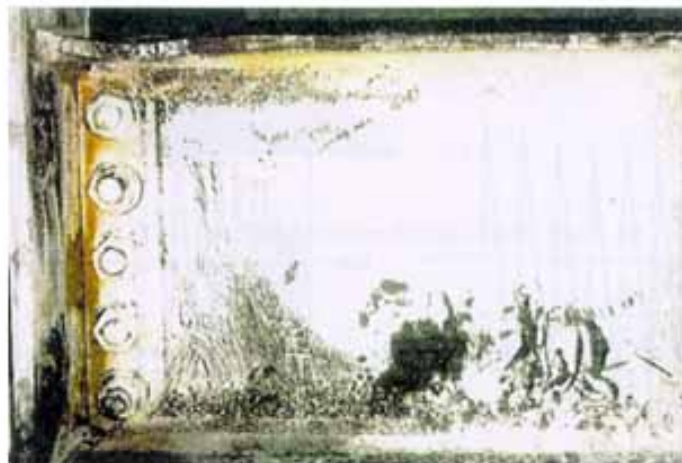
Figure 4.2.5 Plastic Hinge in Beam, 1R

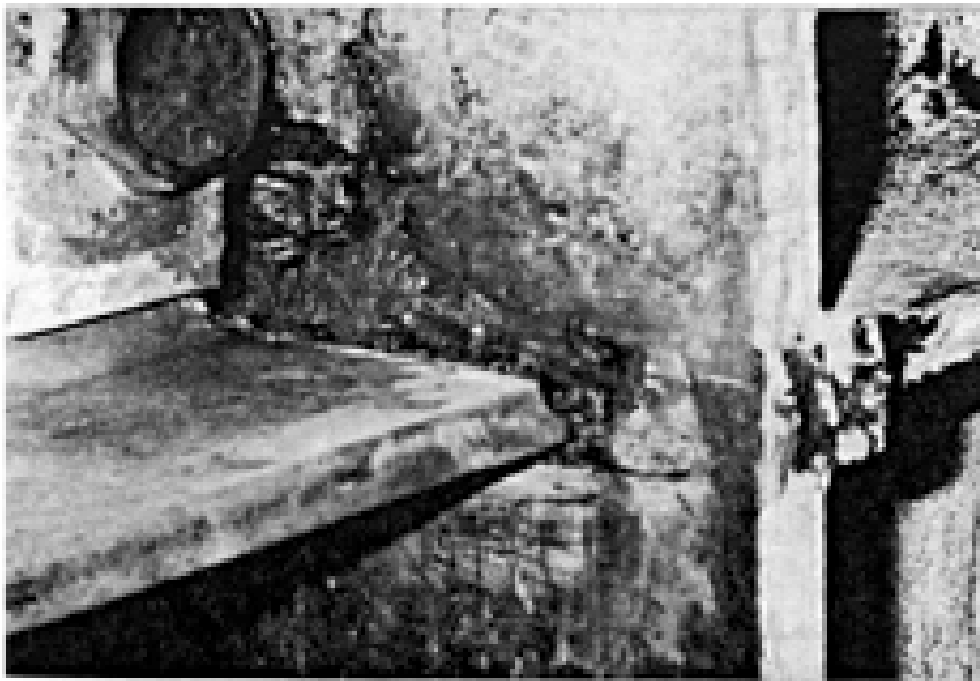
Figure 4.4.1 Gouged Out Crack, Spec. 2R

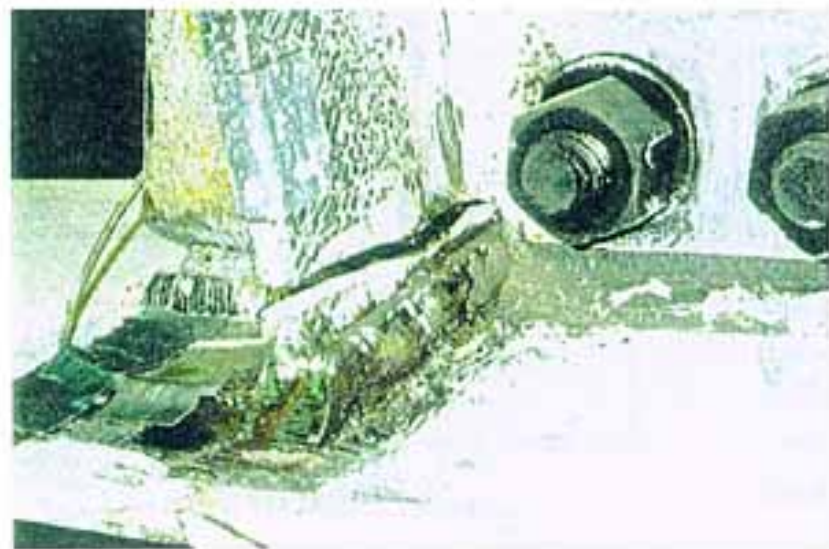
Figure 5.1.5 Fracture at Beam Top Flange, Spec. 3

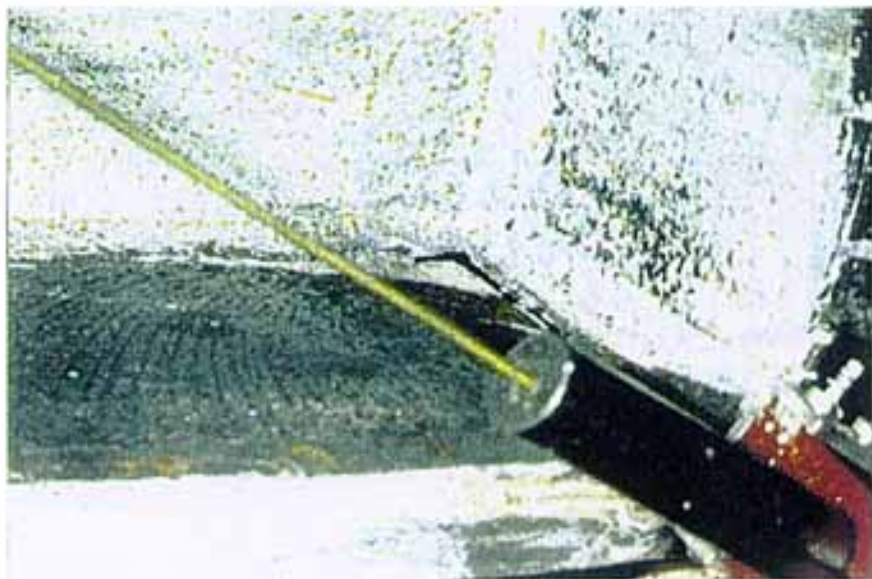
Figure 5.3.5 Crack in Panel Zone, Spec. 6

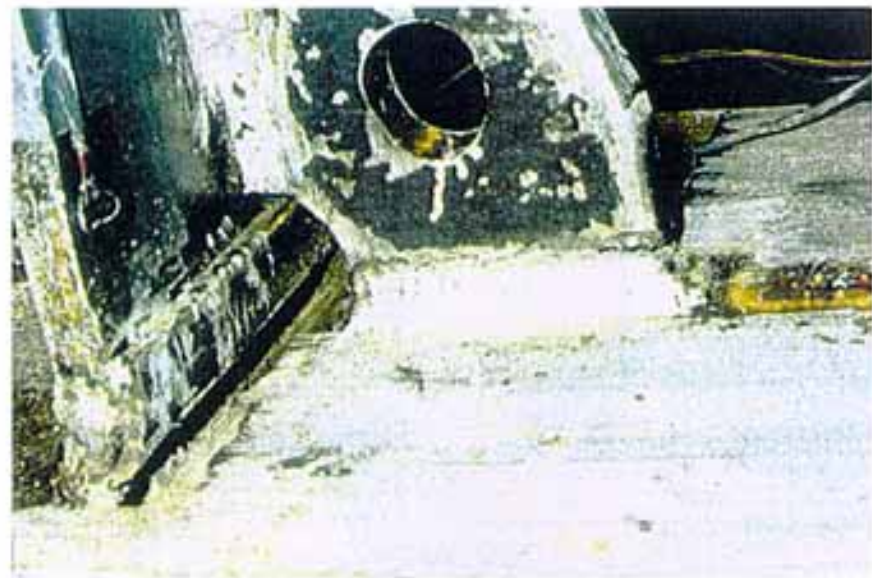
Figure 5.3.4 Pullout at Beam Bottom Flange, Spec. 6

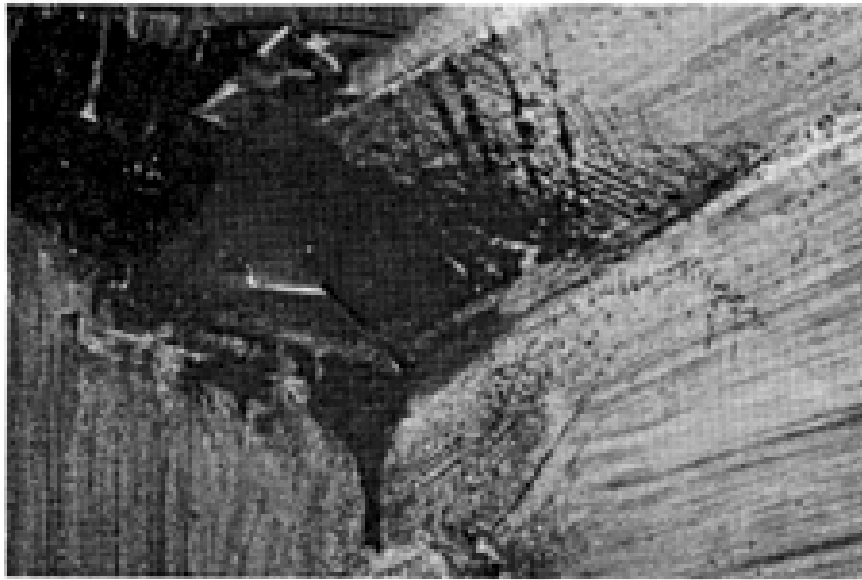
Figure 6.4.5 Crack in Top Flange of Beam

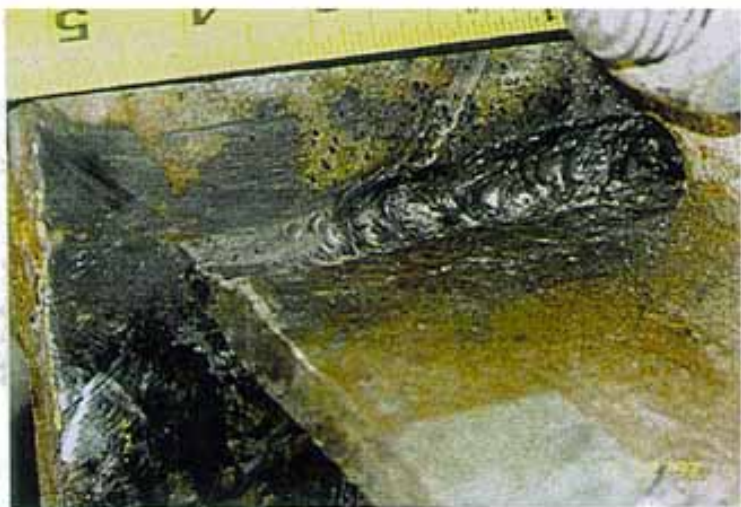
Figure 7.2.2 Gouged Out Top Side, Bottom Flange, Spec. 10

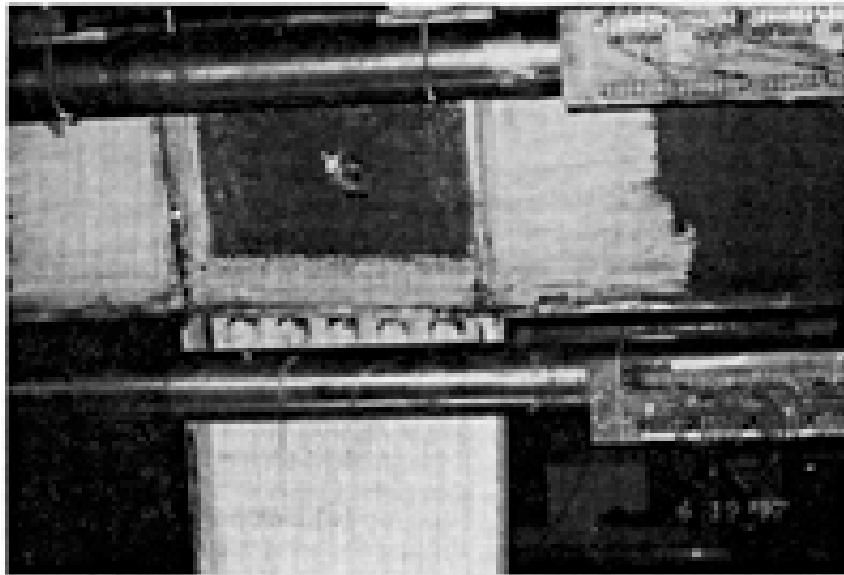
Figure 7.2.6 Panel Zone Deformation, Spec. 10

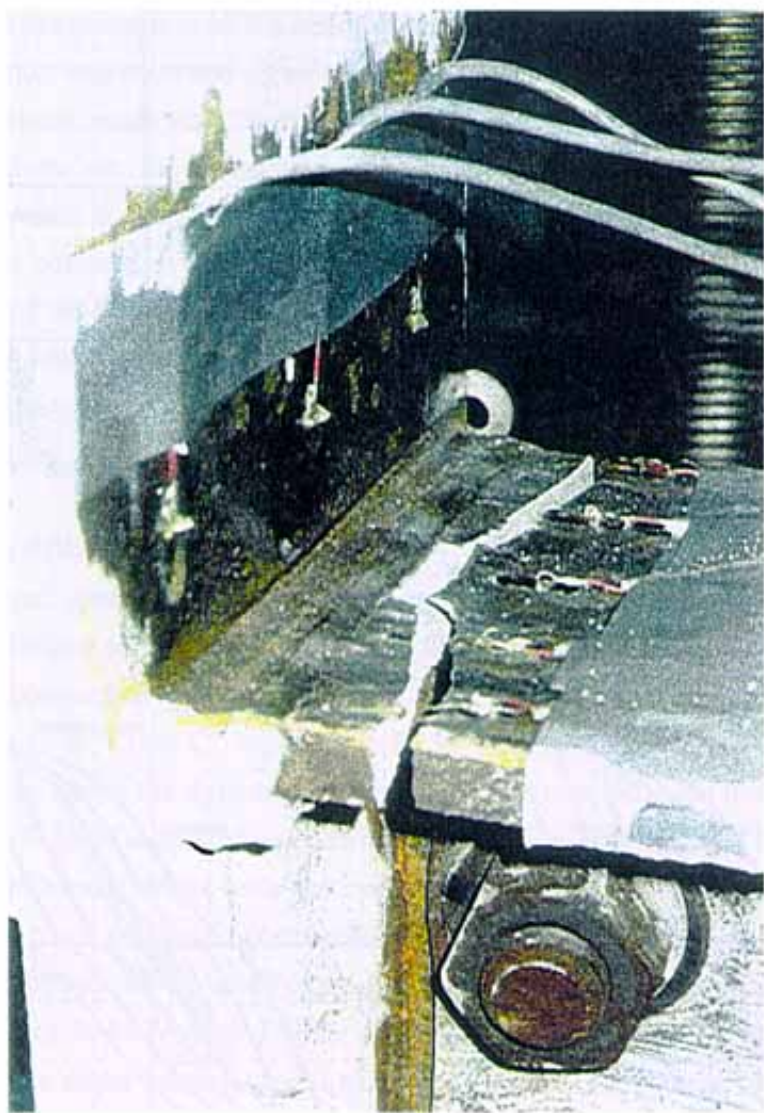
Figure 7.3.4 Crack in HAZ of Beam Top Flange, Spec 11

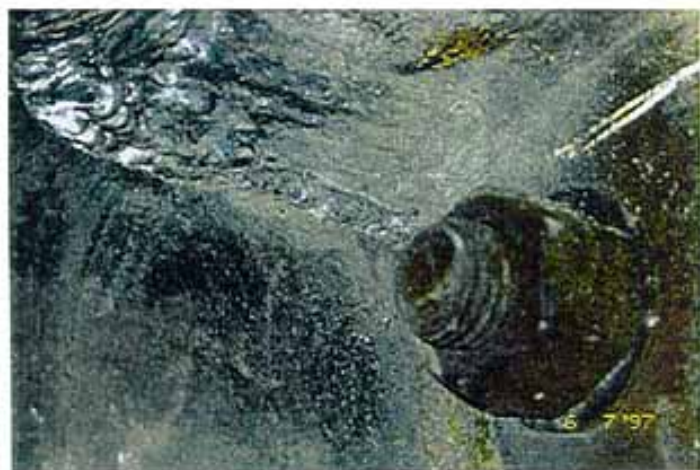
Figure 7.4.2 Overlay Weld at Top Flange; Spec. 14

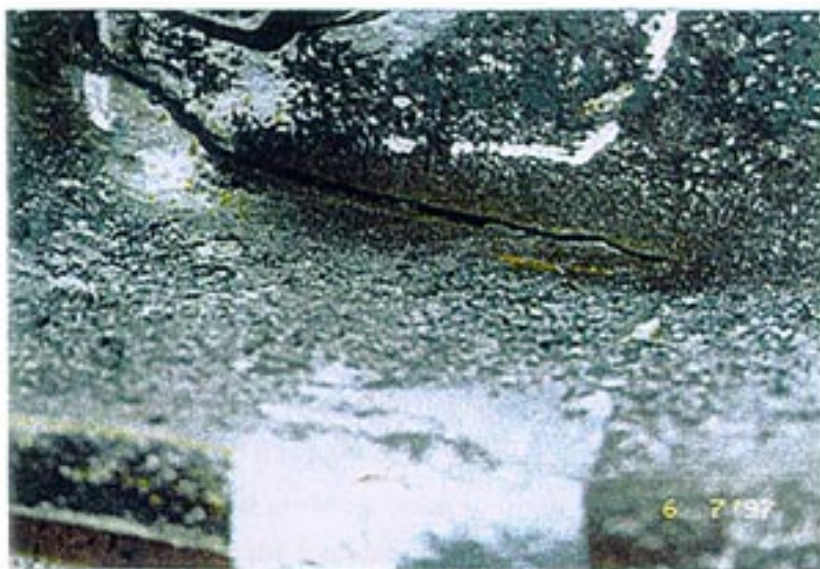
Figure 7.4.5 K-Line Slit at Beam Top Flange, Spec. 14

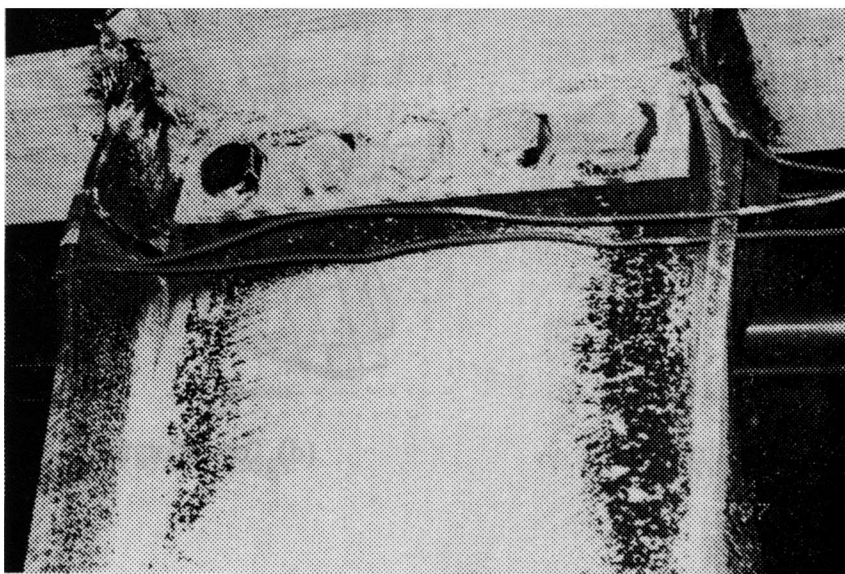
Figure 7.4.7 Buckled Flange Fracture, Spec. 14

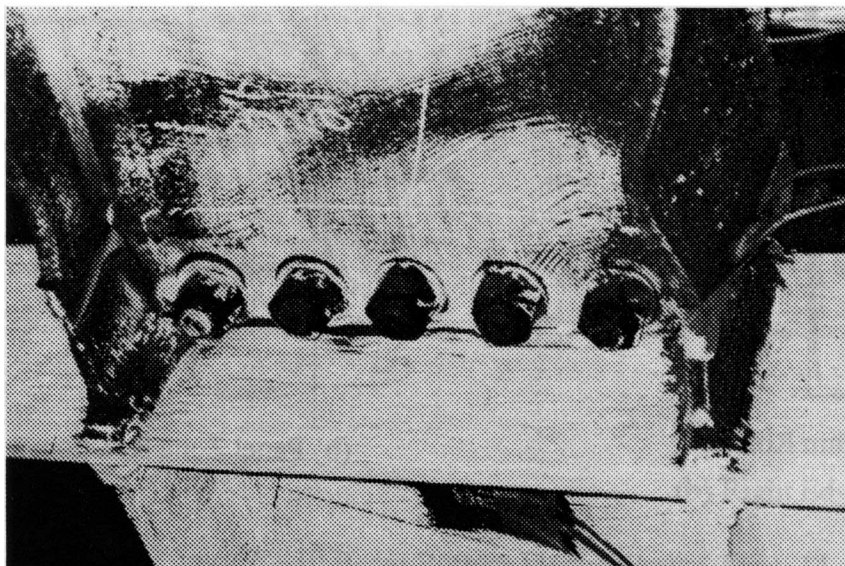
Figure 7.4.8 Bolt Slippage and Flange Buckle, Spec. 14

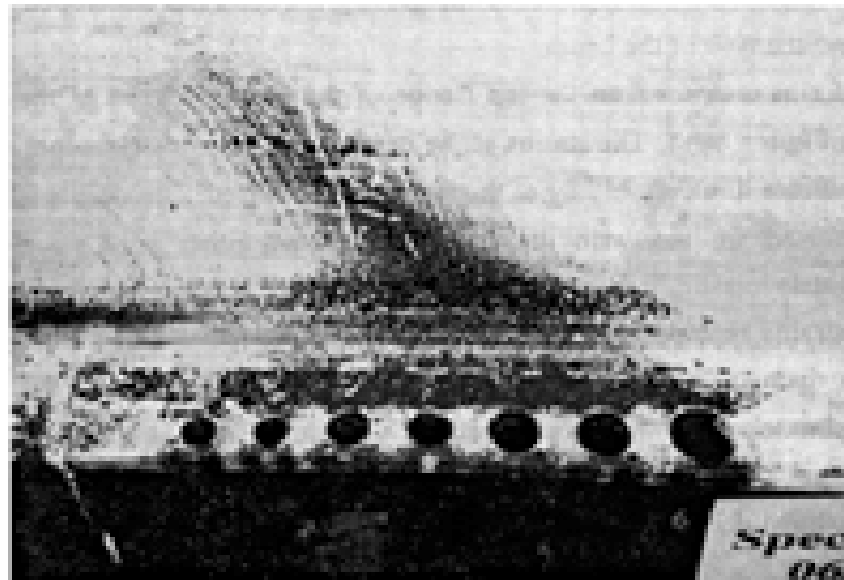
The plastic hinge has been shifted from the column face to the center of the hole group as shown in **Figure 8.1.6**. The holes in the bottom flange of the beam, some of which are out of round, are shown in **Figure 8.1.7**. This figure indicates that the holes have worked as planned and that there has been no tearing either between holes or between the hole and the edge of the flange. A yield band has developed between the hole pattern and the web of the beam.

Figure 8.1.6 Yielding in Flange Perforations, Spec. 13
