Bracing Berkeley

A Guide to Seismic Safety on the UC Berkeley Campus

PEER 2006/01
Pacific Earthquake Engineering Research Center
College of Engineering
University of California, Berkeley
January 2006

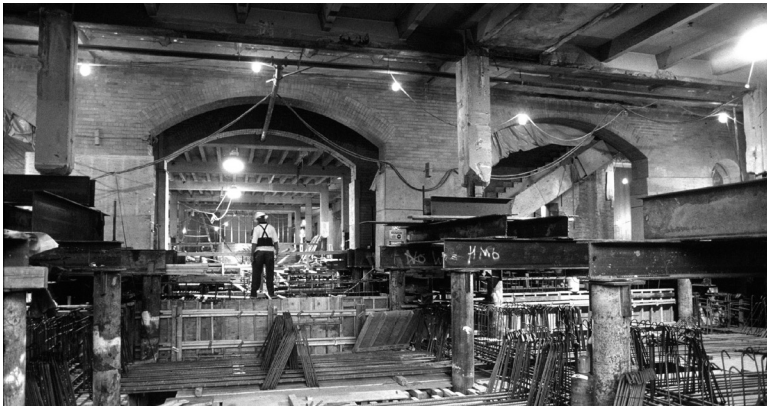
RIGHT:
Detail of installation of base isolators

tal direction, allowing the building to safely ride out earthquakes. The technology was pioneered by UC Berkeley Engineering faculty more than twenty years previously. Base isolators are made with elastomeric bearings that decouple the building from the horizontal components of the ground motion by interposing structural elements with low horizontal stiffness between the structure and the foundation. This layer gives the structure a fundamental period that is much higher than that of a fixed-base foundation system. The type of isolators used for HMMB are called “multilayered laminated rubber bearings,” with steel-reinforcing layers as the vertical load-carrying component of the system. Because of the reinforcing steel plates, these bearings are very stiff in the vertical direction, but are flexible in the horizontal direction. Easy to manufacture, these bearings have no moving parts and are very resistant to environmental degradation.

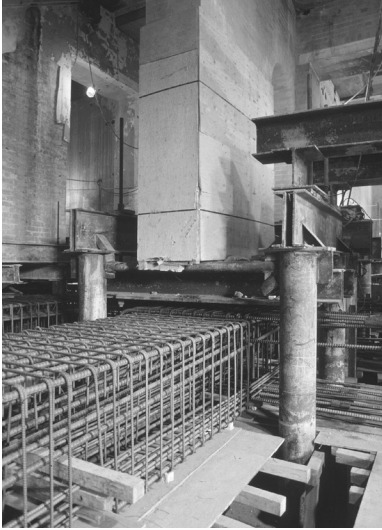
LEFT:
Detail of installation of base isolators.

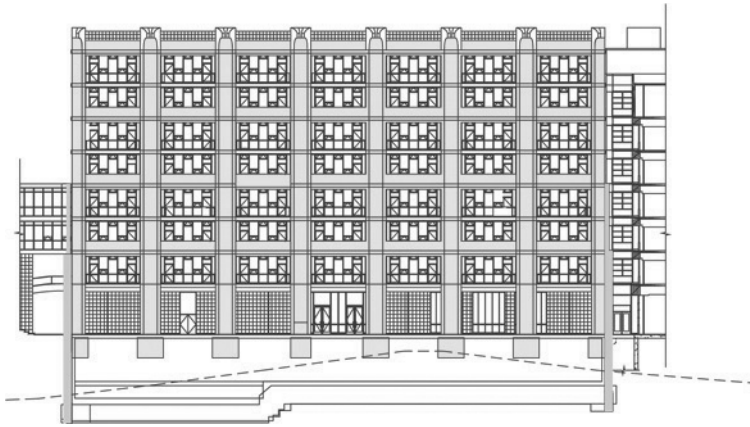
ABOVE:
Elevation showing placement of box
columns.

This brief review of the building determined that in the case of a Rare earthquake (one with a 10 percent chance of occurring within fifty years) the building would perform with a Poor, or near-collapse, rating. This expected performance was due mainly to deficiencies in the longitudinal lateral force-resisting system. The box columns and the floor slabs spanning the distance between them were designed to act as moment frames that resisted applied shear force. However, the floor slabs were not continuous through the box columns, and their attachment to the columns was insufficient for the system to behave like a true frame in the event of a strong lateral load. The other longitudinal walls were too slender to add significant lateral support. Other deficiencies were also noted in the transverse direction, namely that the stress in the transverse shear walls would exceed capacity, and that openings at the first level of these walls weakened them.

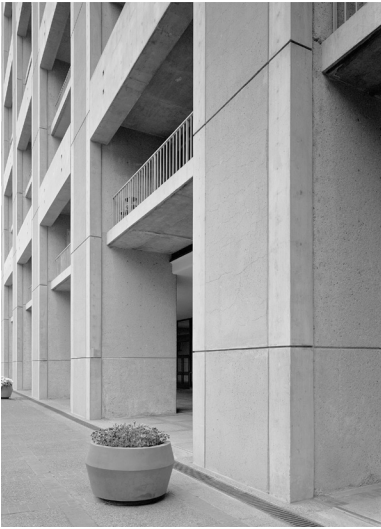
LEFT:
Detail of box columns.

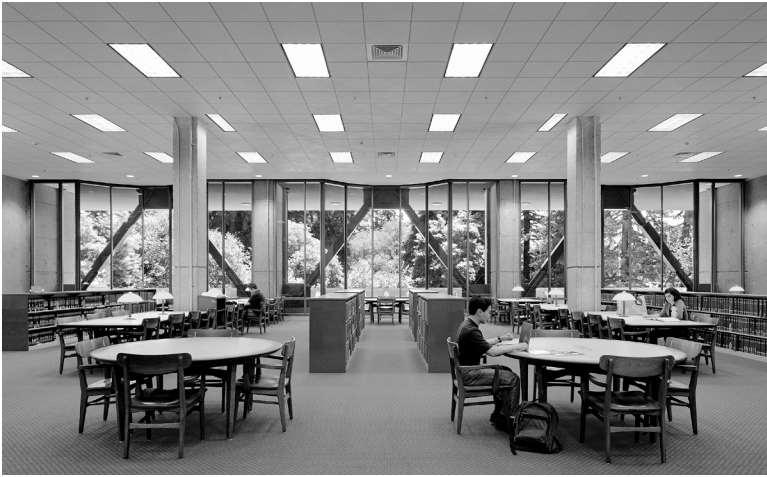
ABOVE:
Interior view of unbonded braces.

tion to anti-seismic technology. Unbonded braces work in a simple and elegant manner. In a traditional steel cross-brace, lateral forces are resisted axially by each cross-member. An applied lateral force will stretch one cross-member in tension and shorten the other in compression. Unbonded braces are made of steel (which is strong in tension) and concrete (which is strong in compression), enabling the braces to exhibit nearly identical properties in both tension and compression. In addition to the braces, new concrete shear walls providing lateral support were added to the two lowest stories, and on the east, west, and south sides a portion of the shear walls extended up to the roof. The walls around the stair cores were strengthened and reinforcement was added to the column-to-slab connections, mitigating the threat of punching shear by the columns. The connections between the precast panel hangers and the roof and floor slabs were strengthened as was the mezzanine level of the library.

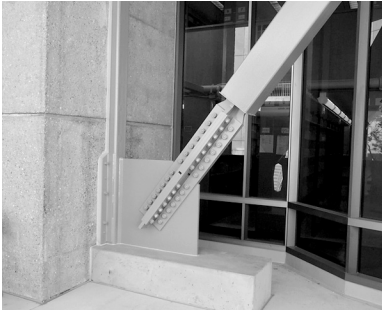
LEFT:
Detail of unbonded brace.

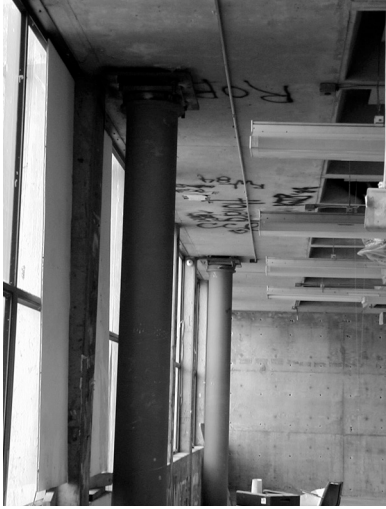
ABOVE:
New interior steel columns in the tower.
BELOW:
Reinforcing bars in new drag struts.

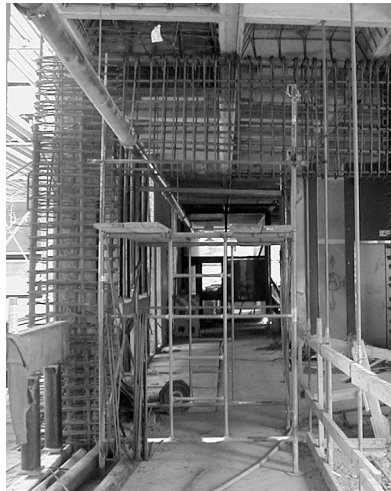
ABOVE:
Rebar laid out for foundation.
RIGHT:
Construction of new shear wall.

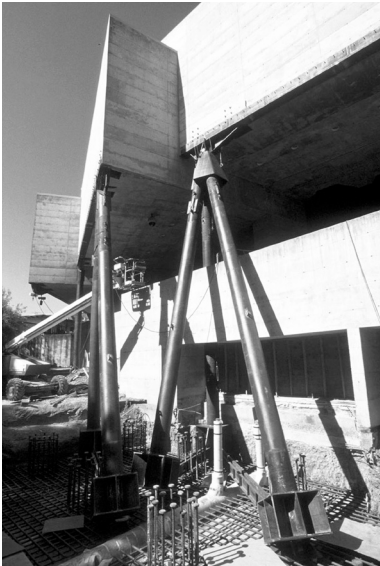
LEFT:
Installation of exterior steel columns.

The exterior retrofit system is designed to catch the building in the event of an earthquake. If the primary structure fails, the steel columns, which are not otherwise structurally loaded, will take over and keep the building from collapsing. These columns sit below the cantilevered galleries and atop new foundation work that includes a series of 3-foot to 3-foot 6-inch piers embedded to depths of up to 60 feet and capped together at grade. The interior system consists of new steel columns that brace the building in vulnerable areas and carry the loads all the way to the foundation. At the perimeter of the galleries, steel trusses tie the building together across the skylights to create continuous diaphragms. Overall, the strategy is an attempt to protect the building against collapse, but it does not incorporate any lateral interior bracing, tree wall strengthening, or tying together of the discrete gallery wings. Due to these deficiencies, the Pacific Film Archive, which can accommodate a relatively high concentration of people at a given time, chose not to reoccupy the building.

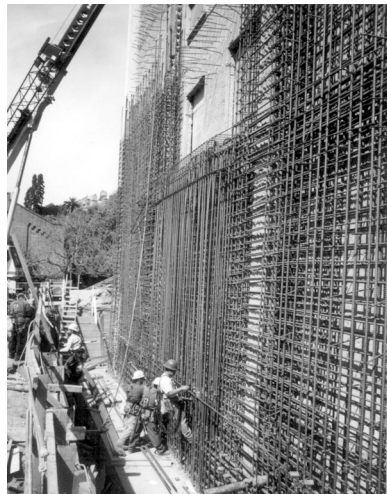
ABOVE AND RIGHT:
View of installation of rebar for new shearwalls.
