PEER Preliminary Notes and Observations on the August 24, 2014, South Napa Earthquake

Pacific Earthquake Engineering Research Center

Report No. 2014/13

September 17, 2014

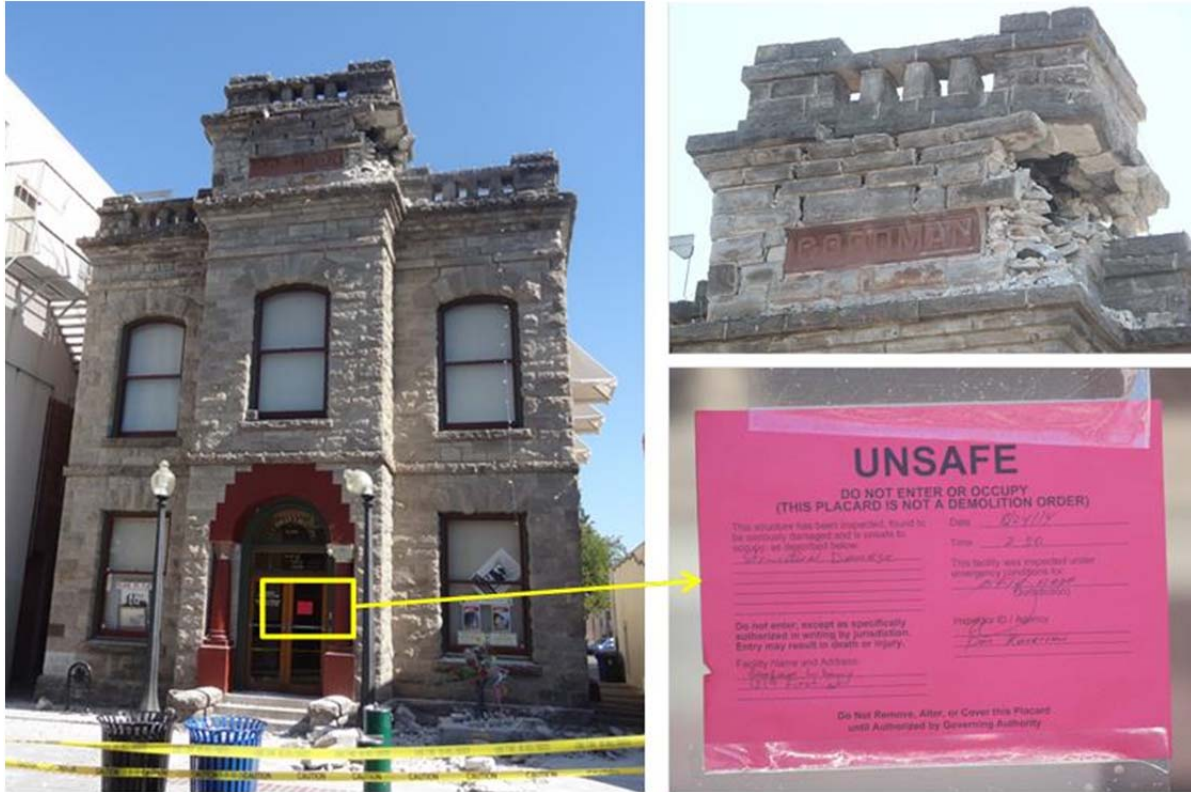
Figure 7 Overview of Goodman historical library building (Building A in the map in Figure 6) and red tag displayed at the building's entrance.

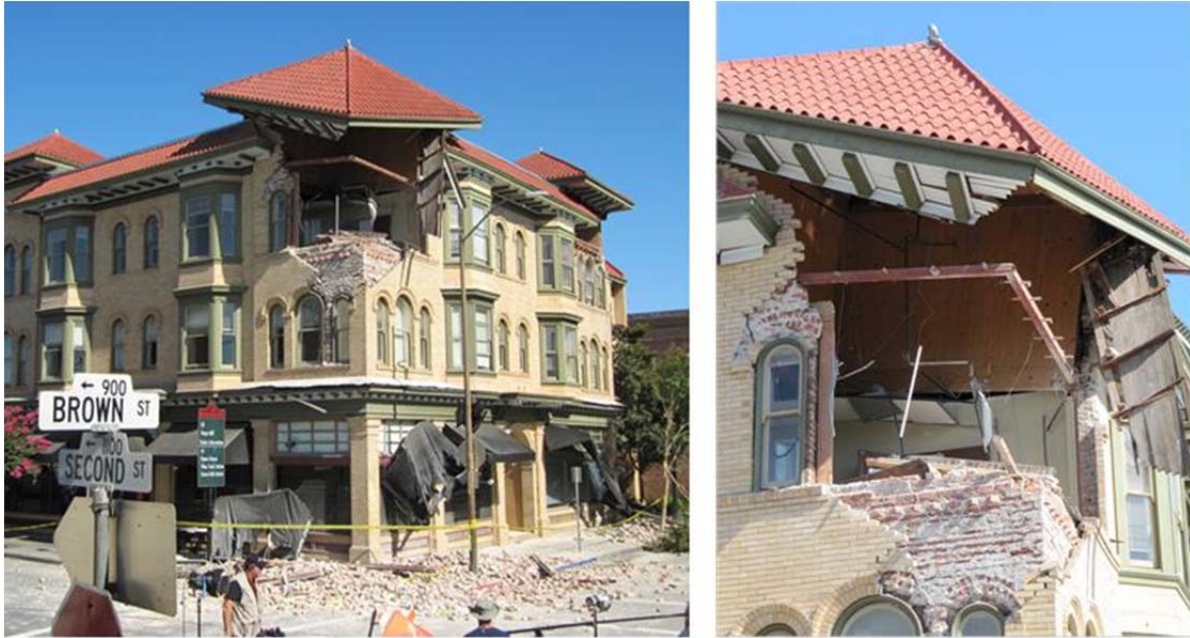
Figure 8 Overview of supporting column and walls at commercial building's top corner (Building B in the map in Figure 6).

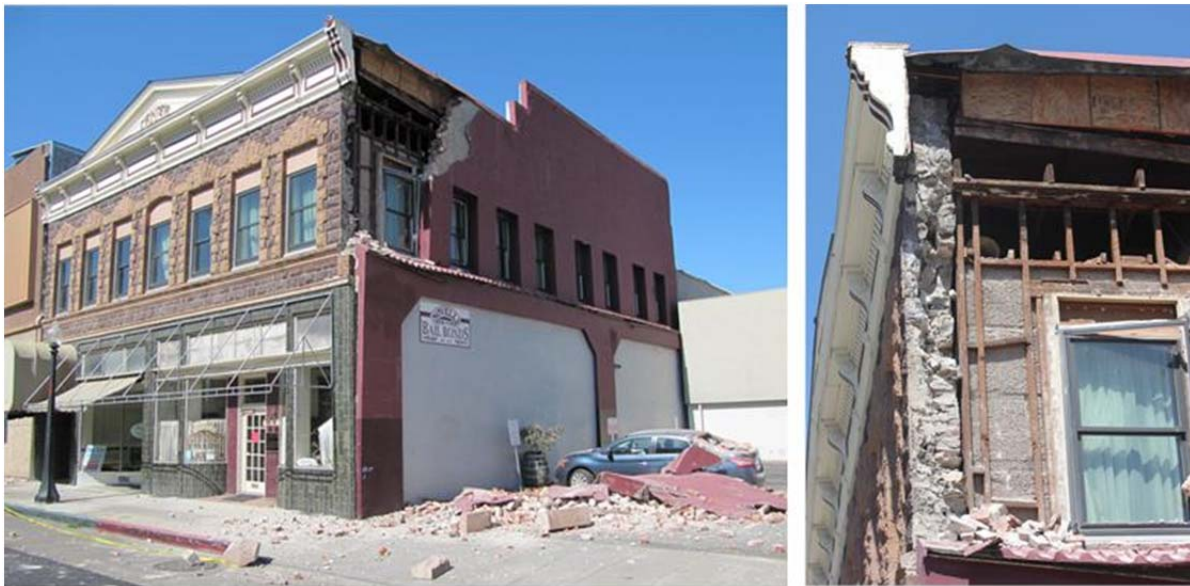
Figure 9 Overview of side wall collapse of a commercial building leading to a the damage of a car parked next to the building (Building C in the map in Figure 6).

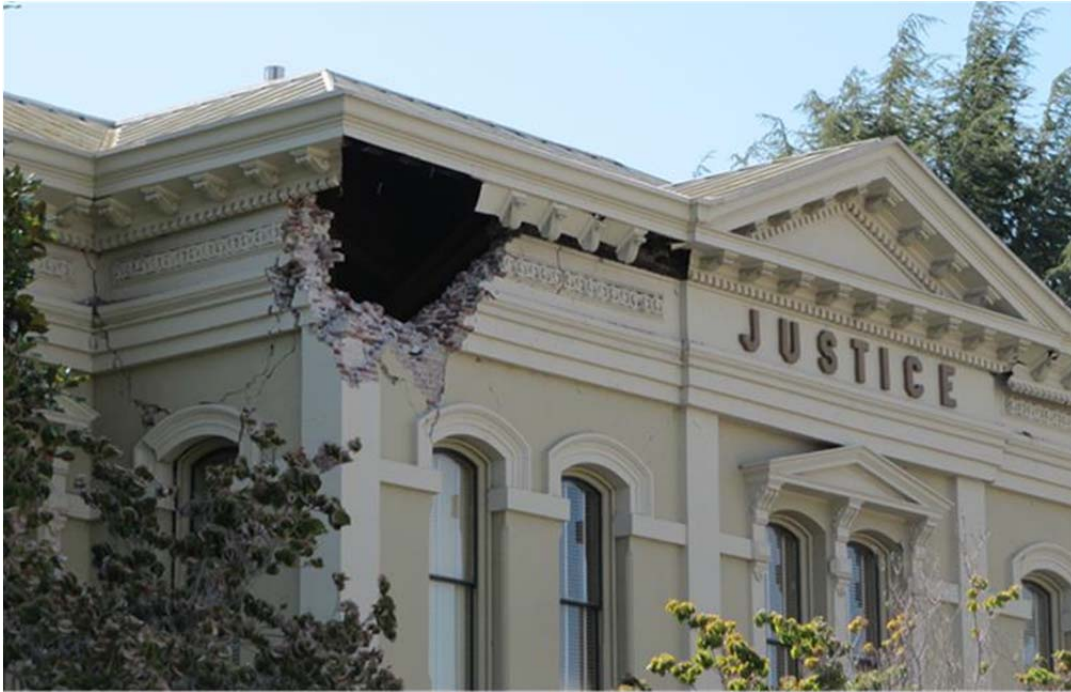
Figure 10 Damage and wide cracks in the top floor bearing wall of Napa Court House (Building D in the map in Figure 6).

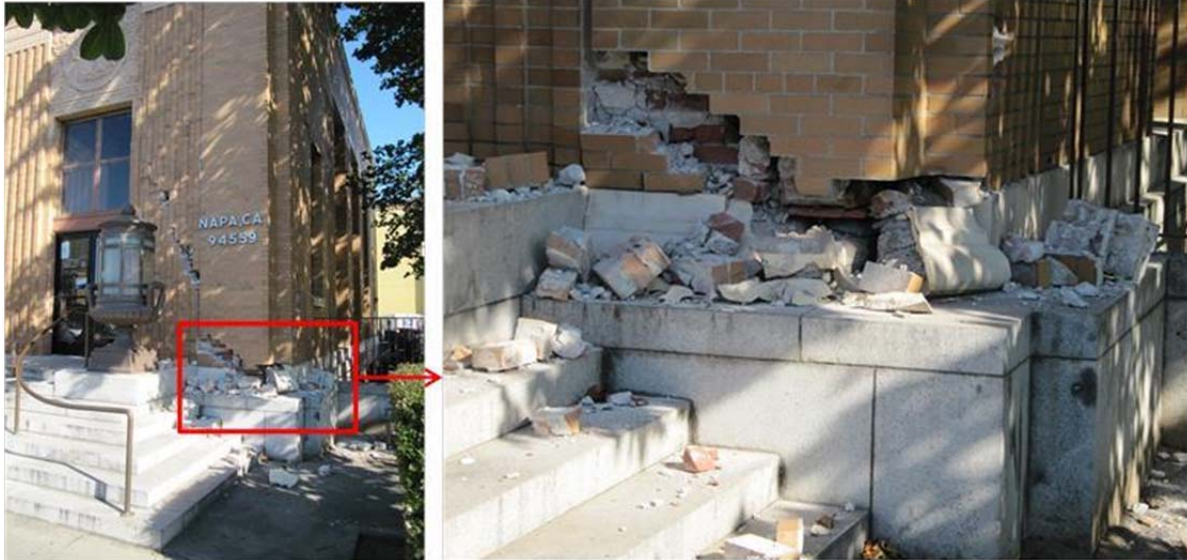
The U.S. Post Office (Building E in the map in Figure 6) experienced wide range of structural and non-structural damage. Partial damage in the masonry bearing walls at both of south and north lower corners of the building is shown in Figure 11 and 12. Most of the façade windows were damaged; see Figure 11.

Figure 12 Damage in the south lower corner of Napa Post Office Building (Building E in the map in Figure 6).

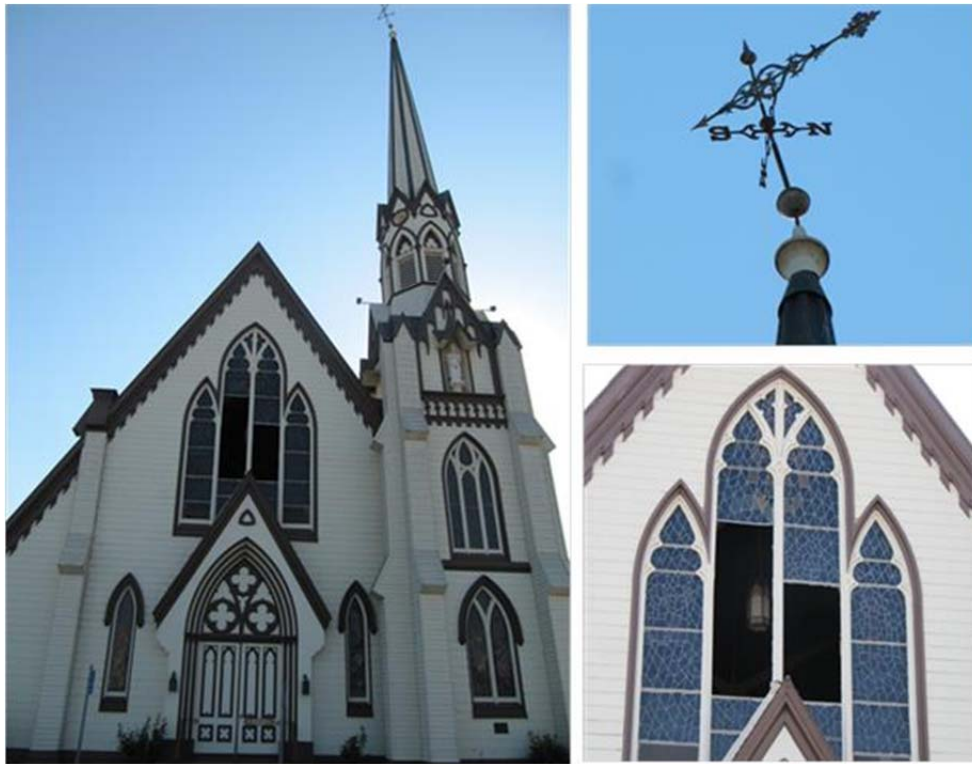
Figure 15 Overview of historic church (Building G in the map in Figure 6) non-structural damage: façade smashed windows and deformed top cross.

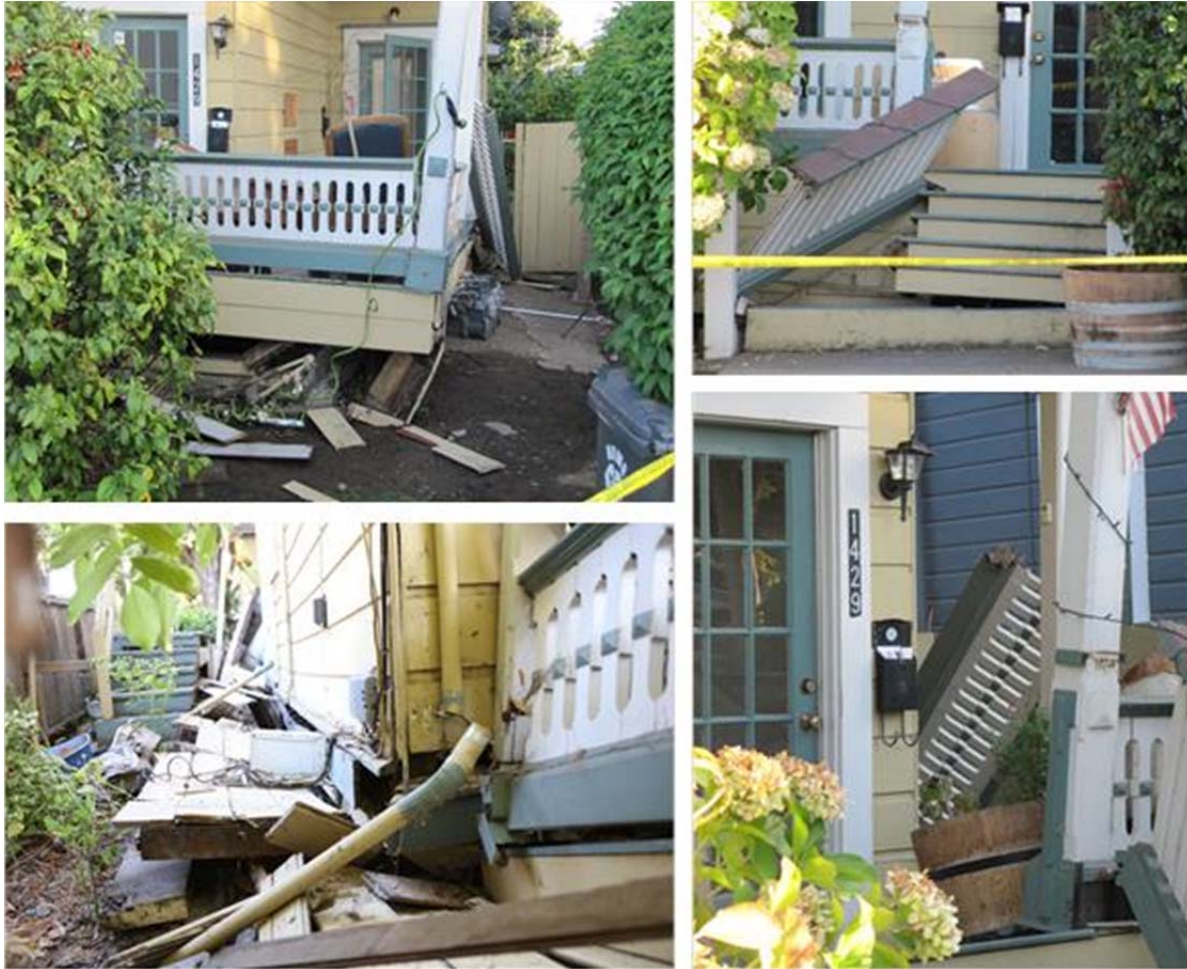
Figure 19 Close-up view of the cripple wall collapse at the east side of the building (top left) separation and elevation change in the main building's entrance stairs (top right) and patio fence (bottom right) utility ducts and pipes damage (bottom left).

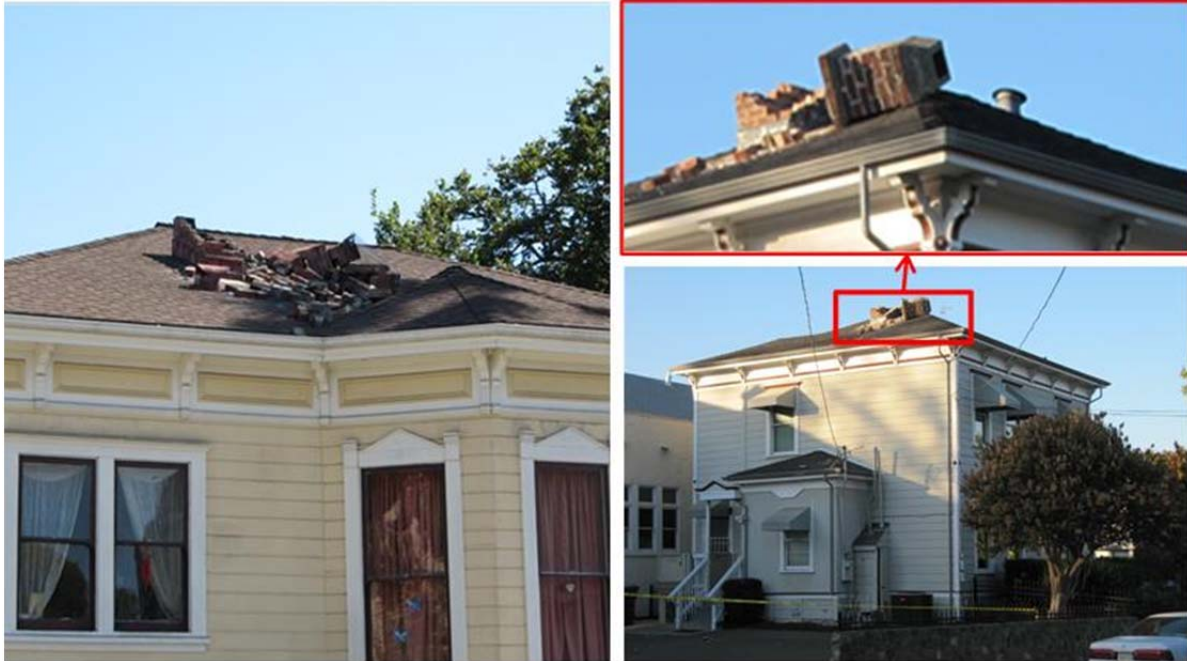
Figure 23 shows the damage that happened to two chimneys in two different residential buildings in downtown Napa, and identified as Building J and K in the map shown in Figure 6. The cosmetic damage that occurred in the façade of one of the shopping malls in downtown Napa is shown in Figure 24. A different form of nonstructural damage is local failure in wire connections in street power distribution lines, which led to electricity outage for hundreds of buildings. Figure 25 shows a wire end connection failure after the earthquake and the efforts exerted by PG&E officials to fix it to restore electricity before night time in downtown Napa the first night after the earthquake.

Figure 23 Damage of residential buildings chimneys in downtown Napa (Buildings shown are Building J (left) and K (right) identified in map in Figure 6).

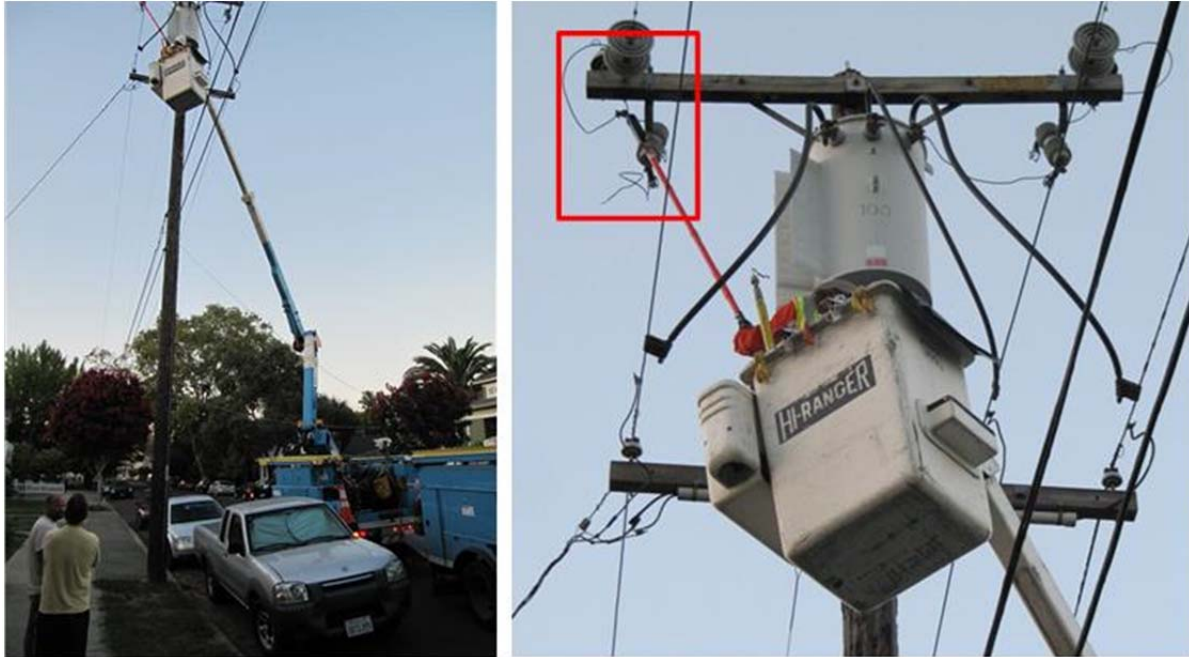
Figure 25 Efforts to fix wires and connections failures in local street power distribution lines.

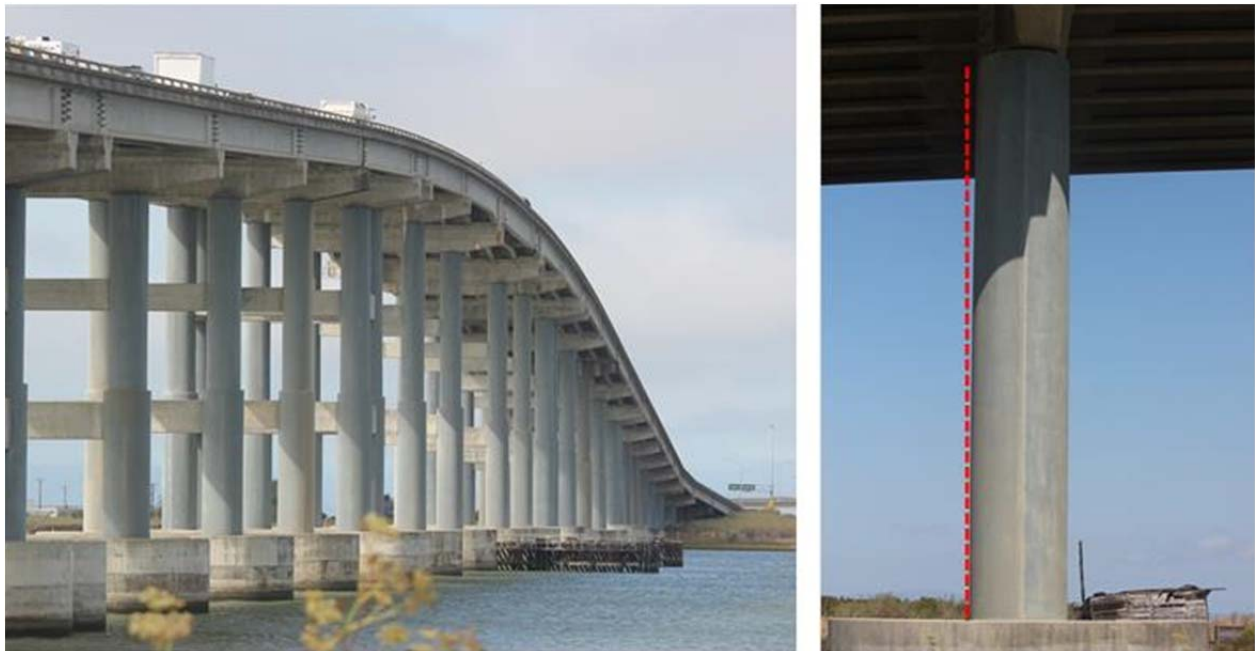
Figure 27 Overview of CA-37 Vallejo bridge (left) and suspected pier tilt close to the bridge approach from the Mare Island side (right).

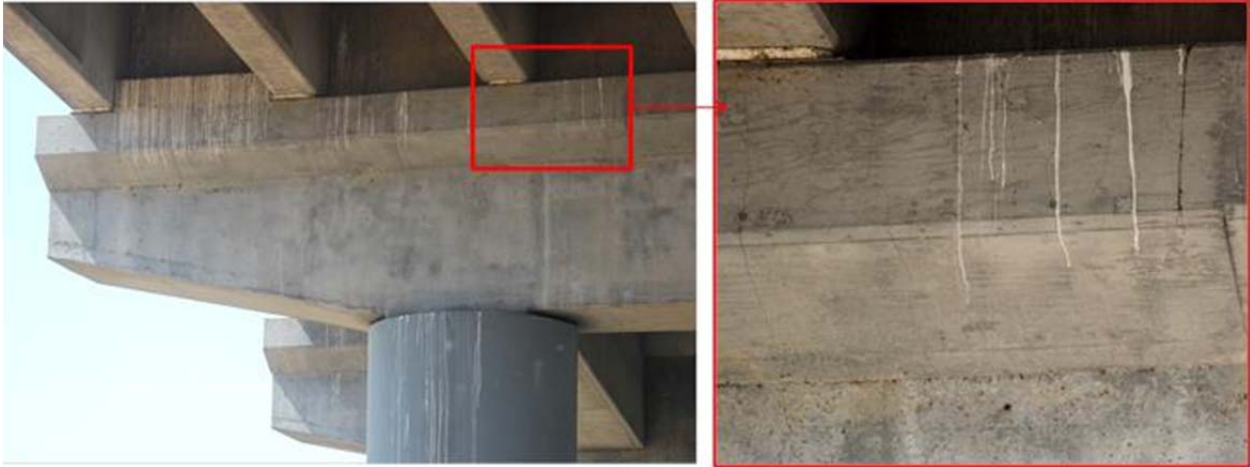
Figure 28 Cracking of one of the bridge piers' cap beam flange.

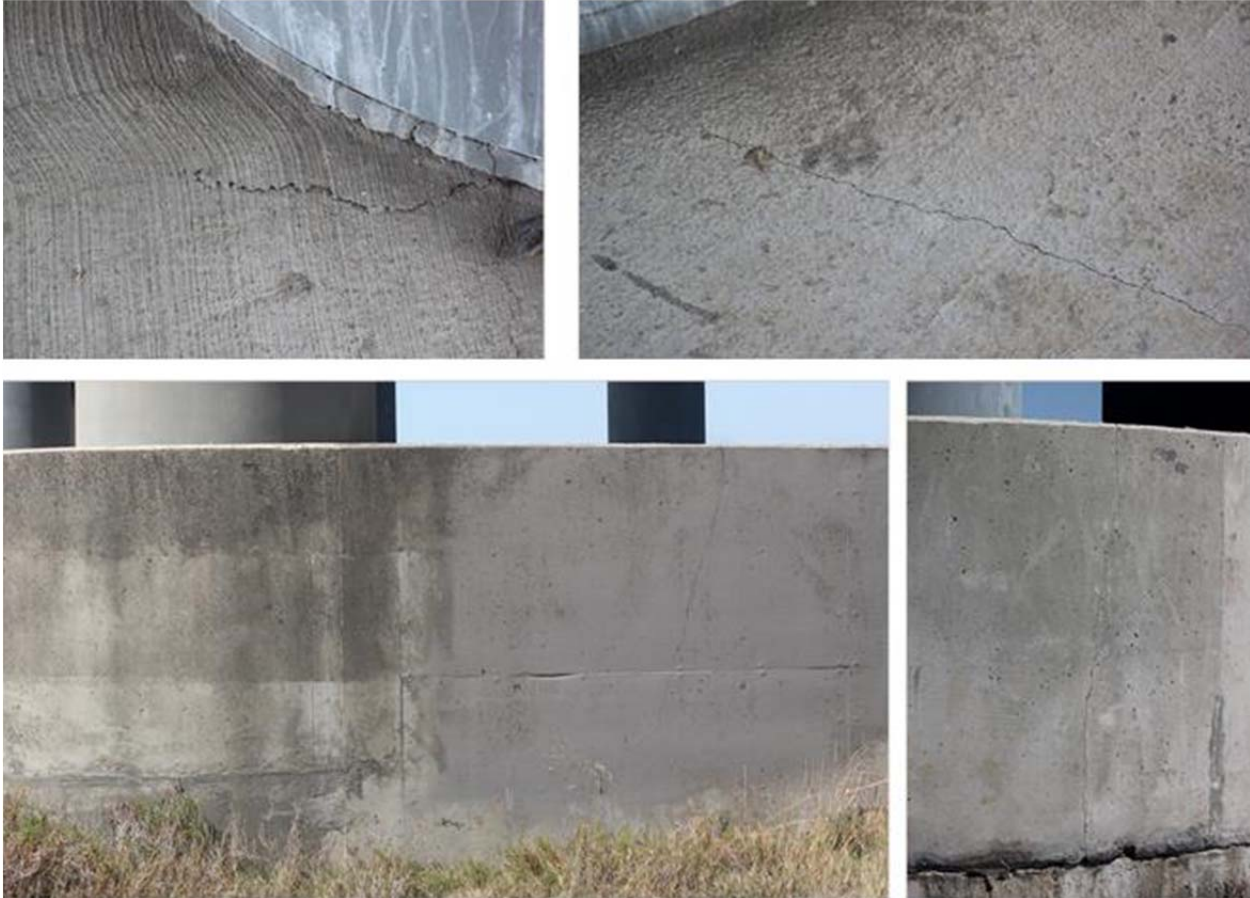
Figure 29 Cracking of one of the bridge pier's pile cap.

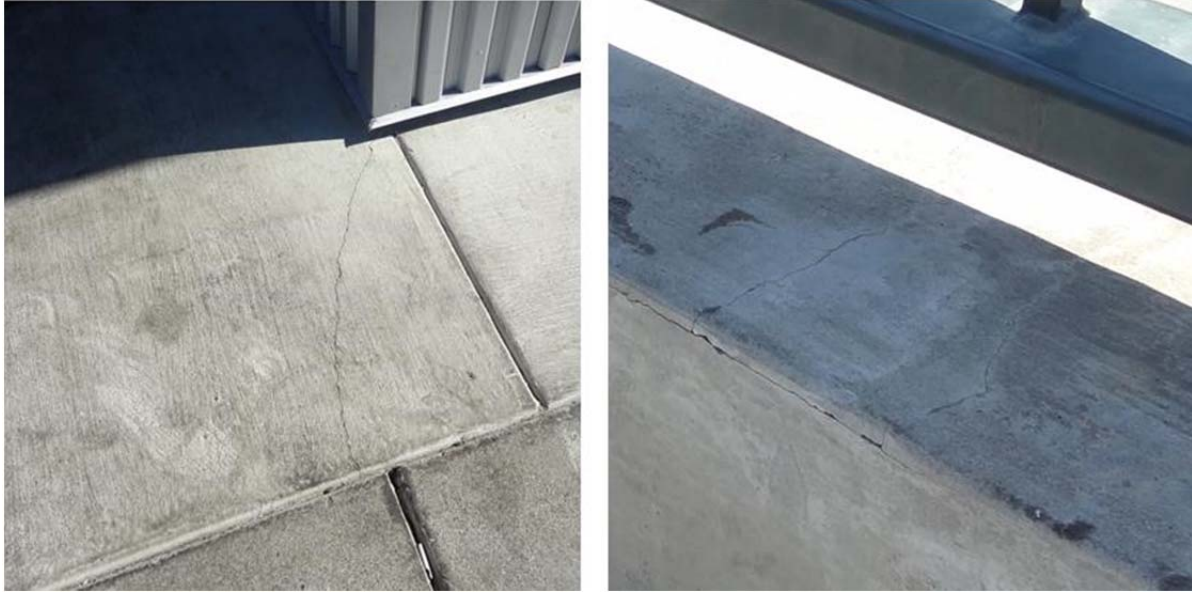
For the First Street Bridge, only minor damage was observed too. Several cracks were observed at various locations in the bridge deck near by the abutment from the Napa downtown side as shown in Figure 30. In addition, relatively large deformations were observed in the expansion joint region after the earthquake. Damage in the filler material used in the expansion joint was observed as shown in Figure 31. The paint marking the traffic lanes at the expansion joint also shows how the joint deformed after the earthquake as shown in Figure 31.

Figure 30 Cracking at various locations close to abutment of the First Street Bridge over Napa Creek from the Napa downtown side.

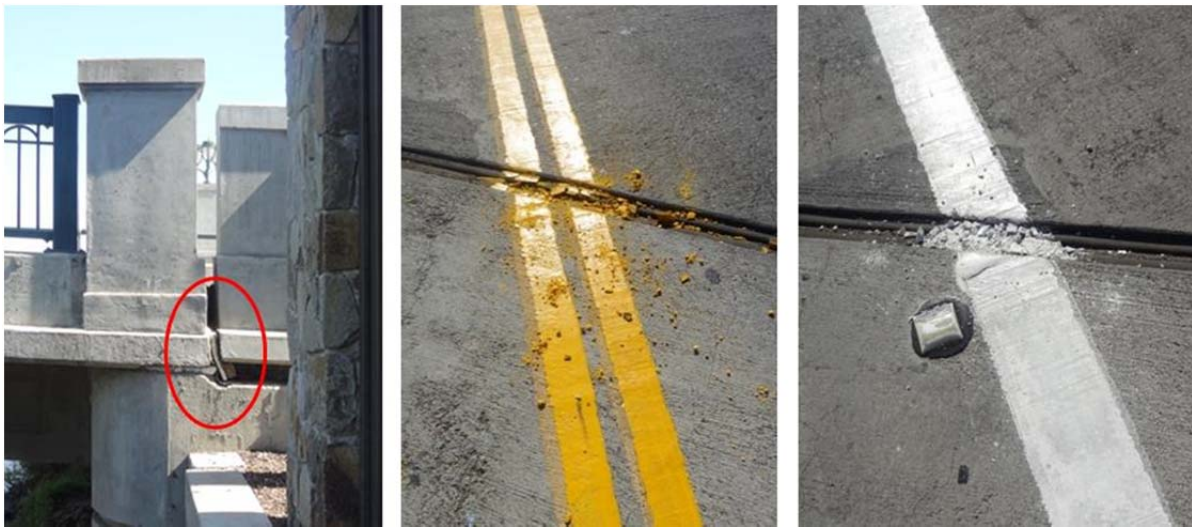
Figure 31 Deformation at First Street Bridge expansion joint led to filler material damage.

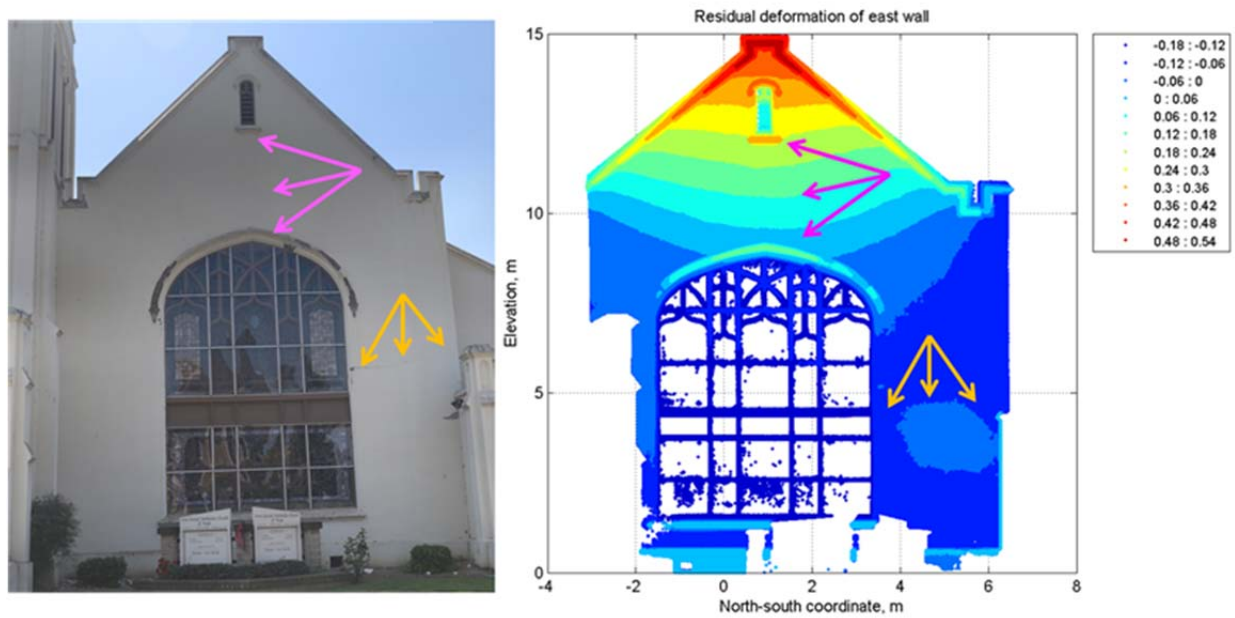
cause the wall to fall on the east side street, dramatically changing the situation. Due to the high hazard of passing traffic and pedestrians, the building was fenced out by a tape right after the earthquake and was red tagged on the following day.

Figure 33 Residual deformation of the east wall.

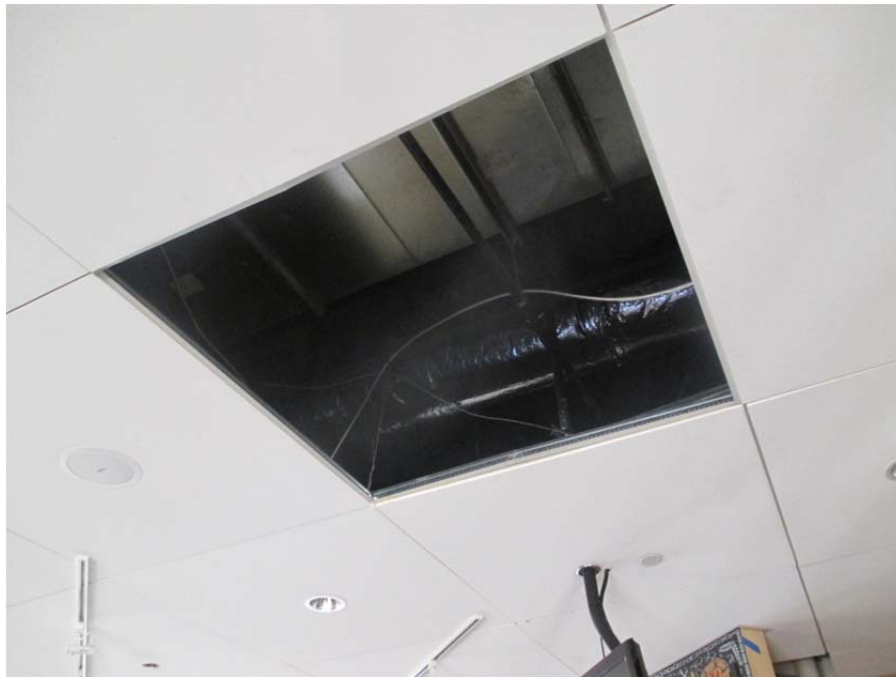
Figure 13 Large 4 ft by 4 ft ceiling panel failed during the earthquake.

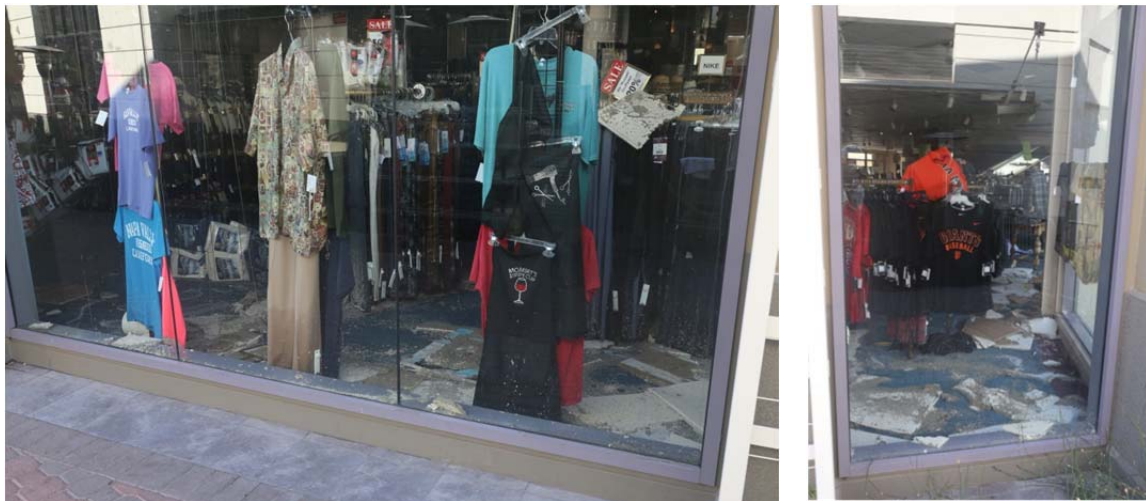
Figure 18 Soaked suspended ceiling tiles and goods on the floor.

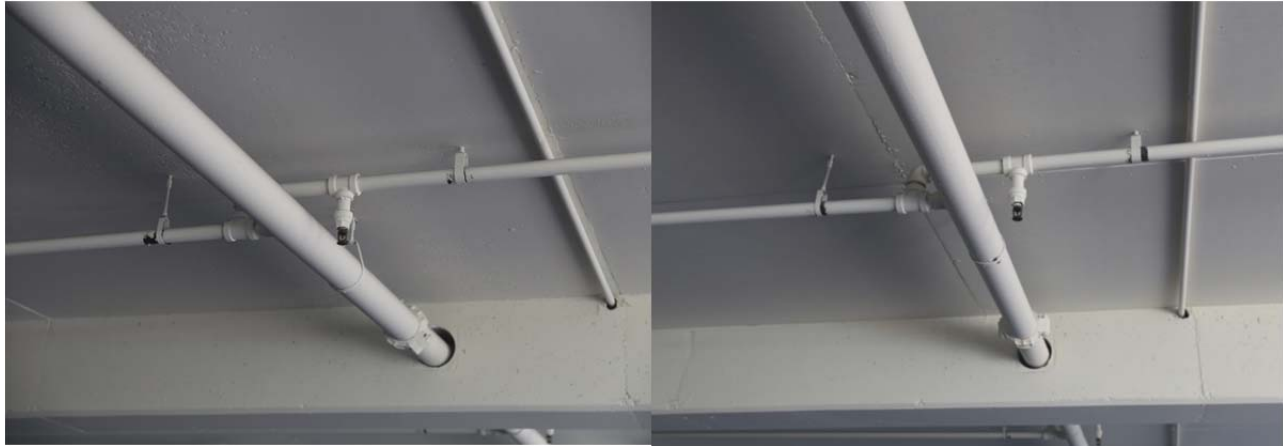
(a) Scratches on the pipes show the amplitude of motion within a supporting bracket (larger for a largely oversized access hole)

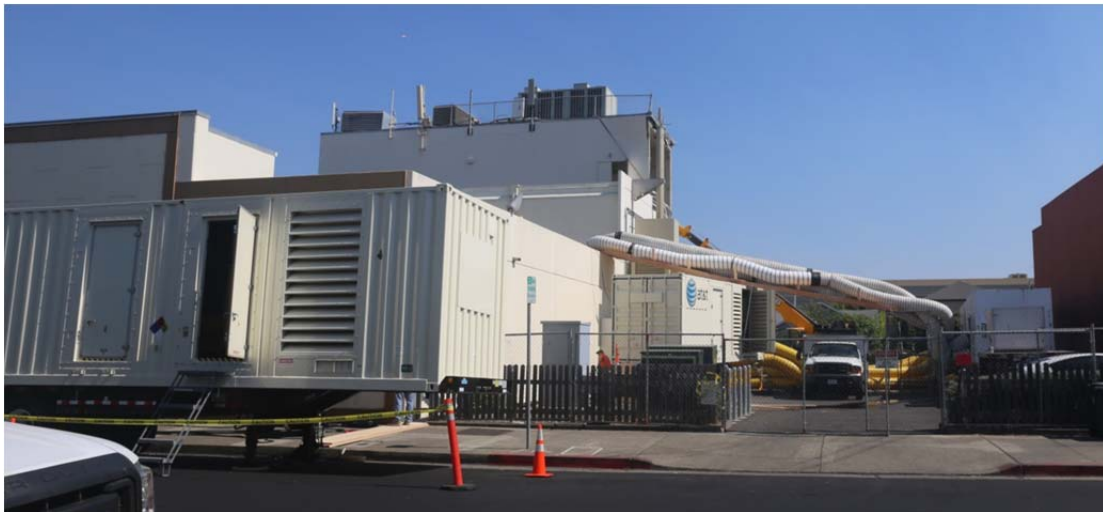
Figure 22 Failure of nonstructural wall at telecommunication center.

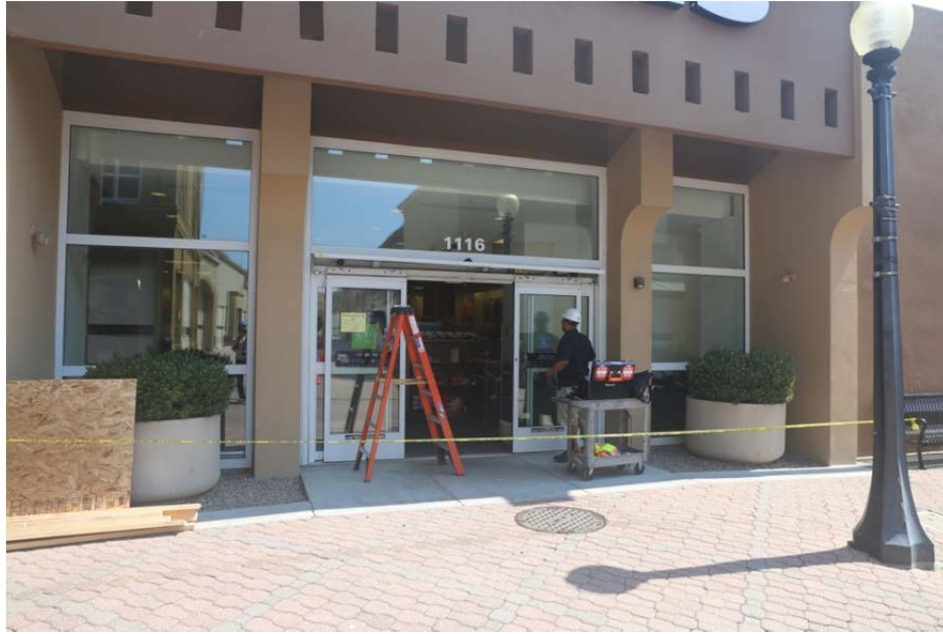
During the field studies it was noticed that an automatic door to one of the large department store in downtown Napa was jammed and was not working properly. Since the building did not have any structural damage, the management began repairs to make it as operational as soon as possible. At the time of the visit, the store was undergoing inspection and the door was being replaced as shown in Figure 29.

Figure 29 Damaged door is under urgent repair.

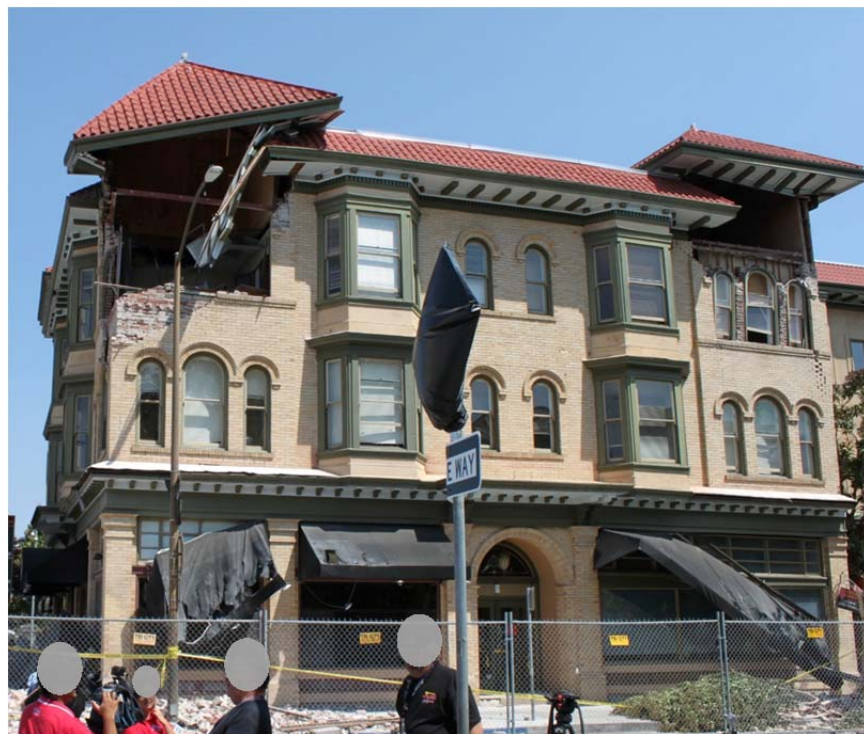
Figure 9 Partial collapse at 1001 2nd Street.

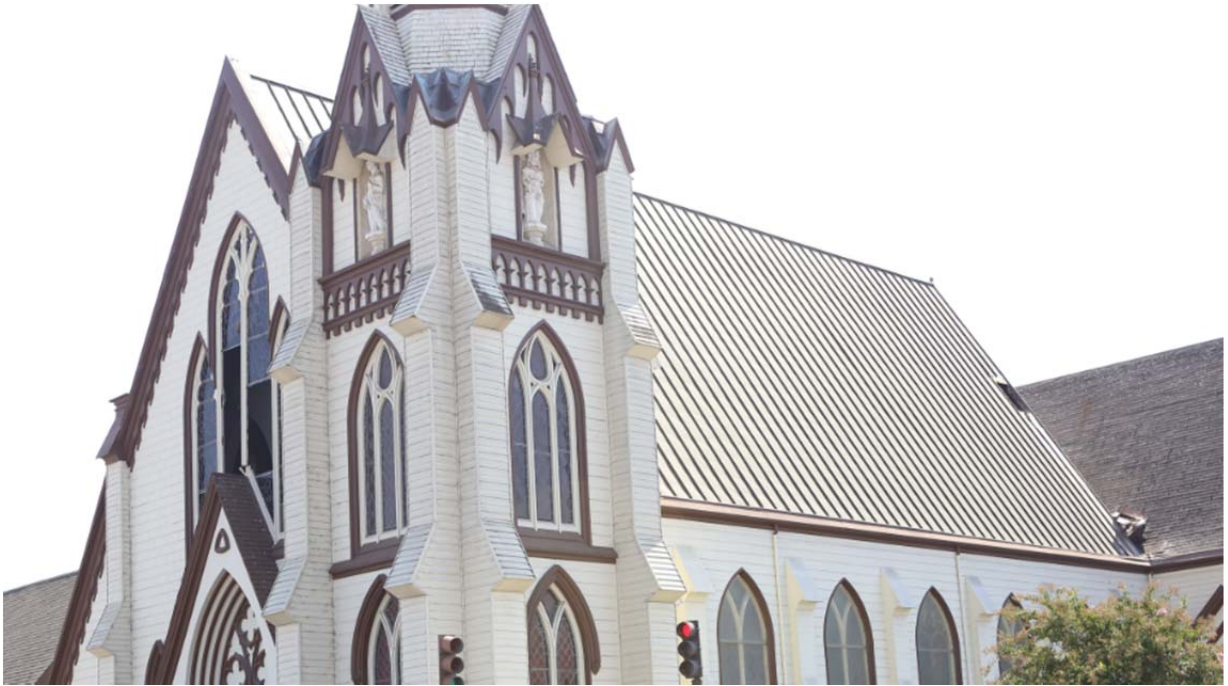
Figure 22

Broken glass windows

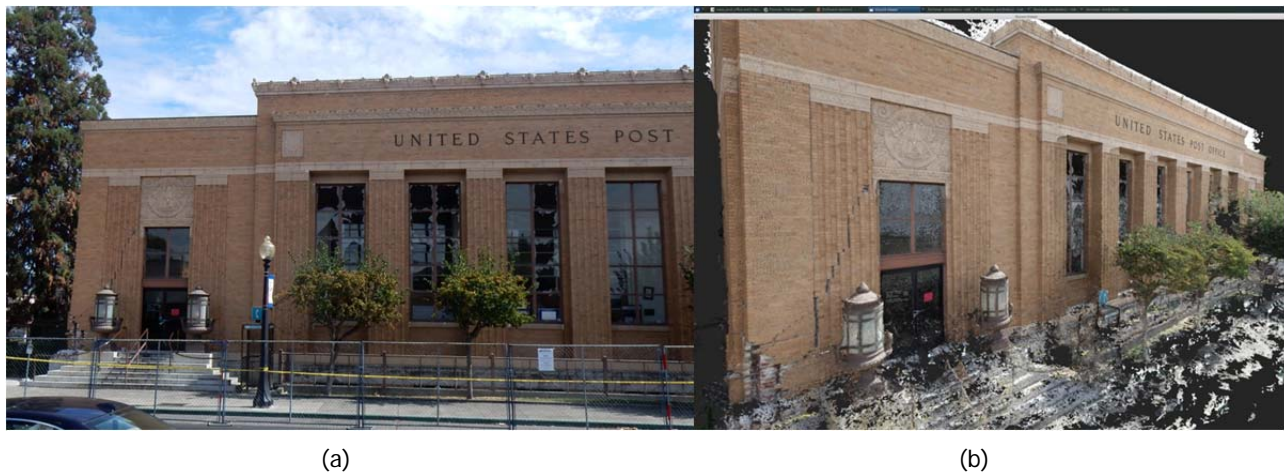
Figure 8 (a) Ground view of post office; and (b) reconstructed model capturing façade and window damage.

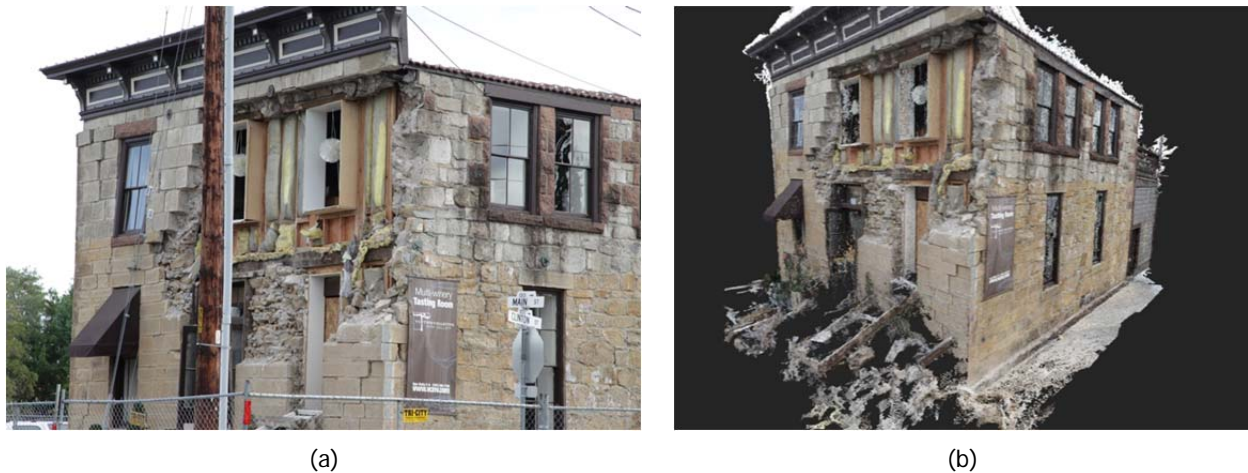
Figure 12 (a) Ground view and (b) reconstructed model showing façade damage and debris field.

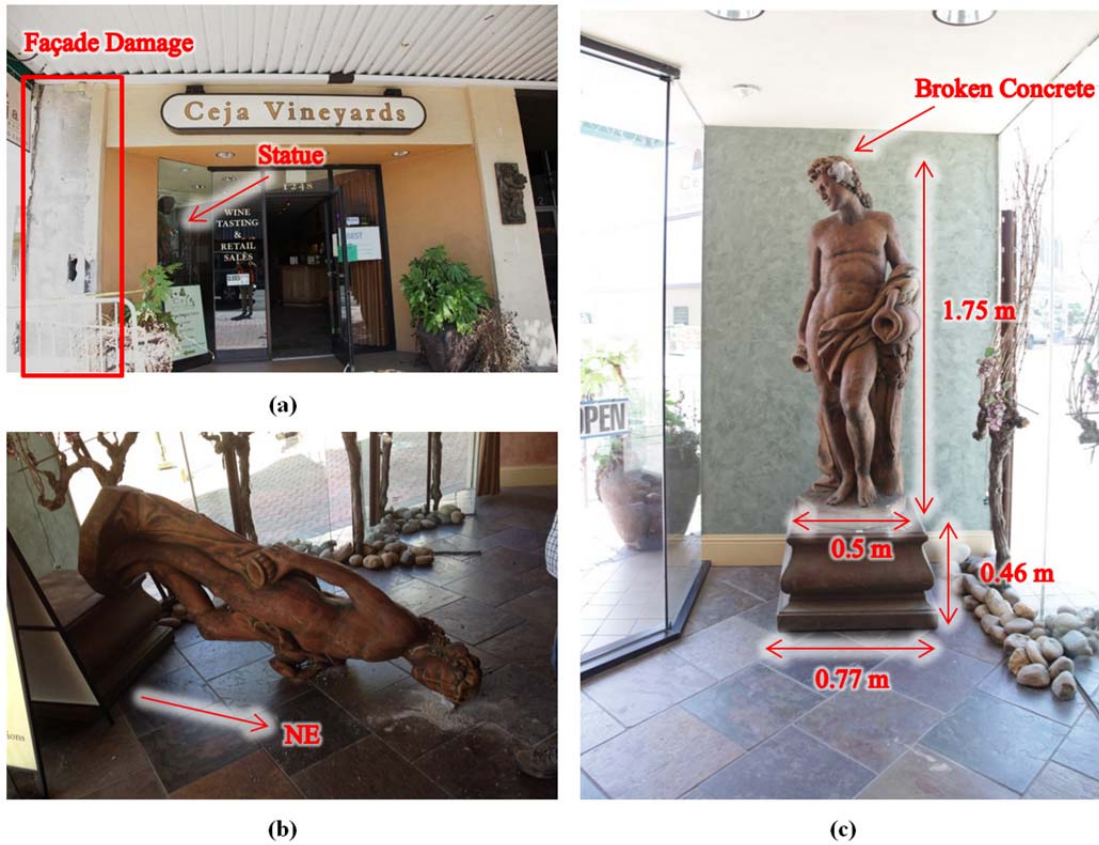
Figure 32 (a) Storefront of Ceja Winery with stucco damage noted and statue location marked; (b) overturned statue following earthquake (photo courtesy of winery owner Amelia Moran Ceja); and (c) erect statue on pedestal.

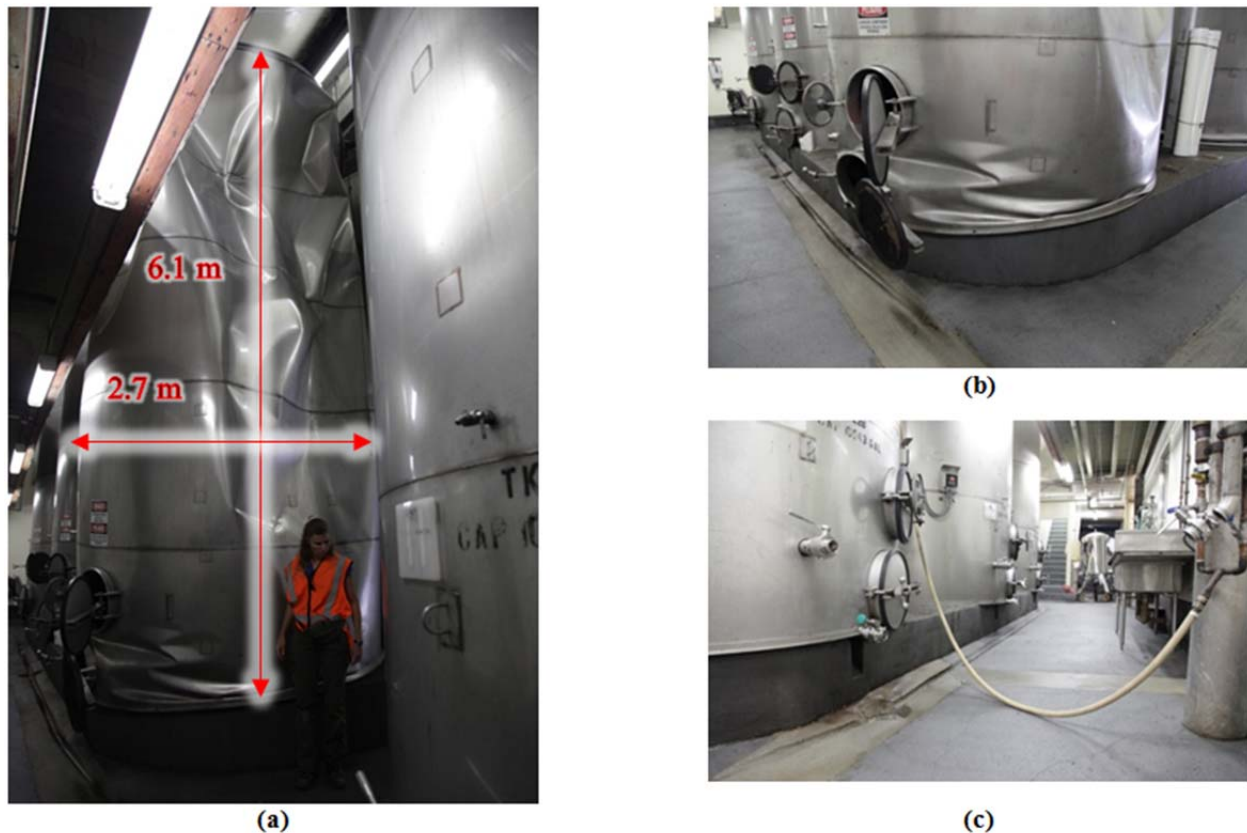
Figure 43 Condition of 10,000 gallon wine tanks following the earthquake: (a) empty buckled tank; (b) buckling of the base of a tank; and (c) significant translation of tanks in the NNW direction.

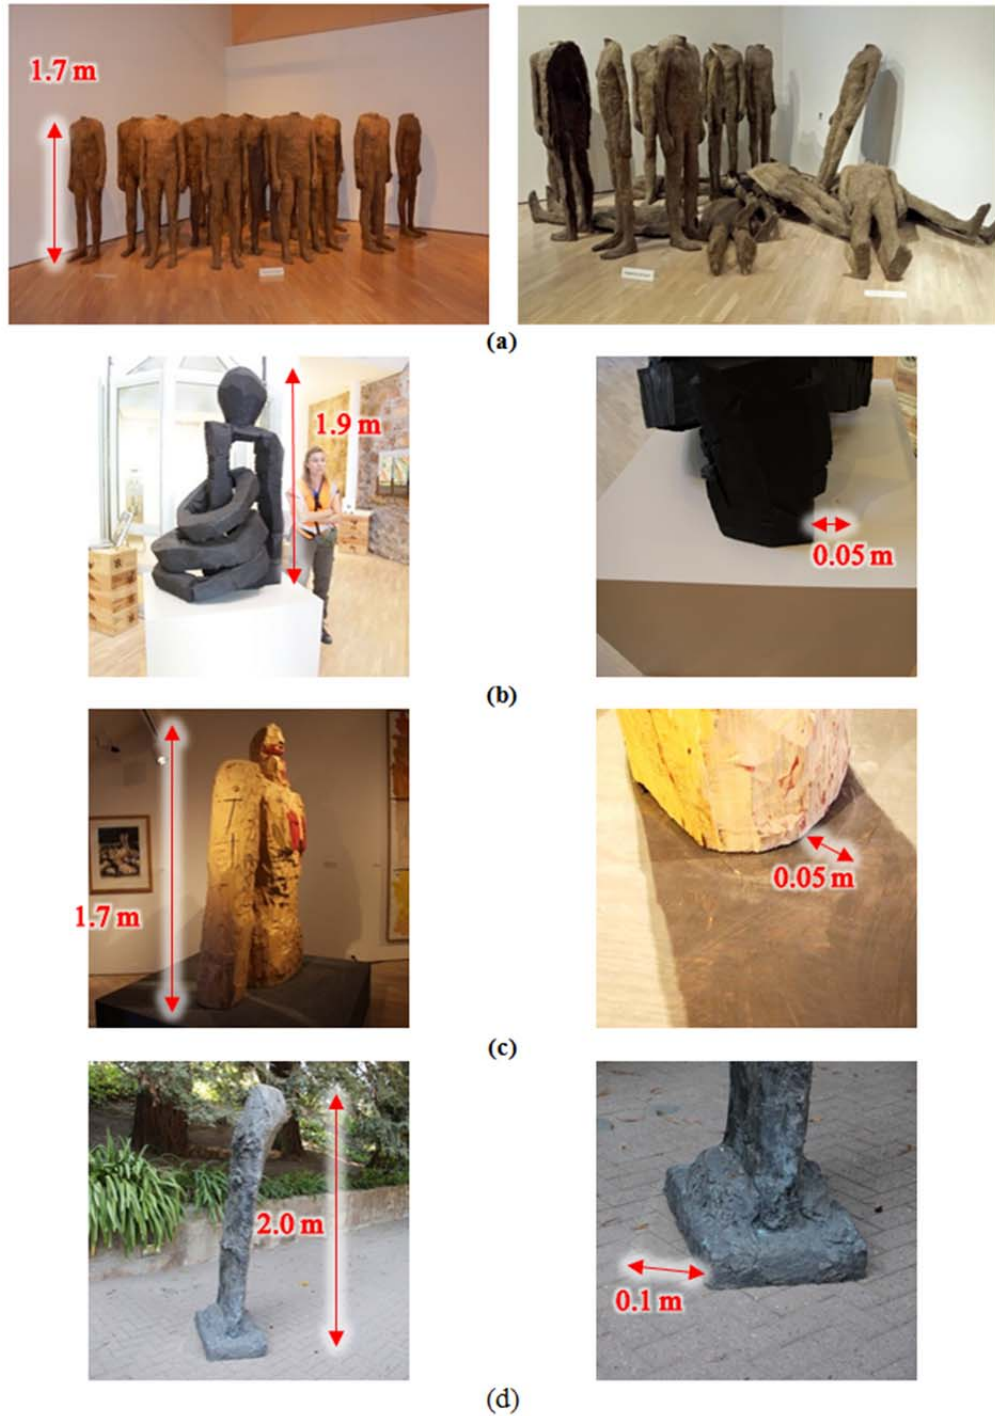
Figure 44 Movement of art objects within the museum with estimated dimensions: (a) overturning and rotation of lightweight, human-form statues on the second-floor; (b) rotation/translation of a large, asymmetric hollow metal sculpture on the ground-floor; (c) rotation/translation of a large, asymmetric wooden sculpture on the second-floor; and (d) rotation/translation of a large, hollow metal sculpture in the courtyard.
