PEER Preliminary Notes and Observations on the August 24, 2014, South Napa Earthquake

Pacific Earthquake Engineering Research Center

Report No. 2014/13

September 17, 2014

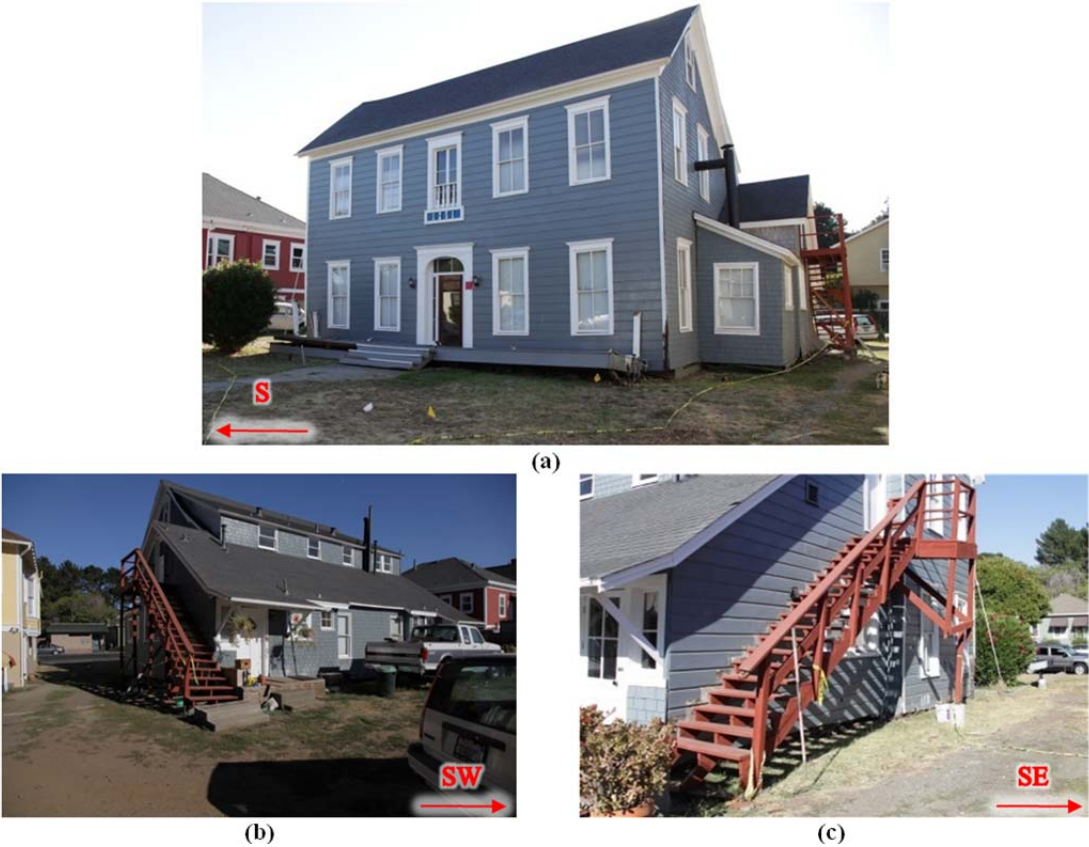
Figure 53 Red-tagged residence at 1251 Jefferson Street: (a) view from Jefferson St; (b) view of dislocated stairs from backyard facing east-southeast; and (c) view of stair damage from backyard facing east-northeast.

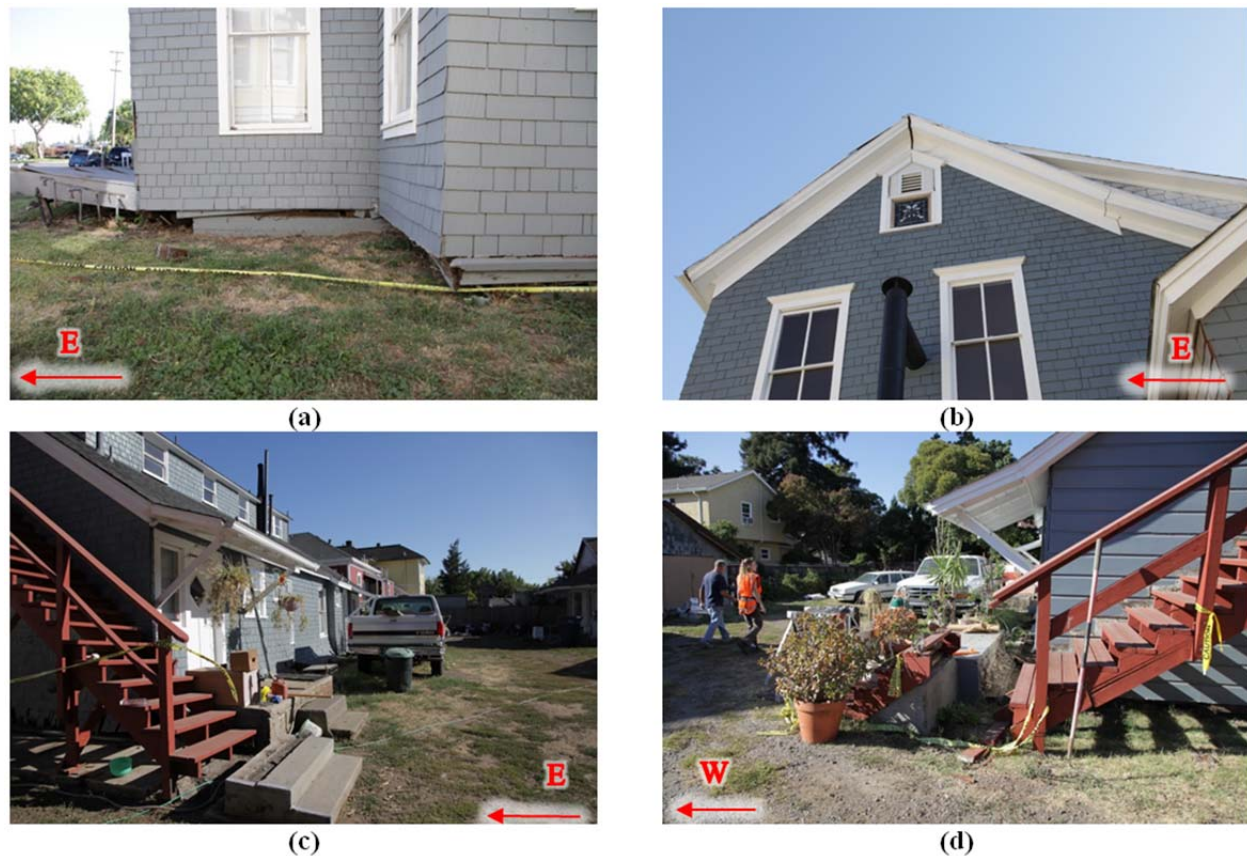
Figure 54 Details of damage at red-tagged residence at 1251 Jefferson Street: (a) collapsed cripple wall and relative displacement between foundation and super-structure of approximately 0.3-0.6 m; (b) crack at roof ridge due to translation of superstructure off of the foundation; (c) displacement of wooden staircase and concrete foundation stairs; and (d) vertical and horizontal displacement of superstructure observed at the rear doorway and staircase.

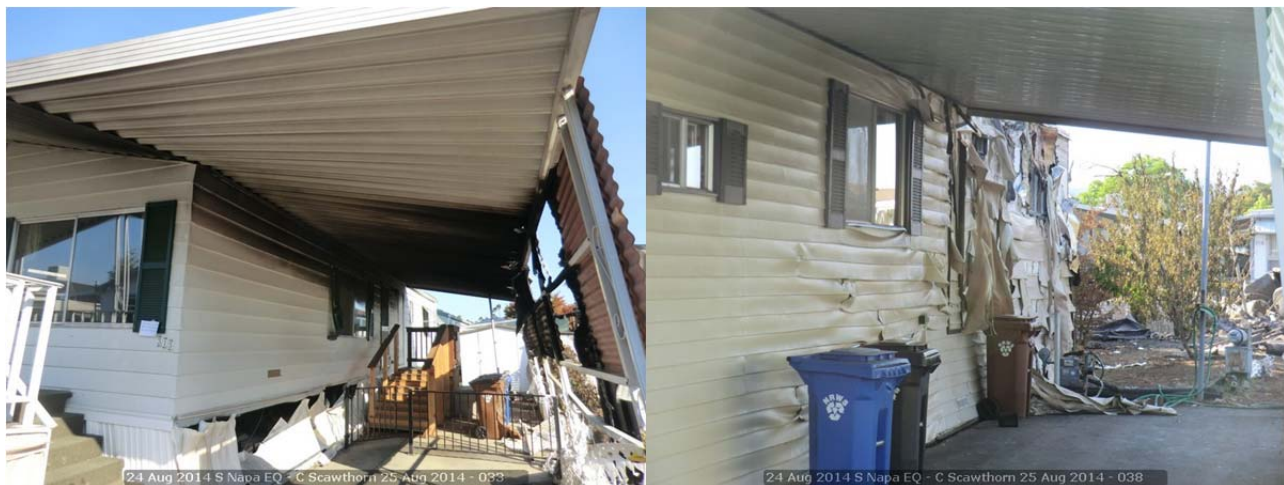
Figure 4 Damage to exposure structures, 317 Patty Way, NVMHP Park, 24 Aug 2014 S. Napa M_w 6.0 earthquake: (a) structure to east of fireground; and (b) structure to south of fireground.
