APPENDICES A, B, C, and D

APPENDIX A Working Group 4 Recommendations for Experimental Program

APPENDIX C Working Group 4: Damage Observations for All Specimens

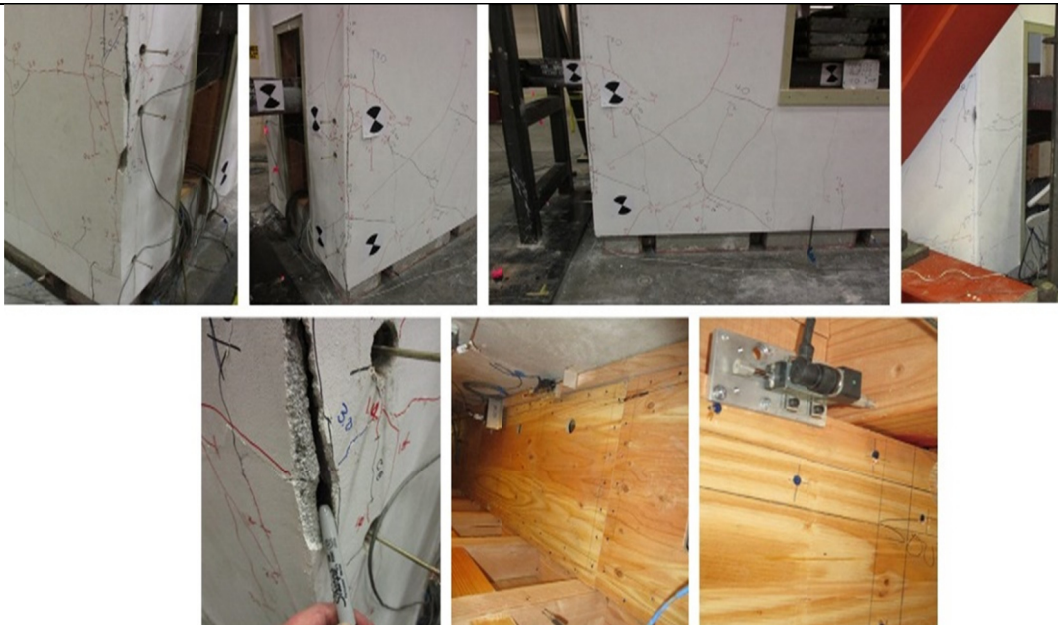
Damage Appearance				Cripple Wall Peak Transient Target Drift Ratio (%)	Hysteresis Curve		
Cripple Wall Finish Materials	Damage Description	Overall Pattern	Local Appearance						
	<p>End Walls: Stucco damage progressed. Stucco at the west end corner was fractured over a significant height. Gaps of up to 1/4-inch were measured.</p> <p>North and South Walls: Hairline cracking and stucco flaring from the base continued. The stucco, however, remained substantially planar.</p> <p>Retrofit: There was no observable damage to the retrofit.</p>

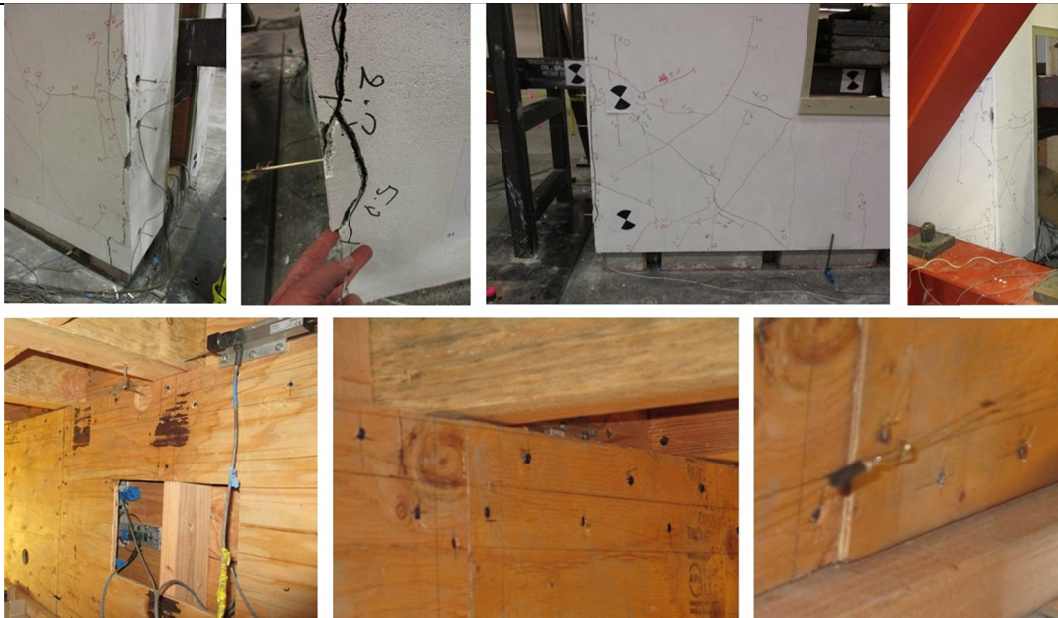
<p>End Walls: Stucco cracking and spalling progressed, as did separation of the stucco from the underlying sheathing and framing.</p> <p>North and South Walls: Stucco slid in-plane approx. 1/4-inch relative to sheathing and framing at the floor level. Additional hairline cracks near the floor line appeared related to additional flaring at the base of the stucco.</p> <p>Retrofit: Very modest withdrawal of nails from the upper top plate was seen (approx. 1/8-inch). Minor rotation of the plywood panels was seen, resulting in minor visible offsets of the panels at abutting panel edges. Very modest working of nail heads into the plywood was also observed.</p>

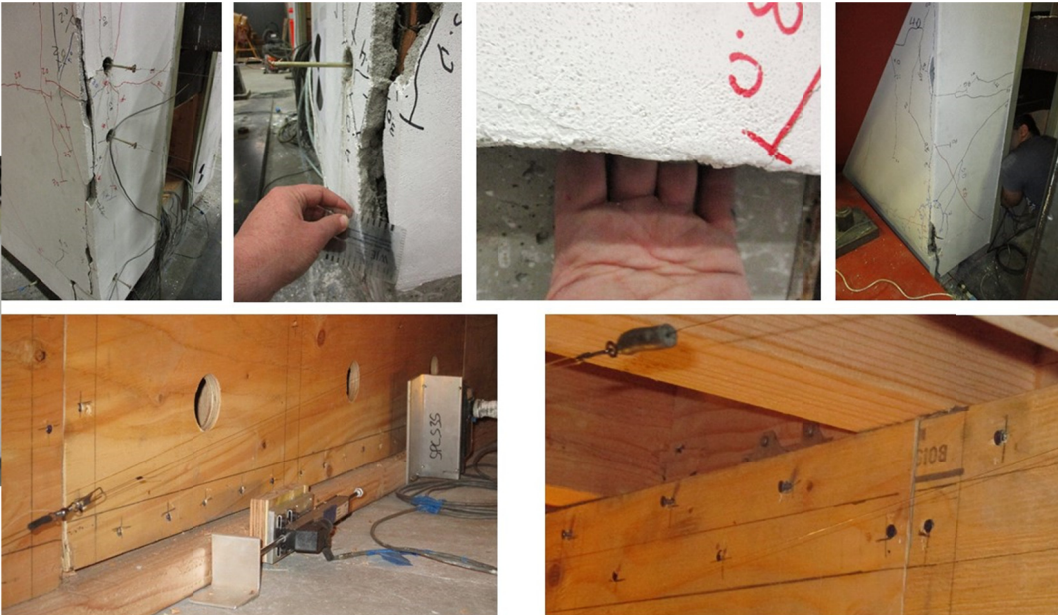
<p>South wall stucco cracking at 6.0% target drift</p>

<p>Gapping of stucco at corners (top left), away from foundation (top middle), rotation of plywood panels (bottom left), and withdrawal of nails from upper top plate (bottom right)</p>	6.0%

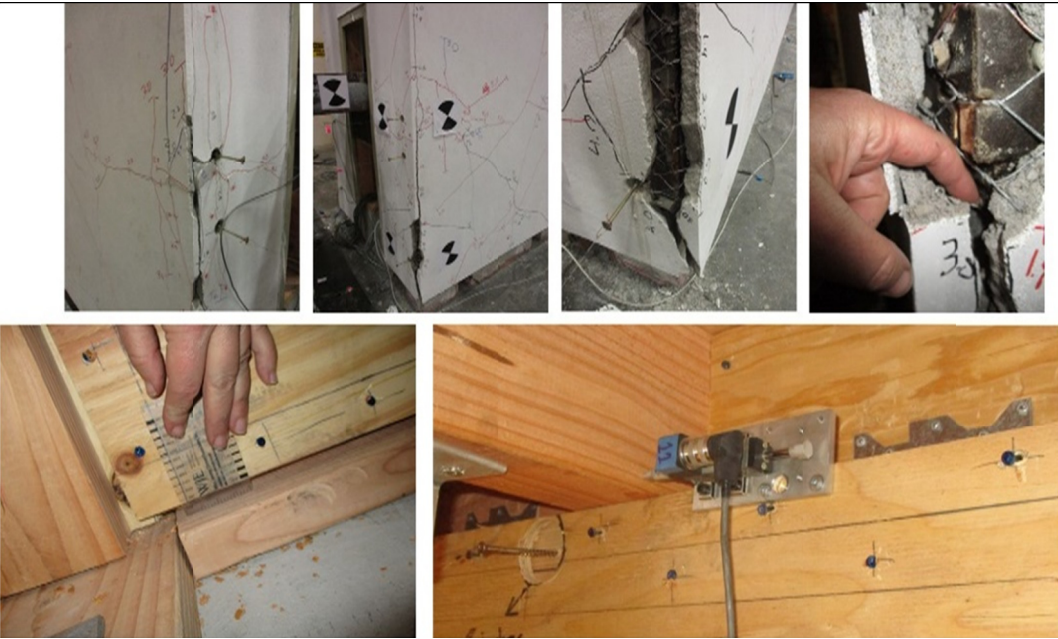
<p>South wall stucco cracking at 7.0% target drift</p>

<p>Continued deterioration of end wall and corner stucco (top), rotation of plywood panels (bottom left), and withdrawal of nails from upper top plate (bottom right)</p>	7.0%

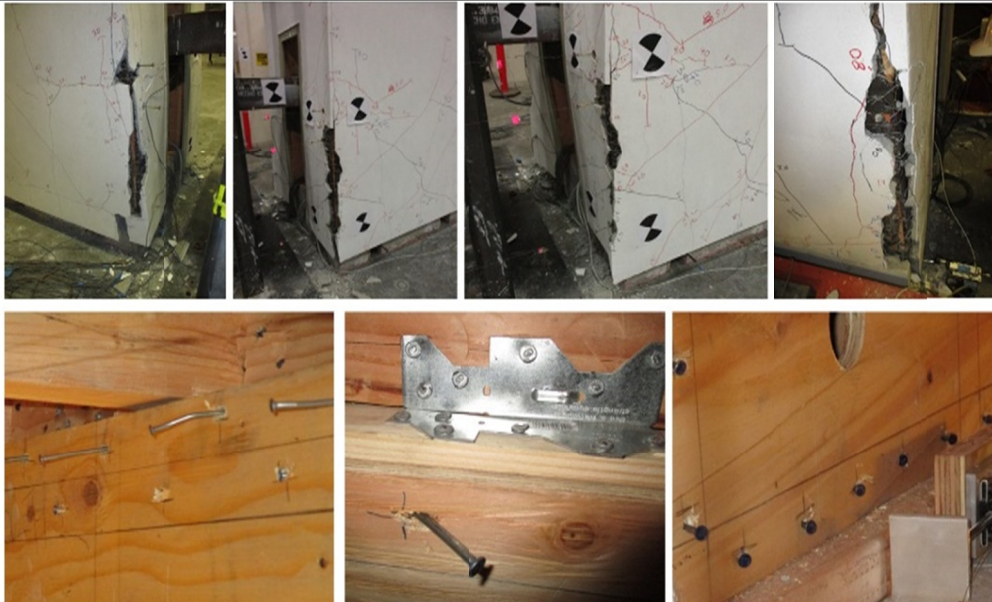
Damage Appearance			Cripple Wall Peak Transient Target Drift Ratio (%)	Hysteresis Curve	
Cripple Wall Finish Materials	Damage Description	Overall Pattern	Local Appearance				
	End Walls: Stucco deterioration and spalling continued. North and South Walls: Negligible new cracking. Retrofit: top plate sheathing nails have started to fall off of the walls.

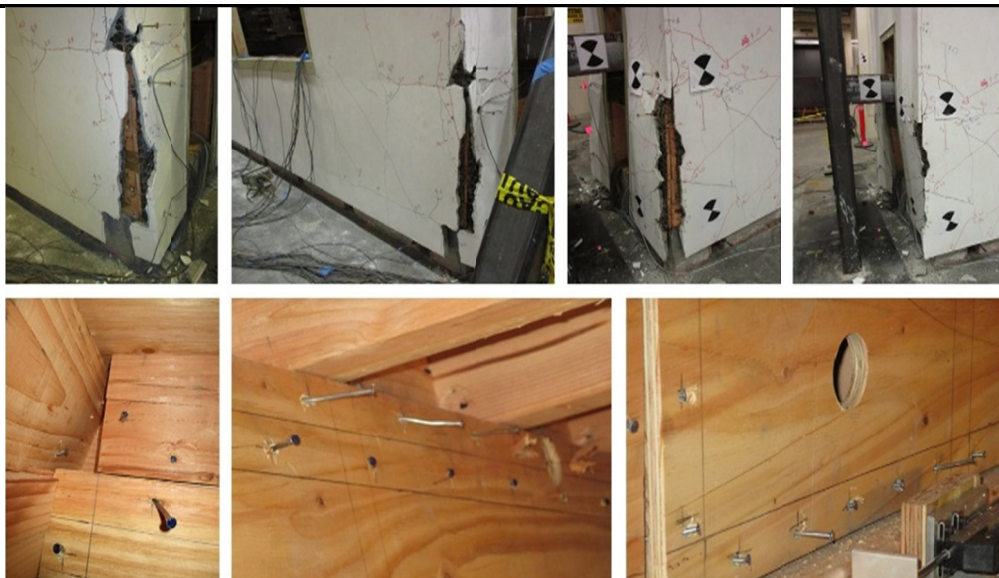
South wall stucco cracking at 12.0% target drift Continued deterioration of end wall and corner stucco (top), sheathing nails to upper top plate have started to fall off wall (bottom left), clip angle has no observable damage (bottom center) and withdrawal of nails from bottom plate and stud (bottom right)						
	End Walls: Stucco deterioration and spalling continued. North and South Walls: Negligible new cracking. Flaring at stucco base up to almost two inches. Retrofit: Diaphragm and upper top plate start being pushed off of the lower top plate and cripple wall. This causes the top of the east wall rim joist to roll towards the west as the top of the rim joist gets pulled with the diaphragm sheathing. The south wall blocking is pulled with the diaphragm also.

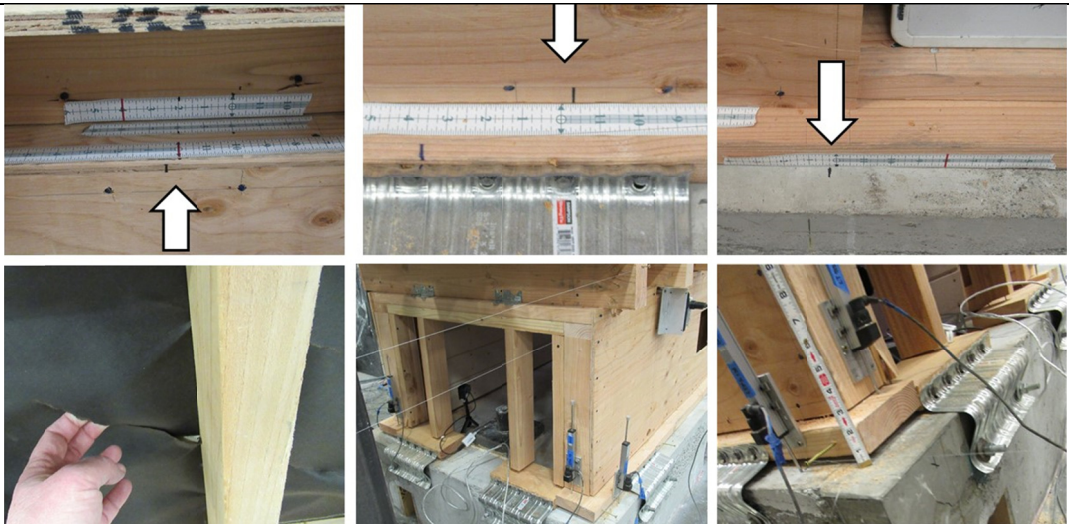
South wall, west end

Slip between top plate and top of plywood (left top), between bottom of plywood and foundation sill plate (top center), and between foundation sill plate and foundation (top right), tearing and buckling of building paper (left bottom), continued west end uplift

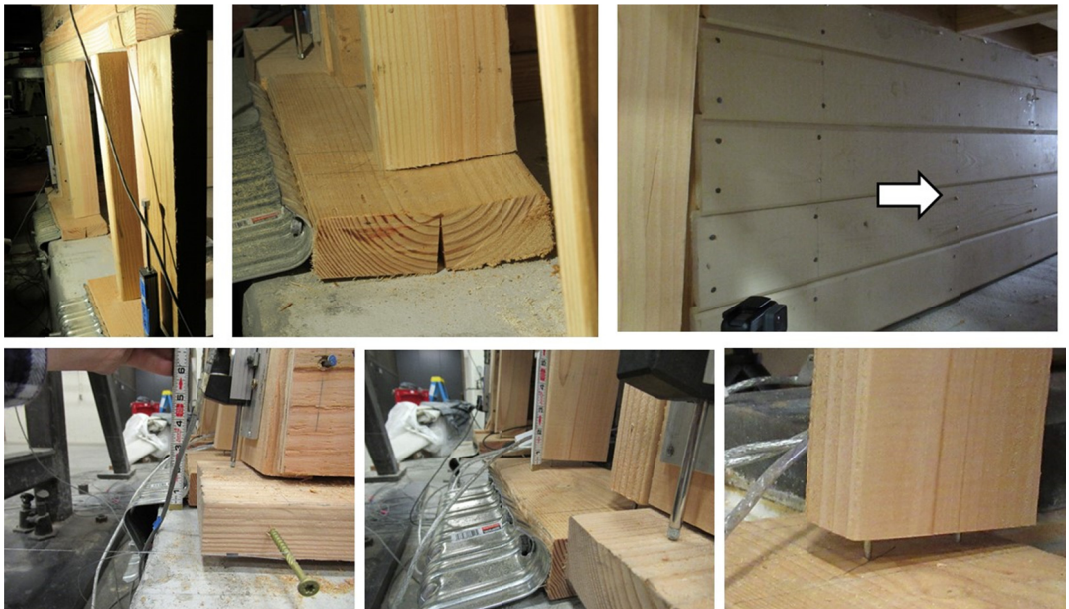
Plywood continues to gap and slide (left, center), sheathing nails are bent in reverse curvature (right)

East wall foundation sill plate fractures with rotation of studs (left top, center top)), siding nails have small amount of withdrawal (right top), uplift continues at west end wall with studs uplifting and stud end nails withdrawing (bottom)

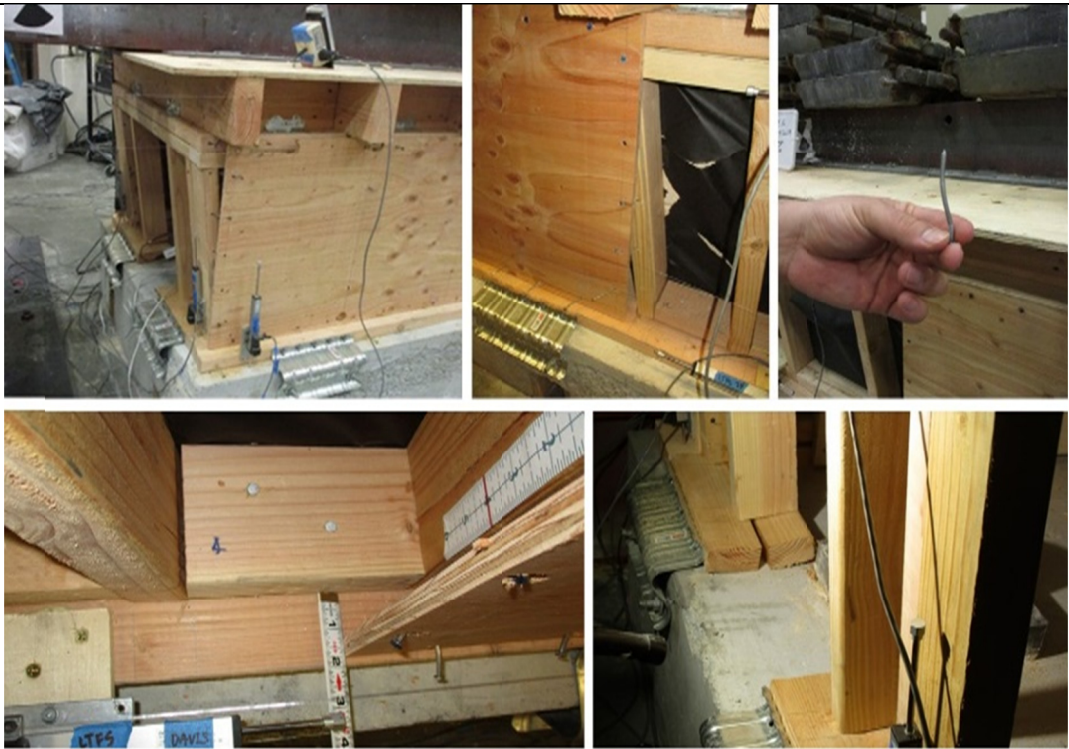
- Plywood substantially detached, moving away from framing, nail falling off
- Gap is opening up at east wall sill plate split

Plywood is substantially detached from and moving away from framing, sheathing nails are starting to fall off, pieces of split east wall sill are moving away from each other (right bottom)

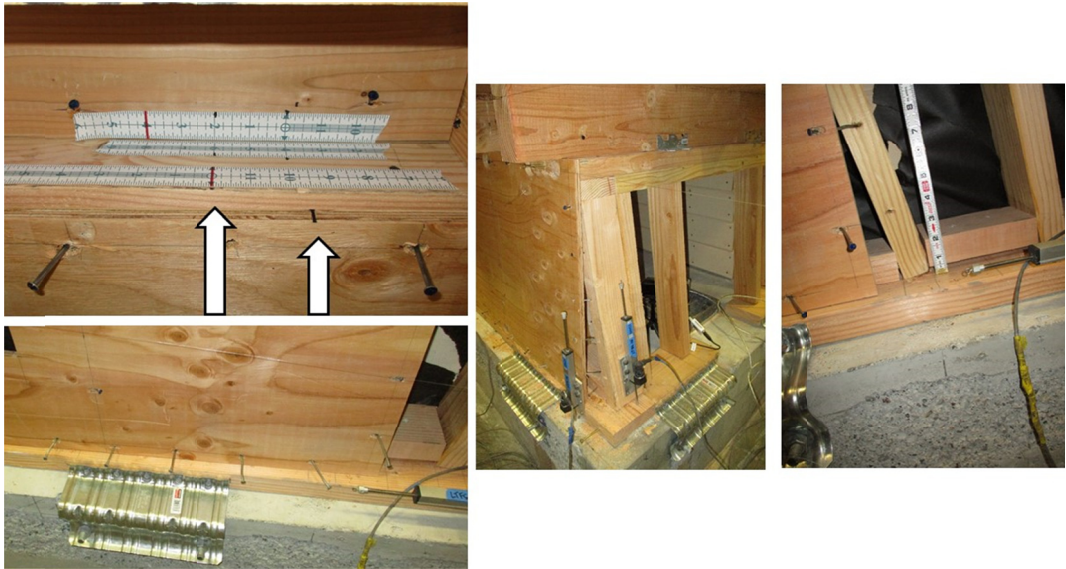
Building paper is substantially destroyed (left), plywood is substantially detached (center), no deformation or damage is visible at the shear clips or anchorage plates (right).

Top of plywood has slipped approximately 2-1/2-inches relative to top plates (left top)
plywood is substantially detached from framing.

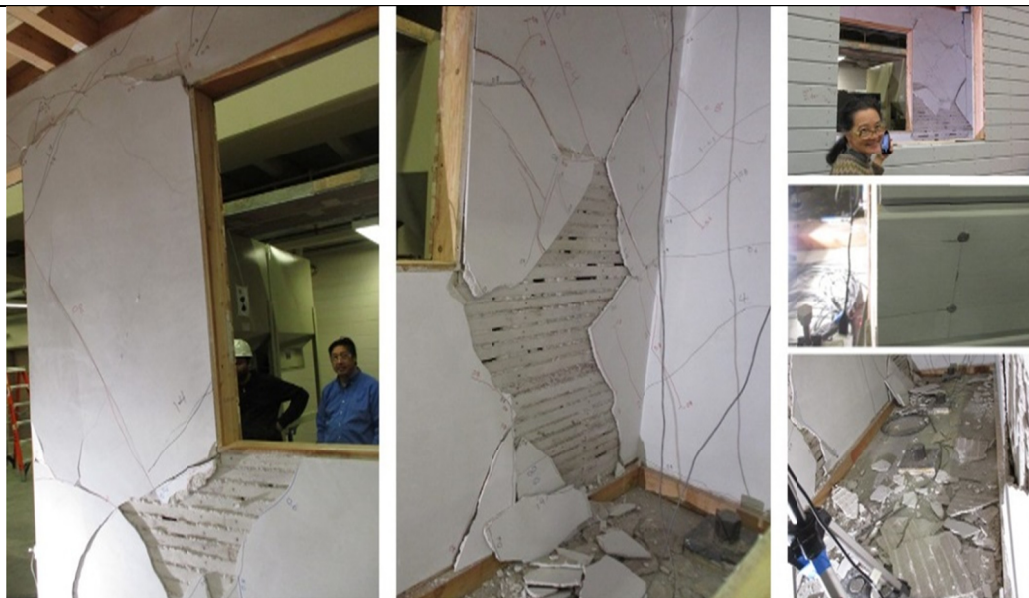
<p>-By end of 1.4% cycles, about hlf of the plaster had fallen or was loose and about to fall. Further marking of plaster cracks had become impractical.</p> <p>-Working of wood siding nails started to be noticed and marked, with modest pull through and withdrawal of siding nail heads, and limited hairline splitting between nail near end and end of board.</p>

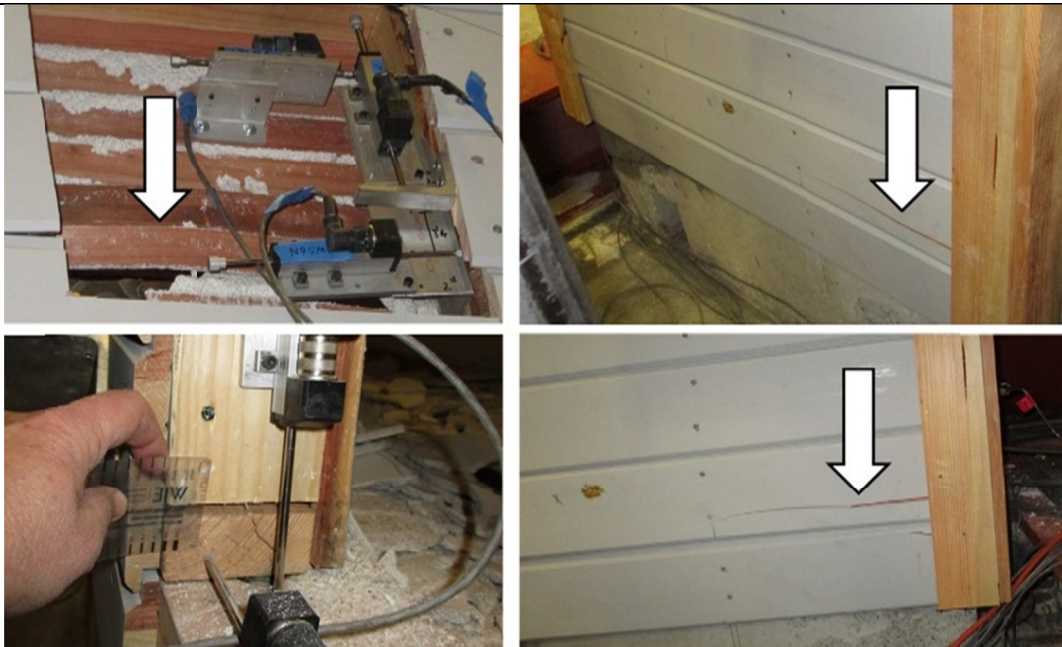
<p>-Vertical gaps at door studs continue.</p> <p>-Wood lath is seen to buckle locally.</p> <p>-Siding at bottom of east end wall cracks in line with wall bottom plate.</p>

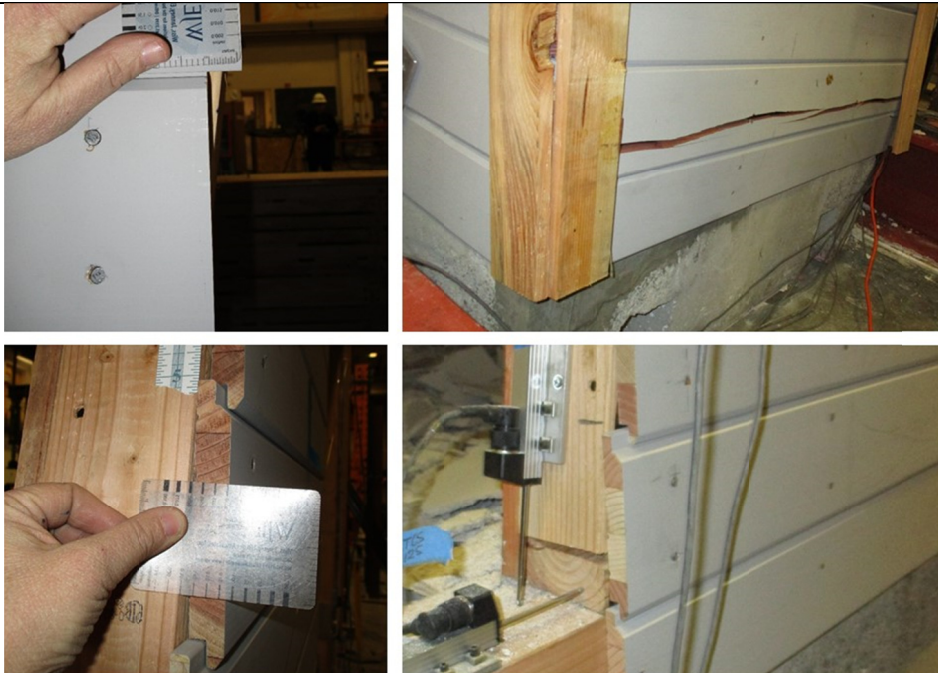
<p>South wall center wall pier pushed to west</p>

<p>Working of siding without significant visible damage to siding or nailing (left top), at compression end of wall piers siding boards are just getting near contact but not bearing on each other (left bottom), at tension end of wall piers gaps between siding boards are opening up (right bottom), crack in end wall siding has progressed (right top)</p>		13%

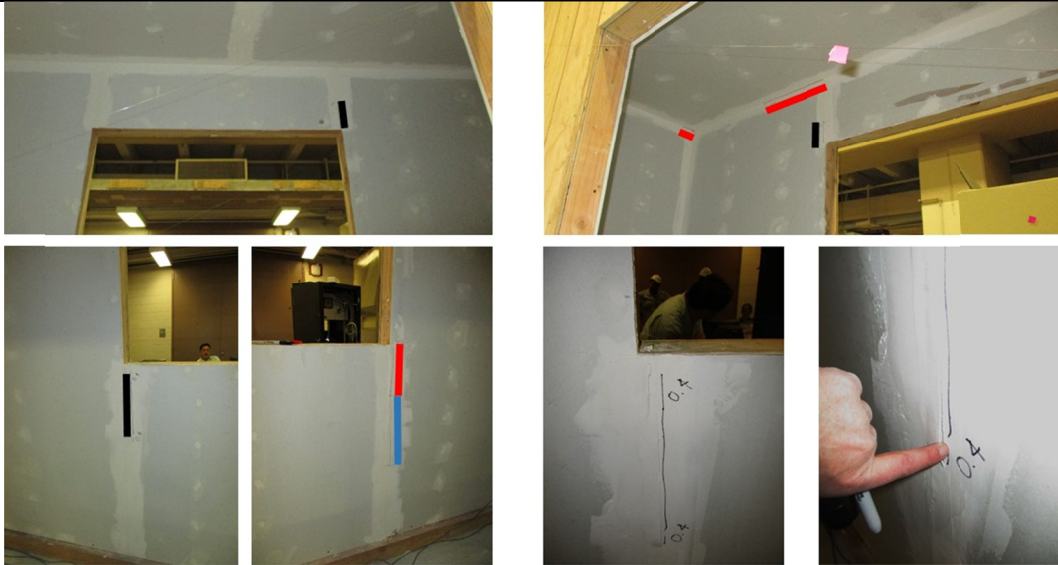
-Cracking, spalling along panel taped joints

Gypboard extent of cracking at north wall window marked on photos, with colors consistent with push, pull and balance of cycles (left) gypboard joint cracking at ceiling (right top), joint tape debonding and loose (right bottom)

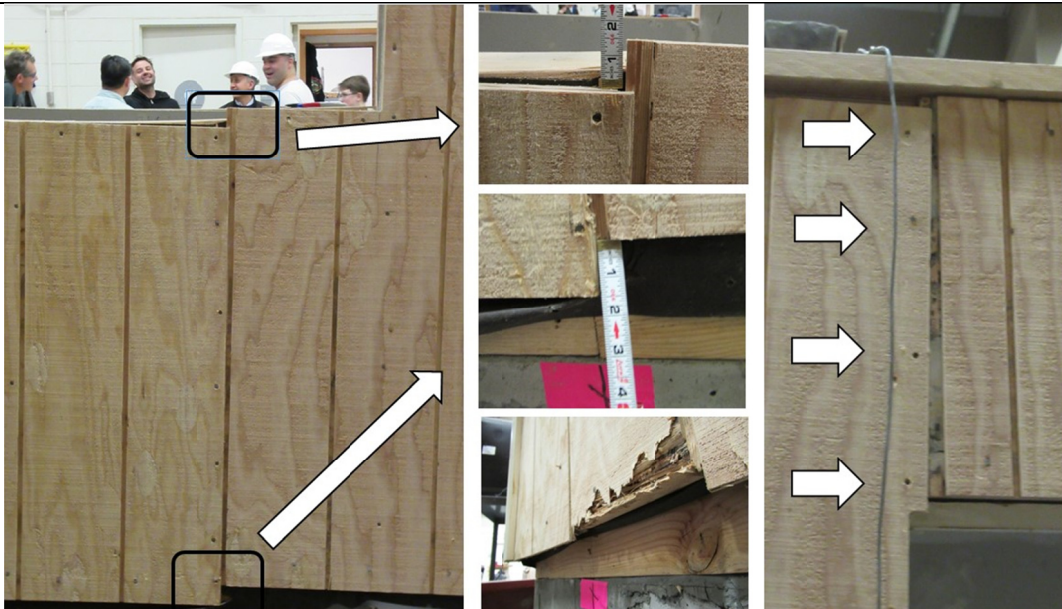
<p>South wall with pull displacement (towards right)</p>

<p>Plywood siding panel rotation results in greater vertical offsets and pull through of nail heads at panel corners and at Panel edge above door, end wall plywood siding is damaged at wall base (center bottom)</p>		4.0% Before first restraint was added

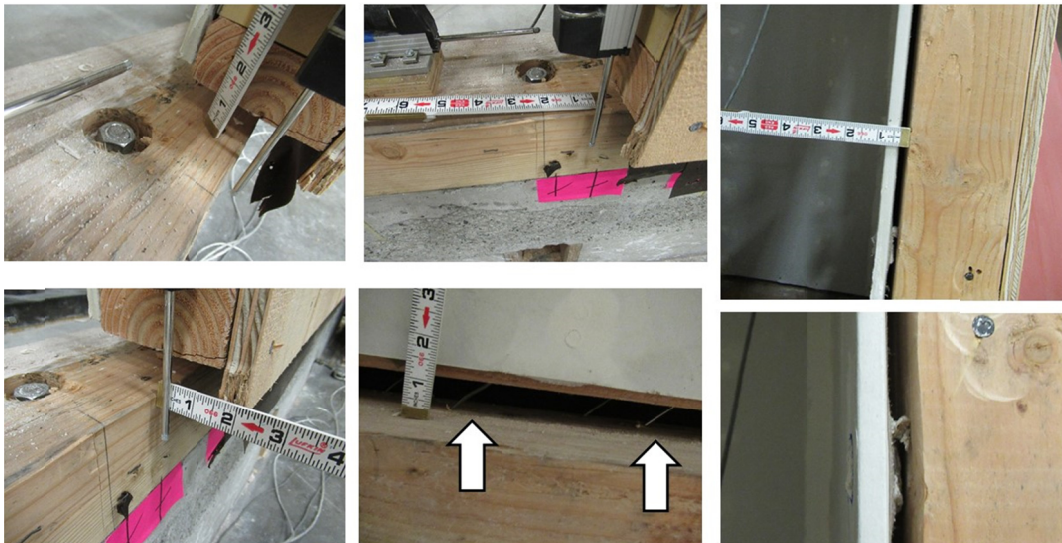
<p>Uplift of the wall bottom plate at the door opening (left top), wall bottom plate slip in the transverse direction so that the wall is no longer in line with the foundation (left bottom), wall bottom plate slip of approximately two inches in the longitudinal d direction (center top), wal bottomplate nails partially withdrawn under uplift and racked due to longitudinal wall slip (center bottom), gypboard seperating from wall framing and gouging of gypsu core at nail (right)</p>

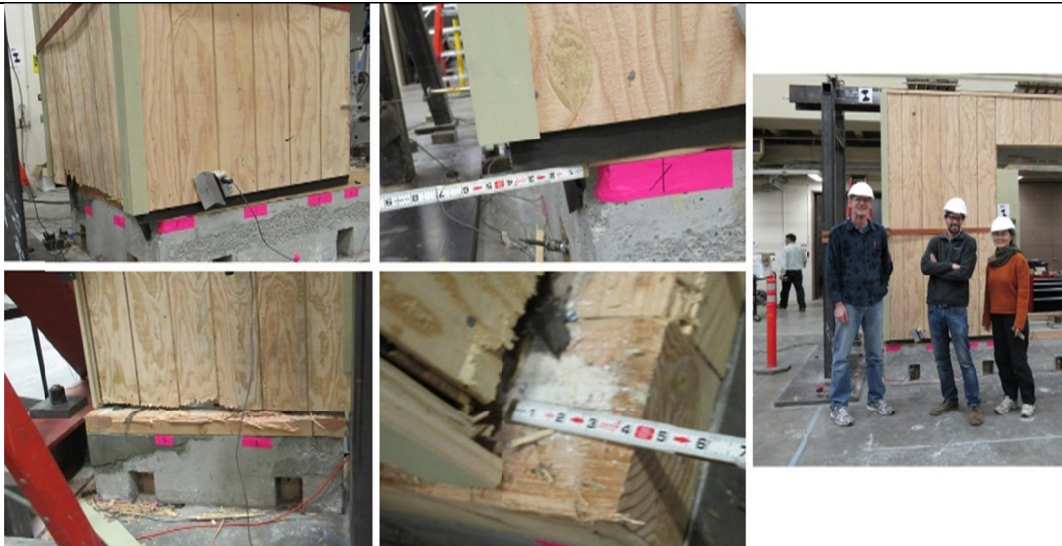
<p>South wall at start of cycles to 6% drift, with restraint added to help keep west wall pier from moving out of plane off of foundation</p>

<p>The superstructure wall being pushed along the 4x6 nailer and foundation, with slip up to four inches measured in both directions (left and center), Thor, Dave and Grace concur with decision to stop testing (right)</p>		6.0%

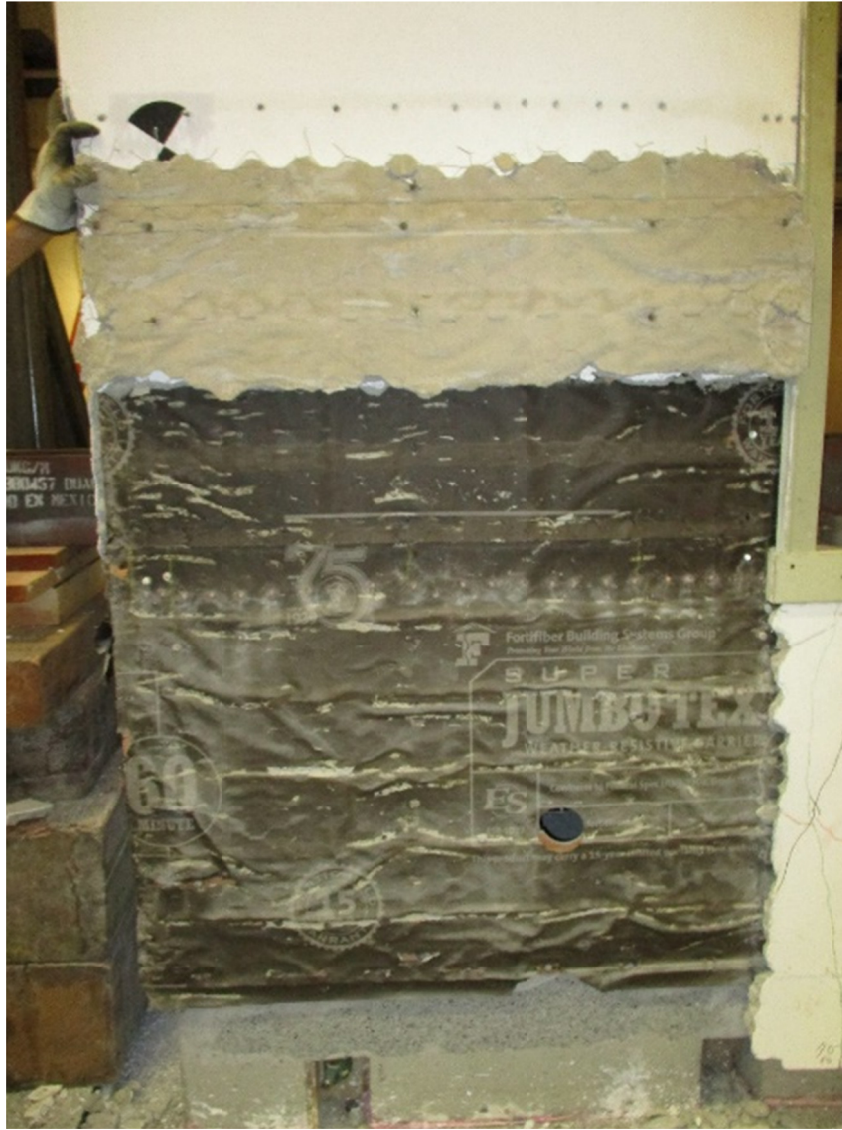
Figure D.6 Stucco underlying conditions at west-end of the south wall.

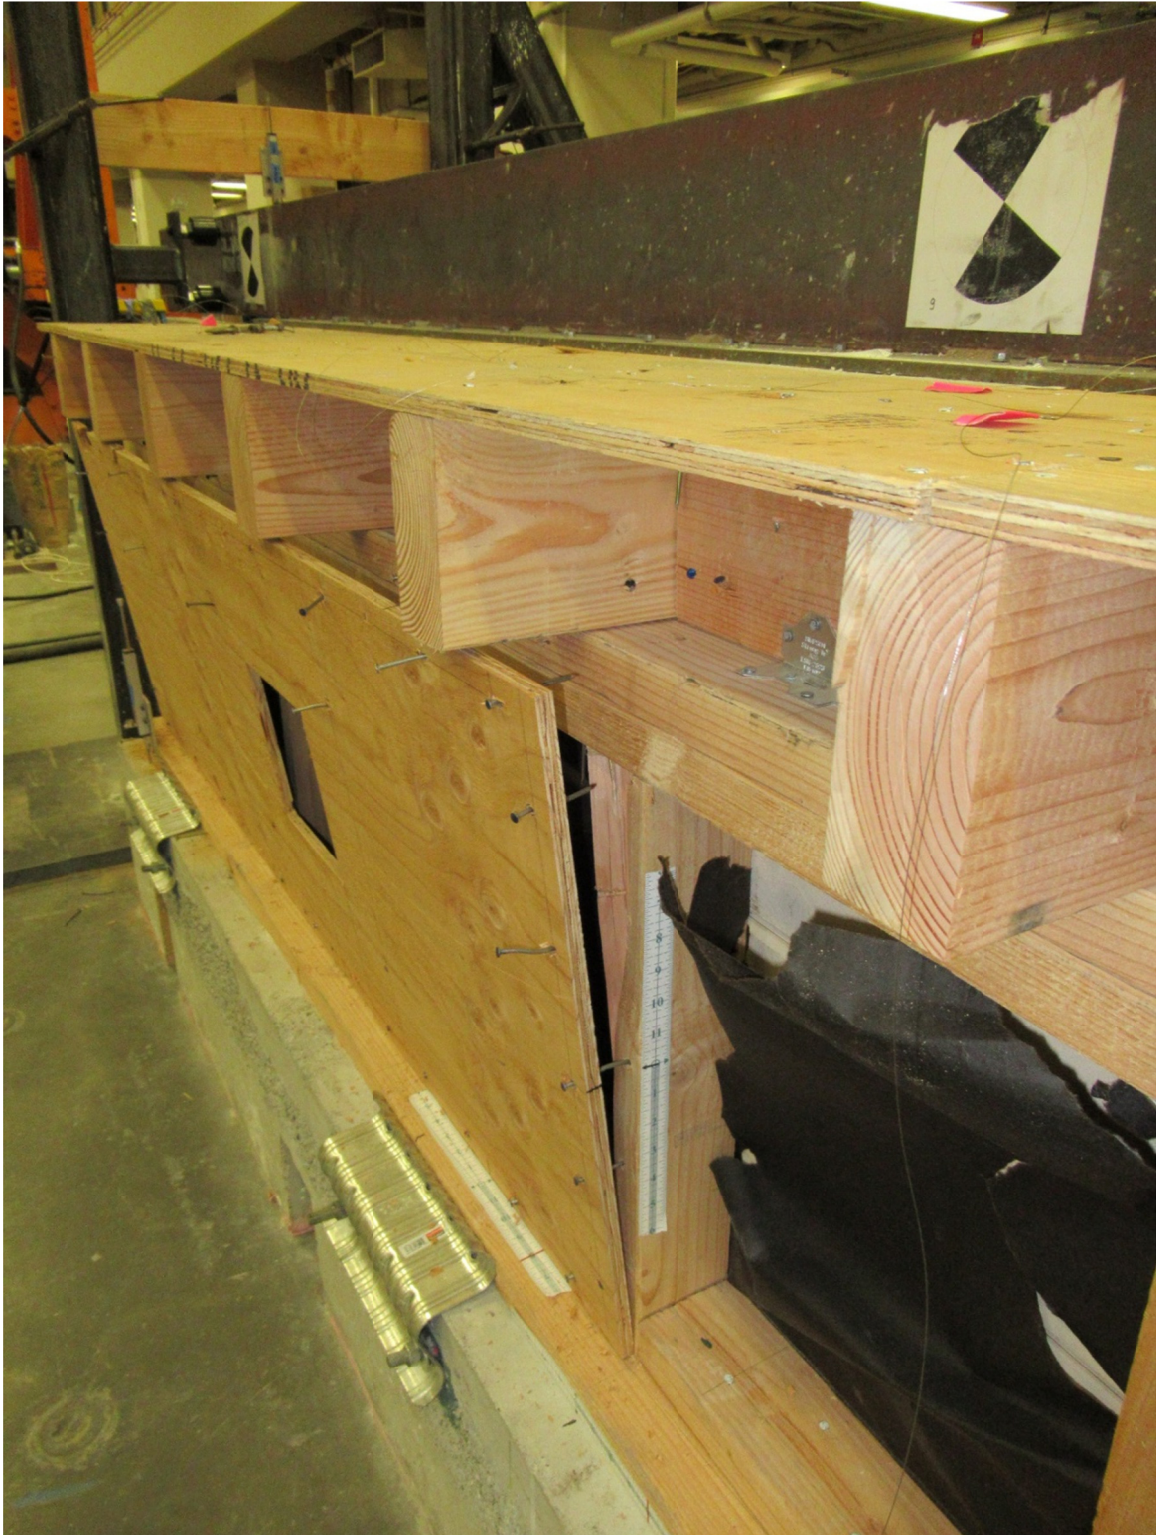
Figure D.39 Sheathing nailing withdrawal at the bottom of the plywood panel.

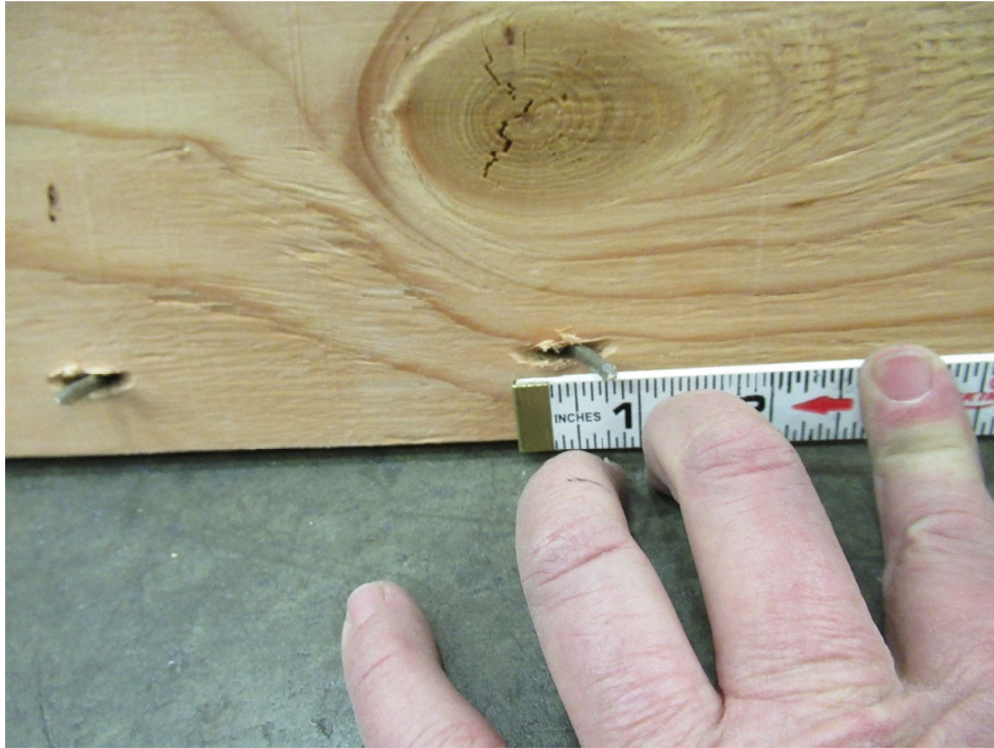
The two plywood sheathing panels on the south wall were removed. The interior face of the sheathing can be seen in Figure D.44 through D.47.. Horizontal slots in the sheathing panel face were seen at all locations where the plywood nails had withdrawn. Most of the slots were horizontal and approximately 3/4 in. long. In addition, the framing had also been significantly slotted at the sheathing nail locations. Where the sheathing had been fully detached, slots of one to 1-1/4 in. were evident. Where the sheathing had remained attached, slots of about 1/2-in. were evident; see Figures D.48 to D.50. While occasional splits in framing were seen, they did not appear to be associated with the plywood nailing.

Figure D.44 Nail slotting observed on interior face of plywood after selective removal.

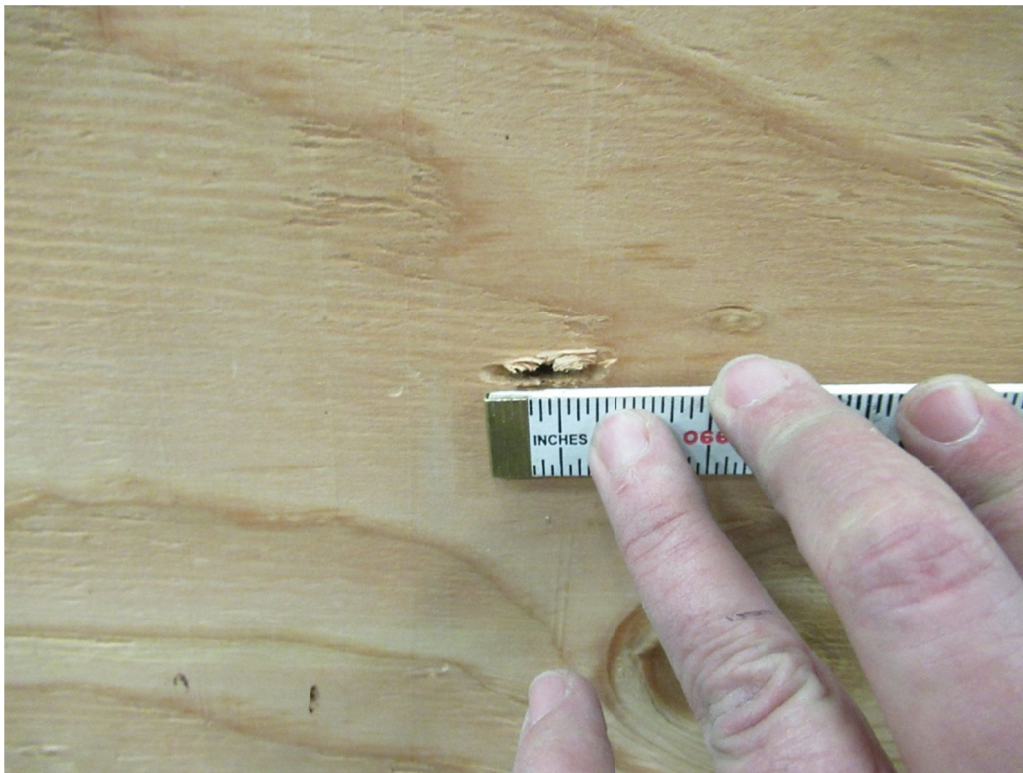
Figure D.45 Nail slotting on interior face of plywood.

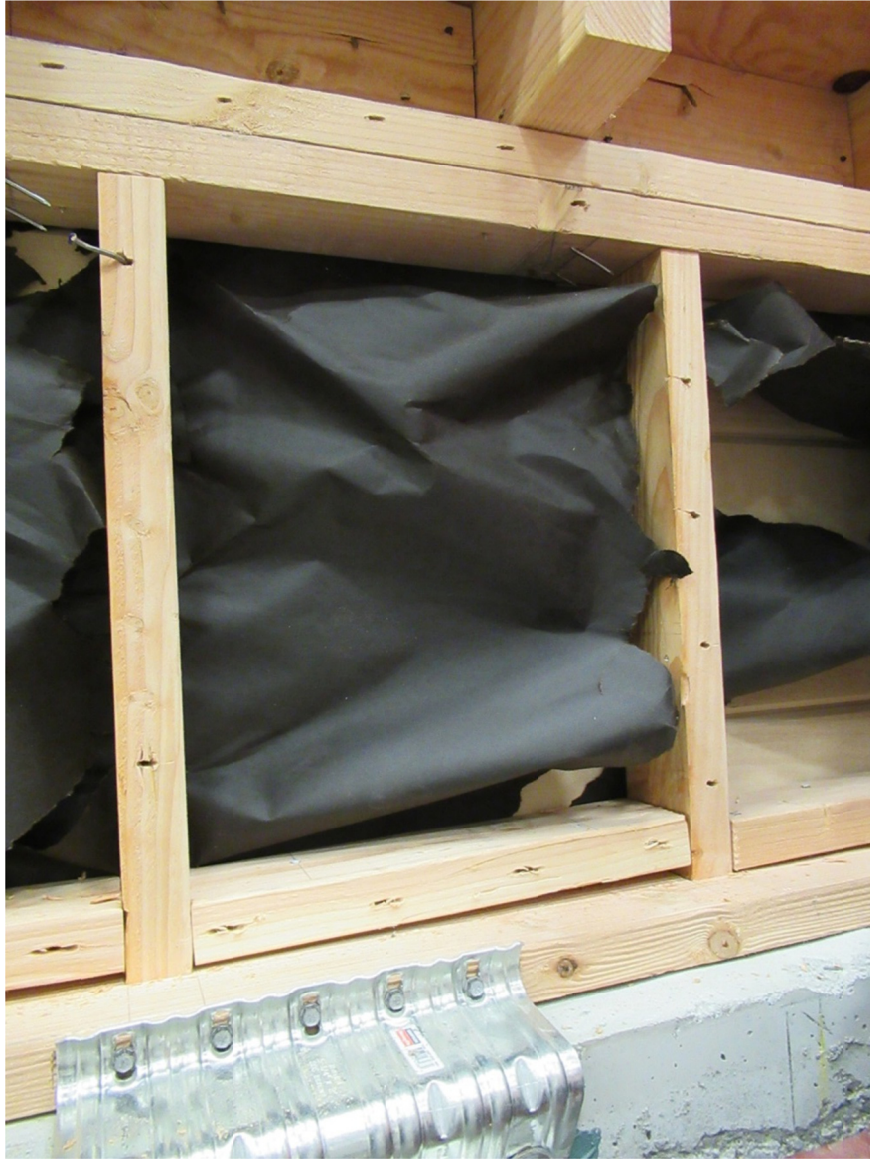
Figure D.48 Slotting observed on cripple wall framing with plywood removed.

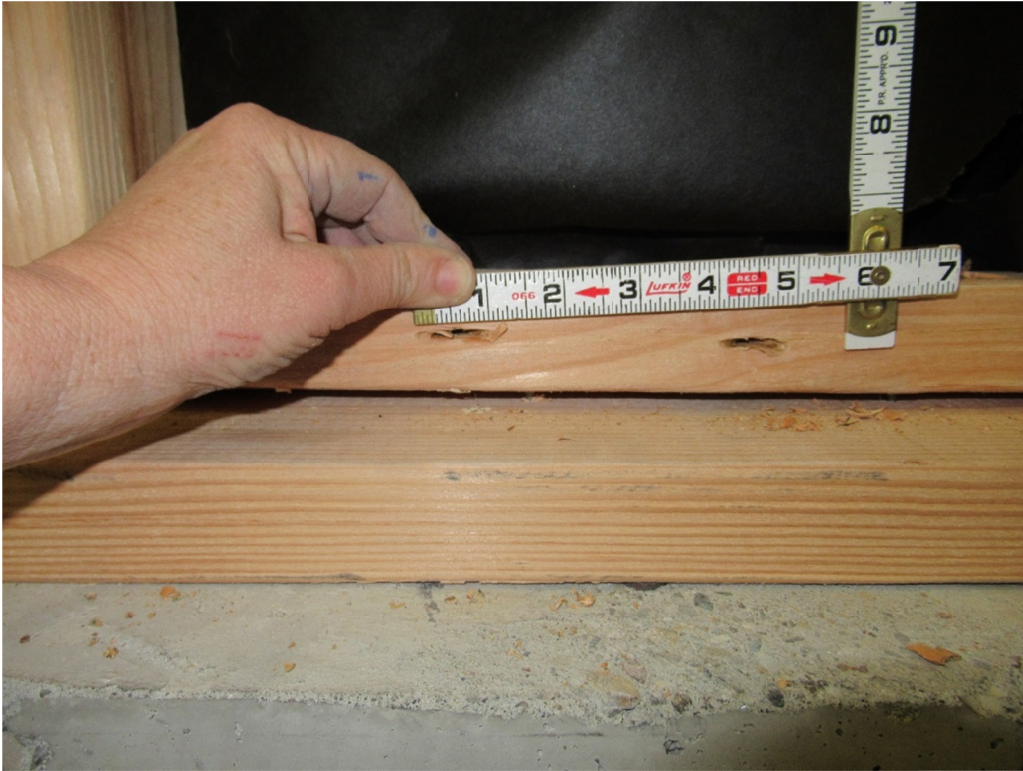
Figure D.49 Slotting observed on cripple wall blocking on top of foundation sill plate with plywood removed.

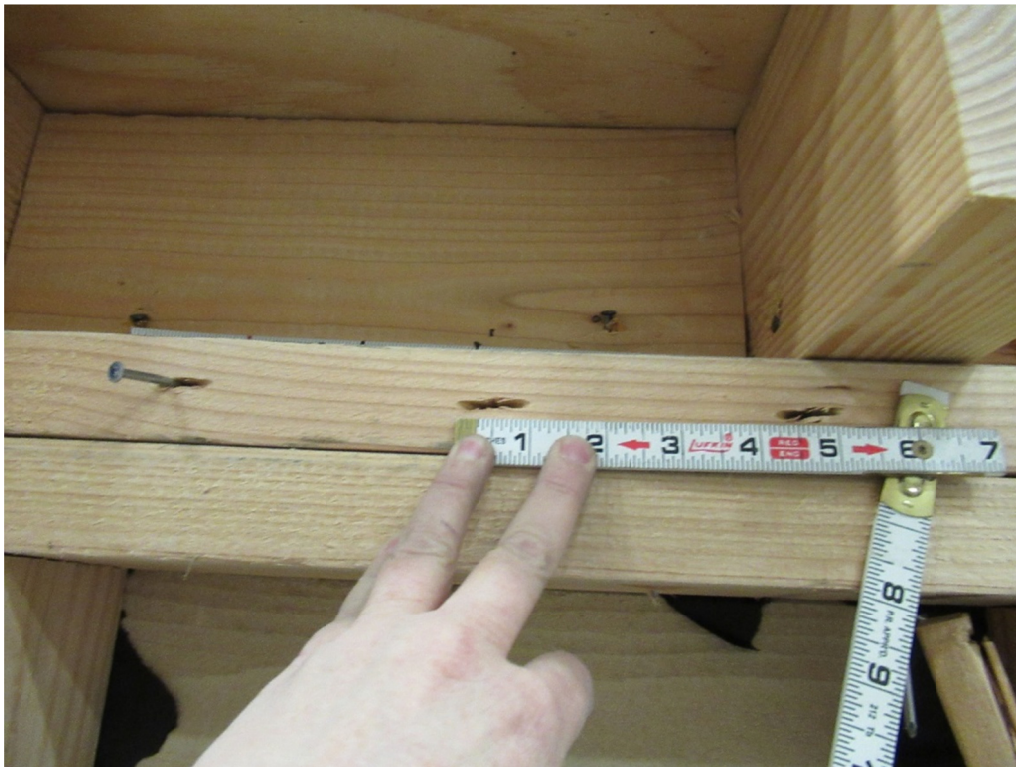
Figure D.50 Slotting observed in cripple wall top plates with plywood removed.

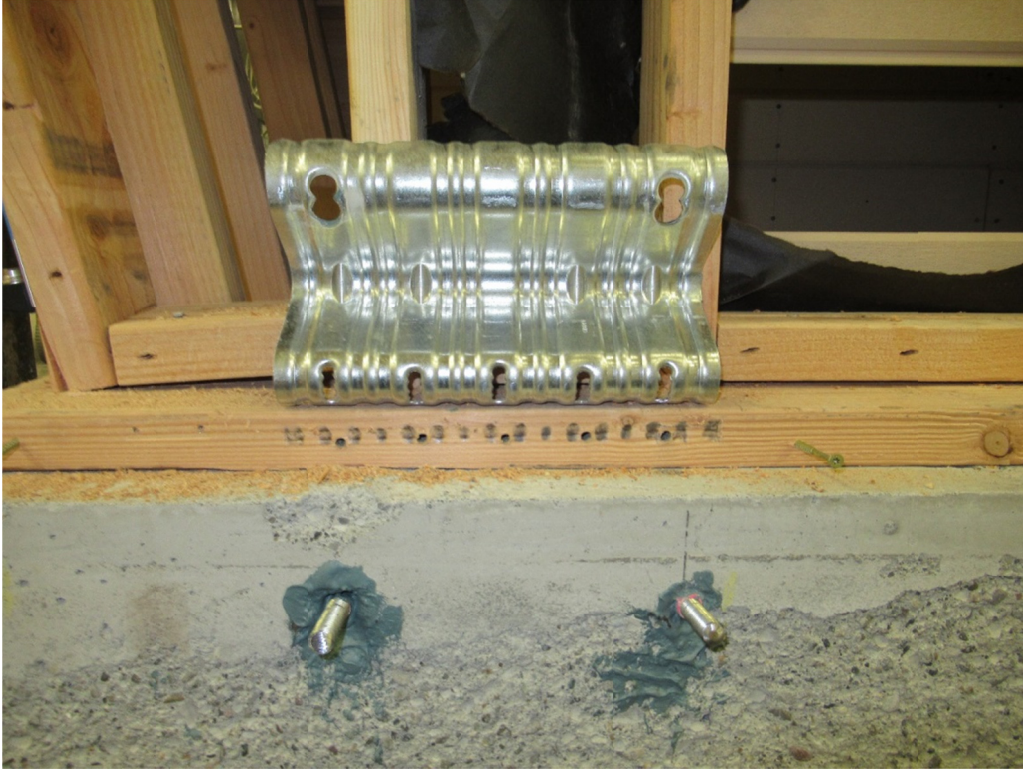
At the end of testing there was little evidence of deformation or damage to the retrofit anchors anchoring the foundation sill plates to the foundation. Observations included a very slight horizontal rotation of the brackets, but too small to be easily measured. About half of the threaded rod nuts were loose, with one backed off about 1/4 in. Several of the threaded rods appeared to be slightly bent vertically, but with 1/16 in. or less of movement. There was no sign of local or global deformation of the retrofit brackets. Two of the retrofit plates were removed to inspect conditions below; see Figures D.58 through D.61. Behind the retrofit plate, minimal crushing and discoloring were noted where dimples in the plate bore against the 2 × 6 foundation sill plate. There was no appreciable distortion or elongation of the SDS screw holes into the 2 × 6 sill plate.

Figure D.58 Foundation and foundation sill plate following removal of retrofit anchor (seen above).

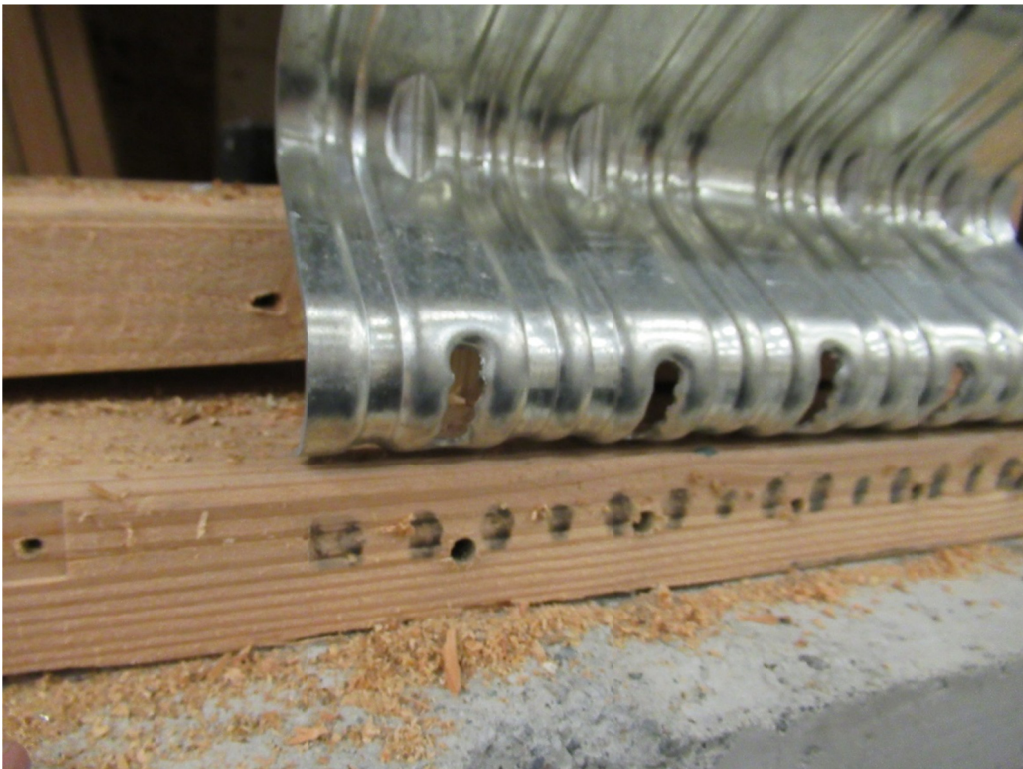
Figure D.59 Foundation sill plate following removal of foundation anchor.

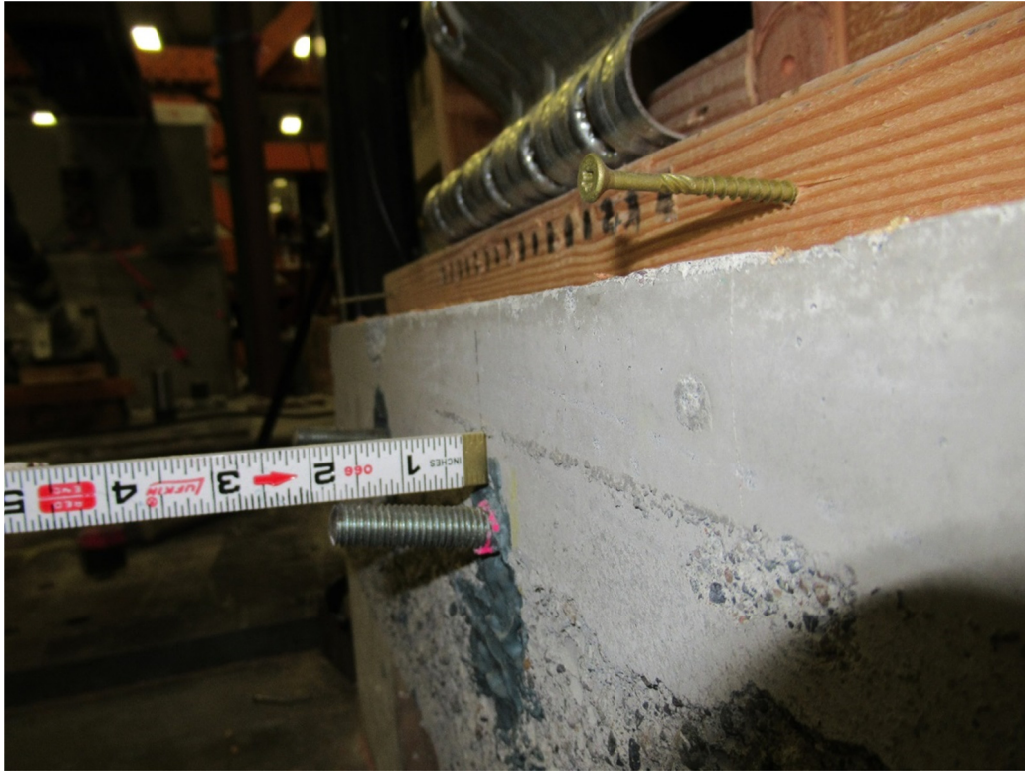
Figure D.60 Foundation anchor following removal of foundation plate.
