APPENDICES A, B, C, and D

APPENDIX A Working Group 4 Recommendations for Experimental Program

APPENDIX C Working Group 4: Damage Observations for All Specimens

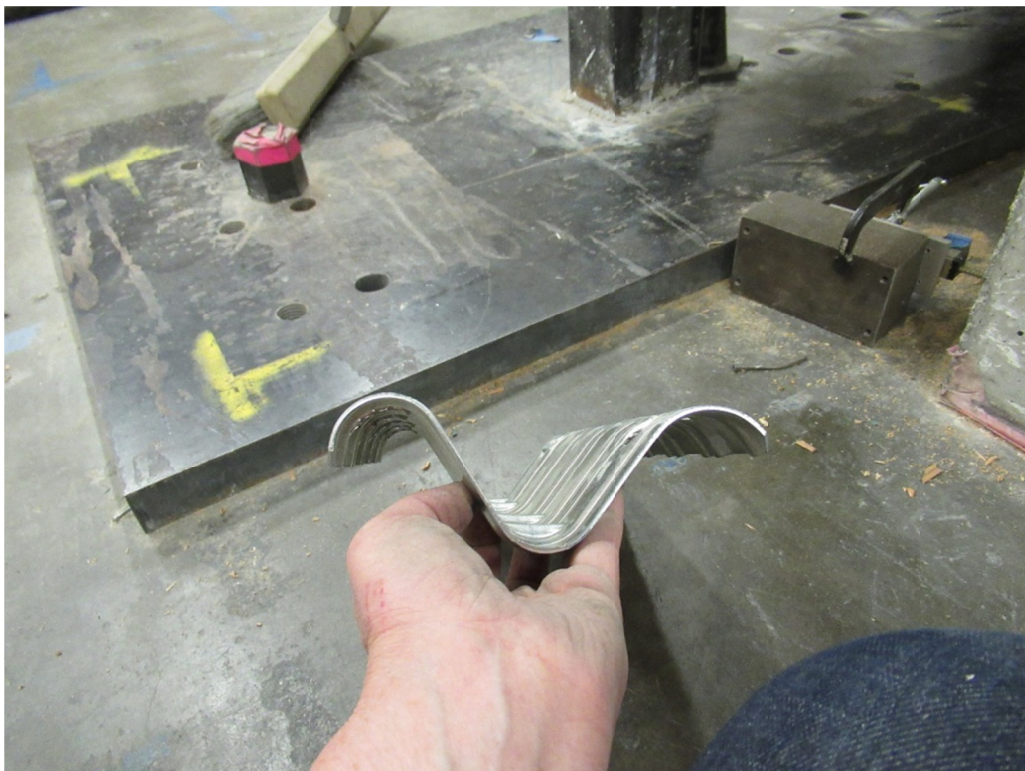
Figure D.61 Foundation anchor plate following removal.

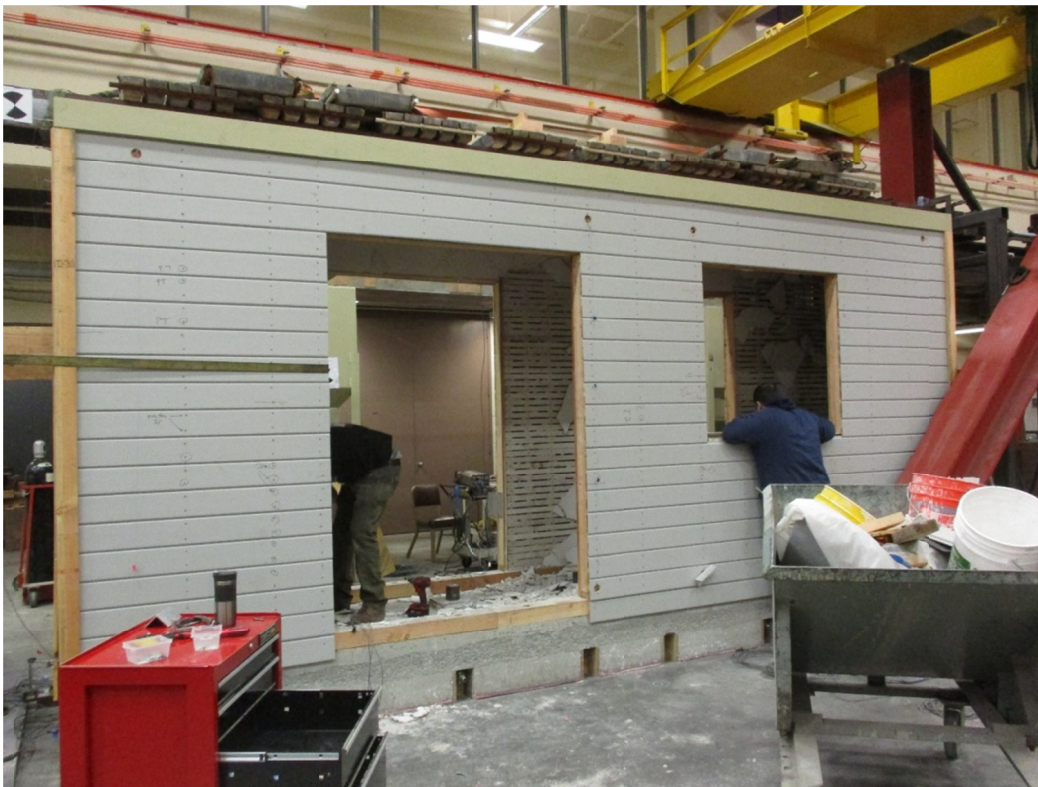
An overall view of the test specimen is provided in Figure D.62. By the end of testing, virtually all of the plaster had fallen off of the wood lath at the north and south walls, and was sitting in piles on the floor. Occasional small patches of plaster remained attached, as did the plaster at the very top of the north and south walls, from the bottom of the headers and up. The plaster at the east and west walls had significant cracking but remained attached to the lath; see Figures D.63 through D.65. The siding showed limited amounts of partial nail withdrawal, nail pull through, and occasional hairline cracking. The nail withdrawal and pull through was generally on the order of 0.10 in.; see Figures D.66 through D.70.

Figure D.62 Specimen C-1 overall photograph at conclusion of testing.

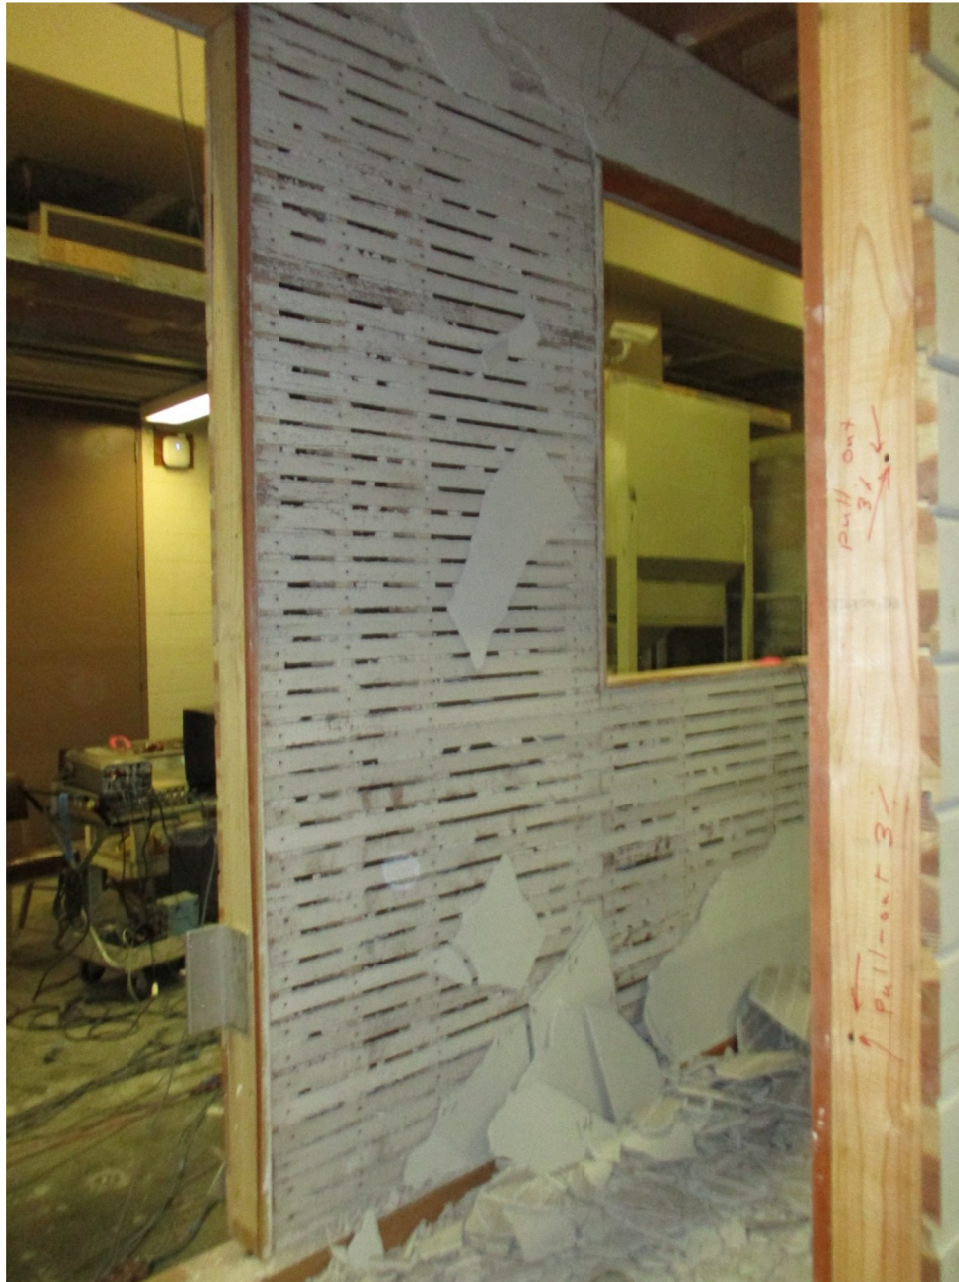
Figure D.63 Plaster remaining at north wall pier; plaster at south wall was in similar condition.

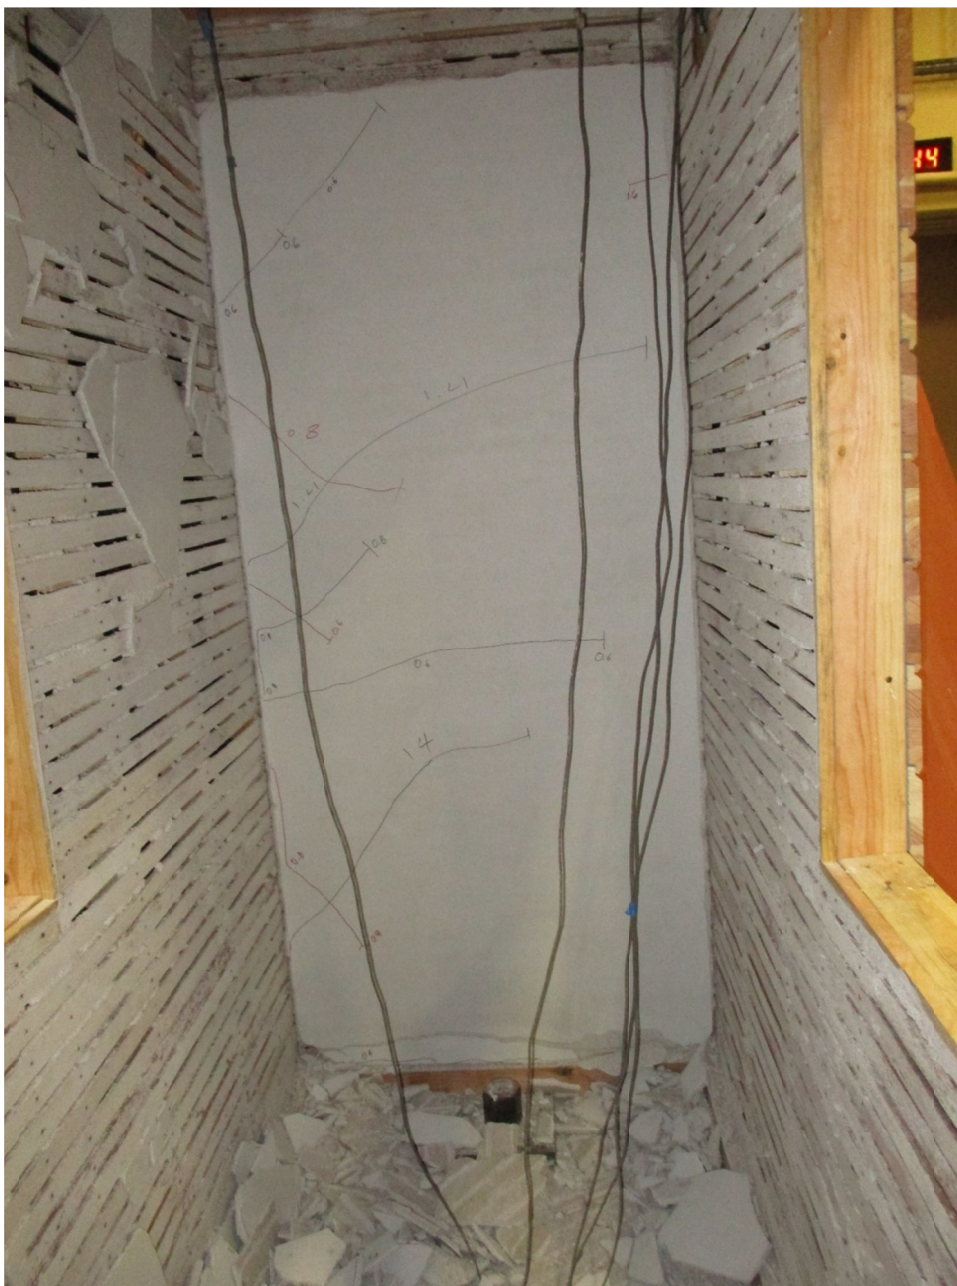
Figure D.64 Plaster cracked but still intact at the east end wall. Note piles of plaster debris on the floor.

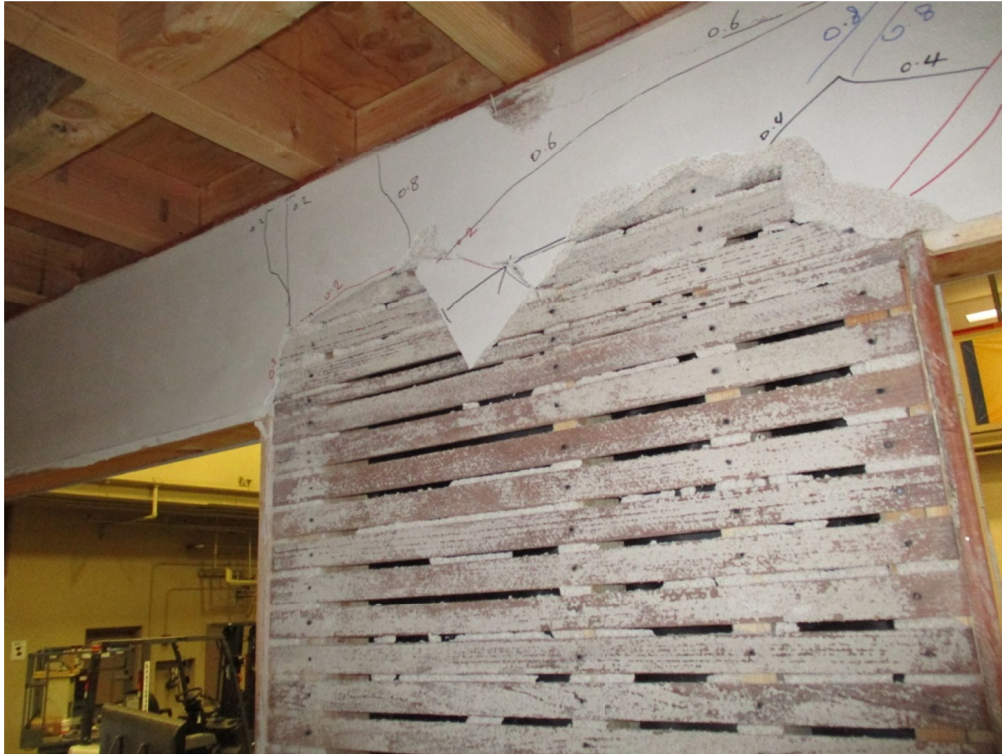
Figure D.65 Plaster still intact at the very top of the south wall; plaster at the south wall was in similar condition.

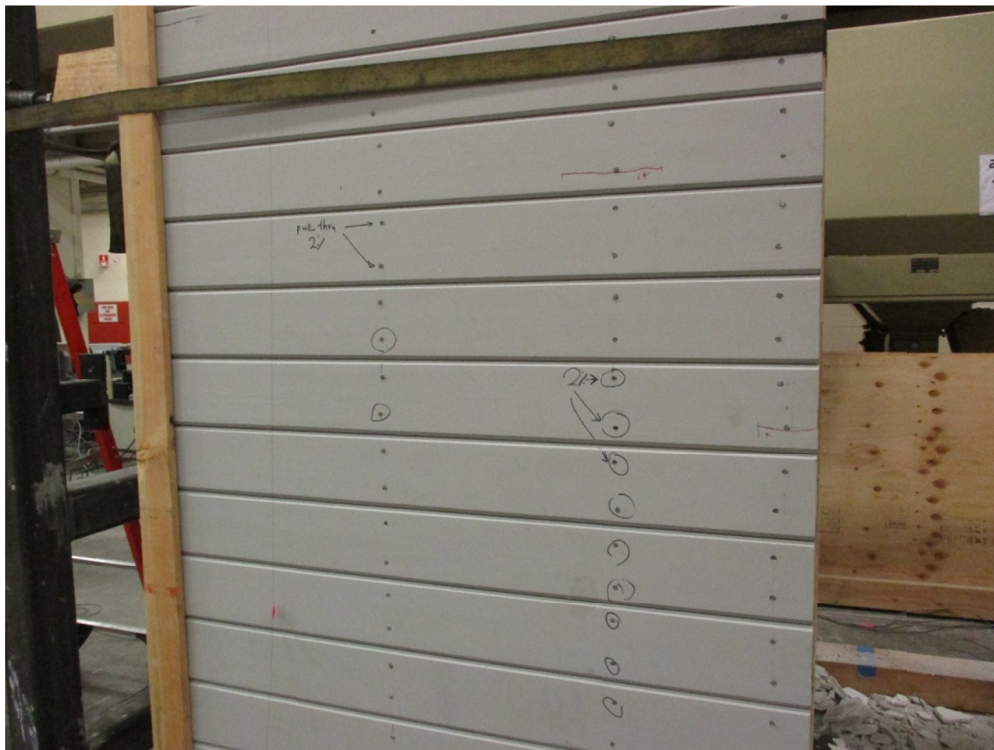
Figure D.66 Siding condition at conclusion of testing. Nails with circles had limited nail withdrawal.

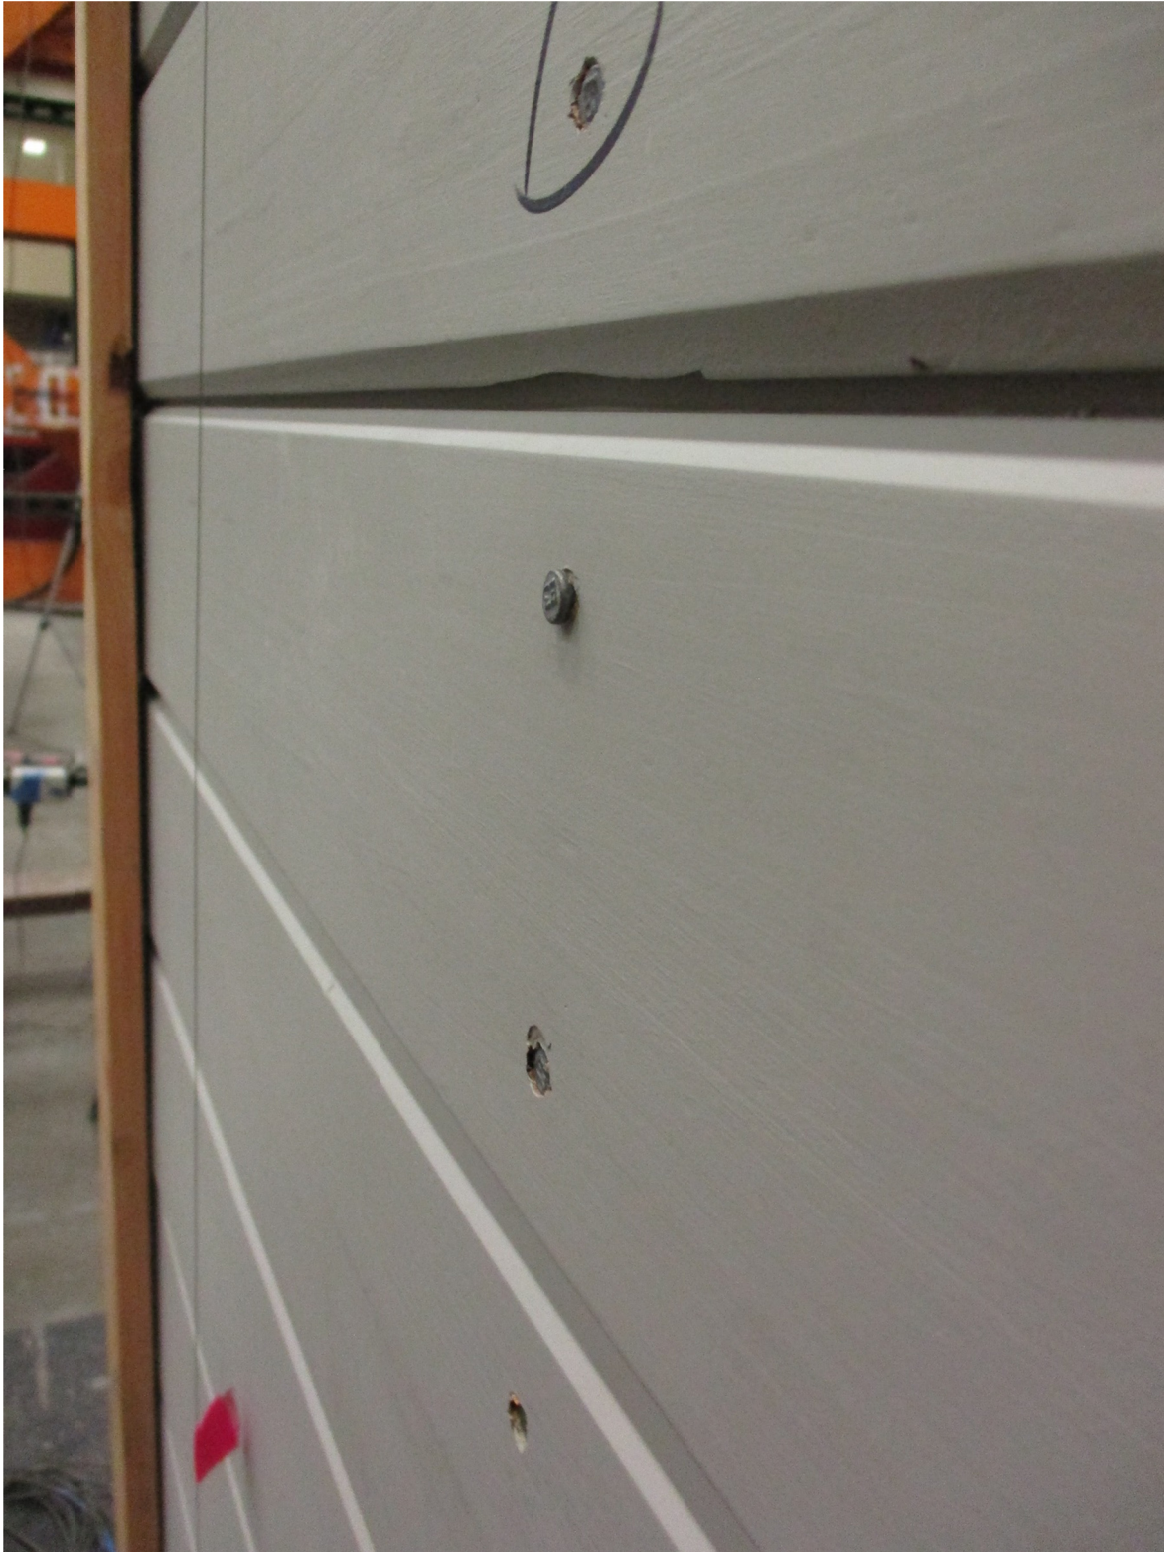
Figure D.67 Siding showing light nail withdrawal and slight nail head pull through at conclusion of testing.

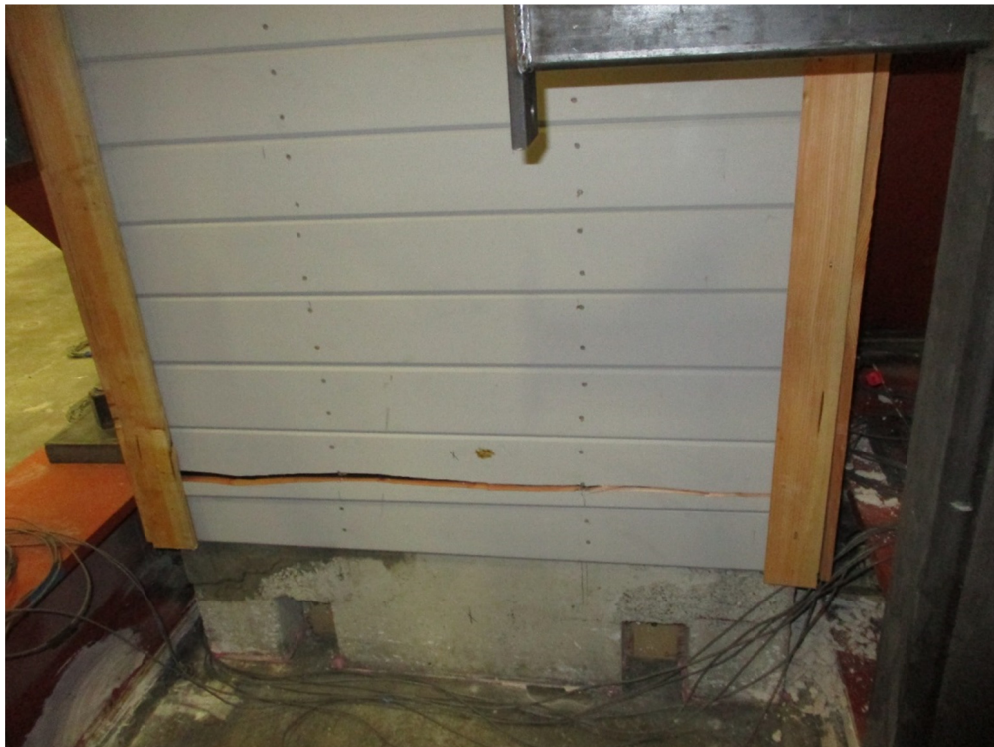
Figure D.70 Splitting of siding at top of foundation at east end wall.

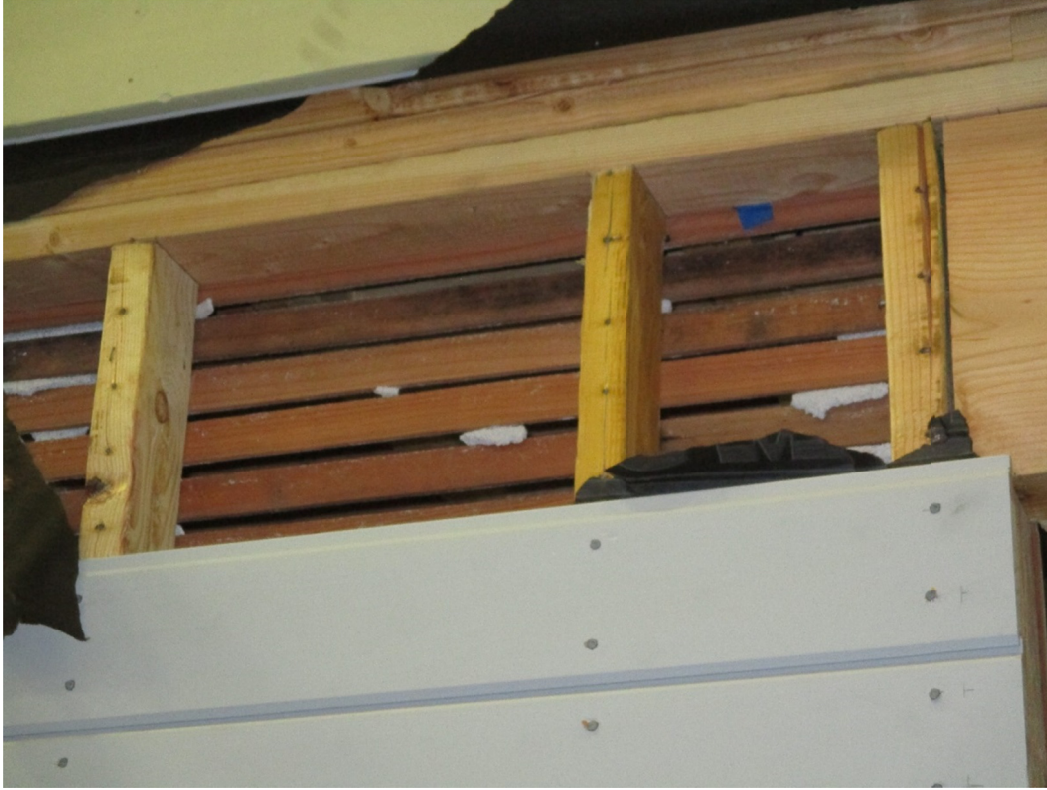
Figure D.75 Close-up of wall framing showing narrow splits at siding nail locations and large splits in vicinity of header.

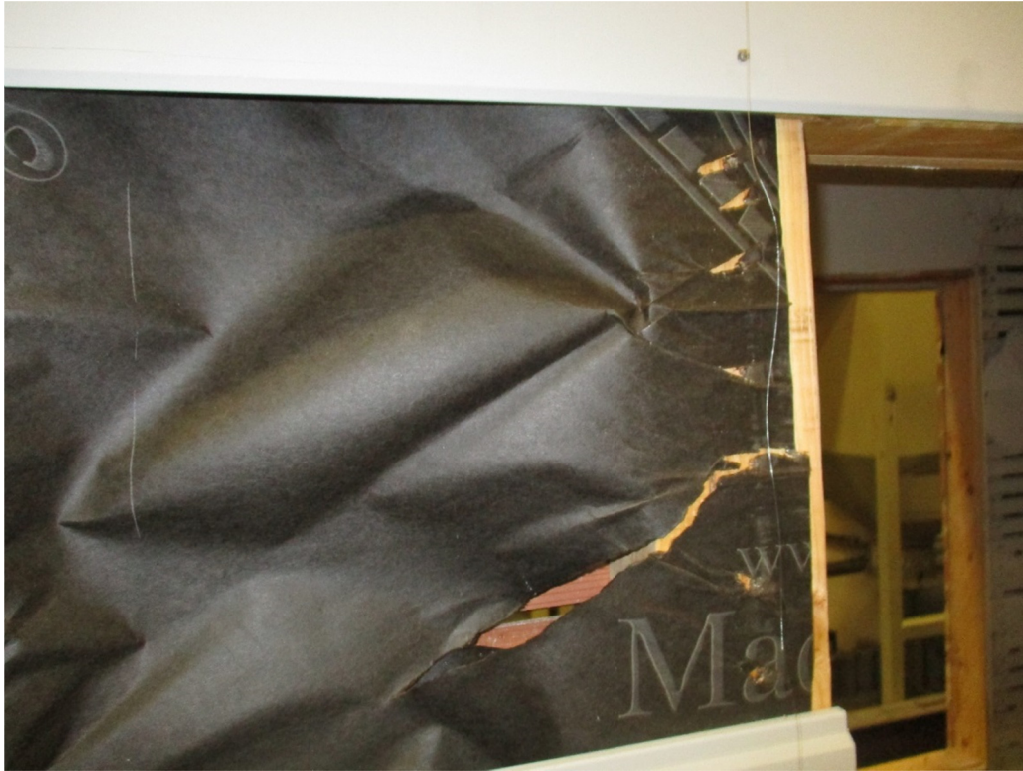
Figure D.81 Building paper was highly disrupted at the conclusion of testing.

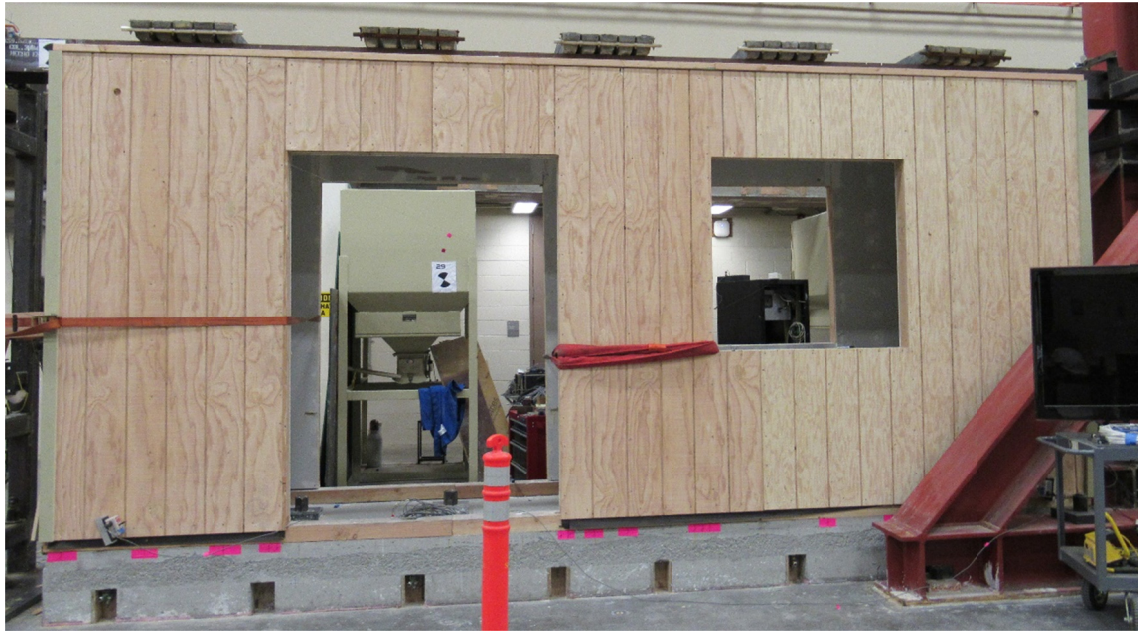
Figure D.82 Specimen C-2 overall view of at completion of testing.

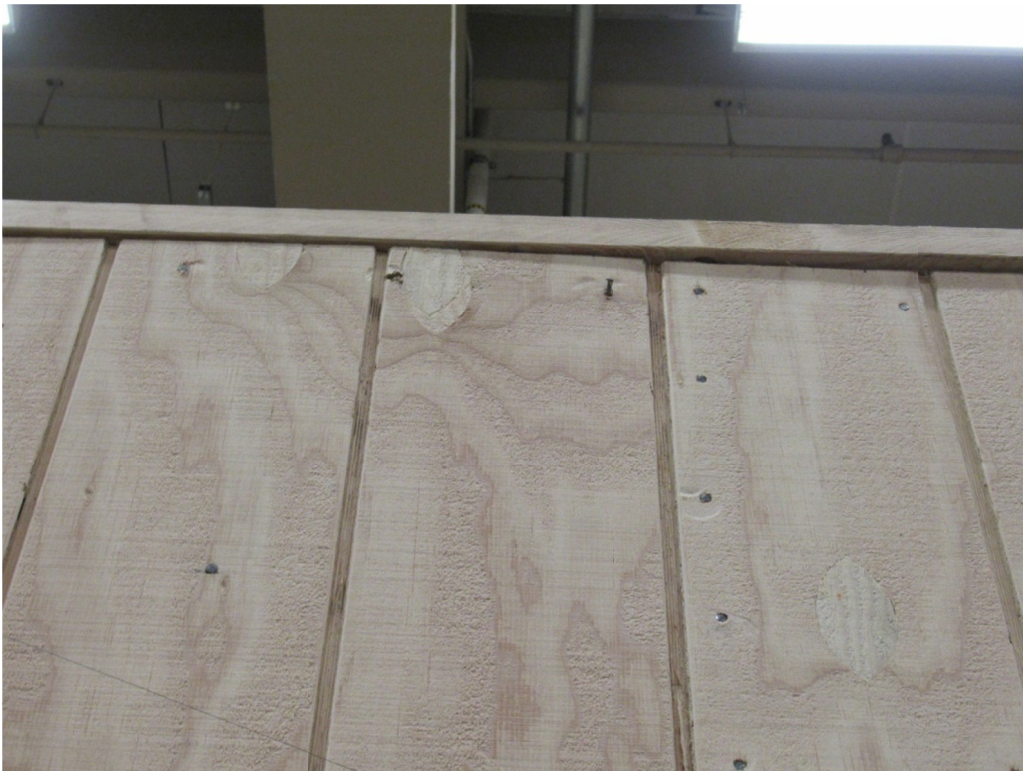
Figure D.85 Specimen C-2 condition of south wall at conclusion of testing.

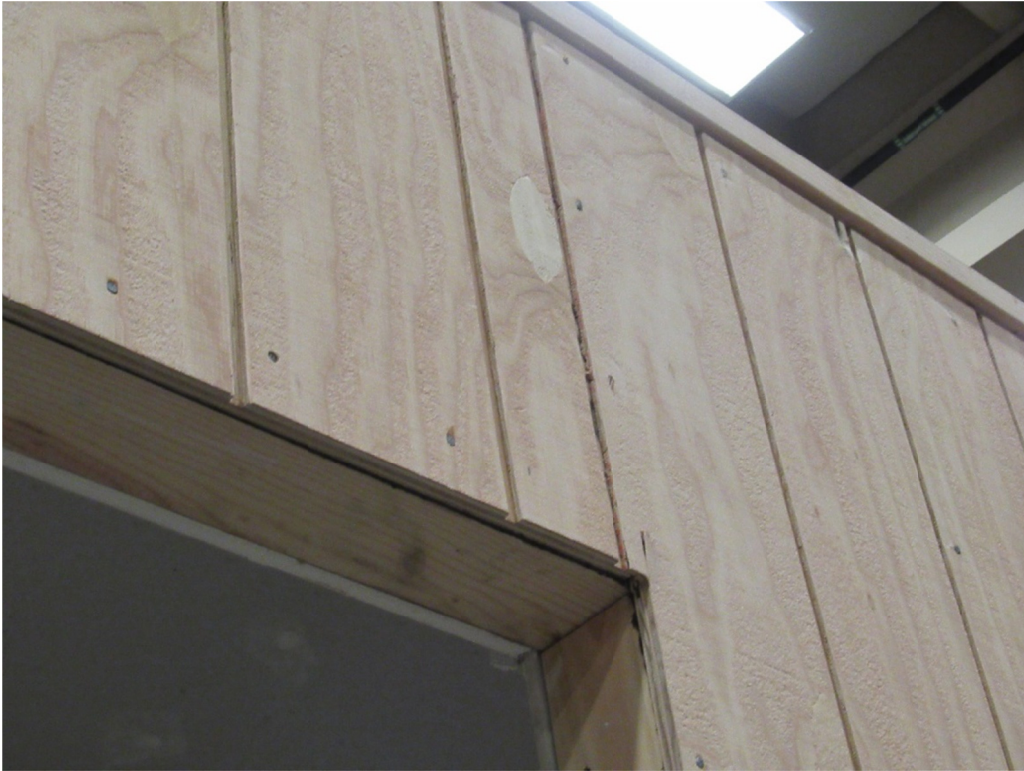
Figure D.86 Specimen C-2 condition of south wall at conclusion of testing.

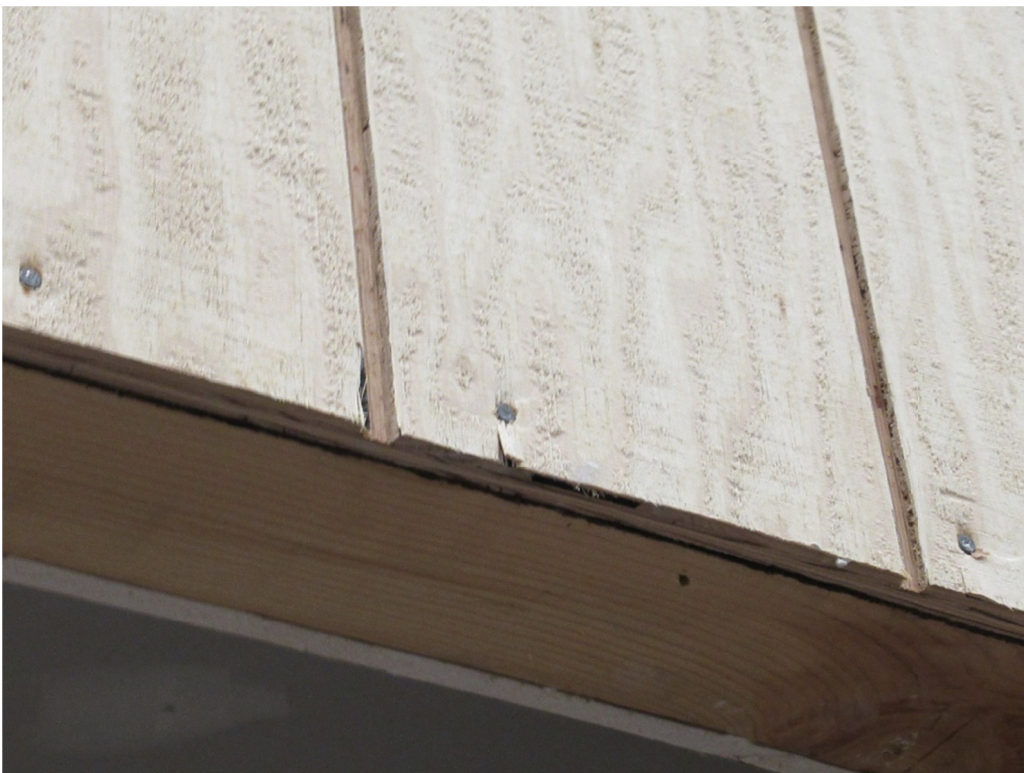
Figure D.87 Specimen C-2 condition of south wall at conclusion of testing.

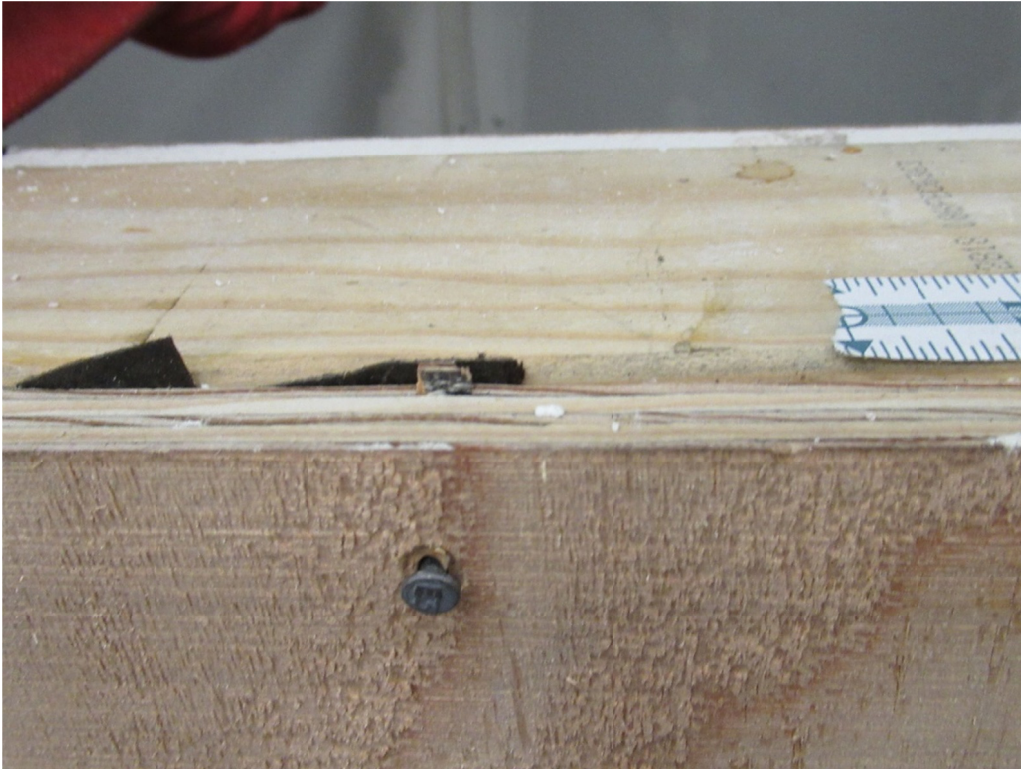
Figure D.88 Specimen C-2 condition south wall at conclusion of testing.

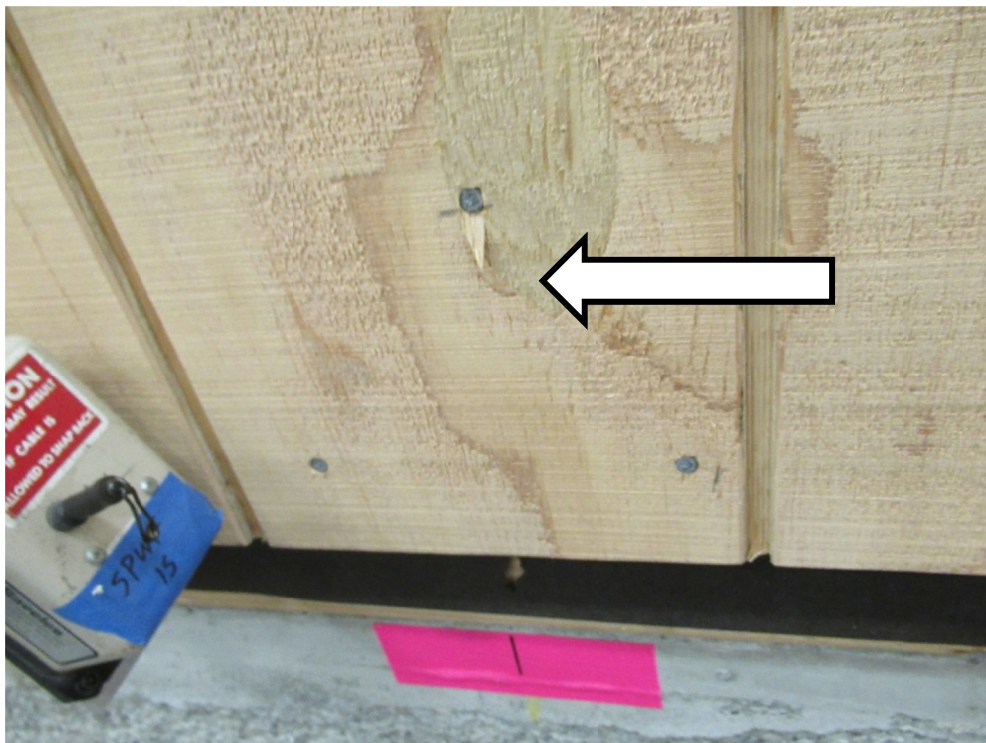
Figure D.89 Local flake in surface ply of T1-11 siding.

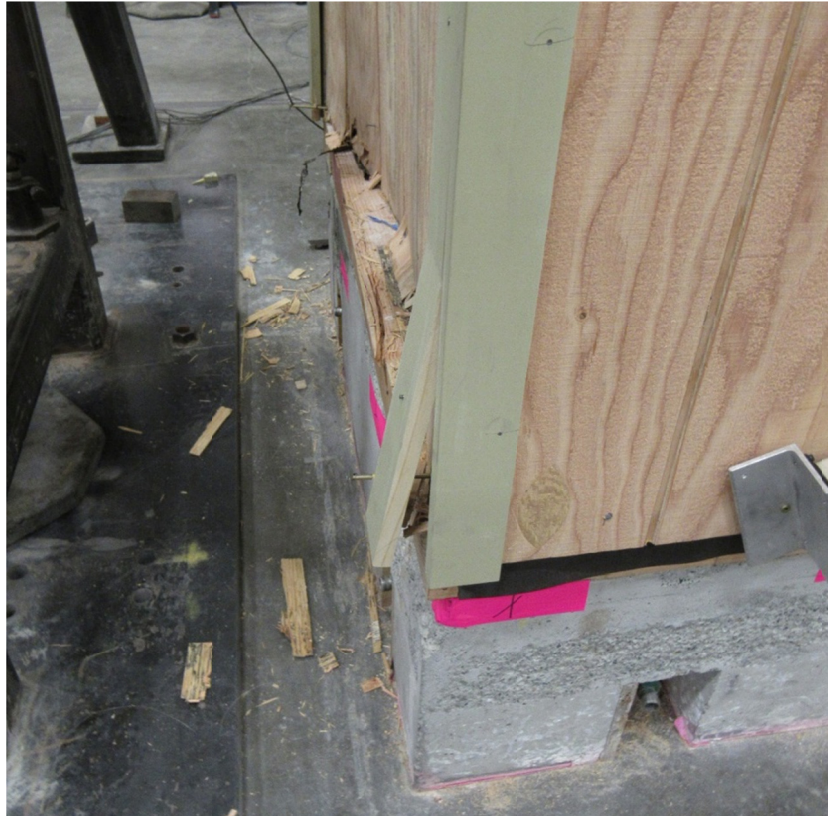
Figure D.90 **Fractured trim a specimen corner.**

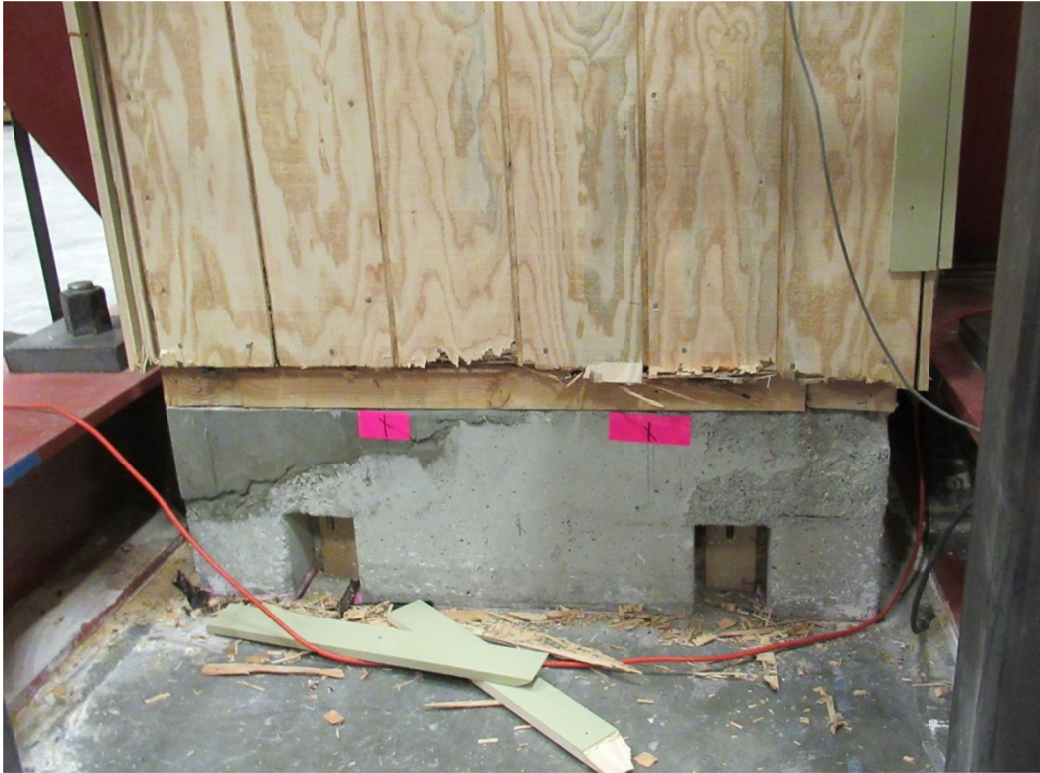
Figure D.91 Siding damage at base on east wall.

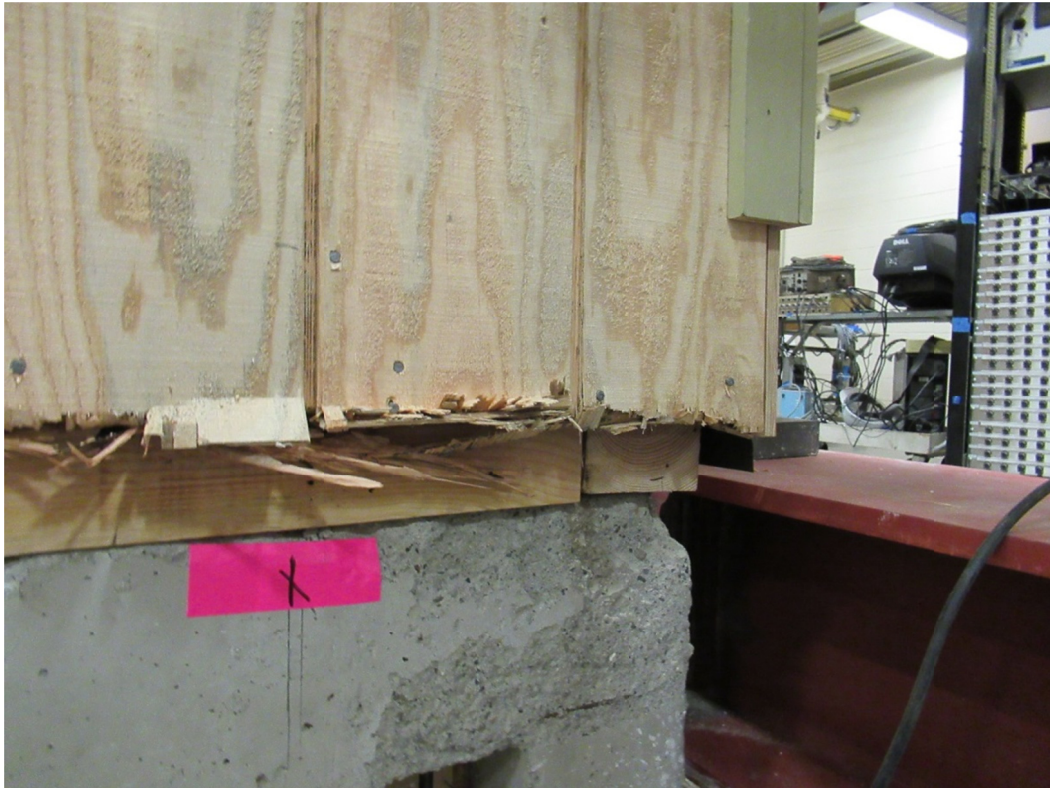
Figure D.92 Siding damage at base on east wall.

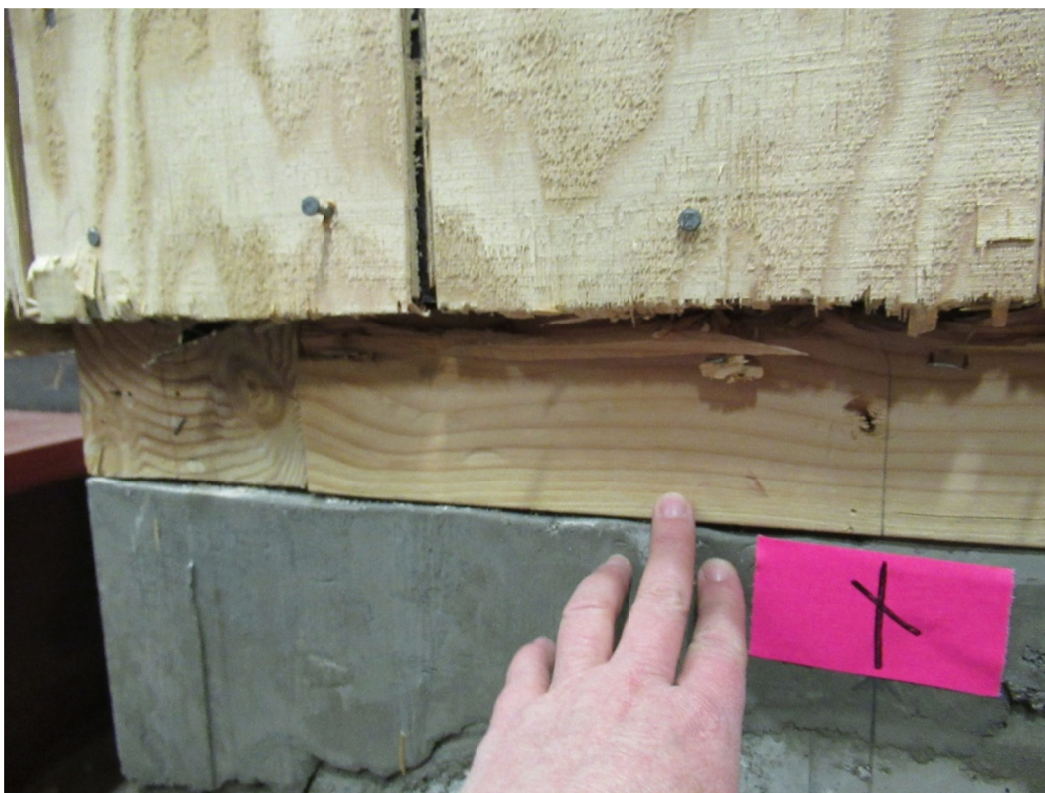
Figure D.93 Siding damage at base on east wall.

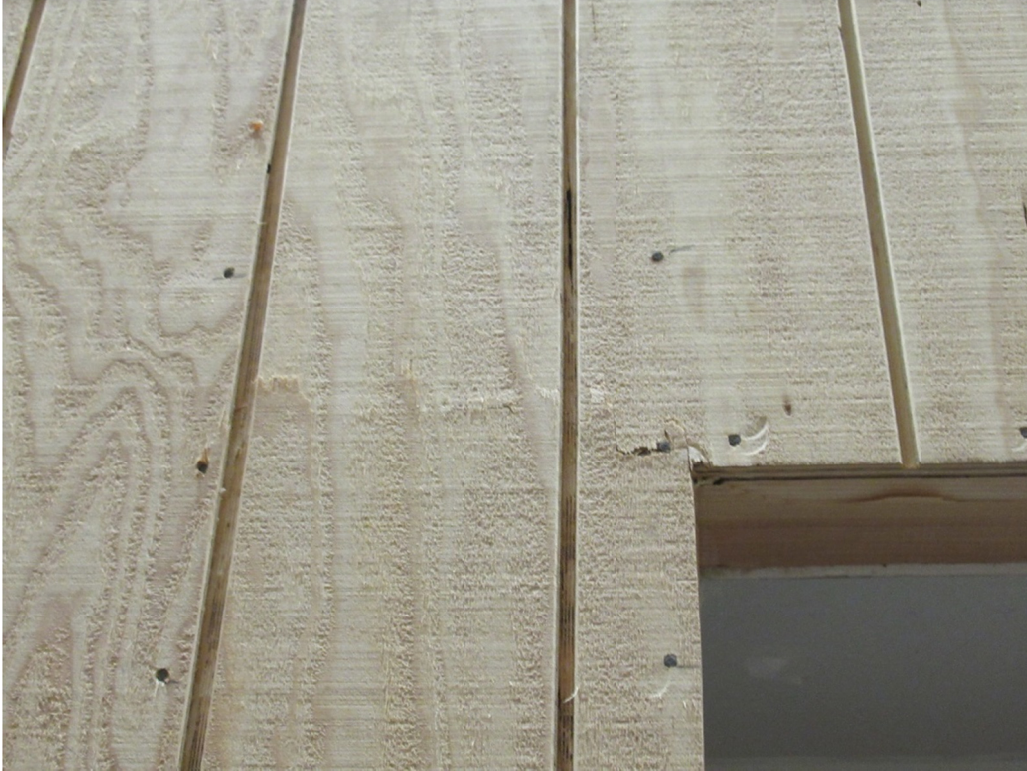
Figure D.94 Tear in siding above window in north wall.

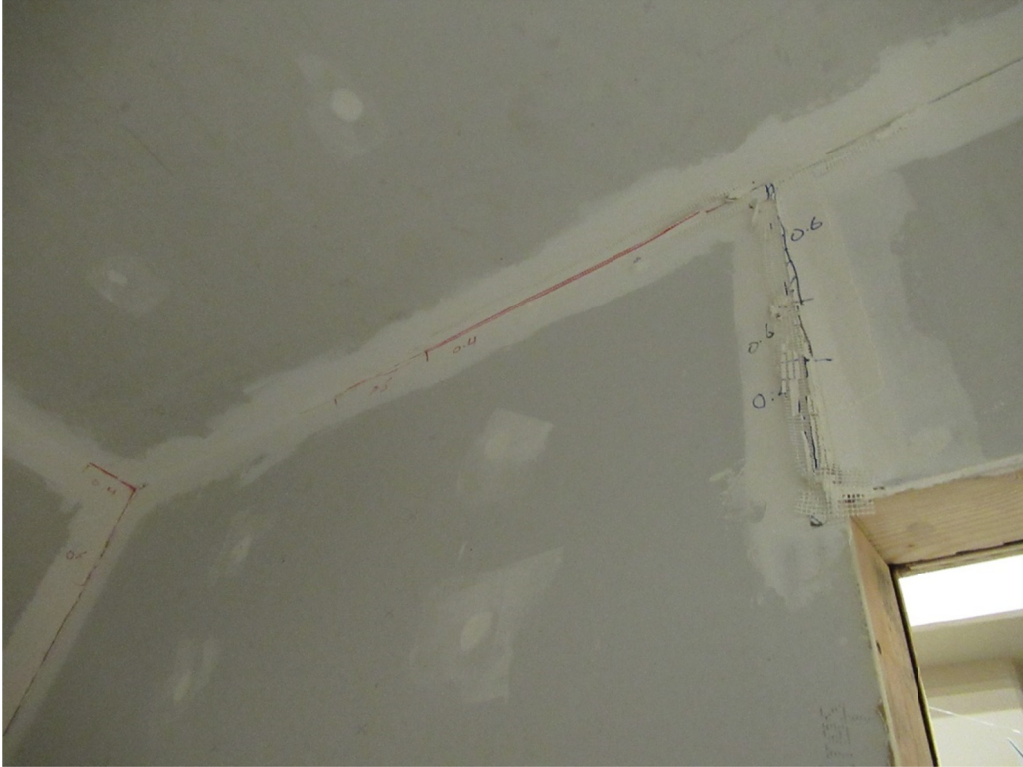
Figure D.101 Tearing and joint compound spalling at gypsum wallboard taped joints.

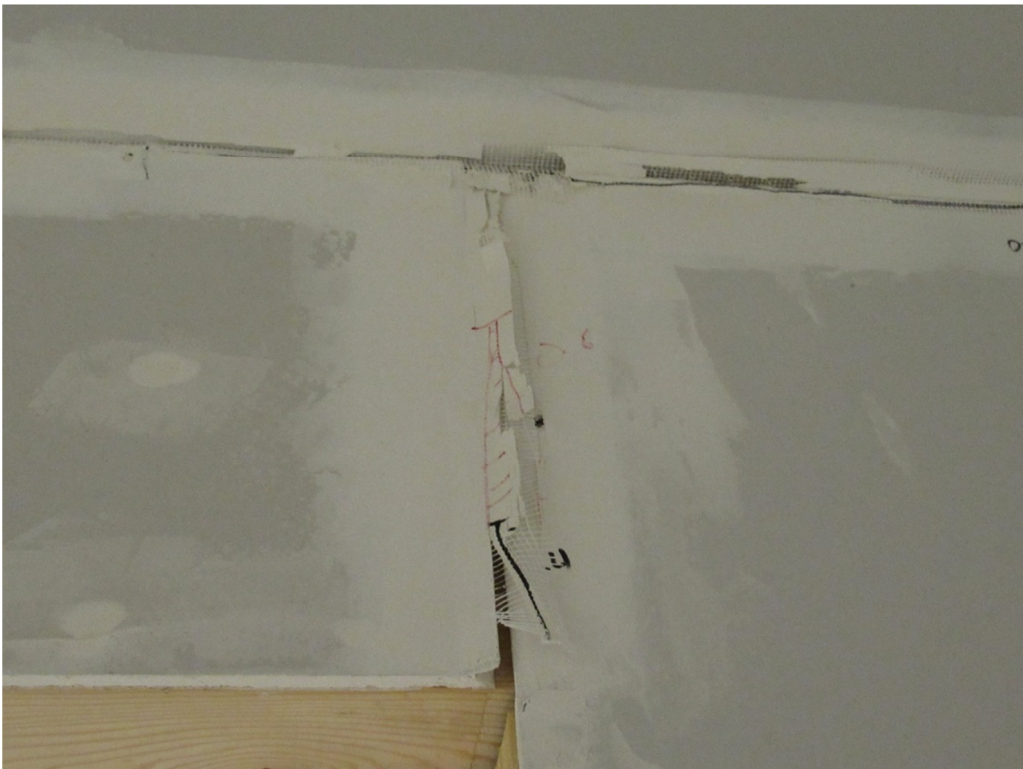
Figure D.102 Tearing and joint compound spalling at gypsum wallboard taped joints.

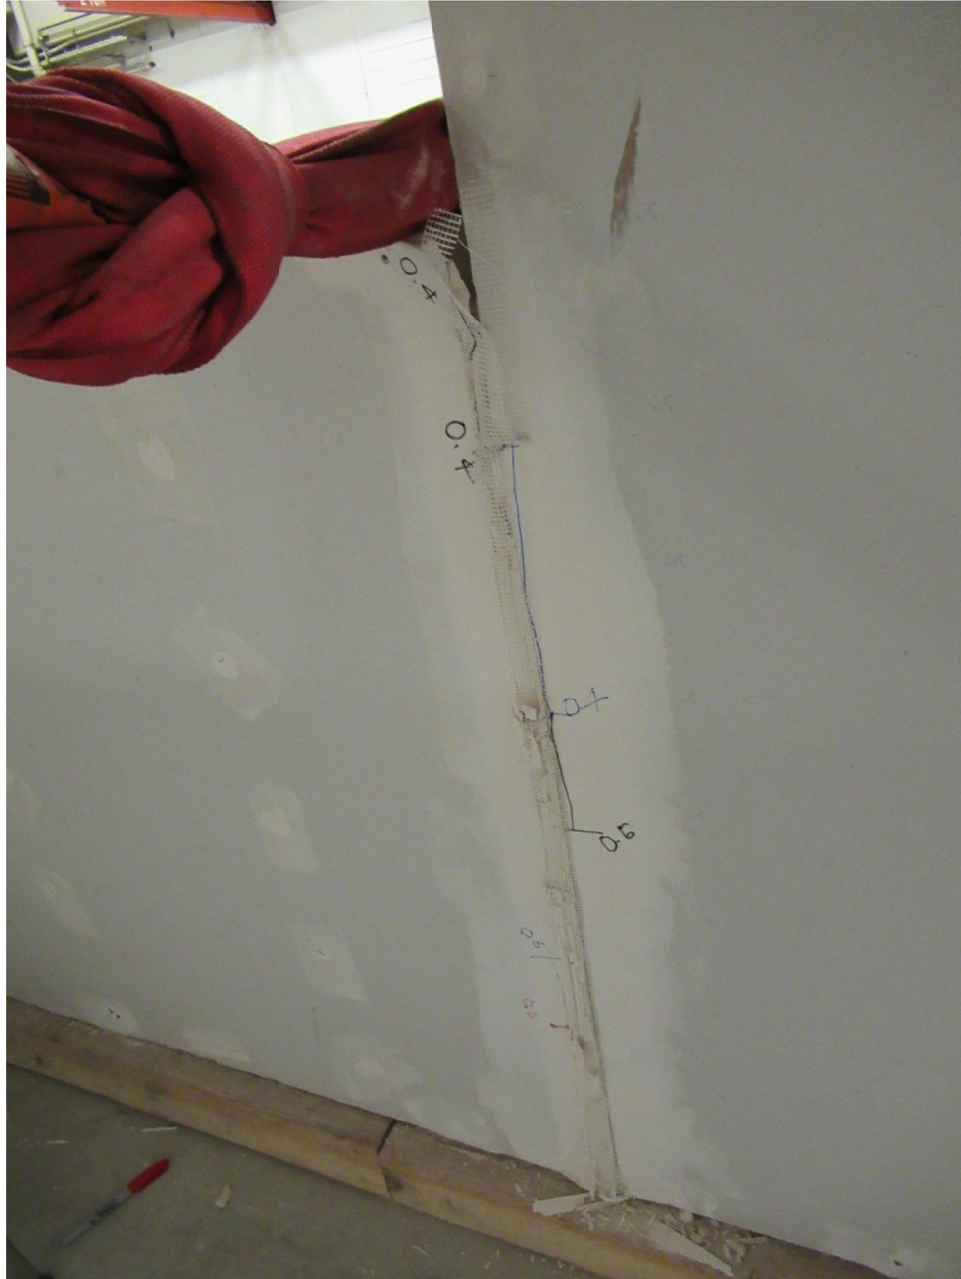
Figure D.103 Tearing and compound joint spalling at gypsum wallboard taped joints.

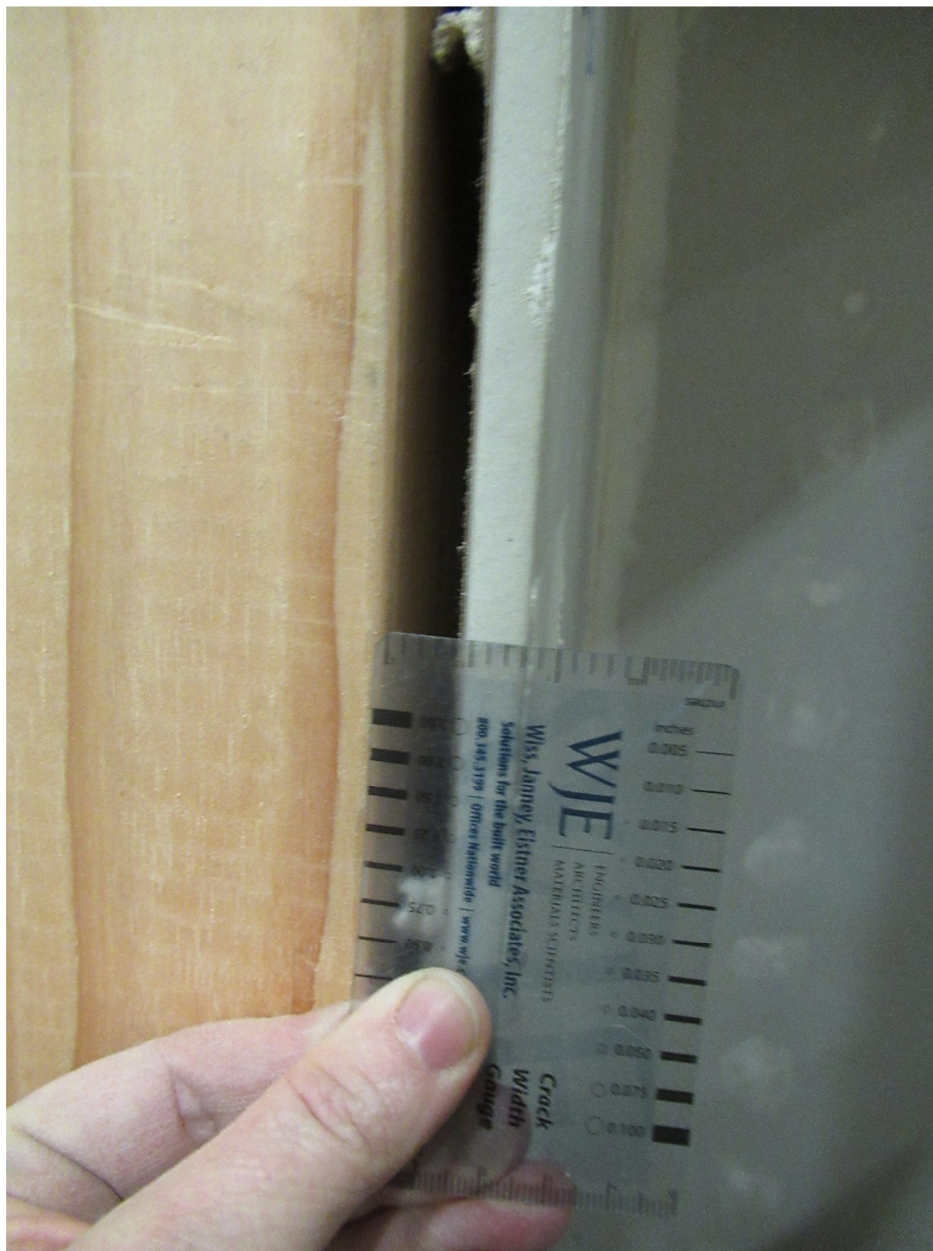
Figure D.104 Separation of the gypsum board wall panel from the wall framing.
