APPENDICES A, B, C, and D

APPENDIX A Working Group 4 Recommendations for Experimental Program

APPENDIX C Working Group 4: Damage Observations for All Specimens

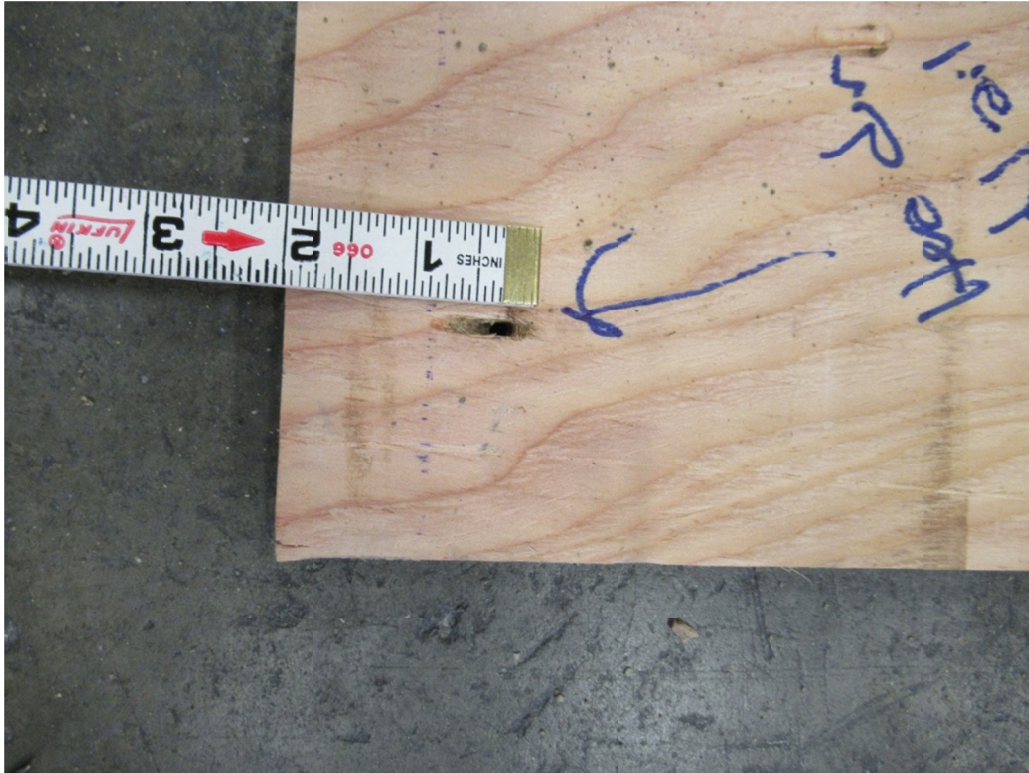
Figure D.109 Slotting of back side of siding at header.

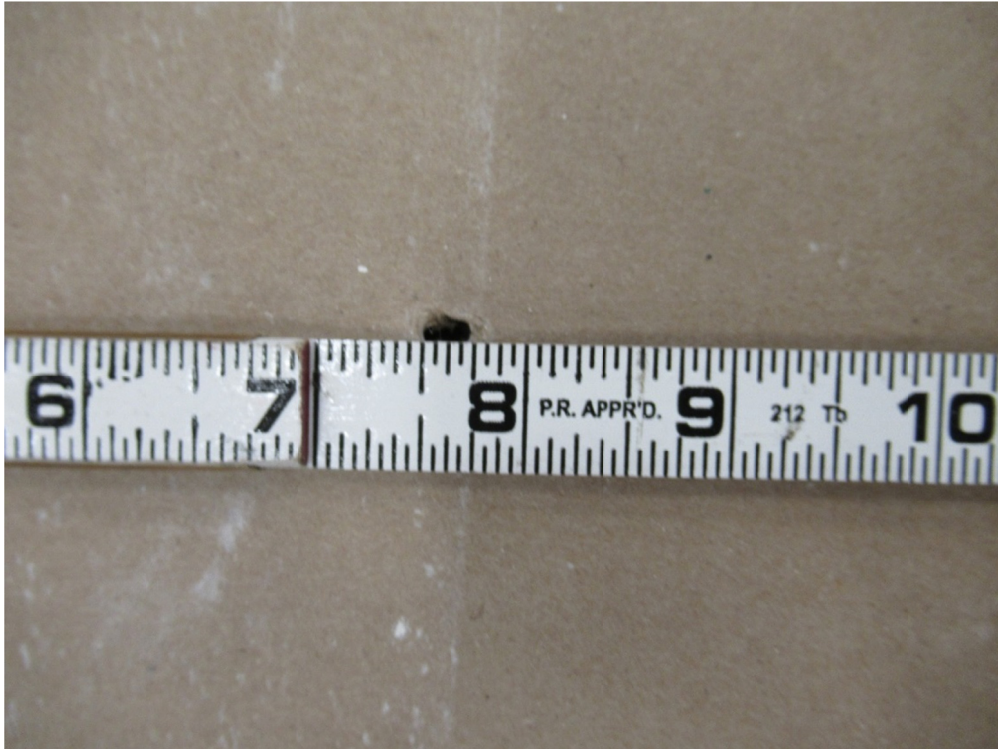
Figure D.111 Nail hole slotting and gouging on inside face of gypsum board panels.

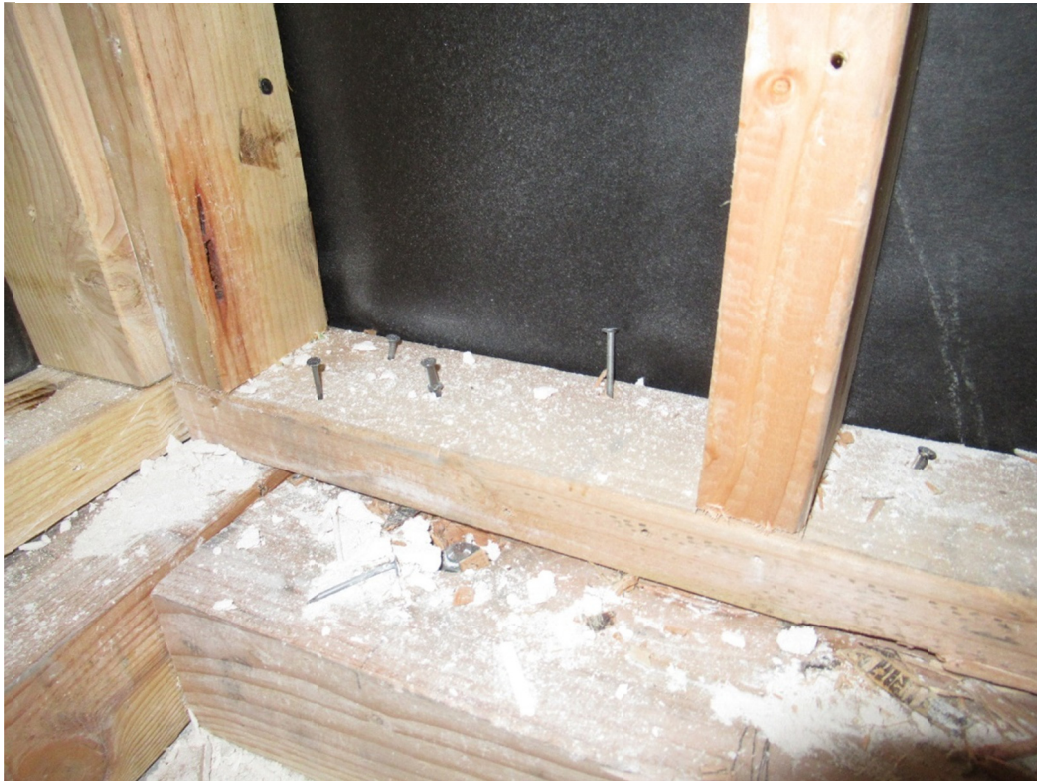
Figure D.114 Bottom plate fastening withdrawal at conclusion of testing.

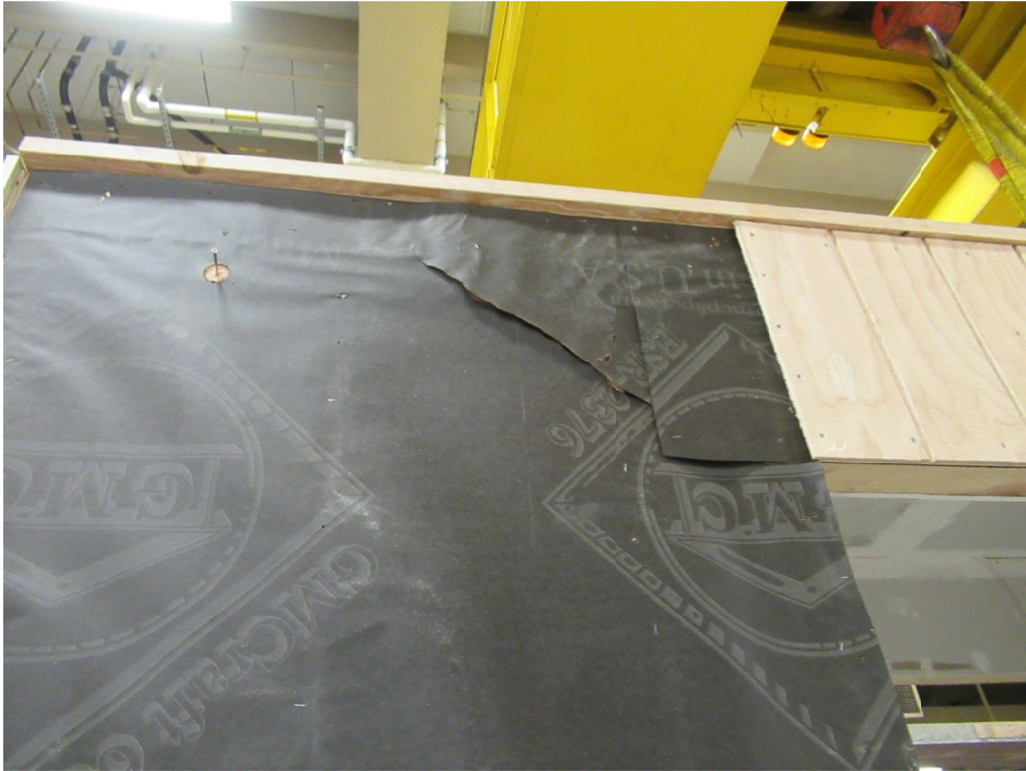
Figure D.118 Torn building paper at conclusion of testing.
