## **Fire-Induced Structural Collapse on Pier 45 at Fisherman's Wharf, San Francisco, California, May 23, 2020**

PEER Report No. 2021/01

Pacific Earthquake Engineering Research Center  
Headquarters at the University of California, Berkeley  
January 2021

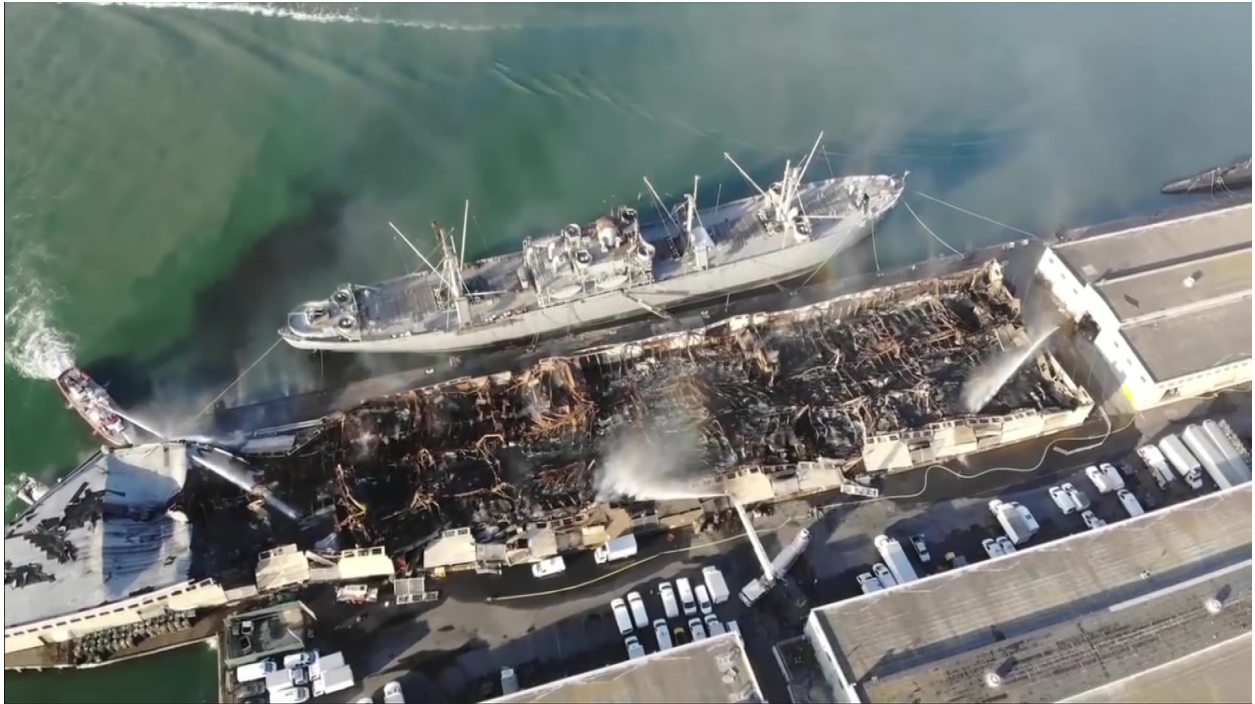
**Figure 2.3: Aerial view of Pier 45 showing extend of damage following the fire exposure.  
(Credit: CBS SF Bay Area, Nathan Wilde)**

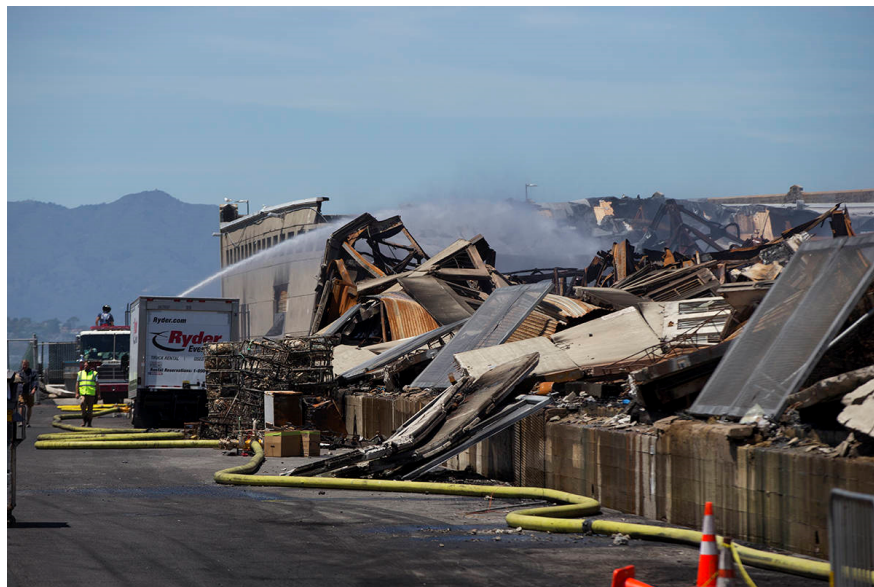
**Figure 3.12: Damaged condition of Shed C from the the west-side view.**

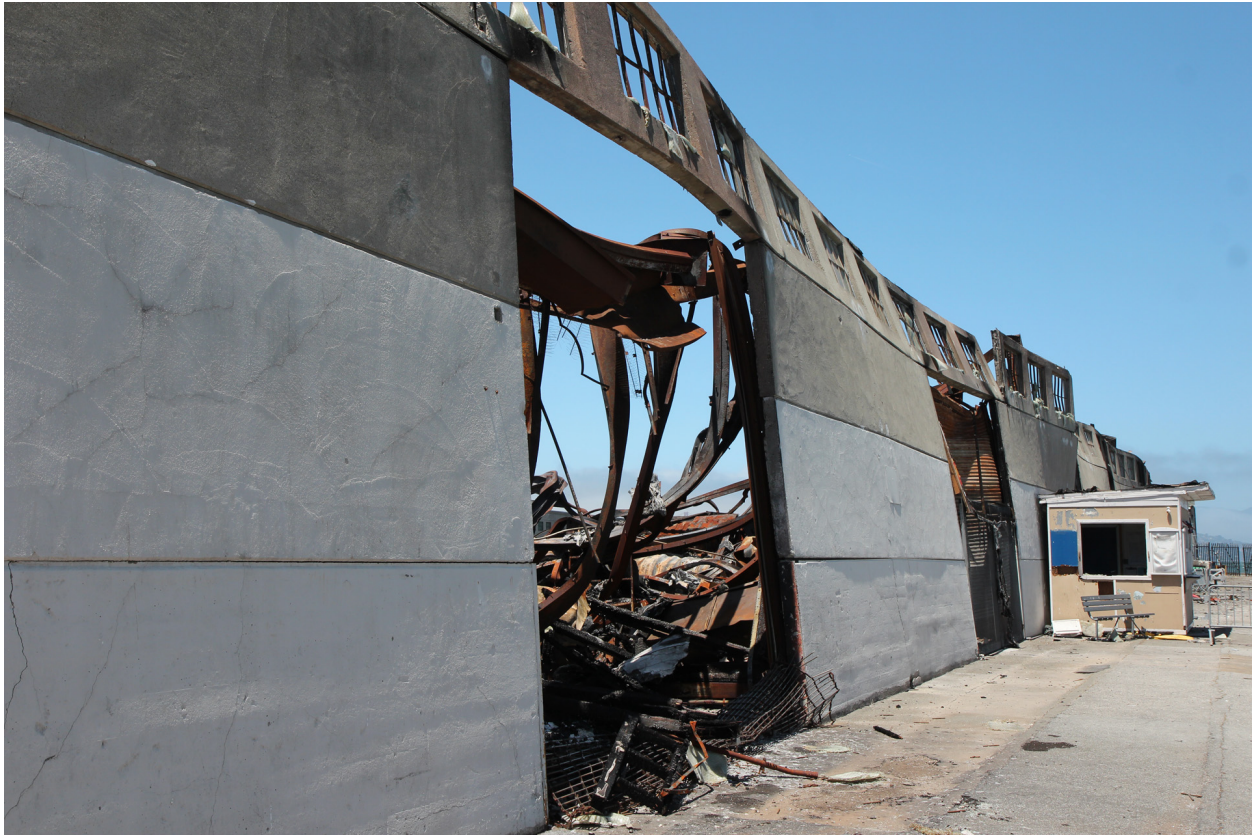
The concrete walls surrounding Shed C were connected to the steel columns by anchor bolts along the height of column. In turn, the column base plates were attached to the concrete base by anchor bolts. As a result of the fire, the east-side wall suffered extensive damage and began to incline inward; see Figures 4.2 and 4.3. The west side of the wall had completely collapsed inward, as shown in Figure 4.4. Figure 4.5 provides a more detailed look of the west side of the collapsed concrete wall.

**Figure 4.2: Damage on the east-side perimeter concrete walls and exterior columns.**

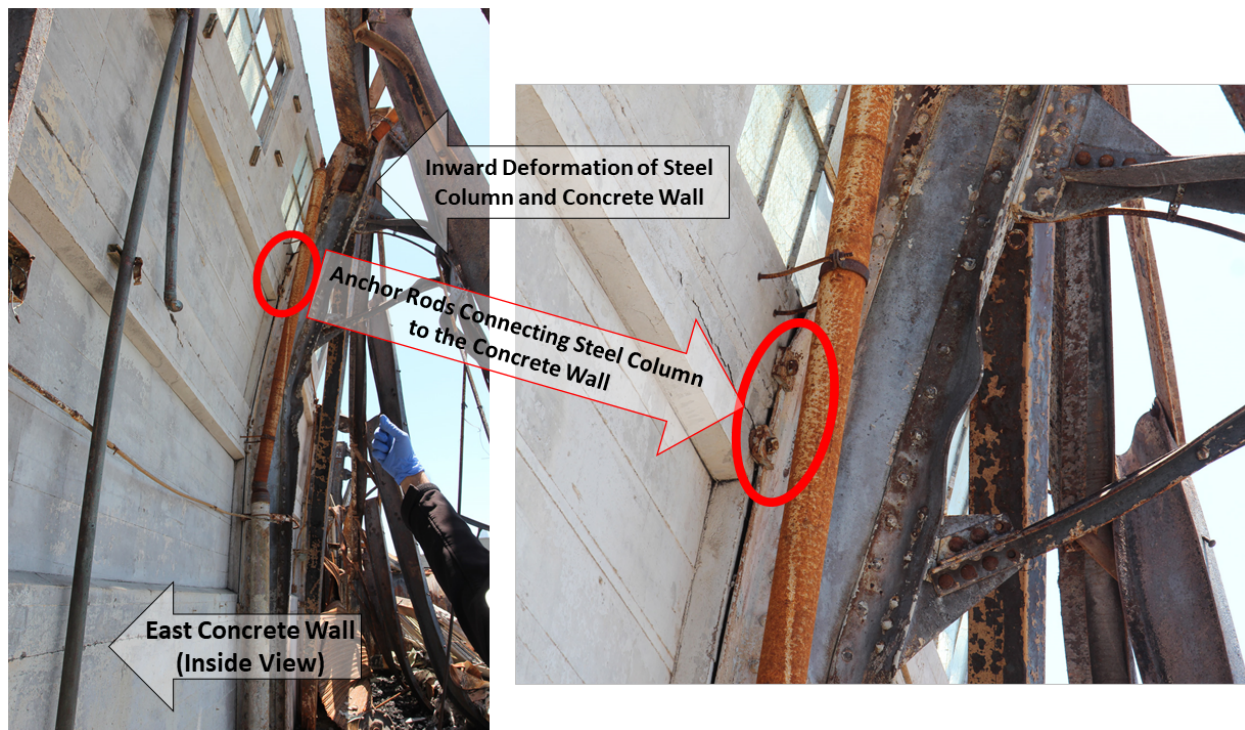
**Figure 4.3: Inward deformation of the built-up steel column and concrete wall on the eastern side of the structure.**

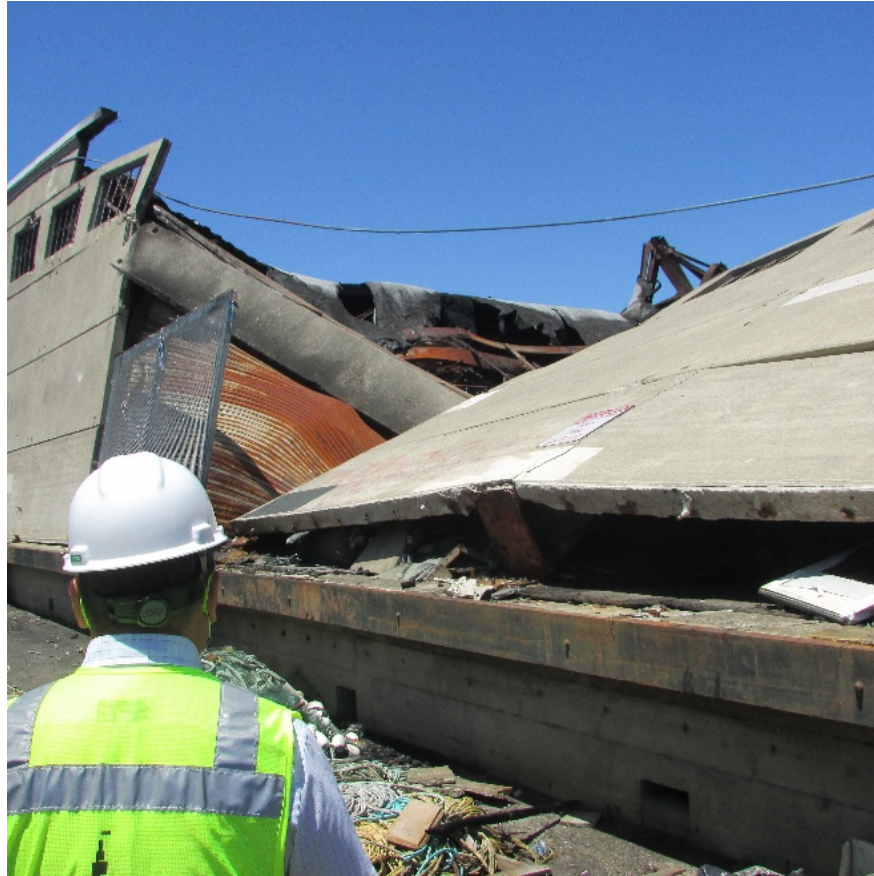
**Figure 4.4: Overturning of the columns supporting perimeter walls on the western side of the structure.**

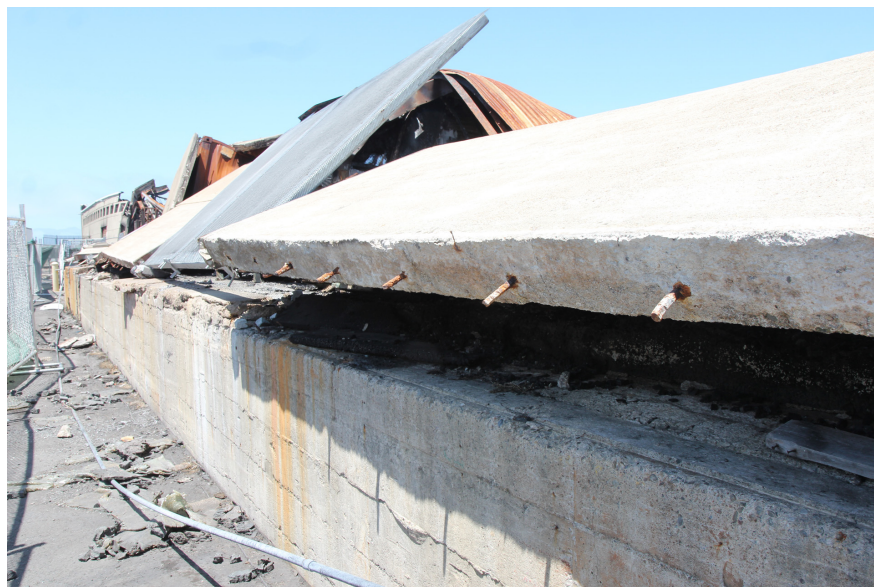
**Figure 4.5: Failure of perimeter walls on the western side of the structure.**

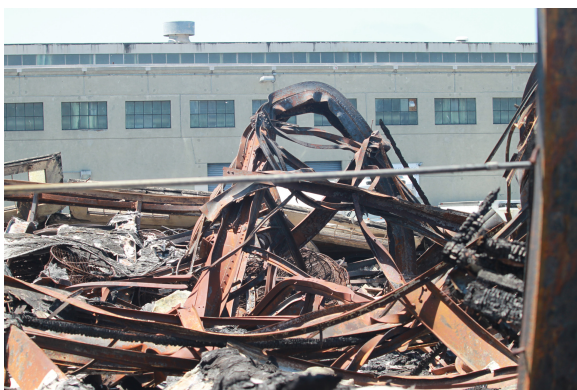
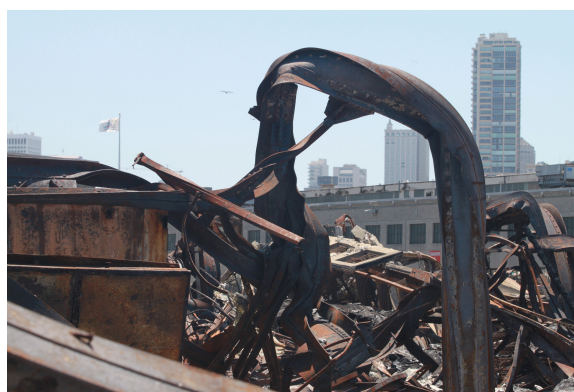
The slenderness ratios for the columns in Shed C varied between 60 to 120, implying they were in the intermediate range, which typically experience greater rates of capacity reduction with increasing temperatures. Furthermore, the flange width to web depth of the cross section was approximately 0.86, while the width to thickness ratios of the flange varied between 26 to 32. These ratios represent a rather stocky cross section. That said, local buckling at the mid-height of the columns is clearly evident, as shown in Figure 4.6, indicating a more significant loss in local buckling strength compared to yield strength with increasing temperatures. It is also important to note that the built-up cross sections maintained their integrity throughout the fire exposure with no rupture observed in the rivets connecting the angle sections to the web plate.

**Figure 4.6: Damage in the middle part of a column on the eastern side of the structure: (a) typical middle column failure; (b) close-up view of middle column failure; and (c) typical column failure on the eastern side of the structure.**

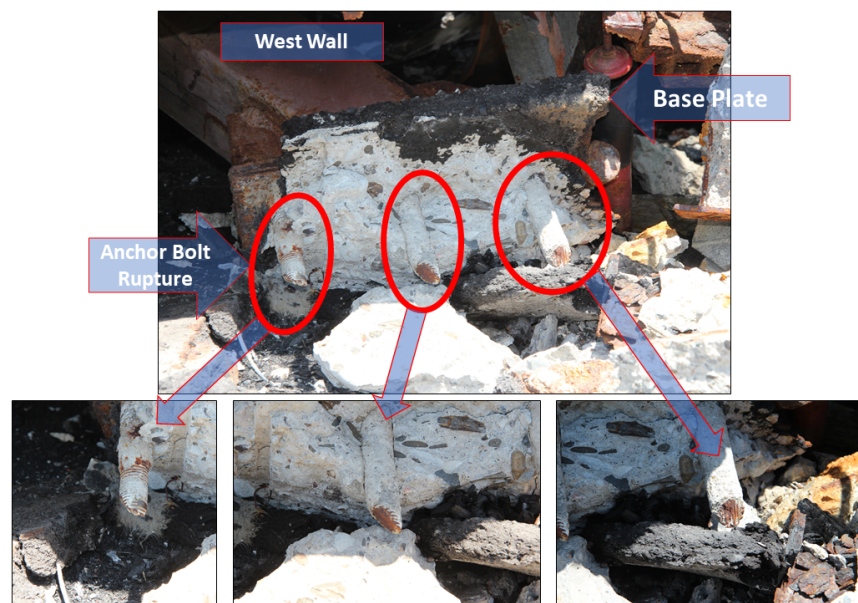
Furthermore, in cases where rupture of anchor bolts did not occur, bowing and failure of the perimeter concrete wall at the foundation resulted in collapse of the columns. This was possibly due to severe corrosion at the foundation of the perimeter wall; see Figure 4.8. This corrosion occurred due to the presence of drainage pipes, coupled with adverse conditions from the maritime environment; see Figure 4.9. It is worth noting that the design and construction techniques typical of the 1920s may have contributed to the failure. Figure 4.8 indicates a very shallow anchorage, and it is not clear if the failure was due to corrosion or the lack of anchorage at the column bases

**Figure 4.7: Pull-out and rupture in the anchor bolts at a 45° angle.**

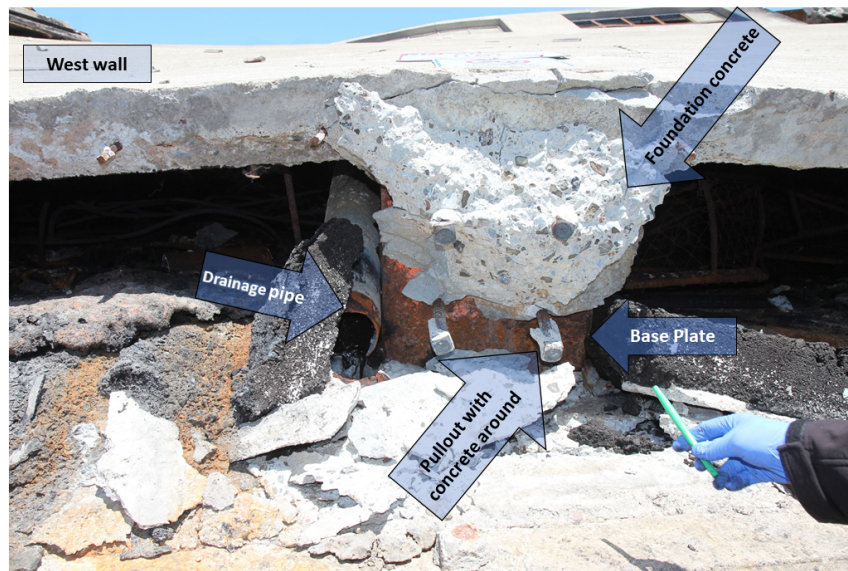
**Figure 4.8: Failure of perimeter walls on the western part of the structure.**

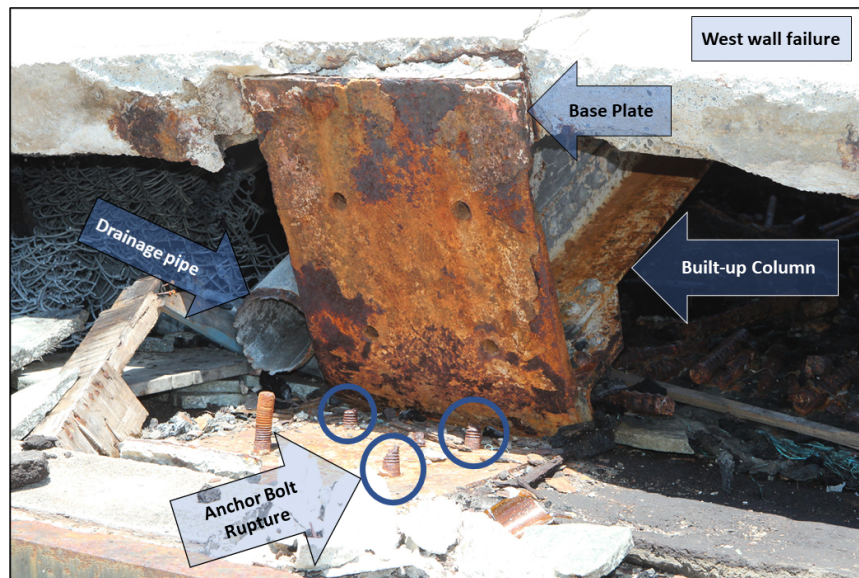
**Figure 4.9: Typical pull-out and failure mechanism in the anchor bolts in the west wall.**

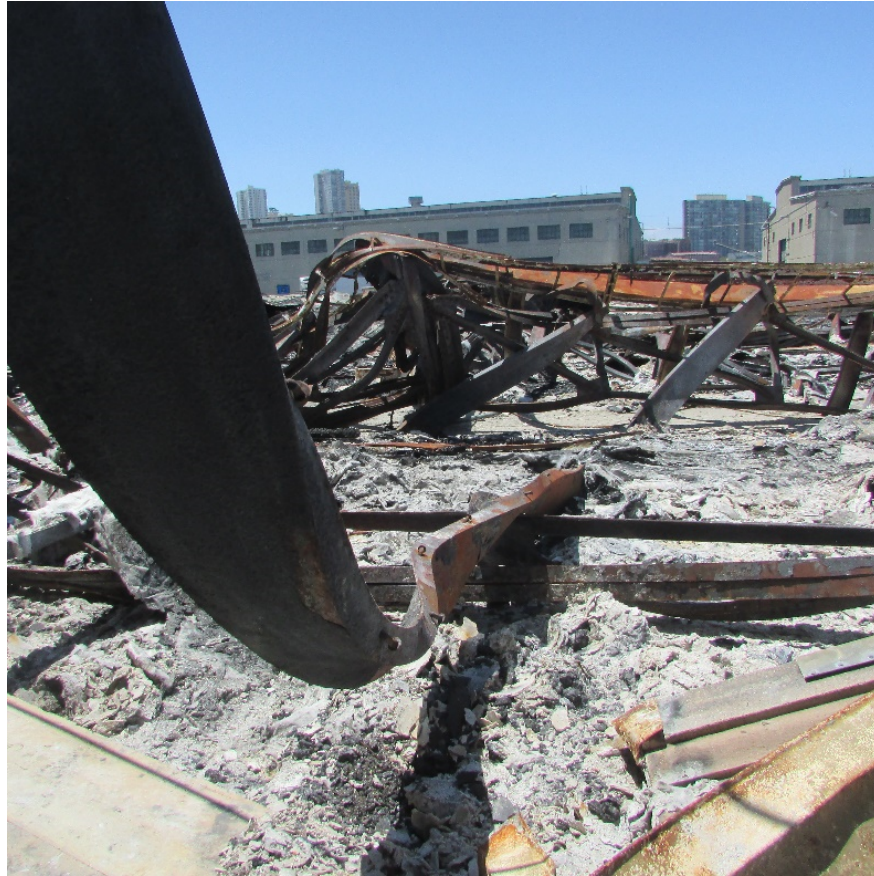
Besides excessive in-plane deflection, significant out-of-plane deflections were also evident in the beams; see Figures 4.10 and 4.11. This indicates the presence of significant fire-induced restraint forces in the beam that developed during fire exposure, transforming its behavior to that of a beam–column. The response of such restrained steel beams (or beam–columns) under fire depends on many factors, including: the specific fire scenario, beam slenderness ratio, location of axial restraint at the supports, and high-temperature properties of steel [Eslami et al. [2018], Kodur et al. [2017], Anvari et al. [2019]].

**Figure 4.10: Significant out-of-plane deformation in collapsed beams.**

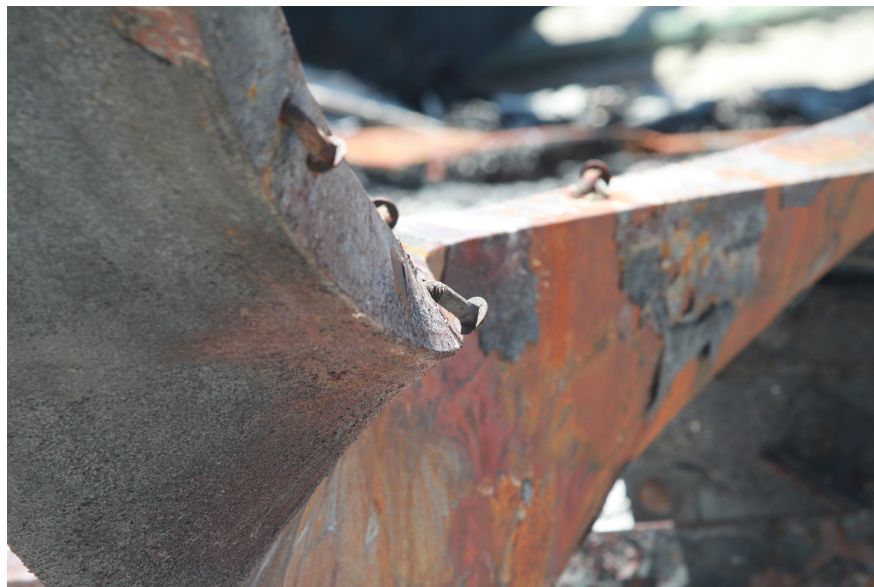
**Figure 4.11: Close-up view of out-of-plane deformations in the beam from thermal gradients and restrained thermal expansion.**

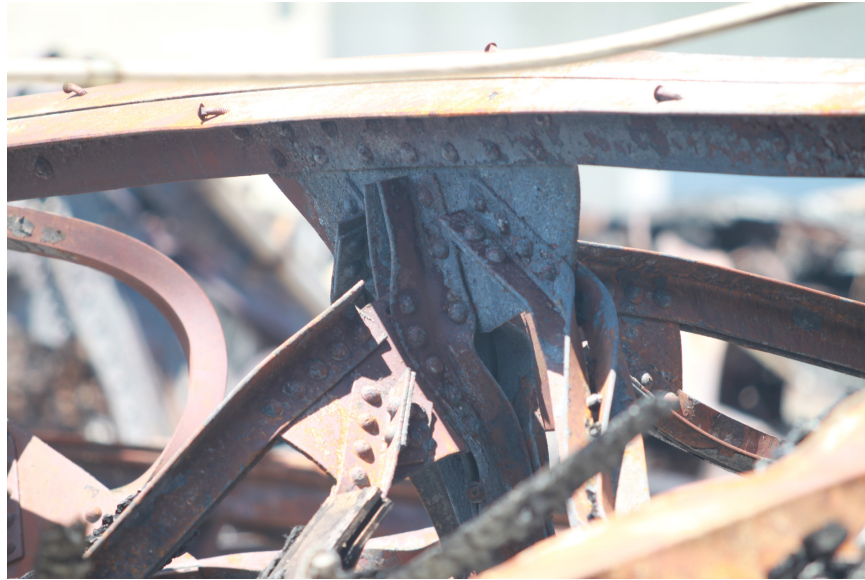
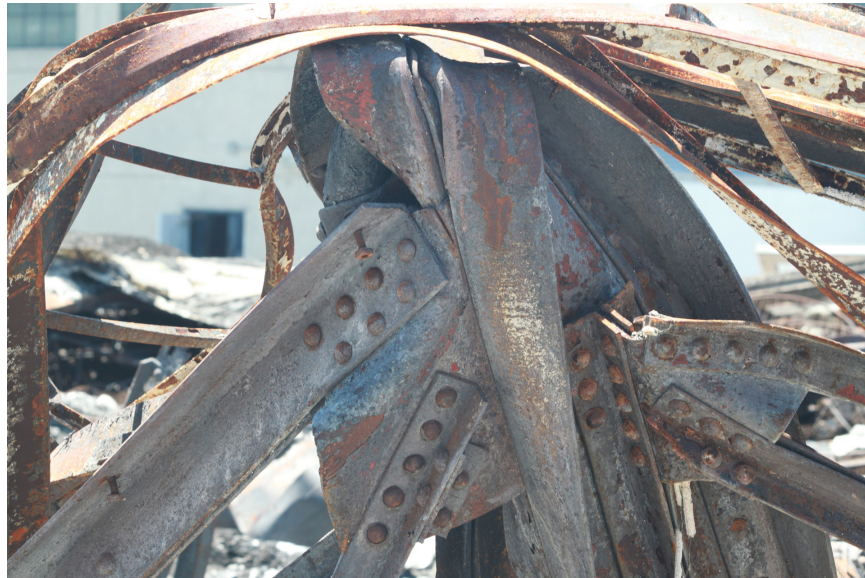
As noted in Section 4.3, the steel column to concrete base connection on the west side of the building failed in numerous ways . This section focuses on the truss-to-column connections. While the top chord, bottom chord, and web members suffered significant fire-induced damage, the connections were found to be relatively intact during the site visit, suggesting adequate performance during fire exposure. There were no records of gusset plate rupture, rivet failure, or block shear failure. This confirms the design concept that the connection may fail after the full capacity of the connecting members is achieved. Figure 4.12 shows samples of damage to truss connections. While excessive deformation of gusset plates can be seen in Figure 4.12, there was no evidence of block shear or rivet failure in the connecting members.

**Figure 4.12: Damage to truss connection: (a) excessive deformation in truss members with no failure in rivet or gusset plate; and (b) typical truss connection exhibiting severe deformation and collapsed connection members.**

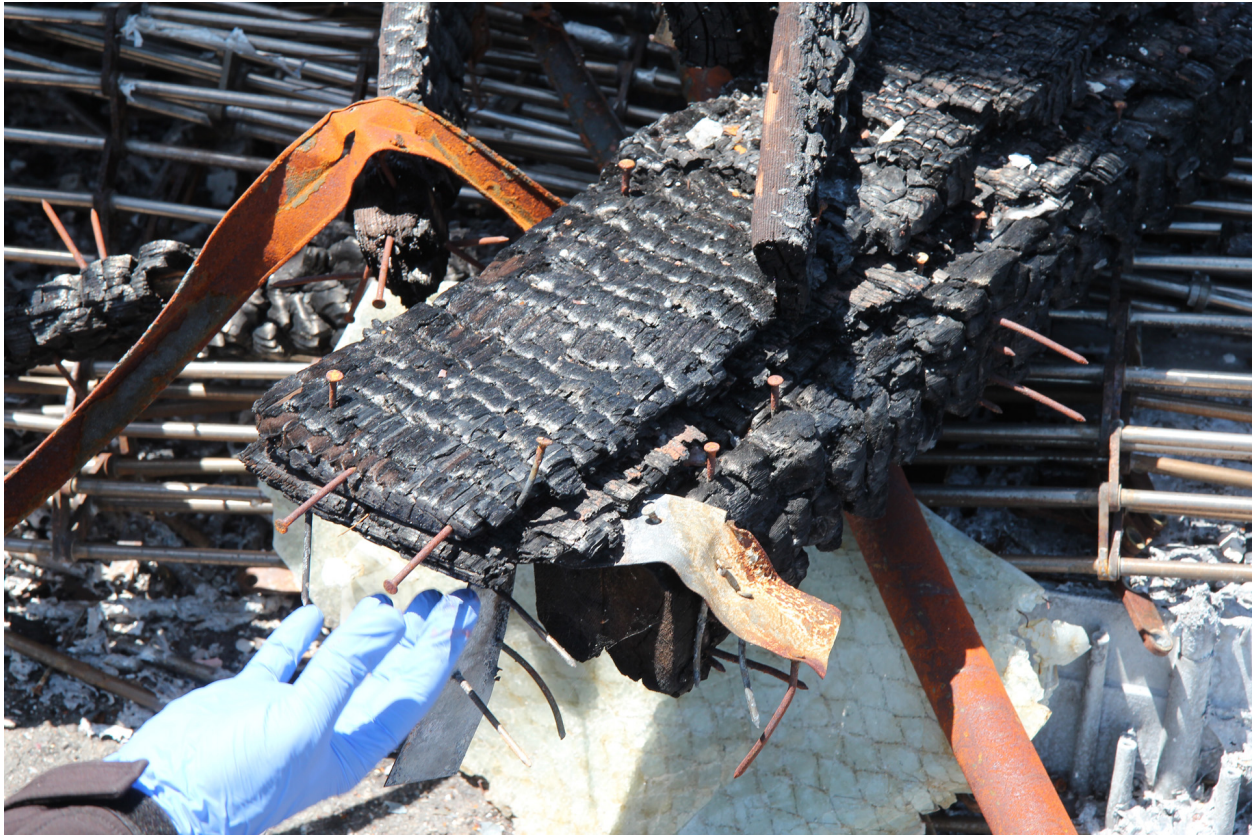
**Figure 4.13: Timber roof charring from the east side of the structure.**

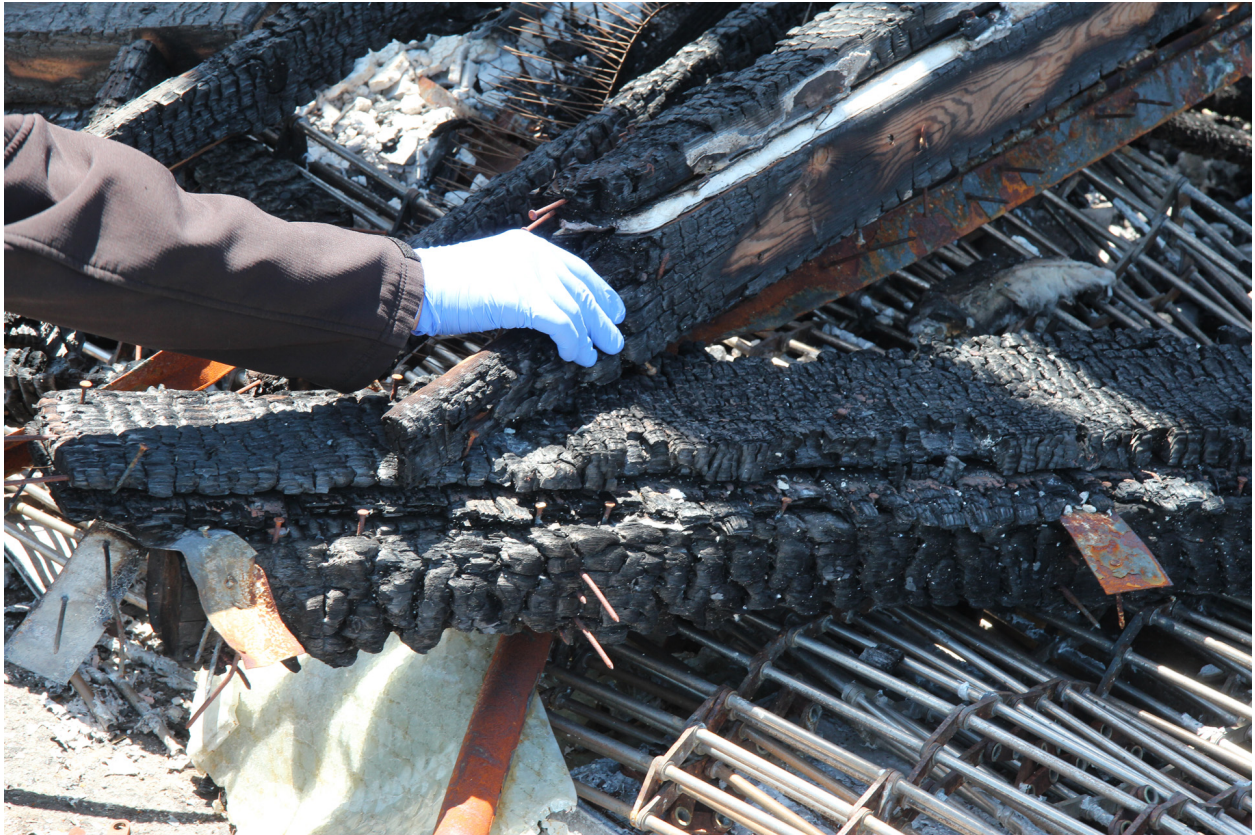
**Figure 4.14: Completely burnt charring of the roof on the east side of the structure.**

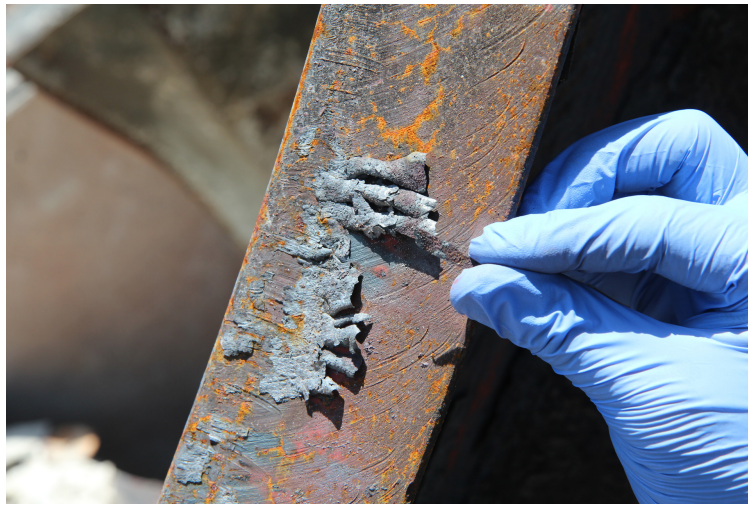
Besides structural failure, mill scale and signs of material flow (phase transformation) were evident on the the outer surfaces of steel beams and truss members. Figures 4.15 and 4.16 show severe mill-scale peeling on the flange of channel-section beams. The resultant morphology, microstructure, and phase transformation (composition) of fire-damaged steel is dependent on the oxidation characteristics and can be correlated to the elevated temperature experienced during the fire [Xie et al. [2018]].

**Figure 4.15:** Mill-scale and material-flow patterns had formed on the outer surfaces of a truss member.

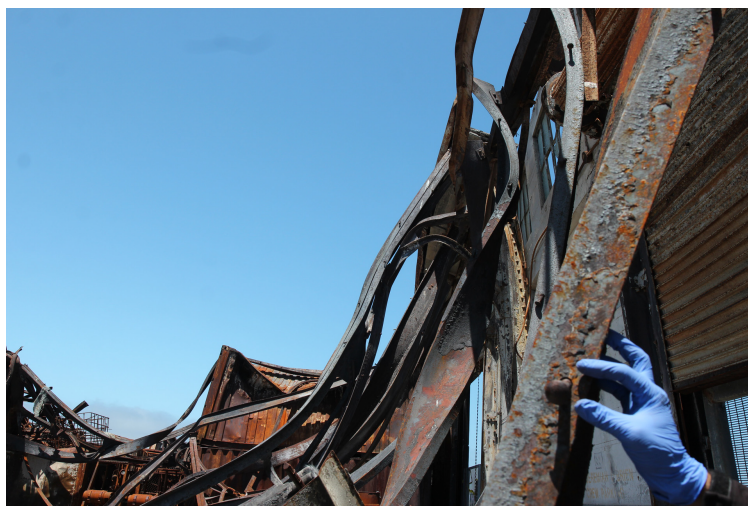
**Figure 4.16:** Mill-scale peeling on the flange of channel-section beams.

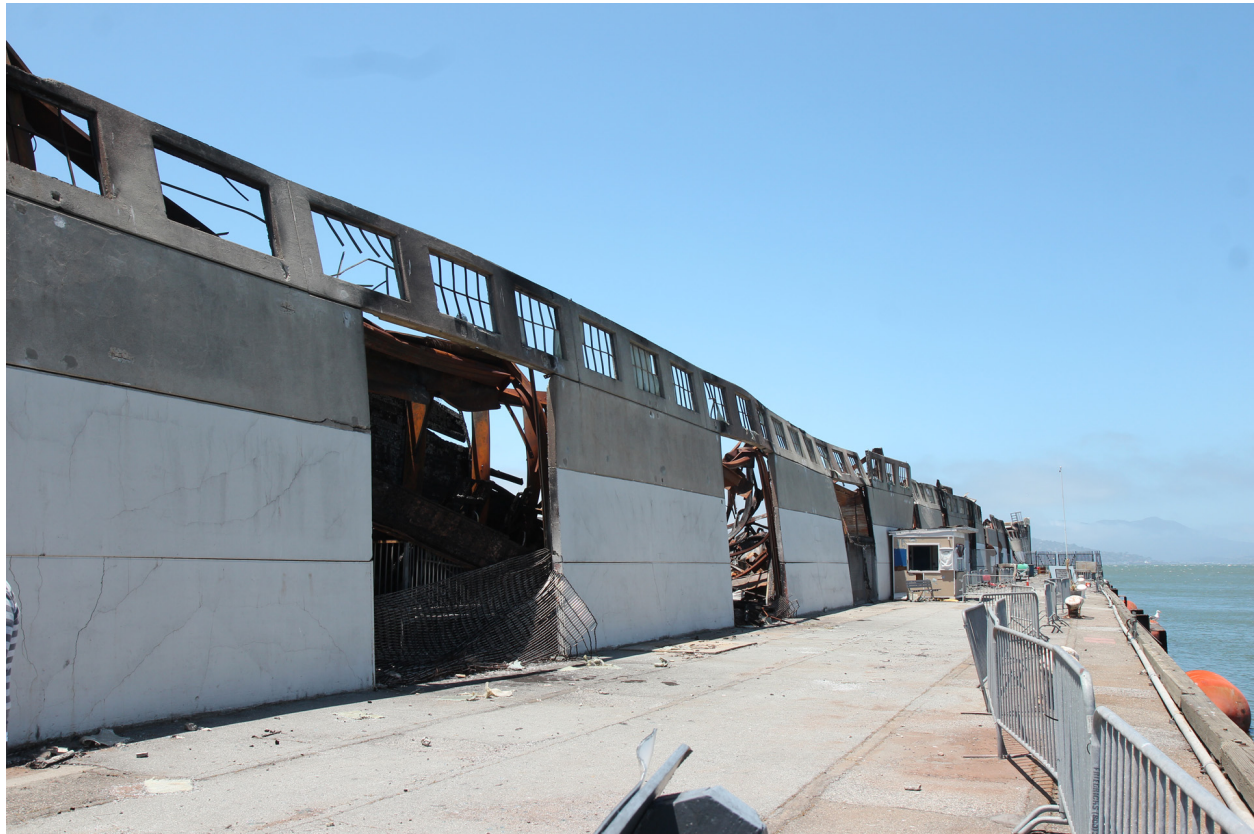
**Figure 4.17: Damage to window and glass in east-side perimeter wall.**

Damage to glass can be seen in the Figures 4.17 to 4.22. It is recommended to conduct furnace tests on samples of undamaged glass of Shed C. Obtaining the melting temperature of glass can significantly help in estimating the actual temperature of the structure. In fact, glass can be used as evidence to evaluate the actual temperature of the Shed C fire [Lentini [1992]].

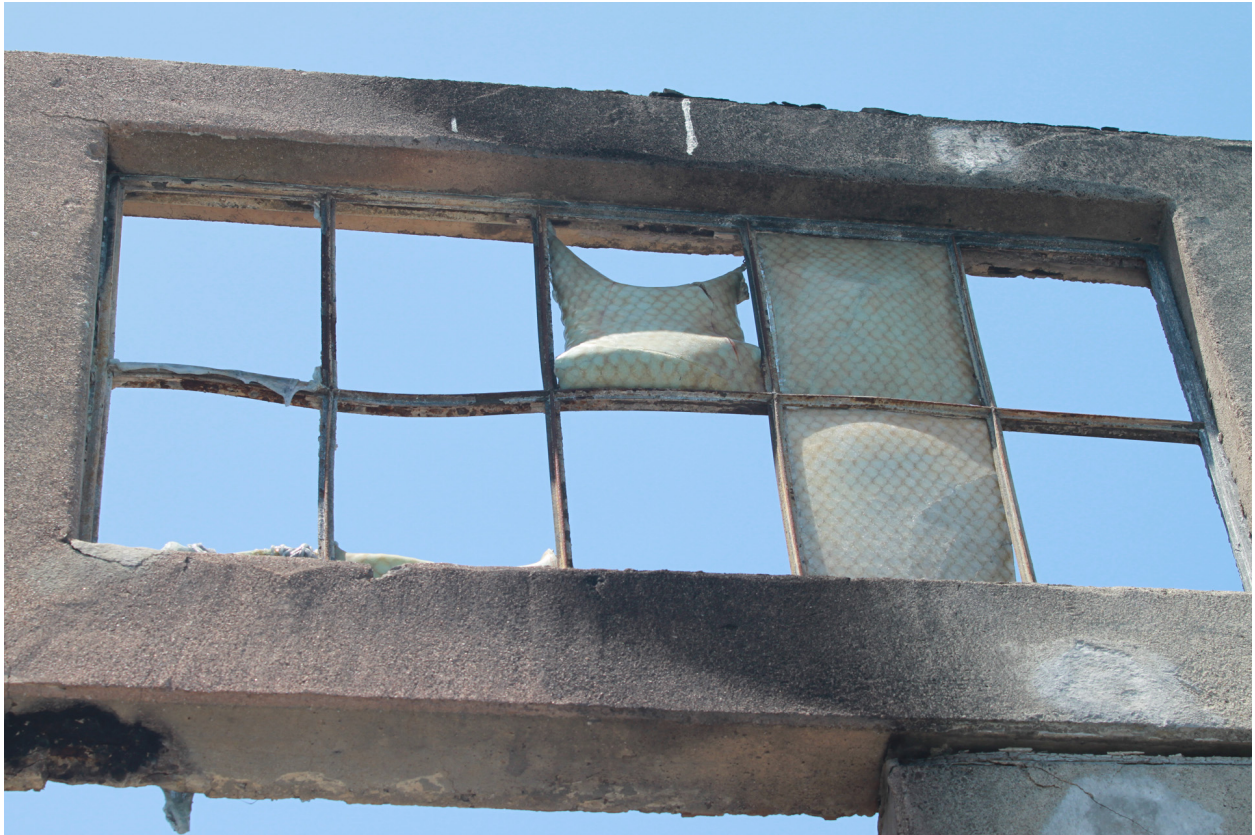
**Figure 4.18: Damage to window frame and glass.**

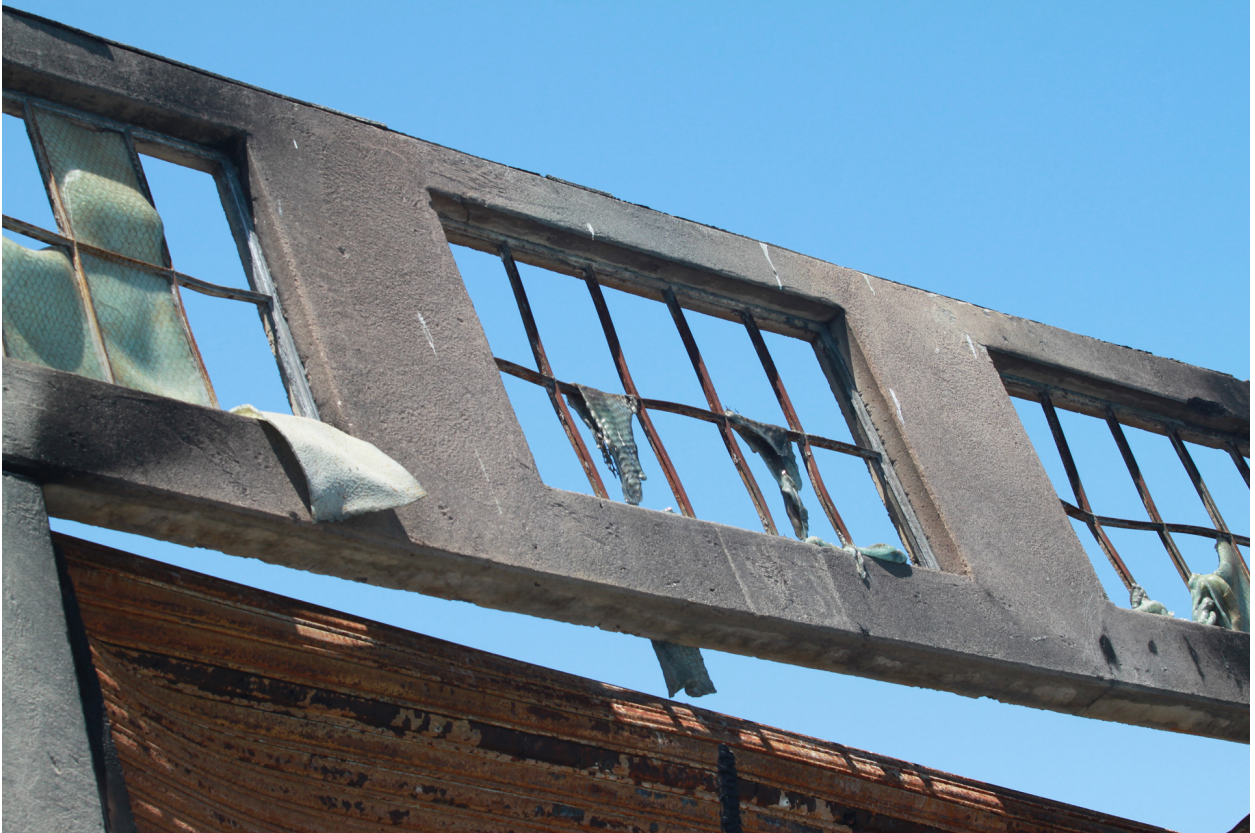
**Figure 4.19: Damage to window frame and molten glass in the east wall.**

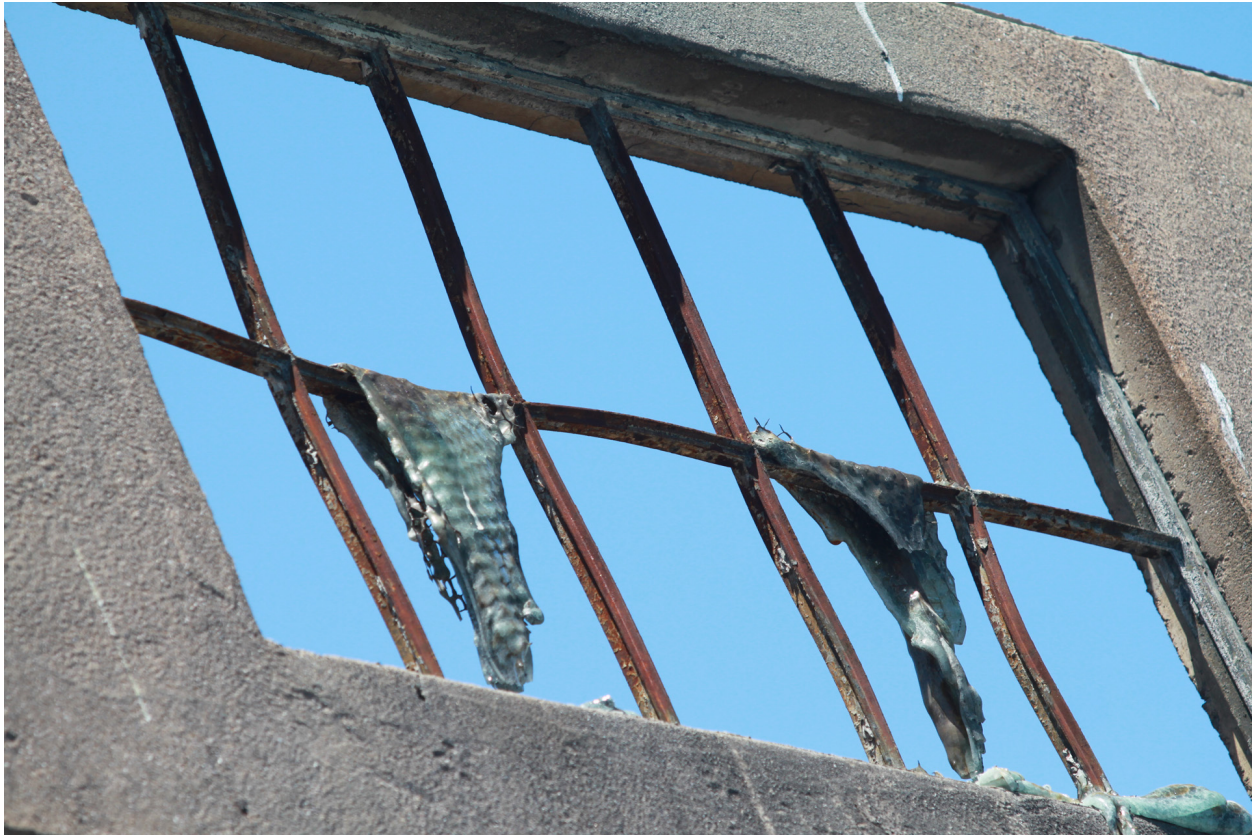
**Figure 4.20: Molten glass in the east wall.**

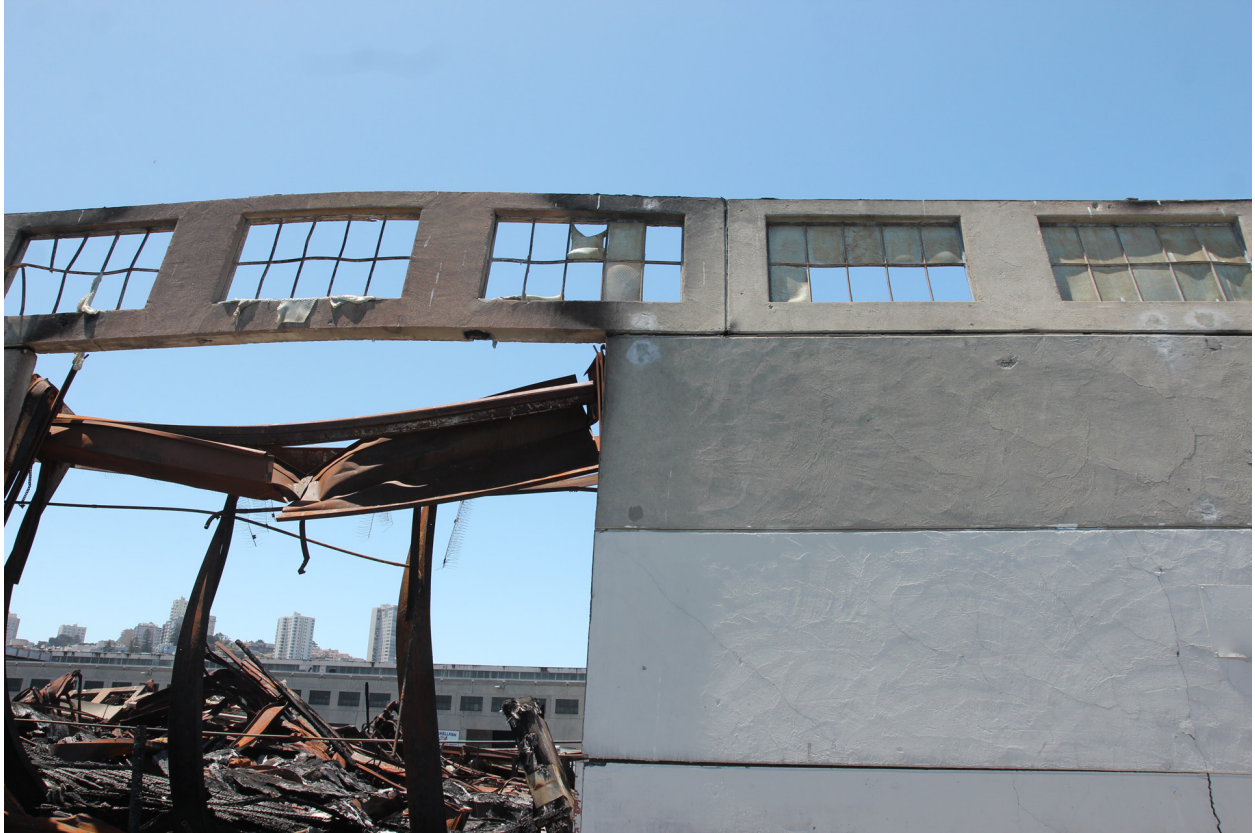
**Figure 4.21: Severe glass damage on the top of opening (left) vs. limited damage on the top of concrete wall (right).**

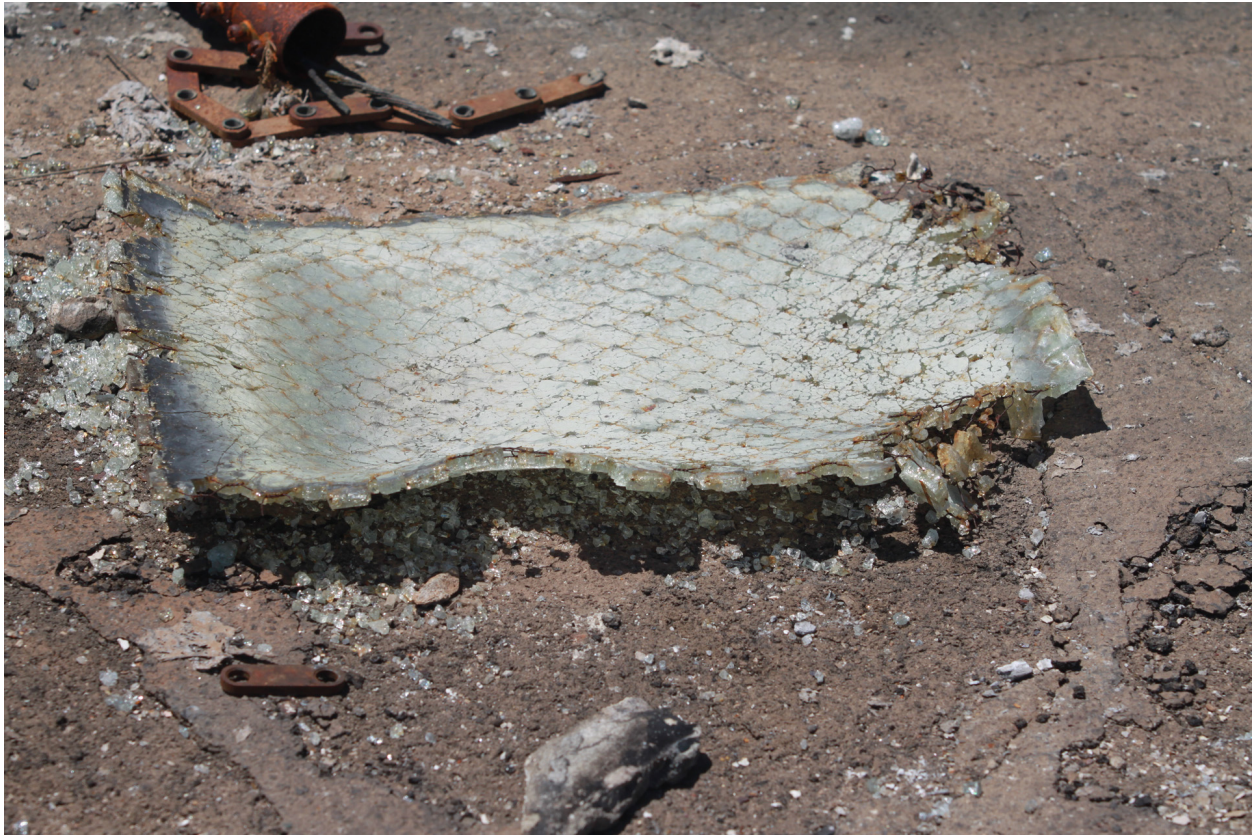
**Figure 4.22: Deformed glass in east side of the structure.**

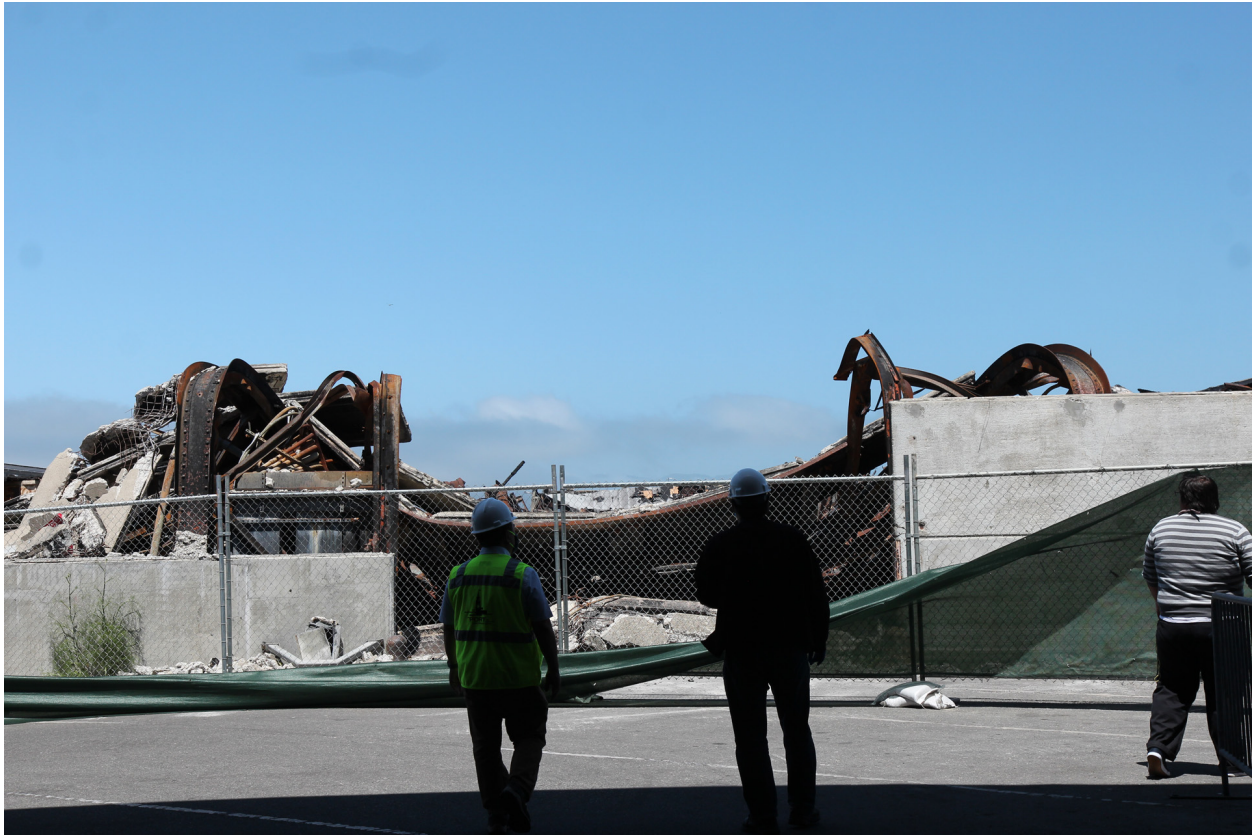
**Figure A.2: Damage as seen from the area between Shed A and Shed C.**

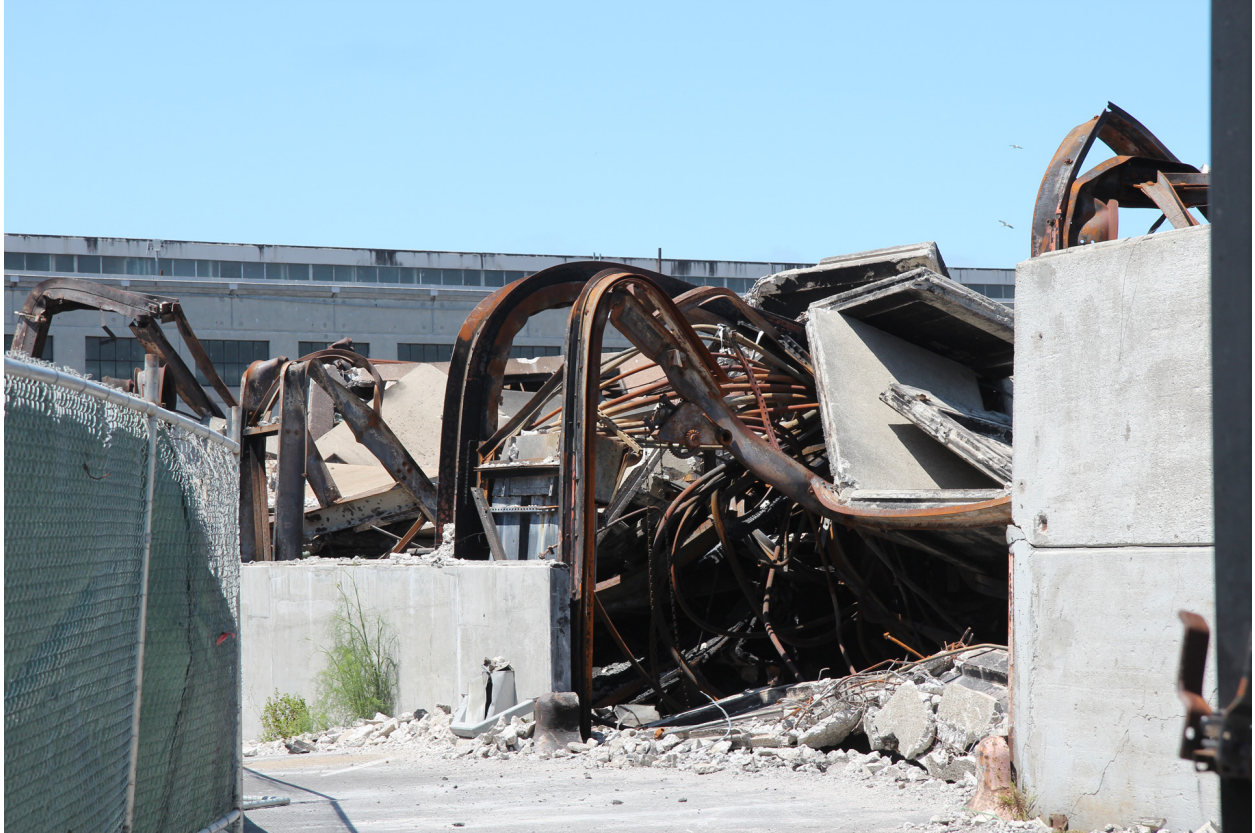
**Figure A.3: Failure of south-side perimeter columns as seen from the area between Shed A and Shed C.**

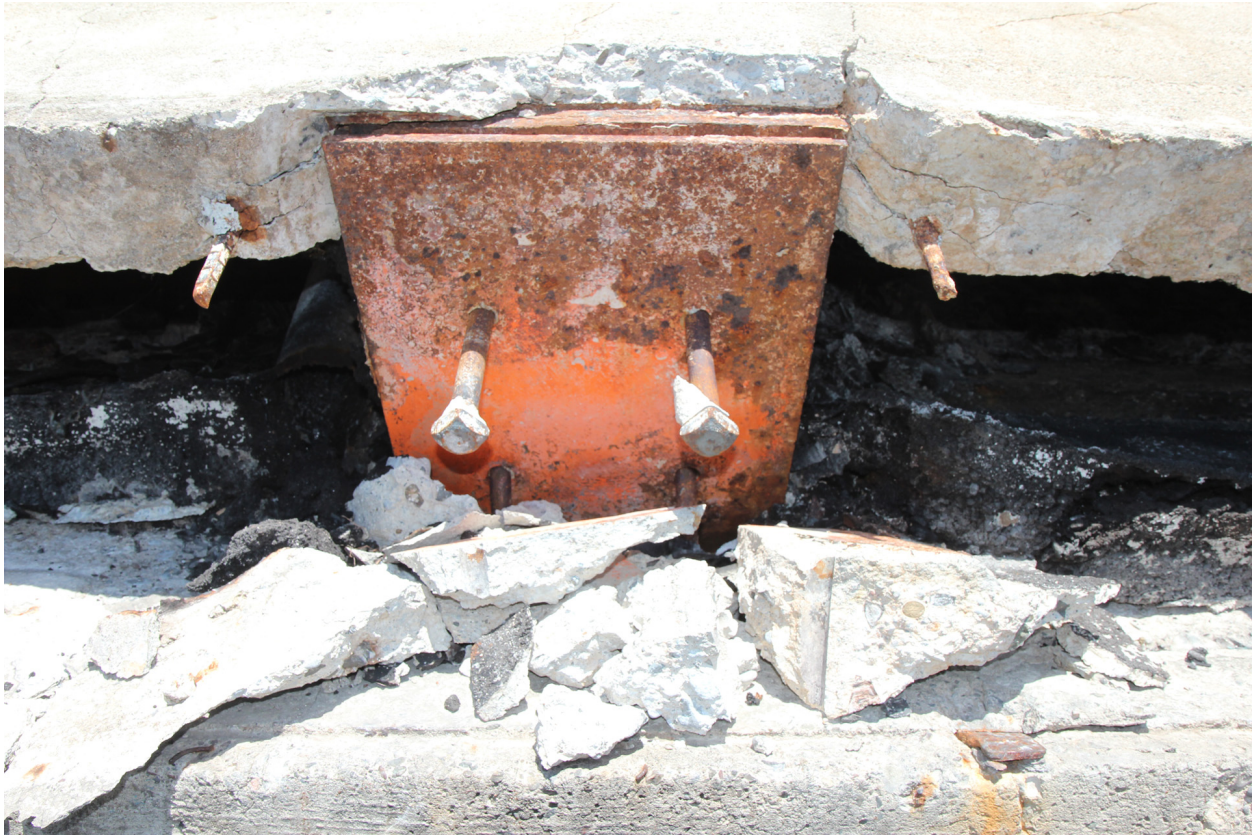
**Figure A.4: Anchor bolt pull out in west wall.**
