## **Fire-Induced Structural Collapse on Pier 45 at Fisherman's Wharf, San Francisco, California, May 23, 2020**

PEER Report No. 2021/01

Pacific Earthquake Engineering Research Center  
Headquarters at the University of California, Berkeley  
January 2021

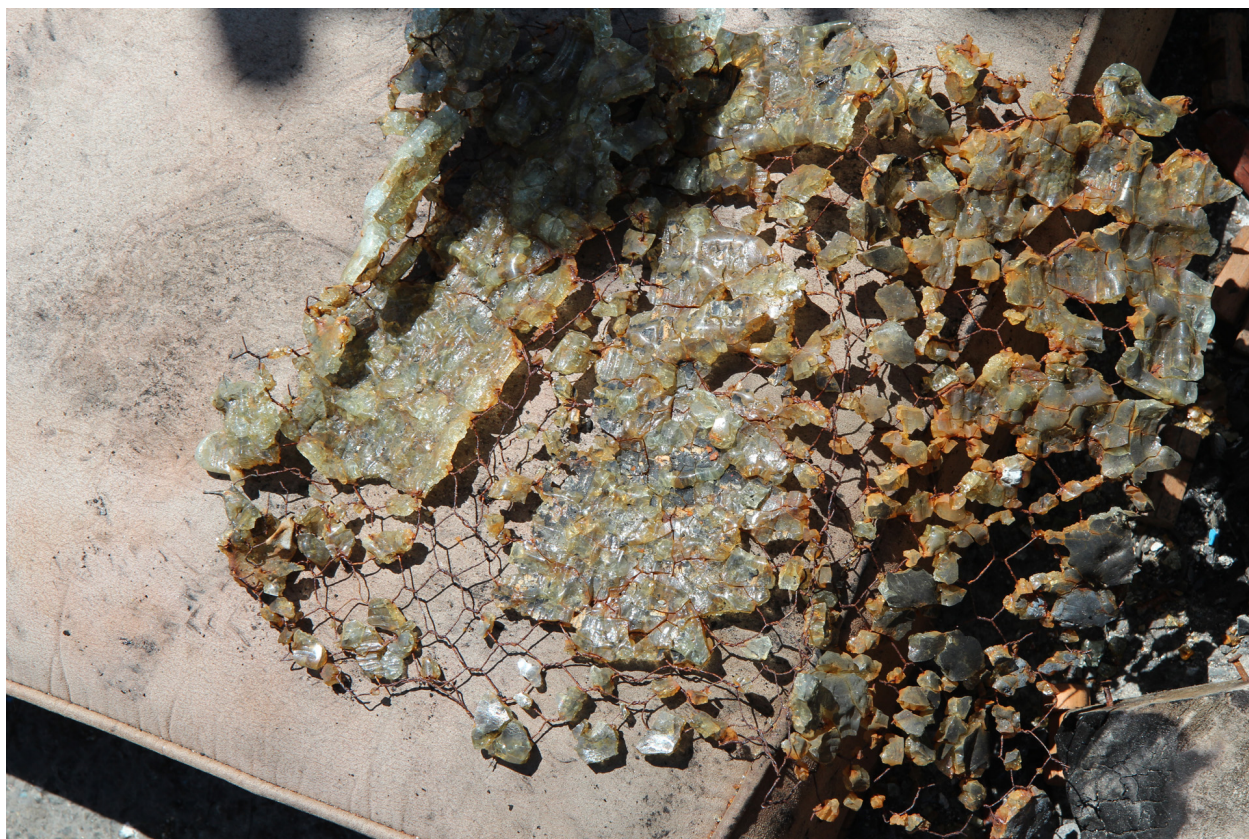
**Figure A.5: Molten glass in west wall.**

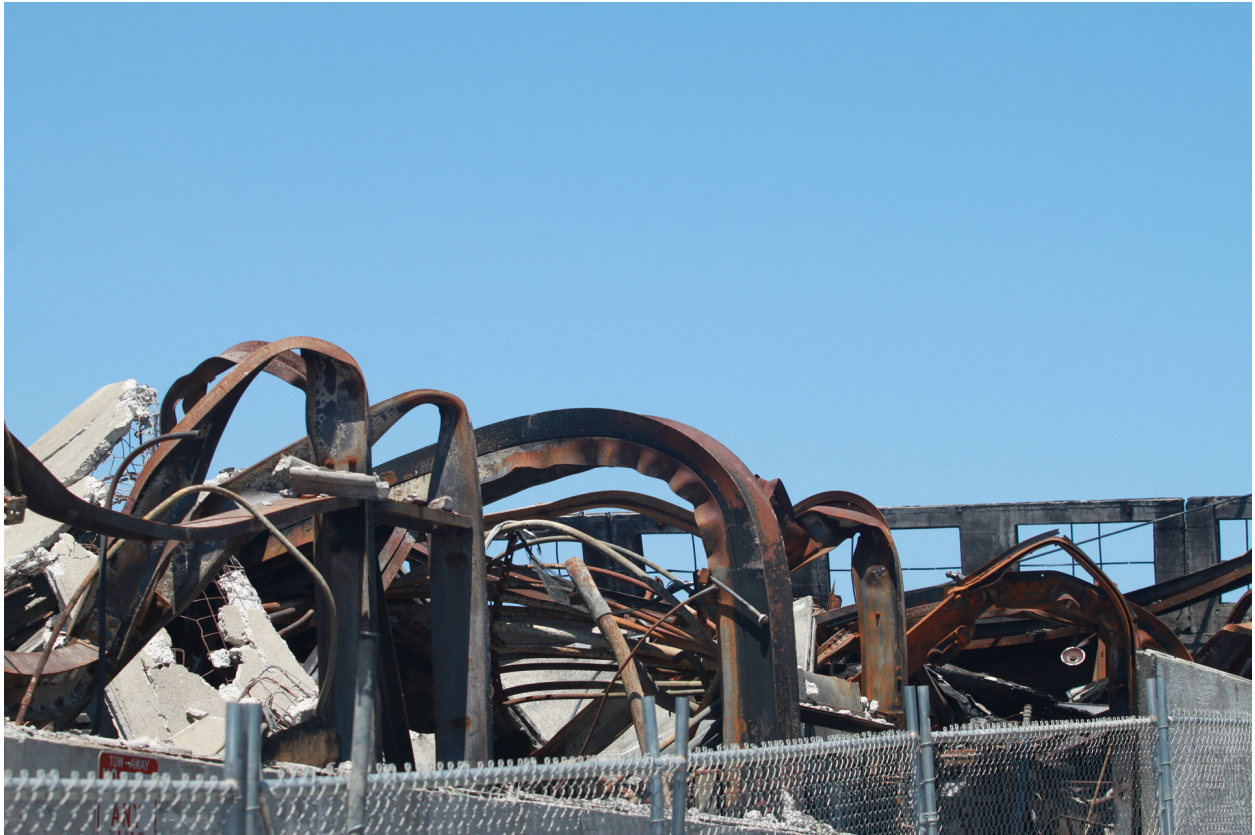
**Figure A.20: Bending of column in the weak axis direction, with local buckling in flanges.**

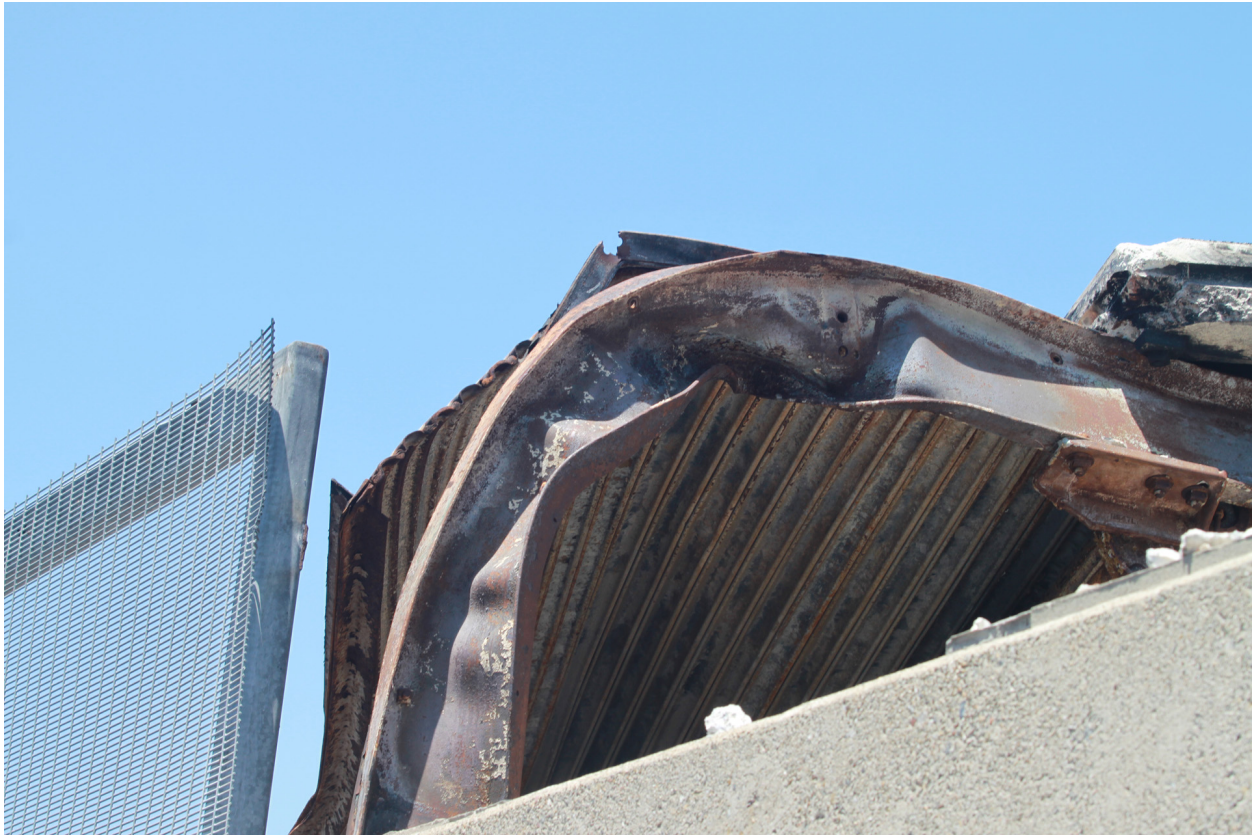
**Figure A.21: Bending of column in the strong axis direction, with local buckling in the web.**

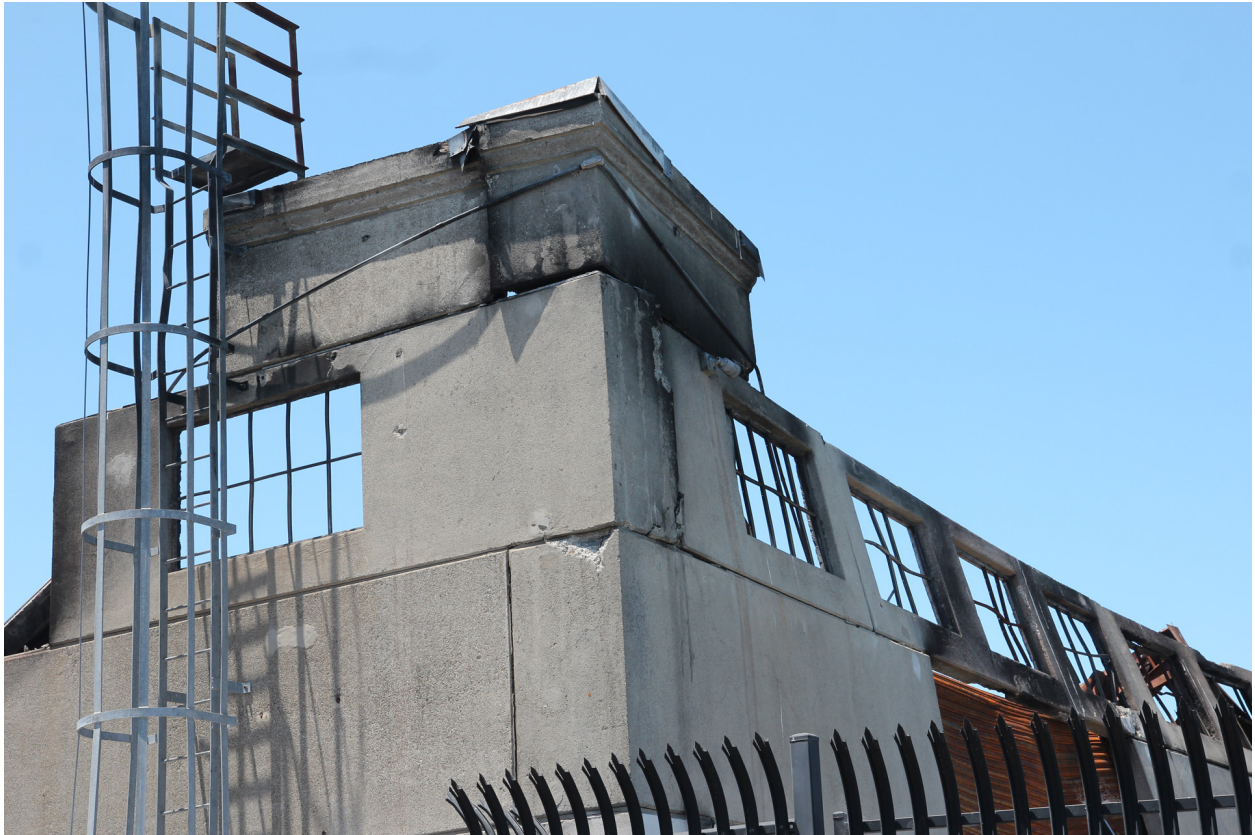
**Figure A.26: Roof access stairs and damage on one side.**

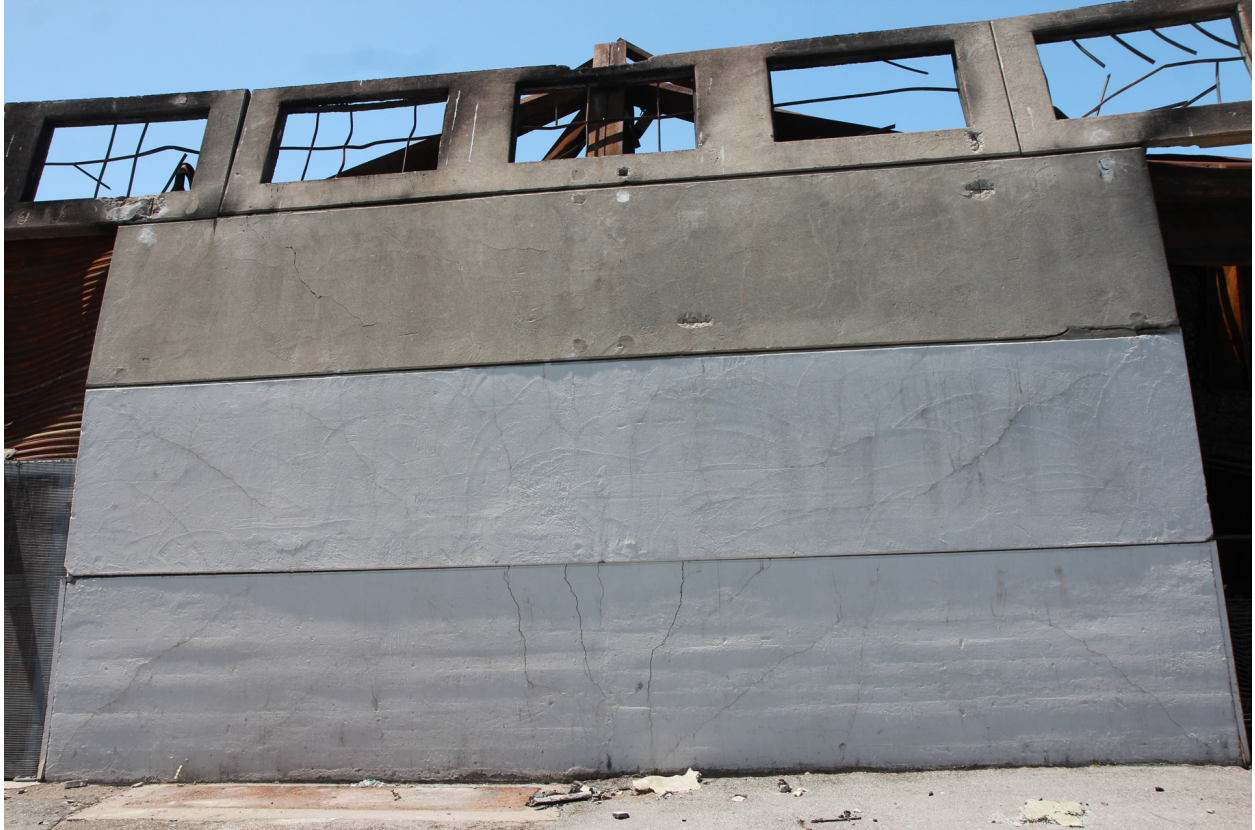
**Figure A.27: Cracks in the concrete wall panel: diagonal at the edges and vertical at the center where the steel column provides support.**

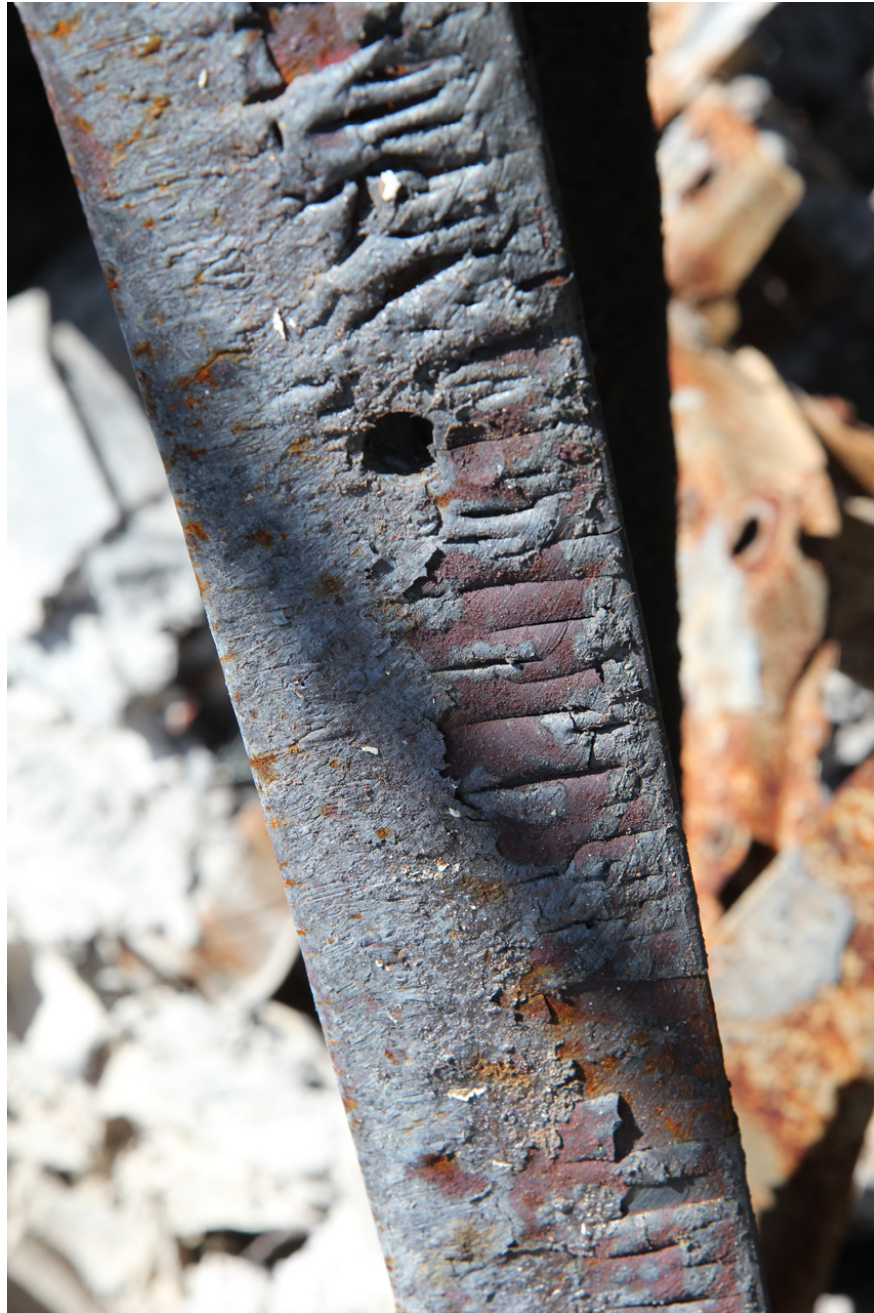
**Figure A.28: Signs of heat-induced material flow in the compression flange of the steel beam.**

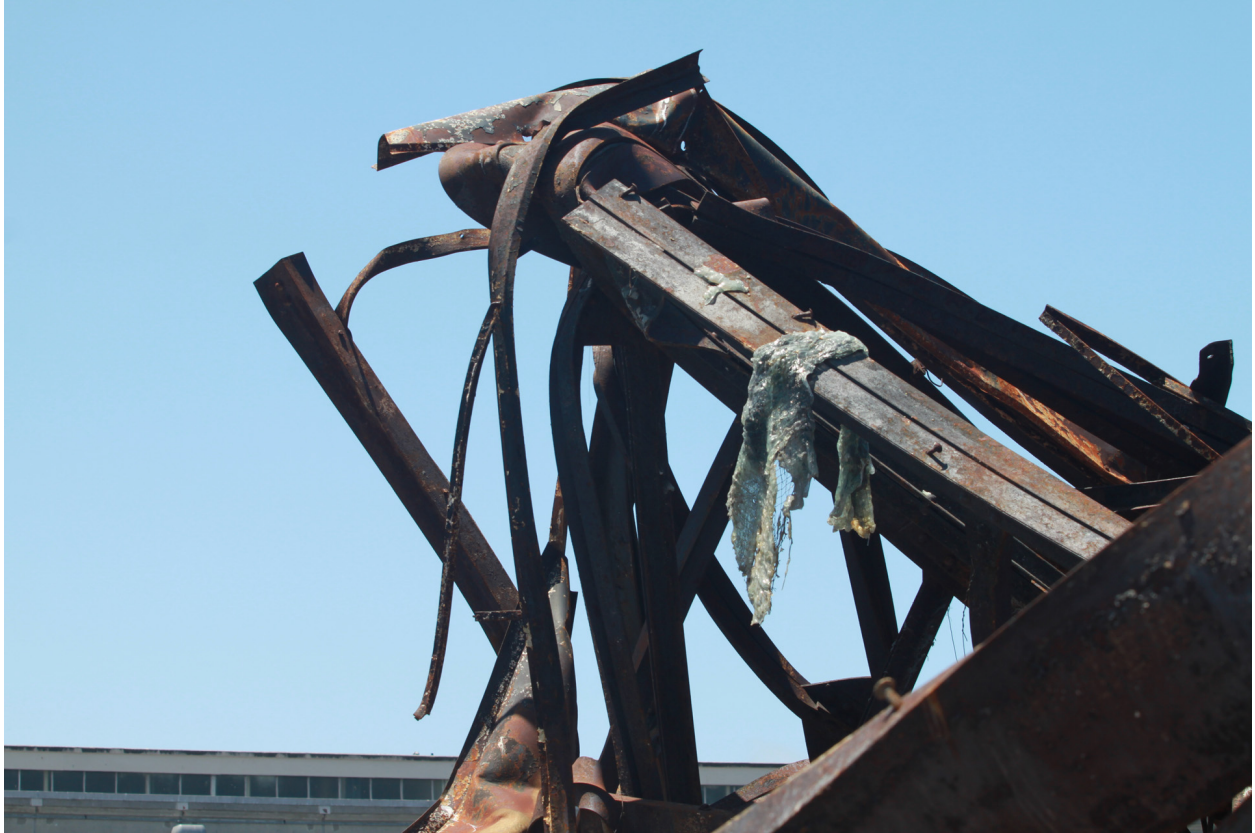
**Figure A.29: Molten glass on steel members, about 10 ft from the east edge, indicating an inward collapse of the glass panels at some locations on the eastern side.**

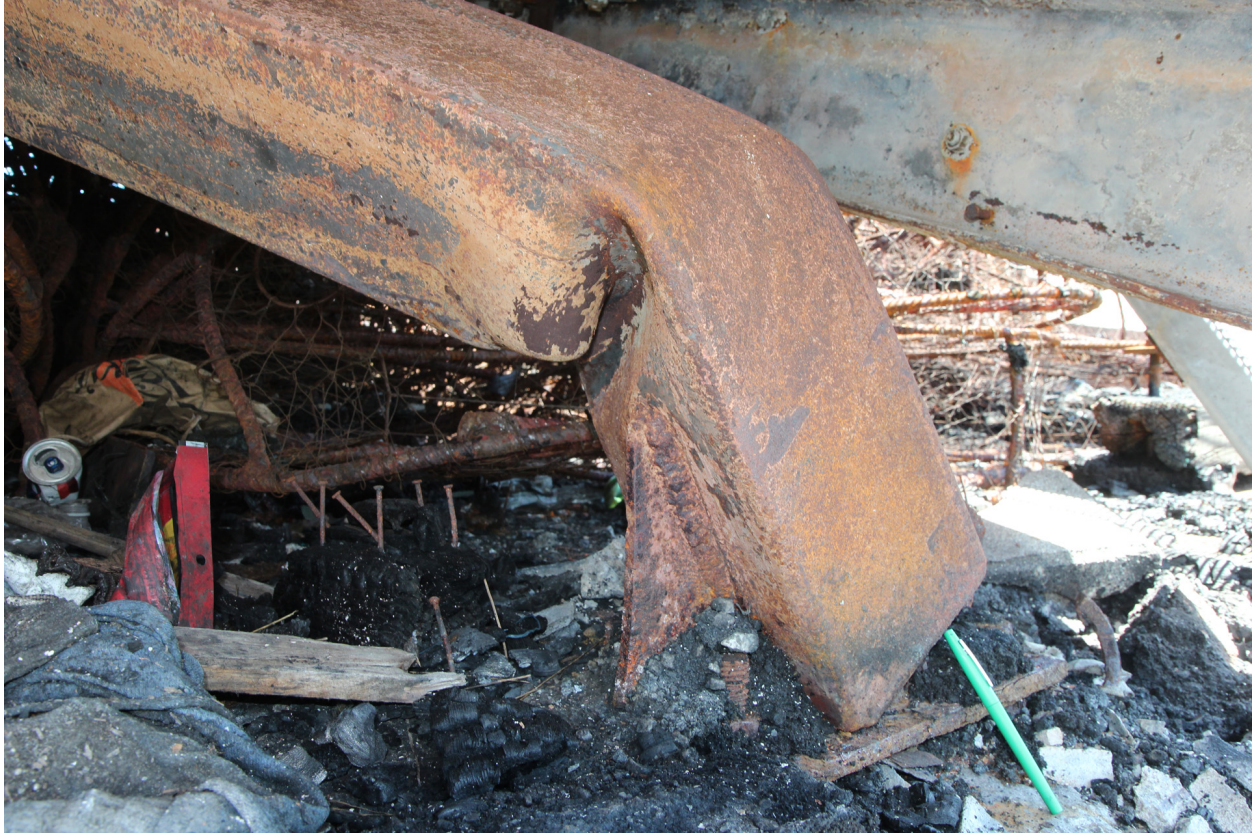
**Figure A.30: Buckling at the base of the HSS column section on the western side of the structure, indicating that the base plate pullout strength exceeded the section's flexural strength.**

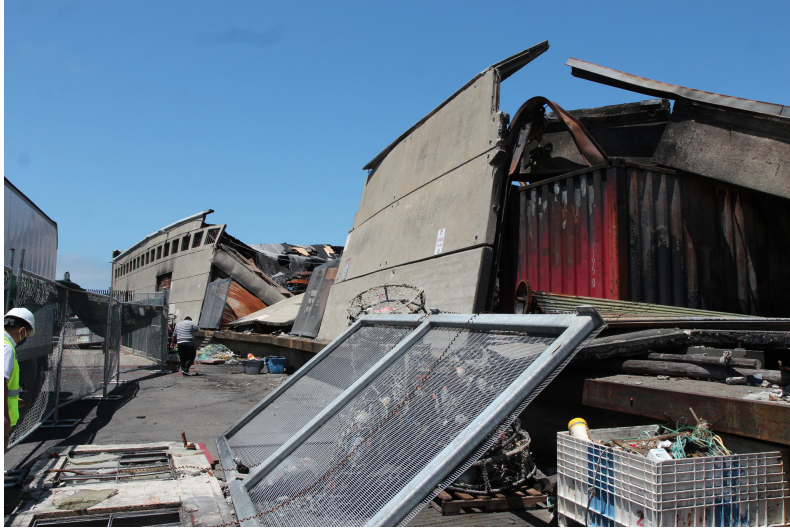
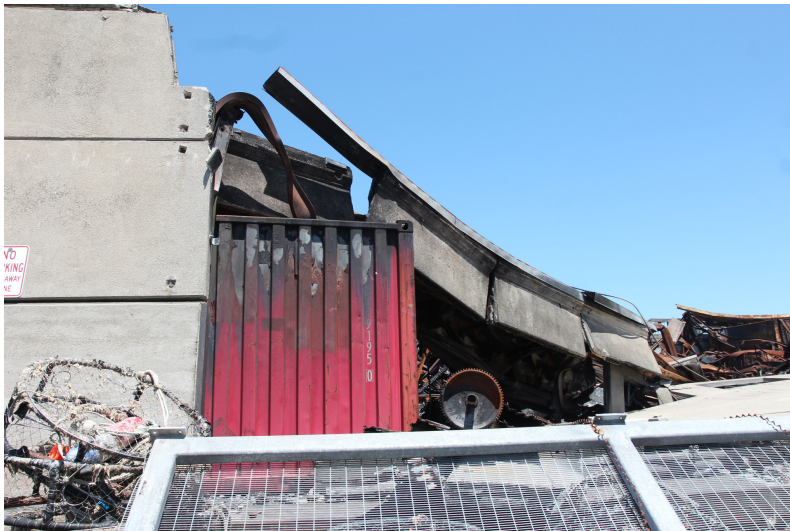
**Figure A.31: Wall collapse and column buckling observations on the western side of the structure: (a) prevention of wall inward collapse because of a container; and (b) buckling of the column at mid-height can be seen.**

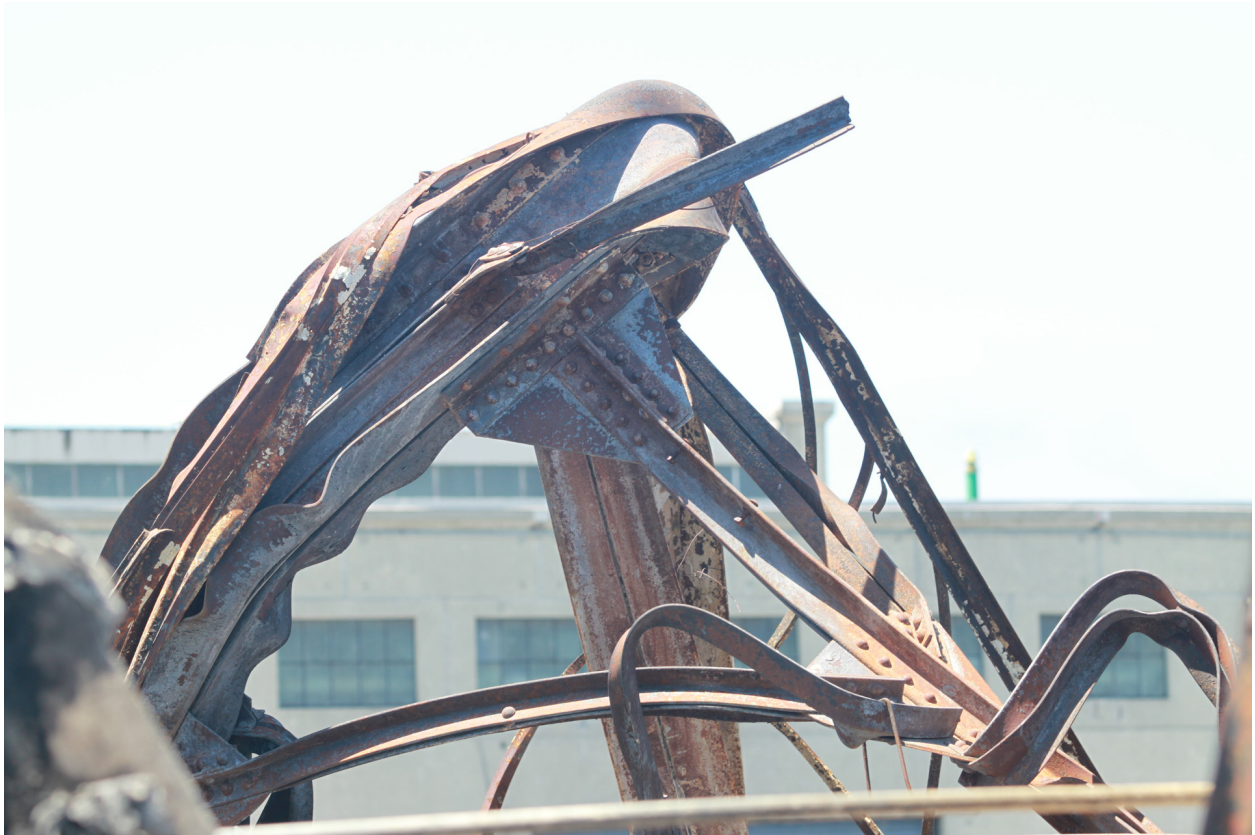
**Figure A.32: Intact gusset plate and connection between twisted steel members.**
