EXPLORING BEHAVIOR OF THIN SHEAR WALL BOUNDARY ELEMENTS

PEER Internship Program – Summer 2012

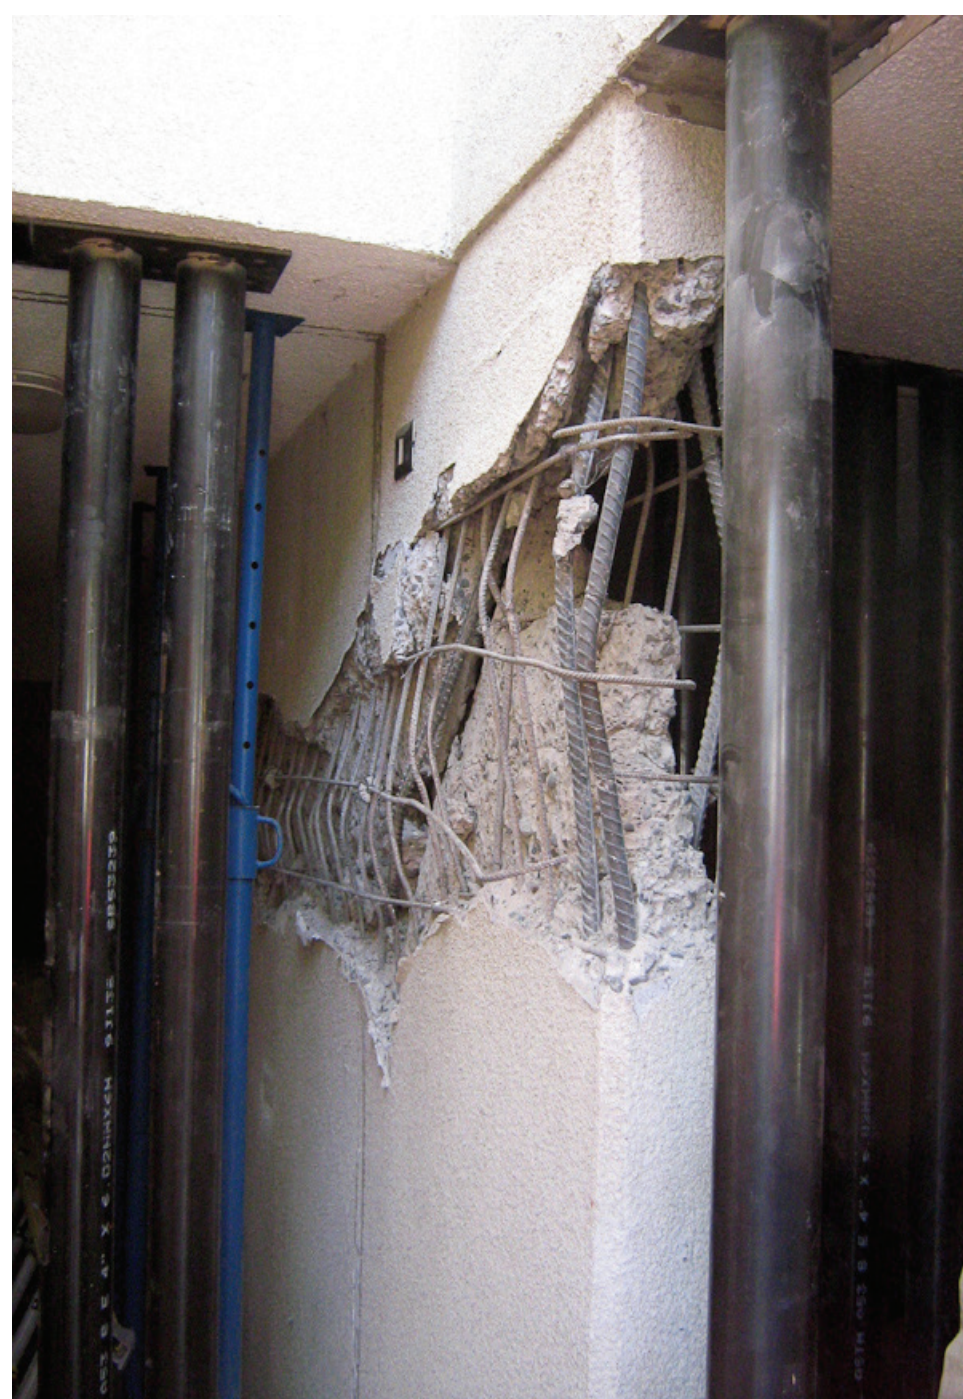
Boundary Element Crushing Failure observed in Chile 2010 Earthquake

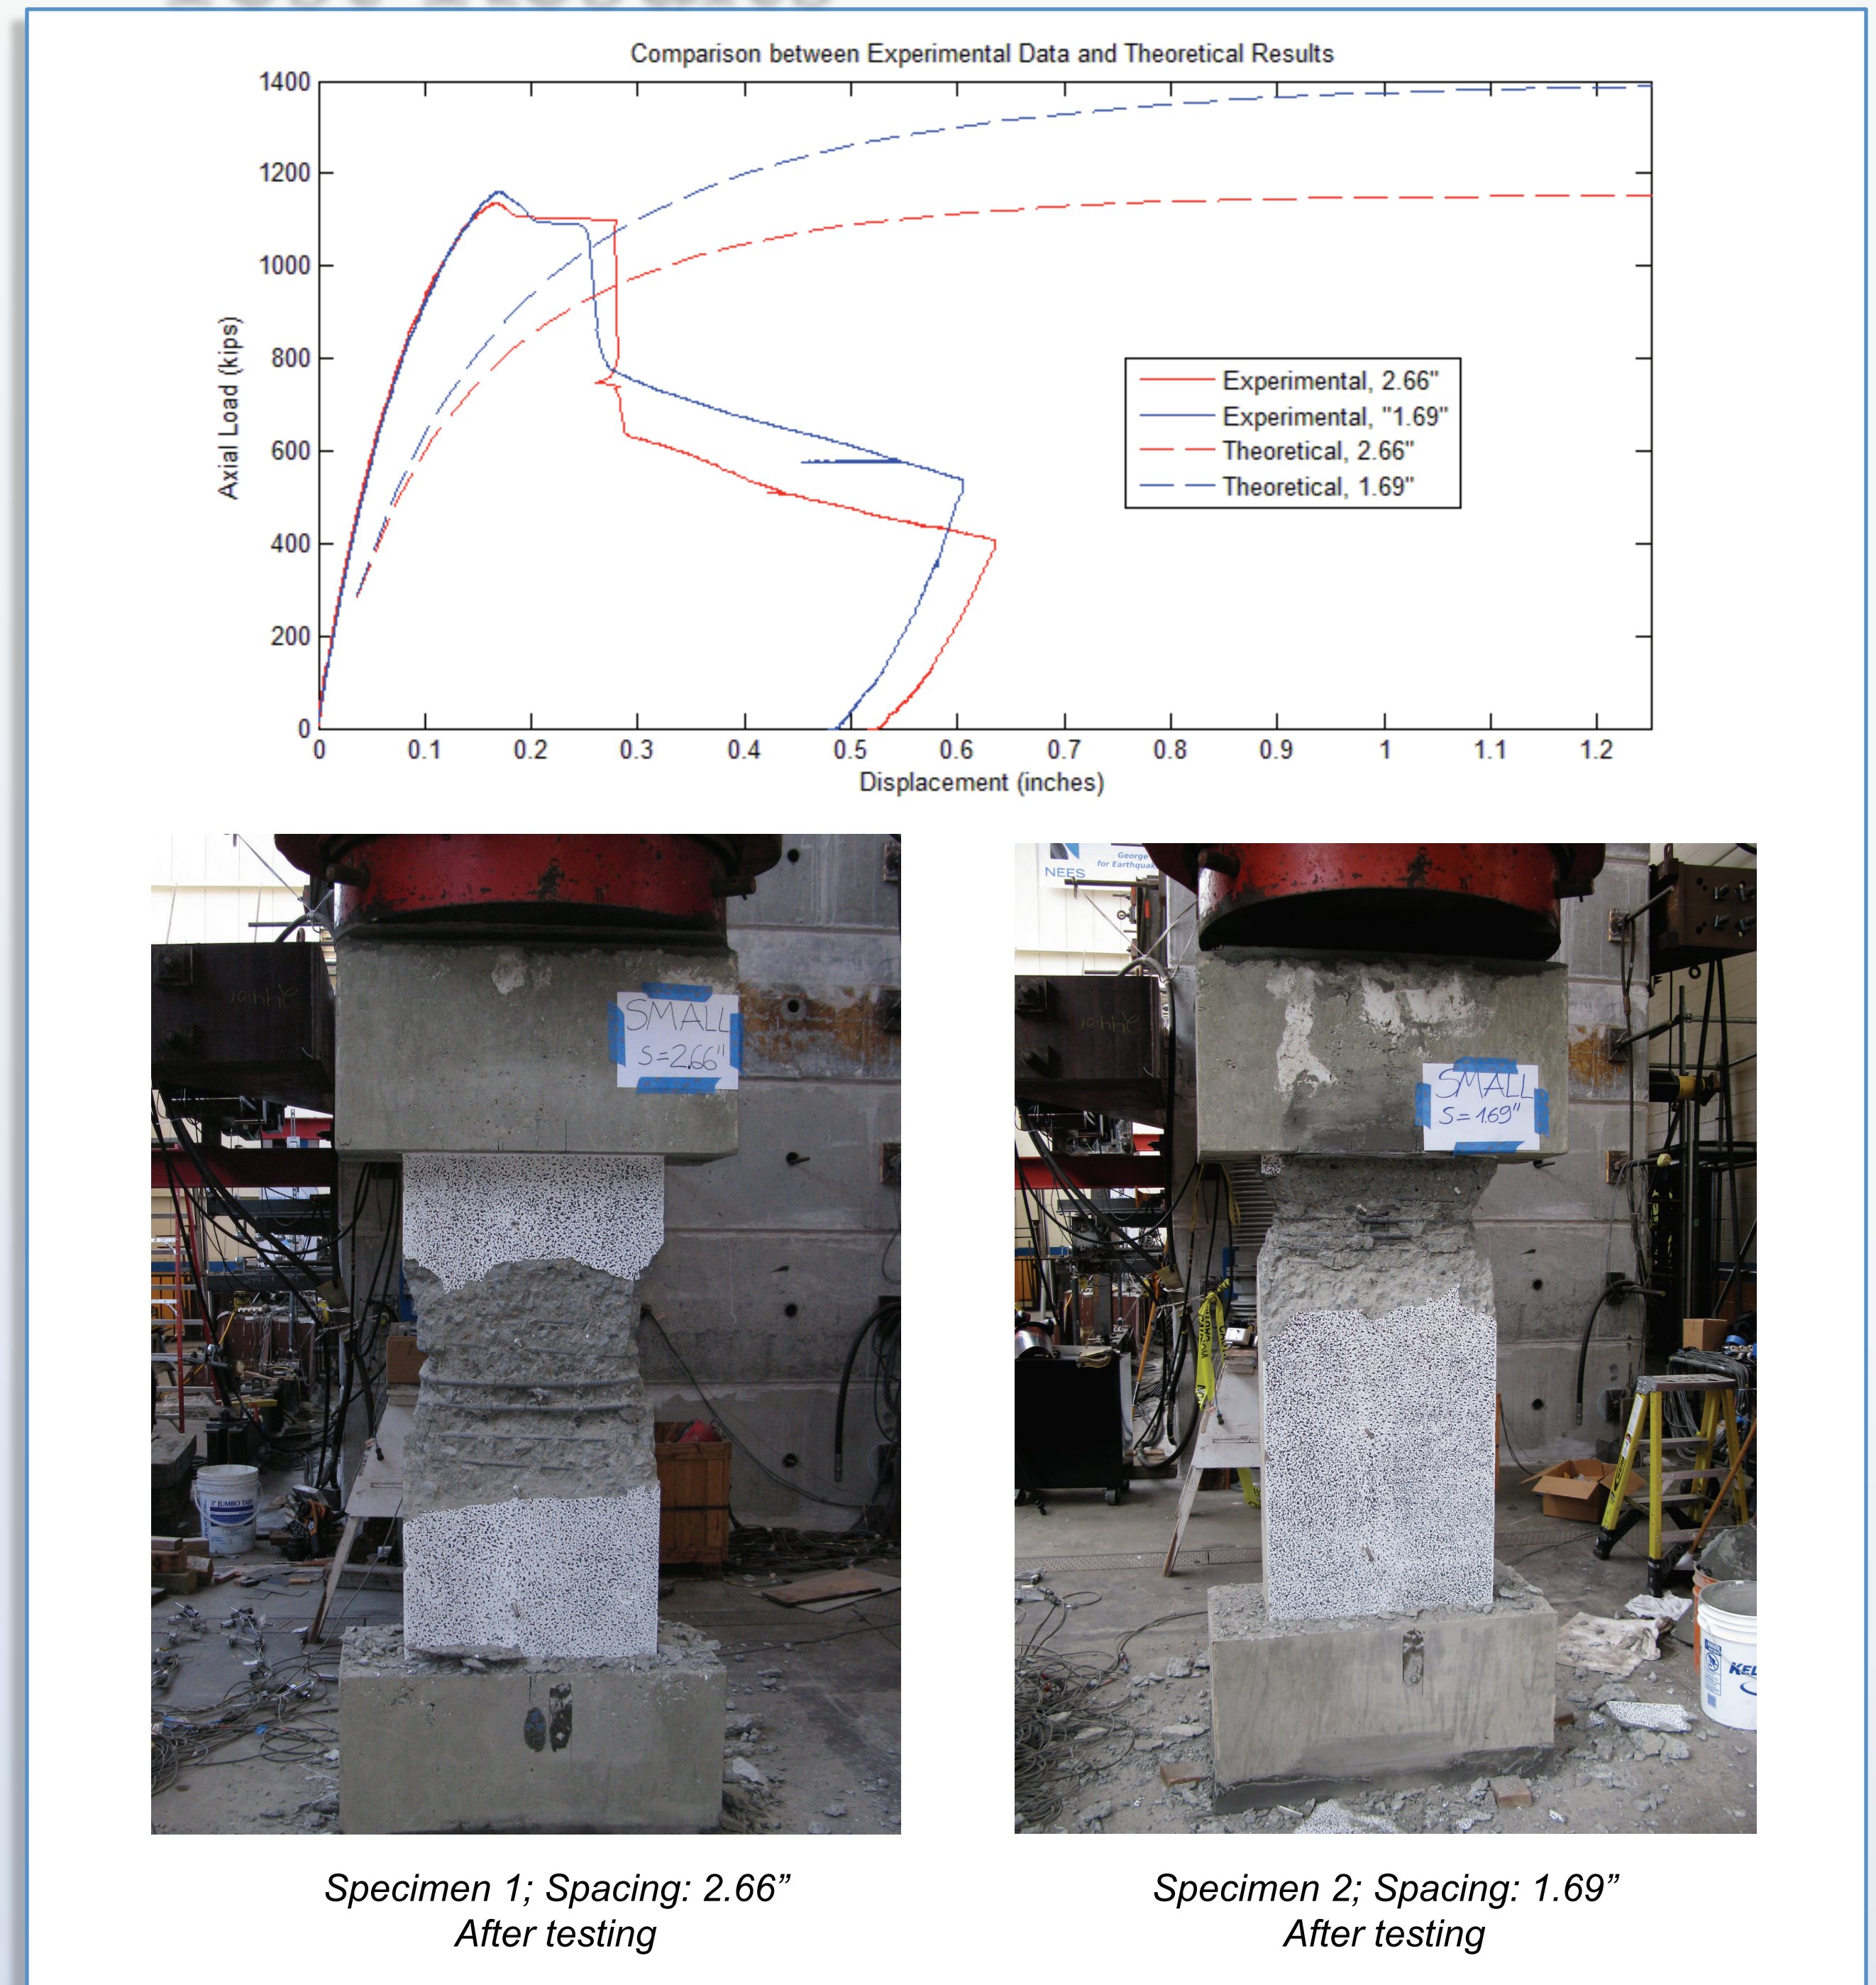
Both specimen were designed with transverse reinforcement spacing that was expected to provide sufficient confinement, thereby leading to a ductile failure following the spalling of the full shear wall face. However, our experiment yielded a brittle response, with only isolated spalling occurring. Confinement in the spalled sections was not adequate in providing the expected increase in axial load capacity. Failure thus occurred when load capacity was lost due to the loss of concrete cross sectional area. Strain measured on Specimen 1 and 2 were 0.388% and 0.347%, respectively. This confirms the lack of ductility, as the specimen were expected to strain to 1.83% and 2.95%, respectively.

Results seem to imply that the decrease in transverse reinforcement spacing did little to alter the behavior of the boundary element at failure. The differences between the two specimen, in terms of load and displacement, were not significant enough to suggest that either spacing layout provided an increase in capacity or ductility.

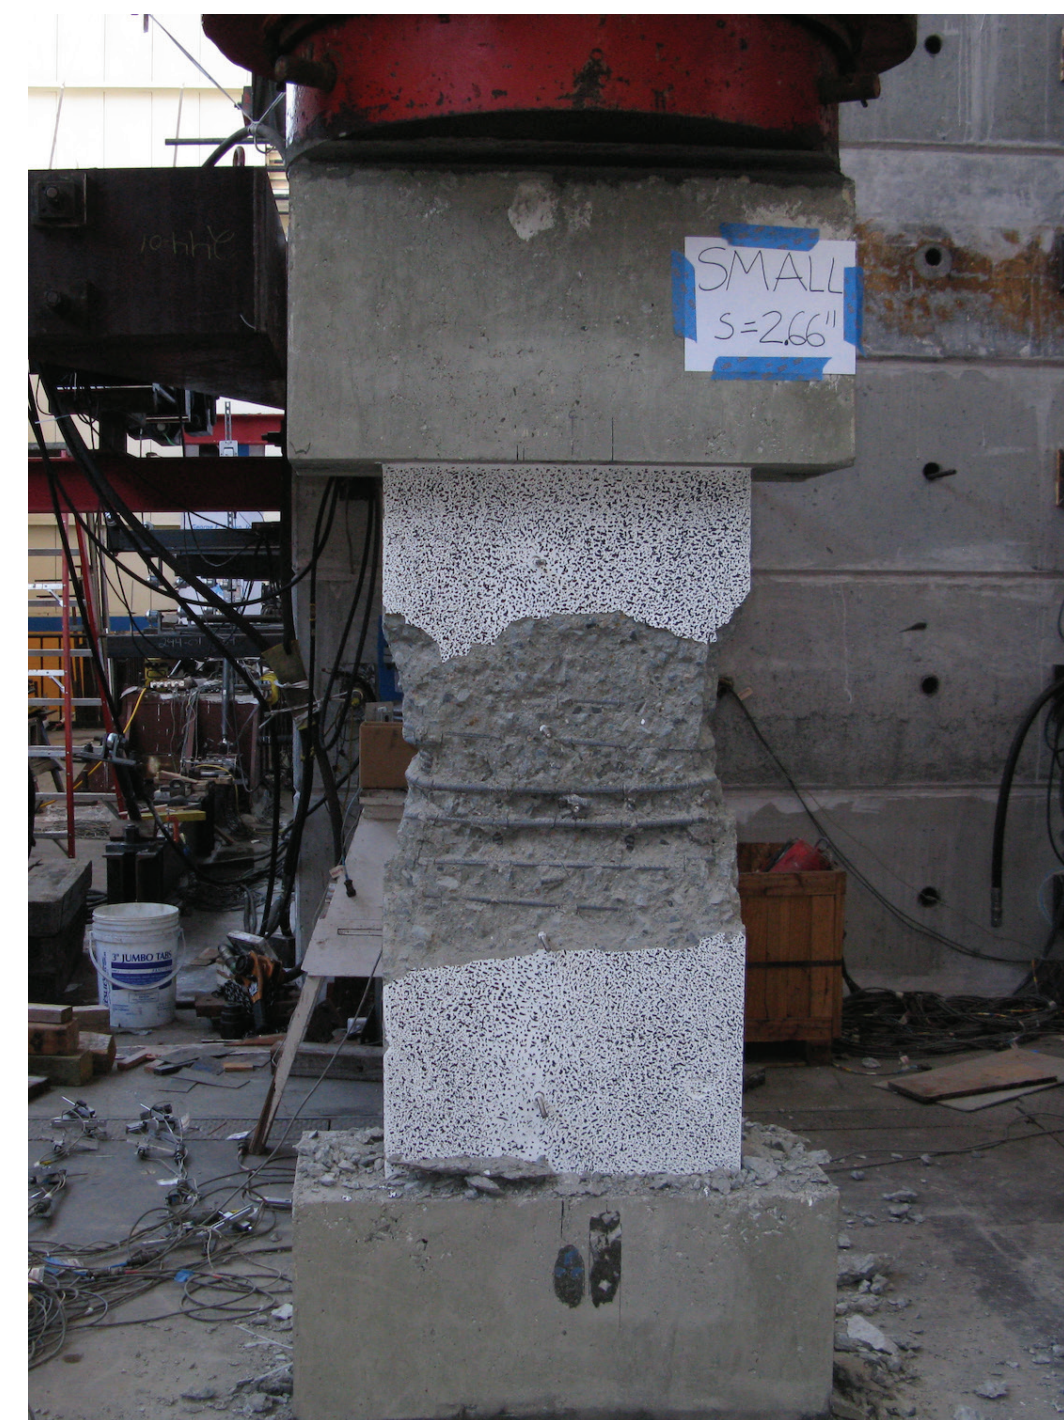
Specimen 1; Spacing: 2.66" After testing

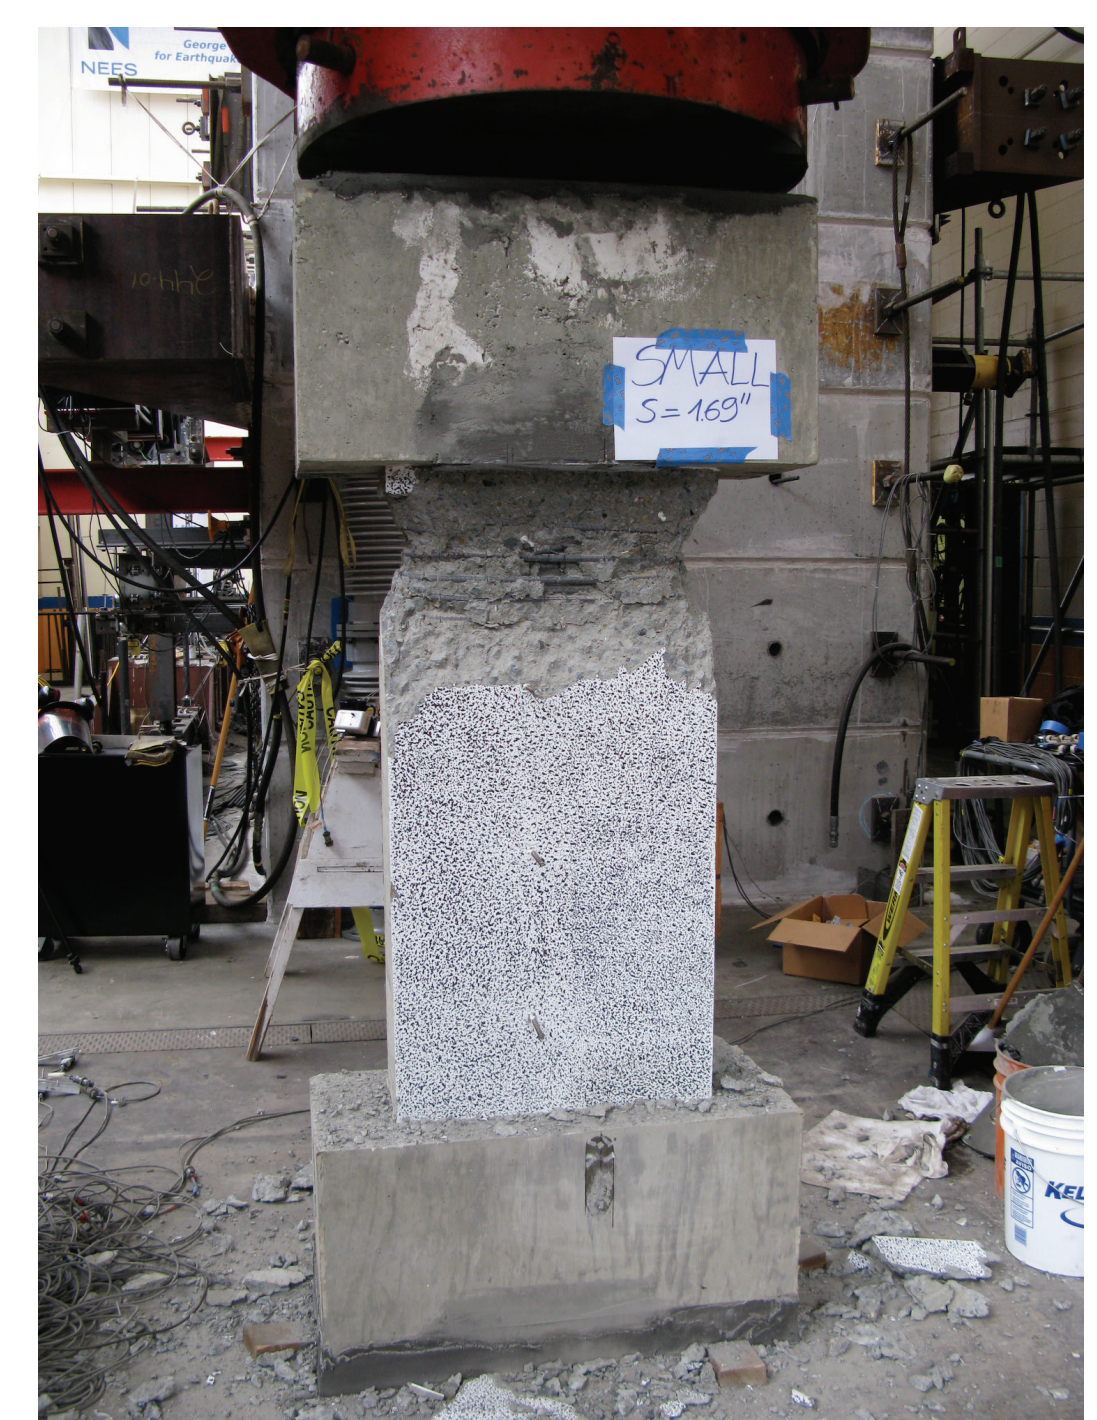
Specimen 2; Spacing: 1.69" After testing

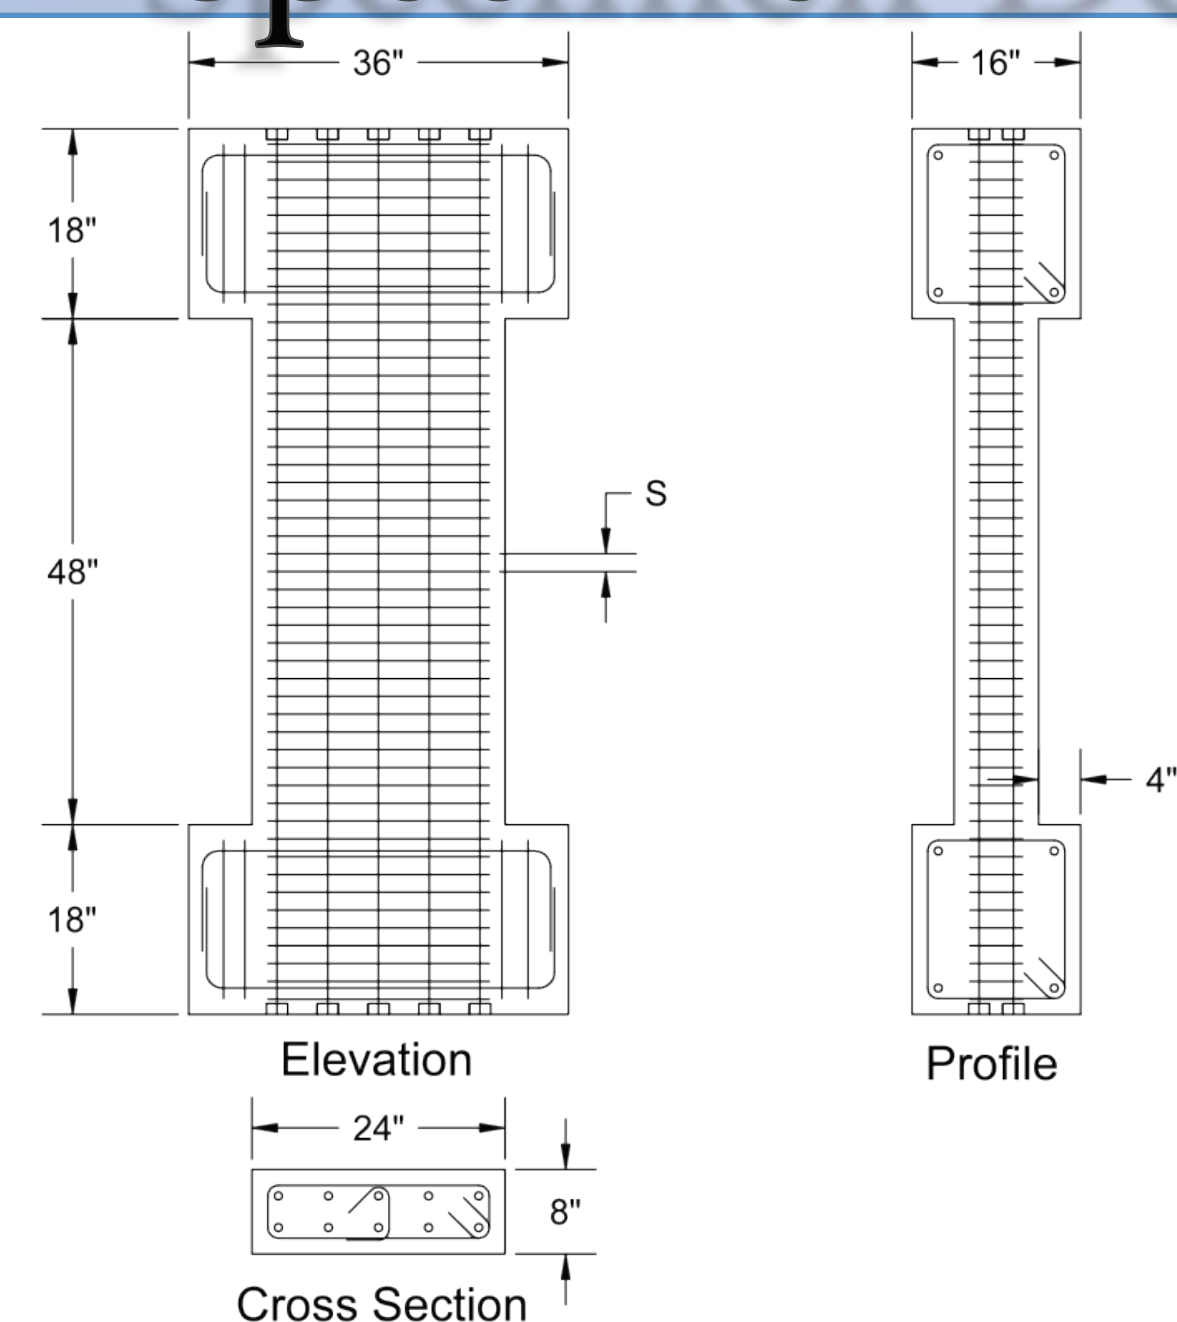
- Tested in compression using 4 million pound press at Richmond Field Station
- Test Region: 48" x 24" x 8"
 - 1.5" clear cover
- Concrete block heads: 36" x 18" x 16"
 - Ensure development length for rebar is achieved
- Rebar at test region comprised of:
 - 10 #5 longitudinal headed rebar
 - #4 transverse at spacing S
 - #4 hook at spacing S
- Transverse spacing based on ACI 318-11 eq .21-4 and 21-5
 - Specimen 1: S = 2.66"
 - Specimen 2: S = 1.69"
