CHALLENGE III

Liquefaction-Induced Building Settlement

Jonathan Bray

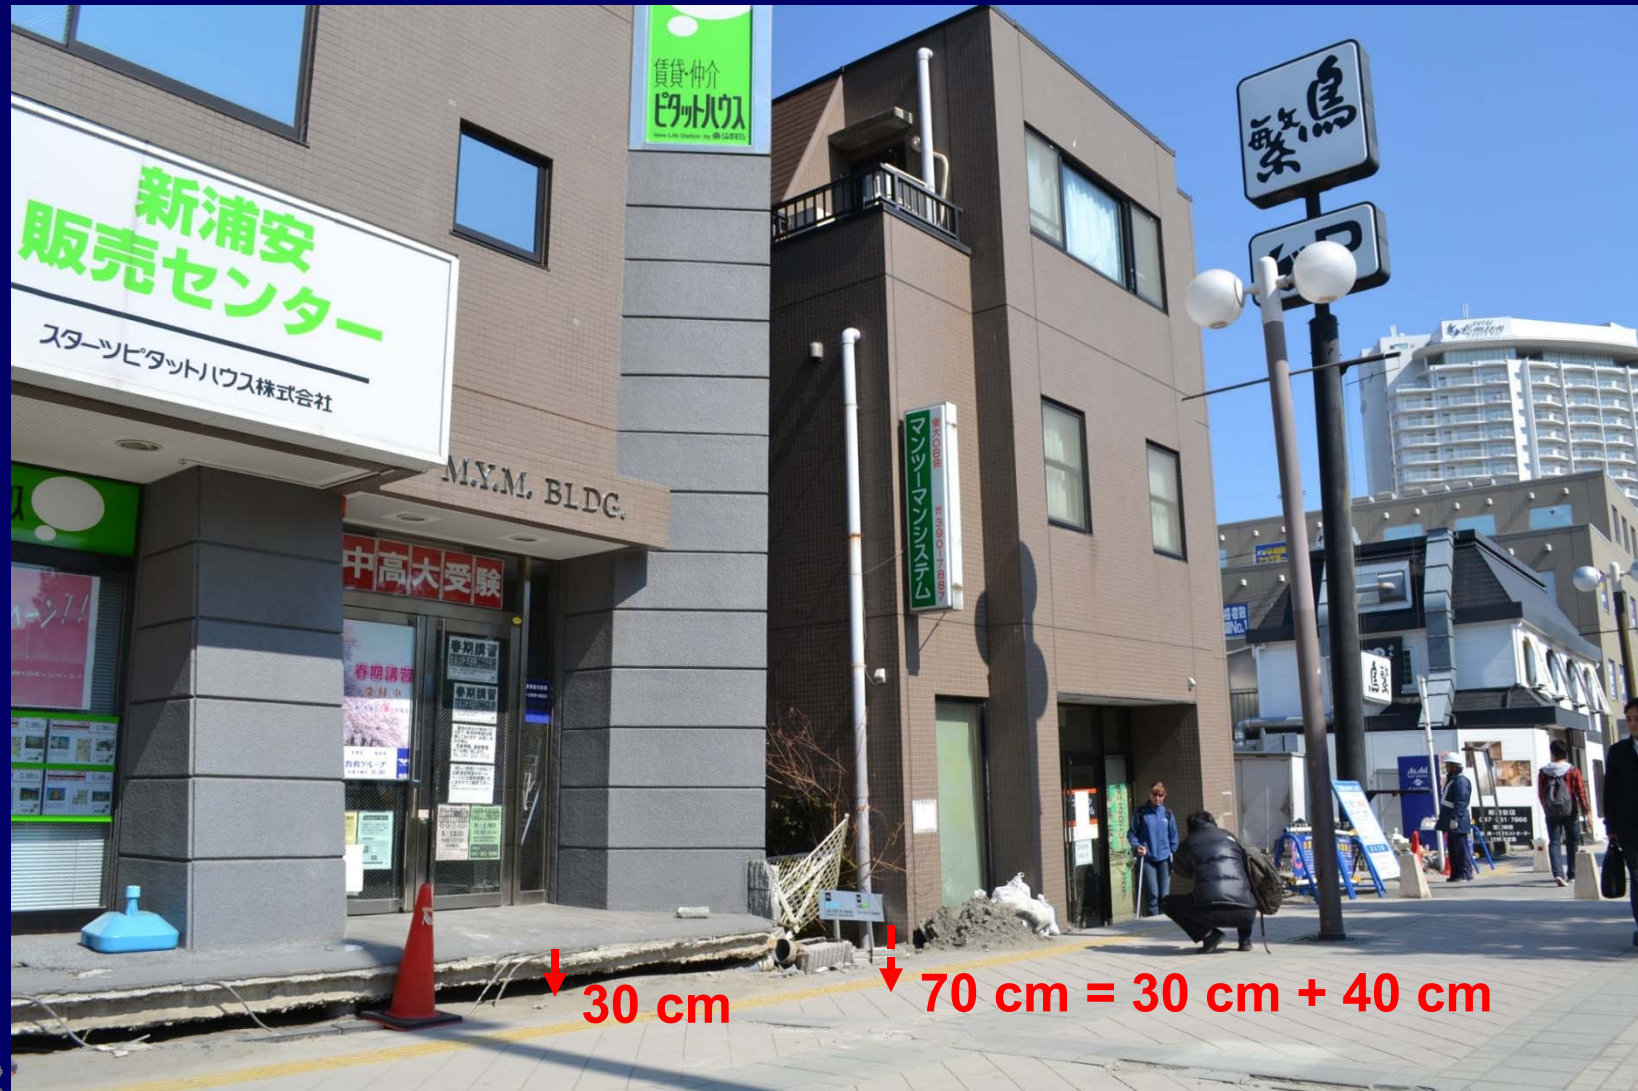
Liquefaction-Induced Building Movements

March 11, 2011 Tohoku, Japan Earthquake ($M_w = 9.0$)

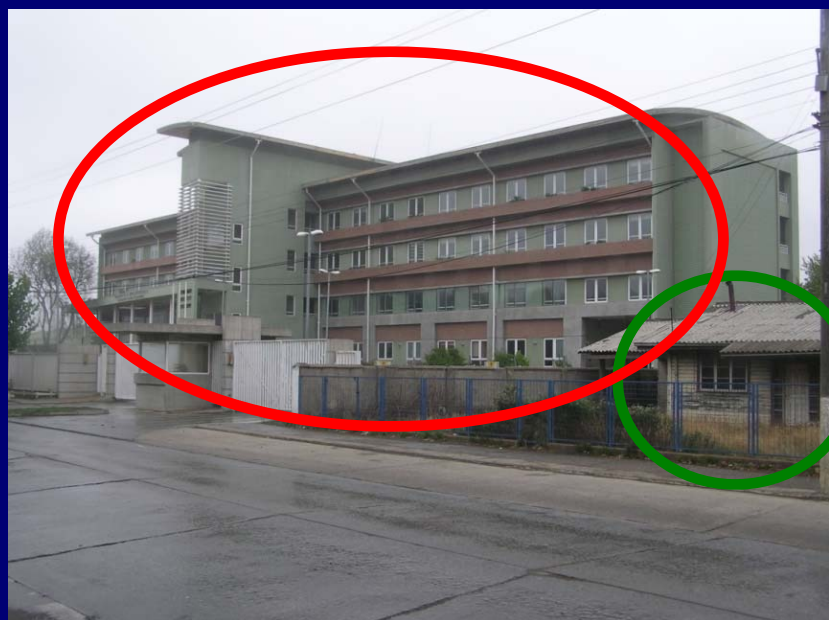
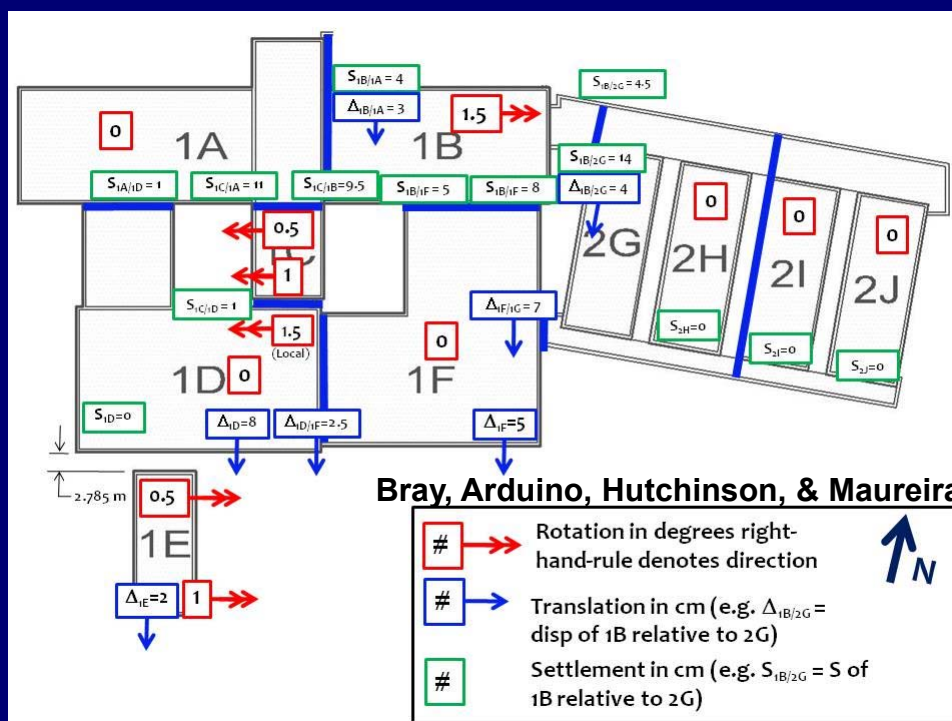
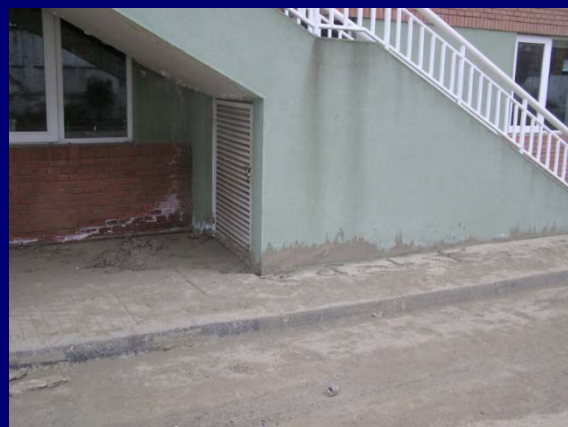
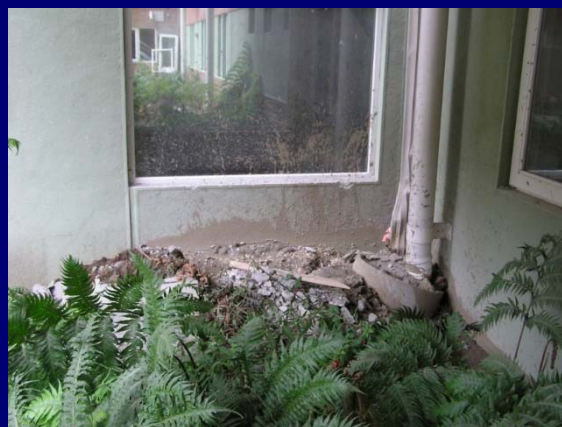
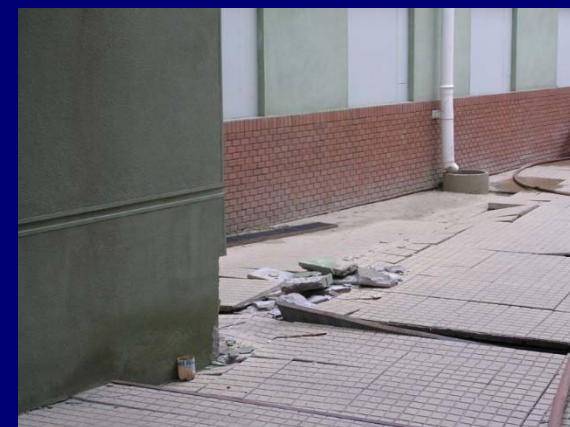
Effects of Buildings on Soil Liquefaction

Hospital in Curanilahue 2010 Maule Chile EQ

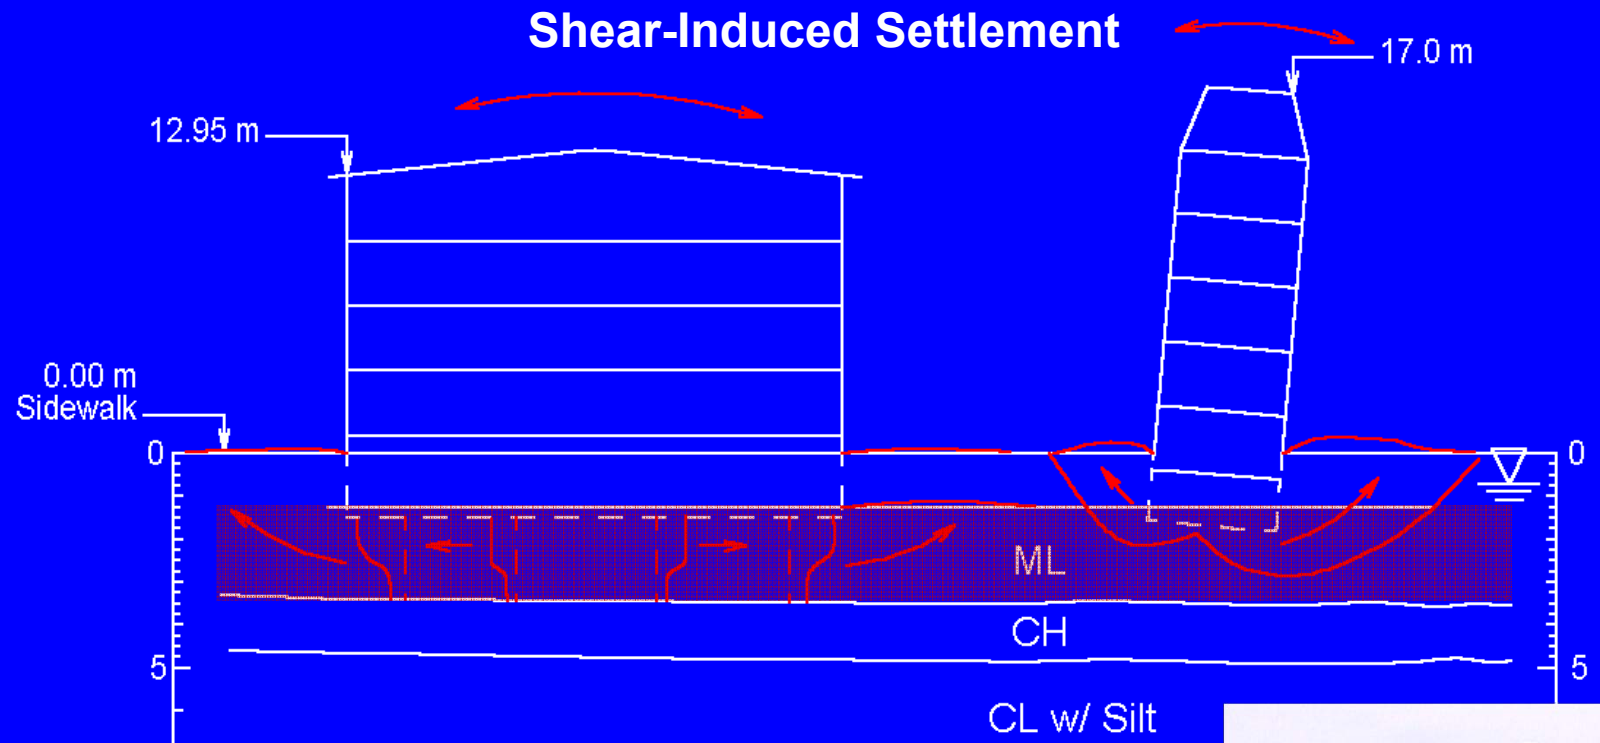
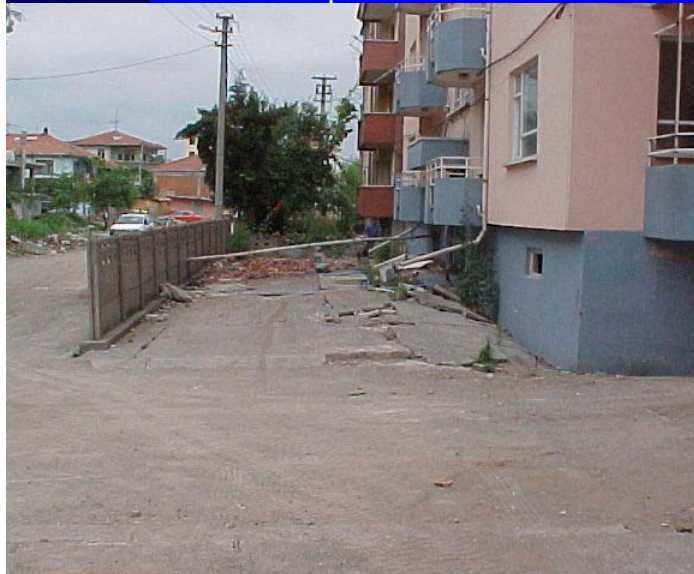
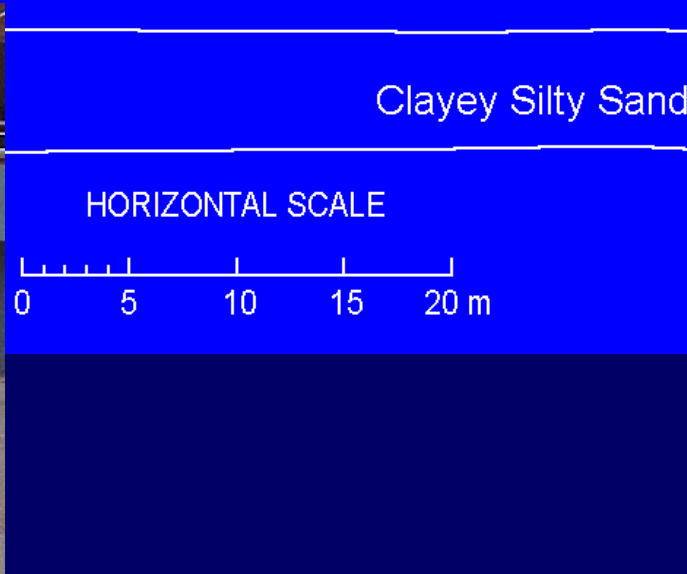
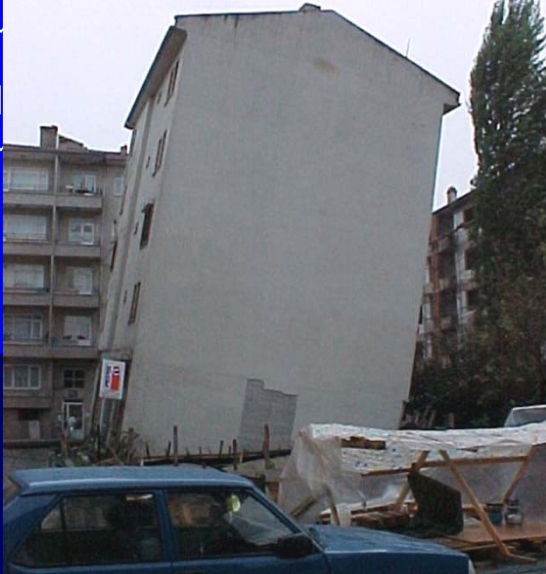
Building Response in Adapazari - 1999 Kocaeli EQ

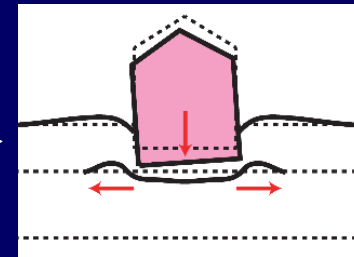
Bearing Capacity Failure (ϵ_{q-BC})

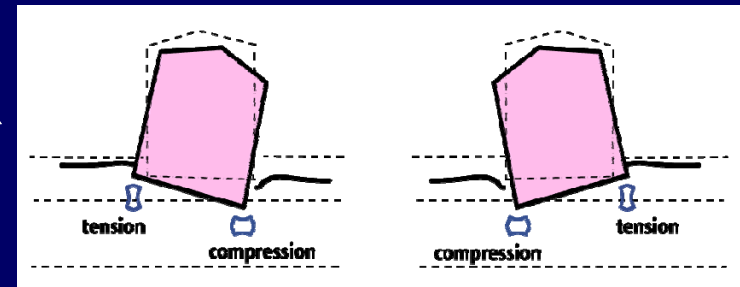
SSI-Induced Ratcheting (ϵ_{q-SSI})

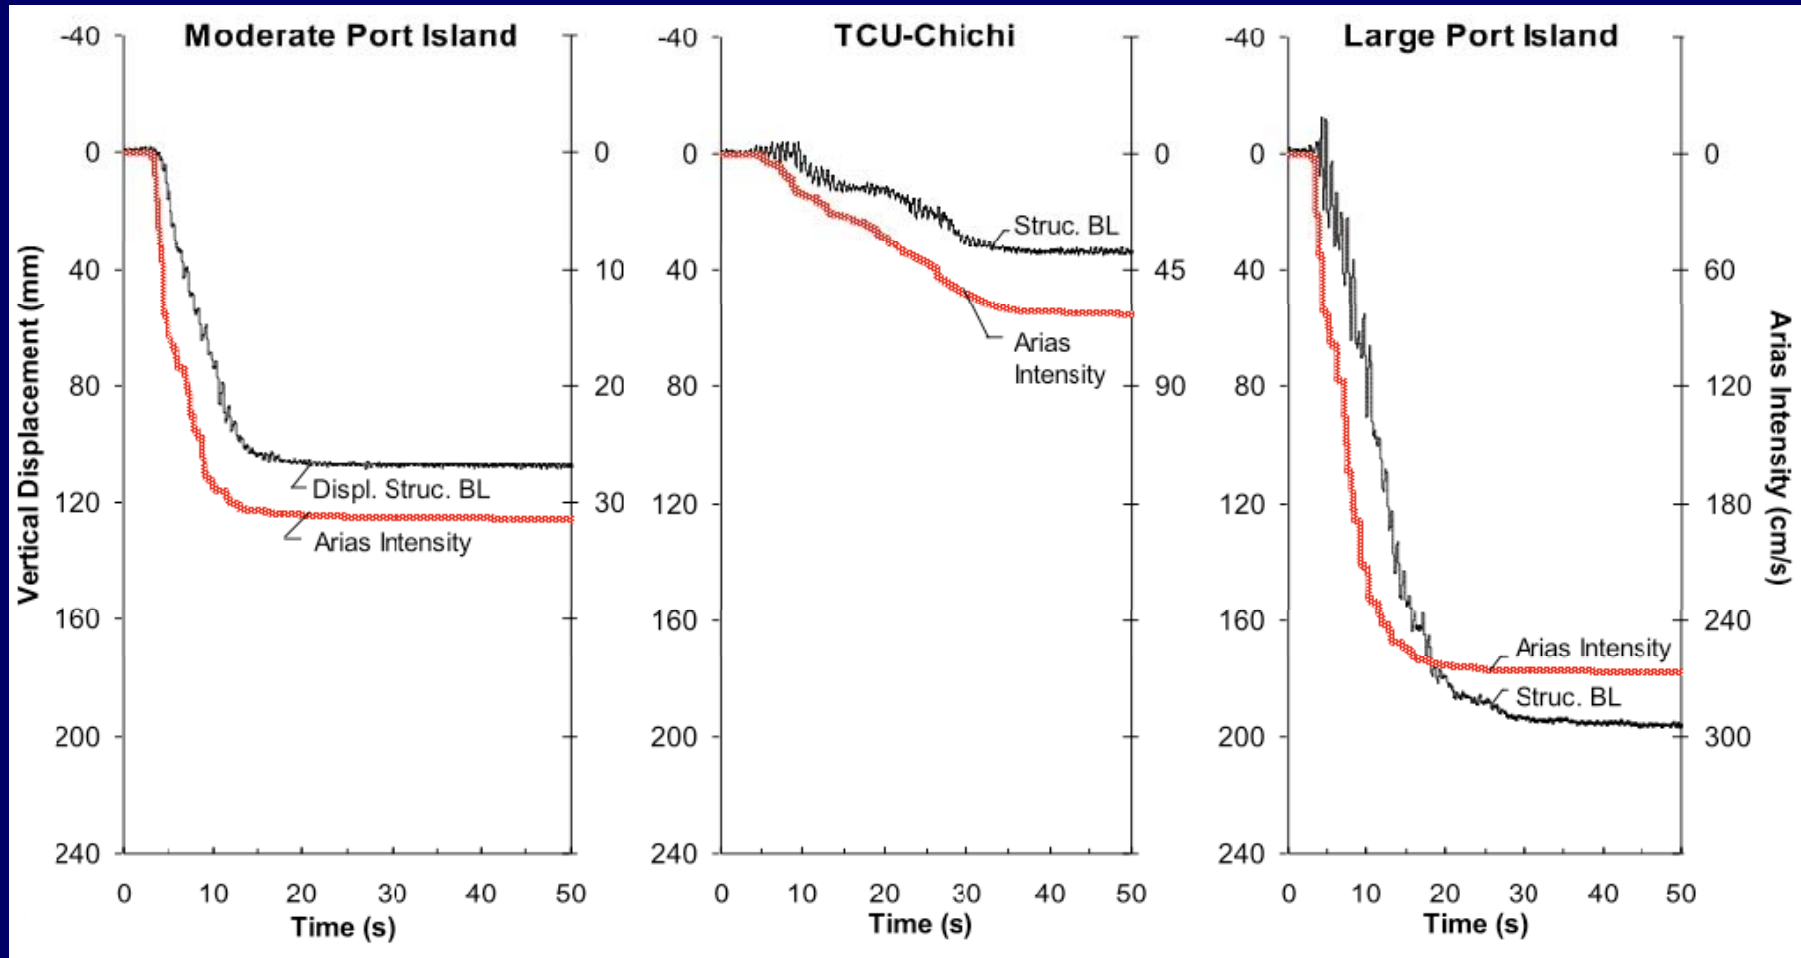
Effects of Ground Motion

$$\text{Shaking Intensity Rate} = \text{SIR} = I_{a_{5-75}} / D_{5-75}$$

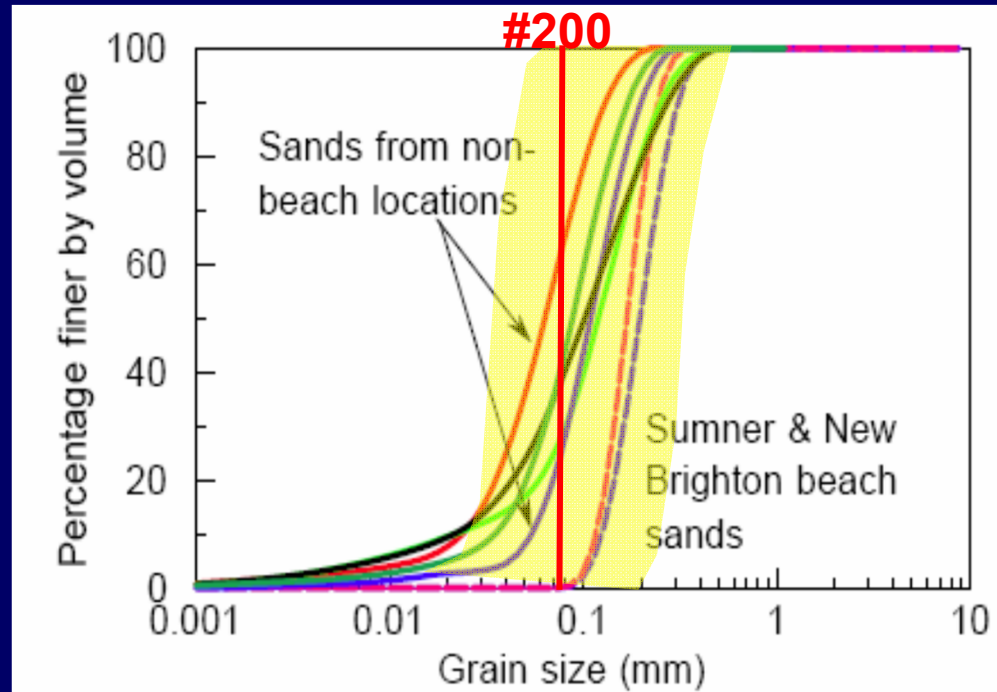
Sand ejecta samples from areas in Christchurch

- Clean fine sands and non-plastic silty sands
- Does soil '*know*' that the #200 sieve exists?

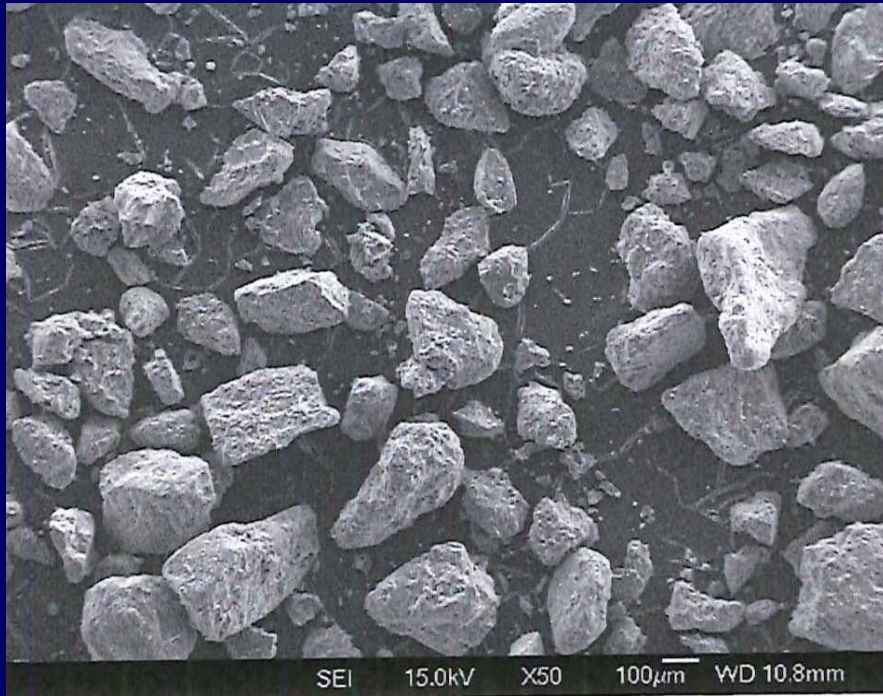
Soil sample Site 3 Natural Soil Panel 1 at -1.76m R.L at 50x magnification.

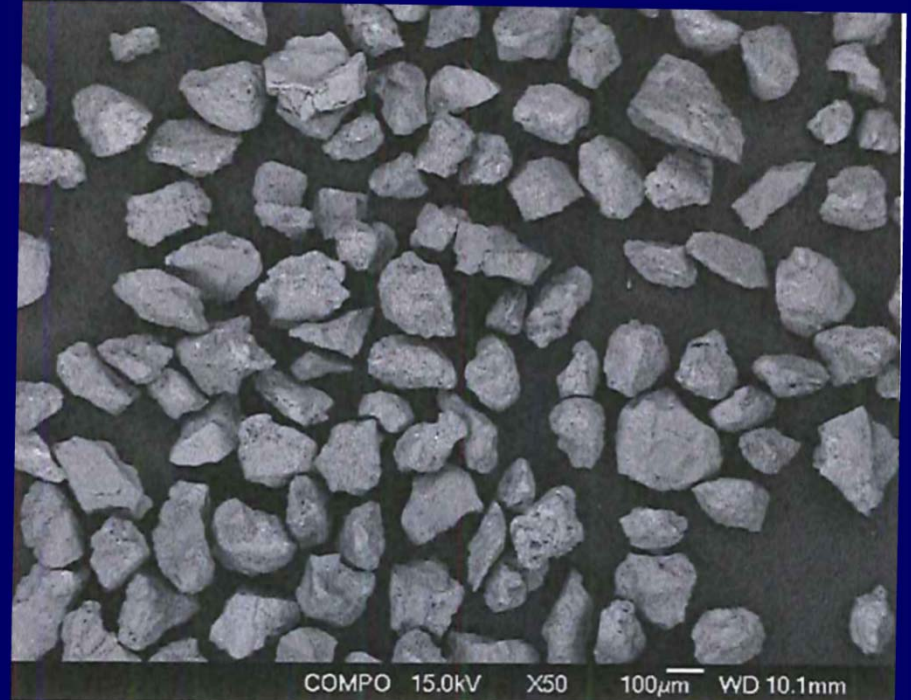
Soil sample Site 4 Natural Soil Panel 2 at -1.94m R.L at 50x magnification.

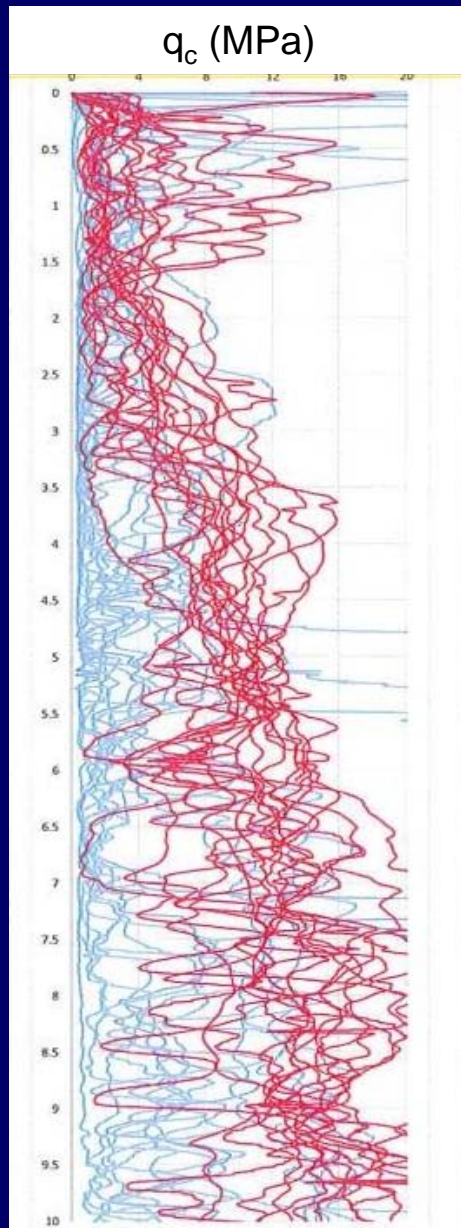
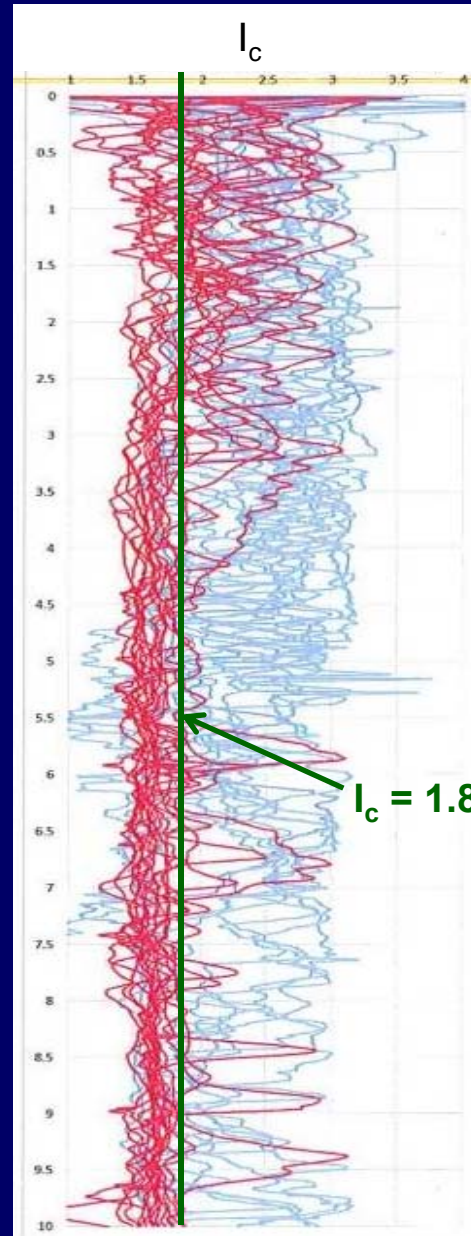
Observations of Liquefaction Ejecta

2010 Darfield EQ
Ejecta Observed
No Ejecta

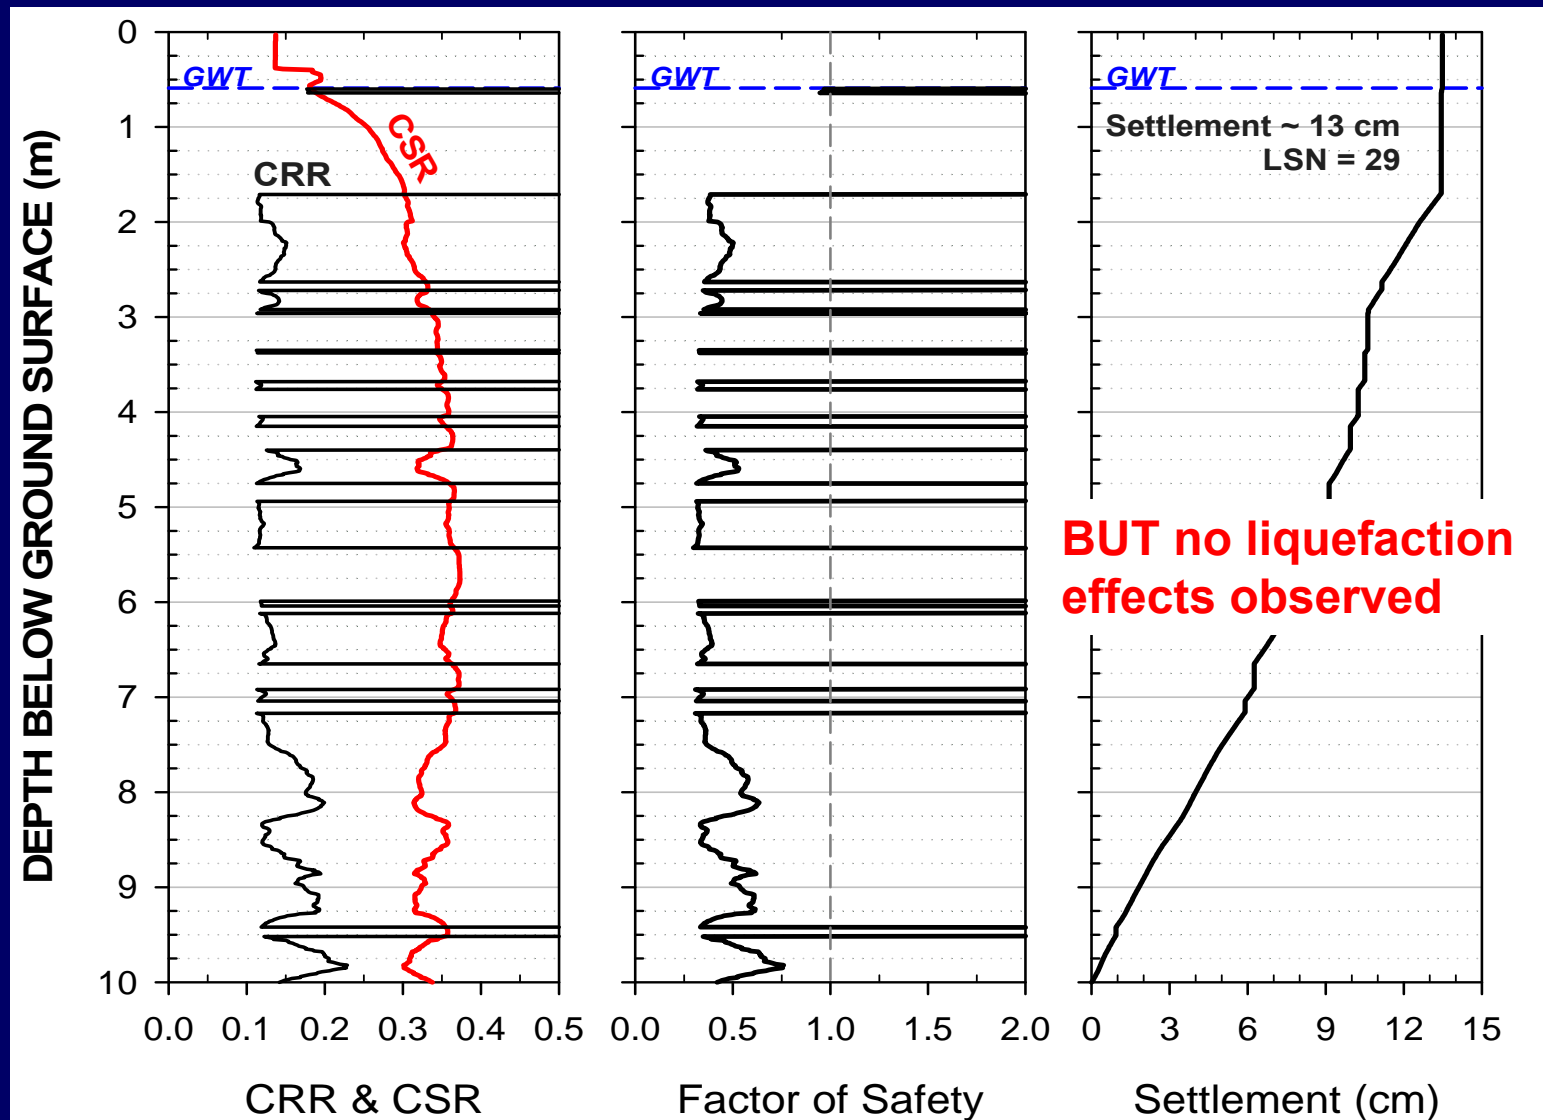
Liquefaction Assessment at Stratified Site

Riccarton Road Site 23 22 Feb 2011 EQ: $PGA = 0.37 g$, $GWT = 0.6 m$ BGS, $P_L = 50\%$, $LPI = 19$, CPT_36420
(Beyzaei et al.; CRR and FS plots exported from CLiq)

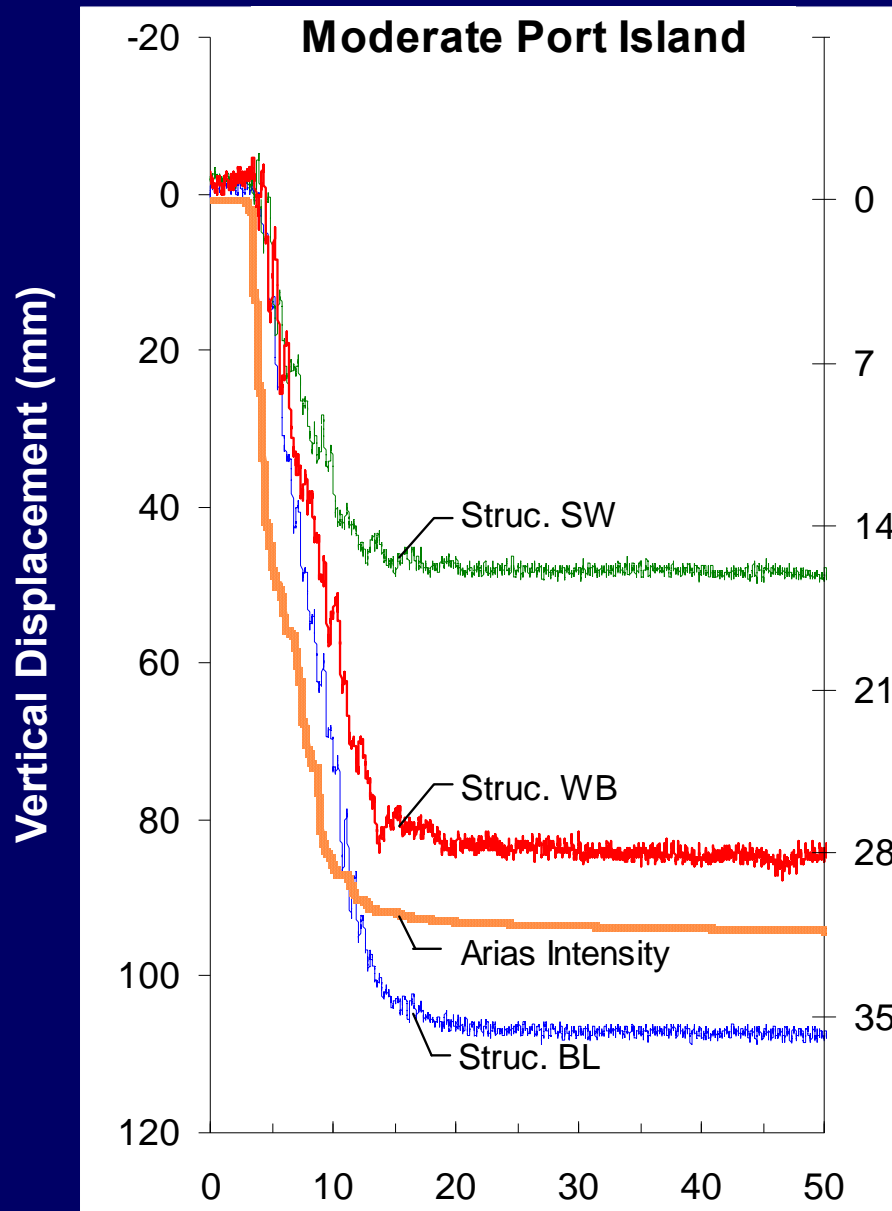
Isolation of Liquefaction Mechanisms in Centrifuge

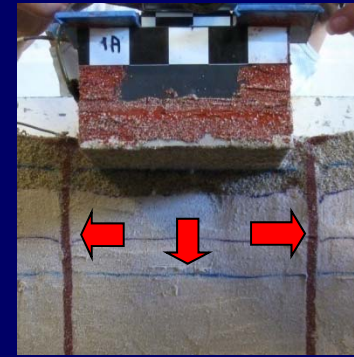
Struc. BL
(Baseline)

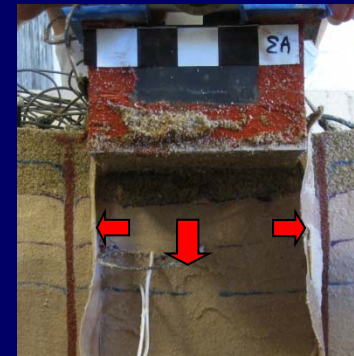
Struc. WB
(Water Barrier)

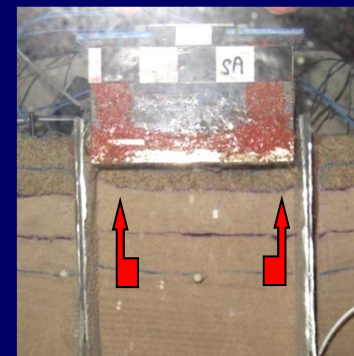
Struc. SW
(Structural Wall)

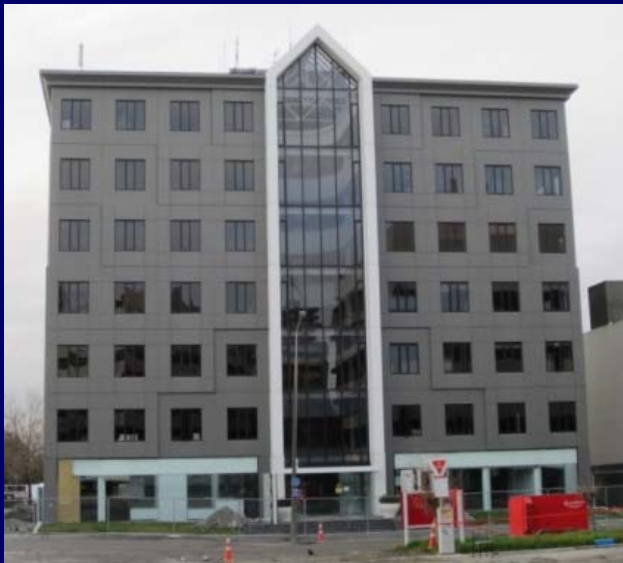
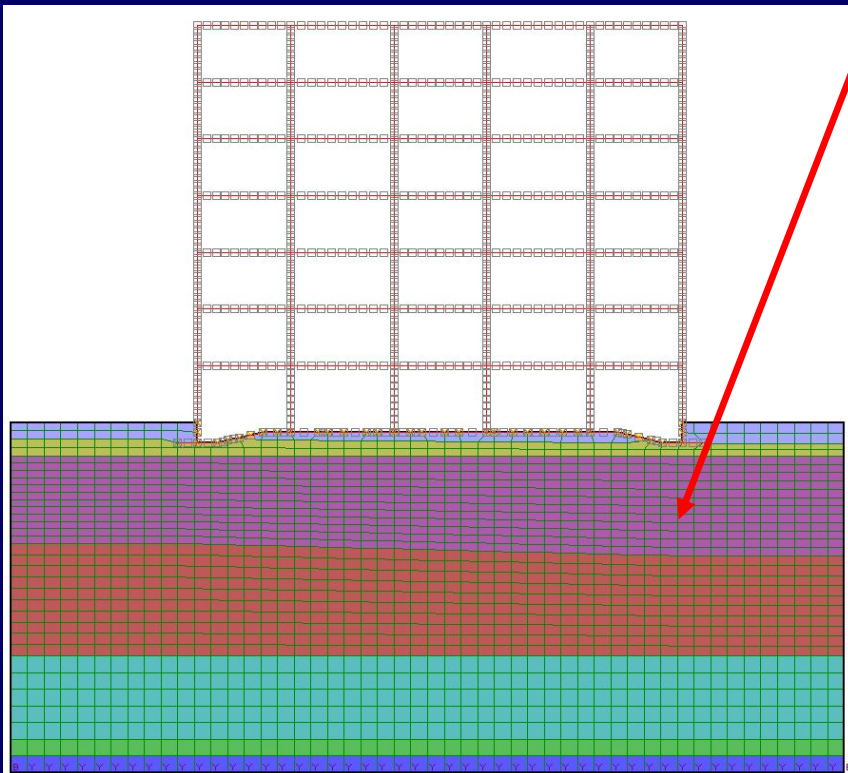
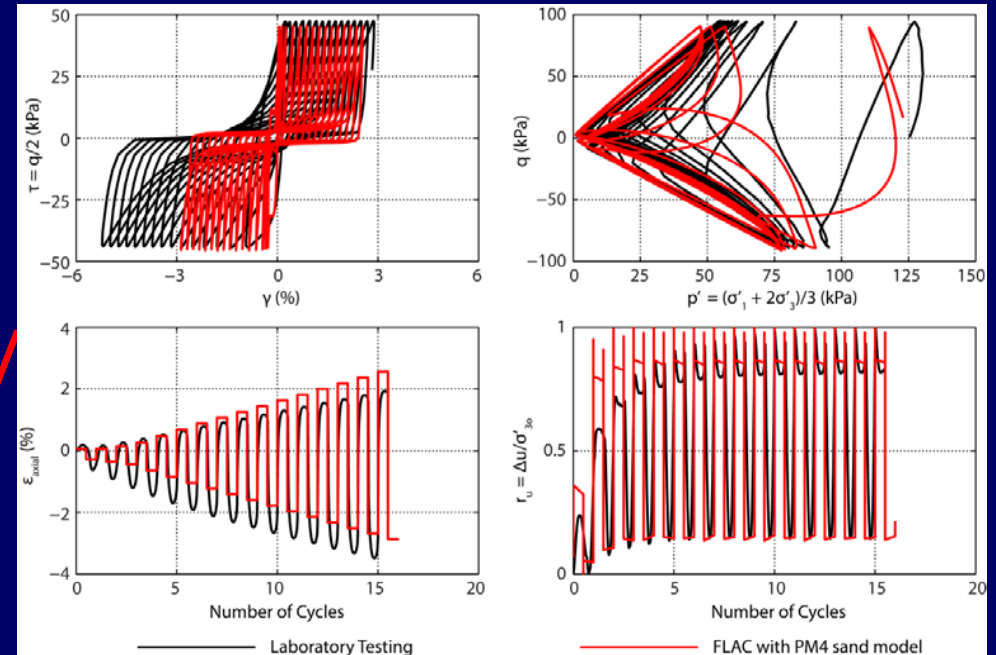
FTG-7 Building Christchurch

SSI Nonlinear Effective Stress Analyses

EQ	Calculated Differential Settlements	Measured Differential Settlements
4SEP10	0.6 to 0.7 cm	No measurements
22FEB11	2.5 to 2.8 cm	1 to 3 cm
13JUN11	2.0 to 2.2 cm	0.1 to 2.1 cm

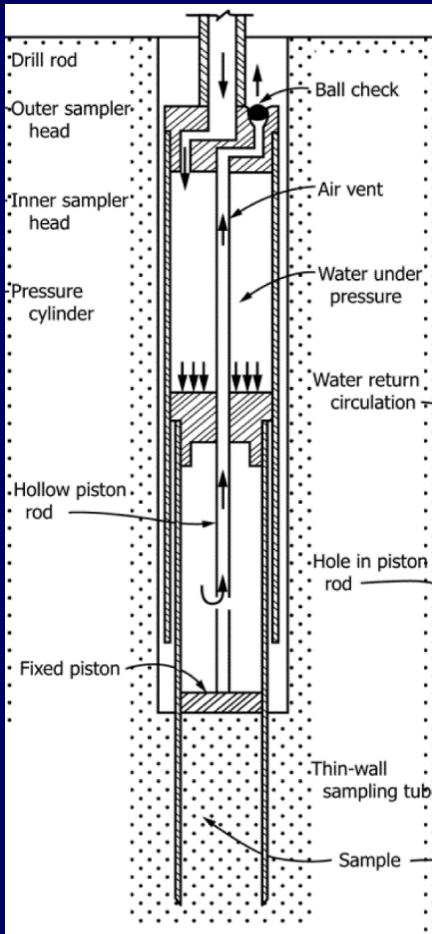
D&M Thin-Walled Piston Sampler
