# **Evaluation of Non-Ductile Reinforced Concrete Building Corner Joint Experiencing Early Column Failure**

**V.M. Sanchez<sup>1</sup>, B. Lloyd<sup>2</sup>, W. Hassan<sup>3</sup>, J.P. Moehle<sup>4</sup>**

## **ABSTRACT**

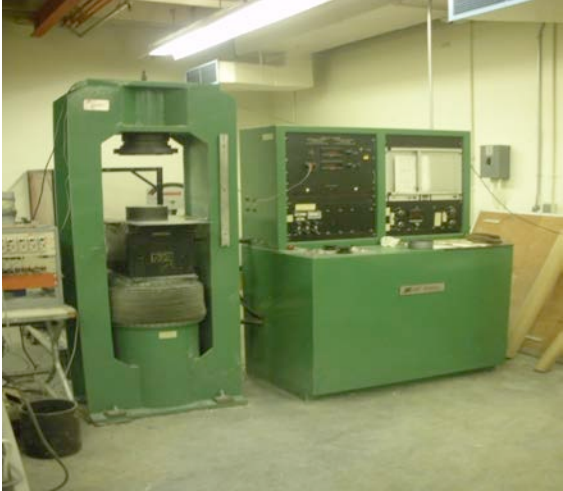
**Figure 3.4: Compression machine used to test concrete cylinders**

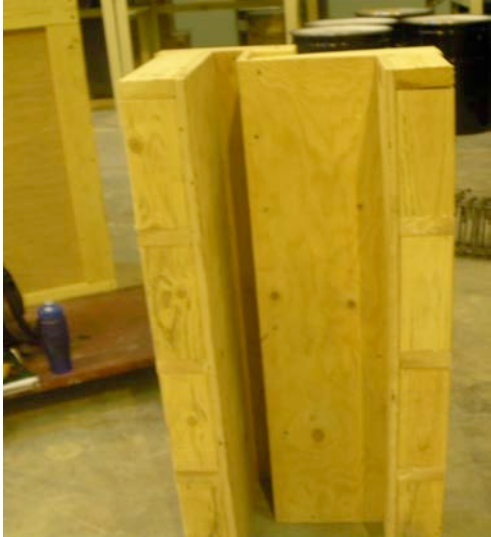
The concrete form consisted of the column laying on the platform while the beam stood vertically. Two polyvinyl chloride pipes with a diameter of 1¼” were installed through the slab section of the form adjacent to the longitudinal beam to leave two holes which then accommodated the thread rod used for attaching the actuator to the longitudinal beam.

**Figure 3.10: Concrete form for the beam**

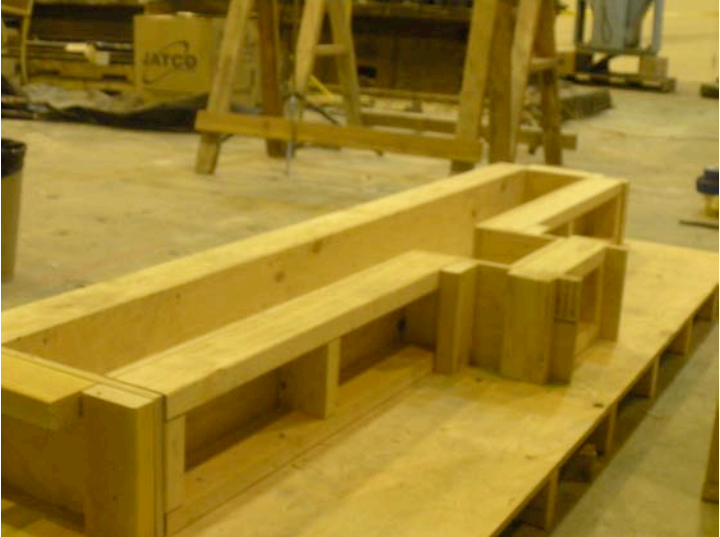
**Figure 3.11: Concrete form for the column & transverse beam**

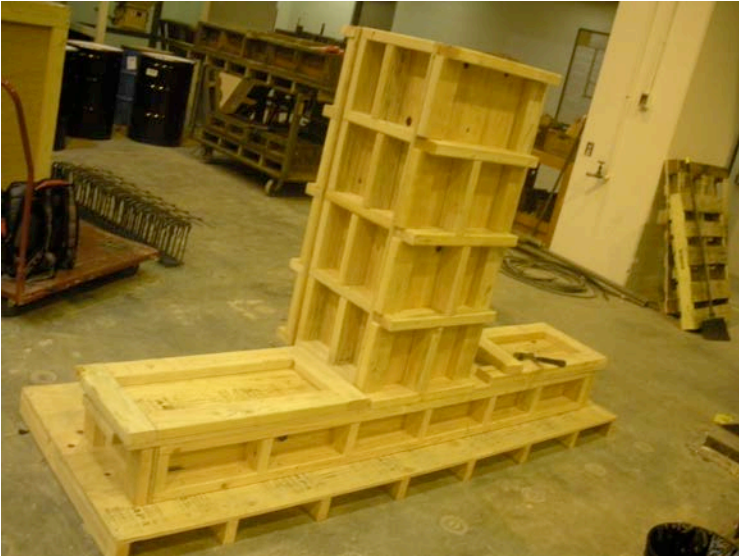
and 2 more in the center of the joint on the free side of the column facing apposite to the transverse beam, to allow for the placement of shear devices. A picture of the longitudinal beam form is displayed in Figure 3.10. Figure 3.11 shows the concrete form for the column and the transverse beam. The concrete form for the assembly is display below in figure 3.12.

**Figure 3.12: Concrete form for the beam column specimen**

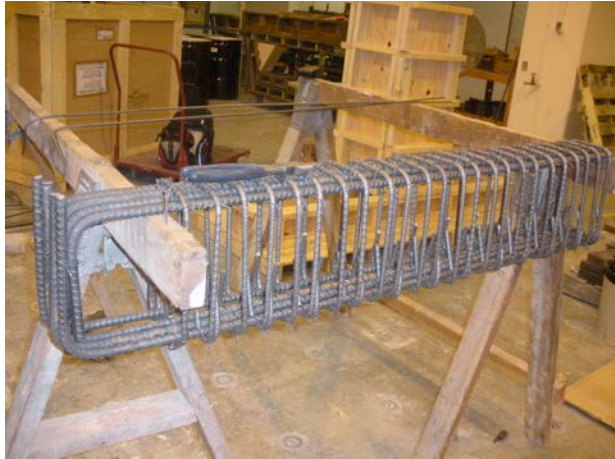
The longitudinal beam together with the slab reinforcing cage was built separately from the column and once they were assembled together the transverse beam's reinforcing was added.

Figure 3.13: Longitudinal beam reinforcement

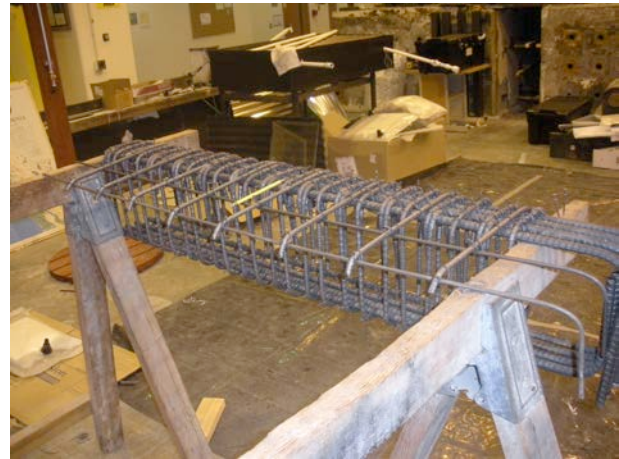
Figure 3.14: Longitudinal beam & slab reinforcement

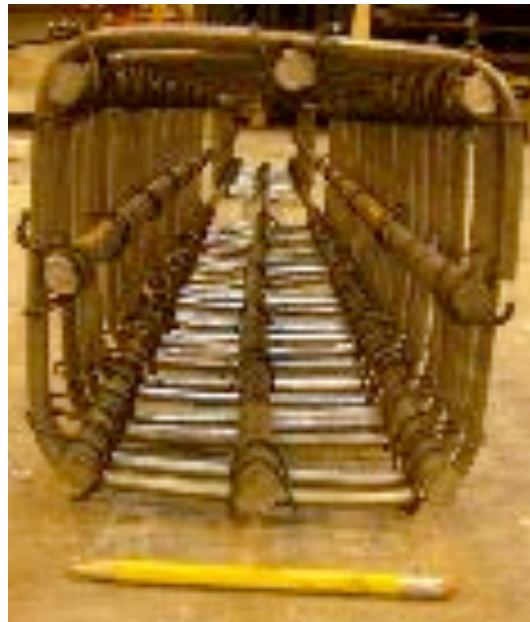
Figure 3.16: Joint reinforcement

The hoops in the column were arranged so that the bent end alternated in all four corners.

However, the bent ends in the beam's stirrups only alternated between the two top (side of the slab) corners. This was done in a consistency manner to better simulate construction practice for older buildings.

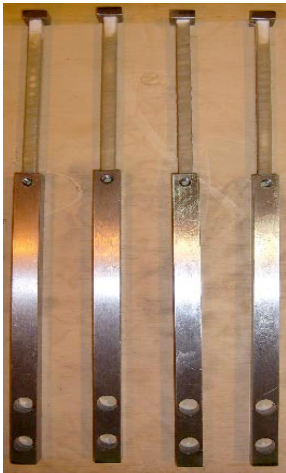
There were four shear devices fabricated and were used to attach displacement transducers. Two of them were installed vertically beneath the center of joint and the other two were placed horizontally on the side of the joint. The devices were made of modified 1/2" thick square stock covered in Teflon tape to prevent concrete confinement. The bottom part was surrounded with foam and it was placed into a 1" diameter tube to provide room for the devices to move freely during joint deformation. Figure 3.17, 3.18 and 3.19 show the four shear devices before being installed, the two devices on the bottom of the joint and the side of the joint shear devices respectively.

**Figure 3.17: Shear devices**

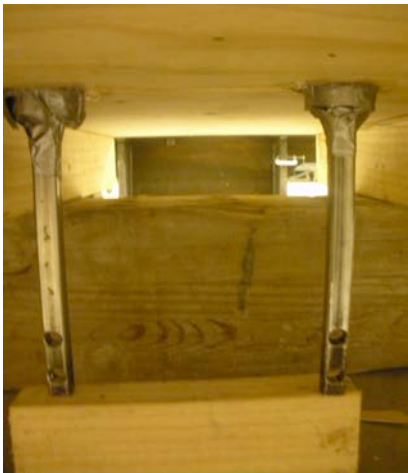
**Figure 3.18: Bottom of joint shear devices**

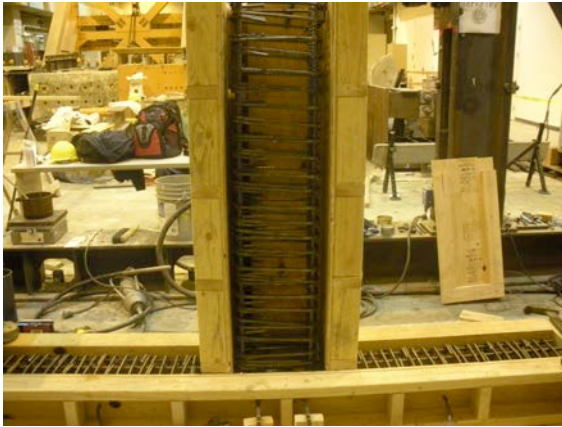
**Figure 3.21: Unit before casting**

While casting a high-frequency vibrator was used to ensure that the concrete fills the entire form. An anchor was placed on top of the beams to allow for a more adequate transportation of the specimen. Workability of the concrete was measured using the slump test which indicated a value of 8".

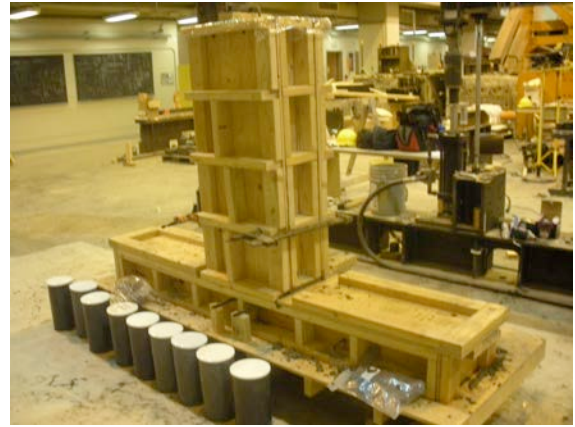
**Figure 3.22: Unit and cylinders after casting**

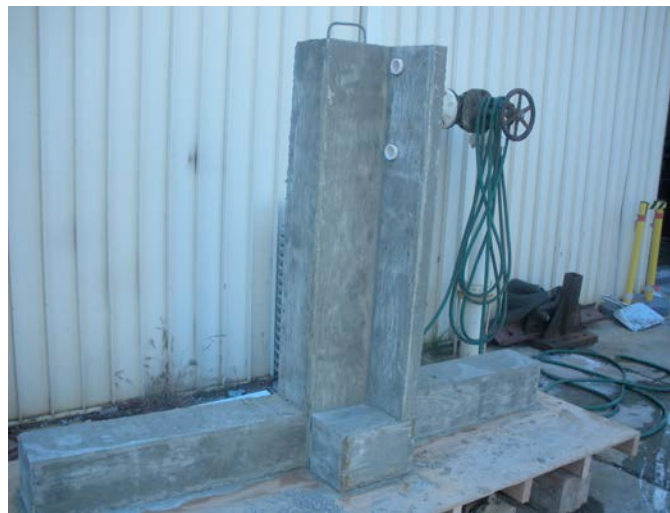
**Figure 3.23: Specimen after removing the form**

After removing the form it was noted that some rock pockets were formed in the slab near the column. These packets were patched using quick drying cement. After patching the specimen, it

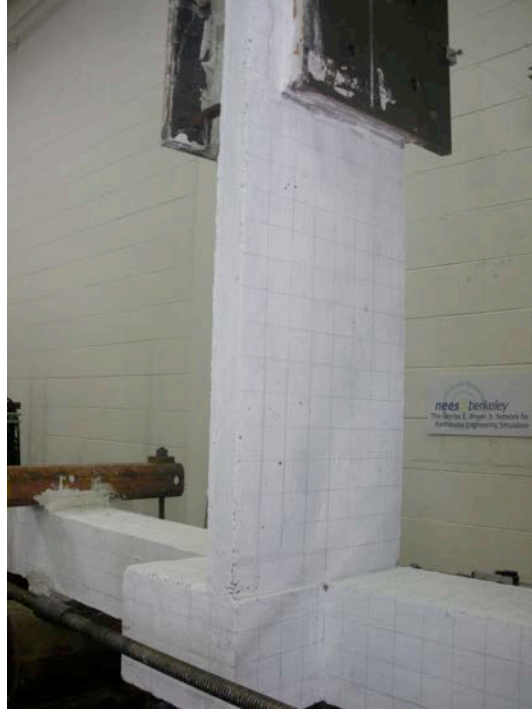
was painted and a grid was drawn. Spacing between each grid was 50 mm, dividing the column width into four divisions. Figure 3.24 shows the grid lines on the specimen.

**Figure 3.24: Grid lines on the specimen**

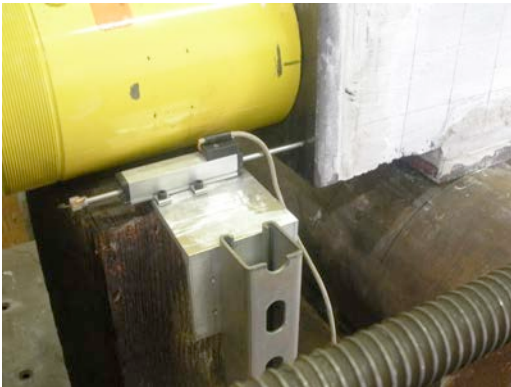
Ten displacement transducers were installed on the specimen to monitor movement during testing. Two displacement transducers were attached to each side of one end of the column to measure the column in-plane movement and two load cells to measure the column's axial compressive load (see Figure 4.1 and 4.2). Two displacement transducers were attached to the shear devices on the bottom of the joint and two more to the devices on the side of the joint to measure the joint's shear strain (see Figure 4.3 and 4.4). The displacement of the beam in the direction of loading was measured by a displacement transducer attached to the plate on the side of the beam (see Figure 4.5 and 4.6). Another displacement transducer was attached to the loading plate on the side of the column onto the wall perpendicular to the direction of loading to measure out-of-plane motion (see Figure 4.7).

**Figure 4.1: Displacement transducer-columncolumn in-plane movement**

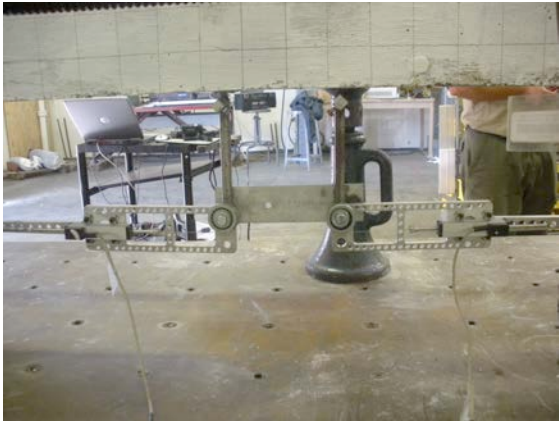
**Figure 4.3: Displacement transducers- shear strain on bottom of joint**

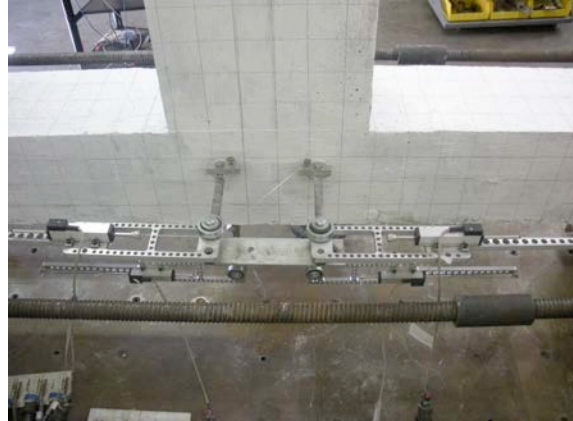
**Figure 4.4: Displacement transducers- shear strain on side of joint**

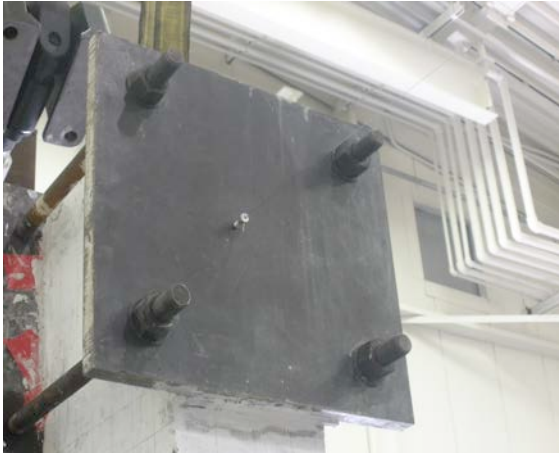
**Figure 4.5: Target for beam in direction of loading displacement transducers**

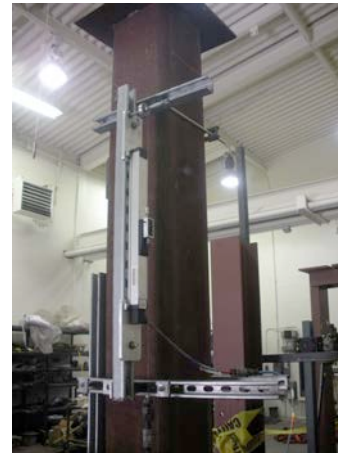
**Figure 4.6: Displacement transducers- beam in direction of loading**

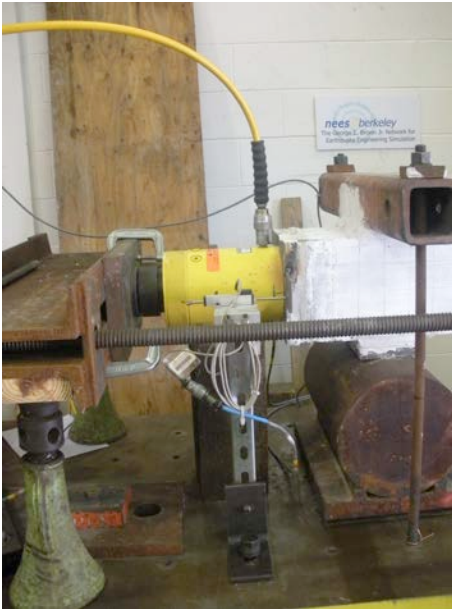
The column was supported by two 12” diameter steel rollers on each end to simulate point of contraflexure. Two hollow square sections were attached on top of the column, directly above the rollers, using four thread rods to secure the column on top of the rollers. The column was subjected to a constant axial load of 20% of its axial capacity. This axial compressive force was produced using a manual hydraulic pump and it was transferred to the column using two, parallel to the column, steel rods (Figure 4.9 and 4.10). The rods spanned from a hollow steel section attached to the frame on one side to a two welded together channels on the other side. Two 1” thick steel square plates were placed on each side between the column and the sections to prevent local yielding. The pressure was measured using two load cells, one on each steel rod (Figure 4.11).

Figure 4.9: Compression pump

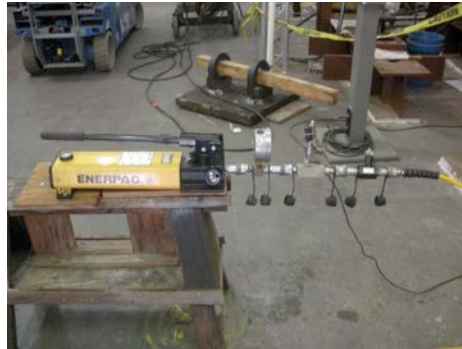
Figure 4.10: Compression pump gage

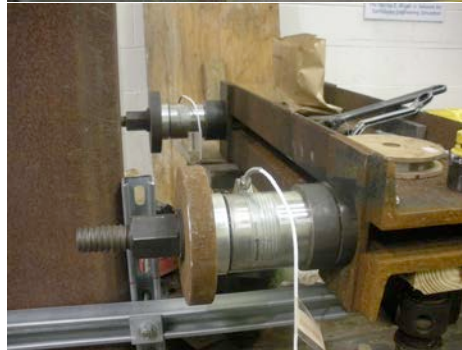
Figure 4.11: Compression measuring load cells

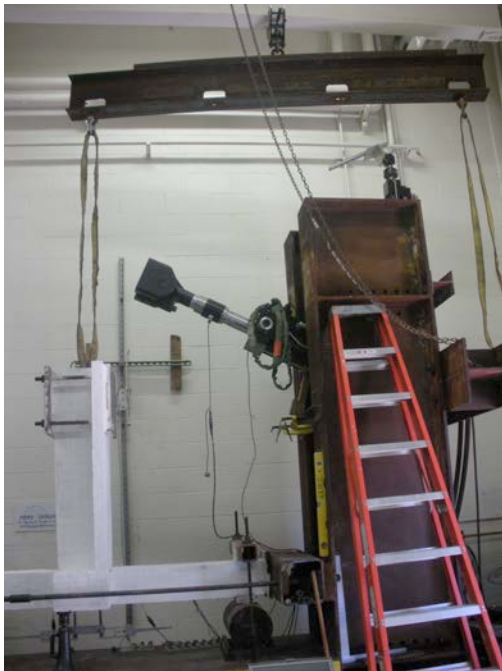
The quasi-static reverse cyclic load was applied transversely to the longitudinal beam. The load was applied on the slab side of the beam (see Figure 4.13). To prevent local yielding and to distribute the pressure one 1" thick steel plates were placed on each side of the beam. To allow for rotation, the actuator exerting this force was pinned connected to the frame. The axial compressive force on the beam coming from its own weight and the weight of the actuator was counteracted by using a balanced system. This system consisted of an elevated horizontal, attached to the roof, I-beam to which the top of the specimen's beam was attached using straps onto one side while heavy lead was suspended from the other end of the I-beam (see Figure 4.12). This system was implemented to test under a more realistic scenario.

**Figure 4.12: Balance system**

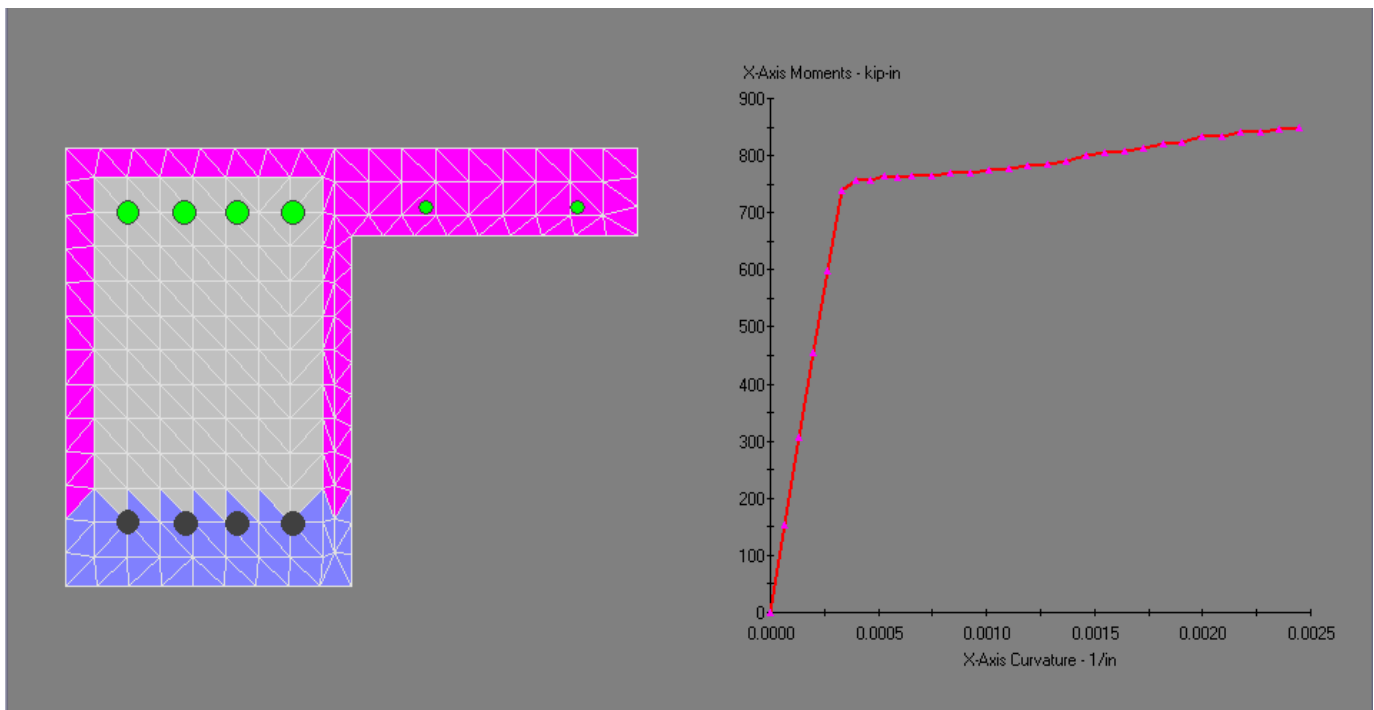
The shear capacity was calculated before testing of the specimen in order to anticipate joint shear failure. The shear yielding capacities for the beam and joint due to the transverse force on the beam were calculated using XTRACT a cross-section analysis computer software. From the XTRACT results the beam's yielding moment capacity is approximately 730 kip-in as shown in Figure 5.1. This means that the yielding transverse load is approximately 15.45 kips.

Figure 5.1: XTRACT output of beam's moment capacity

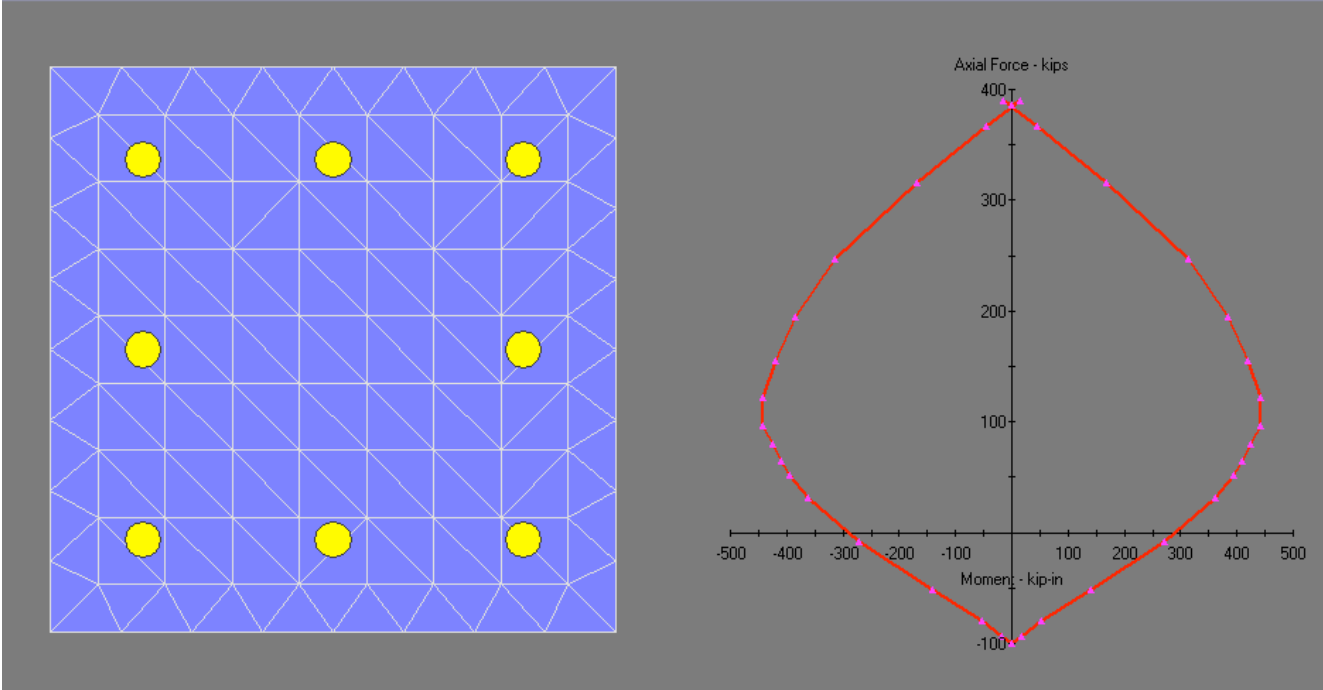
Figure 5.2 illustrates the columns interaction diagram. It shows that at a constant compressive force of 50 kips, the maximum moment capacity is approximately 370 kip-in. The column's moment capacity XTRACT output in Figure 2.3 shows that the yielding moment in the column is

Figure 5.2: XTRACT output of column's interaction diagram

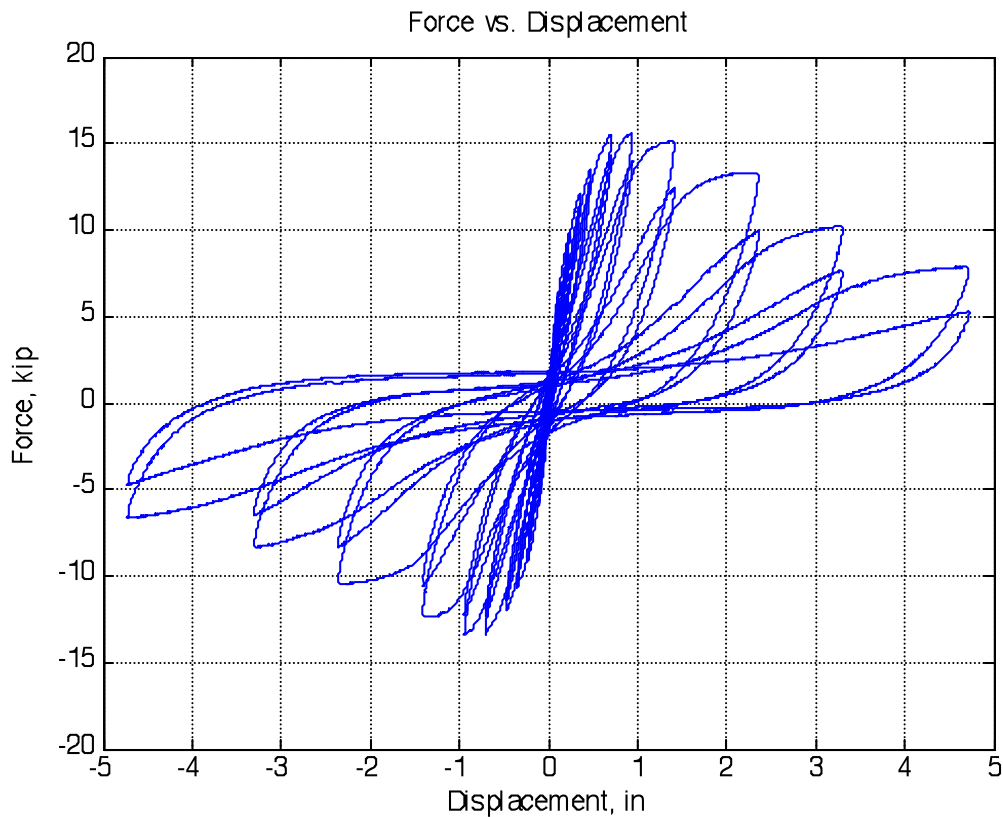
The transverse applied beam load versus beam lateral displacement is shown in Figure 5.4.

The horizontal axis shows the displacement while the vertical axis shows the applied load.

It should be noted that a positive displacement indicates tension in the slab side of the beam while a negative displacement indicates compression in the slab side of the beam.

The maximum

**Figure 5.4: Applied force vs. Displacement**

positive force applied on the beam was 15.59 kips and it occurred during the 2% drift.

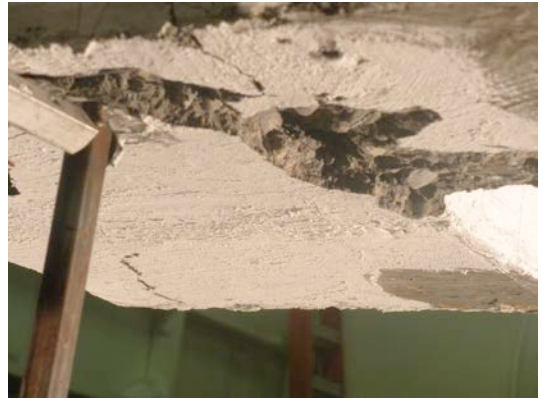
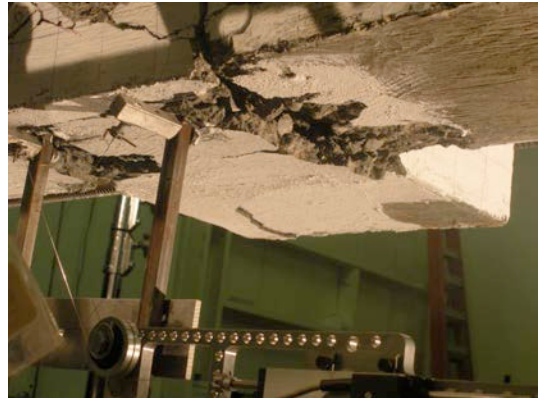
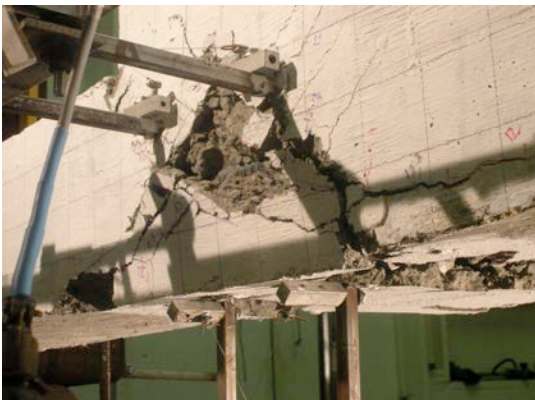
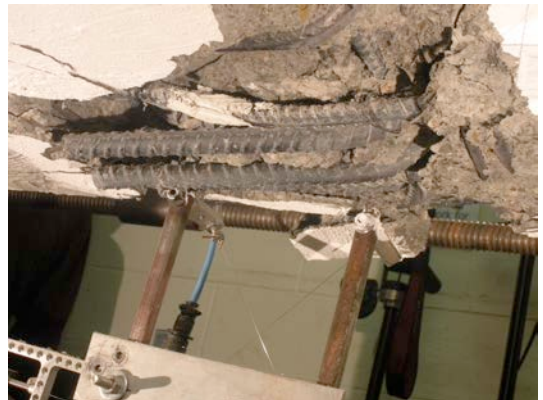
Figure 5.6 shows damage progression of the joint from the first signs of cracking to significant spalling and ending with joint failure.

Figure 5.6: Damage progression leading to collapse

The results acquired from this experiment show that the primary mode of failure is in the joint with significant spalling in the exterior face located behind the transverse beam. After comparing the results with M. Barnes et al. exterior joint results, it was found that the corner joint was weaker than the exterior joint.

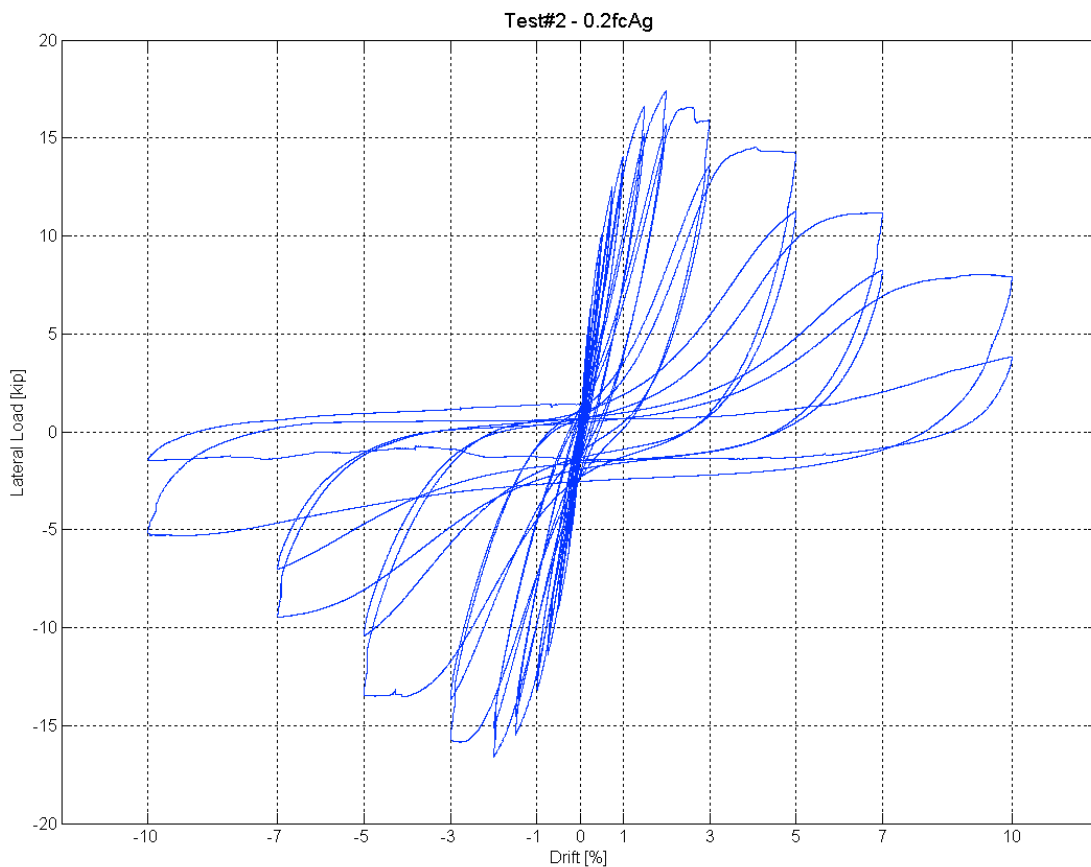
Figure 5.7 shows the lateral load applied versus drift for an exterior joint with similar detailing and subjected to the same constant compression force as the one studied in this research. The seismic performance of the exterior joint was done by M. Barnes et al. From this graph it is noted that the maximum load in the positive direction occurred at a drift ratio of 1.5% with a value of 17.5 kips; in the negative direction, the maximum load occurred at a drift of 2% with a value of 16.5 kips.

**Figure 5.7: Exterior joint Force vs. Drift by M. Barnes et al.**

It seems that the exterior joint is more resistant to displacements as indicated by the higher beam applied force. Although the strength for the exterior joint is initially higher and the stiffness greater, both the strength and stiffness degrade faster and eventually, at 10% drift, becomes weaker than the corner joint. Figure 5.8 shows the envelop curve for the corner joint.

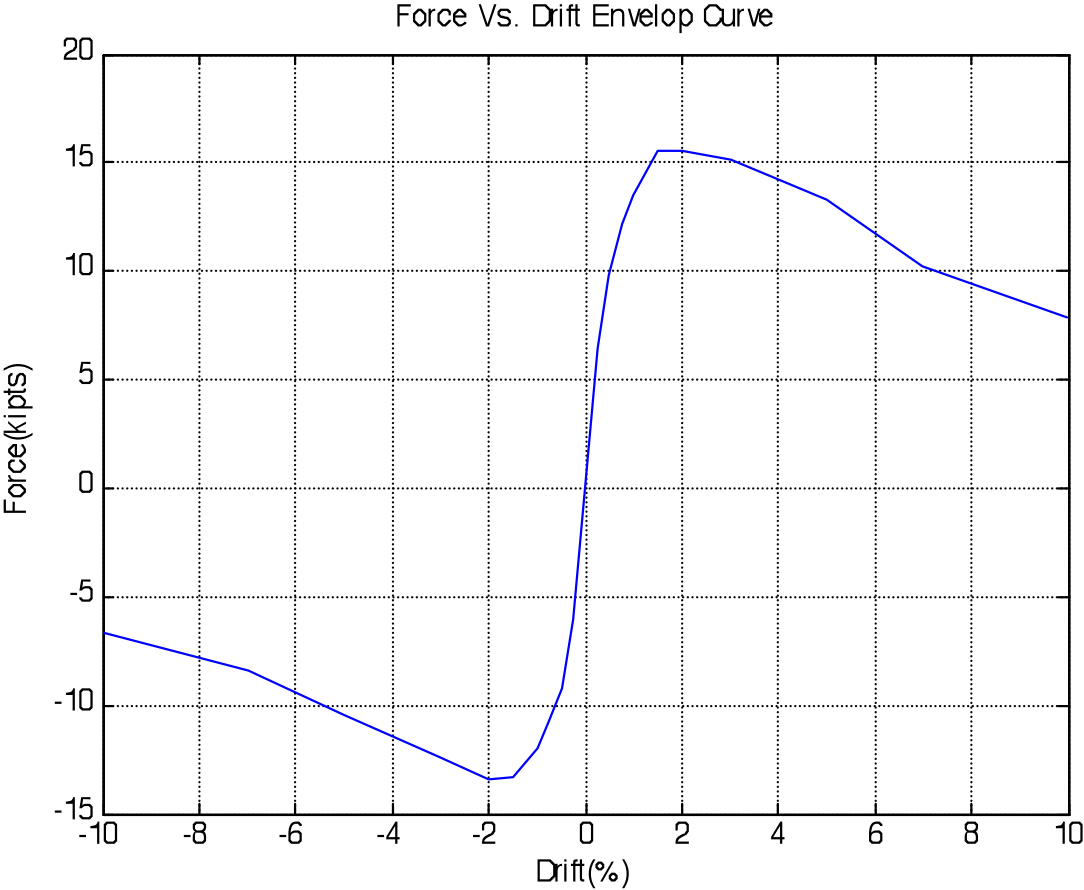
**Figure 5.8: Corner joint Envelop Curve**
