A (Brief) Survey of Structures Affected by Surface Fault Rupture

PEER SURFACE FAULT DISPLACEMENT HAZARD WORKSHOP

Timothy Dawson

California Geological Survey

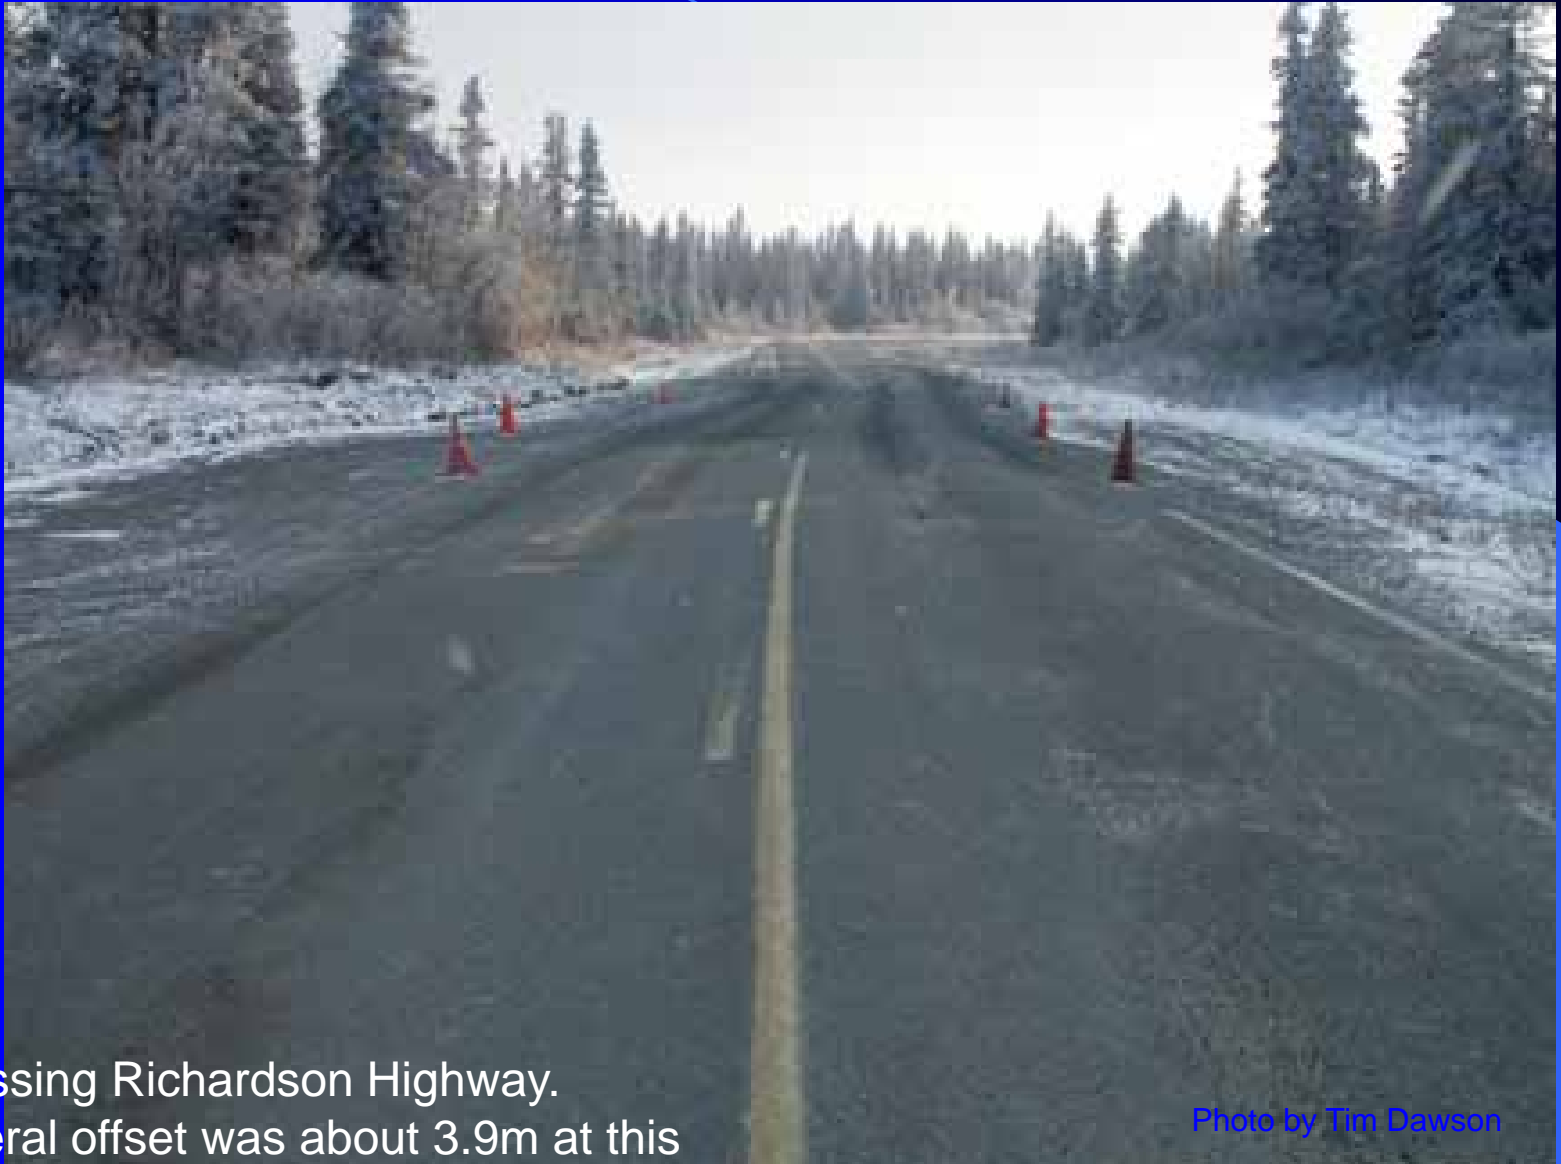
Offset Roads

Fault crossing Richardson Highway.
Right-lateral offset was about 3.9m at this
location
