Measurements of Lateral Spread Using a Real Time Kinematic Global Positioning System

Project No. F-2001-OR-05 65-680422
Continuous GPS: Pilot Applications
Phase II

This report presents deformation measurements collected during two full-scale lateral spread tests in Japan using a networked Real-Time Kinematic Global Positioning System (RTK-GPS).

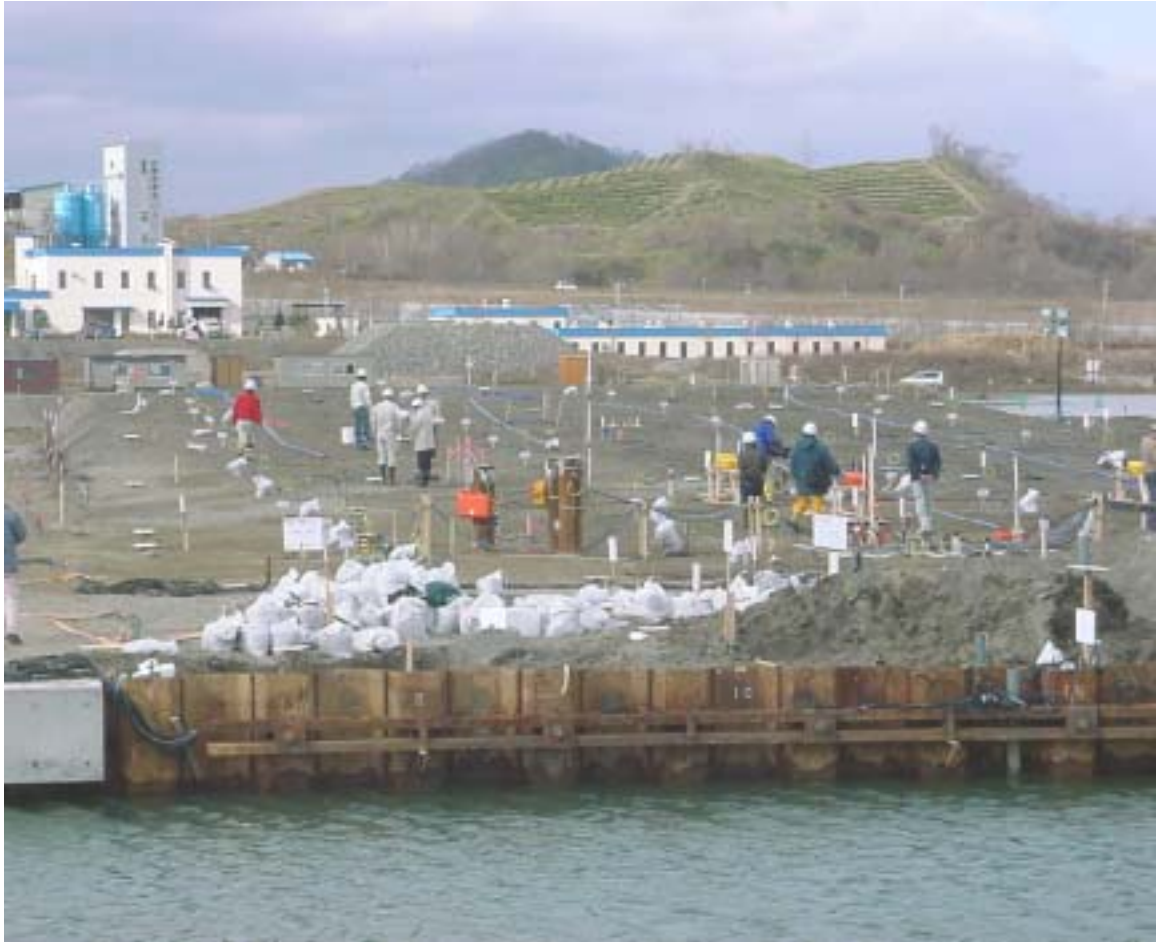
Figure 2 – November 2001 test site.

For the first test in November 2001, the test site was comprised of an area approximately 25m wide by 100m long. One end of the site was bordered by a large waterway with the soil retained by a quay wall as shown in Figure 2. Moving away from the water, the ground surface sloped gently upwards such that the other end of the site was approximately 2.00m higher. The ground surface elevation near the sea wall was +3.00m, and the ground surface elevation at the top of the slope was +5.00m. The waterway elevation fluctuated throughout the day, as did the groundwater elevation, between 0.00m and +1.50m as a result of the proximity to the Pacific Ocean. The entire test area was surrounded by sheet piling installed to tip elevation -5.00m Figure 3 shows the site layout.

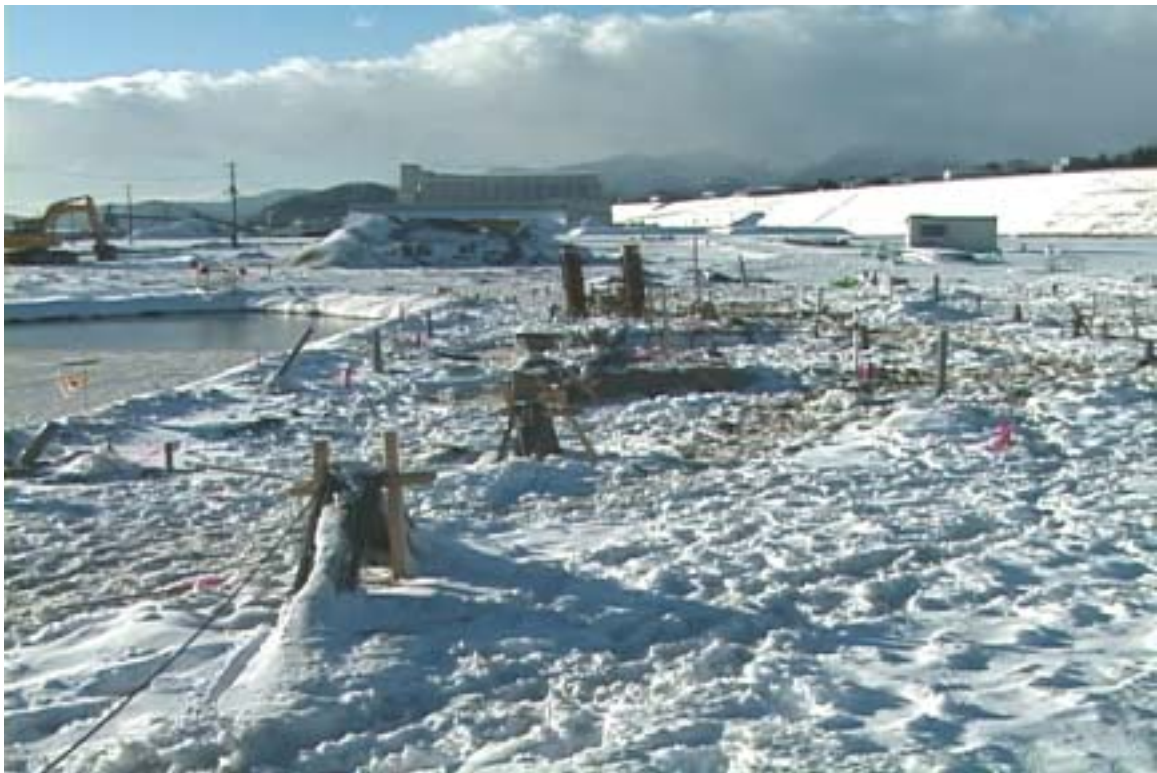
Figure 4 – December 2001 test site.

For the second test in December 2001, the test site was significantly modified in an attempt to induce additional ground deformations. The quay walls and perimeter sheet piling installed as part of the first test were removed, since they tended to impede displacements. Additionally, the test site was regraded to create a steeper slope as shown in Figures 4 and 5.

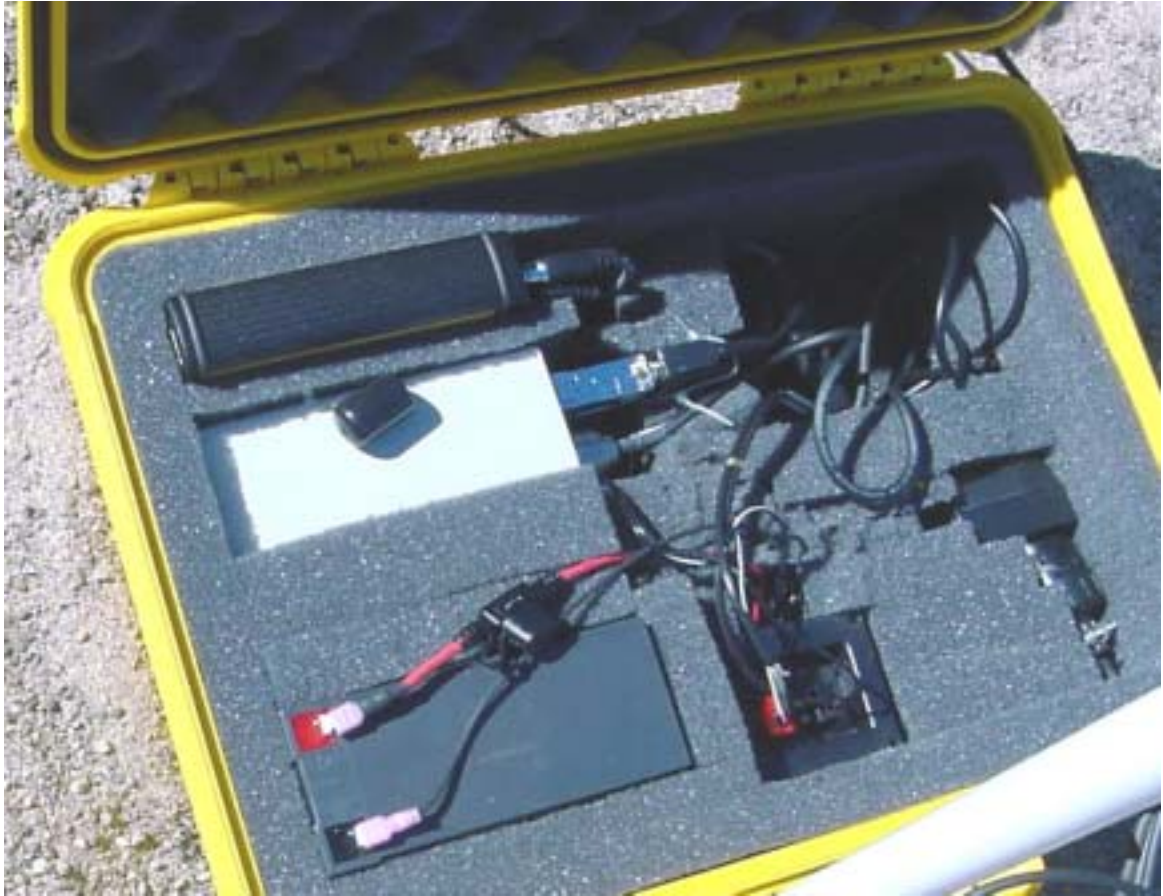
Figure 6 – Equipment enclosure housing the GPS receiver, wireless equipment, and backup power system

A total of twelve GPS units were deployed for the tests. Two of the units served as reference base stations at an offsite monitoring center. The ten remaining units were deployed throughout the site to measure movements of the ground surface, pile foundations, and pipelines. Each of the ten field units were comprised of a GPS receiver and antenna, wireless data transceiver and antenna, and battery backup power system. The equipment was packaged in small weatherproof enclosures to which the GPS and wireless transceiver antennas were attached as shown in Figure 6. The components of a typical field unit consisting of the equipment enclosure, wireless transceiver antenna, and GPS antenna are shown in Figure 7.

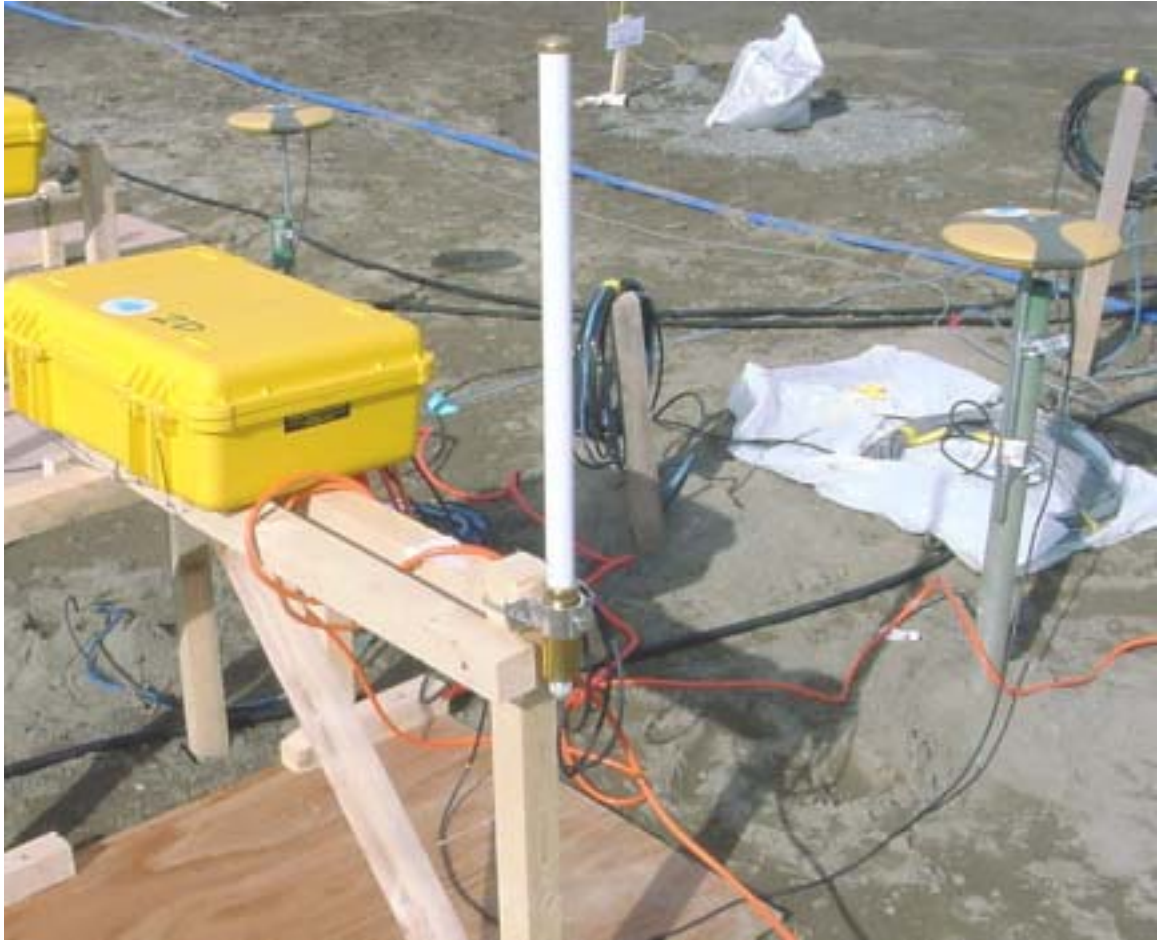
Figure 7 – Typical field unit with equipment enclosure (left), wireless transceiver antenna (center), and GPS antenna (right).

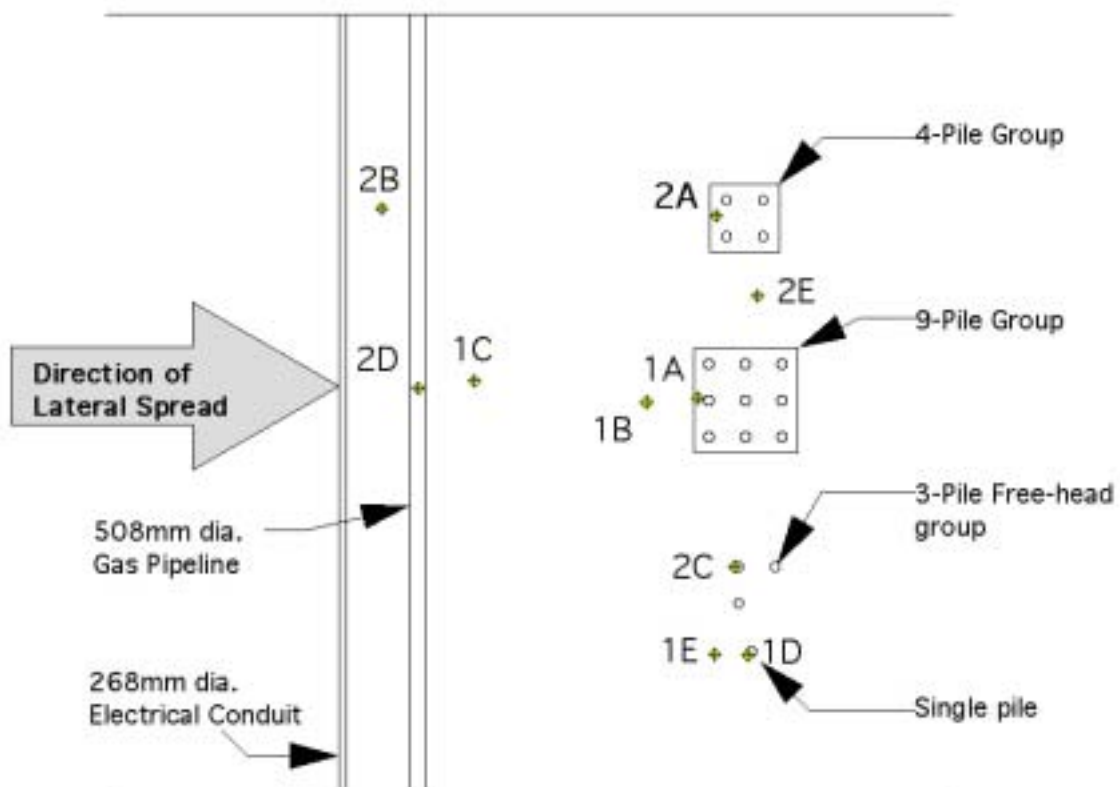
Figure 9 – Layout of GPS field units for December 2001 test

The locations of the GPS field units are summarized in Tables 1 and 2, and Figures 8 and 9, for the November and December tests, respectively. The layouts for both tests were identical with the exception of the location of Unit 2E.

GPS Unit Desig.	Location of GPS Antenna
1A	Mounted to concrete pile cap for 9-pile group
1B	Mounted directly to top of slope inclinometer casing, ~1.5m in front of 9-pile group
1C	Mounted directly to top of slope inclinometer casing, ~7.2m in front of 9-pile group
1D	Mounted to the top of the single pile
1E	Mounted directly to top of slope inclinometer casing, ~1.0m in front of the single pile
2A	Mounted to concrete pile cap for 4-pile group
2B	Mounted directly to top of slope inclinometer casing, ~10.8m in front of 4-pile group
2C	Mounted to the top of the leading pile in the 3-pile free-headed pile group.
2D	Mounted to a vertical post affixed to the gas pipeline
2E	Mounted directly to top of slope inclinometer casing, between 4-pile and 9-pile groups

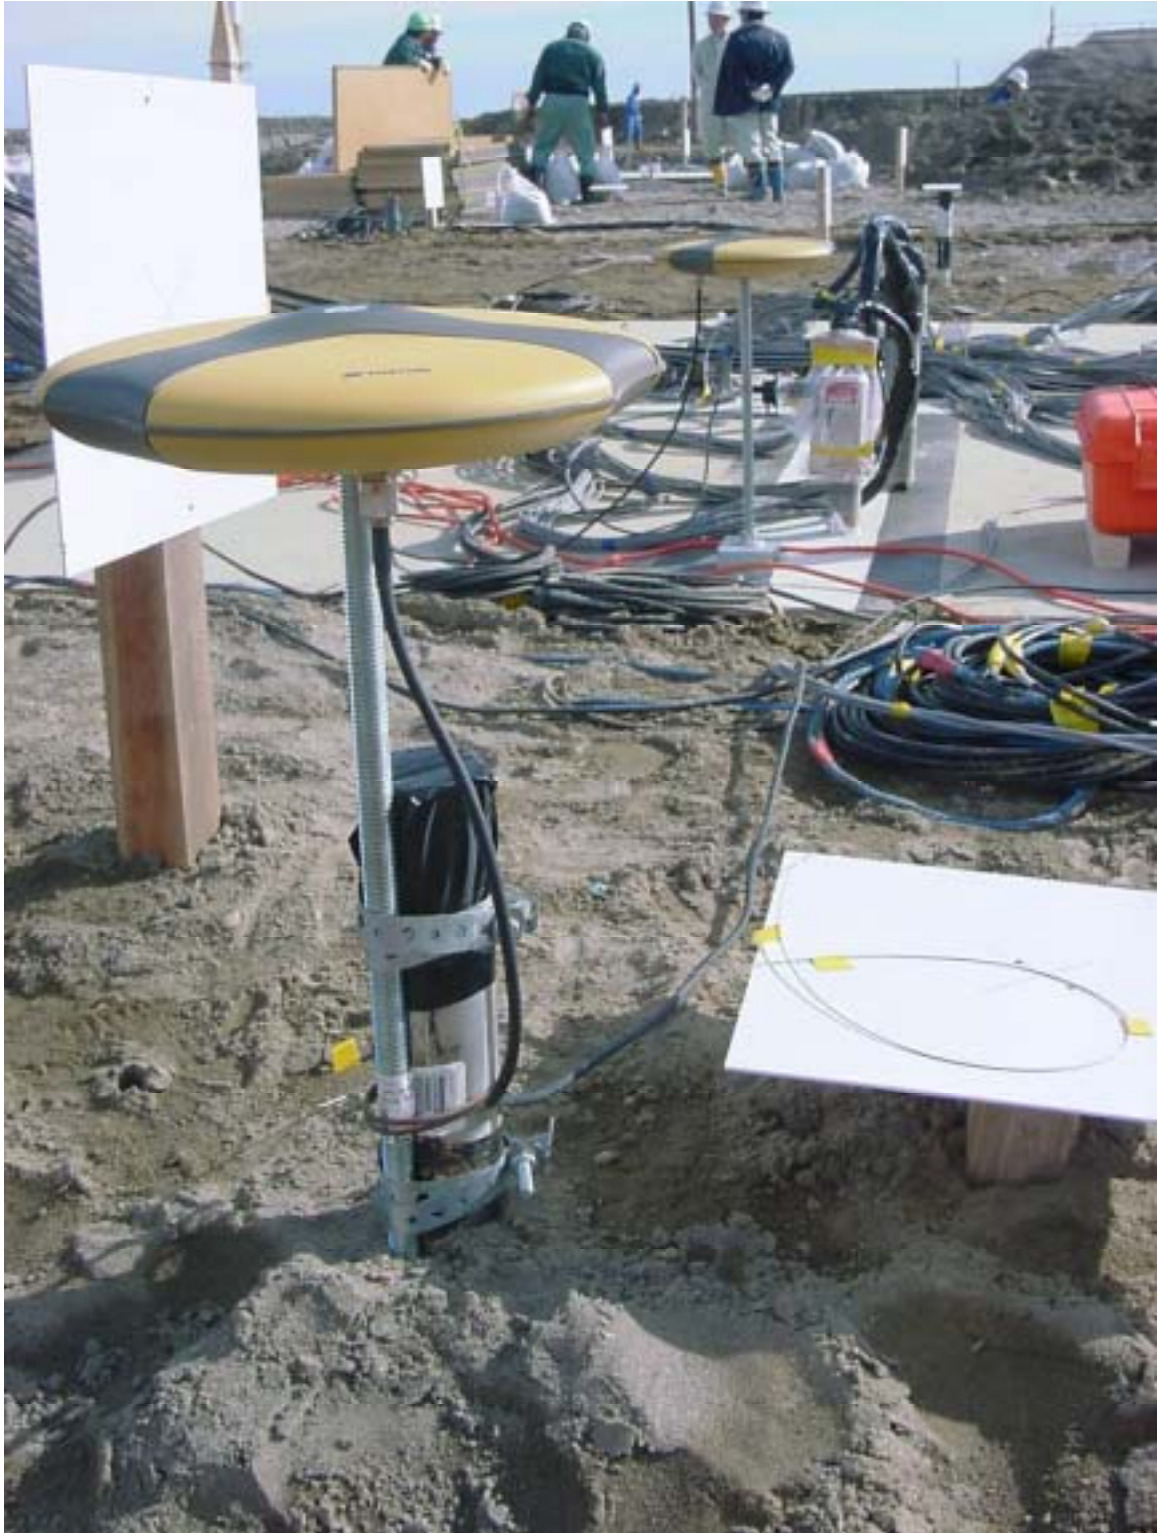
Figure 11 – Units 1A and 1B, November Test

The GPS receiver, wireless communications, and power components for Units 1A and 1B were housed in a weatherproof enclosures which were then secured to the pile cap for the 9-pile group. Photos of the installation of Units 1A and 1B for the November test are shown in Figures 11 and 12. A photo of Unit 1A for the December test is shown in Figure 13.

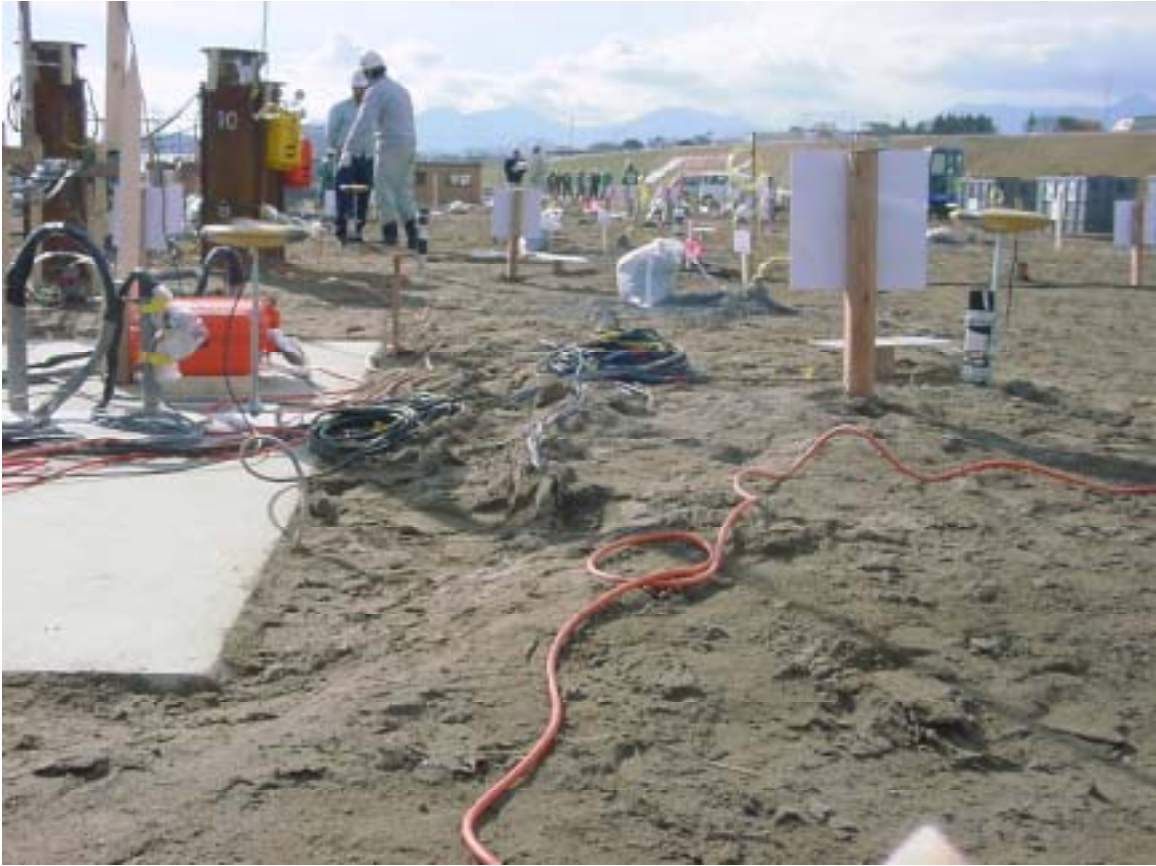
Figure 12 – Units 1A and 1B, November Test

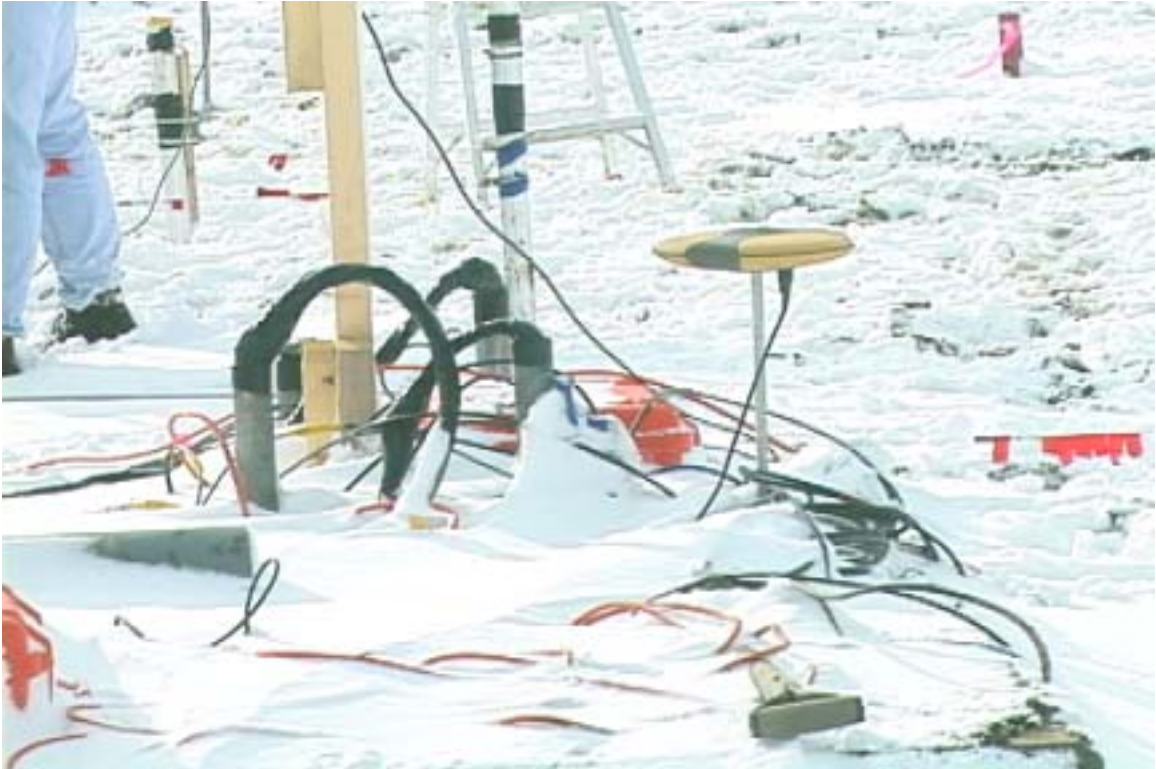
Figure 13 – Unit 1A, December Test

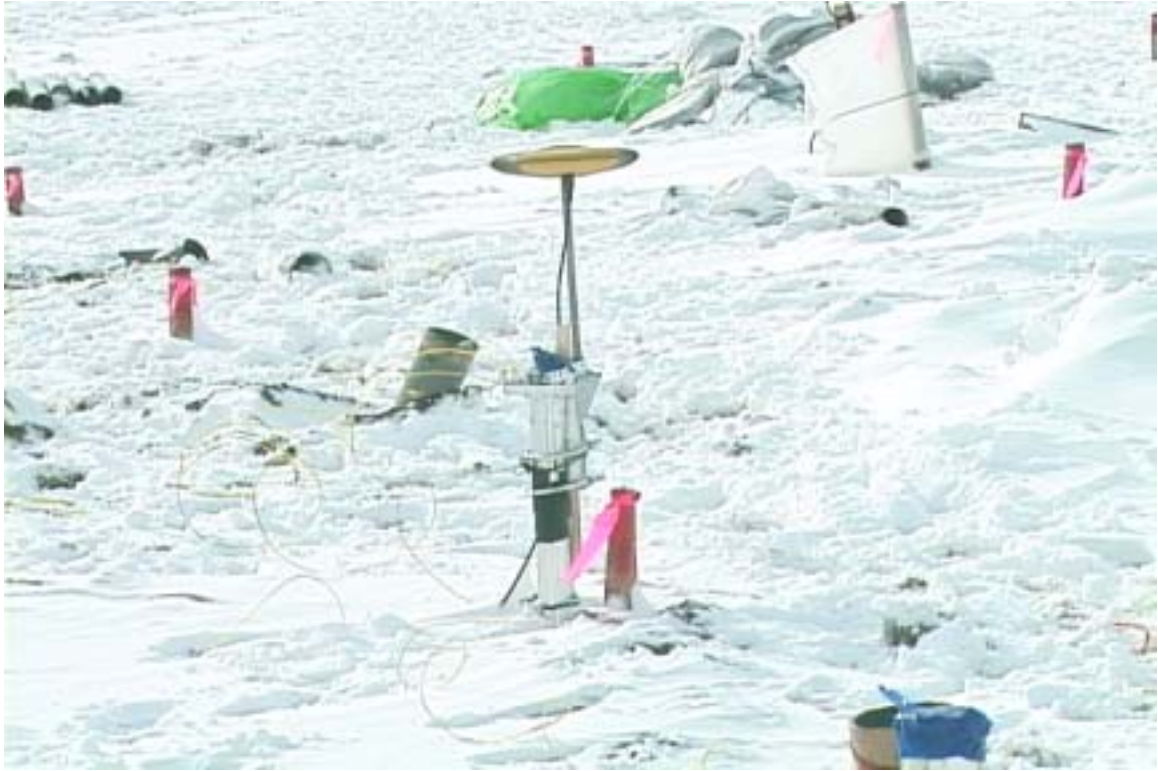
Figure 15 – Unit 1C, December test

For the December test, the raft was not used, and the GPS antenna was located on top of the slope inclinometer casing as shown in Figure 15. The antenna was mounted on to a threaded rod which was attached to the inclinometer casing. The mid-height of the antenna was positioned 79.5cm above the elevation of the surface of the pile cap. Details of both the November and December installation of Unit 1C are shown in Figure 10.

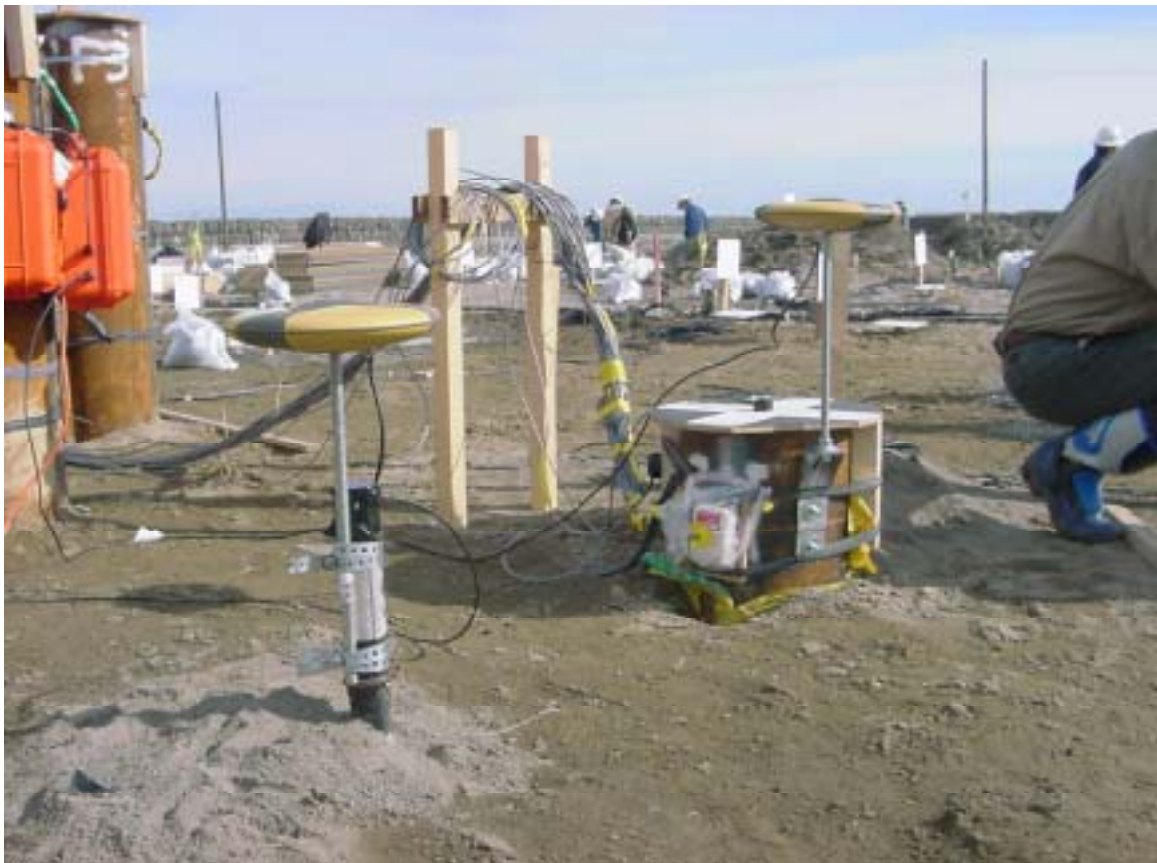
Figure 17 – Units 1D and 1E, November test

The GPS receiver, wireless communications, and power components for Units 1D, 1E, and 2C were housed in a weatherproof enclosures which were attached by wire to the piles. Photos of the installation of Units 1D, 1E, and 2C are shown in Figures 17 and 18.

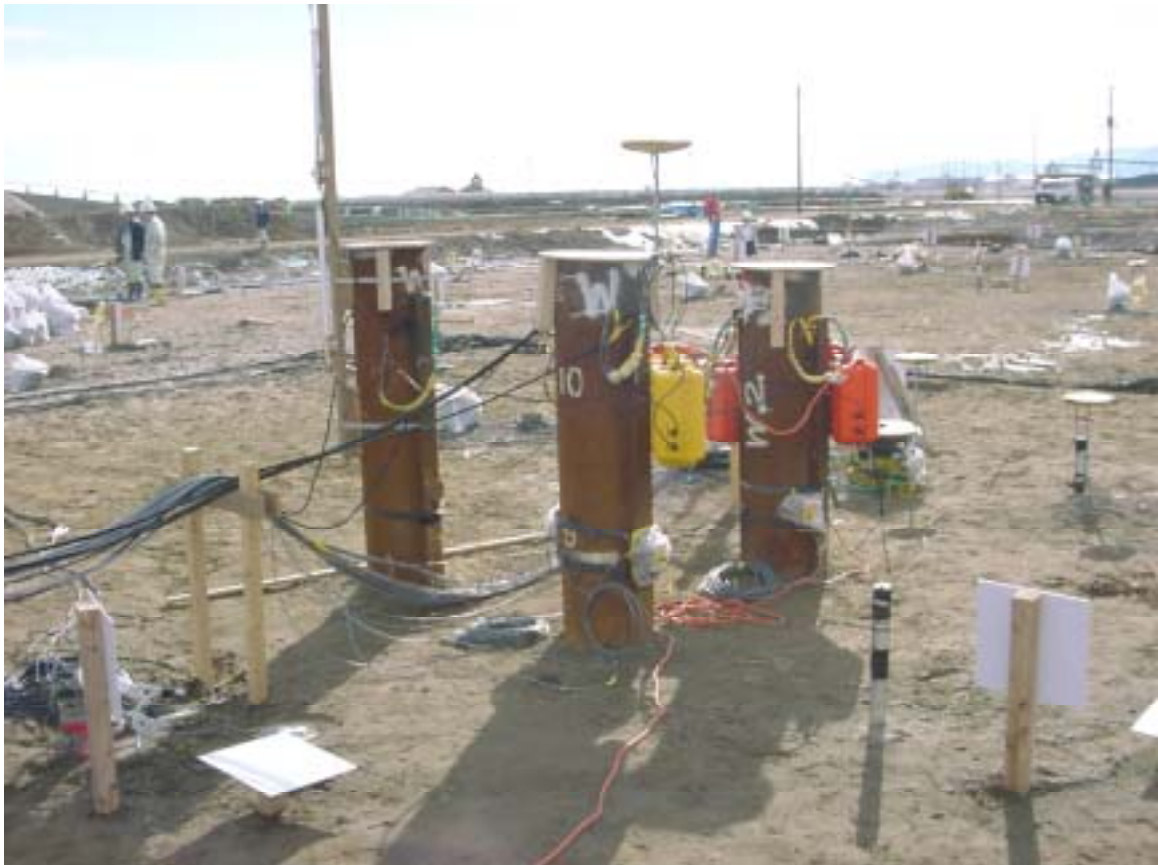
Figure 18 – Units 1D, 1E, and 2C, November test

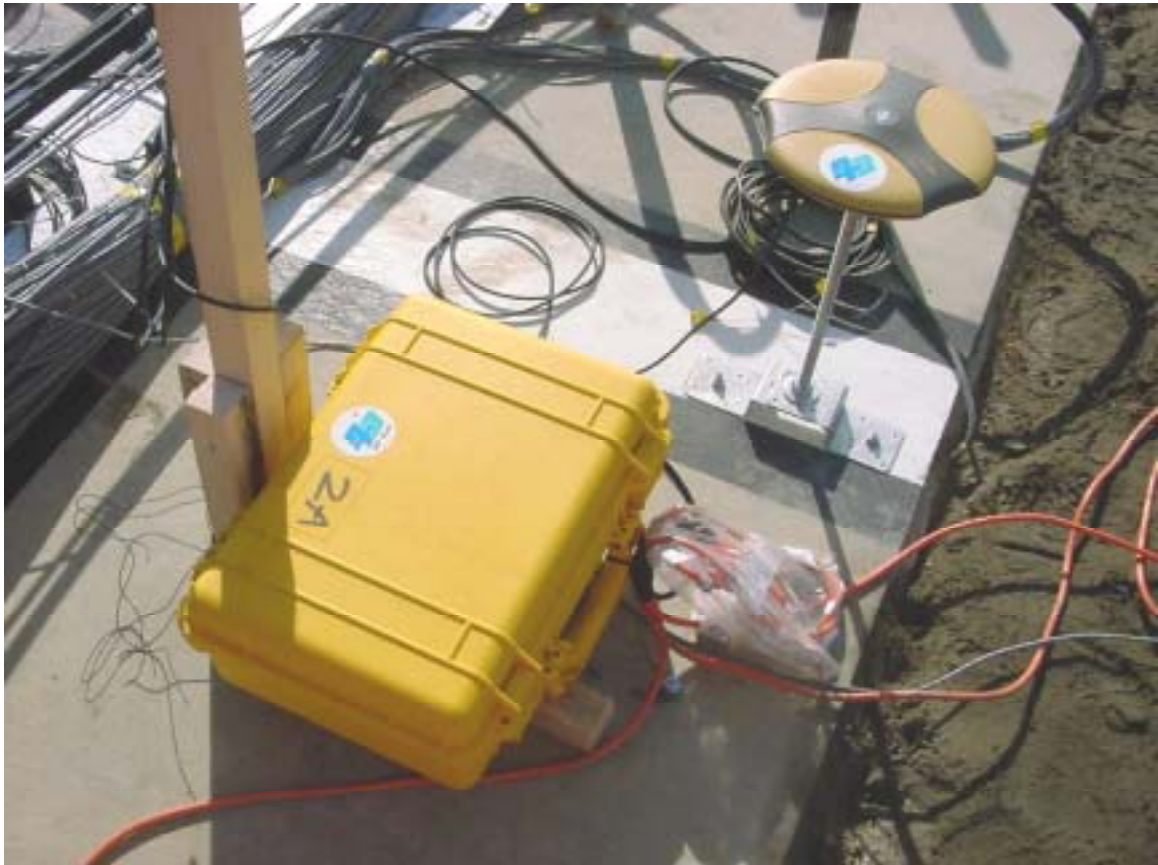
Figure 20 – Unit 2A

Similar to the installation on the 9-pile cap, the GPS antenna for the 4-pile group cap was mounted to the top concrete surface using steel brackets and threaded rod, and the equipment enclosure was secured to the pile cap. A photo of the installation is shown in Figure 20.

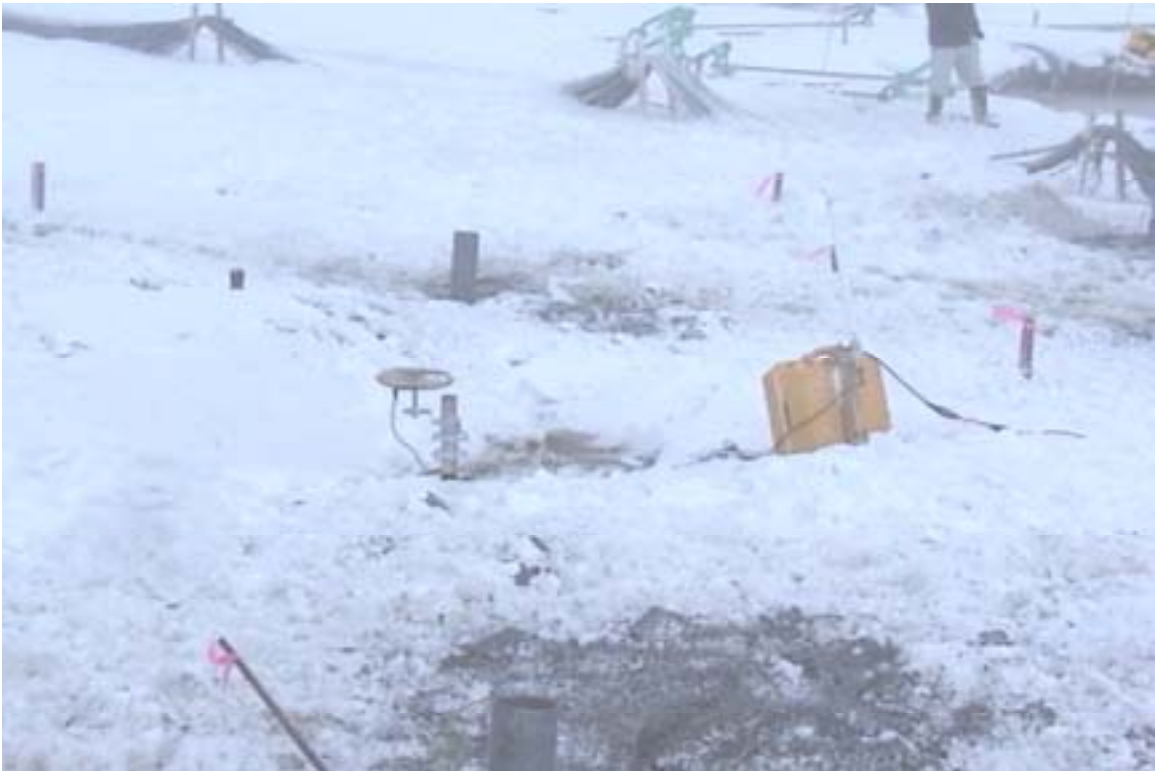
Figure 22 – Unit 2B, December Test

For the December test, the raft was not used, and the GPS antenna was mounted directly to the top of the slope inclinometer casing as shown in Figure 22. The mid-height of the antenna was positioned 79.5cm above the elevation of the surface of the pile cap.

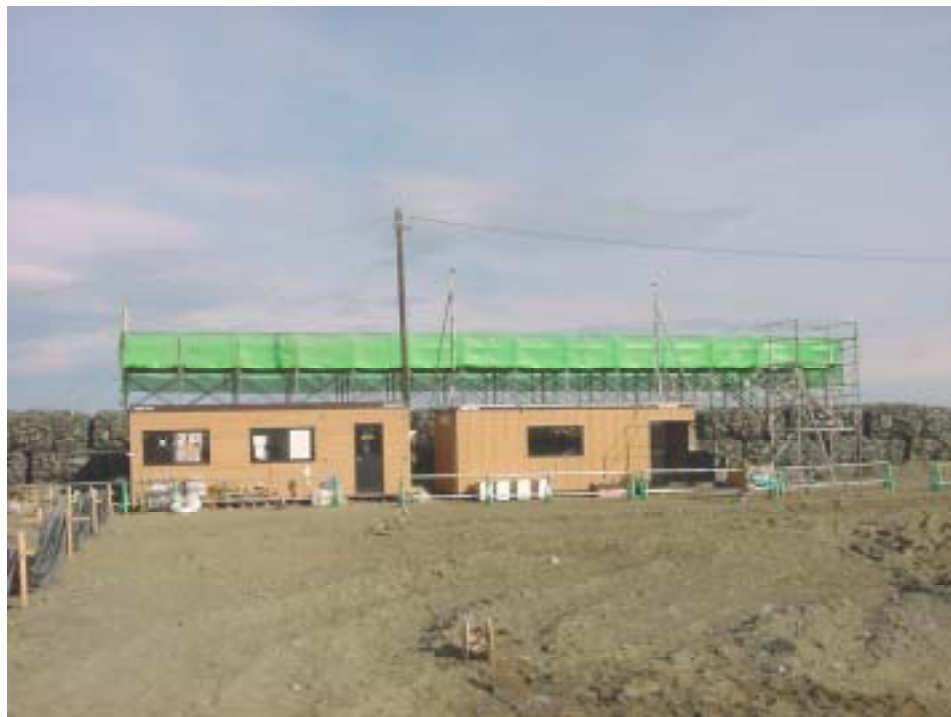
Figure 26 – Monitoring center trailer

A monitoring center was established approximately 100m away from the blast zone in a temporary trailer office. The monitoring center provided a safe offsite environment for Caltrans staff to observe the test during blasting while monitoring the processing status of the GPS field units. A photo of the monitoring center is shown in Figure 26.

The GPS antennas for the two base stations were mounted to the tops of steel poles affixed to the roof of the trailer. This location was chosen to limit potential multipath and line-of-sight errors resulting from nearby steel scaffolding. Additional guy wires and bracing were used to stabilize the poles from wind and other vibration sources. The antennas for the wireless transceivers were also mounted to the pole and provided good line-of-sight with the field units.

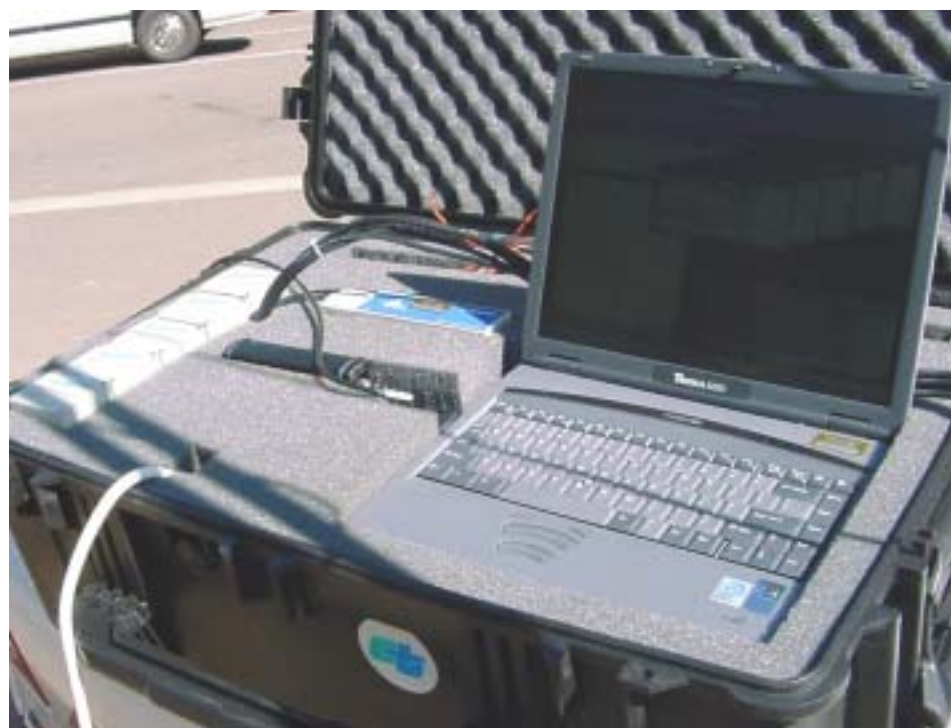
Figure 27 – Monitoring center unit

Two base stations were utilized to process the data from the ten field units. Each base station unit was comprised of a GPS receiver and antenna, five wireless data transceivers, and a laptop computer with the RTK-GPS processing software. These components were packaged in a large weatherproof enclosure as shown in Figure 27. A single base station unit could have been used to capture the data for all ten field units, however, the quantity of data recorded would have taxed the capabilities of the laptop computer. As such, two systems were used, splitting the processing and data logging tasks between them.

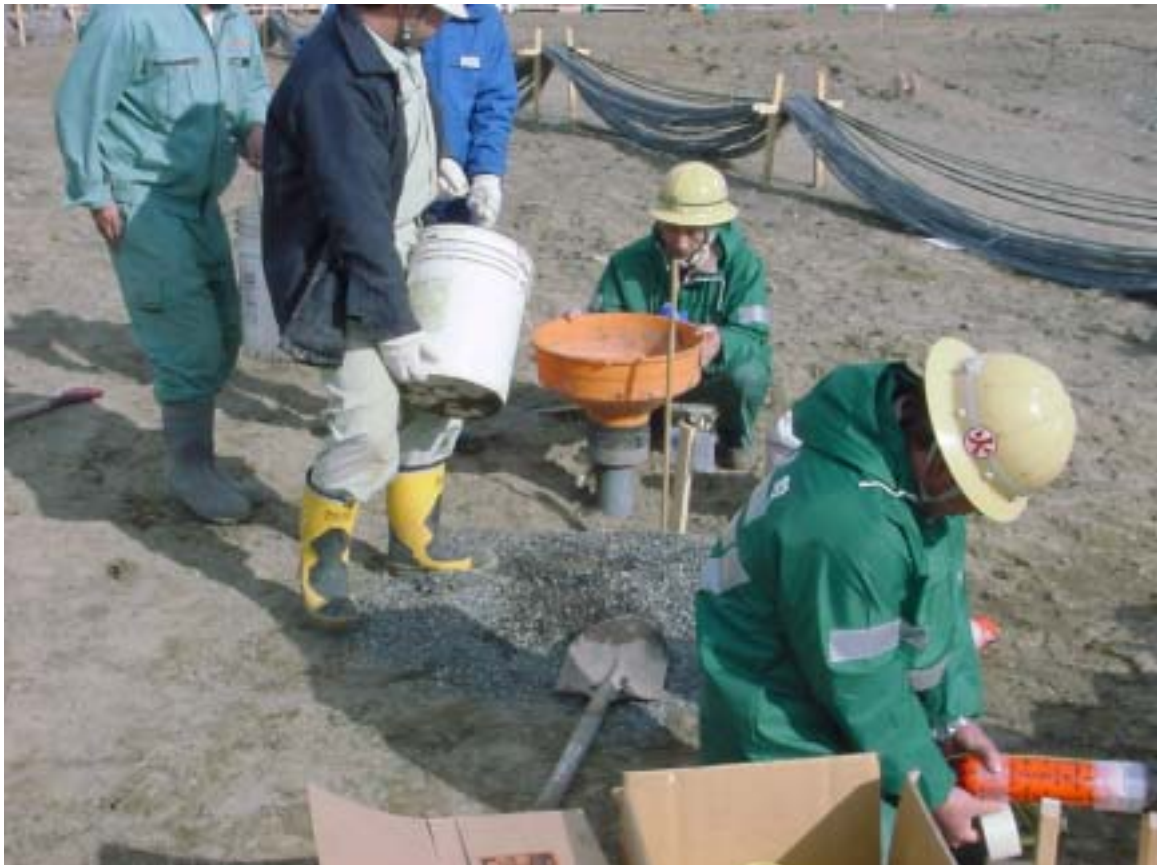
*Figure 28 – Placing explosives*

The ground deformations associated with lateral spread were created by using explosives to induce liquefaction throughout the test site. In preparation for both the November and December tests, a Japanese blasting contractor installed multiple explosives in vertically drilled holes spaced at 6.0m on centers in a regular grid pattern throughout the test site as shown in Figure 28. Two explosive charges were placed in each of the blast holes, shallow charges at elevation -0.500m and deeper charges at elevation -4.500m .

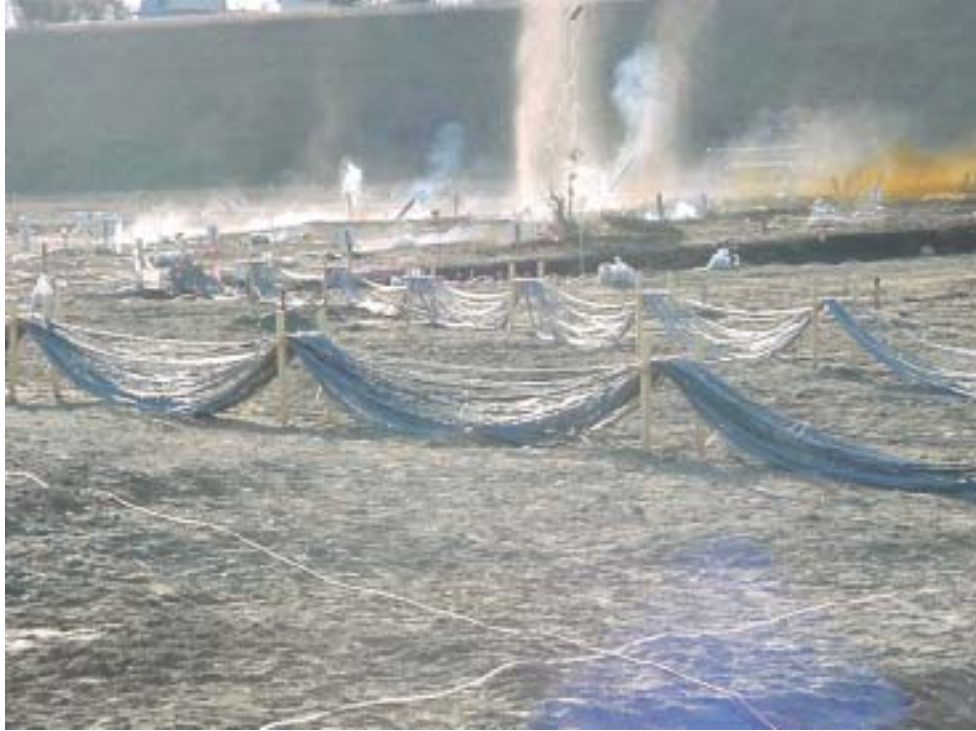
Figure 30 – Blasting underway, November Test

The primary blast sequence commenced at approximately 2:26:24.30 PM local time (192384.30 GPS time), and proceeded over a period of approximately 36 seconds. Figures 30 and 31 show photos of the site during primary blasting. The secondary explosives were detonated after roughly 6 seconds following the completion of the primary blast sequence. The tertiary explosives near the quay wall were detonated approximately 44 seconds later. Figure 32 shows a photo of the blasting near the quay wall.

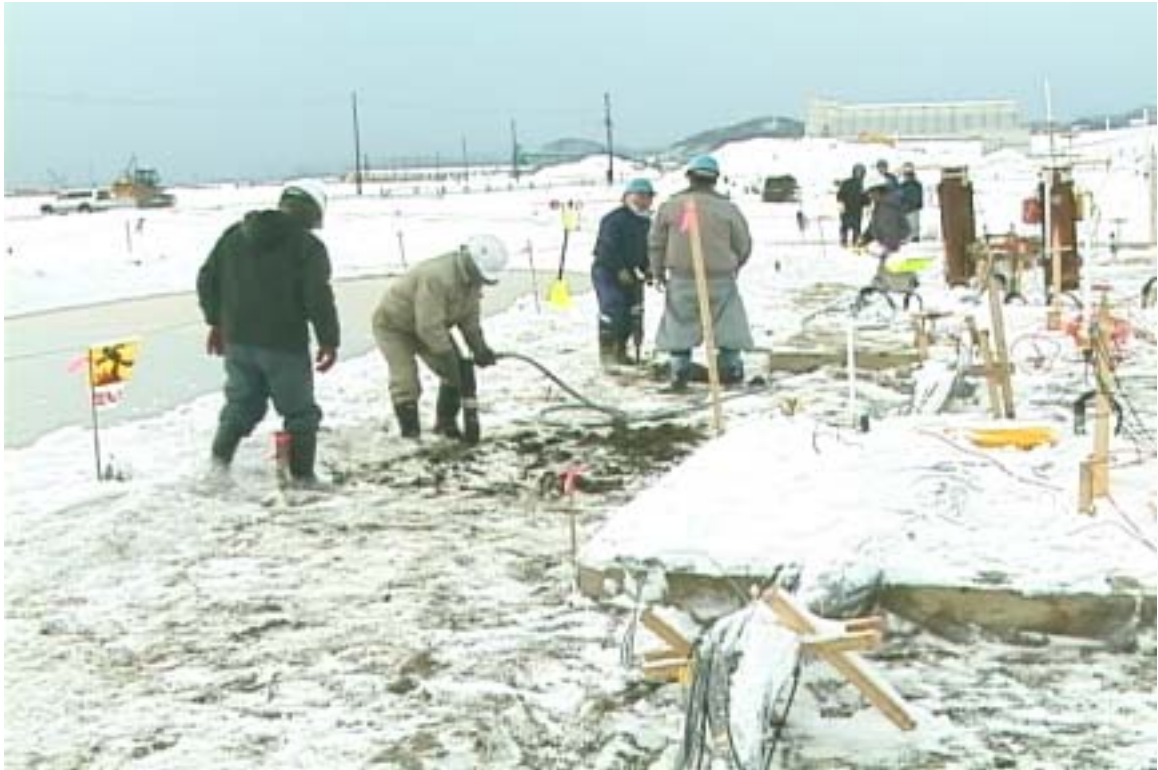
Figure 33 – Jackhammer operation to break up frozen soil surface

The second test took place on December 14, 2001. The execution of the second test was made challenging due to heavy snowfall, temperatures between -10°C and 0°C , and record setting 100kph winds on the day of the test. Ground freeze became an issue since frozen soil is not liquefiable nor conducive to lateral spread. Based upon driving steel stakes throughout sections of the site, the ground freeze was estimated to be approximately 20 to 30cm. As such, on the morning of the test, construction crews used jackhammers to break up the frozen ground surface in an area 3 to 5m buffering the pile groups as shown in Figure 33.

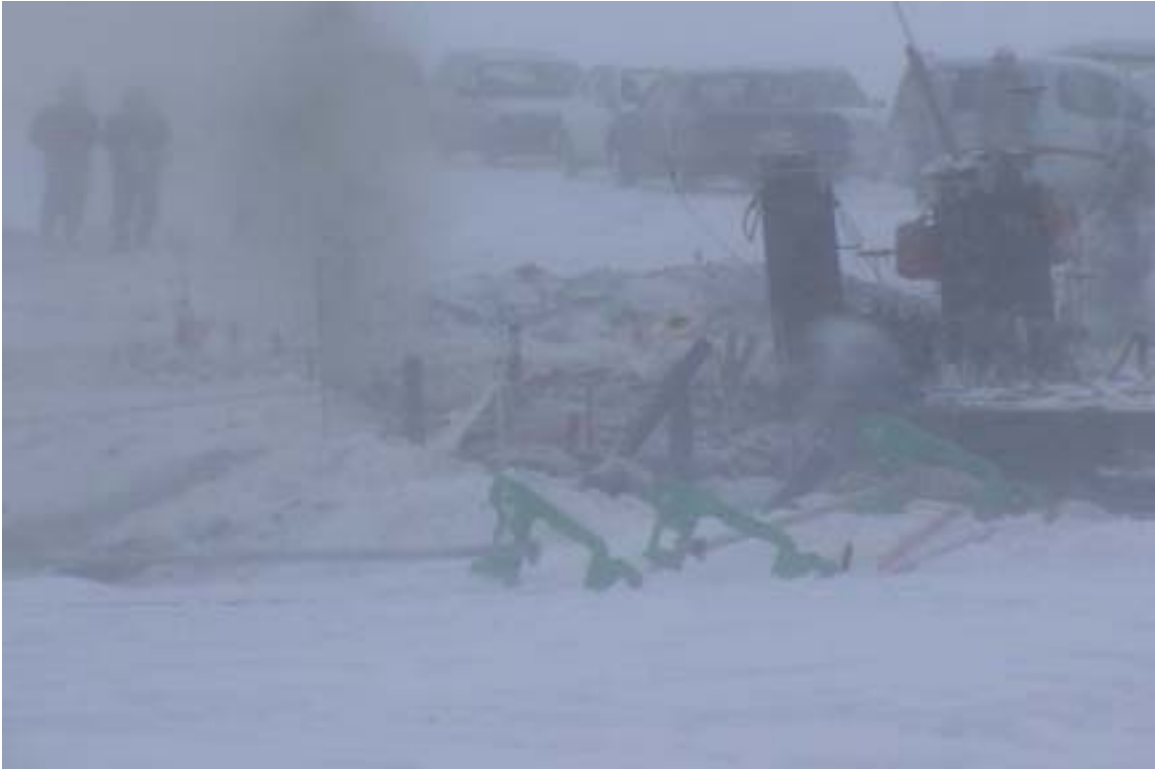
Figure 34 – Blasting underway, December Test

The primary blast sequence commenced at approximately 2:16:41.00 PM local time (451001.00 GPS time), and proceeded over a period of approximately 15 seconds. Approximately 19 seconds prior to the primary blast sequence, the explosives near the toe of the slope and the waterway were detonated. Figure 34 shows a photo during the blasting.

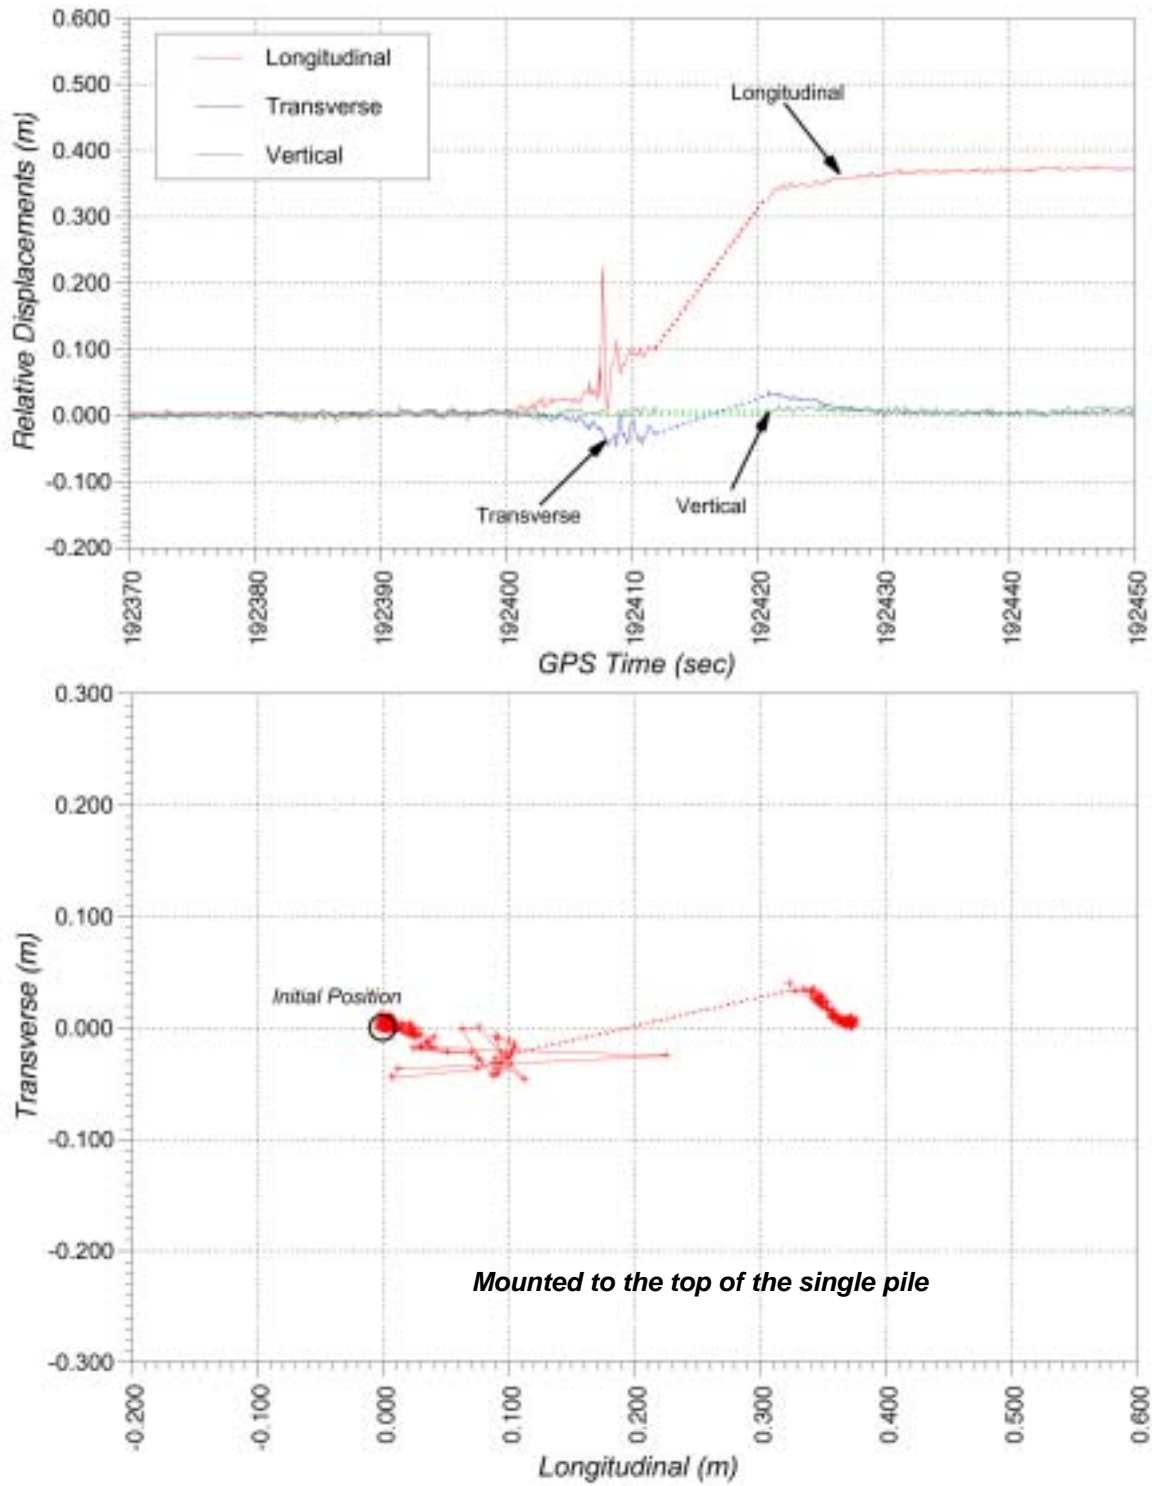
Figure 36 – Time-history record and plot for Unit 1D, November Test
