Measurements of Lateral Spread Using a Real Time Kinematic Global Positioning System

Project No. F-2001-OR-05 65-680422
Continuous GPS: Pilot Applications
Phase II

This report presents deformation measurements collected during two full-scale lateral spread tests in Japan using a networked Real-Time Kinematic Global Positioning System (RTK-GPS).

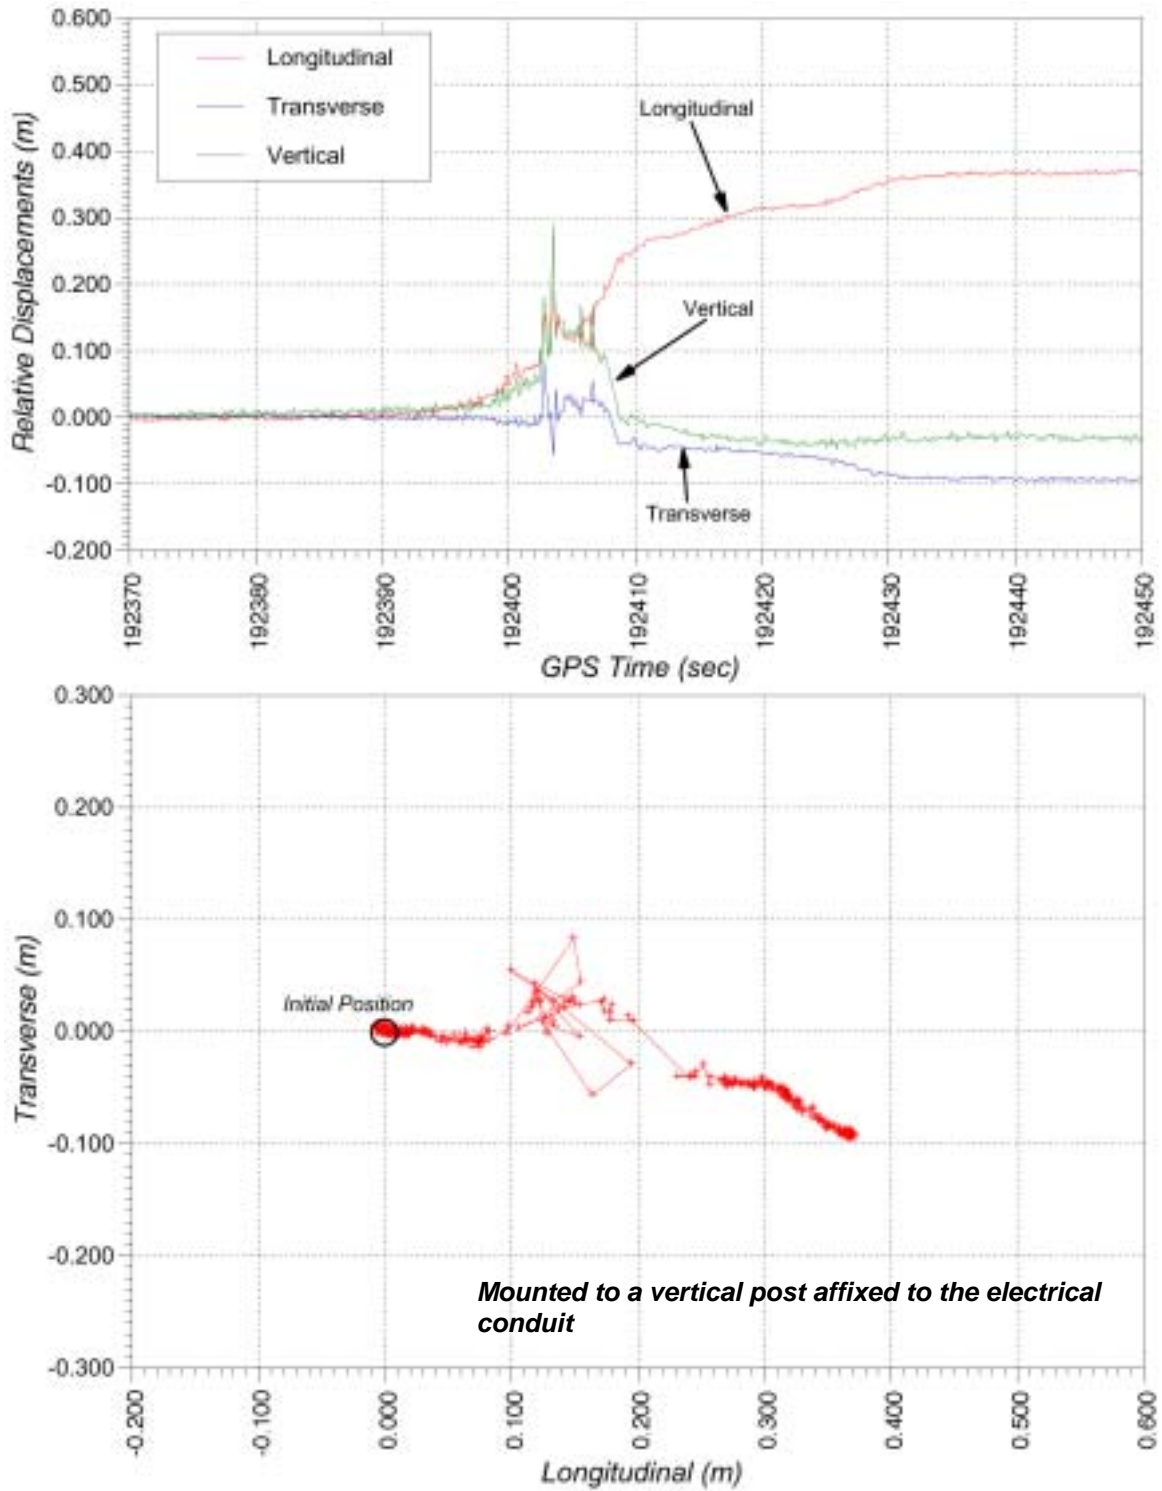
Figure 40 – Time-history record and plot for Unit 2E, November Test

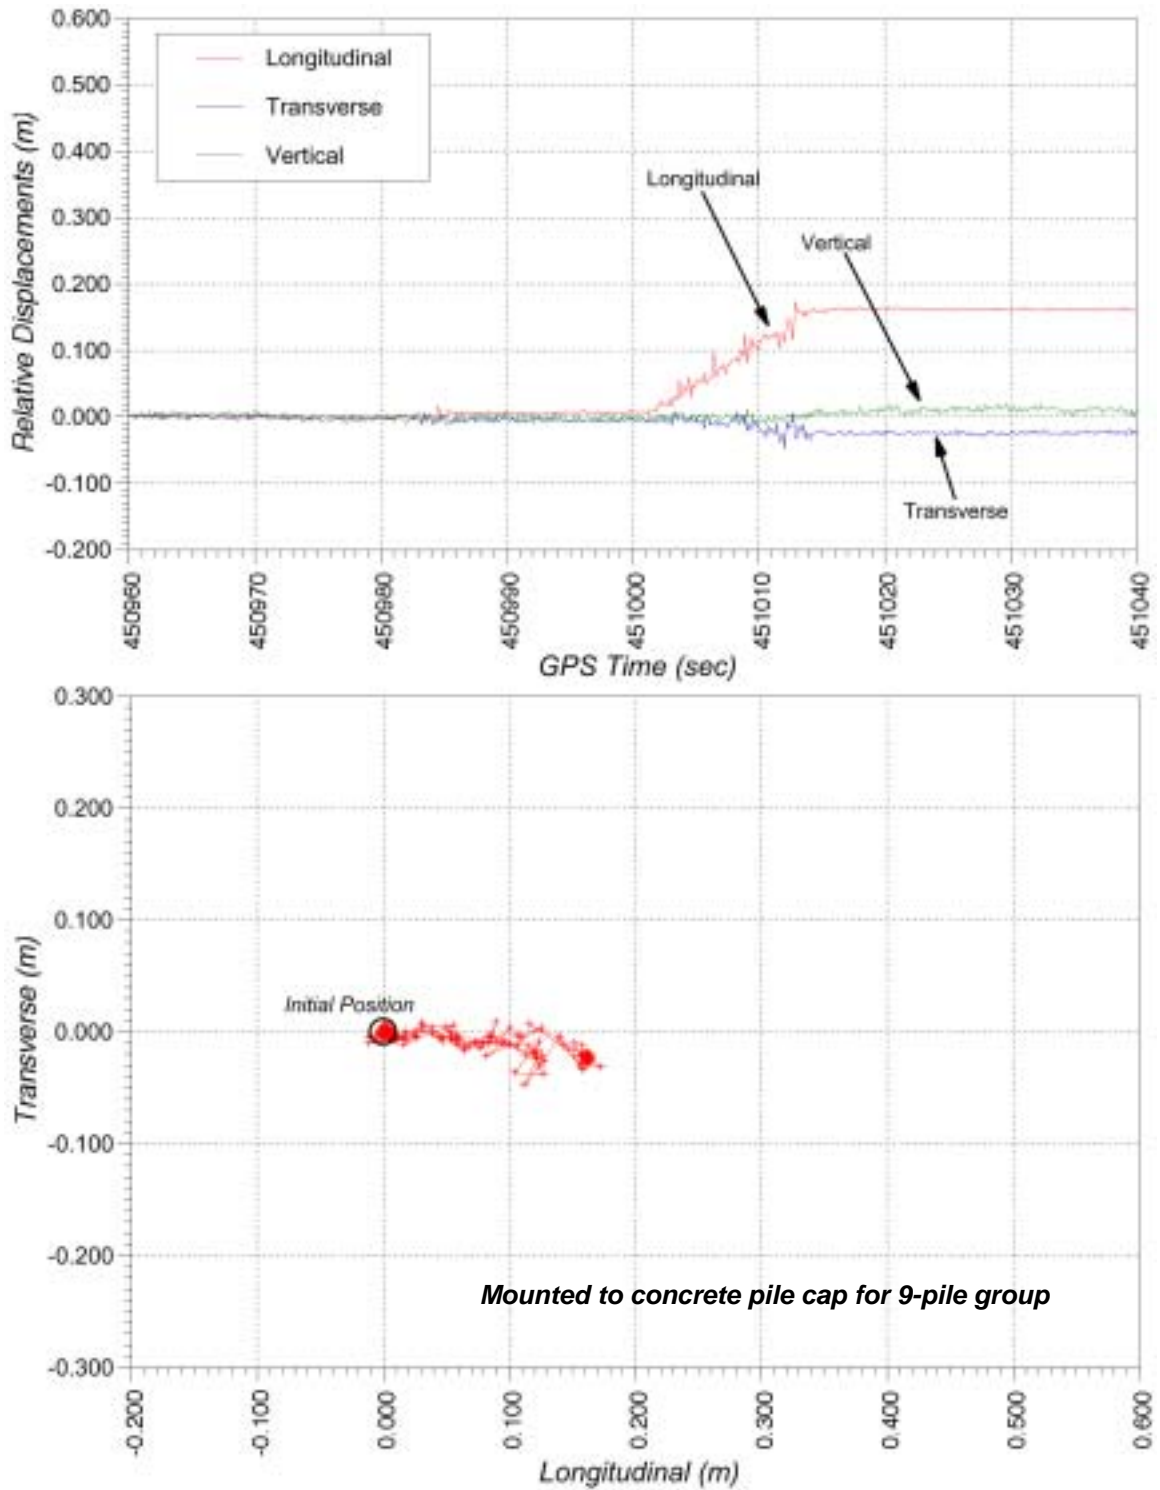
Figure 41 – Time-history record and plot for Unit 1A, December Test

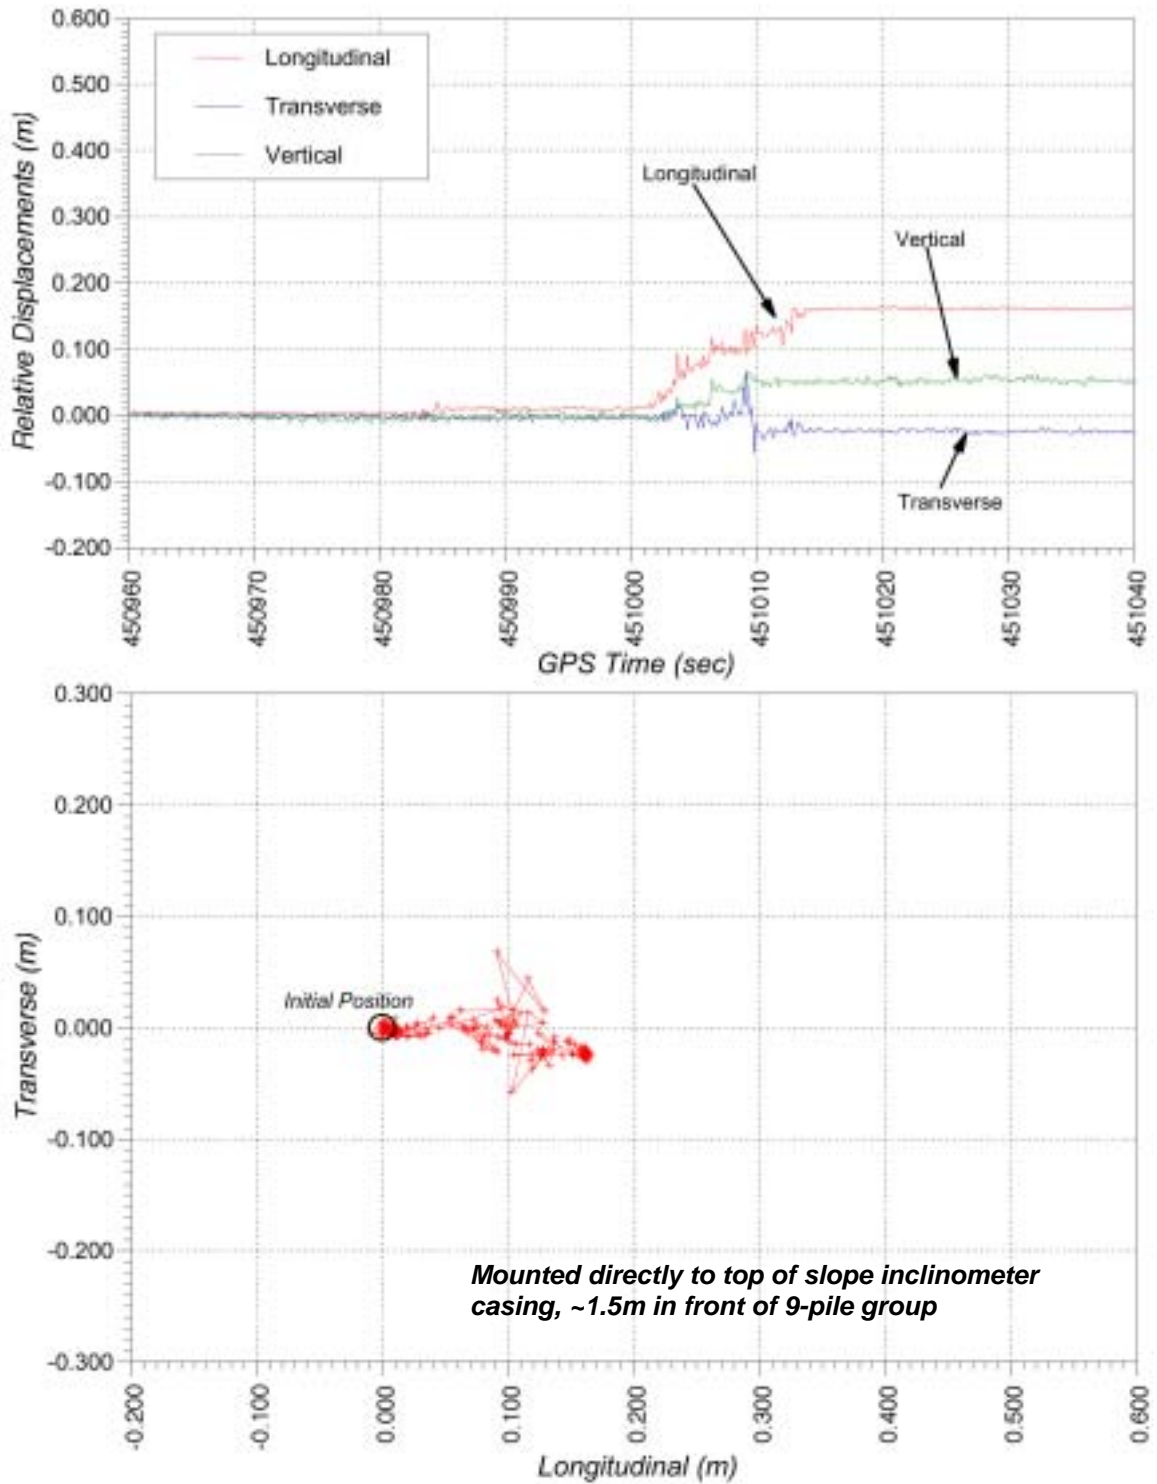
Figure 42 – Time-history record and plot for Unit 1B, December Test

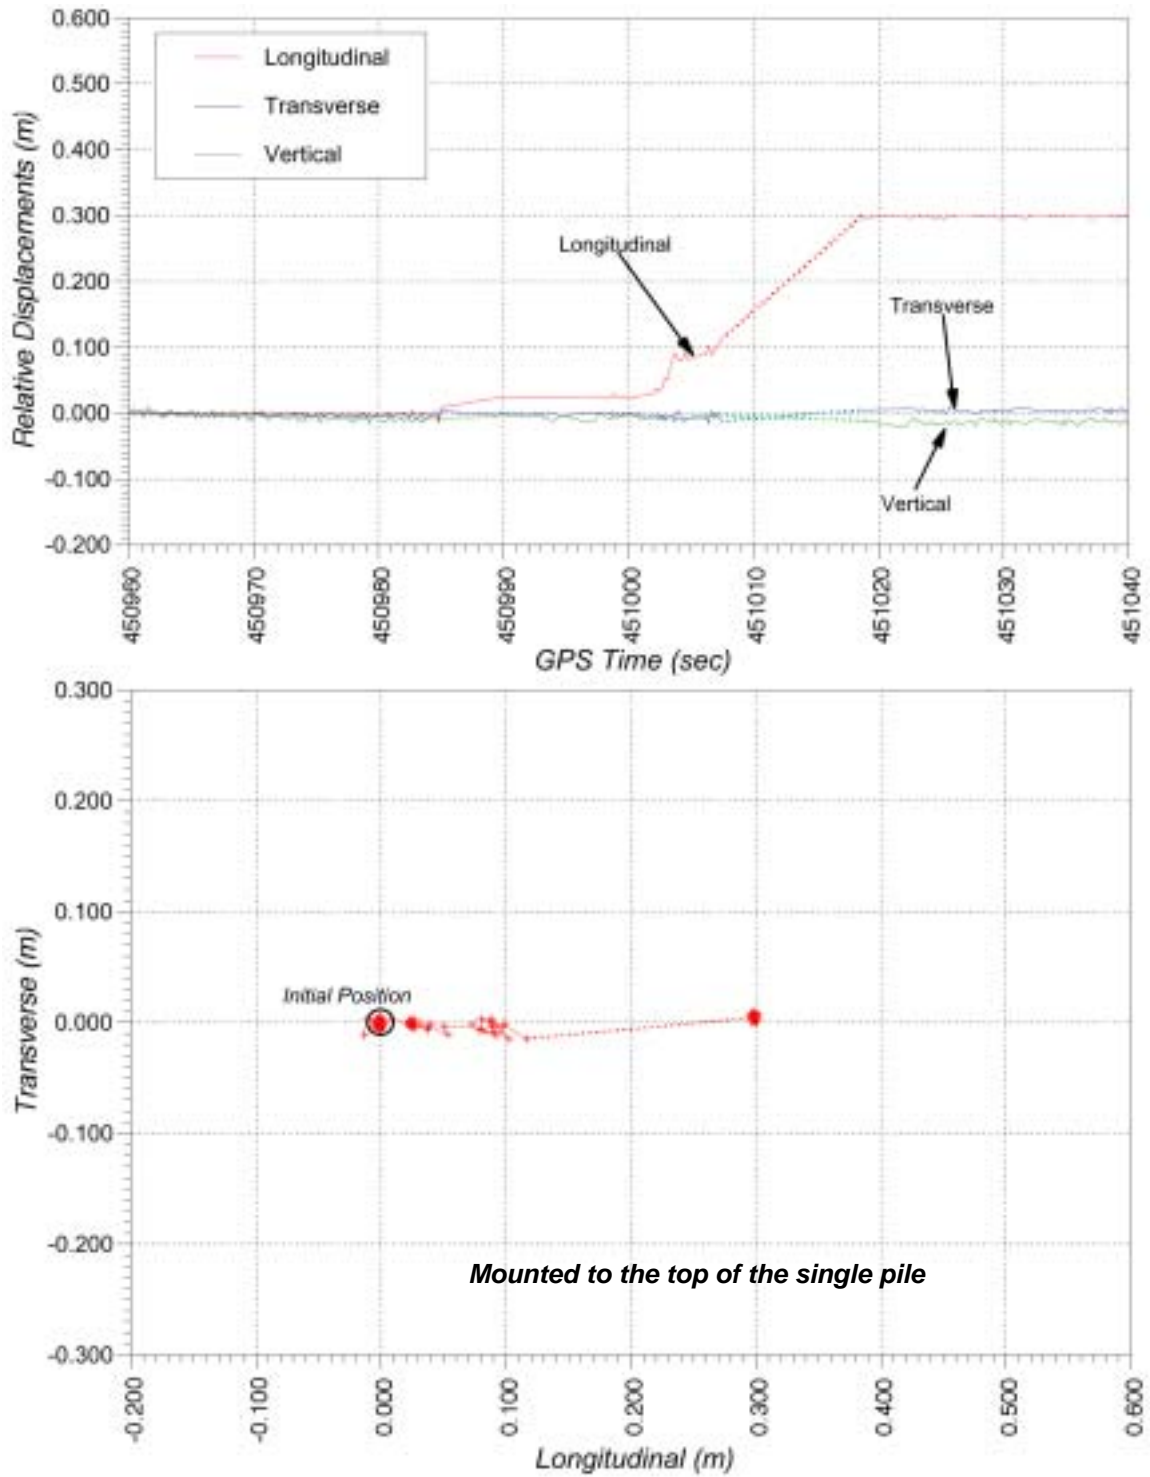
Figure 44 – Time-history record and plot for Unit 1D, December Test

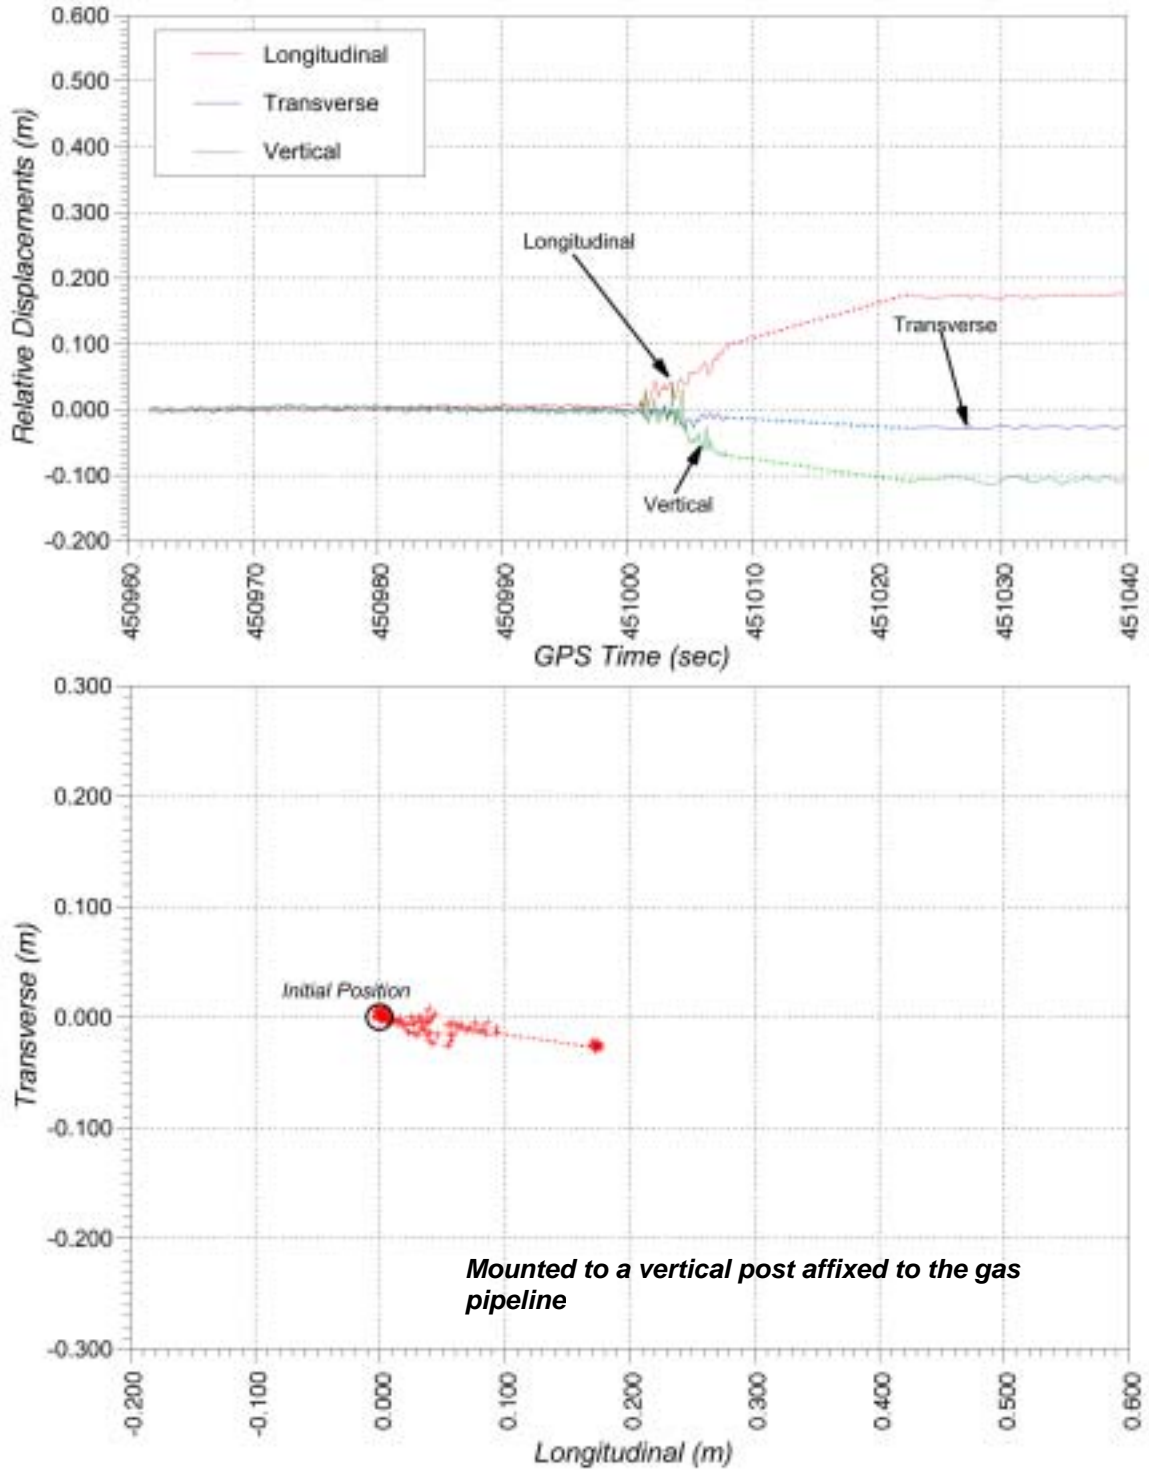
Figure 49 – Time-history record and plot for Unit 2D, December Test

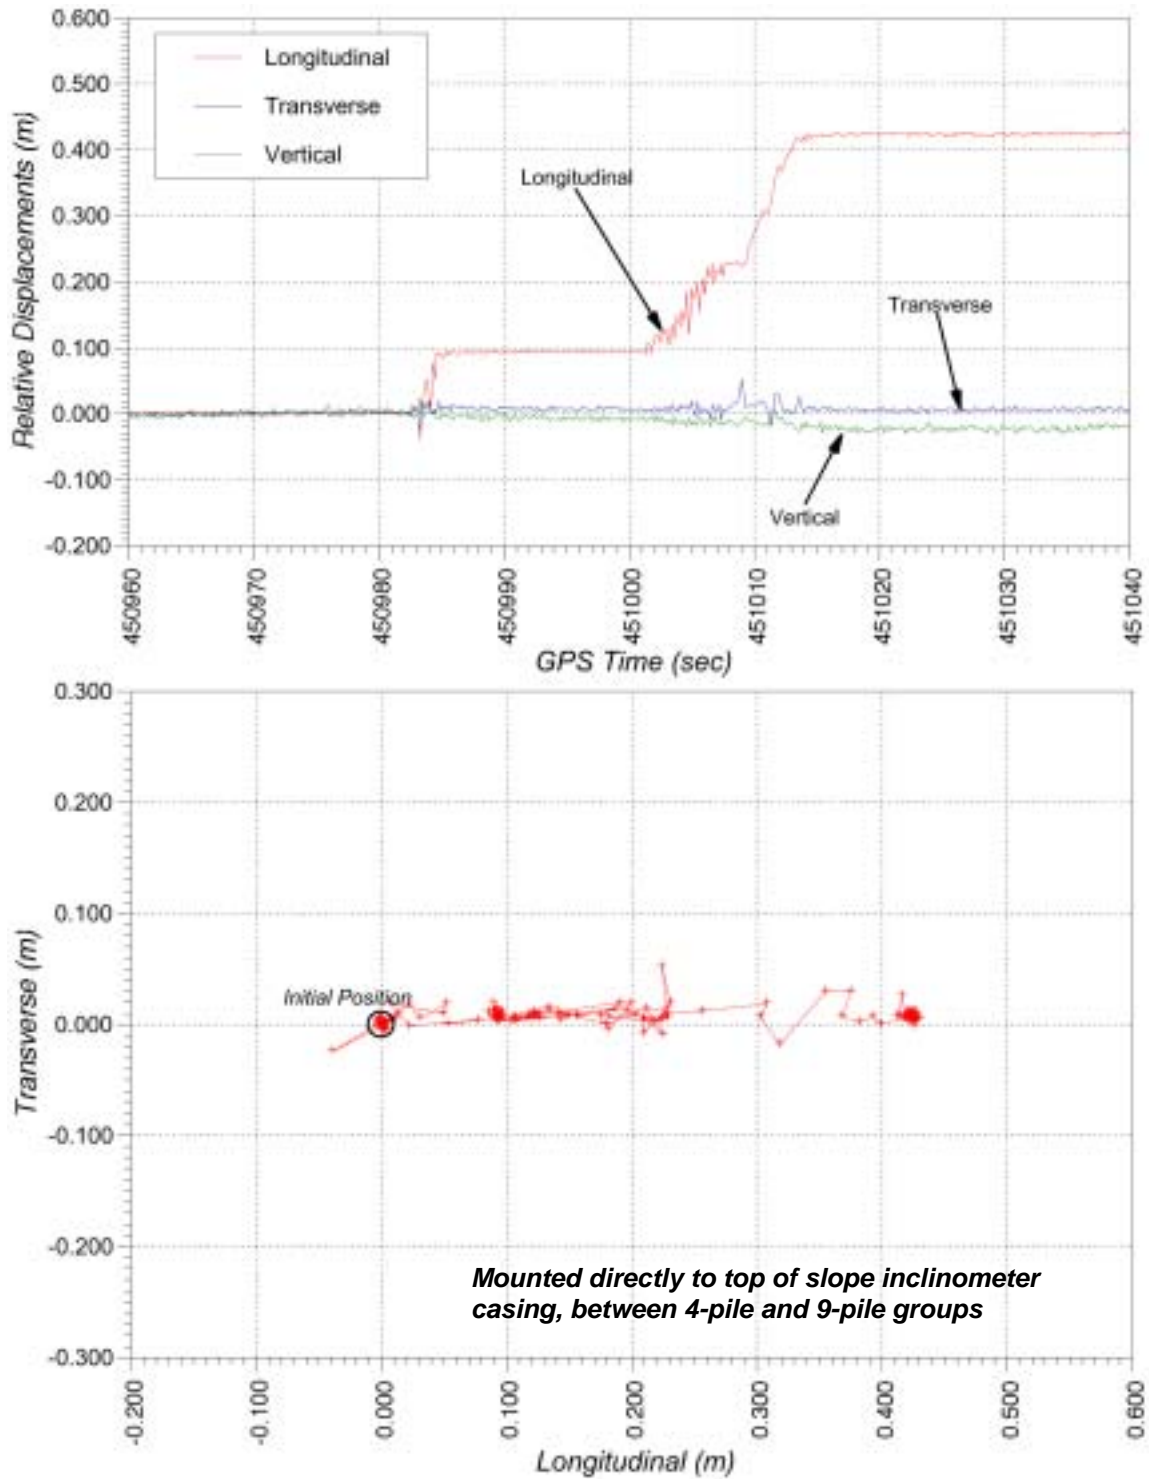
Figure 50 – Time-history record and plot for Unit 2E, December Test

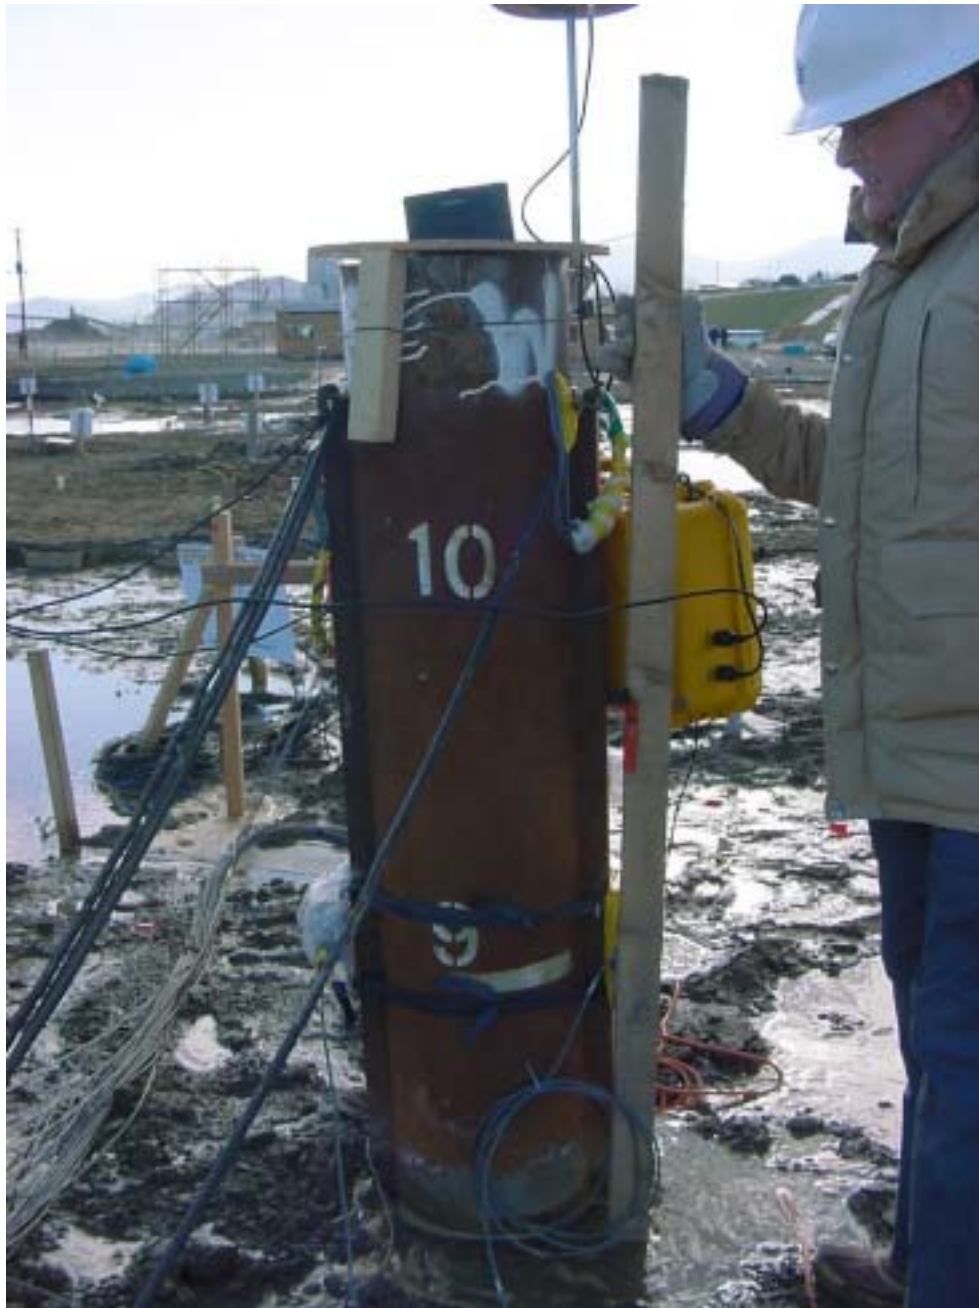
Figure 51 – Measuring rotation of pile, Unit 2C, November test

The largest horizontal displacements measured during both tests were those for Unit 2C, mounted on top of the 3-pile group. Recall from Figure 16 that the GPS antenna was located approximately 1.8m above the ground surface. Following both tests, significant rotations were observed for all of the piles in the 3-pile group. Preliminary measurements from the November test showed that the pile to which Unit 2C was attached had rotated approximately 5° as shown in Figure 51. This rotation accounted for roughly 15cm of the 54.7cm total horizontal

displacement in the November test records. Similar pile rotations were observed in the December test. Tilt meter data collected by researchers from UCSD for both tests should be used and considered in future analyses when evaluating true ground deformations.

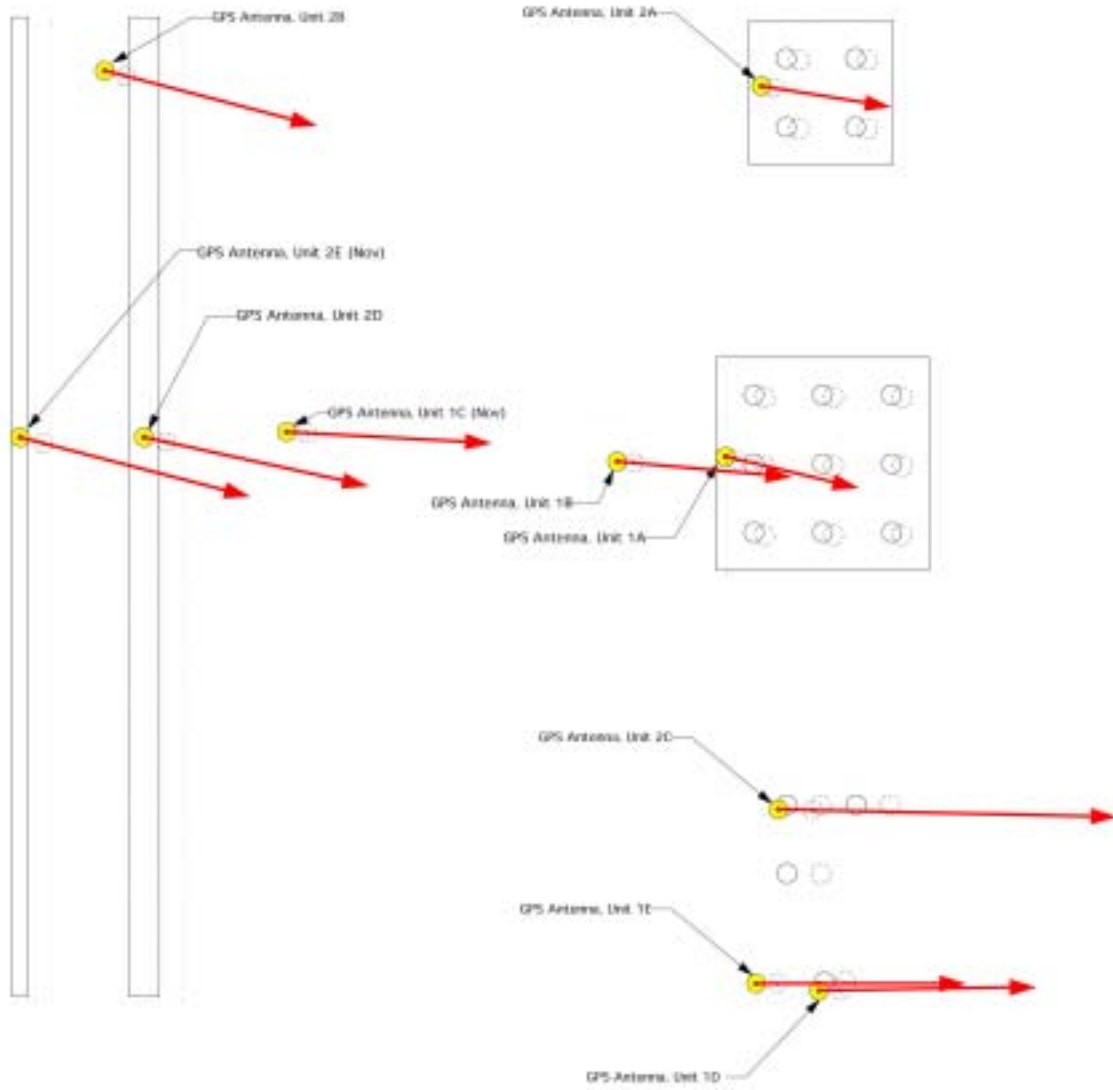
Figure 52 – Vector displacements in horizontal plane, November test

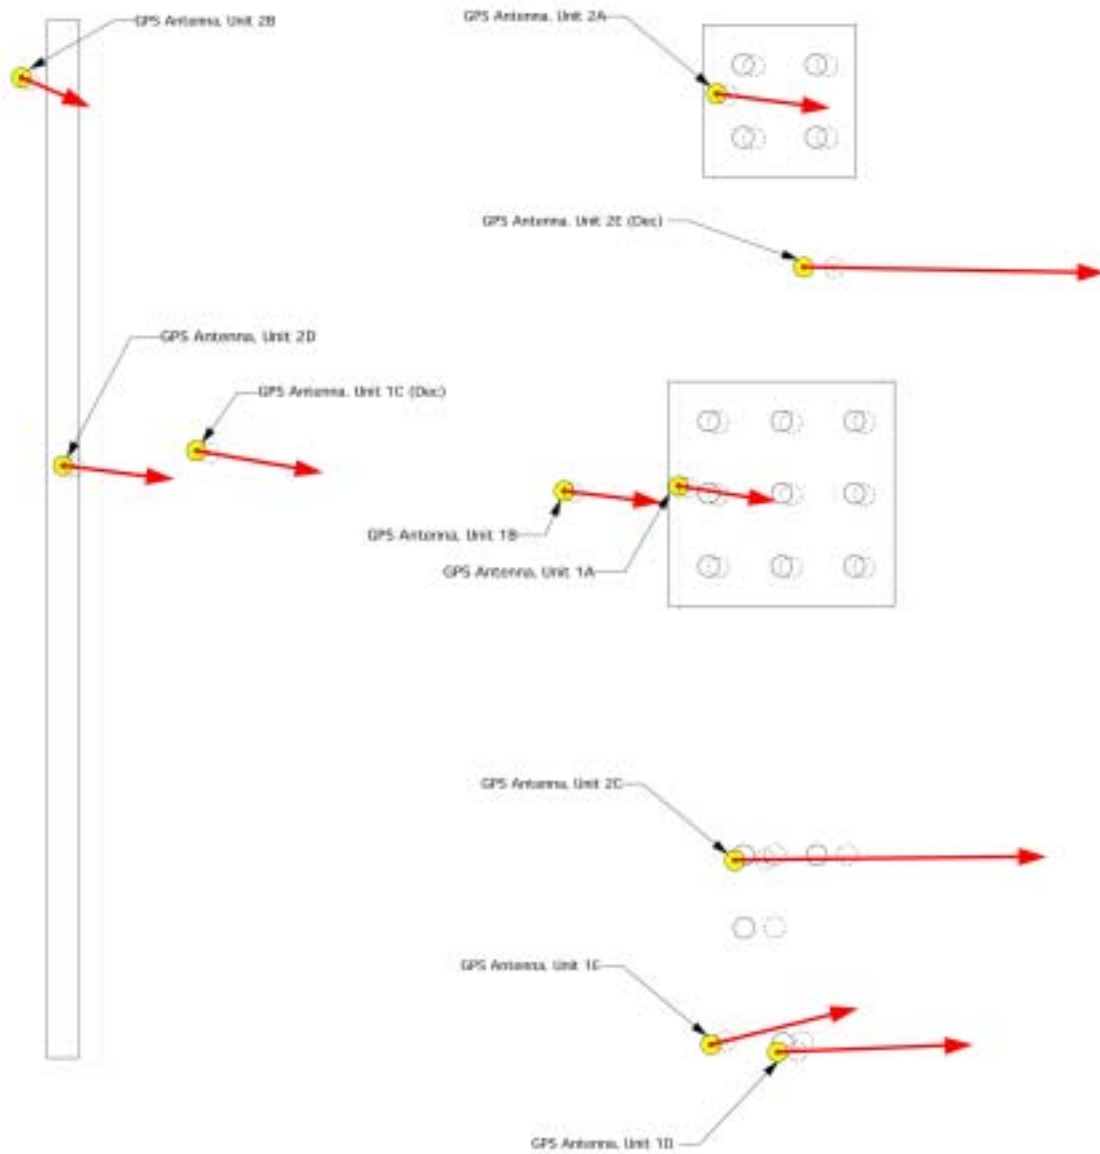
Figure 53 – Vector displacements in horizontal plane, December test

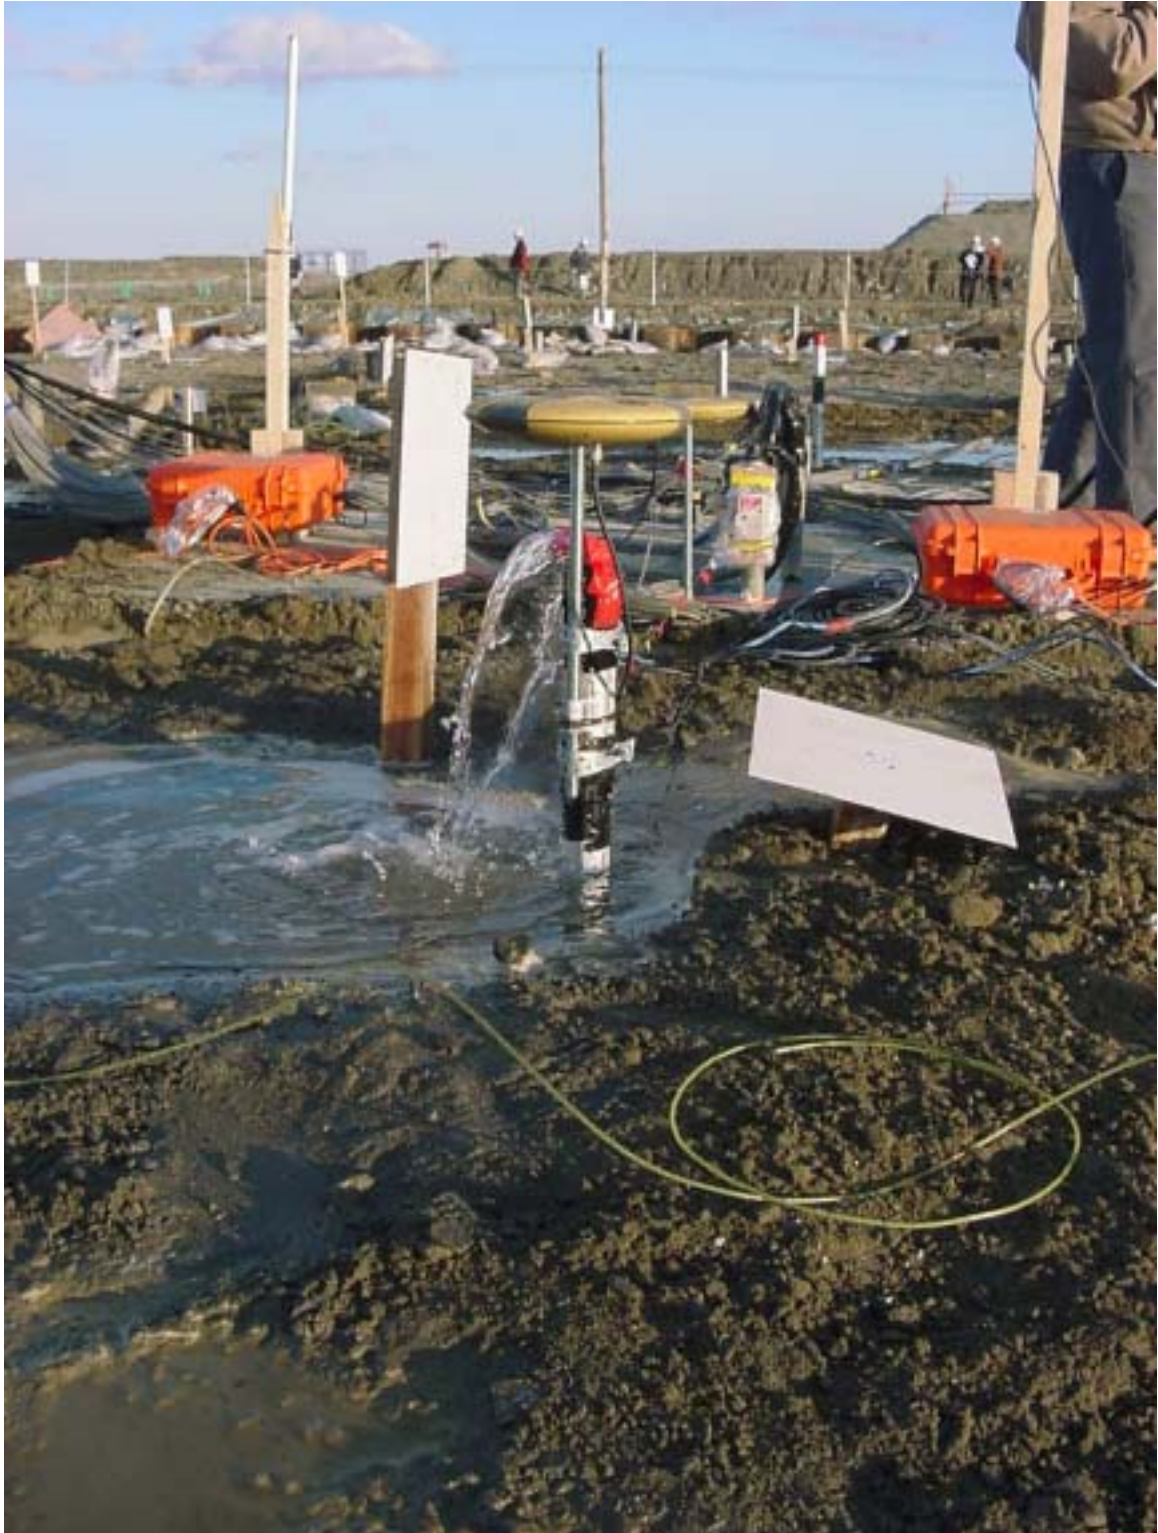
Figure 55 – GPS Unit 1B shortly after blasting

During the November test significant settlements ranging from 9 to 13cm were measured for both free field installations (Units 1C and 2B) as well as for the two underground utilities (Units 2D and 2E). By contrast, measurements from the pile groups (Units 1A, 1D, 2A, and 2C) showed small upward heaving of less than 1cm during and following the blasting that did not subside over time. Although the vertical heaving estimates were near the vertical measurement resolution and could be attributed to measurement error, stability in the data trends seem to indicate otherwise. It is likely that short-term forces on the pipe piles from the blast induced soil heave displaced the piles upwards leaving a permanent vertical set. The GPS antennas installed directly onto slope inclinometer casings (Units 1B and 1E) showed evidence of permanent upward displacements between 2 to 3cm. Immediately following blasting, water was observed coming up through many of the inclinometer casings under high pressure. Figures 55 and 56 show photos of these observations after much of the water pressure was released. The release of pore water pressures through these casings in addition to potential buoyancy forces probably contributed to the upward movement of the casings. One of the inclinometer casings near the 4-pile group was observed to have risen in excess of 30cm as shown in Figure 57. Sand boils around the inclinometer casing can be seen in this photo.

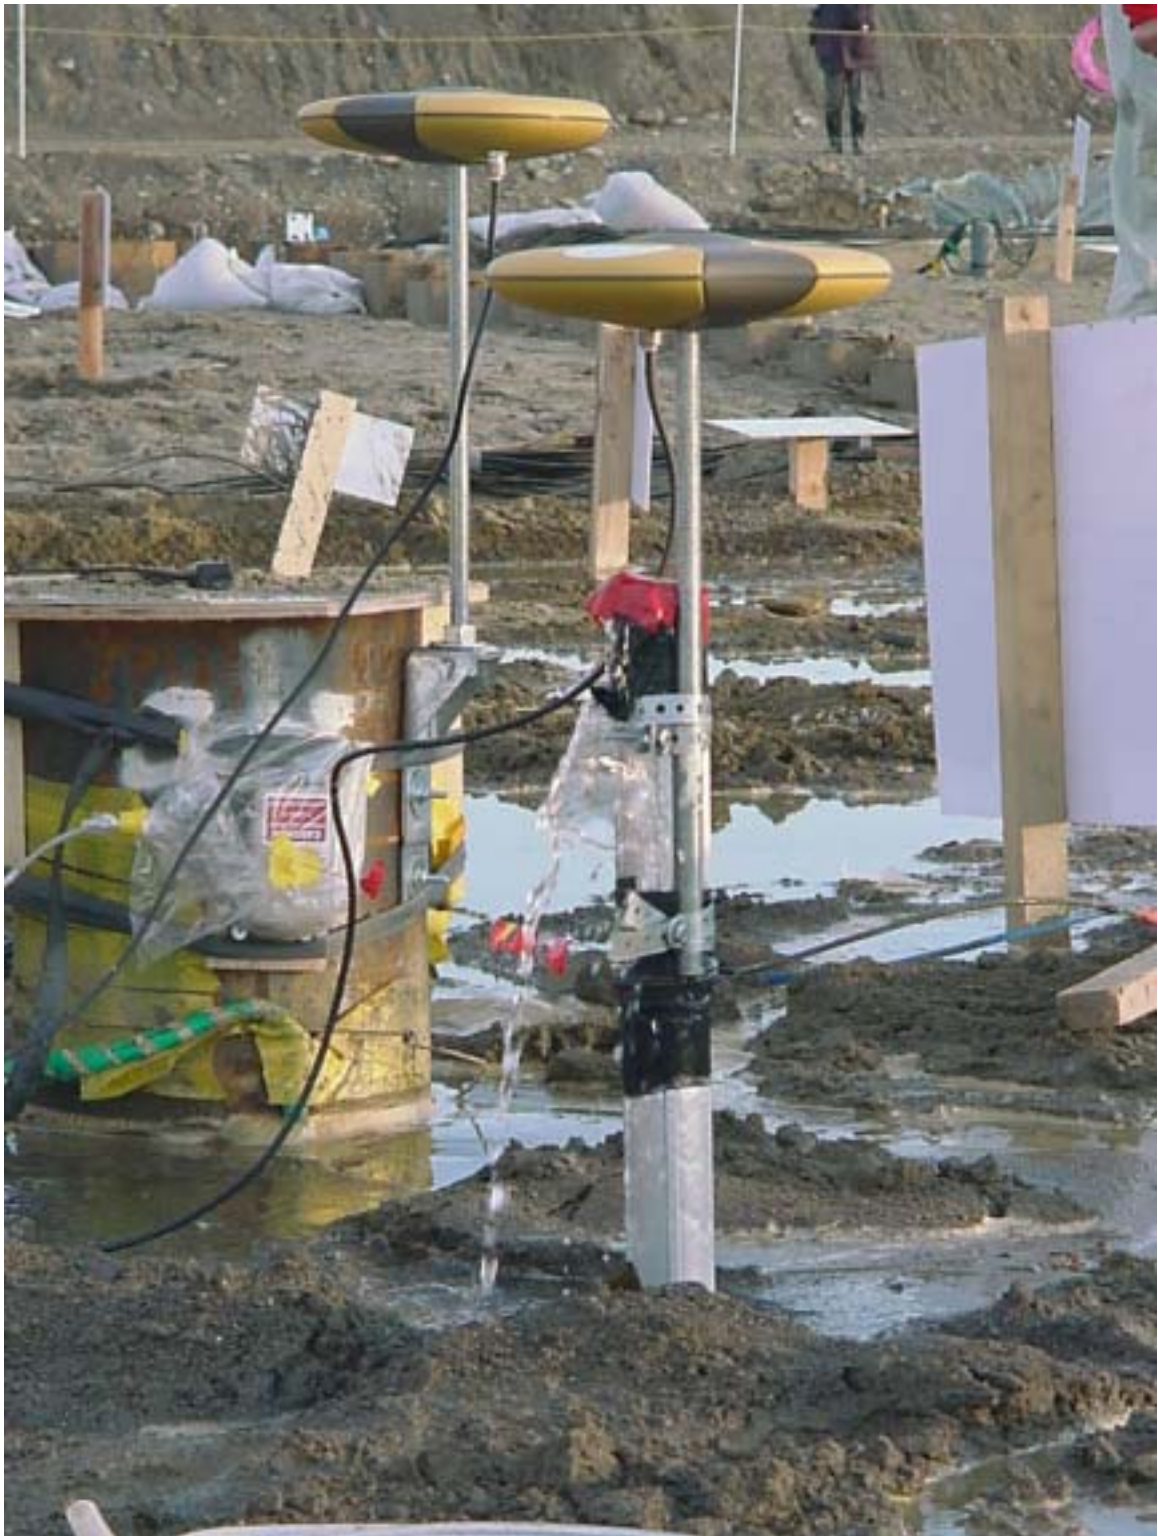
Figure 56 – GPS Units 1D and 1E shortly after blasting

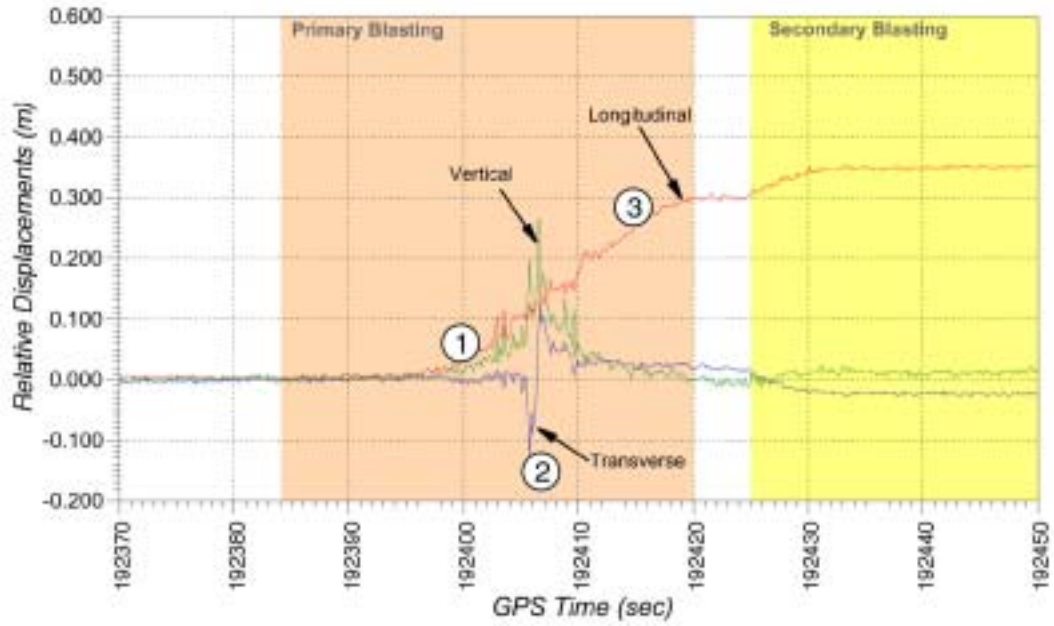
Figure 58 – Explanation of time-history record for Unit 1C, November test

ground surface or test specimen during blasting. Consider the time-history record for Unit 1C during the November test as shown in Figure 58 below.

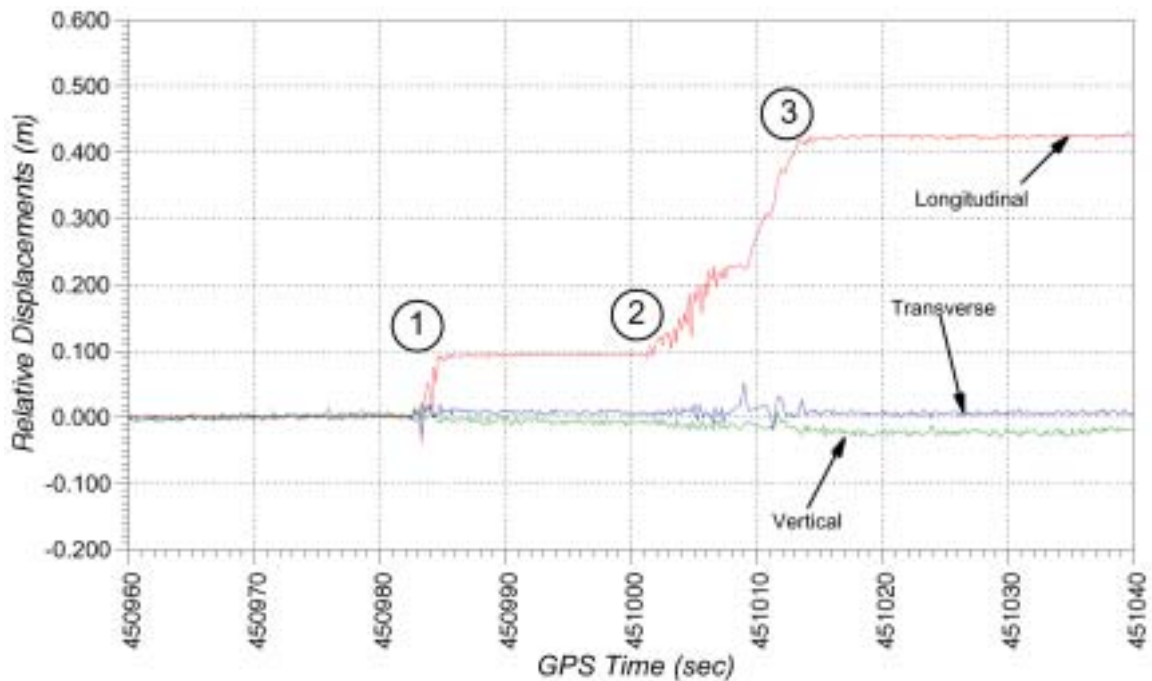
Figure 59 – Explanation of time-history record for Unit 2E, December test

As described earlier in the report, a short series of blasts to loosen the toe were executed prior to the primary blasting sequence for the December test. Most of the time-history records reflect the occurrence of this initial blasting. For example, in the record for Unit 2E the initial blast occurs at approximately 450983 sec as indicated as time (1) in Figure 59. This initial blast caused significant

longitudinal motions. The primary blasting began at approximately 451001 sec as noted by time (2), with completion of blasting at approximately 451013 sec as noted by time (3) in Figure 59.
