**Documenting Incidents of Ground Failure Resulting from the  
August 17, 1999 Kocaeli, Turkey Earthquake:  
Data Report Characterizing Subsurface Conditions**

## **1. Introduction**

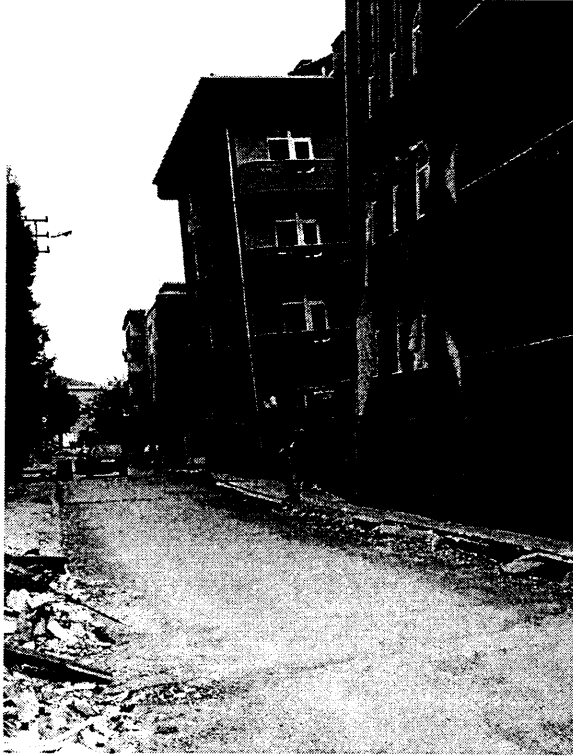
Figure 5-1a: 5-story high building A1 seen in the background. Building A2 is seen in the foreground (Photo courtesy of D. Frost).

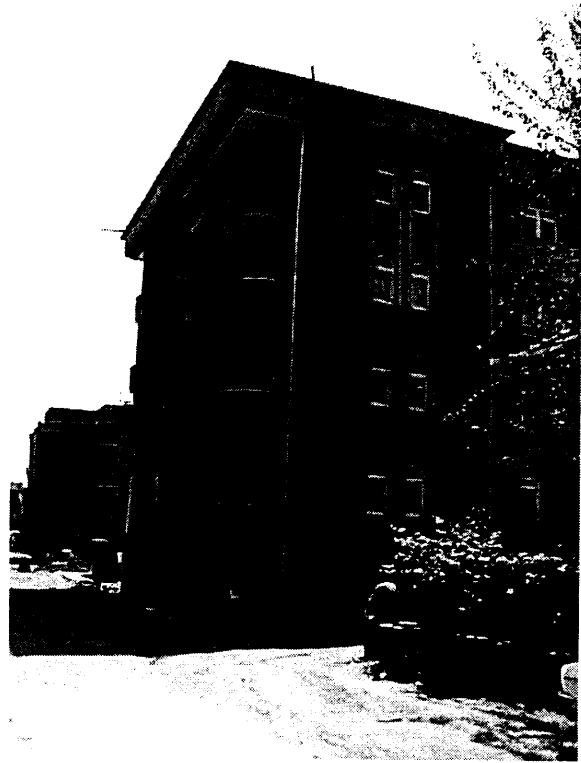
Figure 1b: Building A2 as seen 8 months after the earthquake. Note that building A1 has been demolished.

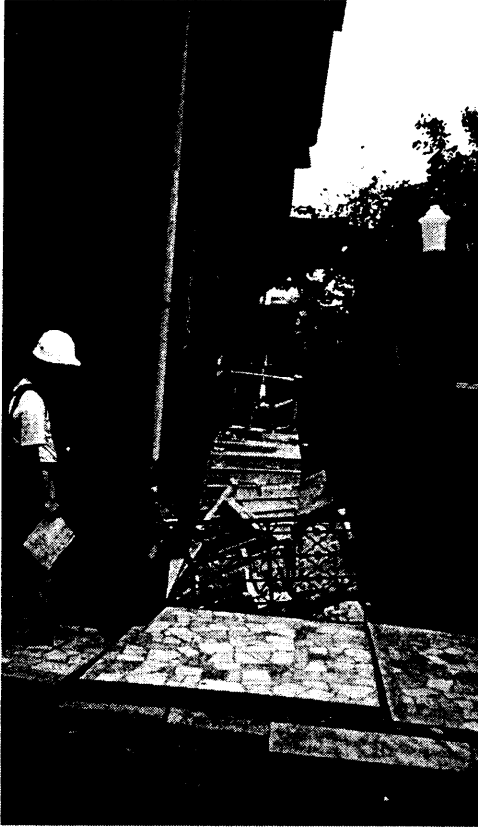
Figure 5-3a: Entrance gate to building A1. 150 cm of settlement were measured at this location 8 days after the earthquake

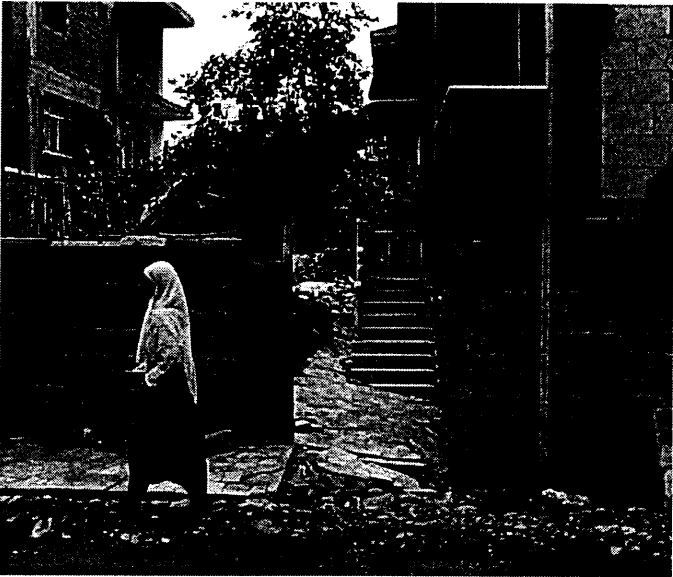
Figure 5-3b: Entrance gate to building A2. 30 cm to 35 cm of settlement were measured at this location 8 months after the earthquake.

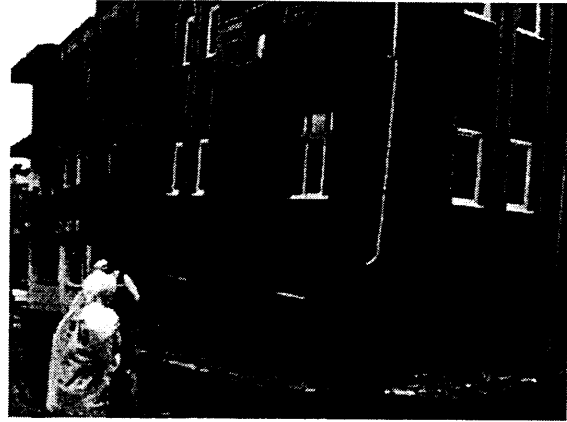
Figure 5-4b: View of the northeast corner of building A1 in which pavement cracking is also evident. However, bulging is not apparent on the east side of the building (Photo courtesy of J. P. Bardet)

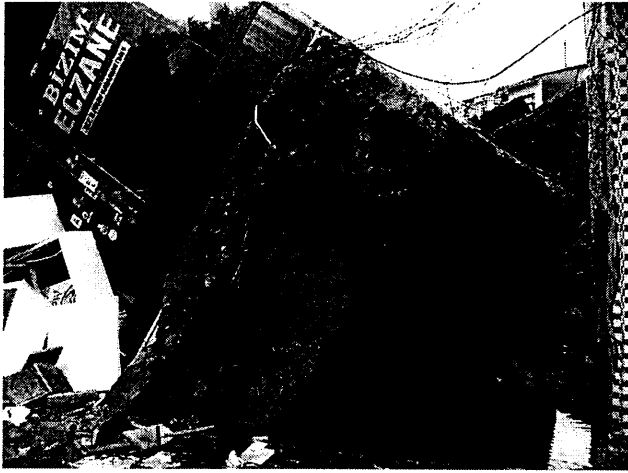
As can be seen in Figure 5-8a, building B1 was founded on a reinforced concrete shallow mat foundation. According to building drawings, and similar to most of the reinforced concrete buildings in Adapazari, this mat consisted of a 35 cm-thick slab reinforced by 1.2 m-high tie beams. The base of the mat was located approximately 1 m below the sidewalk level. Other than the effect of the impact against the neighboring building, the structure of building B1 appeared to be undamaged, essentially rotating as a rigid body.

Figure 5-8a: Close-up of the reinforced concrete mat foundation of building B1 (08/25/1999)

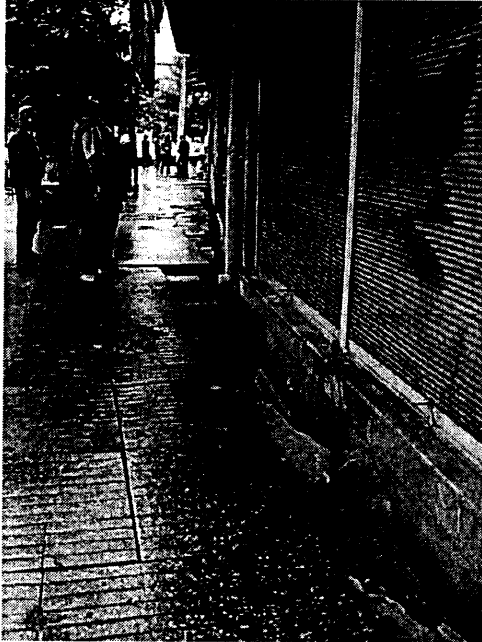
Based on measurements made by Stewart and Baturay 13 days after the Kocaeli earthquake (Stewart and Baturay, 1999), the two 4-story buildings, designated B4 and B5 in Figure 5-7, had a downward movement of 22 cm. Additionally, buildings B4 and B5 translated 31 cm and 22 cm towards the east (away from the street), respectively as shown in Figures 5-8b and 5-9a. Buckling of the back access gate shown in Figure 5-9b also evidenced sliding of building B5.

Figure 5-9a: Gap between the structure of building B5 and the sidewalk along Kuyudibi Ave. (08/25/1999)

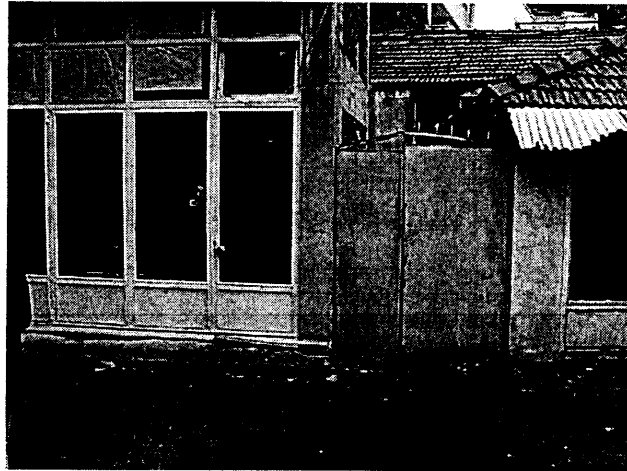
Figure 5-9b: Buckled gate in the back of building B5 evidencing earthquake induced lateral translation of the structure (08/25/1999)

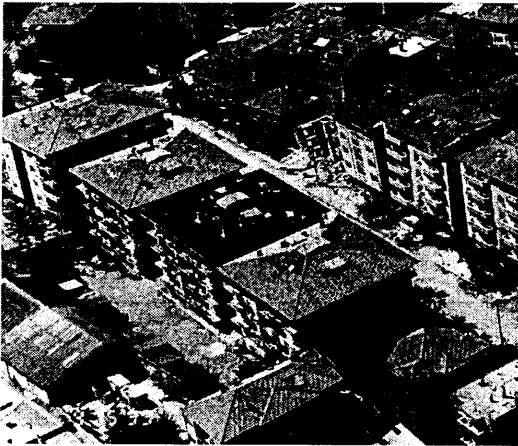
Figure 5-10a: North to south aerial view of Site C before building C1 was demolished. (Photo courtesy of I. M. Idriss)

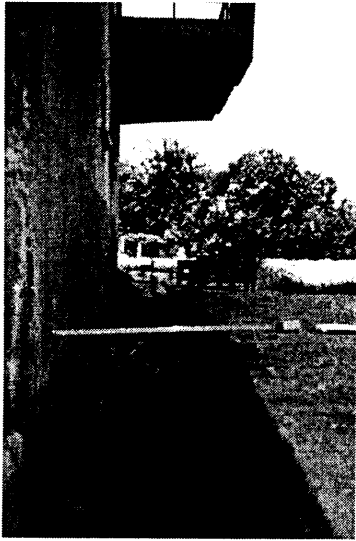
The middle building with the black roof (designated C2 in Figure 5-11) and the building to its North (designated C1) moved toward the street and settled. For example, building C2 translated 57 cm towards the street (west) as shown in Figure 5-12a, 34 cm towards building C1 (north), and the relative vertical movement between it and the pavement was about 35 cm. However, there was no evidence of distress to the building (designated C3) that is located to the left of the middle building with the black roof (Figure 5-10a) and shown in Figure 5-10b. Significant pavement distress and evidence of liquefaction was observed in the alley between buildings C1 and C2 as seen in Figure 5-12b, but no ground failure was observed in the alley between buildings C2 and C3.

Figure 5-12a: Gap between the perimetral sidewalk and eastern side of building C2

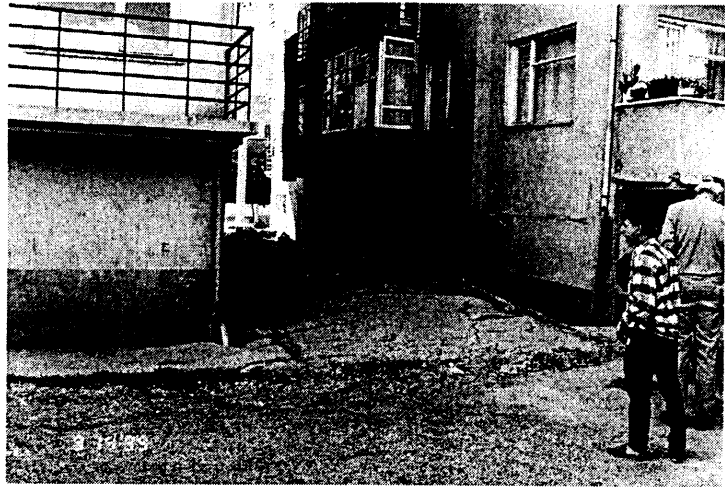
Figure 5-12b: Ground distress observed in alley between buildings C1 and C2. Building C1 is located on the right side of the photograph. (Photo courtesy of I. M. Idriss)

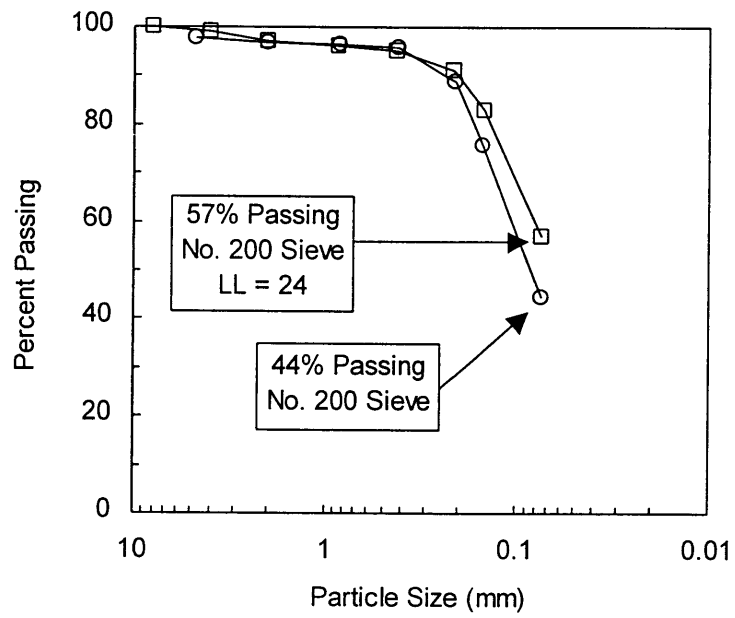
Particle grain size analyses of the brown sediment soil found near the southeast corner of building C1 are shown in Figure 5-13. One of the samples was found to be low plasticity silt (LL=24) and the other, silty fine sand.

Figure 5-13: Particle size analysis curve for the samples of ejecta recovered at Site C. The soil can be described as Silty Sand to low plasticity Silt.

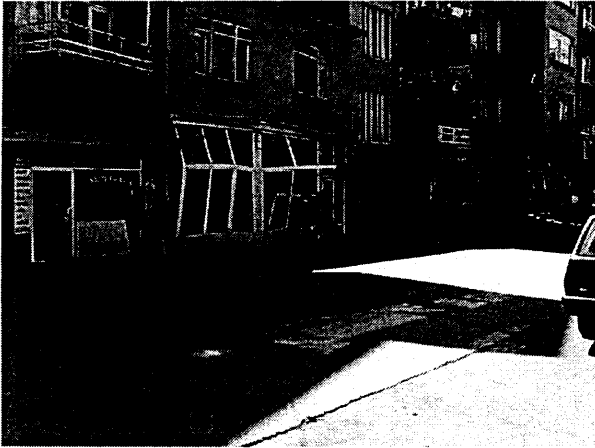
The 5-story reinforced concrete building, designated E1 in Figure 5-19, was probably supported on a 1m to 1.2 m-thick reinforced concrete mat foundation typical of this type of structures in the city of Adapazari. Settlement measurements performed 10 months after the earthquake showed a downward movement of 5 cm to 6 cm at the southwest corner of the building and 20 cm to 25 cm at its southeast corner. The latter measurement is less reliable due to uncertainty of the settlement of the wall used as reference.

Figure 5-18a: 2-story high masonry-brick building (E1 in Figure 2) (08/25/1999)

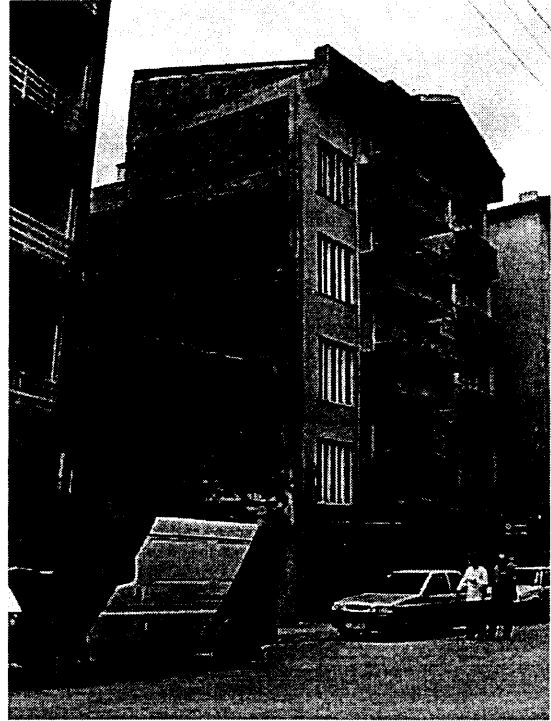
The timber-brick building shown of Figure 5-18a, designated E2 in Figure 5-19, was probably supported by shallow spread footings. This building, as shown in Figure 5-20a, experienced heave of the ground floor and excessive relative settlement between it and the sidewalk causing buckling of the metallic frame seen in Figure 18a. Evidence of liquefaction in the form of brown sand boils was observed along the east wall of the building as seen in Figure 5-21a.

Figure 5-18b: 5-story high reinforced concrete building (E2 in Figure 2)

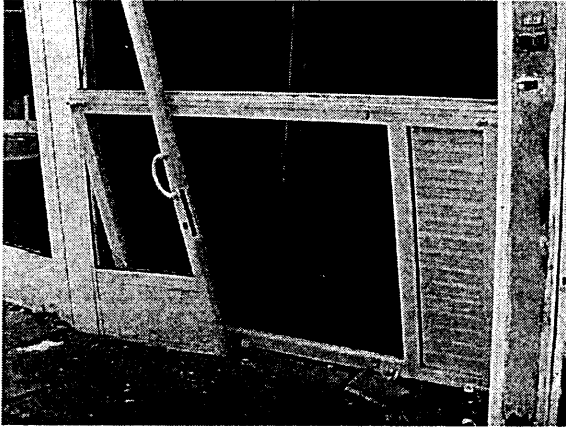
Figure 5-20a: Column punching and floor heave in building E2 (08/25/1999)

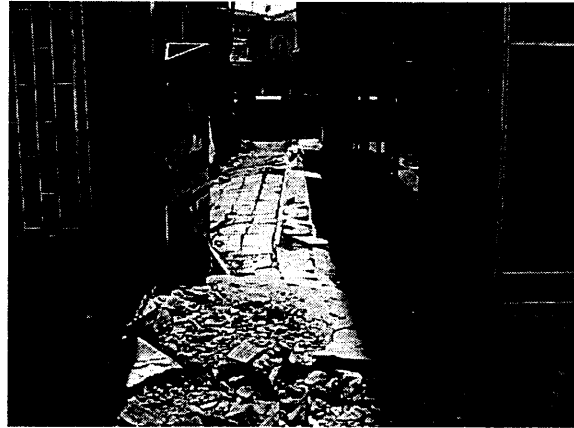
Figure 5-20b: Ground distress and bulging between building E1 and the building located to the west (08/25/1999)

Ground bulging was observed in the alleyway between building E1 and the building located to the west as seen in Figure 5-20b, which is a photograph taken 8 days after the Kocaeli earthquake. Additionally, as shown in Figure 4b, brown sand boils were found along the north side (street front) of the building.

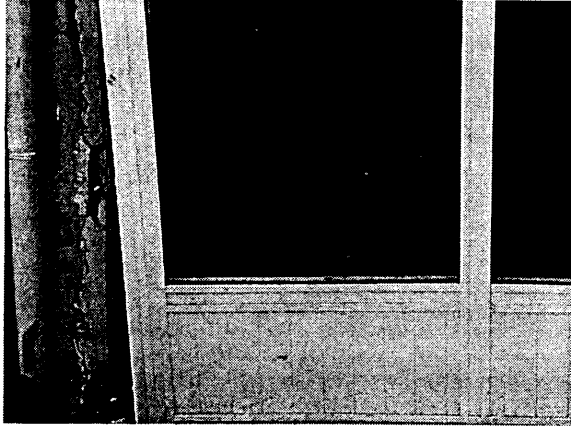
Figure 5-21a: Sand ejecta found along the east wall of building E2 8 days after the earthquake (08/25/1999)

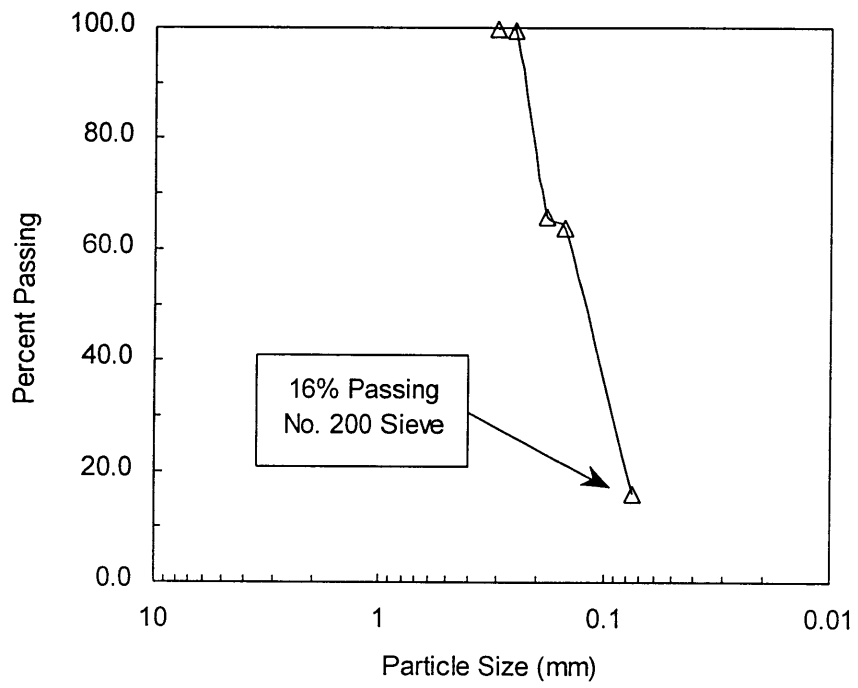
Evidence of liquefaction in the form of sand boils was observed in the vicinity of the site. Figure 5-24 shows the particle size gradation curve for a sample of the brown sediment that was collected. The soil has 16% of material finer than 75  $\mu\text{m}$  and classifies as silty sand according to the USCS.

Figure 5-24: Particle size analysis curve for the sample of brown sediment ejecta recovered at Site F few days after the Kocaeli earthquake. The soil classifies as silty fine sand

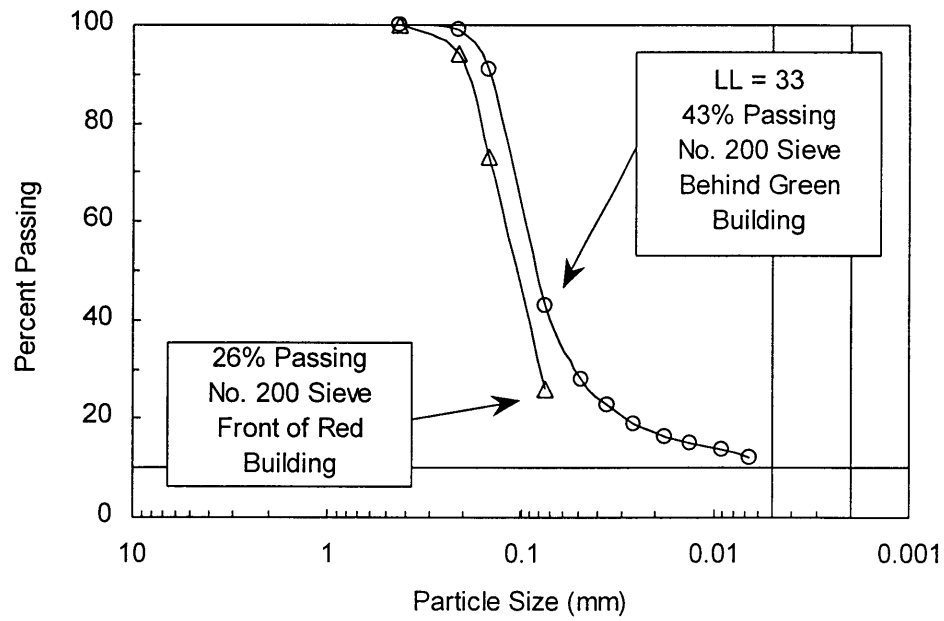
The grounds around these buildings were littered with brown sediment ejecta, evidence of liquefaction. Samples of these sand boils were taken and tested for classification purposes. As shown in Figure 5-28, the soil classifies as silty sand (SM).

Figure 5-28: Particle size analysis curve for different samples of brown sediment ejecta recovered at Site G a few days after the Kocaeli earthquake. Both samples classify as silty fine sand (SM) according to the USCS

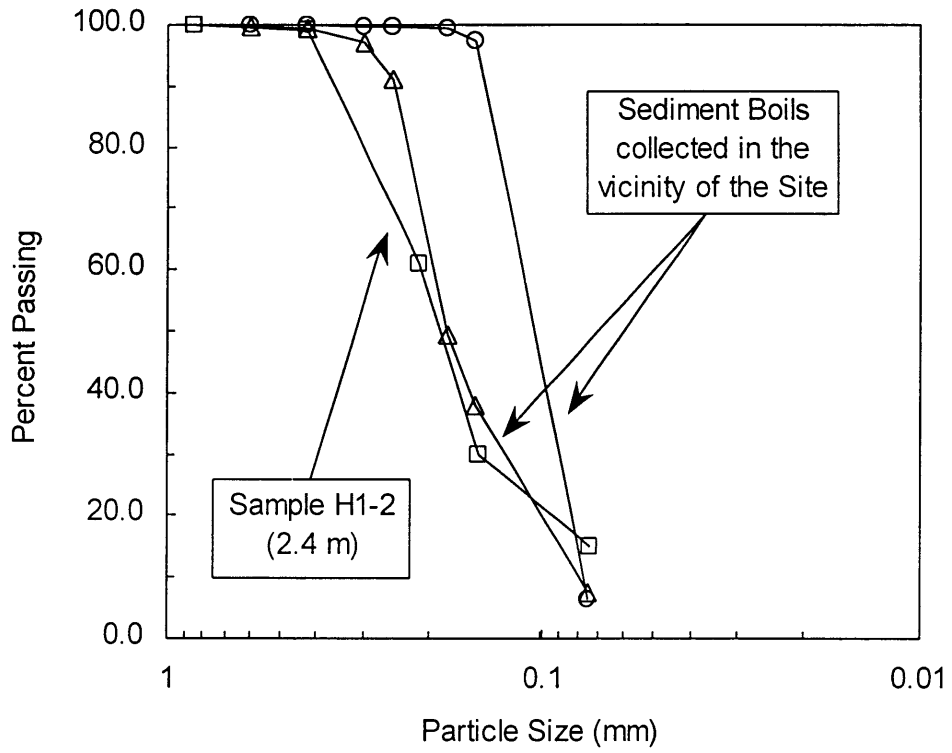
The general area around the building experienced widespread and significant liquefaction (Bray and Stewart, 2000). As shown in Figure 5-31, two samples of sediment boils were collected within 20 meters of building H1. Also shown in Figure 5-31 is a sample that was collected at a depth of 2.4 m at SPT-H1.

Figure 5-31: Particle size gradation curves for two samples of ejected sediment (SP-SM) and a sample of silty sand (SM) recovered at a depth of 2.4m

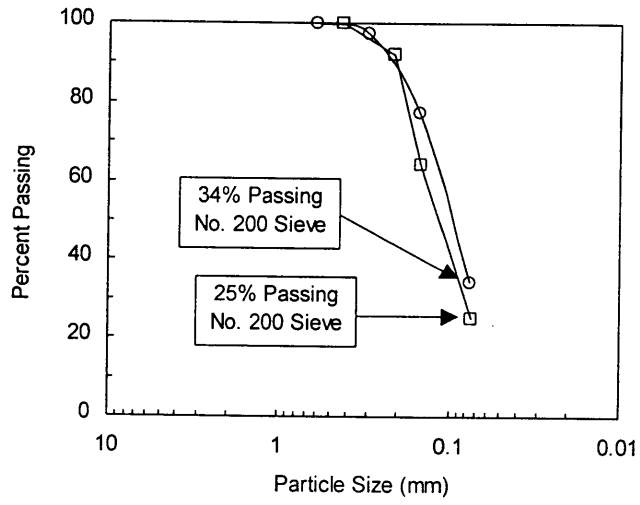
Figure 5-38: Particle size analysis curve for the samples of the tan brown sediment boil ejecta recovered near the northeast corner of building J1. Both soils classify as SM according to the USCS.

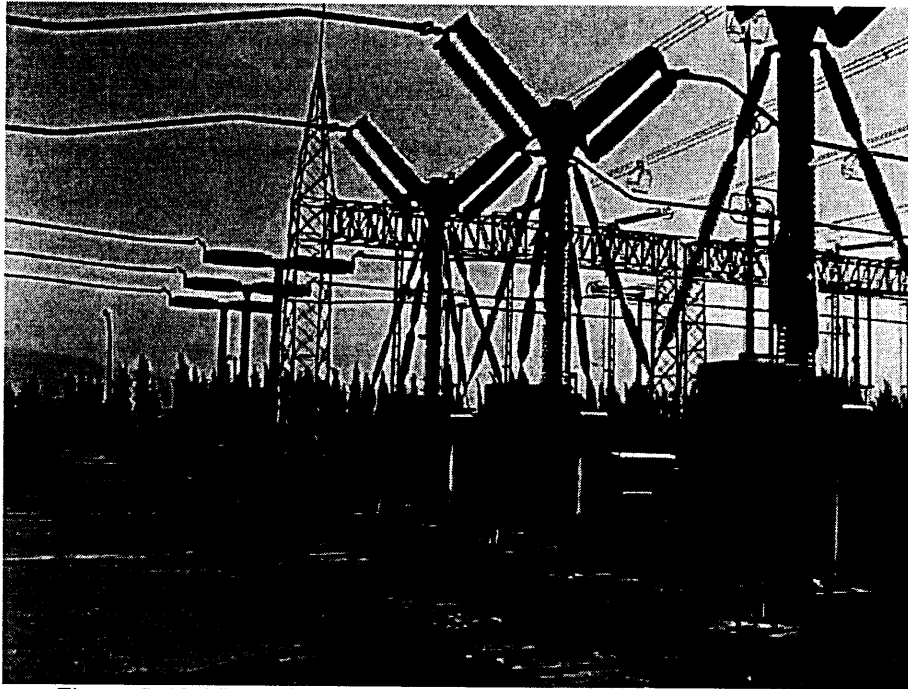
Figure 5-42, shows from South to North, the T-shaped circuit breaker isolators that now replace the damaged Y-shaped ones. Figure 5-43 shows from North to South the tied-down Y-shaped circuit breaker isolators that were not damaged during the earthquake. In the same Figure, only a small distance to the back, one can see the new T-shaped circuit breaker isolators.

Figure 5-43: View of the tied-down Y-shaped circuit breaker isolators

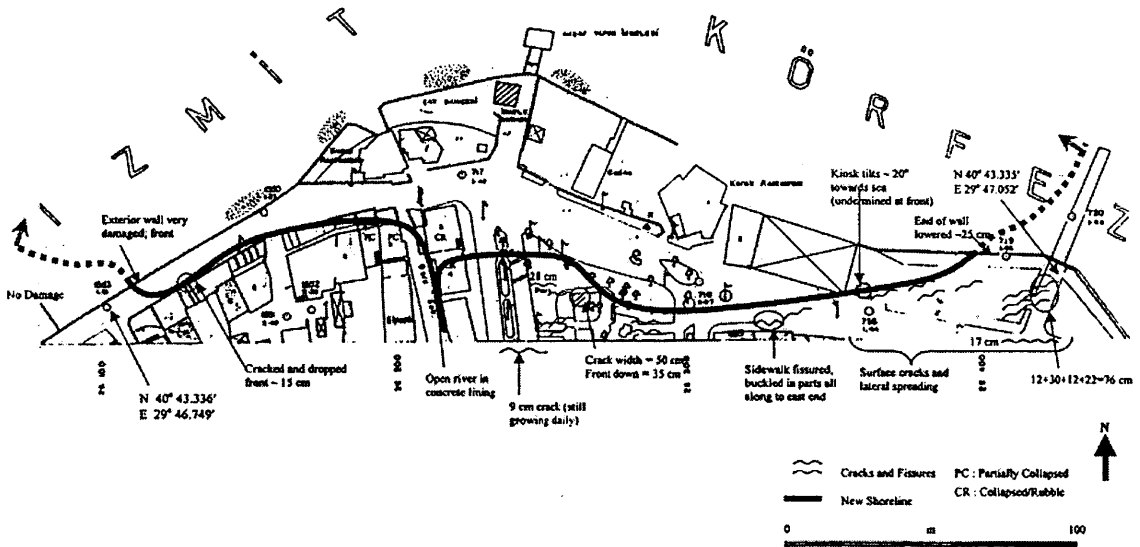
Figure 5-50: Map of failure in the Degirmendere Nose Site.

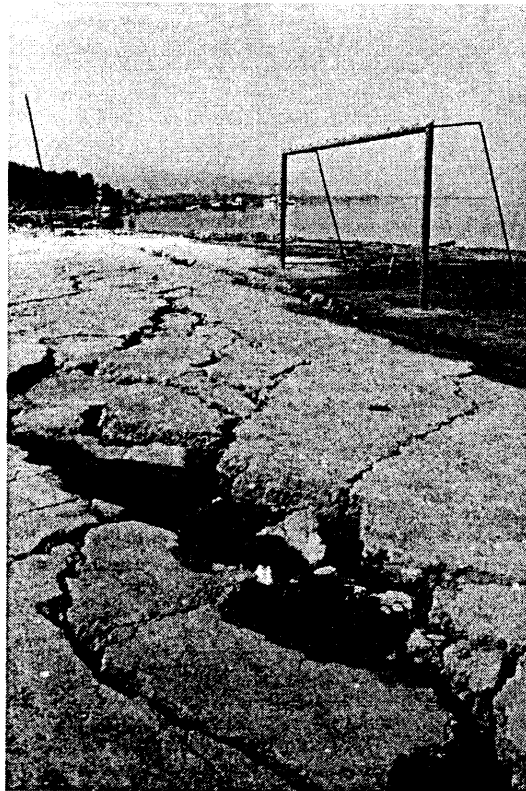
The shore next to a soccer field in the City of Golcuk was another site that underwent lateral spreading. The GPS coordinates of the site are N 40.7177° and E 29.9272°. Figure 5-74 shows the extension cracking that occurred as a result of the lateral movement of the site. A schematic of the site as well as the location of the investigations are provided in Figure 5-75. Figures 5-76 and 5-77 are cross-sections along the site based on the geotechnical investigations performed.

Figure 5-74: Extensive cracking in the Soccer site due to lateral spreading

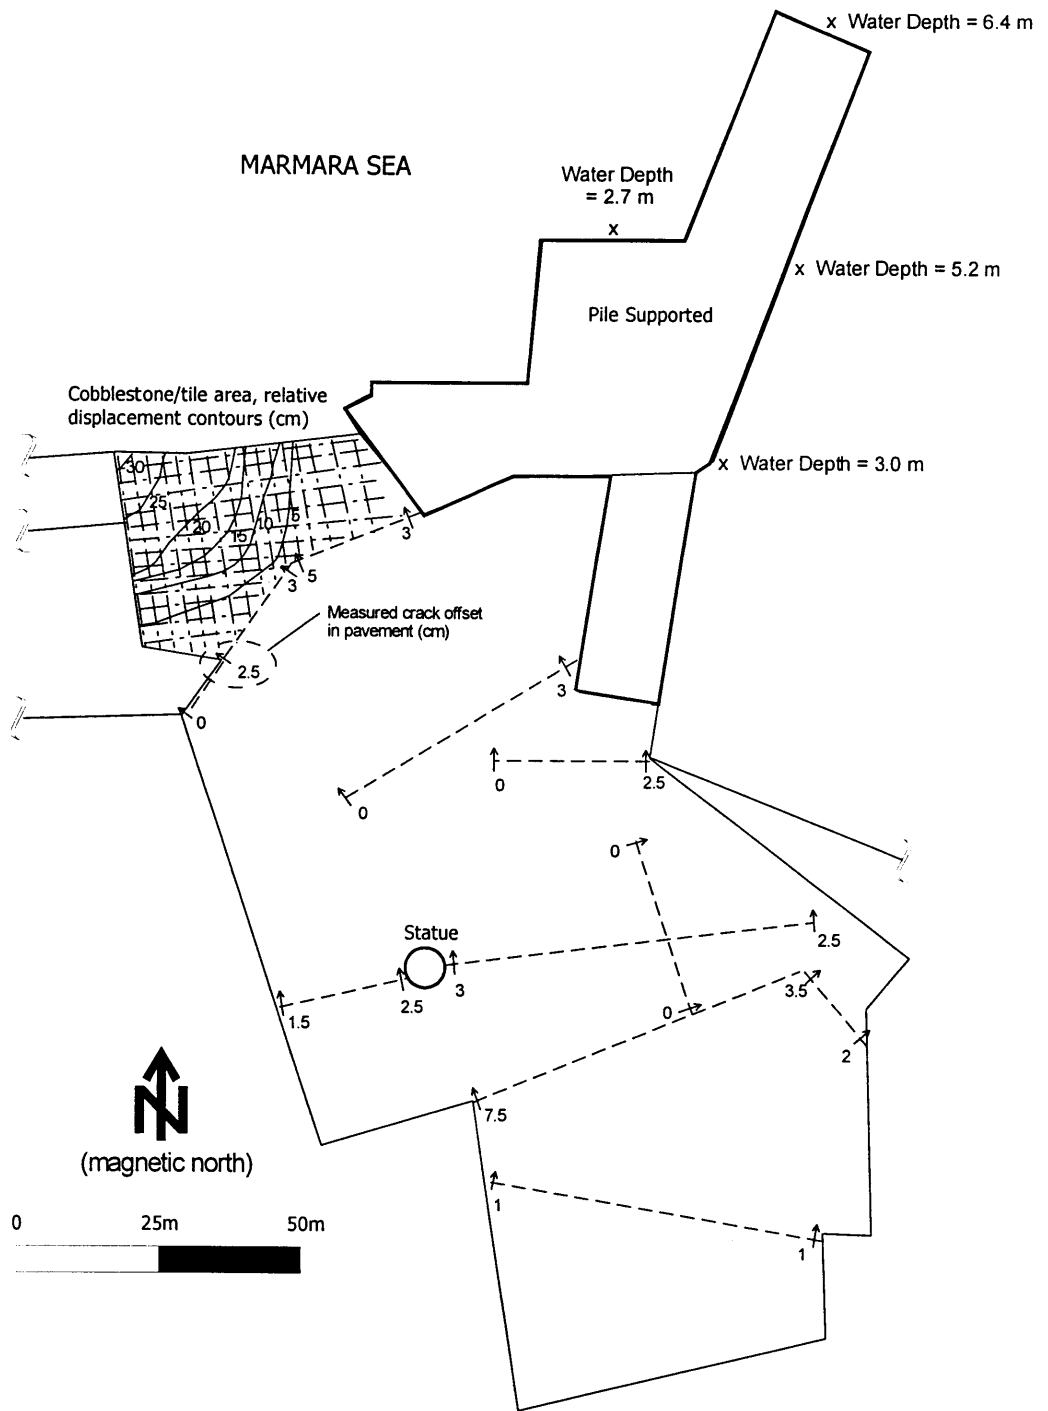
Figure 5-79: Sketch of parking lot and pier at Yalova Harbor

seawall, is paved with cobblestones traversed with marble tiles (Figure 5-81). The tiles/parking area slopes down gently to the north with an average slope of about 3%. The bathymetry around the harbor is not known, but measured water depths at several points around the pier are shown in Figure 5-79.

As shown in Figure 5-79, ground deformations include offsets across cracks in the parking lot, and contours of cumulative deformations across the tiles relative to the south and east ends of the tiled area. The base map in Figure 5-79 is based on length measurements established by pacing, and azimuths from a hand compass. Crack widths were measured with a steel tape.

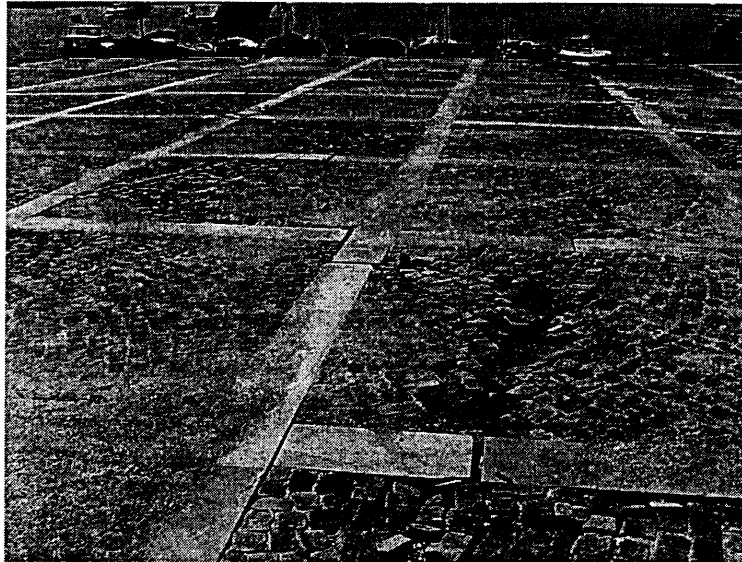
Figure 5-81: Ground cracking in cobblestone/tiles area at Yalova Harbor

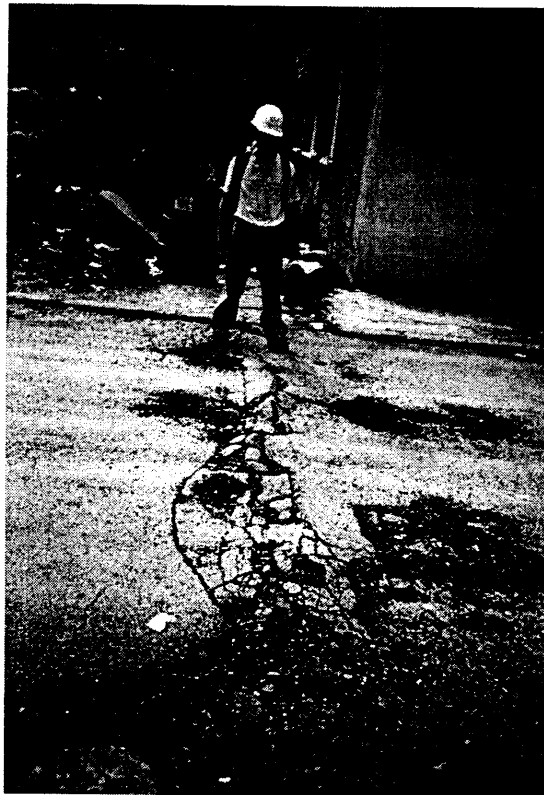
Minor lateral spreading was observed Along Yakin Street, of the City of Adapazari. The GPS coordinates of the site are N 40.77922° and E 30.39487°. Buckling of the pavement (Figure 5-84) and extension cracks (Figure 5-85) of width up to 8cm, were observed. The location of the ground cracks along with the investigation performed on the site is shown in Figure 5-86.

Figure 5-84: Buckling of the pavement in Yakin Street

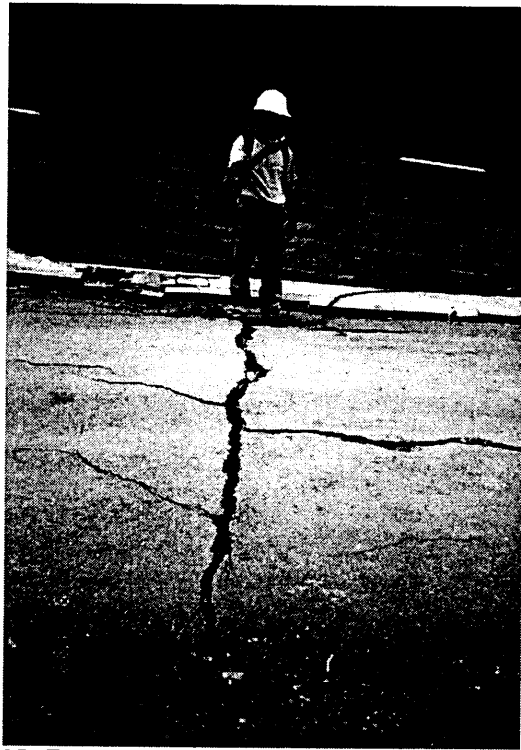
Figure 5-85: Extension cracks on the pavement in Yakin Street

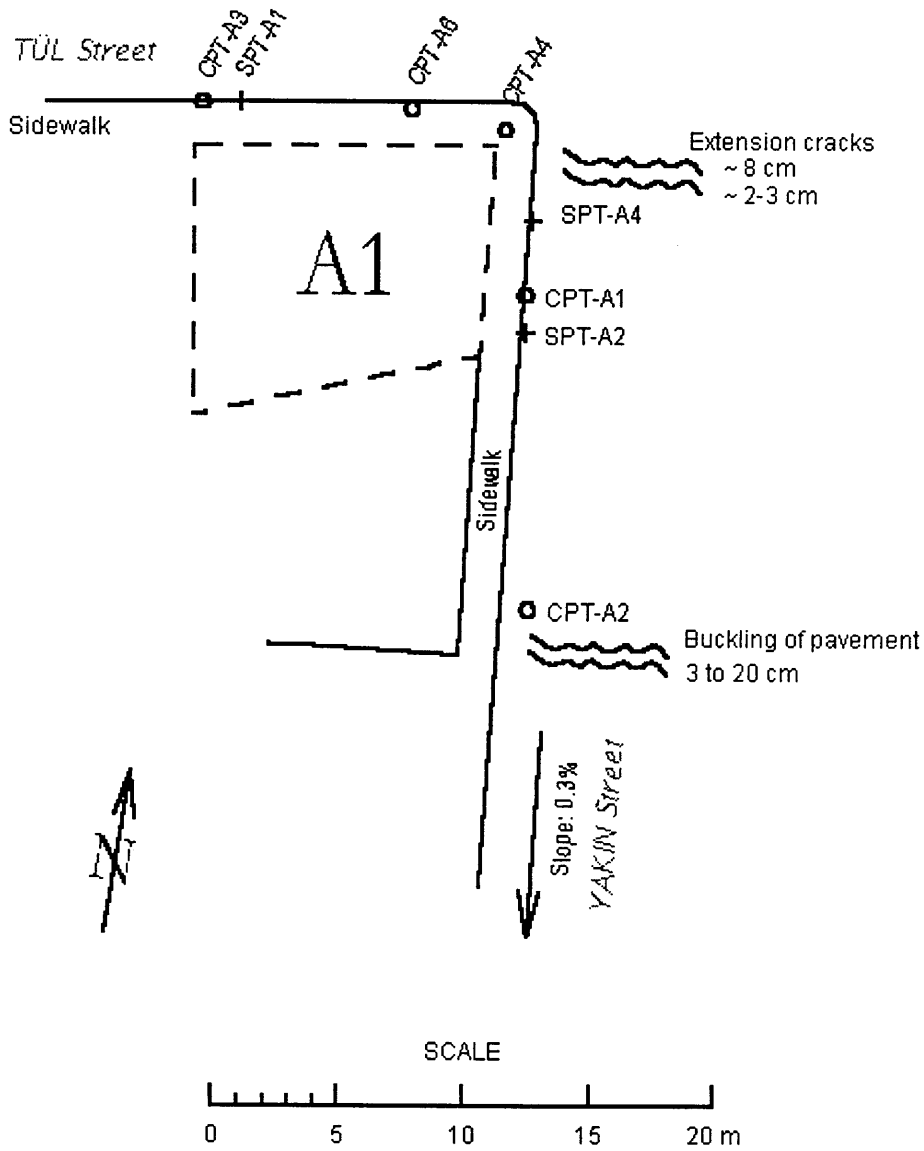
Figure 5-86: Schematic showing the investigation performed on the site and the observations made.

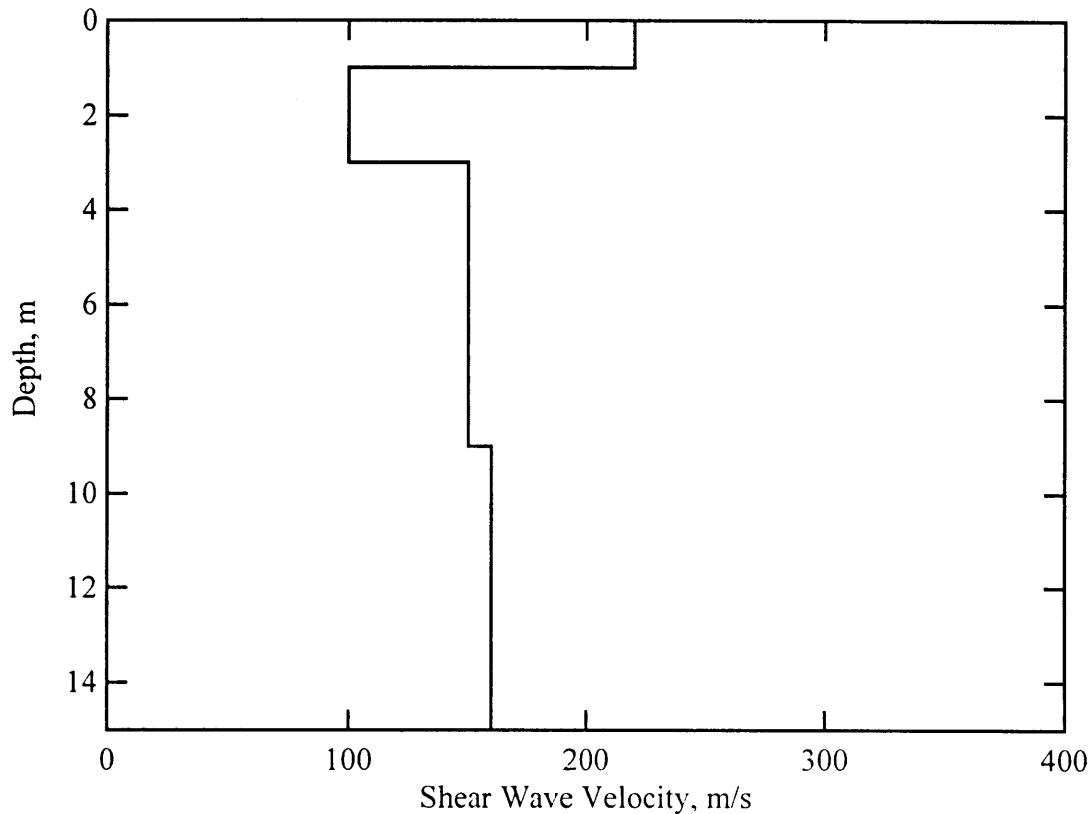
Shear wave velocity profile determined from forward modeling of Site 1-24.

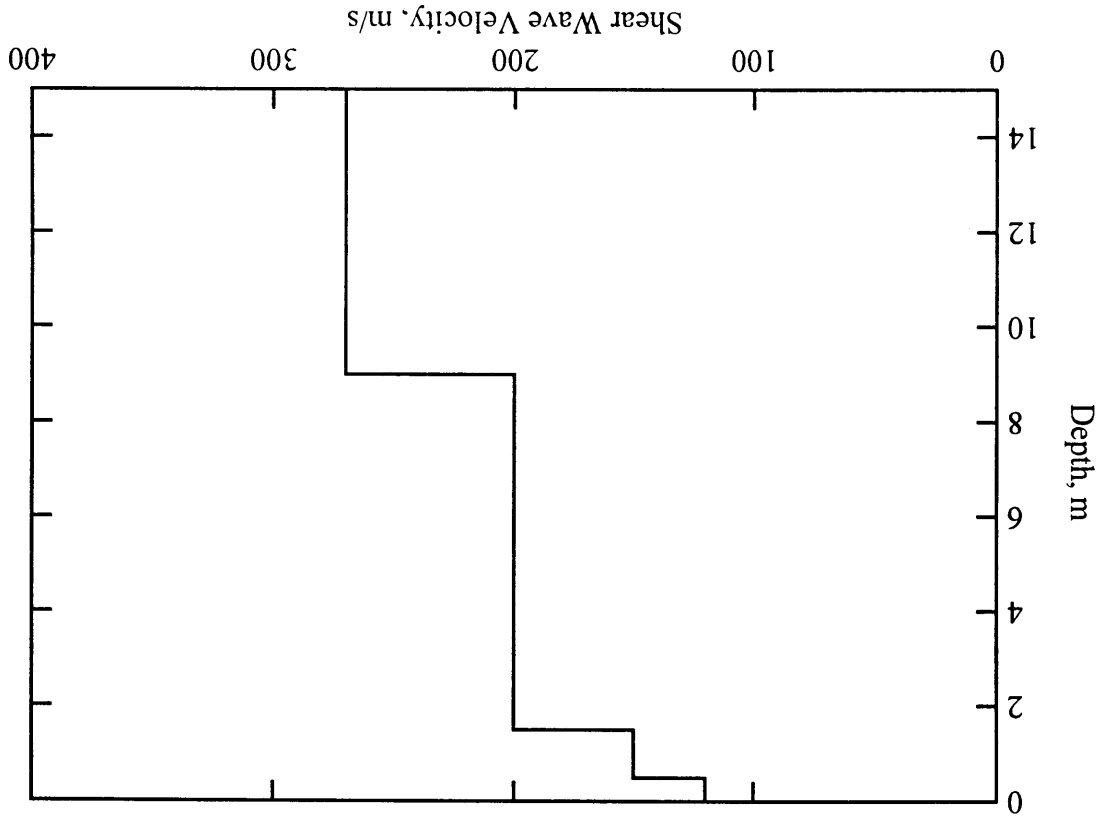
Shear wave velocity profile determined from forward modeling of Degirmendere Nose.
