# February 27, 2010 Chile Earthquake Reconnaissance Team Investigation

## Reinforced Concrete Buildings

Investigate the performance of reinforced concrete buildings (typically 3 – 25 stories) during 8.8 Offshore Maule Earthquake

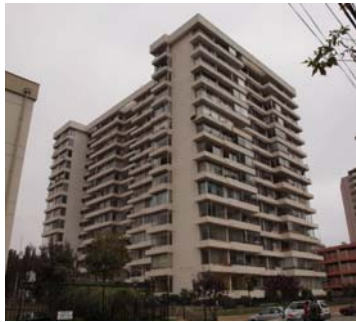
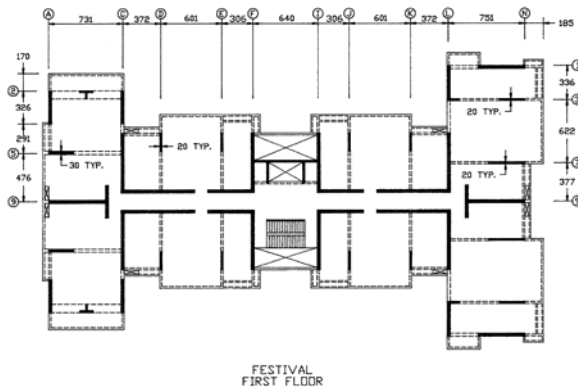
- Festival Building, Viña del Mar, 14 Stories, 1978 construction. Illustrates typical wall building configuration.

A typical building plan has two corridor walls longitudinally with transverse walls.

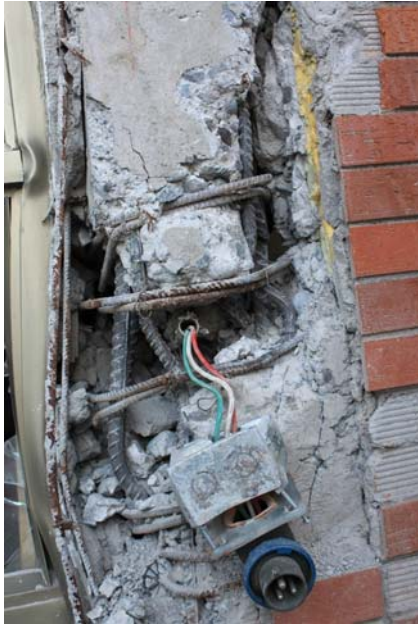
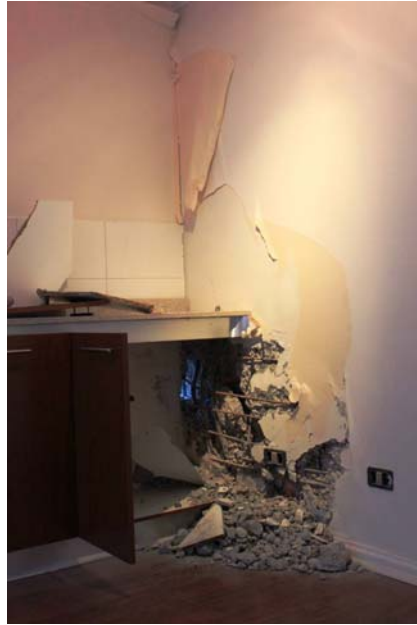
Los Cerezos 33, Ñuñoa, Santiago.

~ 26 story building. Crushed wall from the outside (left) and inside (right). Column below was essentially undamaged.

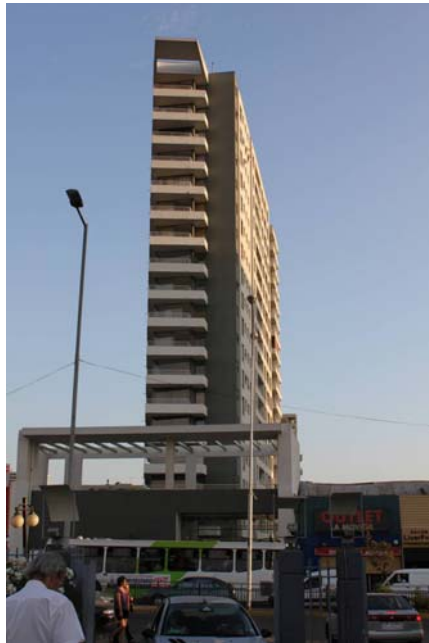
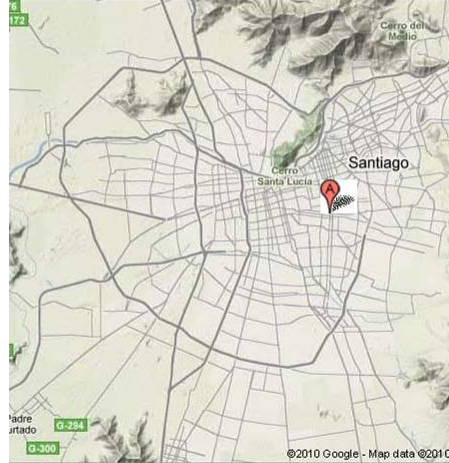
Av. Irarrázaval 2931, Ñuñoa, Santiago.

Emerald Building. ~ 16 stories tall, plan narrow in front, widening to the back.

Roof leaning 22 cm to the left, over walls crushed in the first subterranean level.

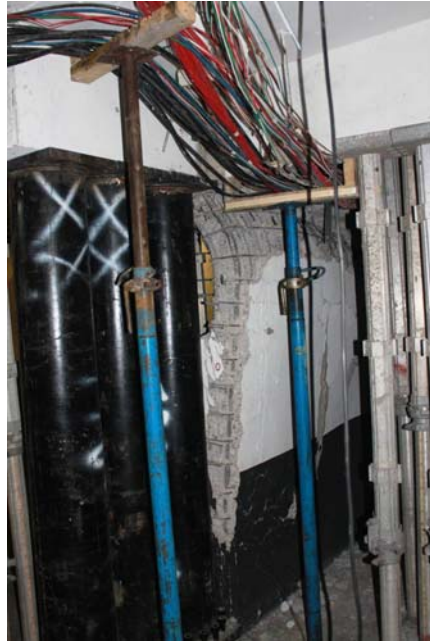
Av. Irarrázaval 2931, Ñuñoa, Santiago.

Buckled wall below grade.

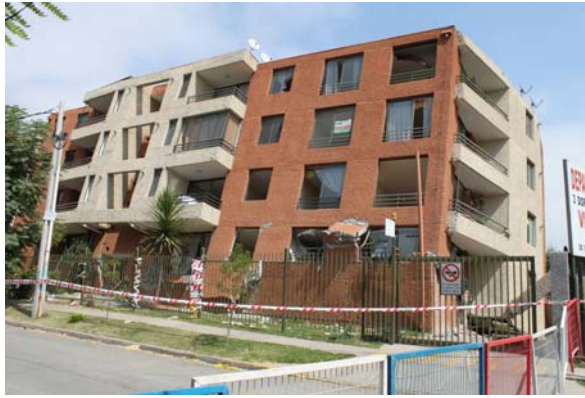
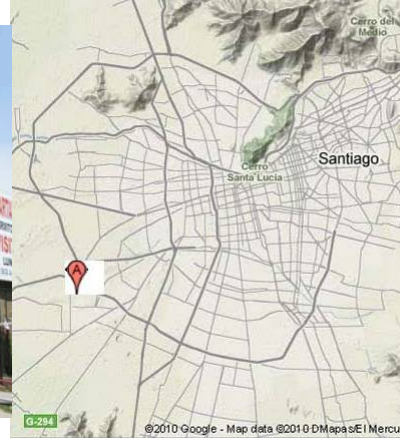
Maipu, Santiago. Edificio Don Tristan

This building collapsed during the main event.

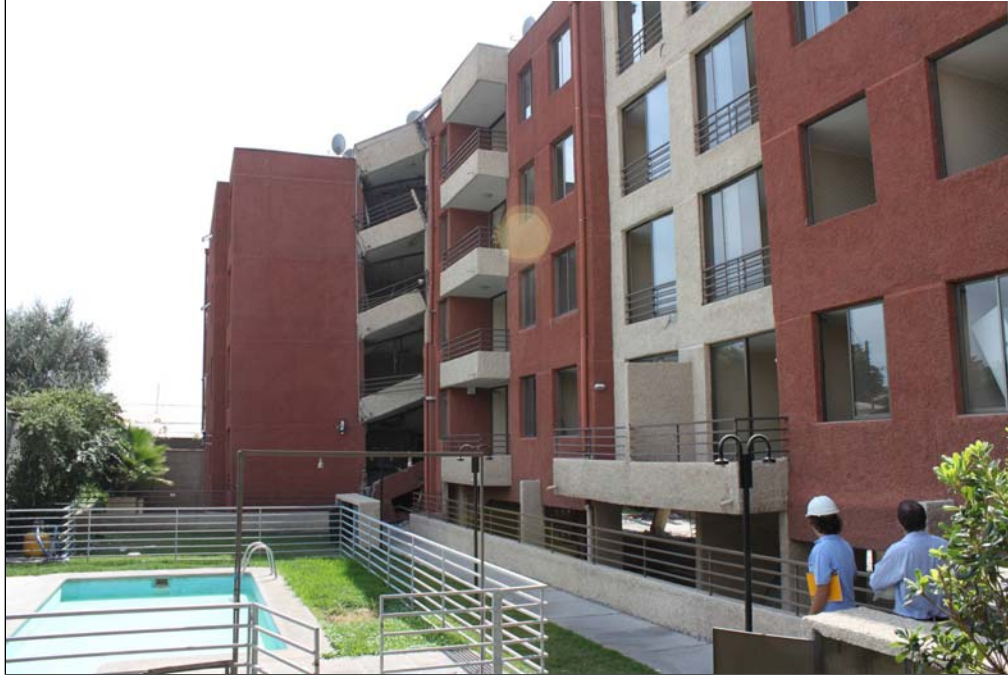
Maipu, Santiago.

Building similar to Building C, located within two blocks.

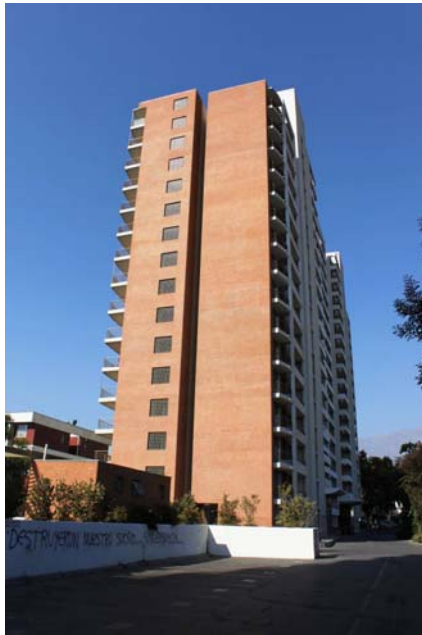
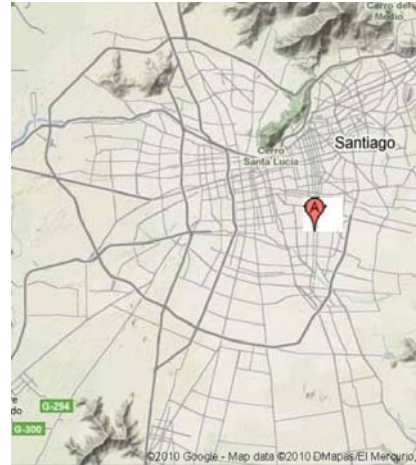
Sol Oriente I and II, Macul, Santiago, Chile.

Complex of highrise condominiums.

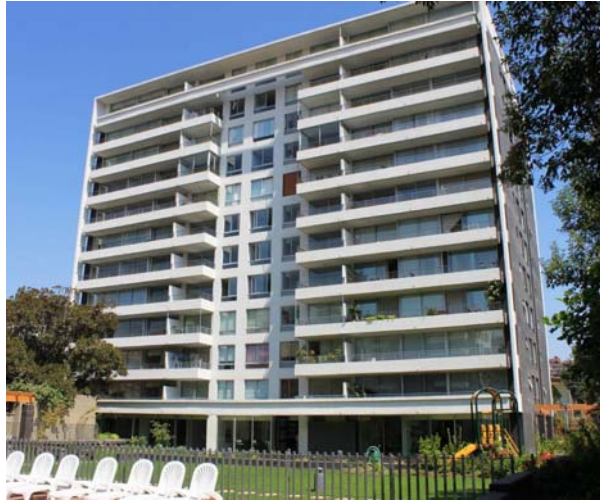
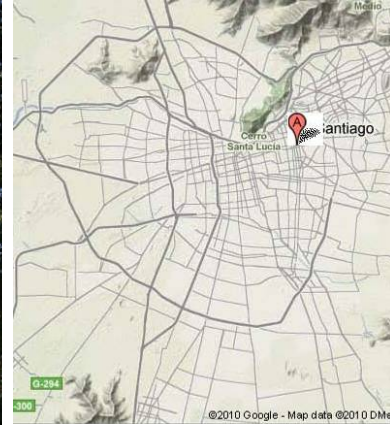
Av Los Leones 1841, Providencia, Santiago, Chile.

12 story reinforced concrete condominium with subterranean parking.

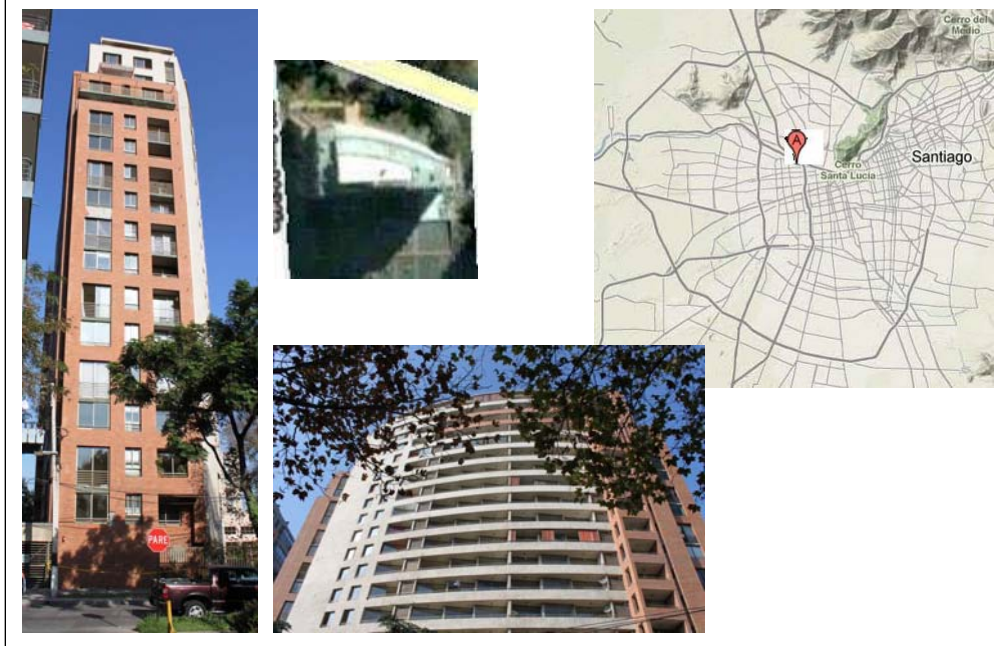
[Av Presidente Balmaceda 2150](#), Providencia, Santiago, Chile.

High rise concrete building. See centrally located Google.earth satellite photo. Elevation to the left is of the narrow part (East face). The bottom center photo is the north face.

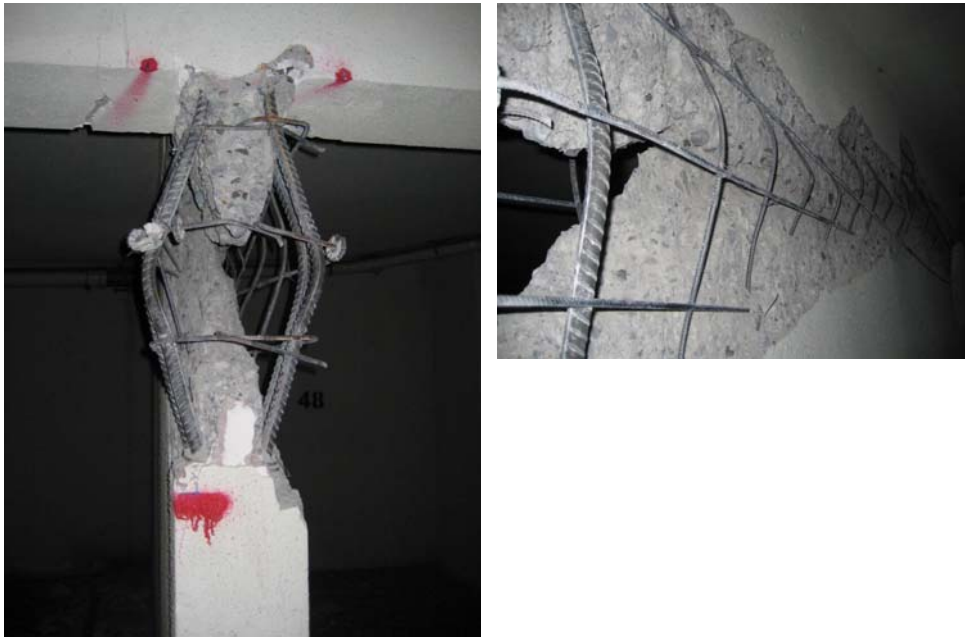
[Av Presidente Balmaceda 2150](#), Providencia, Santiago, Chile.

Interior photos taken by social science members of the EERI LFE team, who had observed a condo-owner meeting. The notes of the EERI LFE Team are copied below.

- This community in Santiago, in the "Central Park" building on Balmaceda Street has suffered structural damages in their high-rise apartment building, which houses about 150 units.

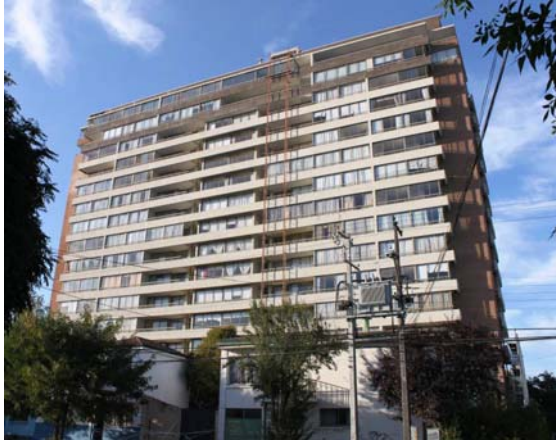
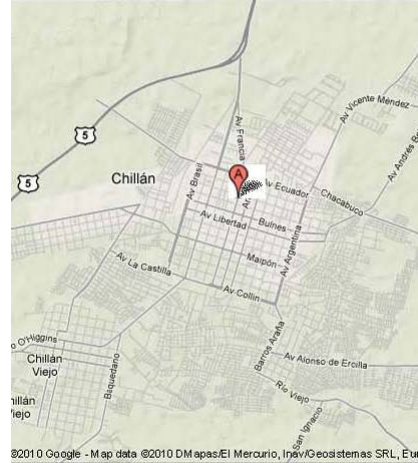
18 de Septiembre 235, Chillan, Chile

15 story concrete building with subterranean levels. Met with construction representative who was conducting repairs.

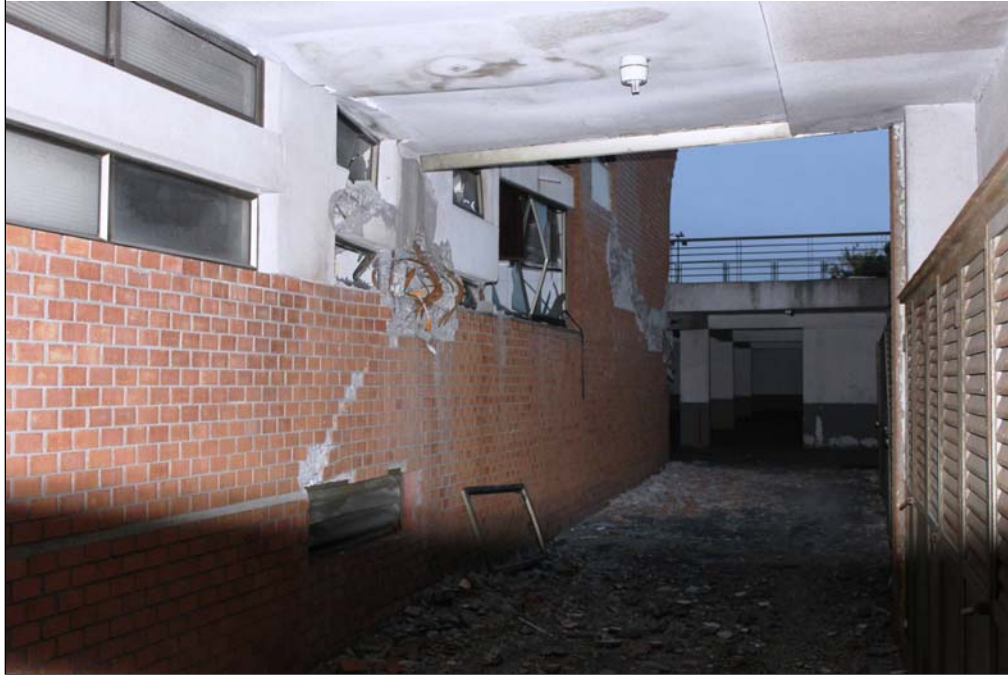
## Concepción, Building A

Approximately 18 story concrete building without subterranean levels.

View under 4-story wing to right of building.

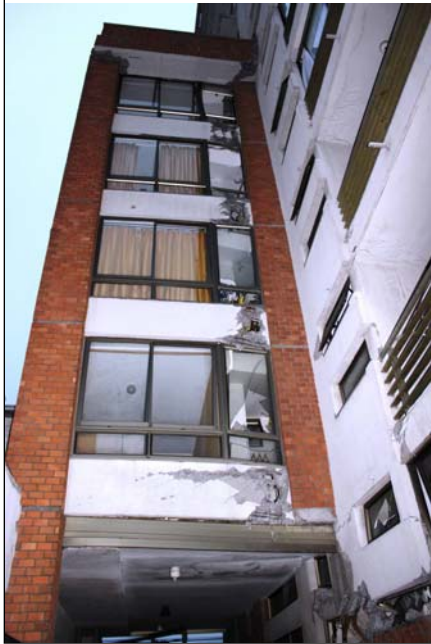
## Concepción, Building A

Approximately 18 story concrete building without subterranean levels.

View back toward 4-story wing to the right of the building. Note that the building has subsided, shearing the wing. Similar damage on the other side of the building.

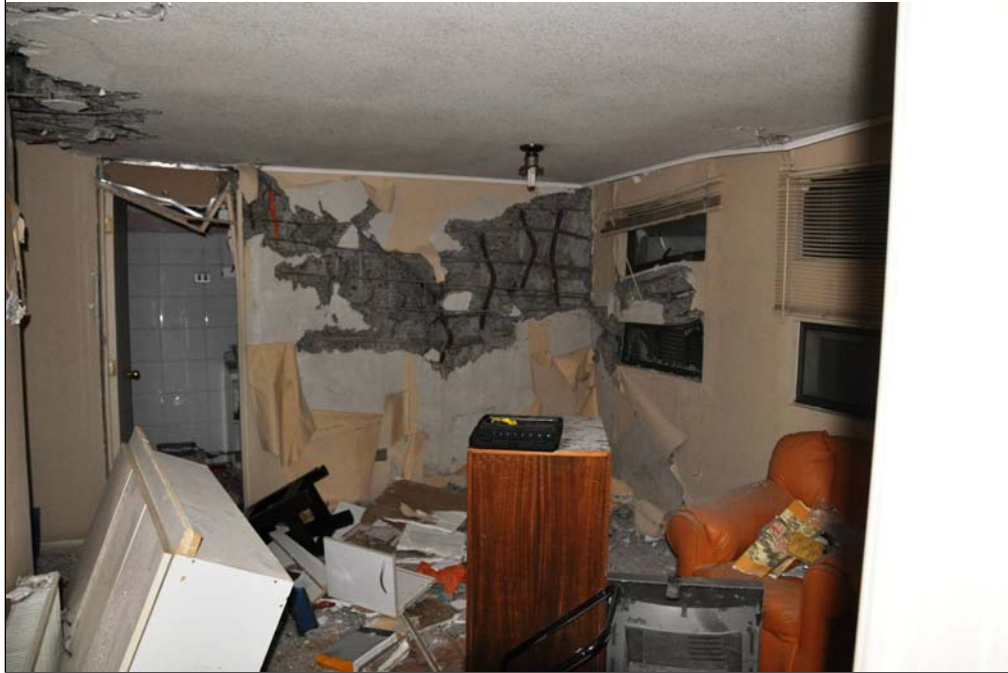
## Concepción, Building B

Approximately 18 story concrete building without subterranean levels.

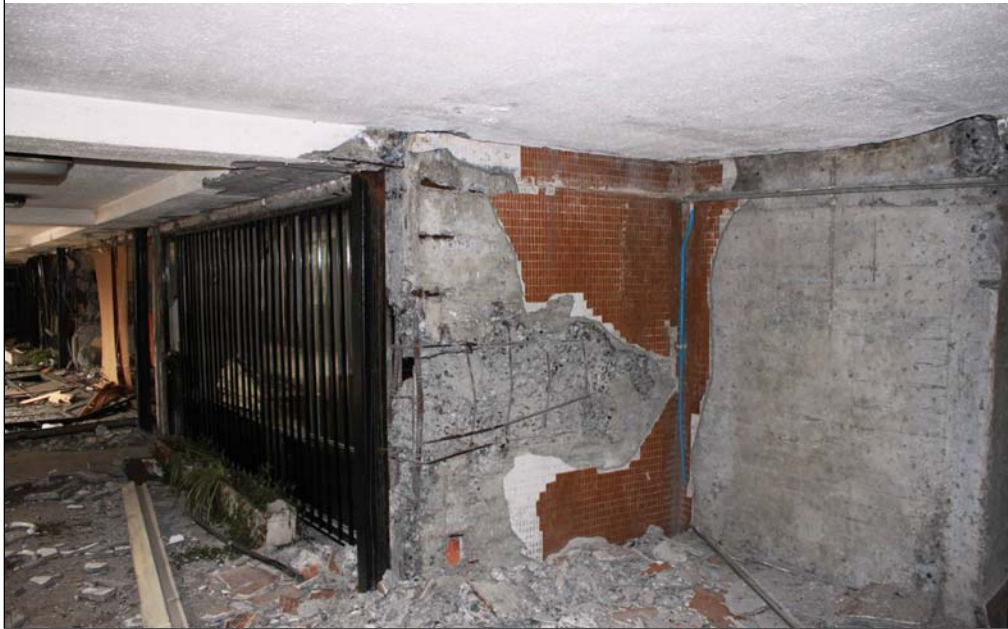
## Concepción, Building C

Approximately 18 story concrete building without subterranean levels.

First level above grade. Street is toward the right.

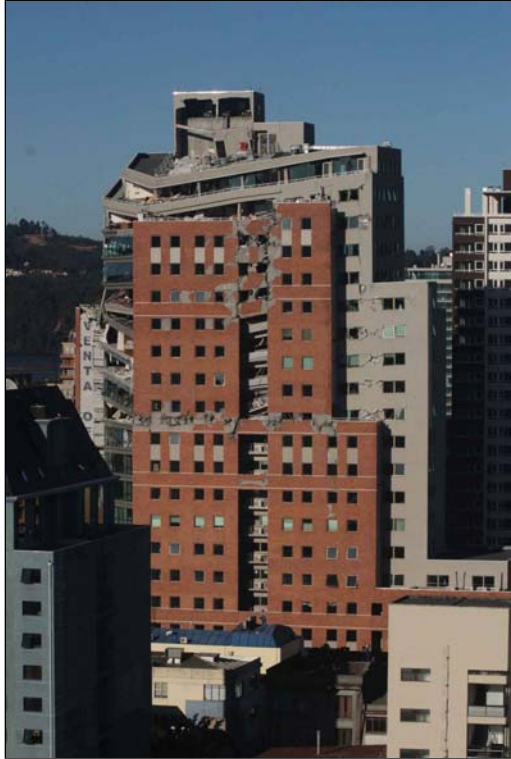
## Concepción, Building D

Approximately 24 story concrete building.

View from roof of nearby building.

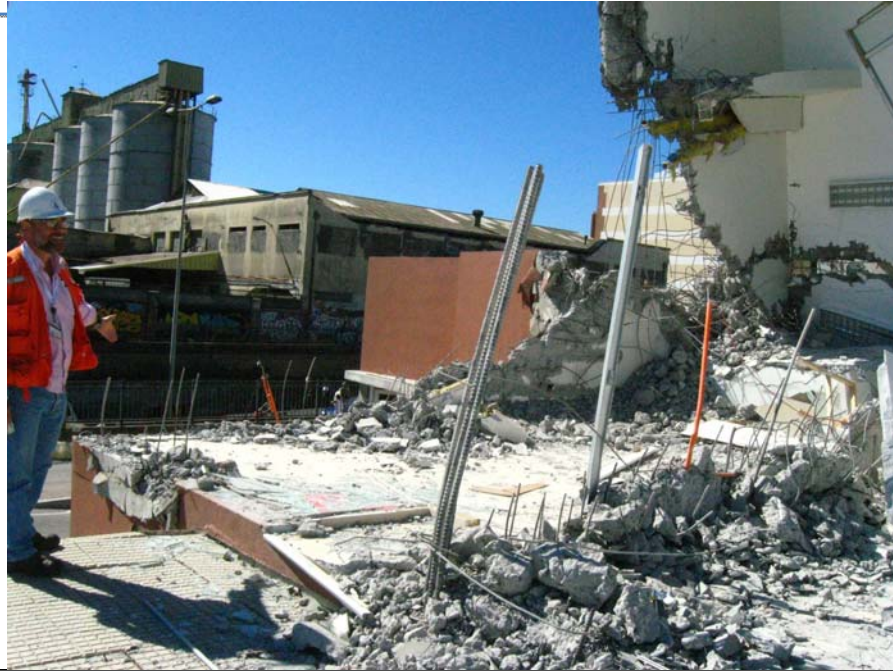
## Concepción, Building I

12 story concrete building. Torre Alto Rio.

Professor Borosc hek standing near corner of first story of building.

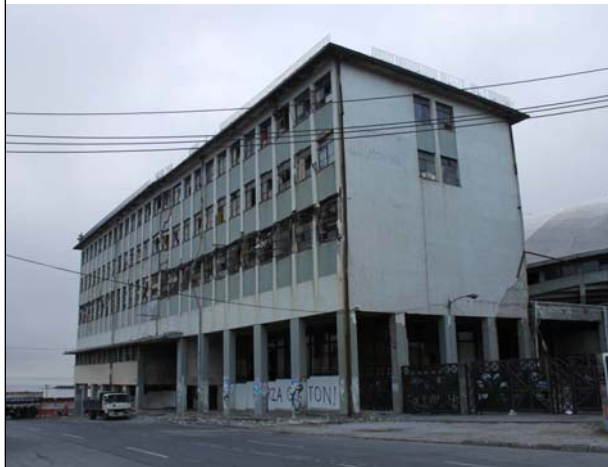
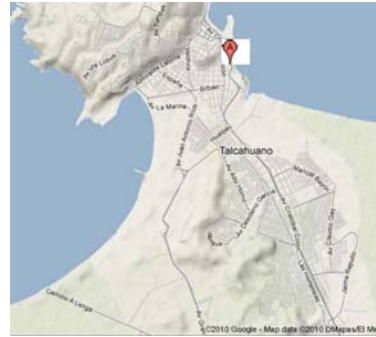
## Talcahuano, Building A

Gymnasium building. Reinforced concrete. Ca 1955.

The superstructure has a joint down the middle, creating two similar building abutting one another. The building on this end has an end wall. The building on the other end has columns all around.

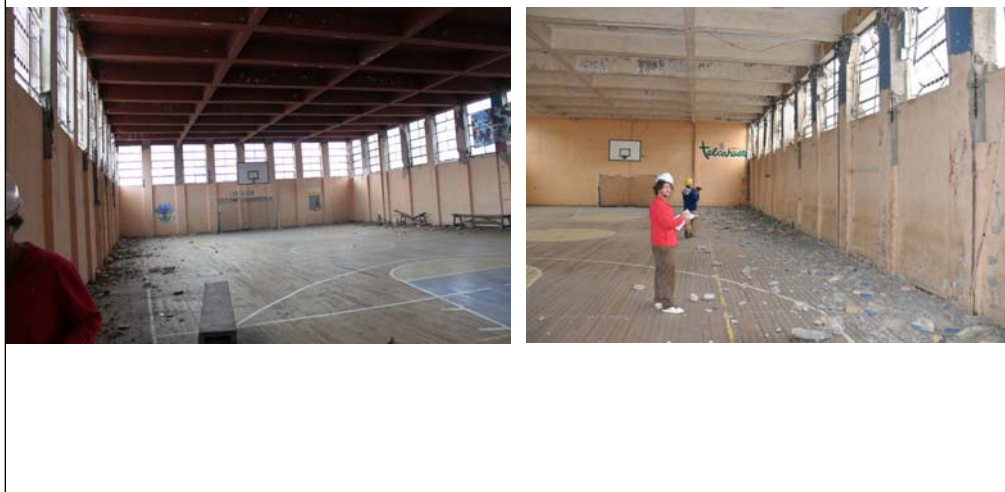
## Talcahuano, Building A

Gymnasium building. Reinforced concrete. Ca 1955.

View inside the western half of the building (left) and the eastern half of the building (right)
