Repair/Upgrade Procedures for Welded Beam to Column Connections

James C. Anderson

Report No. PEER-98/03
Pacific Earthquake Engineering Research center
College of Engineering
University of California, Berkeley
May 1998

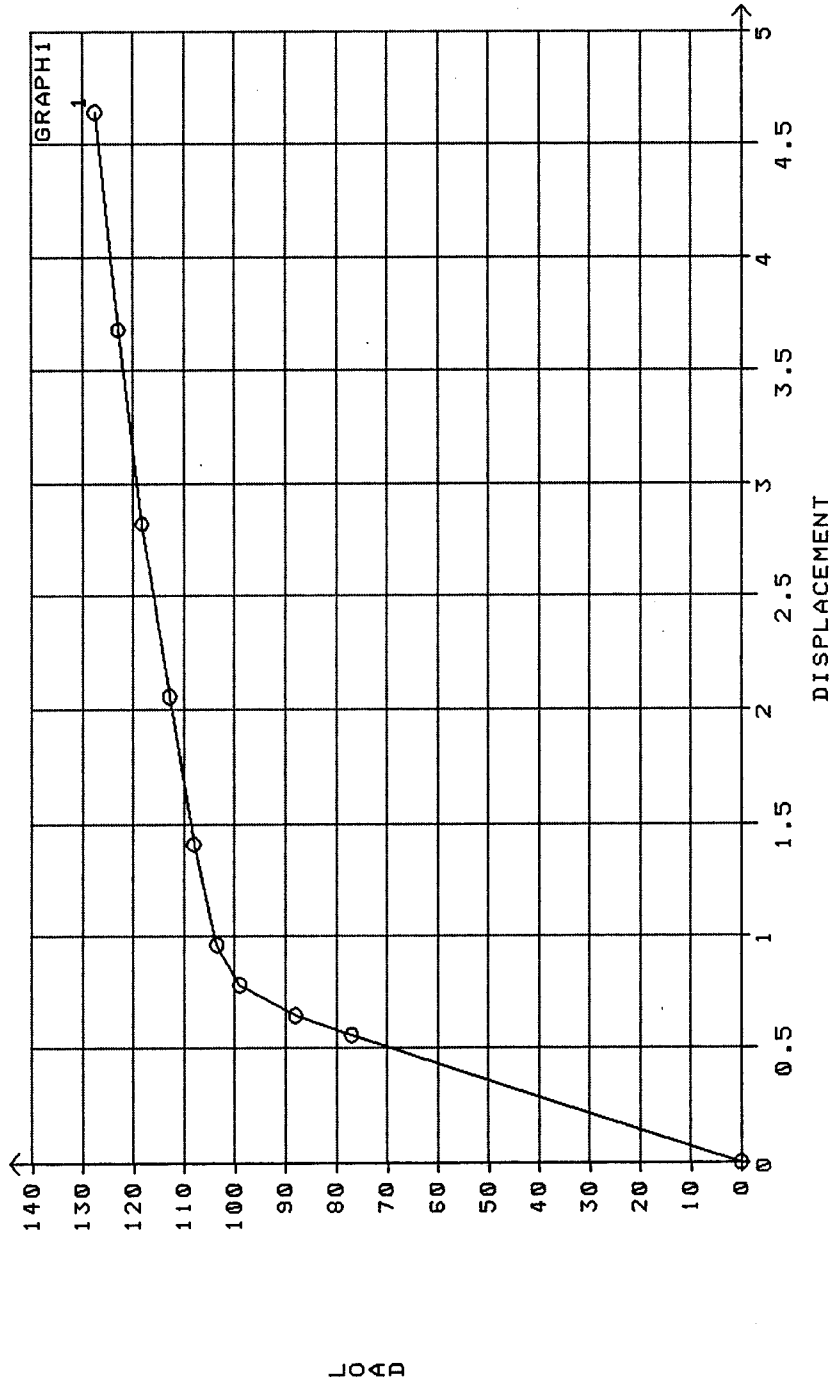
Figure 4.1.1 Calculated Force vs. Displacement, Spec. 1

The cyclic performance of the specimen is summarized in **Figure 4.1.5**. The total rotation was 2.3 percent (**Figure 4.1.5a**), however, the plastic rotation was only 0.5 percent (**Figure 1.5b**). The displacement history, shown in **Figure 4.1.5c**, indicates the nine displacement cycles the specimen was able to sustain. The history of the force at the beam tip, shown in **Figure 4.1.5d**, indicates that there was no unloading of the specimen prior to failure suggesting a sudden type of pullout. At a tip displacement of 1 1/2 inches, the finite element analysis estimated a force of 108 kips (**Figure 4.1.1**). This agrees very well with the 108 kips measured at the beam tip (**Figure 4.1.5d**).

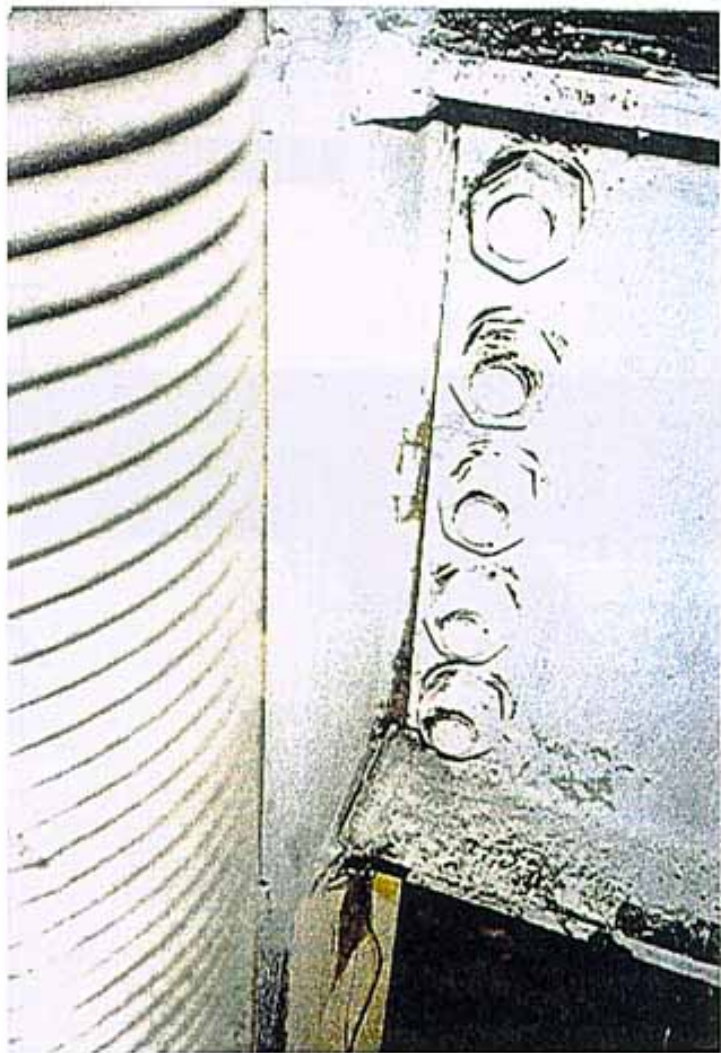
Figure 4.1.4 Bottom Flange Pullout, Sec. I

The specimen sustained three displacement cycles at each amplitude of 1/2 inch, 1 inch and 1 1/4 inches. On the third cycle at a displacement amplitude of 1 1/2 inches, the specimen experienced a pullout at the bottom beam flange (**Figure 4.1.4**) during an upward stroke of the hydraulic cylinder. This type of failure is similar to those experienced by many welded moment frames during the Northridge earthquake. The test was stopped at this point so that the specimen would not be damaged beyond repair.

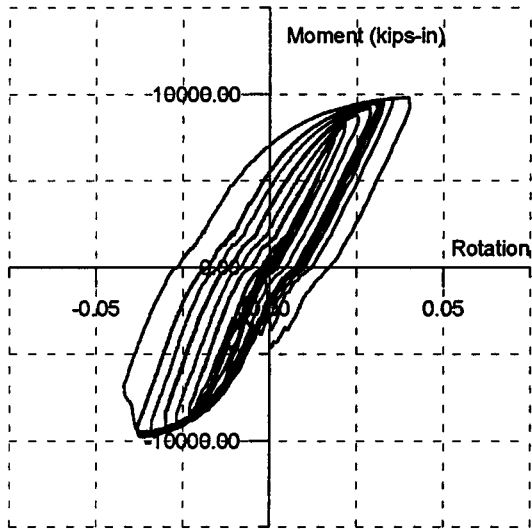
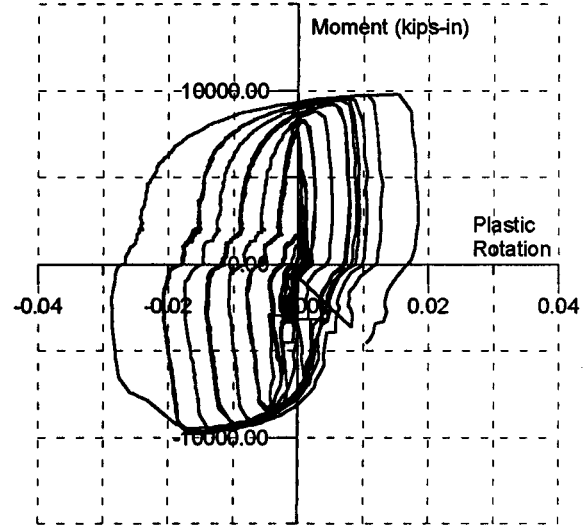
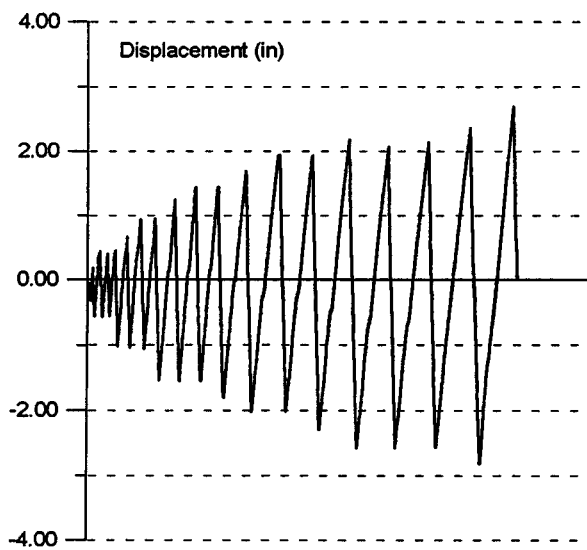
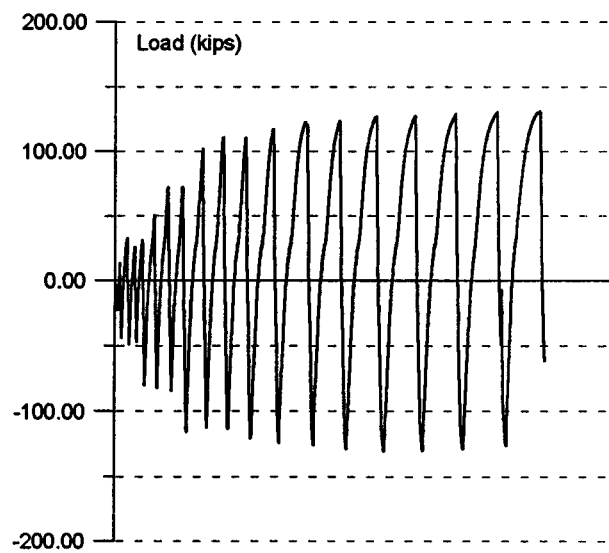
Figure 4.2.3 Cyclic Behavior, Spec. 1R

The cyclic behavior of the specimen after repair is summarized in **Figure 4.2.3**. It can be seen that there is a significant increase in the deformation capacity of the connection. The connection was able to sustain 17 cycles of increasing displacement (**Figure 4.2.3c**) and developed a total rotation of 4.0% (**Figure 4.2.3a**). However, the plastic rotation increased to only 1.5% (**Figure 4.2.3b**), which is still not considered to be adequate. No unloading of the specimen occurred prior to failure (**Figure 4.2.3d**). Failure occurred when a crack opened in the top beam flange (**Figure 4.2.4**). It can be seen that the crack appears to have started in the web cope and then propagated across the beam flange. Whitewash on the beam indicated the formation of a plastic hinge as shown in **Figure 4.2.5**. On the last full cycle, prior to failure, both the top and bottom beam flanges buckled. The moment capacity was increased by 33%.

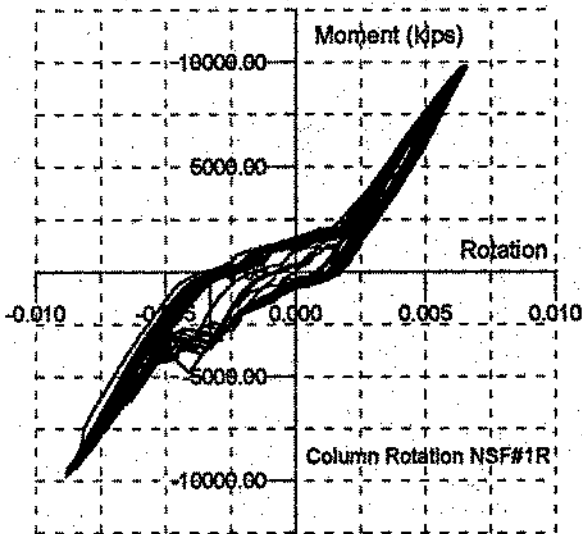
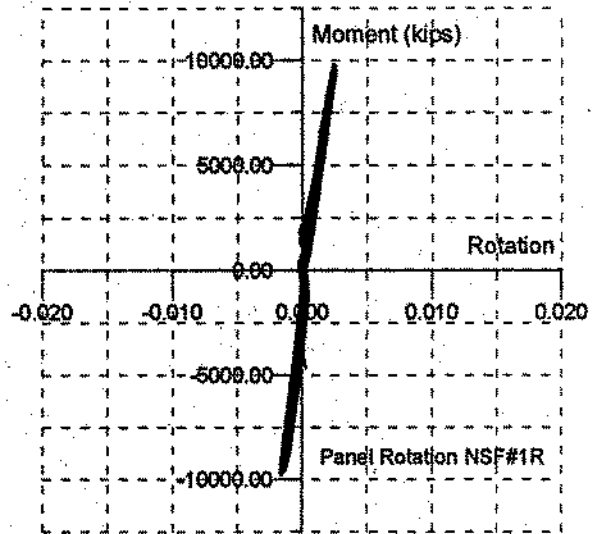
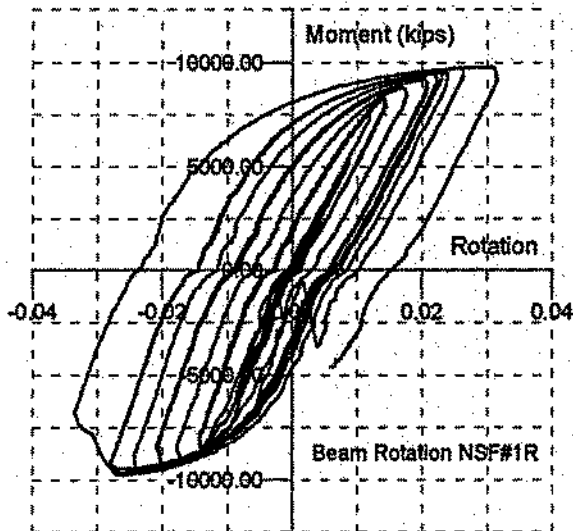
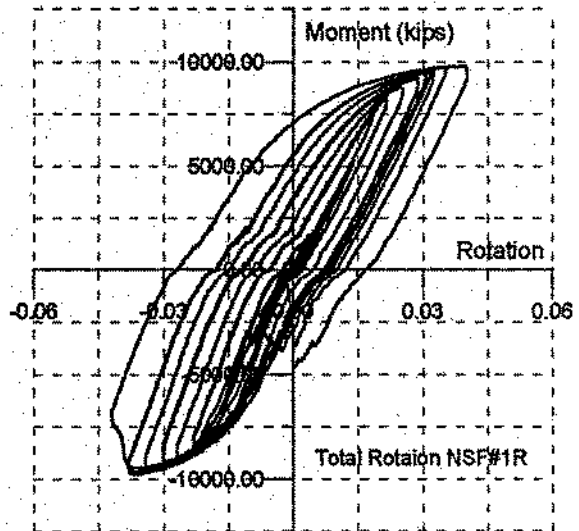
Figure 4.2.6 Rotation Components, Spec. 1R

The rotation components for the repaired specimen are shown in **Figure 4.2.6**. This figure indicates that the panel zone rotation is .25%, the column rotation is .62% and the beam rotation is 3.12% for a total of 4.0%. Since the panel zone remained elastic during the initial test, it was possible to measure strains at this location during the test in the repaired condition (**Figure 4.2.7**). Strain measurements indicate that yielding occurred in the panel zone with strains reaching 0.5%.

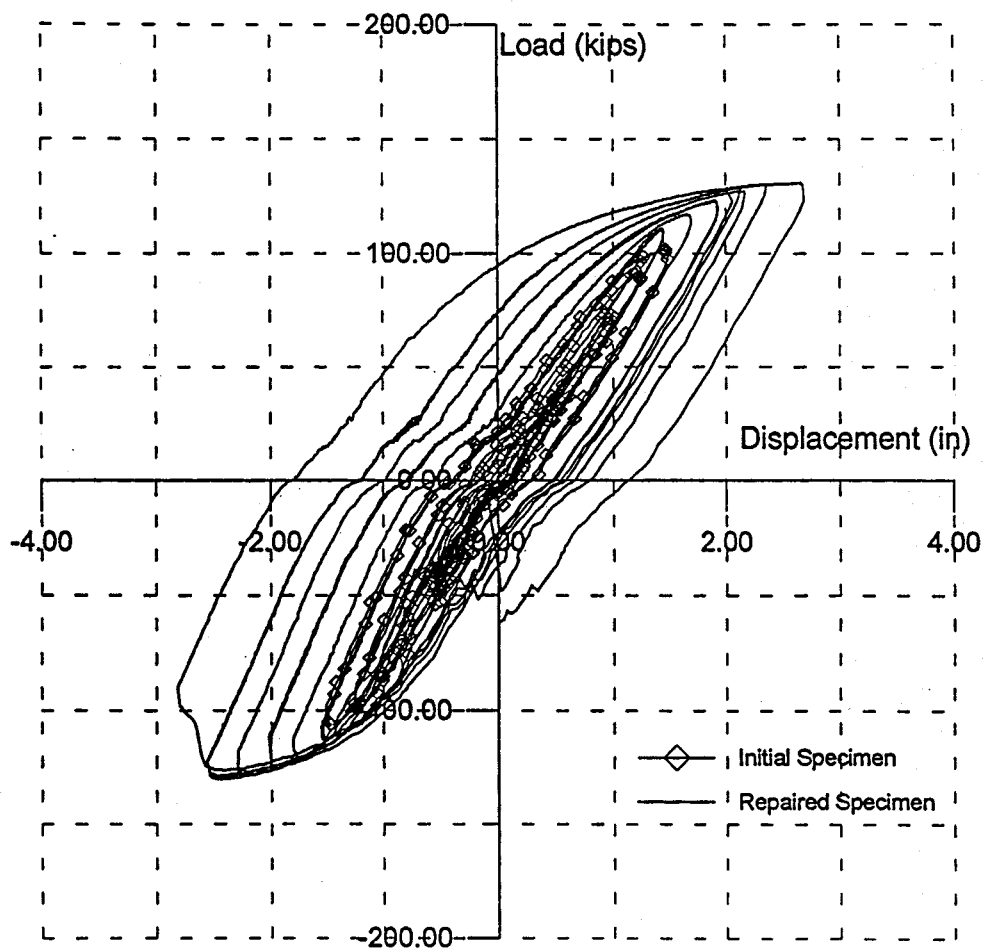
Figure 4.2.8 Comparative Hysteretic Behavior (1 & 1R)

Note that the weld at the top beam flange was made using FCAW with E70T-4 wire and the one at the bottom was made using SMAW with E7018 electrode. Plots of the load versus displacement hysteresis for the original test and for the repair test are compared in **Figure 4.2.8**. This result tends to imply that if the welds on the "standard connection" are done properly and the back-up bar is removed and replaced by a reinforcing fillet weld, the connection will perform in a reasonable manner, at least for the smaller sections considered in this study.

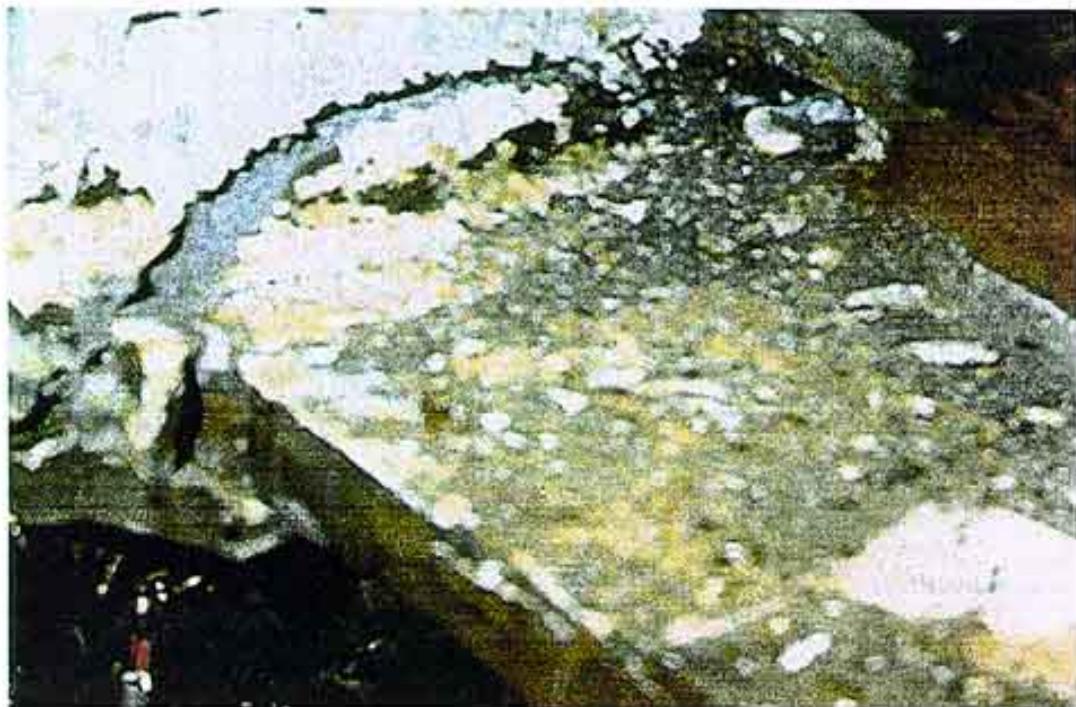
Instrumentation was similar to that for specimen #1 (**Figure 4.1.3**). Failure of this specimen was similar to the previous specimen with a sudden pullout occurring at the bottom beam flange (**Figure 4.3.3**) during an upward stroke of the hydraulic cylinder. The brittle pullout at the bottom flange of the beam also created a vertical crack that ran up the column flange.

Figure 4.3.3 Pullout at Bottom Flange of Beam

The connection pullout at the bottom flange of the beam was repaired in the laboratory using the same Class B weld repair procedure as used for Specimen #1R (**Figure 4.2.1**). The crack in the column flange was found to encompass about one-fourth the flange depth and to extend upward for 1.5 inches. The entire crack area was gouged out as shown in **Figure 4.4.1**. Ductile weld material (E7018) was "battered" onto the column flange and the beam was rewelded to the column (**Figure 4.4.2**). The shear tab was welded along the vertical side with just short returns at the top and bottom. Since there was no visible damage to the weld at the top flange, nothing was done to this weld. Unfortunately, it was not possible to ultrasonically test the repair welds before testing.

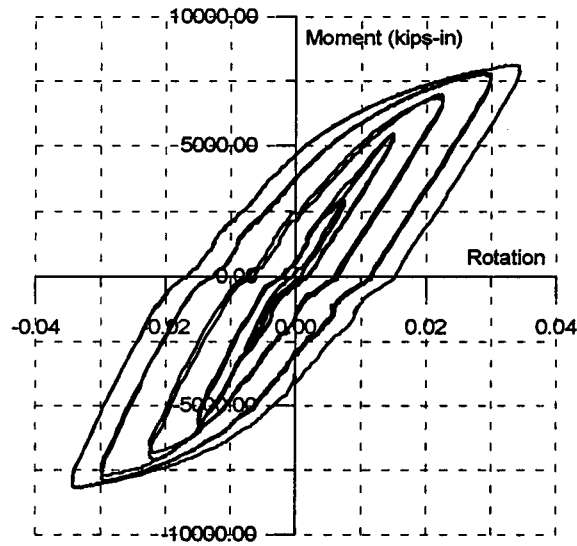
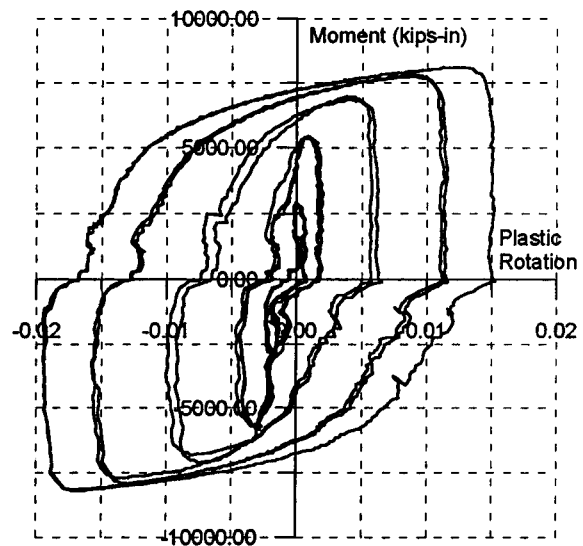
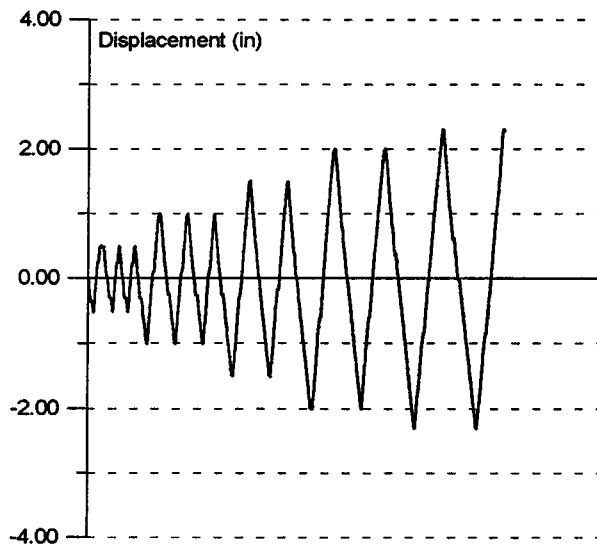
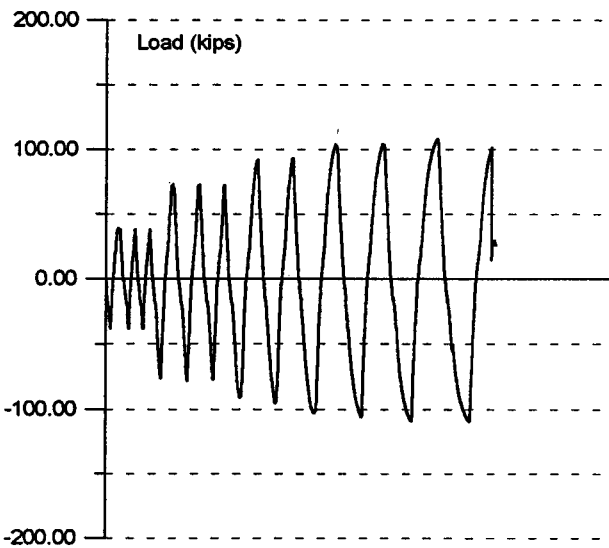
Figure 4.3.4 Cyclic Behavior, Spec. 2

The cyclic performance of the specimen is shown in **Figure 4.3.4**. The specimen was only able to sustain 11 cycles of increasing displacement as shown in **Figure 4.3.4c**, reaching a maximum displacement of 2 1/4 inches which is representative of a total rotation of 3.4 percent (**Figure 4.3.4a**). The plastic rotation was approximately 1.52 percent as shown in **Figure 4.3.4b**. The history of the load at the beam tip, shown in **Figure 4.3.4d** indicates there was no unloading of the specimen prior to failure.

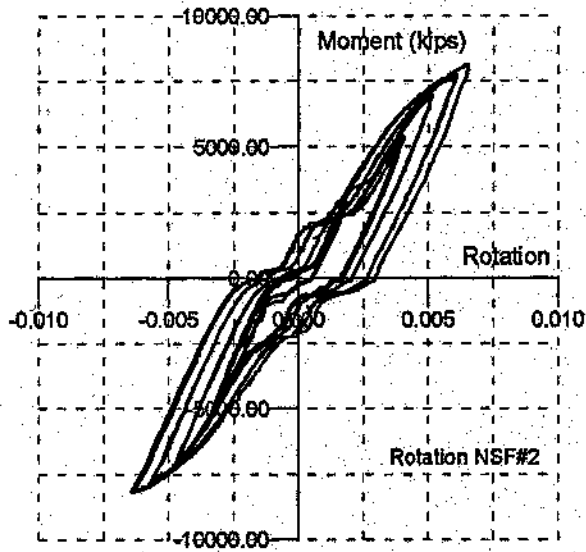
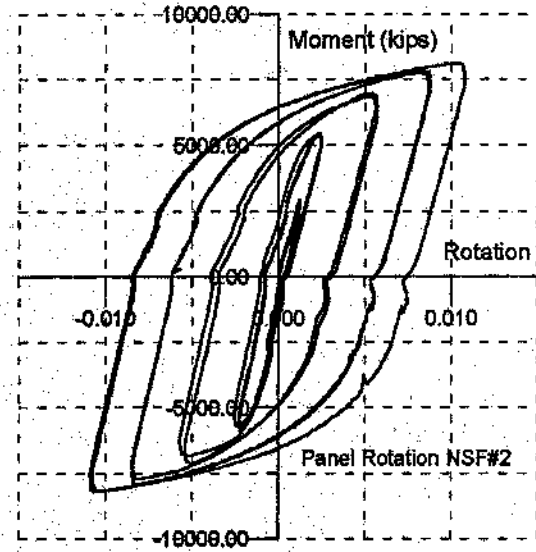
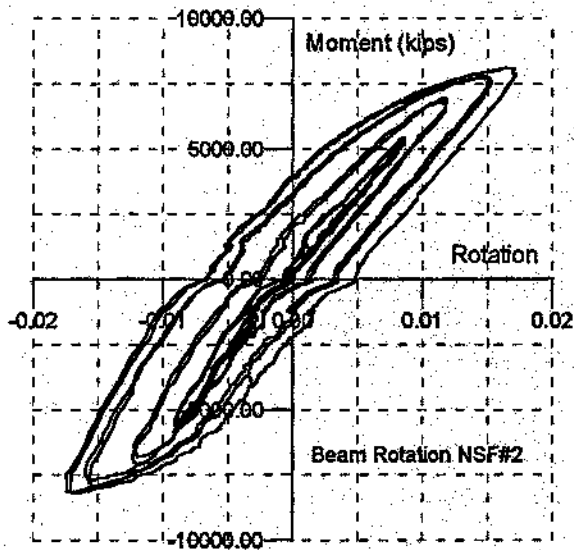
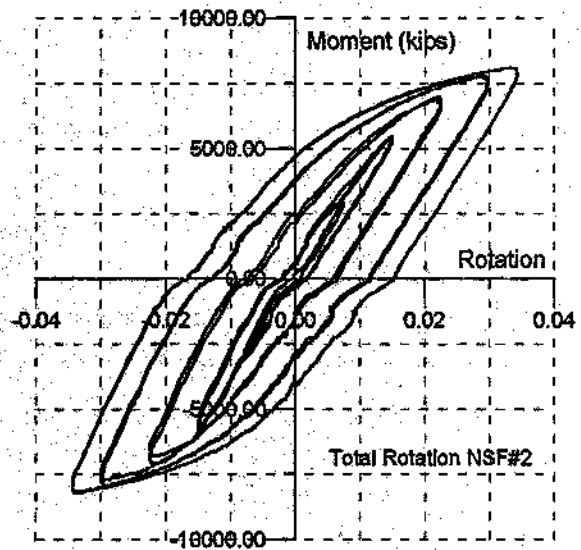
Figure 4.3.5 Rotation Components, Spec. 2

The distribution of the rotation components is shown in **Figure 4.3.5**. This figure indicates that the panel rotation was 1.1%, the column rotation was 0.6% and the beam rotation was 1.7% for a total rotation of 3.4%. Comparison with the similar data for specimen #1 indicates that most of the increased rotation for specimen #2 is due to deformation of the panel zone. Strain measurements at four locations across the bottom flange of the beam, shown in **Figure 4.3.6**, indicate that peak strains were approximately 2.2 percent.

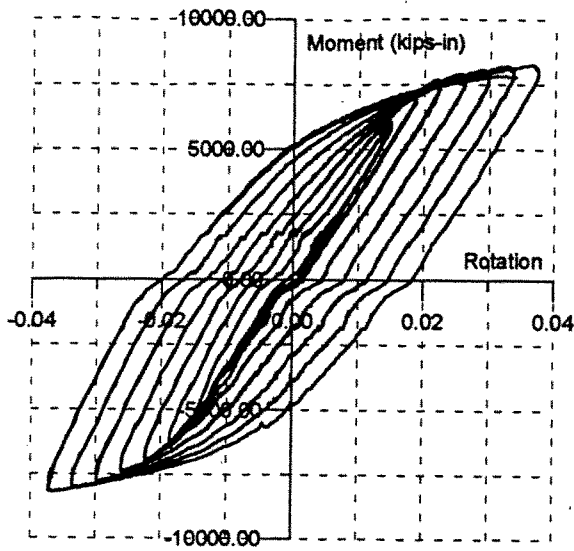
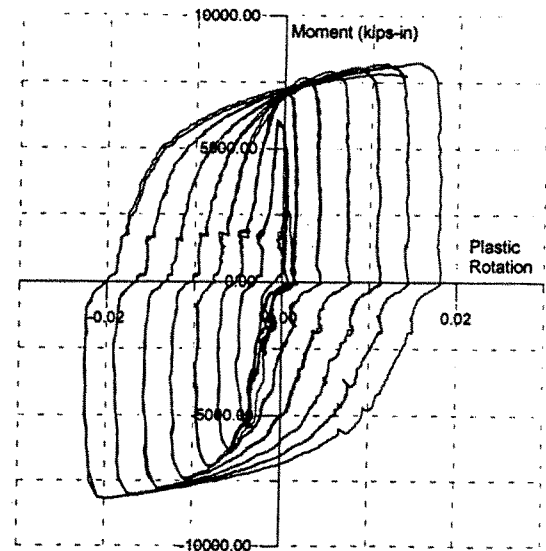
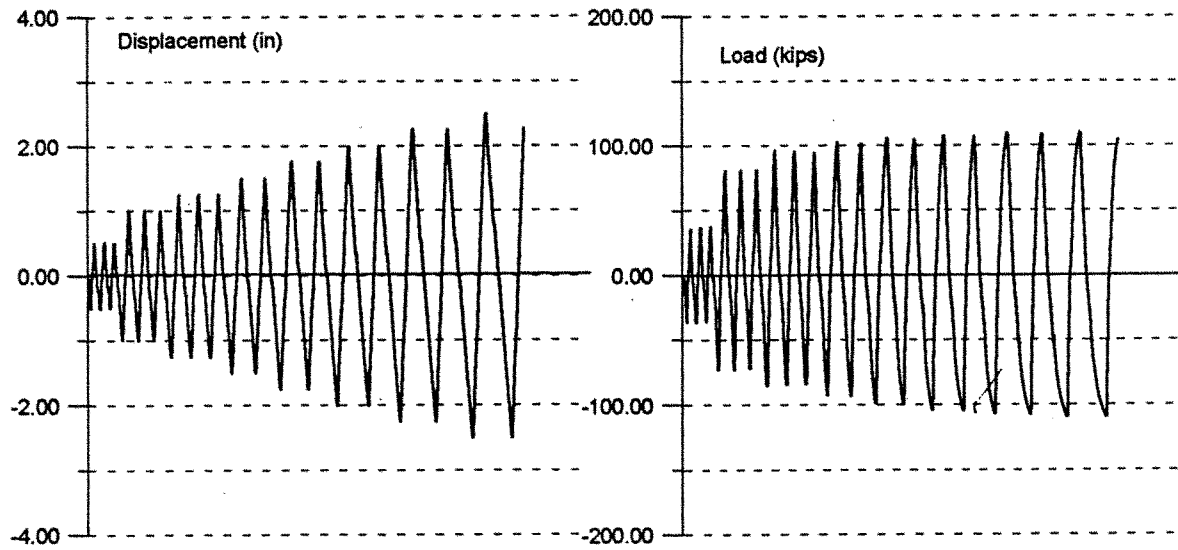
Figure 4.4.4 Cyclic Behavior, Spec. 2R

The cyclic performance is summarized in **Figure 4.4.4**. The specimen was able to sustain 18 cycles of increasing displacement prior to failure (**Figure 4.4.4c**). The total rotation capacity was 3.7% (**Figure 4.4.4a**) of which 2.4% was plastic rotation as shown in **Figure 2.8b**. As indicated in **Figure 4.4.4d**, there no unloading of the specimen prior to failure. The rotation components, shown in **Figure 4.4.5**, indicate that the column rotation was .8%, the panel zone rotation was 1.3% and the beam rotation was 1.6% for a total of 3.7%. Plots of the load versus displacement hysteresis for the original test (#2) and for the repair test (#2R) are compared in **Figure 4.4.6**. Here it can be seen that the capacity of the repaired specimen is equal to that of the initial specimen.

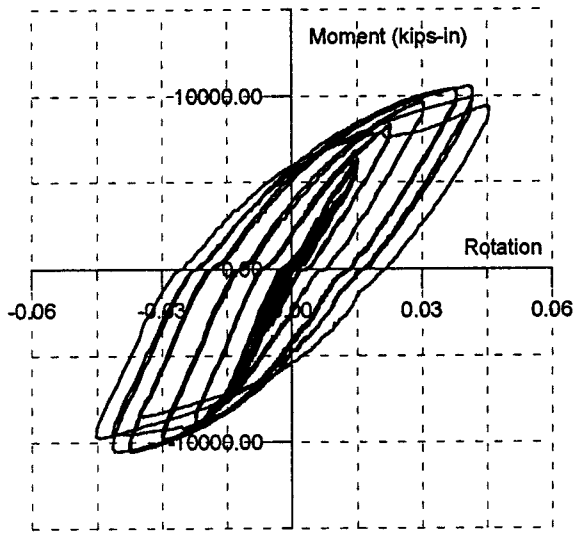
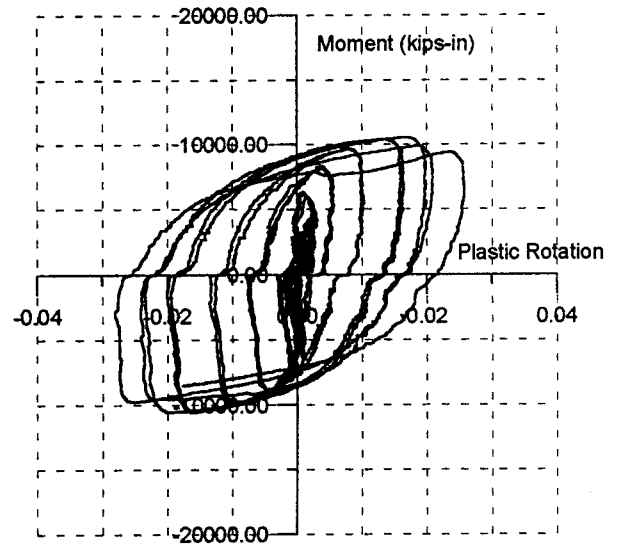
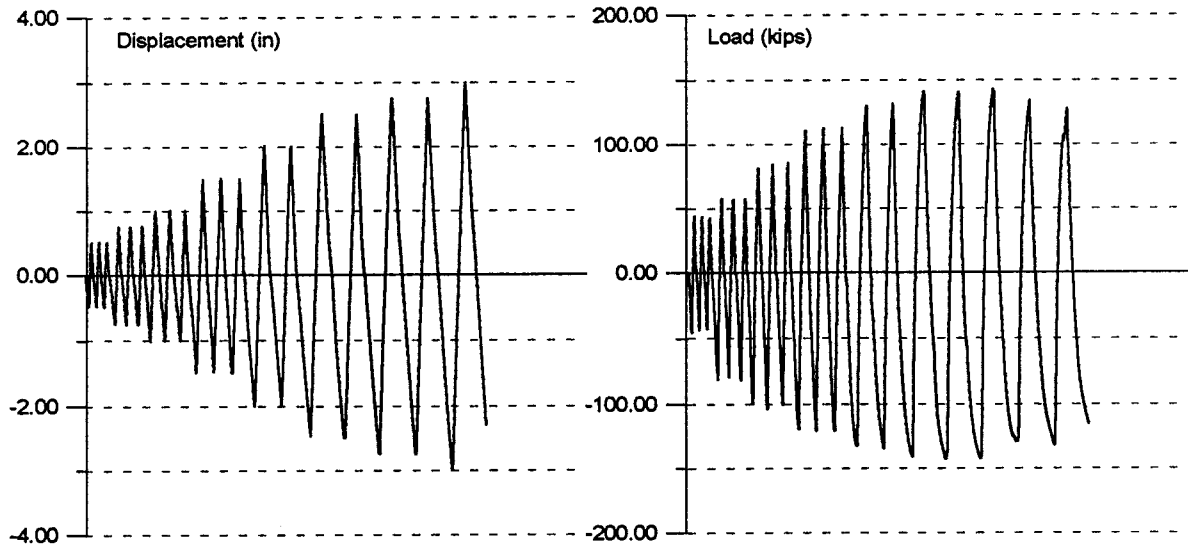
The cyclic behavior of the specimen is summarized in **Figure 5.1.7**. The plot of moment versus rotation (**Figure 5.1.7a**) indicates a total rotation capacity of 4.5 percent with plastic rotation of 2.5 percent as shown in **Figure 5.1.7b**. The displacement history, **Figure 5.1.7c**, indicates that the specimen was capable of sustaining 18 cycles of increasing displacement, reaching a maximum displacement of 3 inches. The load history, shown in **Figure 5.1.7d**, indicates that the specimen is beginning to unload during the last two cycles after reaching a peak load of 140 kips.

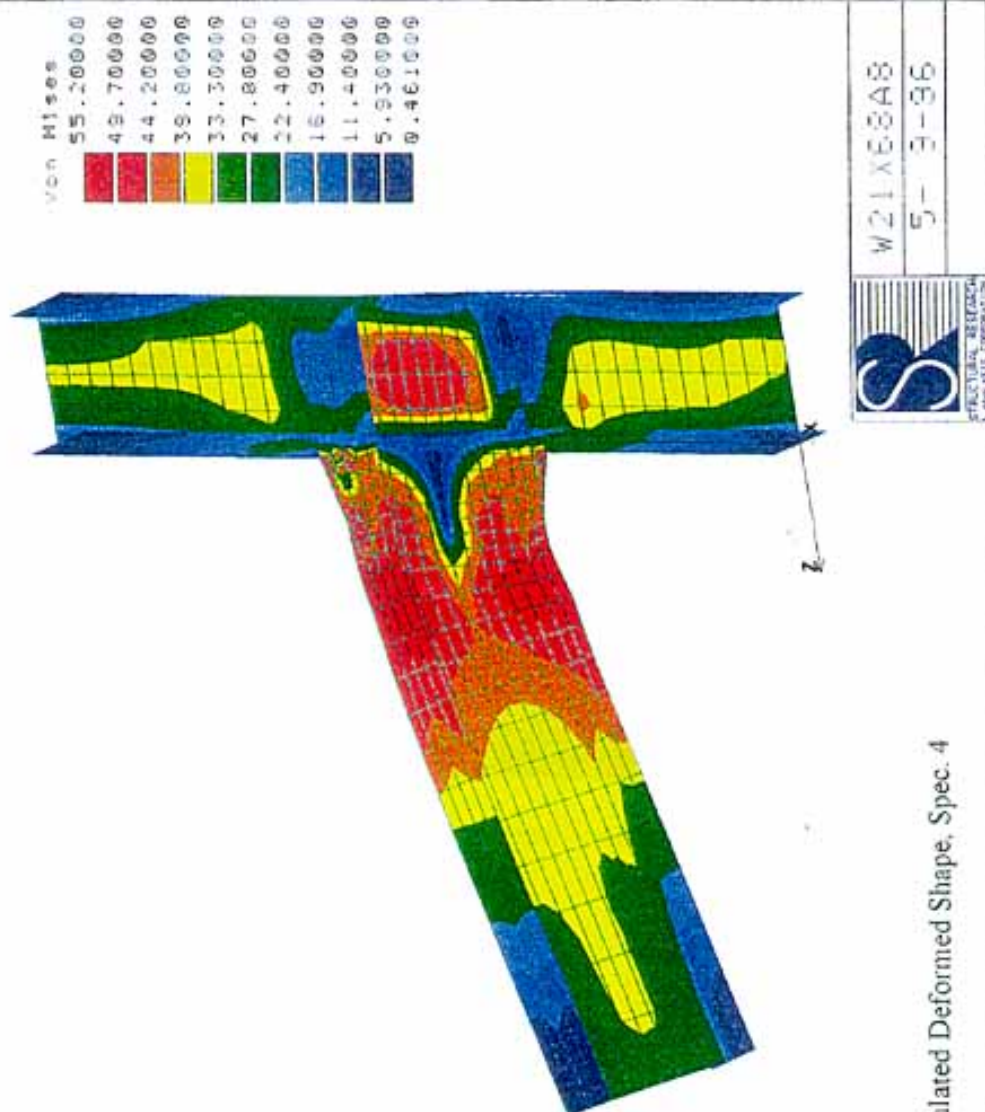
Figure 5.2.5 Calculated Deformed Shape, Spec. 4

A distorted view of the connection is shown in **Figure 5.2.5**. This clearly indicates the effect of the doubler plate in restricting deformations of the panel zone and forcing most of the deformation into the beam.

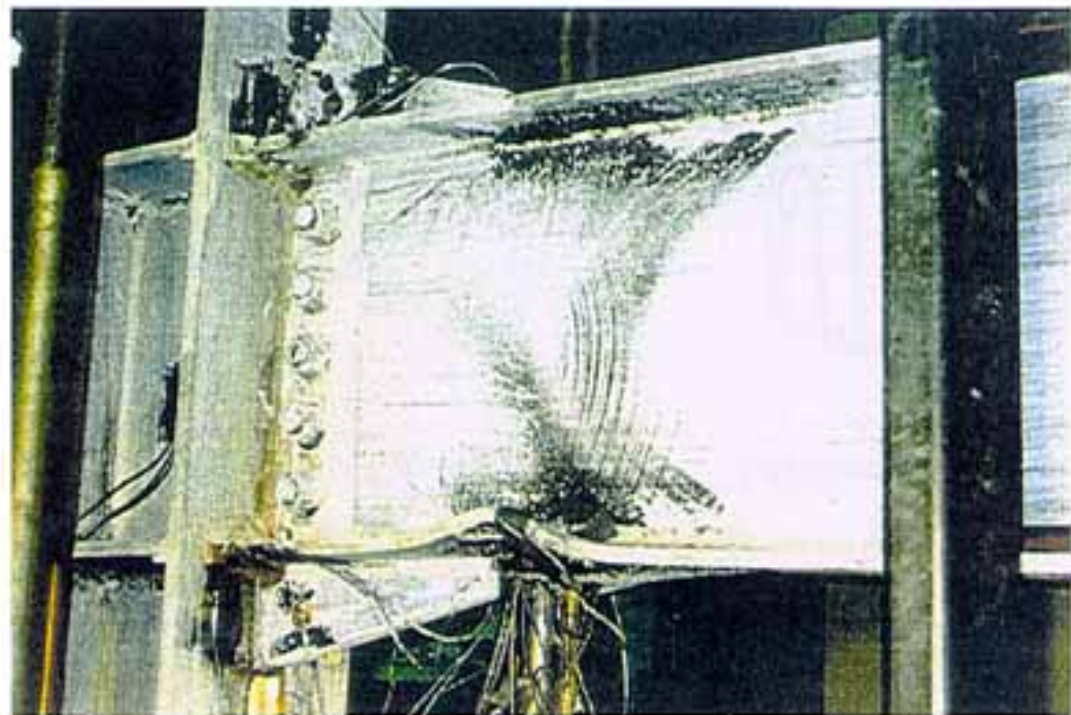
Figure 5.2.6 Plastic Hinge, Spec. 4

The specimen was subjected to 15 cycles of load and reached a total rotation of more than 4%. The test was stopped at this point due to severe deformation in the beam and the concern for damaging the testing equipment. At this point, the top and bottom beam flanges had developed buckles of 1 3/4 inches at the bottom and 2 inches at the top (**Figure 5.2.6**) and the beam web had buckled out of plane. There was only a small crack in the weld at the toe of one of the triangular fins which was due to the prying action of the buckled beam flange. The plastic hinge developed 17 inches from the face of the column at the location of the buckling. By moving the hinge away from the column face, the problems with the web copes which have led to failures in previous specimens were eliminated.

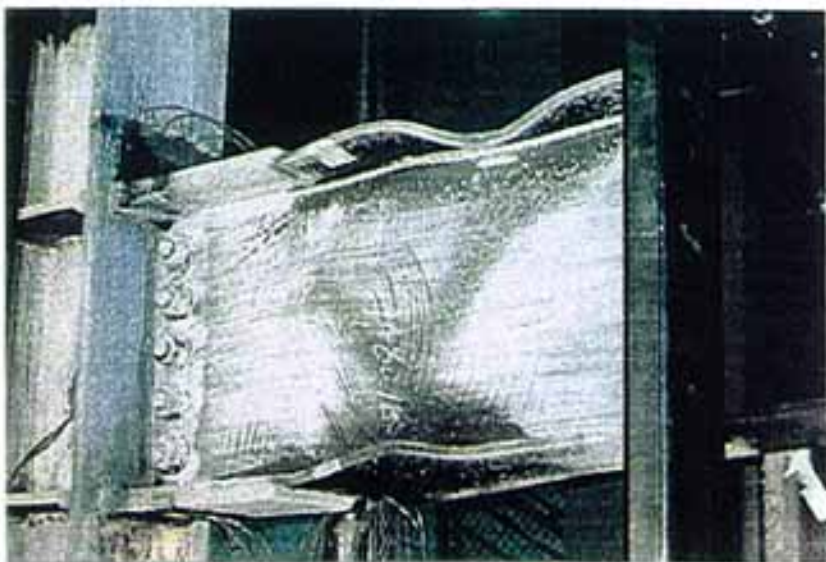
ing the testing equipment. At this point, a plastic hinge had formed at the end of the flange plate as shown in **Figure 6.1.7**. This also agrees with the prediction by the finite element analysis. The top and bottom beam flanges had developed buckles of 1 1/4 inches at the bottom and 2 1/2 inches at the top (**Figure 6.1.8**). The beam web had also buckled out of plane. The welds showed no sign of any cracking. A plastic hinge was developed 16 inches from the face of the column where the buckling occurred. The unloading of the specimen during the last two cycles at 3 inch displacement was due to the local buckling of the beam web and flanges. This resulted in a reduction of 32% in the maximum load capacity.

Figure 6.1.7 Plastic Hinge, Spec. 5

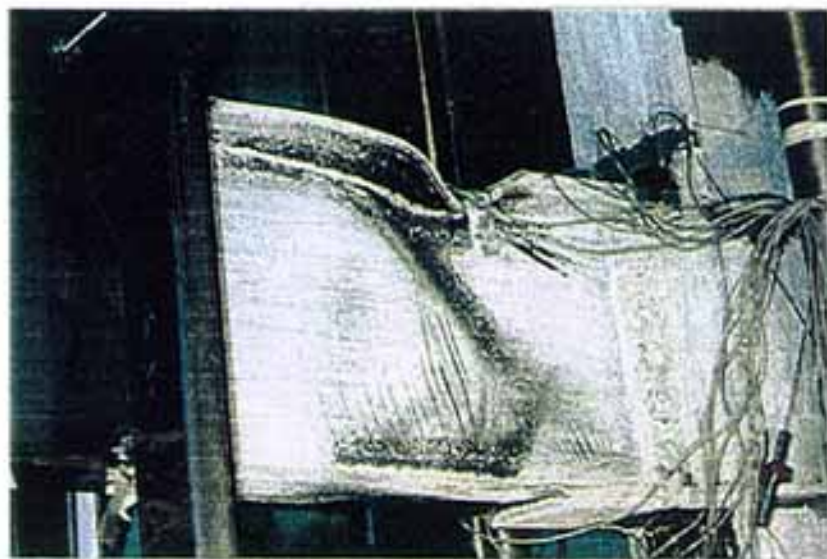
Figure 6.1.8 Flange Buckle, Spec. 5

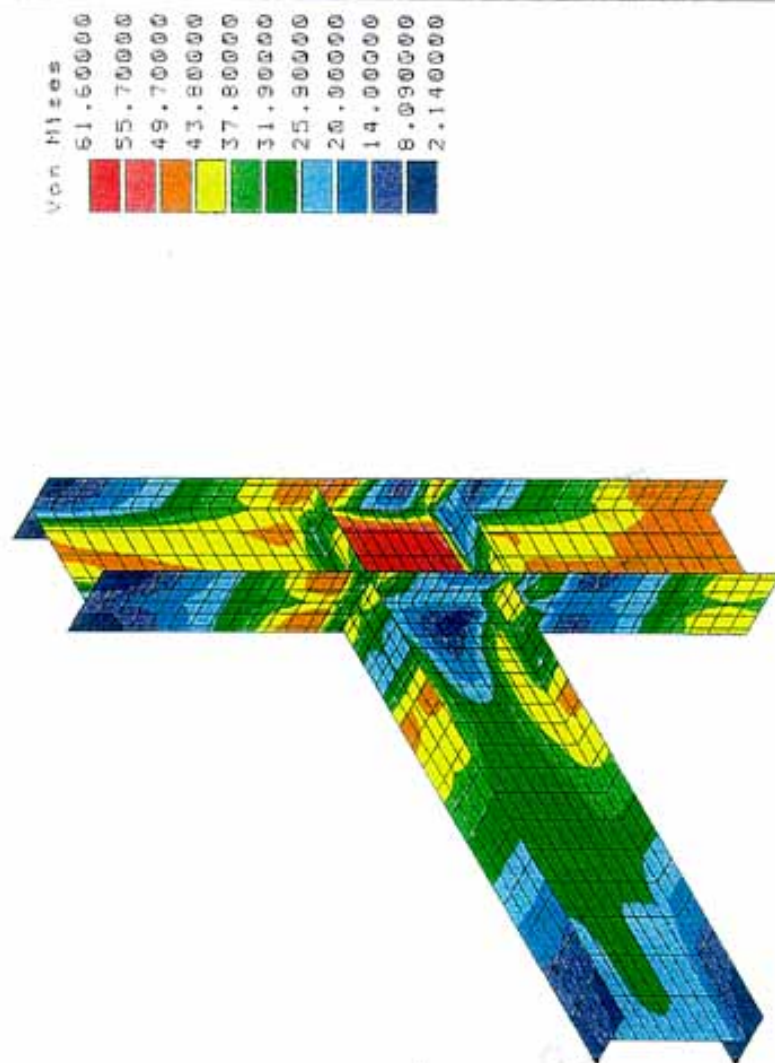
Figure 6.2.2 Calculated Stress Contours, Spec. 7

to develop a displacement of 3 inches, indicating the reduced stiffness when the doubler is removed. At maximum displacement of 4.5 inches, a load of 120 kips is required. A color plot of the Von Mises stress contours, shown in Figure 6.2.2, shows that yielding is just beginning to occur at the ends of the flange plate, however, the stresses in the column are much higher than for Specimen #5. A region of high stress occurs in the unstiffened panel zone indicating yielding. This indicates that most of the deformation is occurring in the panel zone and not in the beam. A distorted view of the connection is shown in **Figure 6.2.3**. This clearly indicates the distortion in the panel zone when the doubler is omitted with almost no deformation occurring in the beam.

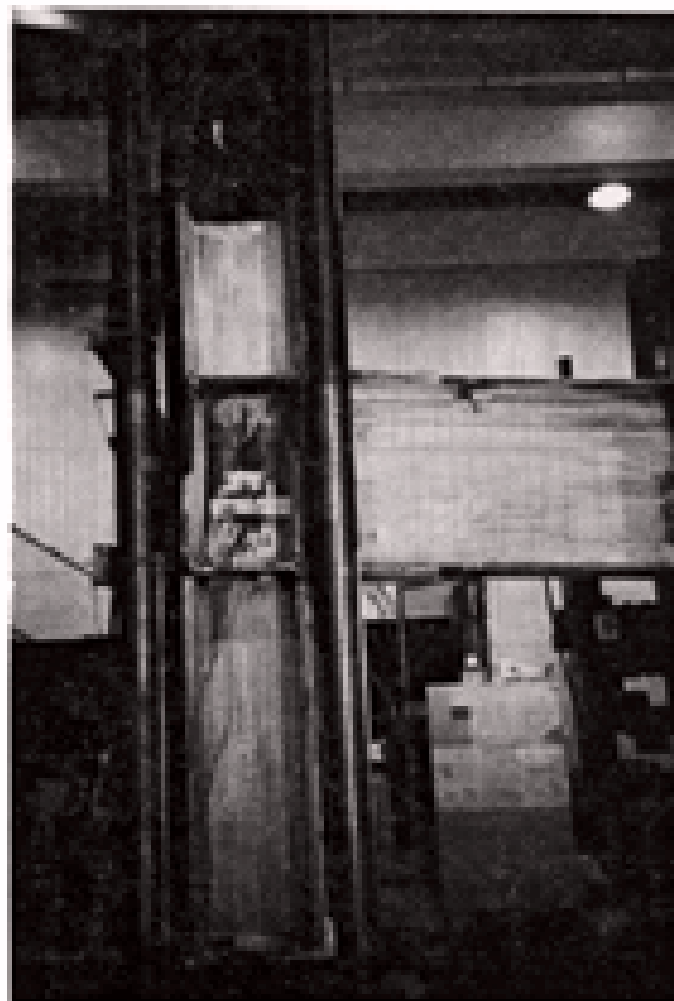
Figure 6.2.6 Panel Zone Deformation, Spec. 7

Since there was no column doubler, there was extensive plastic deformation in the panel zone. Contributions to total rotation, shown in **Figure 6.2.7**, were divided as follows: 1.3% column rotation, 1.7% panel zone, 3.9% beam for a total of 6.9%. The effect of the panel zone thickness can be seen by comparing these results with those of specimen #5.

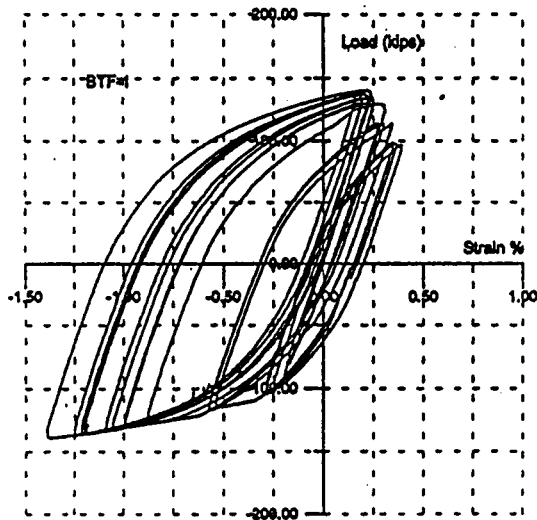
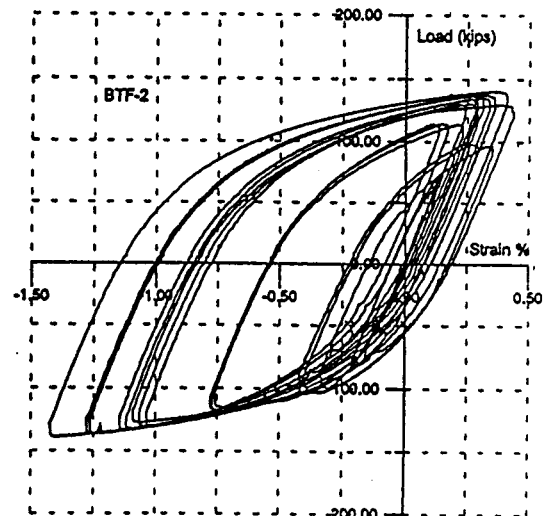
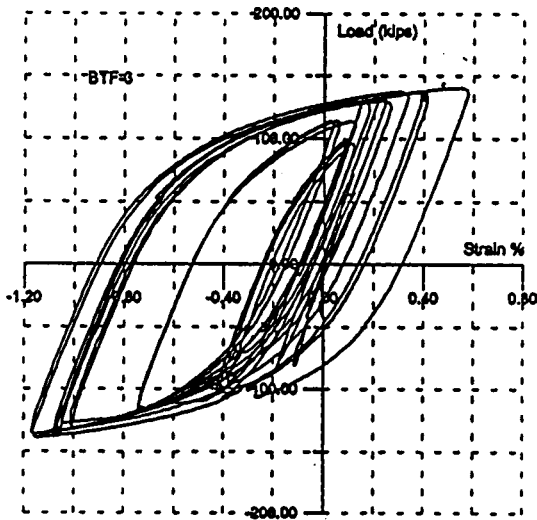
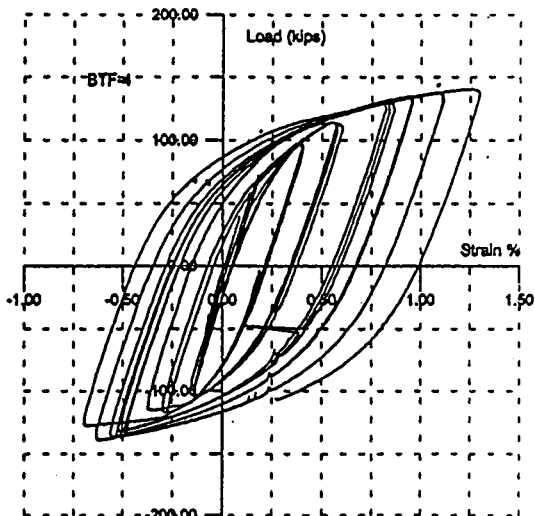
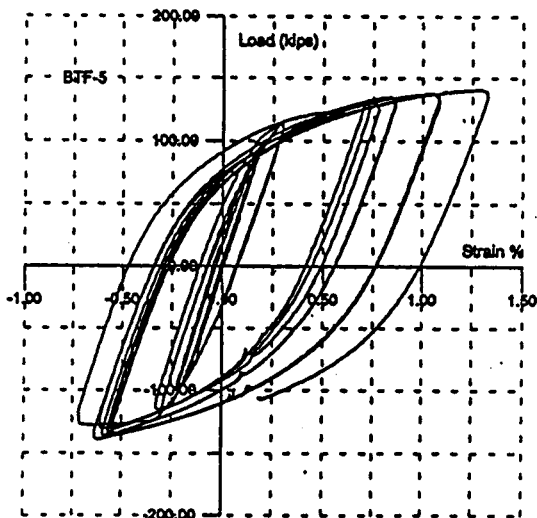
Figure 6.2.8 Top Flange Plate Strains, Spec. 7

The strain distribution across the top flange plate near the column face can be seen in **Figure 6.2.8**. At the center, **Figure 6.2.8a**, the maximum strain was approximately 1.4%. At the middle of the flanges, **Figures 6.2.8b and 6.2.8c**, the strains were recorded as 1.4% and 1.2%. At the edges of the flange plate, strains of 1.3% were measured on both sides as shown in **Figures 6.2.8d and 6.2.8e**. Strains in the top flange of the beam just in front of the flange plate are shown in **Figure 6.2.9**. At the center of the beam, **Figure 6.2.9a**, the maximum strain is 2%, whereas, on either side of the beam, the strains are 2.5% and 2.1% as shown in **Figures 6.2.9b and 6.2.9c**.

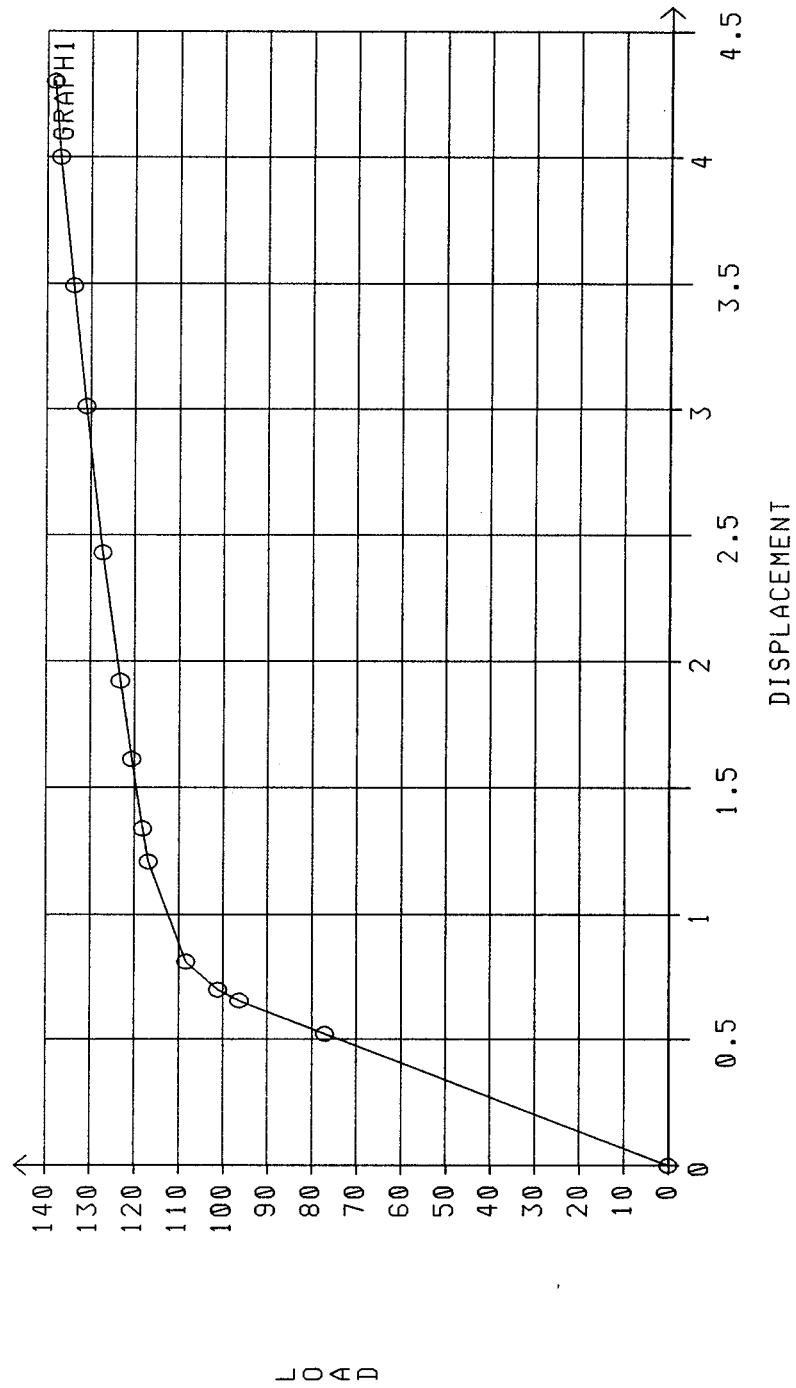
Figure 6.3.1 Calculated Load vs. Displacement, Spec. 8

The load-displacement envelope obtained from the finite element analysis is shown in **Figure 6.3.1**. This curve indicates that a force of 131 kips at the beam tip is required to develop a displacement of 3 inches. At maximum displacement of 4.0 inches, a load of 137 kips is required. A color plot of the Von Mises stress contours, shown in **Figure 6.3.2**, indicates regions of high stress at the ends of the miniplate and the formation of a plastic hinge. Note that the yield region has been moved away from the welded connection to the column flange.

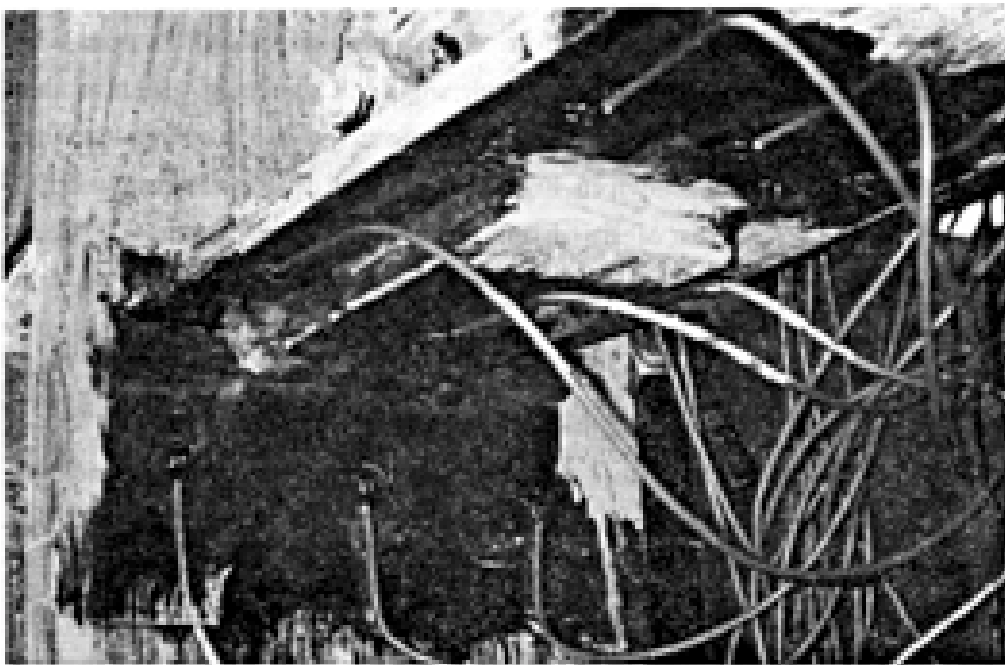
The welded miniplate on the bottom flange of the beam is shown in **Figure 6.3.3**. As can be seen in **Figure 6.3.4**, the cyclic performance of the modified connection was very good. The specimen was able to sustain 19 cycles of increasing displacement (**Figure 6.3.4c**) and reached a total rotation of 6% (**Figure 6.3.4a**). A plastic rotation capacity of 4% (**Figure 6.3.4b**) was achieved although the specimen began to unload on the last three cycles as shown in **Figure 6.3.4d**. This occurred due to severe local buckling of the beam flanges and web, shown in **Figure 6.3.5**, and caused the test to be stopped after two cycles at 4.0 inches of tip displacement (6% total rotation). There was approximately a 32% reduction in maximum load due to this unloading. At this point there was no visible cracking on the test specimen, particularly the welds. However, it appeared the plastic hinge zone had just reached the column face, therefore, it does not seem advisable to reduce the length of the flange plates any further.

Figure 6.3.3 Test Specimen with Miniplate
