Repair/Upgrade Procedures for Welded Beam to Column Connections

James C. Anderson

Report No. PEER-98/03
Pacific Earthquake Engineering Research center
College of Engineering
University of California, Berkeley
May 1998

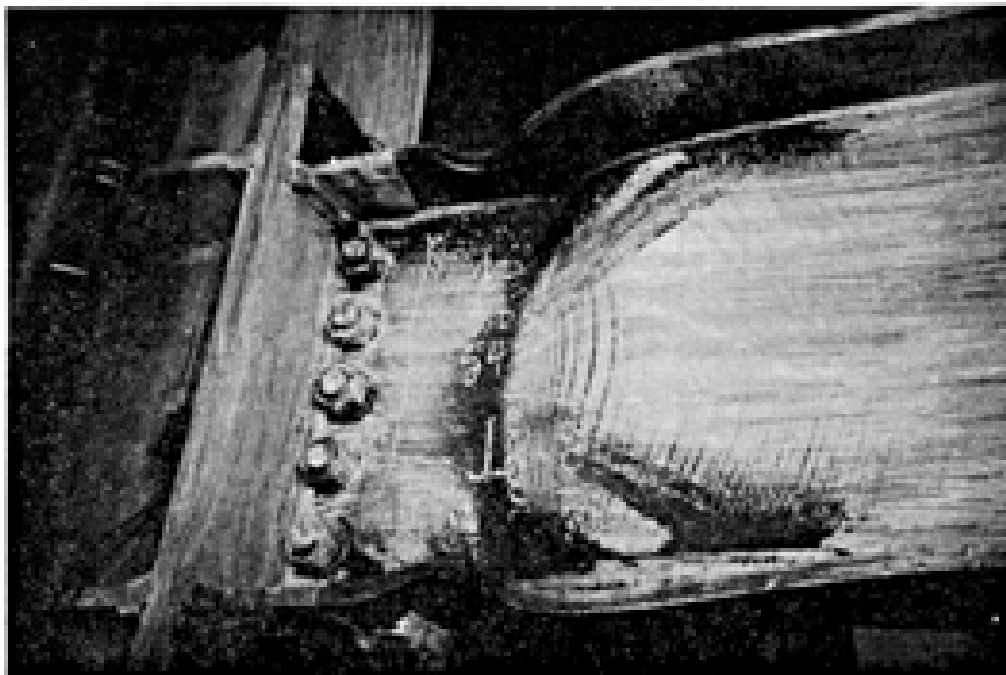
The welded miniplate on the bottom flange of the beam is shown in **Figure 6.3.3**. As can be seen in **Figure 6.3.4**, the cyclic performance of the modified connection was very good. The specimen was able to sustain 19 cycles of increasing displacement (**Figure 6.3.4c**) and reached a total rotation of 6% (**Figure 6.3.4a**). A plastic rotation capacity of 4% (**Figure 6.3.4b**) was achieved although the specimen began to unload on the last three cycles as shown in **Figure 6.3.4d**. This occurred due to severe local buckling of the beam flanges and web, shown in **Figure 6.3.5**, and caused the test to be stopped after two cycles at 4.0 inches of tip displacement (6% total rotation). There was approximately a 32% reduction in maximum load due to this unloading. At this point there was no visible cracking on the test specimen, particularly the welds. However, it appeared the plastic hinge zone had just reached the column face, therefore, it does not seem advisable to reduce the length of the flange plates any further.

Figure 6.3.5 Plastic Hinge and Flange Buckle

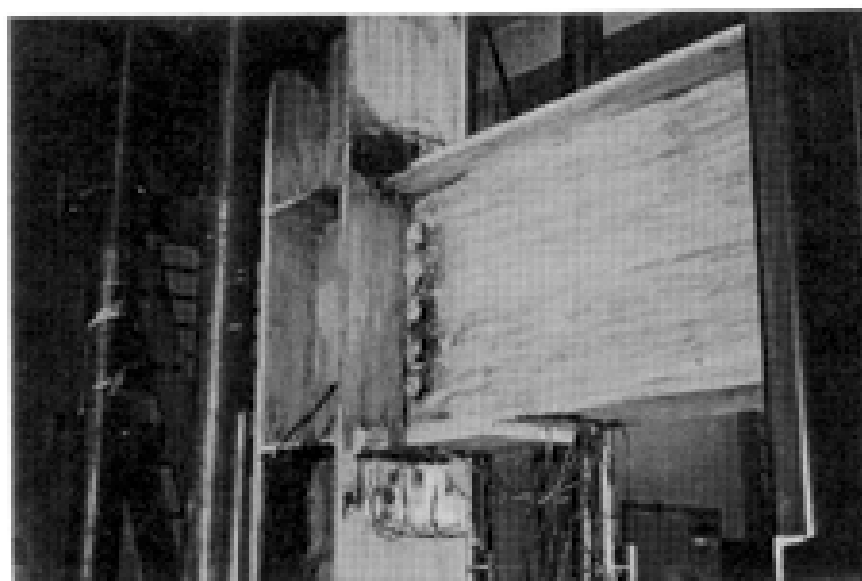
The test specimen with the single flange plate is shown in **Figure 6.4.3**. Cyclic performance, shown in **Figure 6.4.4**, was both predictable and not outstanding. The total rotation, shown in **Figure 6.4.4a** was 3.8% with a plastic rotation of only 1.7% (**Figure 6.4.4b**). The top flange of the beam, without the plate, was the first to show indications of yielding with yielding at the bottom flange occurring only near the end of the test. The specimen was able to sustain 14 displacement cycles as shown in **Figure 6.4.4c**. Unloading of the specimen occurred on the last displacement cycle resulting in a 24% drop in loading capacity (**Figure 6.4.4d**). During the 13th cycle at a displacement of 2.7 inches, inelastic buckling of the top beam flange led to the formation of a slit or tear (ductile crack) which started at the top web cope hole and extended across the top beam flange (**Figure 6.4.5**). At a displacement of 2 inches, the finite element analysis indicates a load of 129 kips at the beam tip. The test results show a load of 130 kips (**Figure 6.4.4d**).

Figure 6.4.3 Test Specimen With Single Flange Plate

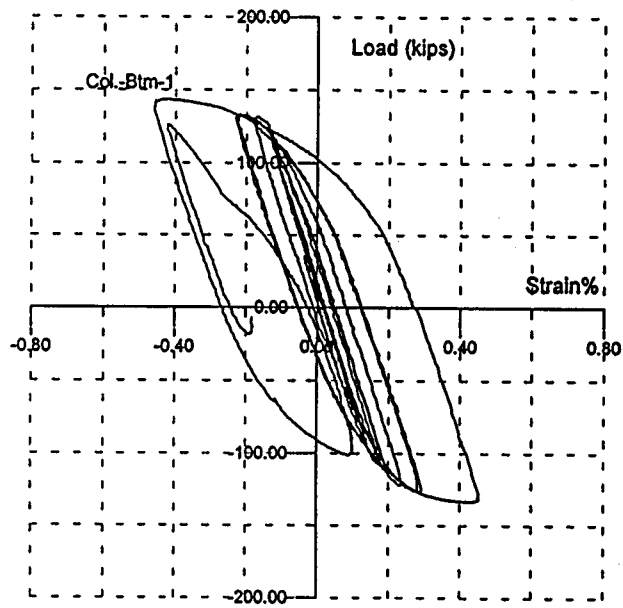
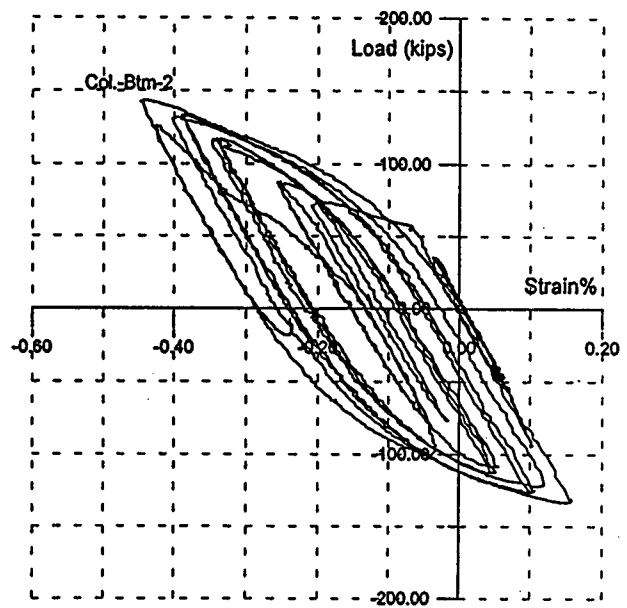
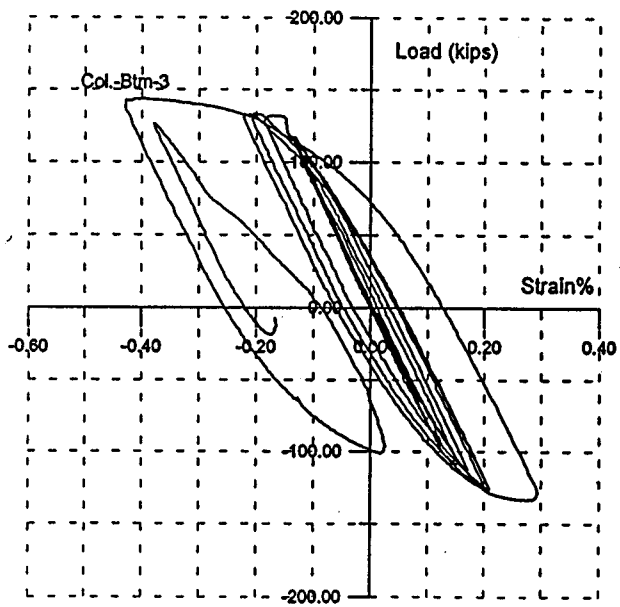
Figure 6.4.9 Column Flange Strains, Spec. 9

behavior of the column flange is indicated by the hysteresis loops showing strain versus beam tip load. Strains measured on the rosette in the panel zone of the column are shown in **Figure 6.4.10**. Inelastic behavior is indicated by strains reaching 1%.

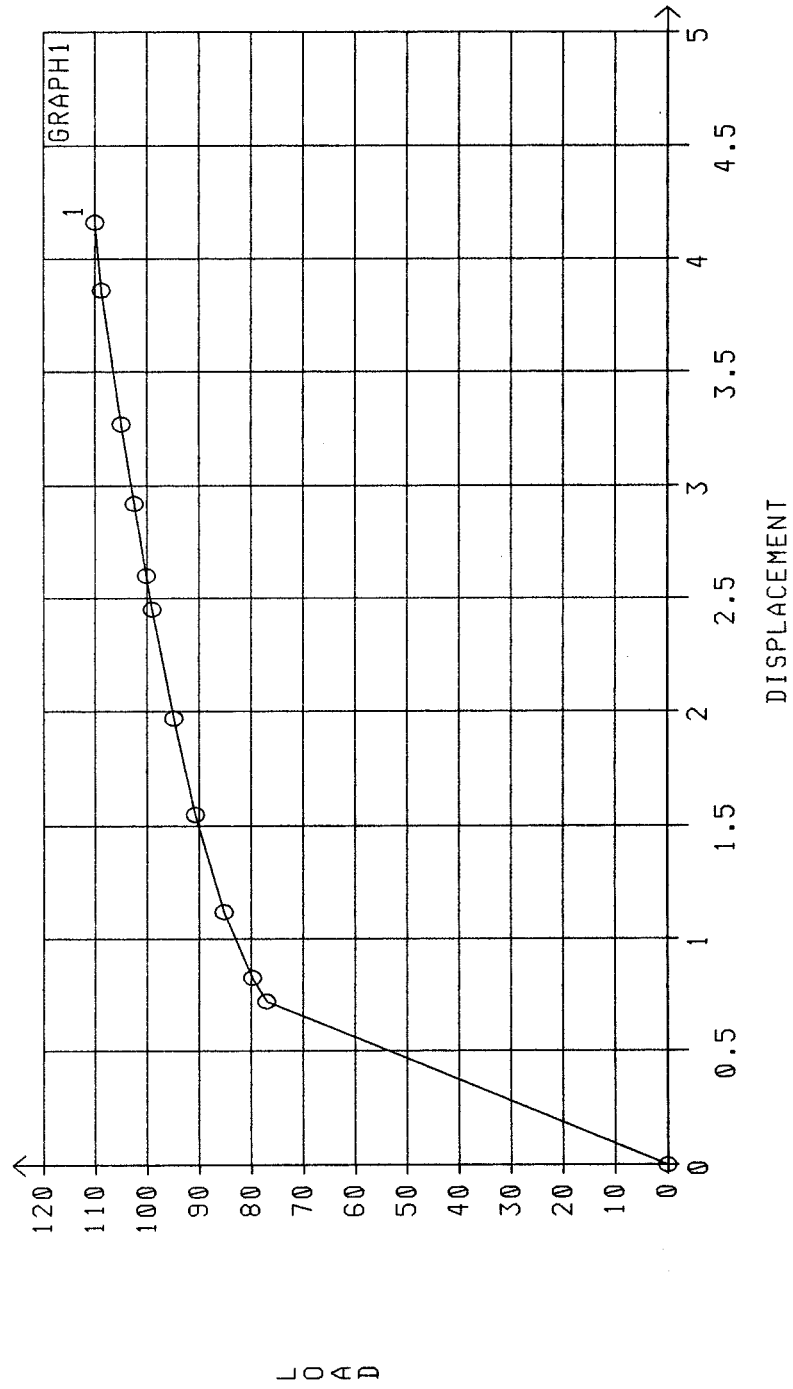
Figure 7.1.1 Calculated Load vs. Displacement, Spec. 12

The load-displacement envelope obtained from the finite element analysis is shown in **Figure 7.1.1**. This curve indicates that a force of 103 kips at the beam tip is required to develop a displacement of 3 inches. A color plot of the Von Mises stress contours is shown in **Figure 7.1.2**. This figure shows very limited yielding in the beam, however, the panel zone is a region of very high stress (56 ksi). This indicates that most of the deformation will occur in the panel zone and not in the beam.

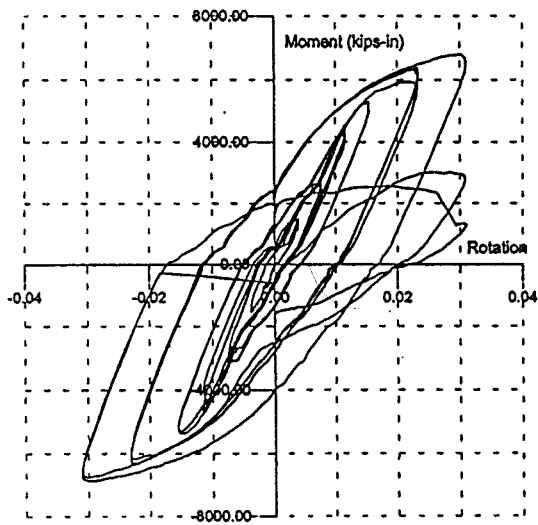
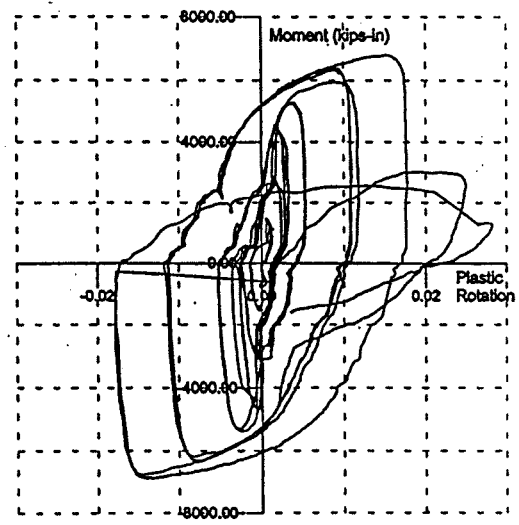
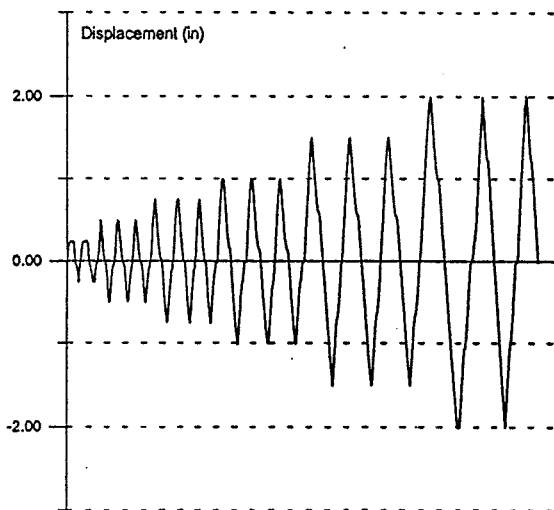
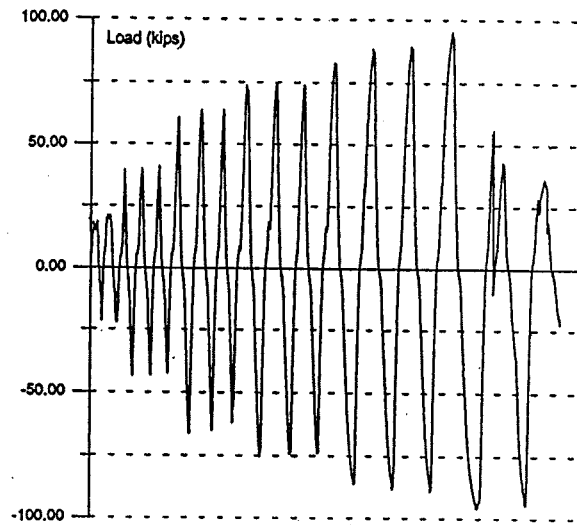
Figure 7.1.3 Cyclic Behavior, Spec. 12

The cyclic performance of the specimen is summarized in **Figure 7.1.3**. The specimen was able to sustain 16 cycles of increasing displacement as shown in **Figure 7.1.3c**. The moment versus rotation history, shown in **Figure 7.1.3a**, indicates that the total rotation was just over 3.1% with plastic rotation of 1.8% as shown in **Figure 7.1.3b**. The loading history, shown in **Figure 7.1.3d**, indicates increasing load up to the second cycle at a tip displacement of 2 inches when a sudden unloading of the specimen occurred. On this cycle at a total rotation of 3 percent, a crack initiated in the root of the weld at the bottom flange of the beam (**Figure 7.1.4**) and propagated diagonally through the column flange and into the panel zone as shown in **Figure 7.1.5**. This type of failure pattern is very similar to those observed in a severely damaged steel frame following the earthquake [12]. At a displacement of 2 inches, the finite element analysis indicates a beam load of 95 kips which is close to the 92 kips measured in the test prior to unloading of the specimen.

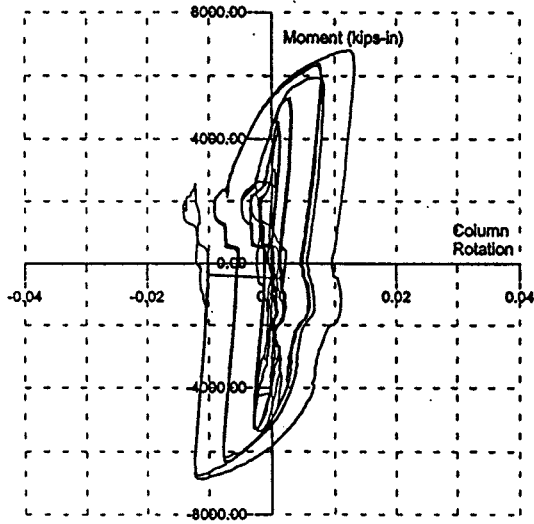
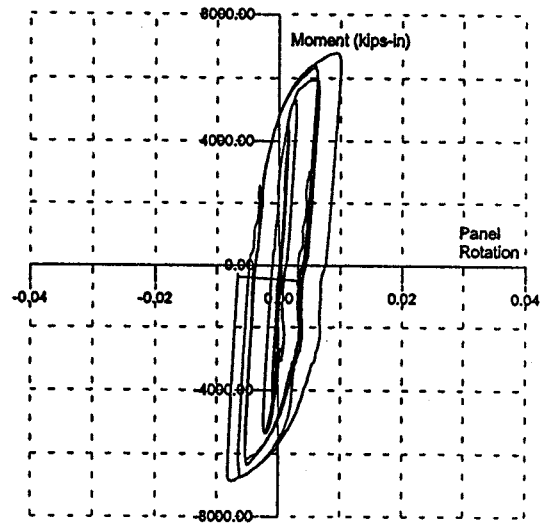
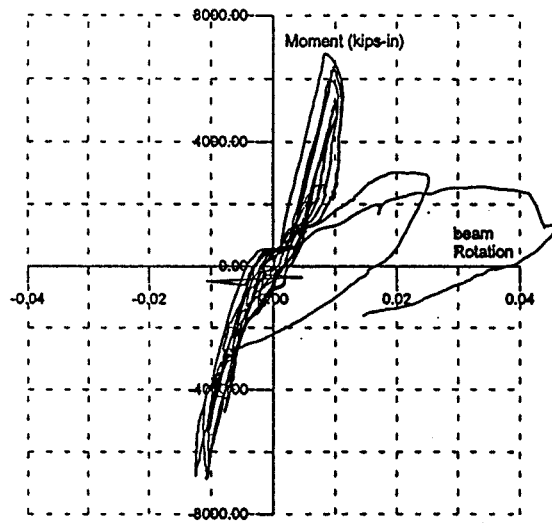
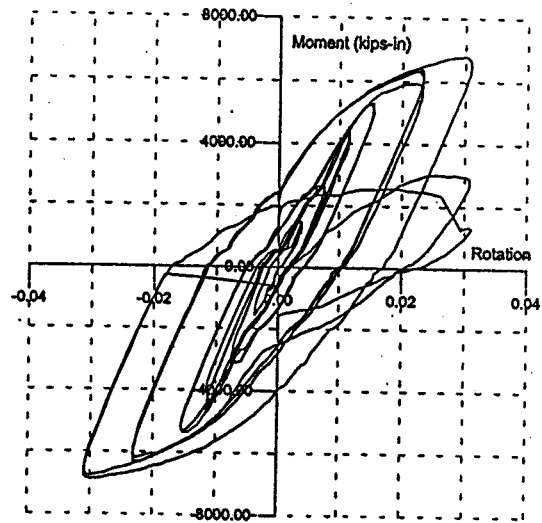
Figure 7.1.6 Rotation Components, Spec. 12

The rotation components in the connection region are shown in **Figure 7.1.6**. This figure indicates that the column rotation was 1.3% (**Figure 7.1.6a**), the panel zone rotation was .8% (**Figure 7.1.6b**) and the beam rotation was 1.0% (**Figure 7.1.6c**) for a total rotation of 3.1% as shown in **Figure 7.1.6d**.

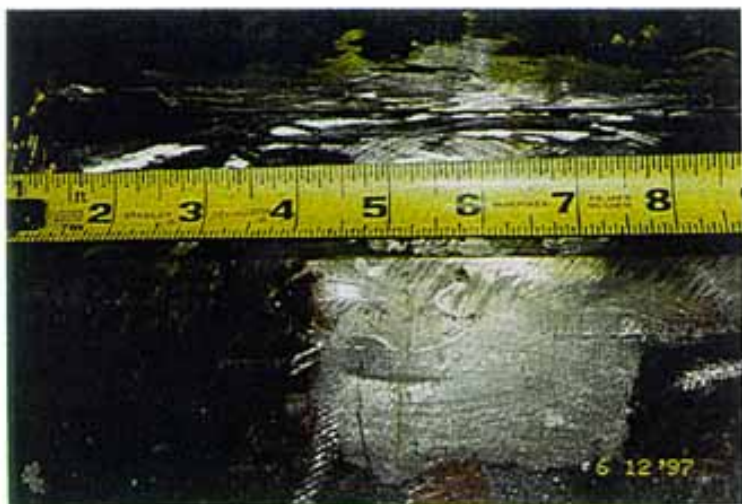
Figure 7.2.3 Gouged Out Bottom Side, Bottom Flange, Spec. 10

The crack at the bottom flange of the beam was repaired in the laboratory following the detail for a "Class A" type of repair. The existing crack was excavated using an air arc, as shown in **Figure 7.2.2**. It was also necessary to remove a small portion of the column flange in order to encompass all of the crack. On the underside of the beam flange, the backup bar was removed and part of the existing weld was removed by air arc according to the repair detail (**Figure 7.2.3**). Approximately 0.125 inches of the crack were removed from the top and bottom of the existing weld, leaving 0.375 inches of the crack in place. At the top flange of the beam, the backup bar was removed and the weld backgouged according to recommended practice. Since the top flange weld was tested and found to be sound, no action was taken on the upper side of this weld.

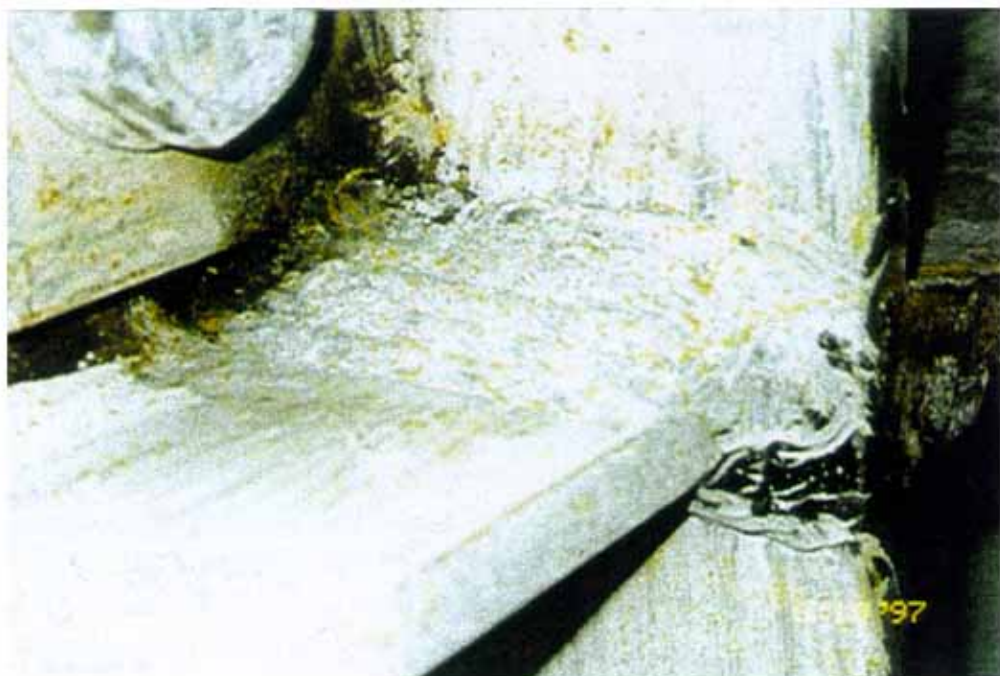
Figure 7.2.4 Overlay Weld, Bottom Flange, Spec. 10

Overlays exceeding the minimum requirements of the "Class A" overlay were applied to both sides of the excavated connection at the bottom flange of the beam, using 23 passes for the upper side and 13 passes for the lower side. All overlay welding was done using SMAW with E7018 electrodes. The completed overlay weld on the top side of the bottom flange of the beam is shown in **Figure 7.2.4**. At the top flange of the beam an overlay weld was applied to only the bottom side of the flange. This simulates a repair without removal of the concrete slab above the top flange, a typical condition occurring in buildings.

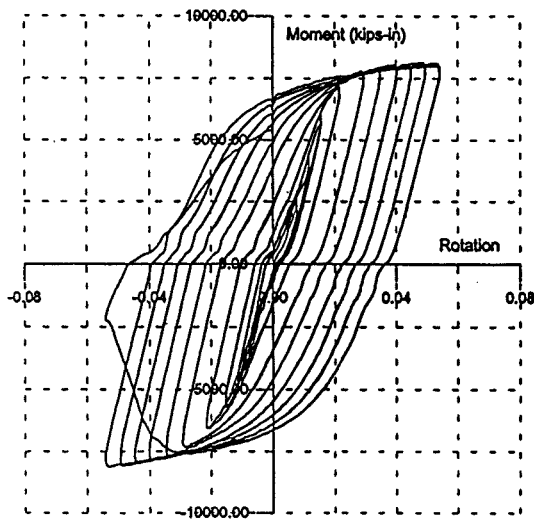
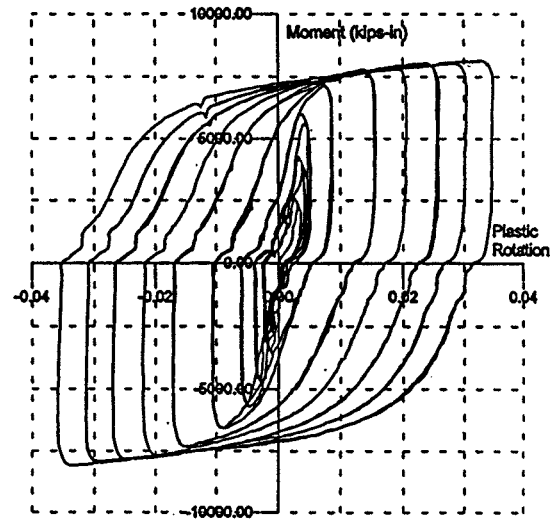
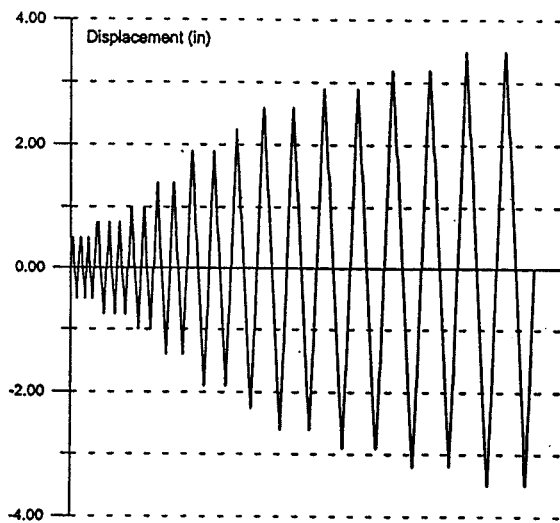
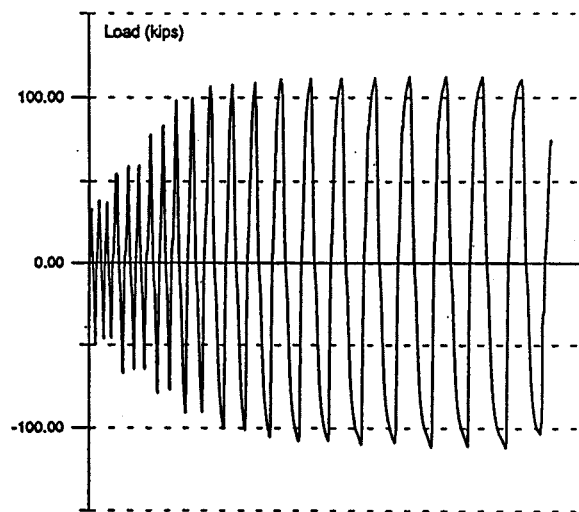
Figure 7.2.5 Cyclic Behavior, Spec. 10

Specimen performance was very good as summarized in **Figure 7.2.5**. The specimen sustained 21 cycles of increasing displacement (**Figure 7.2.5c**) and reached a total rotation of 5.5% (**Figure 7.2.5a**) of which 3.5% was plastic rotation (**Figure 7.2.5b**). There was no unloading of the specimen due to local buckling prior to failure on the last cycle (**Figure 7.2.5d**). It was observed that most of the deformation occurred in the panel zone as expected for this specimen. The resulting deformation in the panel zone can be seen in **Figure 7.2.6**. During the second cycle at 5.5% rotation a crack occurred in the top flange of the beam at the interface of the weld and the parent metal (**Figure 7.2.7**). At the same time a horizontal crack (slit) had started from the web cope and propagated along the k-line of the beam for a distance of 1 1/2 inches. At the bottom flange of the beam, a 4 inch slit occurred in the k-line (**Figure 7.2.8**). However, both of these slits did not propagate rapidly and appeared to have little influence on the overall connection behavior. Failure occurred when the crack in the top flange of the beam propagated from the center to the

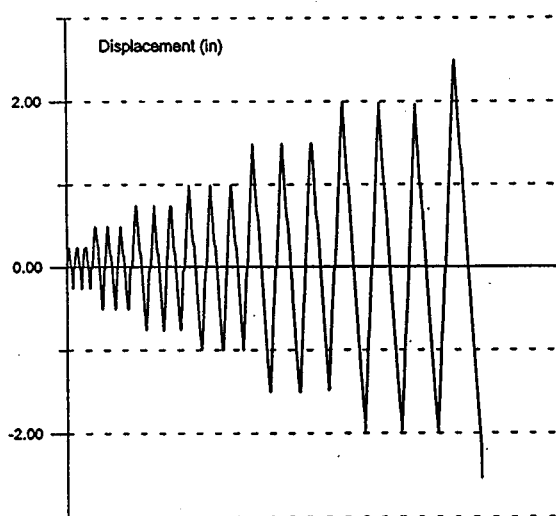
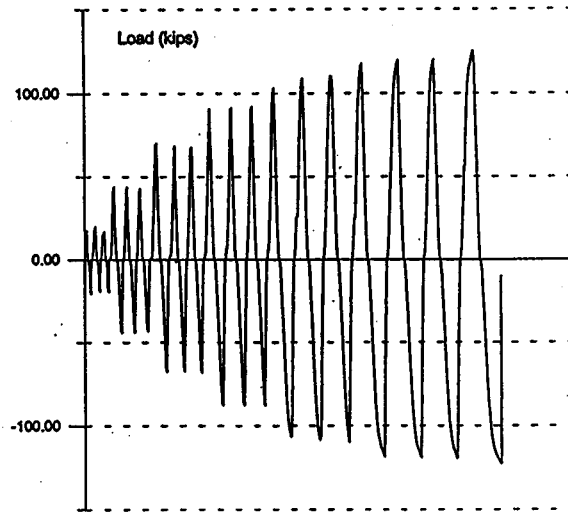
Figure 7.3.3 Cyclic Behavior, Spec. 11

The cyclic performance of the specimen is summarized in **Figure 7.3.3**. The specimen was able to sustain 19 cycles of increasing displacement as shown in **Figure 7.3.3c**. The moment versus rotation curve, shown in **Figure 7.3.3a**, indicates that the total rotation was just over 3.0% with plastic rotation of 1.6% as shown in **Figure 7.3.3b**. The loading history, shown in **Figure 7.3.3d**, indicates there was no unloading of the specimen until the last cycle when failure occurred during the first cycle at a displacement of 2.5 inches (4% rotation). On the first down stroke of this cycle the top flange of the beam suddenly fractured as shown in **Figure 7.3.4**. The crack appeared to start in the web cope and propagate outward to the edges of the beam flange. Note that the finite element analysis indicated a beam tip load of 112 kips at a displacement of 2 inches compared with 118 kips measured in the test.

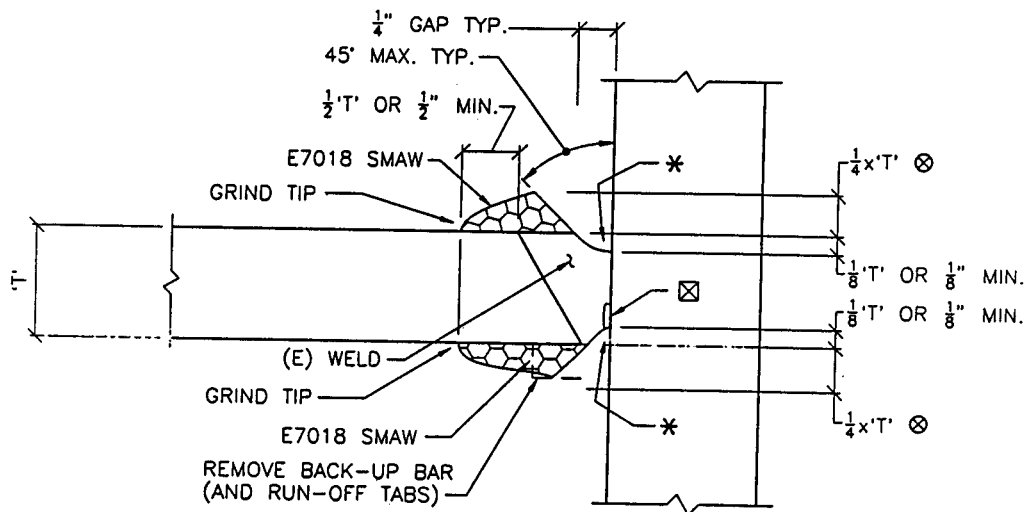
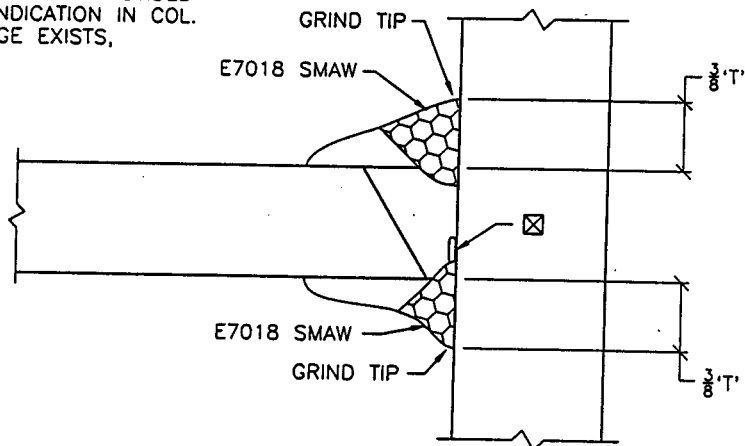
CLASS C REPAIR USING SMAW

- * - GRIND GROOVE IN EXISTING WELD.
- ⊗ - BASED UPON 45° GROOVE ANGLE. INCREASE ACCORDINGLY IF SMALLER ANGLE USED.
- ⊠ - INDICATION TYPE W10 MAY REMAIN PROVIDED NO INDICATION IN COL. FLANGE EXISTS,

The next specimen was not tested prior to applying the weld overlays and no defects were known to be present in the existing welds. This specimen represents a field upgrade of a connection made using FCAW with E70T-4 wire. The overlay procedure is representative of a "Class C" repair. The DLW Task Group [11] classifies a Class C repair as one in which the dynamic joint efficiency is over 50%. In this case a minimum overlay using SMAW is applied as shown in the detail in **Figure 7.4.1**. Backup bars at the top and bottom beam flanges were removed and the root of the weld was backgouged per recommended practice. Overlays exceeding the minimum requirements of the "Class C" overlay were applied to both sides of the top and bottom flanges of the beam. All overlays were done using SMAW with E7018 electrodes. The completed overlay weld on the under side of the upper beam flange is shown in **Figure 7.4.2** and the overlay weld on the upper side of the lower beam flange is shown in **Figure 7.4.3**. Since the overlay weld filled approximately half of the web cope, the remaining opening was plug welded in an effort to reduce the possibility of a secondary failure emanating from this region.

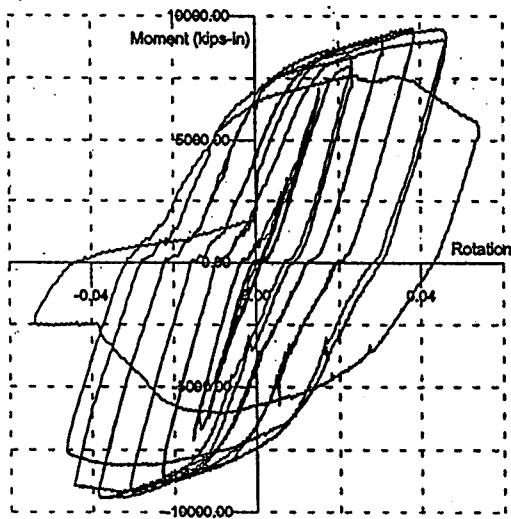
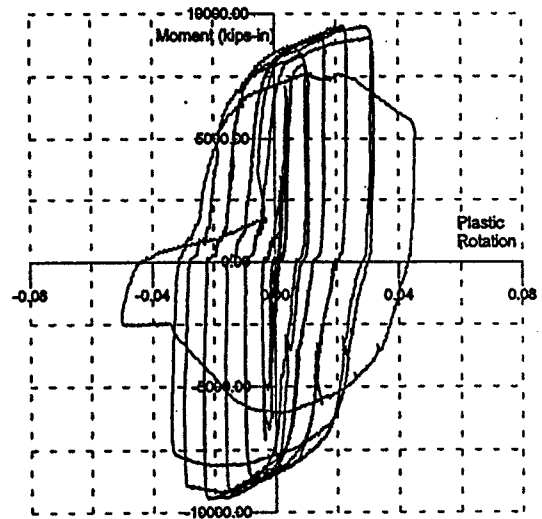
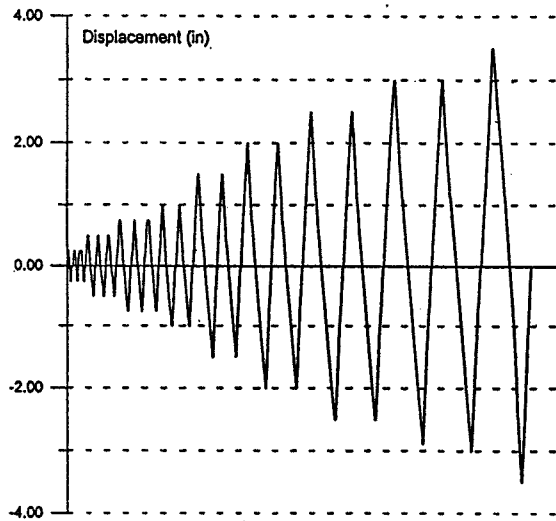
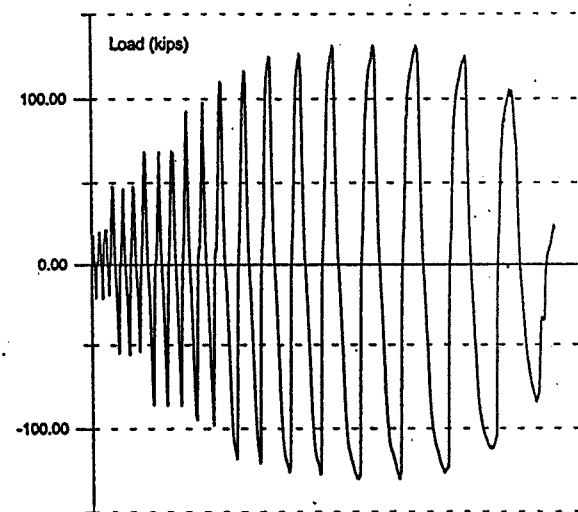
Figure 7.4.4 Cyclic Behavior, Spec. 14

Specimen performance again was very good as summarized in **Figure 7.4.4**. The specimen was able to sustain 20 cycles of increasing displacement (**Figure 7.4.4c**). It developed a total rotation of 4.7 percent (**Figure 7.4.4a**) with a plastic rotation of 3% (**Figure 7.4.4b**) before starting to unload as shown in **Figure 7.4.4d**. At a tip displacement of 2.5 inches (3.9% rotation) small horizontal cracks began to develop in the top and bottom k-line areas of the beam web. At both locations the plug welds in the web copes cracked away from the beam web. During the first cycle at a tip displacement of 3 inches (4.7% rotation) significant buckles began to form in the beam flanges about 4 inches at the top and about 10 inches at the bottom from the face of the column. This caused the specimen to start to unload as mentioned previously and during the last cycle at a tip displacement of 3.5 inches (5.5% rotation) the specimen lost approximately 33% of its moment capacity.

During the first cycle at a tip displacement of 3.5 inches (5.5% rotation), a severe buckle formed in the top flange of the beam about 5 inches from the face of the column. This caused a separation of the flange and the web which in turn caused the horizontal crack at the top k-line to extend almost 7 1/2 inches from the edge of the web cope as shown in **Figure 7.4.5**. At the bottom flange, the horizontal crack extended approximately 3 1/2 inches from the edge of the web cope (**Figure 7.4.6**). On the down stroke, the flexing of the buckled top flange caused a crack to occur and propagate across the flange as shown in **Figure 7.4.7**. With the fracture of the top flange, load was transferred to the web causing yielding around the upper three bolts as can be seen in **Figure 7.4.8**. Yielding of the top and bottom beam flanges extended a distance of 21 inches from the face of the column.

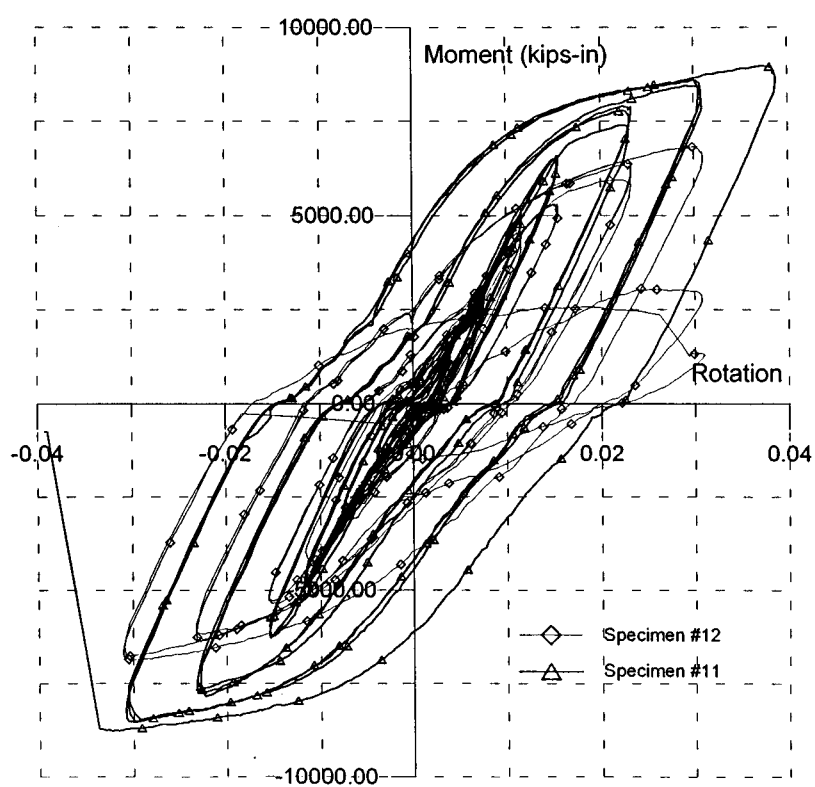
Figure 7.5.1 Comparative Behavior (#11 & #12)

The cyclic behavior of specimen #11 which has a web doubler plate is compared with that of specimen #12 which does not have a doubler plate in **Figure 7.5.1**. It can be seen that due to yielding of the panel zone in specimen #12, the moment capacity of the connection is considerably less than the moment capacity of specimen #11 which has the doubler plate. It can be shown that specimen #12 was only able to develop 90% of the plastic moment capacity of the beam whereas specimen #11 was able to develop 120%. It can also be seen that the change in stiffness between the two specimens is relatively small.

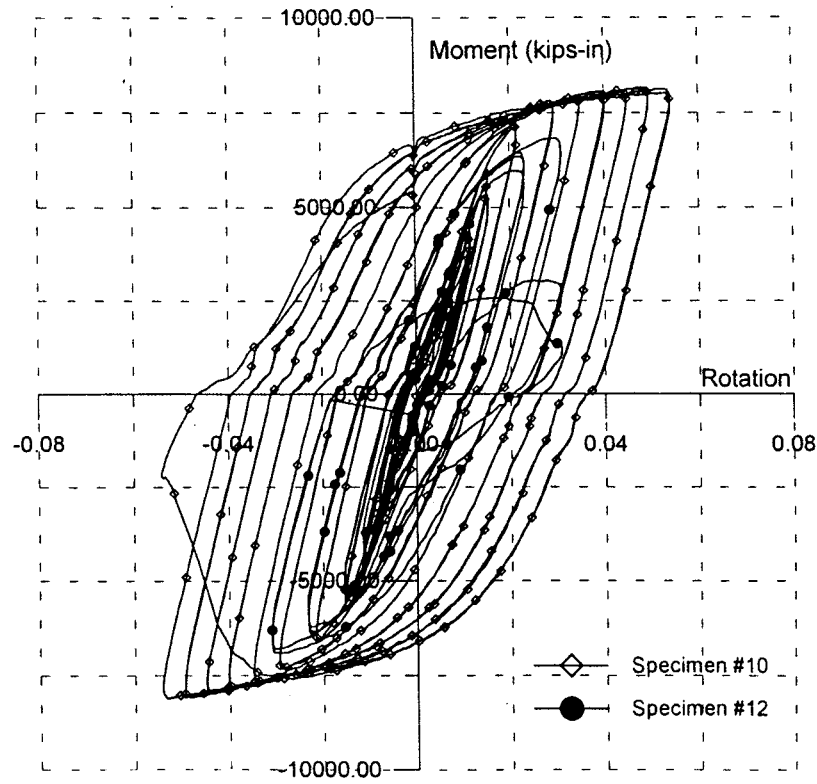
Figure 7.5.2 Comparative Behavior (#10 & #12)

The positive effect of a Class A overlay is shown in **Figure 7.5.2** by comparing the cyclic behavior of specimen #10 with that of specimen #12. The overlay repair has increased the total rotation capacity by 75% (0.031 to 0.054) and has increased the moment capacity by 18% (6833 in-kips to 8083 in-kips).

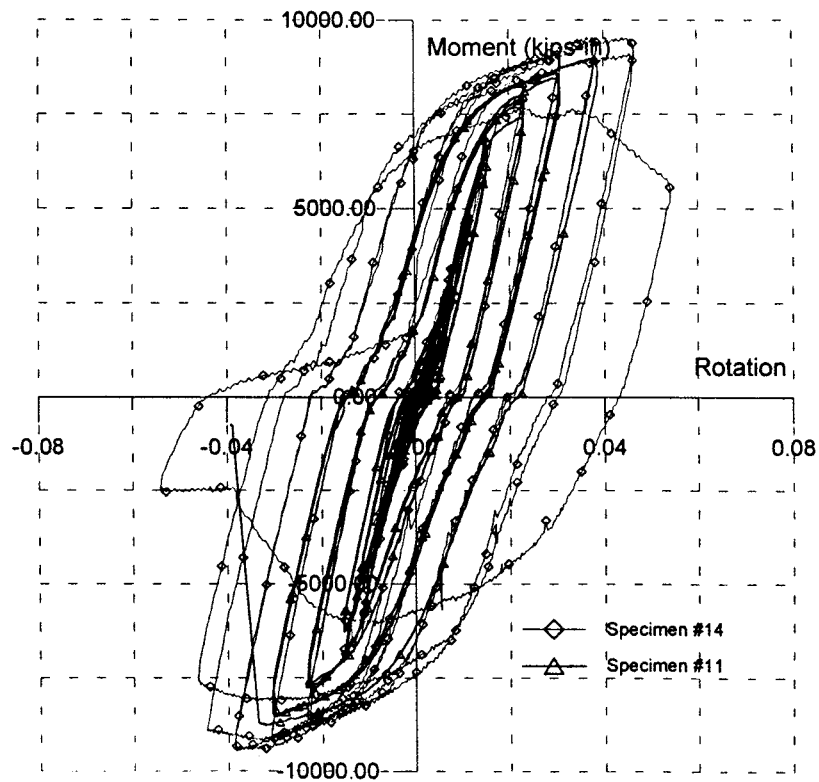
Figure 7.5.3 Comparative Behavior (#11 & #14)

The positive effect of a Class C overlay is shown in **Figure 7.5.3** by comparing the cyclic behavior of specimen #11 with that of specimen #14. This figure indicates that the connection modification using an overlay was able to increase the total rotation capacity by 18% (0.0393 to 0.0467) and to increase the moment capacity by 6.5% (9000 in-kips to 9583 in-kips).

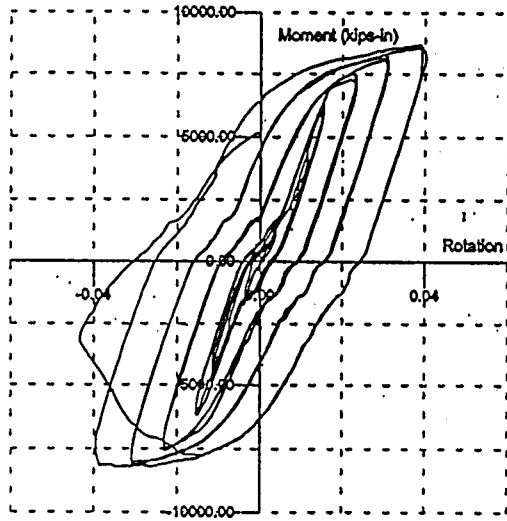
The cyclic behavior of the specimen is summarized in **Figure 8.1.3**. The specimen was able to sustain 20 cycles of increasing displacement as shown in **Figure 8.1.3c**. The plot of moment versus total rotation, shown in **Figure 8.1.3a**, indicates that the specimen was able to develop a total rotation of 4 percent with a plastic rotation of 2.5% as shown in **Figure 8.1.3b**. The loading history shown in **Figure 8.1.3d** indicates there was no unloading of the specimen prior to failure. Failure occurred on the second cycle at a displacement of $2\frac{1}{2}$ inches (4% rotation) by the formation of a crack in the weld at the top flange of the beam (**Figure 8.1.4**). The crack appeared to start in the web cope and then propagate outward to the edges (**Figure 8.1.5**).

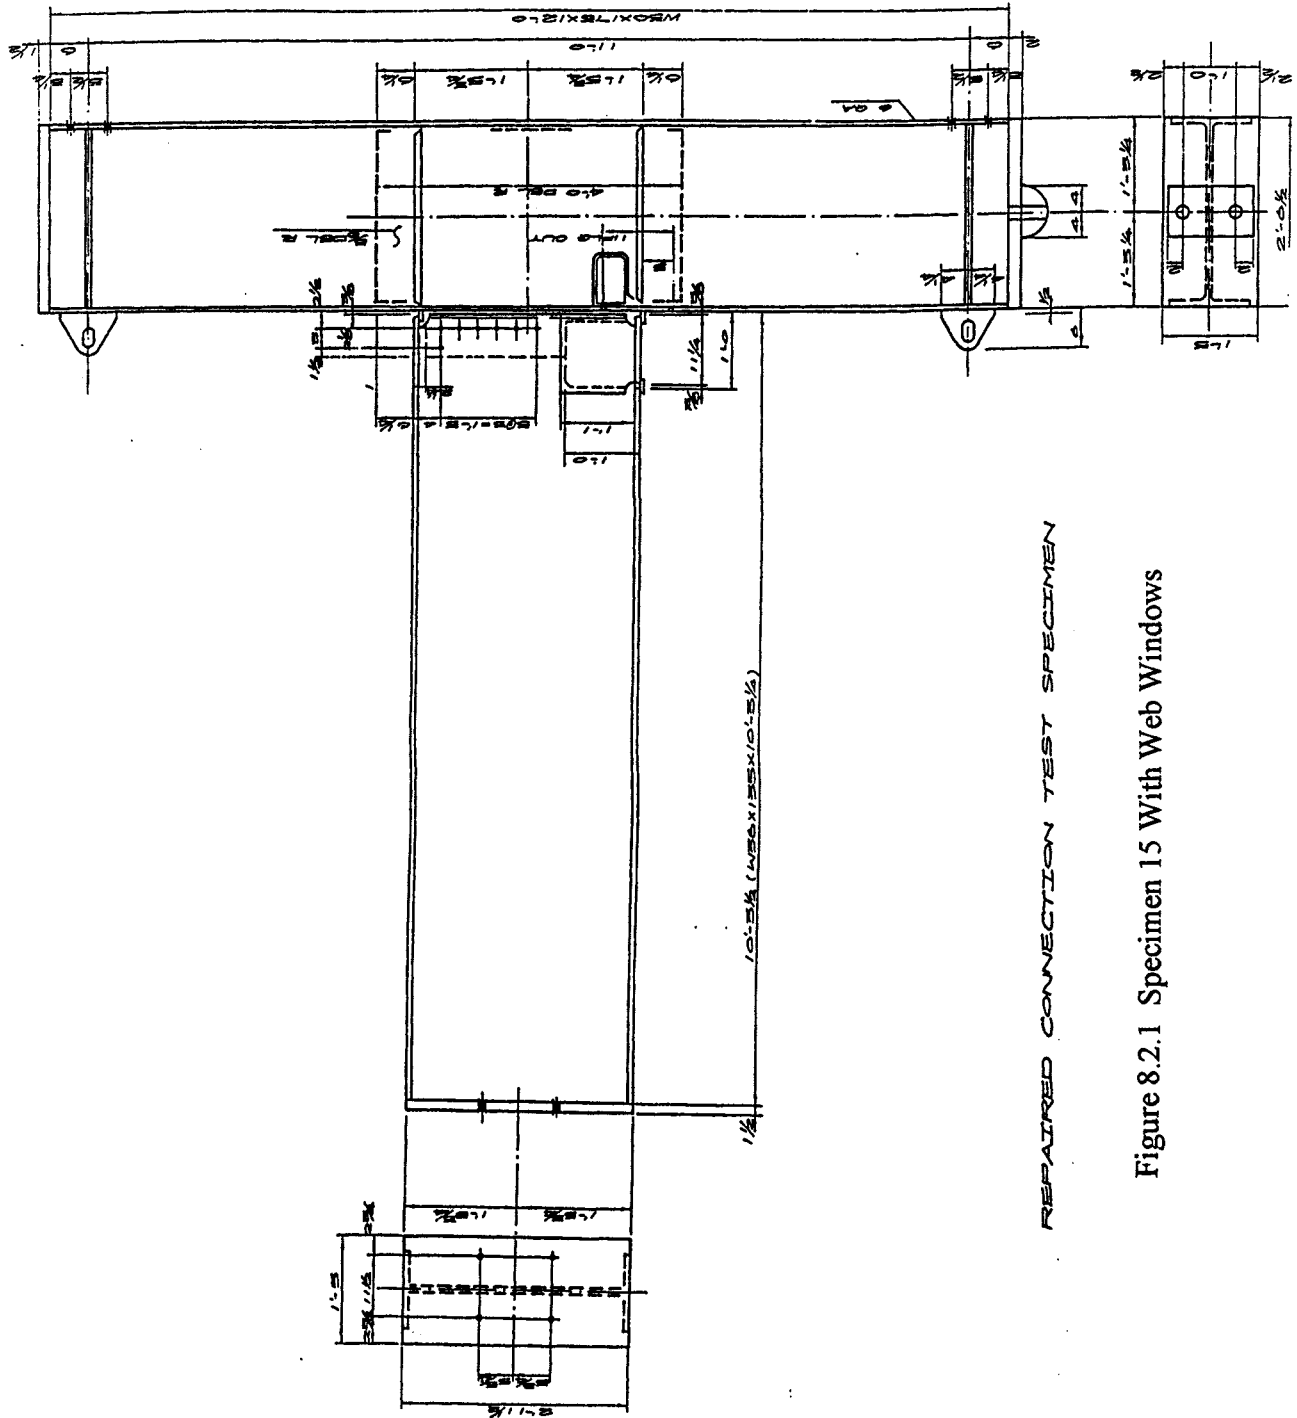
Figure 8.2.1 Specimen 15 With Web Windows

A detail of the full size test specimen is shown in **Figure 8.2.1**. The column is a W30x173 with a height of 11'-0" between connection points. The beam is a W36x135 with a span of 11'-3" from the face of the column to the load point. The panel zone was reinforced with a 5/8 inch web doubler which extended 6 inches above the top continuity plate and 6 inches below the bottom continuity plate. The distance to the actuator from the face of the column was 135 inches and the distance from the face of the column to the displacement transducer was 122 inches. No axial load

REPAIRED CONNECTION TEST SPECIMEN

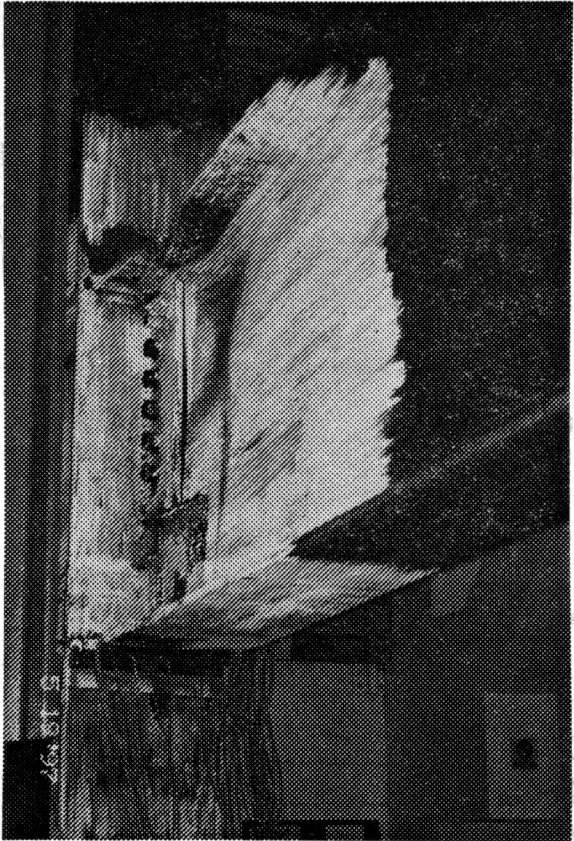
Figure 8.2.4 Buckled Beam Flange and Web, Spec. 15

The results of this test indicate that the performance of this type of repair can be improved by delaying or preventing the buckling of the beam web which appeared to be influenced by the window in the beam web and the nonsymmetry of the closure plate. Addition of a vertical stiffener at this location may further improve performance.

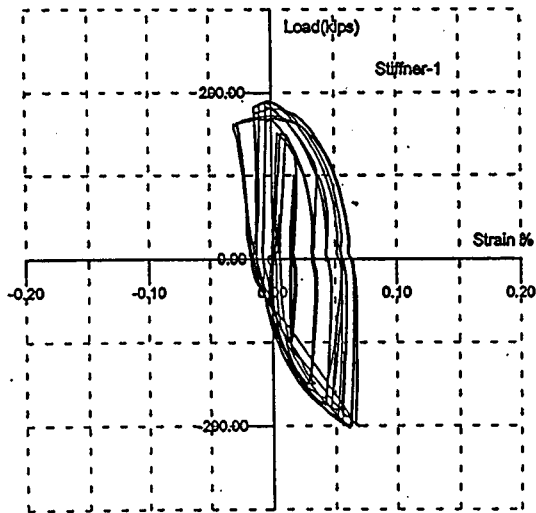
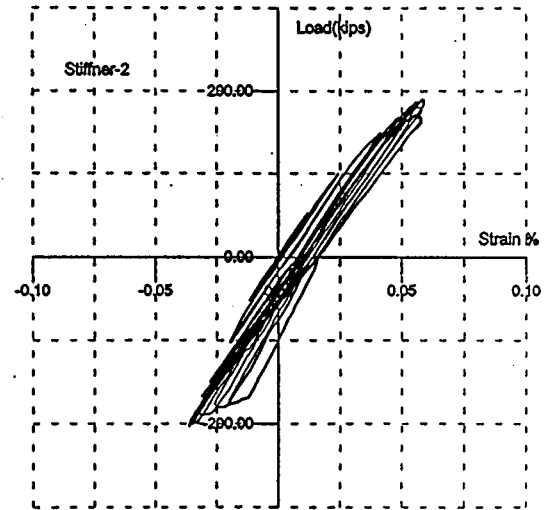
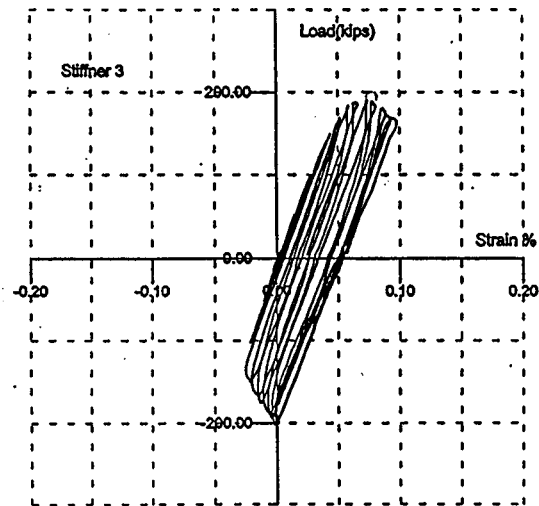
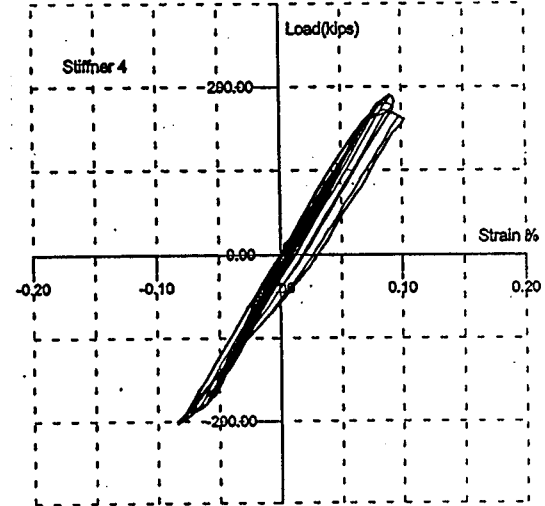
Figure 8.2.11 Column Web Strains Near Windows

Strains recorded in the corner of the panel zone in the vicinity of the web windows are shown in **Figure 8.2.11**. In general the behavior is linear elastic with recorded strains less than 0.1 percent. The gage shown in **Figure 8.2.11a**, indicates some inelastic behavior. This gage is located on the column web between the two windows and adjacent to the column flange replacement plate. Due to the significant amount of welding done in this region as part of the repair process, there may be considerable residual stresses which result in the yielding at the lower recorded strains.

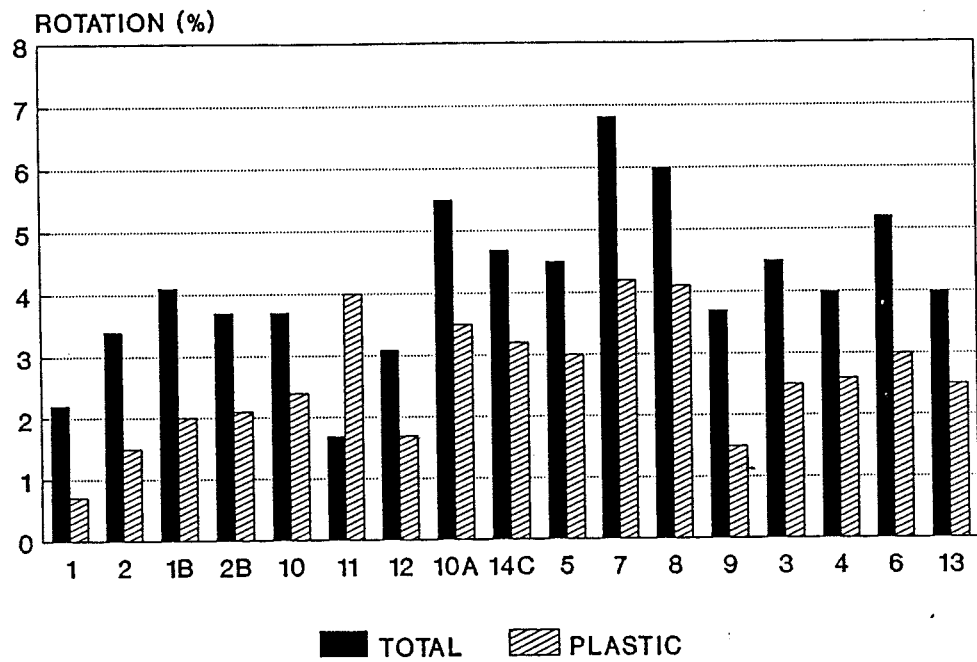
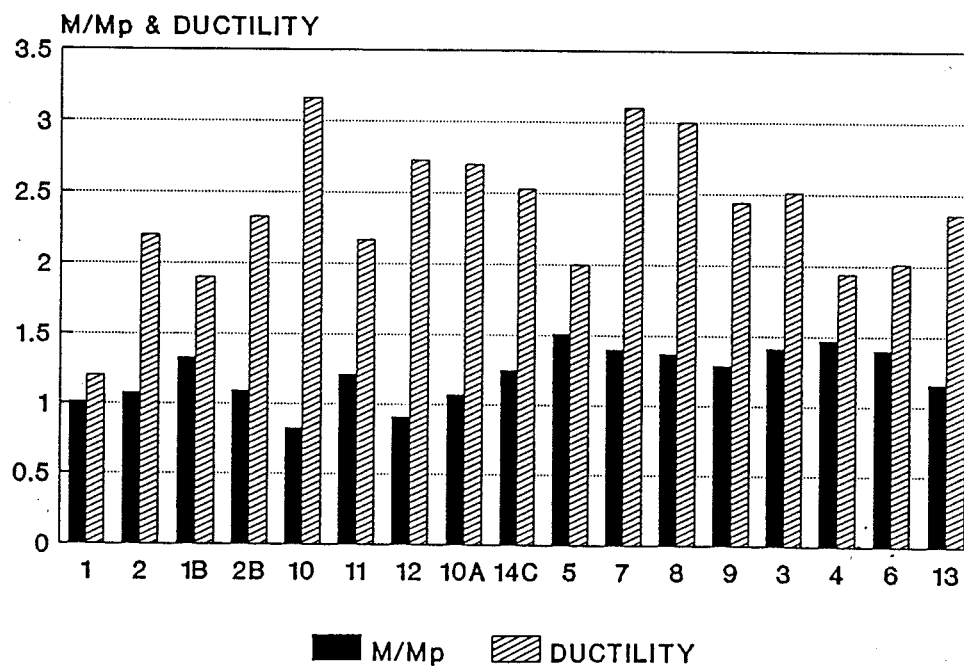
The next three specimens shown in the Figure 9.1, #10, #11, and #12, have a W16x77 column section and were tested in the "as received" condition. Specimen #10 developed a plastic rotation of 2.3% due to large panel zone deformations, however, the moment capacity was less than the plastic moment. Specimens #11 and #12 were only able to develop plastic rotations on the order of 1.7% with specimen #12 having a moment capacity less than the full plastic value.

Specimen #10 was repaired using a Class A weld overlay with SMAW and E7018 electrodes and became specimen #10A. A 3/8 inch vertical crack at the column face was left in place and covered by the overlay weld. It can be seen that this specimen was able to develop a plastic rota-

tion of 3.5% on retesting and the moment capacity was increased above unity. The overlay was successful in immobilizing the crack that was left in the existing weld. Specimen #14 was not tested prior to applying a weld overlay, therefore, this specimen represented a weld modification. After a minimum, Class C overlay was applied, this specimen became #14C. With the overlay, the specimen was able to develop a plastic rotation of 3%, the moment ratio increased to 1.25 and the ductility capacity increased to 2.5. ***Both of the specimens repaired or modified using weld overlays were able to meet the performance criteria of 3% plastic rotation.***

Specimens #5, #7, and #8 have W12x106 columns and are modified using rectangular cover plates on the top and bottom flanges. Specimen #8 uses a mini-plate which is a half sized plate. It can be seen in Figure 9.1a that these three specimens performed very well developing plastic rotation capacities of 3%, 4.3% and 4.1% respectively. With the addition of the cover plates on the flanges, the moment capacity is increased and the moment ratios, shown in Figure 9.1b were 1.5, 1.4, and 1.4 respectively. Ductility ratios ranged between 2 and 3.1. ***All three specimens modified by adding cover plates to the top and bottom beam flanges either met or exceeded the 3% plastic rotation criteria.***
