Bracing Berkeley

A Guide to Seismic Safety on the UC Berkeley Campus

PEER 2006/01
Pacific Earthquake Engineering Research Center
College of Engineering
University of California, Berkeley
January 2006

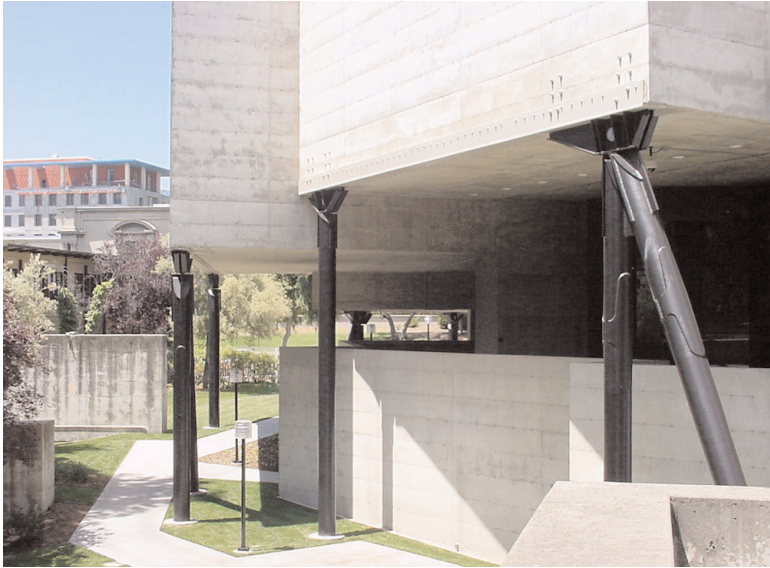
ABOVE:
Berkeley Art Museum after retrofit
with new steel columns.

ducted by SOH & Associates initially downgraded the Museum from a rating of Fair to Poor. The main concern was the fundamental lack of redundancy in the connections within the building frame. SOH & Associates ultimately suggested that the expected building performance in the event of an earthquake would be Very Poor, citing the likelihood of falling hazards, cracking damage, and partial or extensive collapse.

In 1997, Forell/Elsesser Engineers were asked to perform another seismic evaluation of the Museum and to propose conceptual seismic upgrade schemes to inform the budget process. Forell/Elsesser concurred with SOH & Associates' rating of Very Poor. The primary problems they identified were lack of adequate seismic-resistant elements in the direction perpendicular to the tree walls; lack of continuous and reliable load path; lack of redundancy; lack of ductility; major vertical discontinuities and weaknesses; major diaphragm discontinuities; and falling hazards.

The exterior retrofit system is designed to catch the building in the event of an earthquake. If the primary structure fails, the steel columns, which are not otherwise structurally loaded, will take over and keep the building from collapsing. These columns sit below the cantilevered galleries and atop new foundation work that includes a series of 3-foot to 3-foot 6-inch piers embedded to depths of up to 60 feet and capped together at grade. The interior system consists of new steel columns that brace the building in vulnerable areas and carry the loads all the way to the foundation. At the perimeter of the galleries, steel trusses tie the building together across the skylights to create continuous diaphragms. Overall, the strategy is an attempt to protect the building against collapse, but it does not incorporate any lateral interior bracing, tree wall strengthening, or tying together of the discrete gallery wings. Due to these deficiencies, the Pacific Film Archive, which can accommodate a relatively high concentration of people at a given time, chose not to reoccupy the building.

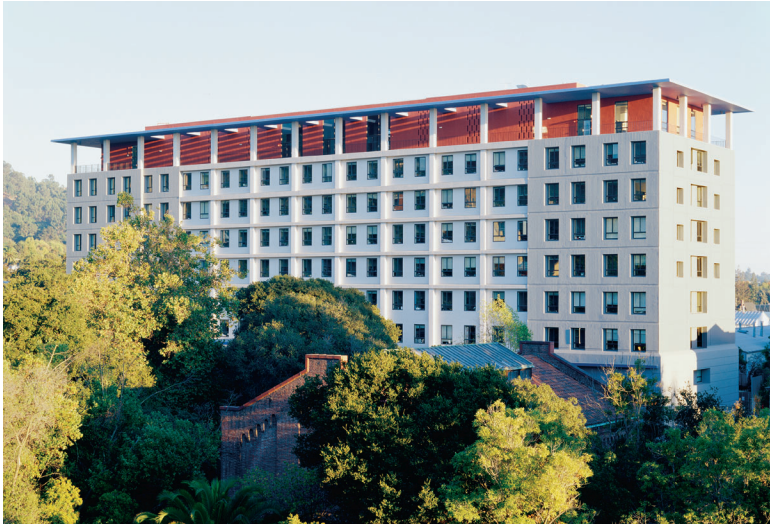
ABOVE:
Barrows Hall after retrofit.
Photo: Liz McBee

The seismic retrofit of Barrows Hall was completed by the architecture firm of Hansen/Murakami/Eshima and the engineering firm of Degenkolb Engineers. Several retrofit schemes were proposed by the design team, including adding buttresses, adding shear walls inside the building, and jacketing both ends of Barrows Hall. After much discussion, the scheme to jacket both ends of the building was selected. The jacketing scheme would increase the strength and stiffness of the building by adding shear walls at the ends of the building. These shear walls would be tied to the building and to the foundation using drag struts (or diaphragm collectors) and boundary reinforcements. The jacketing scheme necessitated removing some windows on the east and west sides.

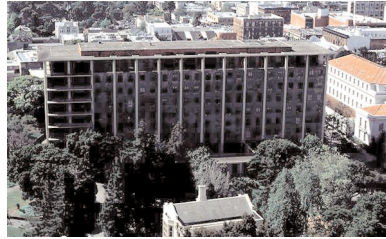
ABOVE:
Barrows Hall before retrofit. Photo by
Steven Brooks.

campus Seismic Review Committee, by chance walked through the building. He was alarmed by what he saw. In his judgment, Barrows Hall would likely suffer local structural and non-structural damage resulting in life-safety risks. He recommended that the Seismic Review Committee reevaluate the seismic safety of the building, but it was not until 1997, when funds became available, that Barrows Hall received a second evaluation. The building was then given a Poor rating, confirming Martin's judgment.

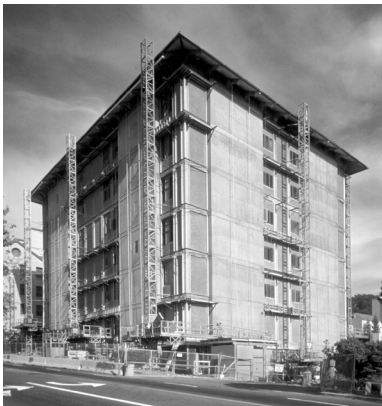
The engineering firm of Forell/Elsesser was hired to evaluate the existing structure and to propose several possible retrofit schemes. The structural system of Barker Hall consists of shear walls and a reinforced concrete pan joist and column structural system. Individual spread footings bear the weight of the columns, while a continuous spread footing around the perimeter of the building bears the weight of the basement wall. The soil condition is dense and sandy clay, which has a relatively high load-bearing capacity. The core elements that would normally resist lateral force were found to be relatively weak in a number of ways. The precast/pretensioned concrete panel cladding system was found to be not only brittle but insufficient to resist the

lateral load due to the pattern of the window openings, which created a random shear wall system. In addition, the tops and sides of the panels were connected to the perimeter beams and columns by dowels, but the bottoms of the

ABOVE:
Barker Hall before retrofit.
LEFT:
Installation of new exterior shear walls.

panels were not connected at all. Shims, instead of dowels, were found between the bottoms of the panels and the beams. Additionally, the perimeter columns did not contain closed ties and the existing frame was found to be inadequate to resist seismic forces.

Forell/Elsesser, and the project architects, Anshen and Allen, drew up the final plan to add eight exterior shear walls (two per side) and collectors, and drilled pier foundations. Later the foundation was changed to a continuous post-tensioned concrete perimeter foundation. The new foundation was constructed 10 feet below the old perimeter foundation. It is a post-tensioned concrete belt beam, 6 feet wide and 11 feet deep. The entire building had to be underpinned because of the close-in construction.

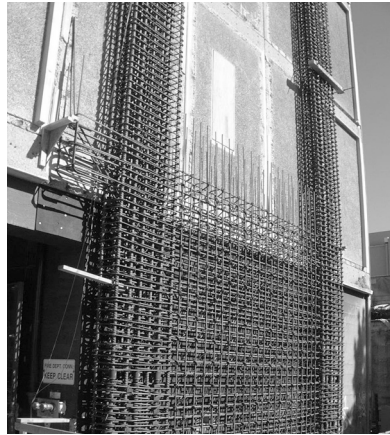
ABOVE:
Rebar for exterior shear walls.
BELOW:
Rebar for foundation.

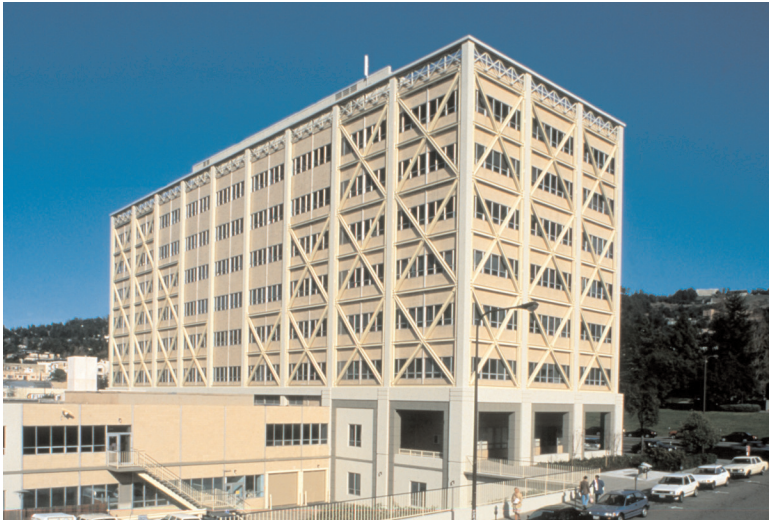
ABOVE:
View of the west and south sides
of University Hall after retrofit.

The seismic deficiency of the original University Hall design was primarily due to its deep beams and short, slender columns. The 8-inch by 7-foot-deep beams were huge compared to the 24-inch square columns. The stiff beams, together with the mass of the 4½-inch-thick concrete floors would easily take the

lateral forces of an earthquake and deliver them to the weaker columns. Without sufficient length over which to develop any flexural strength, these columns would then fail in shear.

Degenkolb Engineers acted as structural engineers on the 1988 University Hall study and proposed three retrofit schemes to UC Berkeley’s Seismic Review Committee. In the chosen scheme, steel X-frames were added to the exterior of the building, providing clear, visual articulation of the long-awaited seismic improvements. To prevent early column failure, the engineers

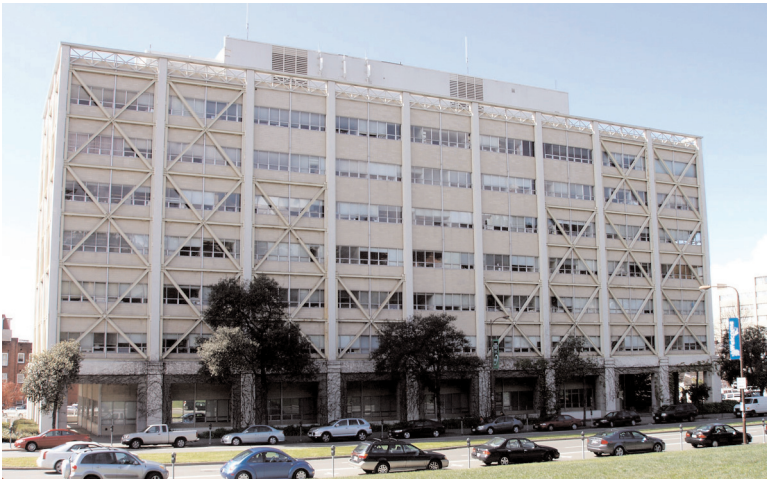
ABOVE:
South entrance to University Hall displays soft story.

Structural engineers found in University Hall an additional seismic deficiency called a “soft story.” Lateral forces acting on a building during an earthquake accumulate as they travel from the top of the structure to the ground. Therefore, the base of the building must provide sufficient resistance to these accumulating loads. If the first story is too weak, it will collapse under the weight of the upper floors—hence the term “soft story.” University Hall suggested this weakness because the first floor is recessed on the south, east, and north sides. The exterior walls of the tower do not extend down to the ground, but stop above the first floor, with columns extending to the ground.

also proposed connecting steel to either side of the concrete columns with epoxy-threaded rods. The scheme also included adding a horizontal truss member to the roof and installing reinforced concrete shear walls to the first floor to prevent soft-story failure.

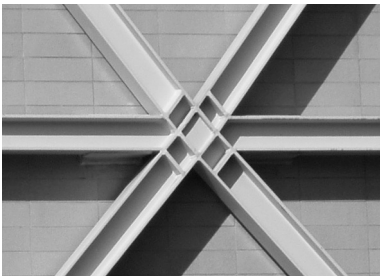
BELOW:
Detail of X-bracing.

Special aesthetic attention was given to the connections of the braced frames, since the connections would be visible on the exterior of the building. Because connections require considerable cutting, drilling, and welding, they frequently end up the messiest looking part of a steel structure. Two critical groups of connections existed in the retrofit system:

the brace intersection where six pieces came together (two beams and four braces) and the column-to-column connections where steel columns connected to concrete columns. At the column-to-column connections, engineers provided steel plates to which fabricators could fillet weld the steel columns on site. These steel plates were connected to the concrete columns by coring across the concrete column and inserting 4- or 5-inch pipes that were then welded to the plates. To make welding as simple as possible, 8-inch wide flange shapes were chosen for all beam, brace, and column sections.
