PEER Preliminary Notes and Observations on the August 24, 2014, South Napa Earthquake

Pacific Earthquake Engineering Research Center

Report No. 2014/13

September 17, 2014

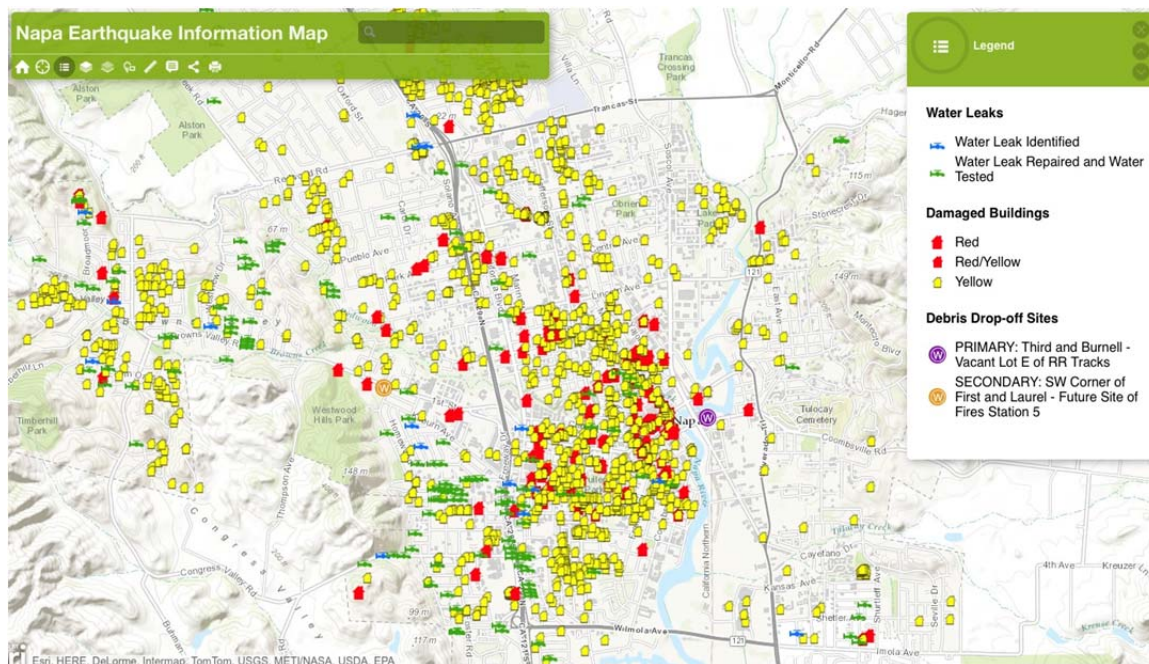
While relatively modest in intensity, the South Napa earthquake caused significant ground shaking and damage in the epicentral region. For instance, in the city of Napa alone, around 500 buildings have been yellow-tagged, and an additional 120 damaged buildings have been red-tagged (Figure 1). These numbers are expected to grow as detailed inspections continue.

Figure 1 Map of Tagged Buildings in Napa, California, damaged in the August 24, 2014, South Napa Earthquake (<http://bit.ly/1lsdLpf>, accessed September 15, 2014).

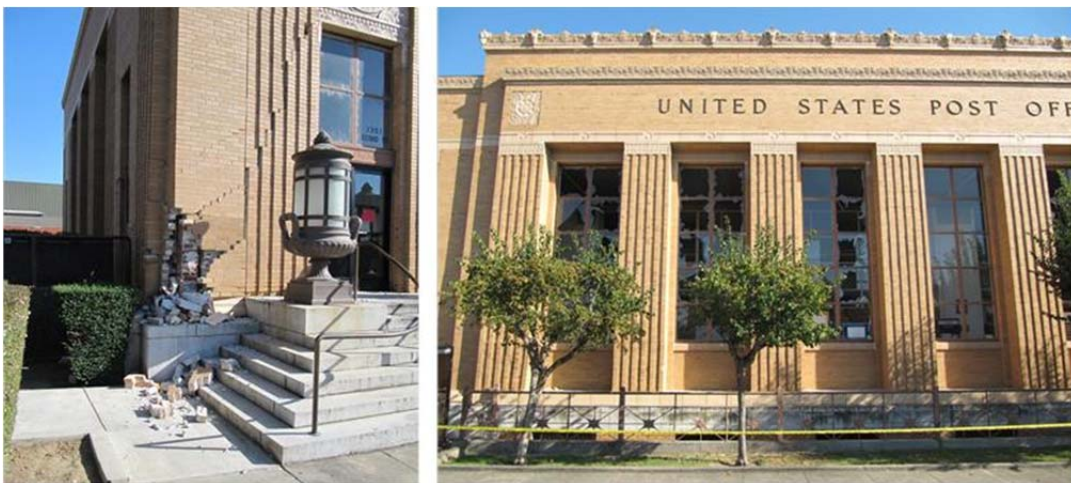
The U.S. Post Office (Building E in the map in Figure 6) experienced wide range of structural and non-structural damage. Partial damage in the masonry bearing walls at both of south and north lower corners of the building is shown in Figure 11 and 12. Most of the façade windows were damaged; see Figure 11.

Figure 11 Damage in the north lower corner of Napa Post Office Building (Building E in the map in Figure 6) and smashed façade and glass windows.

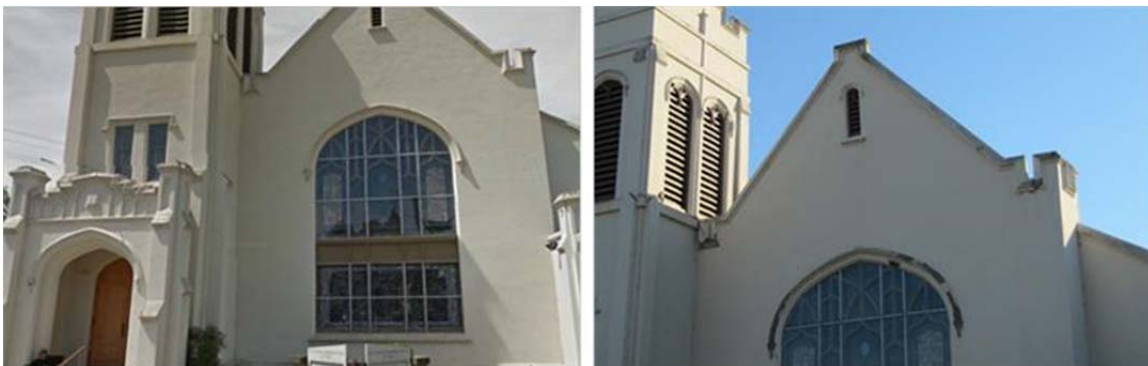
Another example of historical masonry buildings that were partially damaged after the earthquake is church buildings. The damage that took place in a 100-year-old church in downtown Napa (Building F in the map in Figure 6) is shown in Figures 13 and 14. A comparison of the before and after earthquake front side of the church is shown in Figure 13. The street view in Google Maps was utilized to generate the before earthquake picture. The wall on the east side of the church had a visible separation from the roof and it remained inclined toward the nearby street; see Figure 14. The separation can be approximately estimated to be 26 in., and laser scanning of the church building was pursued to quantify the deformation and damage as presented in a following section. Another close-by church (Building G in the map in Figure 6) experienced only nonstructural damage; see Figure 15. The façade windows were smashed and the steel cross and wind-direction arrow permanently deformed after the earthquake; see Figure 15.

Figure 13 Before (left) and after (right) earthquake status of a 100-year-old church (Building F in the map in Figure 6).

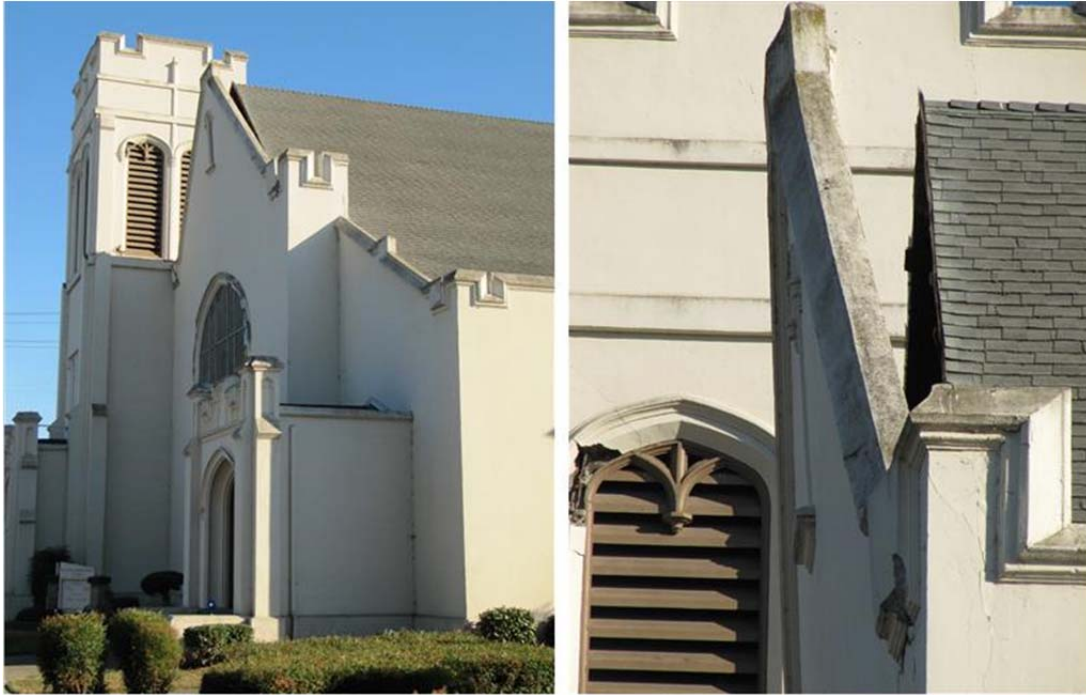
Figure 14 Separation gap between the church (Building F in the map in Figure 6) roof and the east wall in a global (left) and zoomed-in (right) views.

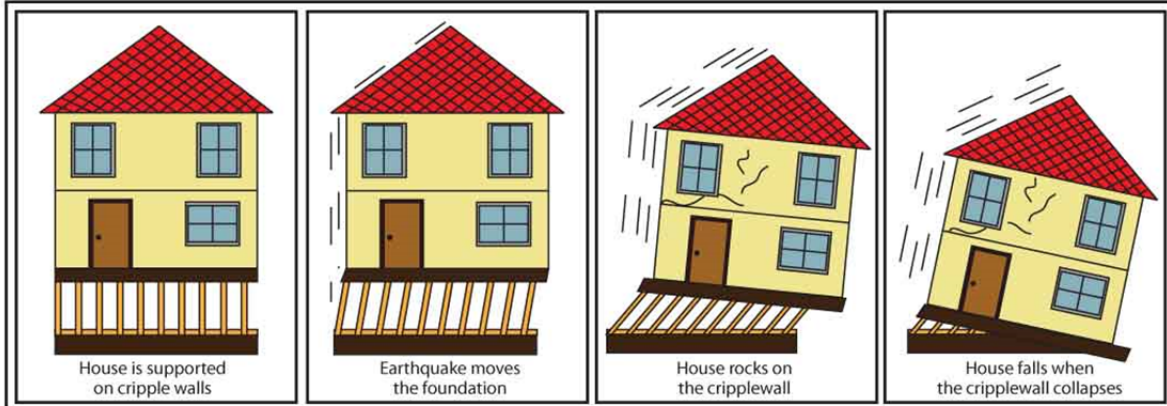
Figure 16 Schematic representation of wood building failure as a result of a cripple wall collapse (Courtesy of Weinstein Construction Corporation).

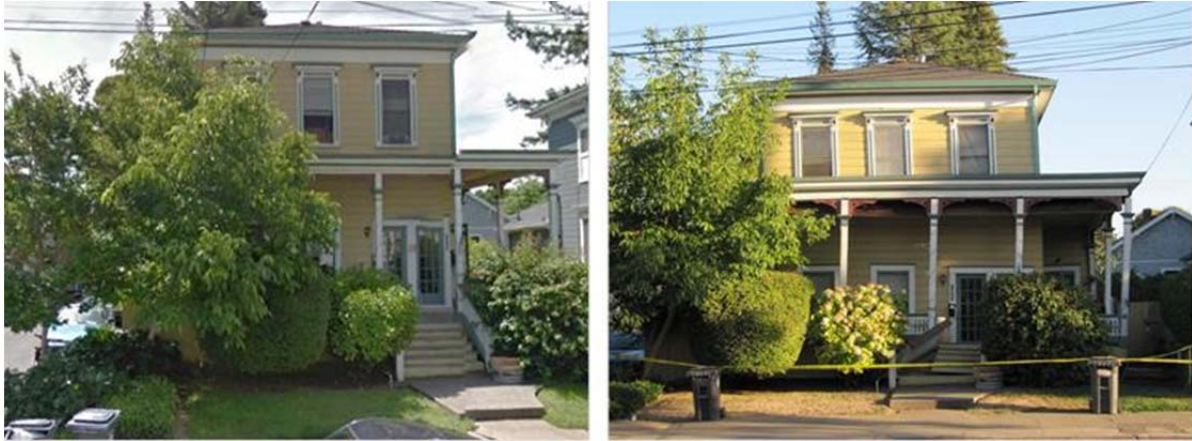
Many of the residential buildings in the downtown of Napa are more than 100 years old. Although some strengthening and retrofitting has been done by the owners, several failures were observed in the aftermath of the earthquake. One example of a wood building that was red-tagged due to almost complete collapse is presented here. One of the main reasons for the building's collapse is the weak cripple wall. An illustration of a typical mode of failure of a wood frame building due to cripple wall collapse is shown in Figure 16. The extensive damage observed in the old residential building in downtown Napa (Building H in the map in Figure 6) is shown in Figures 17 through 19. Figure 17 shows the front side of the building before (Google street view) and after the earthquake. The side sway of the building suggests that the building most likely fell down from the cripple wall in east-to-west direction. Global views of the damaged building are shown in Figure 17. Massive damage can be observed in the additions on the back side of the building as well as the building main frame.

Figure 17 Before (left) and after (right) earthquake condition of the residential wood frame building with a cripple wall design in downtown Napa (Building H in the map in Figure 6).

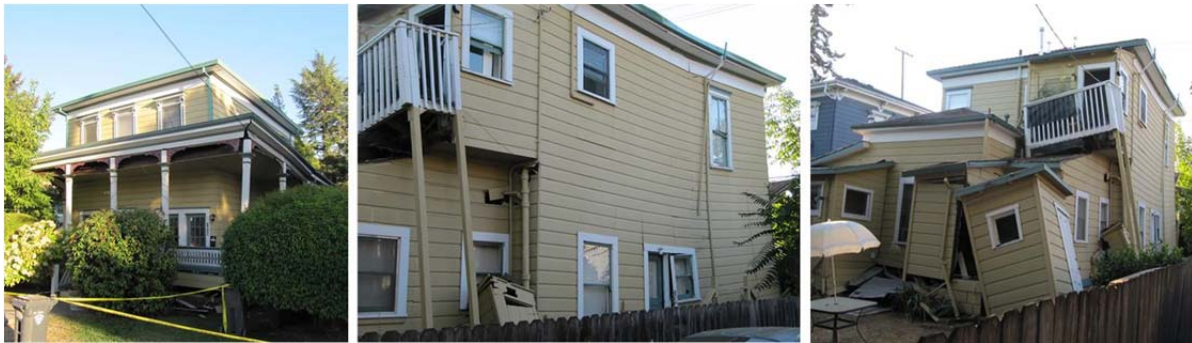
Figure 18 Global views of different sides of an old residential wood building (Building H in the map in Figure 6).

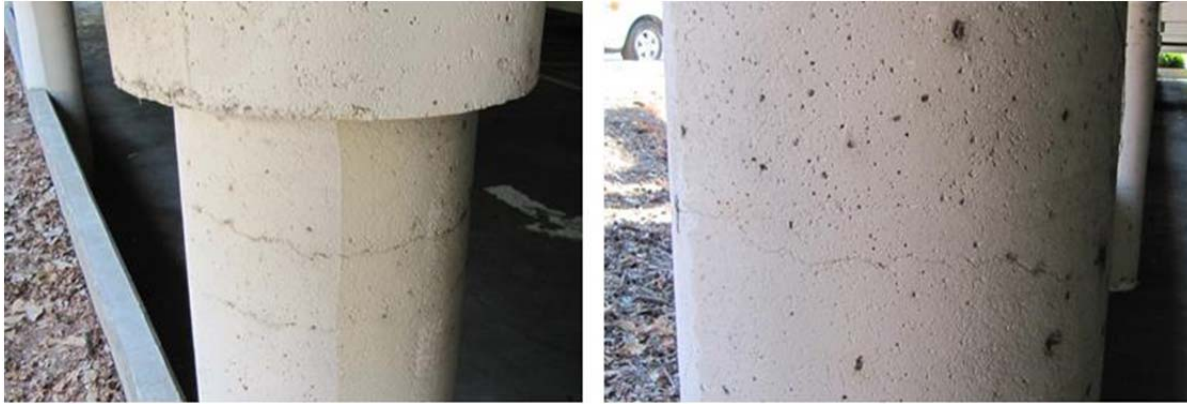
In general, all the RC structures in the areas struck by the earthquake showed no or minor structural damage. In the given multi-story garage example, only minor flexural cracks were observed in the basement floor columns; see Figure 20. Moreover, some diagonal cracks were also observed in a RC shear wall in the basement floor of the same multi-story garage; see Figure 21. Note that the first and second floors of the multi-story garage were inspected and no cracks at all were observed in any of the RC elements.

Figure 20 Flexural cracks in basement floor columns of multi-story RC garage building (Building I in the map in Figure 6).

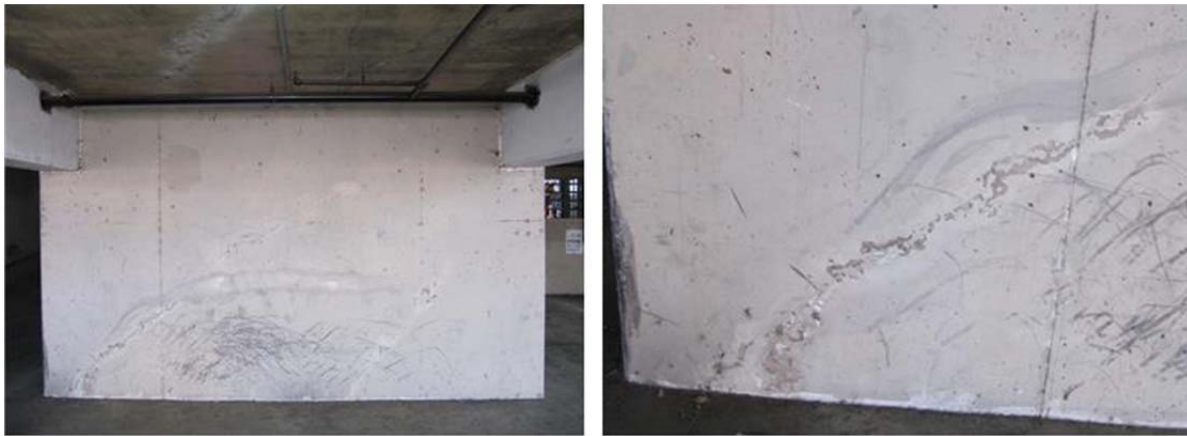
Figure 21 Minor diagonal cracks in basement floor shear wall of multi-story RC garage building (Building I in the map in Figure 6).

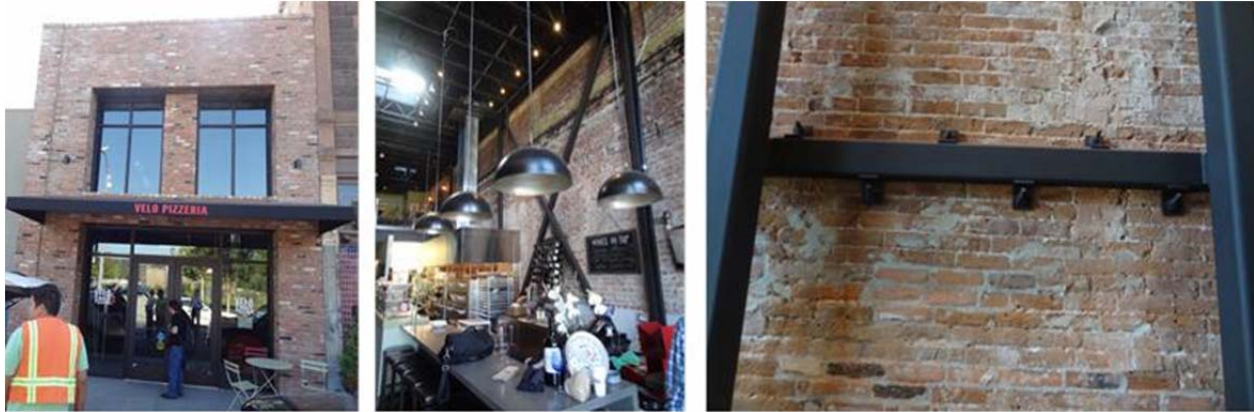
Figure 22 Example of a retrofitted UMB using a steel braced-frame that performed well during the earthquake with no signs of any structural or nonstructural damage.

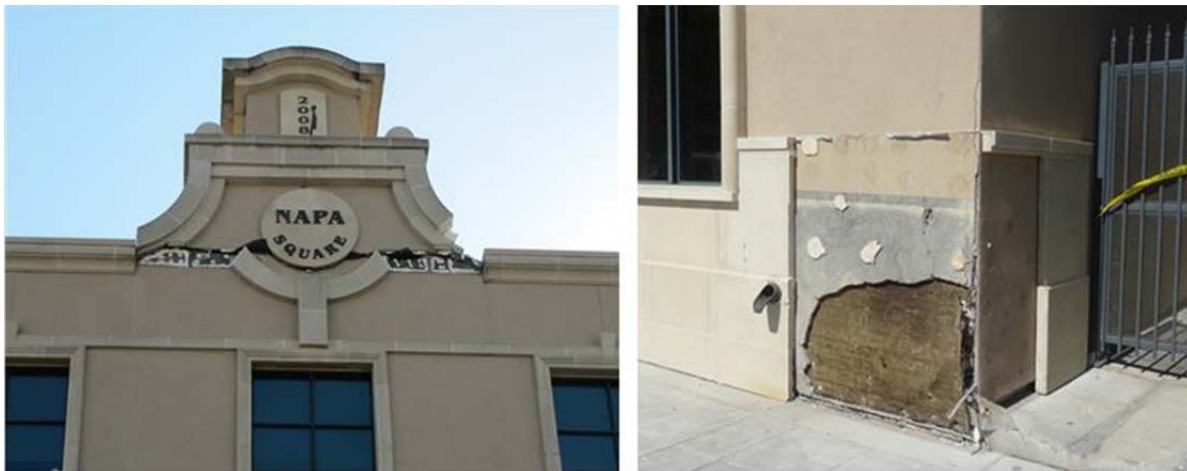
Figure 23 shows the damage that happened to two chimneys in two different residential buildings in downtown Napa, and identified as Building J and K in the map shown in Figure 6. The cosmetic damage that occurred in the façade of one of the shopping malls in downtown Napa is shown in Figure 24. A different form of nonstructural damage is local failure in wire connections in street power distribution lines, which led to electricity outage for hundreds of buildings. Figure 25 shows a wire end connection failure after the earthquake and the efforts exerted by PG&E officials to fix it to restore electricity before night time in downtown Napa the first night after the earthquake.

Figure 24 Damage in shopping mall façade in downtown Napa.

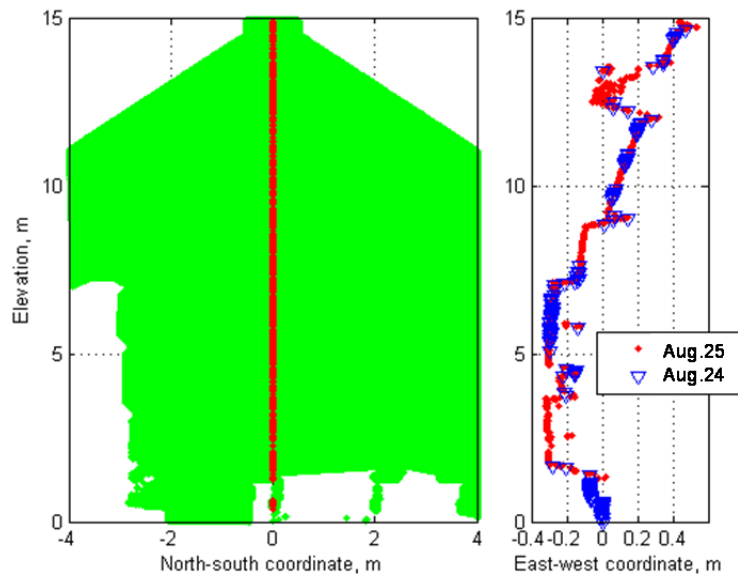
To assess the inclination of the east wall and monitor its condition after the aftershocks, several scans of the church were conducted. On the day of the earthquake the church was scanned from four corners to obtain a complete geometry of the structure. On the following day—about 24 hours later—two more scans of the church were conducted from the east side street. Figure 33 shows the residual deformation of the east wall where color of a point in the point cloud depends on the distance from a vertical plane. The arrows show the locations of visible cracks observed in the wall. Figure 34 shows the location of the vertical slice on the left side and the comparison of the condition of the slices taken right after earthquake and the condition of the same slices 24 hours later. It was concluded that the aftershocks were not strong enough to change the wall's deformation. That said, depending on the magnitude of the aftershocks, future shaking could

Figure 34 Deformations of the wall did not change during the aftershocks.

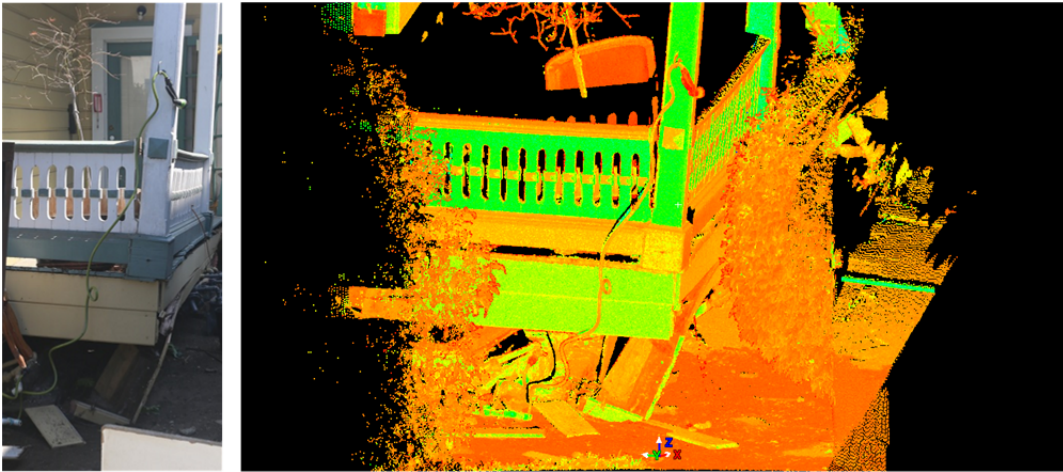
To access the residual displacement and the height of the cripple wall, a laser scan of the corner of the building was performed. Several laser scans were recorded from the same location of the laser scanner, which was installed at north-west corner of the building. Figure 35 shows the photo of the scanned region on the left and the point cloud of the corner of the building. A zoomed view of the corner showing some major member of the building's lateral resistance system is presented in Figure 36. The point cloud was best fit to regular geometric shapes to estimate the size and inclination of the stud; see Figure 36. The prism best fit to the point cloud of the stud revealed that it is most likely 2 in. × 6 in., as shown in the object information window displaying the prism's properties in Figure 37. The angle of inclination of the stud (relative to the vertical axis) is estimated to be -0.7503.

Figure 35 After condition of the wood frame building with a cripple wall design.

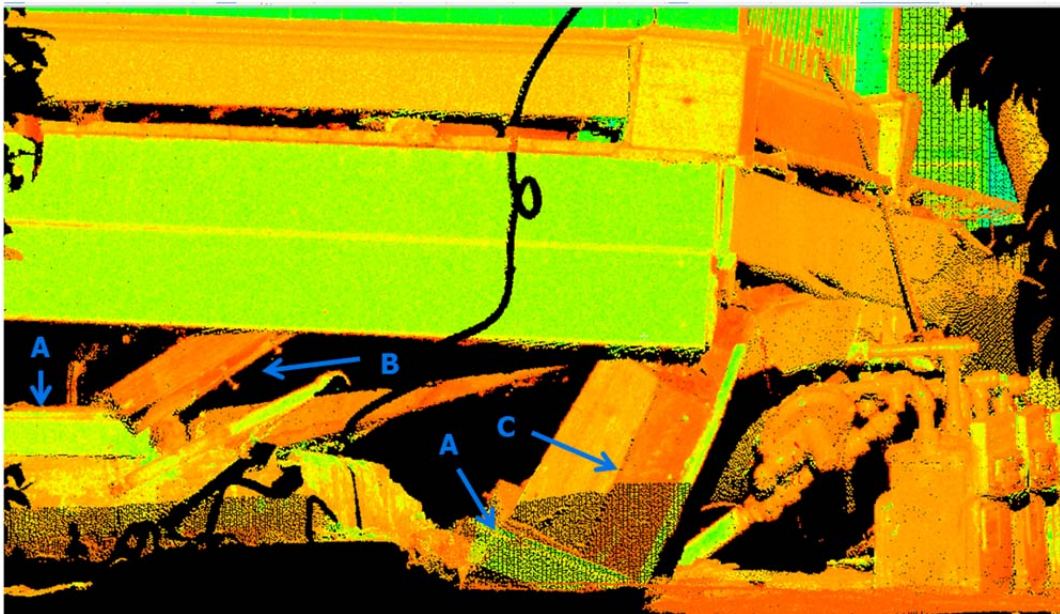
Figure 36 Major structural members of the building: A – sill plate, B- stud, C – corner 4 in. × 4-in.

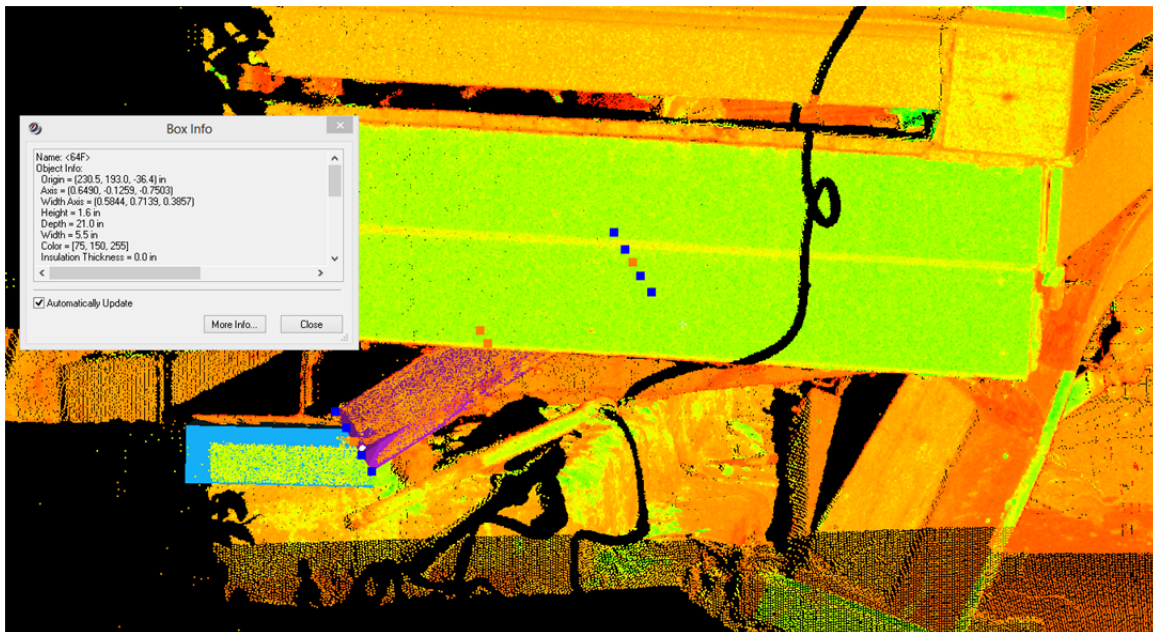
Figure 37 Supporting members of the building: blue – sill plate, pink – stud, most likely 2 in. × 6 in., and 21 in. long based on the point cloud.

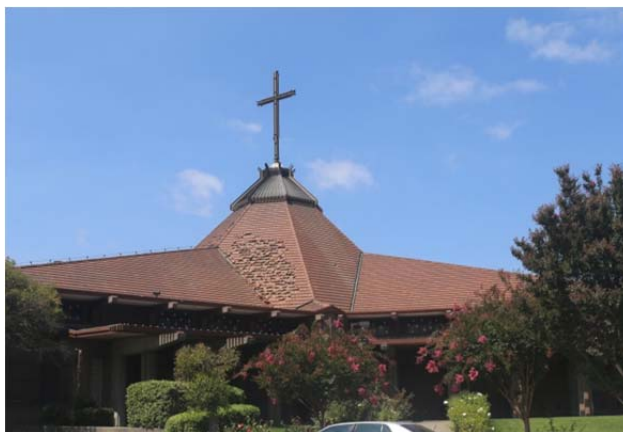
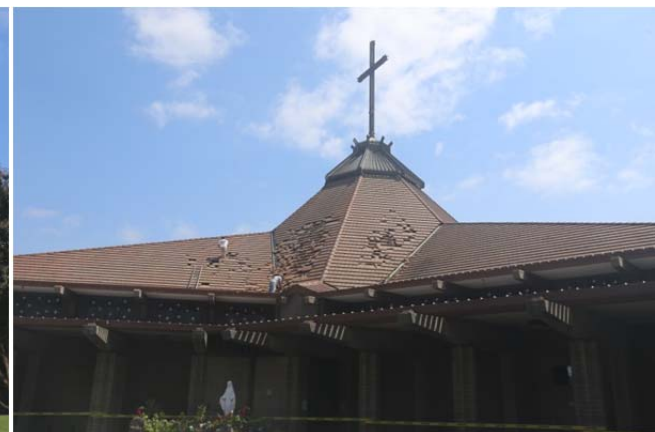
The ground shaking in Napa downtown was quite severe as outlined in the previous section that was amplified on the roof level of a church. Figure 4 shows the satellite view and street view of the church before the earthquake (courtesy of Google maps). The ground observation of the site right after the earthquake revealed massive failures of roof tiles; see Figure 5.

Figure 5 Failures of ceramic roof tiles due to amplified seismic excitation on the roof.

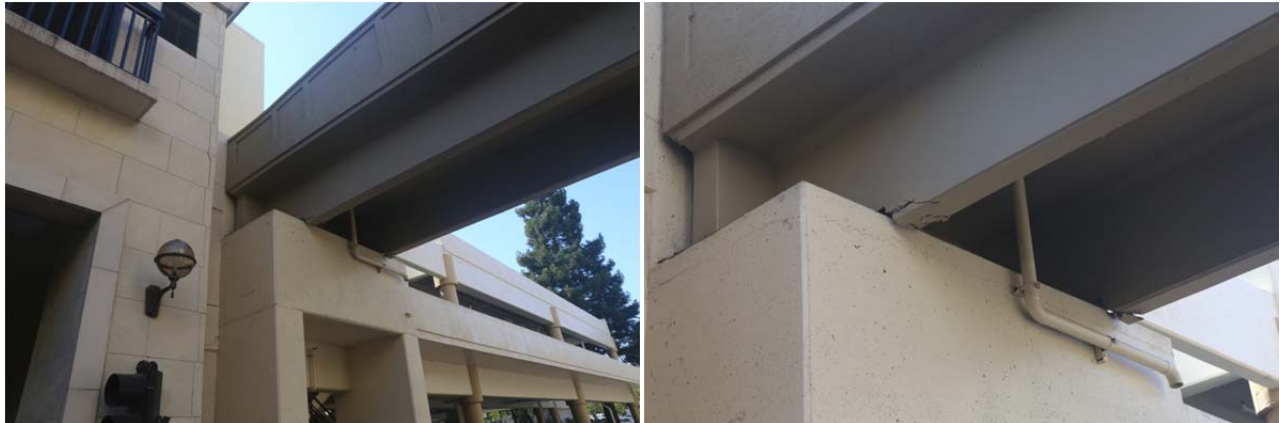
A small bridge connecting a parking lot to a building right next to it exceeded its travel limit as presented in Figure 6. As the result only minor damage was observed at the bottom flanges of the bridge's deck. This failure could be associated with some pounding effect on the parking structure and the building.

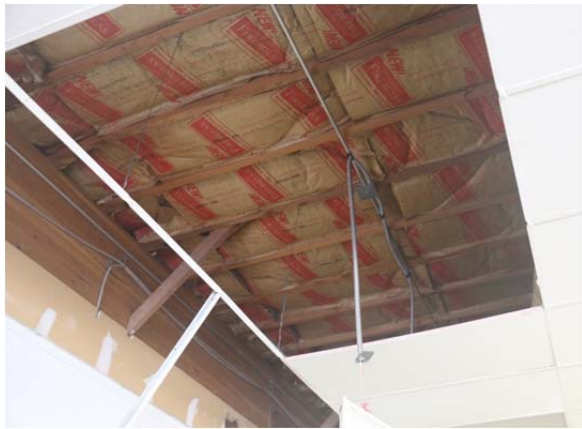
A suspended ceiling installation dated to early 1990s was investigated in the field studies. The system did not have any splice wires and was most likely floating on all sides. The suspended ceilings were installed in a single-story commercial building, with the major failure concentrated around the perimeter of the building: see Figure 7. Some local damage was also observed; see Figure 8.

(a) No brace wires were installed

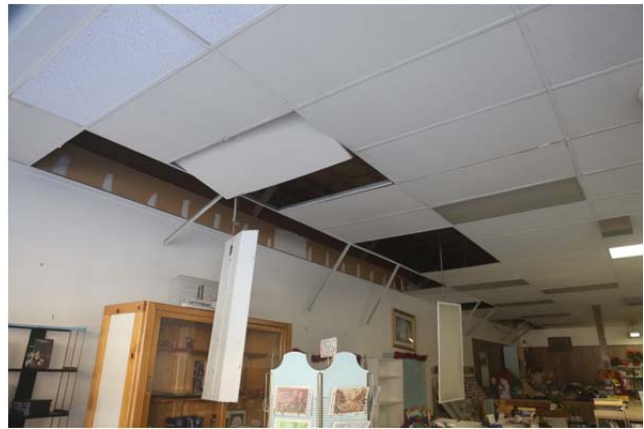
(b) Failure concentrated around perimeter on floating side

Figure 7 Old ceiling installation global failures.

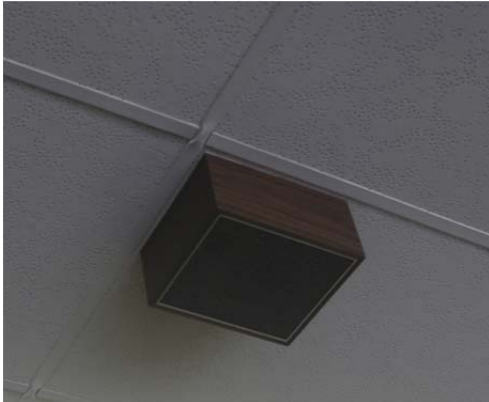
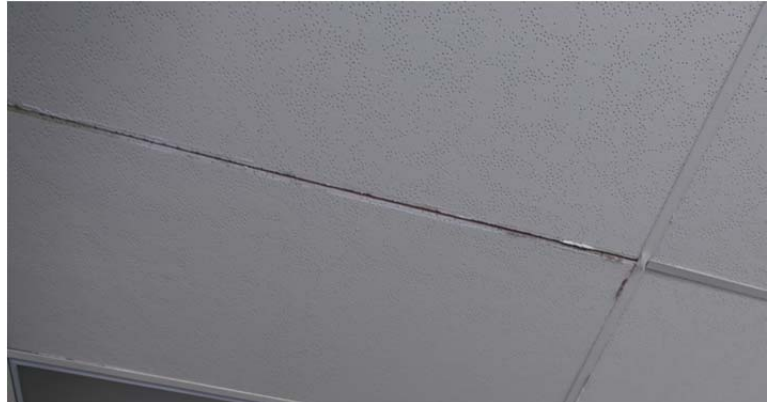
(a) Local buckling at tee intersections

(b) Missing tee-bar failure

Figure 8 Local failure of old ceiling tile installations.

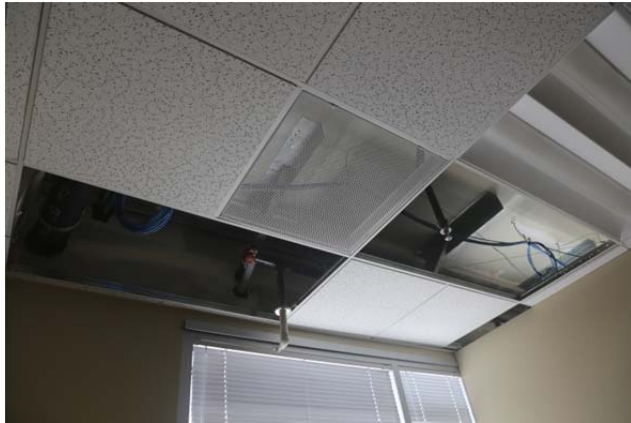
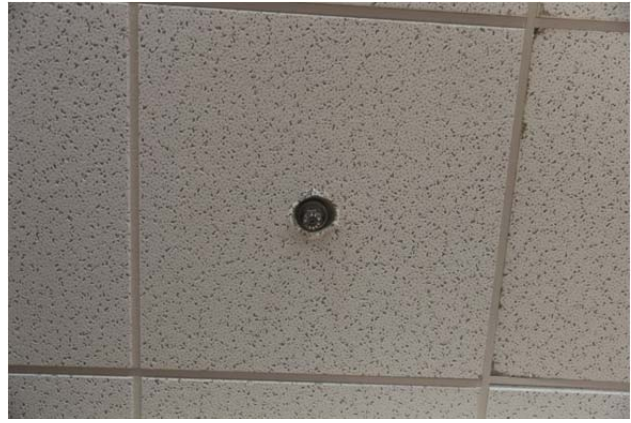
(a) Failure of a panel due to interaction with fire sprinkler

(b) Clearance for the fire sprinkler was exceeded

Figure 9 Recent ceiling installation: local failure.

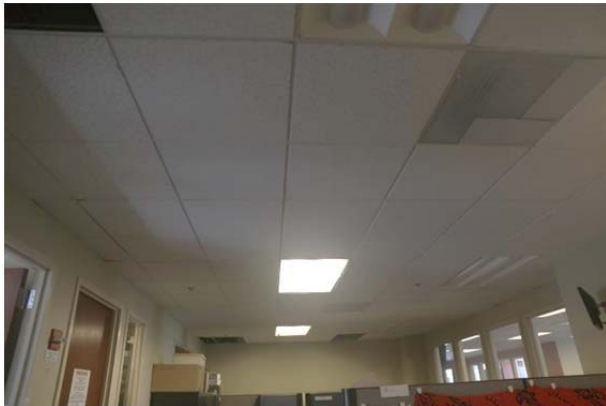
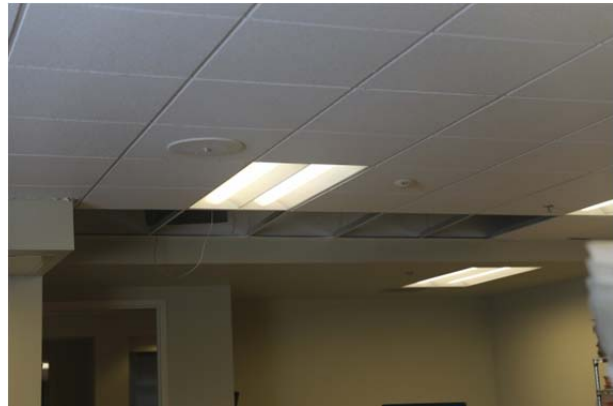
(a) Localized failures at the perimeter

(b) Localized failures at the perimeter

Figure 10 Recent ceiling installation: global failures.

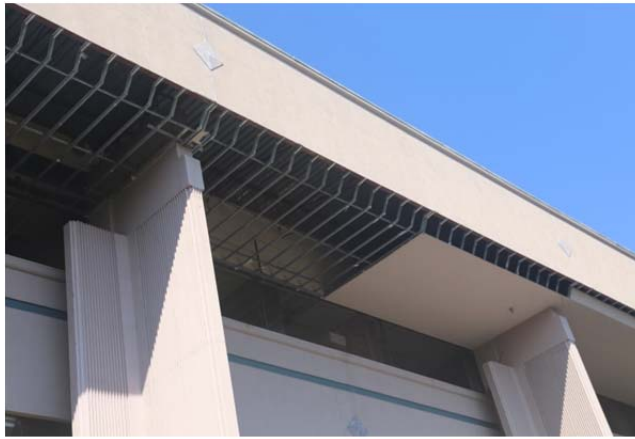
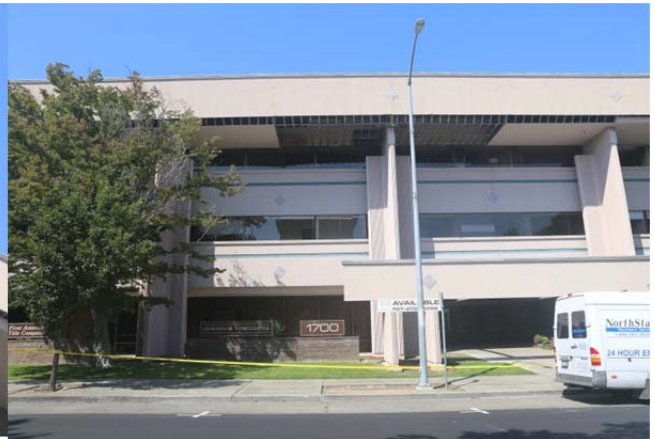
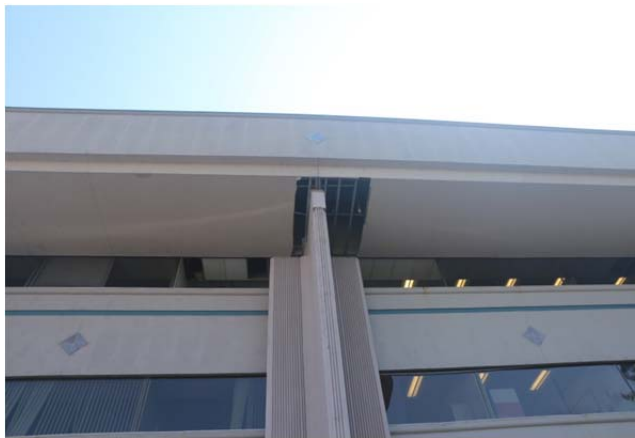
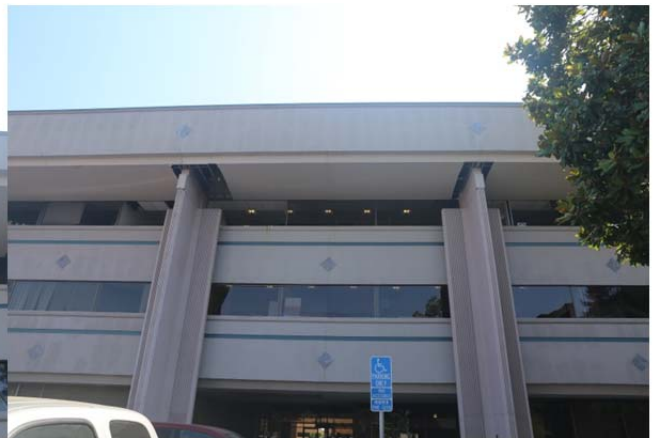
A failure of outdoor installation of sheetrock panels occurred in a three-story building during the earthquake; see Figure 11. The failures were localized around the columns. These failures of the outdoor panels were accompanied by failures of suspended ceilings inside of the building.

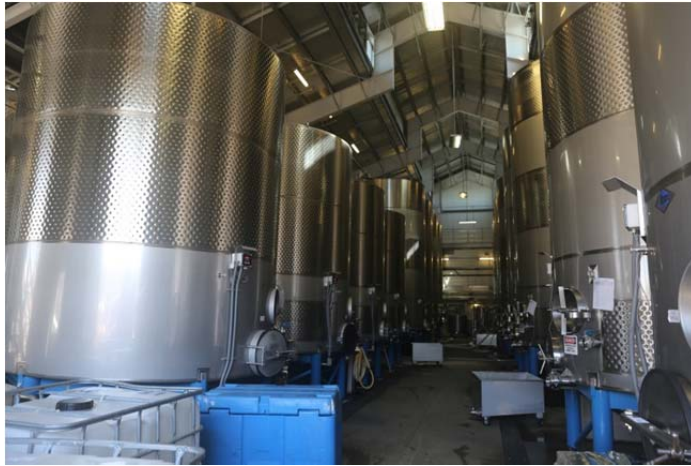
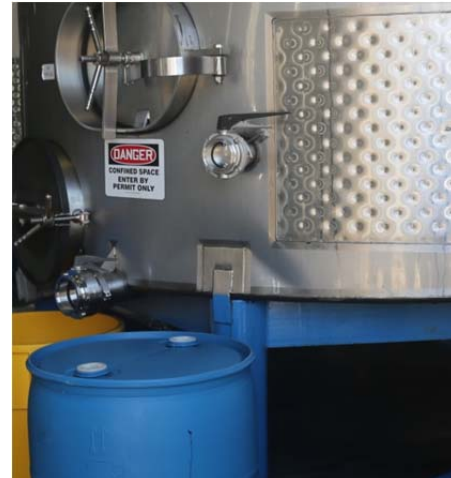
A failure of a tall tank is presented in Figure 15. The local buckling was observed at the attachment points on the tall tanks (on left side of the global photo). The tanks on the left have not suffered this kind of damage due to smaller size.

(b) Local buckling at the bottom of a tall tank

Figure 15 Local buckling at the attachment point of the wine tank.

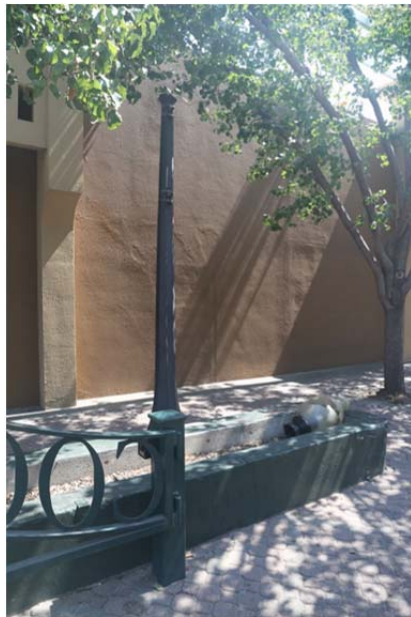
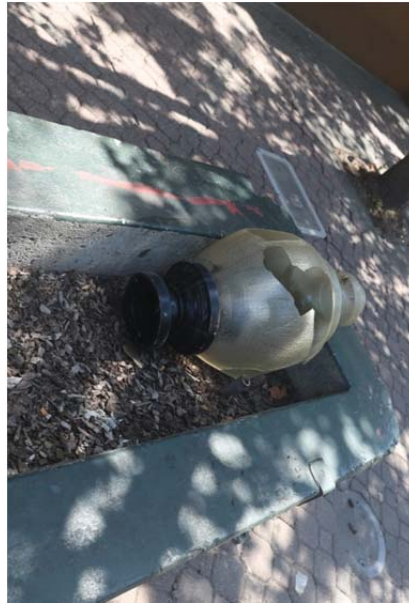
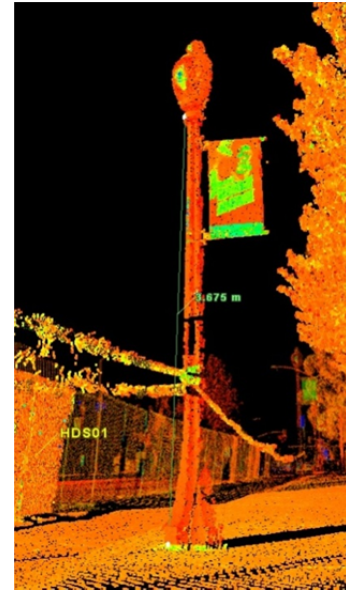
A large light fixture installed on a 3.68-m pole fell on the ground during the earthquake as presented in Figure 16. The light pole was installed right next to a large department store. This could have injured shoppers passing by if the earthquake had happened during operational hours.

(a) Light fixture fell from the light pole

(b) Light fixture on the ground

Figure 16 Failure of a light fixture

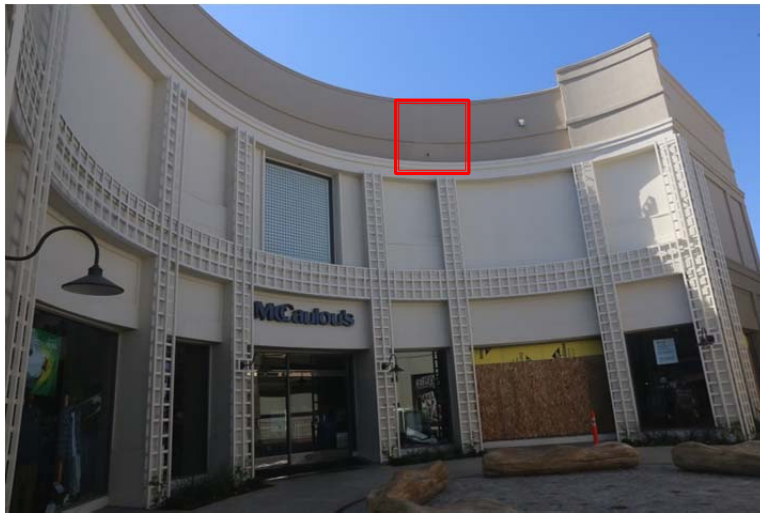
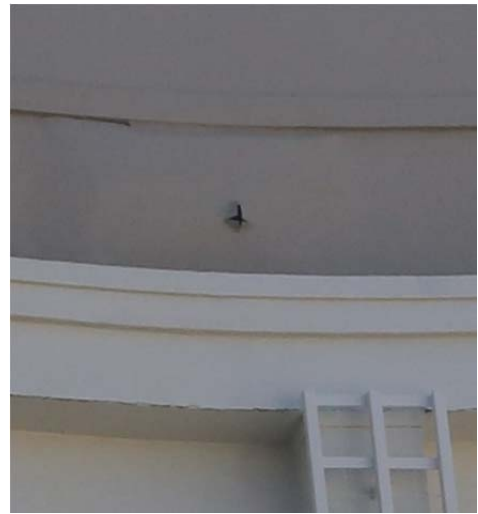
A two story department store in downtown was flooded with water after a pipe burst on the roof (shown in a red square) in the photo of the retaining wall in Figure 17. The water eventually broke through the parapet on the roof and shot across the walkway. The water source was close at the time of the field studies (12 hours after the earthquake), and the building was closed for an inspection. Water coming from the roof and upper story caused massive flooding of the first floor of the department store: carpets were soaked and most likely will need to be replaced in the future. Figure 18 shows soaked goods and suspended ceiling tiles as a result of the earthquake and the flooding. Ten days after the earthquake the department store was still closed. If the hole in the parapet has not developed at the time of pipe failure and flooding, a complete collapse of the roof diaphragm could be expected. Flooding resulted in large monetary losses: the piping system needs to be repaired, suspended ceiling to be replaced, goods cannot be sold due the damage, and flooded carpets need to be replaced in addition to other costs.

(a) Water pipe failed on the roof elevation and poured down through a hole in parapet (red square)

(b) Zoomed view of the hole

Figure 17 Water damages in the department store.

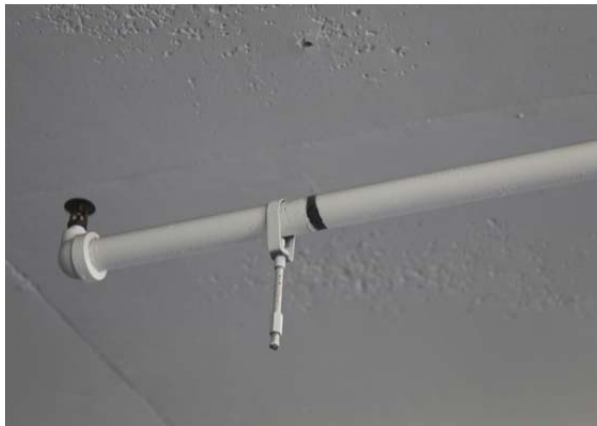
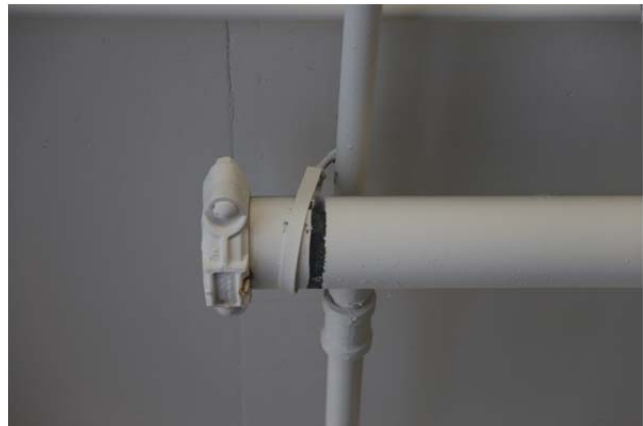
photos were taken on the third floor of the structure; the fourth floor is an open roof. Failure of a ceiling anchor is presented in Figure 20. Residual deflection of one of the end pipes can be clearly observed from the right photo in the same figure.

(a) Failure of the ceiling anchor

(b) Residual deflection of a pipe

Figure 20 Evidence of large deflections of the piping system

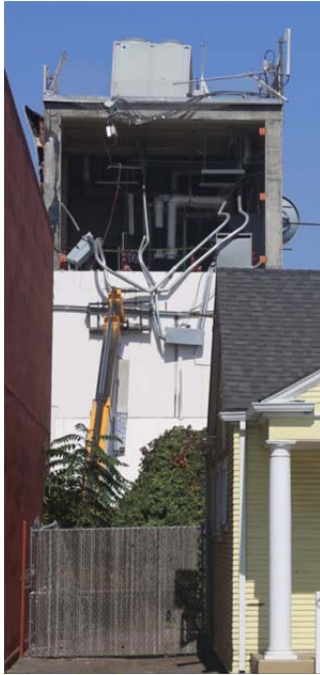
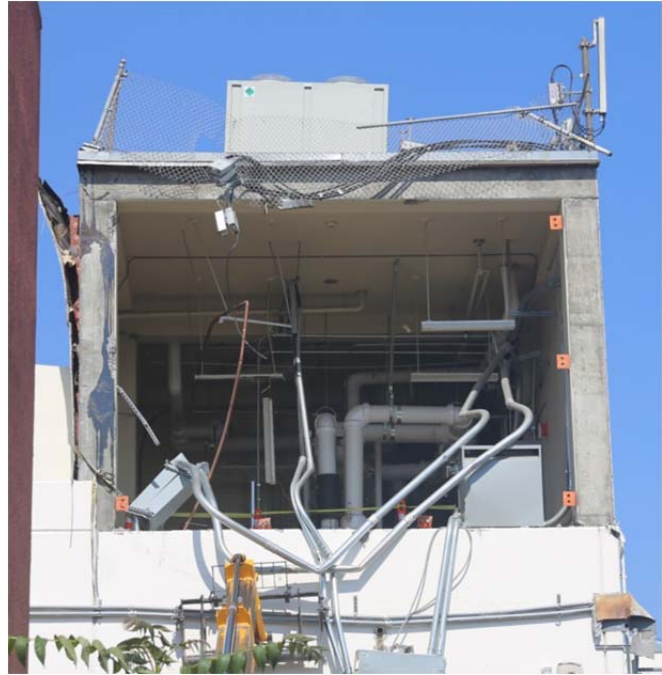
During the earthquake, a massive concrete wall on top of a telecommunication building top floor gave way. The wall was attached to the upper structure by means of brackets as presented in Figure 21. The wall fell down and cut electric power supply from the building. Since the backup generators had no power to cool down the servers inside of the building, an external power generator and a massive cooling unit were brought to the site to keep the computer servers running while the building is being repaired as shown in Figure 22. The building content was

(a) Nonstructural wall suspended on brackets (orange) failed

(b) Zoomed view of the brackets remaining in place; power conduits were damaged during the wall failure

Figure 21 Failure of nonstructural wall at telecommunication center.

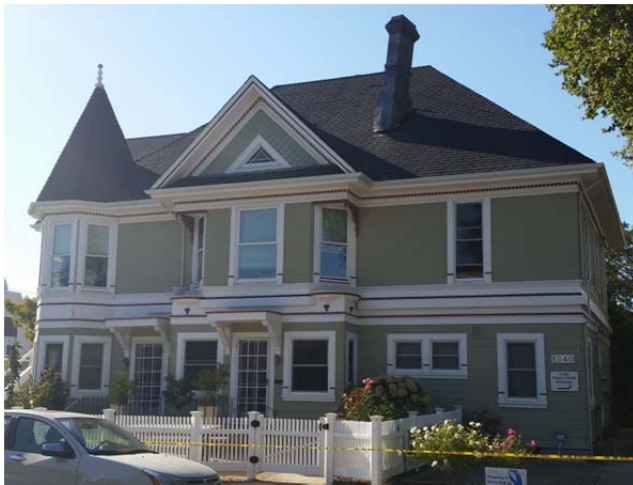
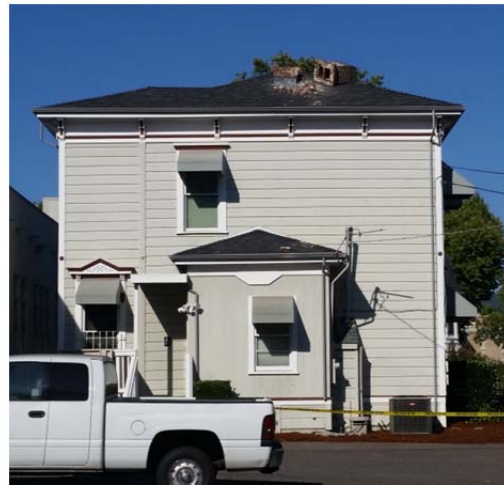
The chimneys constructed from the bricks and stones represented one of the most vulnerable nonstructural components damaged in the earthquake. Poor seismic performance of chimneys constructed from massive and brittle materials were demonstrated in the previous earthquakes worldwide, including the previous 2004 earthquake in Napa [2004]. The major human casualties in both earthquakes were associated with the chimney failures. This section discusses some typical examples of chimney failures. The chimneys vary in size, location within a building, and elevation above the grade. Depending on a failure mode, the chimney failure can create a variety of hazards, including hazards for building occupants as presented in Figure 23 and/or hazards for people outside of the building as shown in Figure 24.

(a) Chimney leaning away from the street

(b) Complete failure with pieces still on the roof

Figure 23 Chimney failures creating danger for building occupants.

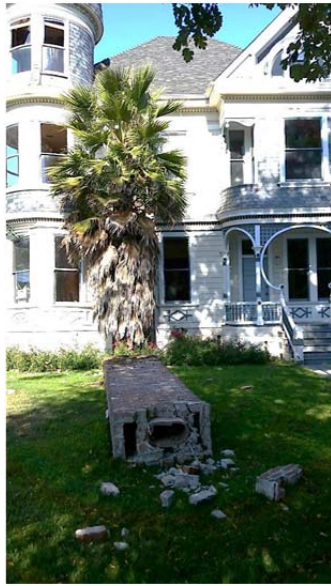
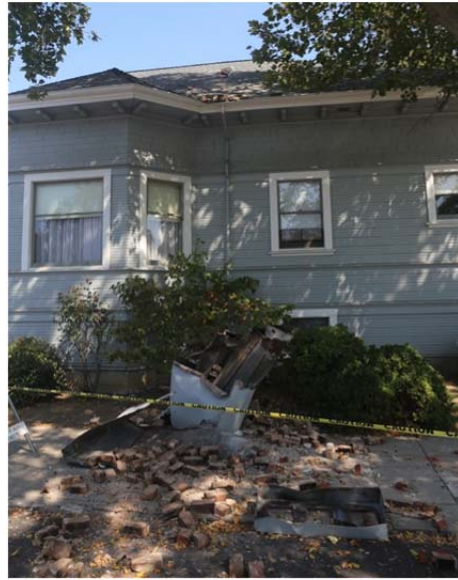
(a) Massive chimney that fell away from the house to the ground

(b) Chimney shattered in pieces on a walkway

Figure 24 Chimney failures creating danger for people outside of buildings

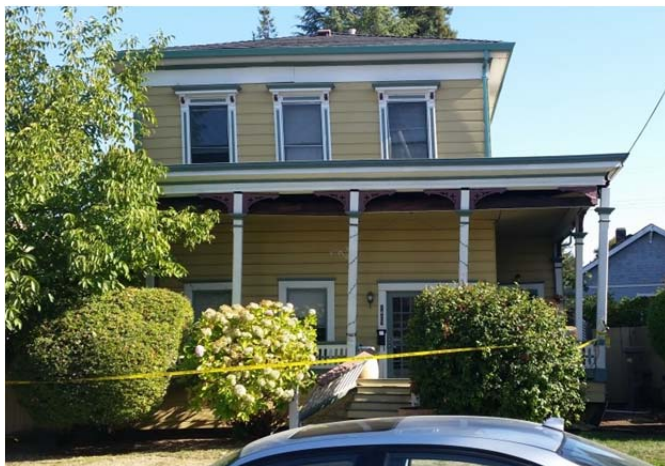
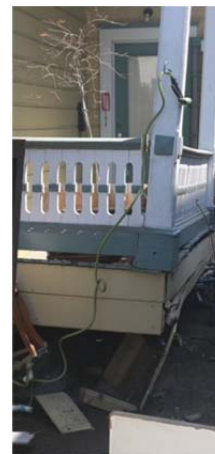
In many cases structural damage can lead to excessive displacements, and the response of the building can impact its power and water supply lines. This hazard was studied based on a wood-frame building with a cripple-wall design shown in Figure 25. The left photo presents the damaged state of the building with large residual drifts on the first and the second levels. A photo on the right shows large residual deformation of the cripple wall level. When cripple wall collapsed, the bottom lumber of the building came in a contact with a gas pipe; see Figure 26.

Figure 25 Failure of wood frame building with a cripple wall design

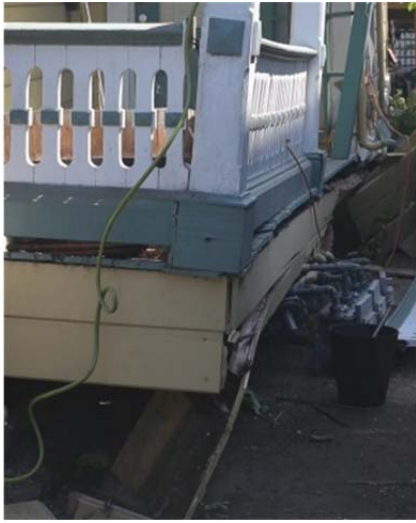
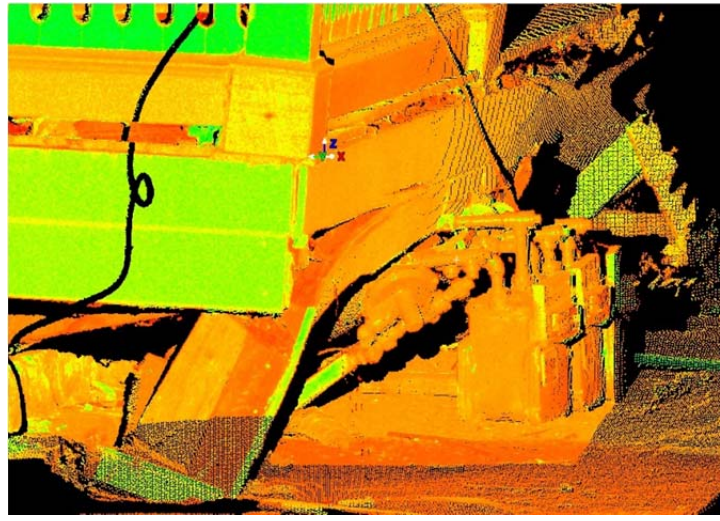
(a) Photo of collapsed porch

(b) Laser scan of collapsed porch

Figure 26 When cripple wall collapsed the bottom lumber of the building remains in a contact with a gas pipe.

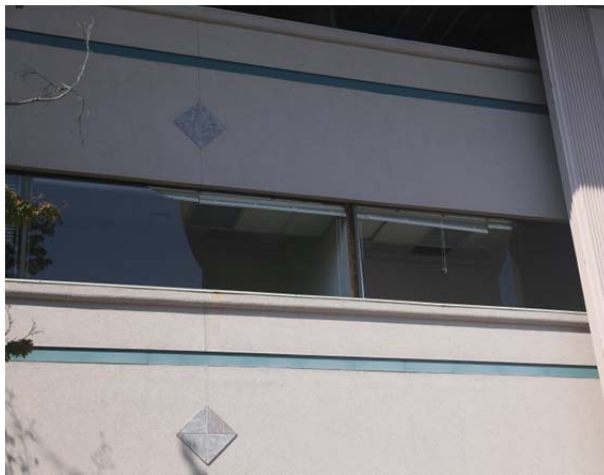
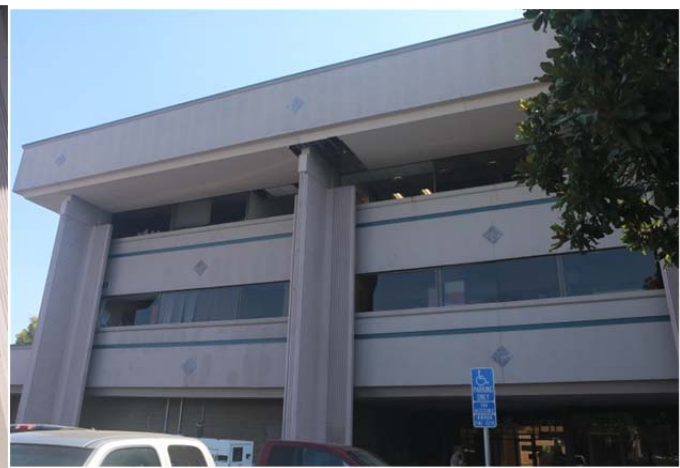
Failure of glass windows were widespread in downtown Napa. To address security issues of the buildings' occupants, the majority of failures were covered by installing plywood sheets instead of windows. While glass replacement of small window openings in residential buildings are not too costly, the cost of replacing large openings can be quite significant and some supply shortage can be expected. In case of massive glass failure in many large window openings, the building can become un-operational for quite some time. Typical glass failures are presented in Figure 27 and Figure 28.

Figure 27 Typical example of window glass failures in a three-story office building.
