PEER Preliminary Notes and Observations on the August 24, 2014, South Napa Earthquake

Pacific Earthquake Engineering Research Center

Report No. 2014/13

September 17, 2014

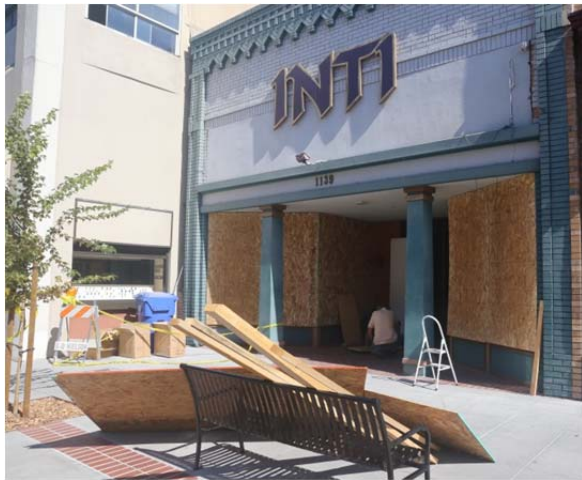
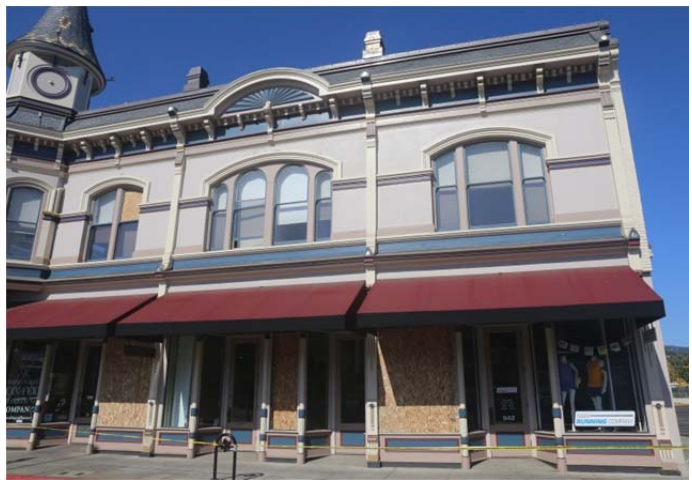
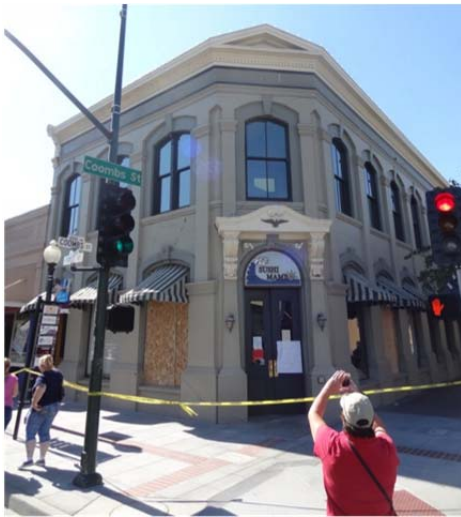
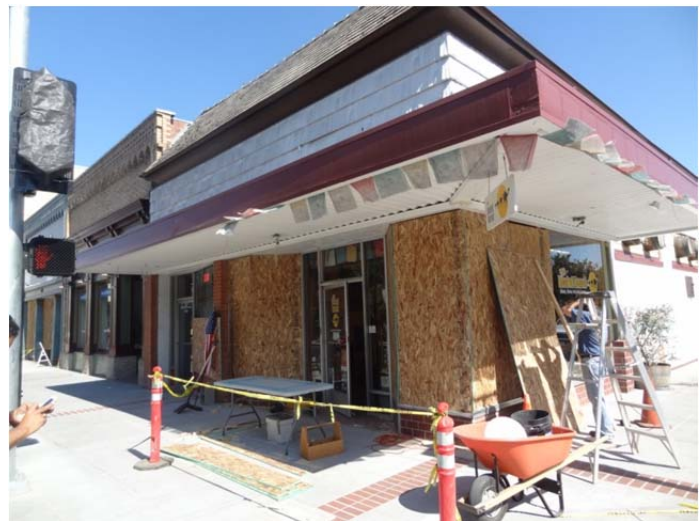
(a) All glass windows failed in a small business

(b) The majority of glass windows of the first floor failed

(c) Glass broken on both sides of the two-story building (torsional effect)

(d) Glass broken on both sides of the single-story building (torsional effect)

Figure 28 Typical example of window glass failures in small buildings with soft story effect.

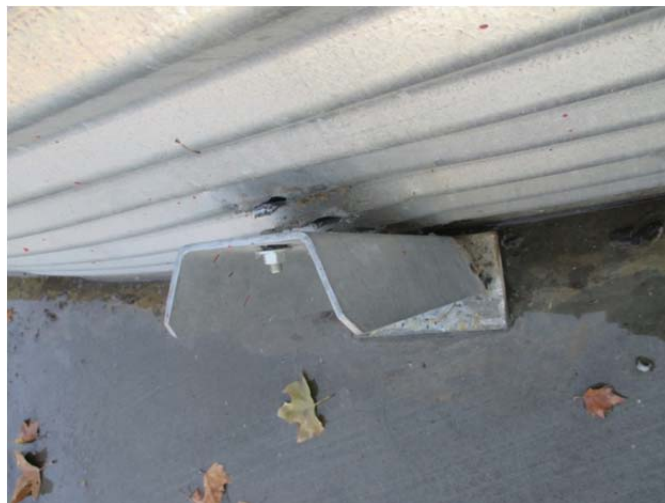
The base anchorage of the water tank at the high school near downtown Napa separated from the tank wall, as shown in Figure 30. As the result, the tank experienced large amplitude shaking during the earthquake, resulting in breaks of the rigid water pipes; see Figure 31. As a result of these deflections, a rain leader pipe from roof failed (left photo). Obviously, this pipe connection needed to be flexible to accommodate the relative displacement between the wall and the tank. Movement of cistern during earthquake caused elbowing of the pipe, which caused it to break; see Figure 31 (right photo).

Figure 30 Base anchorage separated from the tank wall.

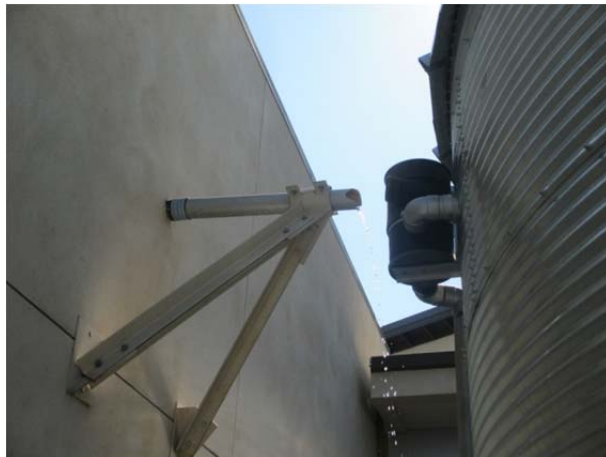
(a) Rain leader pipe roof failed

Figure 31 Failure of water tank.

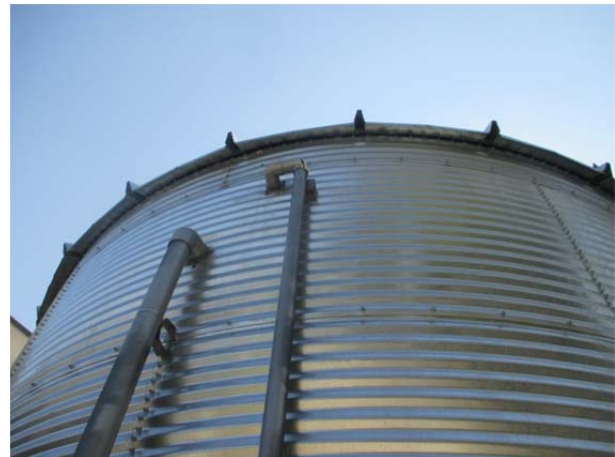
(b) Elbow of the pipe on right failed

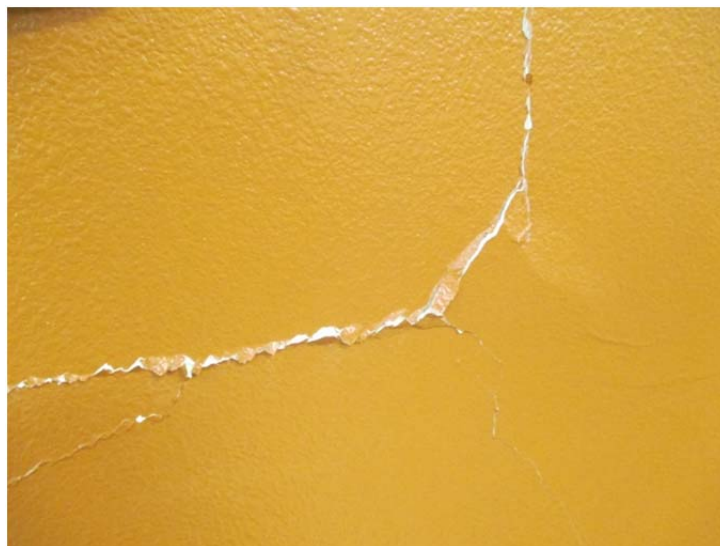
Deformation of the building's frame caused cracking and tearing of gypsum wall panels and their joints. The damage was observed at wood frame building built on school property within last 10 years. Widespread tearing marks were observed in the gypsum board on walls (see Figure 32), mostly at horizontal joints; see Figure 33. This kind of architectural damage is expected after a moderate to strong event.

Figure 32 Tear in gypsum board on walls.

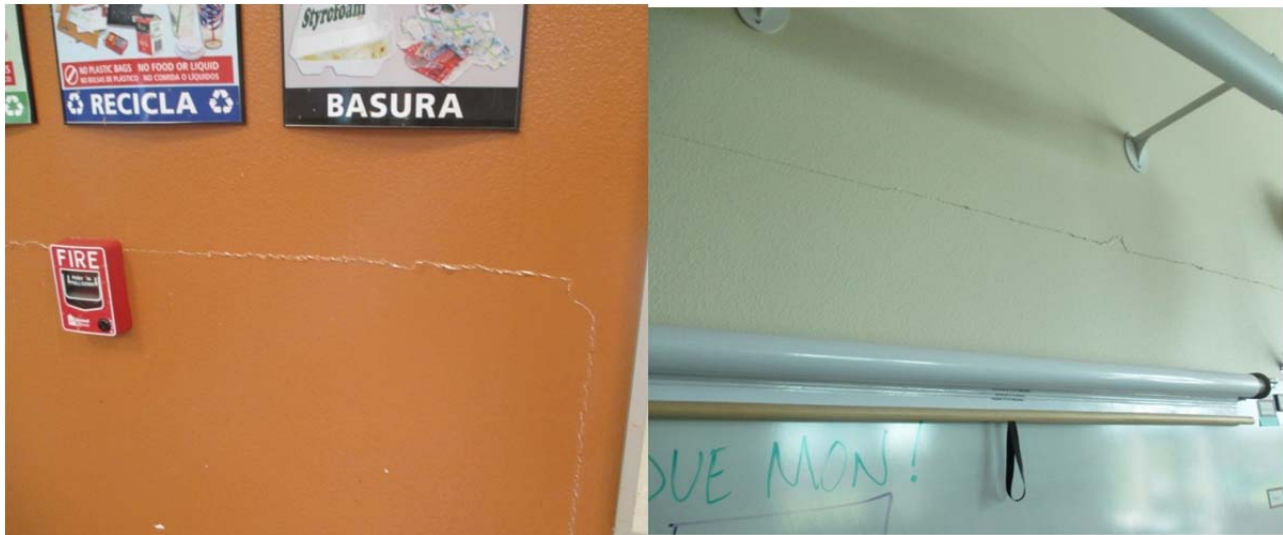
Figure 33 Wide spread tearing marks in gypsum board on walls mostly at horizontal joints.

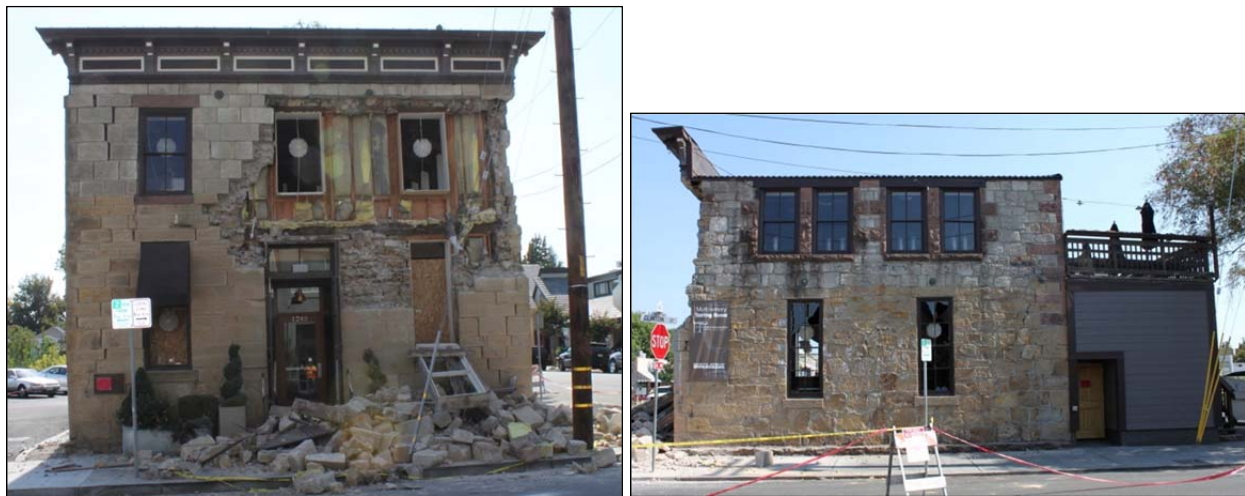
Seven URM buildings were visited during the field investigation. All received unsafe (red) tags during their initial inspection. Most of these buildings were two stories high, but one was three-stories and another one story. Façade collapse and diagonal cracking were observed at two locations; see Figures 1 and 2. A stone parapet was damaged and several stones fell to the ground; see Figure 3, at the historic Goodman Library that houses the Napa County Historical Society. Mortar cracking was visible particularly above the second floor windows in the 113-year-old stone-masonry building. The building at 1245 Main St. (Figure 1) and the Goodman Library sustained minor cracking as was reported after the September 3, 2000, Yountville/Napa Earthquake [Miranda and Aslani 2000], but the remaining URM buildings were reported as undamaged.

Figure 1 URM building at 1245 Main Street.

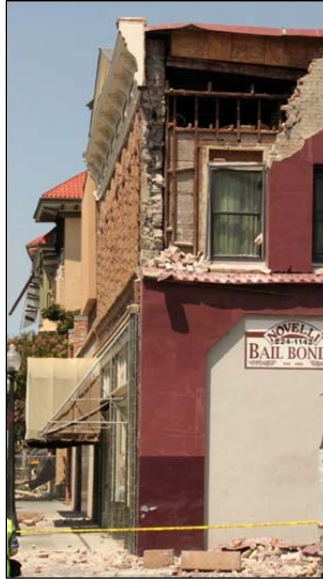
Figure 2 URM building at 810 Brown Street.

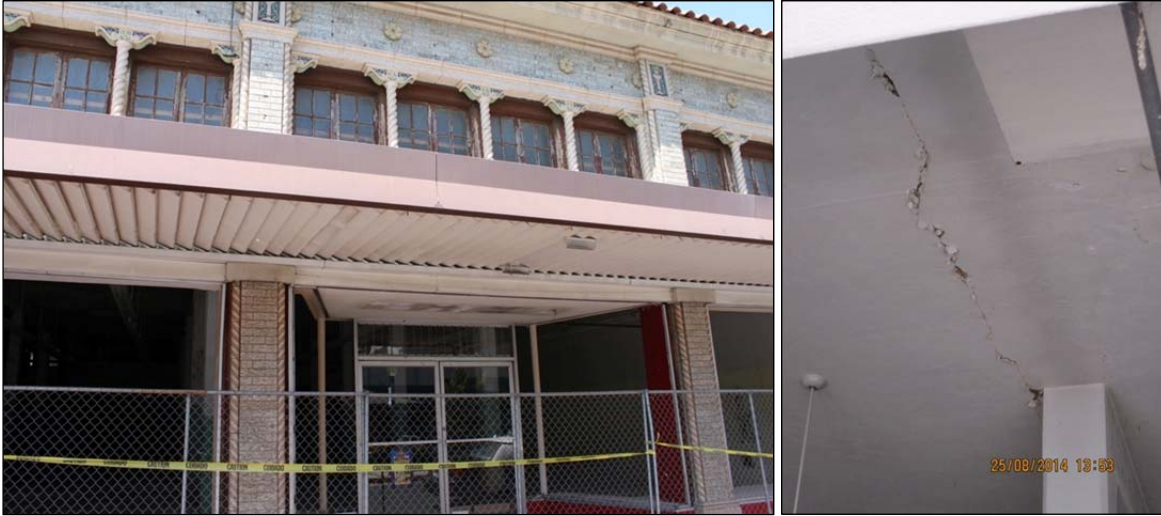
The façade of a vacant building at 1212 1st St. looked undamaged, see Figure 4, but the second-floor diaphragm was cracked. Windows on the first floor shattered, but debris was cleaned and building secured by the day following the earthquake.

Figure 4 URM building at 1212 1st Street.

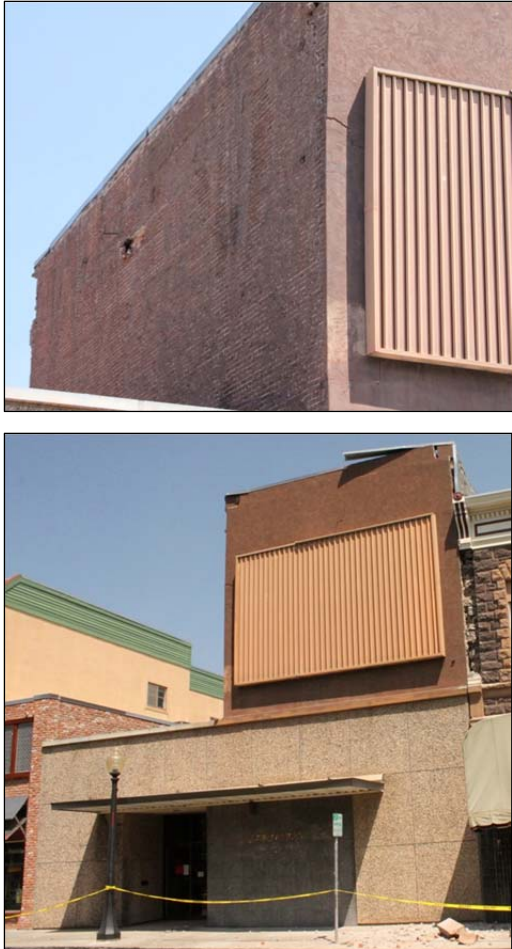
The second floor of 822 Brown Street was damaged, see Figure 5, due to pounding with the adjacent building. Wall-to-roof diaphragm anchorage failure was also observed on the North face of the second floor. The fifth and sixth anchorages from the front of the building protruded from the wall about 8 in. and 3 in., respectively. In two locations, one above and one below the roof diaphragm anchorages, bricks were dislodged from the façade. A portion of the parapet (17 bricks) of the same wall shifted about a half inch.

Figure 5 URM building at 822 Brown Street

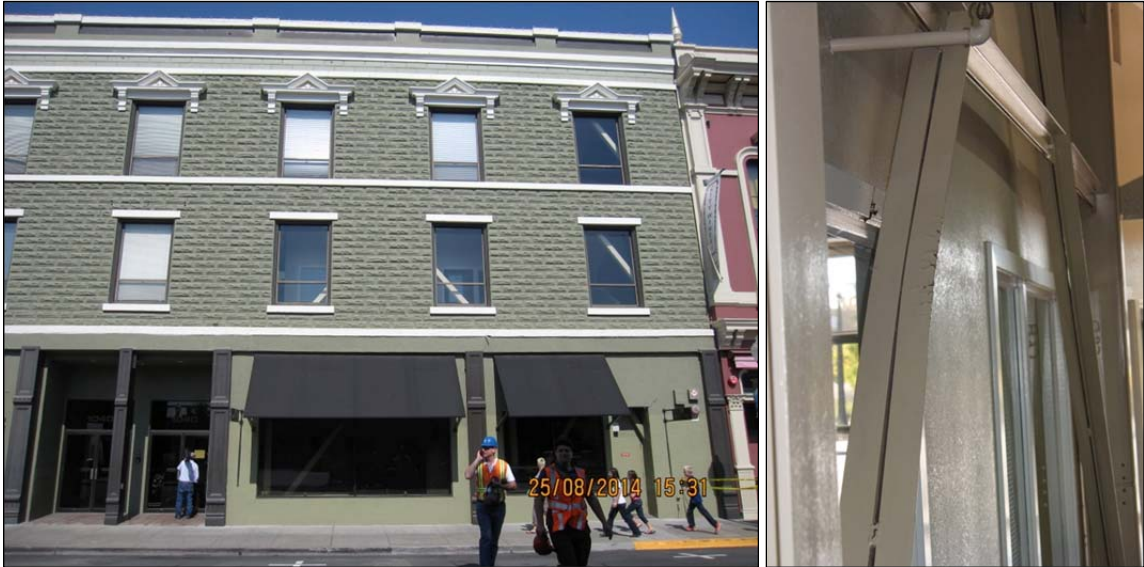
The three-story building at 1040 Main St. was retrofitted in the 1980s with steel braced frames; see Figure 6. Exterior cracks were visible especially noticeable at brace foundation connections. The building was initially red tagged due to parapet safety concerns, but once mitigated the building received a yellow tag and was occupied within 30 hours of the earthquake. Damage was concentrated on the first floor, with localized buckling of several braces and gusset plates.

Figure 6 URM building at 1040 Main Street.

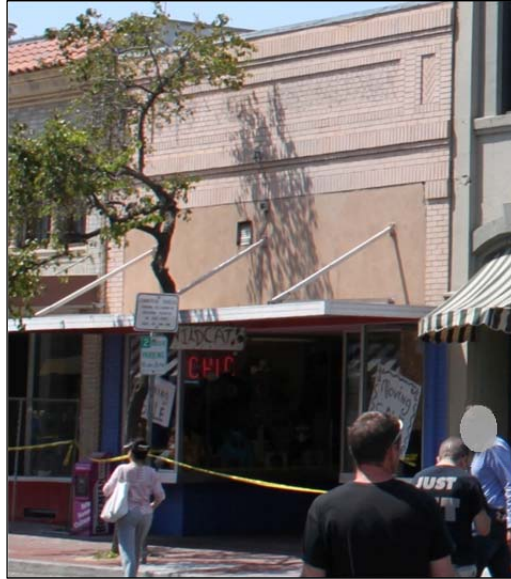
The one story building at 1210 1st St. had no visible structural damage, see Figure 7. It was red-tagged due to safety concerns at an adjacent building.

Figure 7 URM building at 1210 1st Street.

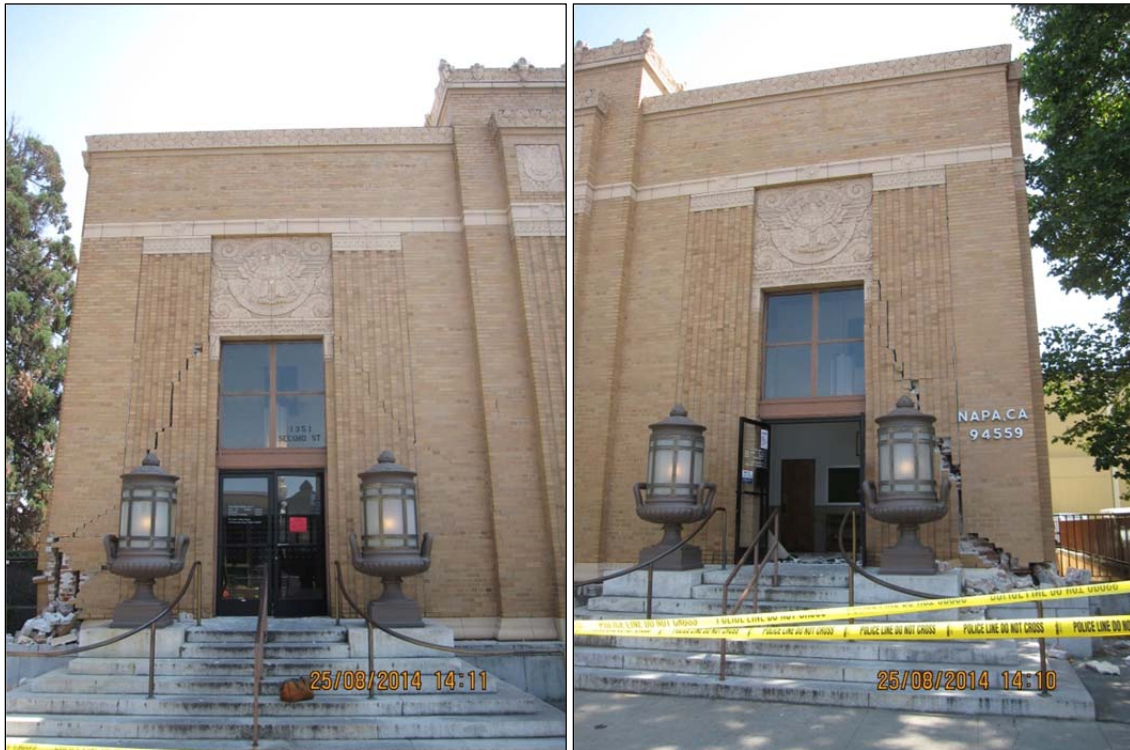
Two brick buildings that exhibited severe damage and posed a risk to life-safety but were omitted from the list of 40 URM buildings discussed were the Napa U.S. Post Office and 1001 2nd St.; both buildings were red-tagged. The post office had severe diagonal cracking, see Figure 8. Large windows along the front of the building broke, as many had previously in 2000 [Miranda and Aslani 2000]. A partial collapse occurred at the second building, see Figure 9. While specific structural details of these buildings are not known, the list of URM buildings may

Figure 8 U.S. Post Office at 1321 2nd Street.

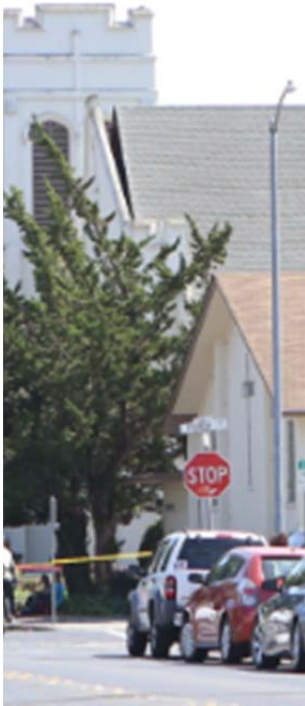
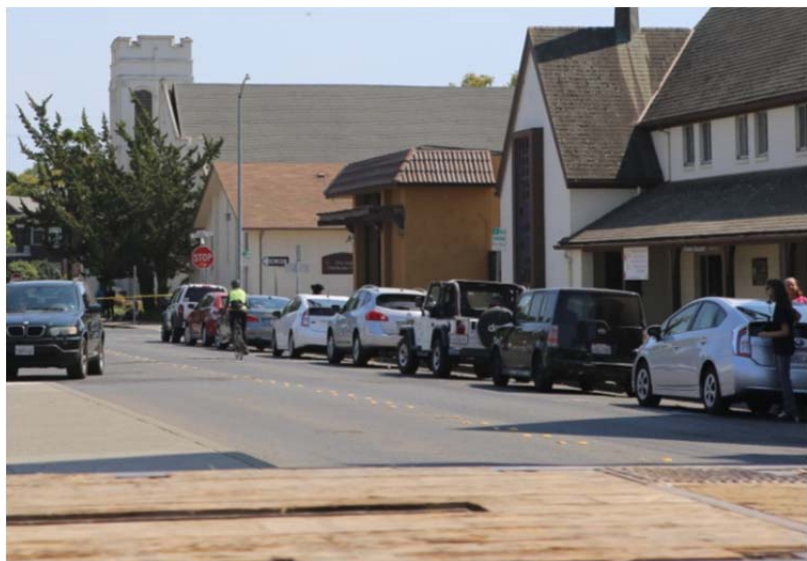
Building Description	First United Methodist Church
Structural Damage	Separation of exterior wall; see Figure 1 and Figure 2
Nonstructural Damage	N.A.

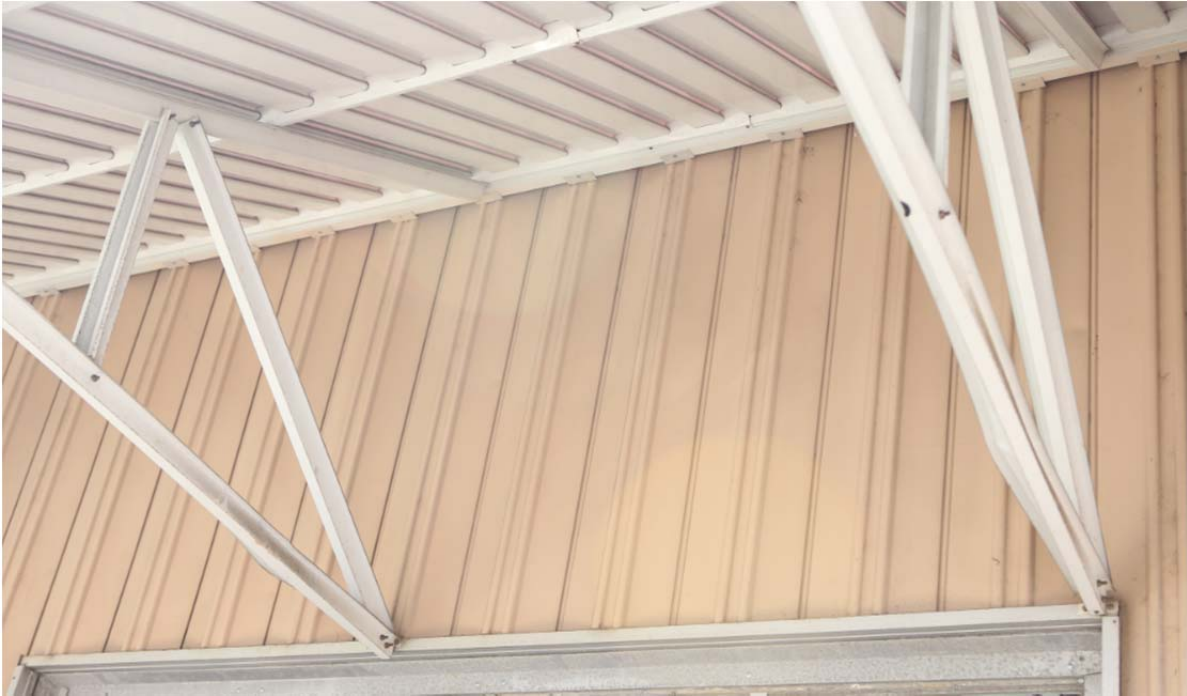
Figure 3

Buckled awning bracing; see Figure

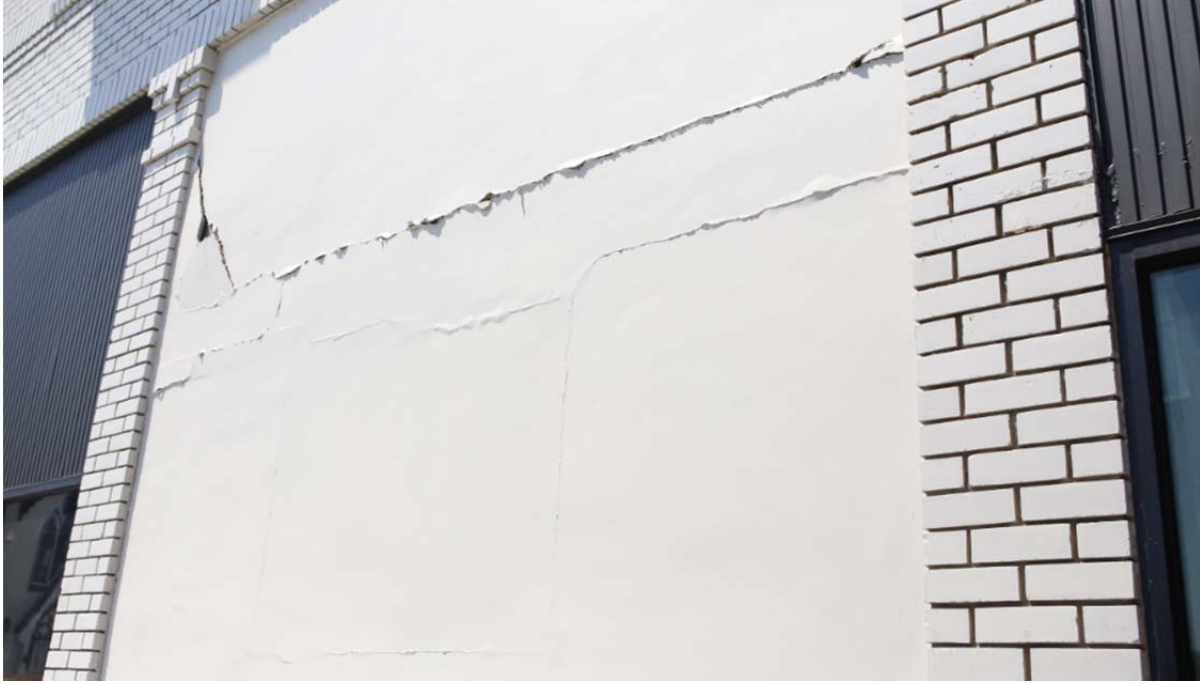
Cracks in exterior drywall; see Figure 4

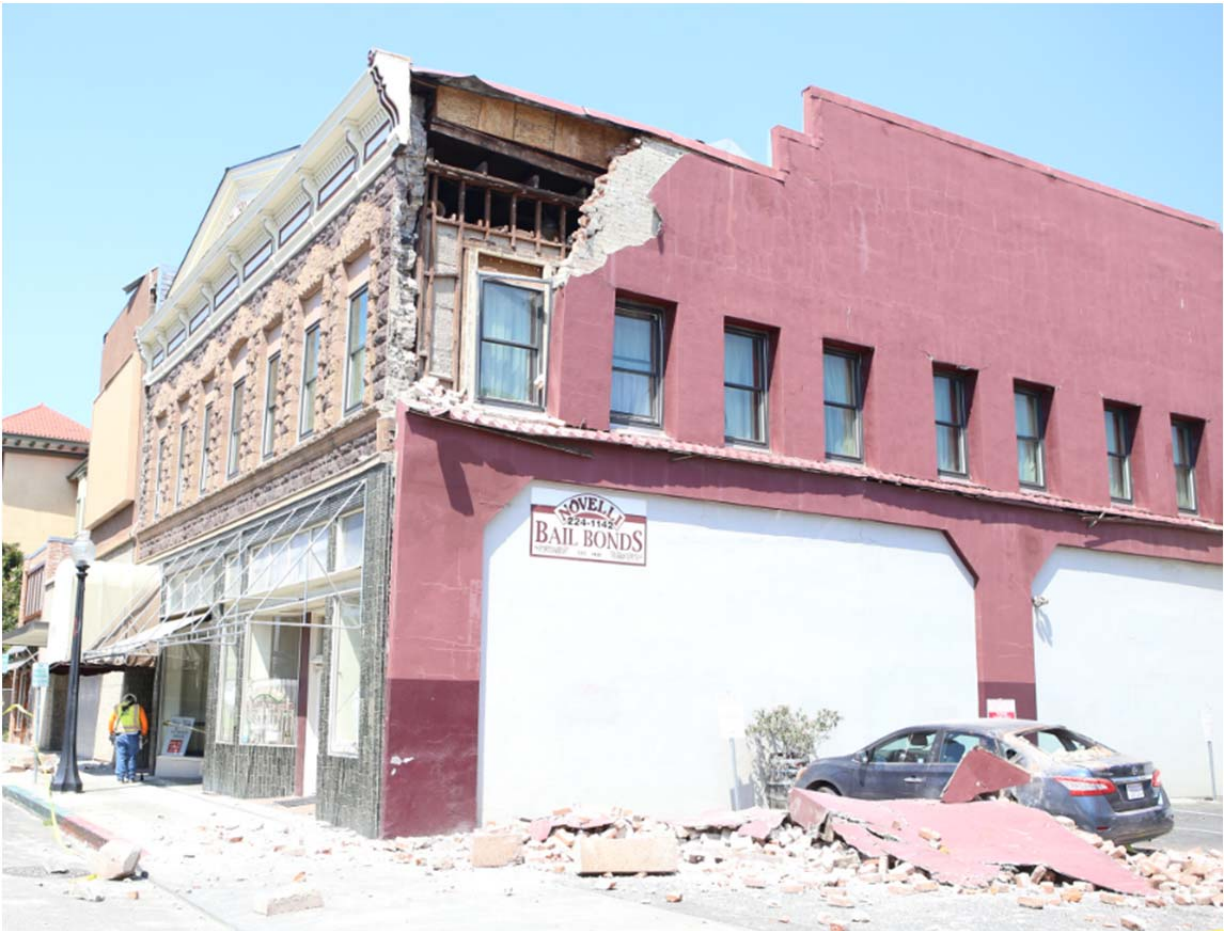
Building Description Masonry (URM) and Wood Construction
Structural Damage Exterior masonry collapse on South-West face; see Figure 5
 Separation of exterior masonry cladding on North face
 Damage (cracks in masonry) at roof of 816 Brown Street; see Figure 6
 Only limited damage to cafe (possibly retrofitted)

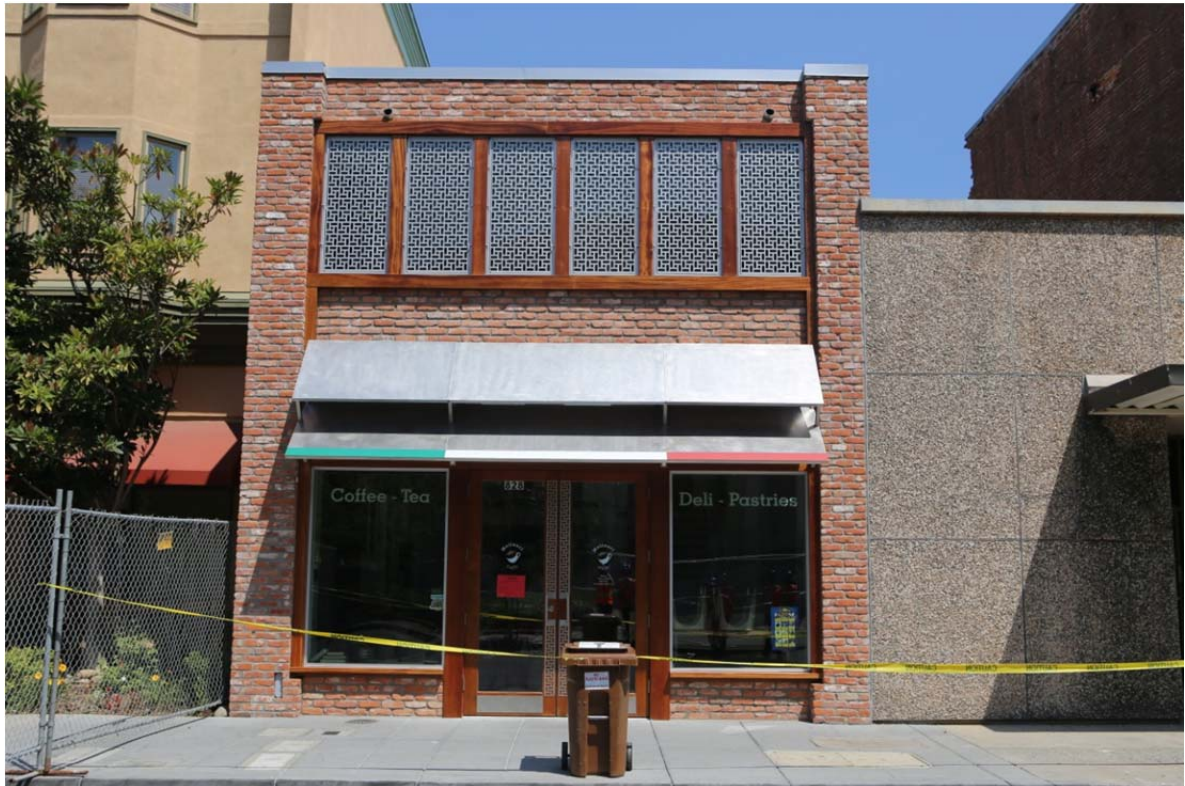
No obvious structural damage seeing from outside but the building was red tagged; see Figure 7

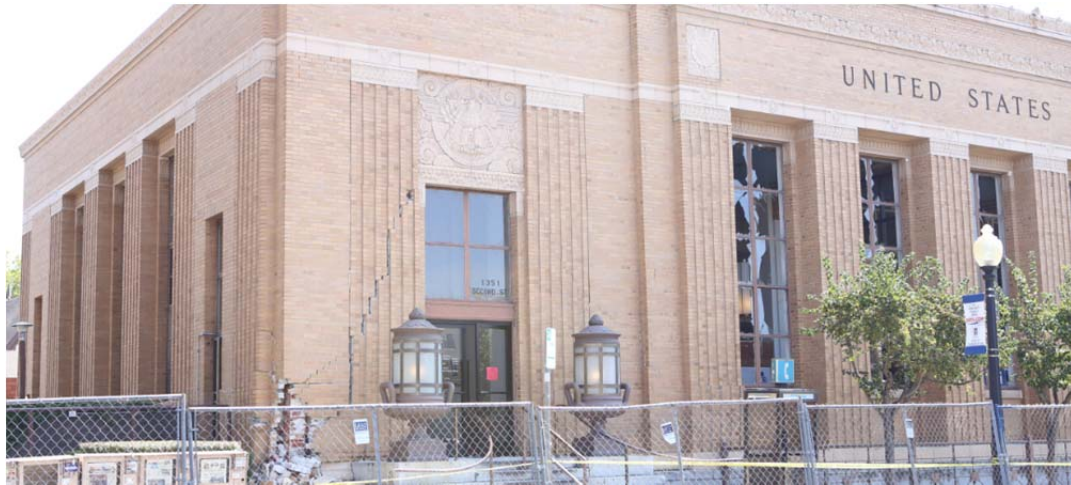
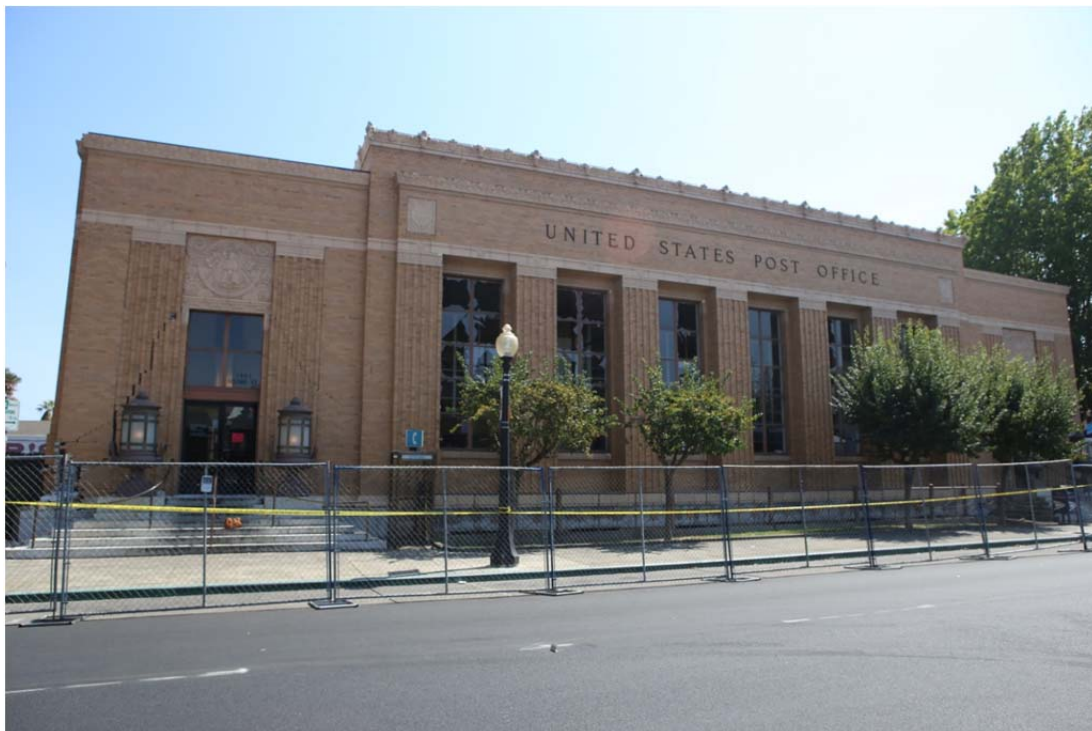
Building Description U.S. Post Office
Structural Damage Red-tagged; see Figure 8 and Figure 9. Substantial cracking of exterior masonry walls
Nonstructural Damage Broken glass on north-west face.

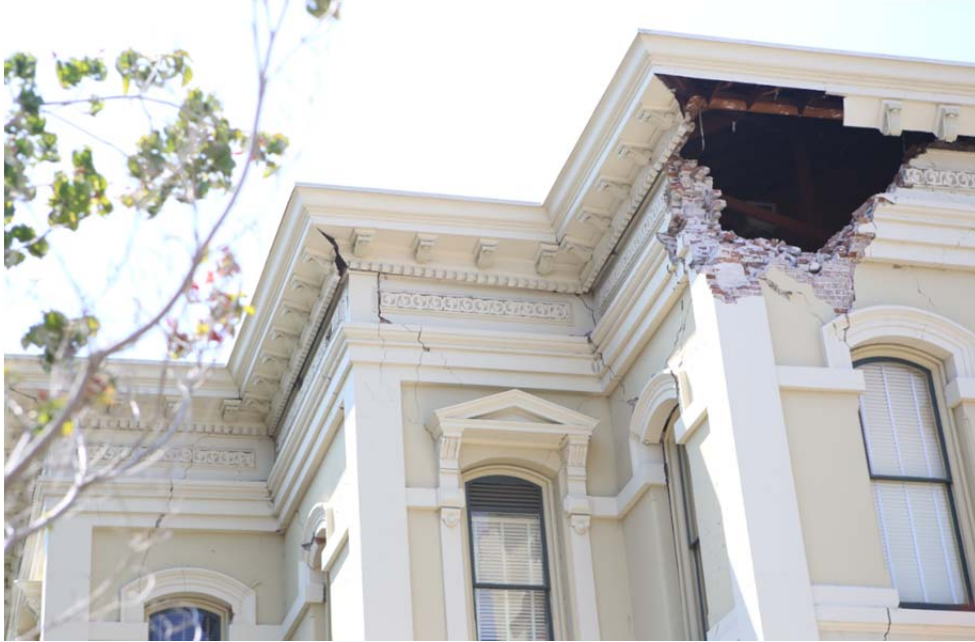
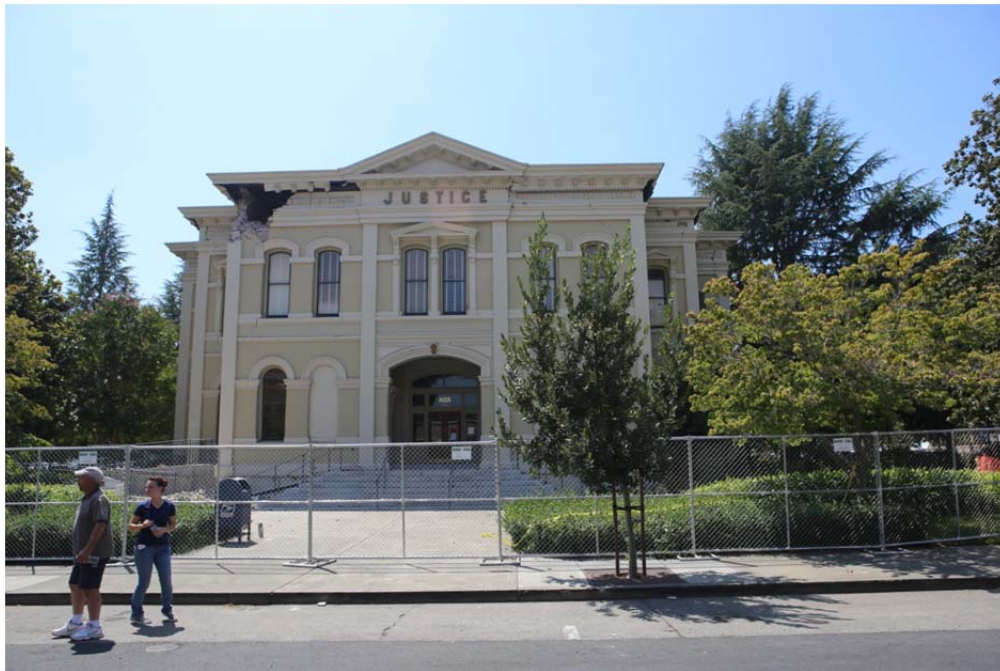
Collapse at roof; see Figure 10 and 11

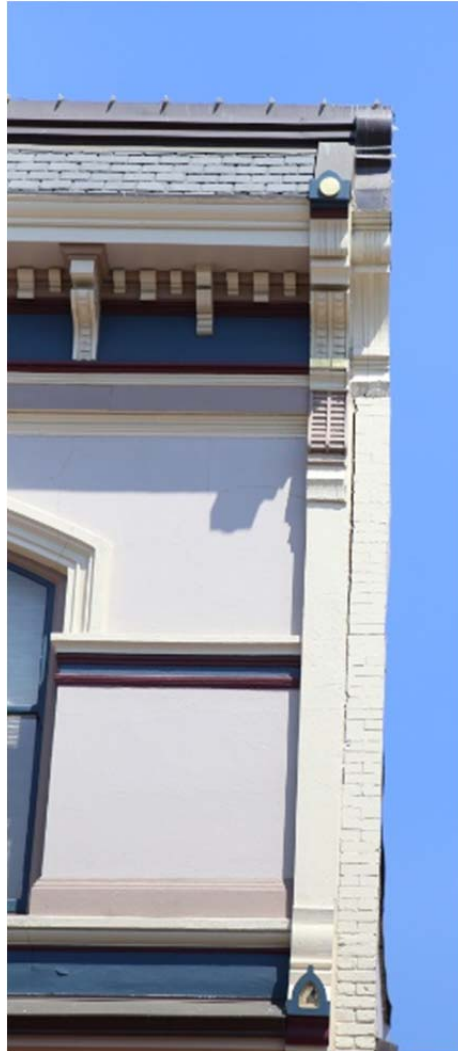
Crack between South-East wall from structural system; see Figure 12

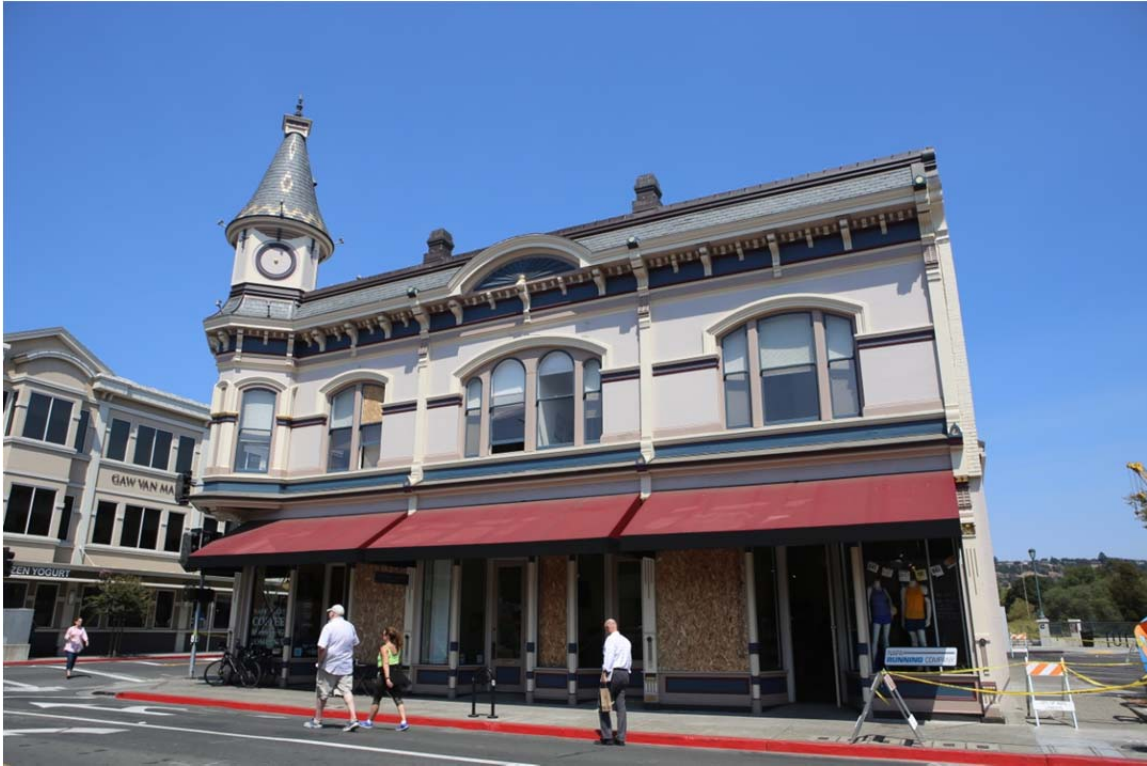
Broken storefront windows; see Figure 13

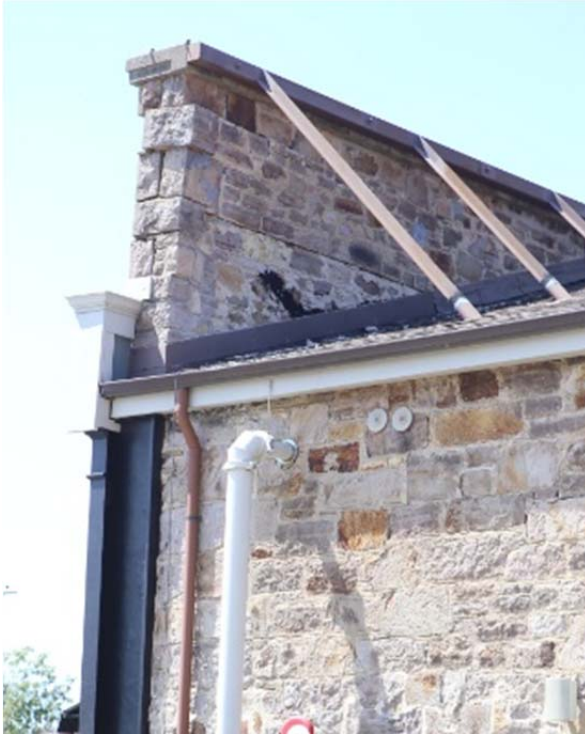
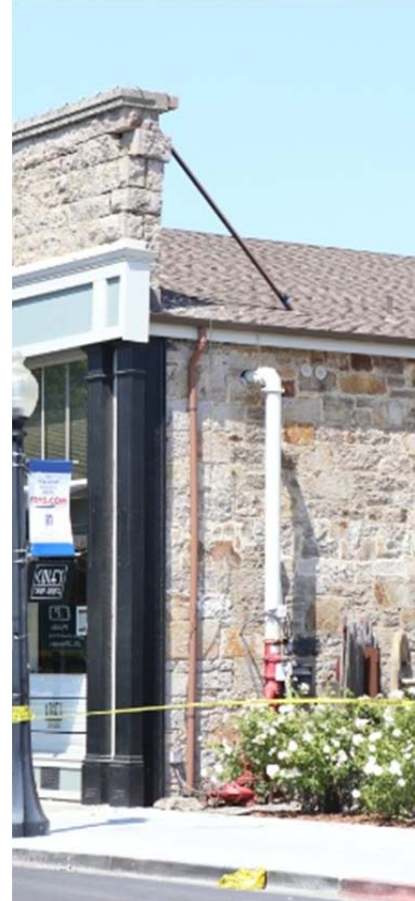
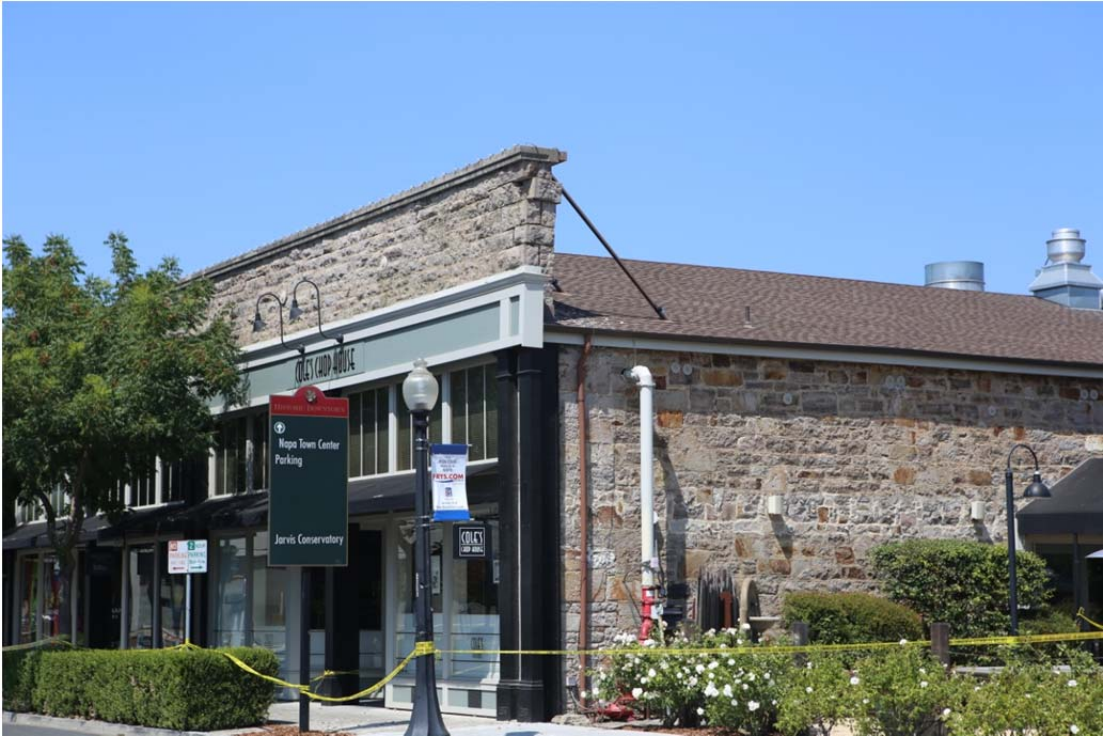
Masonry parapet damage, most likely due to insubstantial lateral support; see Figures 14, 15, and 16

Began on 26 August 2014

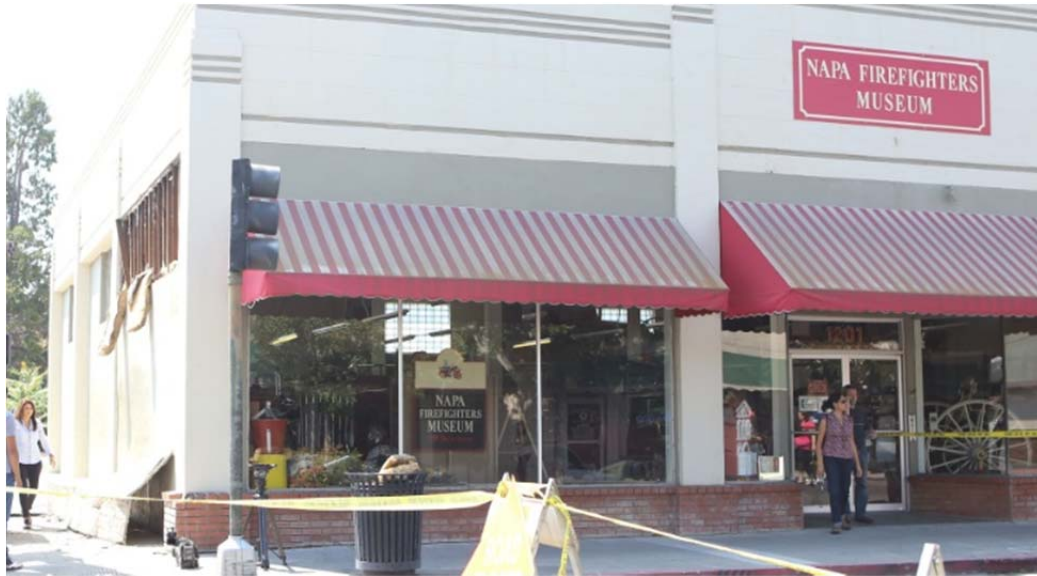
Exterior wall dropped out; insulation exposed; see Figure 17

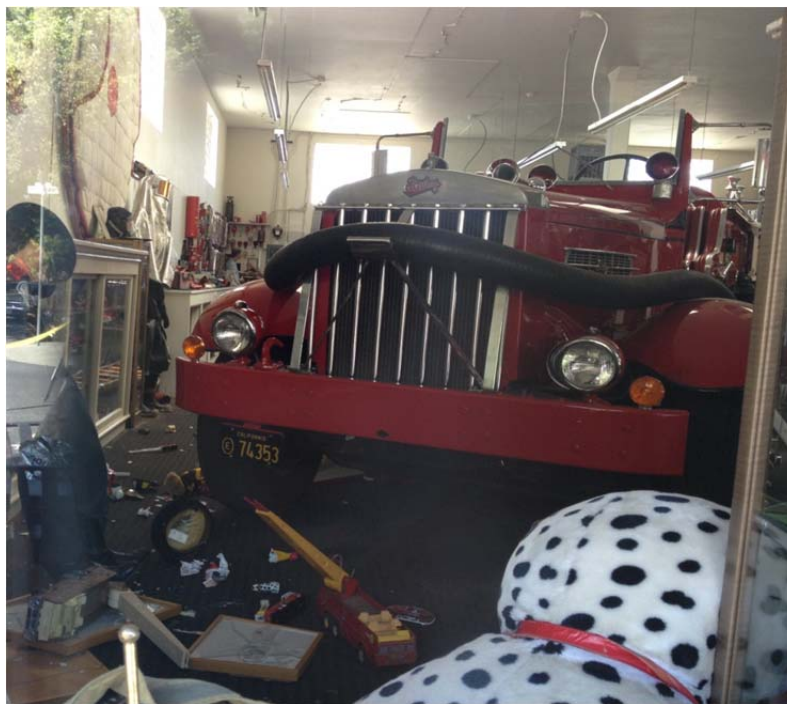
Grocery fallen off, twisting light and ceiling cracks; see Figure 18

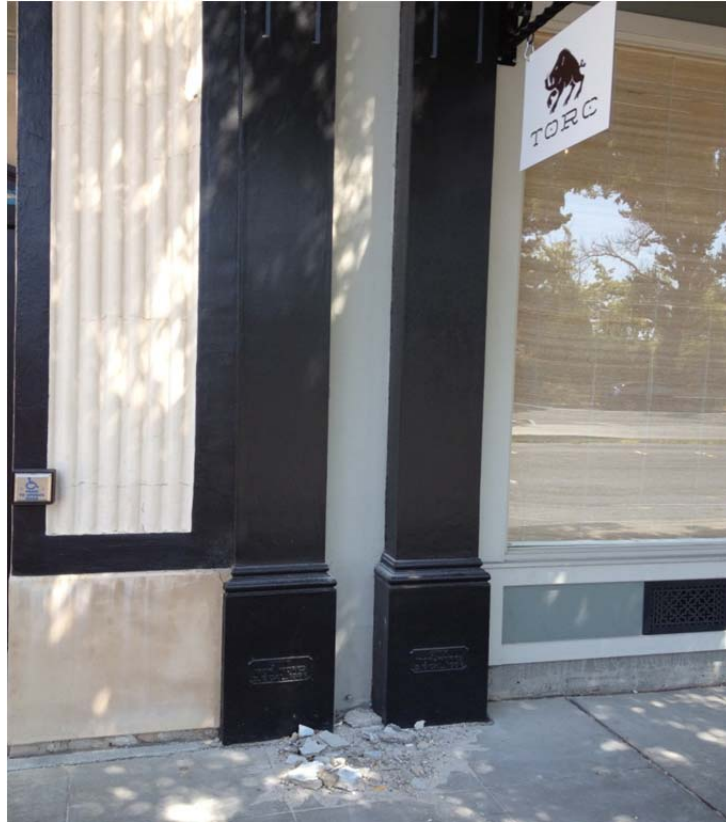
Exterior wall cracking and falling; see Figure 19

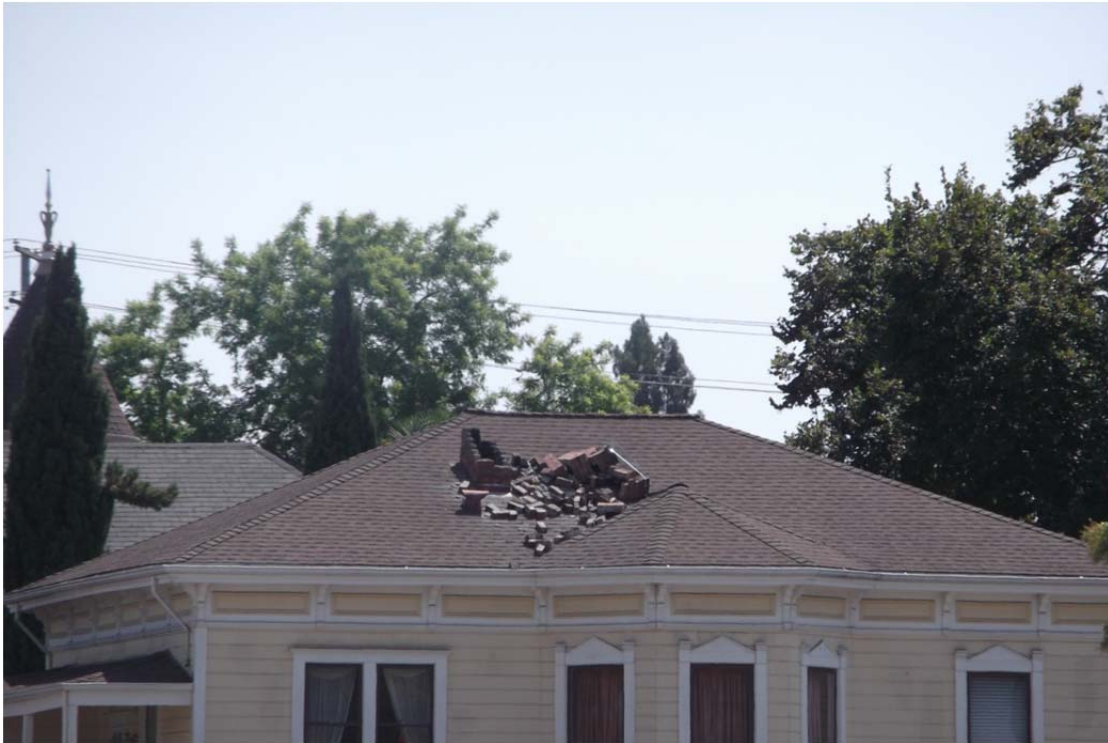
Building Description Wood residential structure
Nonstructural Damage Chimney damage; see Figure 20

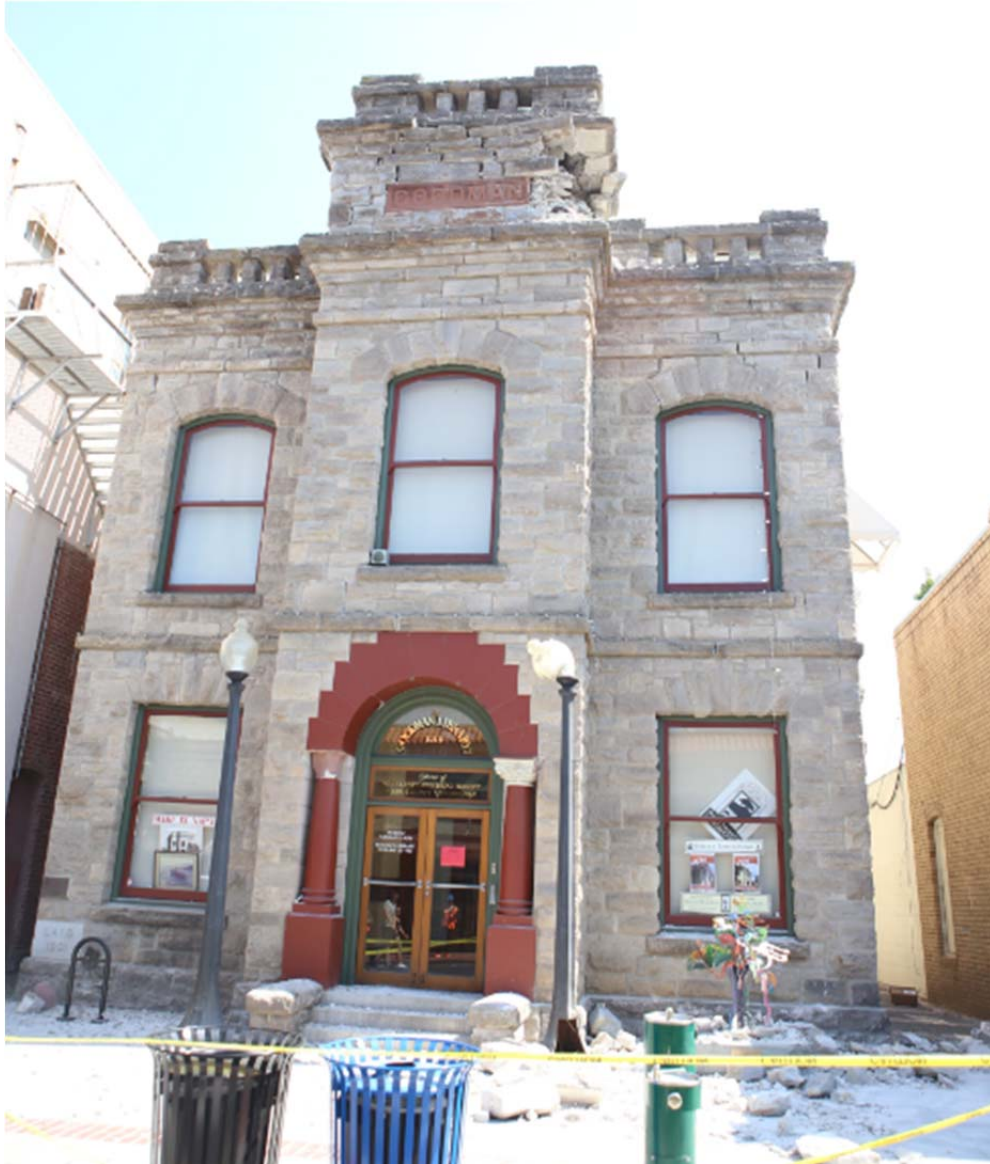
Significant damage to roof parapet; see Figure 21
