PEER Preliminary Notes and Observations on the August 24, 2014, South Napa Earthquake

Pacific Earthquake Engineering Research Center

Report No. 2014/13

September 17, 2014

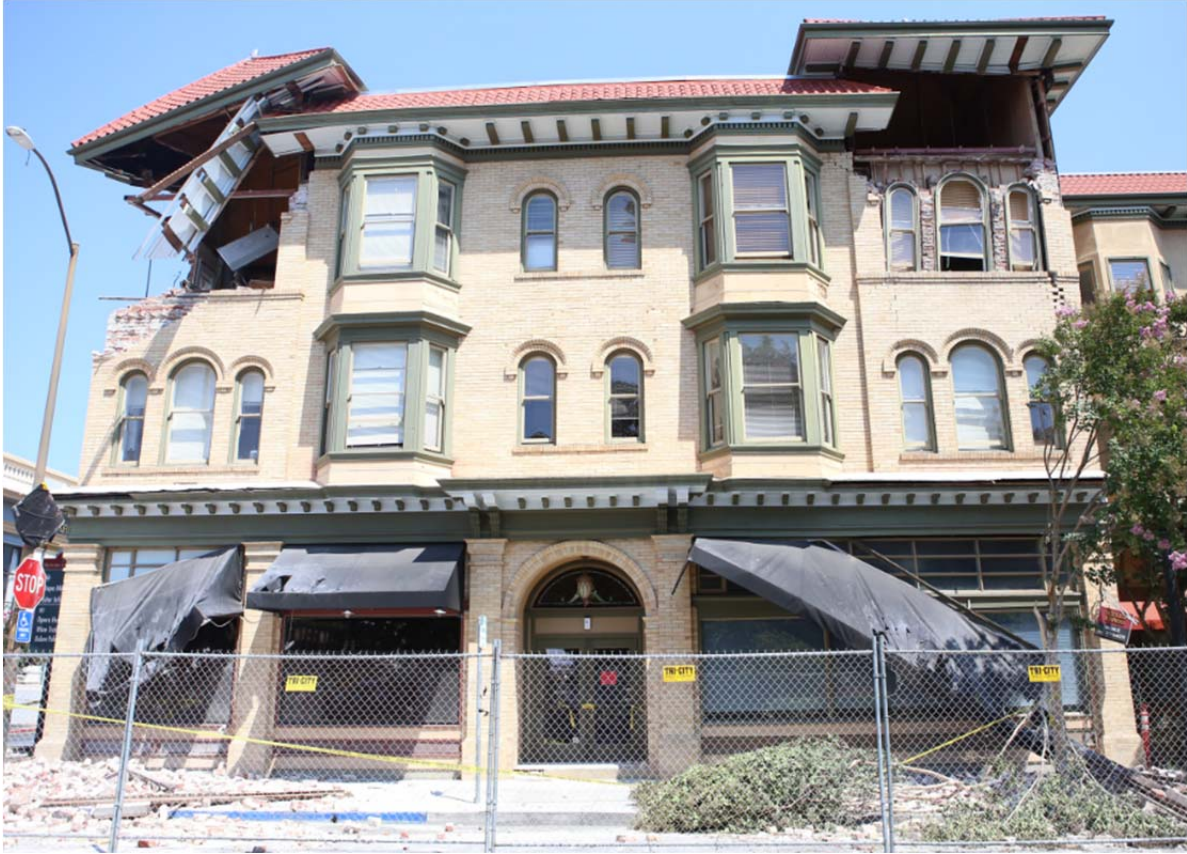
Significant damage at 3rd story; see Figure 23

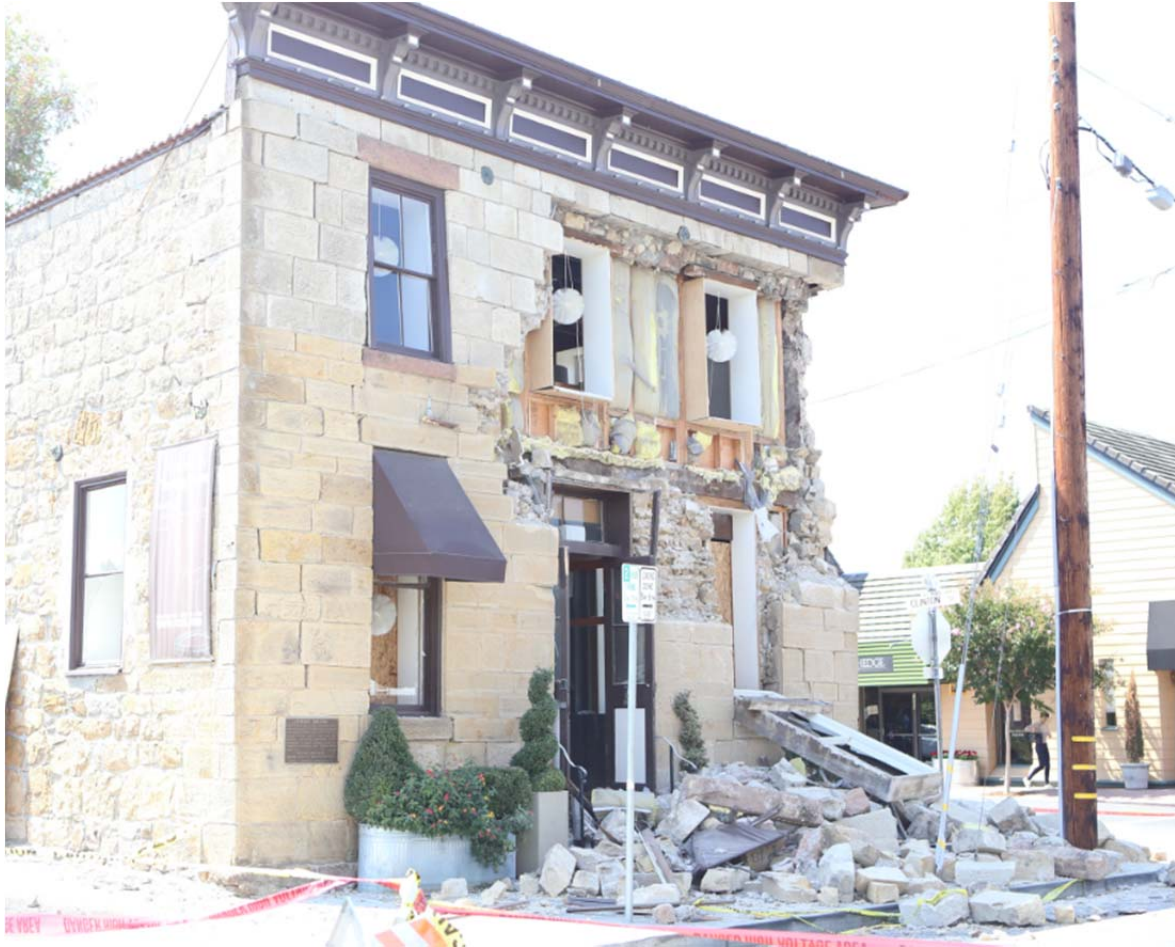
Substantial damage/collapse of exterior masonry; see Figure 24

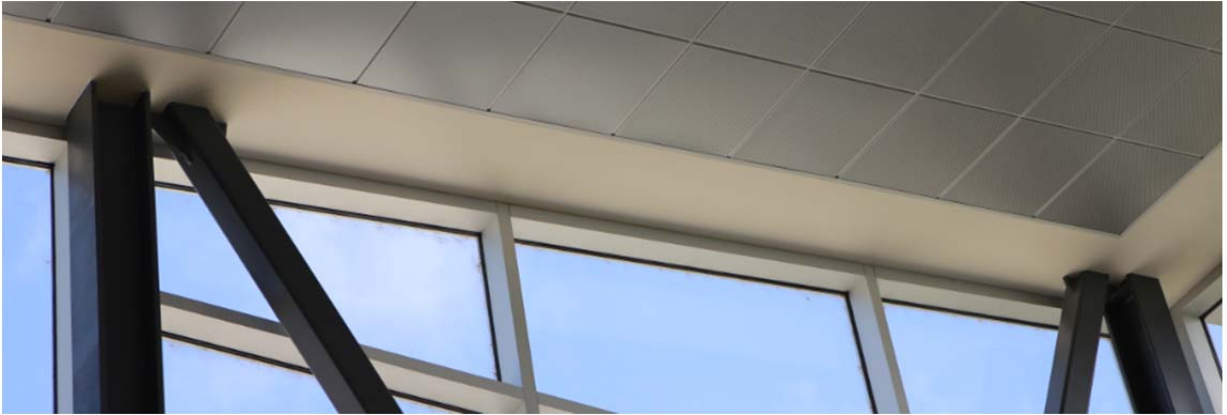
Building Description	Life Sciences Building
	New Construction
	Two-story ordinary concentrically braced frame (OCBF)
	Square hollow structural section (HSS) braces; see Figure 25
	Weak axis column bending; see Figure 26
Structural Damage	None
Nonstructural Damage	Minor; displaced piping (see Figure 27) and concrete spalling (see Figure 28) at east-south corner of building.

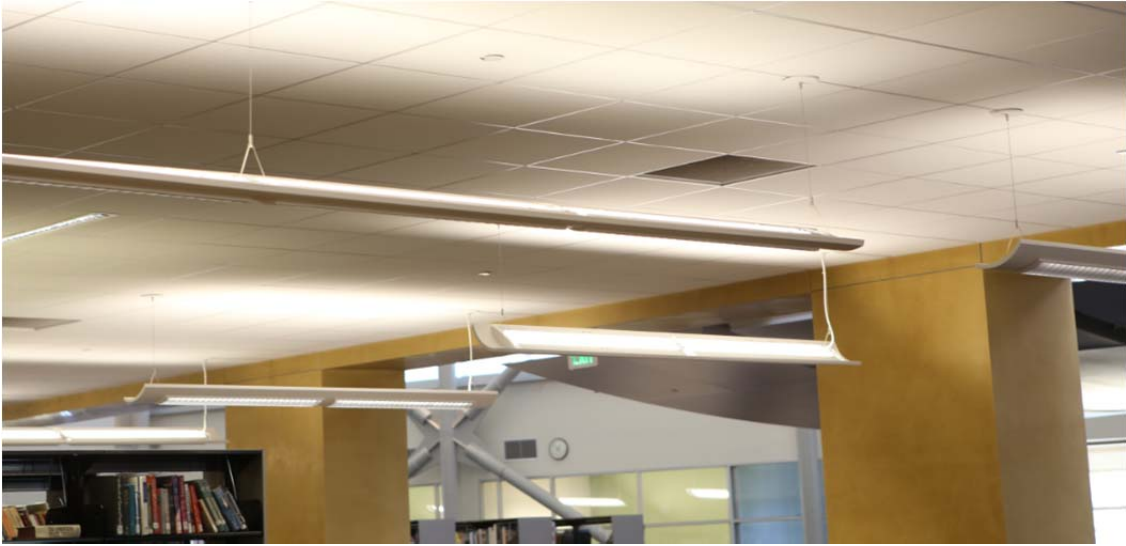
Figure 32

Building Description	McCarthy Library & Media Center
New Construction	Two-story special concentrically braced frame (SCBF) Round hollow structural section (HSS) braces; see Figure 29 Stiffened gusset plates (see Figure 30) and net section reinforcing plates are provided to the round HSS brace ends
Structural Damage	None
Nonstructural Damage	Minor; books were thrown from shelves (see Figure 31), twisted lighting (see Figure 32), dropped ceiling panel (see Figure 33), and dropped fire sprinkler covers (see Figure 34)

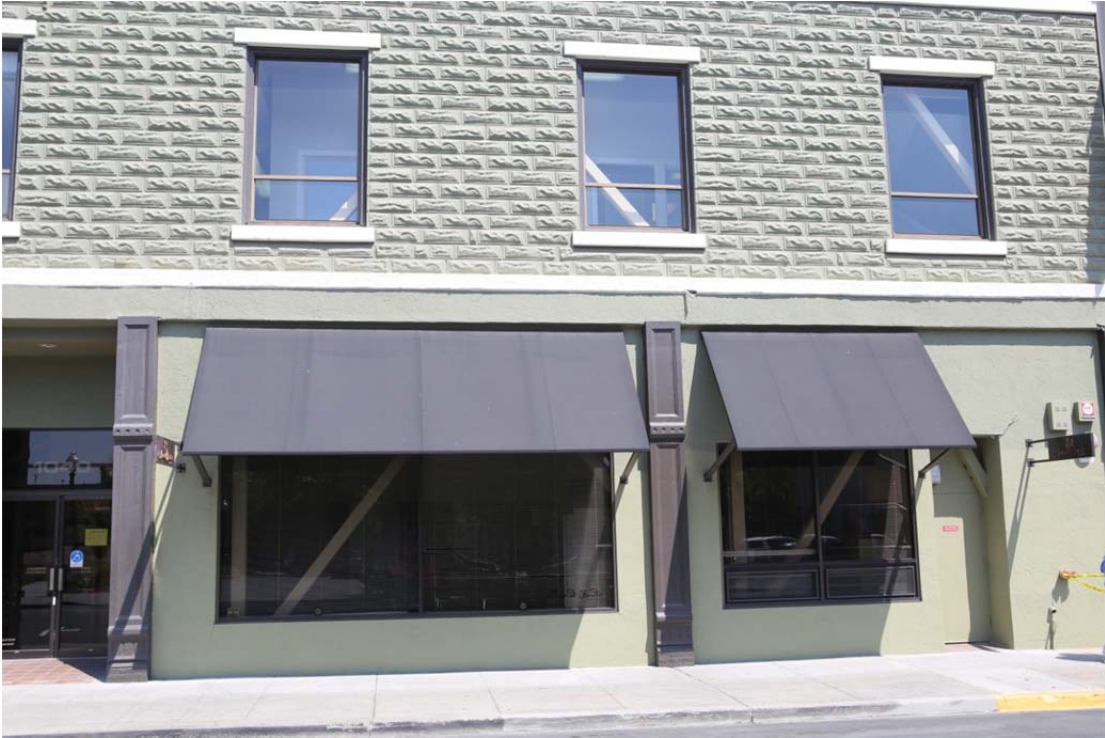
Building Description	Steel concentrically braced Frame retrofit (with in-plane buckling connection detail) Square HSS braces in “Chevron” configuration (perimeter of the building); see Figure 35 Extremely long slot at net section region; see Figure 36 Kept steel cage from original vintage building Steel cage made up of truss system of double angles; see Figure 37
Structural Damage	Out-of-plane buckling interior double angle braces running in south-east to north-west direction; see Figures 38 and 39 Slight cracking at base plate of interior columns; see Figures 40 and 41 Buckling of gusset plate; see Figures 42 and 43 Separation and pulling out of square HSS retrofit from original structure; see Figures 44, 45, and 46. Anchor bolts seem to be too small at some connecting points. Visible drop of back balcony (see Figure 47); crack runs from interior of building to outer balcony (see Figure 48).

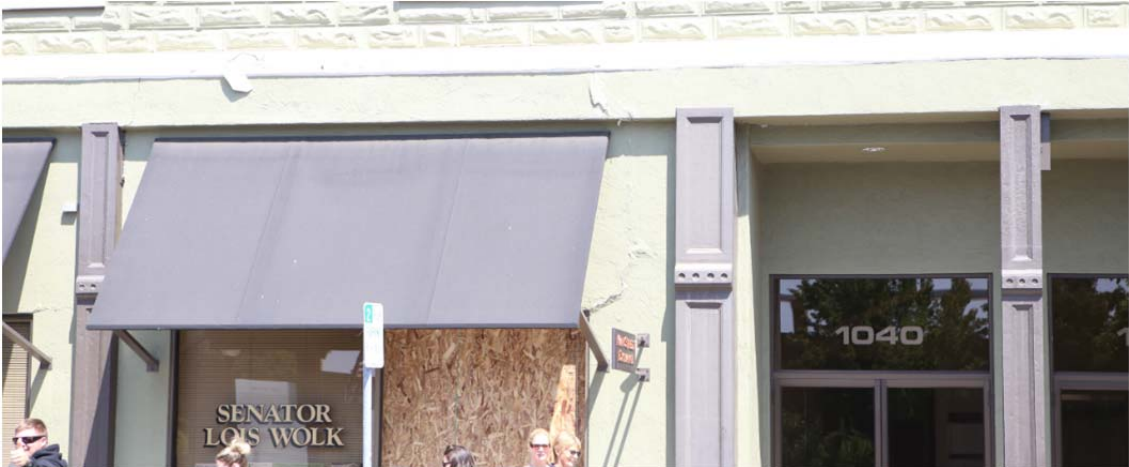
Nonstructural Damage; see Figure 49	Cracking in exterior façade at 1 st story; Broken windows at 1 st story Cracking in dry walls; see Figure 50

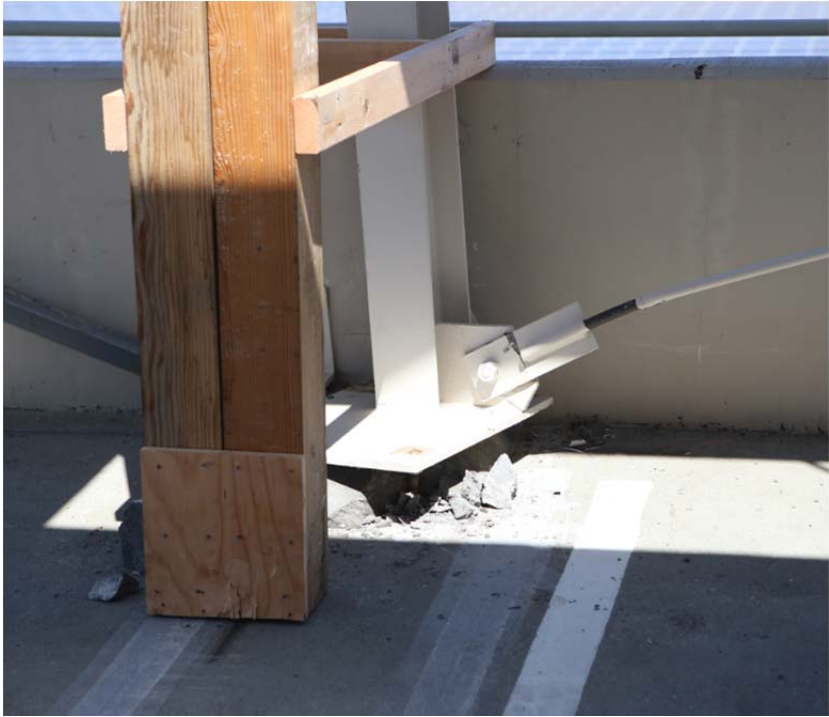
Figure 55

Building Description	Buckling-Restrained Brace Frame (BRBF) Construction; Core Brace BRB BRBs with all bolted connection; see Figure 51
Structural Damage	No visible damage to BRB reinforced structure (the main building) Buckling of tension-only braces at roof of concrete parking structure holding roof solar paneling (see Figures 52 and 53). Wood temporary supports were provided as shown in the figures. All tension only-braces buckling along single outside column line; no visible buckling of other braces at other column lines; see Figure 54. Tearing out of base at base of column and bracing; see Figures 55 and 56. Grout crushing and yield of tension rods are also shown in the pictures.

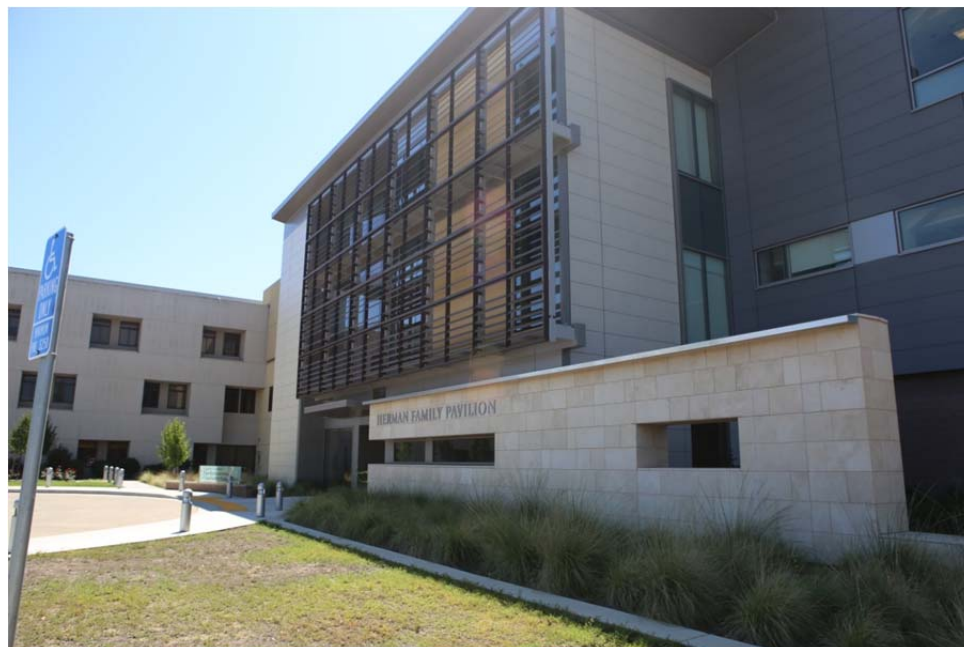
Structural Damage We were not able to go inside; told there was no structural damage; see Figure 58

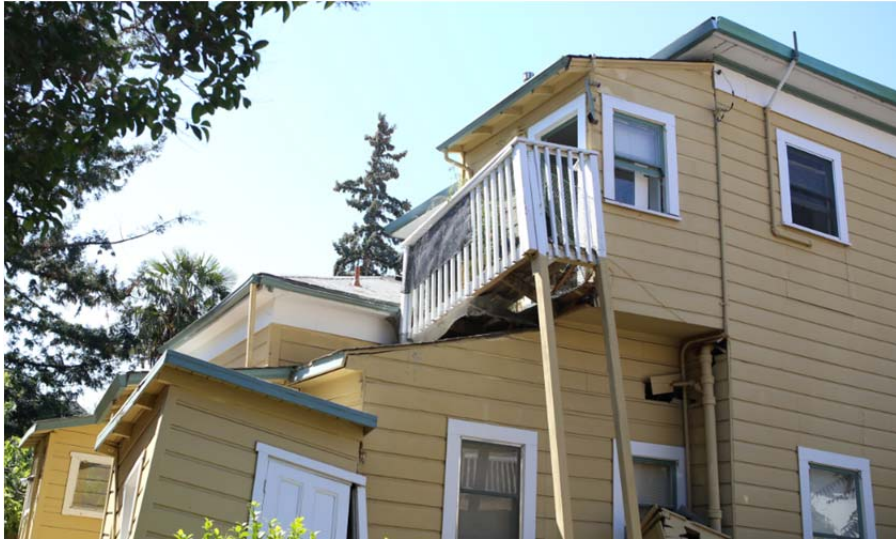
Figure 59

Building Description Residential wood construction.
Structural Damage Soft story at 1st floor; Collapse of 1st story; see Figures 59 and 60

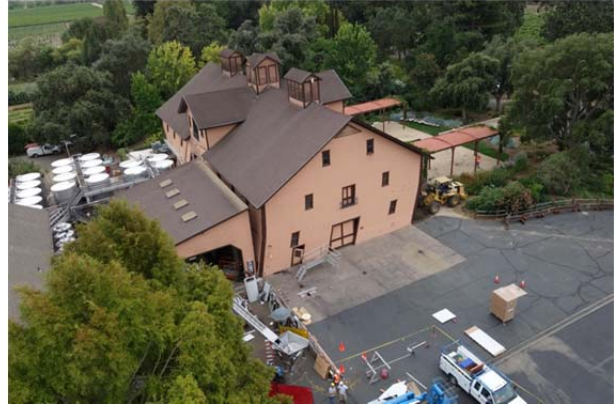
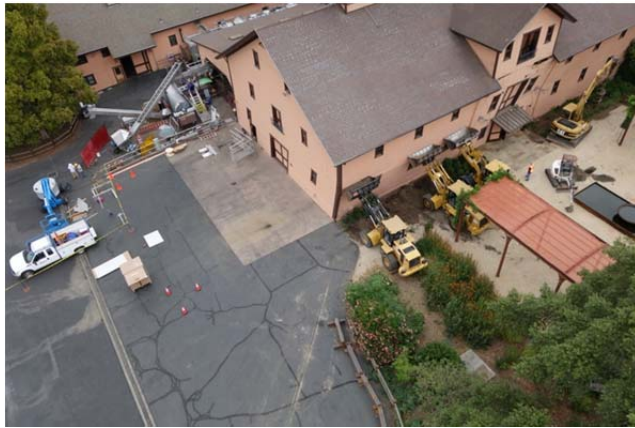
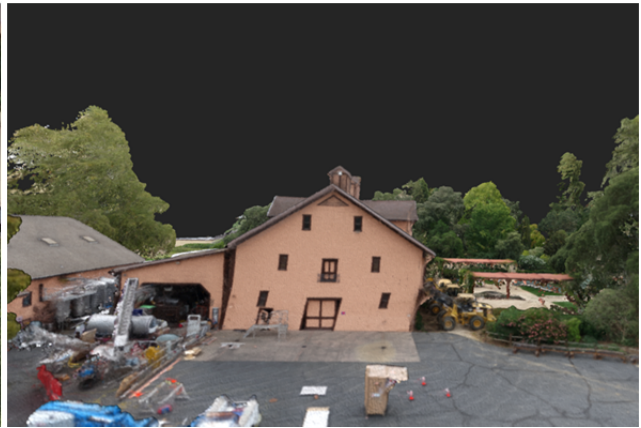
The Trefethen Family Vineyard (Figure 4) is located 8 km North of Napa and spans 0.16 km². Its Eschol building was constructed in 1886 and served as a tasting room for visitors of the winery. During the earthquake, the wooden structure was heavily damaged and weakened to an unknown extent. Access to the structure has been limited and interior surveys delayed due to the risk of collapse. Based on visual inspection from the outside, it appears that multiple, 5000-gallon tanks, partially filled with water have partially toppled, pushing against the west-side of the building, further threatening its structural integrity. Contractors are currently working towards securing the building, by bracing its west-facing side, after observing steady daily drift of about 2.5 cm of a marker placed at the roofline, following the days after the earthquake.

Figure 5 (a) Ground view of damaged structure supported by bulldozers; (b) aerial view of damaged structure; (c) aerial view of damaged structure; and (d) reconstructed model capturing building displacement and façade damage.

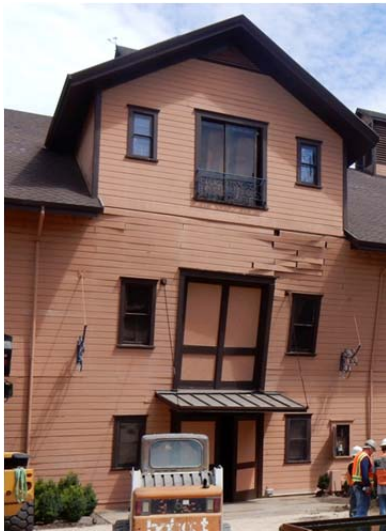
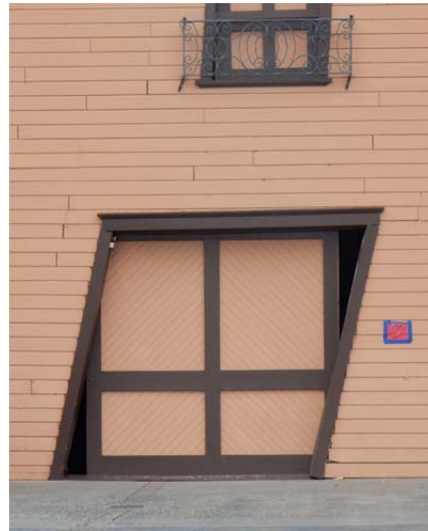
Figure 6 (a) Damage to west façade and (b) close-up of main entrance on north side.

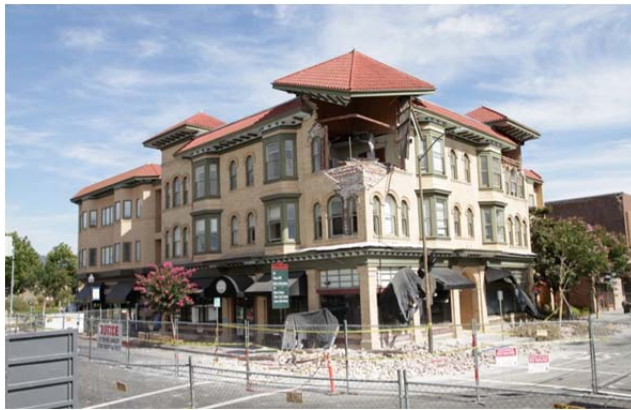
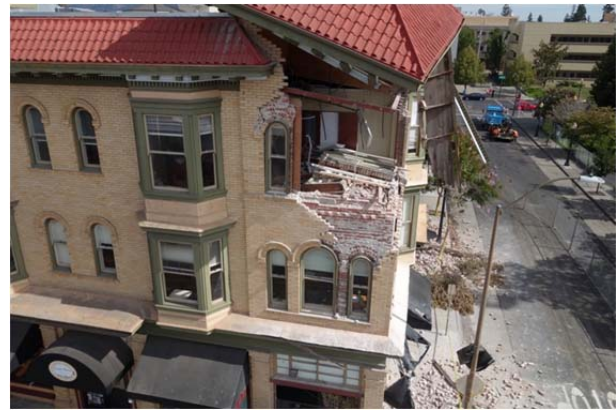
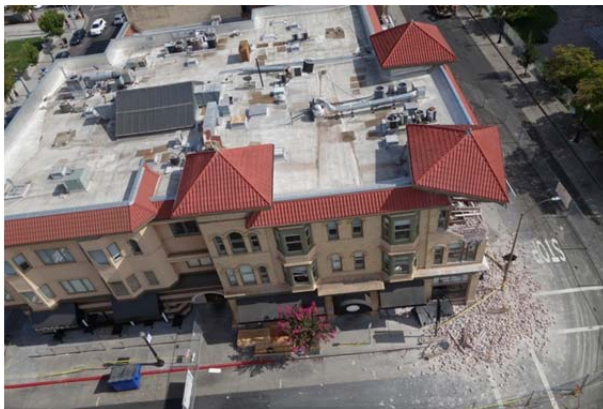
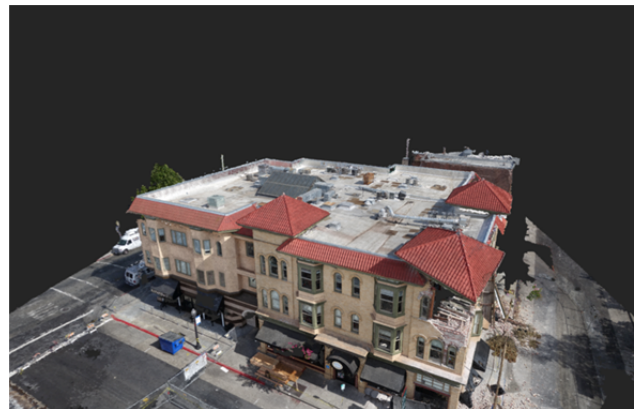
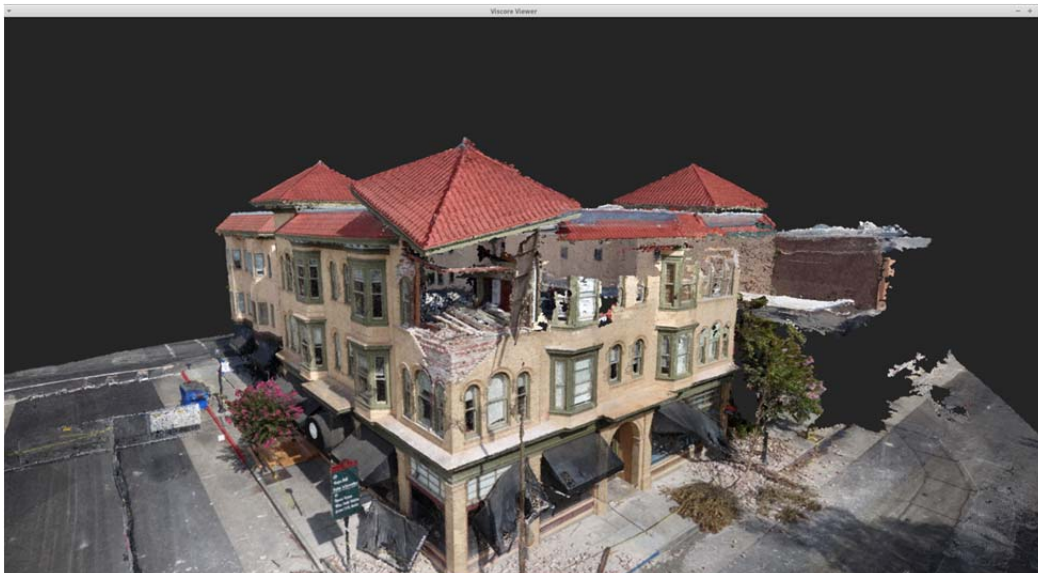
This office building at the corner of 2nd and Brown Streets, suffered from localized wall and roof collapses, as well as significant cracks in its façade, among others. The western corner of the building experienced a top floor collapse, resulting in debris on the ground and an unsupported roof section (Figure 9-10).

Figure 10 (a) Ground view; (b) close up aerial view; (c) top down aerial view; (d) reconstructed model of building; and (e) reconstructed model of damaged building corner.

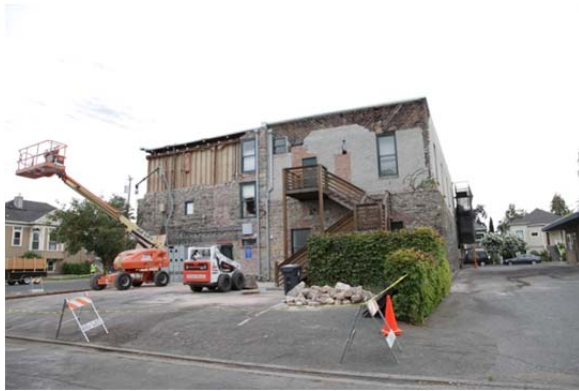
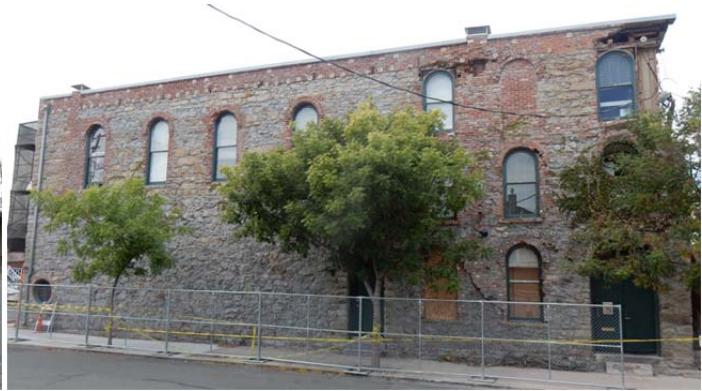
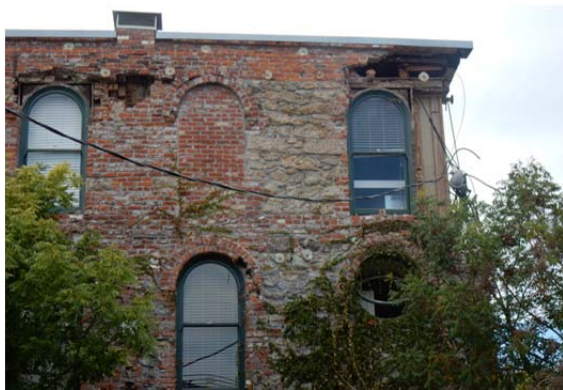
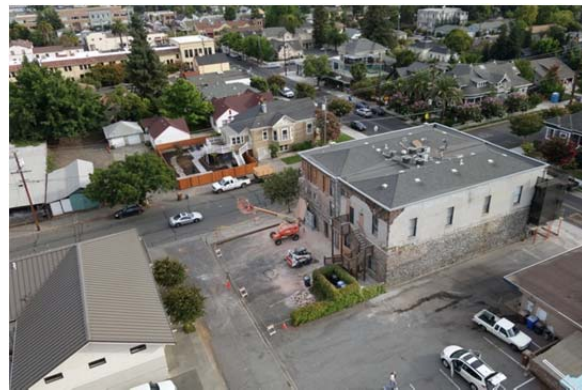
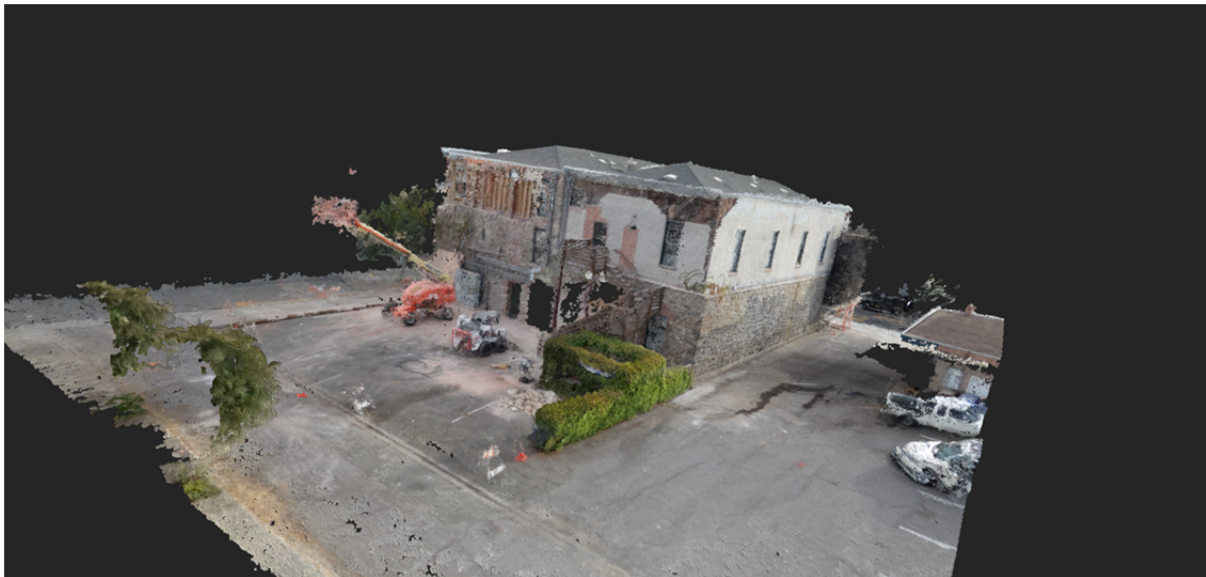
This test-case is a mixed-use building located on Main St, with extensive damage to its façade. The building itself was already in the process of being repaired, exposing the different building materials and reinforcement strategies that had been used over the years (Figures 13 and 14).

Figure 14 (a-b) Ground-level view; (c) detail view of damage masonry façade; (d) aerial view; and (e) reconstructed model.

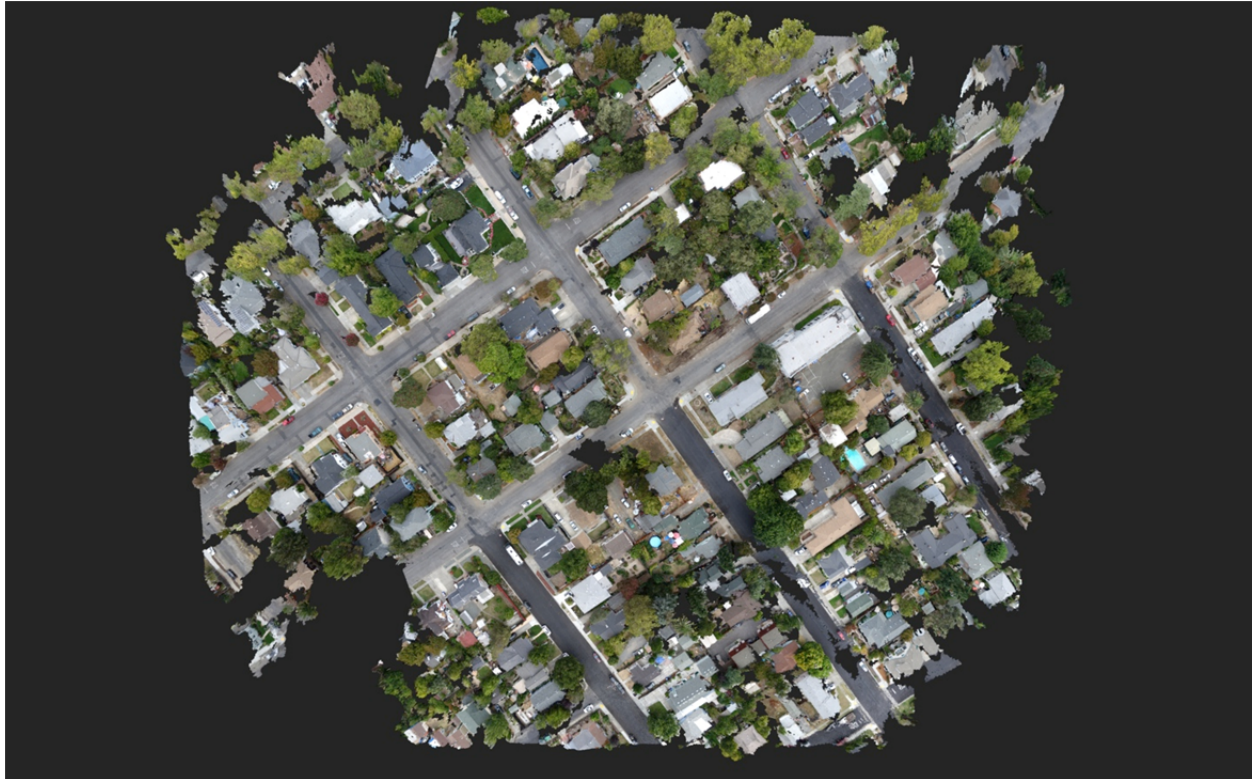
This survey explored airborne acquisition of entire residential blocks in a neighborhood where multiple buildings suffered foundation failures, cracks appeared along roads, sidewalks and driveways and water mains ruptured. Most of the dwellings were single story, wood frame structures with elevated foundation (Figures 15 and 16).

Figure 16 Reconstructed model of surveyed residential city block, capturing structural and non-structural damage to buildings and roadways.

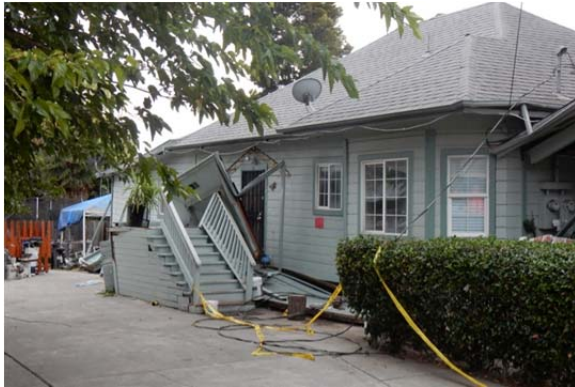
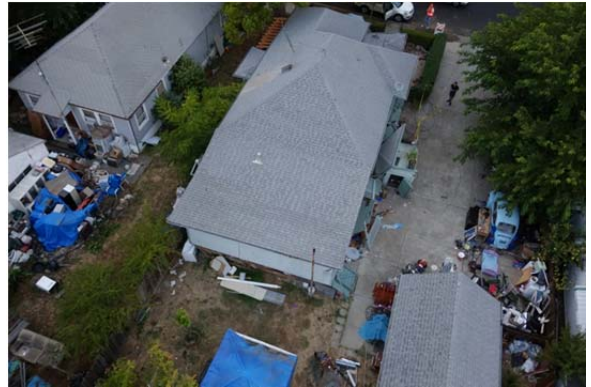
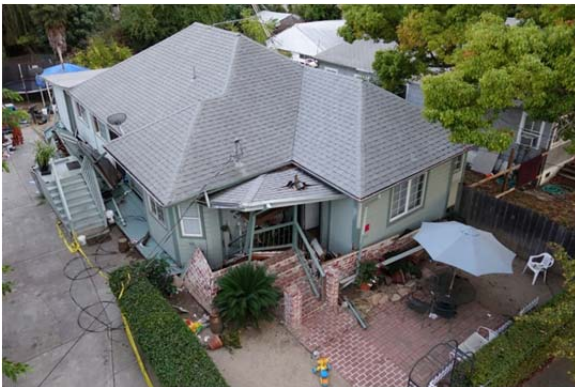
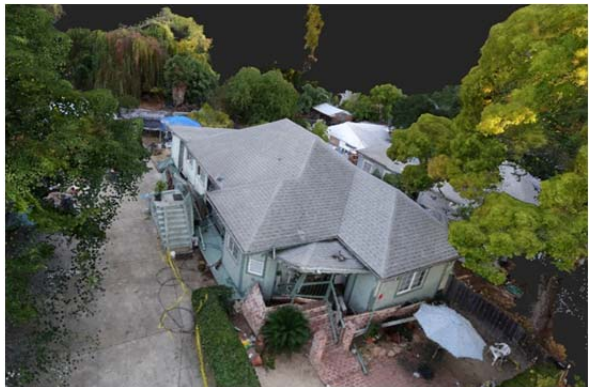
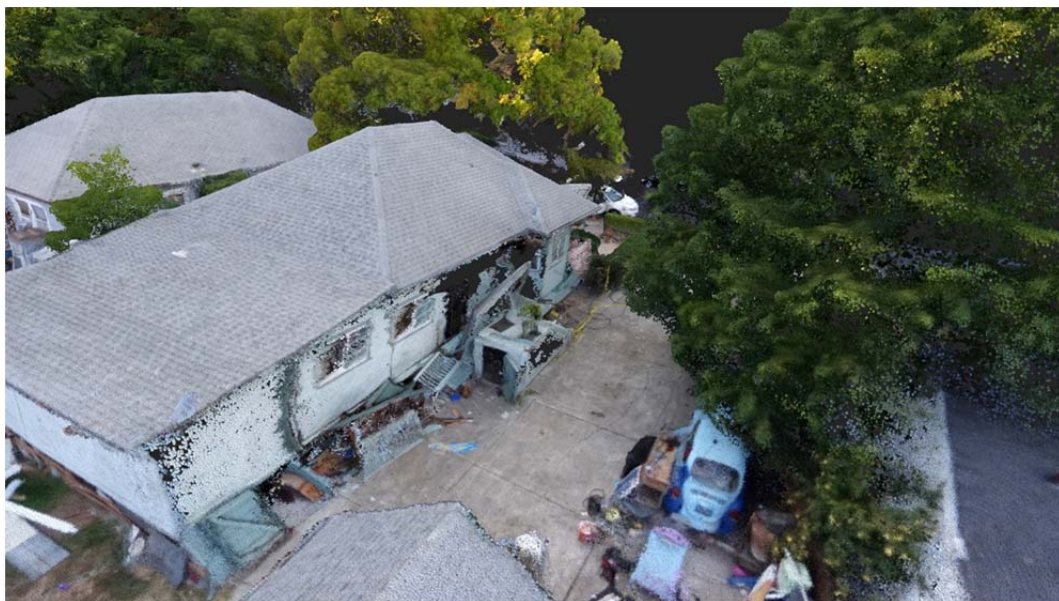
A single story, wood-frame dwelling with complete elevated foundation failure was surveyed, to explore rapid assessment of red-tagged buildings inaccessible through traditional means. This dwelling slid off of its foundation and approximately 1.2 m onto the adjacent property (Figures 17 and 18).

Figure 18 (a) Ground view; (b) aerial view of the back; (c) aerial view of the front; (d) reconstructed model of the front; and (e) reconstructed model of the back.

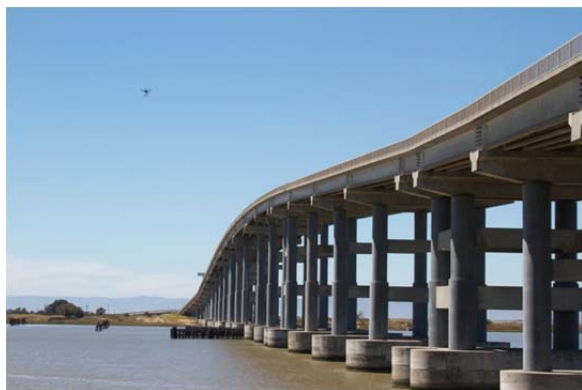
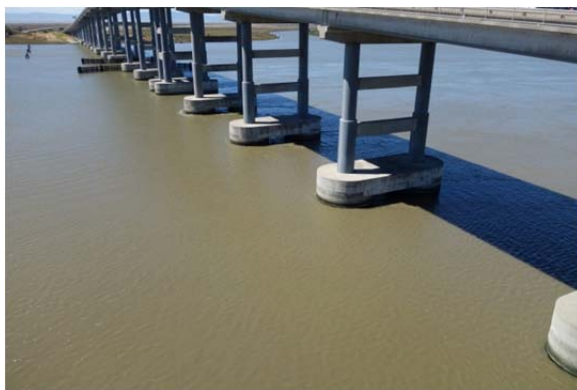
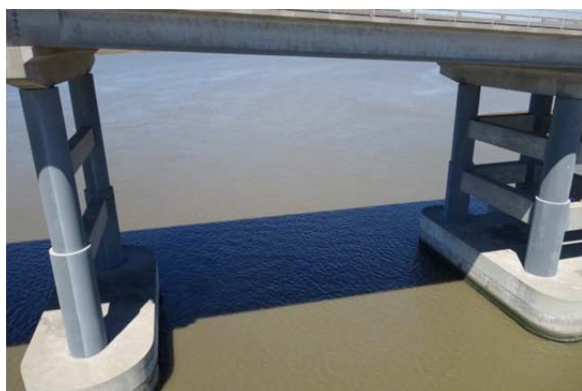
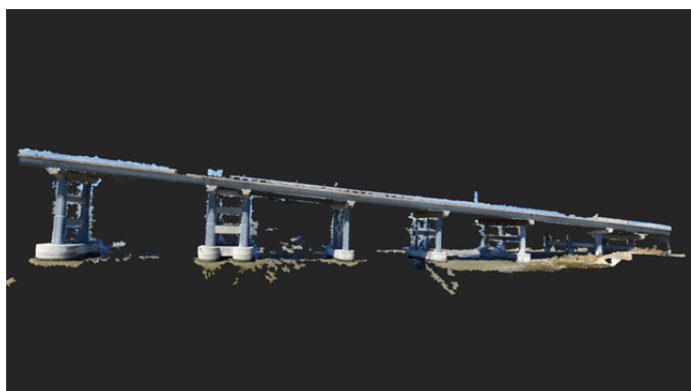
The multi-lane Napa River Bridge (SR-37) was imaged to explore drone utility for the rapid assessment of lifelines with limited access. In this particular case the bridge spanned open water, creating unique challenges for swift, post disaster health assessment (Figures 26-27).

Figure 27 (a) Ground view; (b) aerial perspective view; (c) aerial close up view; and (d) reconstructed model.

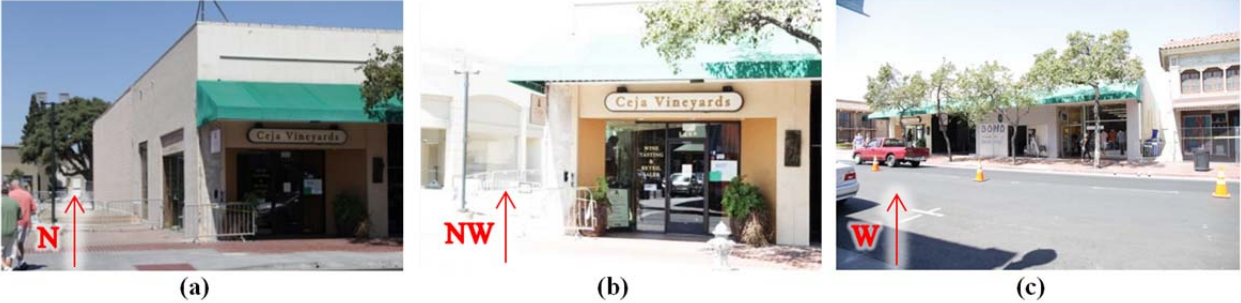
Ceja Vineyards is a small, commercial lounge and wine store in downtown Napa, California. The winery is located in a single-story timber-framed structure which houses four commercial establishments, two lounges and two clothing stores (see Figures 30 and 31). The timber-framed structure has a stucco façade for the end-unit that houses the winery. The structure was inspected by the city and green-tagged; however, the businesses were not open at the time of survey. While no structural damage was observed, cosmetic stucco façade damage occurred at the winery (see Figure 32a). The winery is located 0.25 km from the nearest station, USGS-NCSN Station N016, which observed a peak horizontal ground acceleration of 0.61g.

Figure 31 Exterior of Ceja Vineyards.

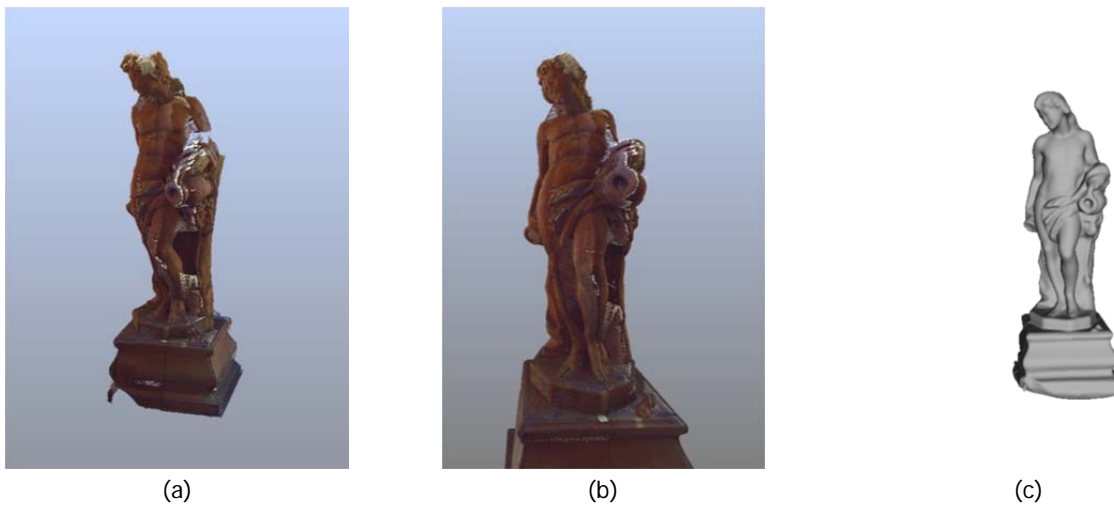
Slight damage was observed on the statue likely due to the impact with the tile floor. Significant cracks developed in the neck and a portion of the head was broken in the immediate vicinity of the impact (see Figure 32). No other areas of damage were observed on the statue or on the adjacent walls. There was approximately 0.2 m of clearance between the at-rest statue and the wall. This clearance and lack of damage indicate that the overturning may have been the only impact event. Given the large ground accelerations and velocities in the downtown area as well as the high aspect ratio (approximately 4), overturning without impact is a plausible mode. No translation or rotation of the pedestal was observed.

Figure 33 (a, b) Snapshots of point clouds from laser scan data of the Ceja Winery statue; and (c) snapshot of digital reconstruction of statue as a triangulated mesh for geometric and mass calculations.

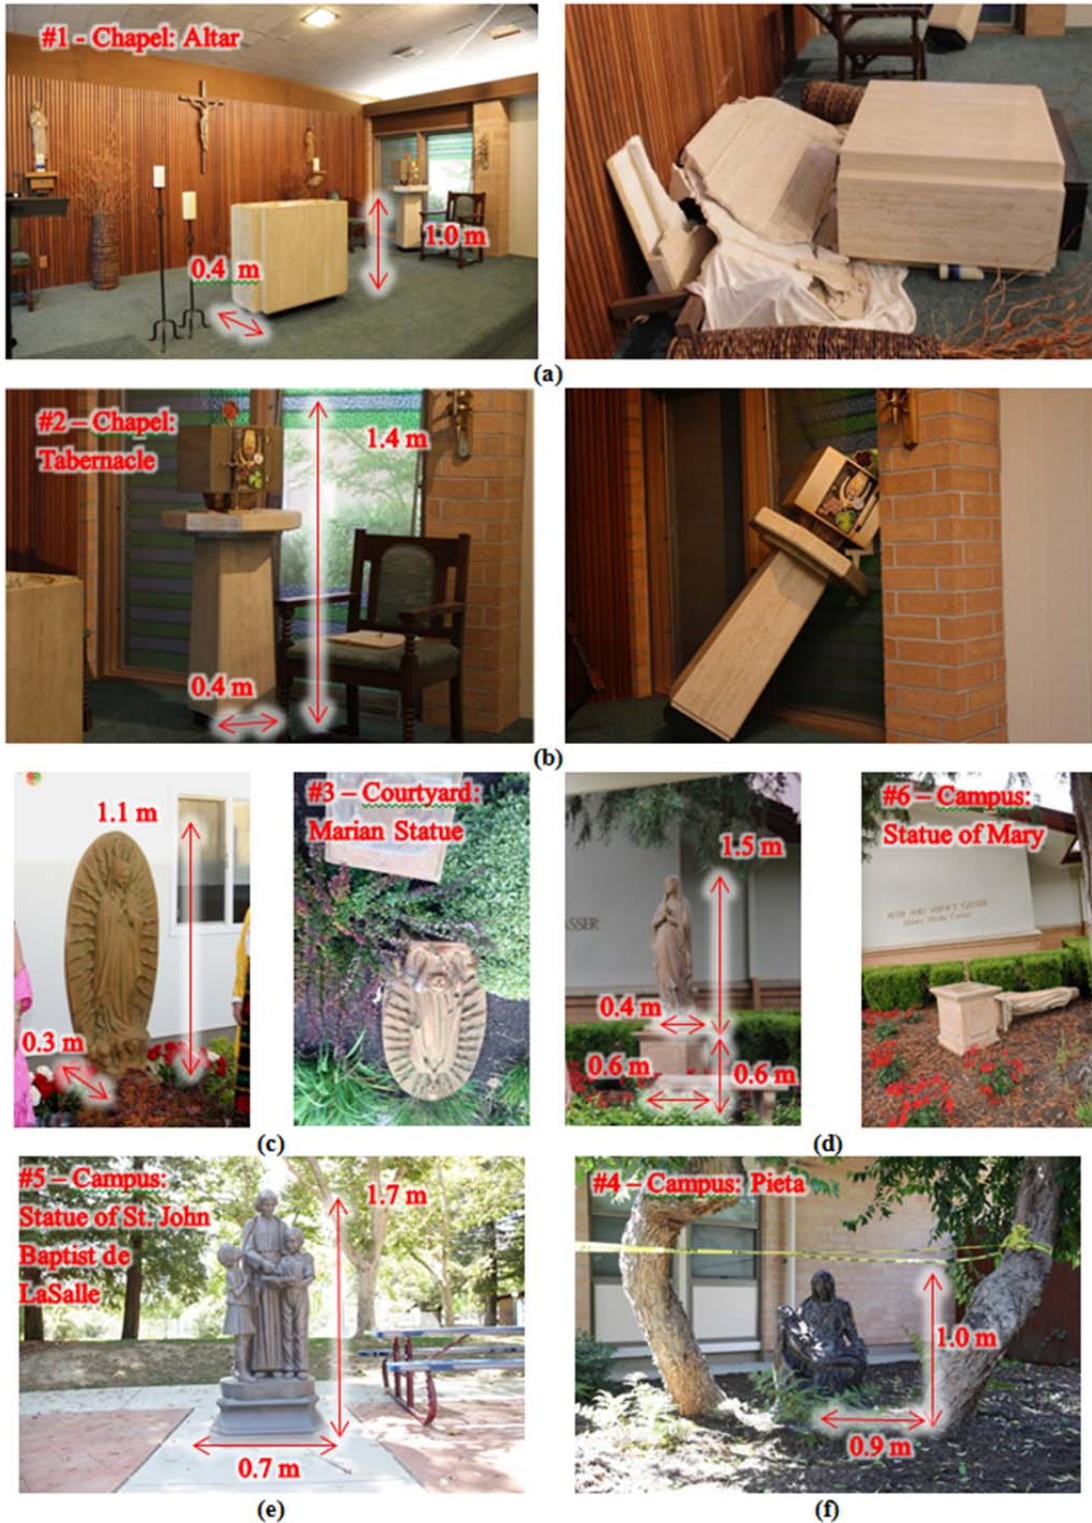
Figure 35 Images of overturned (if available) and original placement of surveyed statues/objects. Approximate dimensions are provided. Some images provided by Justin-Siena High School.

The high school included three additional surveyed statues throughout the campus grounds, as indicated by objects #4-6 in Figures 34 and 35. Each of these three statues had unique boundary conditions, geometric configurations, and restraint mechanisms. The first statue is a small, hollow, copy of the Pieta by Michelangelo (Figure 35f). This lightweight statue was resting unrestrained on a bed of soft mulch and overturned backwards. The overturning was indicated by the school president during the walk-through; although, no photographic documentation is available. The overturning direction correlates to the highly eccentric center of mass of the statue. The second statue is a large statue of St. John Baptist de La Salle and two students (Figure 35e). The statue is originally a hollow cast structure; however, it was recently filled with cement and bolted to the sidewalk in an anti-theft measure. The statue, although quite tall and slender, performed well and no evidence of cracking or translation was observed.

The final surveyed statue was a statue of Mary (Figure 35d), located on the campus grounds adjacent to the Gasser Center Building. This statue is approximately 1.5 m tall with an aspect ratio of approximately 4 and weighing approximately 295 kg. The statue is fiber-reinforced concrete with a rectangular base and complex geometry and mass eccentricities. The statue was resting on a hollow, concrete, rectangular pedestal which was resting unrestrained on a bed of mulch. Similar to the Marian statue in the courtyard, this statue was found rotated 180° about the vertical and a distance away from the pedestal. This is in contrast to the statue found overturned in the Ceja Winery, which remained partially on the pedestal. The response of this statue of Mary was a complex three-dimensional interaction, yet overturned in a direction correlating to an edge of the pedestal. This statue, pedestal and ground system was laser scanned for further analysis (see Figure 38). The response of the two Marian statues on campus in comparison with that of the Pieta replica and the chapel objects emphasizes the complex response of stiff multi-body systems.

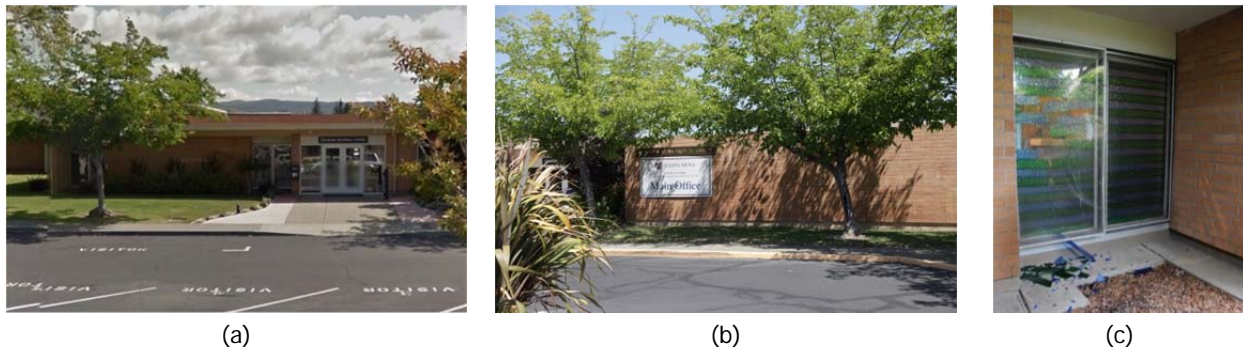
The chapel is located off the Main Office building of the high school, as denoted in Figure 34. The chapel's structure dates back to the original 1966 construction and is a single-story, timber-framed structure attached to the Main Office on its southeast end. The exterior of the building is shown in Figure 36. The religious contents, namely the marble altar and marble tabernacle, were also constructed and placed in 1966. Both objects consisted of a hollow rectangular marble frame and marble top (see Figure 35a and 35b). The top of the altar was significantly wider than that of the base creating a top-heavy structure. Similarly, the tabernacle was constructed of a heavy, metal piece atop the tall marble base. Both the altar and the tabernacle were resting unrestrained on a carpeted surface and can be considered symmetric in elevation. Following the earthquake, the altar was found overturned in the northwest direction. This overturning direction corresponds to the slender (or critical) side of the rectangular structure. The marble tabletop impacted the adjacent wall causing superficial damage to the wall and breaking the tabletop off the base (see Figure 35a). The tabernacle was found overturned in the east direction, resting against the adjacent window. The tabernacle is symmetric in both horizontal directions indicating the overturning direction was indicative of the earthquake and the object's orientation (facing south and east), rather than geometry. Only superficial scratches were incurred to the tabernacle, while the impacted window suffered minor damage (see Figure 36c).

Figure 36 Exterior of Justin-Siena High School: (a) chapel facing northeast; (b) main office facing northeast; and, (c) altar of chapel facing southwest. (a, b: Google Earth Street View; c: Justin Siena High School).

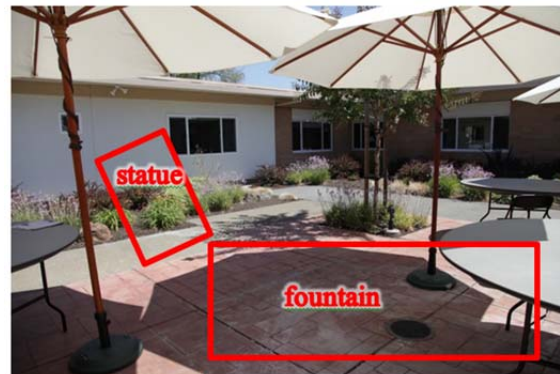
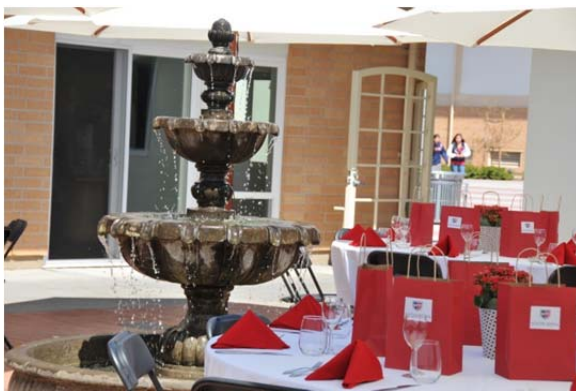
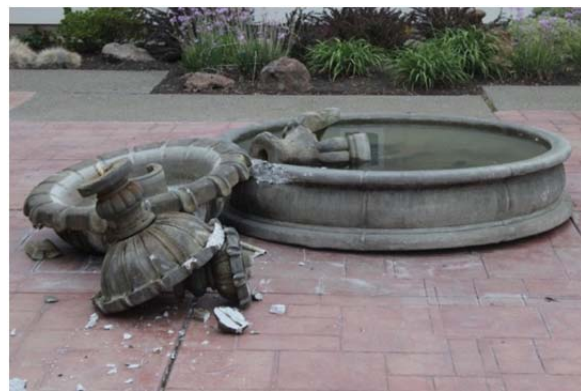
The courtyard is an outdoors area enclosed on four sides by the main office and adjacent buildings. The central portion of the courtyard consists of a small concrete pad and stone inset; while, the perimeter of the courtyard was a garden of mulch and soft soil. Two primary objects occupied this area, namely a concrete Marian statue and a large fountain (see Figure 37a). The fountain, while unrestrained in the center of the courtyard, was originally held together by the interior water pipe and consisted of multiple rigid blocks. The original and collapsed fountains are shown in Figure 37. The Marian statue consists of a likeness of Our Lady of Guadalupe with a smaller hexagonal base and is wider in the central portion of the statue (at the sun rays). The geometric details and shape of the statue are concentrated in the front (originally facing southeast) with a flat, undetailed backside. The statue was placed unrestrained on an unrestrained concrete pedestal in the garden perimeter (soil interface). While no evidence of pedestal

movement was observed, the statue overturned in the southeast direction. Furthermore, the statue was found rotated 180° about the vertical and located a distance from the pedestal. This indicates that the statue did not simply overturn, but rather responded in a complex three-dimensional mode.

Figure 37 (a) Overview of courtyard from the southwest corner post-earthquake with original locations of statue and fountain marked; (b) Fountain of the interior courtyard before; and (c) after the earthquake. (b ,c: photos courtesy of Justin-Siena High School).

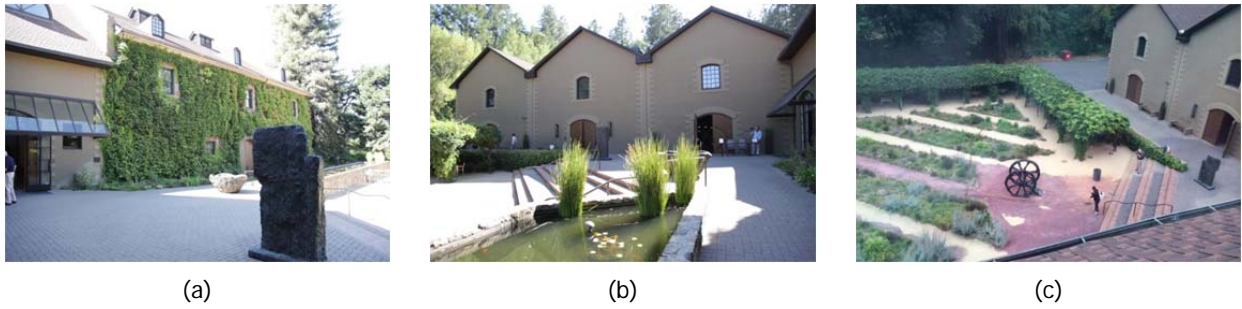
The structures were inspected following the earthquake and were cleared for public access with the exception of Section B which observed out-of-plane motion of the original unreinforced stone walls. In addition to this structural damage, there was significant nonstructural damage at the site including overturning and translation of art objects in the gallery (Section A), collapsed barrel stacks and pallets in the warehouse (see Figure 41), and buckled wine tanks in the storage areas (Section C). Furthermore, failure of two full wine tanks resulted in flooding of the courtyard as seen in Figure 40c. During the site survey, cracking in the concrete floor along the length of the tank storage facilities (Section C) was observed as seen in Figure 42. The cracks may be related to inconsistencies of the foundation along the edge of Sections B and C. Damage to wine tanks in Section C and art objects in Section A are summarized in the following two subsections. Images of the art objects, warehouse, and courtyard immediately following the earthquake on Sunday, August 24, were provided by The Hess Collection. All other images were taken on September 2.

Figure 40 Exterior of The Hess Collection: (a) the art gallery, section A facing northwest; (b) the barrel chai and fermentation tank storage facilities, sections B and C; and (c), the flooded courtyard after failure of two 10,000 gallon wine-filled fermentation tanks.
