PEER Preliminary Notes and Observations on the August 24, 2014, South Napa Earthquake

Pacific Earthquake Engineering Research Center

Report No. 2014/13

September 17, 2014

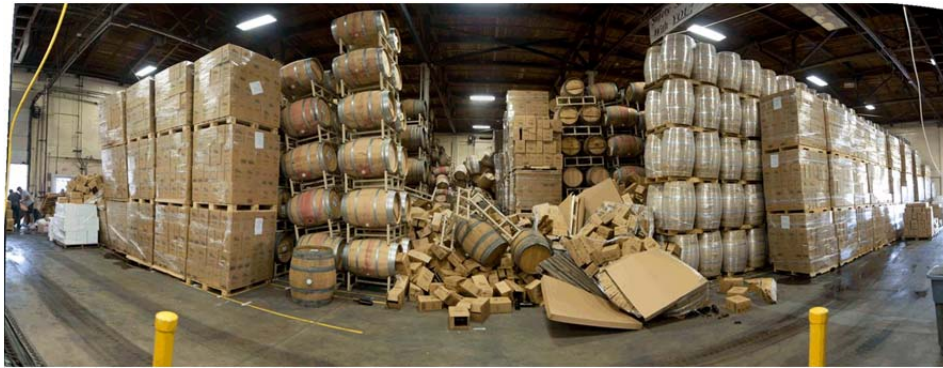
Figure 41 Panoramic view of the contents damage of the modern warehouse. Wine barrels and cases of wine bottles were stacked very high for storage and subsequently collapsed and fell during the earthquake.

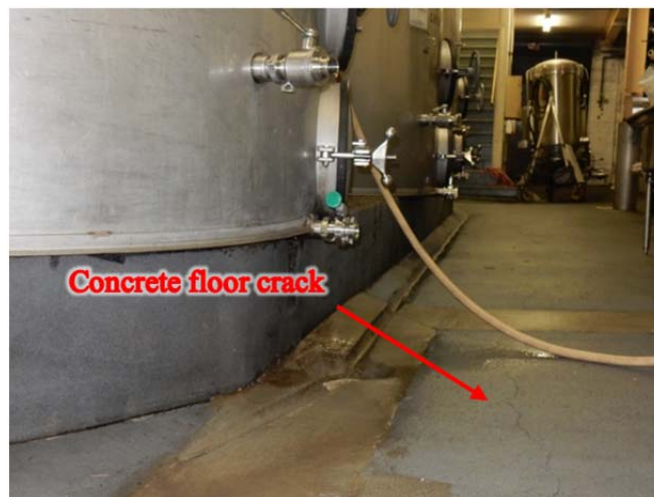
Figure 42 Cracking of concrete floor along the length of structure C, the 1989 addition for wine tank storage.

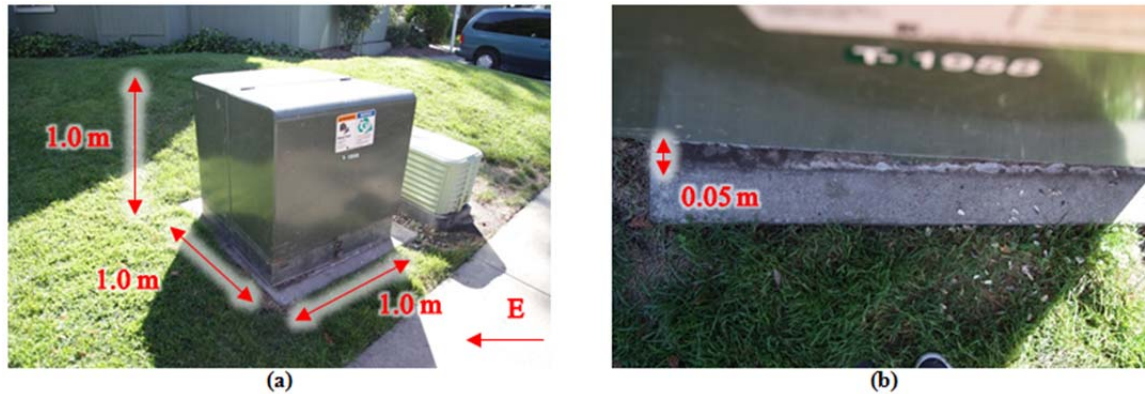
A transformer located on the northeast side of the complex appeared to have translated during the earthquake (see Figure 45). The transformer was hollow, steel and cubic with approximate dimensions of 1 m in length, width, and height. The internal composition of the transformer was not able to be inspected. Prior to this survey, the electrical transformer had been red-tagged and labeled unsafe by the City of Napa on Sunday, August 24. The translation of the transformer was not uniform and a degree of twisting was observed, as seen in Figure 46. Although the anchorage was not able to be inspected, it is likely that the transformer was resting unrestrained on the concrete pad. The transformer translated approximately 0.05 m on the northeast corner. Given the approximate squat aspect ratio of 1, it is likely that the transformer responded in a sliding-

twisting mode. The mass distribution within the transformer was not able to be investigated to understand the twisted position. Although a recording is not available very close to this site, it can be inferred from the response of this transformer that significant peak ground accelerations were experienced to overcome a relatively high level of friction between the steel and concrete.

Figure 46 Rotated electrical transformer (a) facing west, and (b) northeast side facing down.

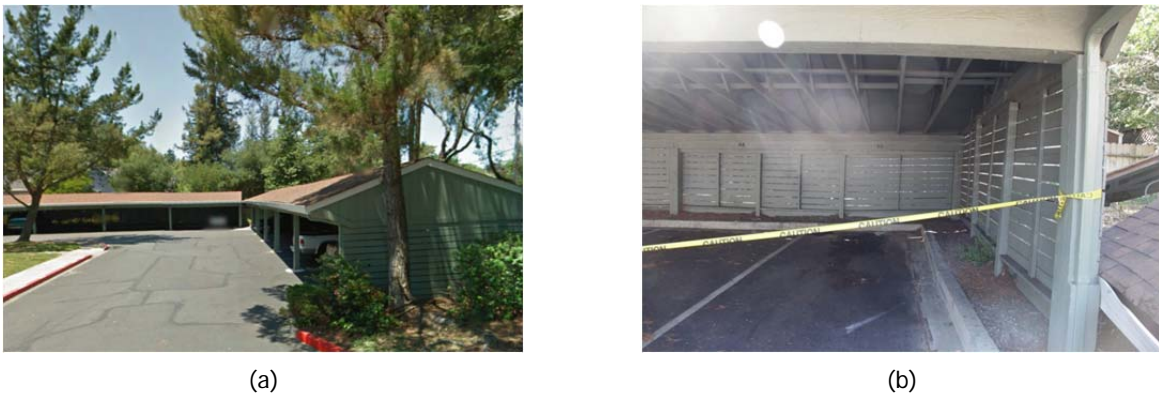
Seven carports were surveyed at the Charter Oaks Apartment Complex, as mapped in Figure 45. The carports were single-story, timber-framed structures with five bays as shown in Figure 47a. Each bay is dimensioned to accommodate two parked vehicles. The carport had a trussed roof system and is supported by timber columns (approximately 20 cm × 20 cm). The interior columns were embedded in concrete posts and surrounded by pavement; whereas, the exterior columns were typically wrapped in aluminum and embedded in soil. The rear of a typical carport was enclosed with a longitudinal timber wall, as shown with the roof system in Figure 47b. Two additional transverse walls typically enclosed the shorter sides of the carport creating a carport enclosed on three sides. An exception to this is Carport #1 (see Figure 45), which did not have enclosed transverse walls. Following the earthquake, five out of seven carports collapsed while two remained standing with noticeable signs of damage. The carport nearest the entrance was red-tagged by the City of Napa on Sunday, August 24 – within 24 hours of the earthquake. The remaining carports did not have red-tags but were cordoned off. Four of the five collapsed carports were oriented with the longitudinal wall in the northwest-southeast direction. The collapse of Carports #3 and #4 is shown in Figure 48 with the perpendicular carports standing. The exception was the collapse of Carport #1 which is likely related to the missing transverse walls.

Figure 47 (a) Carports facing northwest before earthquake (Google Maps); and (b) Non-collapsed carport showing the roofing and wall system.

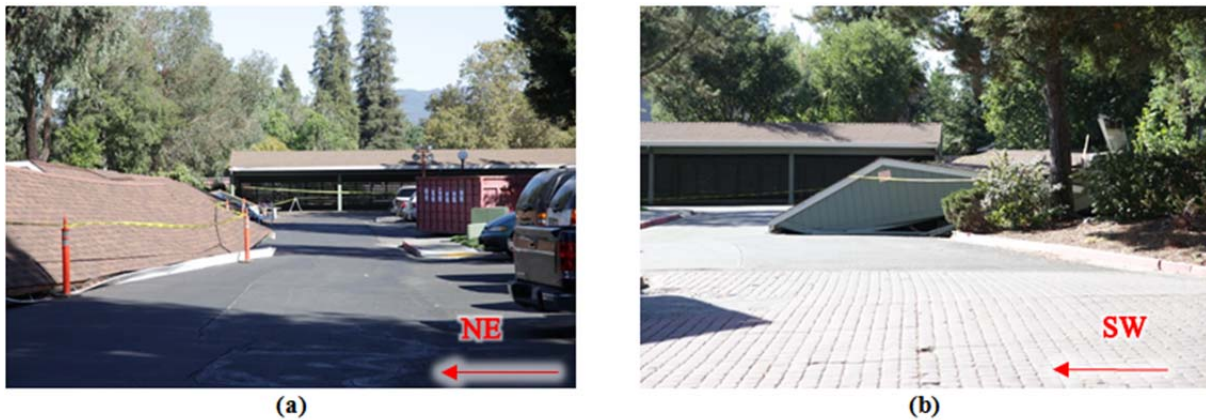
Figure 48 Views of carports post-earthquake showing collapsed and non-collapsed carports facing; (a) Southeast and (b) Northwest.

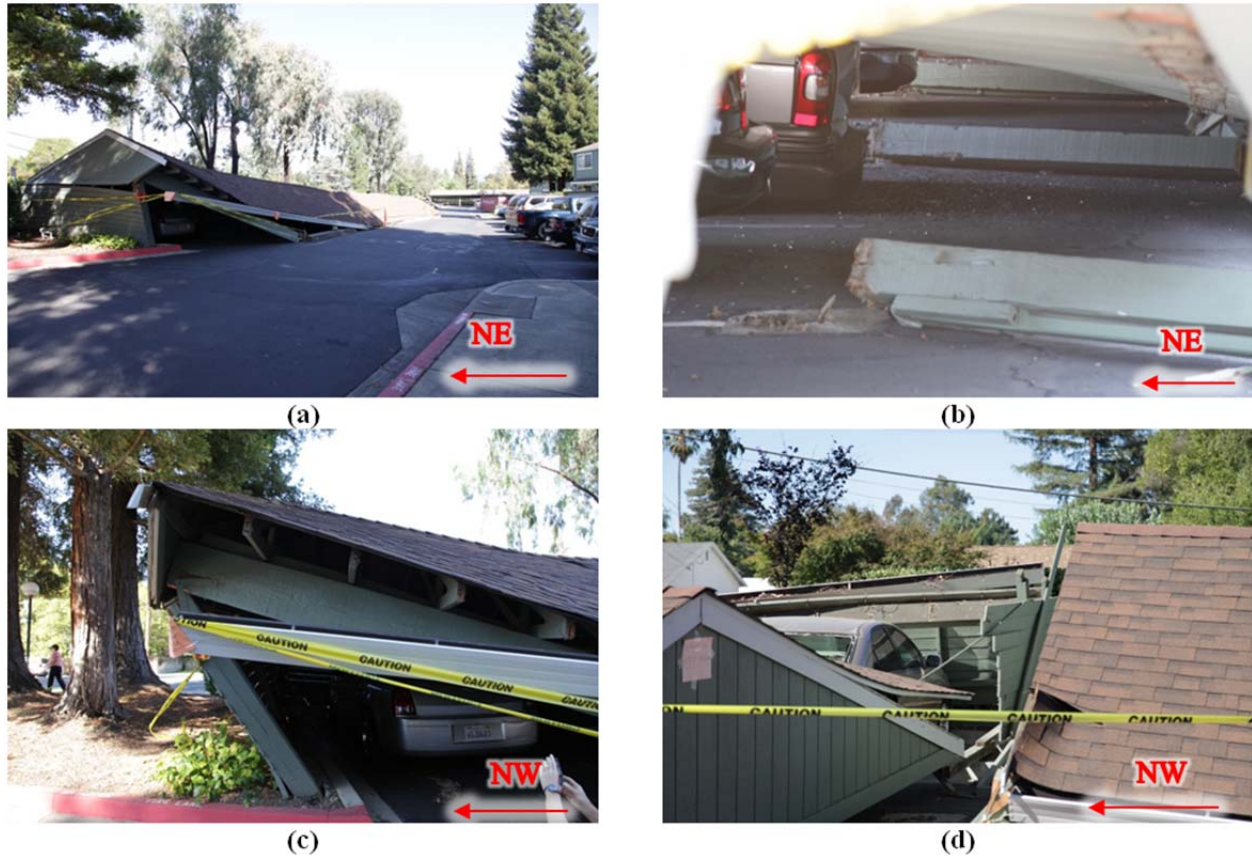
Carports #3-6 collapsed due to interior column shearing, as shown in Figure 49 using Carport #4 as an example. Interior columns sheared at the base embedment in the concrete post. The southernmost exterior column failed similarly at the base; however, the northernmost column was embedded in soil likely with a larger embedment depth (at the curb elevation). This northernmost column did not pull out completely and did not shear at the base. An asymmetric collapse was observed with complete detachment of the roof from the longitudinal and transverse wall at the southern end. Each of these four carports (#3-6) in the northwest-southeast orientation collapsed toward the southwest.

Figure 49 Collapse details for Carport #4: (a) overall collapse along length of carport; (b) view of interior column; (c) west end of carport with partial pullout of column; and (d) east end of carport with complete detachment of roof from the longitudinal and transverse walls.

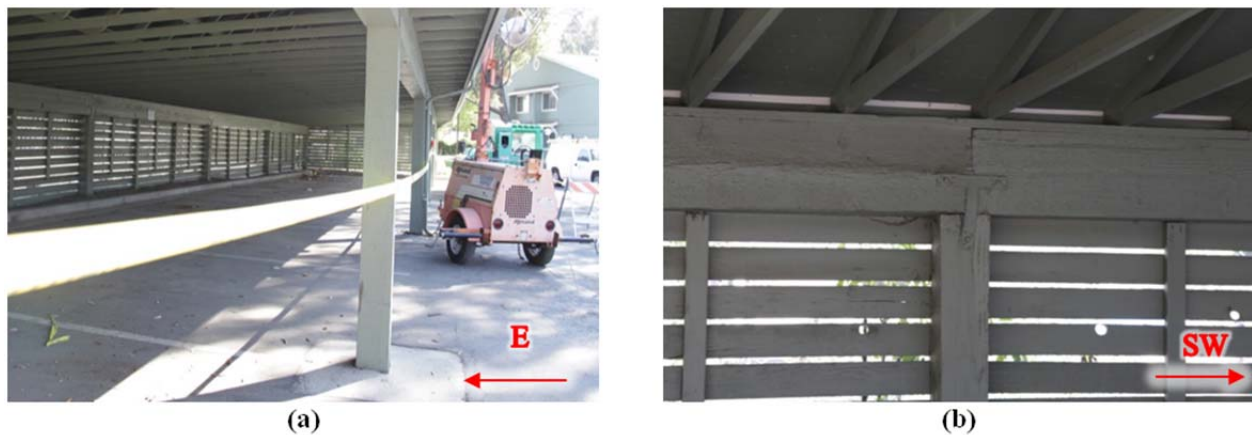
In contrast, the perpendicular carports (#2 and #7) did not collapse yet withstood damage at the connections. Carport #7 is shown in Figure 50a with the longitudinal wall in the southwest direction. A yielded connection of a rear-interior column with the roof is shown in Figure 50b. The connection yielded a permanent displacement of the roof to the southeast. This behavior indicates that the longitudinal wall acted as a shear wall during the earthquake even though it was likely not intended to be load bearing. This correlates to the collapse of the perpendicular carports with much shorter transverse walls.

Figure 50 Details for Carport #7: (a) view looking southwest along longitudinal wall; and, (b) yielded connection of a rear-interior column and roof system showing permanent displacement to the southwest.

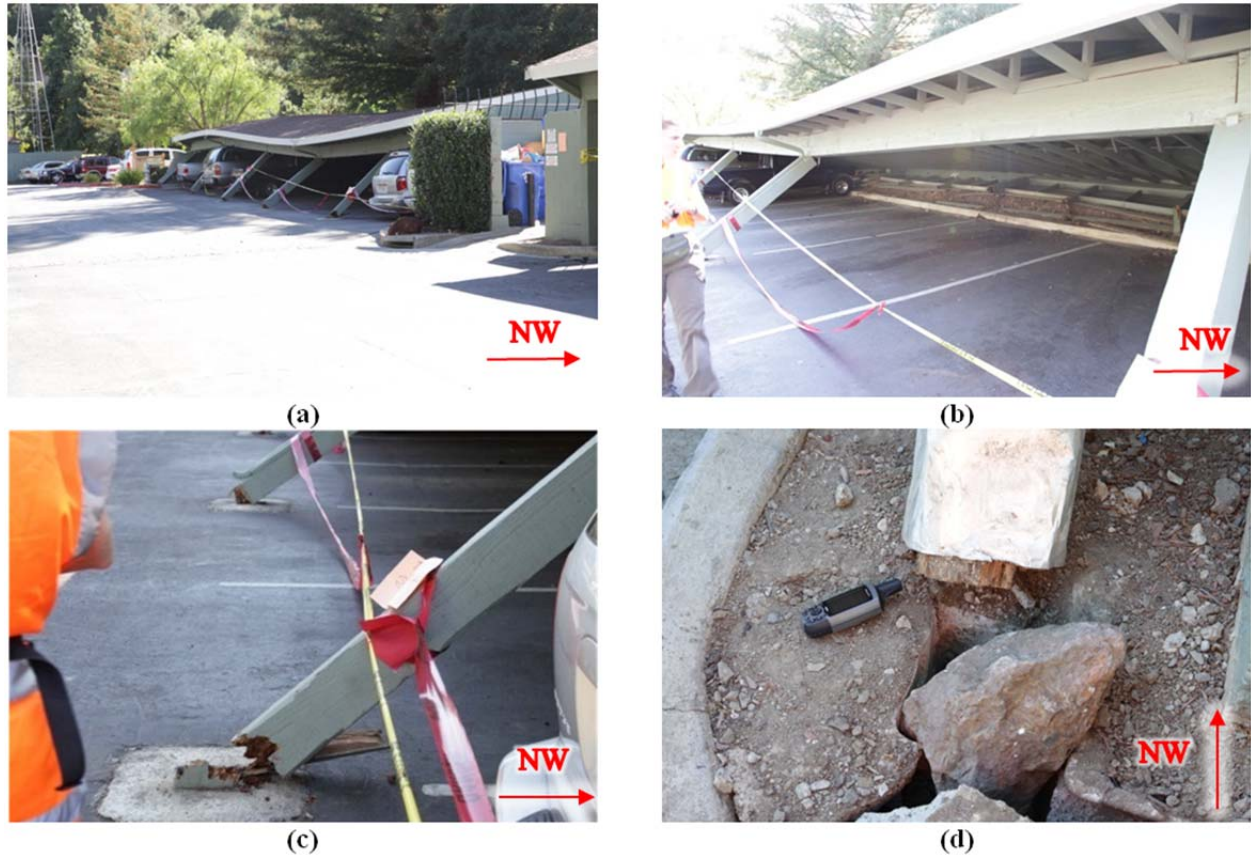
The response of Carports #2-7 indicates a very strong Northwest-Southeast component of the earthquake. However, Carport #1 collapsed despite the longitudinal wall in the southeast direction. Images of the collapse are included in Figure 51. This carport is different from the remaining carports by the lack of transverse walls. In addition, the collapse of this carport was opposite that of Carports #3-6 in that it collapsed toward the longitudinal wall. In this carport, the longitudinal wall collapsed (see Figure 51b) and the interior columns sheared (see Figure 51b and c). However, the exterior columns which were embedded in soil at curb elevation completed pulled out of the embedment (see Figure 51d).

Figure 51 Collapse details for Carport #1: (a) overall collapse along length of carport; (b) view of collapse of longitudinal wall; (c) sheared interior columns; and (d) wrapped timber column pull-out on north end.

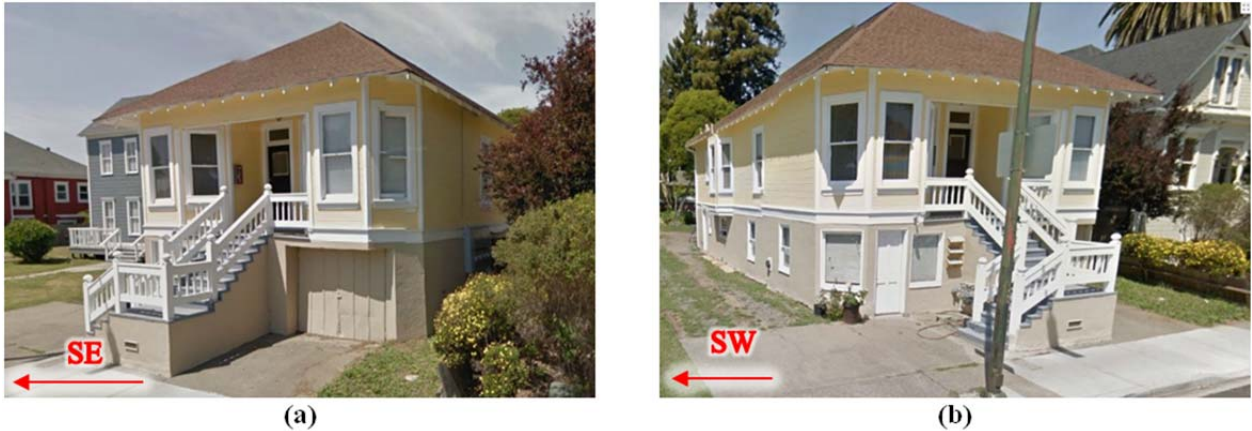
Residence R3, located at 1261 Jefferson Street, is a two-story, wood-frame, multi-family residence with the primary residence on the second floor. Figure 55 presents views of the residence from the street which has a first-story, garage on the north half of the structure extending to the rear of the residence. A separated residential unit occupies the south half of the structure (Figure 55b). The sub-floor of the top-story was cross braced, as viewed from exterior windows of the unfinished first-floor garage. The structure was red-tagged citing failure of the northeast column support, the subsequent tilt of the structure, and the potential for collapse. This structure developed a soft-story type mechanism during the earthquake, as evidenced near the garage door (see Figure 56). The northeast column support failed – as seen in the top, right corner of the garage in Figure 56 resulting in a jammed garage door which emphasizes the tilt of the structure. Furthermore, significant cracks were observed in the vicinity of the gas pipes located on the south side of the exterior staircase (Figure 56c).

Figure 55 Views of red-tagged residence from Jefferson St. facing: (a) southwest and (b) northwest. (Google Earth Street View).

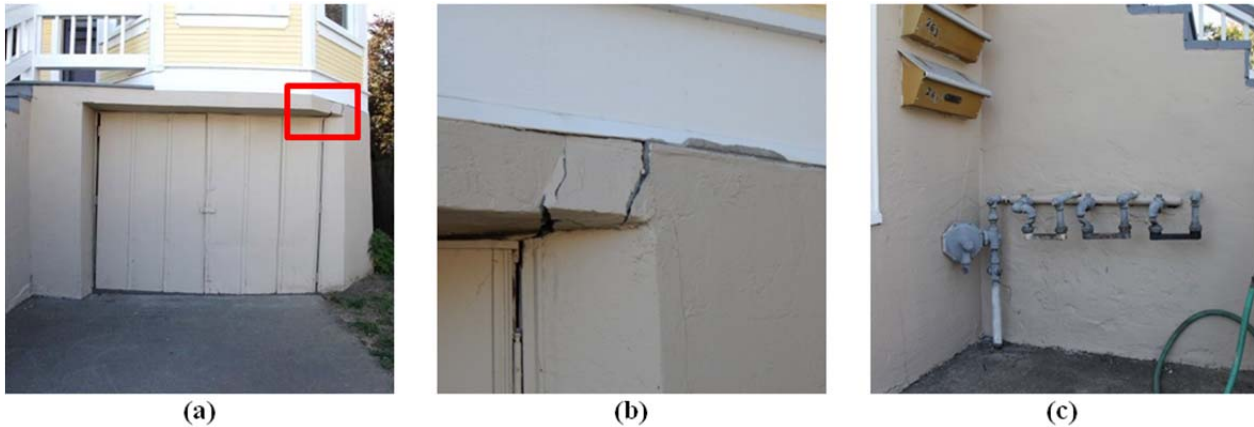
Figure 56 Details of damage at red-tagged residence at 1261 Jefferson Street: (a) soft-story development seen at garage door with outline of support failure; (b) close-up of top-right corner of garage door and corner support failure; and (c) horizontal cracks along gas line.

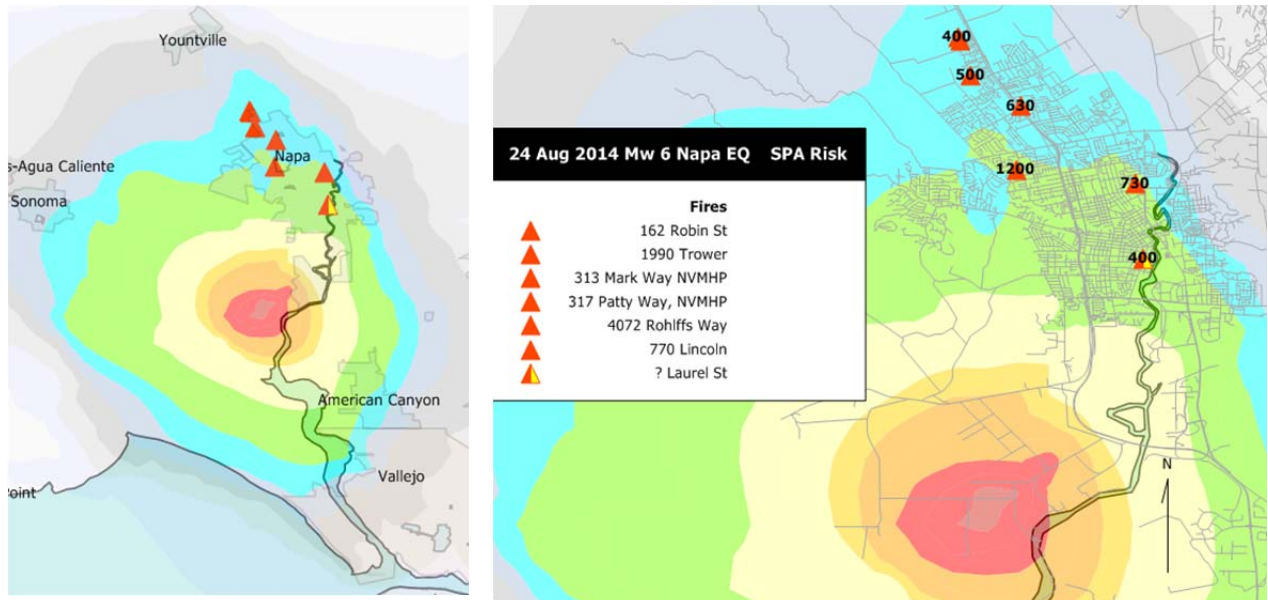
Figure 1 Fires and approx. times overlaid on PGA, 24 Aug 2014 S. Napa Mw 6.0 earthquake (half shaded triangle indicates street number unknown).

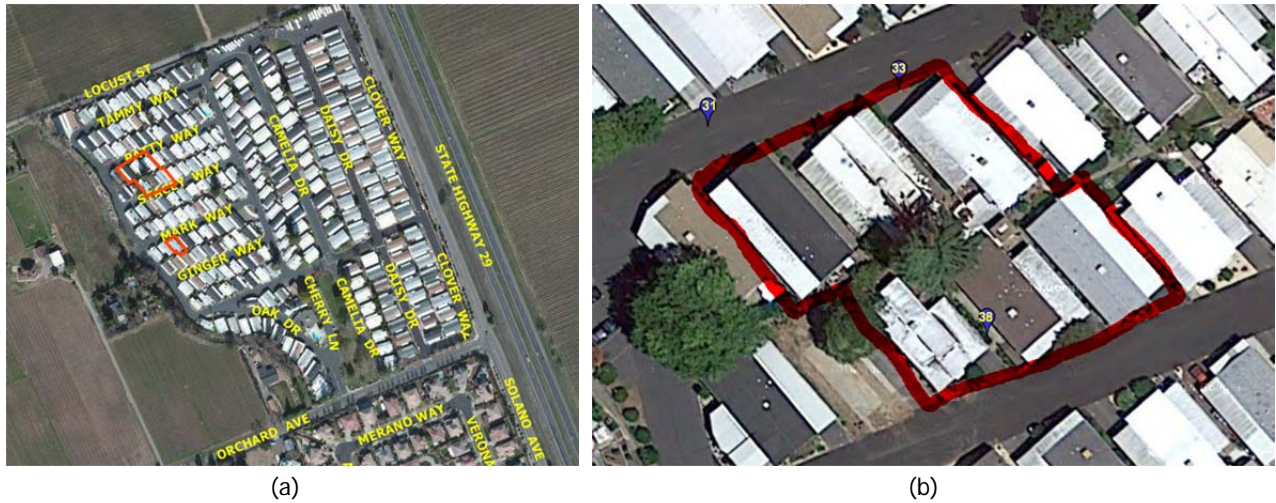
This was the largest fire in the earthquake. First dispatch was of T1 to a report of gas odor but en route, T1 observed a fire in the Napa Valley Mobile Home Park (NVMHP) off of Hwy 29 at Orchard Road and diverted to this incident. T1 encountered a broken water main spewing water at the entrance to the NVMHP on Orchard Road and proceeded to enter the NVMHP. T1 then encountered a single structure fire at 313 Mark Way. The structure was 50% involved; they also observed a second fire at 317 Patty Way, which was 100% involved and impinging on neighboring buildings; see Figure 2. Wind conditions were calm.

Figure 2 (a) NVMHP Park and locations of fires, 24 Aug 2014 S. Napa M_w 6.0 earthquake; and (b) 317 Patty Way fireground, showing locations of photos 31, 33, 38 in Figs. 3 and 4 (damaged buildings outlined in red).

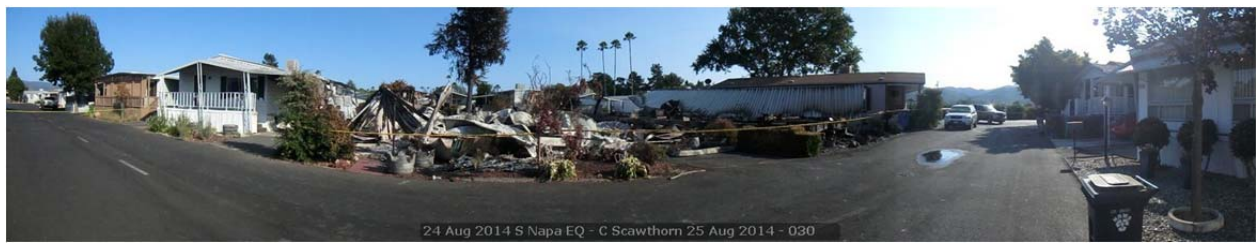
Figure 3 Fireground at 317 Patty Way, NVMHP Park, 24 Aug 2014 S. Napa M_w 6.0 earthquake.
