APPENDICES A, B, C, and D

APPENDIX A Working Group 4 Recommendations for Experimental Program

APPENDIX C Working Group 4: Damage Observations for All Specimens

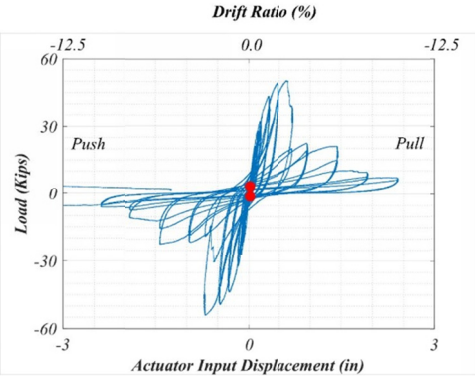
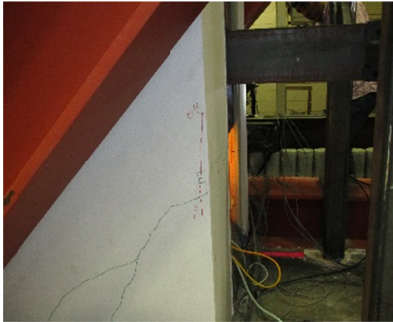
0.4%

End Walls: Stucco cracking initiated in the east and west end walls at the floor level. North and South Walls: Limited spreading and additional hairline cracking was observed.

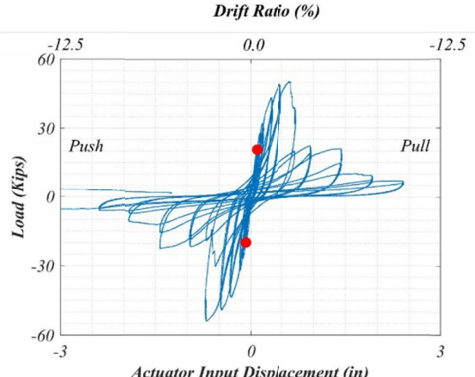
East end wall start of stucco cracking at floor level

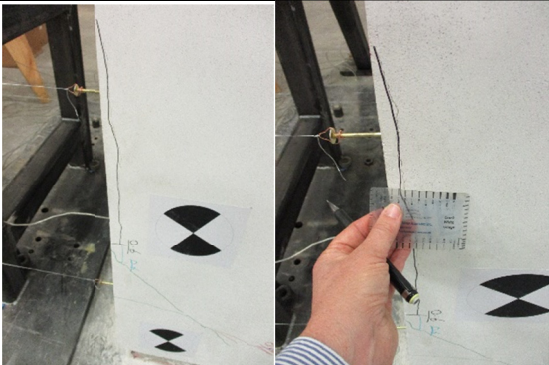
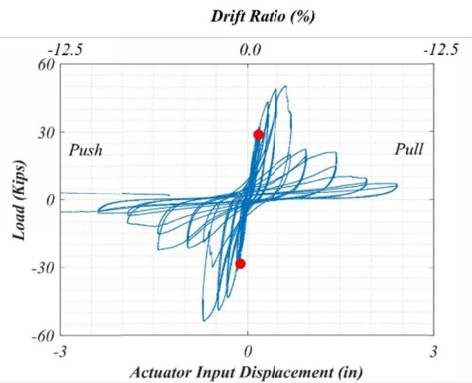
0.6%

Damage Appearance		Cripple Wall Peak Transient Target Drift Ratio (%)	Hysteresis Curve
Cripple Wall Finish Materials	Damage Description	Overall Pattern	Local Appearance		
	<p>End Walls: Stucco cracking at the end walls at floor level started to spread vertically. Maximum crack width measured at 0.050 inches.</p> <p>North and South Walls: Limited spreading and additional hairline cracking was observed. Some horizontal cracking near floor line.</p>

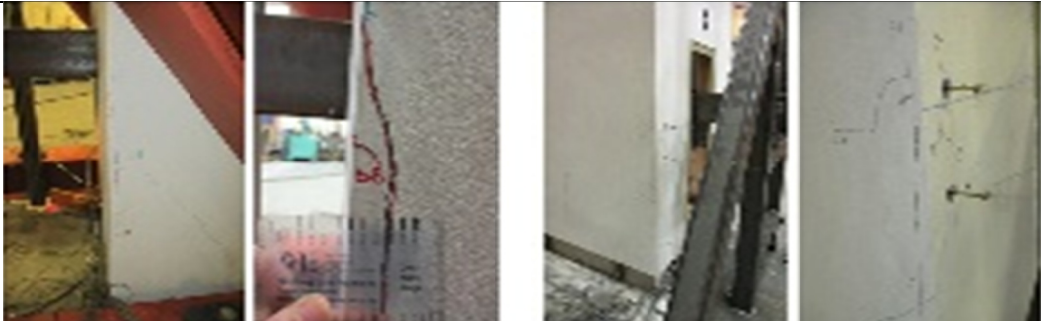
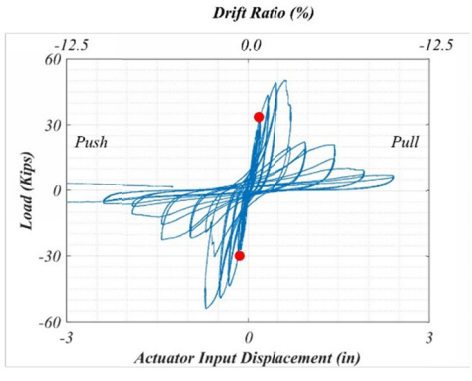
0.8%

<p>End Walls: Stucco cracking at the end walls at floor level continued to spread vertically. Maximum crack width was still measured at 0.050 inches.</p>

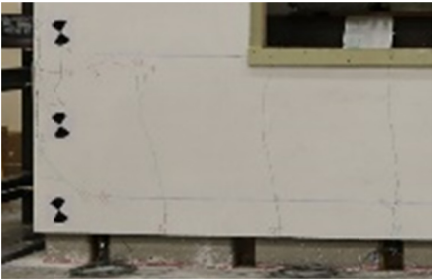
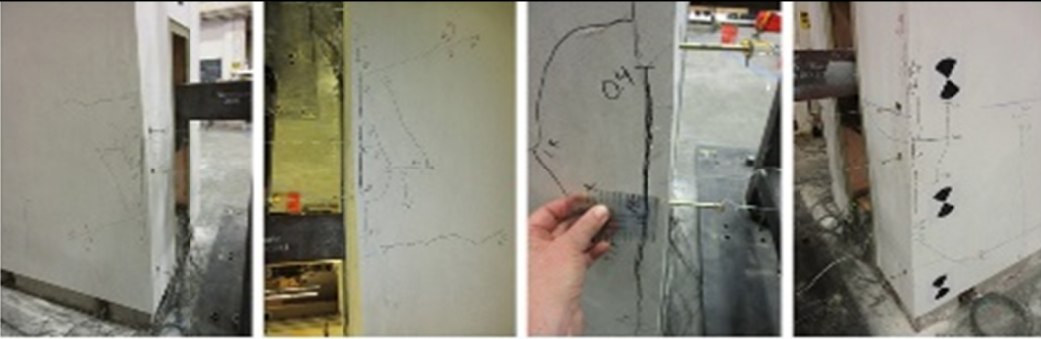
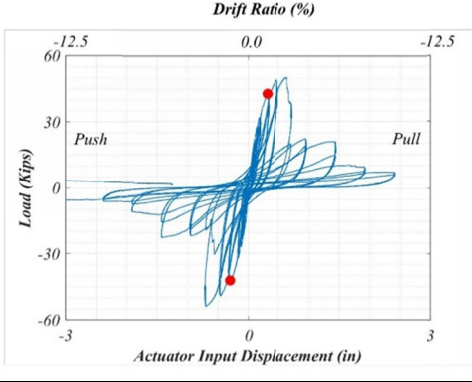
1.4%

<p>End Walls: Stucco cracking at end walls continued to spread and started to open up. Maximum crack widths ranged from 0.075 to 0.125 inches.</p> <p>North and South Walls: Spreading of existing cracks and distributed additional hairline cracking was observed.</p> <p>Interior: Slight offsets in gypsum wallboard panel edges were noted on interior</p>

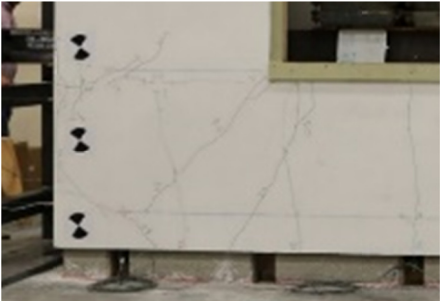
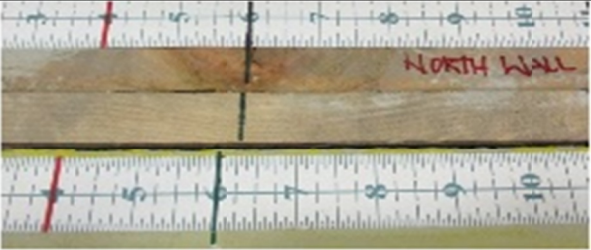
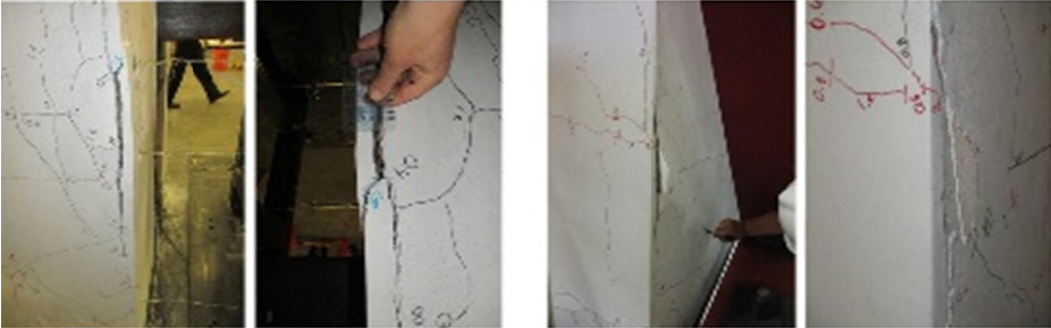
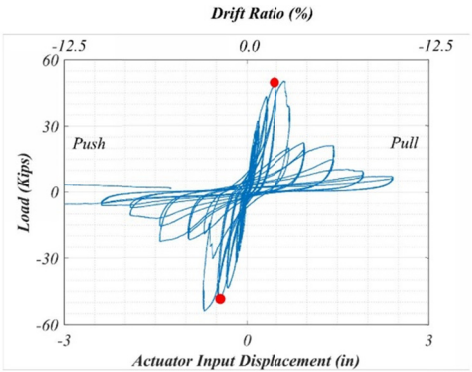
2.0%

Damage Appearance		Cripple Wall Peak Transient Target Drift Ratio (%)	Hysteresis Curve
Cripple Wall Finish Materials	Damage Description	Overall Pattern	Local Appearance		
	<p>End Walls: Stucco continued to deteriorate with the stucco visibly being pushed off the east and west framing, small chunks of stucco starting to work loose, and cracks up to maximum 3/16-inch wide were measured</p> <p>North and South Walls: 1/4-inch slip occurred between stucco and lumber sheathing at floor line while stucco cracking on north and south faces remained near hairline. Cracking remains near hairline but extends over the full height of the cripple wall and is fairly distributed.</p>

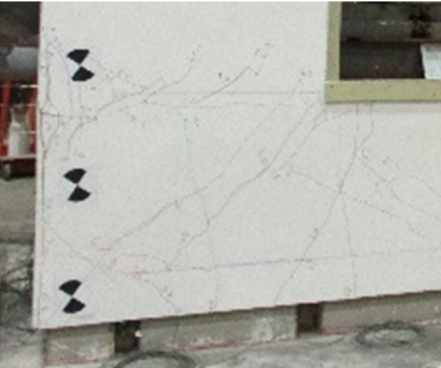
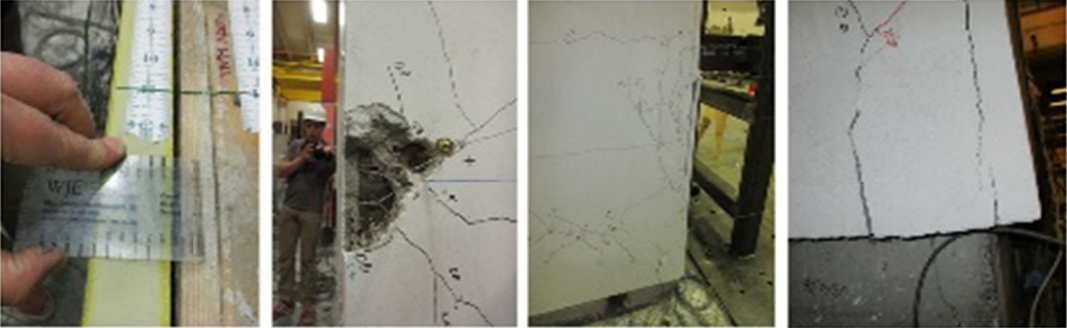
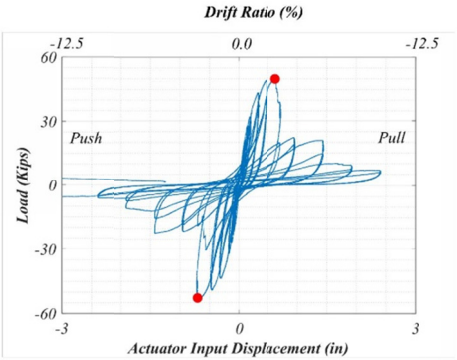
3.0%

<p>End Walls: stucco continues to deteriorate and be pushed off of the framing</p> <p>North and South Walls: Stucco had extensive networks of cracks but they remain near hairline. A 1/8-inch out-of-plane gap opened between the stucco and sheathing at the floor line. Following popping noises, visible out-of-plane gaps opened up between the stucco and the concrete foundation. This is understood to be the stucco debonding from the foundation. The gaps were large enough to slide a crack card into and are estimated at 1/16-inch.</p>

Gap of approximately 1/16-inch between foundation and stucco following loss of bond (above, red arrow), gap between stucco and lumber sheathing at floor level (left) progressing damage to end wall stucco (middle and right)

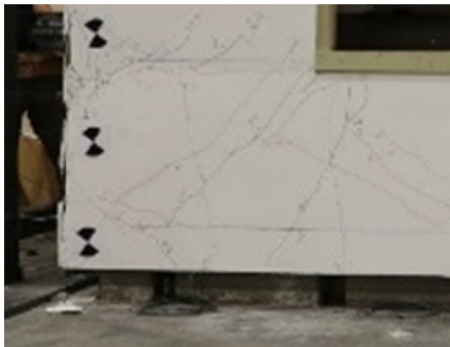
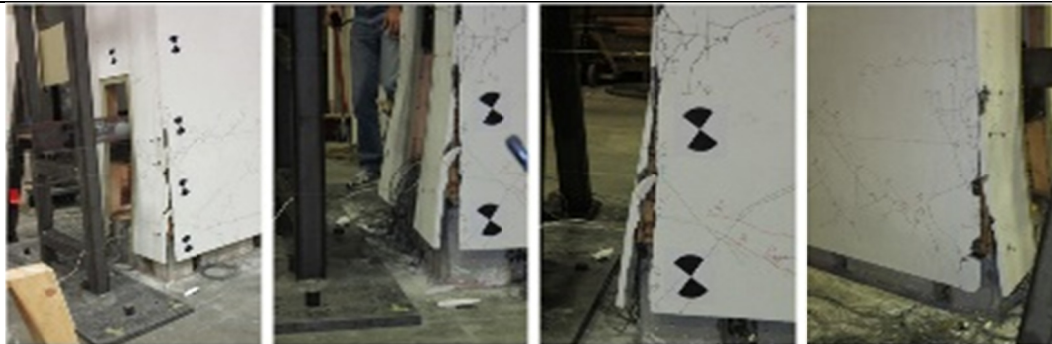
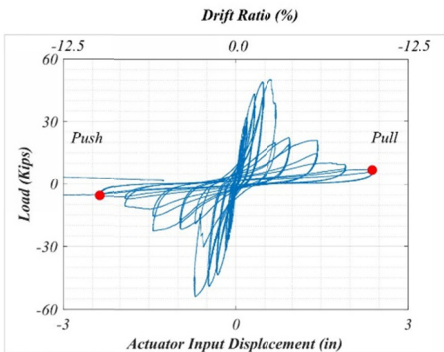
10%

Damage Appearance				Cripple Wall Peak Transient Target Drift Ratio (%)	Hysteresis Curve
Cripple Wall Finish Materials	Damage Description	Overall Pattern	Local Appearance				
	End, north and South Walls: The stucco was seen to be clearly detached from the underlying sheathing and framing over the full height of the cripple wall. The racking of the lumber sheathing below could be observed.

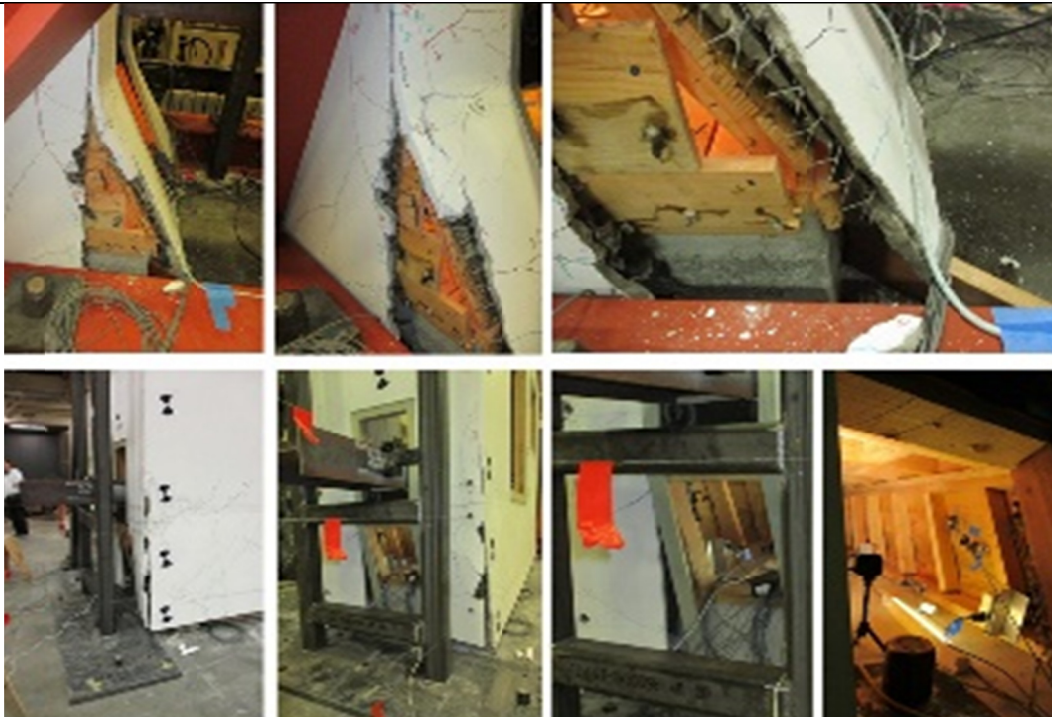
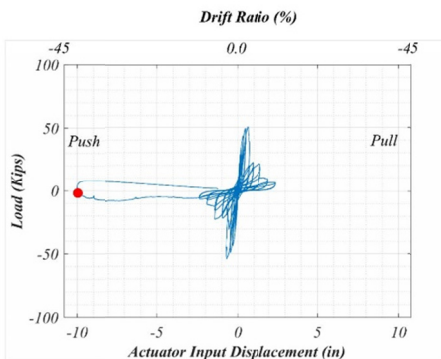
40% Monotonic

The final monotonic push took the 24 inch tall cripple wall to a ten inch (40%) drift. The already separated stucco was pushed away at the east end and sucked under the cripple wall at the west end. The horizontal sliding of the lumber sheathing was clearly visible, with the sheathing nails being fully withdrawn from lower sheathing boards towards the end of the monotonic push. Even with the sheathing board nails being withdrawn, the overlying stucco tended to hold the lumber sheathing boards in place.

Wall 2 stucco cracking at failure (no crack widths provided)

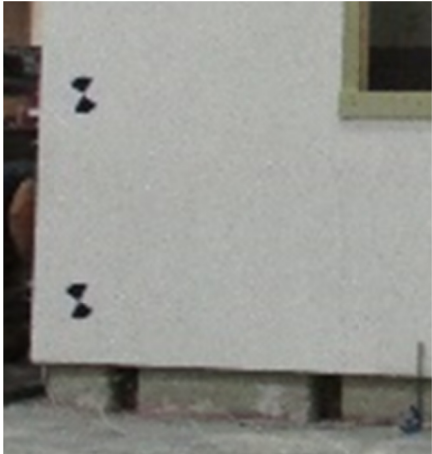
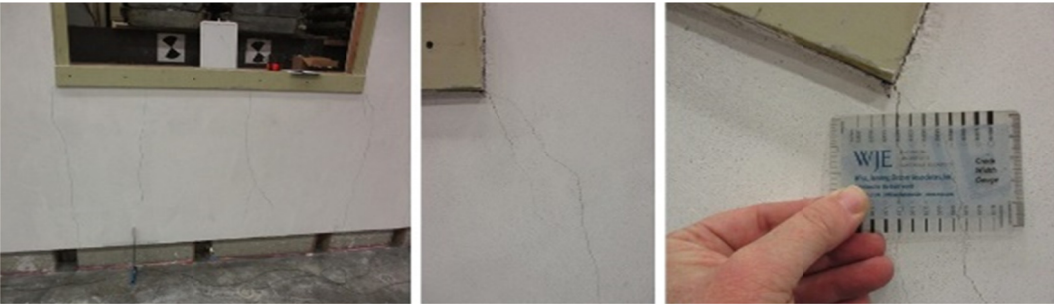
0%	
	End Walls: Cracking was first observed at the west and east end walls near the floor line. Crack widths of up to 0.030 inch were measured. North and South Walls: Limited spread of and new cracking was observed.

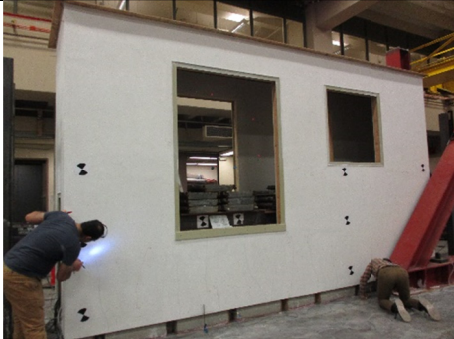
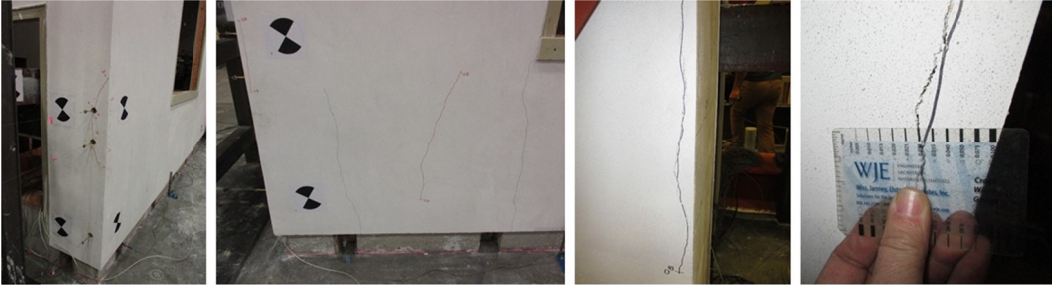
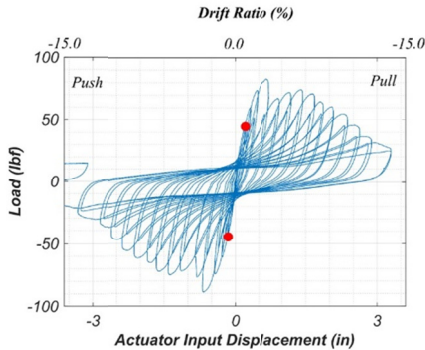
0.8%

End Walls: Cracking was observed to spread up and down from the floor level. North and South Walls: Modest spreading and new hairline cracks were observed.

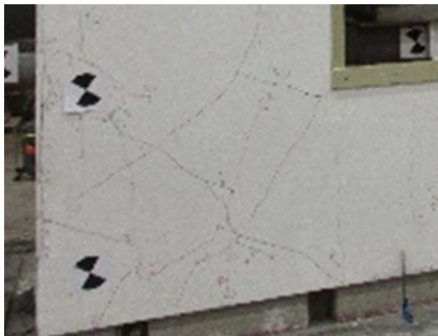
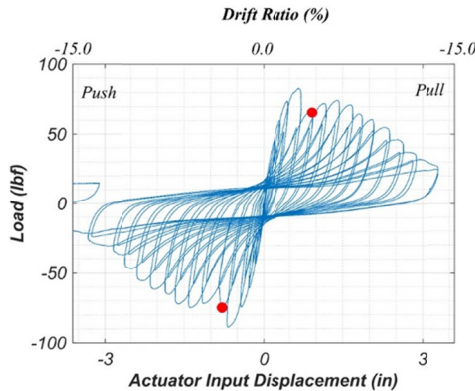
4.0%

Damage Appearance				Cripple Wall Peak Transient Target Drift Ratio (%)	Hysteresis Curve		
Cripple Wall Finish Materials	Damage Description	Overall Pattern	Local Appearance						
	<p>End Walls: Stucco damage progressed. Stucco at the west end corner was fractured over a significant height. Gaps of up to 1/4-inch were measured.</p> <p>North and South Walls: Hairline cracking and stucco flaring from the base continued. The stucco, however, remained substantially planar.</p> <p>Retrofit: There was no observable damage to the retrofit.</p>

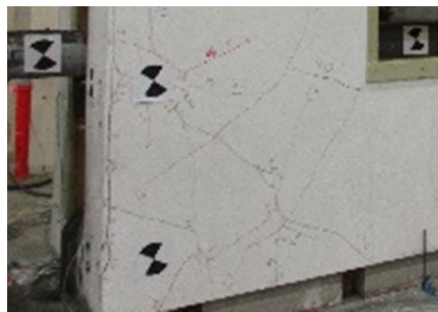
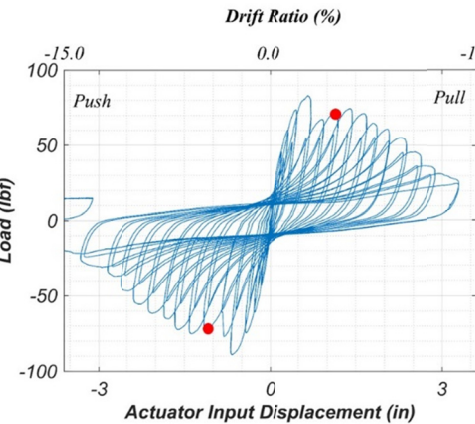
5.0%

<p>End Walls: Stucco cracking and spalling progressed, as did separation of the stucco from the underlying sheathing and framing.</p> <p>North and South Walls: Stucco slid in-plane approx. 1/4-inch relative to sheathing and framing at the floor level. Additional hairline cracks near the floor line appeared related to additional flaring at the base of the stucco.</p> <p>Retrofit: Very modest withdrawal of nails from the upper top plate was seen (approx. 1/8-inch). Minor rotation of the plywood panels was seen, resulting in minor visible offsets of the panels at abutting panel edges. Very modest working of nail heads into the plywood was also observed.</p>

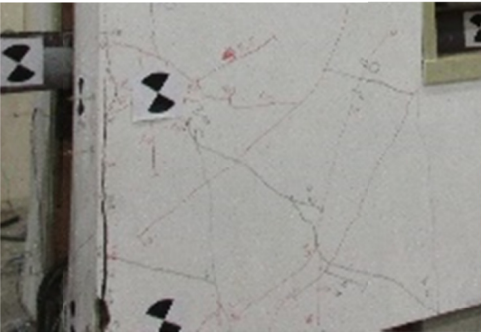
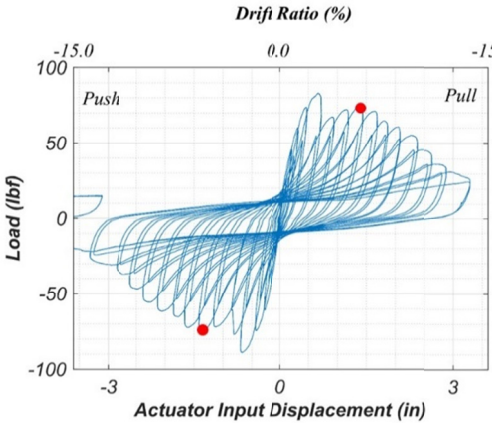
Damage Appearance		Cripple Wall Peak Transient Target Drift Ratio (%)	Hysteresis Curve
Cripple Wall Finish Materials	Damage Description	Overall Pattern	Local Appearance		
	<p>End Walls: Fairly complete fracture of the stucco at the corners was observed over the height of the cripple walls. Gaps of up to one inch opened between end wall stucco and the stucco on the north and south walls.</p> <p>North and South Walls: Very modest progression of cracking occurred. The stucco continued to flare further at the base of the walls. The gap between stucco and foundation increased to approximately 1/2-inch allowing us to put our fingers under the stucco.</p> <p>Retrofit: Further rotation of the plywood panels was seen, with vertical sliding of the plywood panels estimated as up to 1/4-inch at specimen east and west ends and 1/8-inch at interior panel joints. There was no observable damage to the clip angles (shear clips).</p>

<p>South wall stucco cracking at 6.0% target drift</p>

<p>Gapping of stucco at corners (top left), away from foundation (top middle), rotation of plywood panels (bottom left), and withdrawal of nails from upper top plate (bottom right)</p>	6.0%

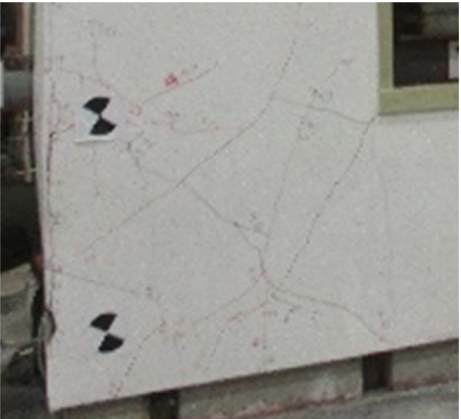
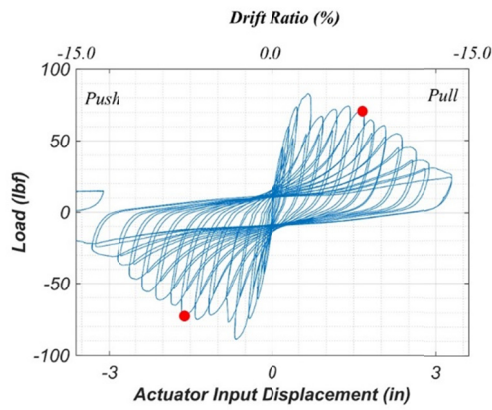
<p>End Walls: Stucco continued to deteriorate with significant additional stucco spalling.</p> <p>North and South Walls: Additional cracking occurred, particularly near wall ends, but remained near hairline.</p> <p>Retrofit: Continued uplift of sheathing was observed at wall ends. Amount of nail withdrawal increased modestly.</p>

<p>South wall stucco cracking at 7.0% target drift</p>

<p>Continued deterioration of end wall and corner stucco (top), rotation of plywood panels (bottom left), and withdrawal of nails from upper top plate (bottom right)</p>	7.0%

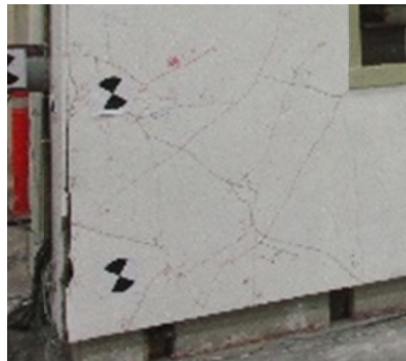
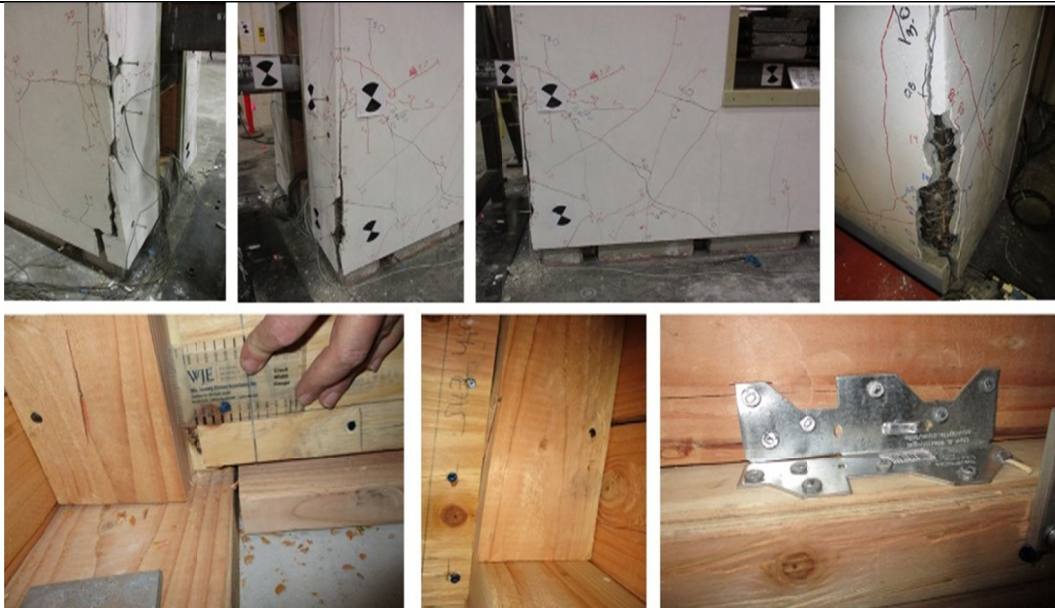
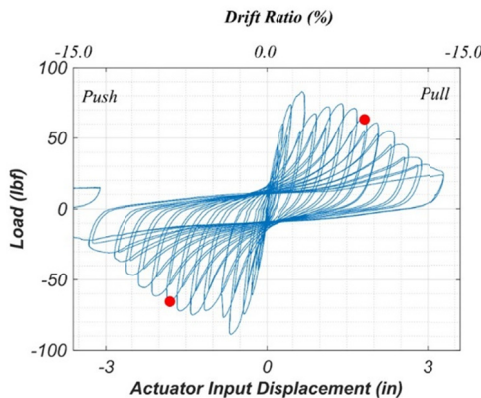
8.0%

Damage Appearance				Cripple Wall Peak Transient Target Drift Ratio (%)	Hysteresis Curve	
Cripple Wall Finish Materials	Damage Description	Overall Pattern	Local Appearance					
	<p>End Walls: Separation of stucco at the corners and breaking of stucco wires continued to increase.</p> <p>North and South Walls: These was no significant progression of cracking. Flaring of stucco at the base increased to approximately 3/4-inch.</p> <p>Retrofit: Cripple wall framing at the end walls was observed to have very visible lean. Rotation of the panels continued to increase. Nails in the upper top plate were withdrawn up to 1/8 to 1/4-inch. Retrofit remains very functional. No observable damage to clip angles.</p>

Continued deterioration of end wall and corner stucco (top), rotation and in-plane slip of plywood panels (bottom left), no observable damage to clip angles (bottom right)

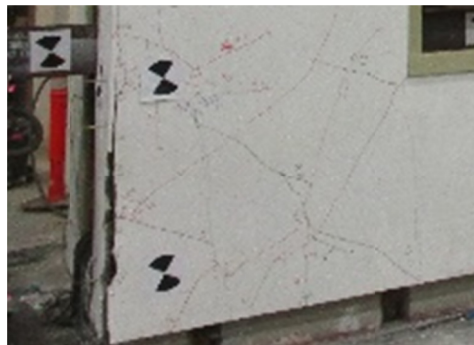
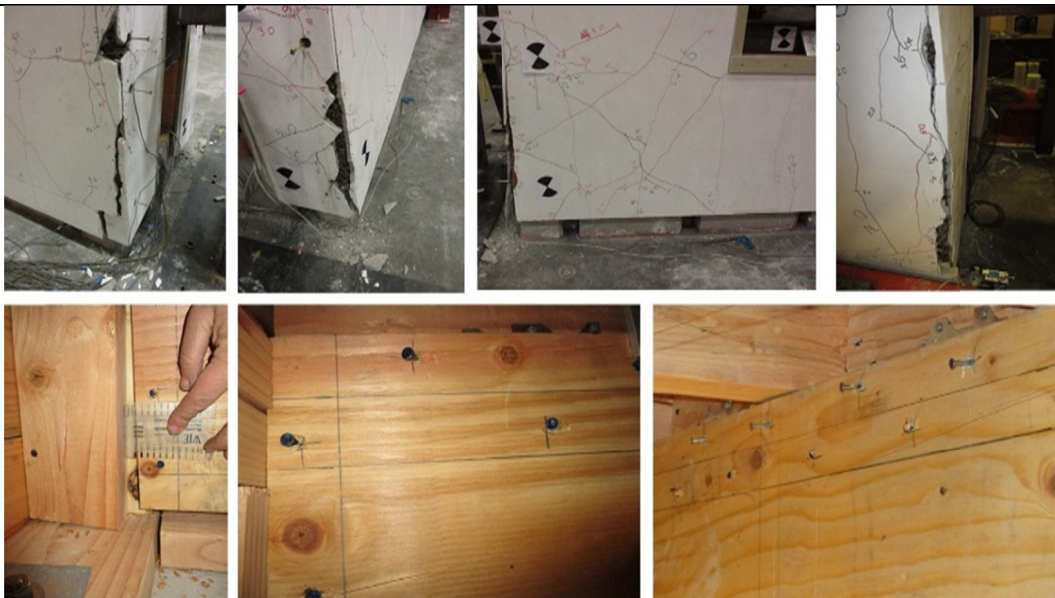
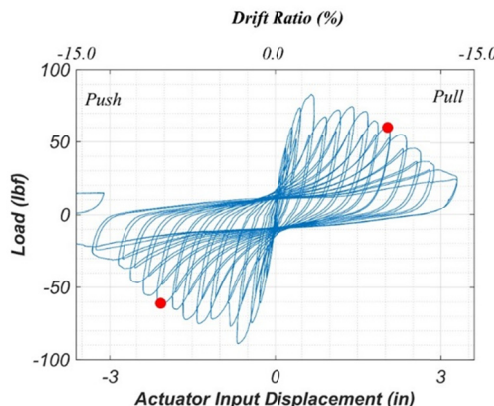
9.0%

<p>End Walls: Similar to 8%.</p> <p>North and South Walls: Similar to 8%.</p> <p>Retrofit: Similar to 8%.</p>

Continued deterioration of end wall and corner stucco (top), rotation of plywood panels (bottom left), and withdrawal of nails from upper top plate (bottom right)

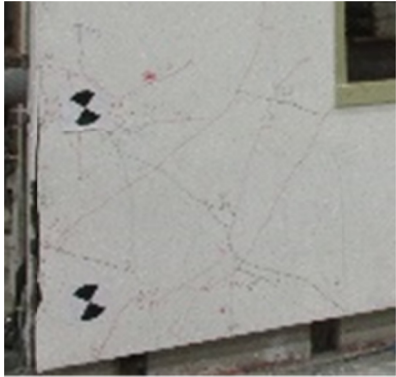
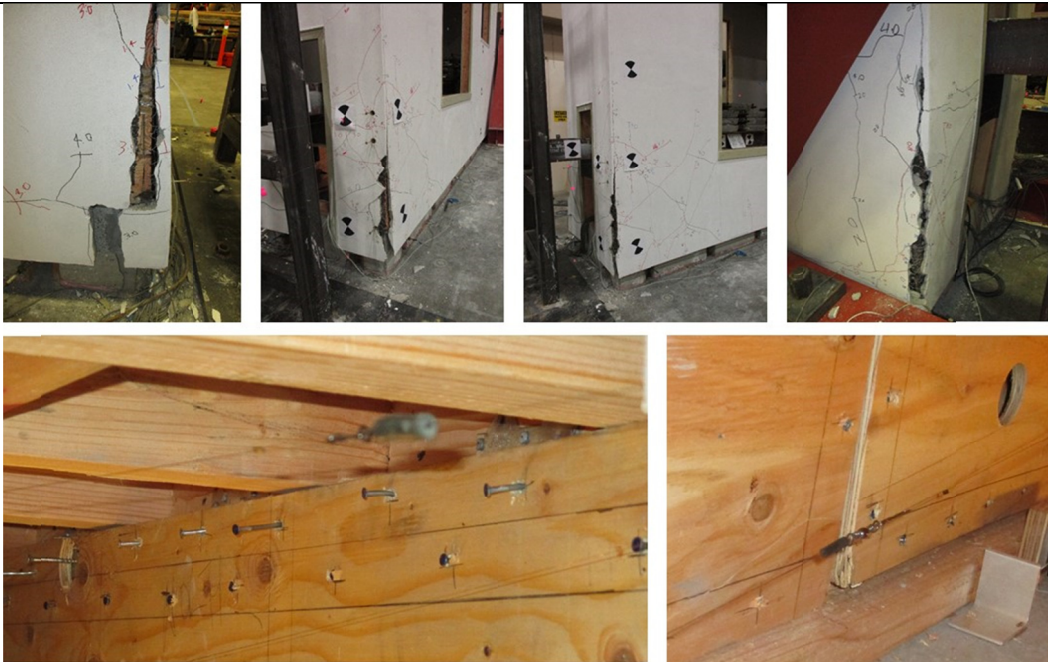
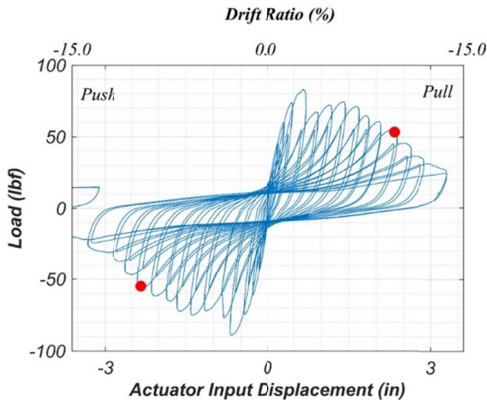
10%

Damage Appearance		Cripple Wall Peak Transient Target Drift Ratio (%)	Hysteresis Curve
Cripple Wall Finish Materials	Damage Description	Overall Pattern	Local Appearance		
	<p>End Walls: Stucco at end walls is significantly detached and separates significantly from underlying sheathing and framing during loading. Wood siding is visible below.</p> <p>North and South Walls: Negligible new cracking. Stucco flare was measured as up to one inch.</p> <p>Retrofit: Some nails in the upper top plate were observed to be withdrawn up to one inch and be deformed (bending with limited change in angle). In limited locations at the top and bottom corners of the sheathing, sheathing nail heads were observed to be pulled through. Some limited gapping between the sheathing and underlying framing was observed.</p>

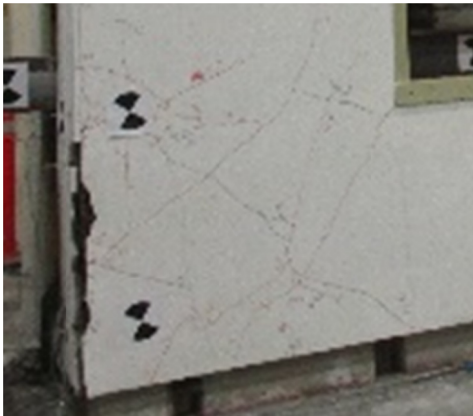
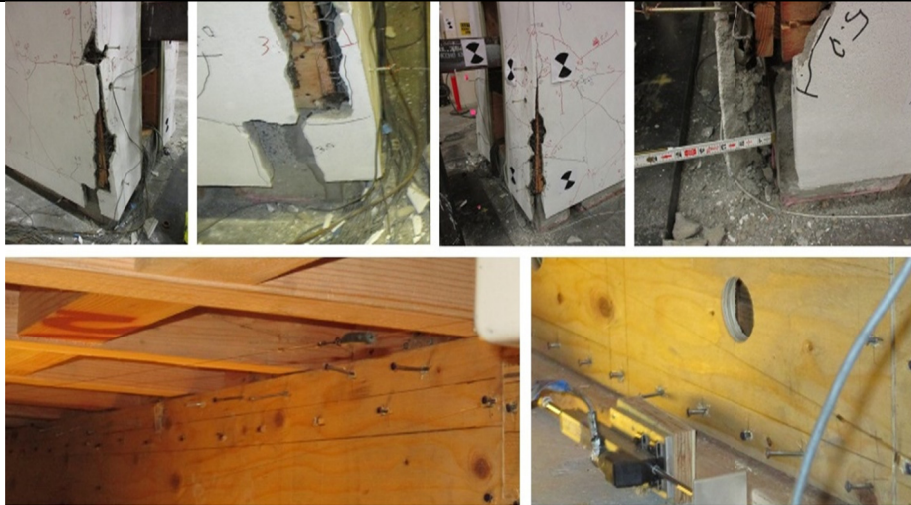
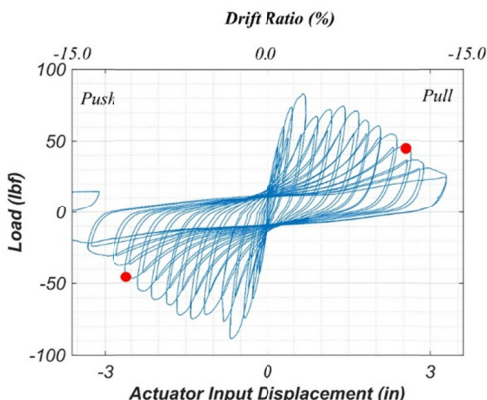
11%

<p>End Walls: Stucco at end walls is significantly detached and separates significantly from underlying sheathing and framing during loading. Wood siding is visible below.</p> <p>North and South Walls: Negligible new cracking.</p> <p>Retrofit: A number of nails into the upper top plate were observed to be completely withdrawn from the framing, and remain in place only due to embedment in the plywood sheathing. Nails at bottom plate were observed to be withdrawn up to between 1/2 and one inch.</p>

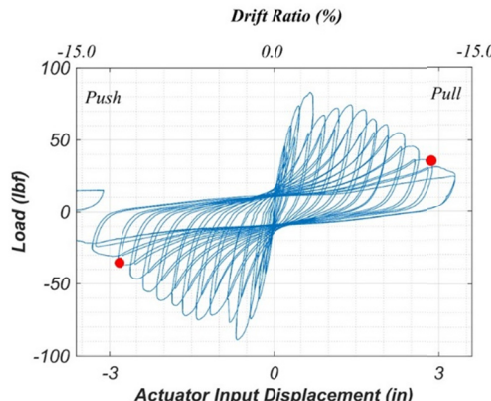
12%

South wall stucco cracking at 12.0% target drift Continued deterioration of end wall and corner stucco (top), sheathing nails to upper top plate have started to fall off wall (bottom left), clip angle has no observable damage (bottom center) and withdrawal of nails from bottom plate and stud (bottom right)						
	End Walls: Stucco deterioration and spalling continued. North and South Walls: Negligible new cracking. Flaring at stucco base up to almost two inches. Retrofit: Diaphragm and upper top plate start being pushed off of the lower top plate and cripple wall. This causes the top of the east wall rim joist to roll towards the west as the top of the rim joist gets pulled with the diaphragm sheathing. The south wall blocking is pulled with the diaphragm also.

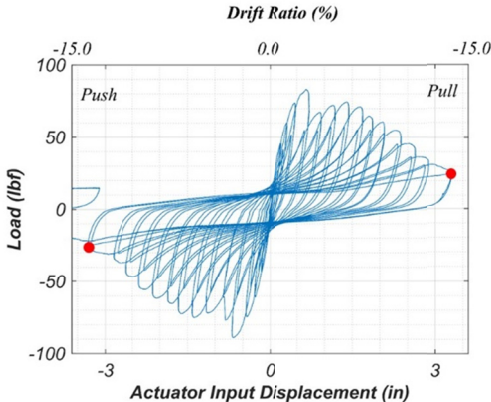
14%

South wall stucco cracking at 14.0% target drift Continued deterioration of end wall and corner stucco (top), top of east wall floor rim joist is rolled to the west (bottom left), and sheathing nails at bottom plate (bottom right)

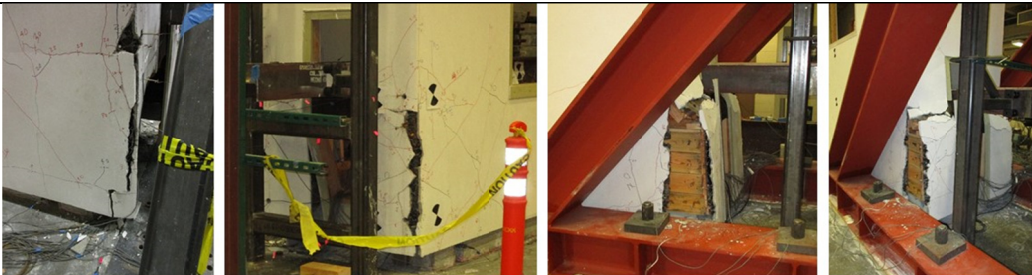
Damage Appearance		Cripple Wall Peak Transient Target Drift Ratio (%)	Hysteresis Curve
Cripple Wall Finish Materials	Damage Description	Overall Pattern	Local Appearance		
	The diaphragm and upper top plate are pushed off of the lower top plate and cripple walls. The cripple walls remain at a very low drift while the majority of the actuator displacement is taken up in diaphragm sliding.		<div>

</div> <p>West end of cripple wall with end wall stucco sucked under the floor and north wall stucco visibly flared (left), and east end cripple wall with little drift occurring over the height of the cripple wall and the floor diaphragm pushed westward off of the cripple wall.</p>	40% Monotonic

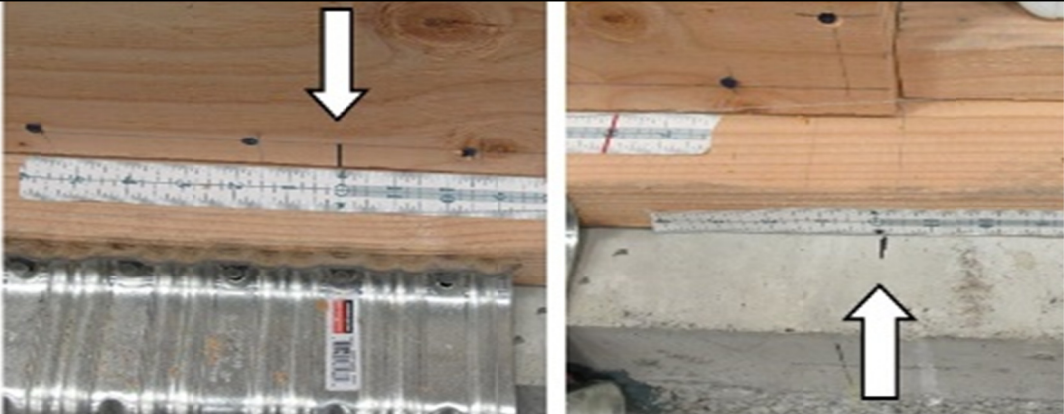
Initial slip between bottom of plywood and foundation sill plate (left), between foundation sill plate and foundation (right)	1.4%

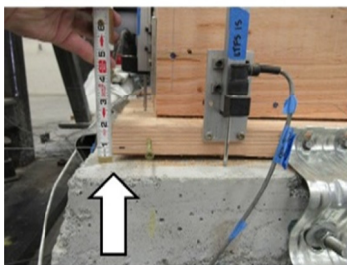
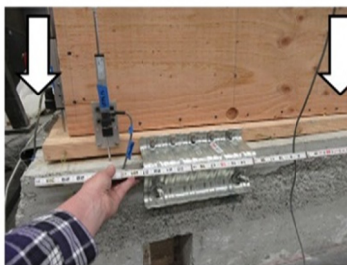
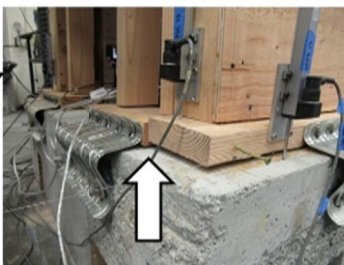
Damage Appearance						
Cripple Wall Finish Materials	Damage Description	Overall Pattern	Local Appearance		Cripple Wall Peak Transient Target Drift Ratio (%)	Hysteresis Curve
	No changes in condition relative to 1.4% drift were observed	NA	NA		2.0%	NA
	<div>-Slip of approximately 1/8-inch at the three interfaces shown</div> <div>-Uplift of west end of south and north wall foundation sill plates</div>	<div>

</div> <div>Slip between top plate and top of plywood (left top), between bottom of plywood and foundation sill plate (top center), and between foundation sill plate and foundation (top right), uplift of south wall foundation sill plate (bottom). Note that west wall foundation sill plate has minimal uplift (bottom right)</div>		3.0%

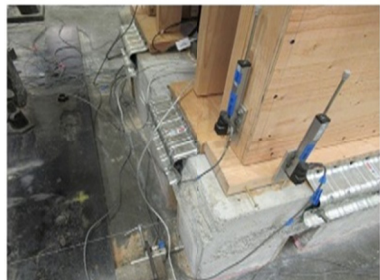
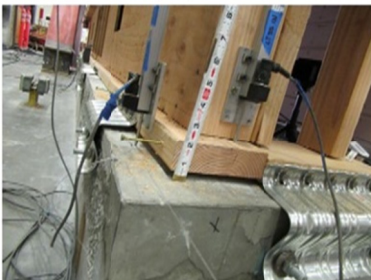
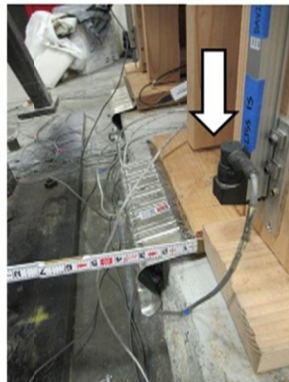
<div>-Slip remained similar to 3% drift</div> <div>-Uplift of foundation sill plate off of foundation at east end wall</div> <div>-Uplift at west end of north and south wall foundation sill plates</div> <div>-West end wall foundation sill plate stays in place and studs uplift off of plate</div>	<div>

</div> <div>Uplift at east end wall, including foundation sill plate uplift off of the foundation and slight stud rocking (top), uplift of north and south walls at west end (bottom), with the west end foundation sill plate staying down and studs lifting off sill plate (bottom right)</div>		4.0%

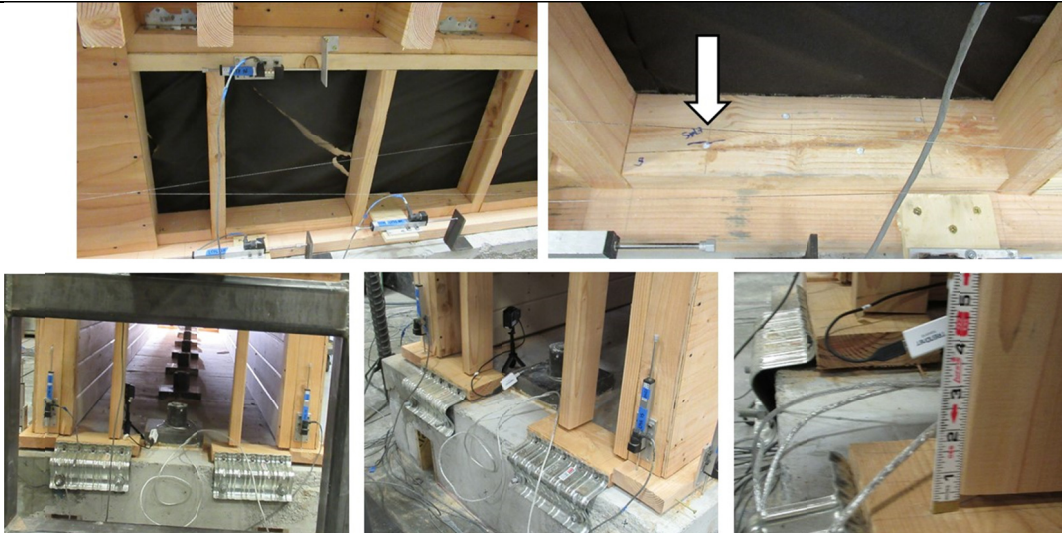
5.0%

Damage Appearance			Cripple Wall Peak Transient Target Drift Ratio (%)	Hysteresis Curve
Cripple Wall Finish Materials	Damage Description	Overall Pattern	Local Appearance			
	<div>-Slip progresses to approx. 1/4-inch</div> <div>-Wall uplift at west end</div> <div>-Building paper develops tension field and tears</div> <div>-First and possibly only split in exposed blocking on top of foundation sill plate</div>

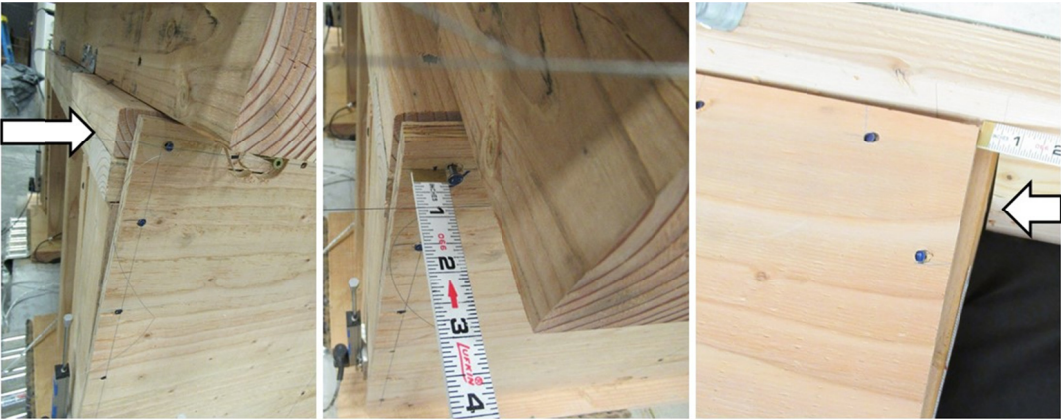
- Slip progresses up to about 3/8-inch
- Uplift continues at west end
- Building paper buckling and tearing has occurred
- Plywood panels are observed to rotate, observed working of plywood nails including withdrawal and partial head pull through

Slip between top plate and top of plywood (left top), between bottom of plywood and foundation sill plate (top center), and between foundation sill plate and foundation (top right), tearing and buckling of building paper (left bottom), continued west end uplift

(center and right bottom)

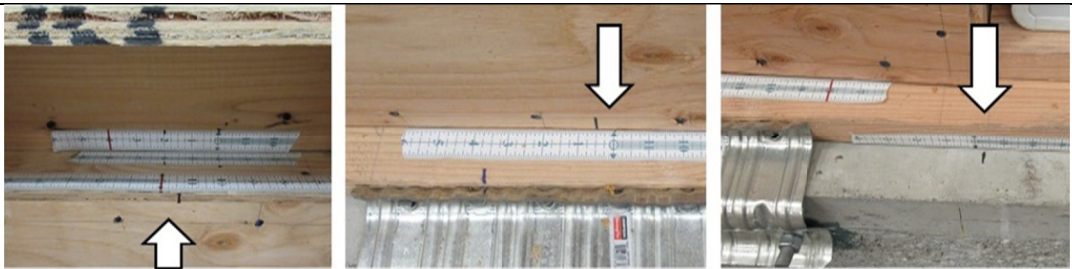
- Slip up to 5/8-inch between top plate and top of plywood, 1/2-inch between foundation sill plate and bottom of plywood, and remains approx. 3/8-inch between foundation sill plate and foundation
- Plywood is pushed away from framing. Gaps open up between plywood and framing with nail withdrawal and partial head pull thorough

Slip between top plate and top of plywood (left top), between bottom of plywood and foundation sill plate (top center), and between foundation sill plate and foundation (top right)

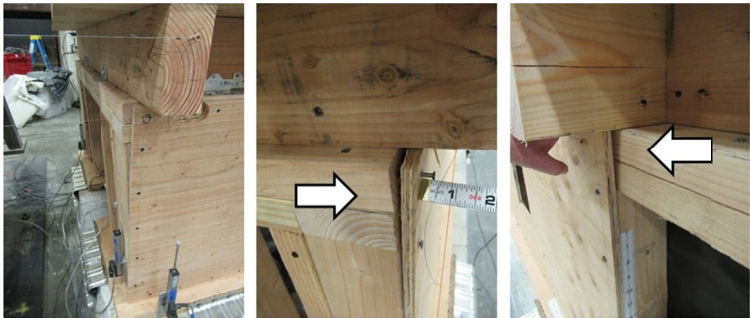
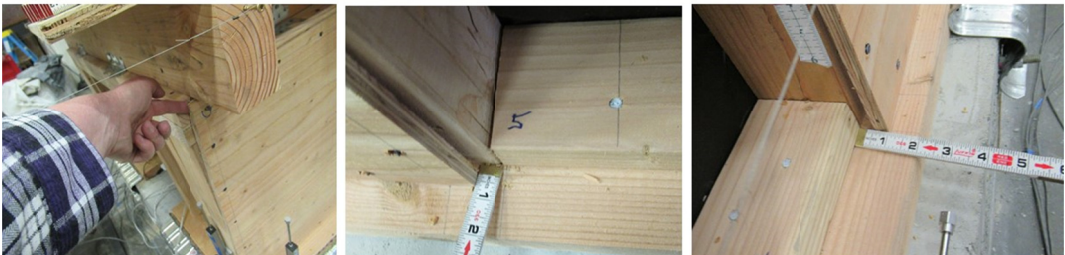
Plywood is being pushed off of framing during cycling, resulting in gaps, nail withdrawal and partial nail head pull through. Gap width is approximately 1/2-inch

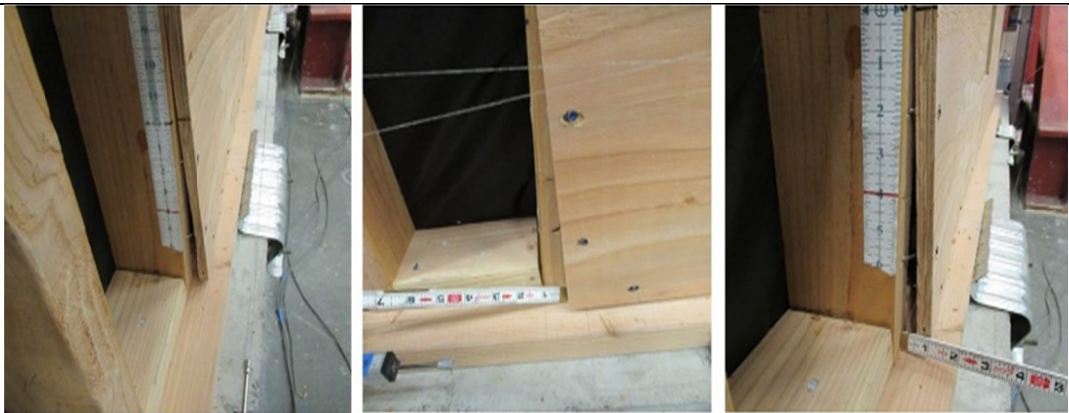
- Slip is up to 3/4-inch between top plate and top of plywood, 1/2-inch between foundation sill plate and bottom of plywood, and remains approx. 1/4-inch between foundation sill plate and foundation
- Gap between plywood and framing continues to grow
- East end foundation sill plate splits with stud rocking

Plywood continues to gap and slide (left, center), sheathing nails are bent in reverse curvature (right)

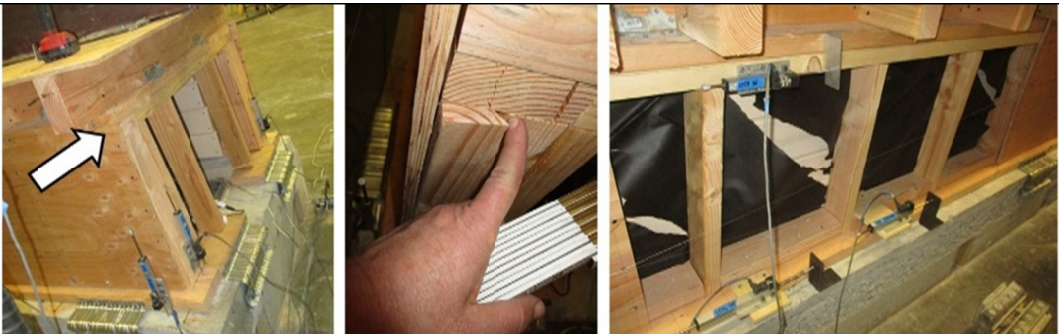
- Split in one corner stud
- Building paper is shredded and buckled
- Plywood is substantially pulled off of supporting framing, nails are substantially withdrawn with little penetration left into framing

Corner stud has split along plywood edge nailing line (left, center), building paper is shredded, buckled (right)

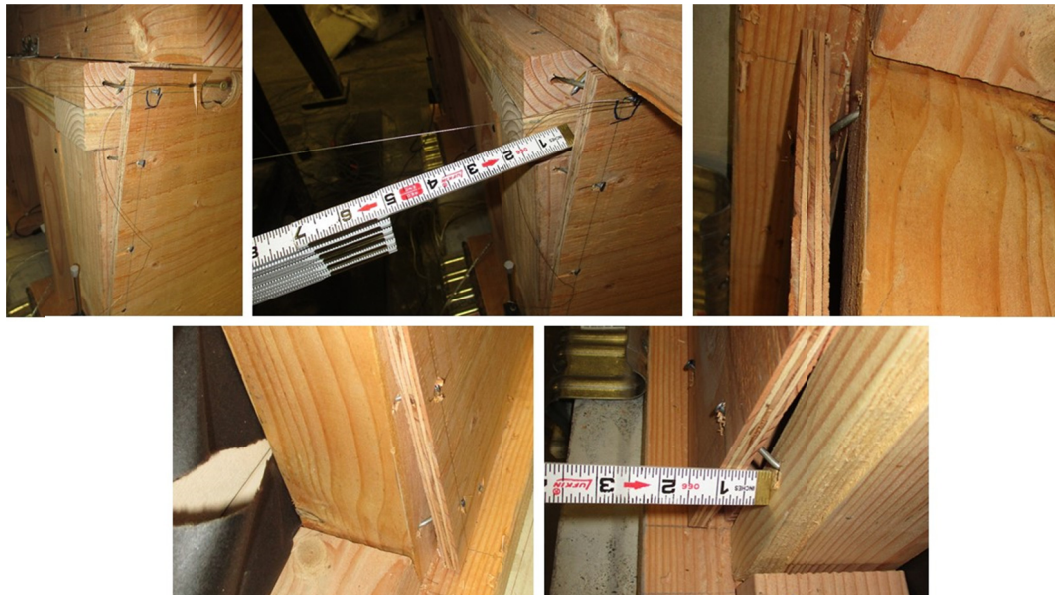
Plywood slip and nail withdrawal at top of cripple wall (top) and bottom of cripple wall (bottom)

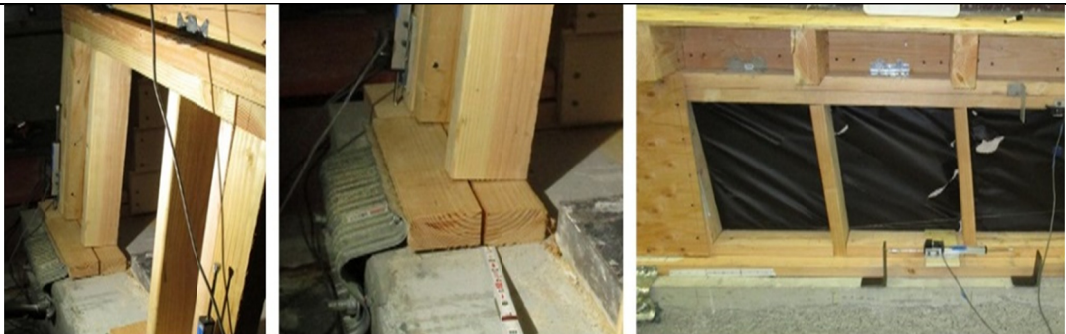
- Foundation sill plate at east end wall is completely split through
- Plywood nails are substantially withdrawn from framing

East end wall sill plates are split completely through (left and center), Top plates are moving free of sheathing, no longer connected (right)

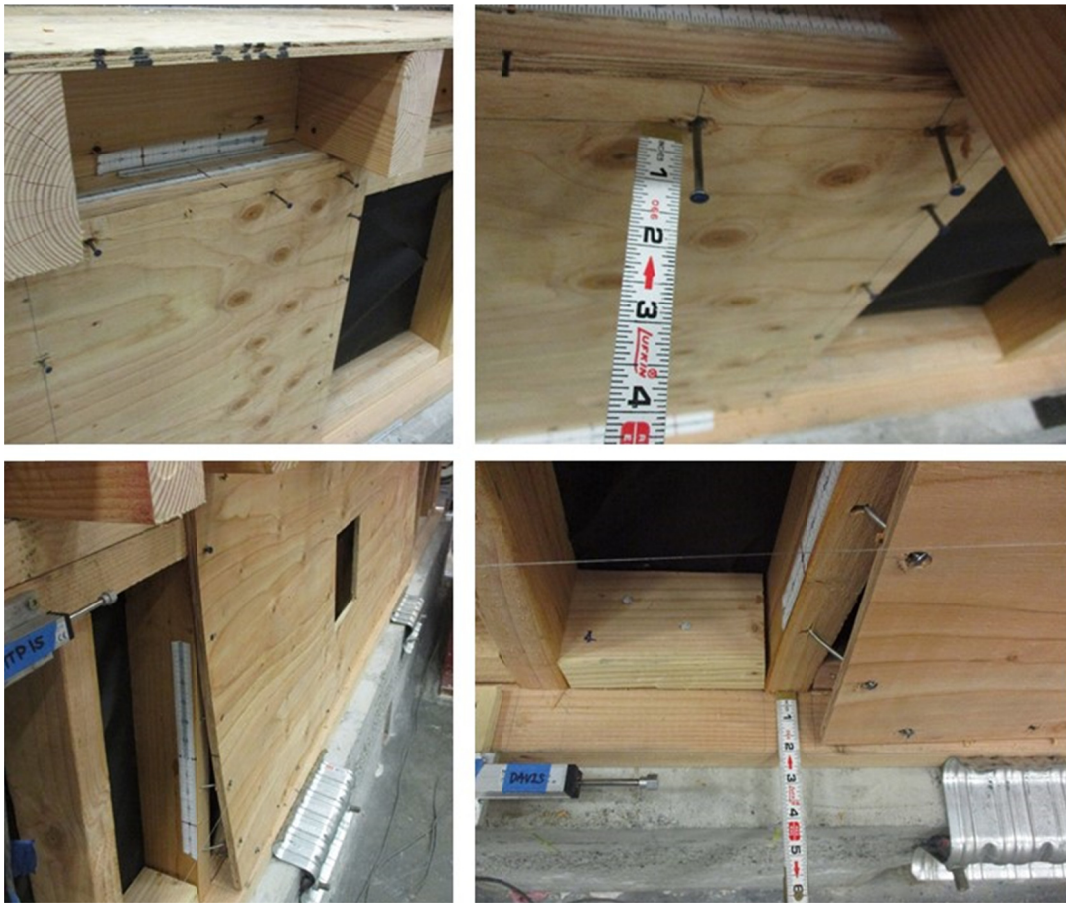
Sheathing nails at top of wall are completely withdrawn from the framing, only retained in place by penetration into the plywood (top) Sheathing nails at bottom of wall are substantially withdrawn, framing and sheathing is gouged around nail (bottom)

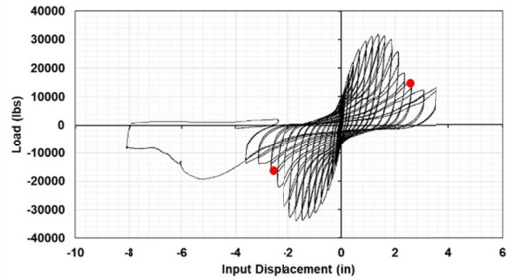
11%

- Plywood substantially detached, moving away from framing, nail falling off
- Gap is opening up at east wall sill plate split

Plywood is substantially detached from and moving away from framing, sheathing nails are starting to fall off, pieces of split east wall sill are moving away from each other (right bottom)
