APPENDICES A, B, C, and D

APPENDIX A Working Group 4 Recommendations for Experimental Program

APPENDIX C Working Group 4: Damage Observations for All Specimens

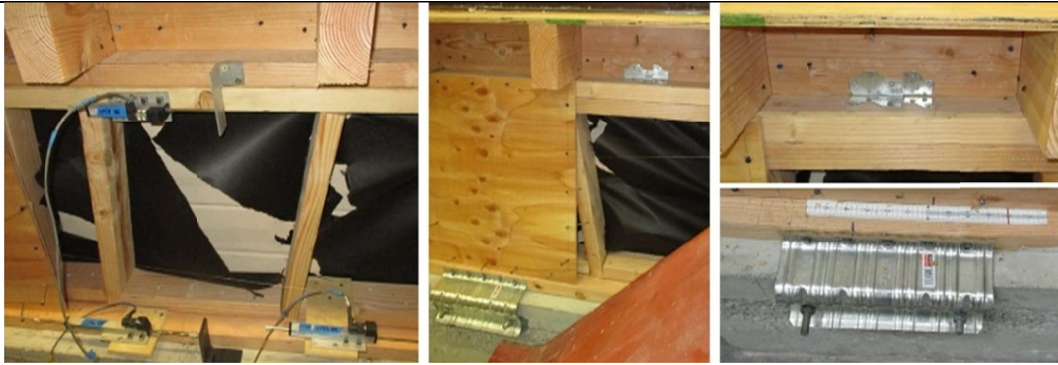
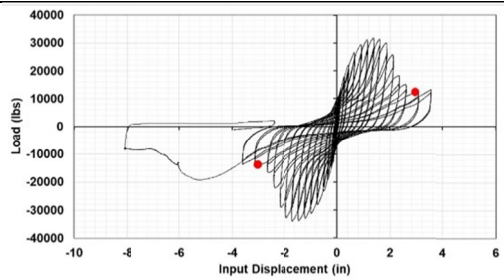
13%

- Slip of up to 2-1/2-inches has occurred between top of plywood and cripple wall top plates
- Building paper is heavily damaged
- Plywood is substantially detached from framing
- Blocking between studs is still substantially intact, shows some signs of uplift from stud rocking
- Shear clips and anchorage plates are substantially intact

Building paper is substantially destroyed (left), plywood is substantially detached (center), no deformation or damage is visible at the shear clips or anchorage plates (right).

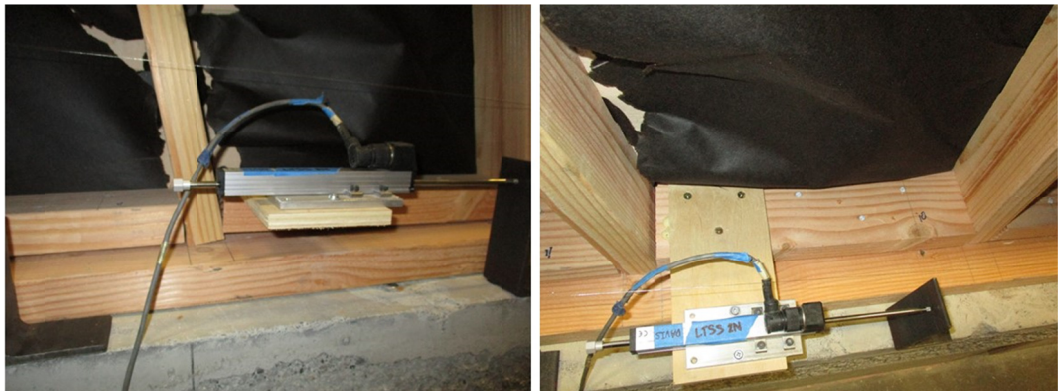
Top of plywood has slipped approximately 2-1/2-inches relative to top plates (left top)
plywood is substantially detached from framing.

Blocks on top of foundation sill plates are still fastened, some uplift is occurring due to wedging of the studs.

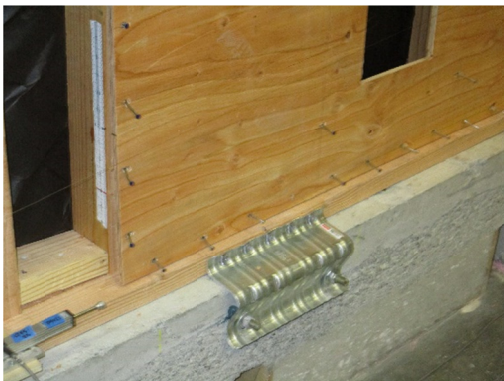
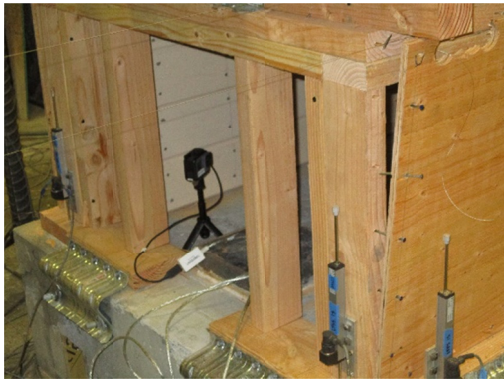
Southe wall

- Plywood is substantially detached from framing
- Anchor plate shows no signs of damage

Plywood nailing is substantially withdrawn while anhorage plate has no visible damage (left) plywood is substantially detached from framing (right)

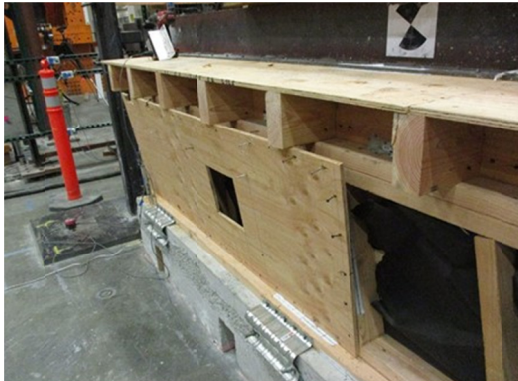
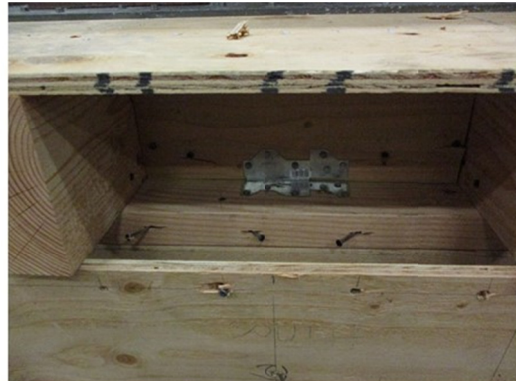
East wall

- Plywood has moved several inches away from framing
- East and west wall experience significant lean, foundation sill plate on east end wall is cracked and separated

The south wall plywood has moved several inches away from the supporting framing

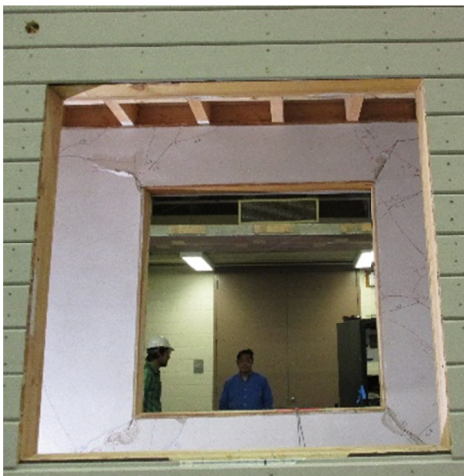
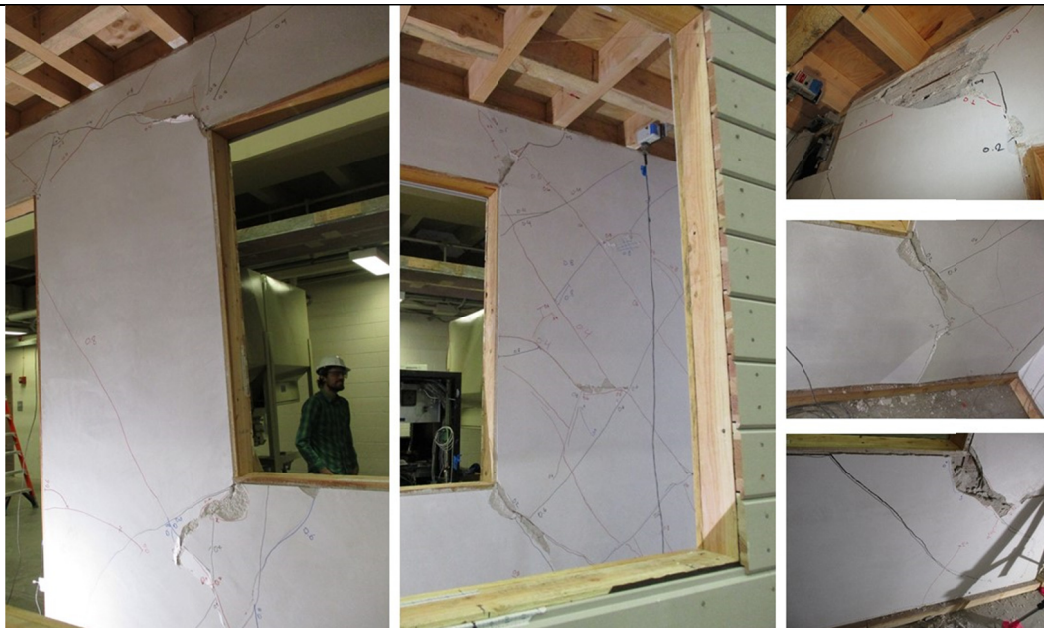
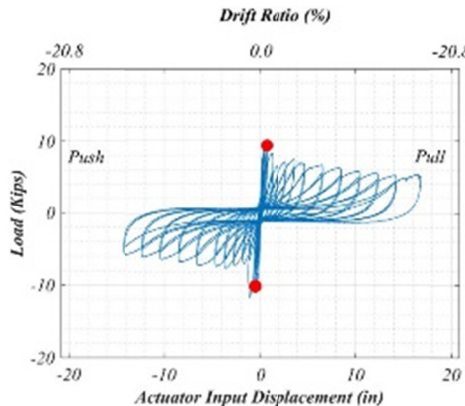
0.8%

Damage Appearance				Wall Peak Transient Target Drift Ratio (%)	Hysteresis Curve	
Wall Finish Materials	Damage Description	Overall Pattern	Local Appearance					
	<p>-Spalling continues, plaster keys are seen falling to bottom of wall cavity.</p> <p>-Cracks spread and widen, with crack widths up to 1/8-inch measured. Cracks at some wall piers have become closely spaced (approx. one foot on center) with classic shear-cracking pattern similar to concrete shear walls.</p> <p>-Plaster is loose and gapped from lath in a number of locations.</p> <p>-Uplift of stud framing at door opening is first observed.</p>

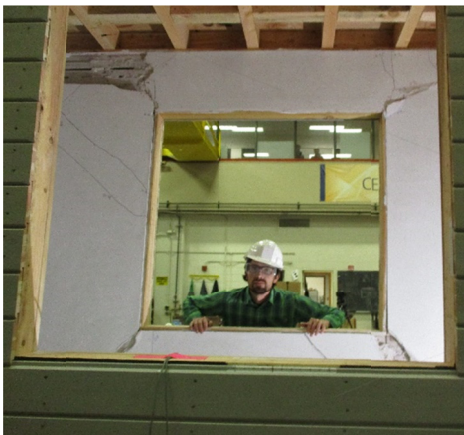
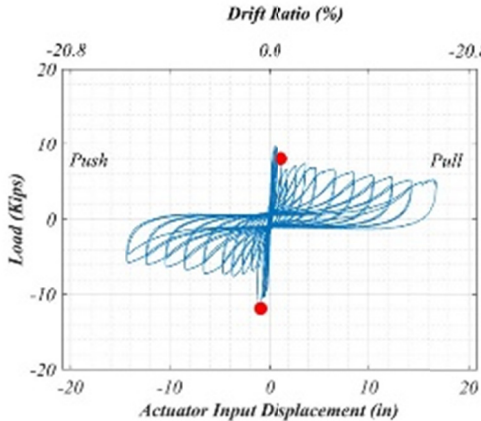
<p>-By end of 1.4% cycles, about hlf of the plaster had fallen or was loose and about to fall. Further marking of plaster cracks had become impractical.</p> <p>-Working of wood siding nails started to be noticed and marked, with modest pull through and withdrawal of siding nail heads, and limited hairline splitting between nail near end and end of board.</p>

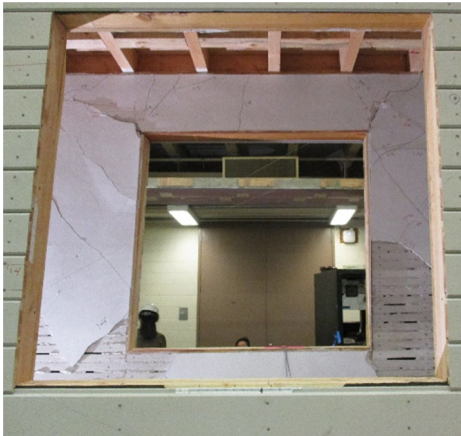
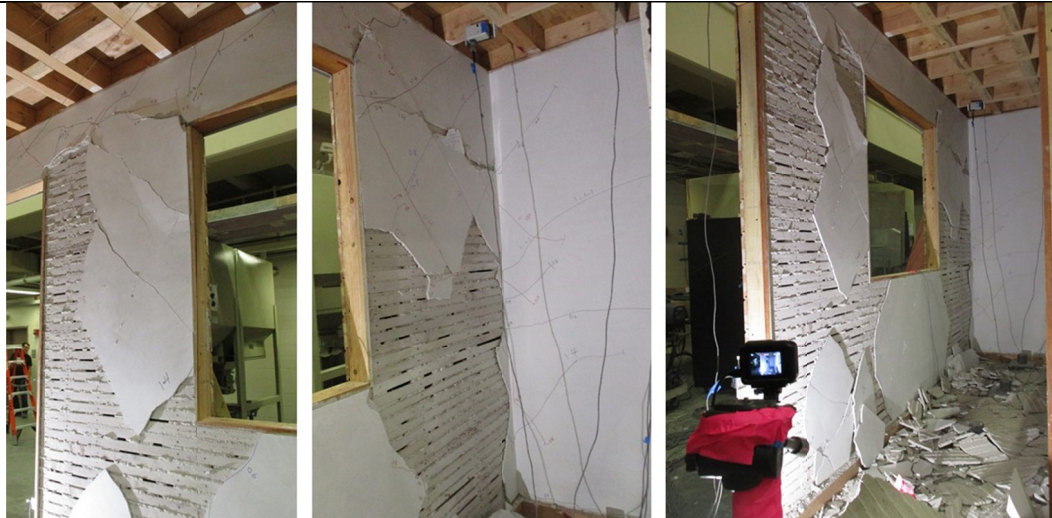
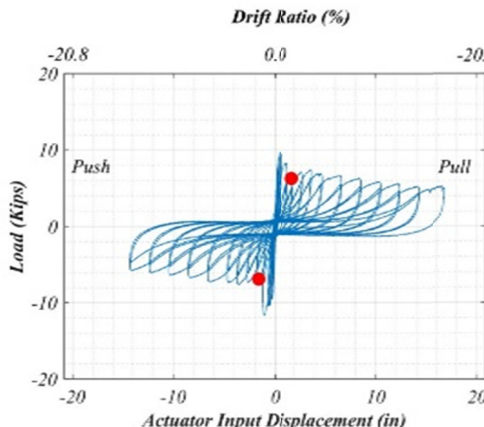
2.0%

Damage Appearance			Wall Peak Transient Target Drift Ratio (%)	Hysteresis Curve
Wall Finish Materials	Damage Description	Overall Pattern	Local Appearance			
	-Plaster spalling continues. -Working of siding nails continues.

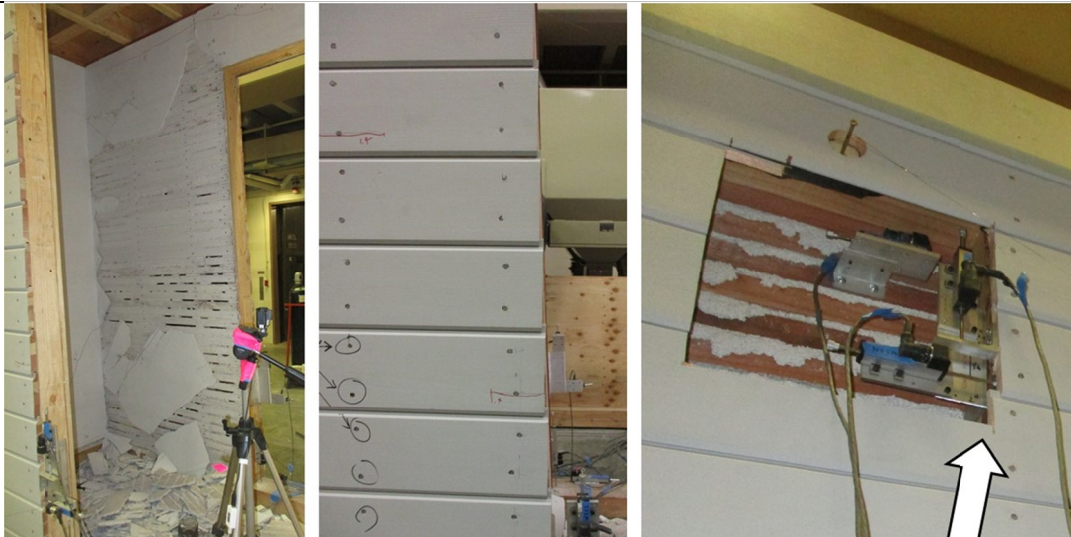
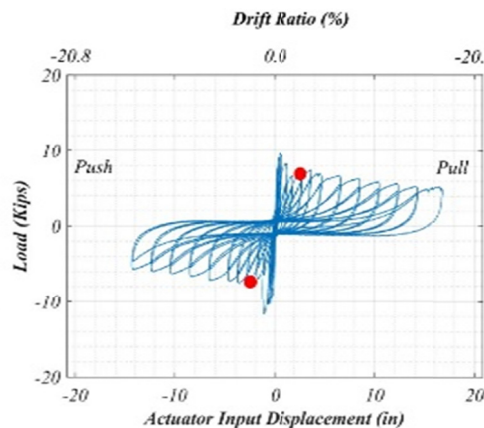
3.0%

-Plaster spalling continues. -Working of siding nails continues.

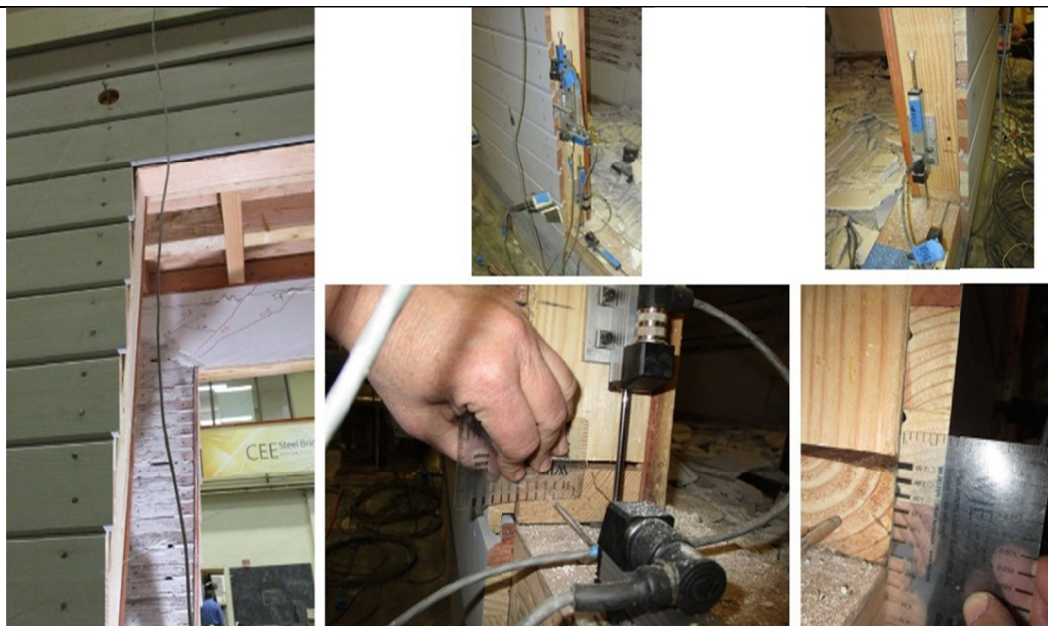
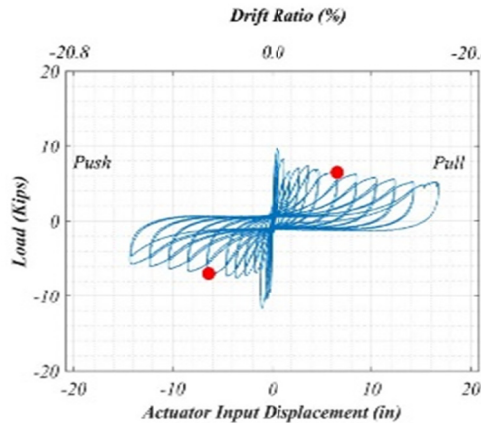
7.0%

Damage Appearance			Wall Peak Transient Target Drift Ratio (%)	Hysteresis Curve
Wall Finish Materials	Damage Description	Overall Pattern	Local Appearance			
	<p>-Working of siding continues, more nail withdrawal is noted.</p> <p>-Vertical gaps of about 1/4-inch are noted between crippler studs at door and wall bottom plates. Gapping occurs when edge of wall pier is in uplift, reverses under compression when loading direction reverses.</p>

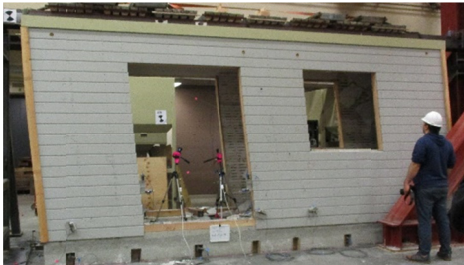
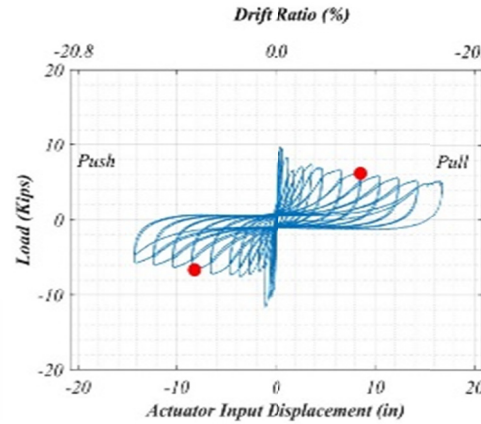
9.0%

<p>-Vertical gaps at door studs continue.</p> <p>-Wood lath is seen to buckle locally.</p> <p>-Siding at bottom of east end wall cracks in line with wall bottom plate.</p>

Continued working of siding (left), door cripple stud uplift off of wall bottom plate (middle and right).				
		Buckling of wood lath seen through observation hole (left top), gapping between stud and bottom plate (left bottom), and splitting in east end wall siding at floor line (right).

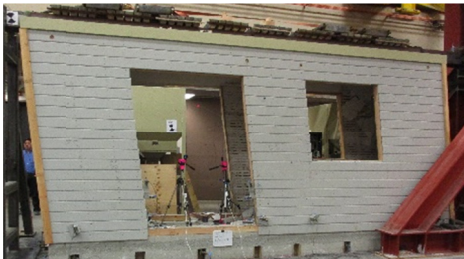
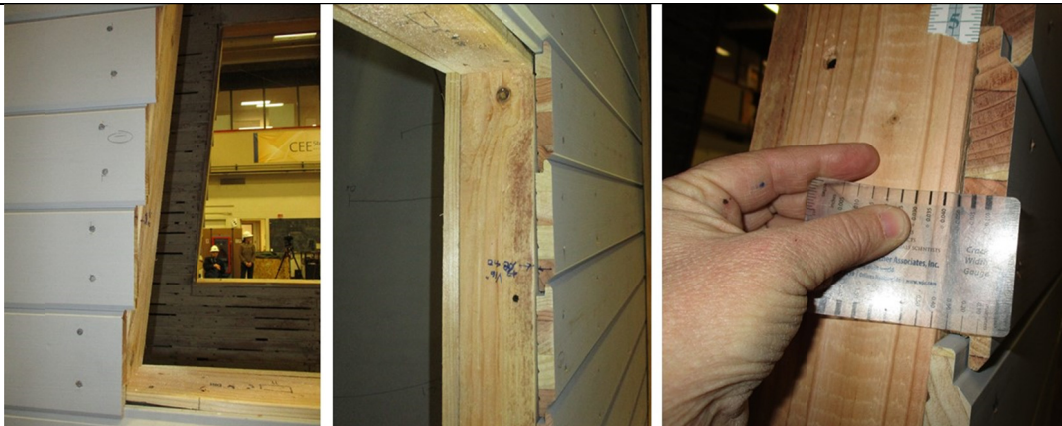
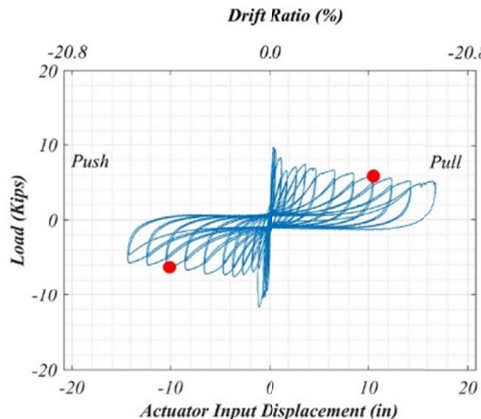
<p>South wall with push direction loading to the west</p>

Damage Appearance			Cripple Wall Peak Transient Target Drift Ratio (%)	Hysteresis Curve
Wall Finish Materials	Damage Description	Overall Pattern	Local Appearance			
	<p>-Siding continues to work, siding condition and gap to wall framing are not significantly changed. There is no indication of siding being progressively worked off of the framing, as was seen with the horizontal lumber sheathing in Specimen AL-1</p>

<p>Continued working of siding with little noted degradation of boards or nailing,, little change in gap between siding and framing.</p>		11%

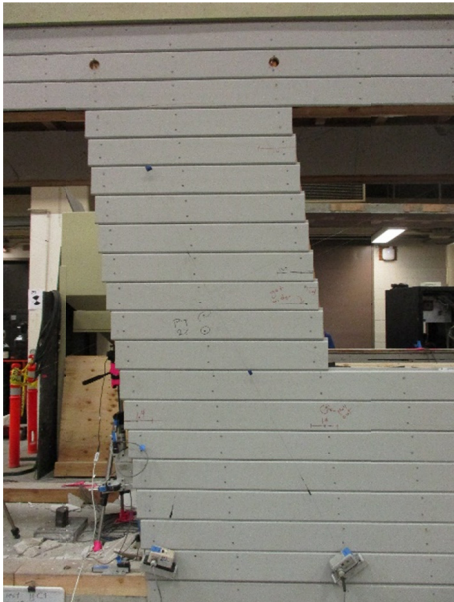
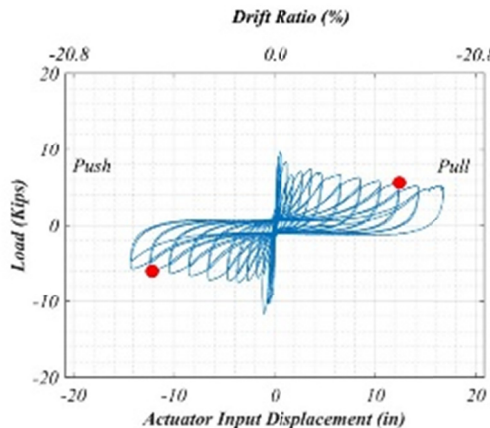
<p>South wall center wall pier pushed to west</p>

<p>-Siding performance similar to 11% -Tension side vertical gapping increases between siding boards, with minor uplift of wall studs -Crack in end wall siding progresses</p>

<p>Working of siding without significant visible damage to siding or nailing (left top), at compression end of wall piers siding boards are just getting near contact but not bearing on each other (left bottom), at tension end of wall piers gaps between siding boards are opening up (right bottom), crack in end wall siding has progressed (right top)</p>		13%

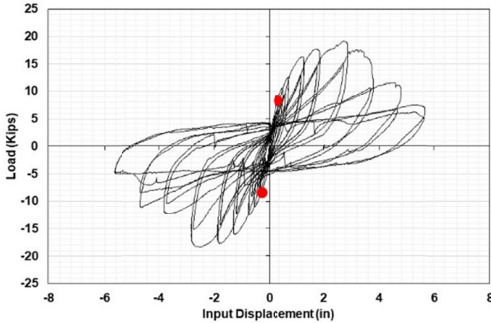
Interior gypboard	0%

-Cracking, spalling along panel taped joints

Gypboard extent of cracking at north wall window marked on photos, with colors consistent with push, pull and balance of cycles (left) gypboard joint cracking at ceiling (right top), joint tape debonding and loose (right bottom)

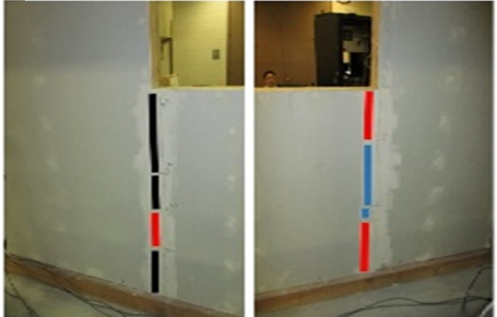
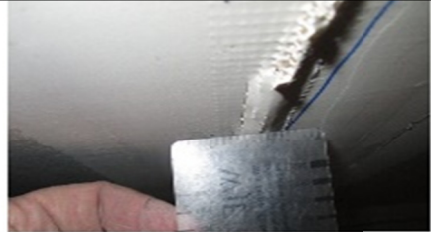
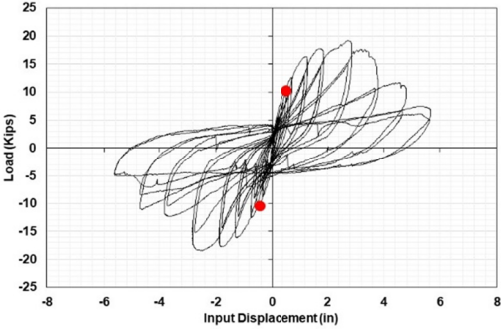
0.6%

Damage Appearance		Wall Peak Transient Target Drift Ratio (%)	Hysteresis Curve
Wall Finish Materials	Damage Description	Overall Pattern	Local Appearance		
	<div>-Gypboard cracking spreads -Gypboard taped joints continue deterioration</div>

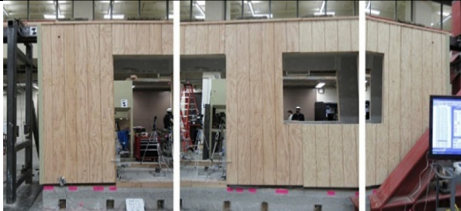
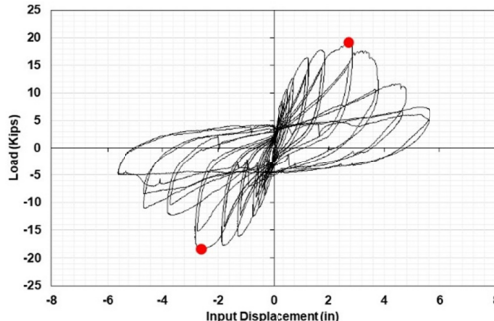
Damage Appearance			Wall Peak Transient Target Drift Ratio (%)	Hysteresis Curve
Wall Finish Materials	Damage Description	Overall Pattern	Local Appearance			
	<p>-Uplift of the wall bottom plate off of the supporting 4x6 nailer had notable increase in the gap dimension and in the length of bottom plate experiencing uplift. The length of plate uplifted extended over several feet in some locations</p> <p>-Rotation of the plywood in the full-height wall piers was visible, with signs of nail working being proportionally higher</p> <p>-Gaps were observed between the base of the plywood siding and the wall framing below</p> <p>-Nailing at the base of the wall gypboard was seen to experience damage as wall uplift occurred. Edge pullout occurred at some locations, with small divots of gypsum core being pulled out</p> <p>-Tape and joint compound at the panel joints was highly deteriorated leaving the panels to move independently of each other</p> <p>-Local fracture of the plywood siding occurred at one window corner</p> <p>-Warping of sill framing at vertical panel joints could be seen. This is thought to be driven by the siding rather than sheathing nailing pattern used. Deformations were seen to be local rather than global</p> <p>-Joints between panels were observed to partially close</p>

<p>South wall with push displacement (towards the left). Left wall pier can be seen to have significant rotation including rotation that is independent of the global specimen overturning</p>	  <p>Bottom plate uplift with increased gap and increased extent of uplift. Damage to gypboard nails at wal base occurs in combination with the bottom plate uplift (left and center), gap between plywood siding and wall bottom plate is large enough that Dave can put is fingers between (right top), Vahid documents sill uplift (right bottom)</p>		3.0%

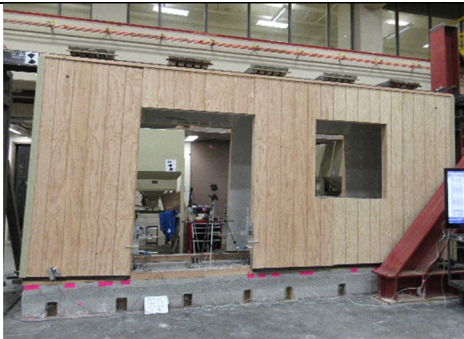
Damage Appearance			Wall Peak Transient Target Drift Ratio (%)	Hysteresis Curve
Wall Finish Materials	Damage Description	Overall Pattern	Local Appearance			
	<p>-Plywood siding panel rotation increases, with nail head pull through seen in a number of locations including at headers and below windows</p> <p>-The plywood siding at the base of the east wall has local crushing and fractures. When the east end wall experienced uplift the bottom of the siding was lifted up and slipped to the west at the same time. As the load reversed, the wall framing sat back down on top of the siding. The siding fractured and got folded under the wall framing</p> <p>-At the base of the wall at the door opening, in addition to uplift of the bottom plater off of the 4x6 nailed, the bottom plate was observed to slip several inches in the longitudinal direction and several inches in the transverse direction, such that the base of the wall was no longer vertically in line with the foundation</p> <p>-Gaps were observed between the gypboard and the framing at the door and window openings. Gouging and slots in the gypsum were observed at nails</p>

<p>South wall with pull displacement (towards right)</p>

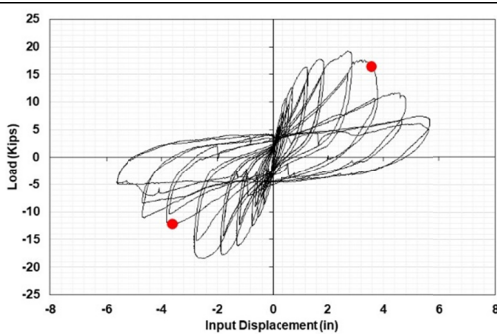
<p>Plywood siding panel rotation results in greater vertical offsets and pull through of nail heads at panel corners and at Panel edge above door, end wall plywood siding is damaged at wall base (center bottom)</p>		4.0% Before first restraint was added

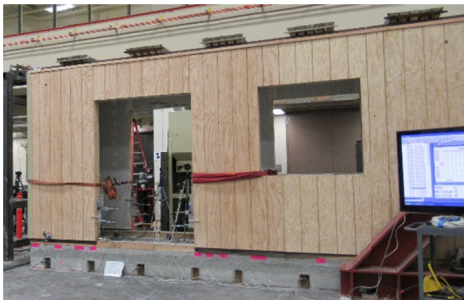
Damage Appearance			Wall Peak Transient Target Drift Ratio (%)	Hysteresis Curve
Wall Finish Materials	Damage Description	Overall Pattern	Local Appearance			
	<p>-The base of the walls at the west wall pier had started to offset out-of-plane similar to the center piers. A second restraint was added for 6% drift cycles</p> <p>-The wall superstructure was generally observed to be pushed off of the 4x6 nailer and foundation</p> <p>-A substantial number of wall bottom plate nails were believed to have been fully withdrawn and there was little remaining capacity</p>

<p>South wall at start of cycles to 6% drift, with restraint added to help keep west wall pier from moving out of plane off of foundation</p>

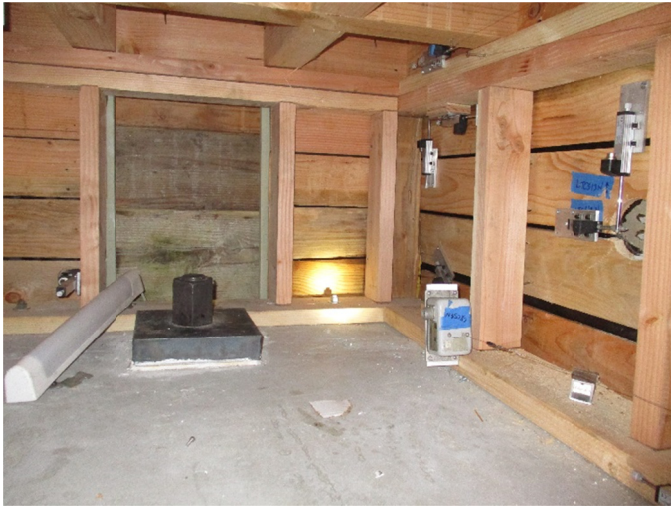
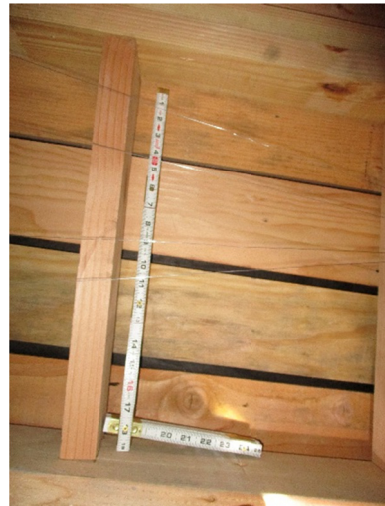
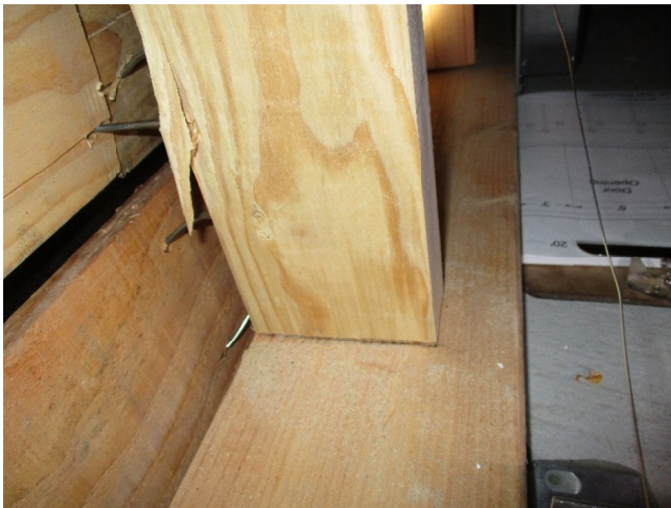
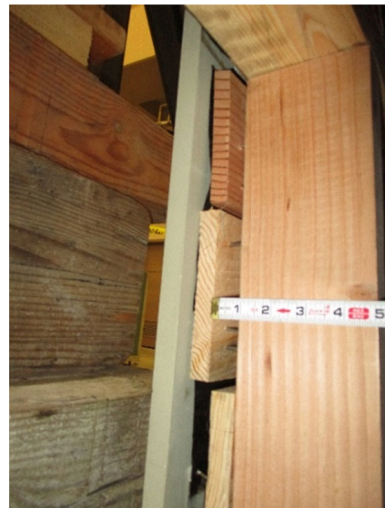
While the crawlspace was overall substantially intact, the horizontal lumber sheathing could be seen to have pulled off of the framing in most locations. In many locations the sheathing boards were pulled one to 2 in. off of the face of the framing; in several instances, the lumber sheathing had completely detached, only held in place by surrounding framing and stucco. The prying off of the lumber sheathing resulted in gaps between the sheathing and studs, and varying spacing between the sheathing boards, which were initially installed with uniform gaps between boards; see Figure D.1.

Figure D.1 Prying of the lumber sheathing resulted in gaps between the sheathing and studs, and varying spacings between the sheathing boards.

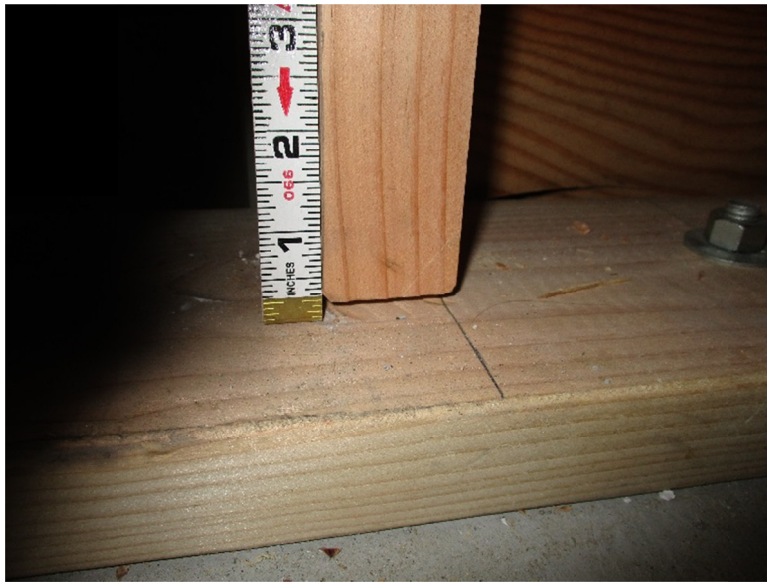
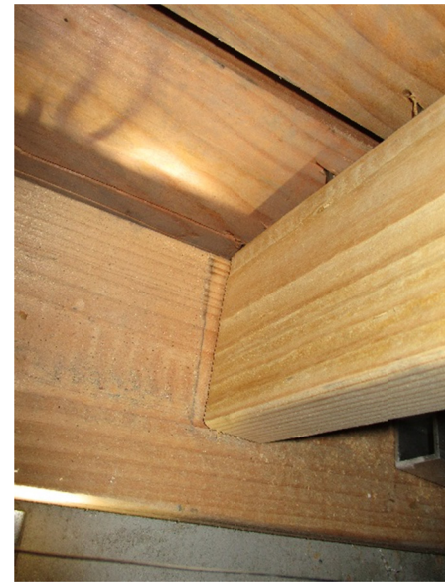
Crushing and gapping could be seen at the stud to foundation sill plate interface. Gapping seen at the end of testing was on the order of 1/8-in. maximum and tended to be over the full stud area. Crushing occurred under the edge of most studs, but was less than 1/16 in. deep. The crushing is thought to be a result of rocking of the studs rather than axial compression over the full stud area; see Figure D.2.

Figure D.2 Crushing of studs potentially due to rocking rather than axial compression over the full stud area.

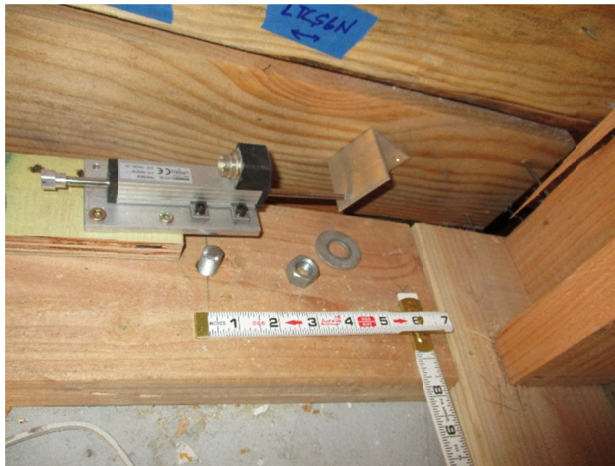
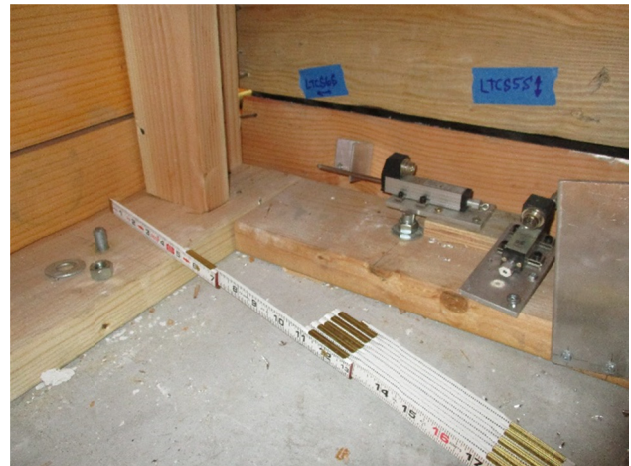
Figure D.3 Negligible change in tension of the instrumented bolts during the entire duration of the test.

The nuts and cut washers were removed from a number of anchor bolts to allow detailed observation of the anchor bolt and surrounding foundation sill plate. There was no apparent indication of any slip, crushing of wood, or other similar behavior in any of the locations examined. The sill plate wood was observed to be slightly smoother under the cut washer, indicating very limited wood crushing. It is not clear if this is a result of the testing or the initial tensioning of the bolts to approximately 400 lbs. The tension of the instrumented bolts was seen to stay very close to 400 lbs during the entire duration of the test; see Figure D.3.

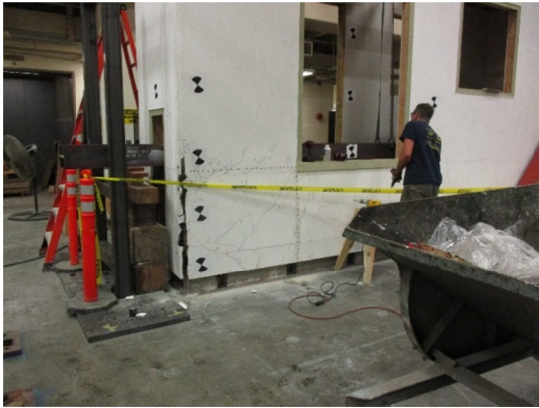
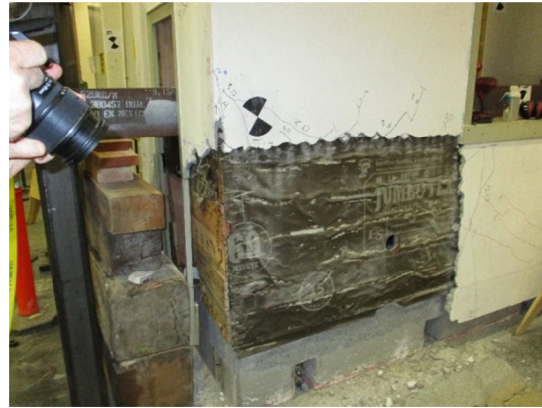
Stucco was removed to observe underlying conditions at the south-west corner of the test specimen, as seen in Figure D.4. The removal involved drilling a series of closely spaced holes, chipping stucco out with a chisel to expose the wire lath, and then cutting the lath. Using this method, each section of stucco was able to be removed substantially intact. At time of removal, the stucco furring nails were providing little or no attachment of the stucco to the underlying framing.

Figure D.4 Stucco underlying conditions observed at south-west corner.

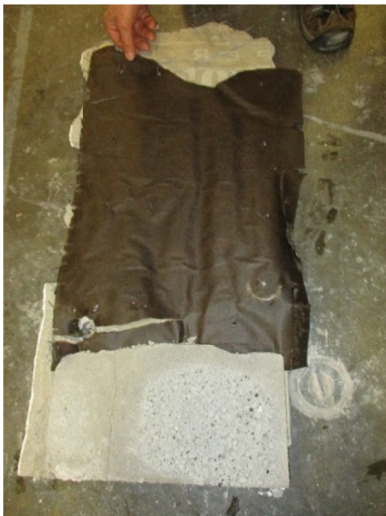
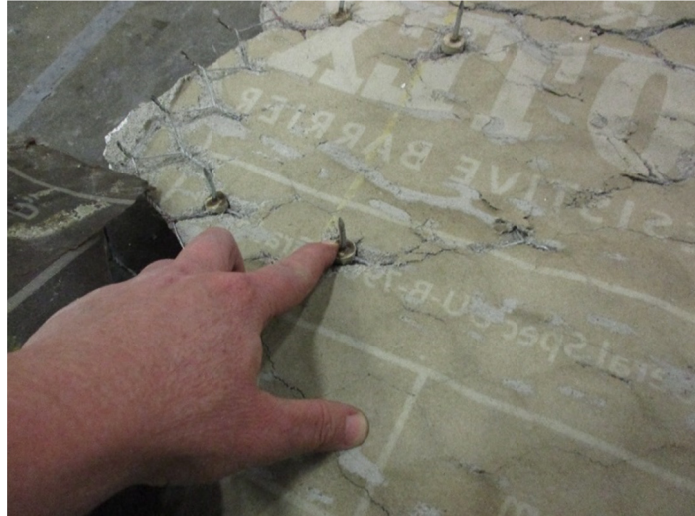
The first section removed was the south end of the west-end wall, extending several feet up from the foundation. This panel showed that the building paper had been trapped in the bottom of the stucco. As a result, the building paper tore during panel removal and remained attached to the panel; it appeared the paper would have remained substantially intact had the panel not been removed. For this west-wall panel, the furring nails were almost exclusively withdrawn from the underlying sheathing. It is believed this is because the movement of the stucco during testing was out-of-plane relative to the sheathing below, thus pushing the stucco off of the sheathing and framing, and putting these nails in direct tension. The stucco was otherwise observed to be in good condition; see Figure D.5.

Figure D.5 Building paper in south-end of the west wall observed to be in good condition.

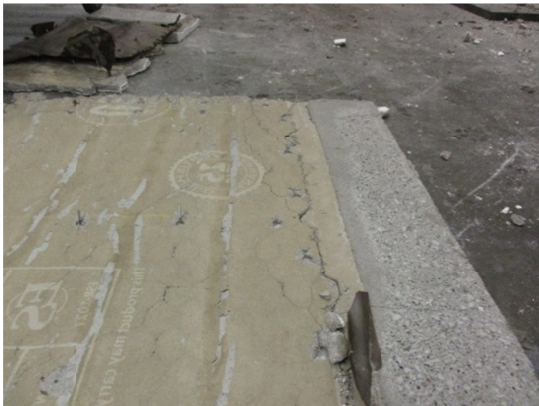
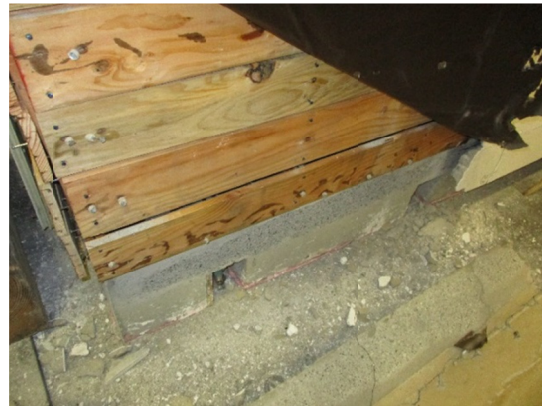
Next, the west end of the south wall was removed from the foundation up by several feet. On this panel, the stucco furring nails almost exclusively had the head of the nail pulled out of the stucco, and the remaining nails were embedded in the sheathing; see Figure D.6. During testing, the cripple wall stucco began flaring out away from the foundation and framing. The flaring increased as the level of displacement increased, which is consistent with the observed pull out of the nail heads, and the stucco being forced to ride over the top of the nail heads. The widening flare from the bottom of the wall upward from the foundation indicates the increasing number of nails pulling out of the wall as the test progressed.

Figure D.6 Stucco underlying conditions at west-end of the south wall.

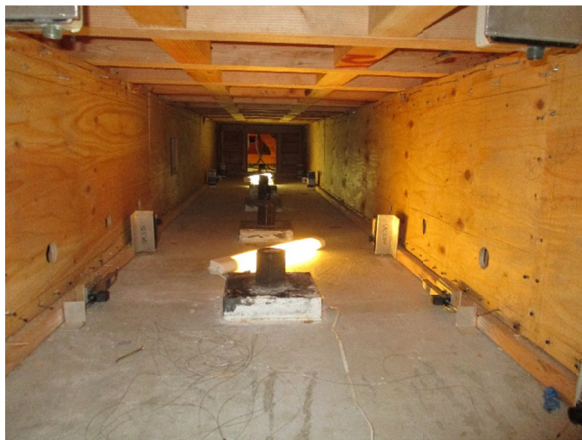
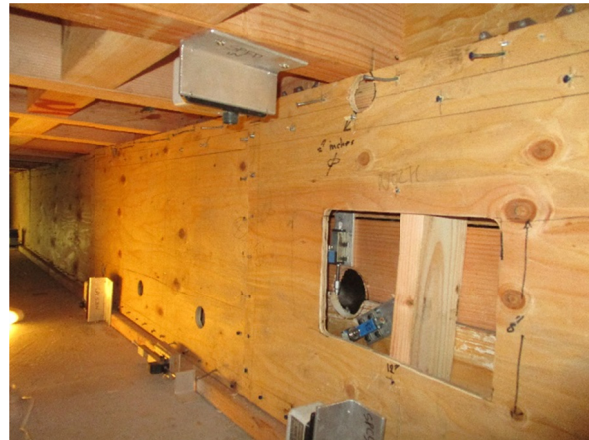
Figure D.8 **Substantially intact longitudinal walls of crawlspace.**

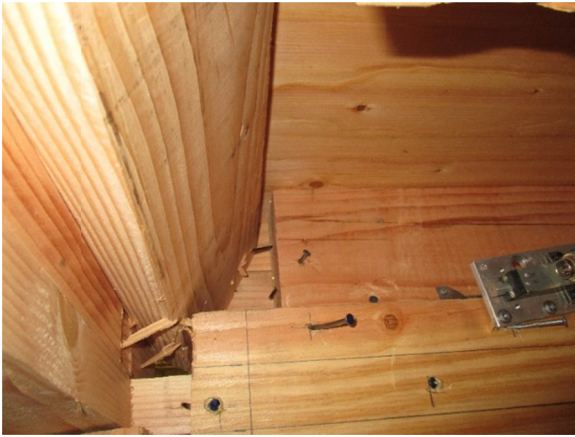
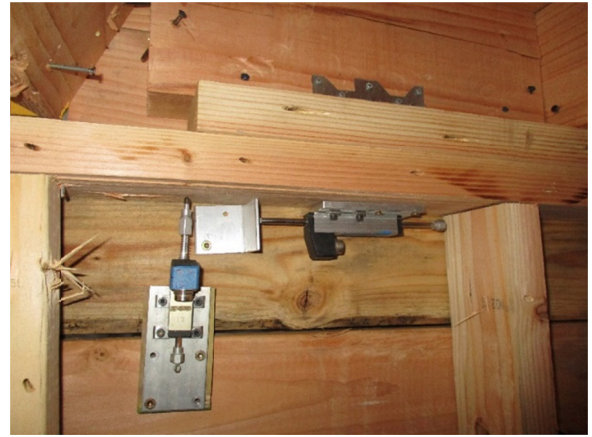
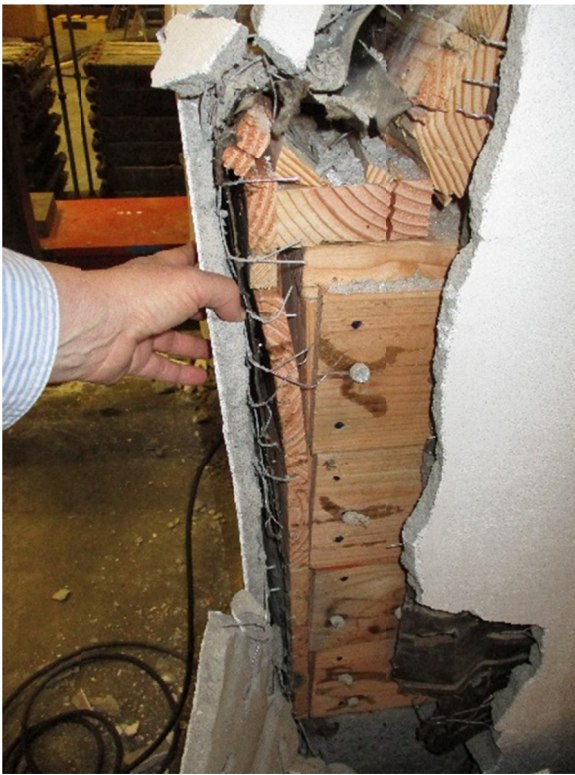
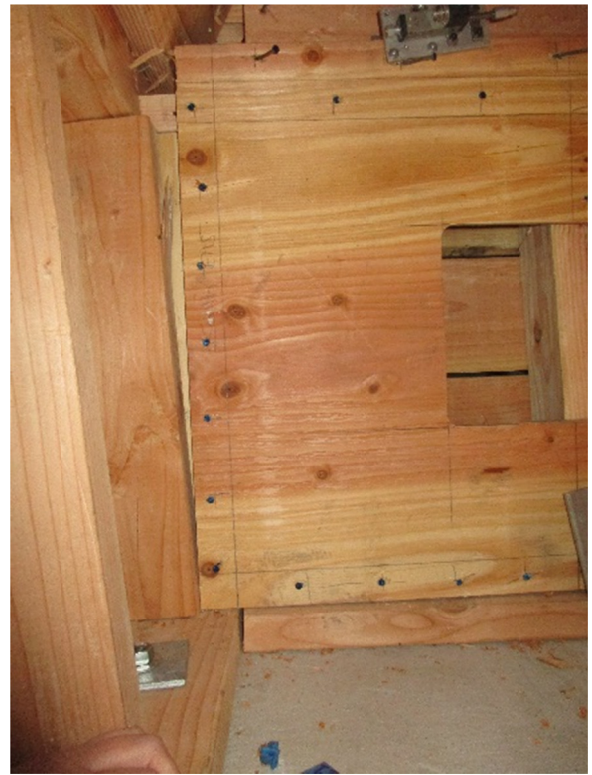
Figure D.9 Framing disruption at the east-end wall from the diaphragm slip.

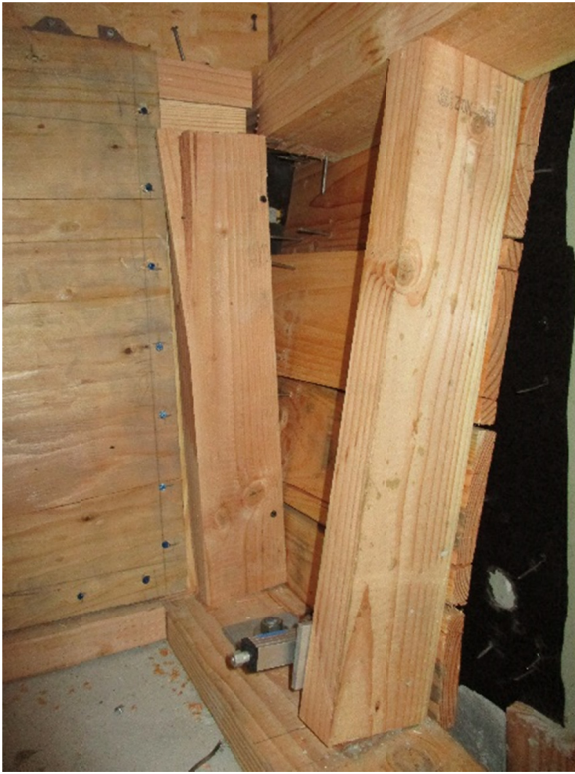
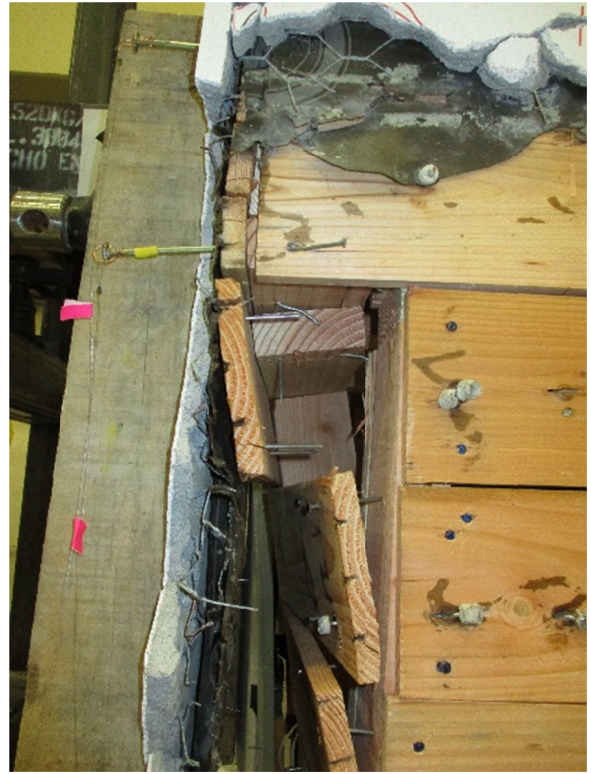
Figure D.10 Framing and sheathing disruption at the west-end wall from the diaphragm slip.

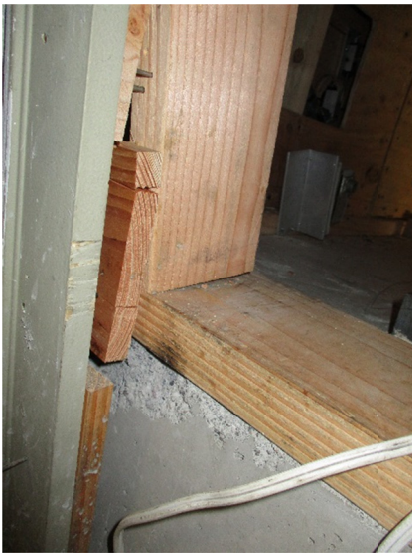
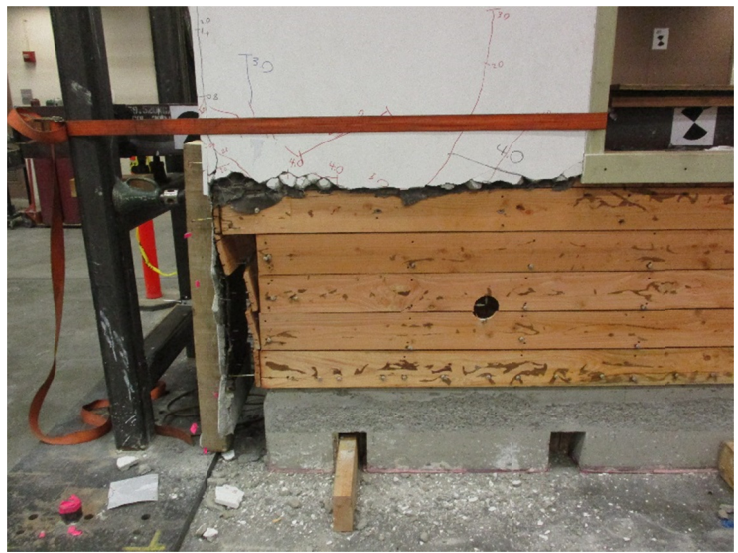
On the east- and west-end walls, the horizontal sheathing was seen as having pulled off of the framing, which is similar to behavior observed in Specimen AL-1; see Figure D.11.

Figure D.11 Pull out of horizontal sheathing from framing east and west walls.

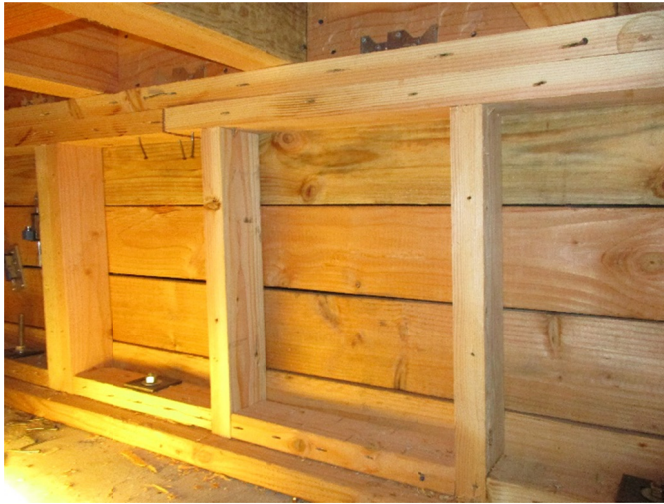
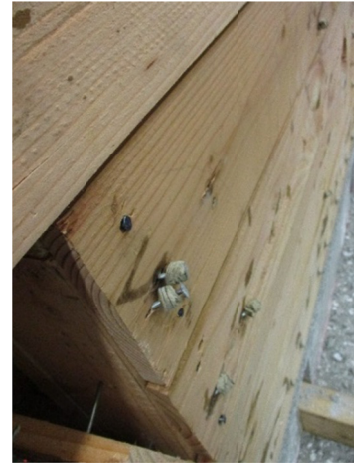
On the longitudinal (north and south) walls, the lumber sheathing had significantly less disruption. The sheathing boards were seen from the interior to generally be flush to the cripple wall framing, and to have generally uniform spacing (consistent with original installation). Some limited nail withdrawal was visible from the exterior, but not the significant withdrawal seen in Specimen AL-1; see Figure D.12.

Figure D.12 Significantly less disruption of lumber sheathing of longitudinal (north and south) walls.

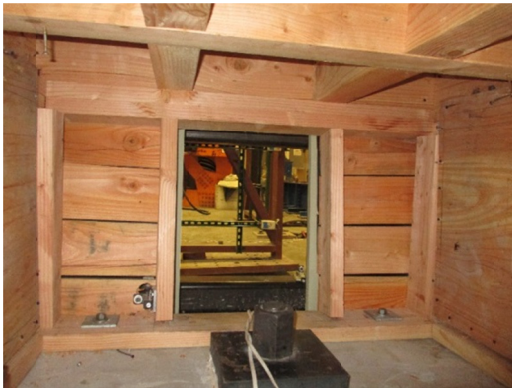
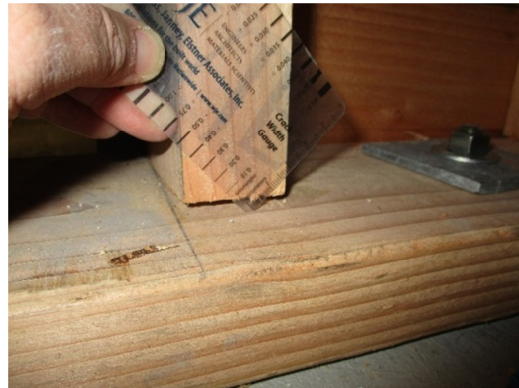
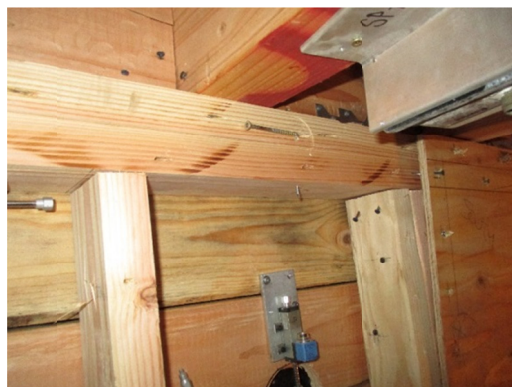
Crushing and gapping could be seen at the stud to foundation sill plate interface at the east- and west-end walls. Gapping seen at the end of testing was on the order of 1/8 in. maximum and tended to be over the full stud area. Crushing was seen to have occurred under the edge of most studs, but less than 1/16in. deep. The crushing is thought to be a result of rocking of the studs rather than axial compression over the full stud area; see Figure D.13(a) and (b) for the east-end wall and Figure D.13(c) for the south wall, with much less evident gapping.

Figure D.13 Crushing and gapping at the stud to plate interface at the (a) east-end wall; (b) bottom of east end wall stud; and (c) top of south-wall stud.

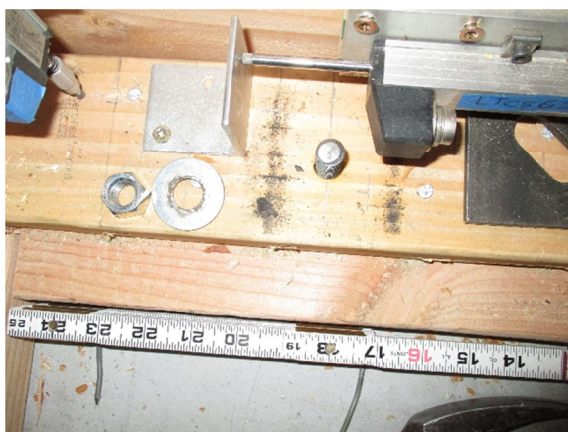
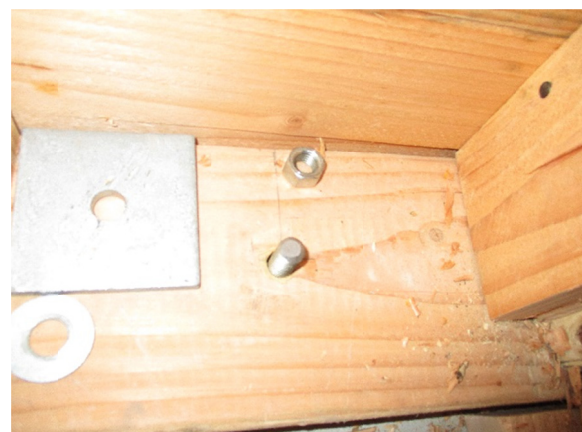
The nuts and cut washers were removed from a number of anchor bolts to allow detailed observation of the anchor bolt and the 2×4 blocks that were connected to the foundation sill plate and foundation using the anchor bolts; see Figure D.14. There was no apparent indication of any slip, crushing of wood, or other similar behavior in any of the locations examined. The 2×4 blocking wood was observed to be slightly smoother under the cut washer, indicating very limited wood crushing. At the start of testing, the anchor bolts had been tightened to an initial tensioning force of approximately 100 lbs; during testing the anchor bolt loads were increased to between 500 and 1200 lbs. Figure D.14(a) shows an anchor bolt on the south wall. Figure D.14(b) shows an anchor bolt on the east wall.

Figure D.14 Anchor bolt and surrounding foundation sill plate.

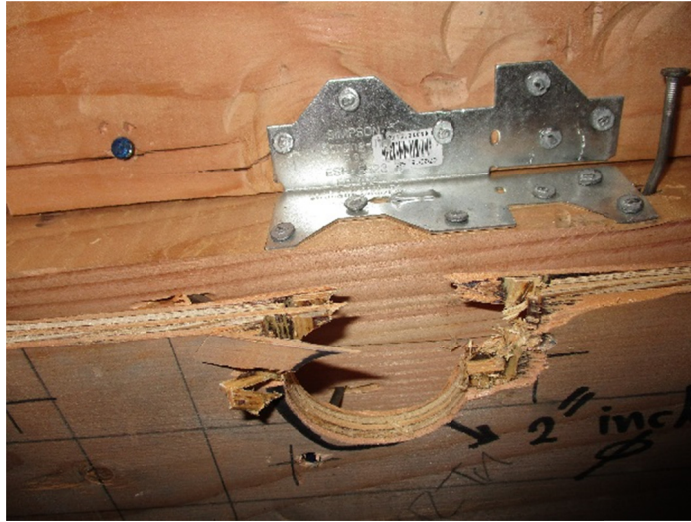
The cripple wall top plates had been attached to the rim joist of the floor framing above with fourteen A35 shear clips on each of the 20-ft-long walls, as required by the FEMA P-1100 retrofit provisions; see Section 3.5. These angle clips are an important part of the load path that allows the capacity of the plywood retrofit sheathing to develop. The A35 clips did not show any indication of slip, degradation, or deformation or of the framing interface. Figure D.15 shows an A35 clip following testing.

Figure D.15 Condition of A35 clip following testing.
