APPENDICES A, B, C, and D

APPENDIX A Working Group 4 Recommendations for Experimental Program

APPENDIX C Working Group 4: Damage Observations for All Specimens

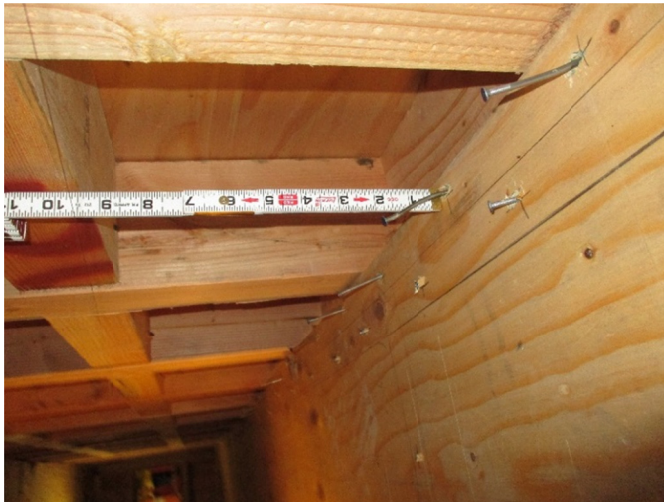
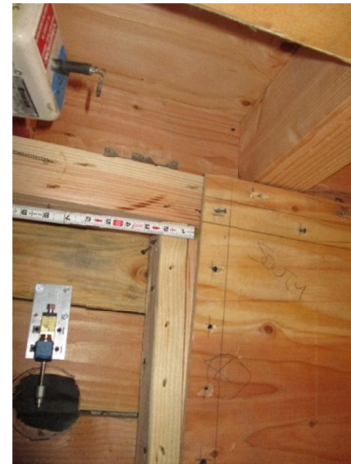
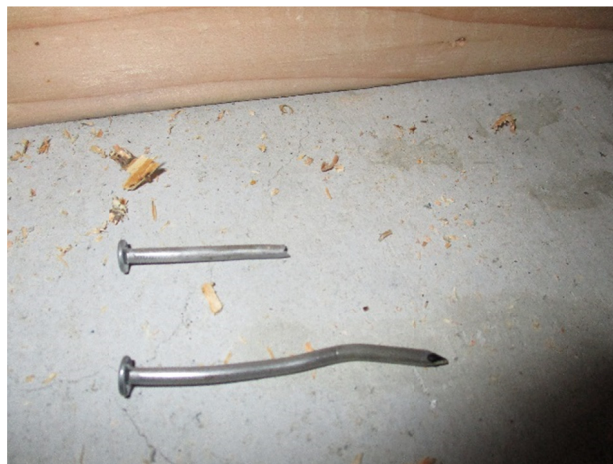
The nailing for the plywood retrofit sheathing experienced significant withdrawal from the framing over most of the sheathing area. The sheathing nailing into the upper top plate withdrew ~ 2 in. over most of the plywood length. Because of the extent of this withdraw, the nails had completely withdrawn from the top plate framing. Most were left loosely embedded $1/2$ in. into the plywood, and some had dropped to the floor of the crawlspace. This is consistent with the upper top plate having moved with the floor diaphragm when it broke free of the cripple walls. The withdrawal of the nails from the lower top plate was on the order of $1/4$ in. to $1/2$ in. Most nails were observed to be significantly bent but not fractured. A few nails were found to be fractured; see Figure D.16.

Figure D.16 Nailing damage for the plywood retrofit sheathing.

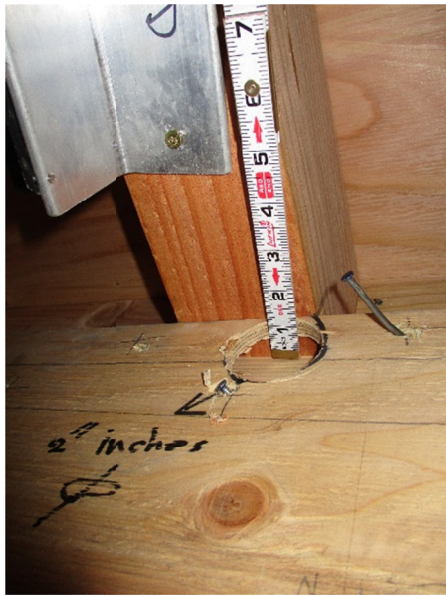
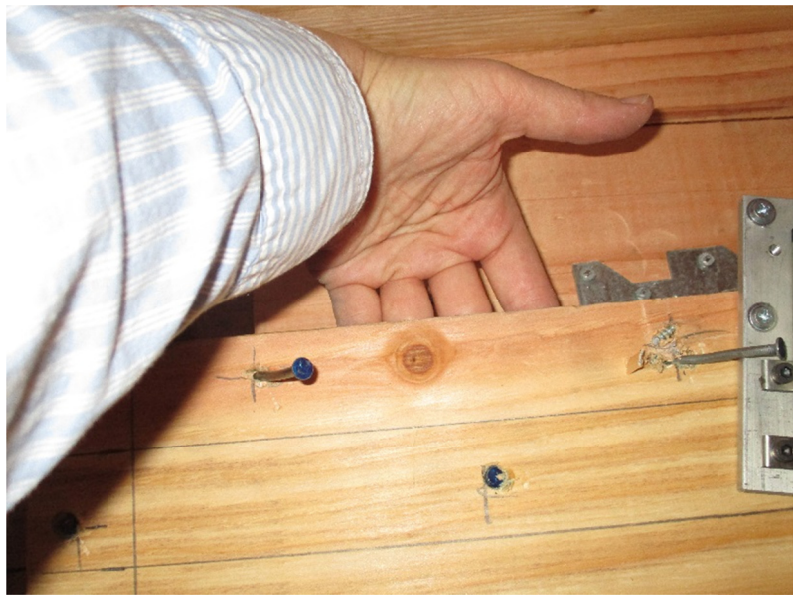
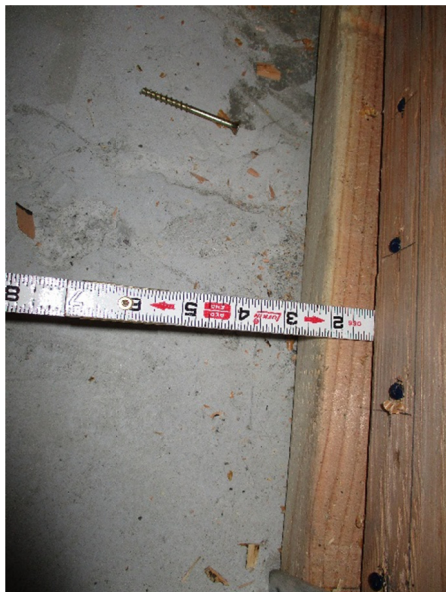
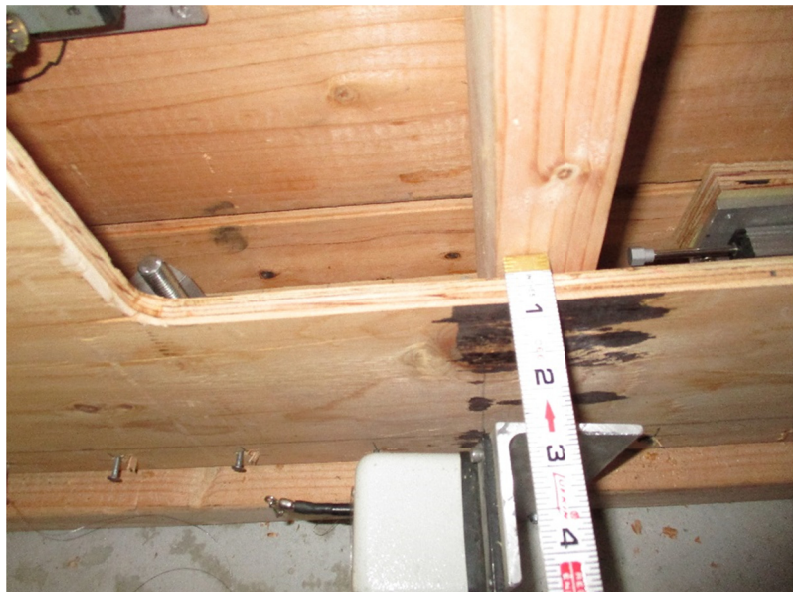
Out-of-plane gaps were observed between the plywood sheathing and the supporting cripple wall framing. Gaps were estimated to $1/2$ -in. to $3/4$ in. at the top [see Figure D.17(a) and (b)], approximately $1/2$ in. at the bottom (Figure D.17(c)), and approximately $1/4$ in. at mid-height of the plywood; see Figure D.17(d).

Figure D.17 Gaps between the plywood sheathing and the supporting cripple wall framing.

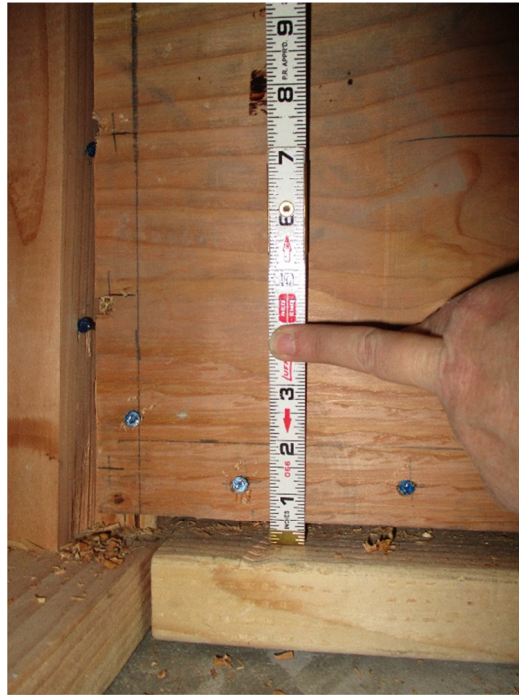
Figure D.18 Gapping at base of the plywood due to vertical upward movement at an end of the plywood.

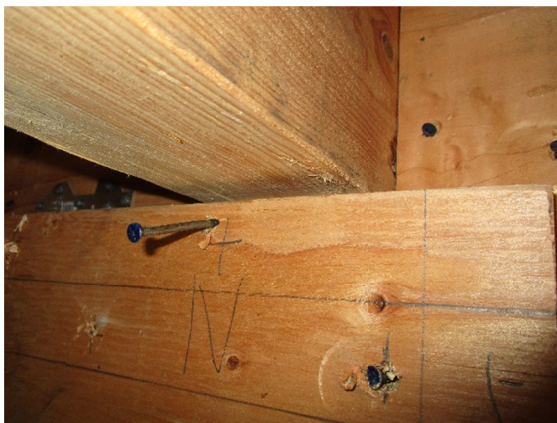
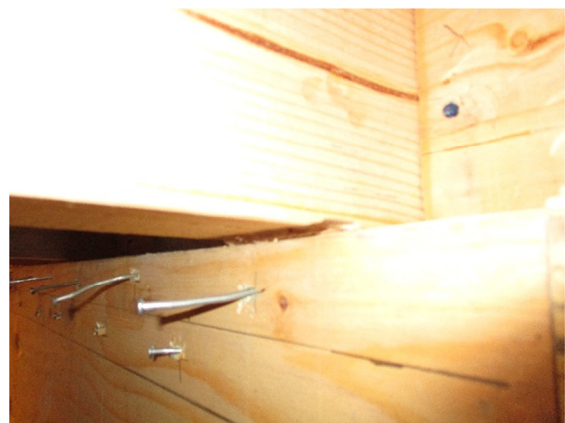
For the most part, there was no evidence that the plywood slipped enough vertically to bear on the framing above, as seen in Figure D.19(a). In one location, however, crushing of the floor joist consistent with plywood panel bearing down was observed; see Figure D.19(b).

Figure D.19 Plywood vertical slip toward the framing above (a) not touching; (b) only spot observed to touch framing. Arrow shows location of limited crushing.

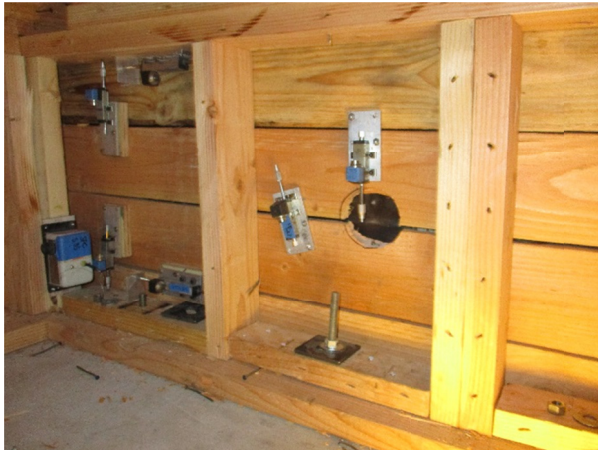
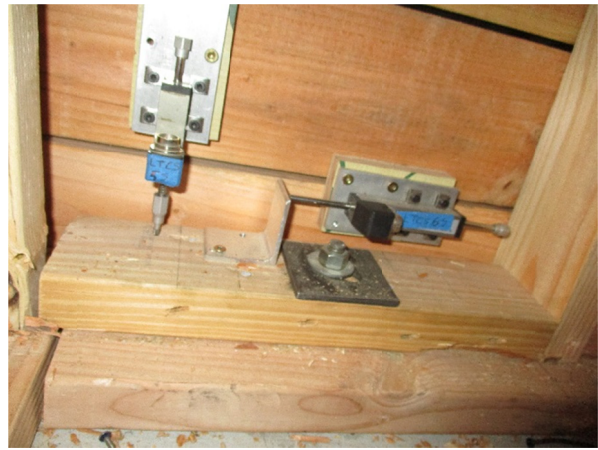
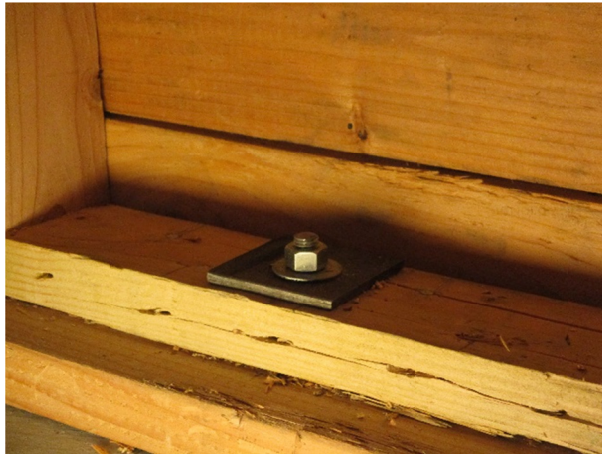
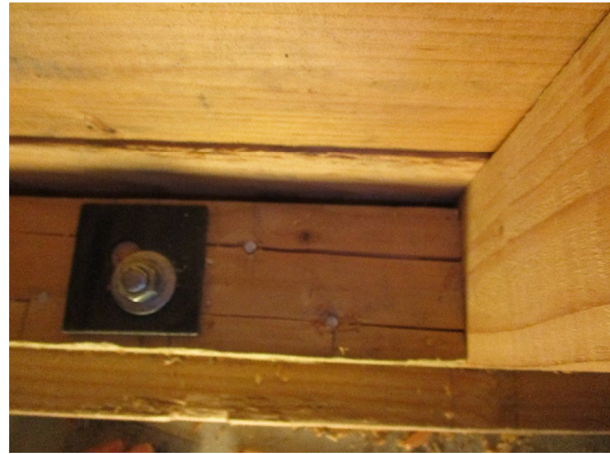
Plywood cripple-wall sheathing was removed in selected locations to allow more complete access to observe splitting of the blocking. Figure D.21(a) shows an overview of the framing with the plywood removed. Figure D.21(b) shows a block with no splitting. Figure D.21(c) and (d) show the one block in which splitting occurred. The splitting can be seen in both the vertical and the top faces of the block. This block occurred near the middle of the north wall.

Figure D.21 Plywood cripple wall sheathing was removed to allow more complete access to observe splitting of the blocking. Gaps between the plywood sheathing and the supporting cripple wall framing are shown: (a) overview of the framing with the plywood removed; (b) a block with no splitting; and (c) and (d) the one block where splitting occurred.

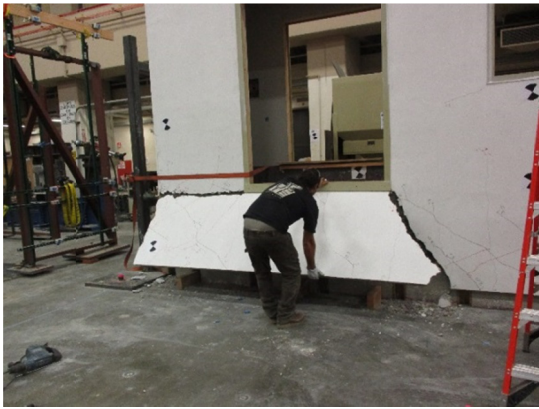
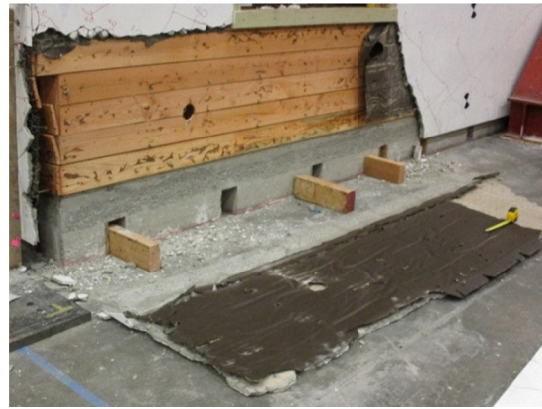
Stucco was removed to observe underlying conditions at the south west corner (Figure D.22) and south-east corner of the test specimen. The removal involved drilling a series of closely spaced holes, chipping stucco out with a chisel to expose the wire lath, and then cutting the lath. Using this method, each section of stucco was able to be removed substantially intact. At time of removal, the stucco furring nails provided little or no attachment of the stucco to the underlying framing.

Figure D.22 Stucco removed to observe underlying conditions at the south-west corner and south-east corner.

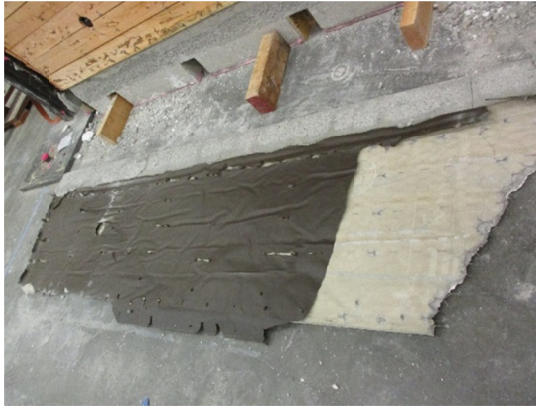
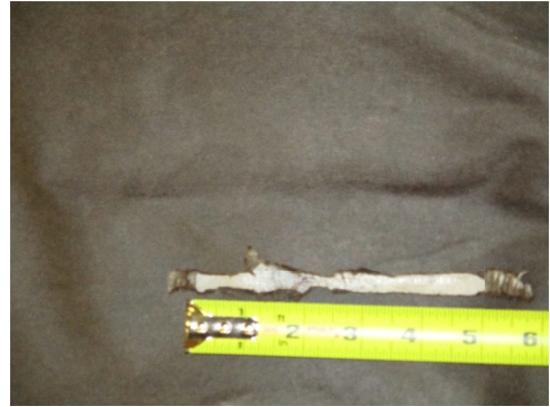
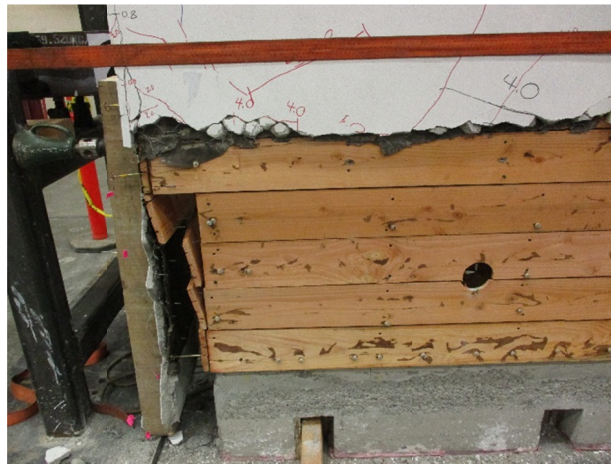
The first section removed was the west end of the south-end wall, which extended several feet up from the foundation. In this panel, the building paper had adhered to stucco and came off with the removal of the stucco. Except for tearing at the corner, the building paper did not have

any significant tears. It did have slots of up to 5 in. that had been gouged by stucco nails; see Figure D.23(a) and (b). The stucco nails remained embedded in the lumber sheathing with the heads pulled out of the stucco; see Figure D.23(c).

Figure D.23 Stucco inspection in the west end of the south end wall: (a) building paper damage status while was adhered to stucco; (b) slots of up to 5 in. gouged by stucco nails; and (c) stucco nails remained embedded in the lumber sheathing with the heads pulled out of the stucco.

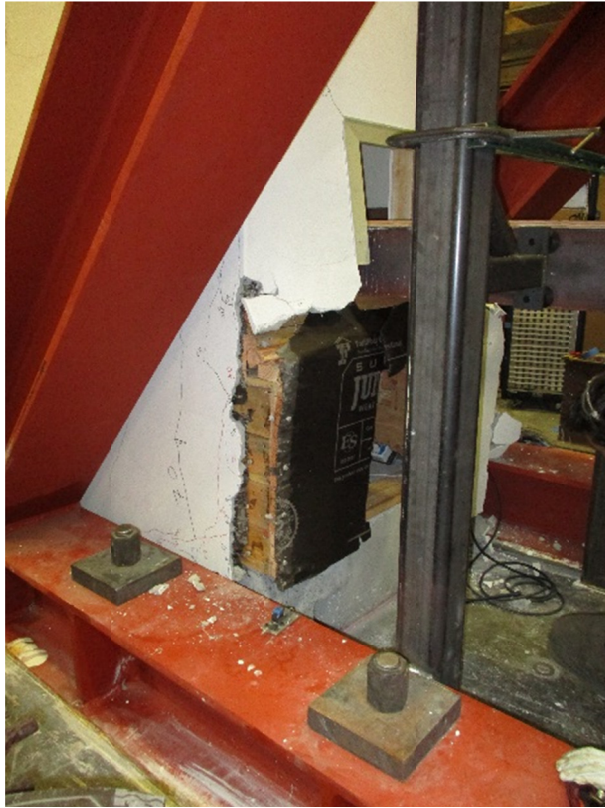
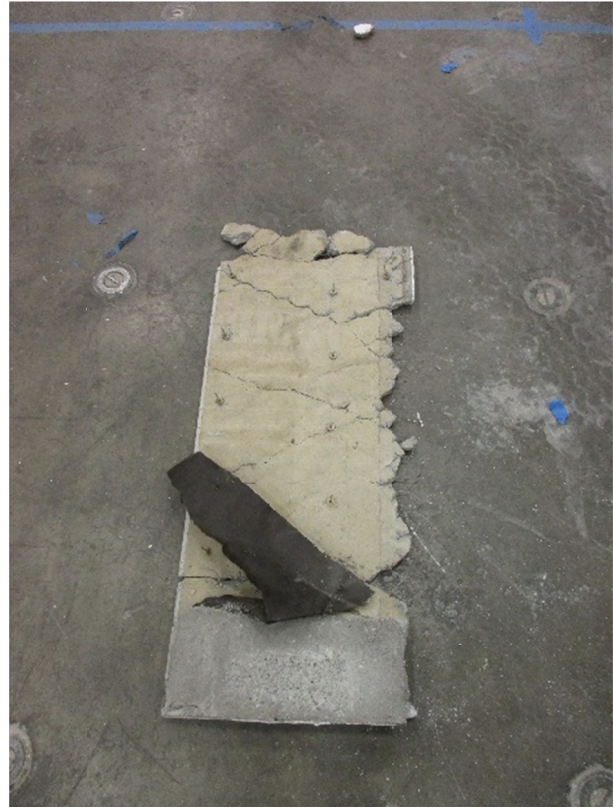
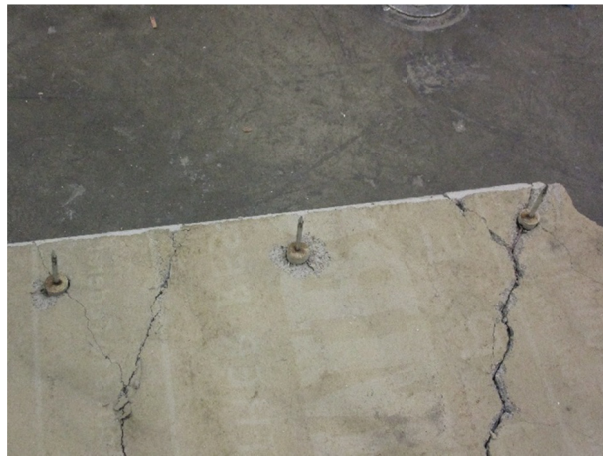
The second section removed was the south end of the east wall. Similar to the west-end wall section removed from Specimen AL-1, the stucco appears to have been pushed out of plane, resulting in tension of the stucco nails and withdrawal of the nails from the lumber sheathing; see Figure D.24.

Figure D.24 Stucco inspection in the south end of the east wall.

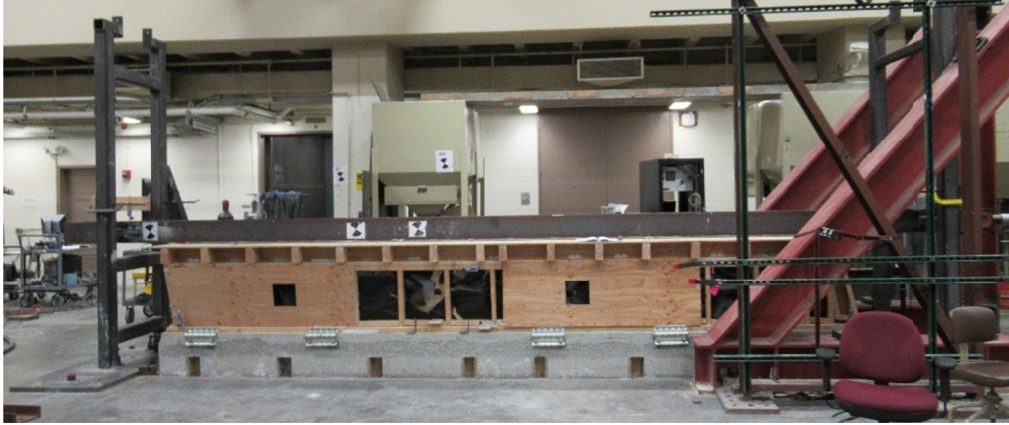
Figure D.25 Specimen B-1 overall view of south wall at conclusion of testing.

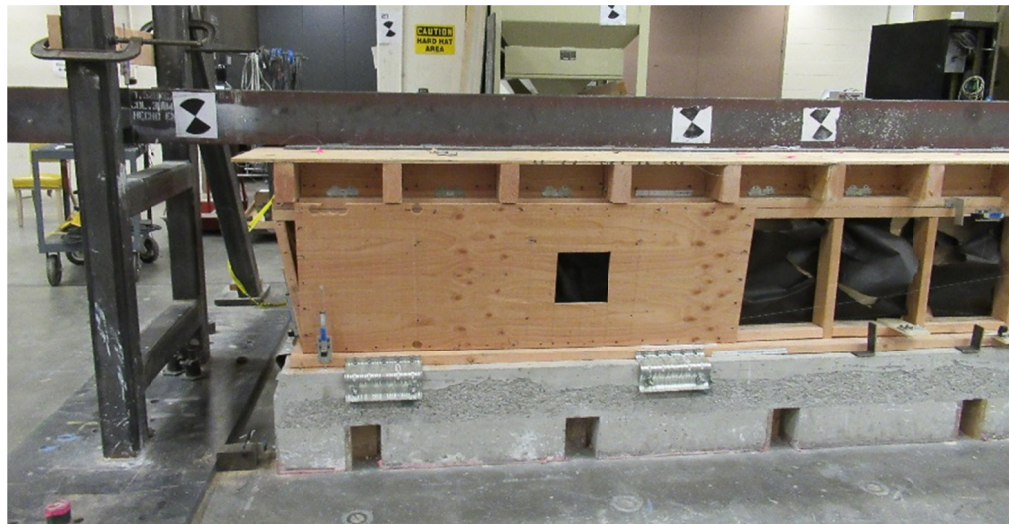
Figure D.26 Specimen B-1 west end of south wall at conclusion of testing.

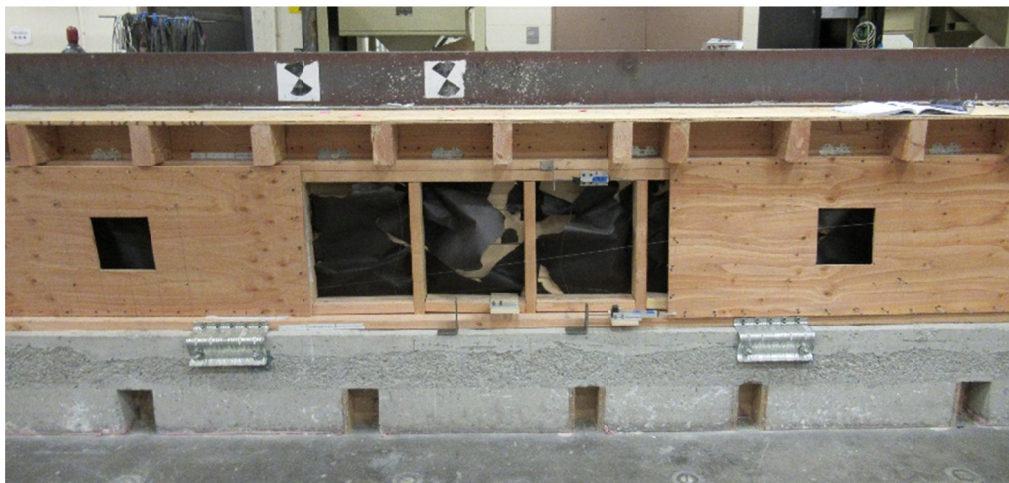
Figure D.27 Specimen B-1 center portion of south wall at conclusion of testing.

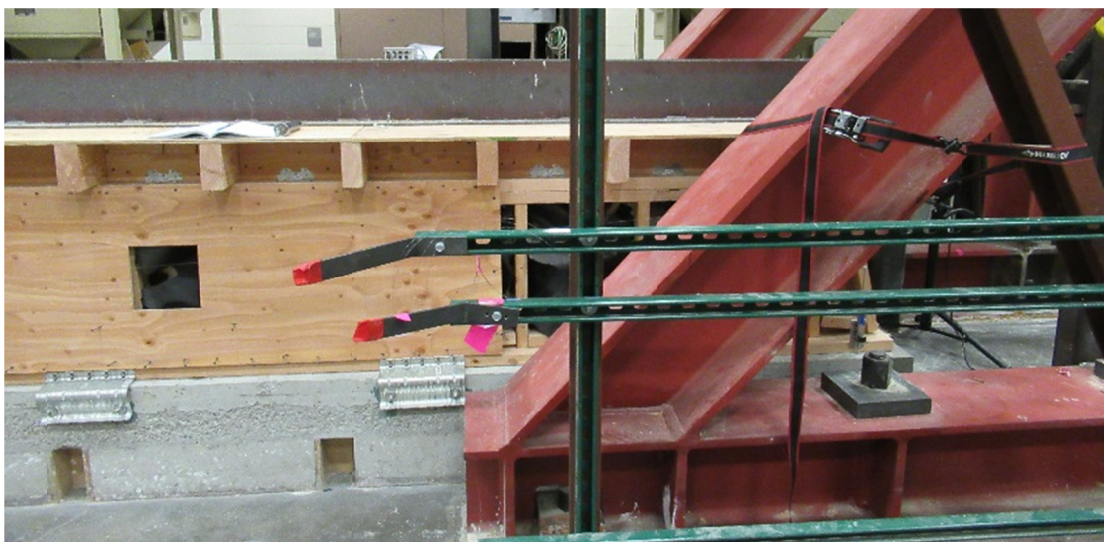
Figure D.28 Specimen B-1 east end of south wall at conclusion of testing.

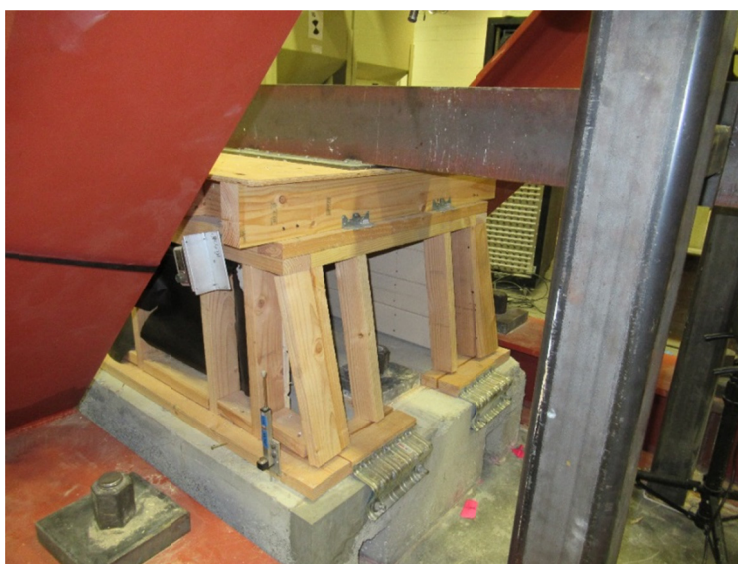
Figure D.29 Specimen B-1 east end at conclusion of testing.

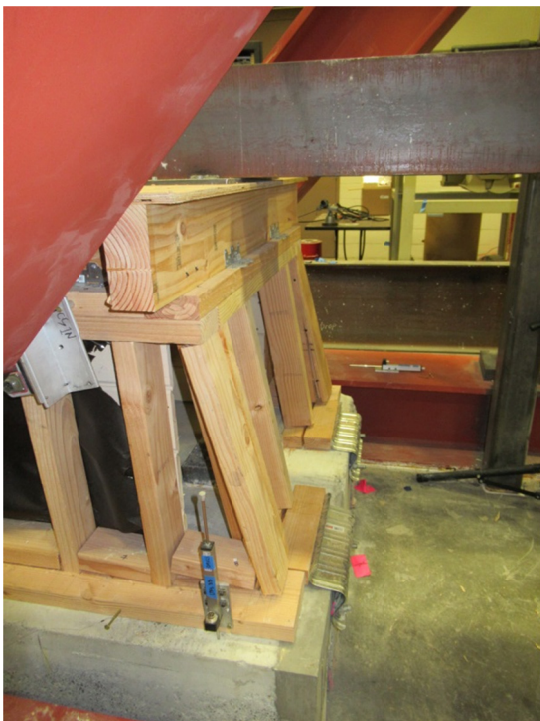
Figure D.30 Specimen B-1 east end at conclusion of testing.

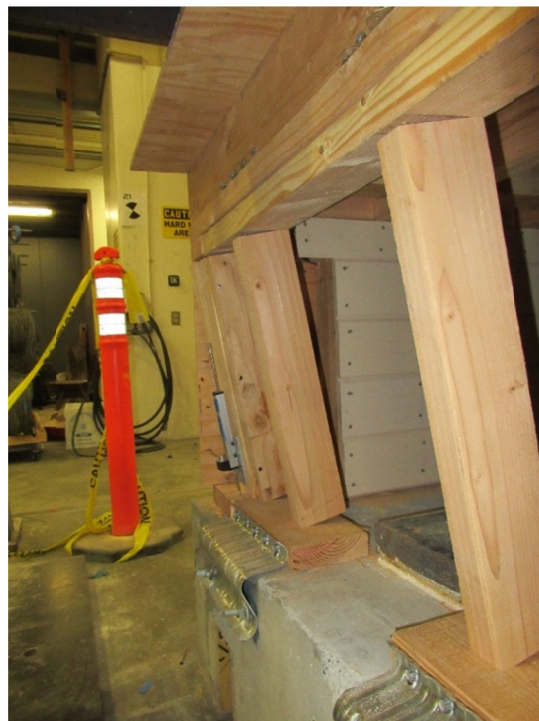
Figure D.31 Specimen B-1 west end at conclusion of testing.

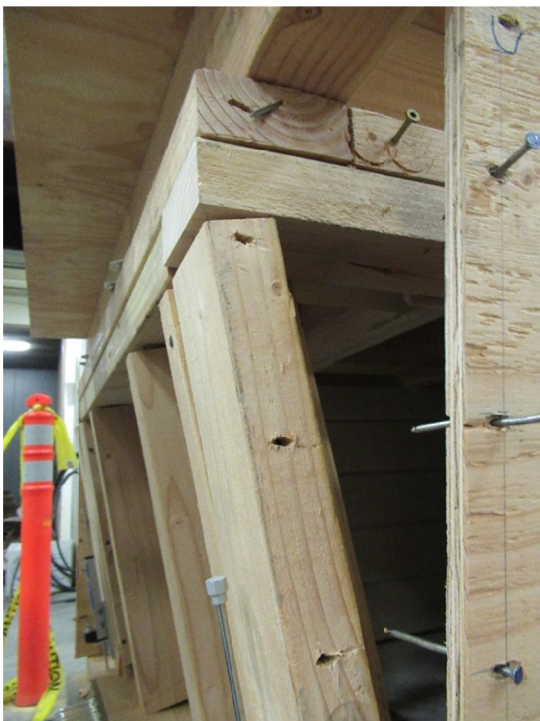
Figure D.32 Specimen B-1 west at conclusion of testing

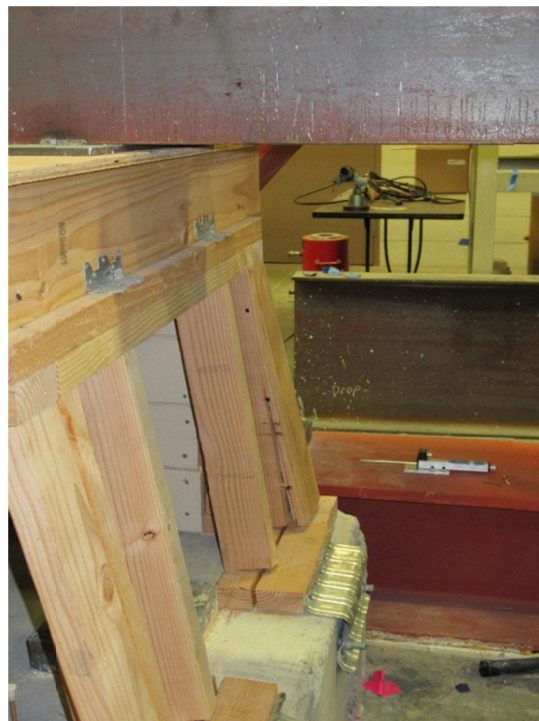
At the east end, both 2×6 foundation sill plates split through their full 1-1/2-in. height, as seen in Figure D.33. The splitting resulted from out-of-plane leaning of the studs and the restraint provided by the retrofit anchor. As a result of the splitting of the foundation sill plates, these anchors would no longer be able to provide in-plane shear capacity. Also at the east end of the north and south walls, the 2×4 blocks nailed to the 2×6 foundation sill plate had lifted up, with the face nails partially withdrawn. Some blocks lifted up more than 1-1/2 in. but others considerably less; see Figure D.34. At the west end, the studs rotated but the 2×6 foundation sill plates did not split. Local stud splitting occurred but was not of structural concern.

Figure D.33 Specimen B-1 west end at end of testing. The foundation sill plates are seen to have split through their full depth.

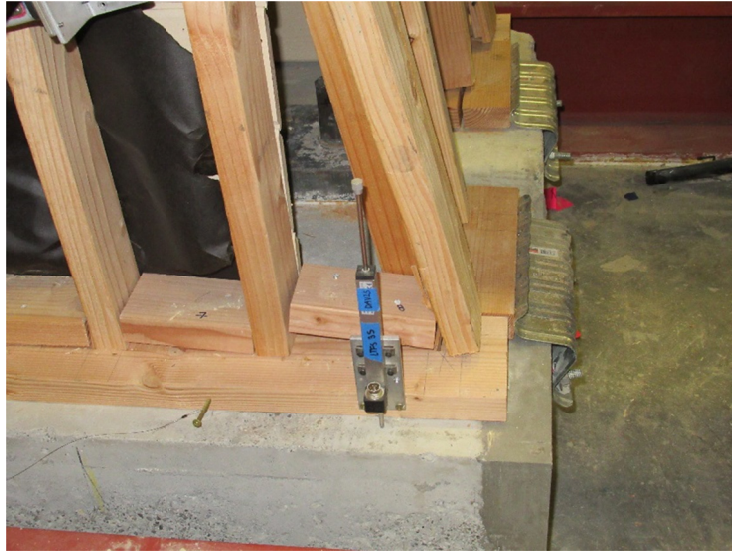
Figure D.34 Specimen B-1 east end at end of testing. Note: 2× blocks on foundation sill plate that have lifted up.

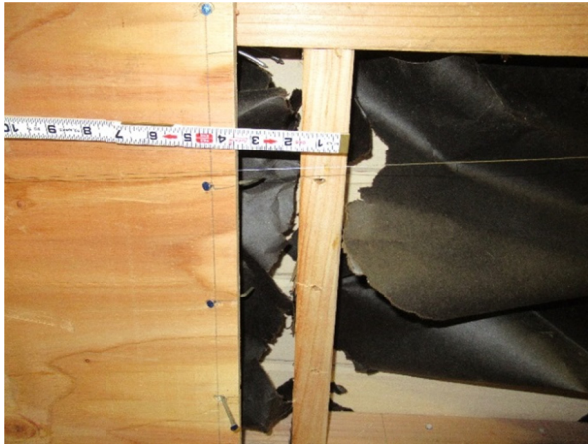
At the end of testing the specimen was pushed back as close to vertical as possible and examined. The full north- and south-side the top of the studs had separated from the top plates above; see Figure D.35 and D.36. As shown in Figure D.35, the stud that used to be located under the edge of the plywood had fallen about 4 in. to the right of the plywood sheet. In Figure D.36, the end nails that fastened the top plate to the stud can be seen to be fully withdrawn. This separation is assumed to have occurred following the final monotonic push while the specimen was being re-centered. In one case, the top of the stud was observed to have split; see Figure D.37. This is believed to have occurred when the top of the studs slid.

Figure D.35 South wall plywood at conclusion of testing. Note that the stud has shifted approximately 4 in. relative to the plywood that used to be nailed to the stud.

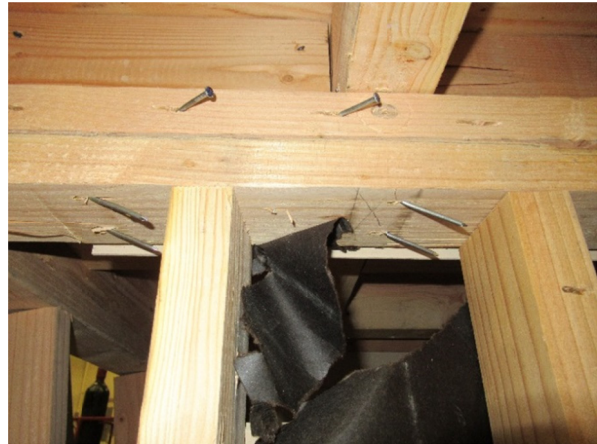
Figure D.36 South wall at conclusion of testing. Note with drawn stud end nails at original stud location and new stud location approximately 4 in. to the left.

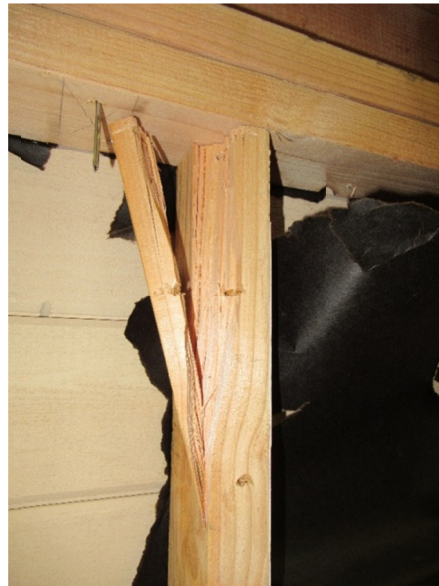
Figure D.37 South-wall stud shifted approximately 4 in. to the left. Stud splitting is believed to have occurred when the stud shifted.

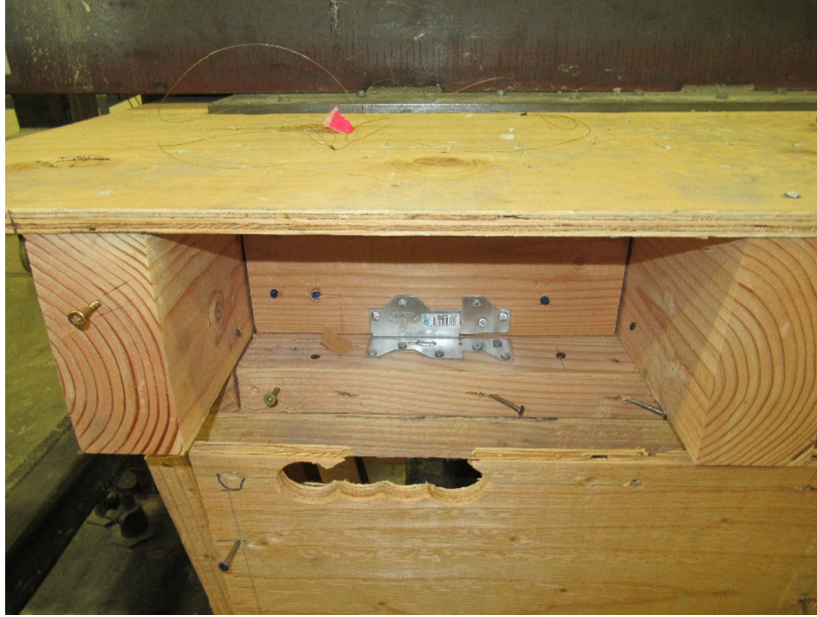
The clip angles between the cripple-wall top plates and the floor-joist blocking did not have any noticeable signs of deformation or deterioration; see Figure D.38.

Figure D.38 Shear clip with no visible indications of deformation or damage.

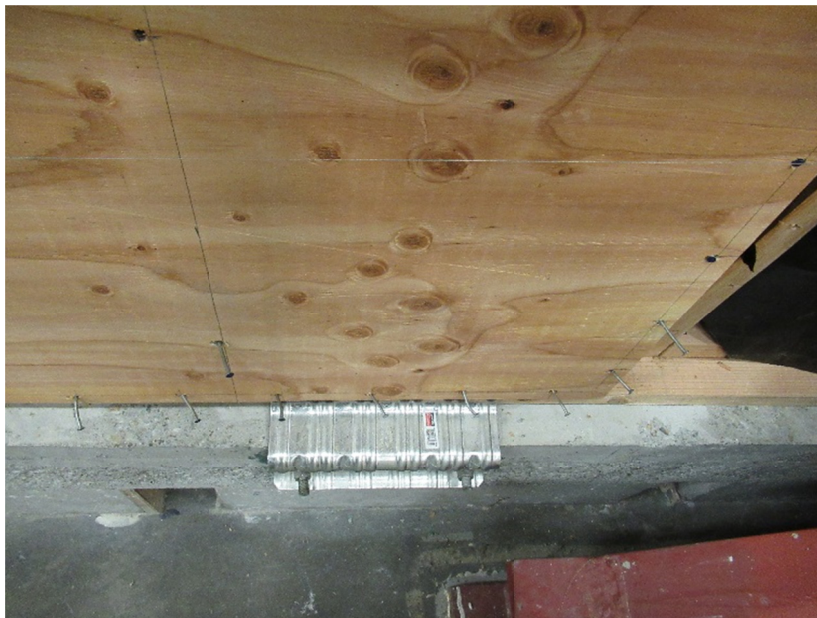
Of the four sections of retrofit plywood sheathing that had been installed, three of the panels had completely detached from the framing along the panel bottom and about one-third of the way up the vertical ends. For these nails, the failure mode was almost exclusively nail withdrawal. One plywood panel had completely detached at the top and one-third of the way down the sides, and was also separated from the top plates about 3 in. For these nails, two-thirds failed with a head pull-through mechanism and the other third in withdrawal; see Figures D.39 to D.40. Almost all of the nails that had withdrawn extended 1-1/2 in. past the face of the plywood, which left 1/2 in. of the nail lodged the plywood and 1/2-in. protruding out the back. The nails were no longer engaged in the framing at all, and showed indications of bending; see Figures D.41 through D.43.

Figure D.39 Sheathing nailing withdrawal at the bottom of the plywood panel.

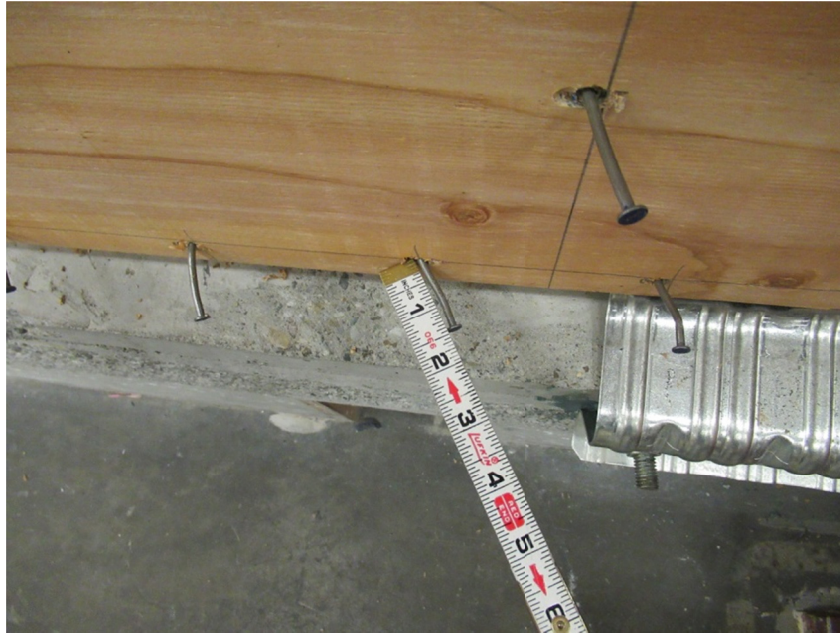
Figure D.41 Sheathing nails withdrawn enough to no longer engage the framing.

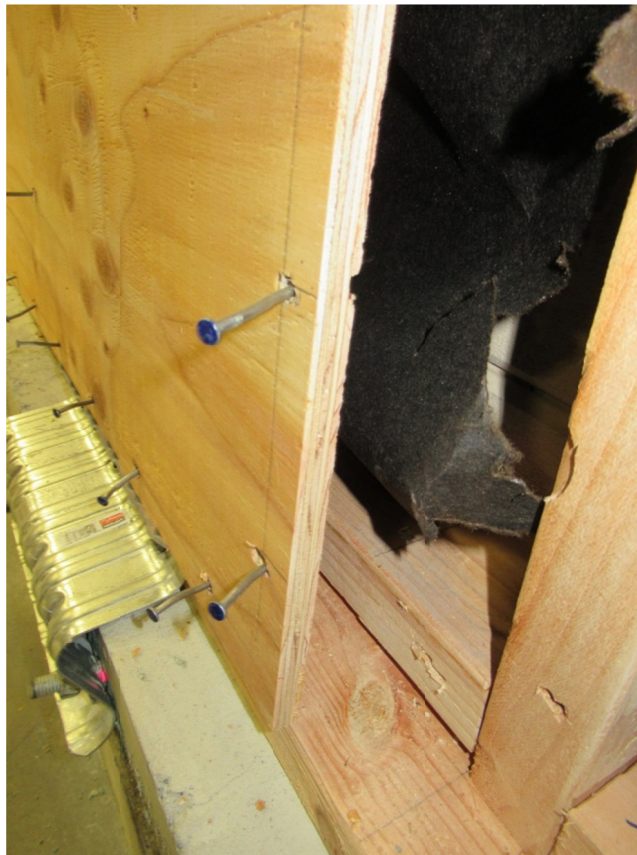
Figure D.42 Nails withdrawn from framing and only embedded in plywood.

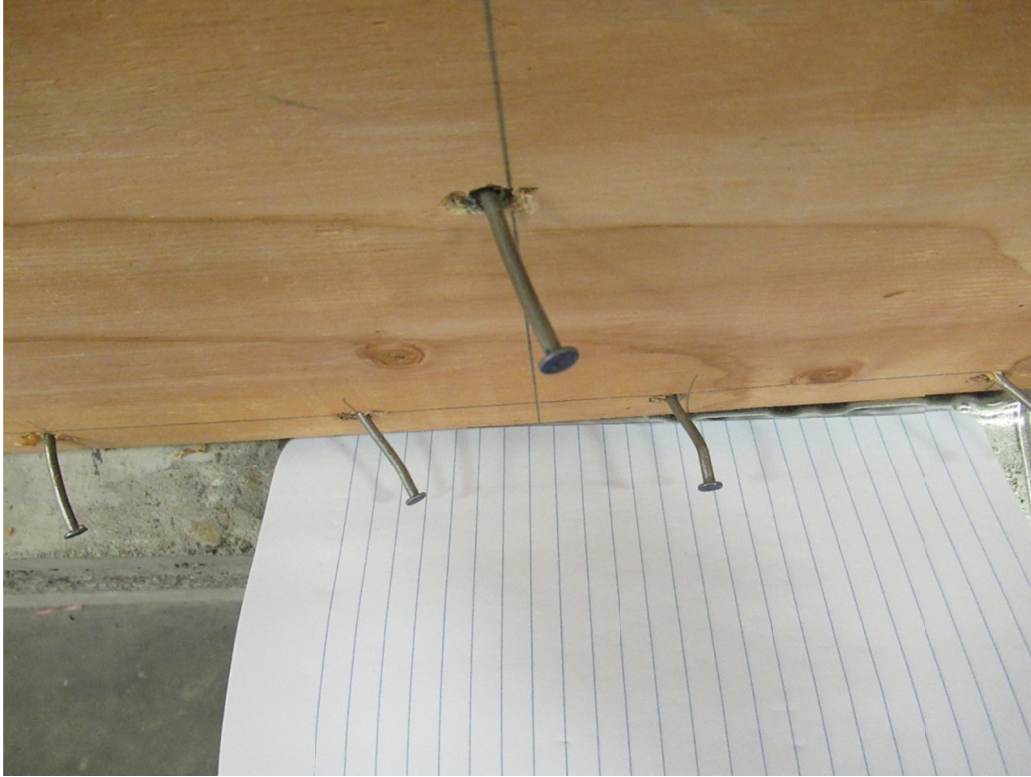
Figure D.43 Sheathing nails withdrawn and bent.

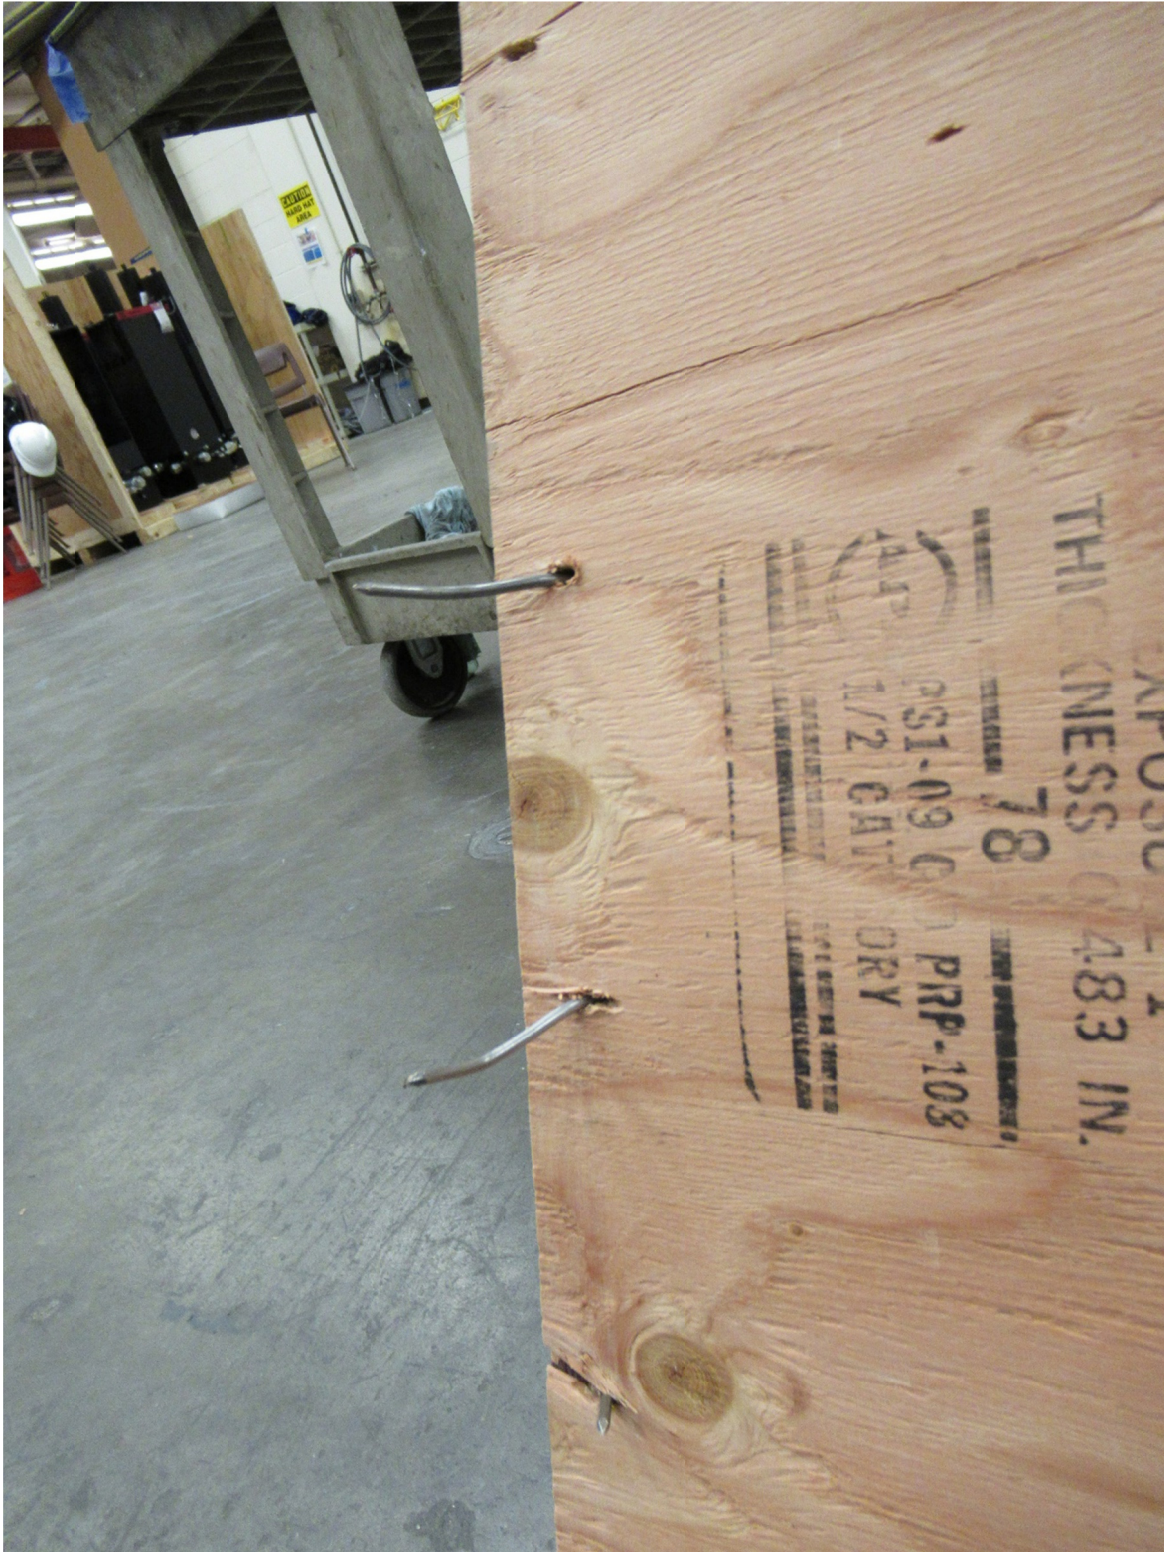
Figure D.46 Nails and slotting at interior face of plywood following selective removal.

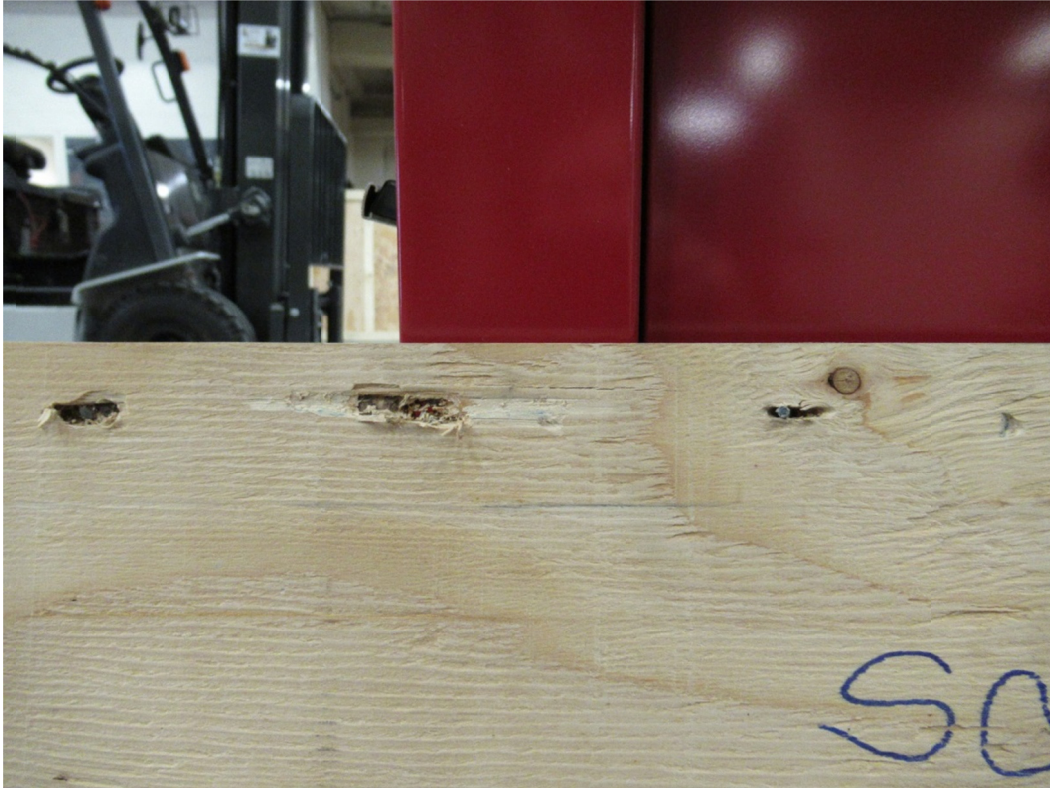
Figure D.47 Nail slotting on interior face of plywood at panel edge.

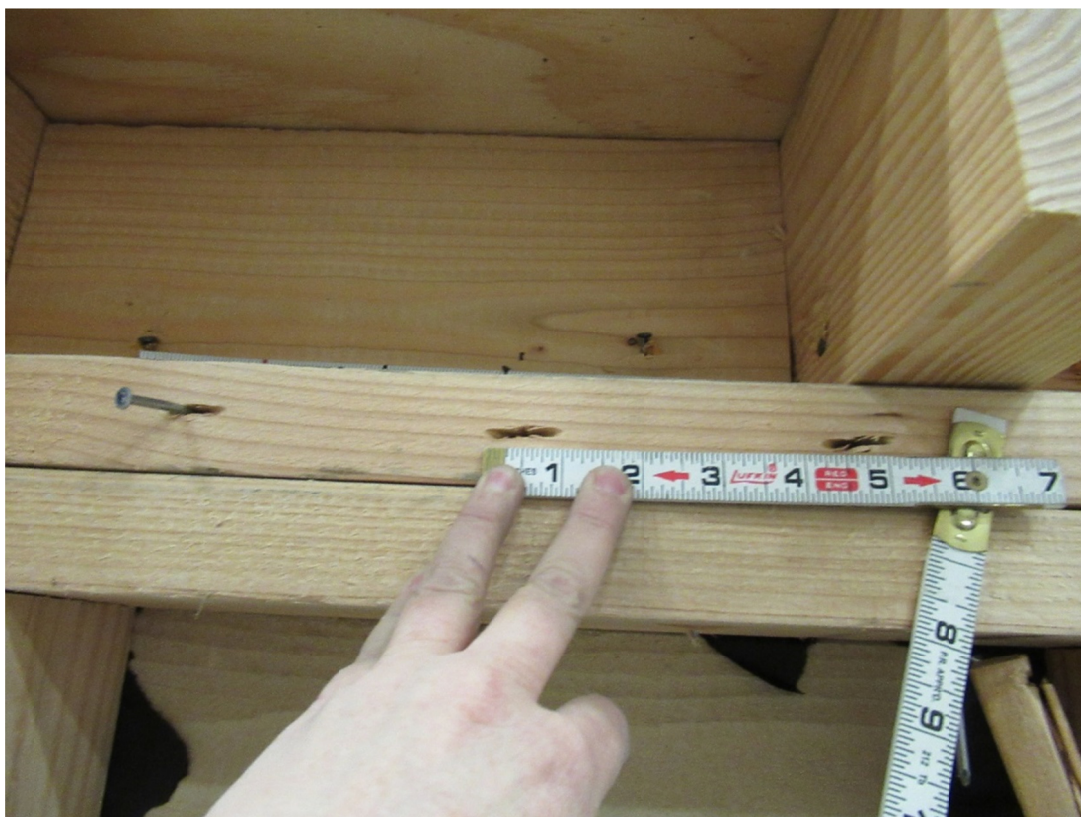
Figure D.50 Slotting observed in cripple wall top plates with plywood removed.

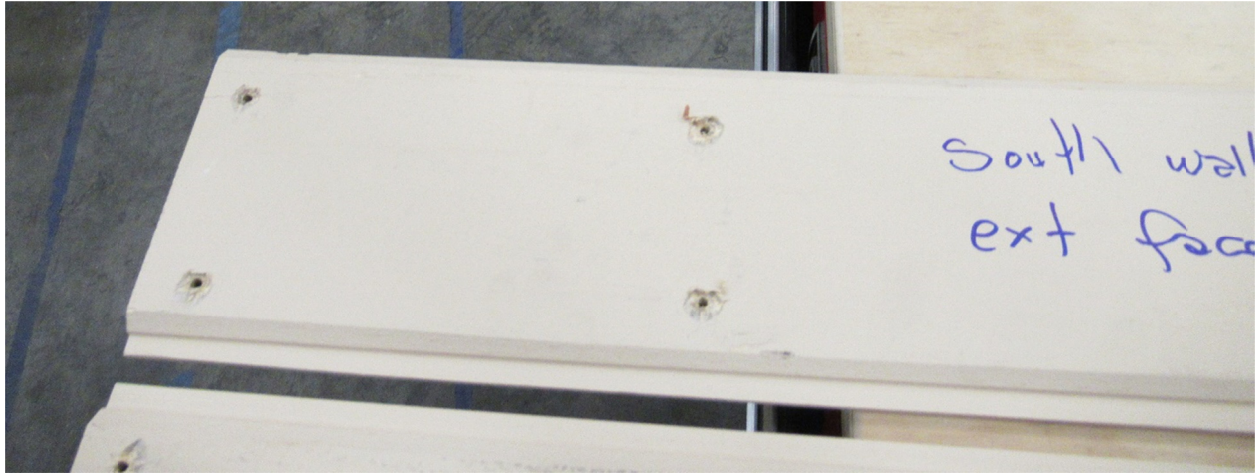
Several sections of the shiplap siding were removed for inspection. The exterior face of the siding once removed can be seen in Figures D.51 and D.52. Except for damage around the nail heads, which occurred during siding removal and some hairline cracking, there was no notable damage seen on the exterior face of the siding. The interior face of the siding can be seen in Figures D.53 through D.55. While some nail holes remained round, others were elongated up to about 3/4 in. Where siding was removed, small splits were observed in the studs at each siding nail, as seen in Figures D.56 and D.57. Note: the nails were very easy to pull during removal of the siding; this is thought to be related to the studs splitting. The same behavior was noted in Specimen C-1 shiplap siding.

Figure D.51 Exterior face of shiplap siding,

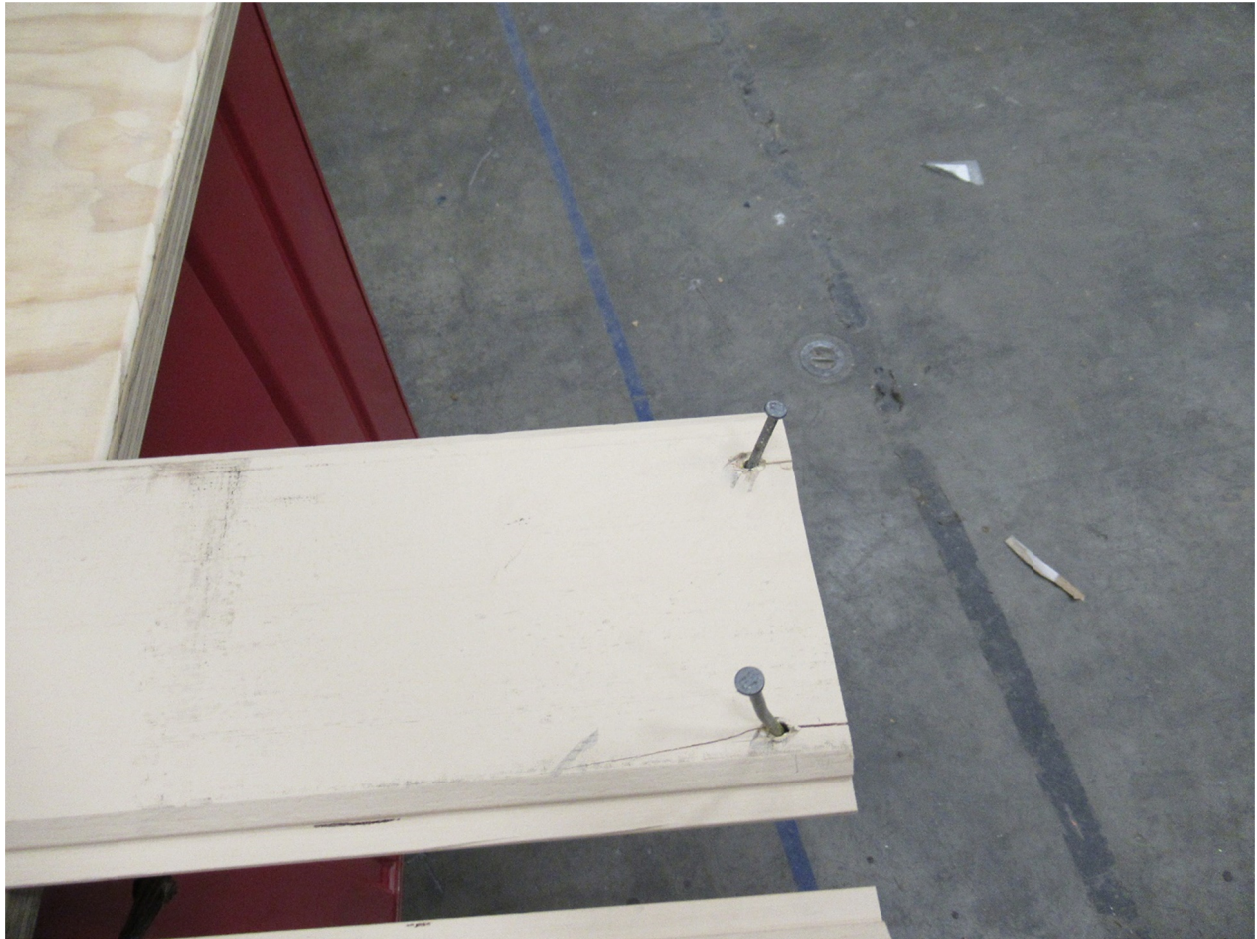
Figure D.52 Exterior face of shiplap siding,
