APPENDICES A, B, C, and D

APPENDIX A Working Group 4 Recommendations for Experimental Program

APPENDIX C Working Group 4: Damage Observations for All Specimens

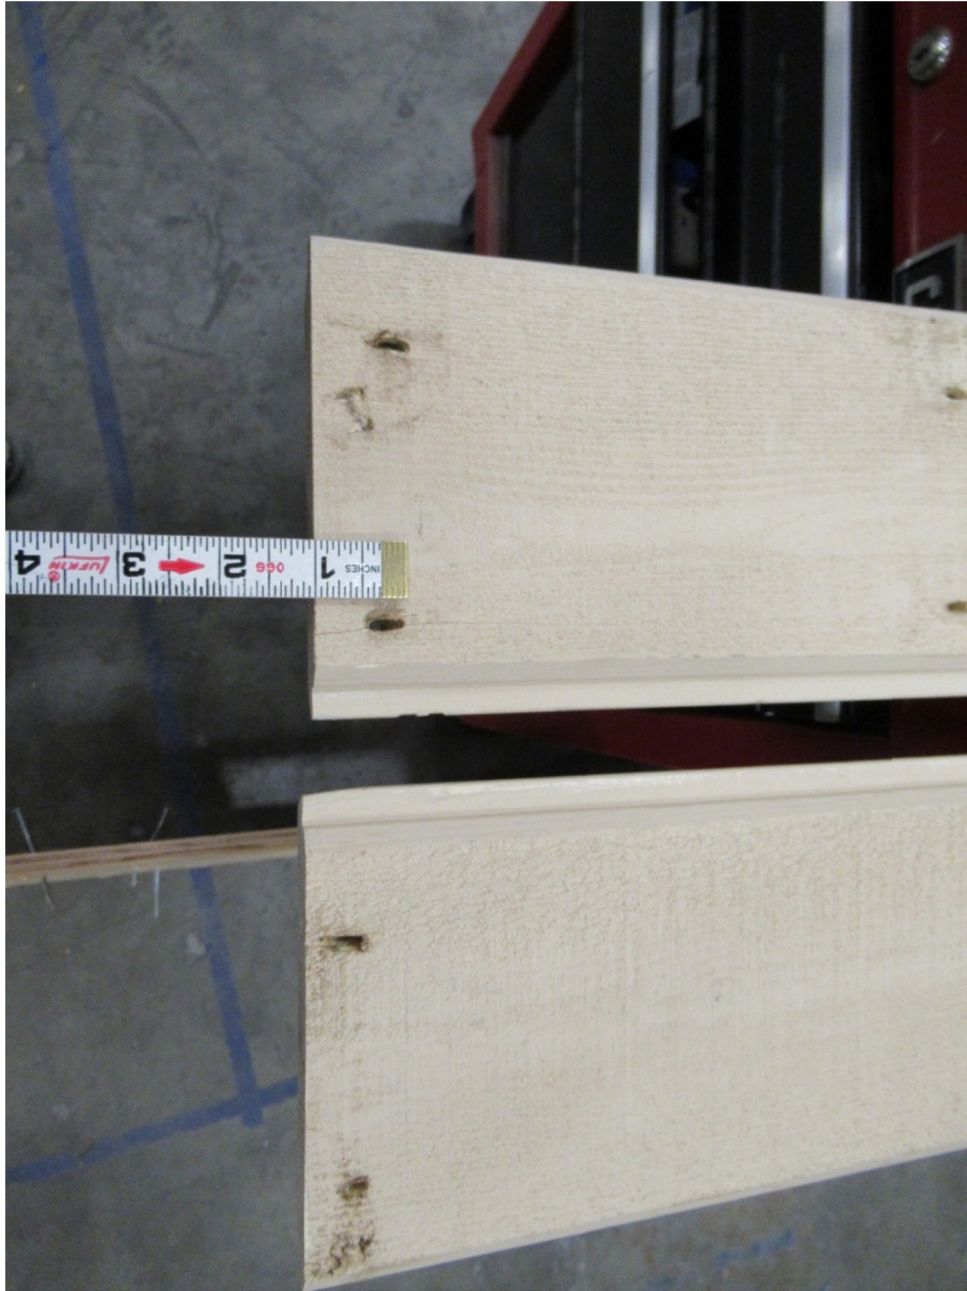
Figure D.53 Interior face of shiplap siding showing slotting of the siding that is not evident from exterior face.

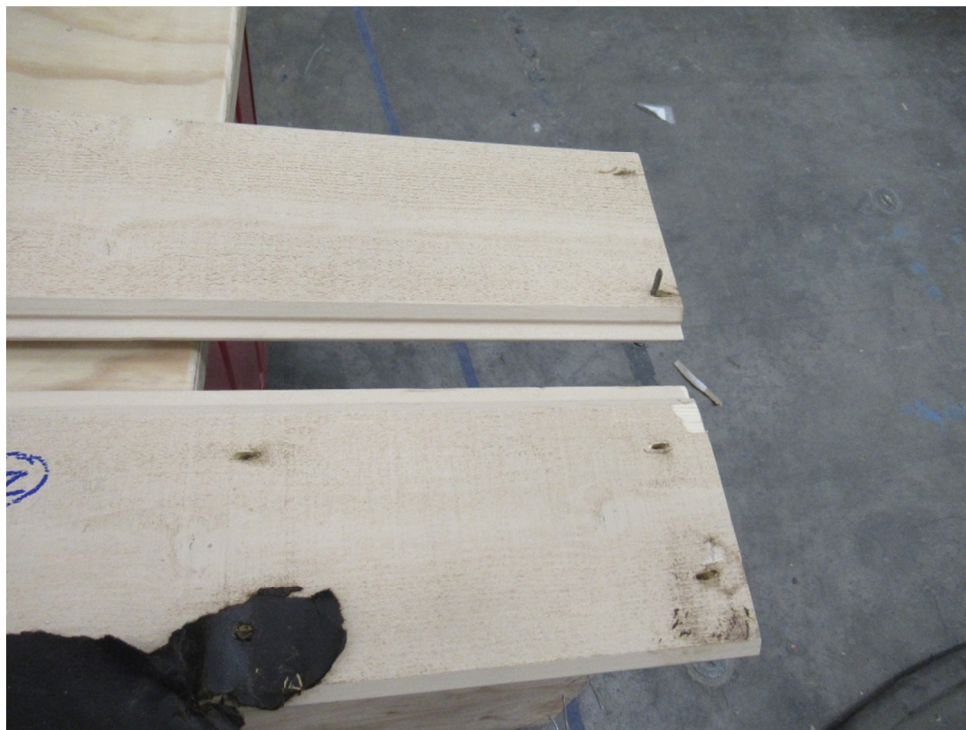
Figure D.54 Interior face of shiplap siding.

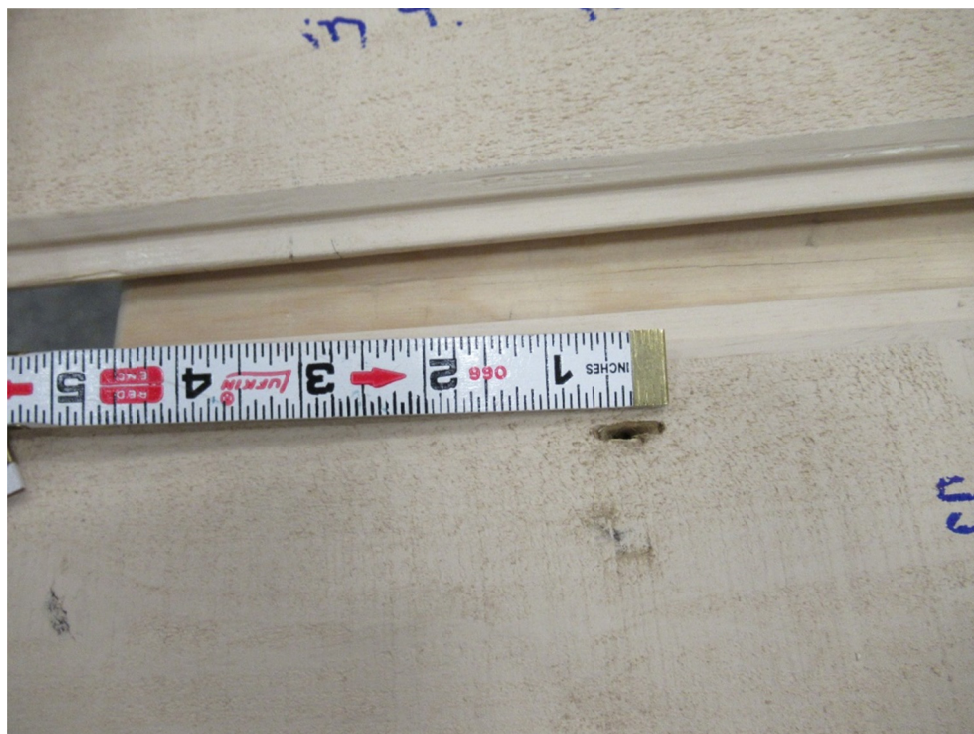
Figure D.55 Interior face of shiplap siding.

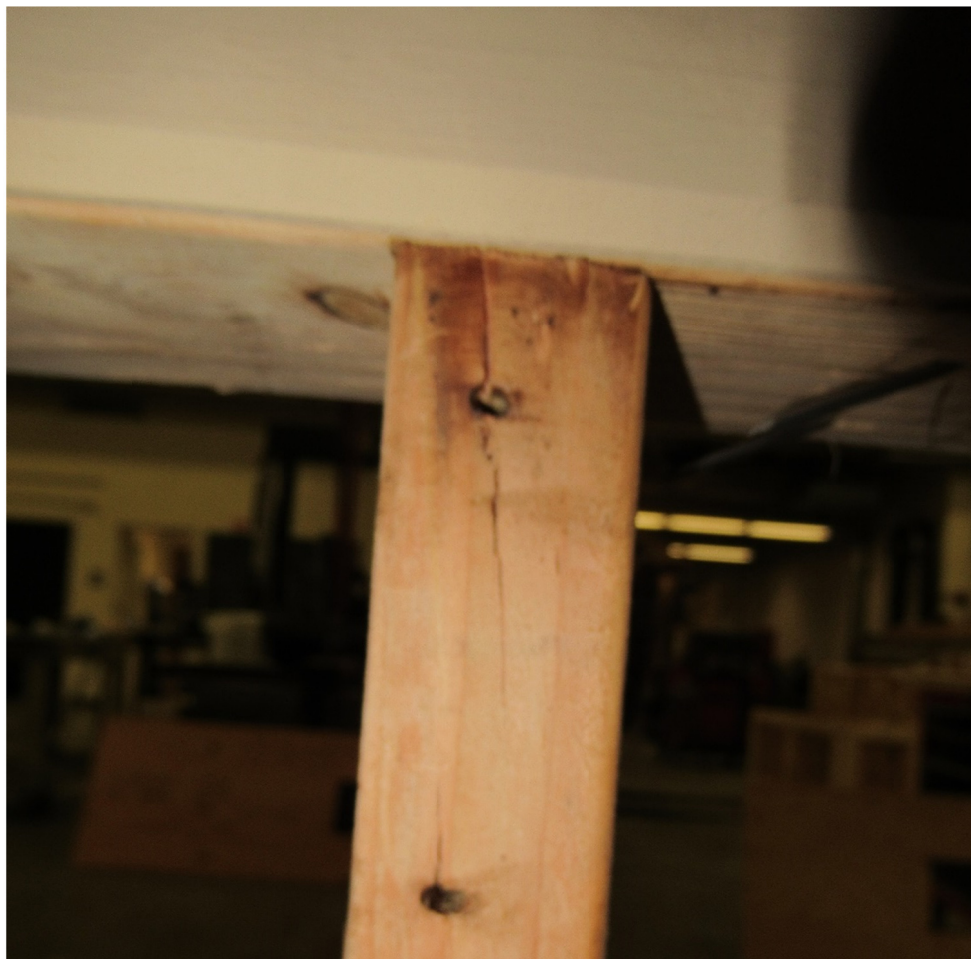
Figure D.56 Local splitting at stud end with horizontal lumber siding removed.

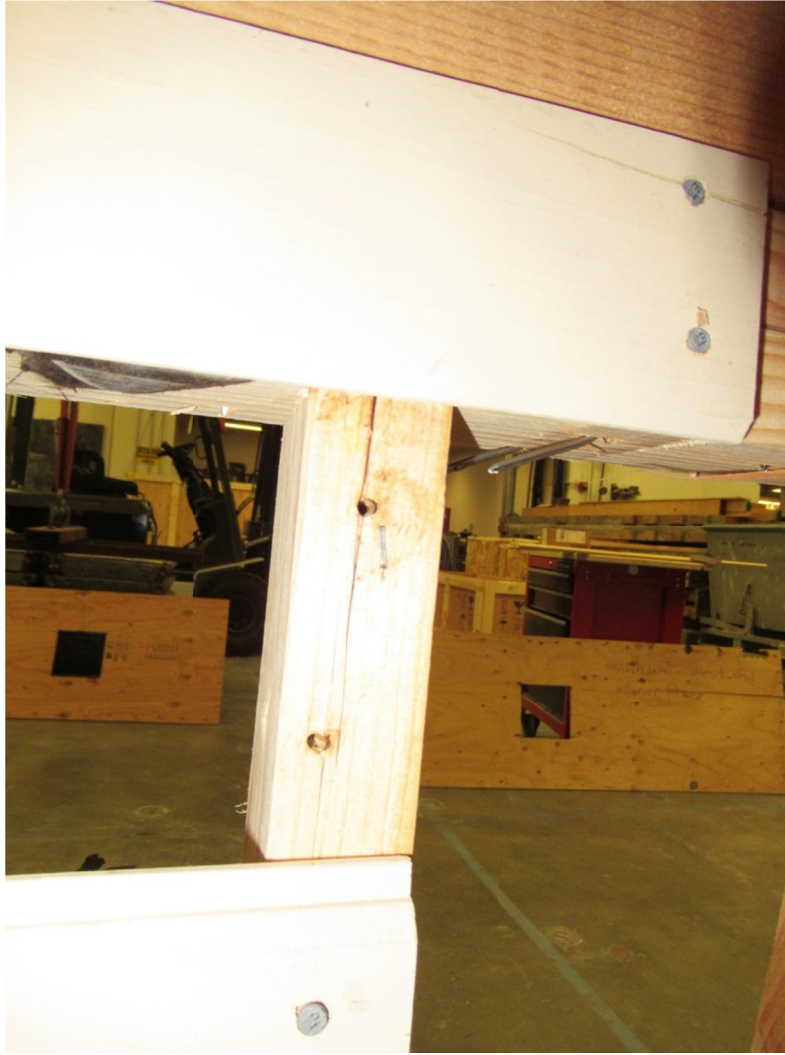
Figure D.57 Local splitting of stud with horizontal wood siding removed.

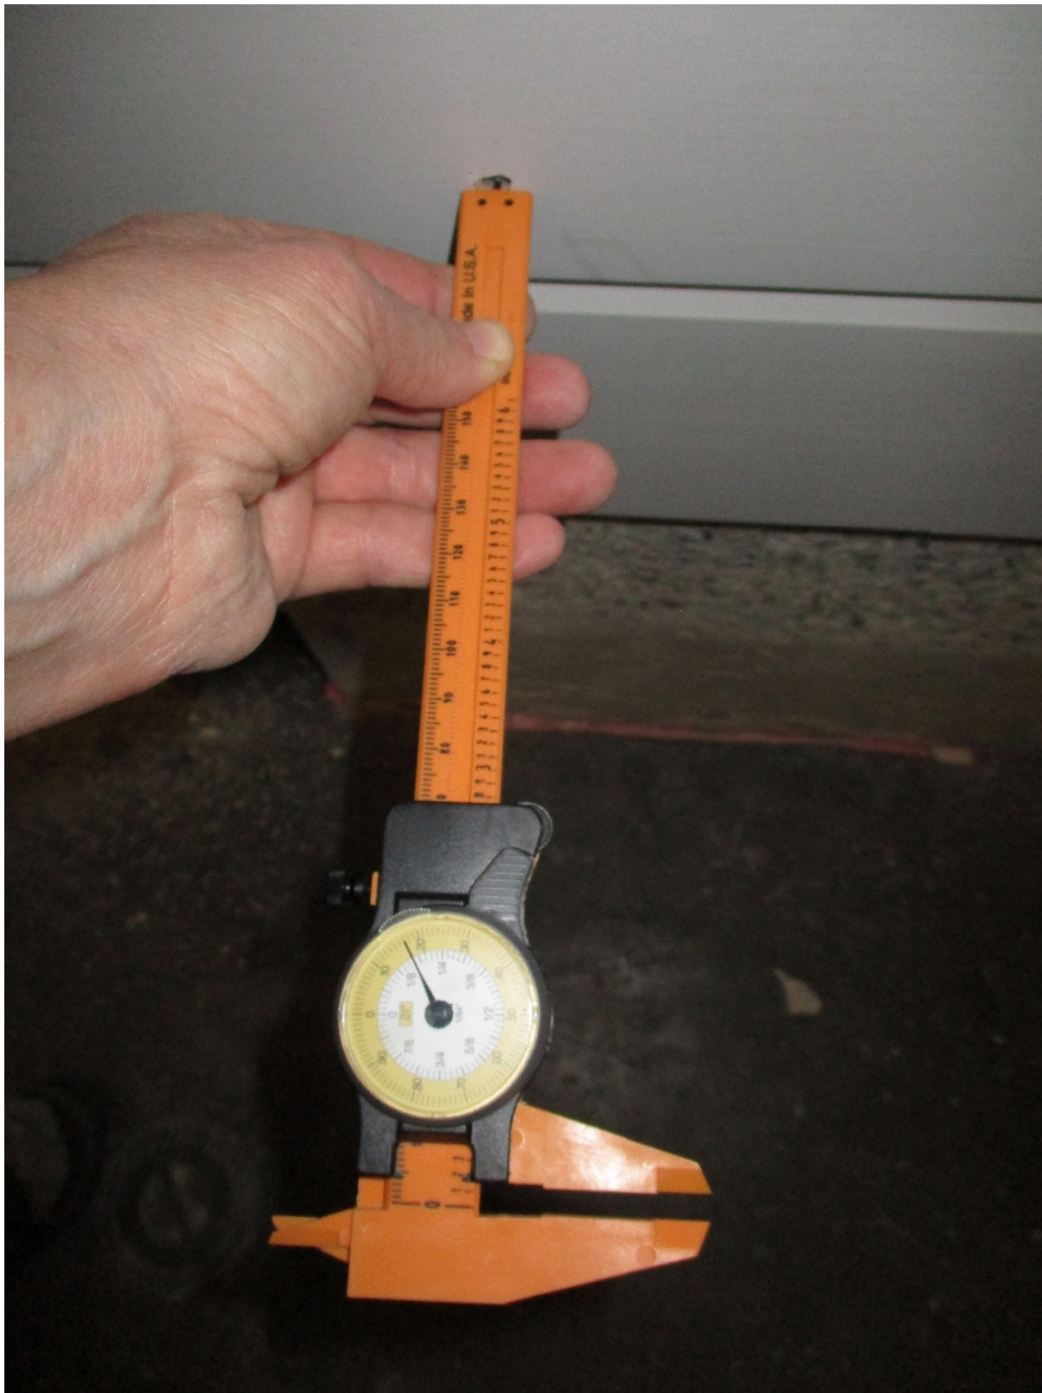
An overall view of the test specimen is provided in Figure D.62. By the end of testing, virtually all of the plaster had fallen off of the wood lath at the north and south walls, and was sitting in piles on the floor. Occasional small patches of plaster remained attached, as did the plaster at the very top of the north and south walls, from the bottom of the headers and up. The plaster at the east and west walls had significant cracking but remained attached to the lath; see Figures D.63 through D.65. The siding showed limited amounts of partial nail withdrawal, nail pull through, and occasional hairline cracking. The nail withdrawal and pull through was generally on the order of 0.10 in.; see Figures D.66 through D.70.

Figure D.68 Head pull through at siding nailing.

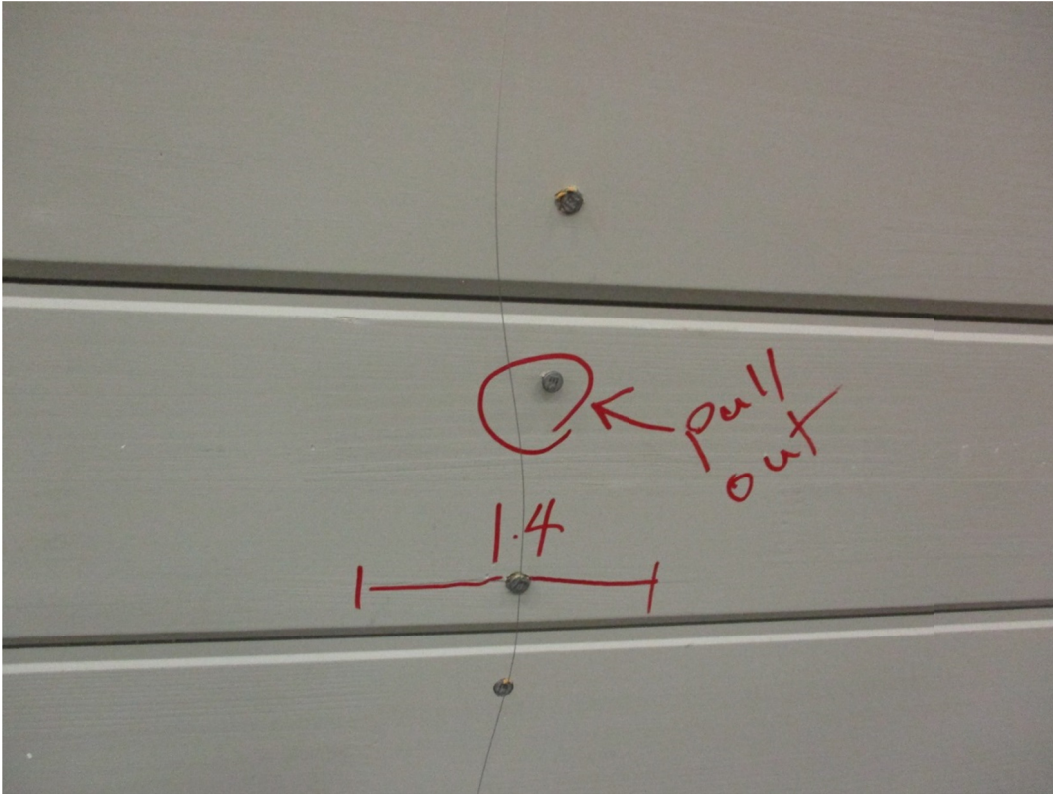
Figure D.69 Siding nail withdrawal at conclusion of testing.

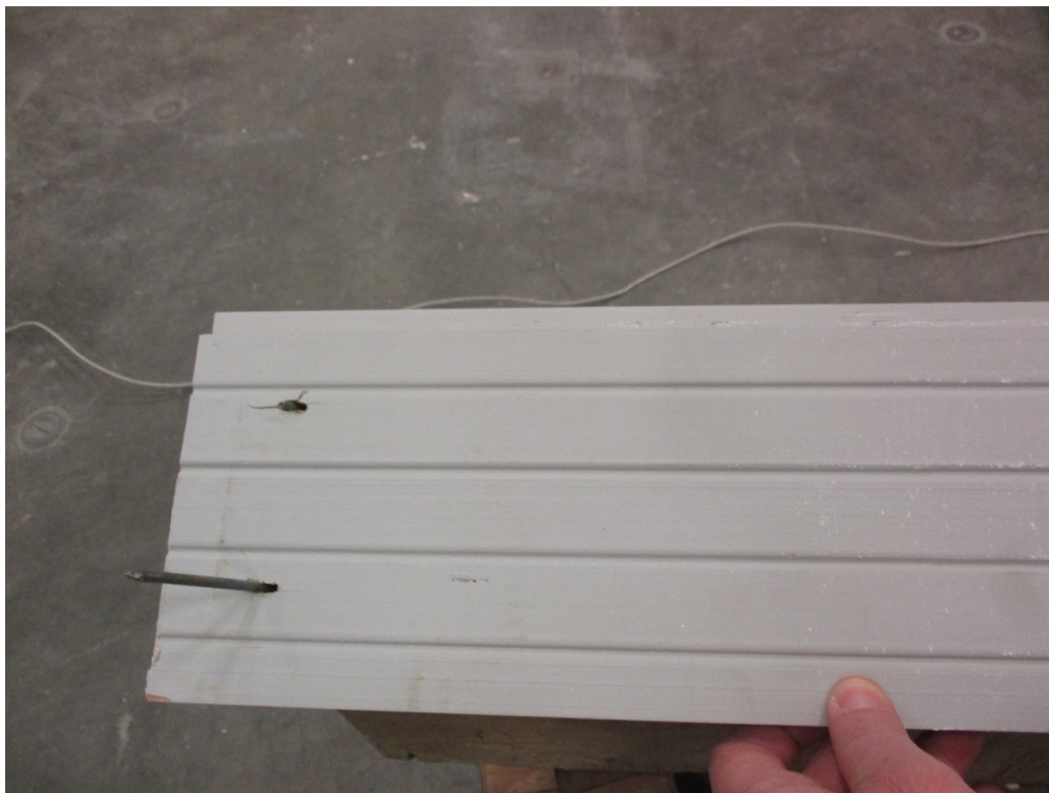
Several siding boards were removed to permit detailed observation of the siding conditions. Figures D.71 through D.73 show the backside of the siding and evidence of slotting of the siding back face. Figures D.74 and D.75 show local splitting of the studs observed at each siding nail. The siding nails were noted to be relatively easy to remove, which is believed to be in part to the stud splitting at the nails. Similar observations were made of the siding in Specimen B-1. The splitting was narrow, and there was generally a separate crack at each nail rather than the cracks propagating from each nail to each nail. For these reasons, the cracks did not cause concern regarding the capacity of the stud but did appear to affect the siding.

Figure D.71 Interior face of siding following removal.

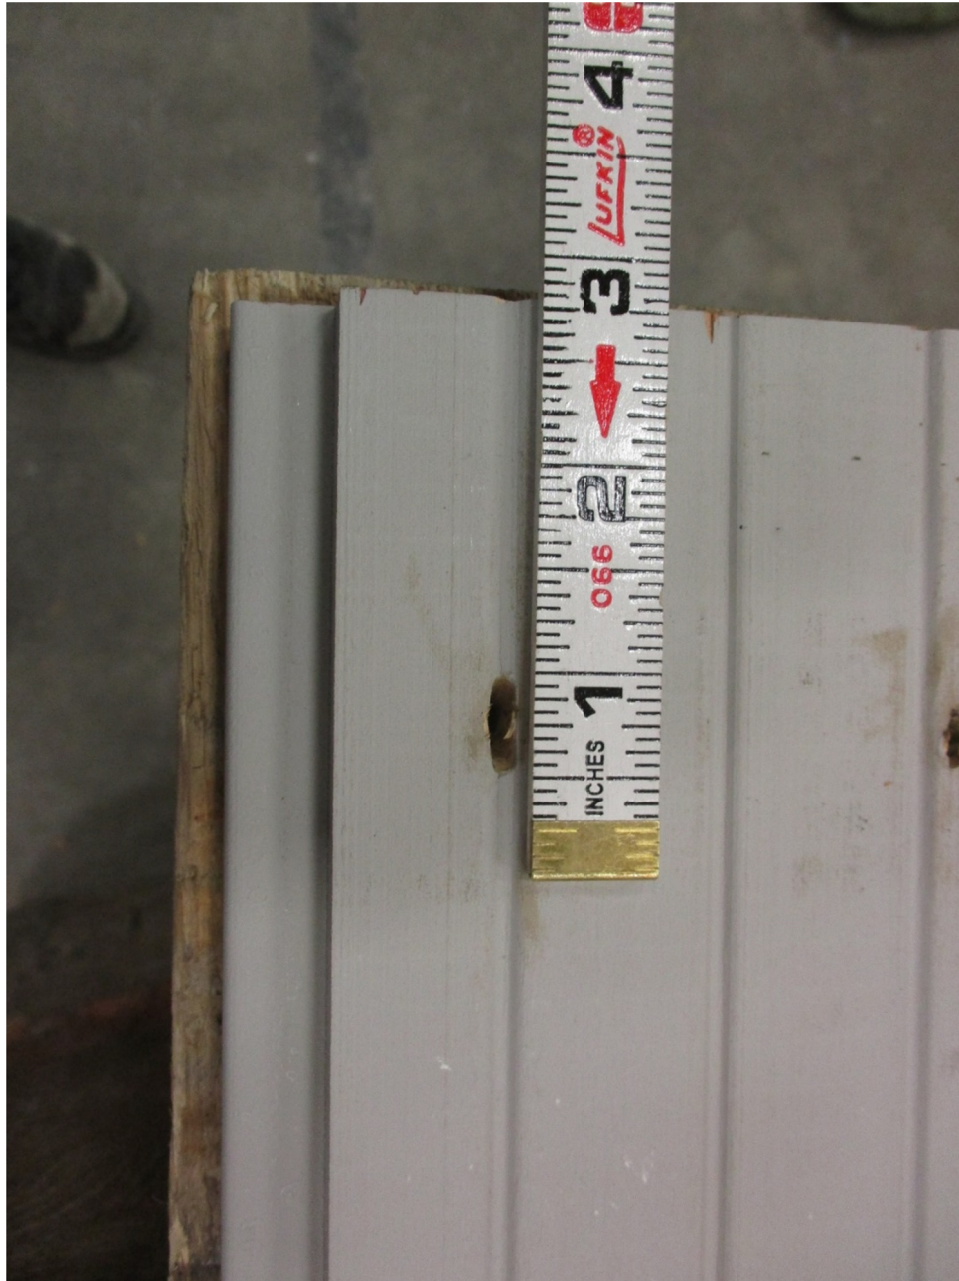
Figure D.72 Interior face of siding following removal, showing nail slots in siding.

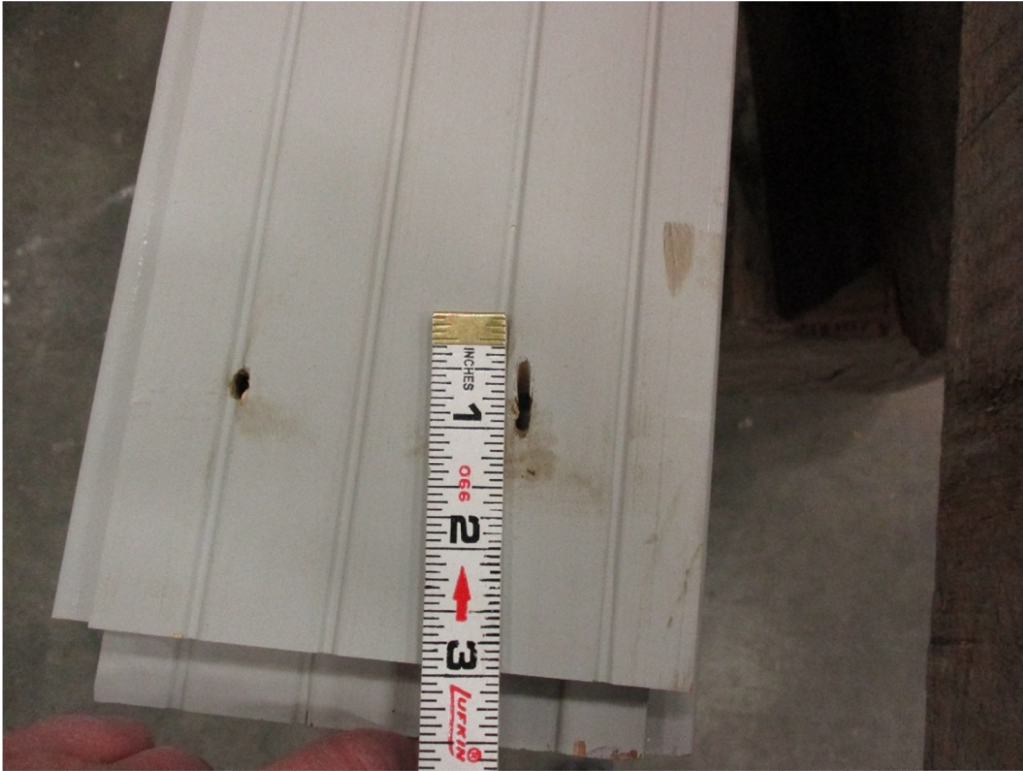
Figure D.73 Interior face of siding following removal, showing nail slots in siding.

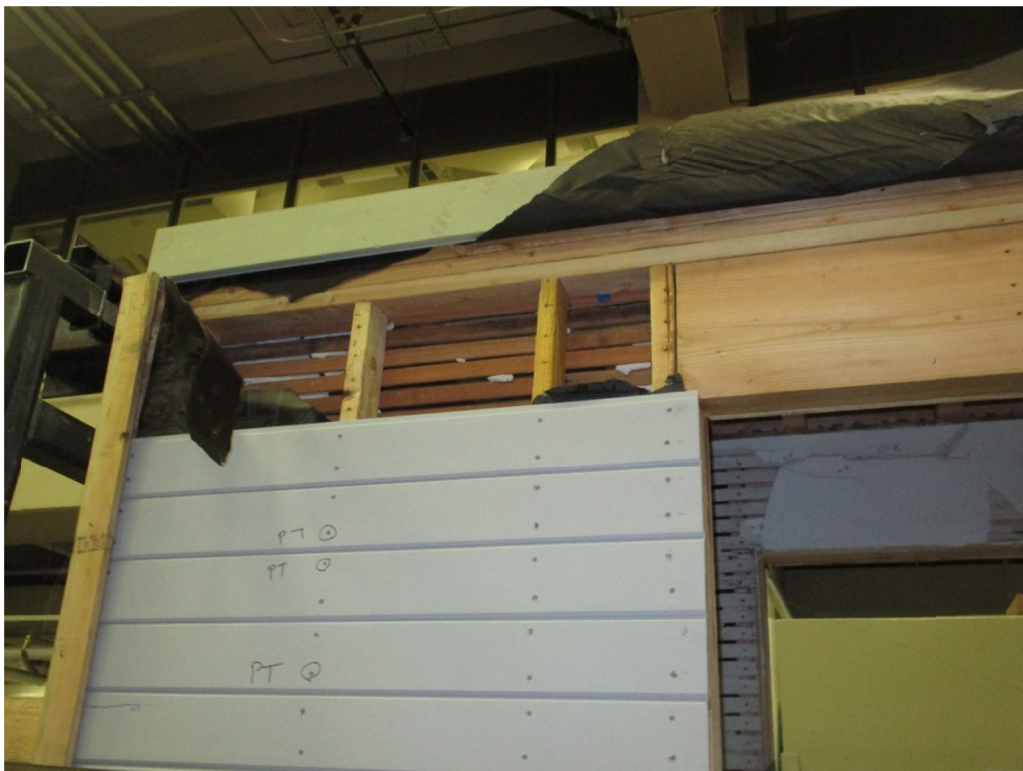
Figure D.74 Wall framing observed after siding removal.

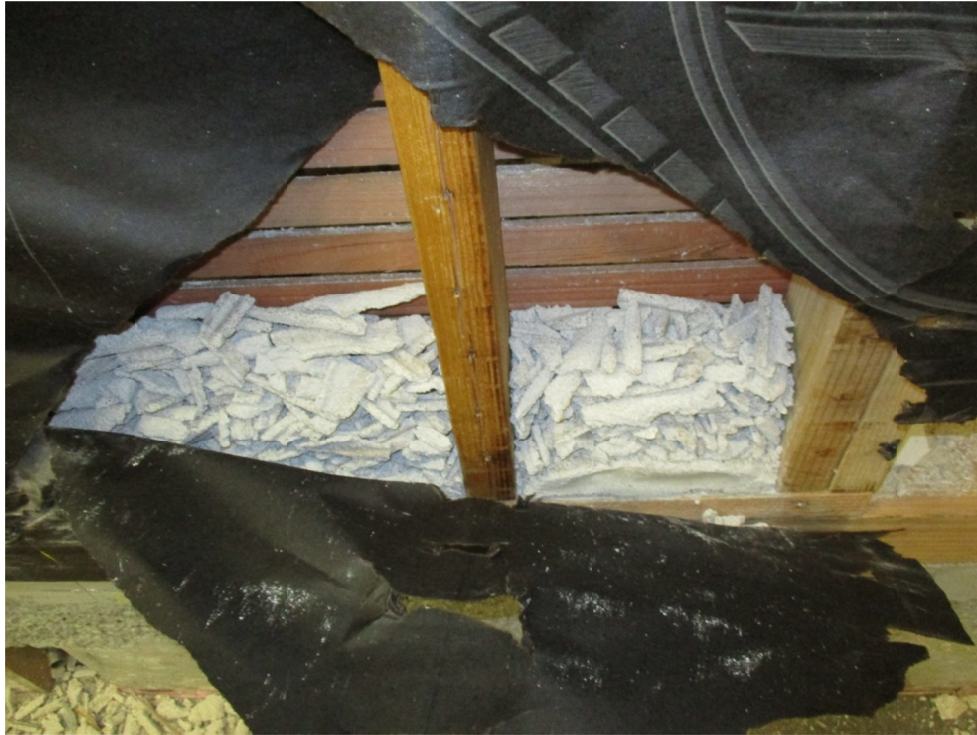
At the conclusion of testing, as previously discussed, most all of the plaster on the north and south walls was completely detached from the wood lath and sitting on the floor of the test specimen. As the plaster finish broke off of the interior face, the plaster keys that anchored the plaster to the lath also fell down into the stud cavity. As a result, the stud cavity was filled with a significant accumulation of fallen keys; see Figures D.76 and D.77. During testing, the falling of the keys sounded similar to rain. Even after the interior face plaster and the back keys had fallen, in many locations plaster remained wedged between the lath boards; see Figure D.78. The plaster remaining between boards was fairly widespread, and is believed to have helped the wood lath contribute some strength and stiffness even after the plaster had fallen off. The back side of the wood lath (Figure D.79) and the studs where the lath was attached (Figure D.80) did not show signs of hold elongation or splitting.

Figure D.76 Piled plaster keys at the bottom of the wall stud cavity at conclusion of testing.

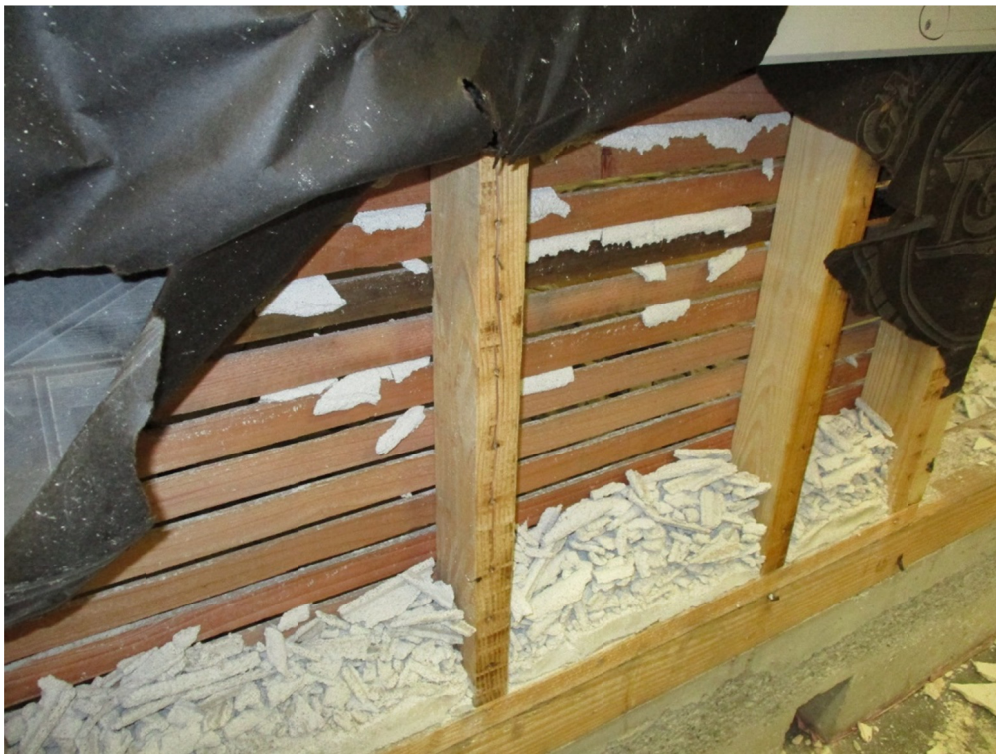
Figure D.77 Plaster keys still remaining in place and pile of fallen keys at conclusion of testing.

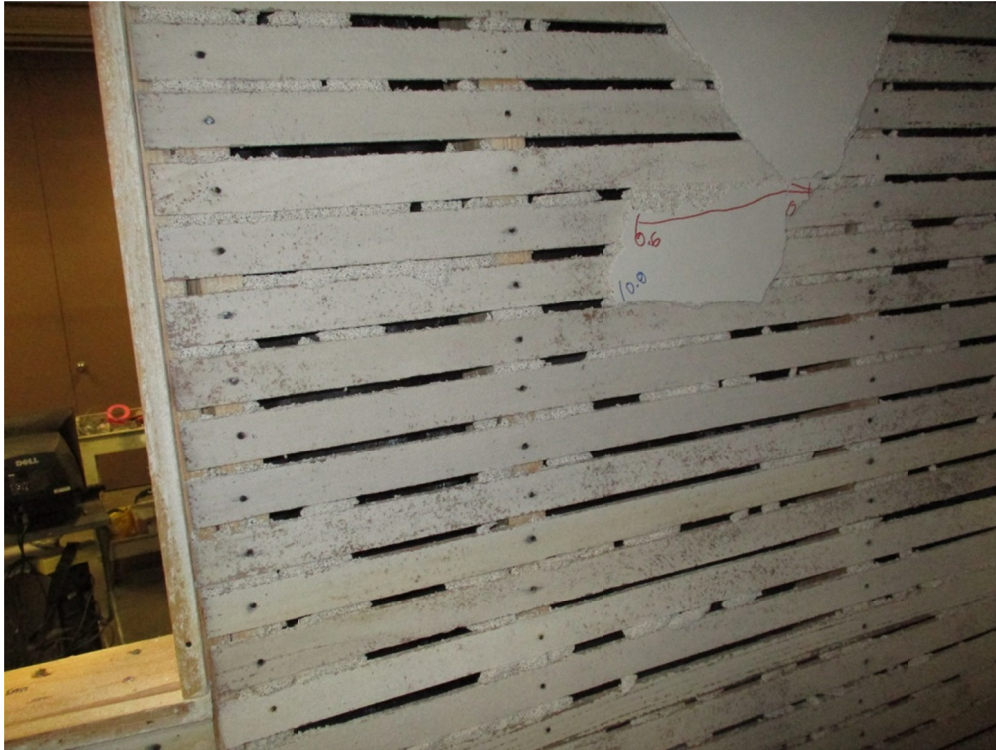
Figure D.78 Plaster keys still remaining between wood lath boards at conclusion of testing.

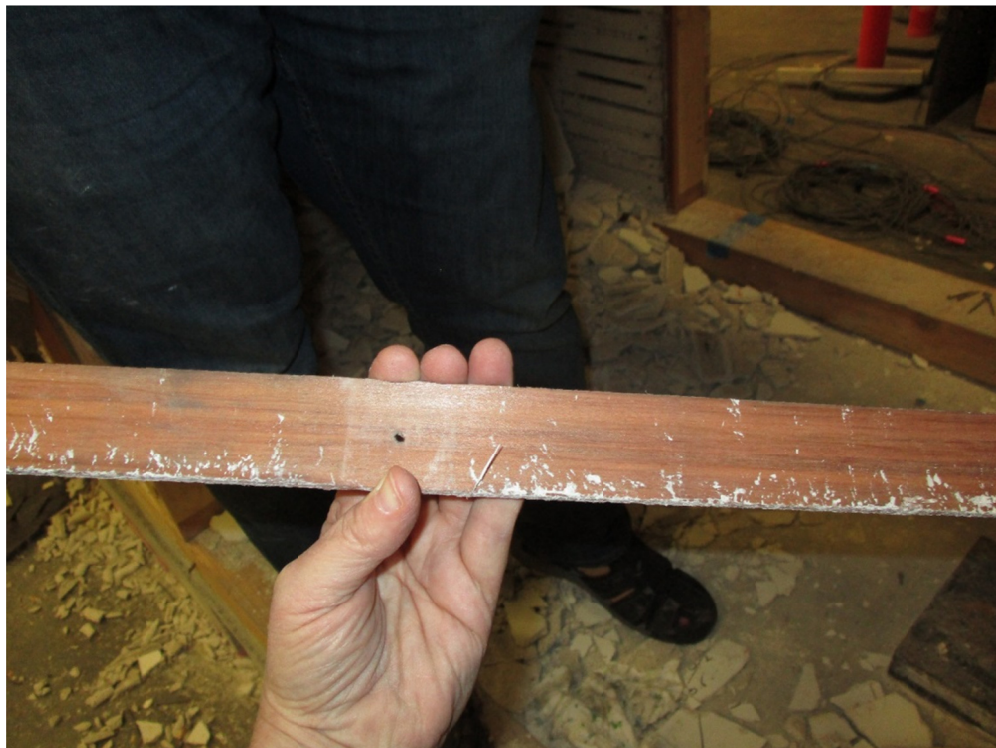
Figure D.79 Back side of wood lath board with nail hole showing no signs of enlargement or elongation.

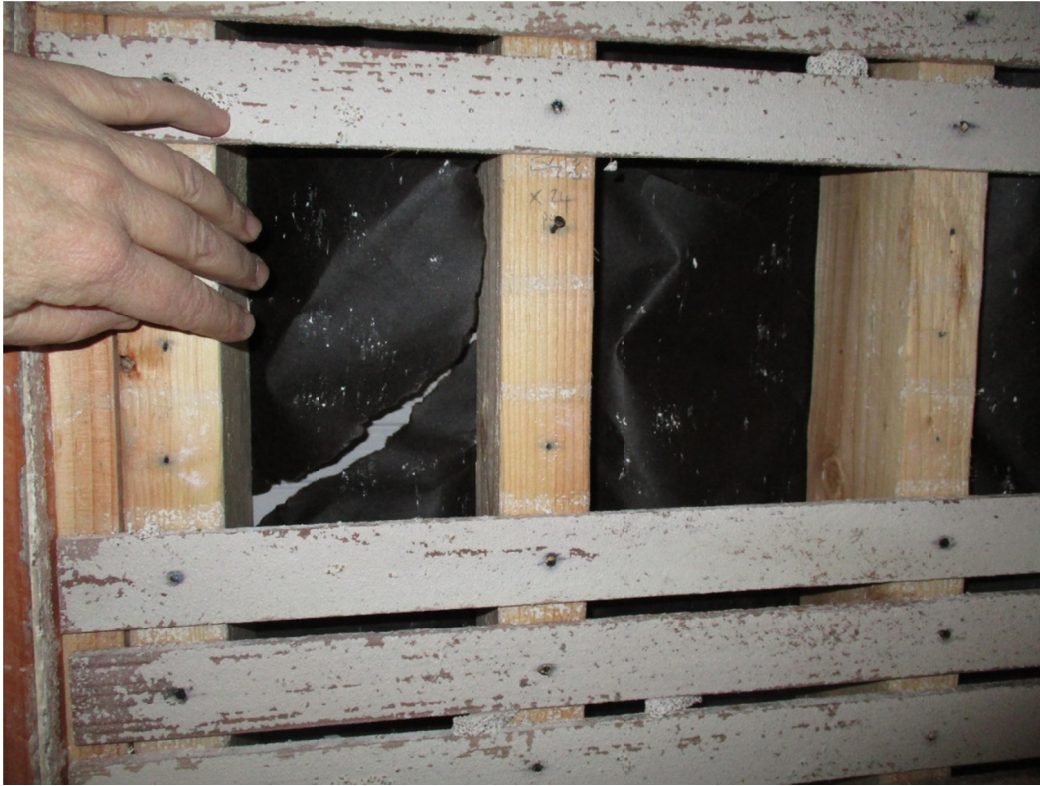
Figure D.80 Studs below removed wood lath boards showing no signs of splitting or slotting at lath nail locations.

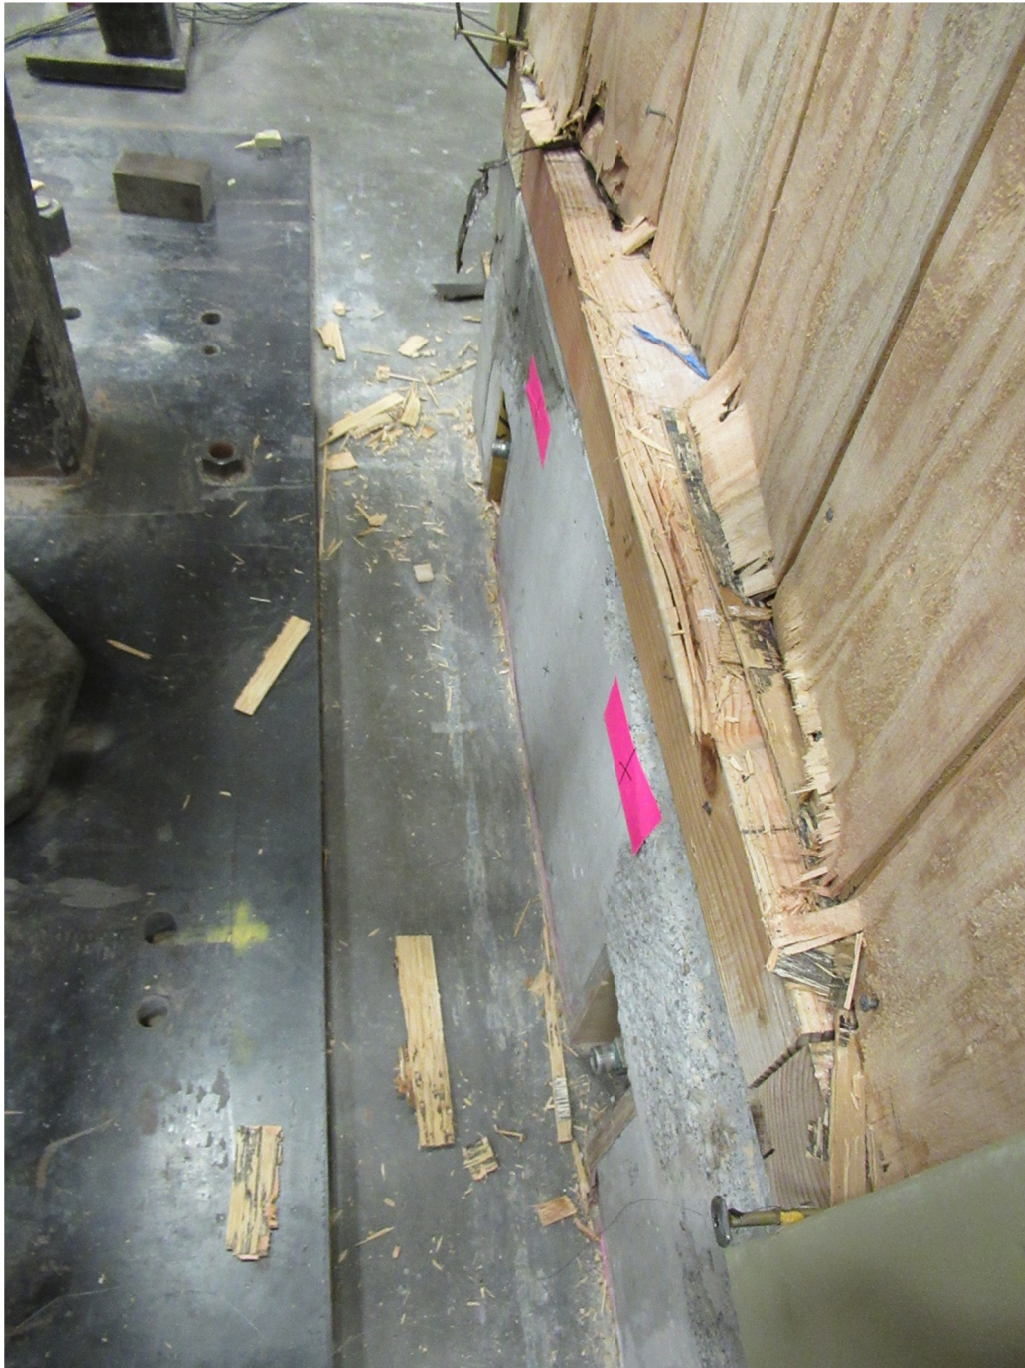
Figure D.83 Specimen C-2 base of west end of at conclusion of testing.

On the interior, the west wall bottom plate that slid and got wedged against the north at south wall bottom plates can be seen in Figures D.99 and D.100. This resulted in the concave appearance at the base of this wall seen in Figure D.83. Offset of the taped gypsum wallboard joints could be seen throughout the interior; see Figures D.101 through D.103. At the edges of gypsum wallboard panels alongside the doors and windows, partial detachment of the gypsum wallboard from the framing could be seen, with some separations up to 1/2-in.; see Figures D.104 and D.105. In addition, gouging of the gypsum wallboard at the nails could be seen, and in some cases were of a fairly significant length; see Figure D.106. Over much of the floor perimeter, debris from the gypsum wallboard was observed, including flaked pieces of joint compound, and gypsum from the core of the board gouged by nails at the bottom of the walls; see Figure D.107. Also visible on the interior at a pocket in the gypsum wallboard for instrumentation, the nails holding the 2 × 4 wall bottom plate to the foundation sill plate can be seen to have significantly withdrawn and did not extend into the foundation sill plate; see Figure D.108.

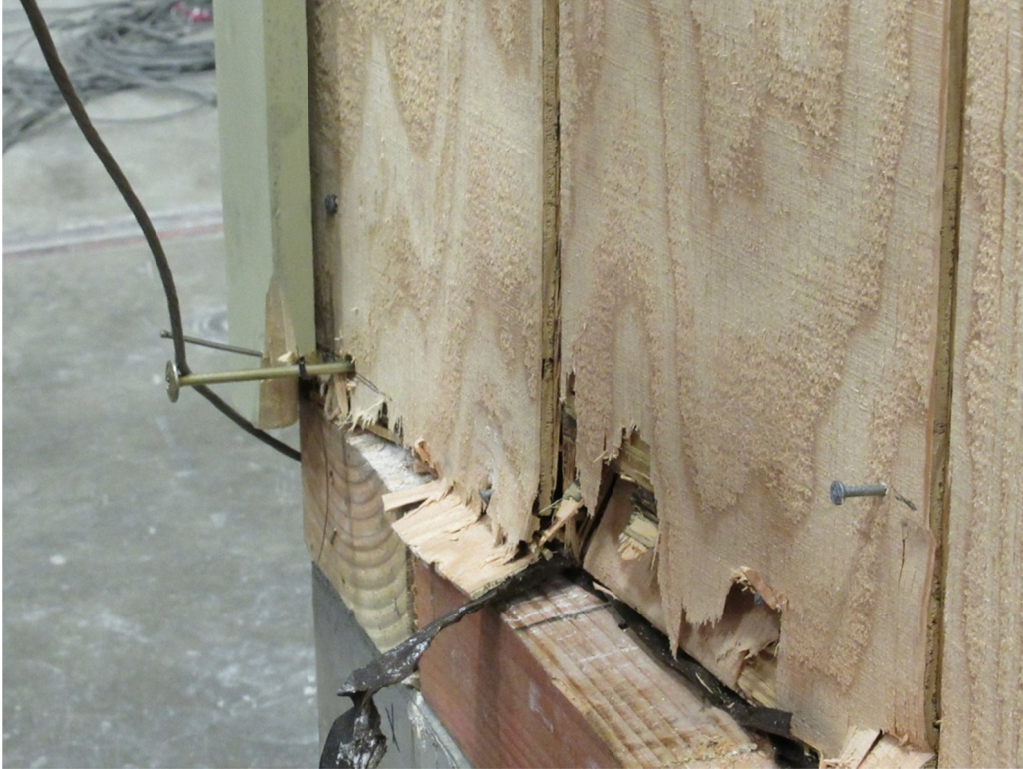
Figure D.84 Specimen C-2 Base of east end of at conclusion of testing.

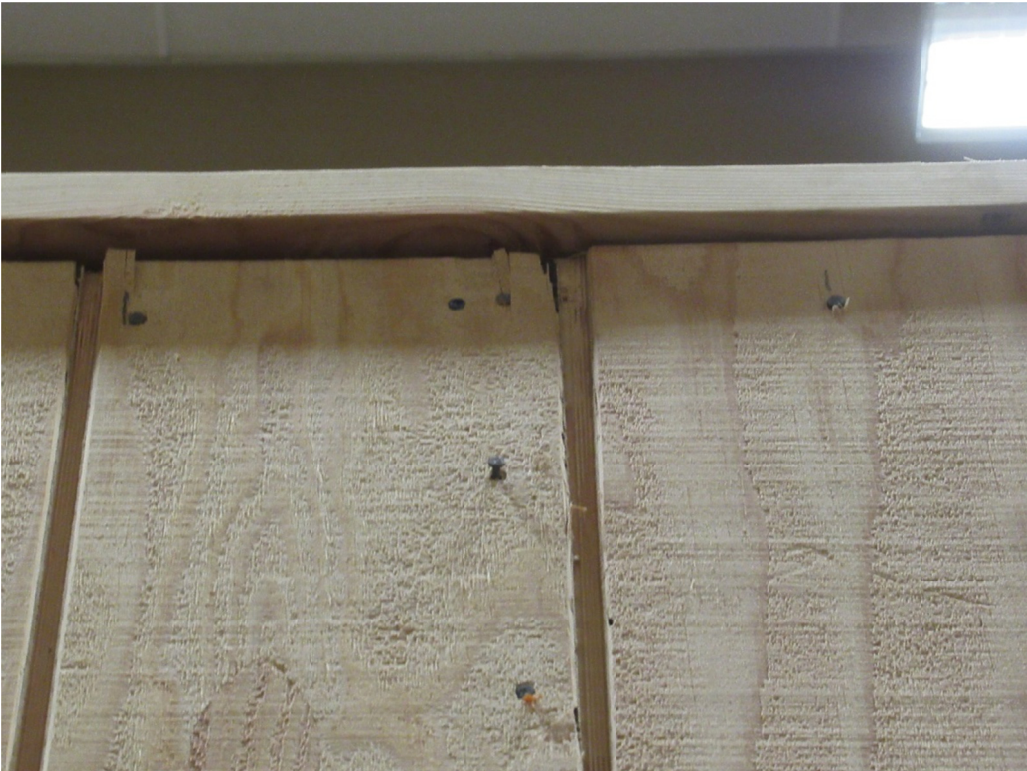
The north wall, in addition to nail withdrawal patterns similar to the south wall, developed a fracture approximately 12 in. long from the top corner of the window and extending east (Figure D.94). A vertical offset at the T1-11 joint and nail working can be seen in Figures D.95 and D.96. Additional working of sheathing nails can be seen in Figures D.97 and D.98.

Figure D.95 Working of edge nails at the T1-11 vertical joint.

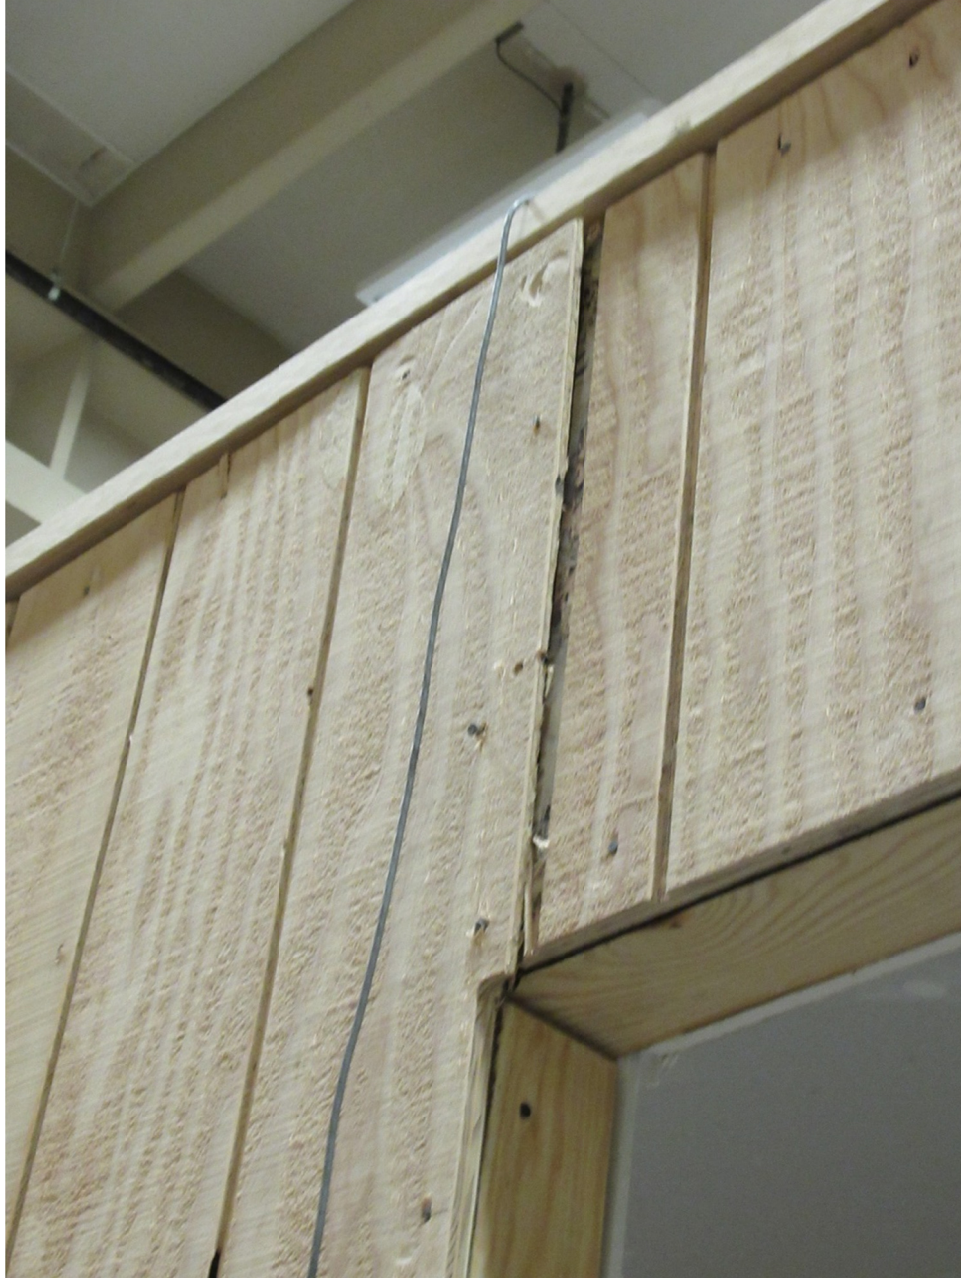
Figure D.96 Working of edge nails at the T1-11 vertical joint.

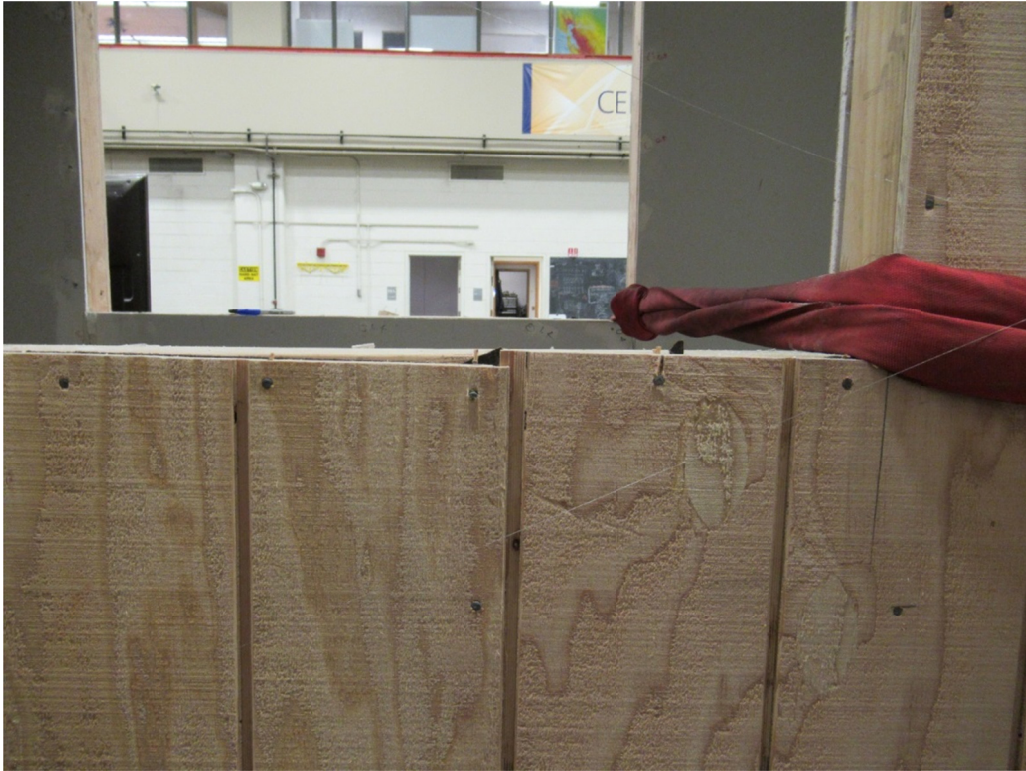
Figure D.97 Working of edge nails at the T1-11 vertical joint.

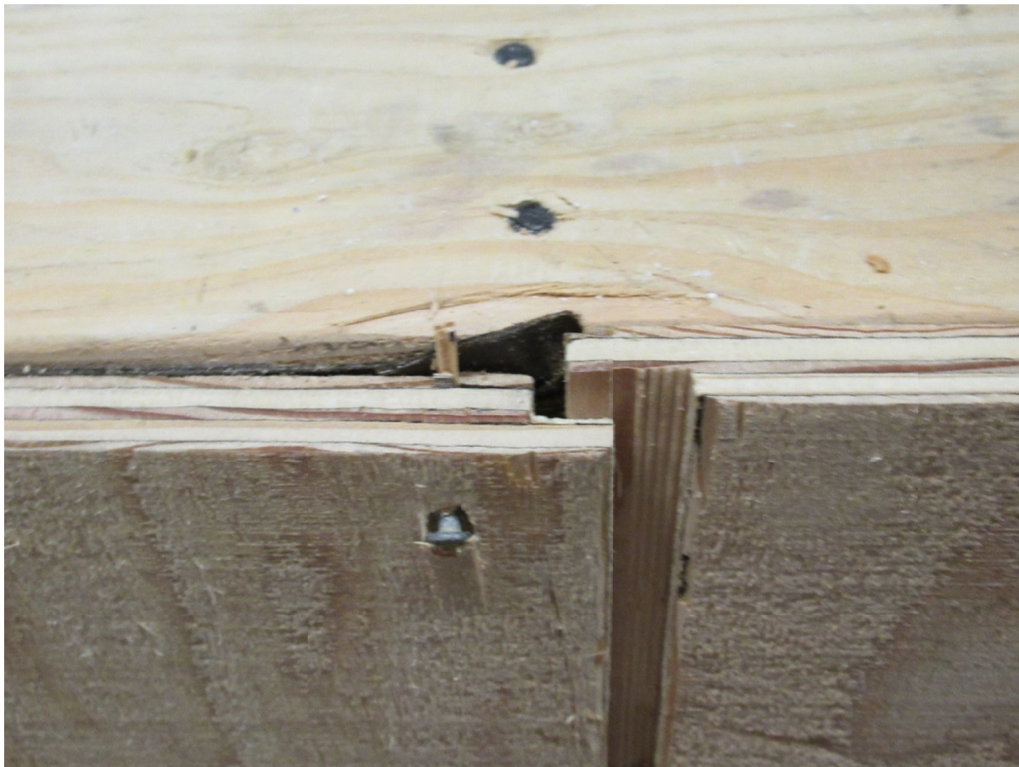
Figure D.98 Working of edge nails at the T1-11 vertical joint.

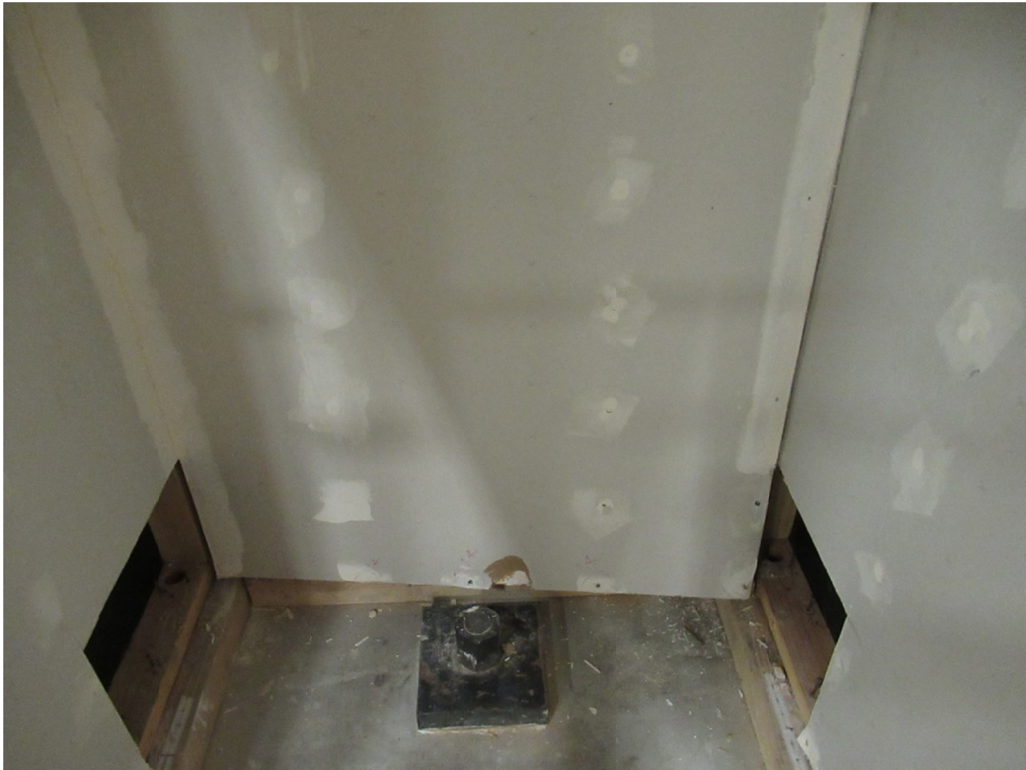
Figure D.99 Base of west-end wall where bottom plate got caught on perpendicular wall framing.
