APPENDICES A, B, C, and D

APPENDIX A Working Group 4 Recommendations for Experimental Program

APPENDIX C Working Group 4: Damage Observations for All Specimens

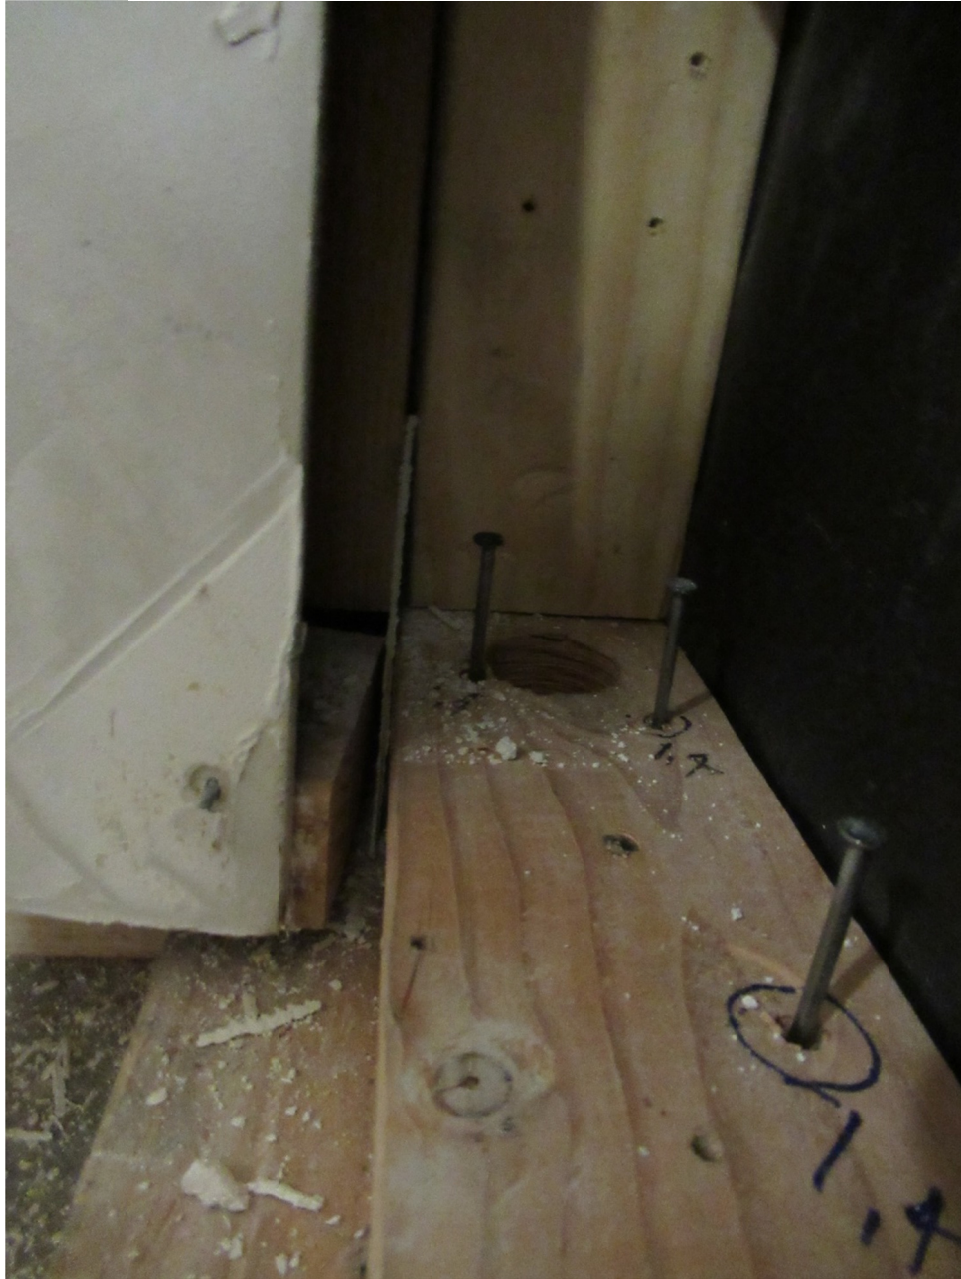
On the interior, the west wall bottom plate that slid and got wedged against the north at south wall bottom plates can be seen in Figures D.99 and D.100. This resulted in the concave appearance at the base of this wall seen in Figure D.83. Offset of the taped gypsum wallboard joints could be seen throughout the interior; see Figures D.101 through D.103. At the edges of gypsum wallboard panels alongside the doors and windows, partial detachment of the gypsum wallboard from the framing could be seen, with some separations up to 1/2-in.; see Figures D.104 and D.105. In addition, gouging of the gypsum wallboard at the nails could be seen, and in some cases were of a fairly significant length; see Figure D.106. Over much of the floor perimeter, debris from the gypsum wallboard was observed, including flaked pieces of joint compound, and gypsum from the core of the board gouged by nails at the bottom of the walls; see Figure D.107. Also visible on the interior at a pocket in the gypsum wallboard for instrumentation, the nails holding the 2 × 4 wall bottom plate to the foundation sill plate can be seen to have significantly withdrawn and did not extend into the foundation sill plate; see Figure D.108.

Figure D.100 Close-up of west wall bottom plate to left, withdrawn bottom plate nails to right.

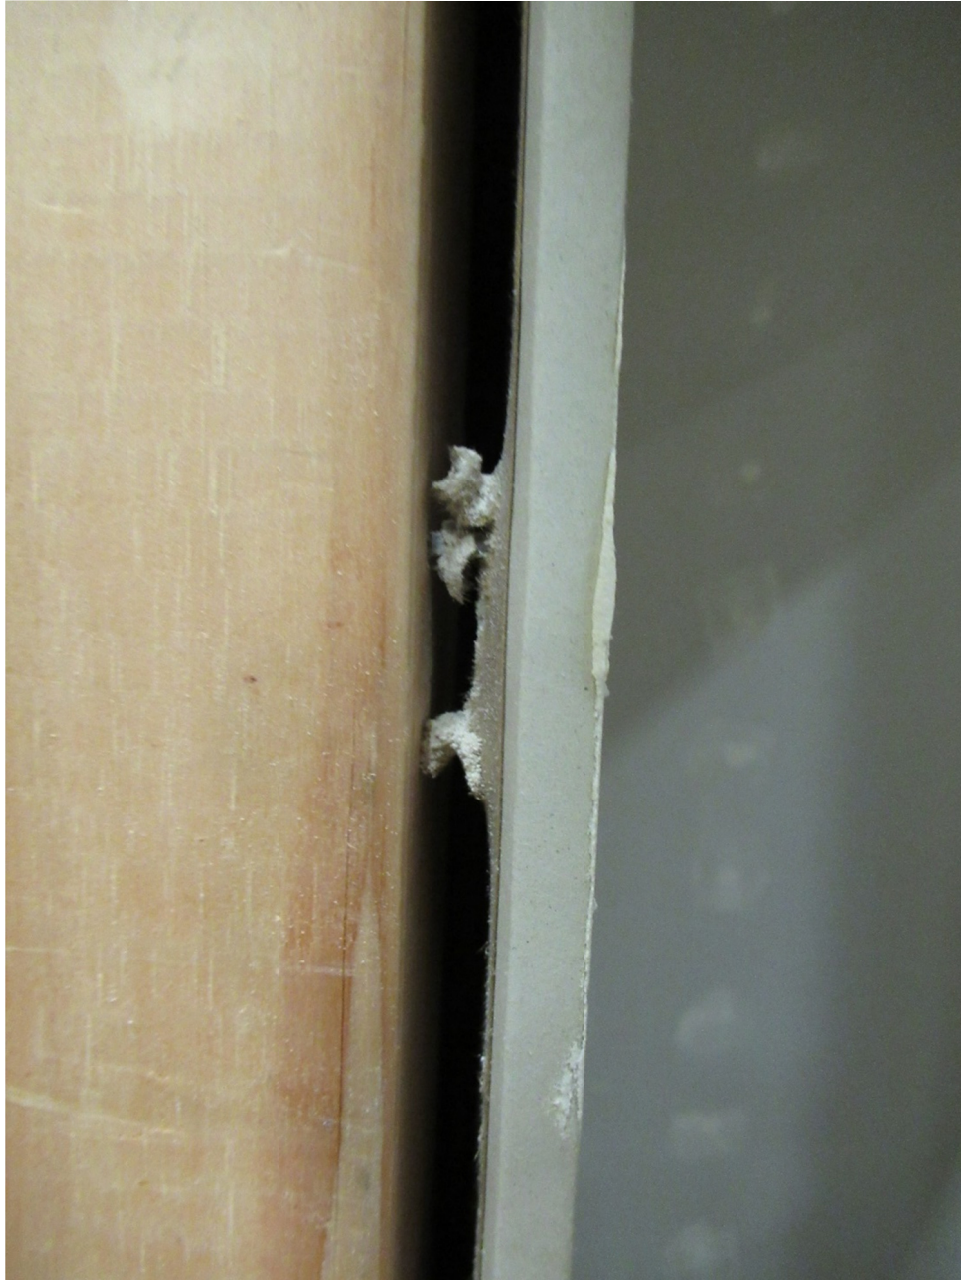
Figure D.105 Separation of gypboard from framing.

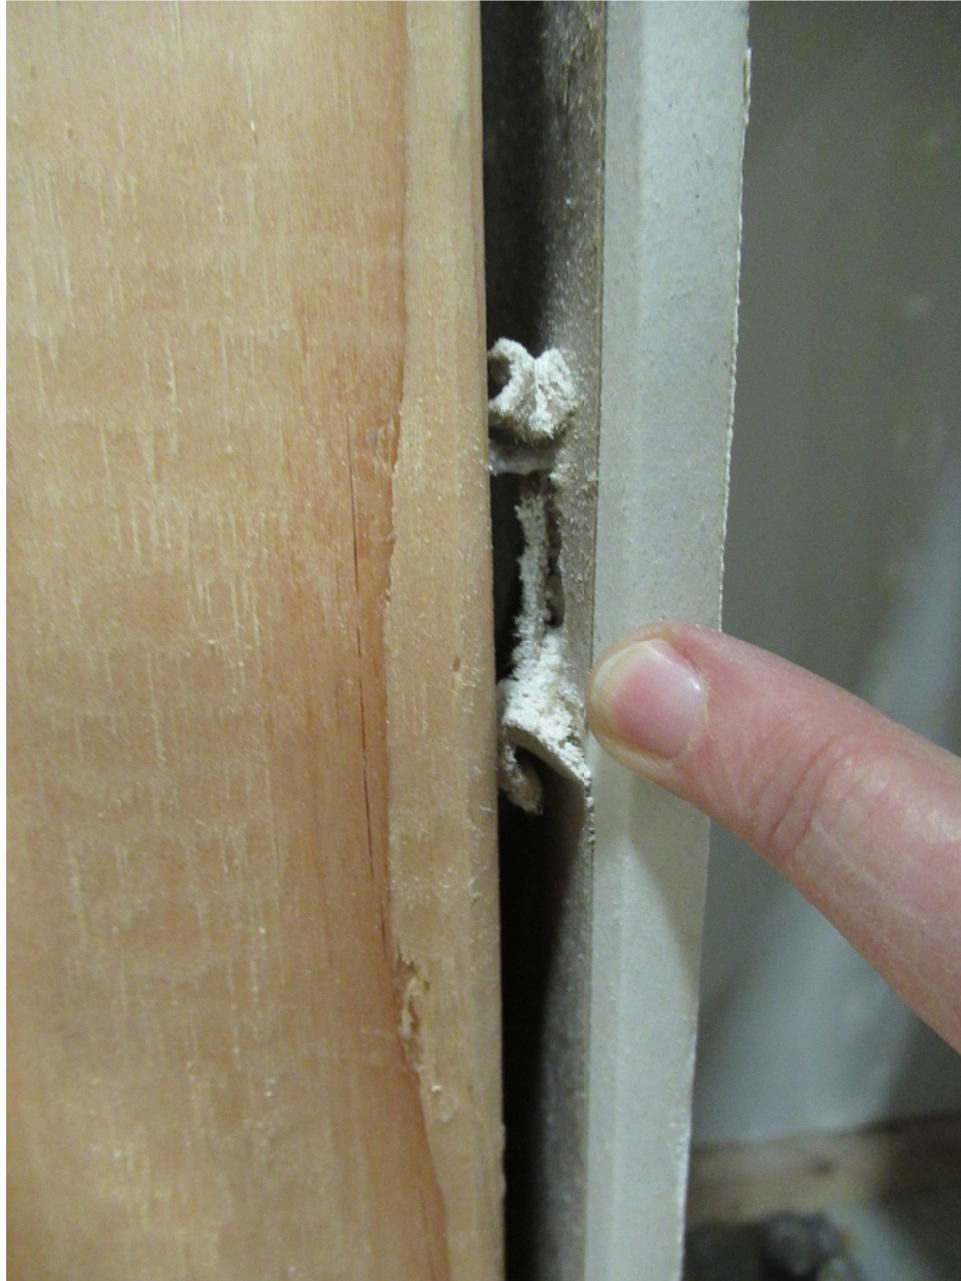
Figure D.106 Gouging of the gypsum wallboard back face at side of door opening.

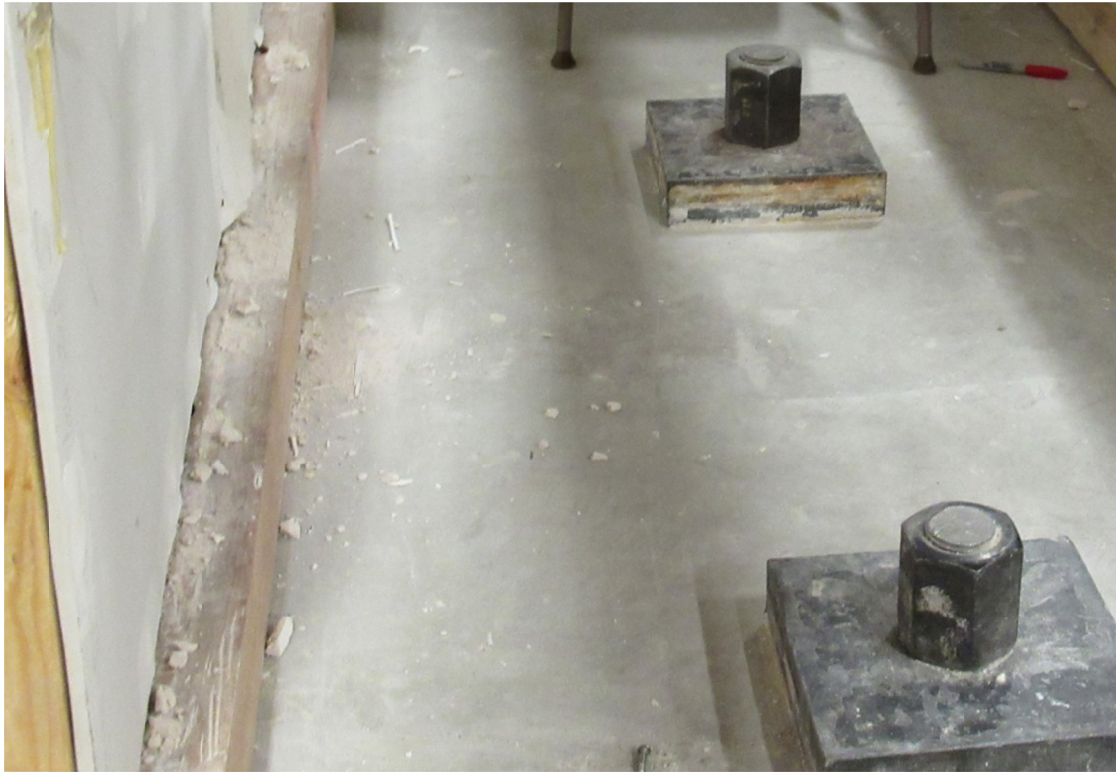
Figure D.107 Gouging of gypsum wallboard at the base of the walls.

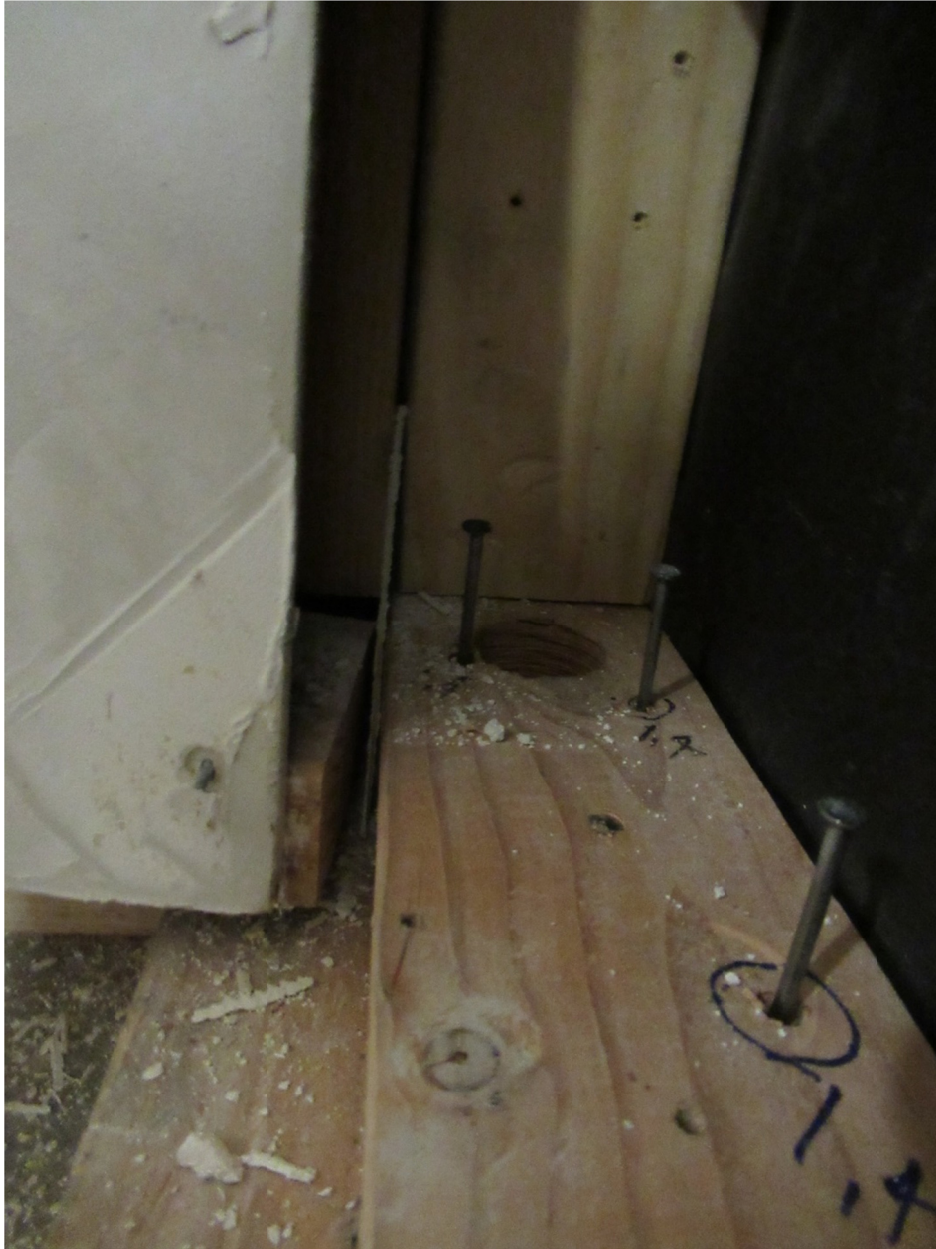
Figure D.108 Bottom plate nails withdrawn from the bottom plate.

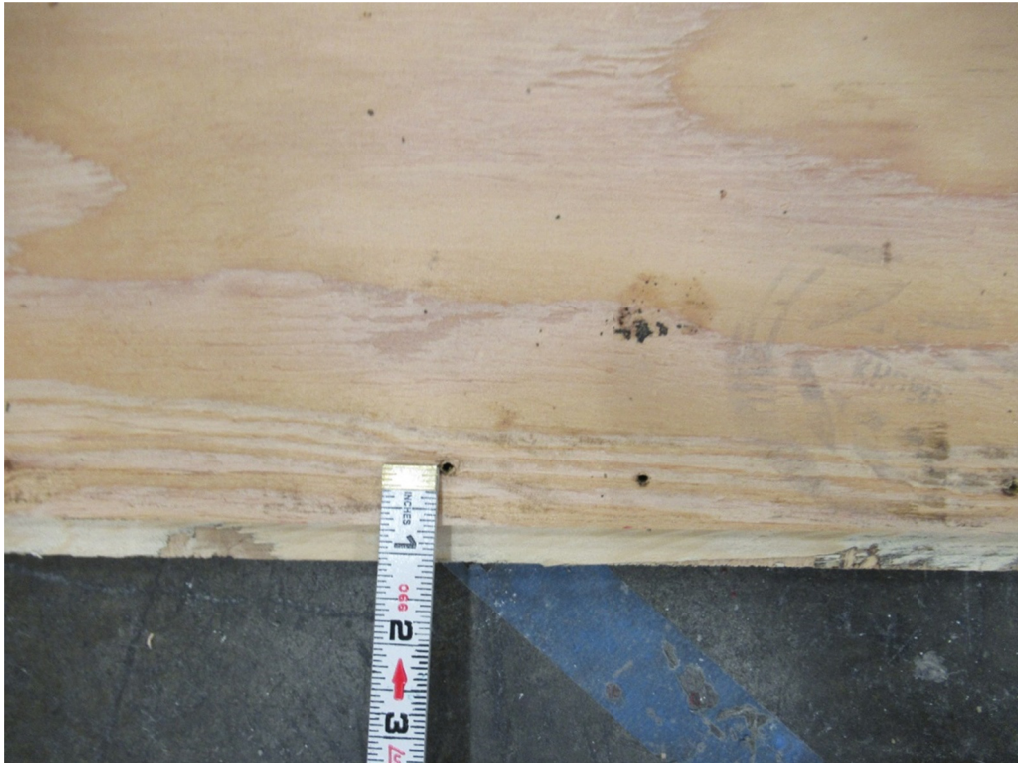
Sections of the T1-11 siding were removed for more detailed examination. With the exception of the damage already discussed, the T1-11 siding was seen to be in good condition. At the back face of the siding the nail holes from the sheathing nails were seen to be only minimally elongated, with the only exception being the nailing from the sheathing to the header; see Figures D.109 and D.110.

Figure D.110 Lack of nail hole enlargement or slotting, typical for inside face of siding.

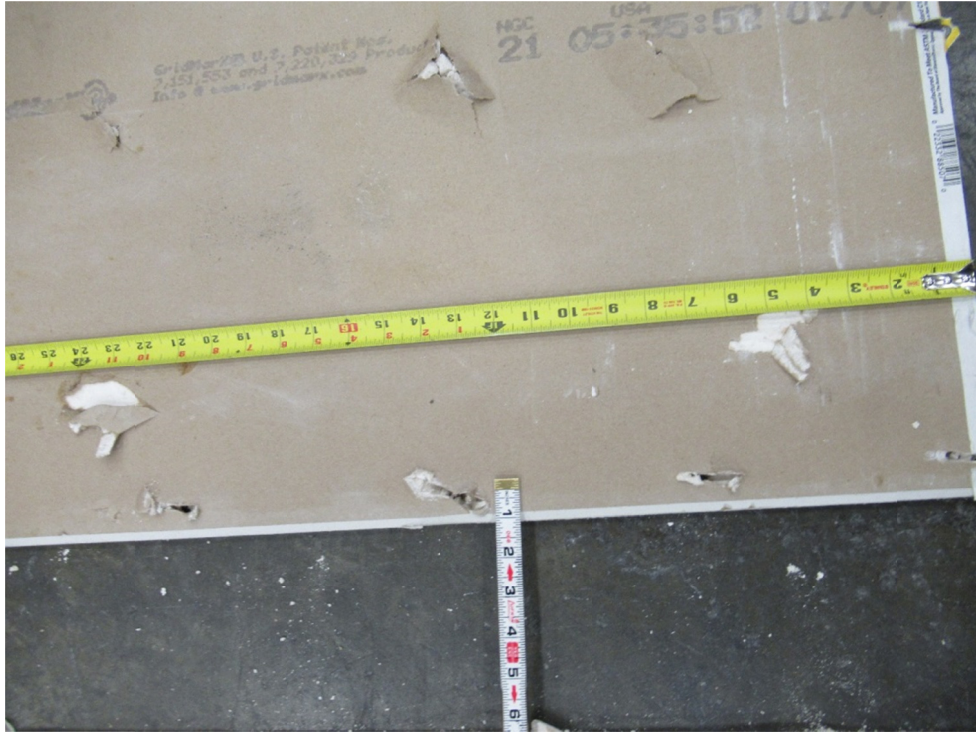
Sections of gypsum wallboard were taken off for more detailed inspection. On the back face of the gypsum wallboard, although there were some nail holes with minimal elongation, there were a number of instances of extensive elongation and gouging. The range can be seen in Figures D.111 through D.113. Vertical gouges were observed alongside doors and windows, with gouges tending toward diagonal at the header. Bottom nails had gouged towards the bottom edge, in some cases pulling out a plug of the gypsum core.

Figure D.112 Nail hole slotting and gouging on inside face of gypsum board panels.

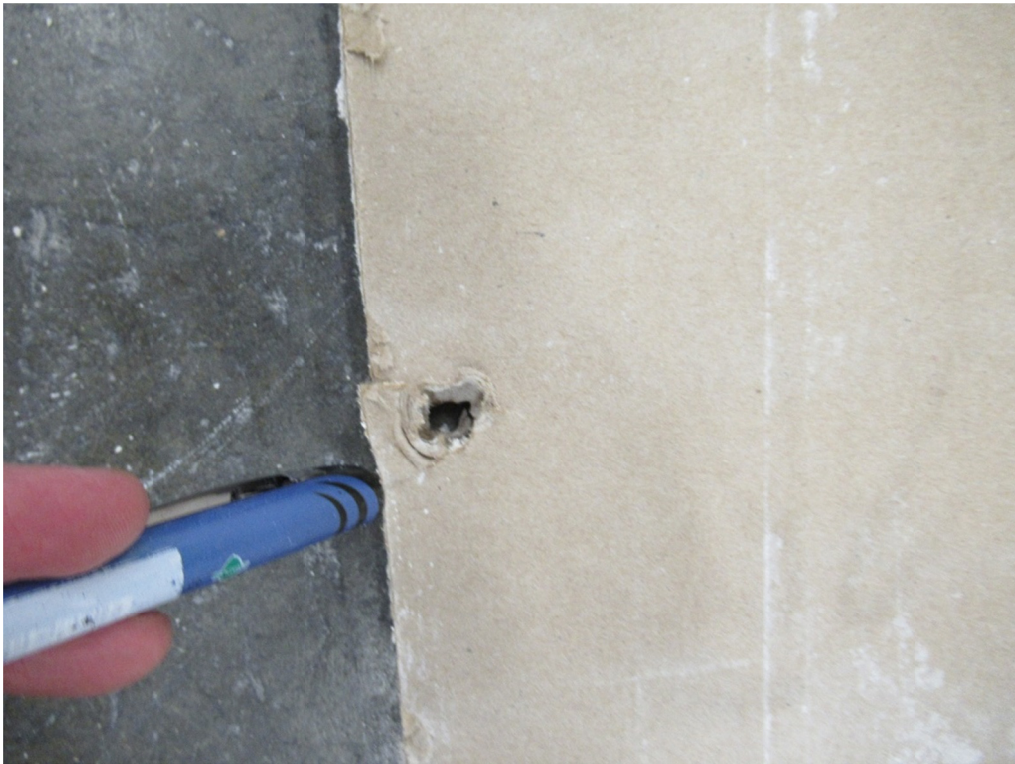
Figure D.113 Nail hole slotting and gouging on inside face of gypsum board panels.

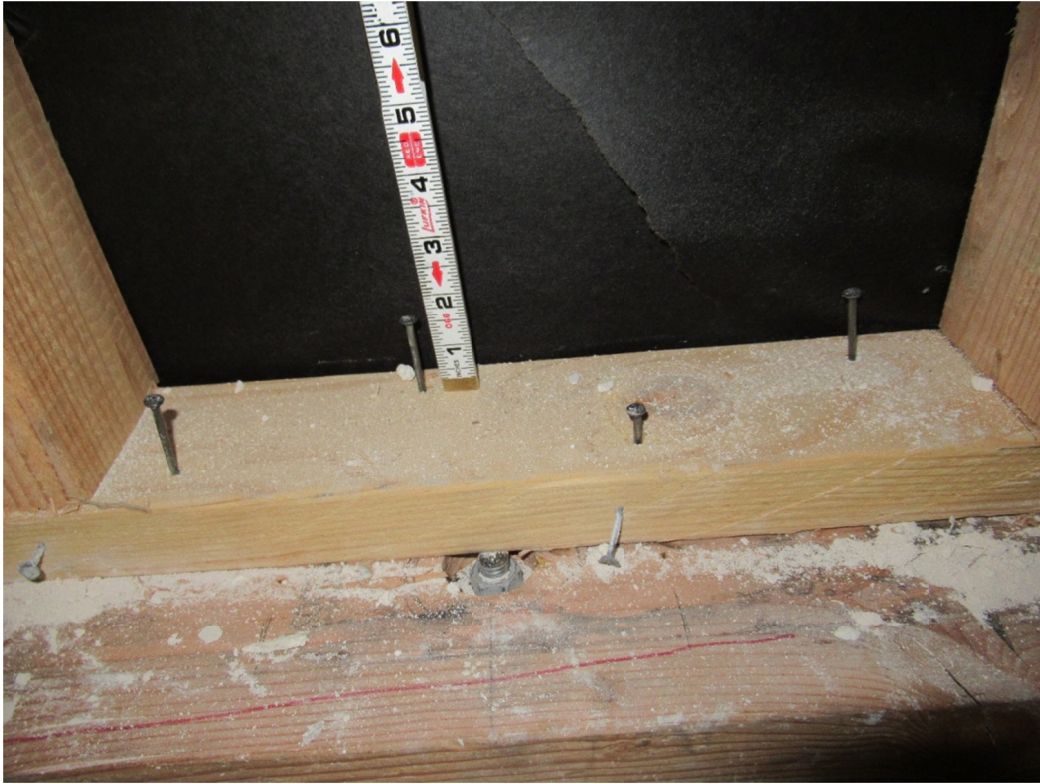
By the end of the test, most all of the nails fastening the 2×4 wall bottom plate to the foundation sill plate had been withdrawn. This included a number of nails that were simply withdrawn and did not re-engage (Figures D.114 and D.115); and nails that withdrew and were bent over between the 2×4 and the foundation sill plate; see Figures D.116 and D.117.

Figure D.115 Bottom plate fastening withdrawal at conclusion of testing.

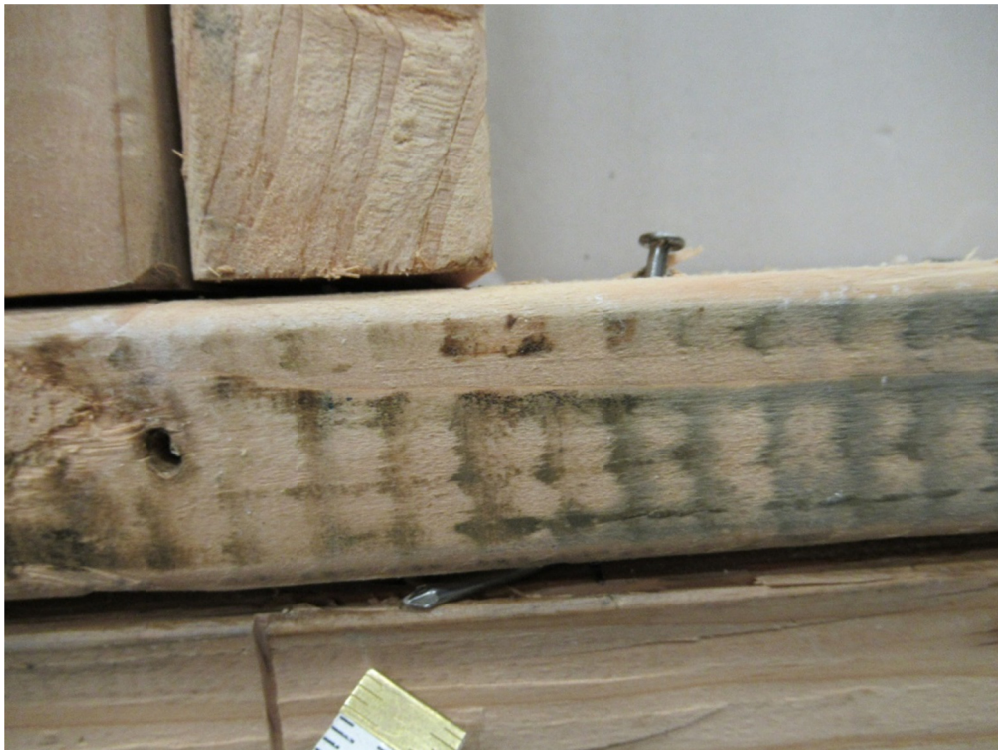
Figure D.116 Bottom plate fastening withdrawal at conclusion of testing. Bottom of nail is bent and point can be seen between bottom plate and 4x nailer below.

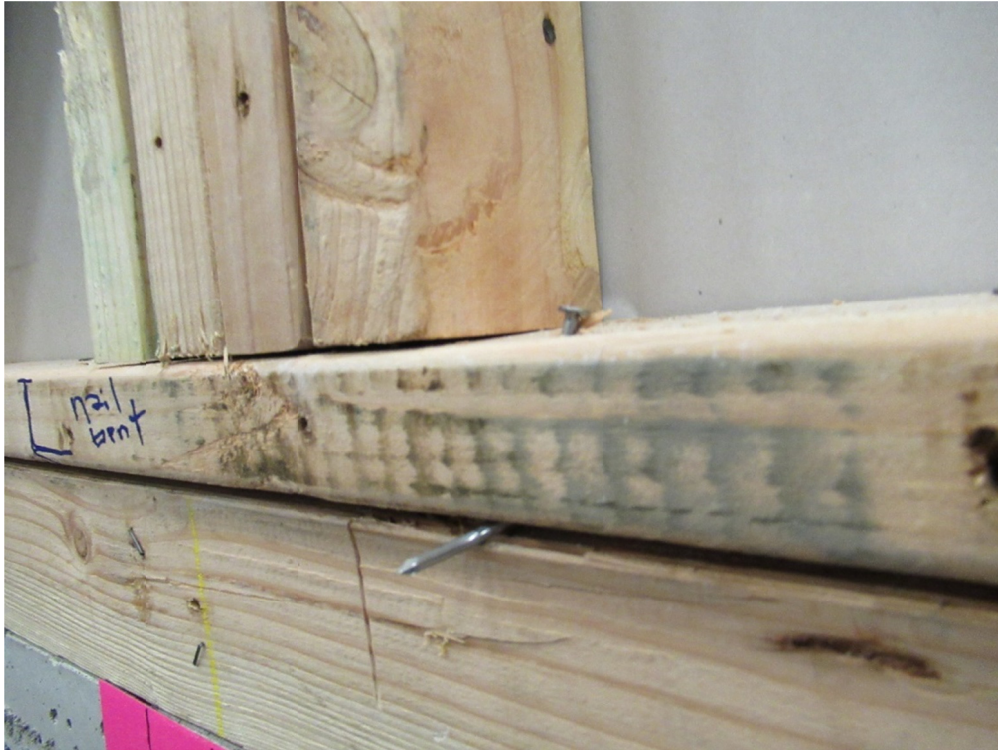
Figure D.117 Bottom plate fastening withdrawal at conclusion of testing. Bottom of nail is bent and point can be seen between bottom plate and 4× nailer below.

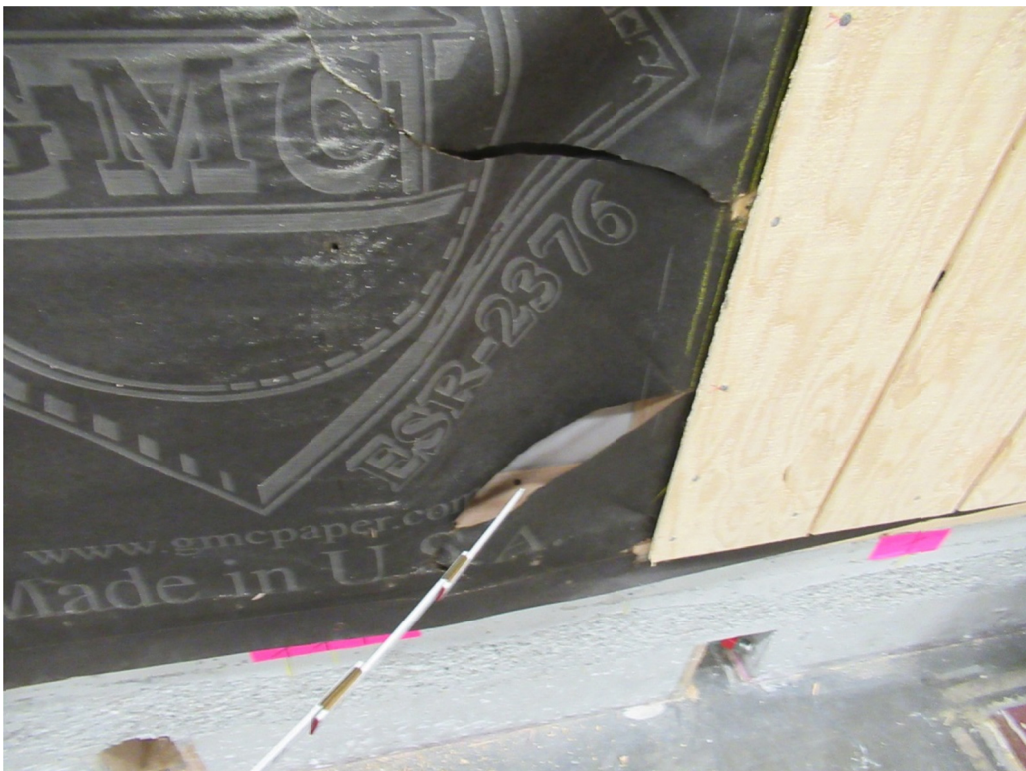
The building paper could not be observed until the conclusion of the test. When examined, it was found to be systematically torn in the vicinity of the headers; see Figures D.118 and D.119.

Figure D.119 Torn building paper at conclusion of testing.
