## **Fire-Induced Structural Collapse on Pier 45 at Fisherman's Wharf, San Francisco, California, May 23, 2020**

PEER Report No. 2021/01

Pacific Earthquake Engineering Research Center  
Headquarters at the University of California, Berkeley  
January 2021

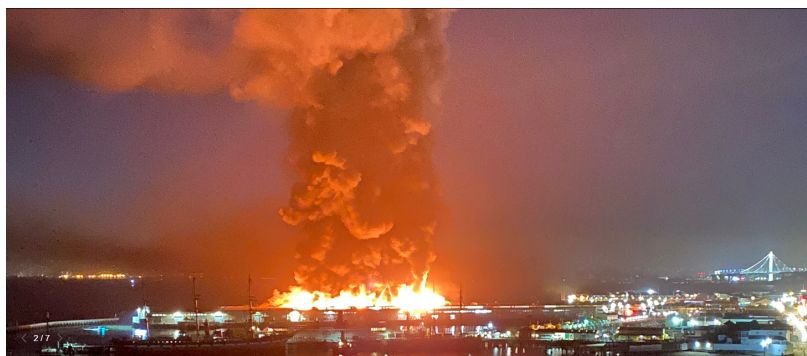
**Figure 2.1: (a) Location of Pier 45 in the northern quadrant of the city (Credit: Google Earth); (b) sketch showing Pier 45 and Sheds A, B, C, and D; and (c) visible flames and smoke from this fire (Credit: Dan Whaley/AP Photo).**

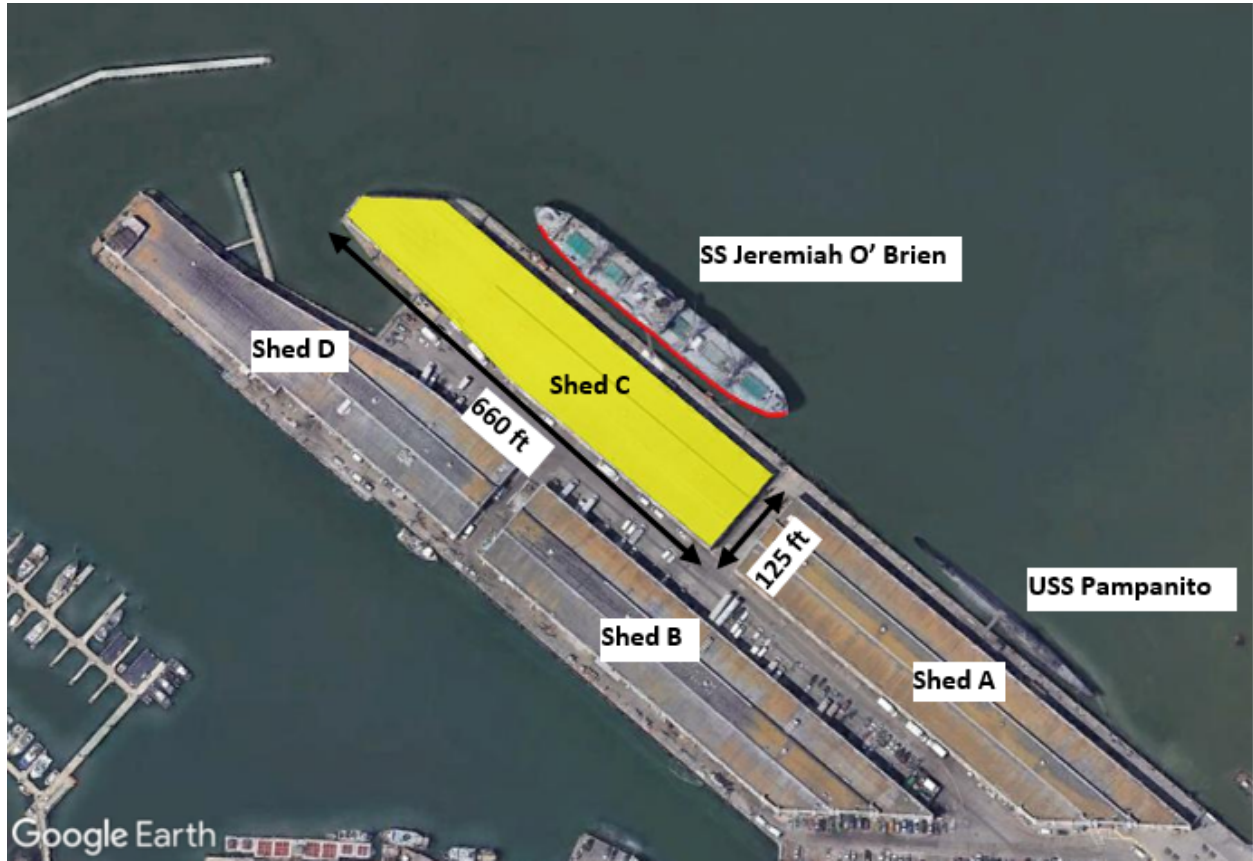
**Figure 2.2: Aerial view of Pier 45 depicting sheds A, B, C, and D prior to fire exposure. The area affected by the fire, Shed C, is highlighted in yellow, along with the exposed perimeter of SS Jeremiah O'Brien highlighted in red.**

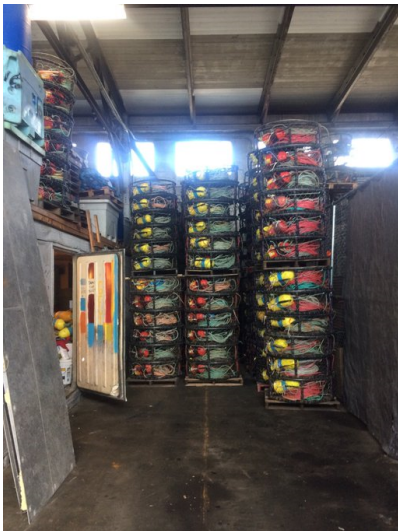
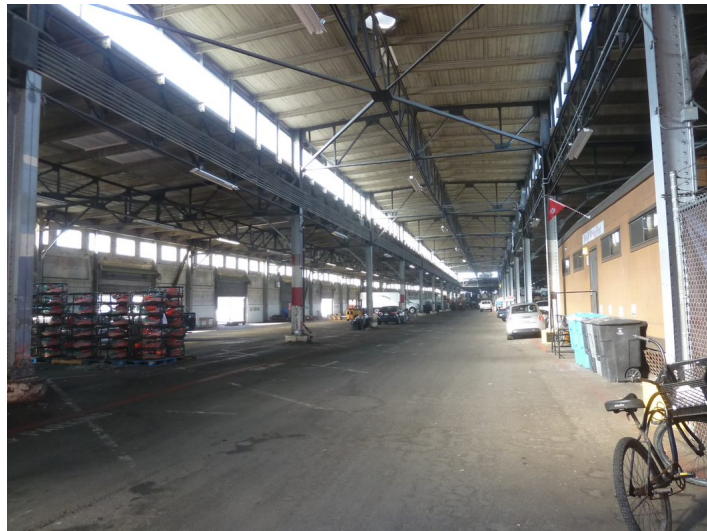
Figure 2.5 shows fishing equipment piled outside of Shed C. Note: large amounts of fishing equipment similar to what is shown in Figure 2.5 may have served as fuel for the fire. Figure 2.6 shows the type of equipment being housed in Shed A, which is identical equipment that had been stored in Shed C. The historic SS Jeremiah O'Brien ship was spared from the fire, and it was towed to Pier 35 the Tuesday afternoon after the fire.

**Figure 2.6: Passageway in Shed A: (a) fishing equipment; and (b) Shed A is identical in construction to Shed C.**

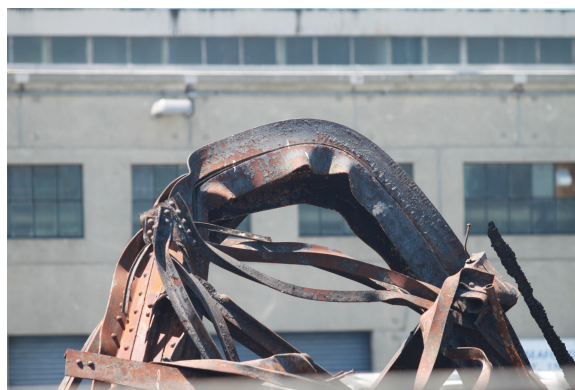
**Figure 4.6: Damage in the middle part of a column on the eastern side of the structure: (a) typical middle column failure; (b) close-up view of middle column failure; and (c) typical column failure on the eastern side of the structure.**

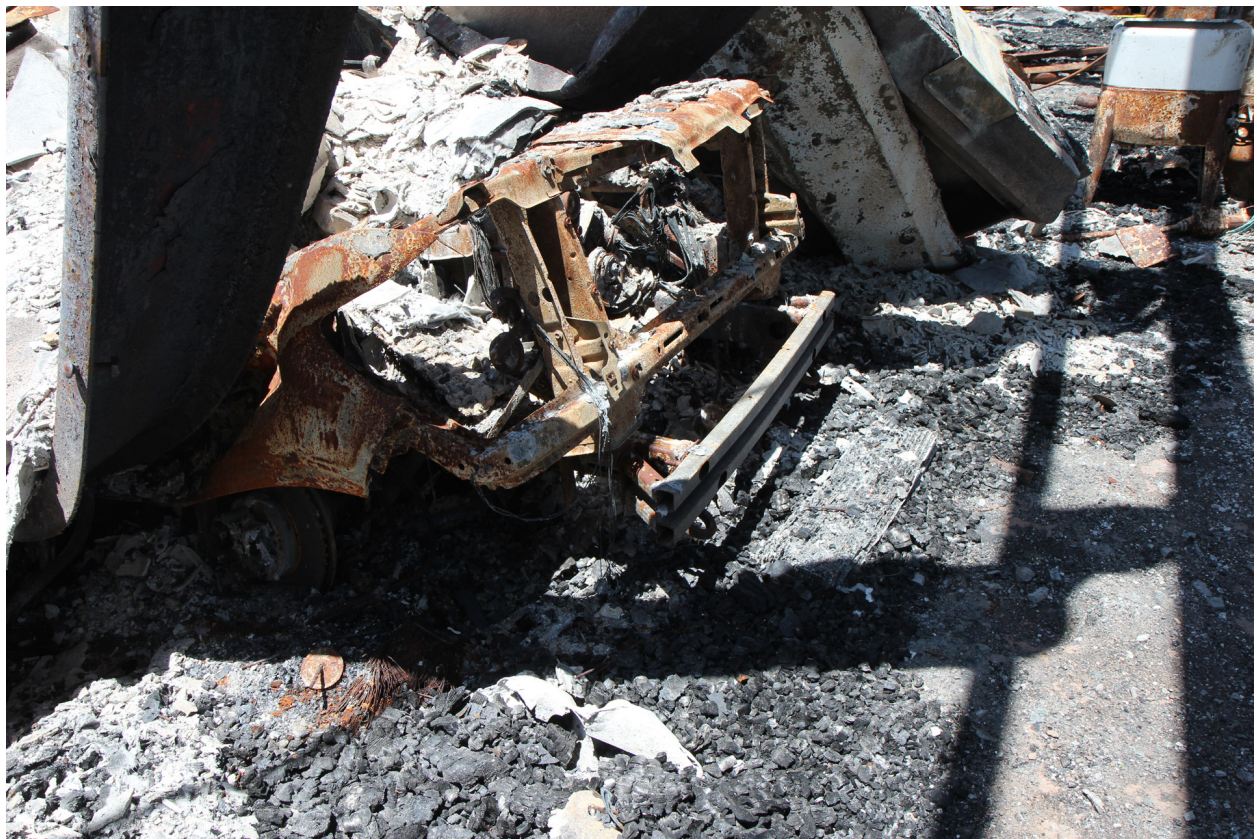
**Figure A.22: Remnant of an automobile.**

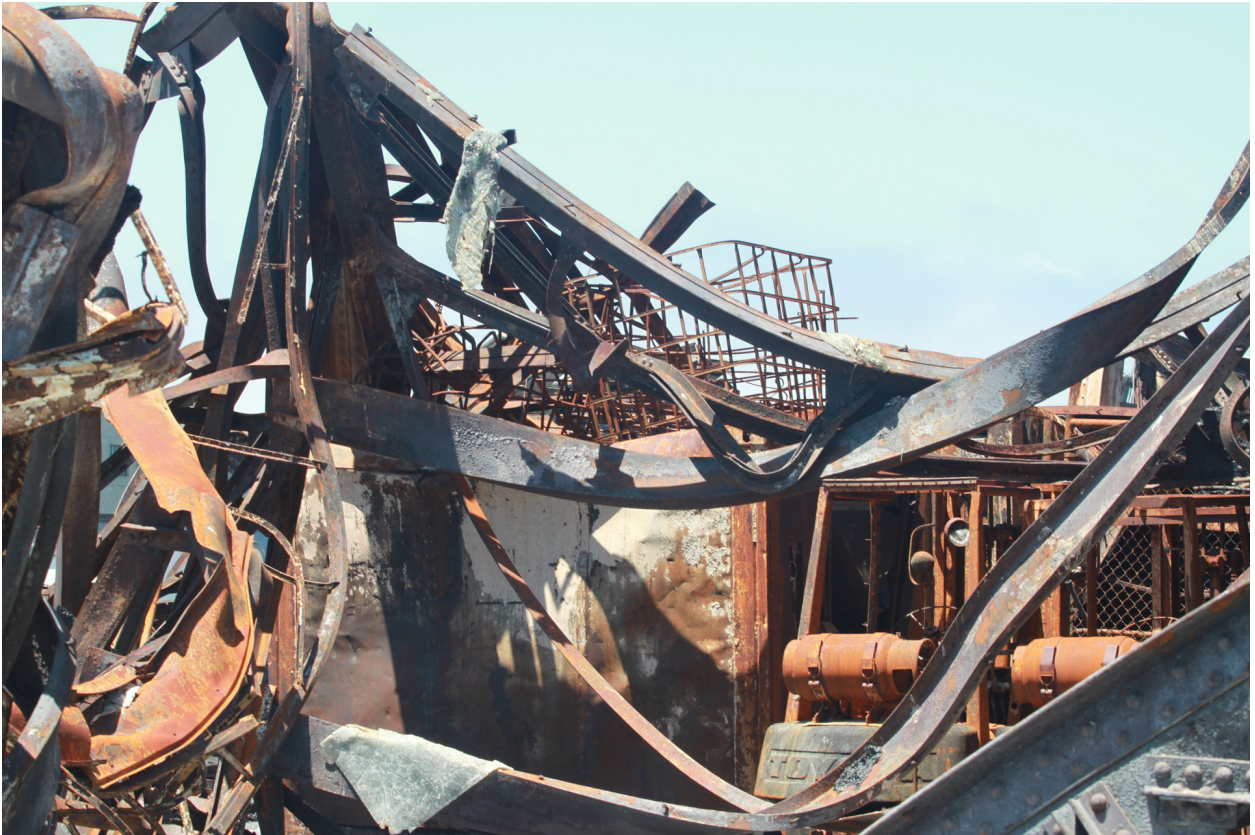
**Figure A.23: Forklifts with propane tanks (seen on the bottom right corner).**

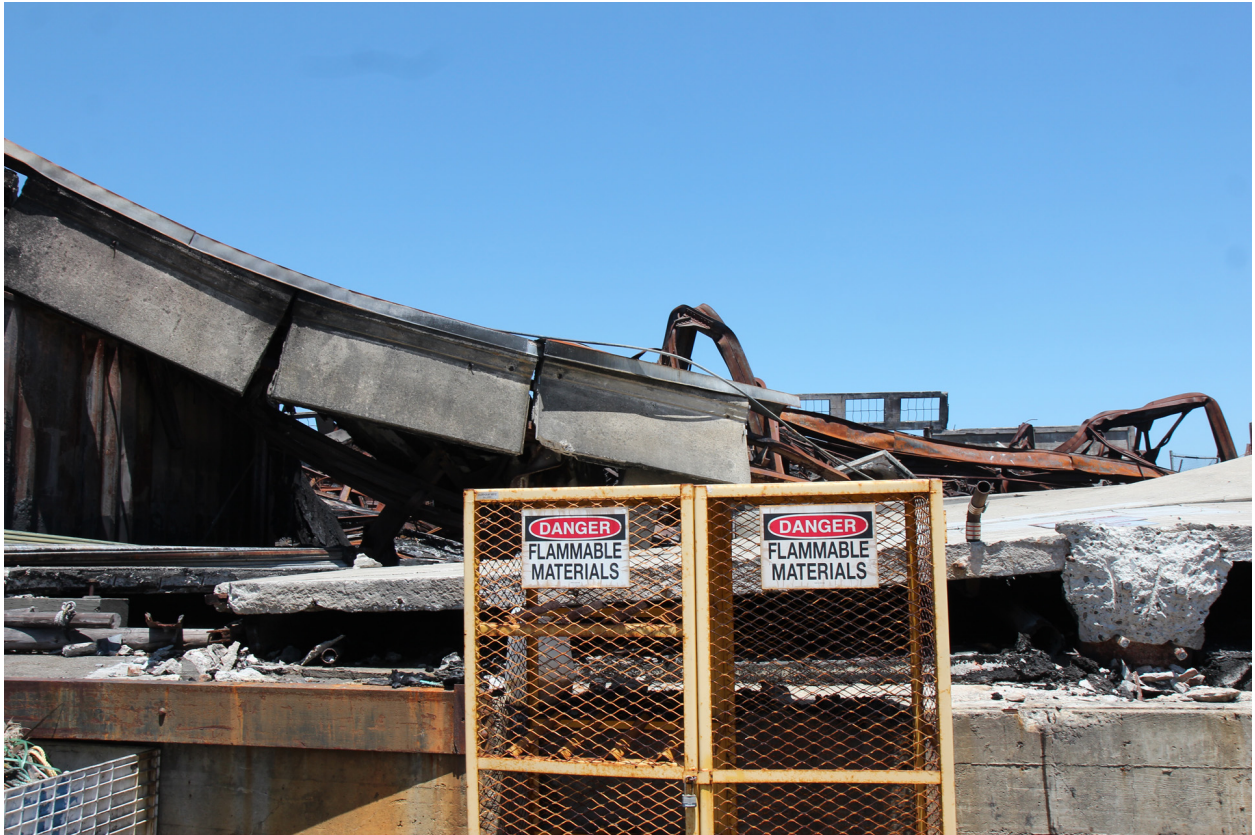
**Figure A.24: An acknowledgment of presence of flammable materials.**

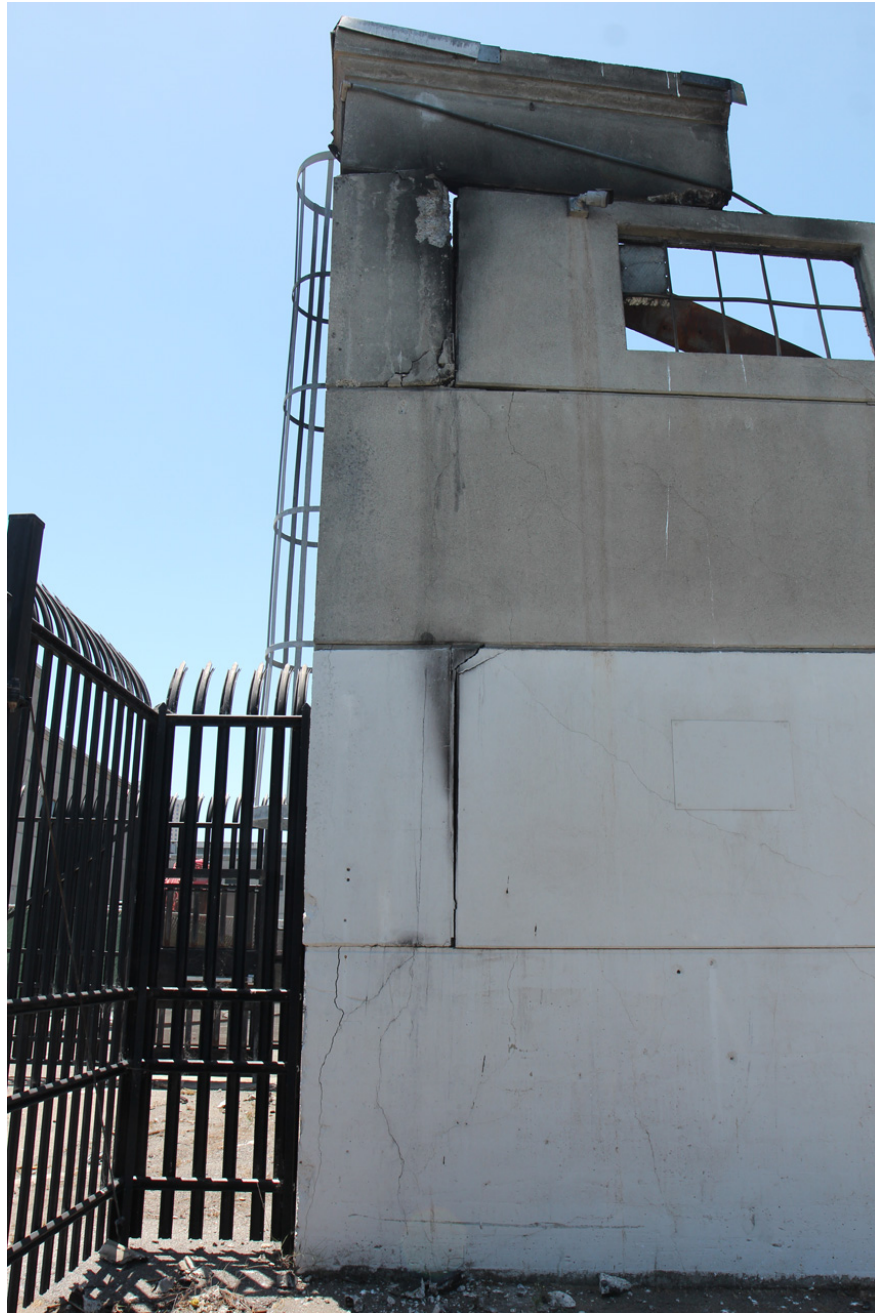
**Figure A.25: Corner of the building.**
