# **Research Needs for Structural Design for Tsunamis**

**Ian Robertson and Gary Chock**

# **Proposed Scope of the ASCE Tsunami Design Provisions**

### **ASCE 7 Chapter 6 - Tsunami Loads and Effects**

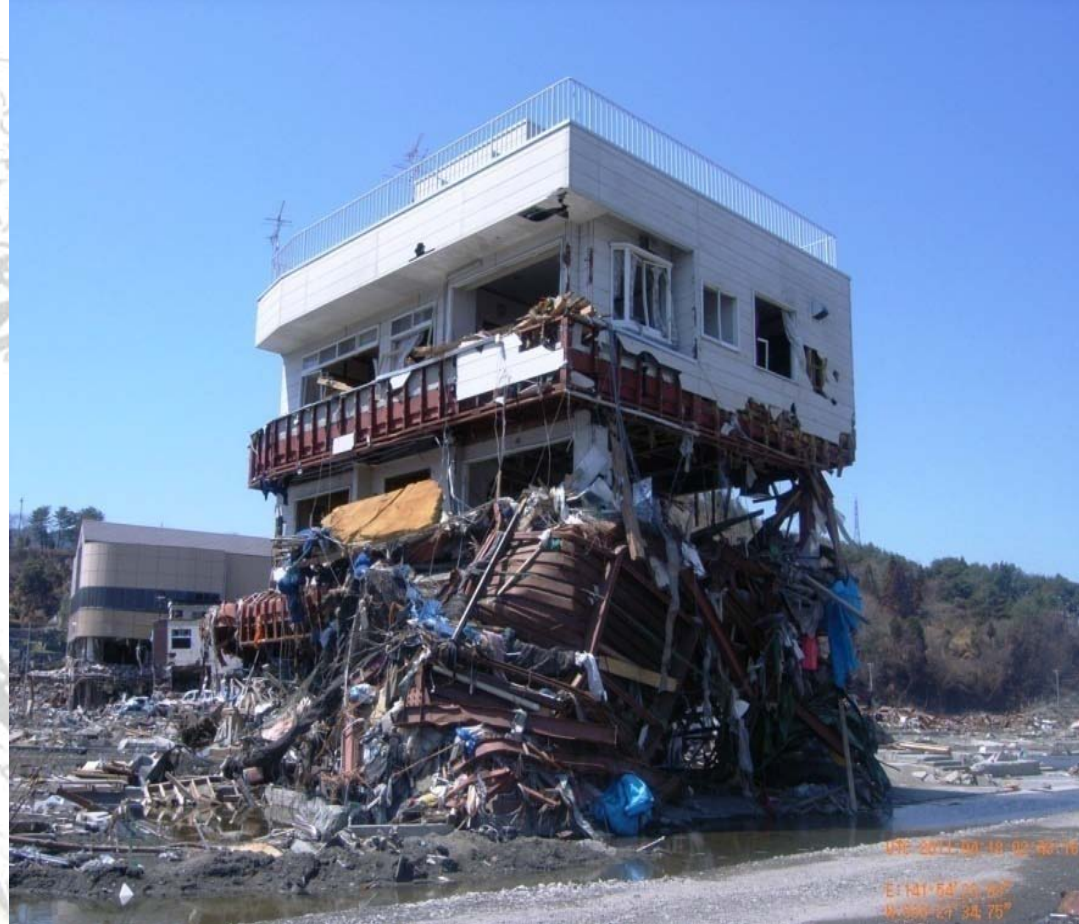
Three-Story SMRF with 5 meters of debris load accumulation wrapping

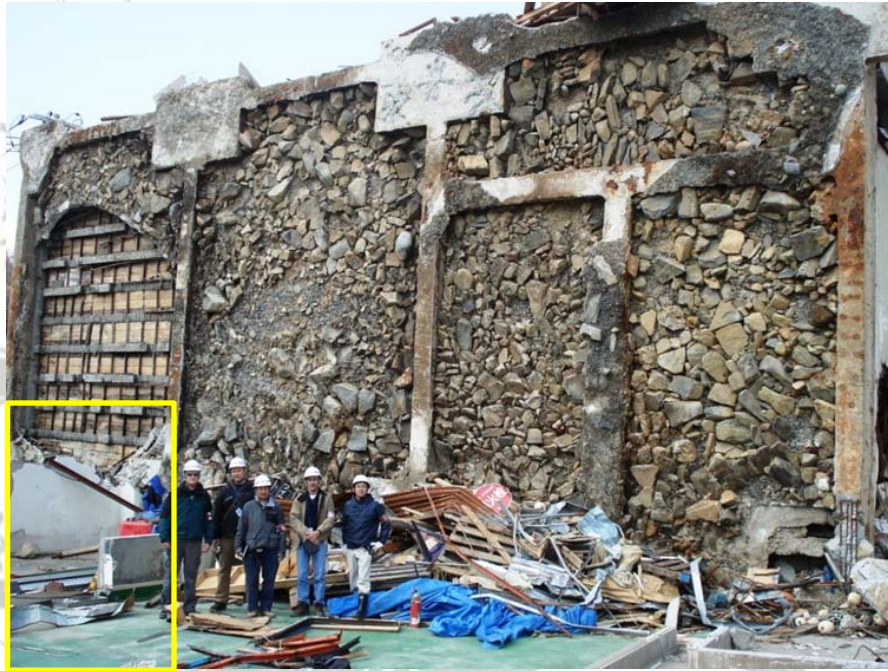
Two-Story Refrigerated Concrete Warehouse (9000 kN deadweight) on Bearing Piles floated at 7 m inundation depth during inflow and then overturned about 20 meters from original position after floating over 2 m wall

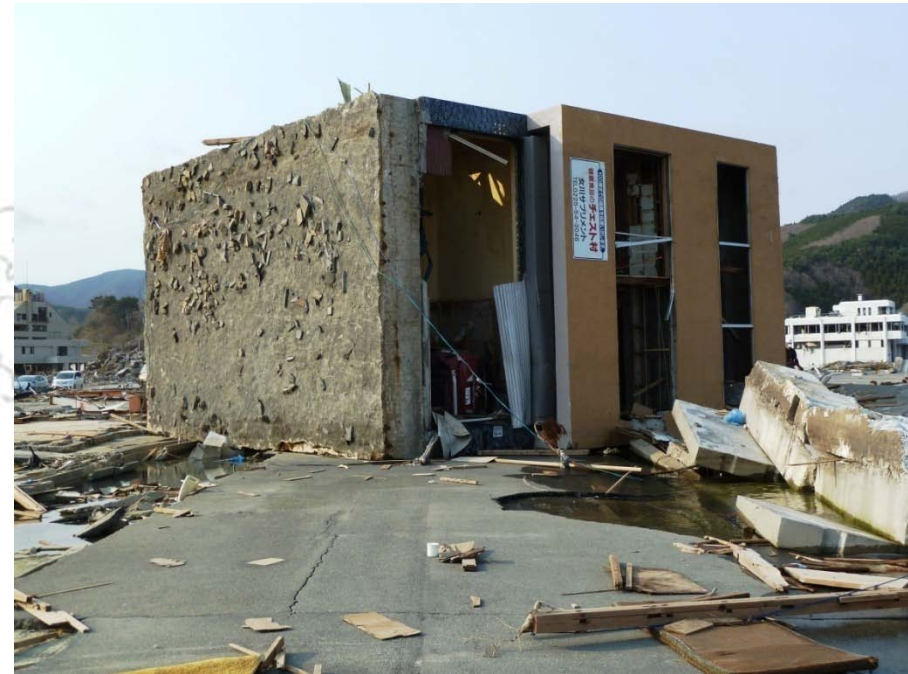
Three-Story Concrete Retail Building (2050 kN deadweight) on mat foundation overturned during return flow when submerged in 8 m/s flow; would have toppled at only 3 m/s

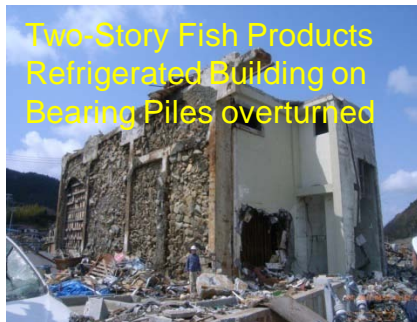
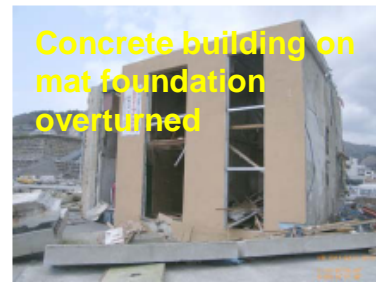
ONAGAWA "HEALTH SUPPLEMENT" BUILDING  
(OVERTURNED IN RETURN FLOW)

ELEVATION OF  
FAR SIDE WALL

PHOTO OF OVERTURNED BUILDING  
(Chock)

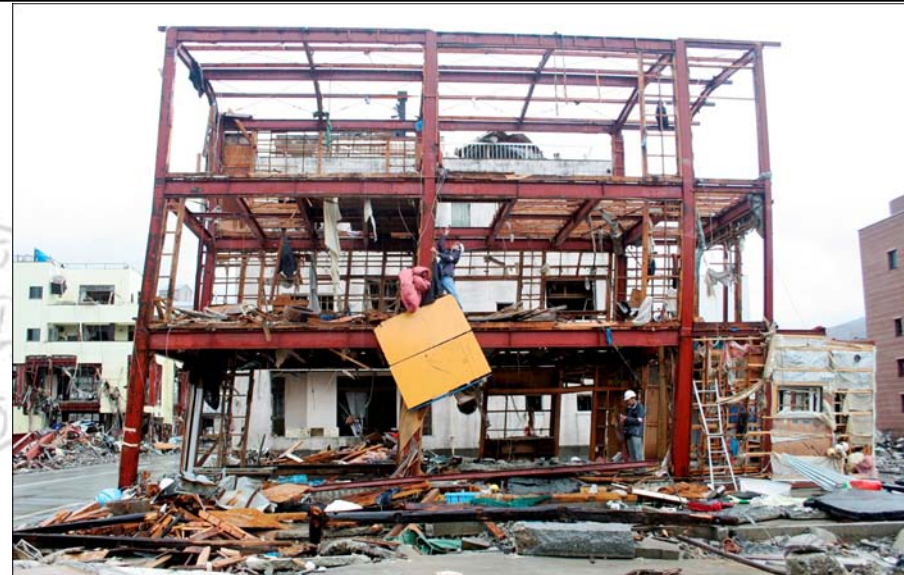
# Onagawa Three-Story Steel Building Frame Survival by Load Reduction

- This three-story steel moment-resisting frame exposed to 8 m/s outflow estimated from video analysis.
- At about 67% blockage of the original enclosure (33% open), the return flow is sufficient to yield the top and bottom of the second story columns with 30-cm drift of third floor (First story column is stronger section.)
- Subsequently sustained flow induced further displacement until loss of all cladding finally reduced the building's projected area. Otherwise collapse of cladded building would have occurred.
- LiDAR scan shows final 50-cm third floor drift.

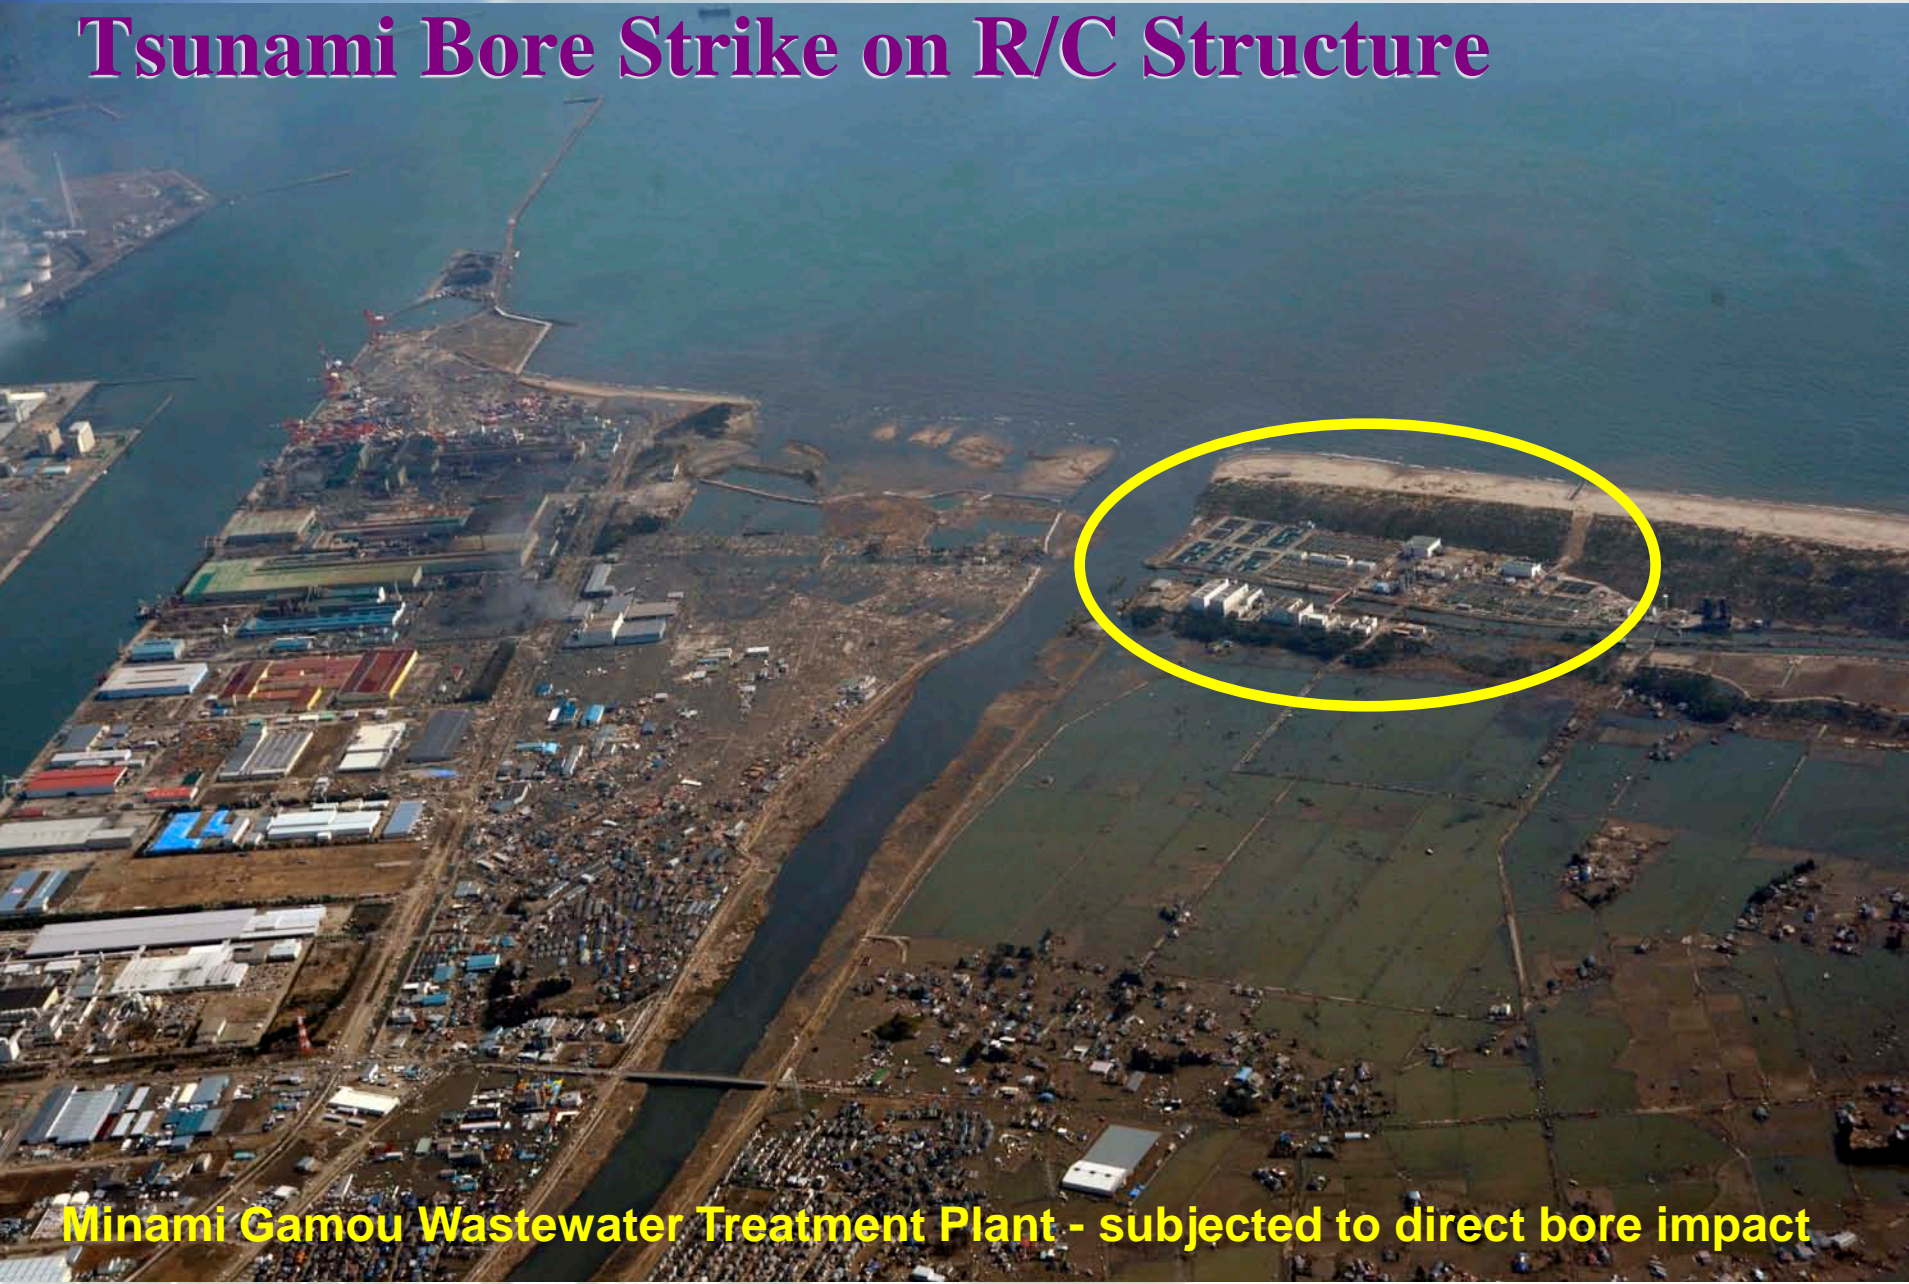
## Tsunami Bore Strike on R/C Structure

**Minami Gamou Wastewater Treatment Plant - subjected to direct bore impact**

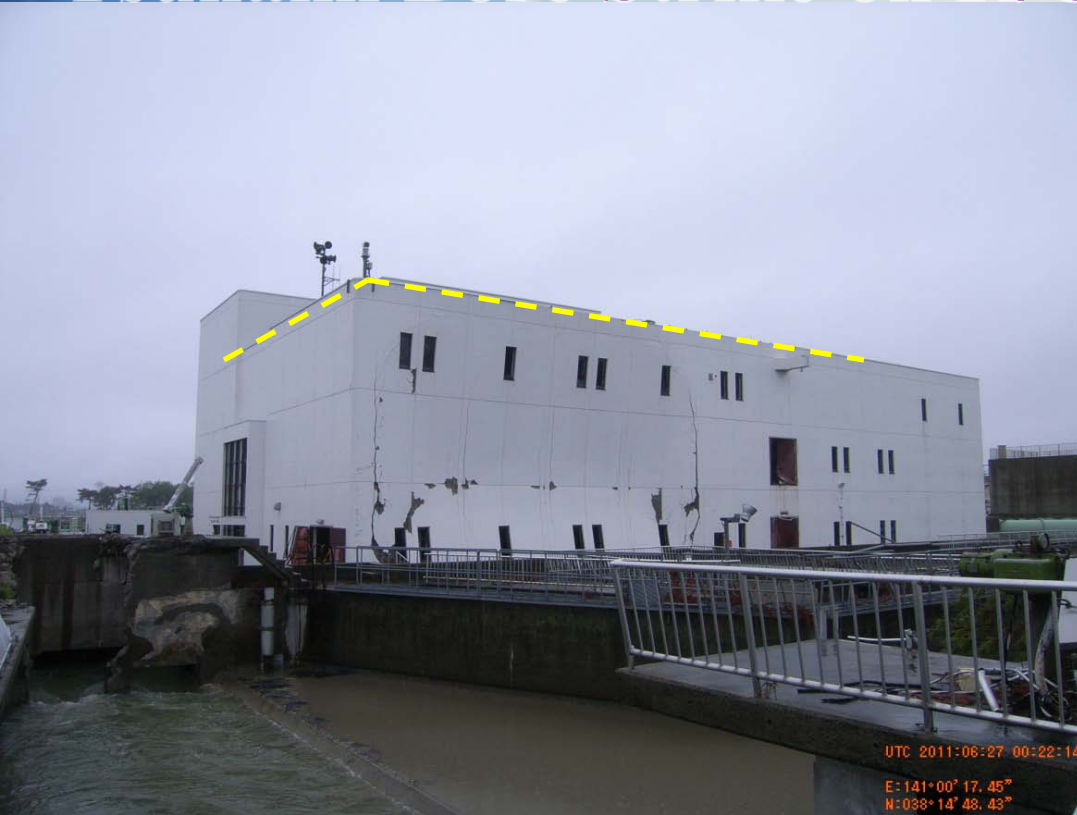
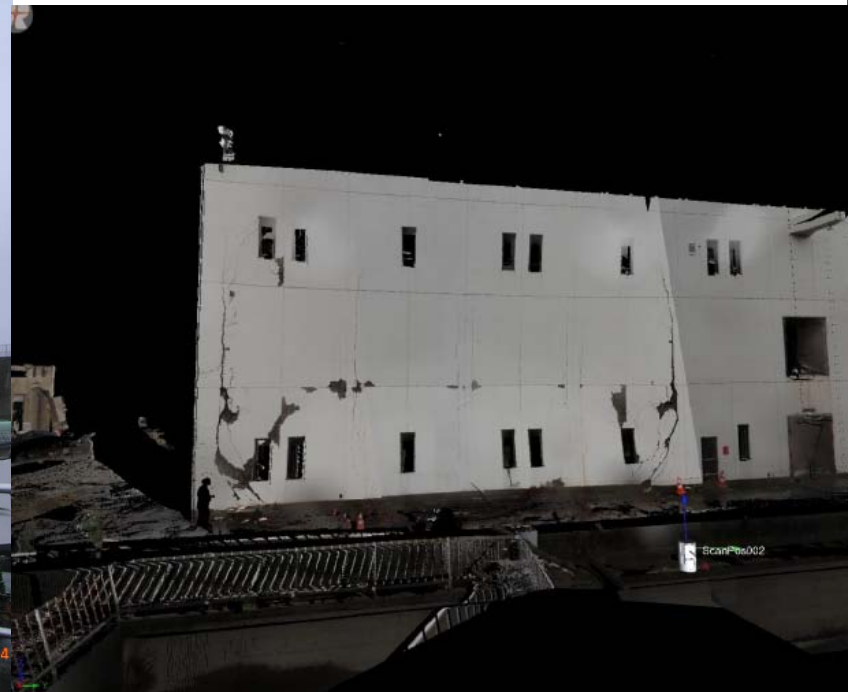
## Tsunami Bore Strike on R/C Structure

**Minami Gamou Wastewater Treatment Plant - subjected to direct bore impact**

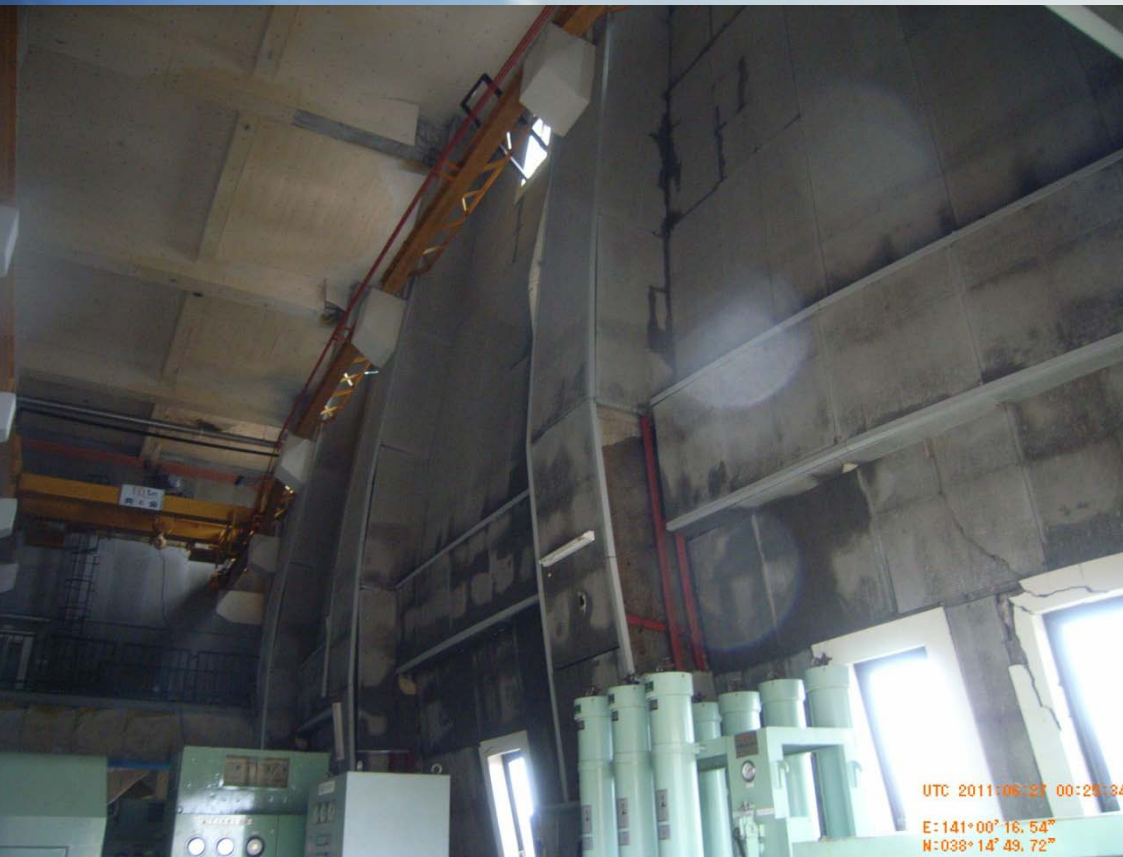
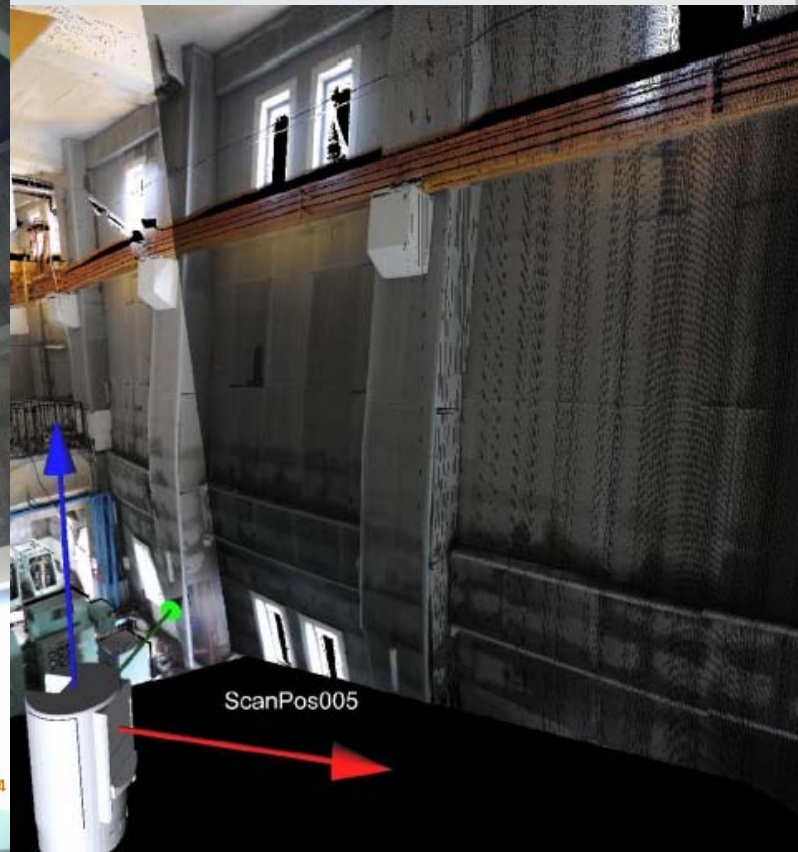
# Sendai R/C Structure

**Minami Gamou Wastewater Treatment Plant**

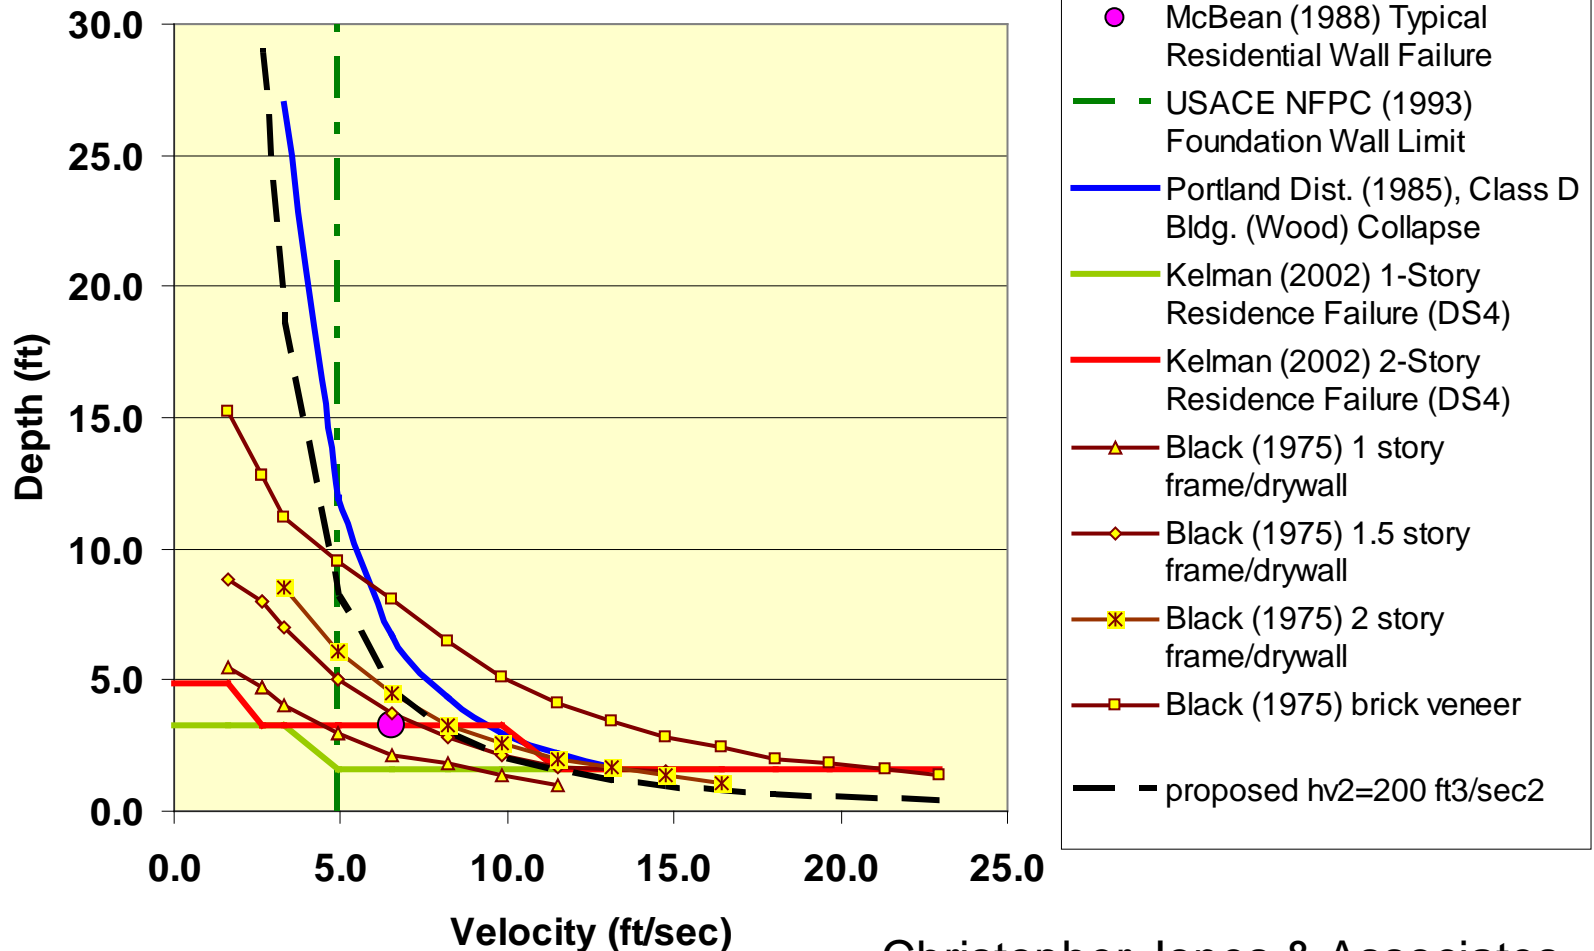
# Wood Residential Building Failure

Flood Depth and Velocity Associated with Building Failure/Collapse
