Cripple Wall Small-Component Test Program: Dry Specimens

**A Report for the “Quantifying the Performance of
Retrofit of Cripple Walls and Sill Anchorage in Single-
Family Wood-Frame Buildings” Project**

PEER Report 2020/17

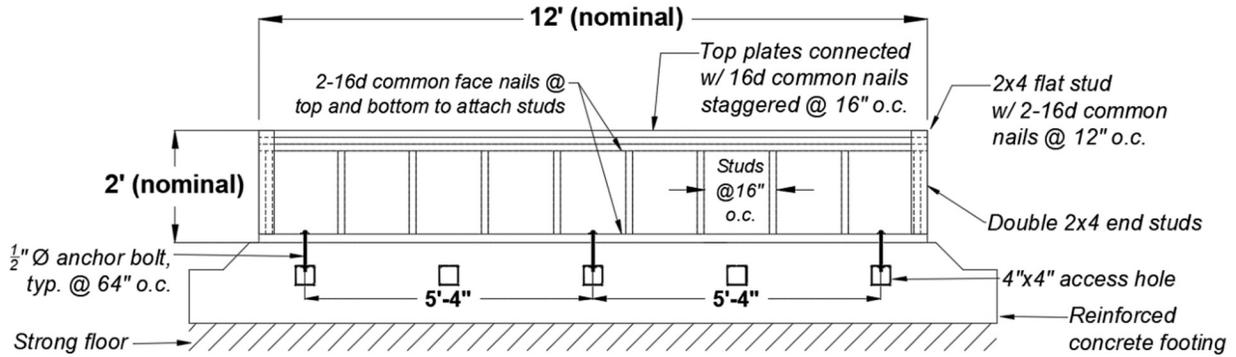
Figure 2.1 2-ft-tall cripple wall framing.

1. Sill plates are 2x6 and top-plates are 2x4.
2. Anchor bolts are $\frac{1}{2}$ " \varnothing with $2\frac{1}{2}$ " (min.) $\times \frac{3}{16}$ " square washer (to receive load cell on top).

Elevation
Framing Details (Interior Face)
2' Tall Cripple Wall

Seven of the eleven cripple wall specimens in this report are nominally 2 ft in height and 12 ft in length, as shown in Figure 2.1. The remaining four specimens are nominally 6 ft in height and 12 ft in length; see Figure 2.2. Note that the anchor bolt spacing shown in these figures applies on to existing cases. Minor differences in length can be attributed to the nuances of the exterior finish detailing. The height of the cripple wall is measured from the base of the sill plate to the top of the uppermost top plate. Framing members were constructed with #2 Douglas Fir, with wall studs and top plates nominal 2 × 4 members and sill plates nominal 2 × 6 members. All studs were placed at

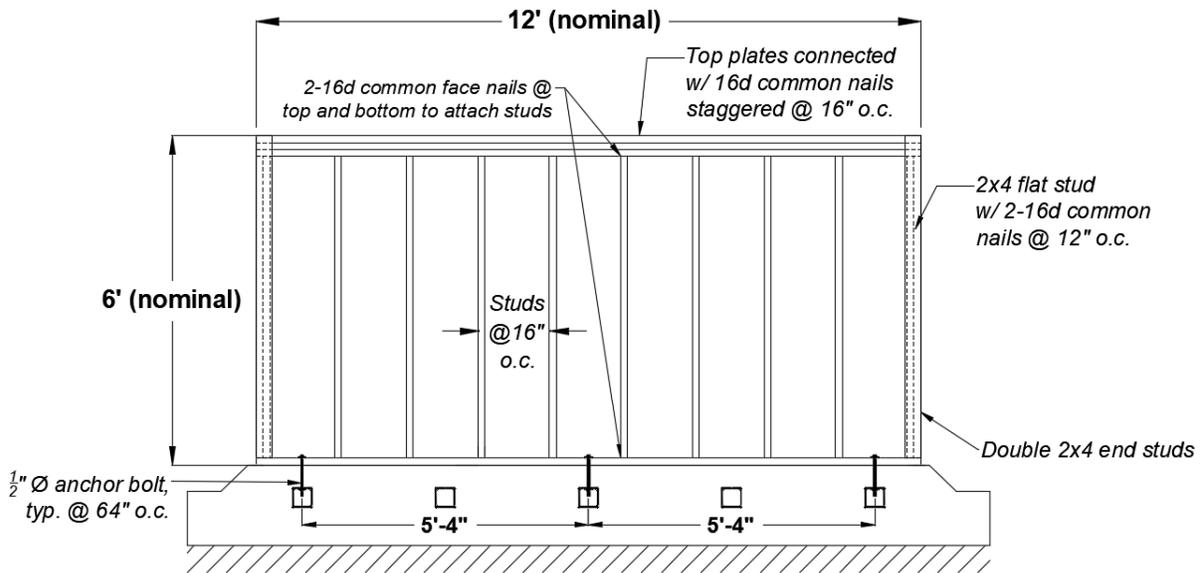
Figure 2.2 6-ft-tall cripple wall framing.

1. Sill plates are 2x6 and top-plates are 2x4.
2. Anchor bolts are $\frac{1}{2}$ " \varnothing with $2\frac{1}{2}$ " (min.) $\times \frac{3}{16}$ " square washer (to receive load cell on top).

Elevation
Framing Details (Interior Face)
6' Tall Cripple Wall

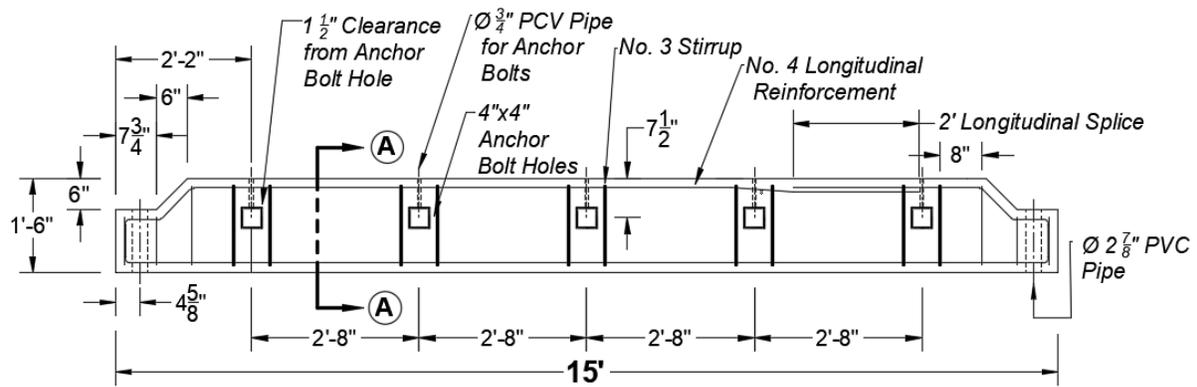
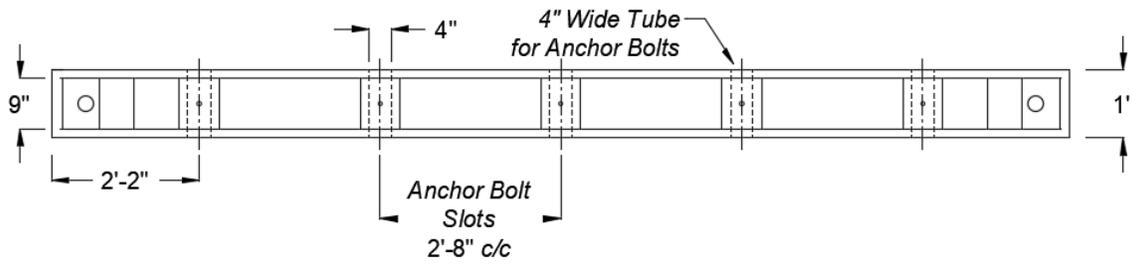
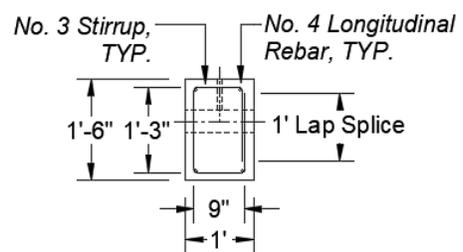
Figure 2.3 Concrete footing details for cripple wall tests.

Note:
 1. All concrete cover is 1-1/2".

Elevation

Plan View

Section A-A

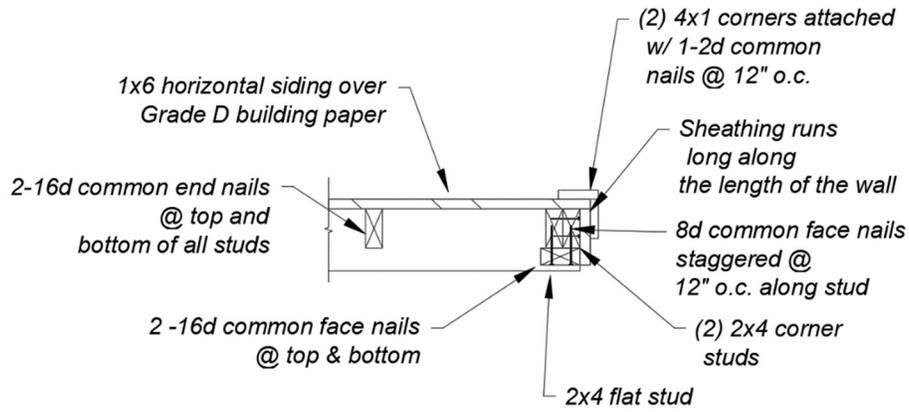
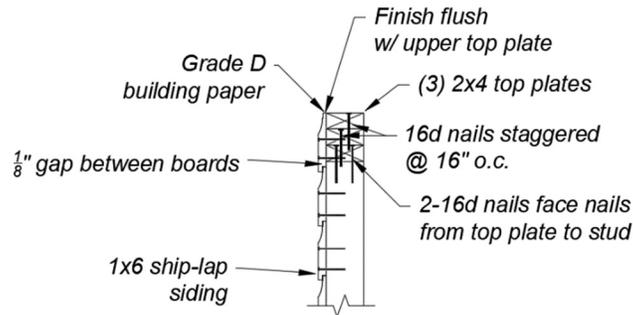
Figure 2.6 Corner and top of wall detail for *horizontal siding exterior finish* with top boundary condition B.

Plan View Detail
Horizontal Siding (HS)
Top Boundary Condition B

Top of Wall Detail
Horizontal Siding (HS)
Top Boundary Condition B

all exterior finishes were terminated at the top of the upper top plate. The framing details for top boundary condition B can be seen in Figure 2.5. The top of the wall and corner details specific to the horizontal siding specimens can be seen in Figure 2.6. Photographs of this boundary condition for the horizontal siding finished specimens are provided in Figure 2.7. Figures 2.8 and 2.9 provide the same details for the horizontal siding over diagonal sheathing finished cripple walls, and Figures 2.10 and 2.11 show these details for the T1-11 wood structural panel finished walls. Nailing details for attachment of the exterior finishes are provided in Section 2.3.

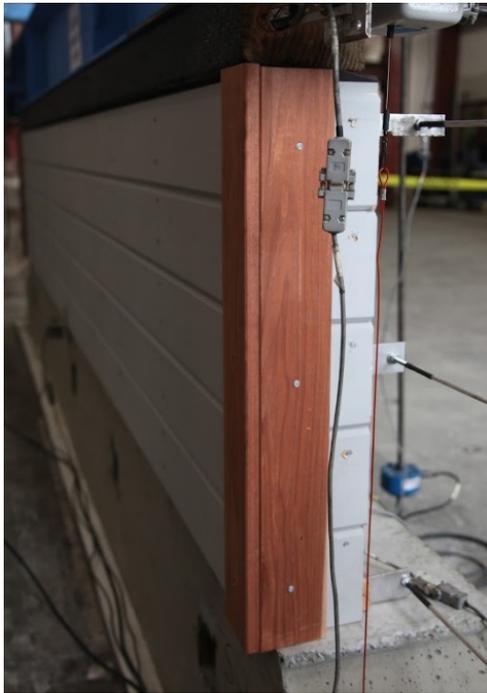
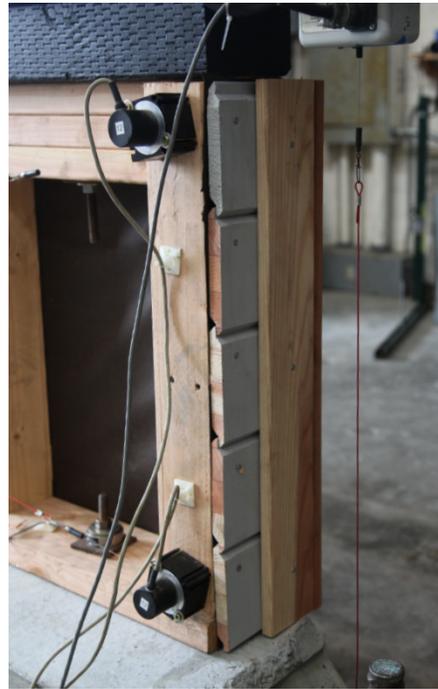
Figure 2.7 Isometric corner views showing top boundary condition B details of horizontal siding finished cripple walls (exterior, left; interior, right).

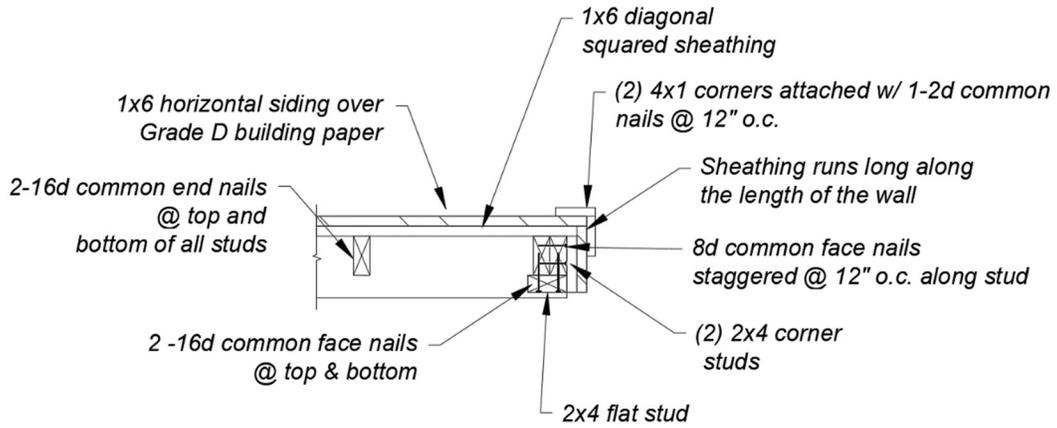
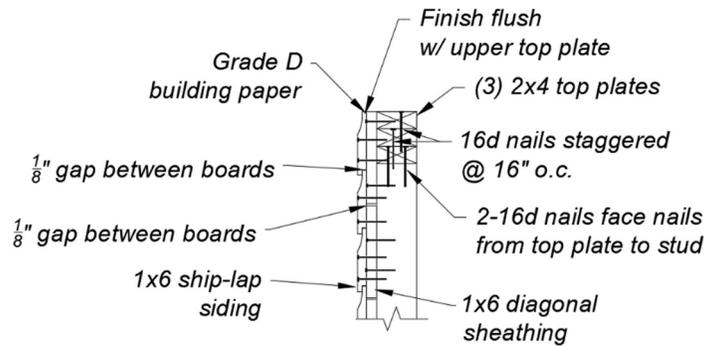
Figure 2.8 Corner and top of wall detail for horizontal siding over diagonal sheathing exterior finish with top boundary condition B.

Plan View Detail
Horizontal Siding Over
Diagonal Sheathing (HS+DSH)
Top Boundary Condition B

Top of Wall Detail
Horizontal Siding Over
Diagonal Sheathing (HS+DSH)
Top Boundary Condition B

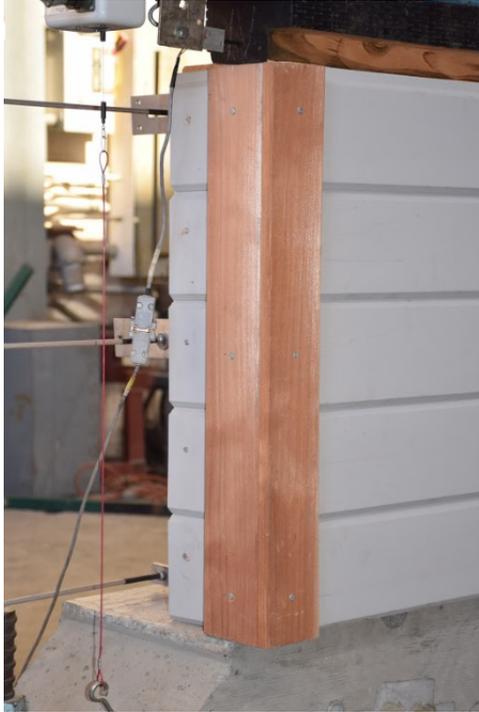
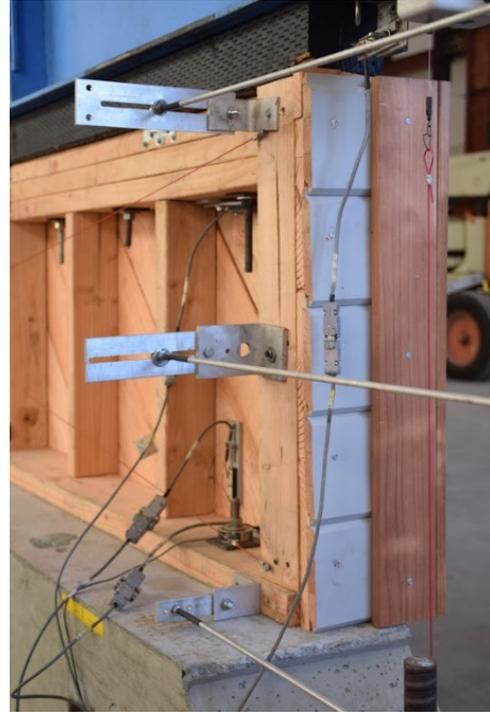
Figure 2.9 Isometric corner views showing top boundary condition B details of horizontal siding over diagonal sheathing finished cripple walls (exterior, left; interior, right).

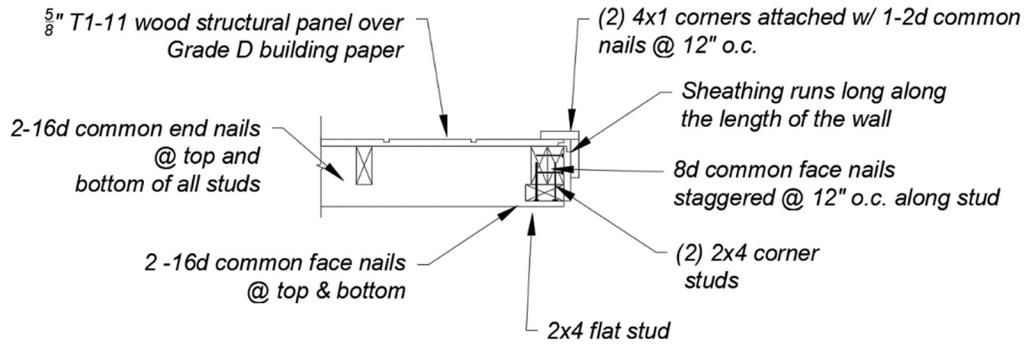
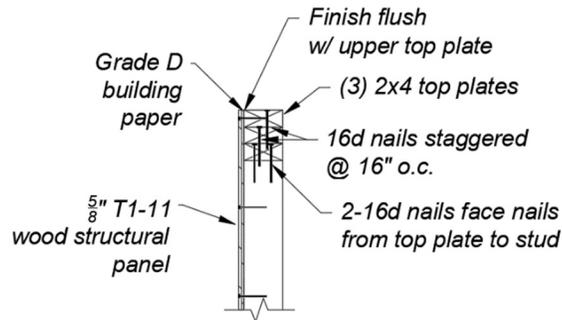
Figure 2.10 Corner and top of wall detail for T1-11 wood structural panel exterior finish with top boundary condition B.

Plan View Detail
T1-11 Wood Structural Panel (T)
Top Boundary Condition B

Top of Wall Detail
Top Boundary Condition B
T1-11 Wood Structural Panel (T)

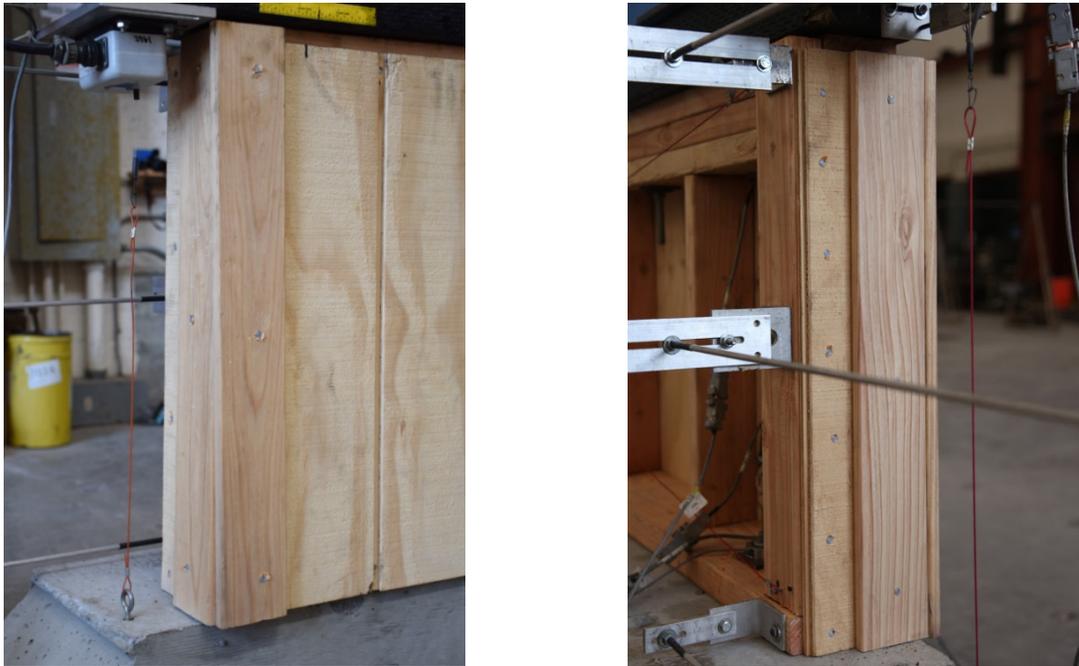
Figure 2.11 Isometric corner views showing top boundary condition B details of T1-11 wood structural panel finished walls (exterior, left; interior, right).

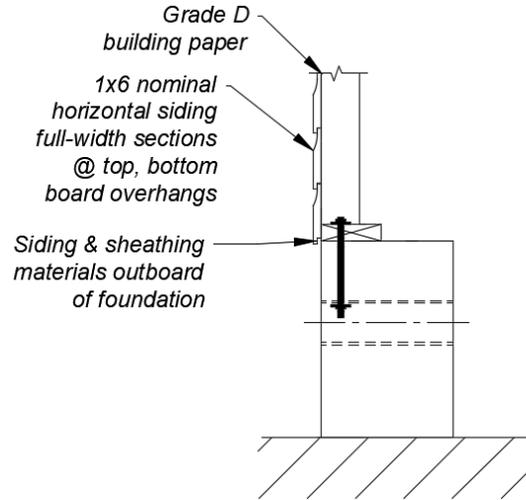
Figure 2.12 Bottom of the wall detail for horizontal siding exterior finish bottom boundary condition c.

**Bottom of the Wall Detail
Bottom Boundary Condition c
Horizontal Siding (HS)**

Bottom boundary condition c orientates the cripple wall so that all exterior finishes are outboard of the foundation. This is the same whether there is a combined finish material or whether there is only the presence of a siding finish. Regardless of a single or combined finish material, the innermost material is flush with the face of the footing. This is the most common condition found in California homes. This boundary condition allows all finish materials to rotate freely as the cripple wall deforms. All finishes terminate at the base of the sill plate besides horizontal siding. Due to the fixed height of the cripple walls and flush with the top of the wall alignment of the horizontal siding boards, the bottommost siding board overhangs at the base of the wall. The overhang is 1/4 in. for the 2-ft-tall specimens and 3-3/8 in. for the 6-ft-tall specimens. Figure 2.12 provides the detail of bottom boundary condition c for the horizontal siding exterior finished cripple walls, and Figure 2.13 shows a photograph of the boundary condition. The same details of the horizontal siding over diagonal sheathing finished specimens are shown in Figures 2.14 and 2.15, and in Figures 2.16 and 2.17 for the T1-11 wood structural panel finished walls. Nailing details for attachment of the exterior finishes are provided in Section 2.3.

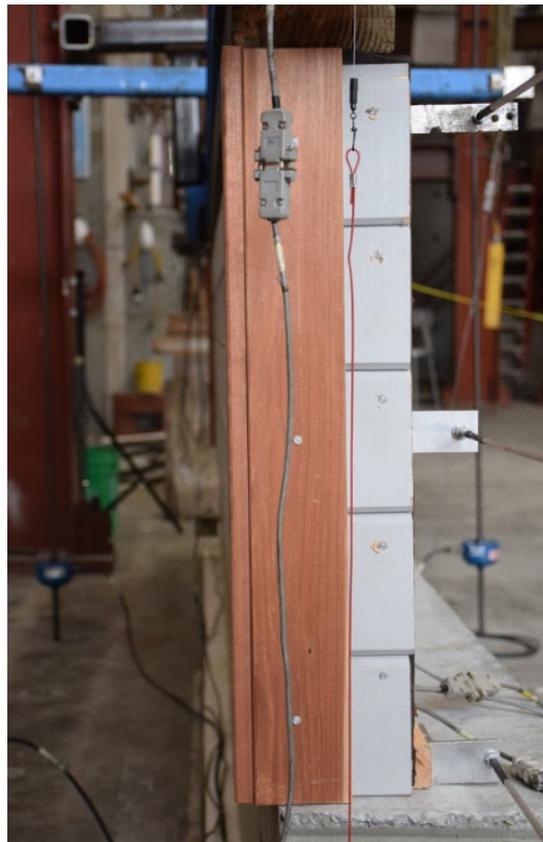
Figure 2.13 Corner view showing horizontal siding exterior finished cripple wall with bottom boundary condition c.

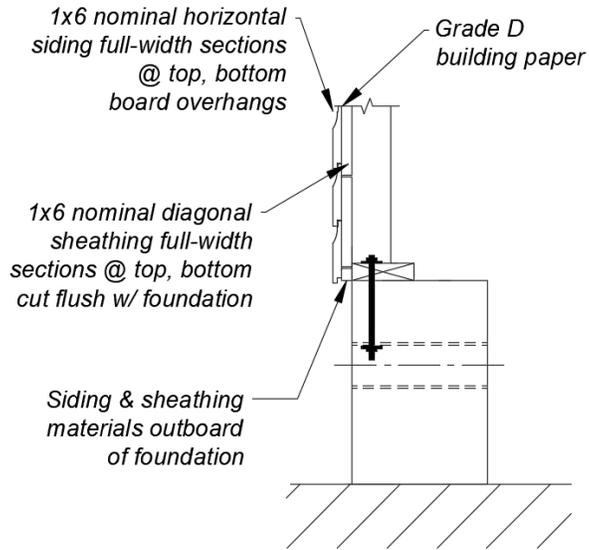
Figure 2.14 Bottom of the wall detail for horizontal siding over diagonal sheathing exterior finish with bottom boundary condition c.

Bottom of the Wall Detail
Bottom Boundary Condition c
Horizontal Siding Over
Diagonal Sheathing (HS+DSh)

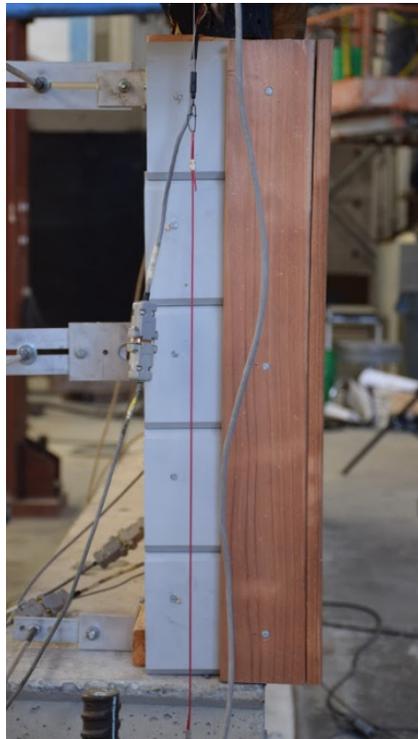
Figure 2.15 Corner view showing horizontal siding over diagonal sheathing exterior finished cripple wall with bottom boundary condition c.

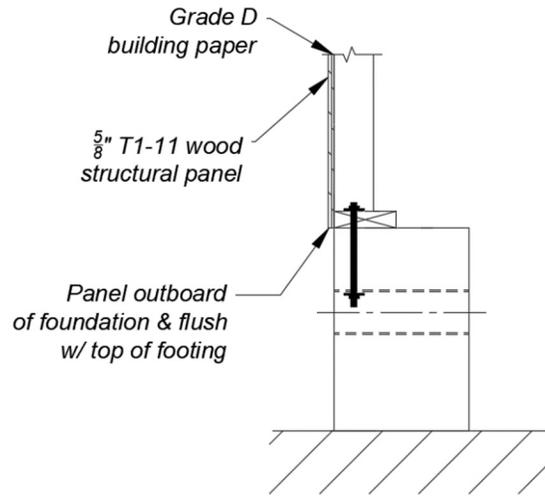
Figure 2.16 Bottom of the wall detail for T1-11 wood structural panel exterior finish with bottom boundary condition c.

**Bottom of the Wall Detail
Bottom Boundary Condition c
T1-11 Wood Structural Panel (T)**

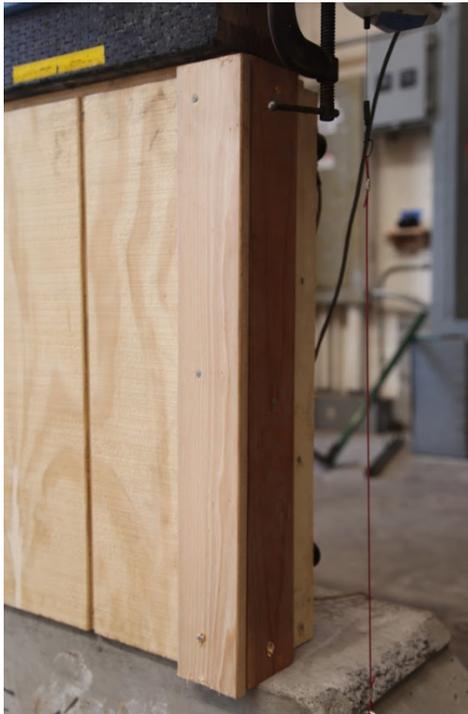
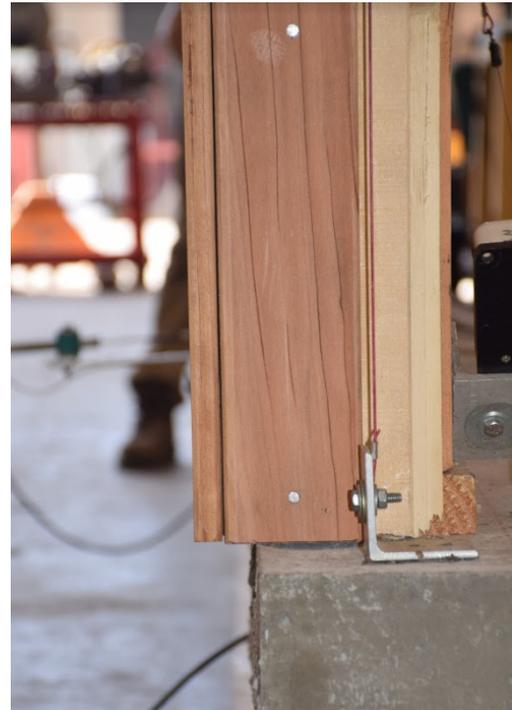
Figure 2.17 Corner view showing T1-11 wood structural panel finished cripple wall with bottom boundary condition c.

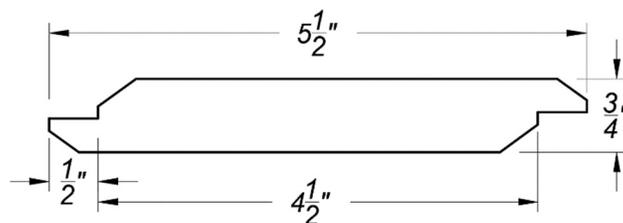
Figure 2.18 Horizontal siding board dimensions.

Horizontal siding boards were shiplap 1×6 nominal ($3/4$ in. \times $5\frac{1}{2}$ in.), construction grade redwood. The details of the dimensions can be seen in Figure 2.18. Full siding boards were installed flush with the uppermost top plate. An $1/8$ -in. gap was placed between siding boards, leaving a $3/8$ in. overlap between each siding board. No siding boards were trimmed at the base of the cripple wall, thus leaving an overhang for all cripple walls with horizontal siding. This culminated to $3\text{-}3/8$ -in. overhang for the 6-foot-tall cripple walls and a $1/8$ -in. overhang for the 2-ft-tall cripple walls. Grade D building paper was stapled onto the framing before installation of the siding. The horizontal siding was fastened with 2-8d nails per stud. Only the outermost end stud was nailed to the ends. The top siding board was fastened entirely to the top plates. For the 2-ft-tall specimens the bottom siding board had one nail fastened to the stud and the other fastened to the sill plate, and for the 6-ft-tall specimens only one nail was used to fasten the siding board (attached to the sill plate) due to the large overhang of the siding board. All nails used were 8d common hot-dip galvanized. Nails were spaced 3 in. apart on siding boards, centered about the middle of the board. Two pieces of 4×1 redwood boards were used as corner trim, which is a common aesthetic addition to cover up the corner joints of finishes. These were fastened with 2d common nails at 12 in. on center. Figure 2.19 provides details of layout of the 2-ft-tall cripple wall with horizontal siding. A photograph of the elevation and the nailing pattern is shown in Figure 2.20. The same details were provided for the 6-ft-tall cripple walls with horizontal siding and is shown in Figures 2.21 and 2.22. Since the 6-ft-tall cripple wall had a significant overhang of the bottom siding board, a photograph is provided to show this overhang in Figure 2.22. Nailing details for the construction of the horizontal siding finished specimens are provided in Figure 2.23.

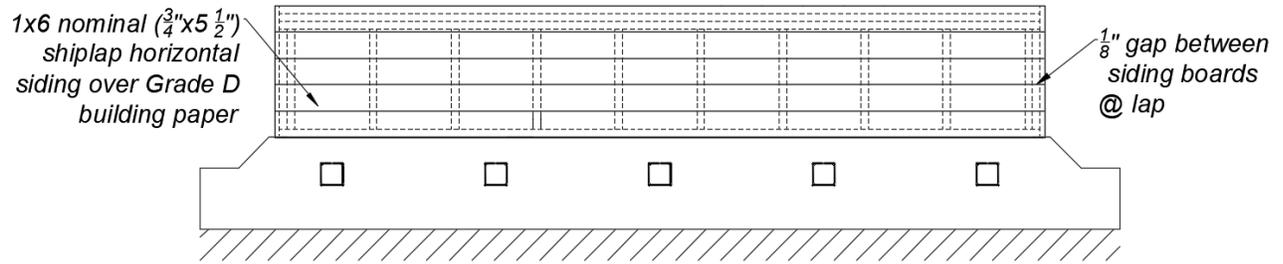
Figure 2.19 Elevation view with details for 2-ft-tall horizontal siding finished cripple wall.

1. Full siding boards maintained through entire height.
2. Siding is flush to uppermost top plate and outboard of footing.
3. Boards are installed from bottom to top, bottom board overhangs footing.

Elevation
Horizontal Siding (HS)
2' Tall Cripple Wall

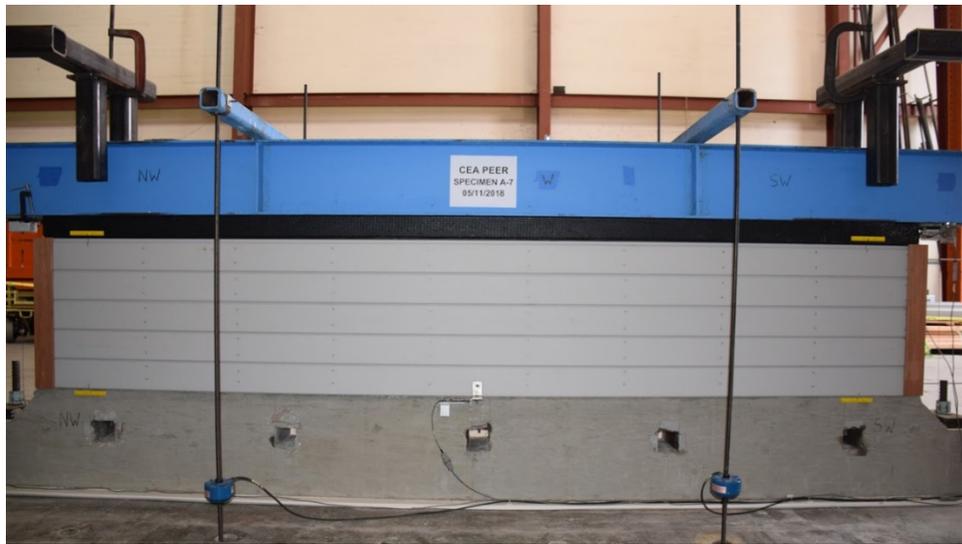
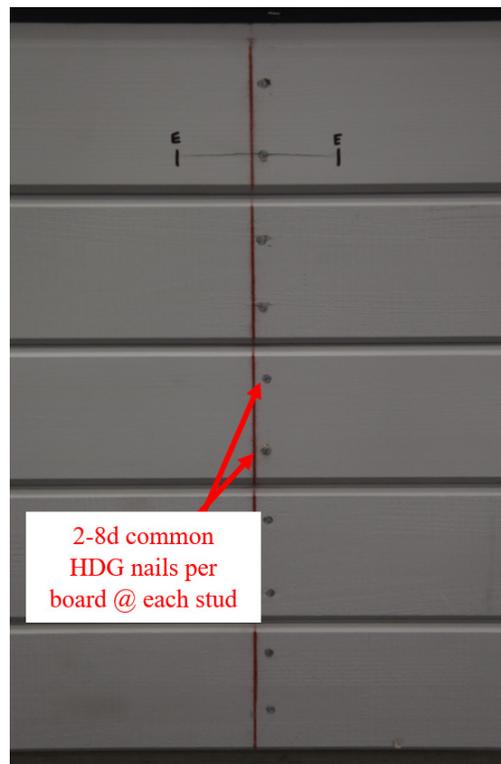
Figure 2.20 Photographs of the elevation view of a 2-ft-tall cripple wall with horizontal siding finish: (a) elevation view; and (b) nailing detail.

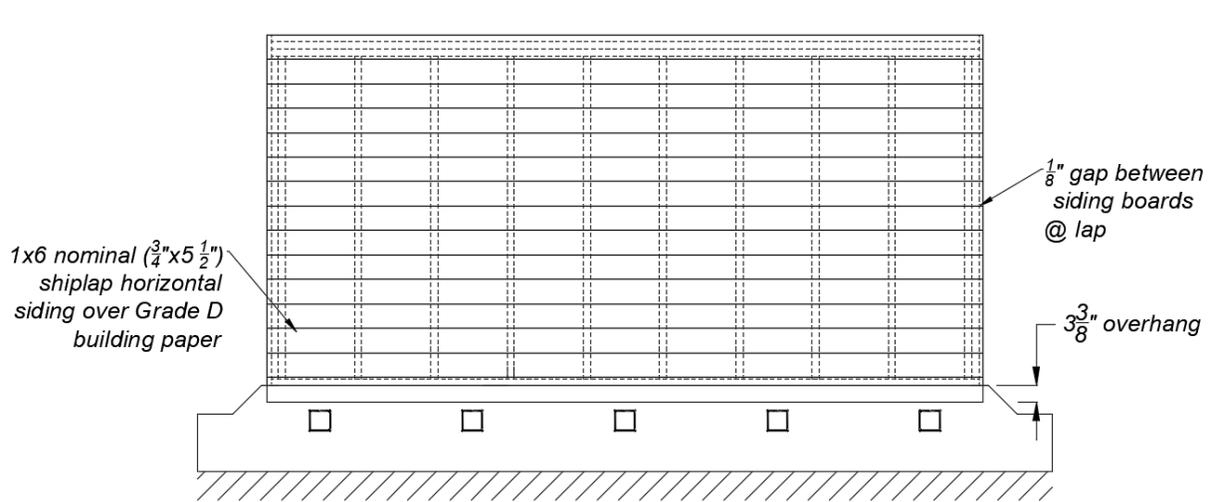
Figure 2.21 Elevation view with details for 6-ft-tall cripple wall with horizontal siding finish.

1. Full siding boards maintained through entire height.
2. Siding is flush to uppermost top plate and outboard of footing.
3. Boards are installed from bottom to top, bottom board overhangs footing.

Elevation
Horizontal Siding (HS)
6' Cripple Wall

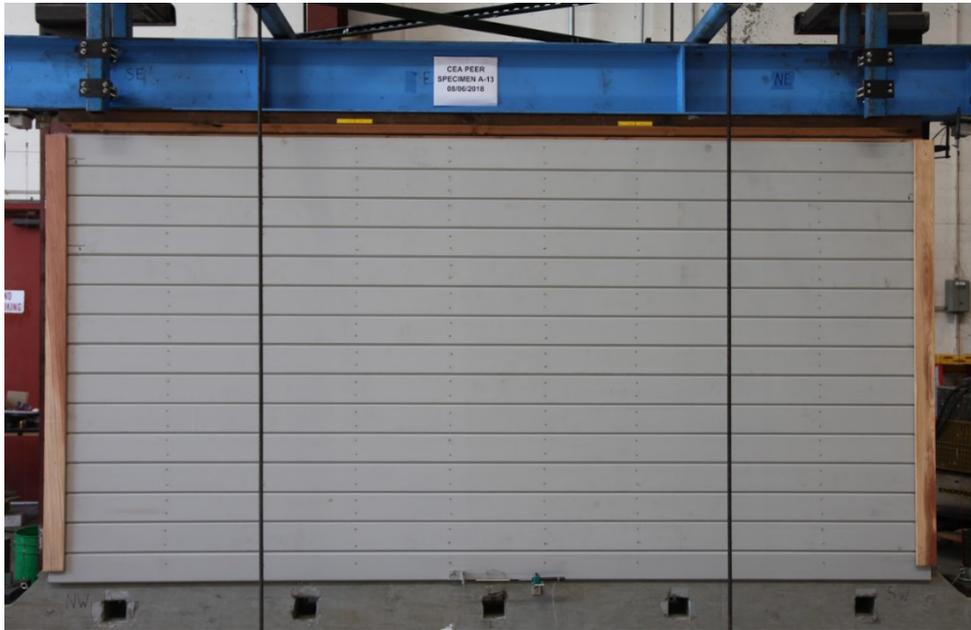
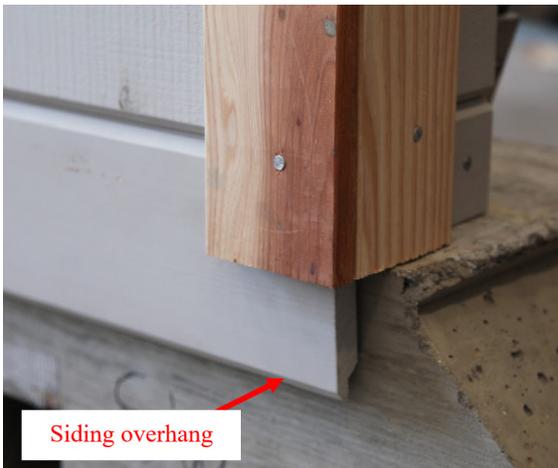
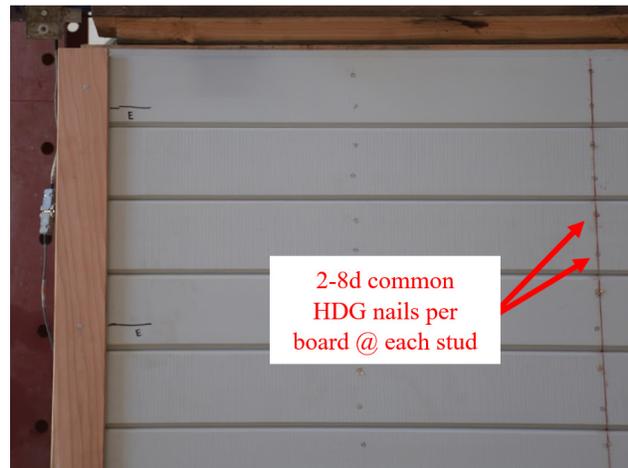
Figure 2.22 Photographs of the elevation view of a 6-ft-tall cripple wall with horizontal siding finished: (a) elevation view; (b) siding overhang; and (c) nailing detail.

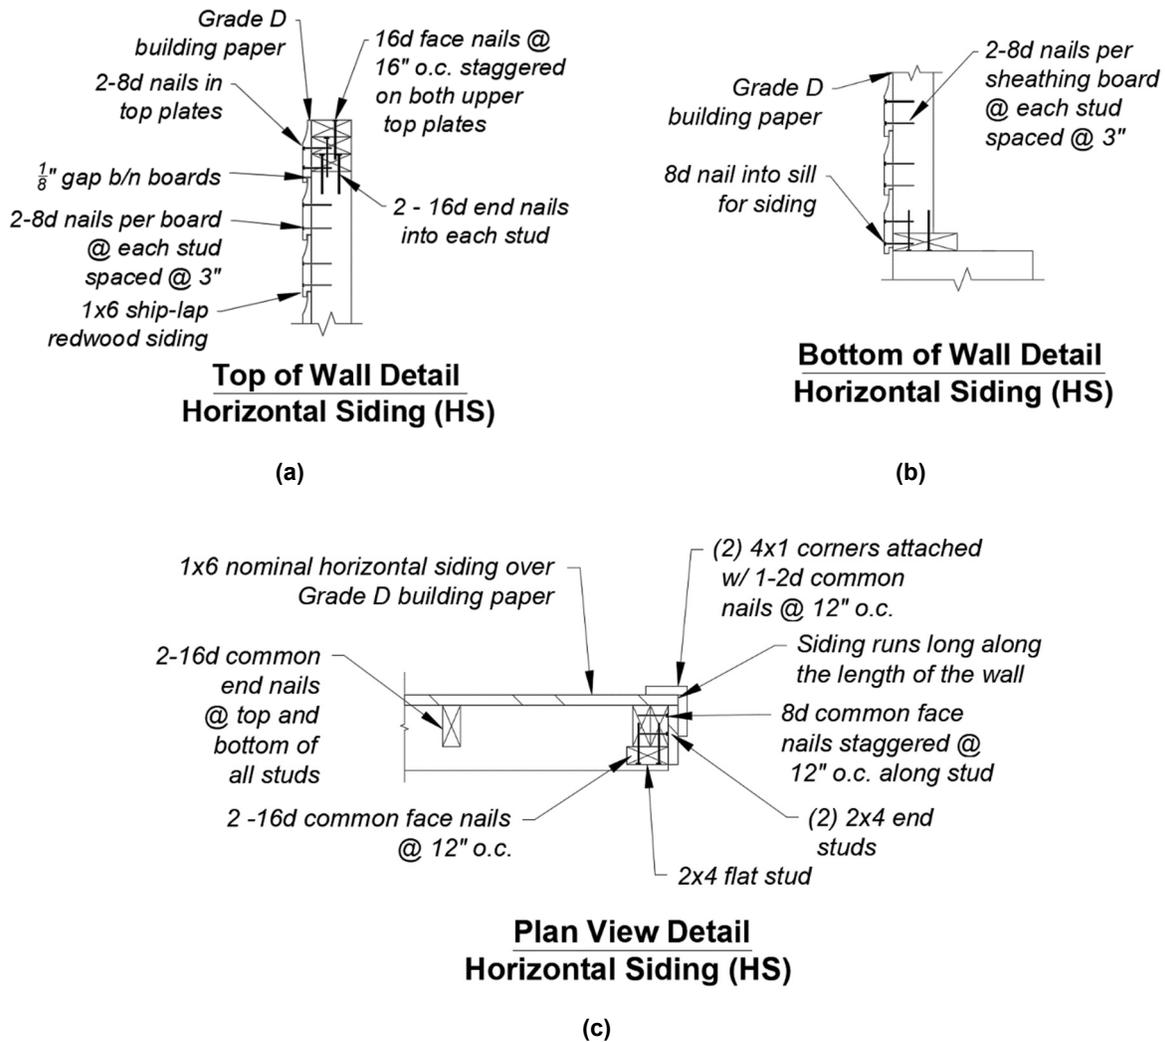
Figure 2.23 Framing and finish nailing details for cripple walls with horizontal siding finish: (a) top of the cripple wall; (b) bottom of the cripple wall; and (c) plan view of corner.

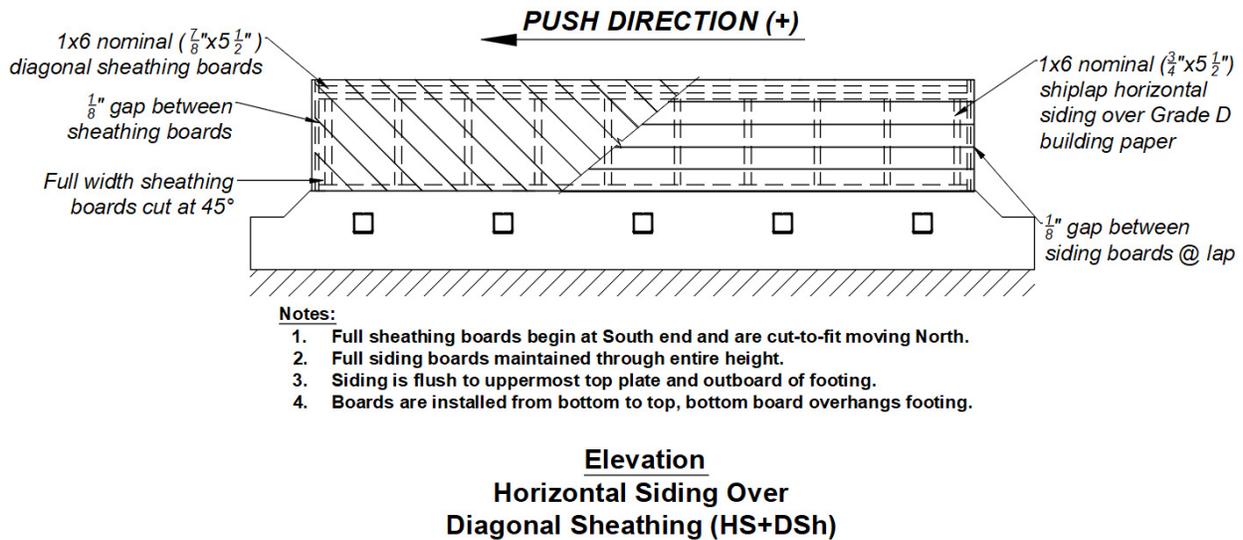
Figure 2.24 Elevation view of 2-ft-tall cripple wall with horizontal siding over diagonal sheathing finish.

Cripple walls finished with horizontal siding over diagonal sheathing were constructed with the same siding material as the horizontal siding over framing cripple walls. The diagonal sheathing boards used were square-edged, 1 × 6 nominal (7/8-in. × 5-1/2-in.) construction grade Douglas Fir. The same type of sheathing was used regardless of the sheathing orientation (horizontal or diagonal). Diagonal sheathing boards were installed at a 45° angle. A 1/8-in. gap was placed between each board using an 8d common nail to allow for expansion. Installation for the sheathing started with a full width board at one end, with each board after cut to fit onto the framing of the cripple wall. Sheathing boards were fastened to the framing with 2–8d nails per stud whereas the edge nailing was 2–8d nails per board along the sill plate, uppermost top plate, and outermost end studs. Specimens with diagonal sheathing were overlaid with Grade D building paper prior to installation of the horizontal siding boards. The horizontal siding was fastened with 2–8d nails per stud. Only the outermost end stud was nailed to the ends. The top siding board was

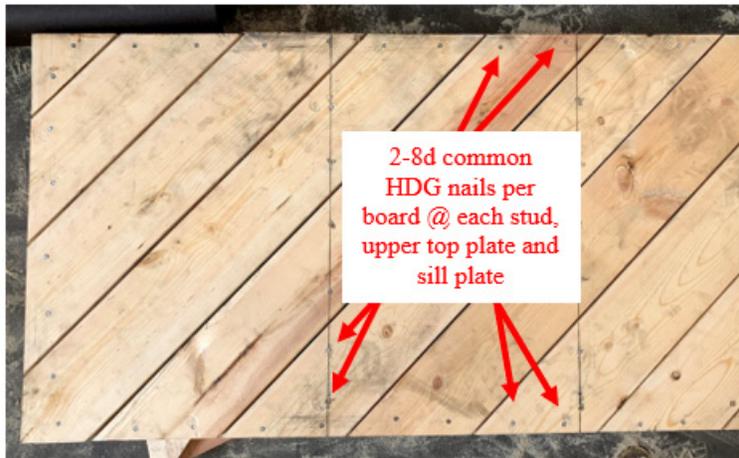
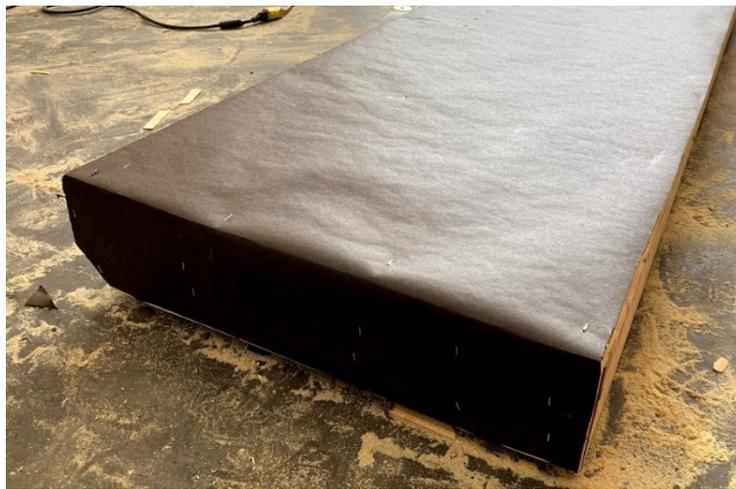
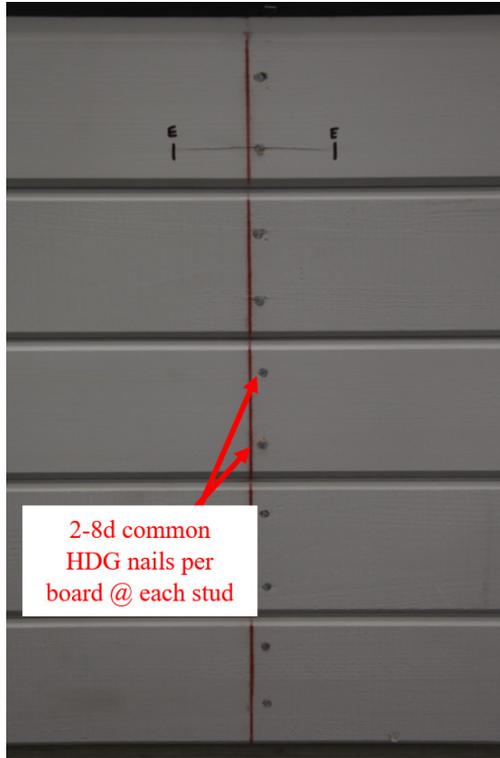
Figure 2.25 Horizontal siding over diagonal sheathing application sequence: (a) diagonal sheathing application; (b) building paper application; and (c) horizontal siding application.

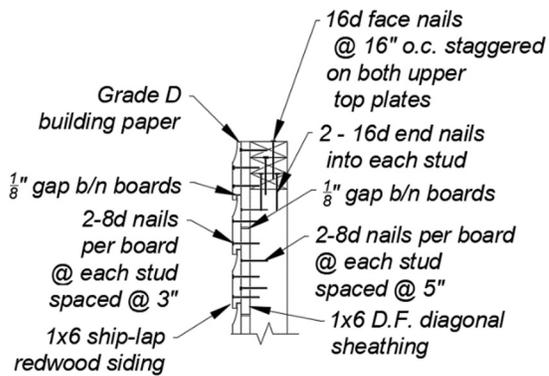
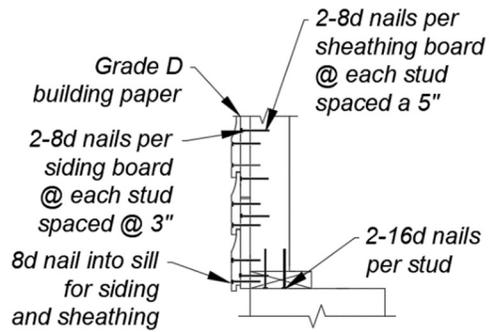
Top of Wall Detail
Horizontal Siding Over
Diagonal Sheathing (HS+DSh)

Bottom of Wall Detail
Horizontal Siding Over
Diagonal Sheathing (HS+DSh)

fastened entirely to the top plates and the bottom siding board had a single nail fastened to the stud through to the sill plate. All nails used were 8d common hot-dipped galvanized. Nails were spaced around 3 in. apart on horizontal siding boards and 5 in. apart on diagonal sheathing boards. The spacing of the nails increased for diagonal sheathing boards due to the increased width of each board along the studs (5-1/2 in. for horizontal siding boards and 7-3/4 in. for diagonal sheathing boards). Nails were centered on siding and sheathing boards. Two pieces of 4 × 1 redwood boards were used as corner trim, which is a common aesthetic addition to cover up the corner joints of finishes. These were fastened with 2d common nails at 12 in. on center. Figure 2.24 shows the arrangement of both siding and sheathing materials as well as a reference to the direction of loading. The finish application sequence is shown in Figure 2.25. Nailing details horizontal siding over diagonal sheathing cripple walls can be provided in Figures 2.26 and 2.27. An additional nailing detail for the attachment of the diagonal sheathing to the framing.

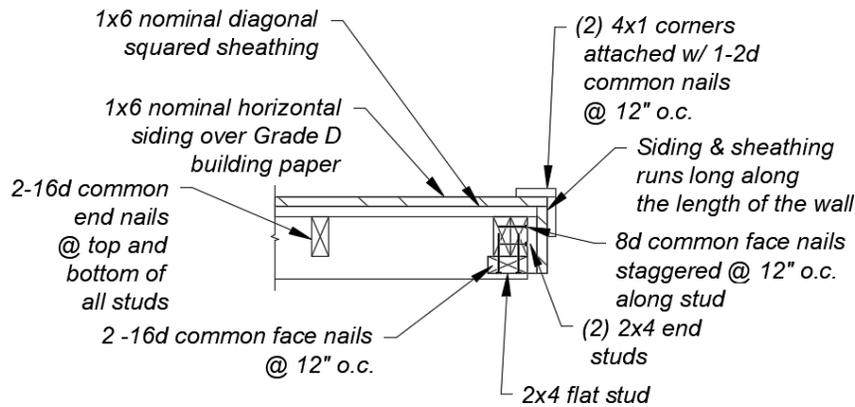
Figure 2.26 Framing and finish nailing details for cripple walls with horizontal siding over diagonal sheathing finish: (a) top of the cripple wall; (b) bottom of the cripple wall; and (c) plan view of corner.

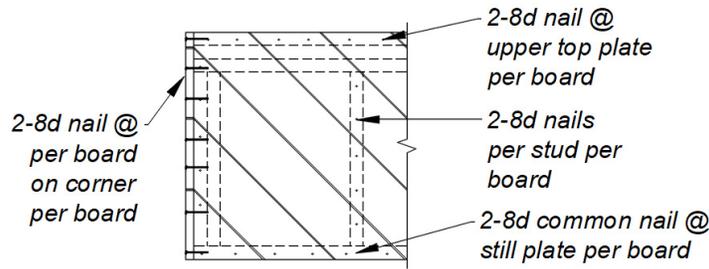
Nailing Detail
Horizontal Siding Over
Diagonal Sheathing (HS+DSH)

Figure 2.27 Diagonal sheathing nailing details.

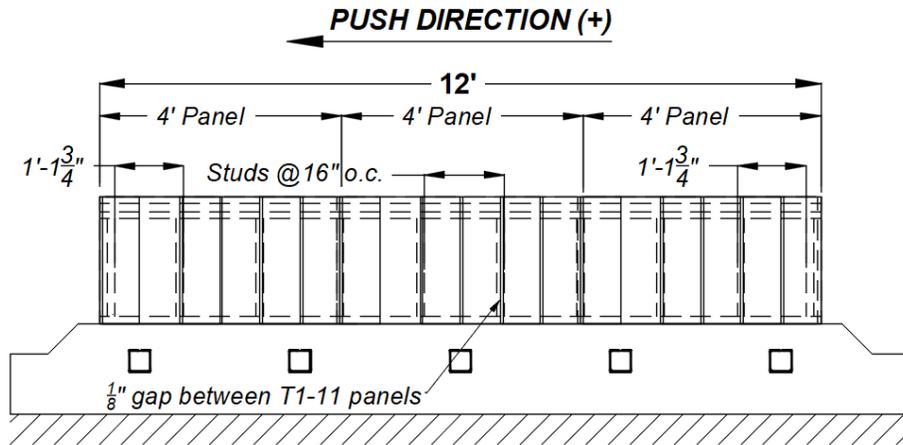
Elevation
T1-11 Wood Structural Panel (T)
2' Cripple Wall

Figure 2.28 Elevation view with details for a 2-ft-tall cripple wall with T1-11 wood structural panel finish.

The T1-11 wood structural panels used are plywood, 5/8-in.-thick \times 4-ft-tall \times 8-ft-wide sections, with an 8-in. on center groove pattern. Modifications were made to the length of the T1-11 cripple walls (12 ft-4-1/2 in. to 12 ft) to fit three full 4-ft sections along the cripple wall. This was done by shortening the two stud bays at the ends from 16 in. to 13-3/4 in., thus keeping the cripple wall symmetric. A 1/8-in. gap was placed between panels to allow for expansion. An elevation view of the T1-11 finished 2-ft-tall cripple walls can be seen in Figure 2.28 and a corresponding photograph is shown in Figure 2.29. The same detail and photograph for the T1-11 finished 6-ft-tall specimens can be found in Figures 2.30 and 2.31, respectively.

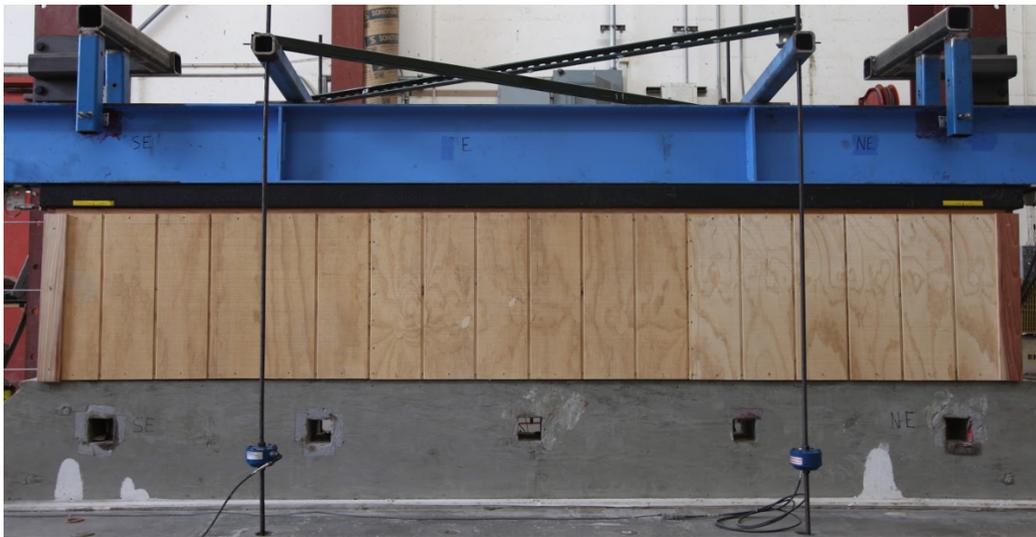
Figure 2.29 Photograph of elevation view of a 2-ft-tall cripple wall with T1-11 wood structural panel finish.

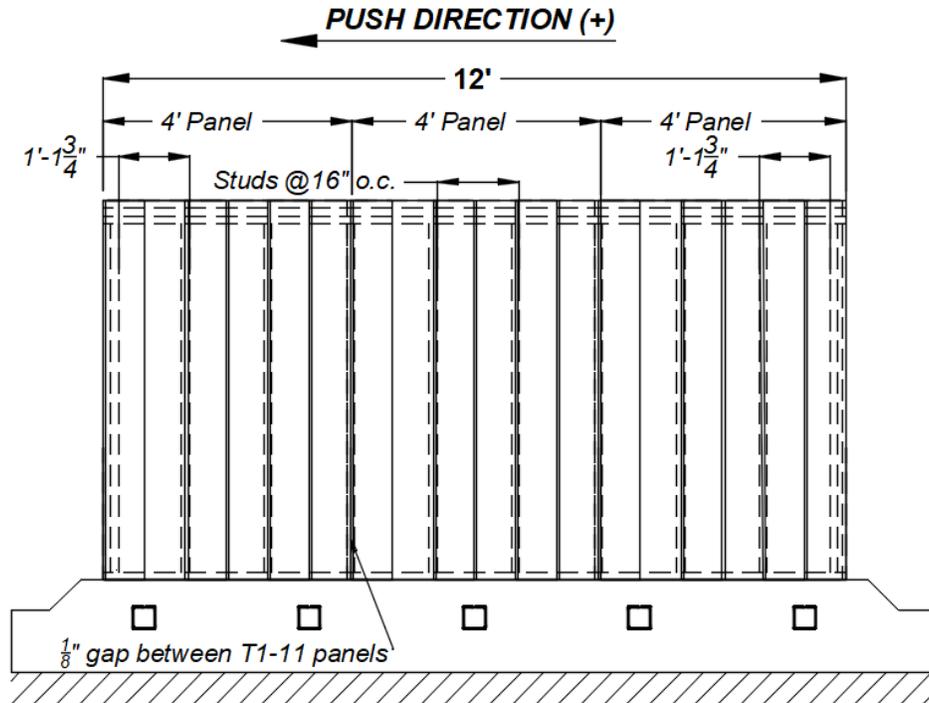
Elevation
T1-11 Wood Structural Panel (T)
6' Cripple Wall

Figure 2.30 Elevation view with details for a 6-ft-tall cripple wall with T1-11 wood structural panel finish.

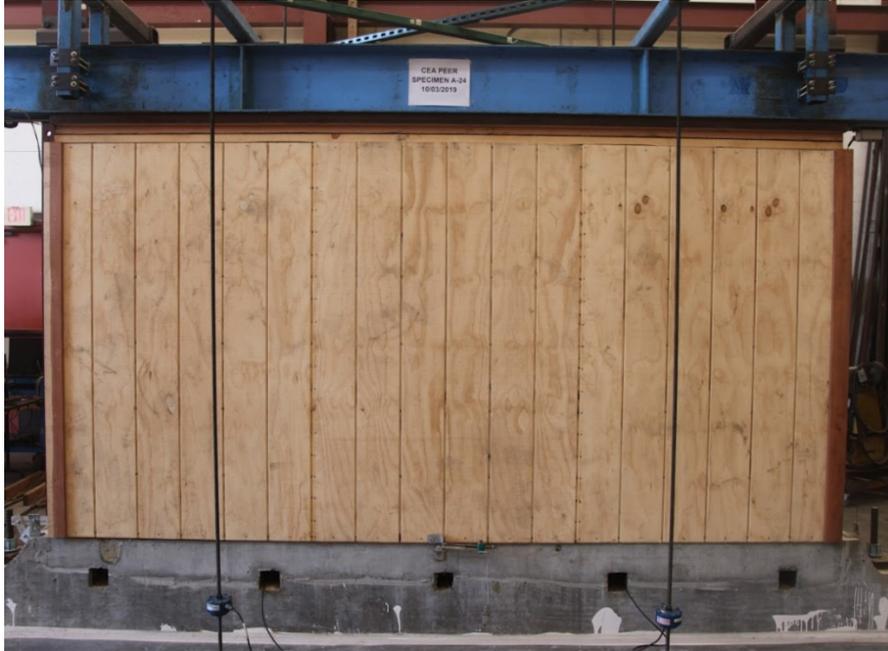
Figure 2.31 Photograph of elevation view of a 6-ft-tall cripple wall with T1-11 wood structural panel finish.

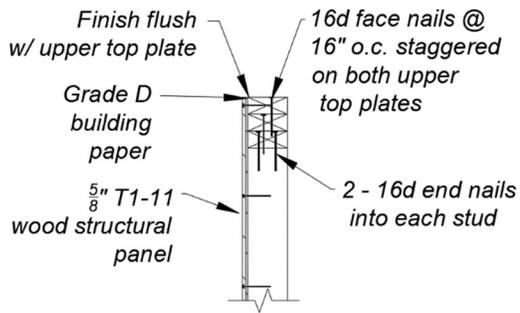
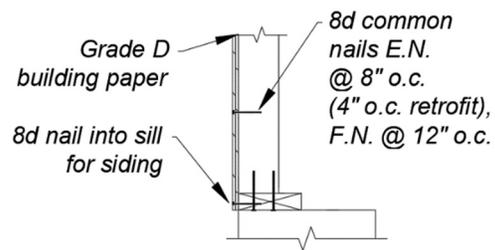
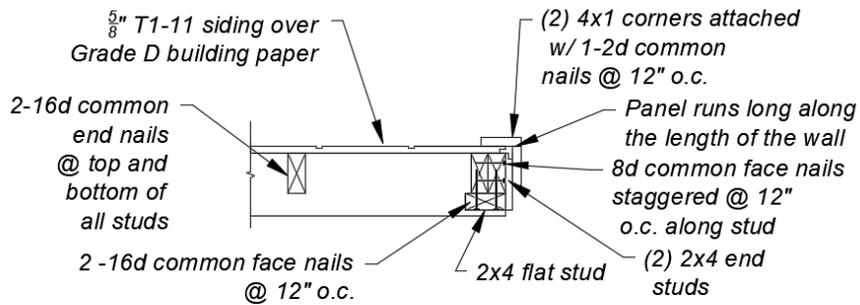
Top of Wall Detail
T1-11 Wood Structural Panel (T)

Bottom of Wall Detail
T1-11 Wood Structural Panel (T)

Plan View Detail
T1-11 Wood Structural Panel (T)

Figure 2.32 Framing and finish nailing details for the cripple walls with T1-11 wood structural panel finish: (a) top of the cripple wall; (b) bottom of the cripple wall; and (c) plan view of corner.

The T1-11 panels were fastened with 8d common, hot-dipped galvanized nails, edge nailed at 8 in. on center and field nailed at 12 in. on center for the existing case and edge-nailed at 4 in. on center and field-nailed at 12 in. on center for the retrofitted case (retrofit details will be discussed later). For the existing case, the T1-11 installation process entailed fastening one T1-11 panel with nails along three edges; see Figure 2.28. The un-nailed edge was secured by putting the next T1-11 panel in place and beginning the same nailing pattern on the next panel. As is common practice, the underlying edge of each T1-11 panel is not nailed but is secured by being pinched by the overlapping panel, as shown in Figures 2.34 and 2.35. Similar to other dry finishes, two pieces of 4 \times 1 redwood boards were used as corner trim. Figure 2.32 through 2.34 provide construction details for the installation of the T1-11 wood structural panels.

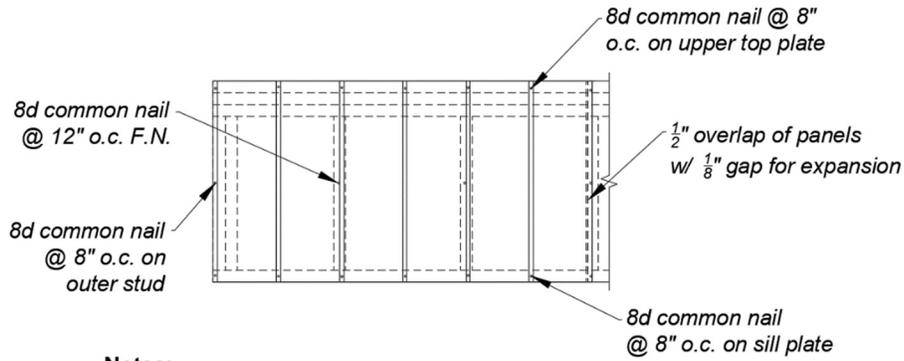
1. $6\frac{1}{2}$ " spacing used for first 2 nails on upper top plate and sill plate in order to align nails on stud @ 8" spacing.

Figure 2.33 Nailing detail for existing T1-11 cripple wall.
