Cripple Wall Small-Component Test Program: Dry Specimens

**A Report for the “Quantifying the Performance of
Retrofit of Cripple Walls and Sill Anchorage in Single-
Family Wood-Frame Buildings” Project**

PEER Report 2020/17

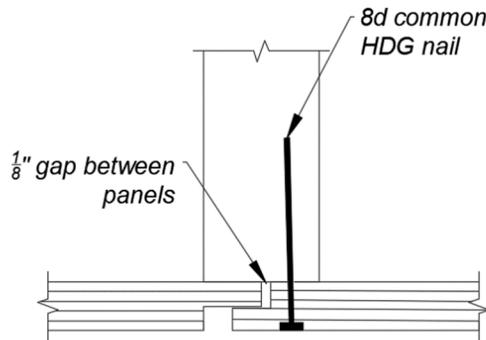
Nailing Detail
Stud - Plywood Joint
Existing T1-11 Wood Structural Panel (T)

Figure 2.34 Nailing detail of T1-11 panel overlap for existing T1-11 cripple wall.

The T1-11 panels were fastened with 8d common, hot-dipped galvanized nails, edge nailed at 8 in. on center and field nailed at 12 in. on center for the existing case and edge-nailed at 4 in. on center and field-nailed at 12 in. on center for the retrofitted case (retrofit details will be discussed later). For the existing case, the T1-11 installation process entailed fastening one T1-11 panel with nails along three edges; see Figure 2.28. The un-nailed edge was secured by putting the next T1-11 panel in place and beginning the same nailing pattern on the next panel. As is common practice, the underlying edge of each T1-11 panel is not nailed but is secured by being pinched by the overlapping panel, as shown in Figures 2.34 and 2.35. Similar to other dry finishes, two pieces of 4 \times 1 redwood boards were used as corner trim. Figure 2.32 through 2.34 provide construction details for the installation of the T1-11 wood structural panels.

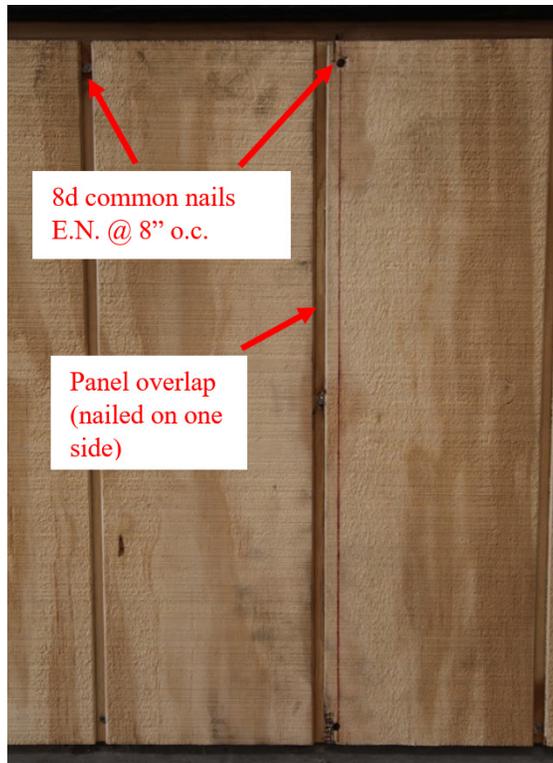
Figure 2.35 Existing T1-11 cripple wall nailing pattern.

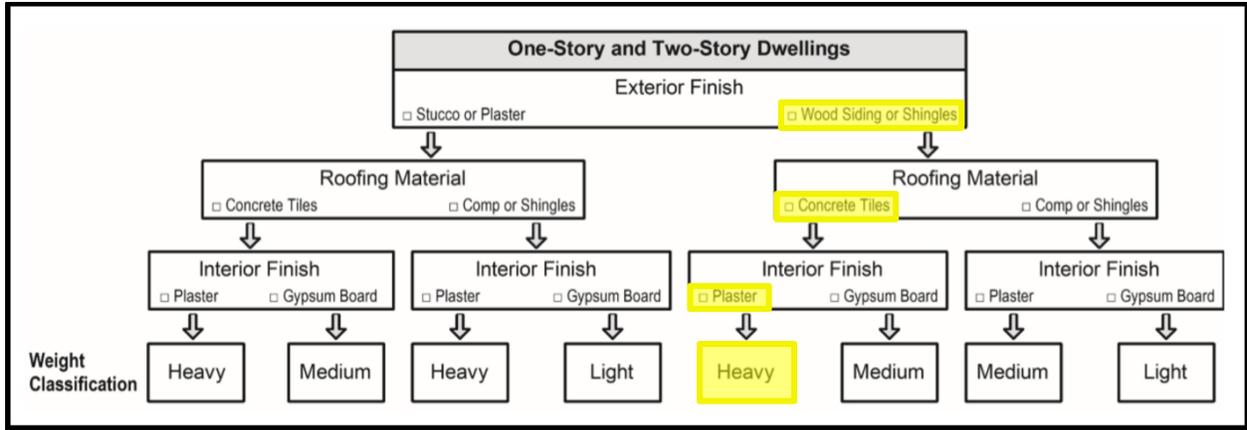
Figure 2.36 FEMA P-1100 weight classification flow chart.

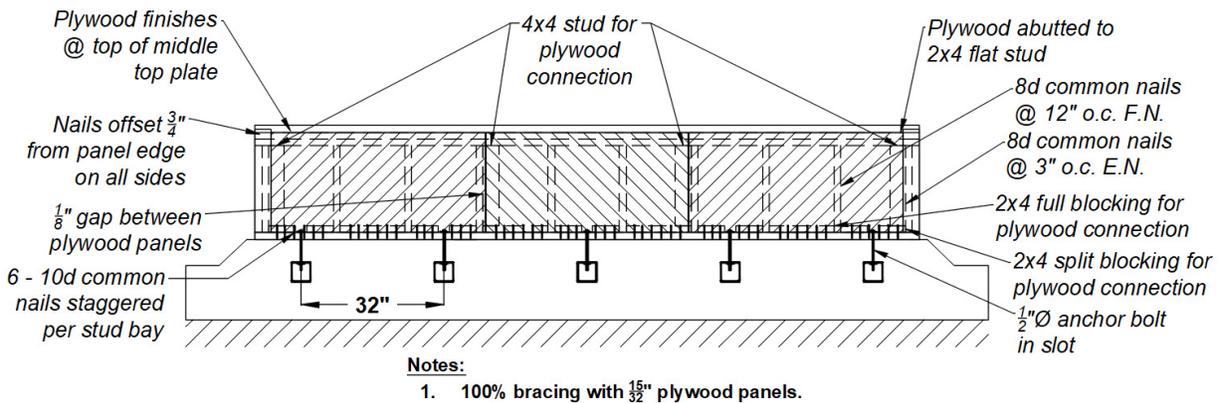
Elevation
Retrofit Framing Details (Interior Face)
2' Tall Cripple Wall
5 Anchor Bolt Configuration

Figure 2.37 Retrofit design for the 2-ft-tall cripple wall with horizontal siding exterior finish (Specimen A-8).

From the table, the row representing two-story heavy construction for a 2400 ft² dwelling was used. The square footage is based on two stories with 1200 ft². For the 2-ft-tall cripple walls, 12 ft of wood structural panels, edge nailed at 2 in. on center, was required for a perimeter wall line. The retrofit design used consisted of fully sheathed walls with 15/32-in.-thick plywood, edge nailed at 3 in. on center, which essentially provided the same capacity as what the *FEMA P-1100* retrofit prescribed. This modification was chosen to sheath the full length of the specimens. From Tables 2.2 and 2.3, 21 all-thread, 1/2-in. anchor bolts were required along the perimeter wall, which was 40 ft in length for the model dwelling considered. For the 12-ft section of wall tested, five anchor bolts were used. In addition, *FEMA P-1100* requires an extra anchor bolt at each end of the cripple wall. Five anchor bolts were slotted into the pre-existing anchor bolt slots on the foundation, spaced at 32 in. on center, and the additional two anchor bolts were embedded 10 in. into the foundation and epoxied with Simpson Strong-Tie SET-XP, 12 in. inward from the outer two most anchor bolts, as shown in Figure 2.37.

The two exceptions to this anchor bolt layout occurred with the 2-ft-tall cripple wall with horizontal siding exterior finish and the 2-ft-tall cripple wall with T1-11 wood structural panels. The horizontal siding specimen used five anchor bolts spaced at 32 in. on center, as shown in Figure 2.37, which is the same as Specimen A-5 (the 2-ft-tall cripple wall with stucco over horizontal sheathing exterior finish). The reason for the difference was that the *FEMA P-1100* guidelines had not been finalized at the time of testing for both of these specimens. In Appendix A.3, the calculations for determining the retrofit design for Specimen A-8 are provided. For the 2-ft-tall cripple wall with T1-11 wood structural panel, no additional retrofit was required as per *FEMA P-1100* Table 8.3-1 once the nail spacing was decreased from 8 in. on center to 4 in. on center along the edges of the panels. The minimum nailing requirements for the T1-11 wood structural panels is 8d common nails at 6 in. on center along the edges and 12 in. on center over the field. The anchor bolt arrangement did not change from its existing counterpart.

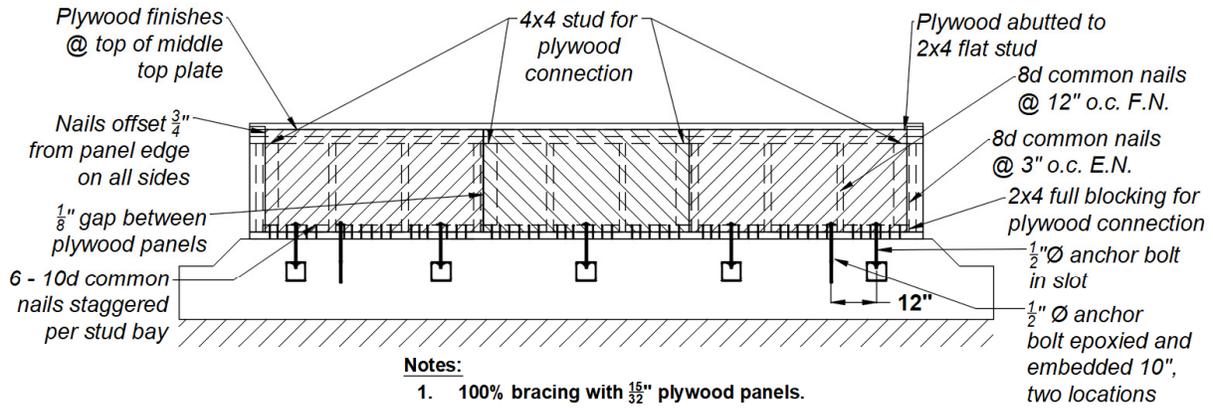
Elevation
Retrofit Framing Details (Interior Face)
2' Tall Cripple Wall
7 Anchor Bolt Configuration

Figure 2.38 Retrofit design for the 2-ft-tall cripple wall with horizontal siding over diagonal sheathing exterior finish (Specimen A-10).

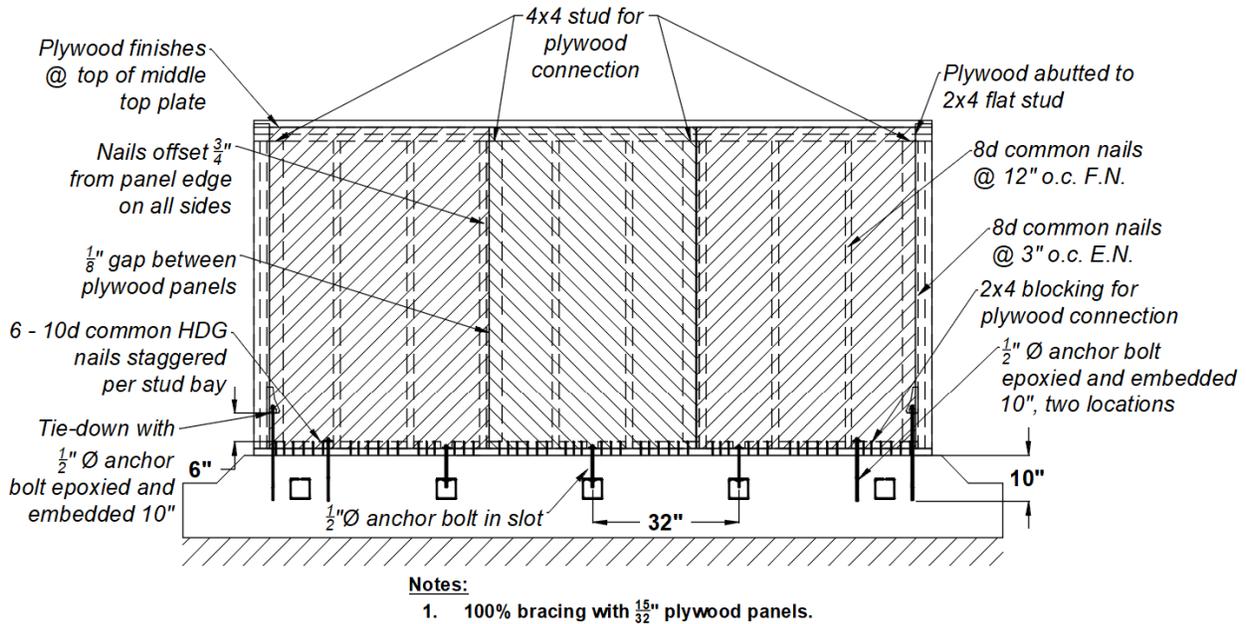
Elevation
Retrofit Framing Details (Interior Face)
6' Tall Cripple Wall
7 Anchor Bolt Configuration w/ Tie-Downs

Figure 2.39 Retrofit design for the 6-ft-tall cripple wall with horizontal siding exterior finish (Specimen A-14).

For the 6-ft-tall cripple walls with tie-downs, 13 ft and 3 in. of wood structural panels, edge nailed at 2 in. on center, were required for a perimeter wall line. Again, this modification was intended to sheath the full wall, which changed the edge nail spacing to 3 in. on center. Therefore, the 6-ft-tall cripple wall was fully sheathed with 15/32-in.-thick plywood, edge nailed at 3 in. on center. As with the 2-ft-tall specimens, 21 anchor bolts along the perimeter wall were required as per *FEMA P-1100*. For the test specimen, five of the anchor bolts were required along with the two additional anchor bolts at each end of the wall. Due to the geometry of the cripple wall and foundation, the location of the anchor bolts attached to the tie-downs did not align with the anchor bolt slots on the foundation. Therefore, these anchor bolts, as well as the additional anchor bolt added at each end, were embedded 10 in. into the foundation and epoxied into place, as shown in Figure 2.39. The remaining three anchor bolts were slotted into the pre-existing anchor bolt slots on the foundation and spaced at 32 in. on center.

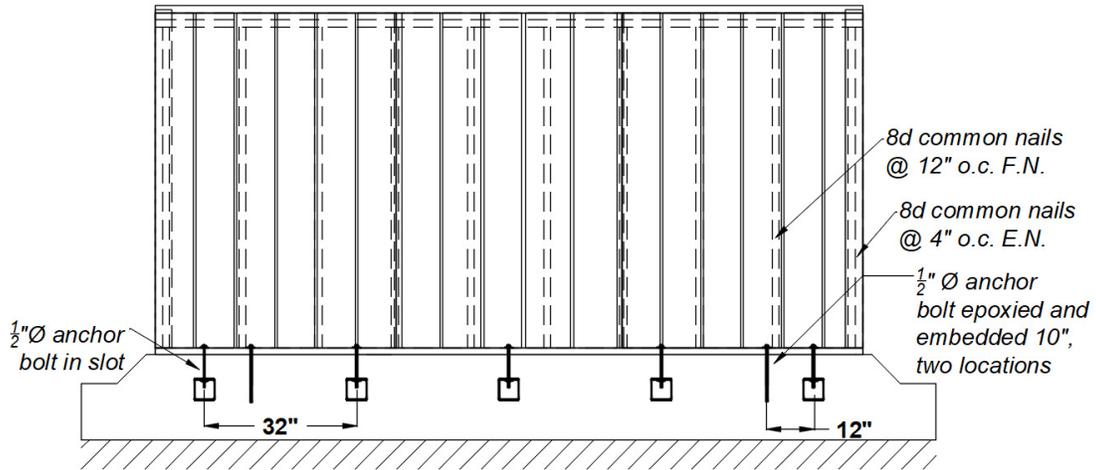
Elevation
Retrofit Framing Details (Interior Face)
6' Tall T1-11 Cripple Wall (T)
7 Anchor Bolt Configuration

Figure 2.40 Retrofit design for the 6-ft-tall cripple wall with T1-11 wood structural panel exterior finish (Specimen A-24).

The retrofit design for cripple walls with T1-11 wood structural panels does not follow the typical *FEMA P-1100* retrofit design provisions used for the rest of the retrofitted cripple walls because the T1-11 is a wood structural panel; thus the addition of plywood on the interior was deemed excessive. In lieu of adding plywood to the interior of the framing, additional nails were added to the T1-11 panels. Originally, the nailing for the T1-11 panels was 8d common, HDG, nails edge-nailed at 8 in. on center and field-nailed at 12 in. on center. For the retrofit design, the edge-nail distance was cut in half to 4 in. on center. In addition, the original T1-11 design only had three edges of the panels nailed and relied on the next panel to sandwich the underlying panel. For the retrofit design, an additional row of nails was added to the underlying panel as shown in Figures 2.43 and 2.45. A comparison of the nailing patterns is shown in Figure 2.44. No additional anchor bolts were installed for the 2-ft-tall specimen (3 anchor bolts spaced 64 in. on center). The decision was made to use seven anchor bolts for the 6-ft-tall specimen, three original and four added in accordance with the *FEMA P-1100* prescriptive retrofit design; see Figure 2.40.

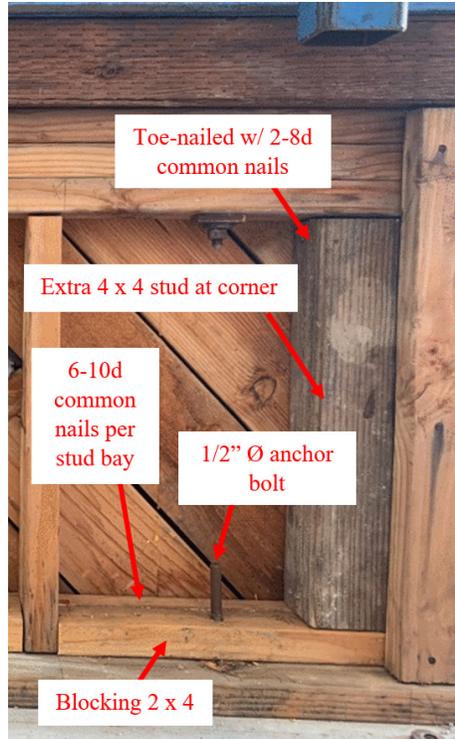
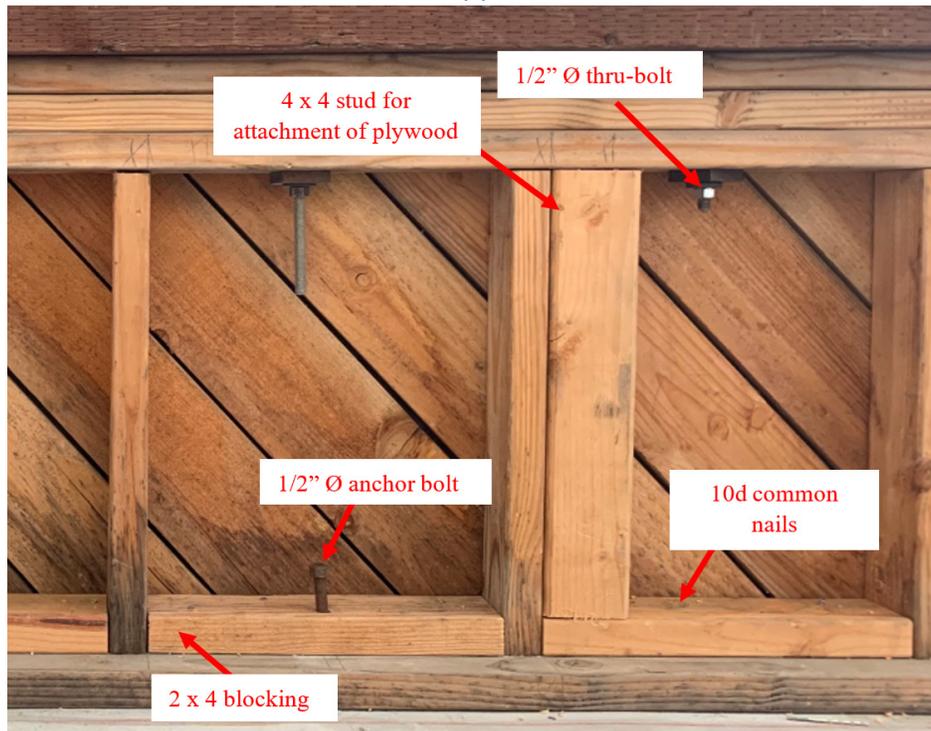
Figure 2.41 Retrofit application details: (a) interior corner retrofit detail; (b) interior retrofit detail; and (c) plywood attachment detail.

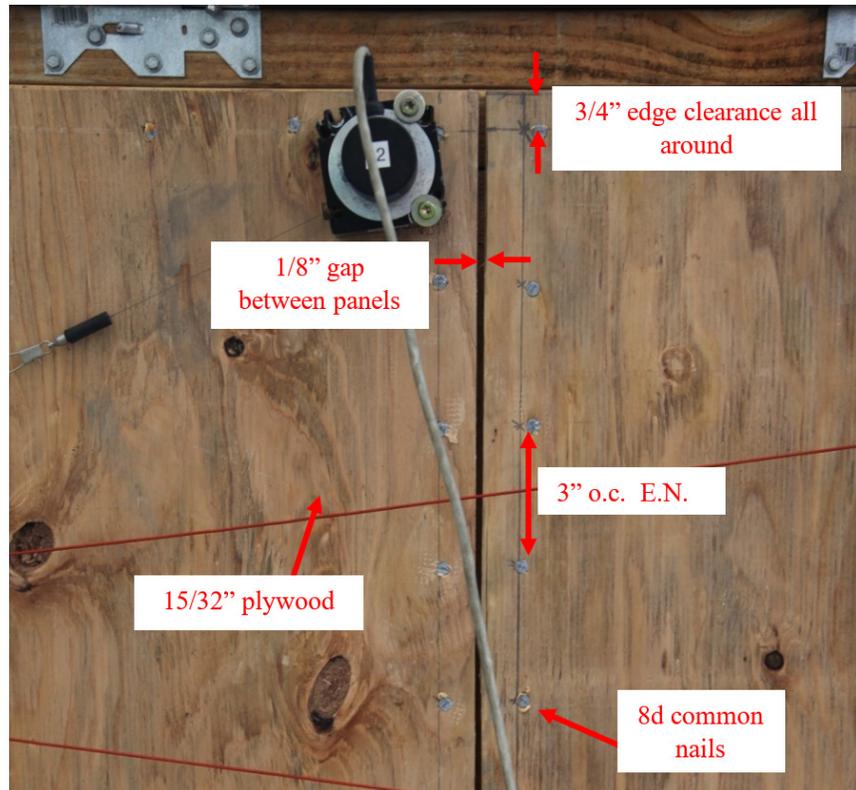
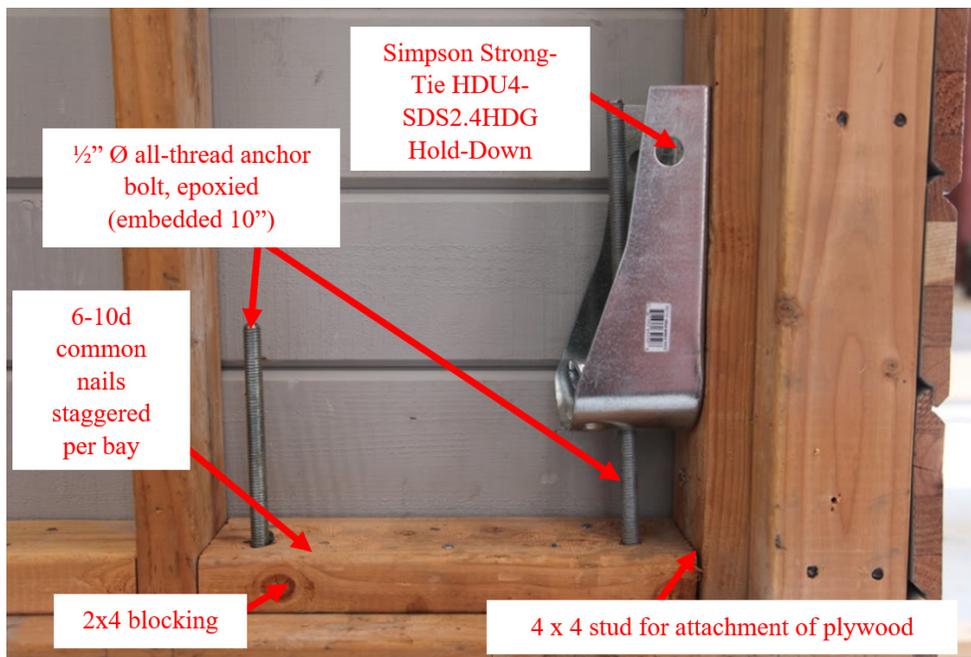
Figure 2.42 Specimen A-14 tie-down placement.

To accommodate the retrofit, additional 4×4 end studs were toe-nailed in the interior framing space, with common nails top and bottom at each end of the wall, and two interior 4×4 studs were toe-nailed in with 2–8d common nails top and bottom at each interior third. The addition of studs and blocking plates were used to allow the plywood panels to be nailed to the cripple wall. The interior of the framing before the application of plywood for a retrofitted specimen is shown in Figure 2.41 (a) and (b). The plywood used was $15/32$ -in.-thick Grade 32/16 plywood and was placed in three 4-ft sections, fully sheathing the interior face of the wall. Panels were attached with 8d common nails at 3 in. on center along the edges and 12 in. on center along the field. A $1/8$ -in. gap was left between panels to allow for expansion, and the nails were placed $3/4$ in. from the panel edge to prevent from nails tearing through the panel edges, as shown in Figure 2.41. Plywood panels terminate at the top of the middle top plate. For the 6-ft-tall cripple wall with horizontal siding, Simpson Strong-Tie HDU4-SDS2.5HDG hold-downs were used for the tie-downs at both ends. The tie-downs were hot-dip galvanized and fastened with six $1/4$ -in. \times 2-1/2 in. Strong-Drive SDS screws into the end studs; see Figure 2.42.

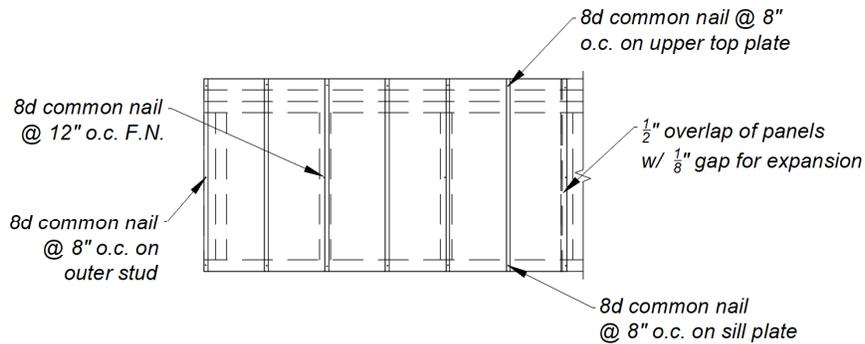
Figure 2.43 Nailing detail of T1-11 wood structural panels for retrofitted T1-11 cripple wall.

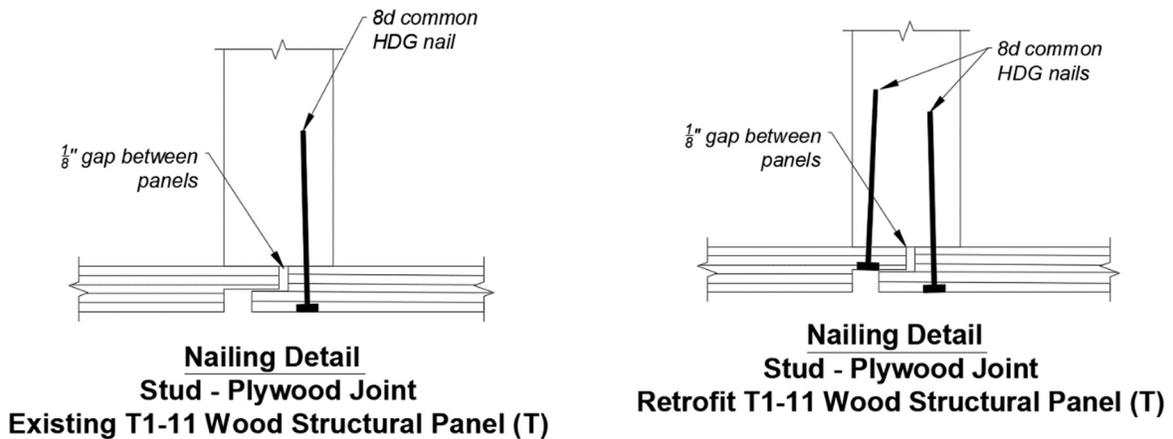
Figure 2.44 Nailing detail for existing (left) and retrofitted (right) T1-11 cripple walls.

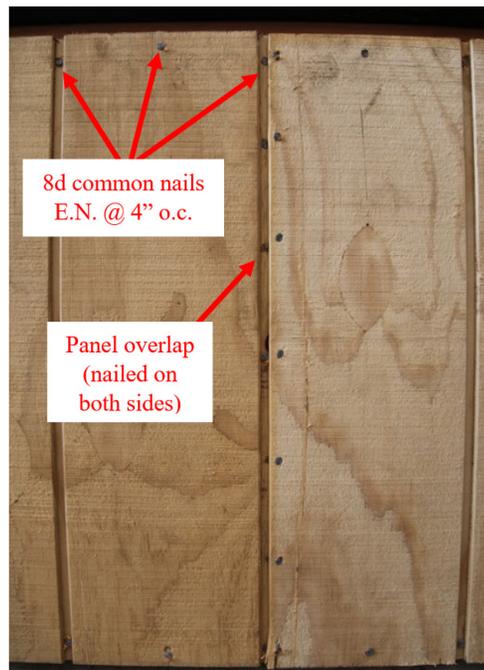
Figure 2.45 Retrofitted T1-11 cripple wall nailing pattern.

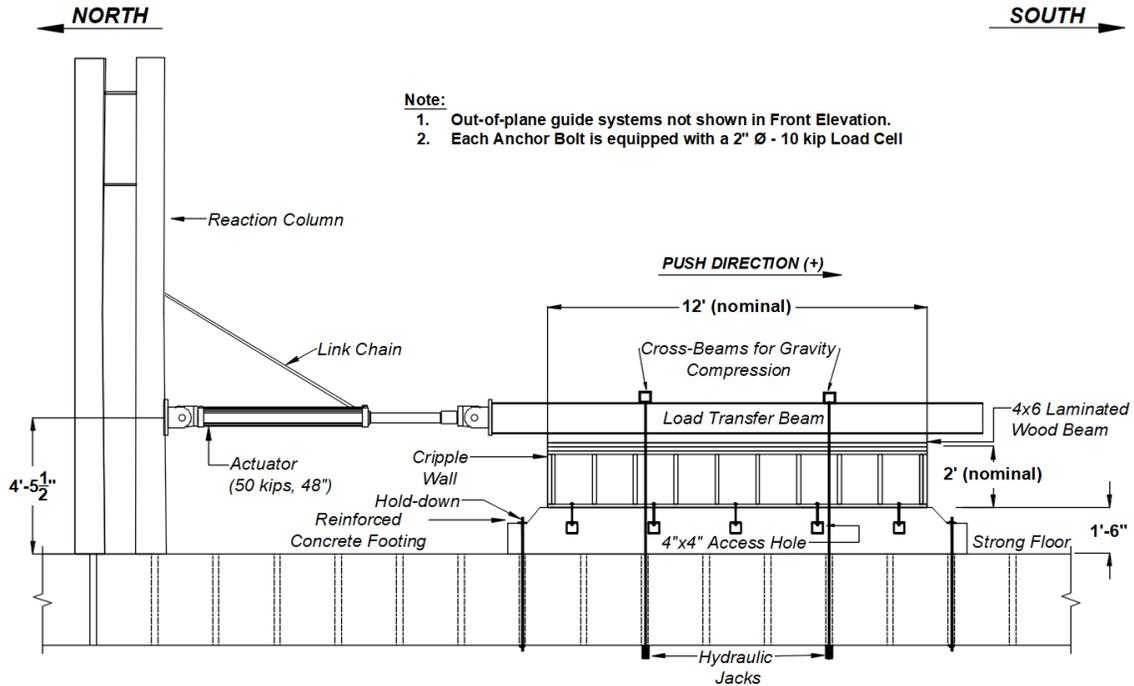
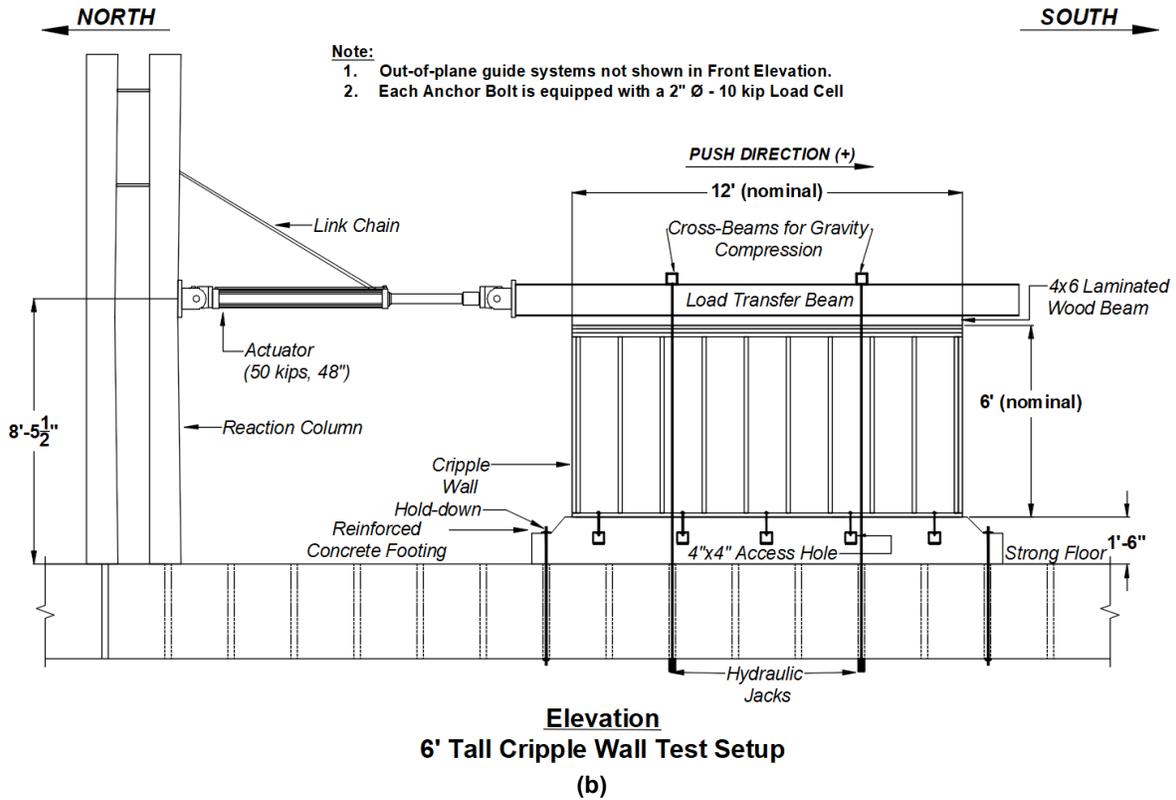
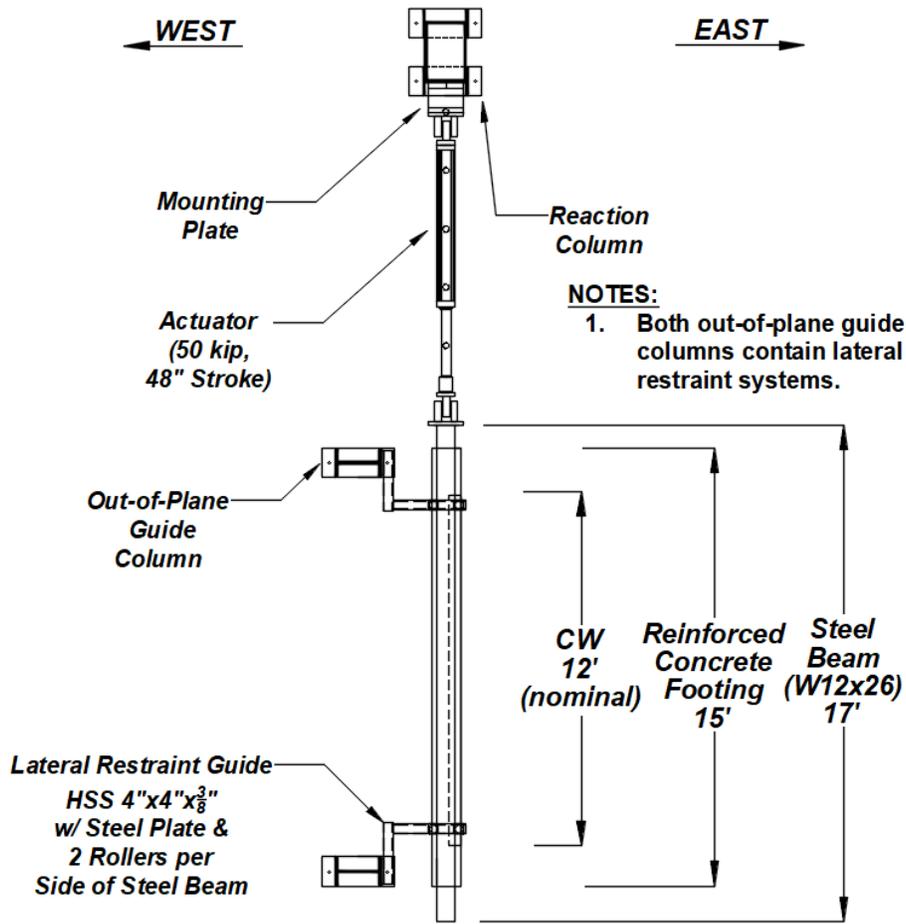
Figure 2.46 Test setup: (a) elevation for 2-ft-tall cripple wall (interior face); (b) elevation for 6-ft-tall cripple wall (interior face); and (c) plan view.

Figure 2.46 (continued).

Figure 2.46 shows a plan view and elevations view of the test setup for both the 2-ft-tall and 6-ft-tall specimens. A complementary photograph of the 2-ft-tall test setup is shown in Figure 2.47. The same test setup was used for all cripple walls in this report, with the exception of the cripple wall tested with a light vertical load. The modifications to the test setup for the light vertical load are discussed in the following section. The lateral load was applied with a 48-in. (total) stroke, servo-controlled, hydraulic horizontal actuator capable of imposing 50 kips. The actuator was

mounted to a strong wall using an actuator mounting plate, with its weight carried via a link chain back to the reaction wall so as to not impose a vertical load on the cripple wall. The lateral force was transferred from the actuator to the cripple wall with a stiff steel beam (W12 × 26 section). To allow for uninhibited movement of the finishes and plywood panels (when present in retrofitted walls) during testing, a 4 × 6 laminated wood beam was used as a spacer between the steel beam and the uppermost top plate of the cripple wall. This also facilitated ease of assembly of the specimens. A 1 in. × 1 in. notch was cut out of the laminated wood beam to allow for the exterior finish materials to freely rotate. Details of the connection of the steel beam, laminated wood beam, and cripple wall framing can be seen in Figure 2.48. The connection from the steel beam to the laminated wood beam was made with pairs of 3/8 in-diameter × 3-1/2-in. long lag bolts at 16 in. on center spacing, connected from the bottom flange of the steel beam top of the wood beam. The laminated wood beam was selected to be sufficiently thick as to preclude connection between the lag bolts and the cripple wall top plates. The cripple wall specimens were connected to the laminated wood beam using 1/2-in. diameter × 7-1/2-in. long, Grade 2 steel thru bolts spaced at 32 in. on center. These bolts were countersunk into the laminated wood beam and fastened with nuts and washers at the bottom of the lowermost top plate.

Before any loads were applied to the cripple wall, pairs of rollers were fastened to the sides of the out-of-plane guide. This can be seen in Figures 2.46 and 2.47. The rollers were greased, and a 1/16-in. gap was left between the steel plate and the steel transfer beam so as to not impose any artificial loads via friction force at the contact interface of the plates and beam. The purpose of implementing an out-of-plane guide system was to ensure that the imposed displacement during testing is only in-plane.

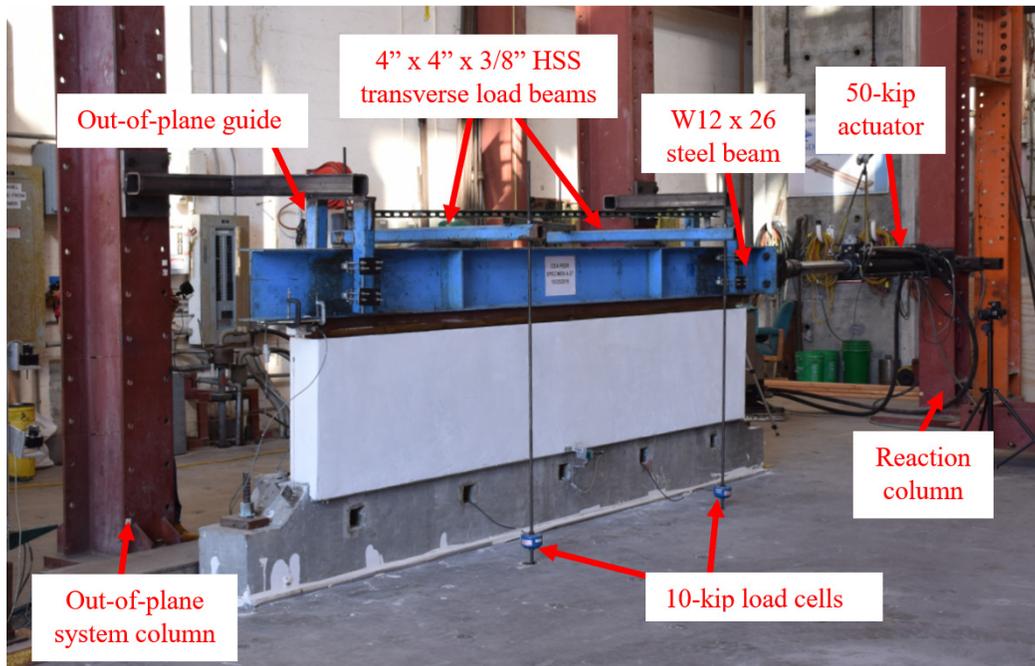
Figure 2.47 Isotropic view of the test setup for 2-ft-tall cripple walls.

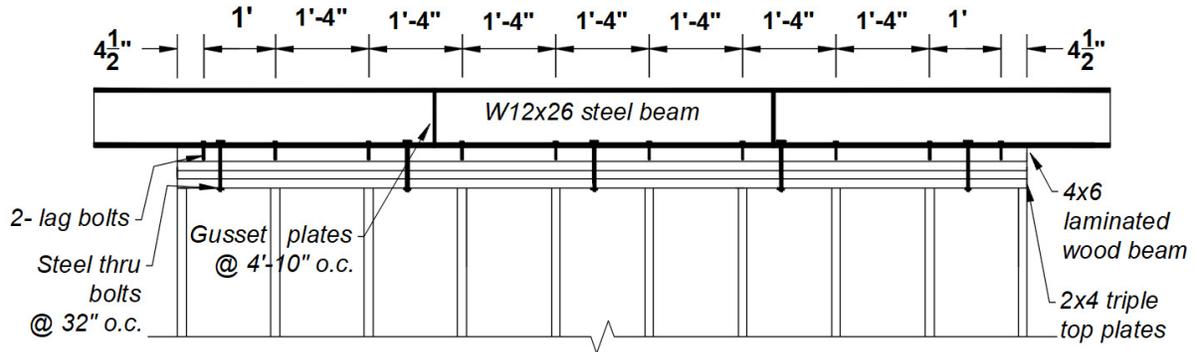
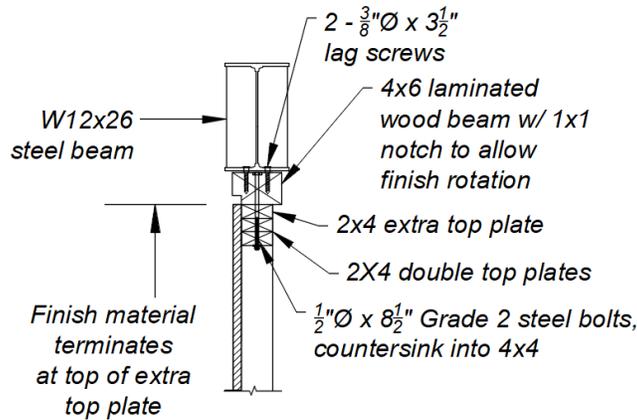
**Elevation
Steel Beam Connection**

**Top of Wall Detail
Steel Beam Connection**

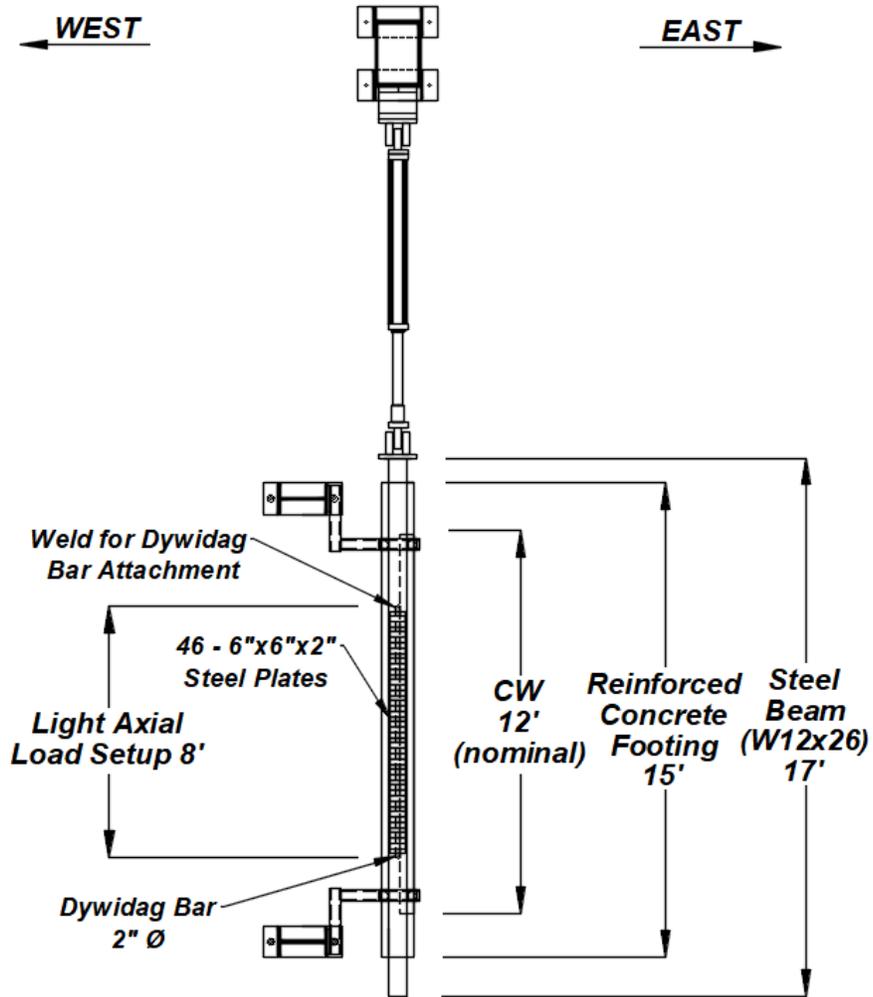
Figure 2.49 Test setup for light vertical load cripple wall.

One of the eleven tests was subjected to 150 lbs/ft vertical load (1800 lbs total), denoted as the light vertical load case. The vertical load application setup required modification because the hydraulic jacks were not able to impose such small loads precisely and accurately. The modifications involved replacing the transverse load beams, rods, axial load cells, and hydraulic jacks with 46 steel plates and a Dywidag bar. The steel beam and laminated wood transfer beam accounted for 400 lbs of the required vertical load, and thus the steel plates and Dywidag bar were designed to account for the remaining 1400 lbs. The steel plates were 6 in. × 6 in. × 2 in., and the bar was 2 in. in diameter. The steel plates and bar were centered on top of the steel load transfer beam and then welded in place, as shown in Figures 2.49 and 2.50.

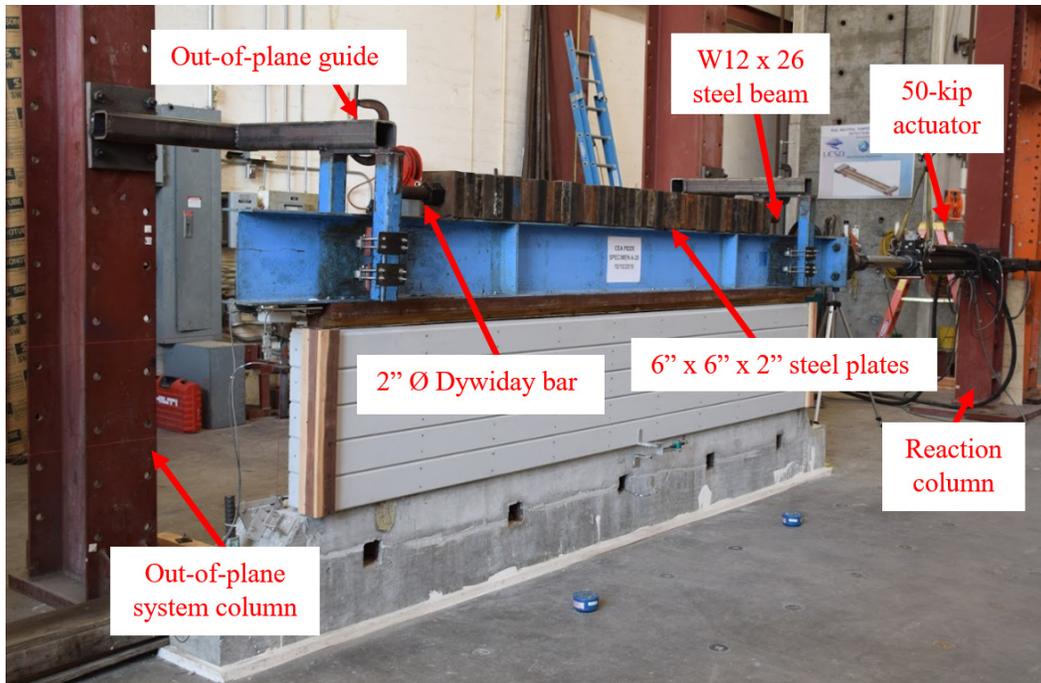
Figure 2.50 Isometric view of the test setup for 2-ft-tall cripple walls with light vertical load.

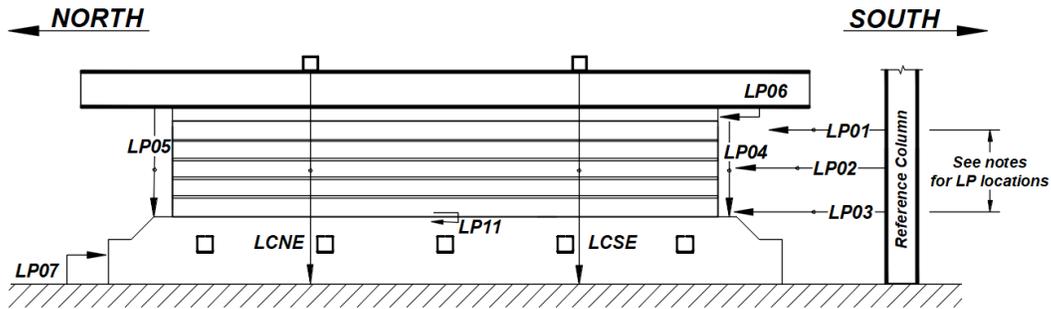
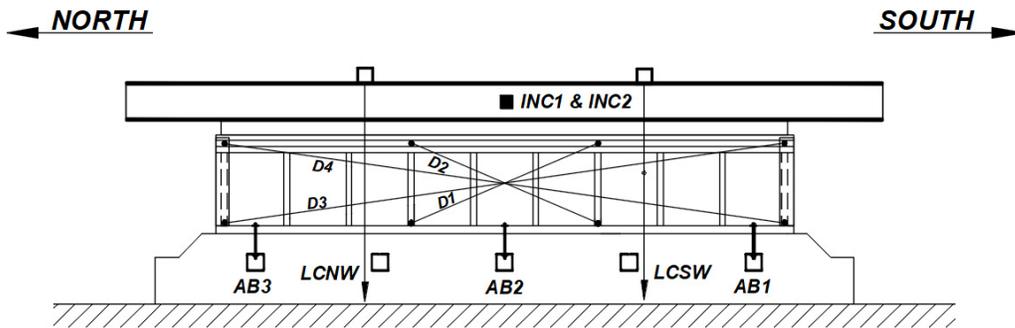
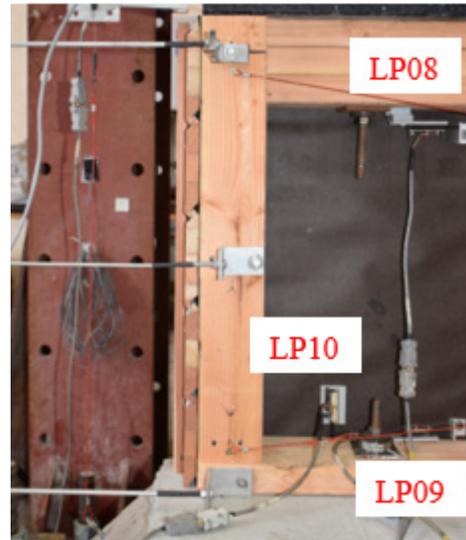
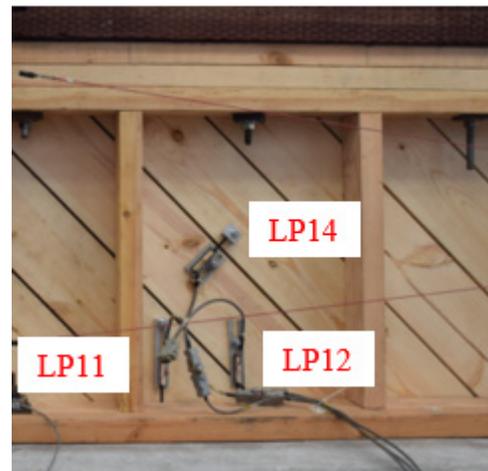
1. LP01, LP02, and LP03 measure lateral displacement with LP01 attached to middle of second top plate, LP02 attached to middle of stud, and LP03 attached to middle of sill plate.
2. LP04 and LP05 measure the uplift at each end of the wall.
3. LP06 monitors the slip between the horizontal transfer beam and the upper top plate.
4. LP07 monitors the slip of the footing.
5. LCNE and LCSE monitor the axial load on the East Side of the wall.
6. LP11 monitors displacement of siding relative to the footing.

1. AB1-AB3 are instrumented with 2" Ø Donut Load Cells measuring uplift loads.
2. Pairs of strength potentiometers are mounted on framing studs or plywood panels for retrofit cases.
3. INC1 measures longitudinal rotation of load transfer beam. INC2 measures the transverse rotation of the load transfer beam.
6. LCNW and LCSW measure the applied axial load.
7. D1-D4 monitor the diagonal distortion.

Figure 2.51 Instrumentation details for a 2-ft-tall cripple wall: (a) elevation for the horizontal siding finish face; (b) elevation for the framing face; (c) instrumentation details for horizontal siding; and (d) instrumentation details horizontal siding over diagonal sheathing.

1. LP08 and LP09 monitor the siding slip.
2. LP10 monitors uplift of bottom siding board.

1. LP11 and LP12 monitor the sheathing uplift.
2. LP14 monitors sheathing board gap.

Figure 2.51 (continued).

Extensive measurements of displacements, rotations, and loads were performed on each cripple wall specimen. Each specimen had slight variations in instrumentation depending on its exterior finish and retrofitting condition. Figure 2.51 shows the instrumentation details for a 2-ft-tall cripple wall. Figure 2.51(a) and (b) show the exterior (finish) and interior (framing) elevations, respectively. Figure 2.51(c) provides a detail for the interior of a horizontal siding exterior finished cripple wall, and Figure 2.51(d) provides the same detail for a horizontal siding over diagonal sheathing cripple wall. Figure 2.52 shows the instrumentation details for Specimen A-13, a 6-ft-tall cripple wall with horizontal siding exterior finish.

The overall response of the cripple wall was characterized using displacements measured by displacement transducer LP01. LP01, plus transducers LP02 and LP03, were connected to a stationary reference column tensioned into strong floor. For a 2-ft-tall cripple wall, LP01 was attached to the top of the middle top—24 in. from the top of the concrete footing—and captured the total displacement at the top of the cripple wall. LP02 was attached to the middle of the cripple wall, at a height of 12 in. from the top of the footing. This intermediate displacement transducer was used to define the deflected shape of the cripple wall. LP03 was attached to the middle of the sill plate and was used to measure the absolute displacement of the sill plate. For a 6-ft-tall cripple wall, LP01 was connected to the middle of the upper top plate—72 in. from the top of the concrete footing—and LP03 was connected to the middle of the sill plate. LP02 was placed in the middle of the cripple wall, 36 in. from the top of the concrete footing. By taking the difference between LP01 and LP03, the relative displacement of the cripple wall could be determined (neglecting sill slippage). Details of these transducers can be seen in Figure 2.51(a) and 2.52(a). A photograph of

Uplift of the cripple wall was measured at each end with displacement transducers LP04 and LP05, shown in Figures 2.51(a) and 2.51(a). For 2-ft-tall cripple walls, the uplift measurements were also out of the resolution range of the transducers. This was not expected to be the case with 6-ft-tall cripple wall specimens. The slip between the steel transfer beam and the uppermost top plate was measured by LP06. It should be noted that even if slip between steel transfer beam and top plate occurred, it did not affect the amount of displacement imposed on the cripple wall specimen as that was controlled by LP01, which is attached to the cripple walls itself. Displacement transducer LP07 was attached to the strong floor and measured the slip between the foundation and strong floor. The foundation was tensioned to ensure that no slip occurred at this interface.

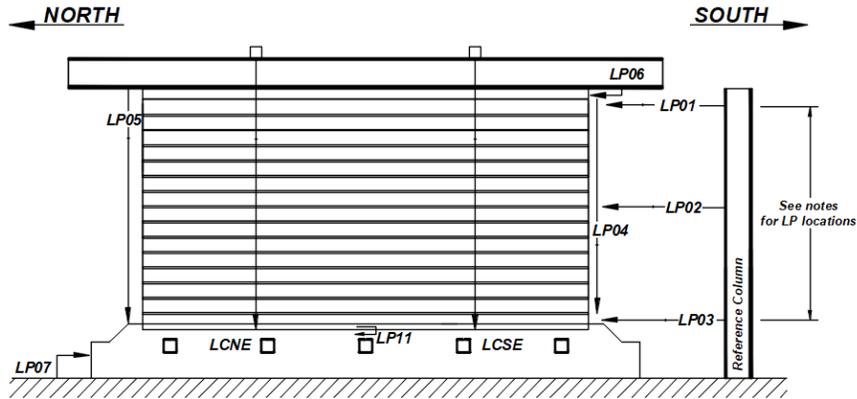
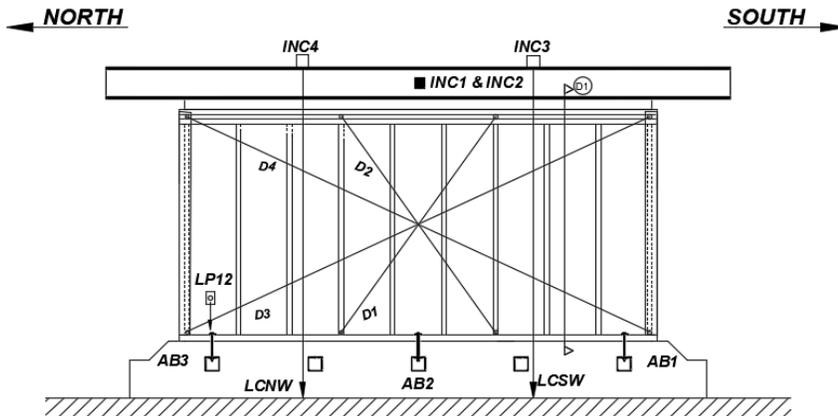
1. LP01, LP02, and LP03 measure lateral displacement with LP01 attached to middle of second top plate, LP02 attached to middle of stud, and LP03 attached to middle of sill plate.
2. LP04 and LP05 measure the uplift at each end of the wall.
3. LP06 monitors the slip between the horizontal transfer beam and the upper top plate.
4. LP07 monitors the slip of the footing.
5. LCNE and LCSE monitor the axial load on the East Side of the wall.
6. LP11 monitors displacement of siding relative to the footing.

1. AB1-AB3 are instrumented with 2" \varnothing Donut Load Cells measuring uplift loads.
2. Pairs of strength potentiometers are mounted on framing studs or plywood panels for retrofit cases.
3. INC1 measures longitudinal rotation of load transfer beam. INC2 measures the transverse rotation of the load transfer beam.
4. INC3 and INC4 measure the rotation of the transverse beams where axial load is applied.
5. LCNW and LCSW monitor the axial load on the West Side of the wall.
6. LP12 monitors the uplift of the bottom siding board relative to the sill plate.

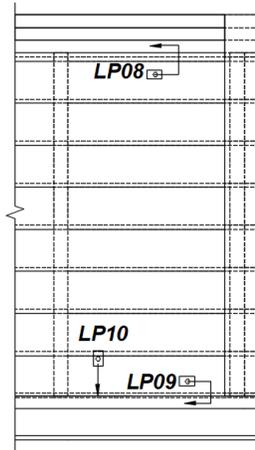
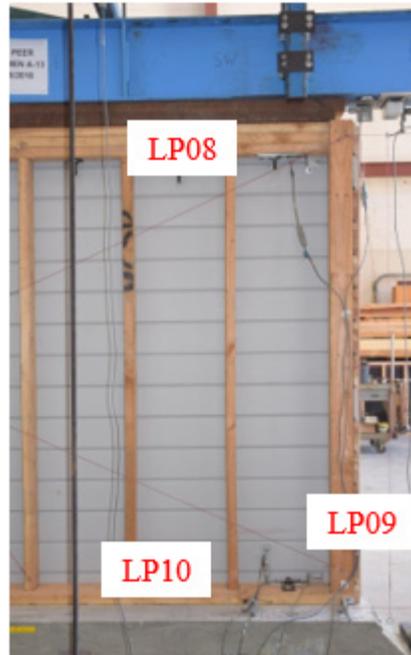
Figure 2.52 Instrumentation details for a 6-ft-tall cripple wall: (a) elevation for the horizontal siding finish face; (b) elevation for the framing face; and (c) instrumentation details for horizontal siding.

1. LP08 and LP09 monitor the sheathing slip.
2. LP10 monitors the sheathing uplift

Instrumentation Detail (D1)
Sheathing

Figure 2.52 (continued).

As mentioned before, there were small variations in the instrumentation of some of the cripple wall specimens depending on the exterior finish and the retrofit condition; details are available in Appendix B.1.

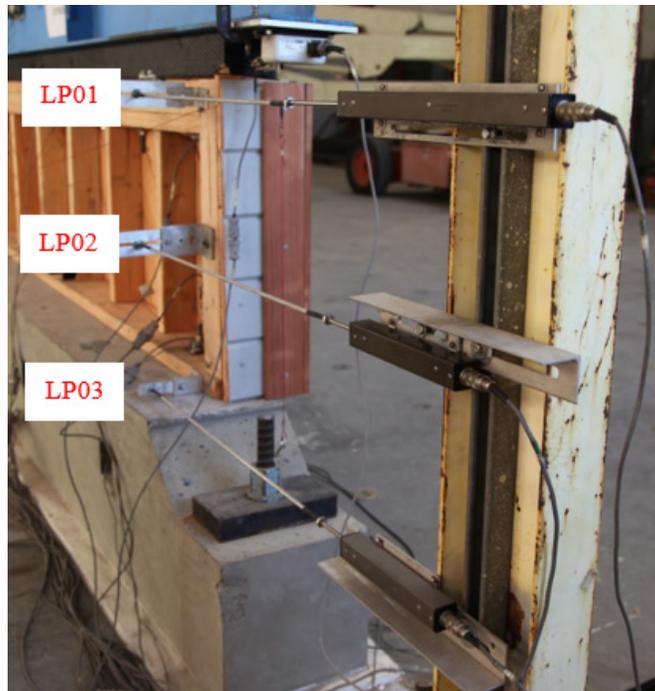
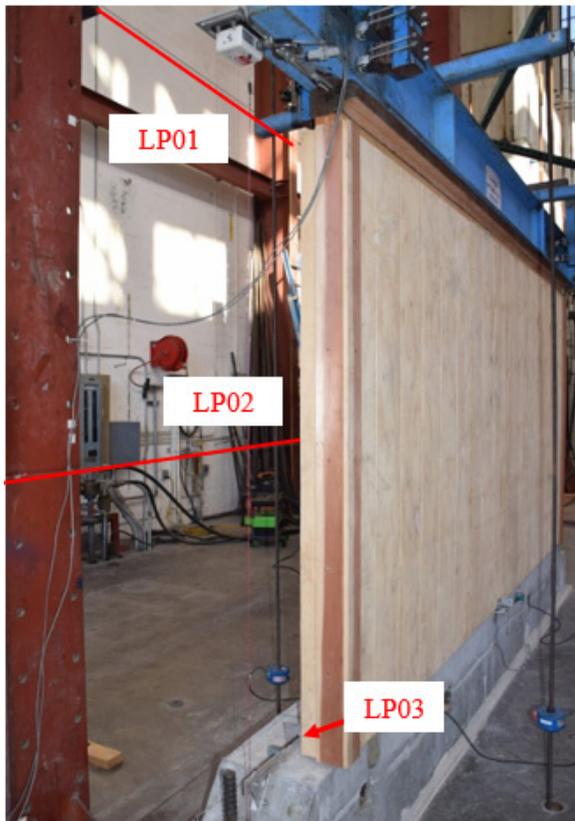
Figure 2.53 Displacement transducers LP01–LP03 placement: (a) 2-ft-tall cripple wall; and (b) 6-ft-tall cripple wall.

the placement of transducers LP01–LP03 can be seen in Figure 2.53(a) for a 2-ft-tall cripple wall and Figure 2.53(b) for a 6-ft-tall cripple wall.

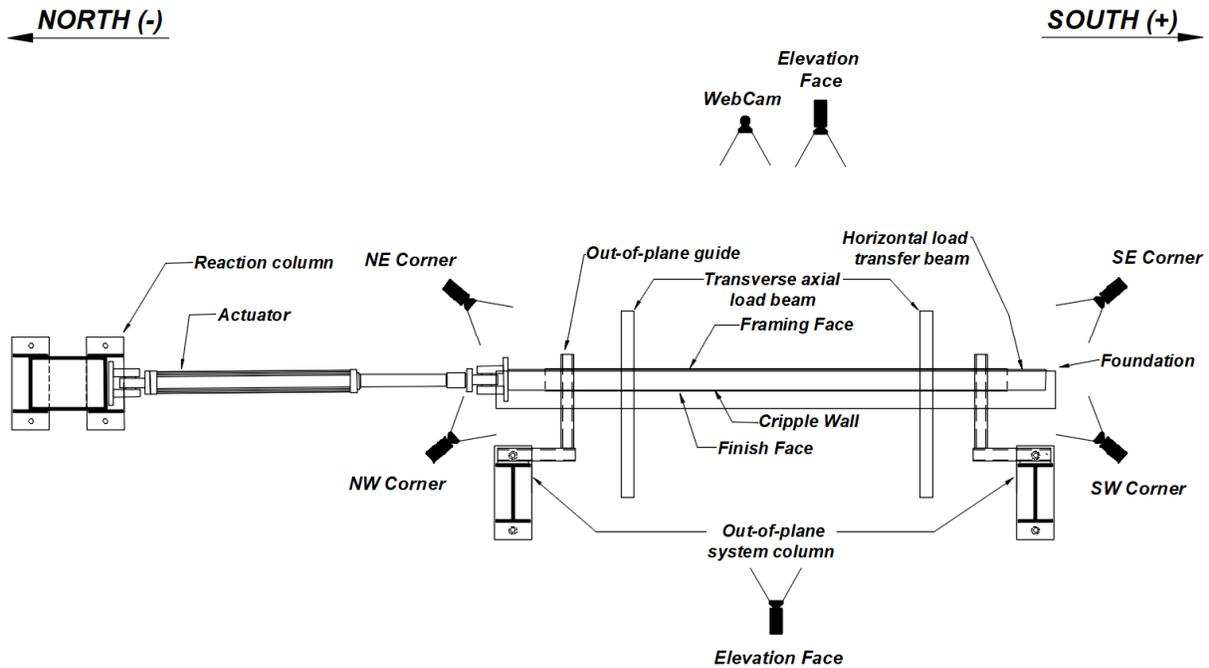
Figure 2.54 Layout of cameras and scope of view (for all but Specimens A-7 and A-8).

For each test, both extensive high-resolution digital photographs and videos documented the pre-test, during test, and after test state of each cripple wall specimen. During testing, photographs were taken at the push and the pull of the first cycle for each drift ratio level as well as at the end of the last cycle of the drift ratio level for the 0.2%–1.4% drift amplitudes. Five to six cameras were used to capture the live motion of the cripple wall during testing. Figure 2.54 shows the locations of each of the cameras used to record tests. The first two tests had the cripple wall facing the opposite direction; therefore, the arrangement of cameras was modified as shown in Figure 2.55. One of the cameras was a live web camera with views of the finish face of the cripple wall. These tests recorded the test continuously from start to finish. During video processing, the recordings of the webcams were edited and overlaid with the loading protocol as well as the lateral force–lateral displacement hysteresis of the cripple wall. The other three to four cameras worked to capture various angles of the walls that were deemed most important to help understand the specimen’s behavior during testing. The framing face and finish face were often recorded with these cameras as well because the video resolution of these cameras is higher than that of the webcams. Other important areas to take video were the ends of the cripple walls. All of the cripple walls would bear on the foundation at their ends, which caused these areas to accumulate more significant damage than the framing or finish faces, especially at low drift amplitudes.
