Cripple Wall Small-Component Test Program: Dry Specimens

**A Report for the “Quantifying the Performance of
Retrofit of Cripple Walls and Sill Anchorage in Single-
Family Wood-Frame Buildings” Project**

PEER Report 2020/17

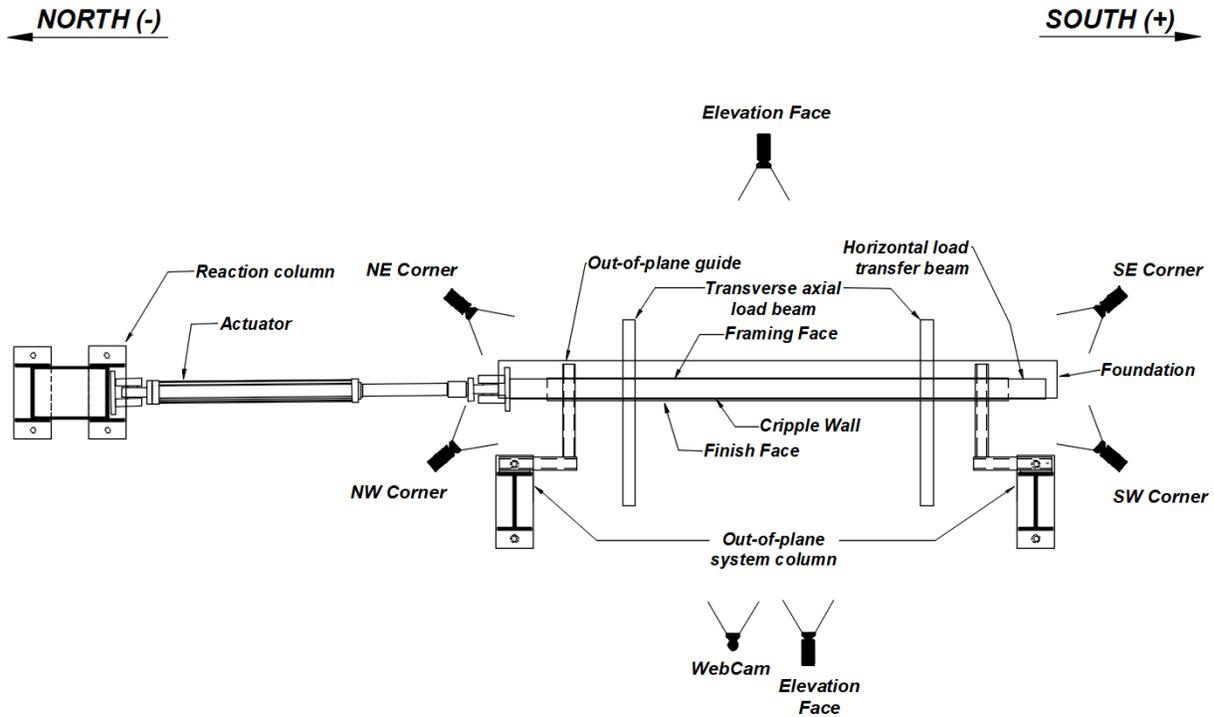
Figure 2.55 Layout of cameras and scope of view for Specimens A-7 and A-8.

For each test, both extensive high-resolution digital photographs and videos documented the pre-test, during test, and after test state of each cripple wall specimen. During testing, photographs were taken at the push and the pull of the first cycle for each drift ratio level as well as at the end of the last cycle of the drift ratio level for the 0.2%–1.4% drift amplitudes. Five to six cameras were used to capture the live motion of the cripple wall during testing. Figure 2.54 shows the locations of each of the cameras used to record tests. The first two tests had the cripple wall facing the opposite direction; therefore, the arrangement of cameras was modified as shown in Figure 2.55. One of the cameras was a live web camera with views of the finish face of the cripple wall. These tests recorded the test continuously from start to finish. During video processing, the recordings of the webcams were edited and overlaid with the loading protocol as well as the lateral force–lateral displacement hysteresis of the cripple wall. The other three to four cameras worked to capture various angles of the walls that were deemed most important to help understand the specimen’s behavior during testing. The framing face and finish face were often recorded with these cameras as well because the video resolution of these cameras is higher than that of the webcams. Other important areas to take video were the ends of the cripple walls. All of the cripple walls would bear on the foundation at their ends, which caused these areas to accumulate more significant damage than the framing or finish faces, especially at low drift amplitudes.

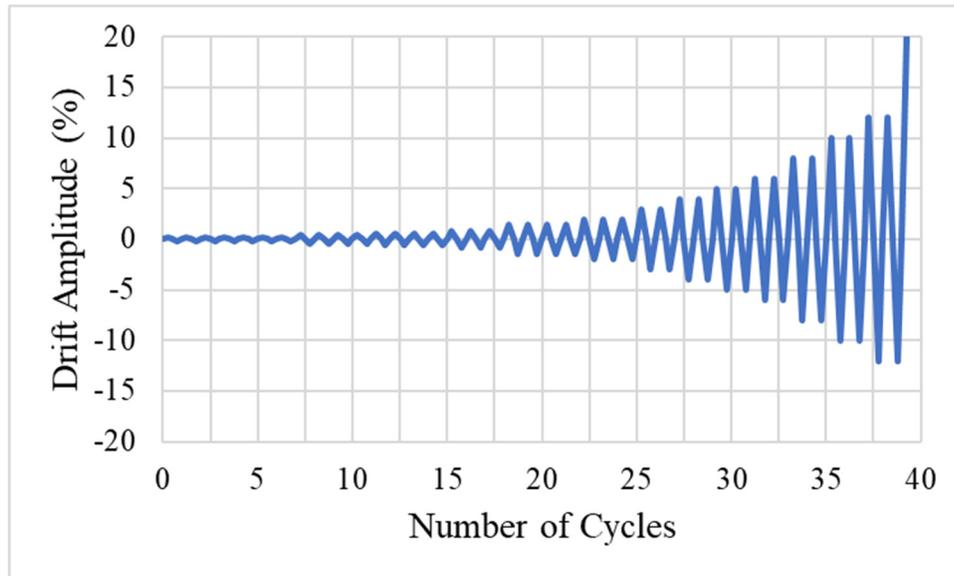
Figure 2.56 Loading protocol for the 2-ft-tall Specimen A-7.

The loading protocol for each test varied slightly depending on the rate of post-peak strength degradation of the individual specimen. All cripple walls underwent the same loading protocol up until the specimen realized a loss greater than 60% of its measured lateral strength. At this point in the protocol, the following and each subsequent drift ratio level was increased by 2%, rather than 1%. If the 60% loss in strength did not occur, each drift ratio level would remain at an increase of 1% per cycle grouping. The loading protocol would progress until an 80% loss in strength was realized. At this point, a monotonic push would be conducted, typically to a global drift of 20%. The amplitude of the monotonic push might vary slightly depending on instrumentation constraints. Figure 2.56 shows the loading protocol for Specimen A-7 (a 2-ft-tall cripple wall), and Table 2.4 gives details of the loading protocol. Figure 2.57 shows the loading protocol for Specimen A-13 (a 6-ft-tall cripple wall), and Table 2.5 gives details of the loading protocol. See Appendix A.4 for details of the loading protocol for each test.

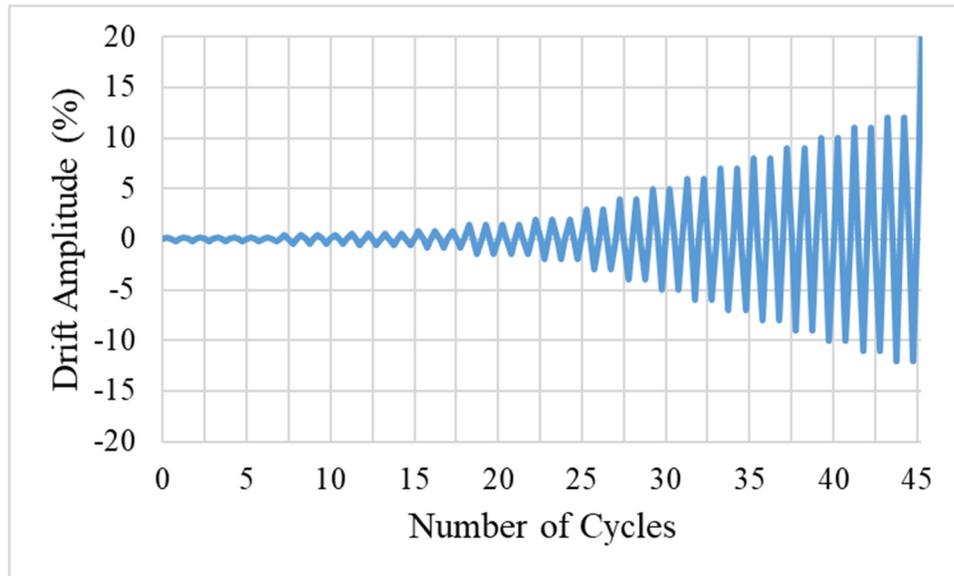
Figure 2.57 Loading protocol for the 6-ft-tall Specimen A-13.

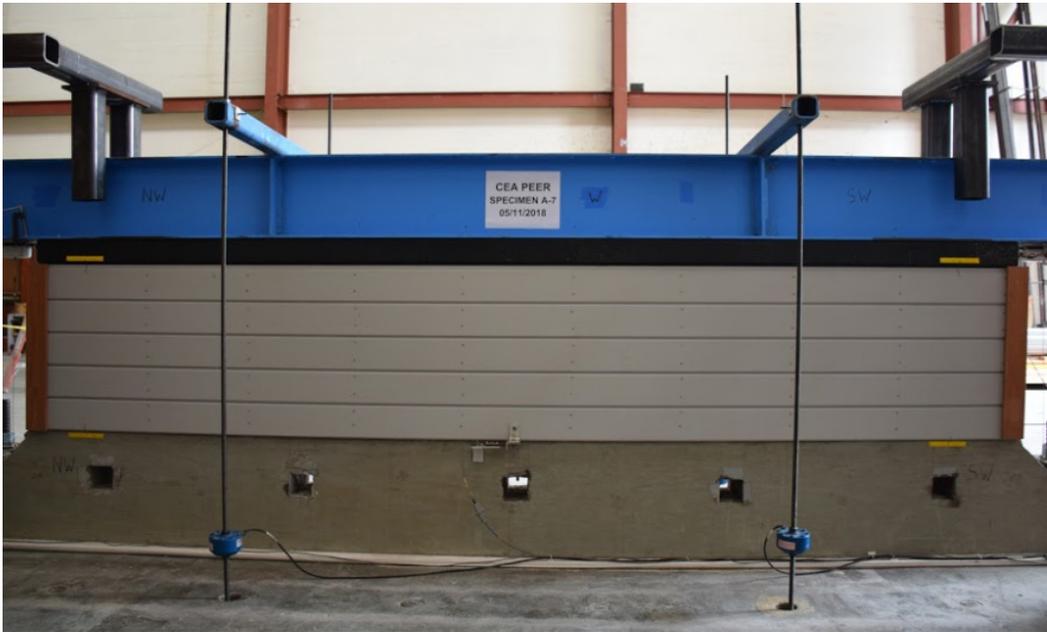
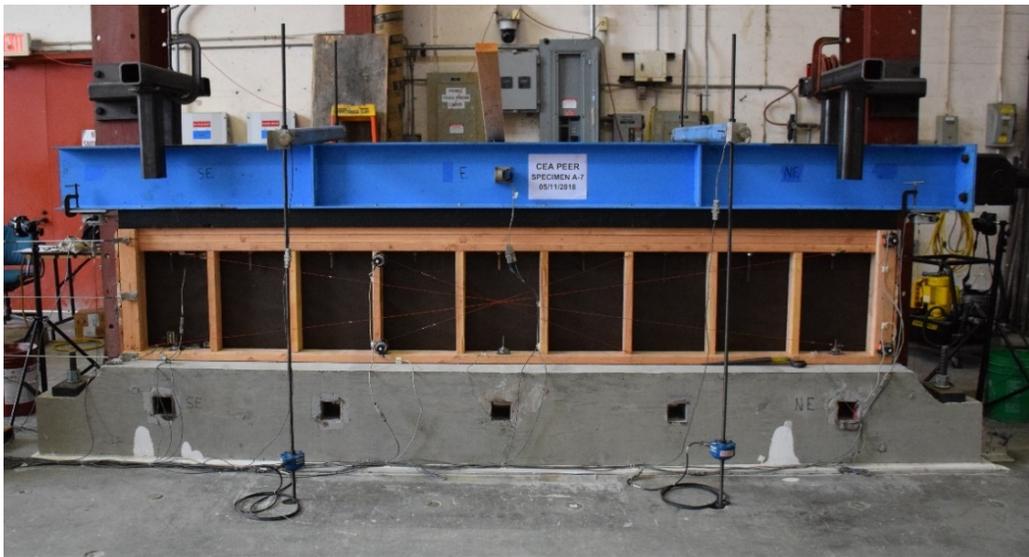
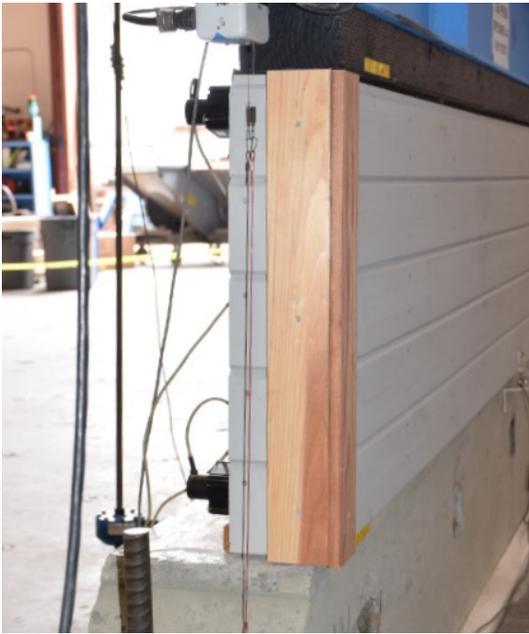
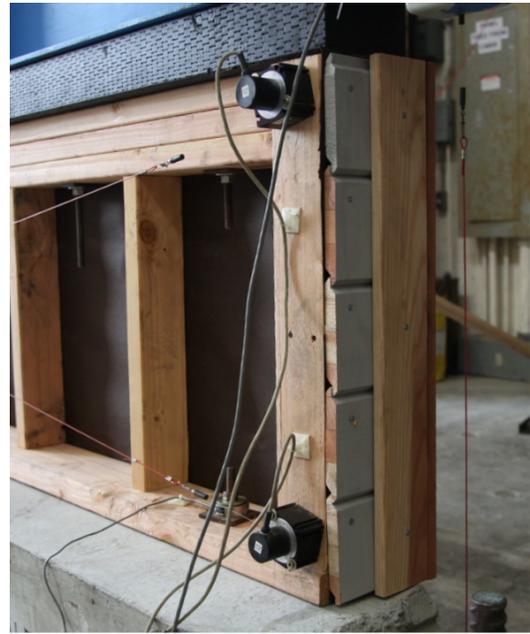
Figure 3.1 Specimen A-7 pre-test photographs for existing 2-ft-tall cripple wall with horizontal siding exterior finish: (a) exterior elevation; (b) interior elevation; (c) north exterior corner; and (d) north interior corner.

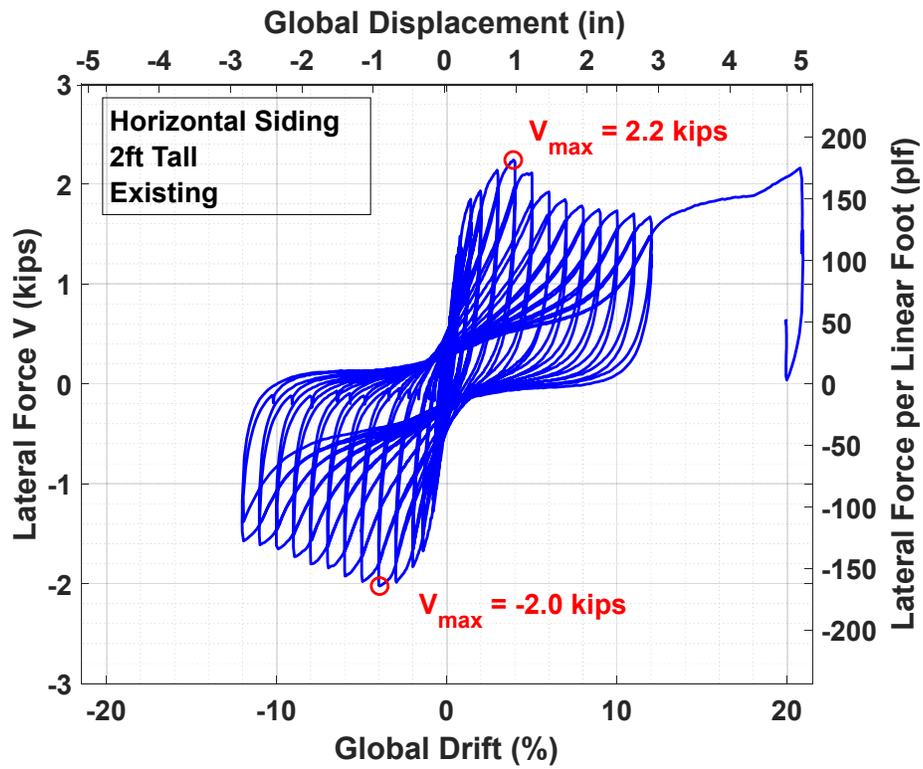
Figure 3.2 Specimen A-7 lateral force versus *global* lateral drift and displacement hysteresis.

This section presents the global lateral force-displacement response of the specimens of interest in this report. For context, the presentation includes an overview photograph sequence of each specimen, followed by the lateral force-displacement hysteresis of the corresponding specimen; see Figures 3.2–3.33. It is noted that both global total and global relative displacement are presented, where the relative displacement accounts for the displacement of the cripple wall only, ignoring displacement between the foundation and the sill plate. In addition, secondary axes are incorporated in each plot to present the lateral load per lineal foot of wall length and the drift (i.e., displacement/cripple wall height). It should be noted that maximum lateral load in the positive and negative directions are identified in each hysteresis. While discussing the individual hysteresis is useful, a cross comparison amongst the various specimens is adopted herein, with particular emphasis on eliciting the impact of the parameters varied. In this regard, a cross-comparison of all dry finished specimens is first provided; subsequently, the effect of individual parameters considered in the Phase 1 matrix are discussed.

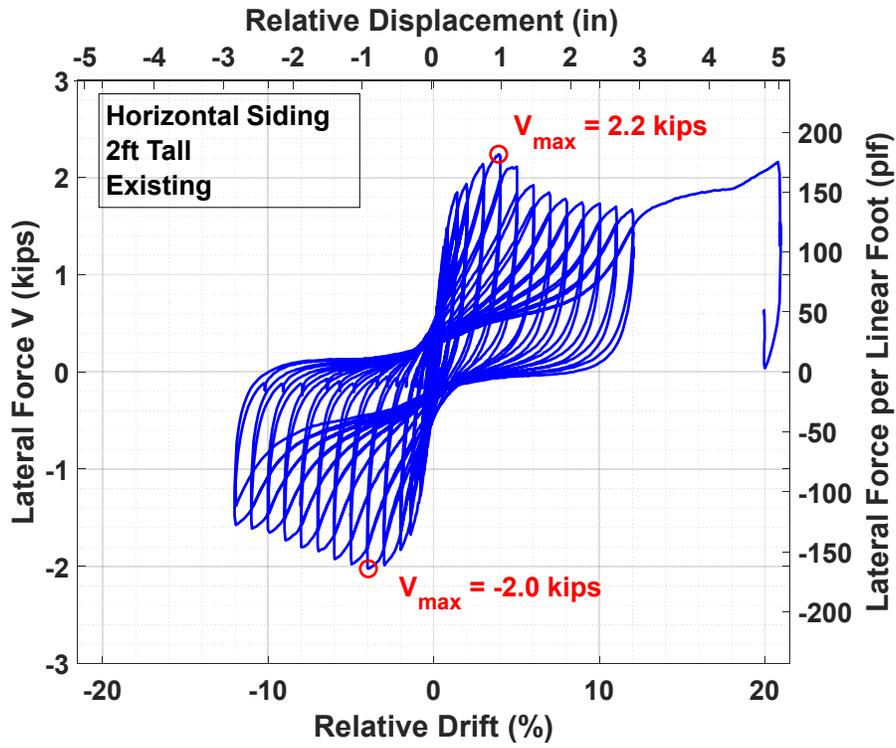
Figure 3.3 Specimen A-7 lateral force versus *relative* lateral drift and displacement hysteresis.

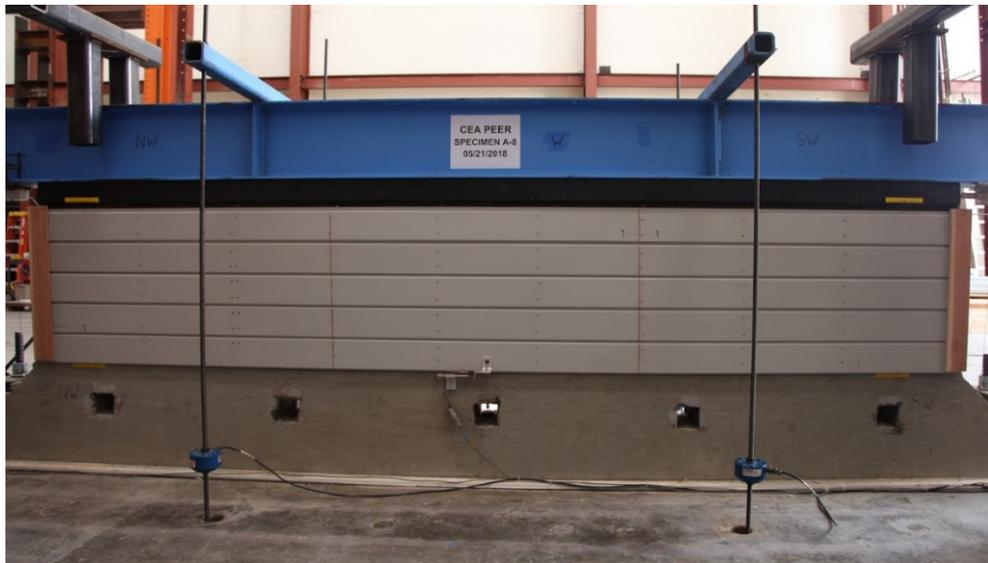
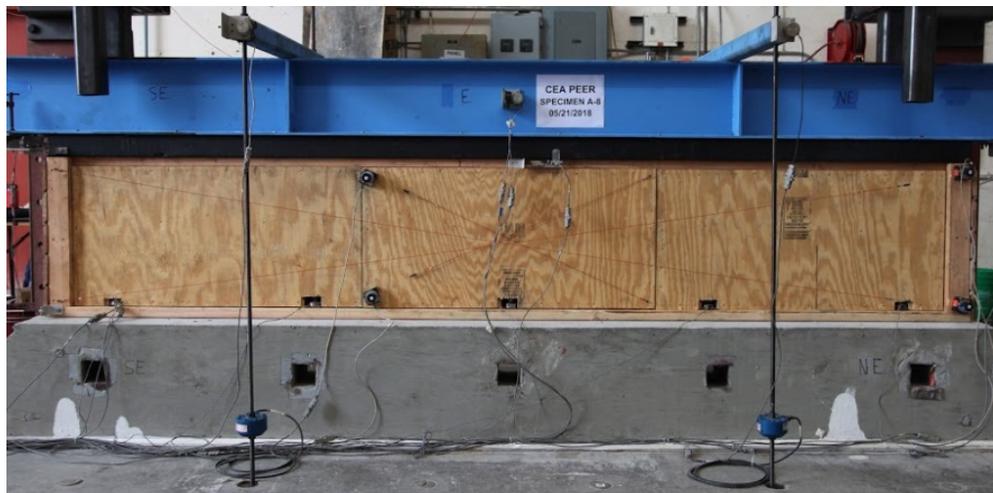
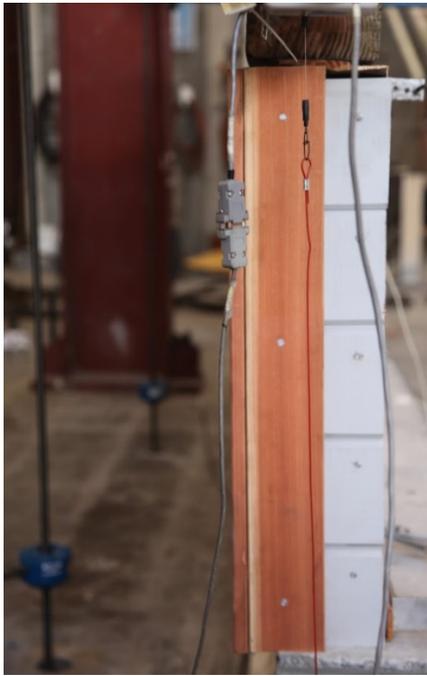
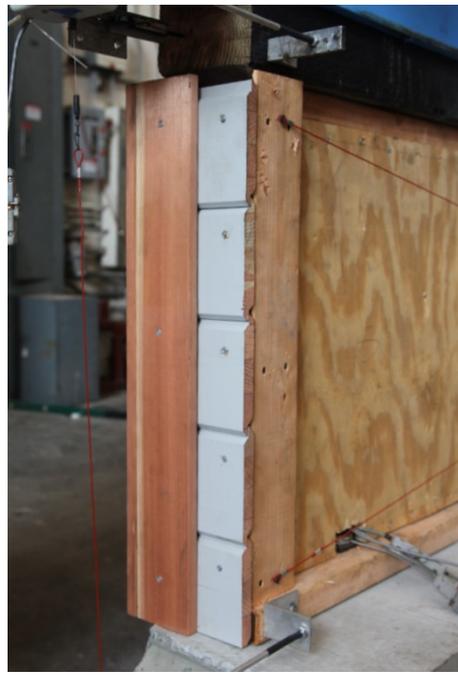
Figure 3.4 Specimen A-8 pre-test photographs for the retrofitted 2-ft-tall cripple wall with horizontal siding exterior finish: (a) exterior elevation; (b) interior elevation; (c) south corner view; and (d) south interior corner.

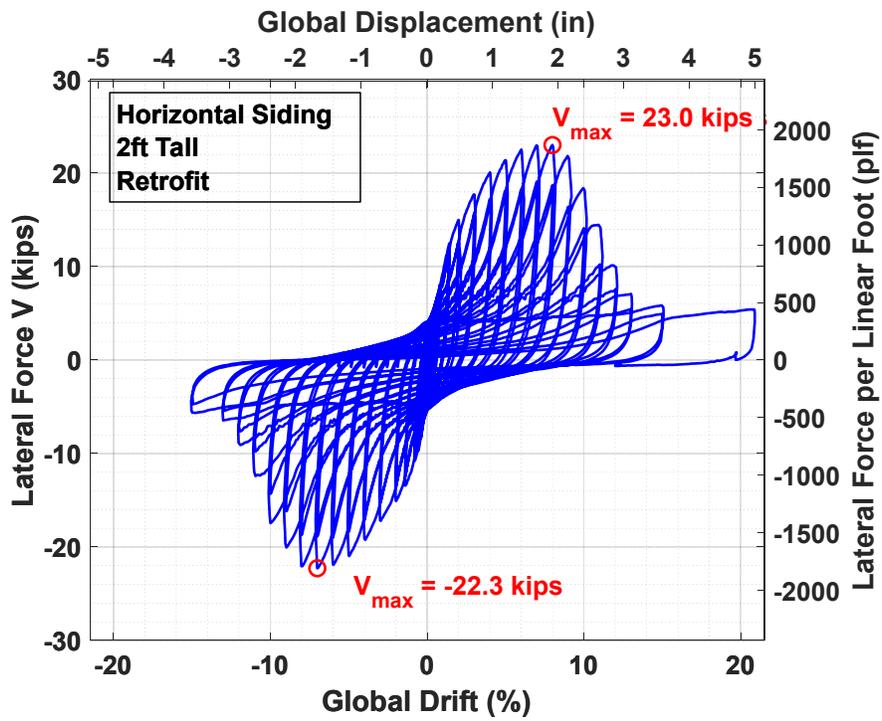
Figure 3.5 Specimen A-8 lateral force versus *global* lateral drift and displacement hysteresis.

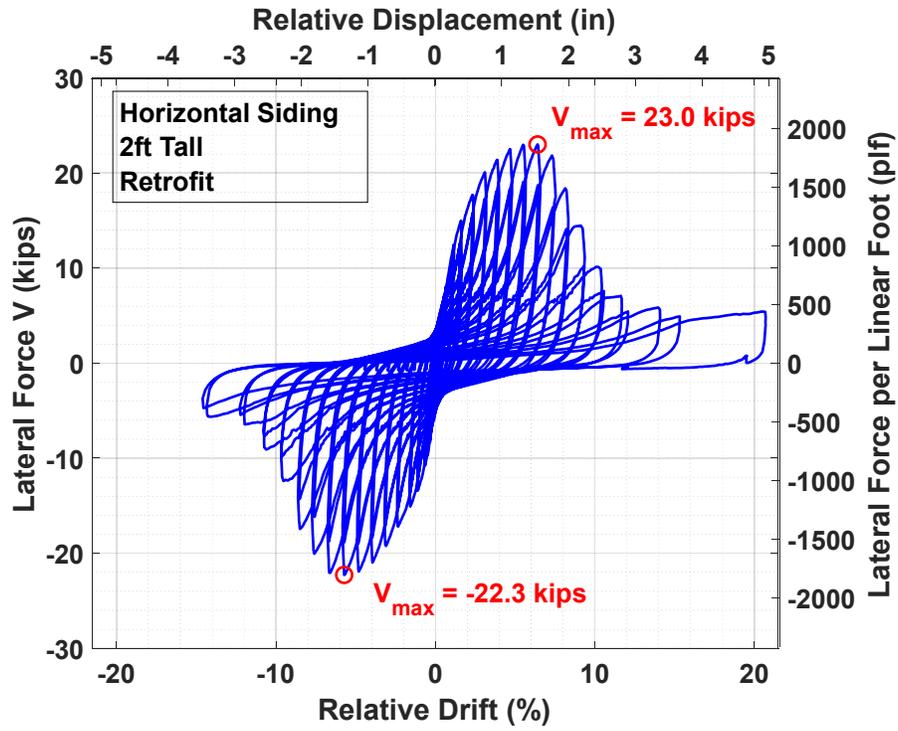
Figure 3.6 Specimen A-8 lateral force versus *relative* lateral drift and displacement hysteresis.

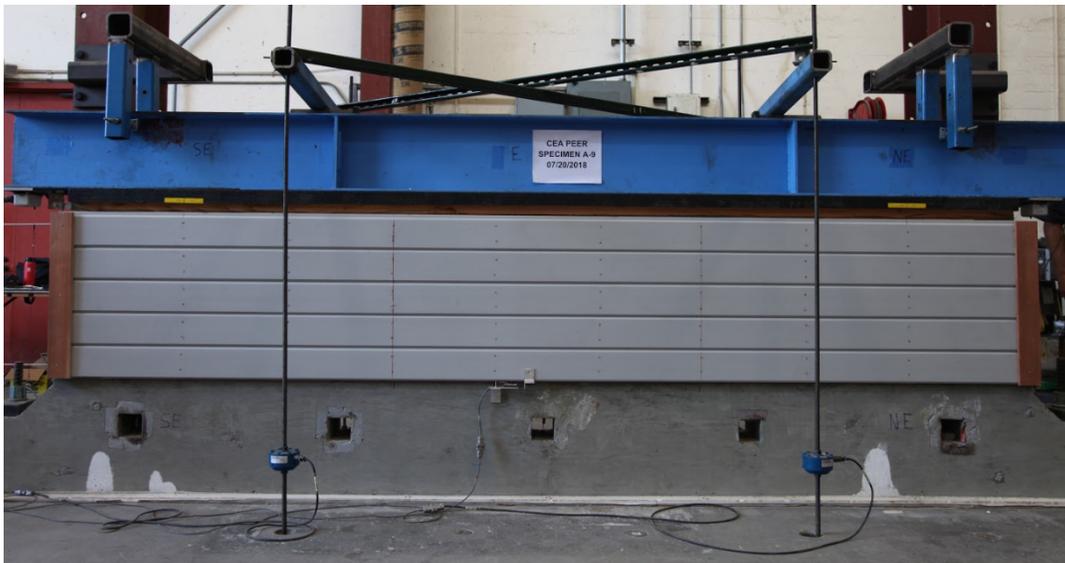
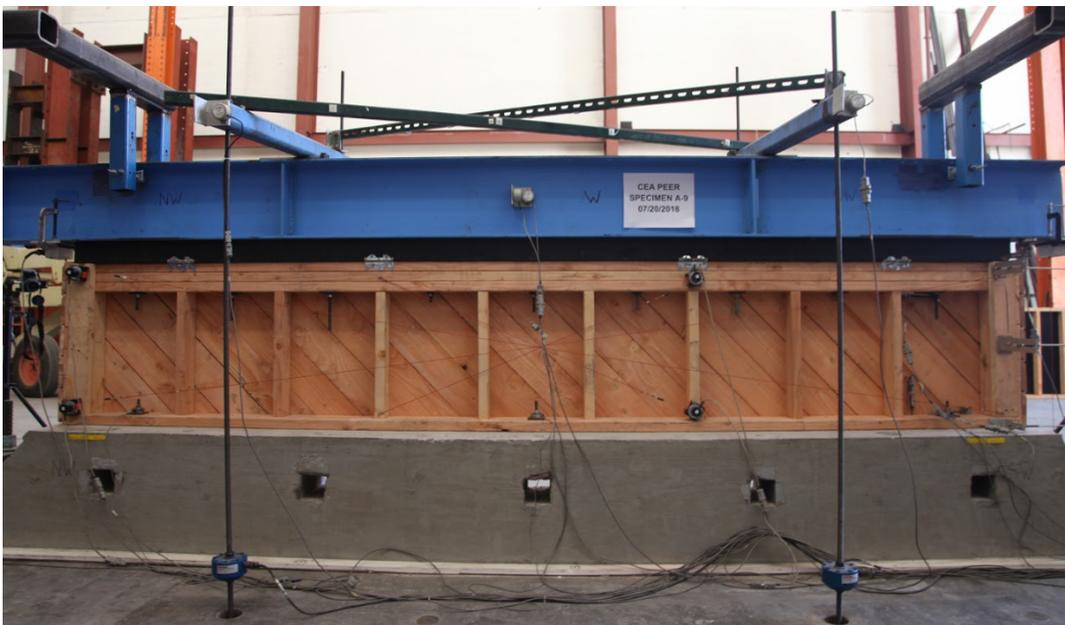
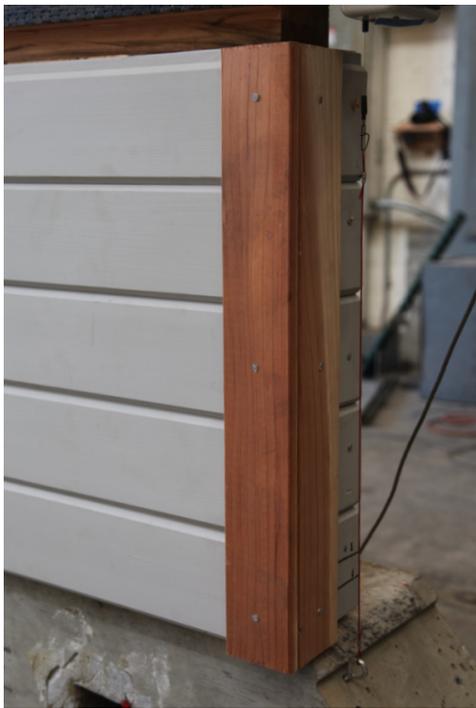
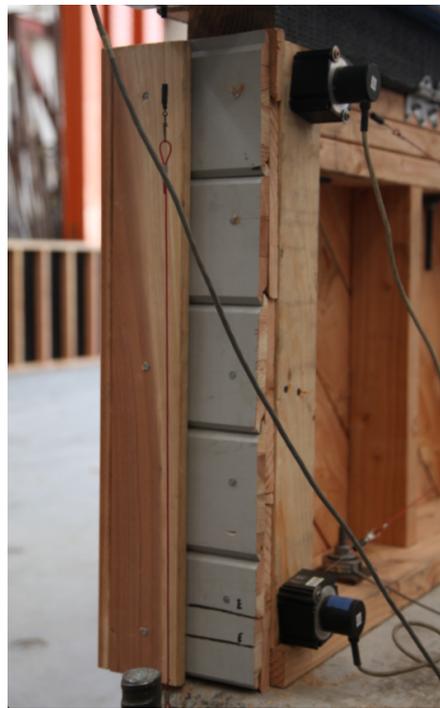
Figure 3.7 Specimen A-9 pre-test photographs for the existing 2-ft-tall cripple wall with horizontal siding over diagonal sheathing exterior finish, heavy vertical load: (a) exterior elevation; (b) interior elevation; (c) north exterior corner; and (d) north interior corner.

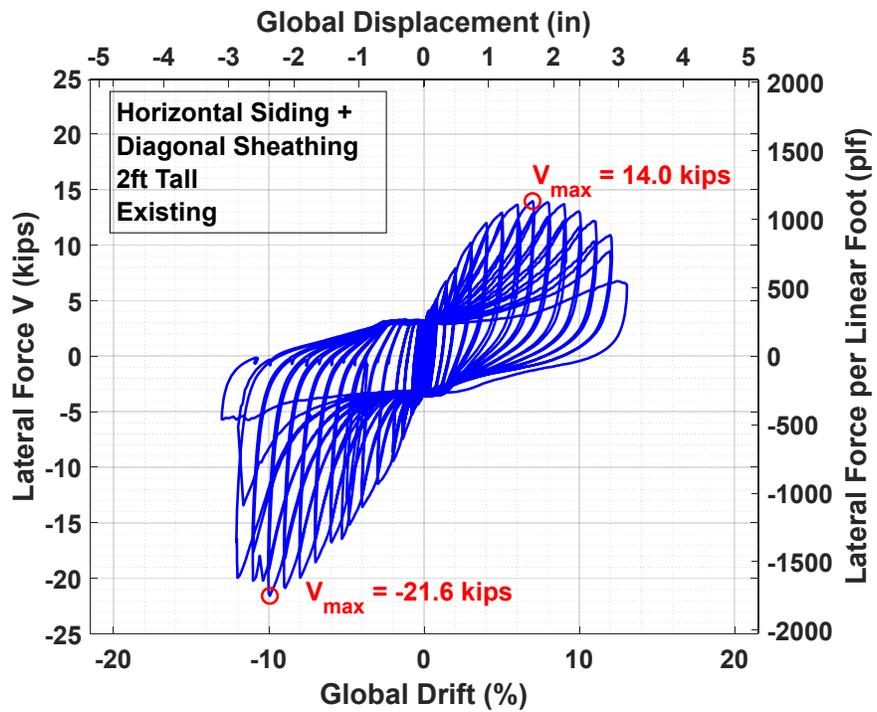
Figure 3.8 Specimen A-9 lateral force versus *global* lateral drift and displacement hysteresis.

For the horizontal siding over diagonal sheathing finished cripple walls, Specimens A-9 and A-28, the lateral strength was around 50% higher in the pull direction than the push direction; see Figures 3.8 and 3.32. As noted, this can be attributed to the orientation of the diagonal sheathing boards. Due to their orientation, the diagonal sheathing boards would separate upon pushing the specimen, whereas when the cripple wall was being pulled on, the diagonal sheathing boards closed-up. At later displacement cycles, the 1/8-in. gaps between the diagonal sheathing boards had completely closed. This caused the sheathing to bear on each other and act as a wood structural panel, resulting in a dramatic increase in capacity at later displacement cycles. It would be expected that the same phenomena would occur for the Specimen A-10, the retrofitted counterpart of Specimen A-9; however, the relative contribution of the diagonal sheathing was suppressed in the presence of the retrofit and dictated the response. In fact, the retrofit diagonal sheathing specimen was so strong, the case of Specimen A-10 failure in all seven anchor bolts occurred, prior to it gaining the added capacity due to the gaps in the diagonal sheathing closing. As a result, the response of Specimen A-10 was close to symmetric. It should be noted that Specimen A-9 also failed due to fractures of the anchor bolts, and Specimen A-28 failed due to a cross-grain split along the entire span of the sill plate. Further discussion on the anchor bolt failures in these specimens is presented in Section 3.3.

By far the largest sill-to-foundation relative displacements occurred in the retrofitted and existing cripple walls with horizontal siding over diagonal sheathing. For the existing cripple wall, Specimen A-9, the peak displacement in the push direction was 1.22 in. and in the pull direction was 2.30 in. For the retrofitted cripple wall, Specimen A-9, the peak displacement in the push direction was 2.77 in. and 2.72 in. in the pull direction. These displacements are so much larger than the rest of the cripple walls because both cripple walls experienced anchor bolts failures during the test. Therefore, once the anchor bolt failures occurred, nearly all of the imposed lateral displacement was culminated in the form of sill plate sliding. This is evident when looking at the lateral force versus global displacement hysteresis compared with the lateral force versus relative displacement hysteresis in Figures 3.8 and 3.9 for Specimen A-9 and Figures 3.11 and 3.12 for

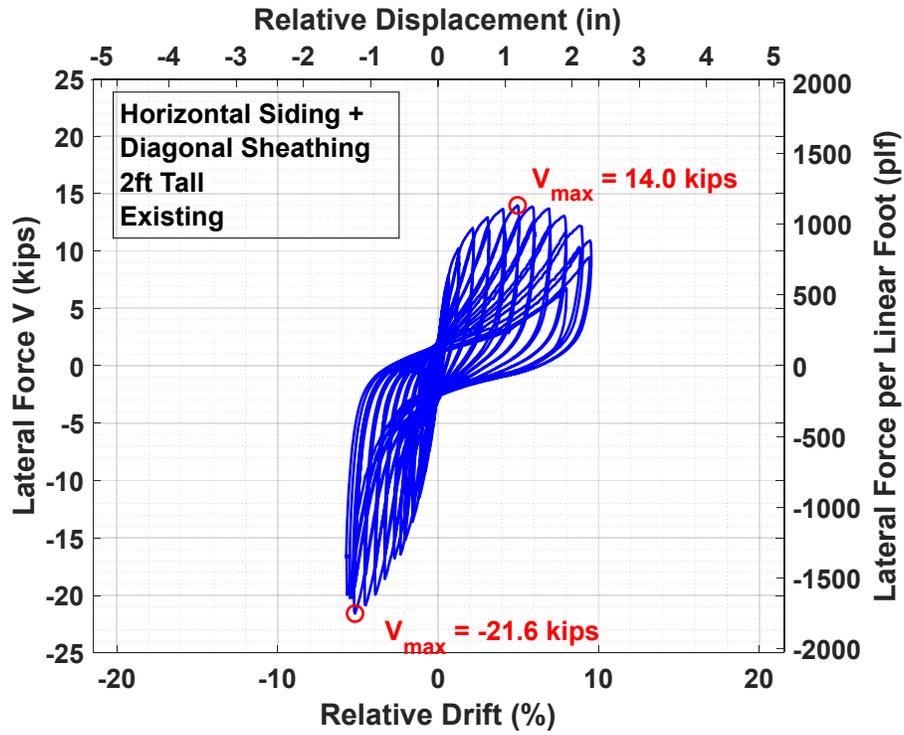
Figure 3.9 Specimen A-9 lateral force versus *relative* lateral drift and displacement hysteresis.

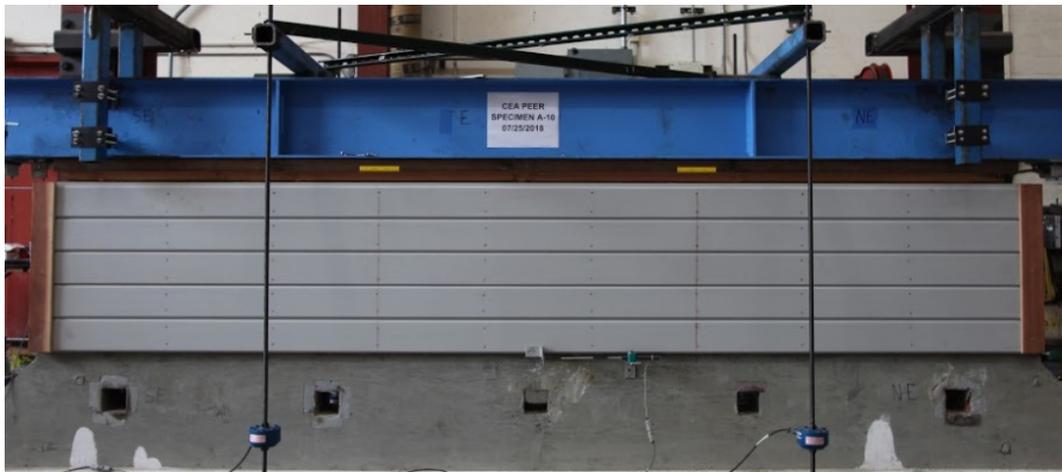
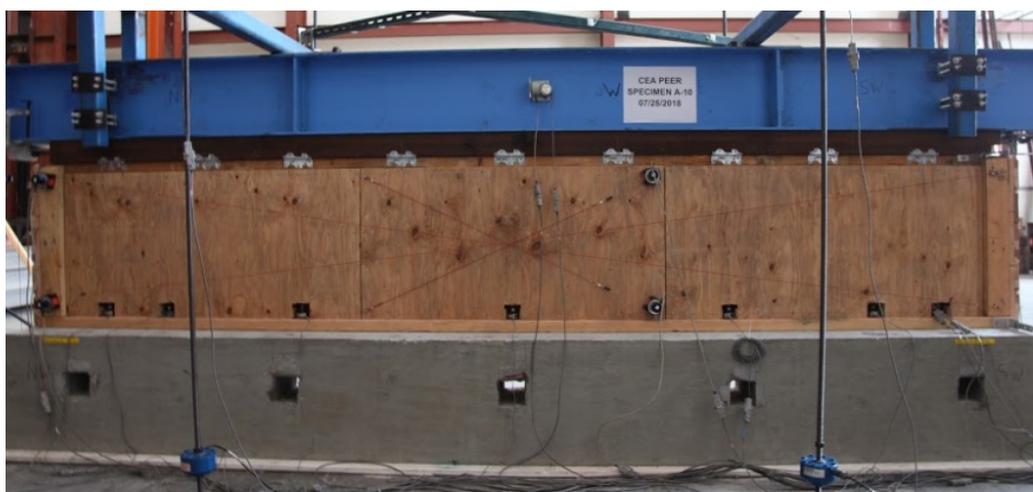
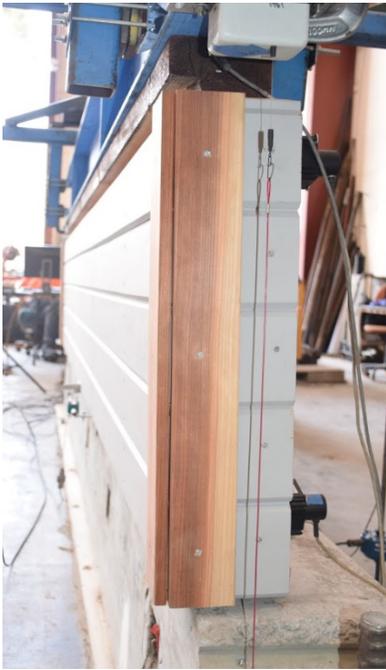
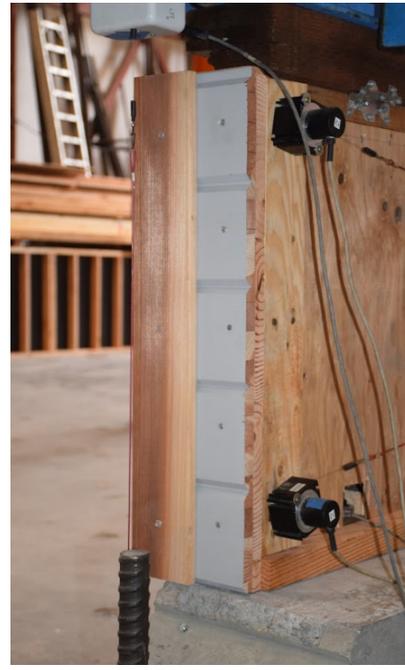
Figure 3.10 Specimen A-10 pre-test photographs for the retrofitted 2-ft-tall cripple wall with horizontal siding over diagonal sheathing exterior finish): (a) exterior elevation; (b) interior elevation; (c) north exterior corner; and (d) north interior corner.

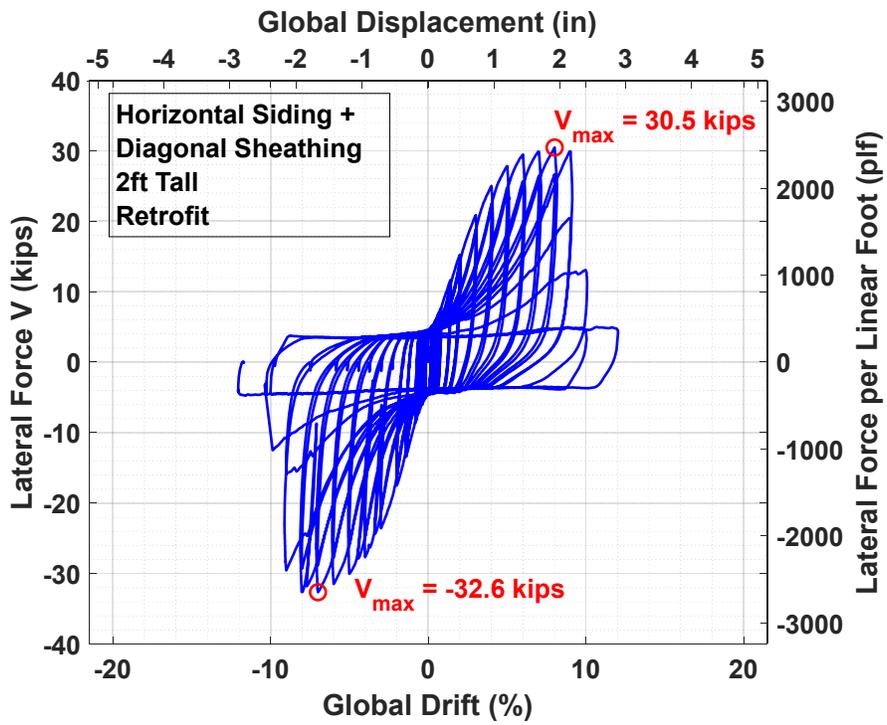
Figure 3.11 Specimen A-10 lateral force versus *global* lateral drift and displacement hysteresis of.

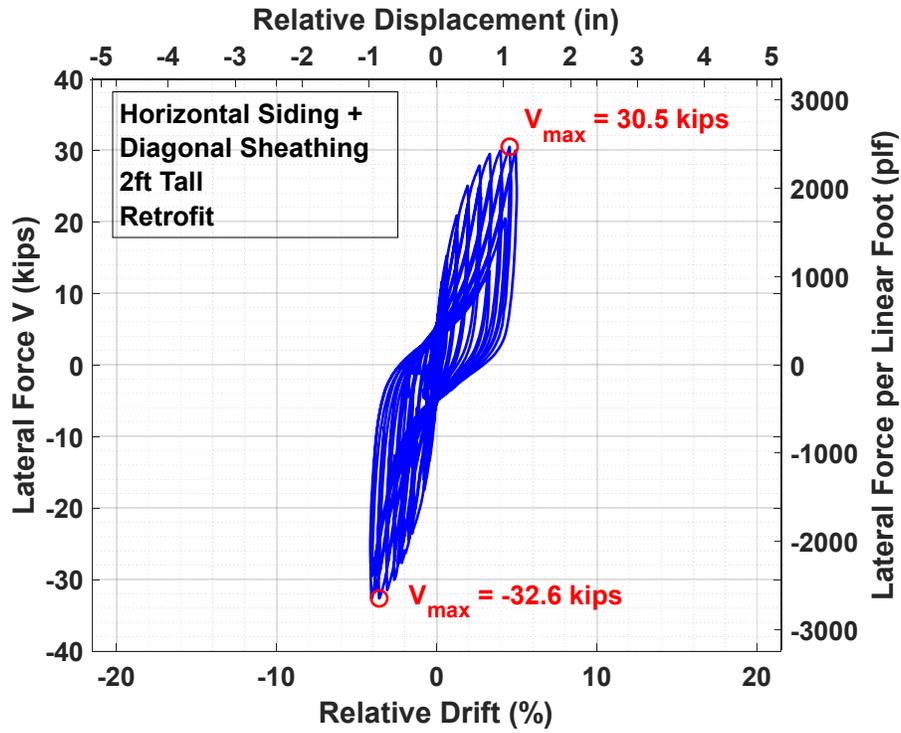
Figure 3.12 Specimen A-10 lateral force versus *relative* lateral drift and displacement hysteresis.

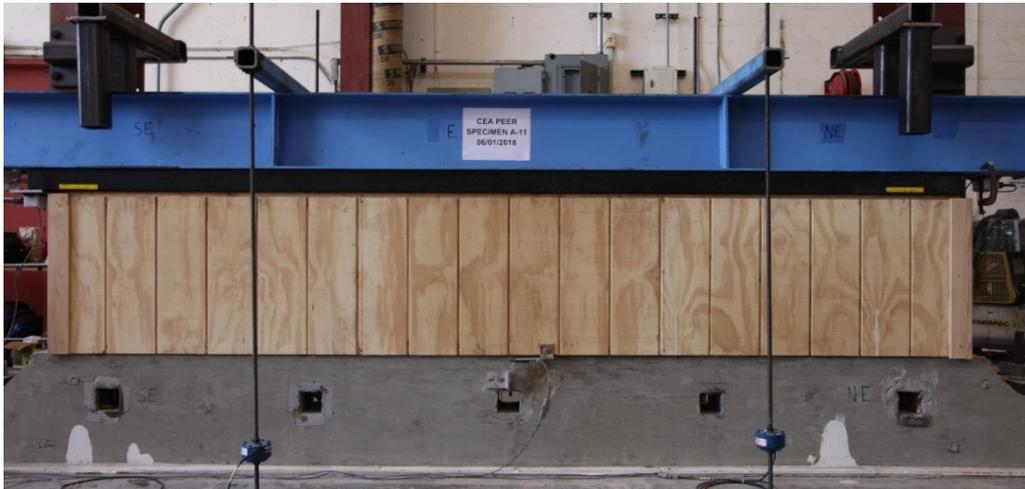
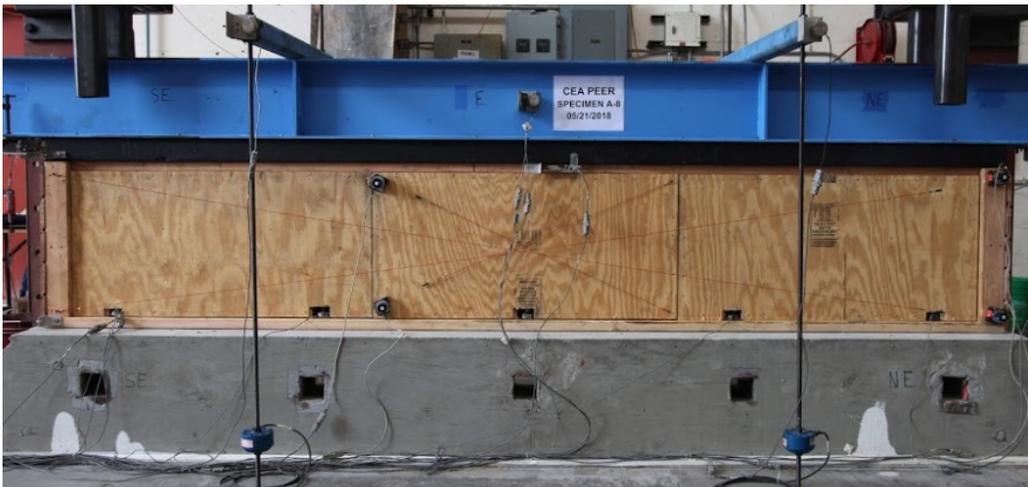
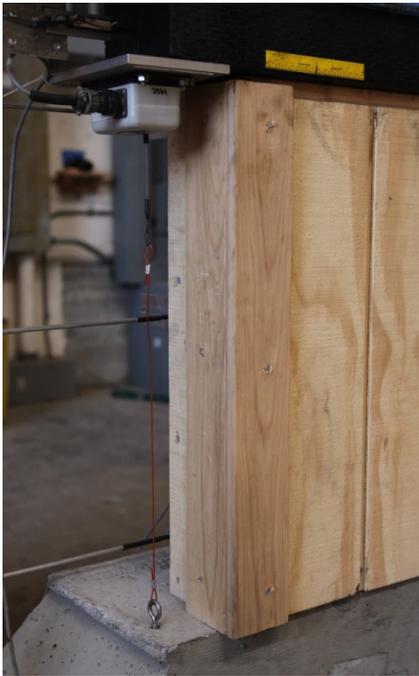
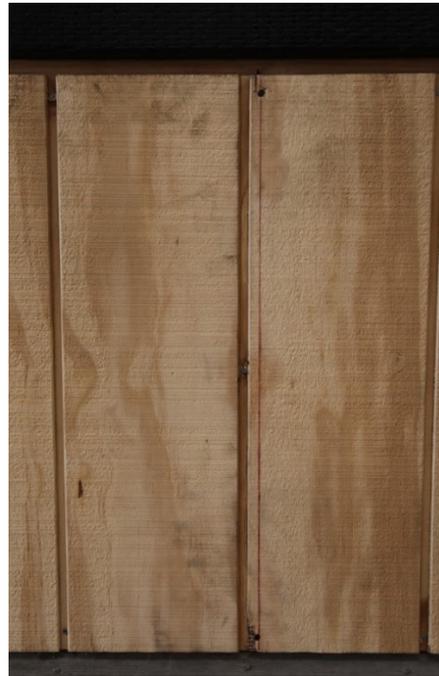
Figure 3.13 Specimen A-11 pre-test photographs for the existing 2-ft-tall cripple wall with T1-11 wood structural panel exterior finish: (a) exterior elevation; (b) interior elevation; (c) south exterior corner; and (d) nailing detail.

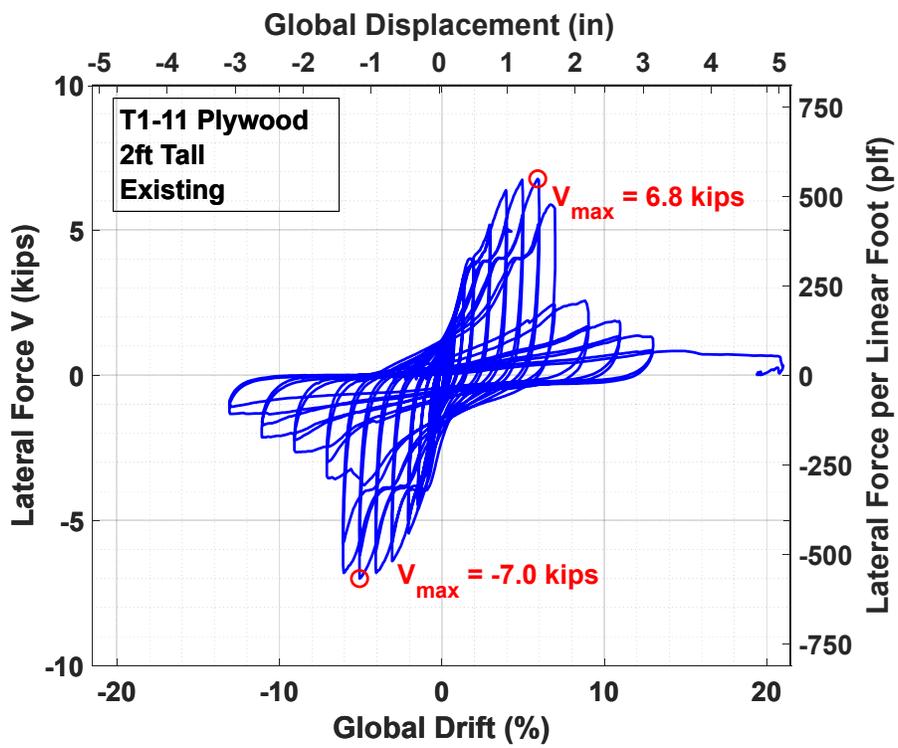
Figure 3.14 Specimen A-11 lateral force versus *global* lateral drift and displacement hysteresis.

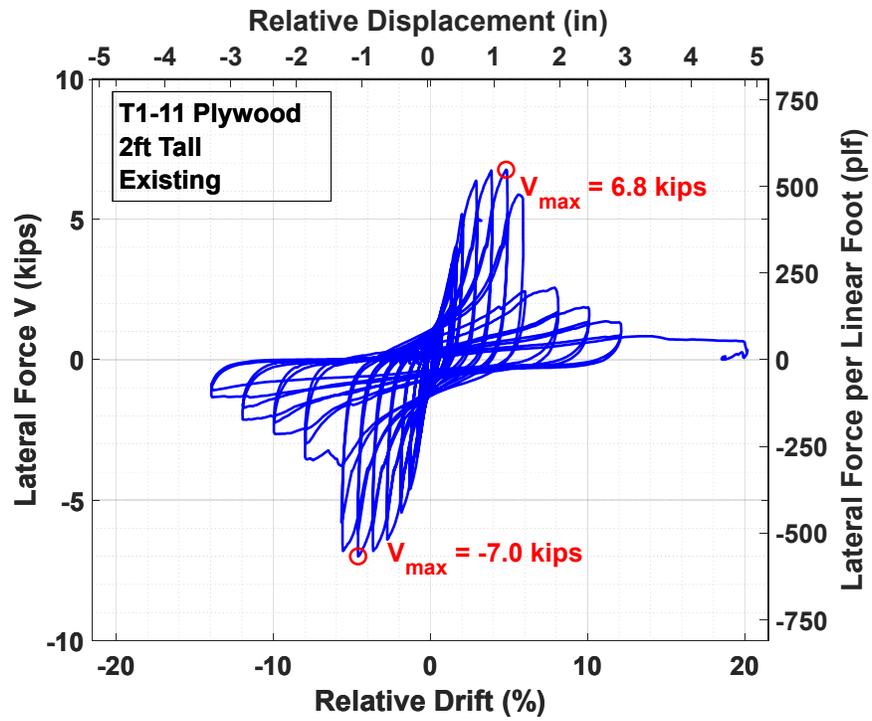
Figure 3.15 Specimen A-11 lateral force versus *relative* lateral drift and displacement hysteresis.

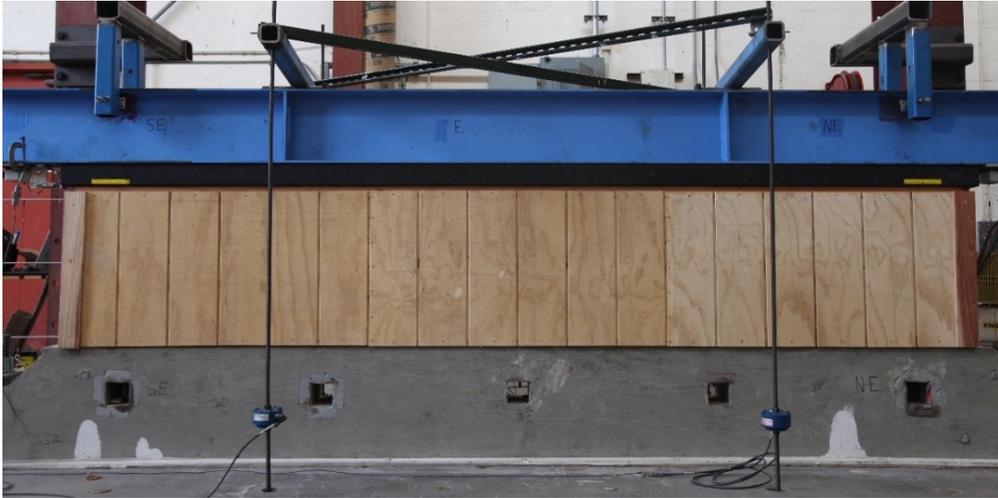
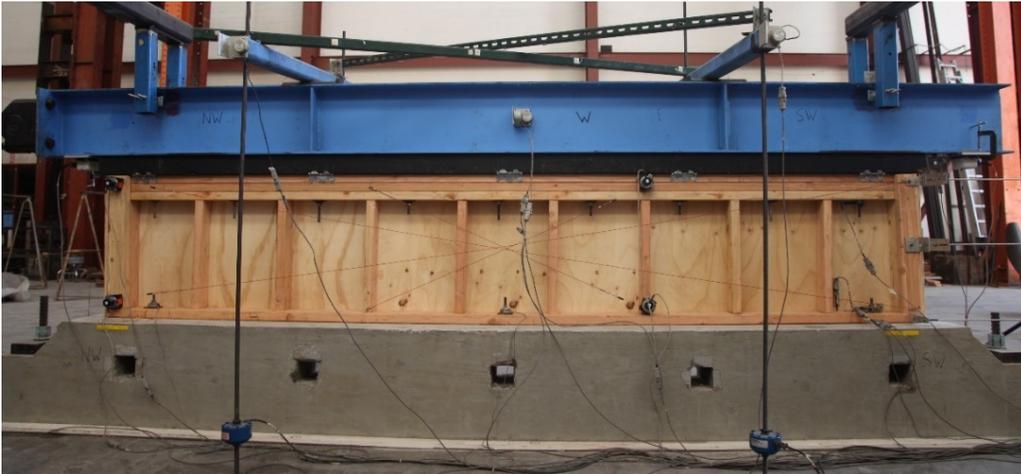
Figure 3.16 Specimen A-12 pre-test photographs for the retrofitted 2-ft-tall cripple wall with T1-11 wood structural panel exterior finish: (a) exterior elevation; (b) interior elevation; (c) north exterior corner; and (d) nailing detail.

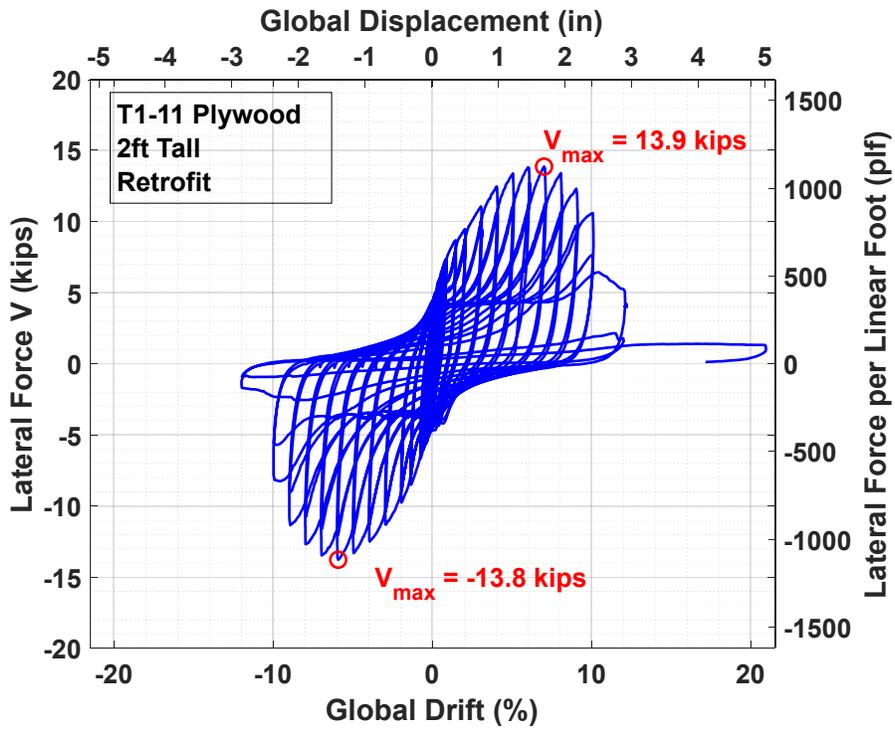
Figure 3.17 Specimen A-12 lateral force versus *global* lateral drift and displacement hysteresis.

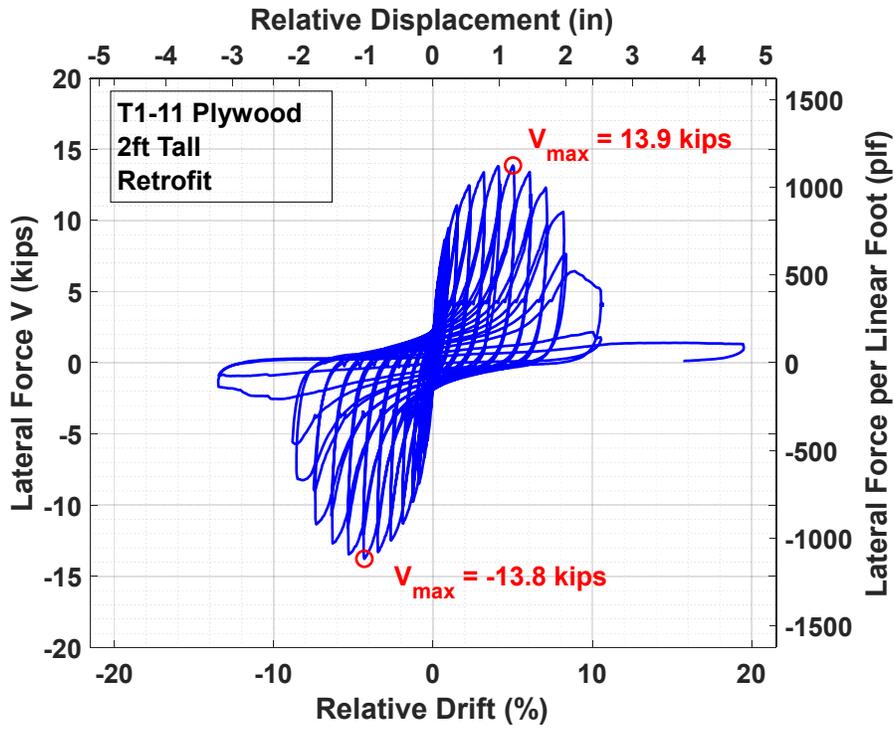
Figure 3.18 Specimen A-12 lateral force versus *relative* lateral drift and displacement hysteresis.
