Cripple Wall Small-Component Test Program: Dry Specimens

**A Report for the “Quantifying the Performance of
Retrofit of Cripple Walls and Sill Anchorage in Single-
Family Wood-Frame Buildings” Project**

PEER Report 2020/17

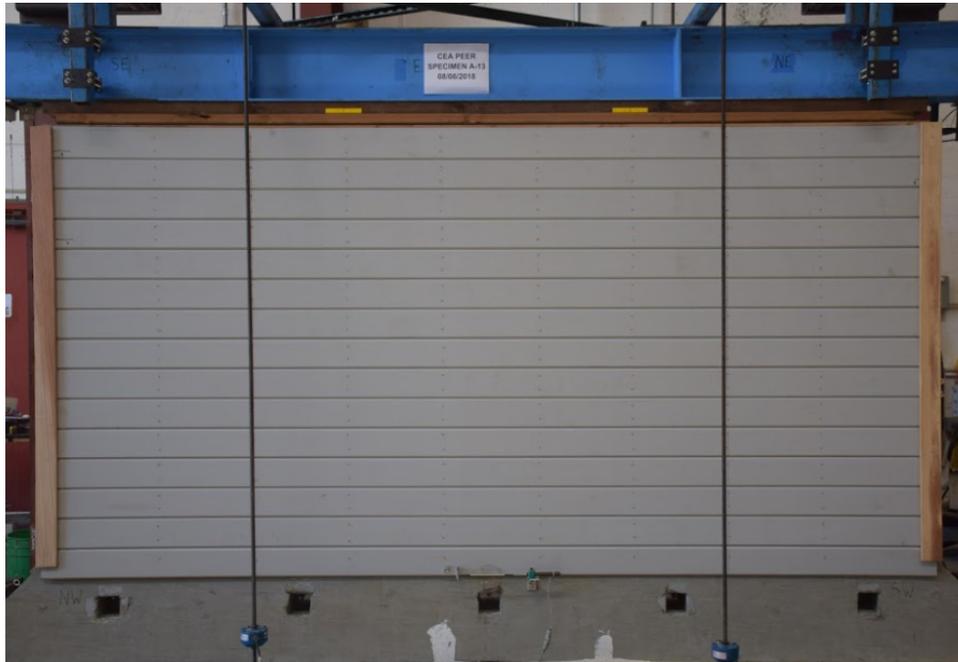
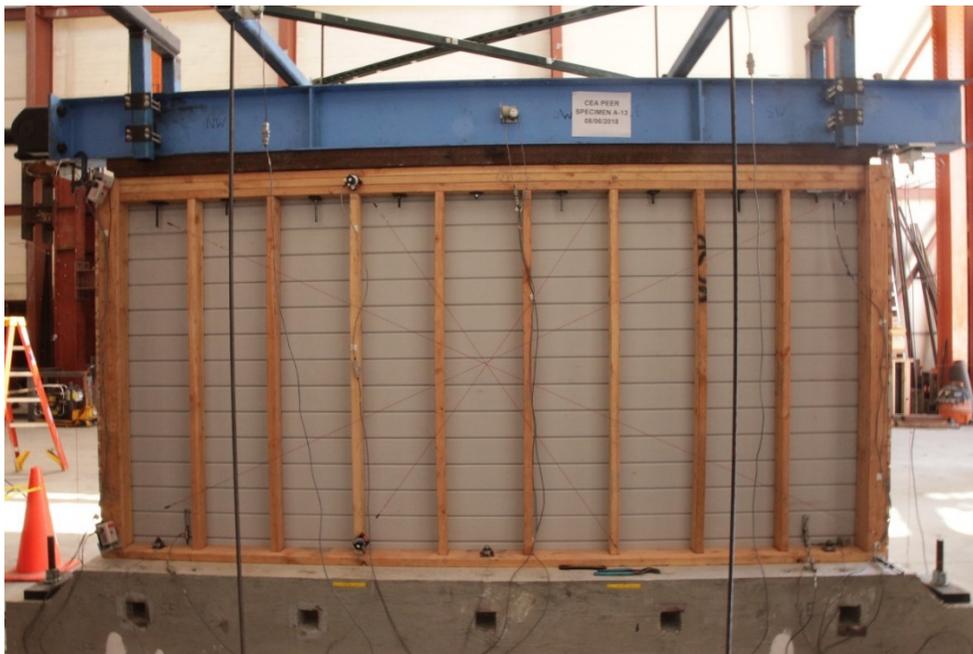
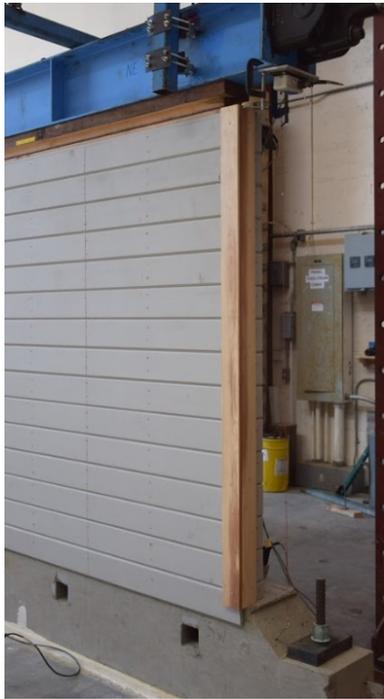
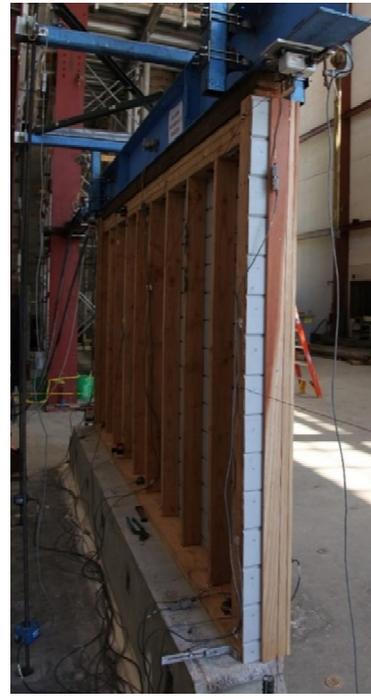
Figure 3.19 Specimen A-13 pre-test photographs for the existing 6-ft-tall cripple wall with horizontal siding exterior finish: (a) exterior elevation; (b) interior elevation; (c) north exterior corner; and (d) south interior corner.

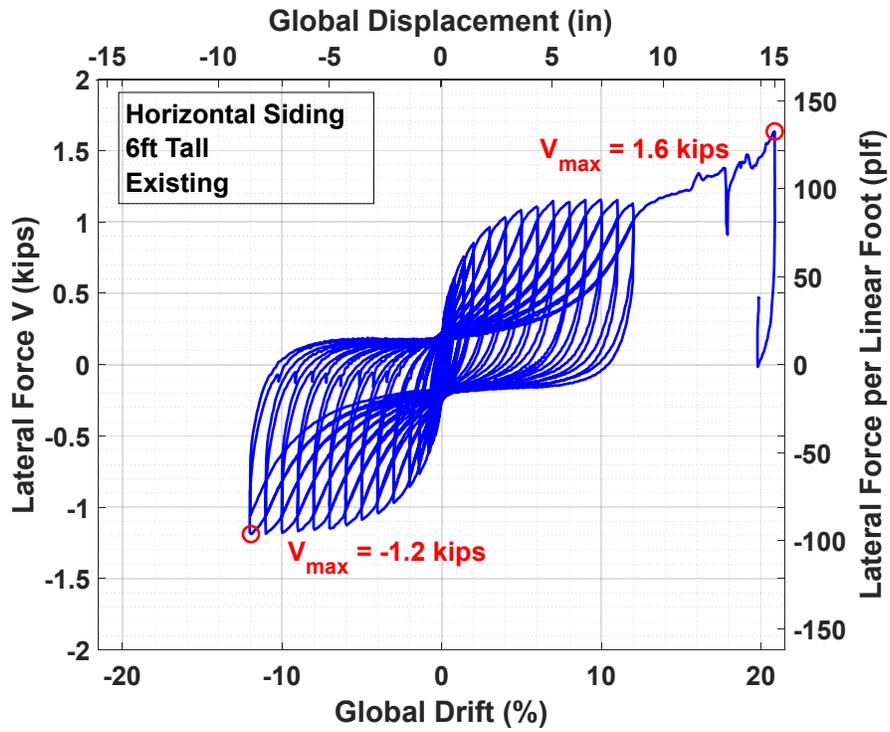
Figure 3.20 Specimen A-13 lateral force versus *global* lateral drift and displacement hysteresis.

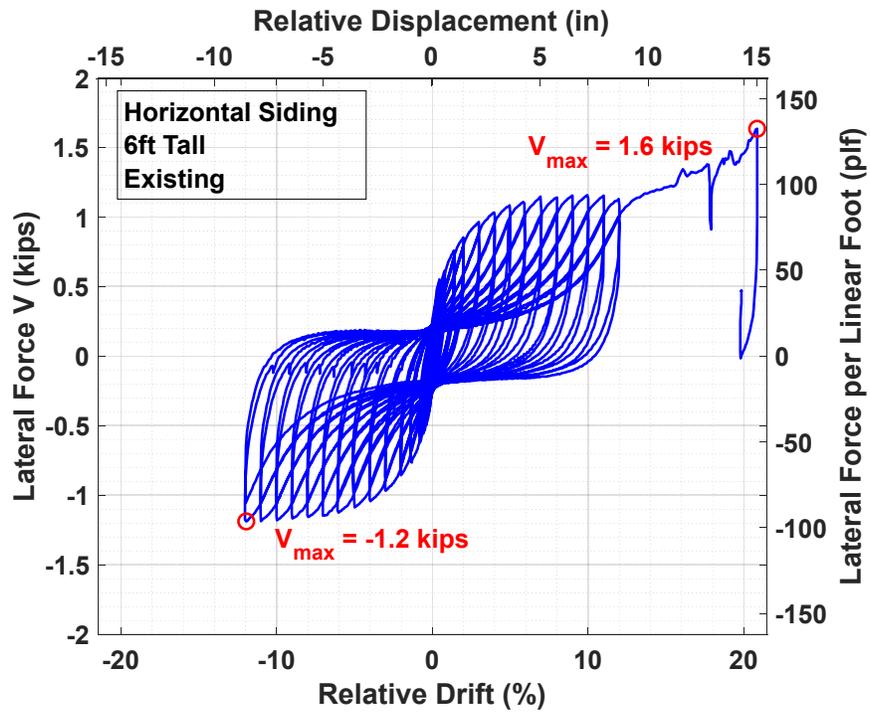
Figure 3.21 Specimen A-13 lateral force versus *relative* lateral drift and displacement hysteresis.

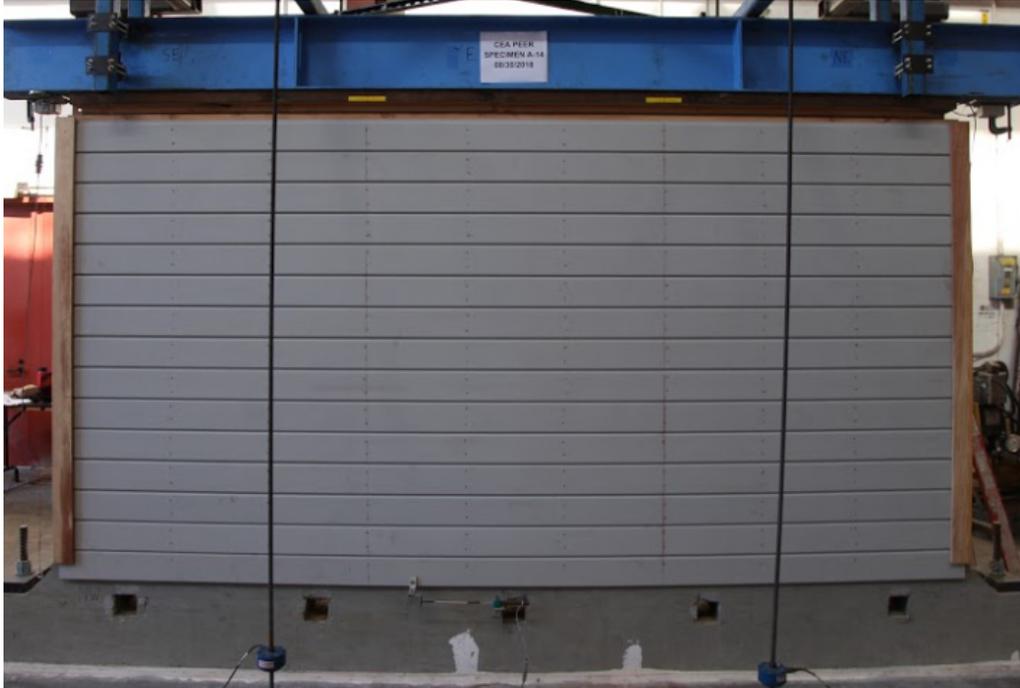
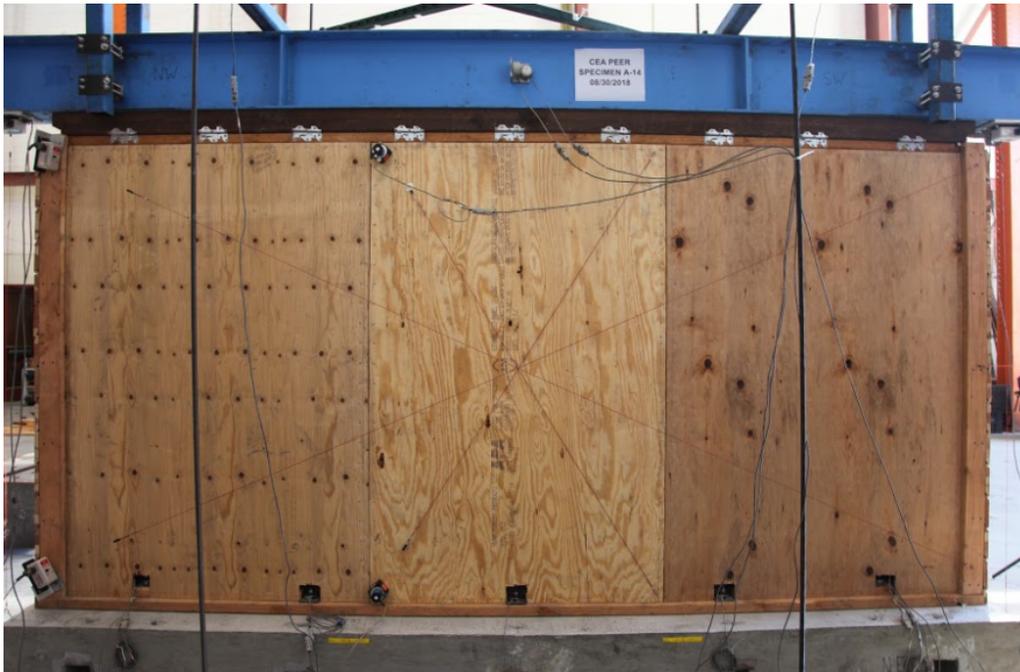
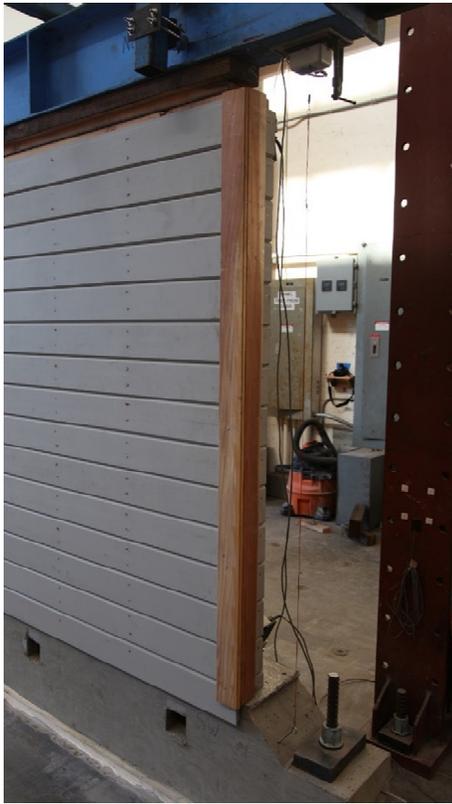
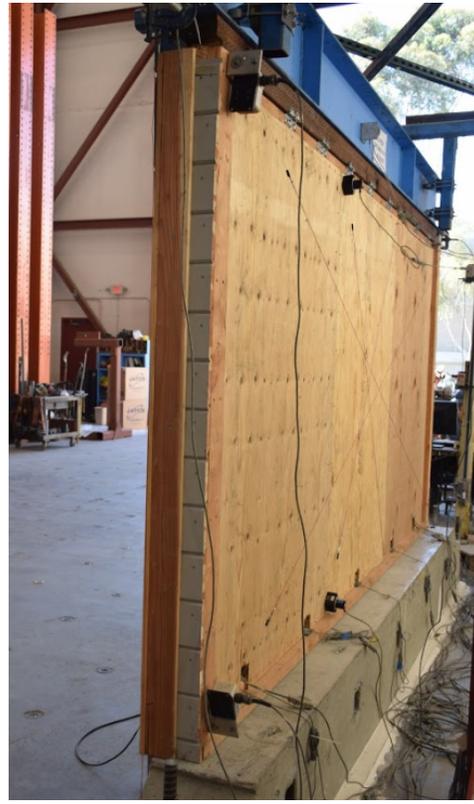
Figure 3.22 Specimen A-14 pre-test photographs for the retrofitted 6-ft-tall cripple wall with horizontal siding exterior finish: (a) exterior elevation; (b) interior elevation; (c) north exterior corner; and (d) north interior corner.

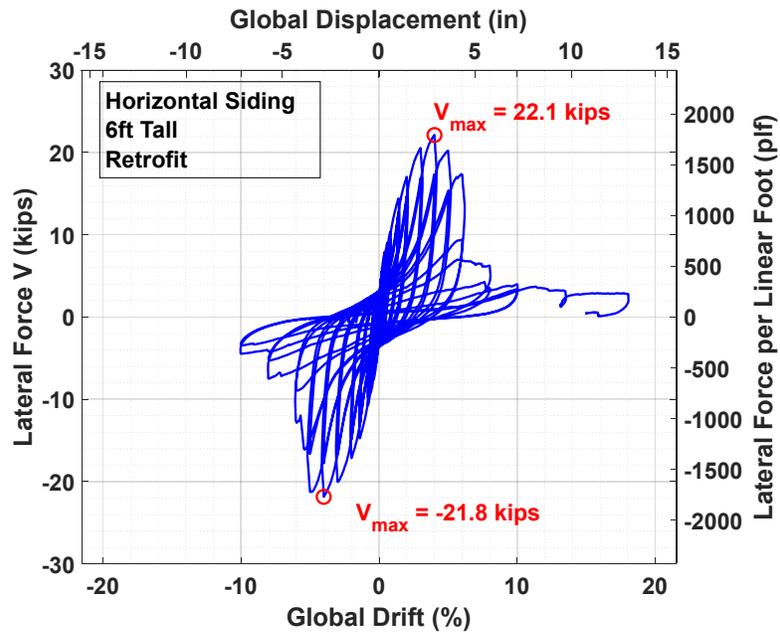
Figure 3.23 Specimen A-14 lateral force versus *global* lateral drift and displacement hysteresis.

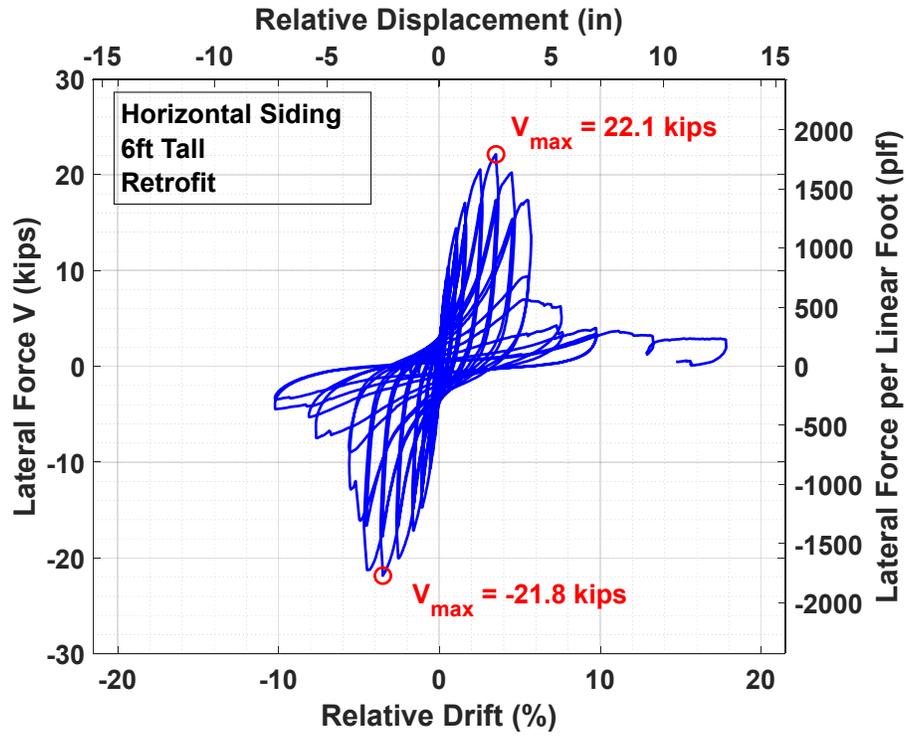
Figure 3.24 Specimen A-14 lateral force versus *relative* lateral drift and displacement hysteresis.

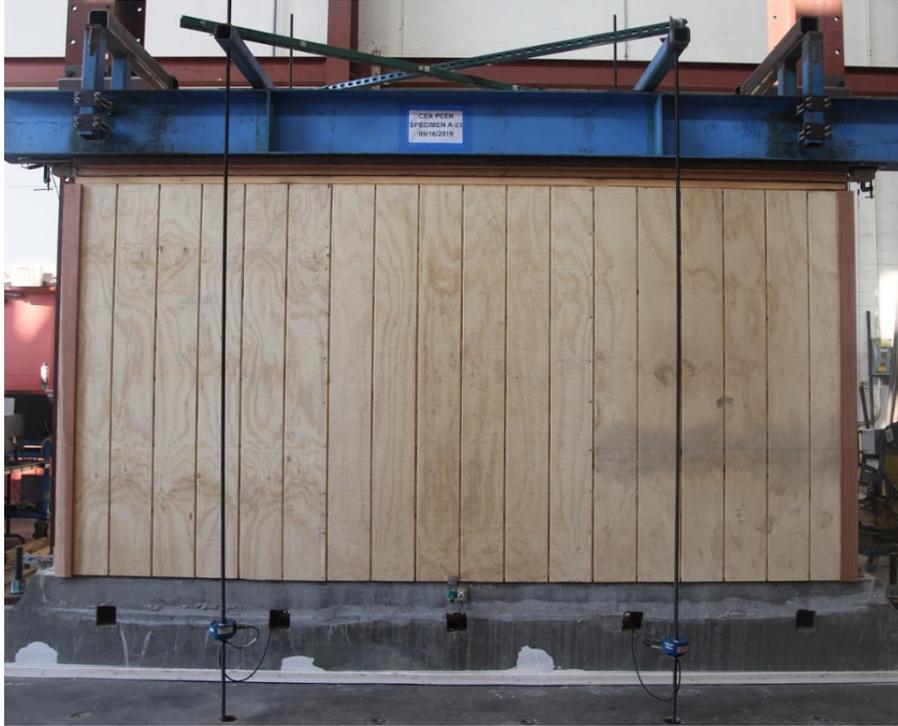
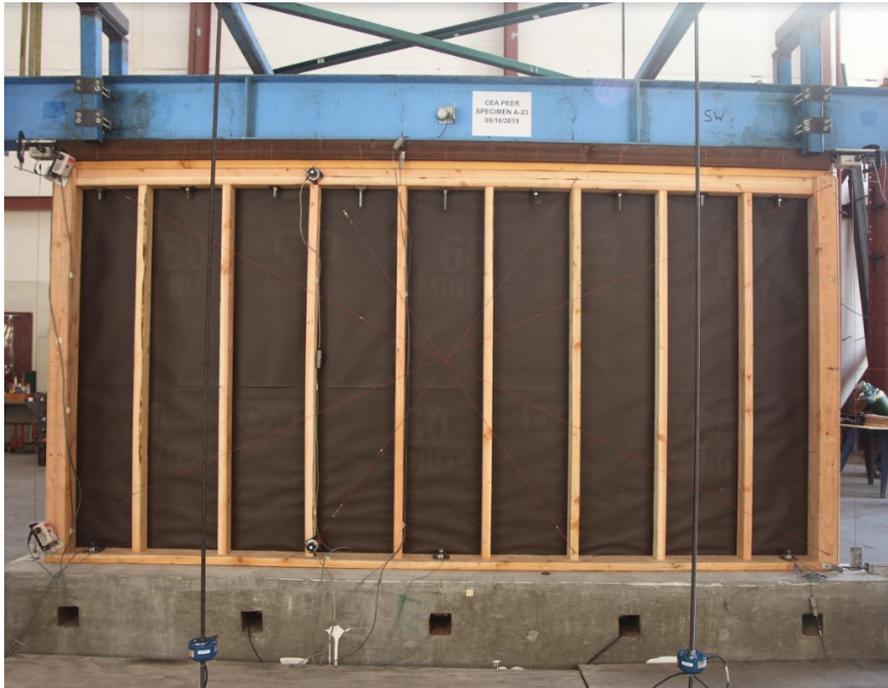
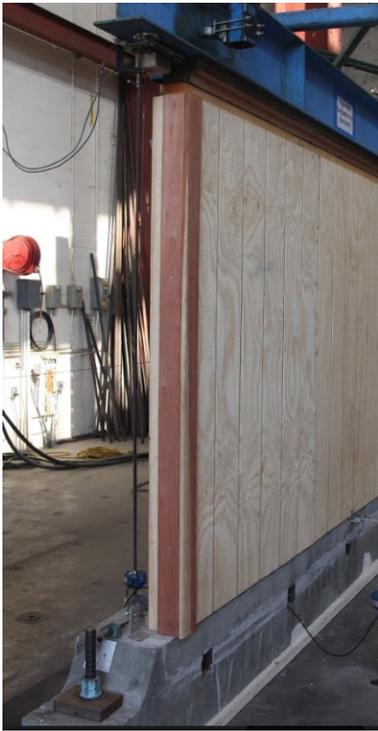
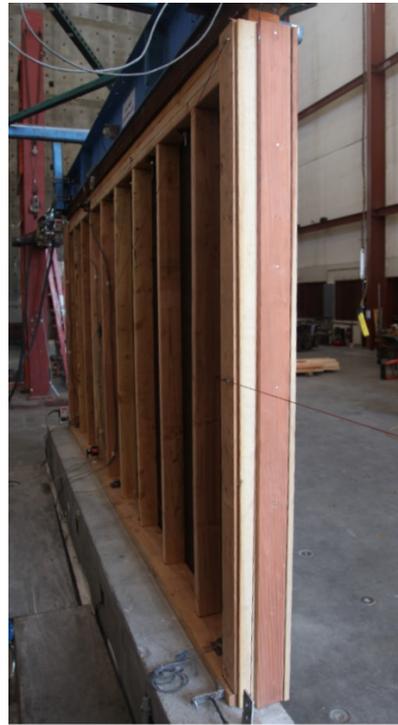
Figure 3.25 Specimen A-23 pre-test photographs for the existing 6-ft-tall cripple wall with T1-11 wood structural panel exterior finish: (a) exterior elevation; (b) interior elevation; (c) south exterior corner; and (d) south interior corner.

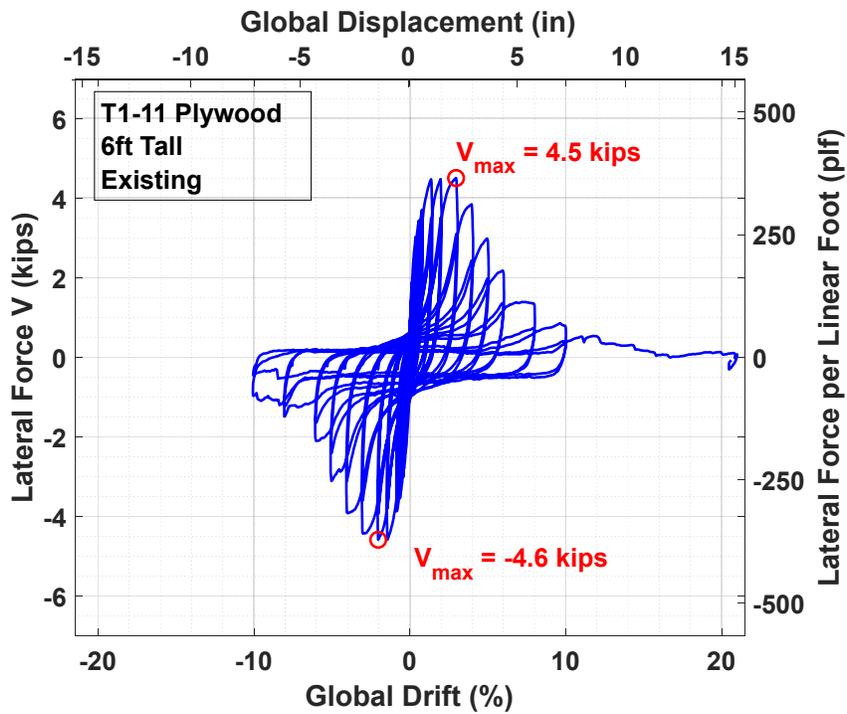
Figure 3.26 Specimen A-23 lateral force versus *global* lateral drift and displacement hysteresis.

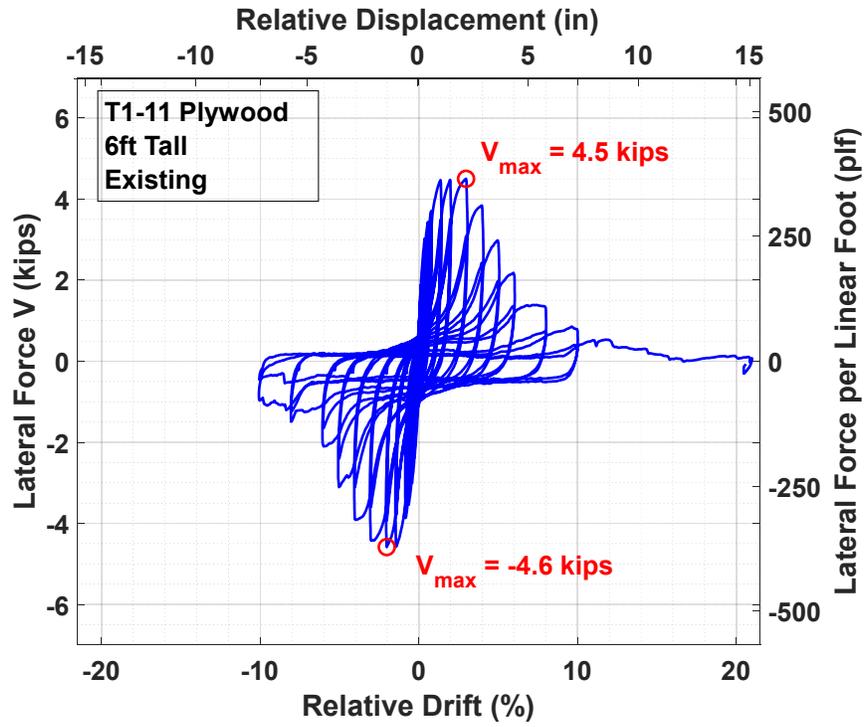
Figure 3.27 Specimen A-23 lateral force versus *relative* lateral drift and displacement hysteresis.

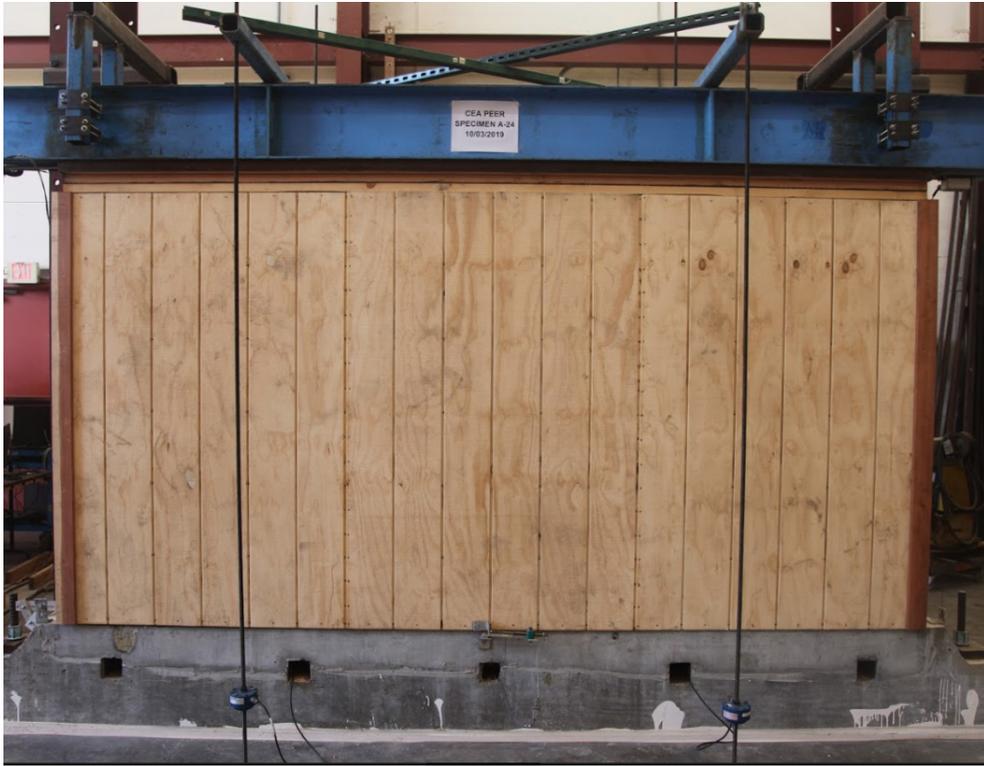
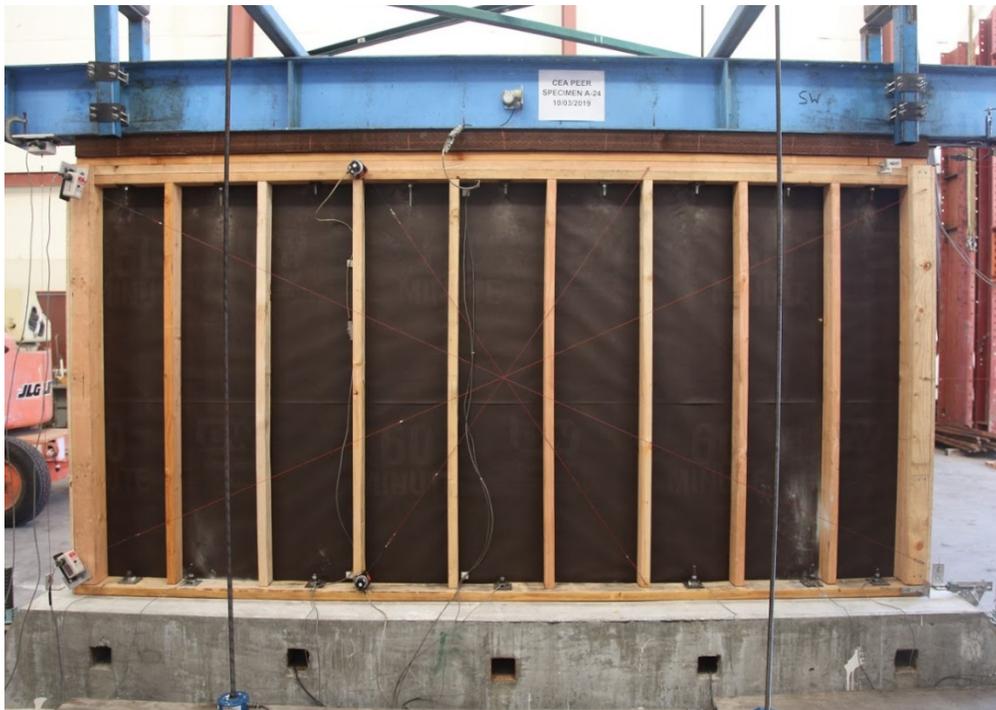
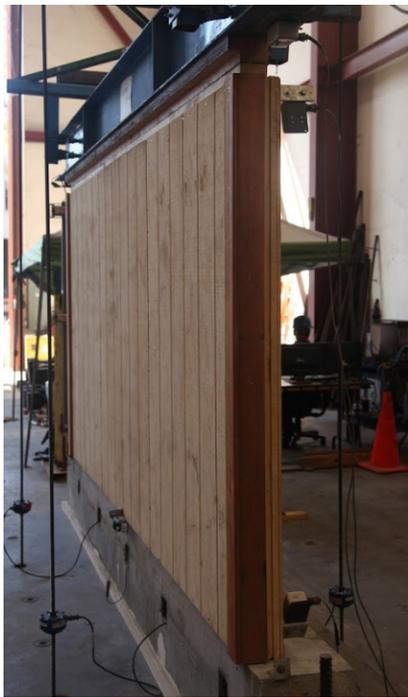
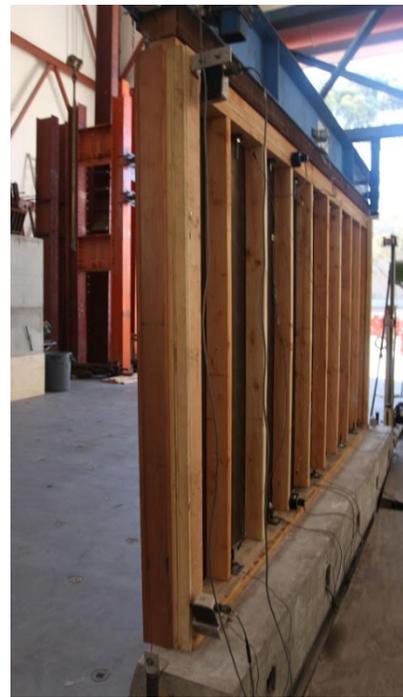
Figure 3.28 Specimen A-24 pre-test photograph for the retrofitted 6-ft-tall cripple wall with T1-11 wood structural panel exterior finish): (a) exterior elevation; (b) interior elevation; (c) north exterior corner; and (d) north interior corner.

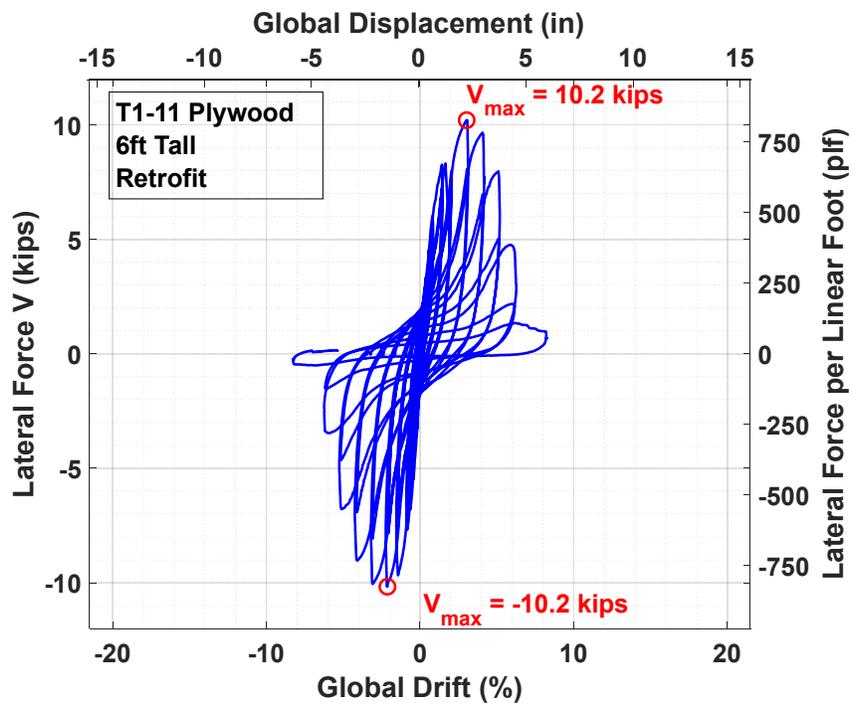
Figure 3.29 Specimen A-24 lateral force versus *global* lateral drift and displacement hysteresis.

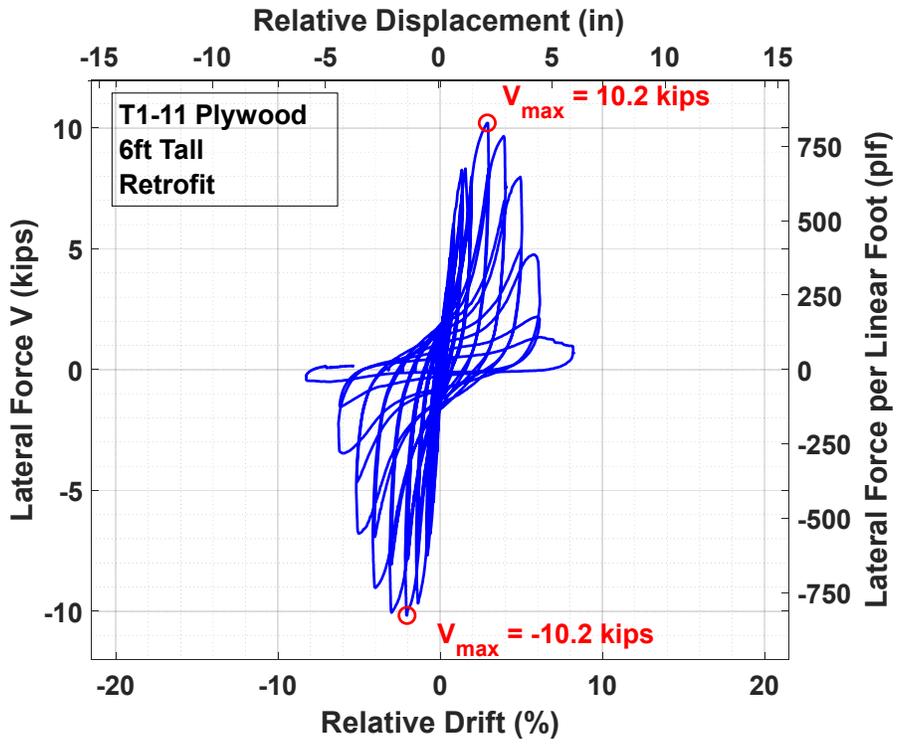
Figure 3.30 Specimen A-24 lateral force versus *relative* lateral drift and displacement hysteresis.

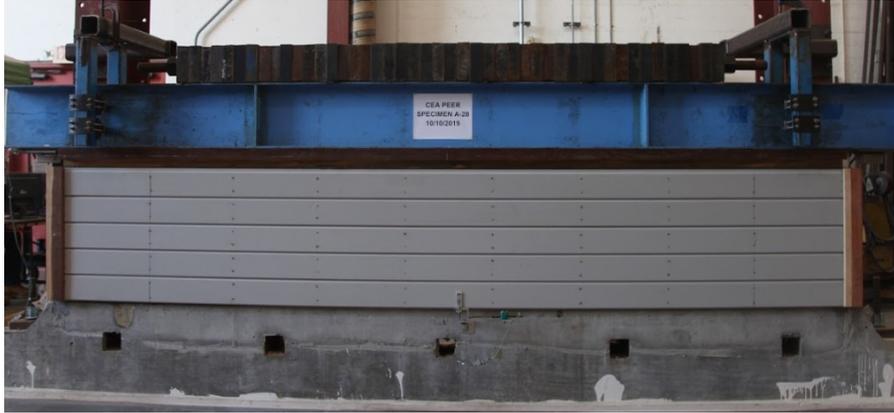
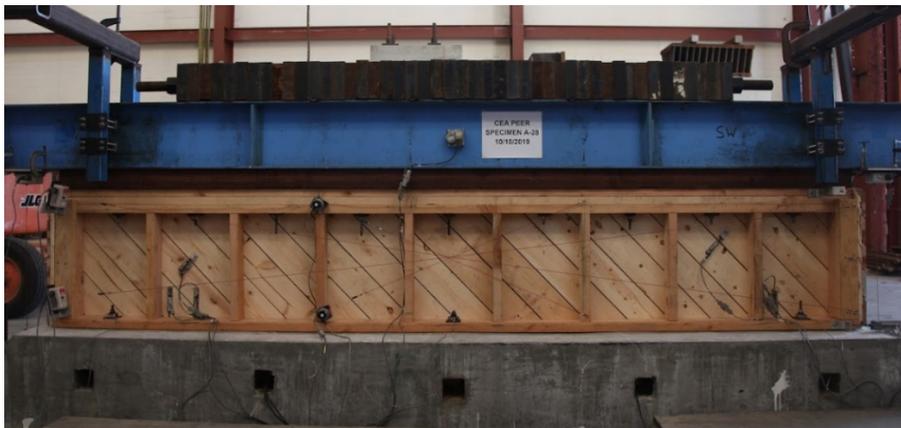
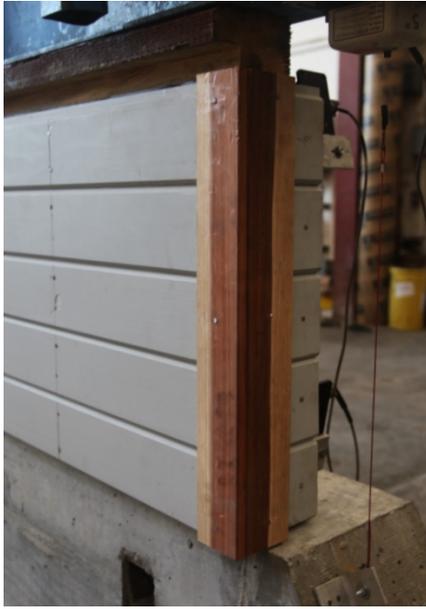
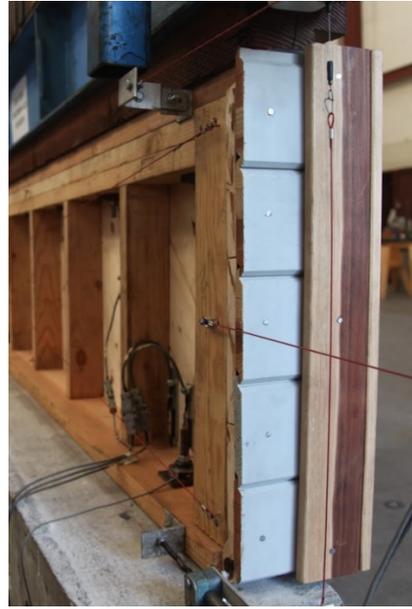
Figure 3.31 Specimen A-28 pre-test photographs for the existing 2-ft-tall cripple wall with horizontal siding over diagonal sheathing exterior finish, light vertical load: (a) exterior elevation; (b) interior elevation; (c) north exterior corner; and (d) north interior corner.

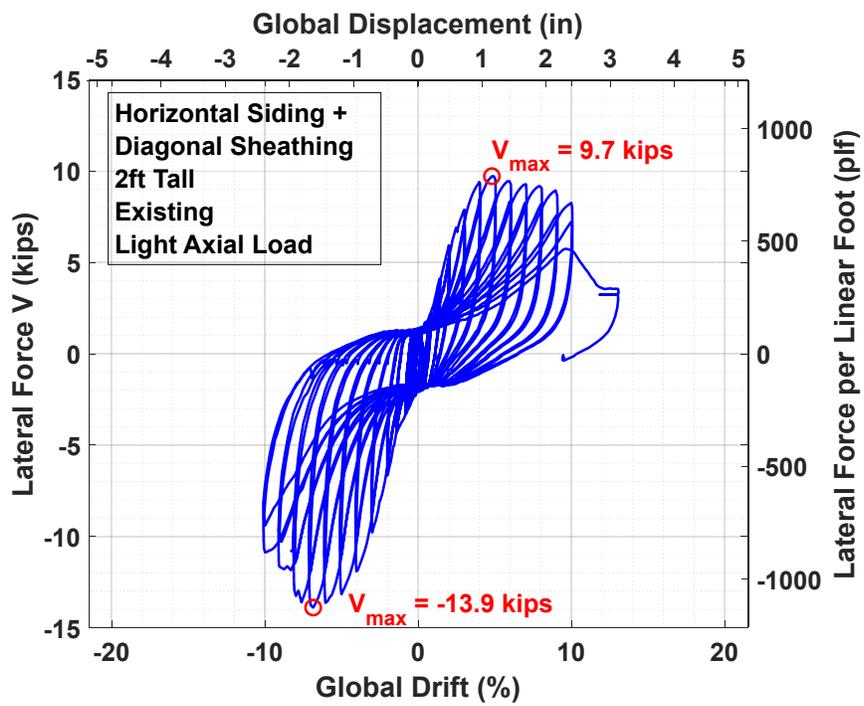
Figure 3.32 Specimen A-28 lateral force versus *global* lateral drift and displacement hysteresis.

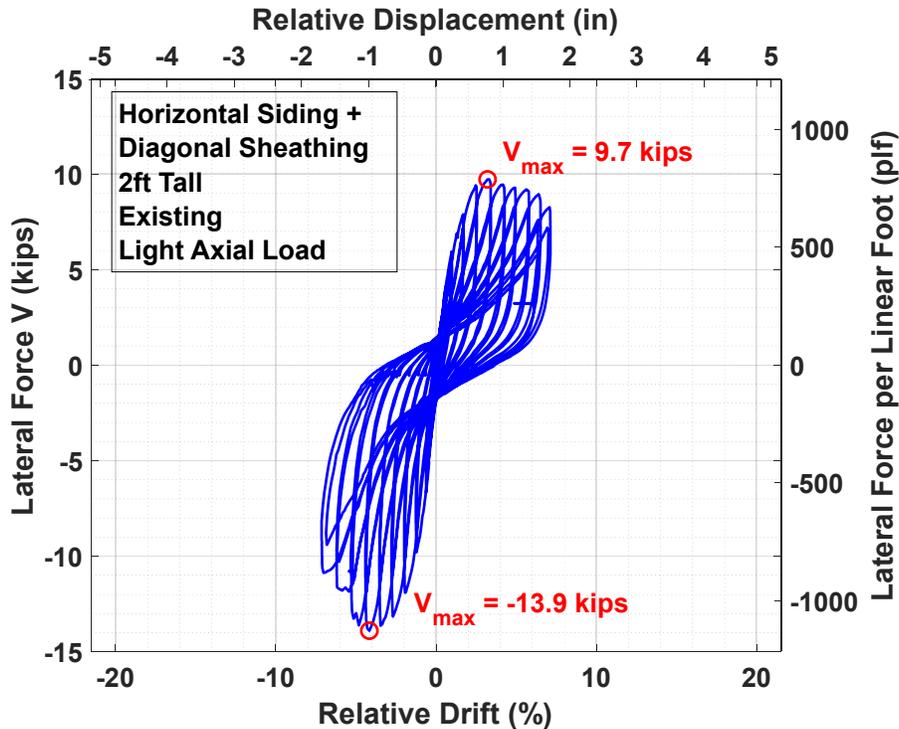
Figure 3.33 Specimen A-28 lateral force versus *relative* lateral drift and displacement hysteresis.

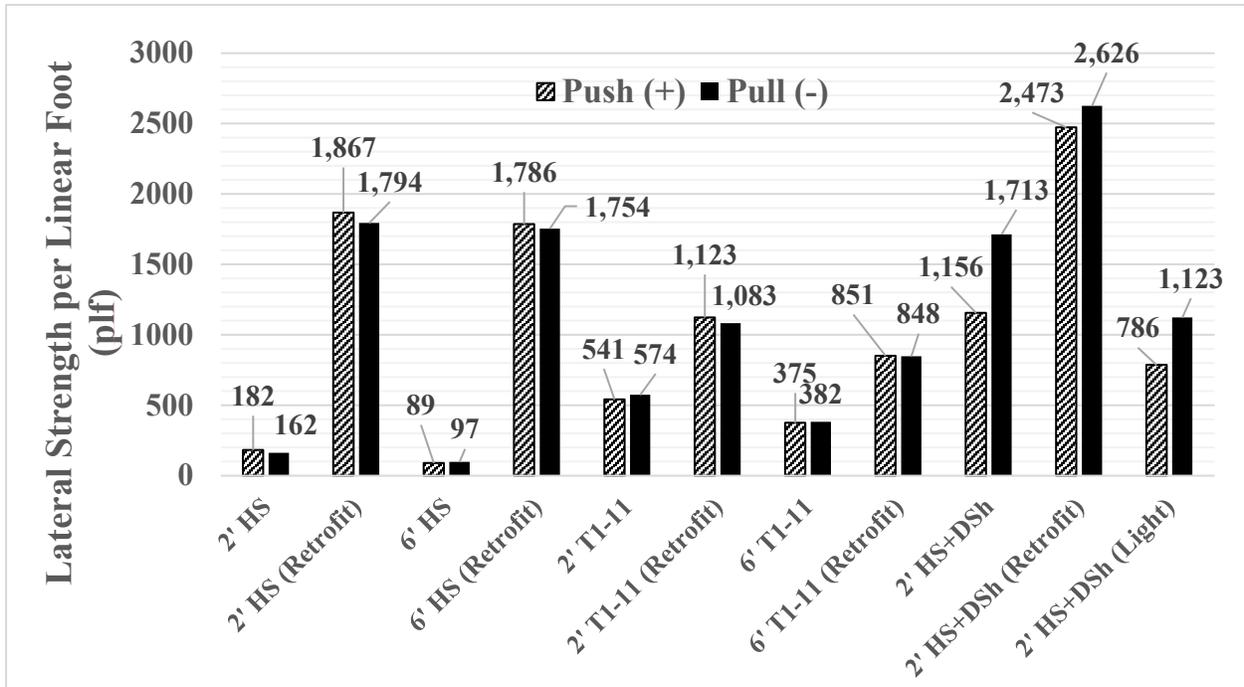
Figure 3.34 Comparison of lateral strength per linear foot of cripple walls.

Figures 3.34–3.36 summarize the key response parameters of all dry (non-stucco) specimens, namely, the lateral strength, and drift capacities at strength. Additional parameters of interest are also identified and summarized in the following figures, as defined in Figure 3.37.

Analysis of the summary of lateral strengths (Figure 3.34) indicates that of the three exterior finishes tested, the combination of horizontal siding over diagonal sheathing exhibited by far the highest strengths of any of the finishes. In the existing condition, Specimen A-9 had a lateral strength per linear foot of 1,156 plf in the push direction and 1713 plf in the pull direction. This amounted to a 724% increase in capacity, on average, between the push and pull directions of loading, over Specimen A-7, the existing 2-ft-tall cripple wall with horizontal siding exterior finish, and a 157% increase in capacity over Specimen A-11, the existing 2-ft-tall cripple wall with T1-11 plywood exterior finish. Assuming the horizontal siding contributes 179 plf (per results obtained from Specimen A-8), and assuming the diagonal sheathing contributes the remaining strength, its contribution is 970 plf in the push direction and 1551 plf in the pull direction. On average between push and pull directions, the lateral strength contribution from the diagonal sheathing was 1261 plf, exceeding the average strength of the retrofitted cripple wall with T1-11 plywood exterior finish. While wood structural panels like T1-11 plywood typically provide the largest amount of shear resistance in shear walls and cripple walls, the panels contain most of their nailing on the perimeter, whereas the diagonal sheathing boards contain two nails on each stud, which is an overall increase in the amount of nails across the cripple wall. This caused an increase

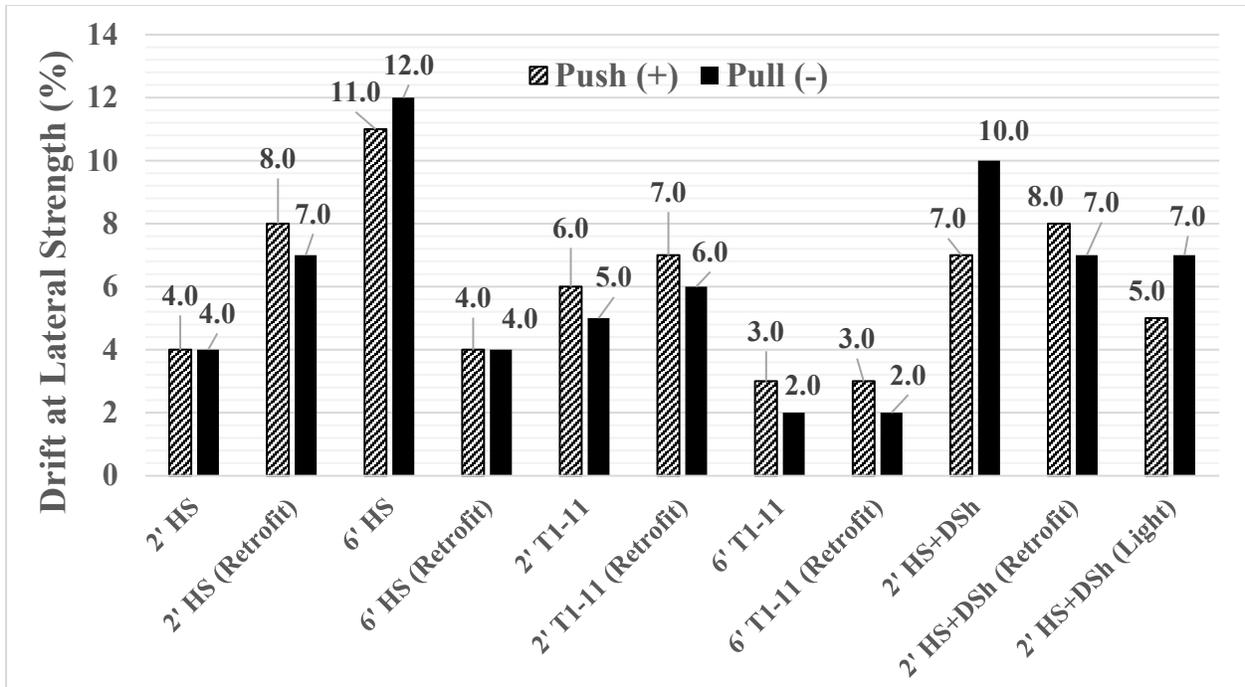
Figure 3.35 Comparison of *global* drifts at lateral strength.

All cripple walls showed significant differences in the global and relative response due to the displacement of the sill plate along the foundation, as demonstrated when comparing Figures 3.35 and 3.36. Three cripple walls tested did not have the capacity to overcome the frictional resistance between the sill plate and foundation. In the previous report, an analysis was made of the required force to initiate sill to foundation displacement. For cripple walls with a 450 plf vertical load, the required force is around 5.5 kips. Three cripple walls, all existing specimens, did not exhibit degradation in their lateral load; thus, it may be assumed their strength was not strictly attained. These include: the 2-ft-tall and 6-ft-tall wall with horizontal siding, and the 6-ft-tall wall with T1-11 wood structural panel specimens. In the case of the horizontal siding specimens, it is noted that their lack of lateral load degradation is due to the relatively low load carrying capacity and correspondingly large lateral displacement. While very large lateral displacements could have caused the specimen to attain a failure mechanism and thus degradation in lateral load, such large displacements would have been an artifact of the test setup.

Overall, the global drifts at strength ranged from 2% to 12% global ratio drift. By omitting the displacement of the sill plate relative to the foundation, the range drastically reduced to 2% to 6.4% drift ratio. This range excludes Specimen A-13, the existing 6-ft-tall cripple wall with horizontal siding exterior finish, whose strength occurred at 11% drift ratio in the push direction and 12% drift ratio in the pull direction (global and relative). Figures 3.20 and 3.21 show the global and relative response of Specimen A-13; it can be seen that the lateral load continued to increase until 12% drift and further increased when a monotonic push was initiated. The choice was made to initiate a monotonic push after the 12% drift ratio cycle as the lateral strength was converging on 1.2 kips. Although this decision did not strictly follow the loading protocol, which requires a monotonic push be initiated upon attainment of an 80% reduction in lateral load, it allowed attainment of comparable drift amplitudes of prior specimens (i.e., ~20%) while also minimizing the potential for damage to instrumentation. During this push, the lateral load increased 45% up to 1.6 kips. It should be noted that the responses were corrected for “P-Δ” effects from the applied vertical load, meaning that the lateral contribution of the vertical load, which is inherent due to the mechanism of vertical load application, was accounted for in the data in the presented results. The increase in load is largely due to the gaps between the siding boards closing at large displacements. While the existing 2-ft-tall cripple wall with horizontal siding exterior attained lateral strength at 4% drift with 186 plf in the push direction and 4% drift ratio with 162 plf in the pull direction, this specimen maintained lateral strength at 11% drift with 89 plf in the push direction and 12% drift ratio with 97 plf in the pull direction, respectively, which was only a reduction of 51% and 40% capacity in the push and pull directions, respectively; see Figure 3.2. In addition, the secant

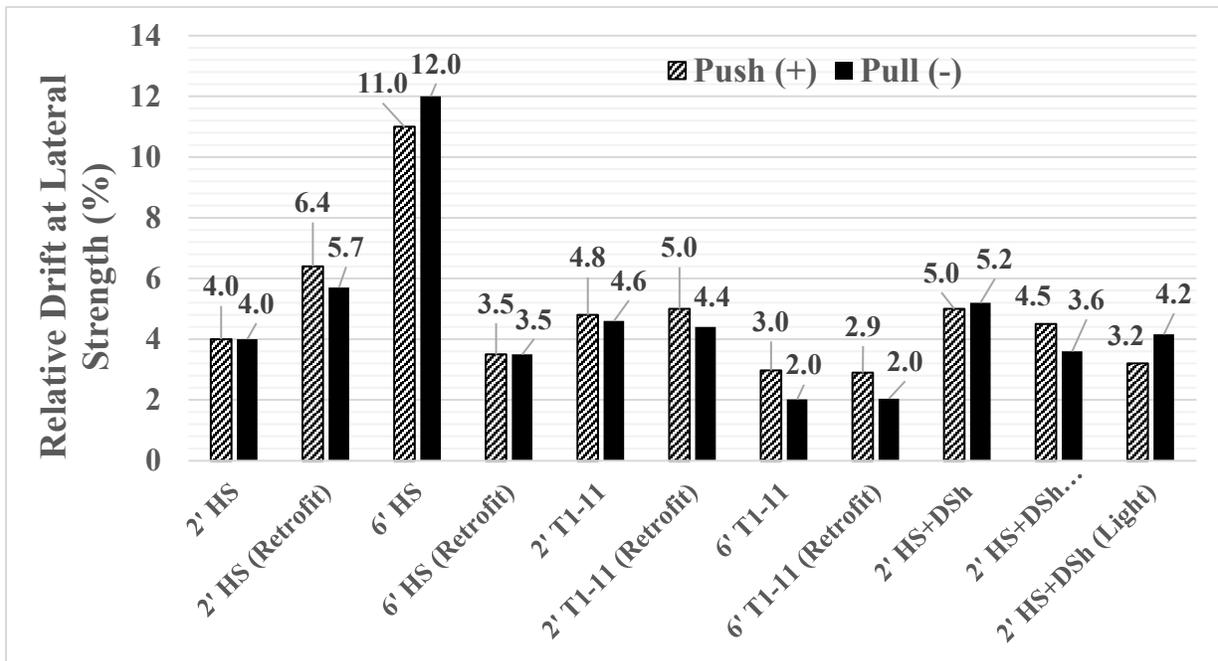
Figure 3.36 Comparison of *relative* drifts at lateral strength.

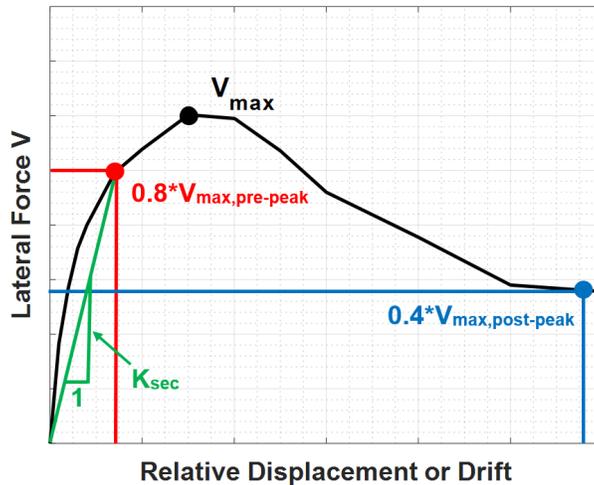
Figure 3.37 Schematic defining key parameters cross-compared amongst specimens in report: initial secant stiffness, relative drift at 80% lateral strength (pre-strength), and relative drift at 40% lateral strength (post-strength) from a monotonic envelope of the response.

stiffness for both existing cripple walls with horizontal siding were the lowest of any specimens. Note that the secant stiffness is defined as the slope extending from the origin to a point on the pre-peak portion of the envelope curve that is equal to 80% of the maximum lateral load for the relative displacement response; see Figure 3.37, which also provides graphical interpretations of relative displacement at 80% of strength, pre-peak, and relative displacement at 40% strength, post-peak. The results of both existing cripple walls with horizontal siding demonstrate the large flexibility of this type of finished wall. It is noted for contrast, that by 12% relative drift, all other cripple wall had lost at least 80% of their capacity or failed due to fractured anchor bolts or cracked sill plates.

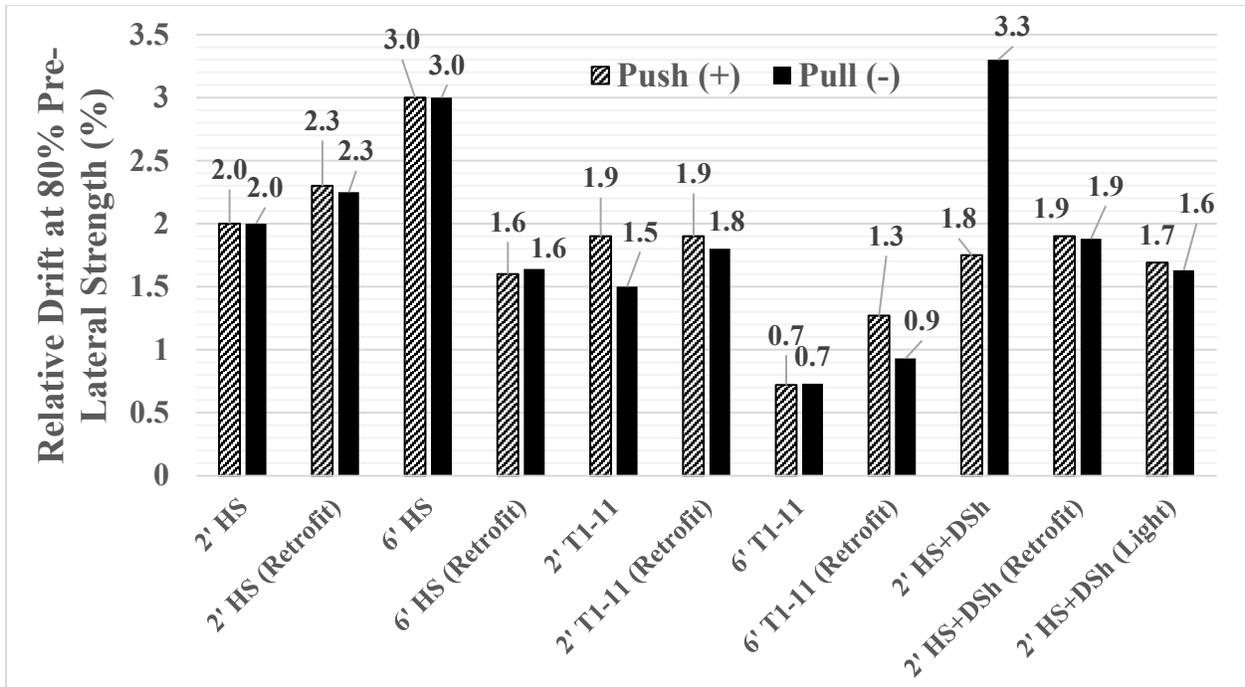
Figure 3.38 Comparison of *relative drift at 80% lateral strength, pre-strength* ($0.8 V_{max}$).

Figure 3.38 shows the relative drift at 80% of the pre-peak strength. Cross comparison of all dry finish specimens shows that all of the cripple walls achieved 80% strength in at least one direction between 1.5% and 2.3% drift ratio. The 6-ft-tall cripple walls with the T1-11 finish gained strength much earlier, from 0.7–1.3% drift ratio, while the existing 6-ft-tall cripple wall with horizontal siding was at 80% strength by 3% drift ratio. This is an important metric for understanding the behavior of the cripple walls because it provides a sense of how much displacement is required to achieve most of the capacity.

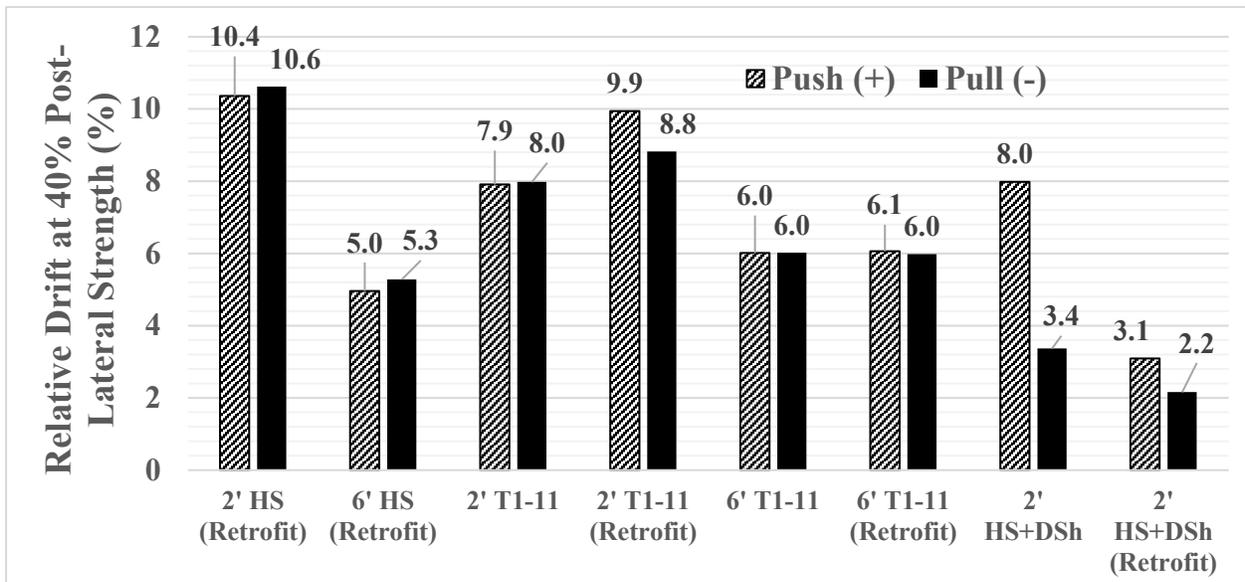
Figure 3.39 Comparison of *relative drift at 40% lateral strength, post-strength* ($0.4 V_{max}$); note that select specimens did not observe a drop in lateral load and thus are not included in this plot.

Figure 3.39 provides the relative drift of cripple walls at 40% of strength post-peak. Eight of the eleven dry finished specimens had a 60% drop in strength. Both existing cripple walls with 2-ft-tall and 6-ft-tall horizontal siding never crossed this threshold. The 2-ft-tall specimen began losing strength after 4% drift, but only lost 40% strength by 12% drift. The 6-ft-tall specimen never had a reduction in load during the entire loading protocol. It should also be noted that the cripple wall with horizontal siding over diagonal sheathing and light vertical load lost load abruptly due to a crack forming along the entire length of its sill plate. There was a large range in the relative drift ratios where this criterion was attained: from 2.2% to 10.6%. The most consistent response when considering the retrofit and existing specimens amongst the exterior finishes were the T1-11 specimens, especially for the 6-ft-tall specimens. For both the existing and retrofitted cripple walls, a 60% loss in strength occurred between 6.0% and 6.1% drift. For the T1-11 2-ft-tall specimens, it occurred between 7.9% and 9.9% drift. It should be noted that the horizontal siding over diagonal sheathing specimens only achieved a 60% loss in strength due to its anchor bolts fracturing; these values would have been higher had loss of strength resulted from the actual wall losing capacity.
