Cripple Wall Small-Component Test Program: Dry Specimens

**A Report for the “Quantifying the Performance of
Retrofit of Cripple Walls and Sill Anchorage in Single-
Family Wood-Frame Buildings” Project**

PEER Report 2020/17

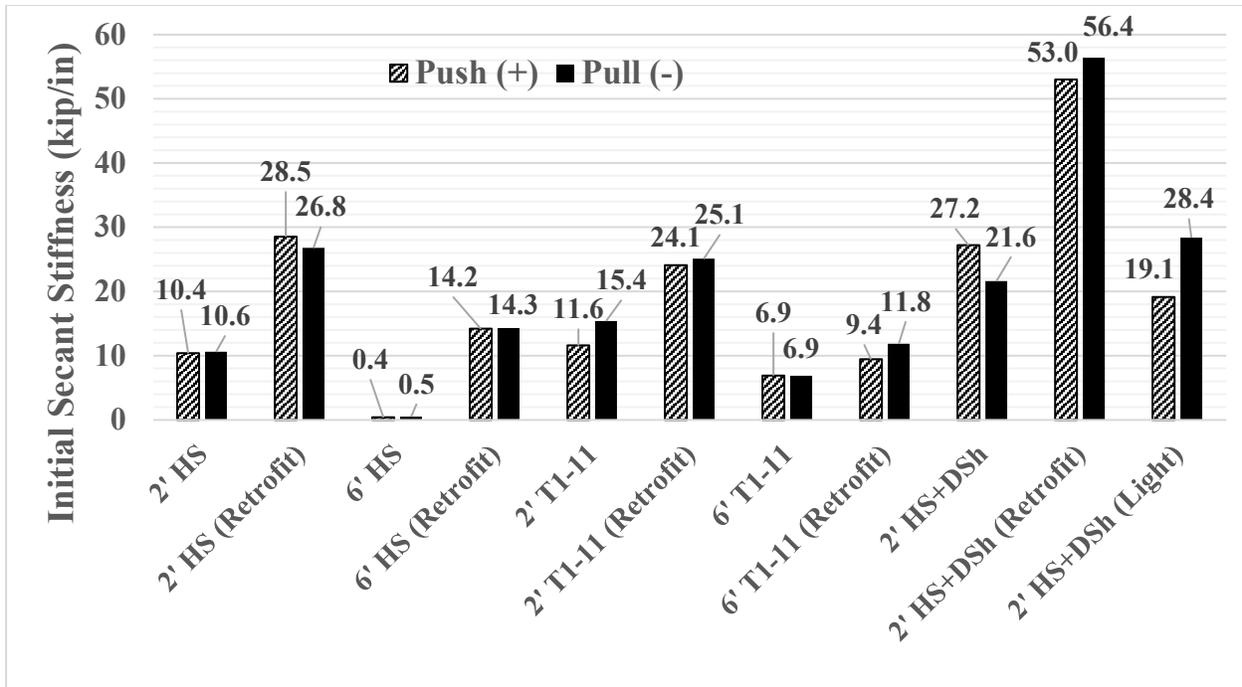
Figure 3.40 Secant stiffness associated with the *relative drift* at 80% pre-strength.

Figure 3.40 shows the initial secant stiffness for all specimens. It should be noted that the initial stiffness values provided in Figure 3.40 are based on relative drift values. A comparison of all dry specimens demonstrates that the secant stiffness of the existing cripple wall with horizontal siding over diagonal sheathing and heavy vertical load, namely, Specimen A-9, was the largest, with a value of 27.2 kip/in in the push direction and 21.6 kip/in in the pull direction. In contrast, the existing 2-ft-tall cripple wall with horizontal siding, namely Specimen A-7, had the lowest

secant stiffness, with values of 4.7 kip/in in the push direction and 4.4 kip/in in the pull direction. The T1-11 specimens observed a secant stiffness of 11.6 kip/in. and 15.4 kip/in. for the existing condition in push and pull directions, respectively. On average between both directions of loading, the increase in secant stiffness from horizontal siding to horizontal siding over diagonal sheathing was nearly 600% and from T1-11 wood structural panels to horizontal siding over diagonal sheathing was around 80%, showing diagonal sheathing alone contributes more to strength and stiffness of any of the dry finish materials. It would be expected that a taller cripple wall would be more flexible than a shorter one; this is confirmed in a comparison of the existing 2-ft- to the 6-ft-tall specimens. For the horizontal siding finish, there was nearly a 90% reduction in stiffness from the 6-ft- to the 2-ft-tall specimen, and for the T1-11 finish there was nearly a 50% reduction in stiffness from the 6-ft- to the 2-ft-tall specimen.

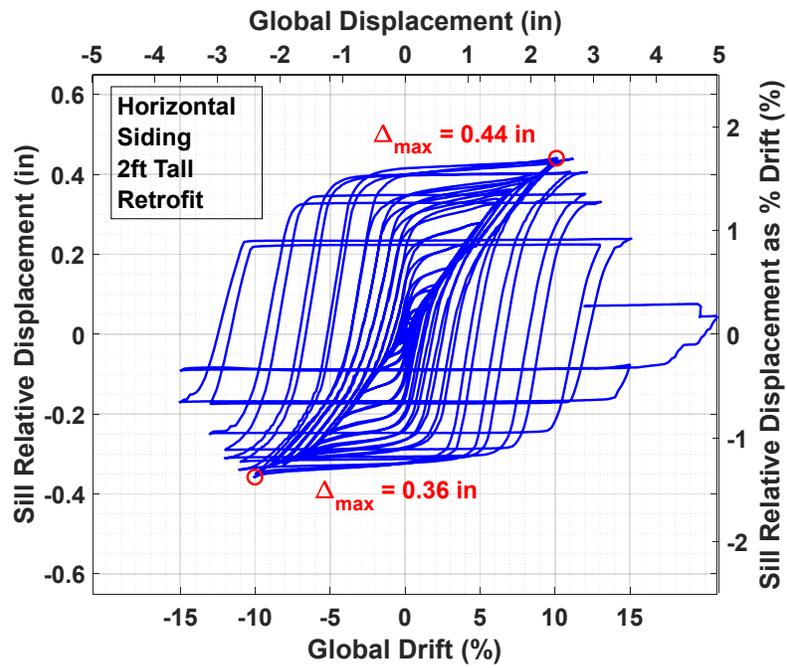
Figure 3.41 Specimen A-8 sill plate to foundation relative displacement versus *global* drift.

Figures 3.30 through 3.41 show the displacement of the sill plate relative to the foundation versus the lateral load for all cripple walls, with the exception of Specimens A-7, A-13, and A-23, which did not observe significant sill plate movement. It would be expected that cripple walls with larger load capacities would have the most displacement of the sill plate relative to the foundation occur, and this is generally the trend. This was the case with all retrofitted specimens. Specimens A-8 and A-14 experienced the lowest amount of sill movement for retrofitted specimens with horizontal siding exterior finishes. The sill-to-foundation displacement was similar for both, 0.44 in. in the push direction and 0.36 in. in the pull direction for the 2-ft-tall cripple wall and 0.37 in. in the push direction and 0.36 in. in the pull direction for the 6-ft-tall cripple wall. Specimen A-12, the retrofitted T1-11 cripple wall, had a lower peak capacity compared to Specimen A-8 and Specimen A-14. The sill sliding displacement was larger: 0.48 in. in the pull direction for the 2-ft-tall cripple wall and 0.40 in. in the push direction. The increased displacement was due to the reduced amount of anchor bolts resisting the movement of the sill plate. Specimen A-12 contained three anchor bolts while Specimen A-8 contained five anchor bolts, and Specimen A-14 contained seven anchor bolts. This helps to explain why the sill plate displacement for Specimen A-8 was larger than that of Specimen A-14, despite the two walls having similar peak loads. The lowest displacement of the cripple walls with appreciable displacement was for Specimen A-11, the existing T1-11 cripple wall. The peak sill plate displacement for Specimen A-11 was 0.26 in. in the push direction and 0.11 in. in the pull direction. The large discrepancy between the push and pull displacements is partly due to the peak strength exceeding the frictional resistance required for sliding to occur for less drift cycles than the higher strength cripple walls. Another possible factor is due to the alignment of the anchor bolts within the sill plate. If the anchor bolts are located towards one side of the slot than the other, the ability for the sill plate to slide in one direction of the anchor bolt hole is less than in the opposite direction. And lastly, as stated before, Specimen A-11 was tested in two sessions due to issues with the controller for the actuator. The imposed displacement was a push to 2% drift before the test stopped and a 2% drift pull could be imposed. The test resumed after the weekend, which allowed time for the wall to relax and led to an asymmetry in early drift cycles, as seen by the large difference in peak sill displacement values.

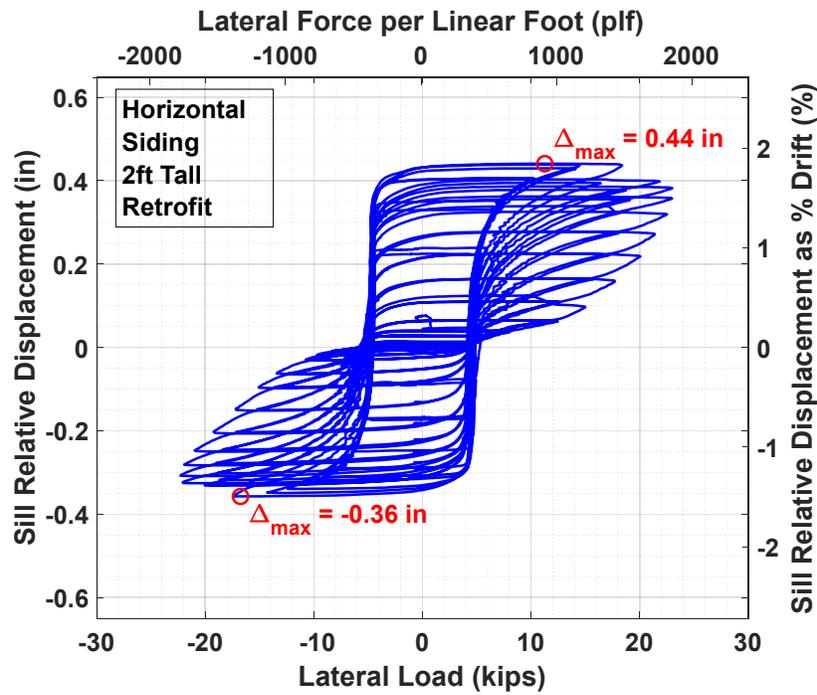
Figure 3.42 Specimen A-8 sill plate to foundation relative displacement versus lateral strength.

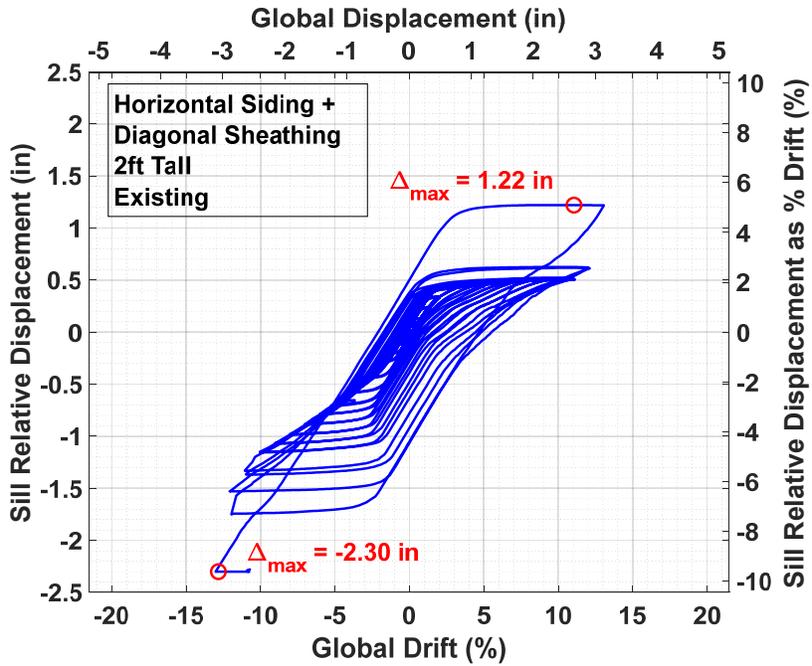
Figure 3.43 Specimen A-9 sill plate to foundation relative displacement versus *global* drift.

By far the largest sill-to-foundation relative displacements occurred in the retrofitted and existing cripple walls with horizontal siding over diagonal sheathing. For the existing cripple wall, Specimen A-9, the peak displacement in the push direction was 1.22 in. and in the pull direction was 2.30 in. For the retrofitted cripple wall, Specimen A-9, the peak displacement in the push direction was 2.77 in. and 2.72 in. in the pull direction. These displacements are so much larger than the rest of the cripple walls because both cripple walls experienced anchor bolts failures during the test. Therefore, once the anchor bolt failures occurred, nearly all of the imposed lateral displacement was culminated in the form of sill plate sliding. This is evident when looking at the lateral force versus global displacement hysteresis compared with the lateral force versus relative displacement hysteresis in Figures 3.8 and 3.9 for Specimen A-9 and Figures 3.11 and 3.12 for

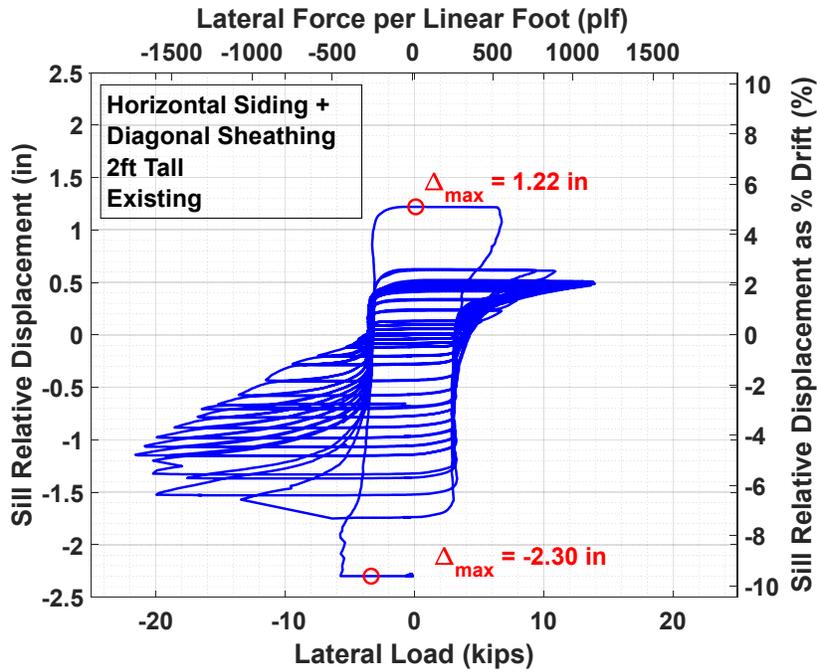
Figure 3.44 Specimen A-9 sill plate to foundation relative displacement versus lateral strength.

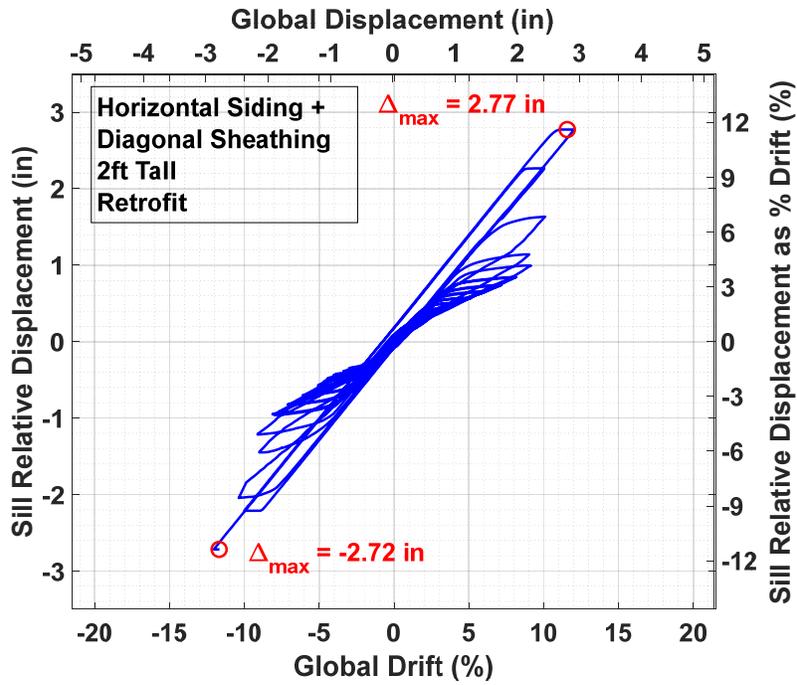
Figure 3.45 Specimen A-10 sill plate to foundation relative displacement versus *global* drift.

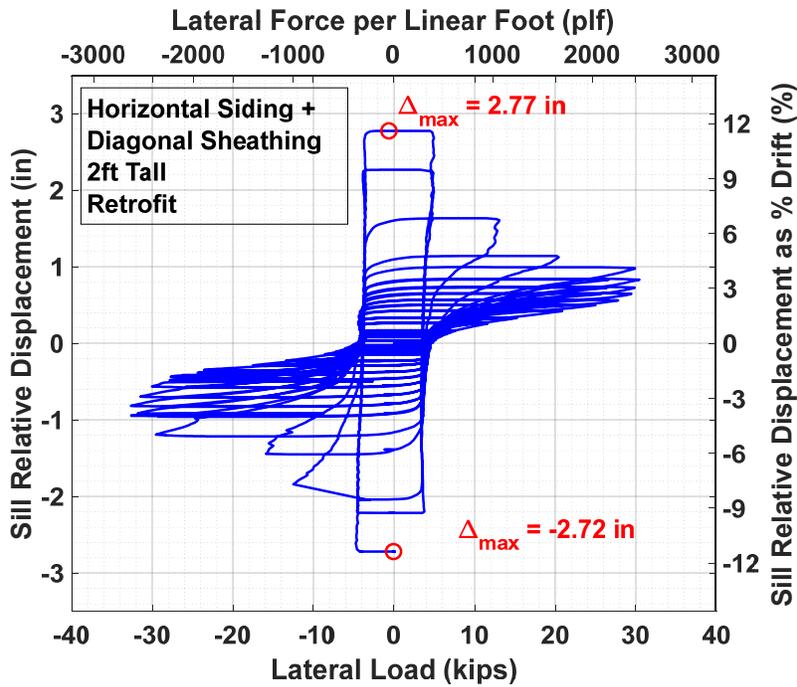
Figure 3.46 Specimen A-10 sill plate to foundation relative displacement versus lateral strength.

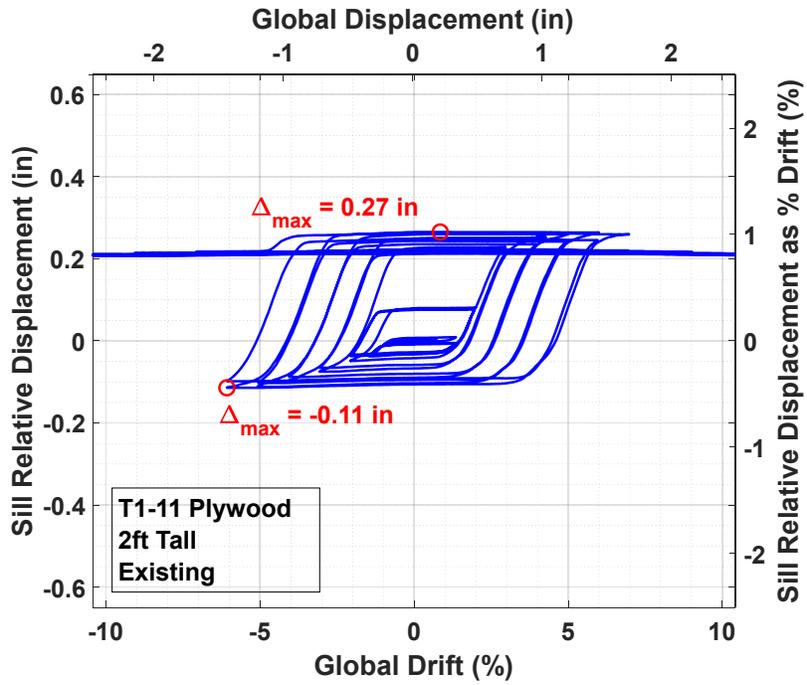
Figure 3.47 Specimen A-11 sill plate to foundation relative displacement versus *global* drift.

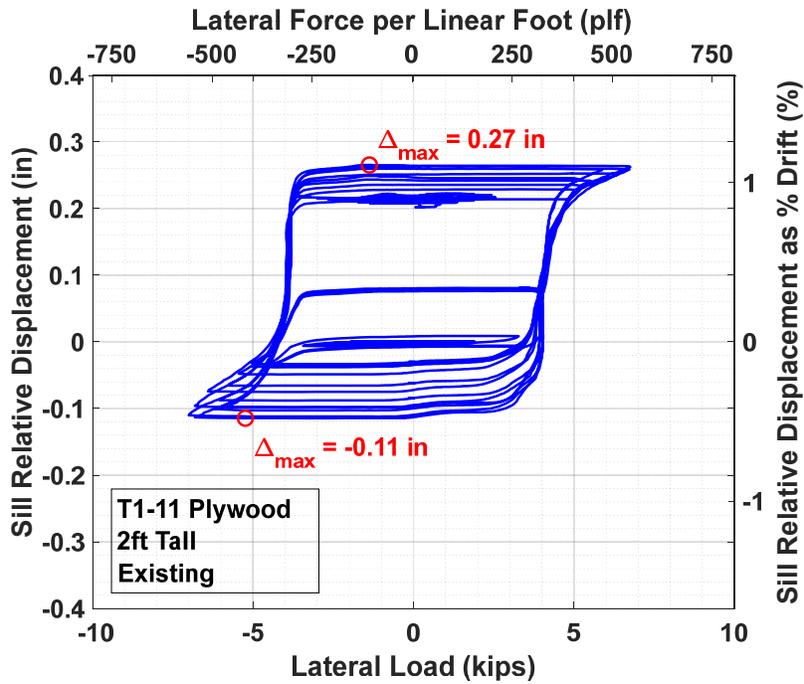
Figure 3.48 Specimen A-11 sill plate to foundation relative displacement versus lateral strength.

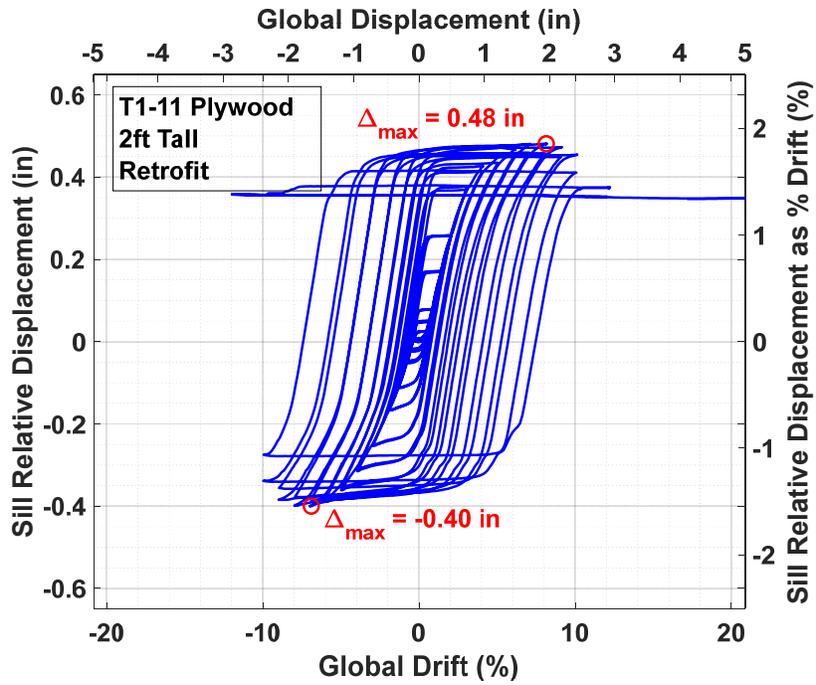
Figure 3.49 Specimen A-12 sill plate to foundation relative displacement versus *global* drift.

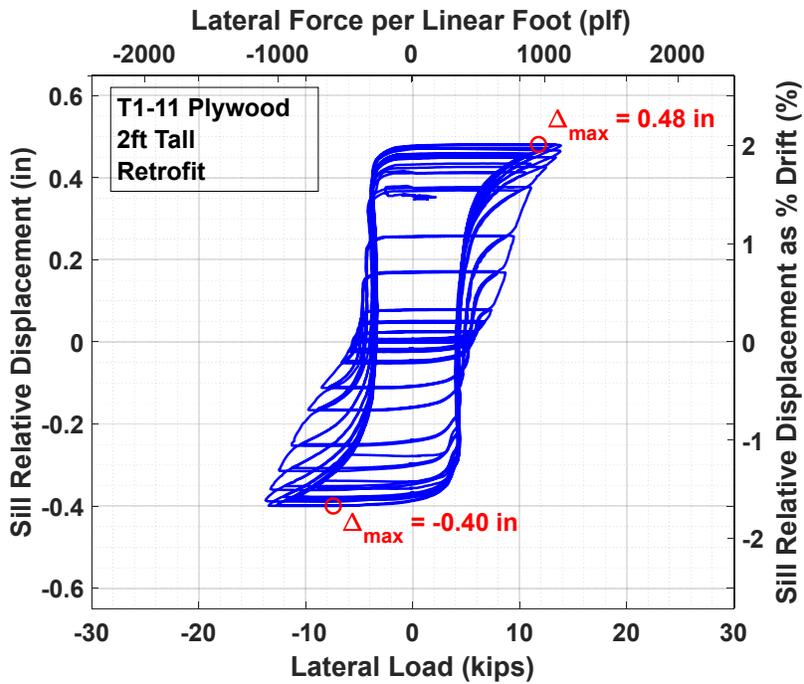
Figure 3.50 Specimen A-12 sill plate to foundation relative displacement versus lateral strength.

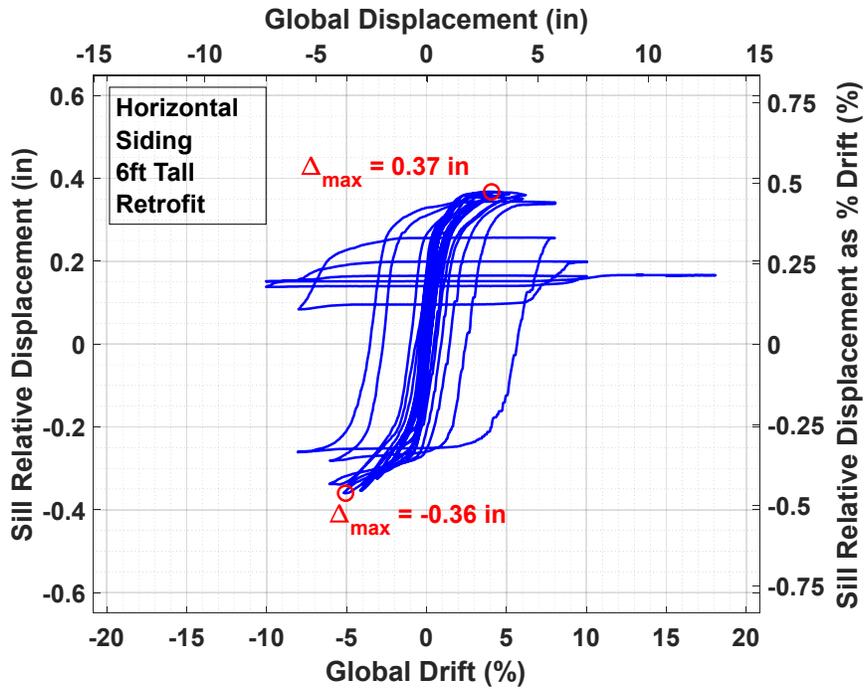
Figure 3.51 Specimen A-14 sill plate to foundation relative displacement versus *global* drift.

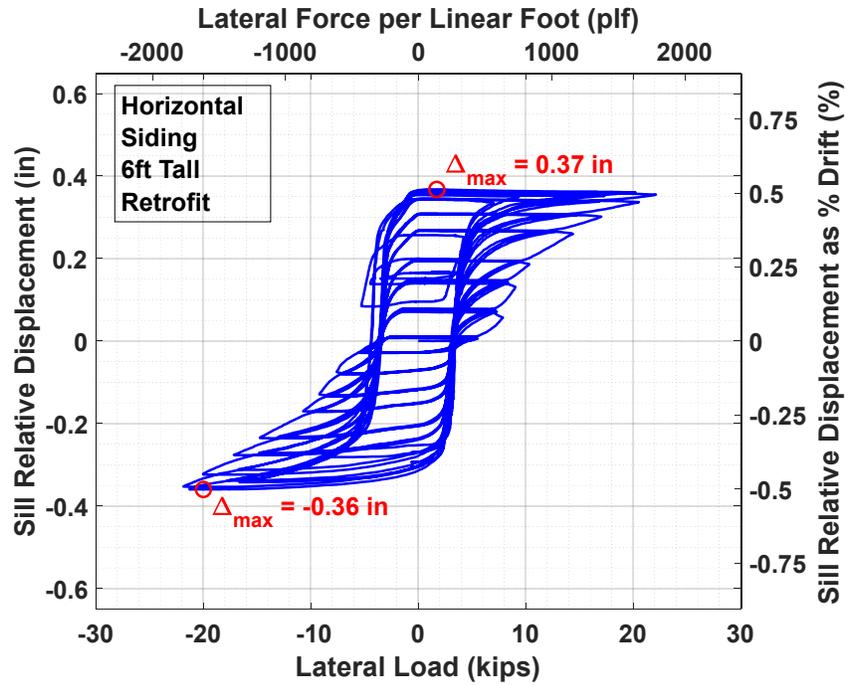
Figure 3.52 Specimen A-14 sill plate to foundation relative displacement versus lateral strength.

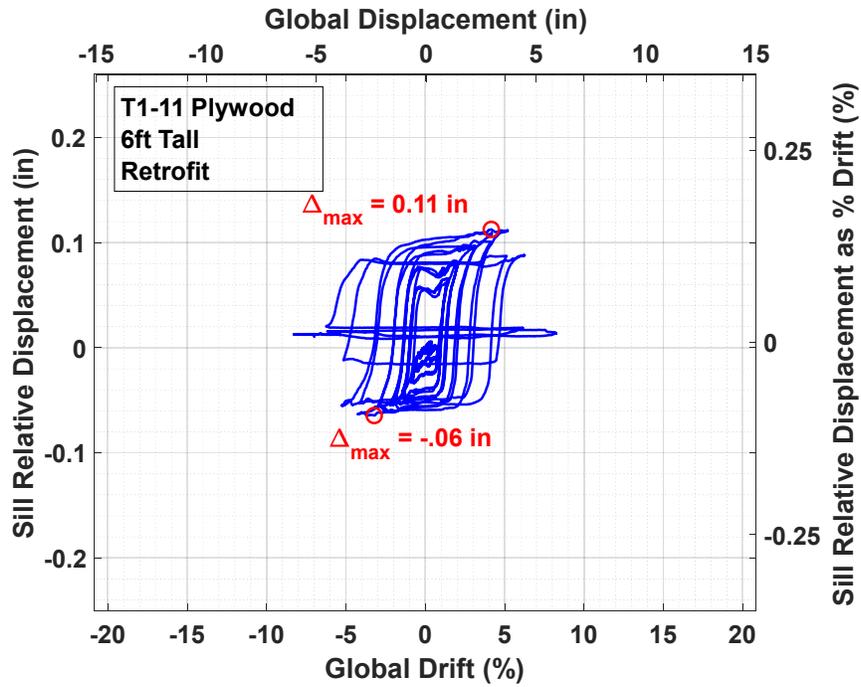
Figure 3.53 Specimen A-24 sill plate to foundation relative displacement versus *global* drift.

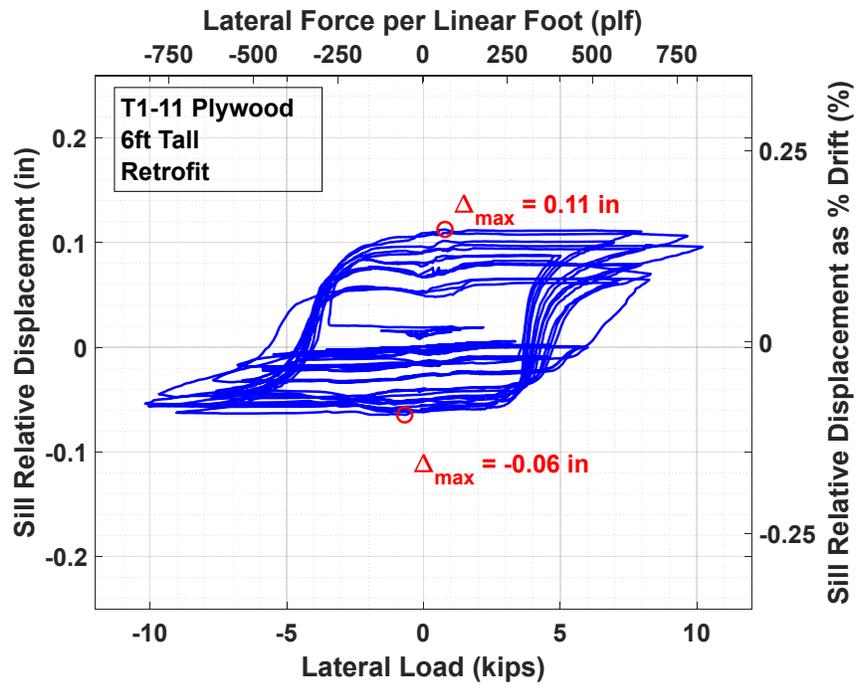
Figure 3.54 Specimen A-24 sill plate to foundation relative displacement versus lateral strength.

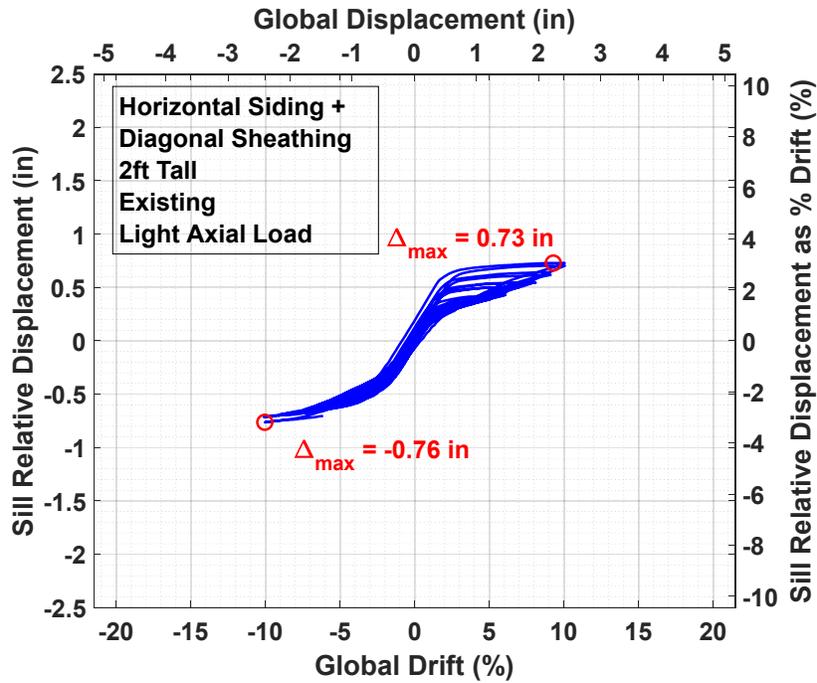
Figure 3.55 Specimen A-28 sill plate to foundation relative displacement versus *global* drift.

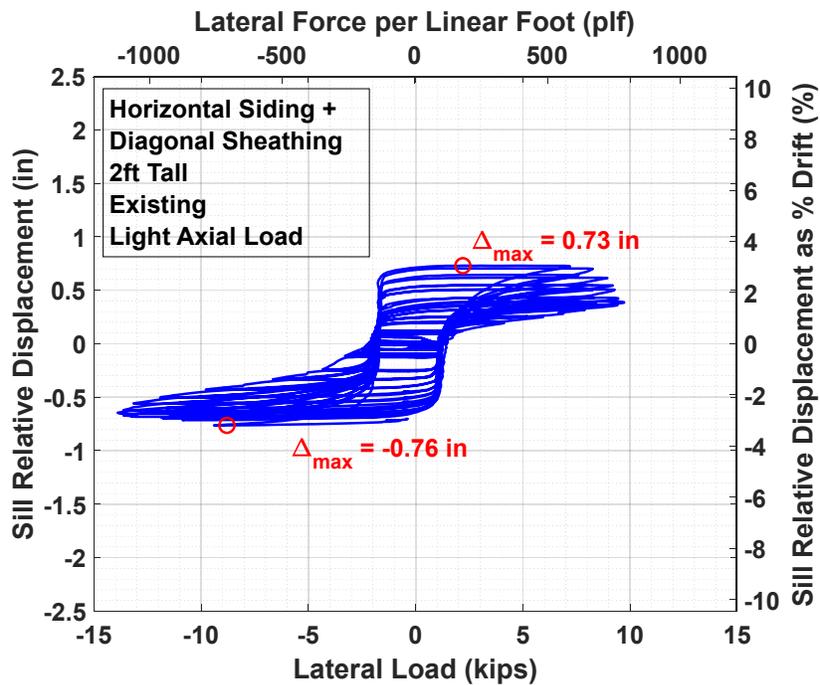
Figure 3.56 Specimen A-28 sill plate to foundation relative displacement versus lateral strength.

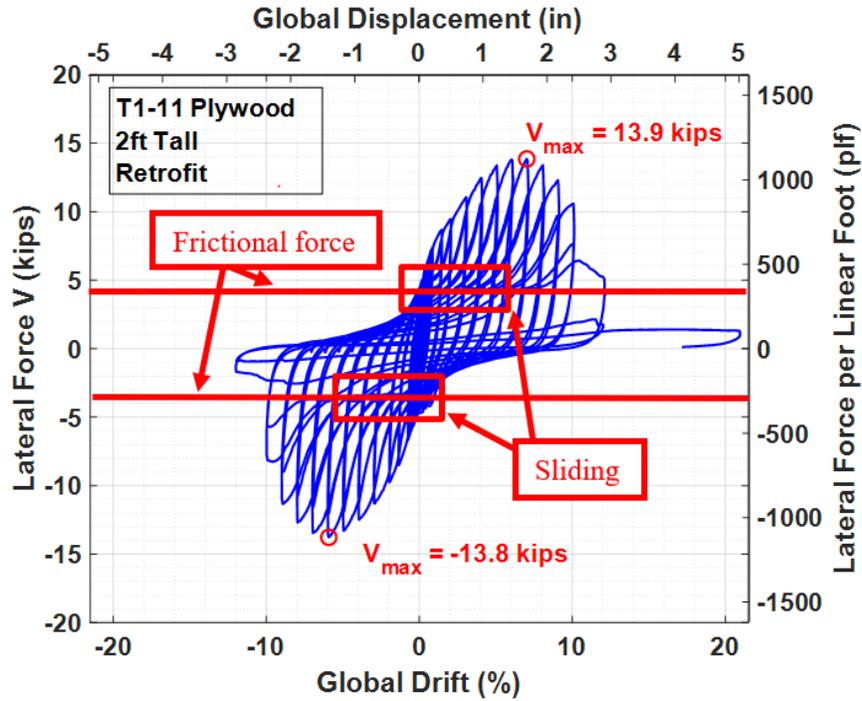
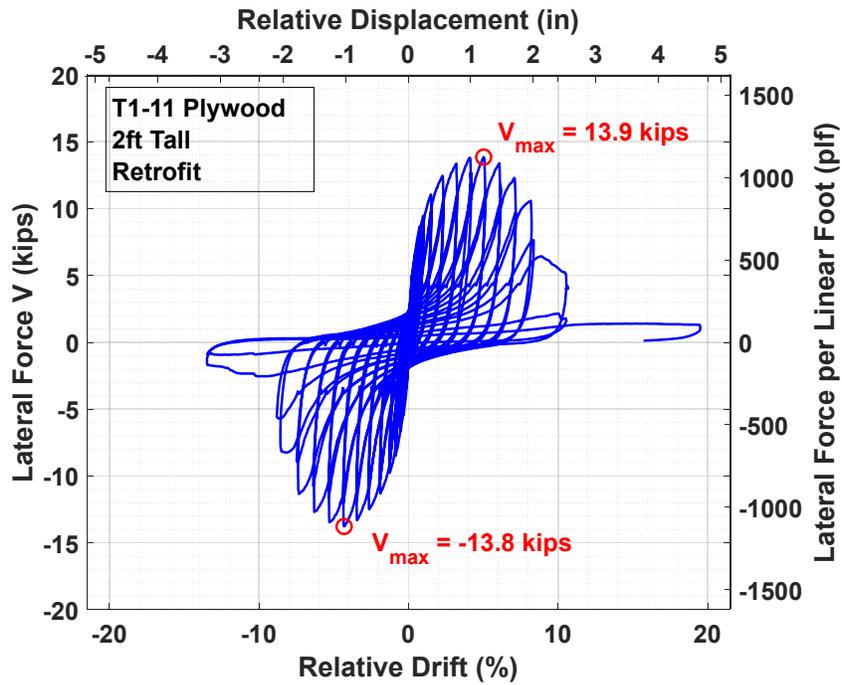
Figure 3.57 Global and relative responses showing the frictional force between the sill plate and foundation; (a) *global* response; and (b) *relative* response.

The vertical load for all specimens is 450 plf or 5.5-kips, with the exception of Specimen A-28 that had a vertical load of 150 plf. The weight of the cripple walls varied depending on the construction details and density of the lumber. Higher moisture contents in the lumber equates to a slightly heavier specimen. The amount of material used for all cripple walls that had displacements of the sill plate relative to the foundation was equal, with the exception of the cripple wall with the return walls. The weight was 0.14-0.26 kips for the 2-ft-tall cripple walls and 0.25-0.46 kips for the 6-ft-tall cripple walls. The anchor bolts were tensioned to around 0.2-kip. The amount of lateral load imposed to initiate sliding also varied. These variations can be attributed to the different tension in anchor bolts from test to test, the fluctuations in vertical load, and the anticipated range in static coefficient due to nominal material interface variability. Accounting for the variations in anchor bolt tensions, Table 3.2 shows the static coefficient of frictions between the sill plate and the foundation for all 2-ft-tall specimens that had displacements between the sill plate and foundation. The data is not given for the 6-ft-tall walls or the light vertical load wall as it was not as clear when the cripple walls overcame the frictional resistance between the sill plate and the foundation. The average static coefficient of friction for all specimens that had displacement of the sill plate relative to the foundation is approximated to be 0.64 with a range of values from 0.59 to 0.68. The static coefficient of friction between dry wood and concrete has been measured as 0.62 [Aira et al., 2014].

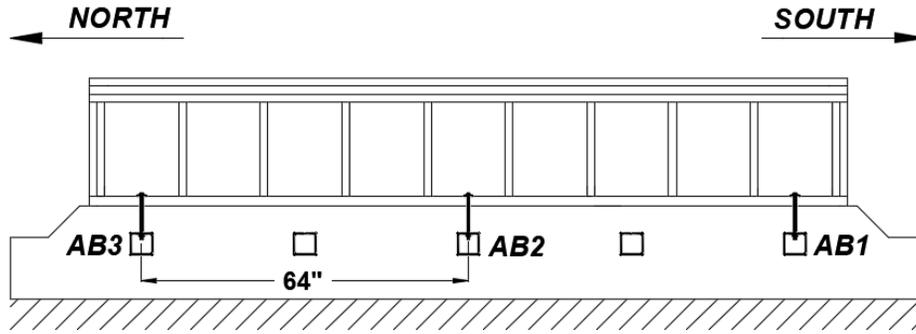
Figure 3.58 Specimen A-12 three anchor bolt layout for existing cripple walls and the retrofitted 2-ft-tall T1-11 cripple wall.

In order to measure the tension developed in each anchor bolt, 10-kip donut load cells were placed on top of the square plate washers. For existing cripple walls, three anchor bolts were used, spaced at 64 in. on center. The anchor bolt layout for these cripple walls can be seen in Figure 3.58. Specimen A-12 (the retrofitted 2-ft-tall cripple wall with T1-11 wood structural panel finish) had the same three anchor bolt arrangement as all existing cripple walls. For all other retrofitted cripple walls, additional anchor bolts were added as per the *FEMA P-1100* retrofit guidelines. Specimens A-10, A-14, and A-24 implemented four additional anchor bolts. The location of anchor bolts for Specimen A-10 can be seen in Figure 3.60, for Specimen A-14 can be seen in Figure 3.61, and Specimen A-24 can be seen in Figure 3.62. For Specimen A-8, the locations of anchor bolts can be seen in Figure 3.59. The typical spacing for anchor bolts in the retrofitted cripple was 32 in. on center. For Specimens A-10, A-14, and A-24, two additional anchor bolts were epoxied into place 12 in. inward of the outermost anchor bolts. The embedment depth of the epoxied anchor bolts was 10 in. into the foundation. Specimen A-14 utilized two tie-downs fastened to the innermost end stud, which changed the spacing slightly as seen in Figure 3.45. Specimen A-8 was tested prior to the publication of the *FEMA P-1100* guidelines; therefore, the retrofit details were derived from engineering calculations based on ATC-110 retrofit guidelines [ATC 2014]. All anchor bolts were tensioned to around 200 lbf prior to testing as observed in the field. Initial anchor bolt loads are provided in Table 3.4.

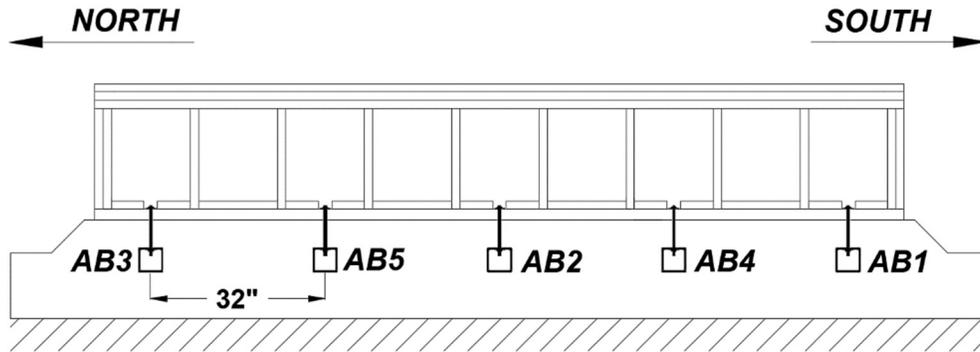
Figure 3.59 Specimen A-8 five anchor bolt layout used for the retrofitted 2-ft-tall cripple wall with horizontal siding.

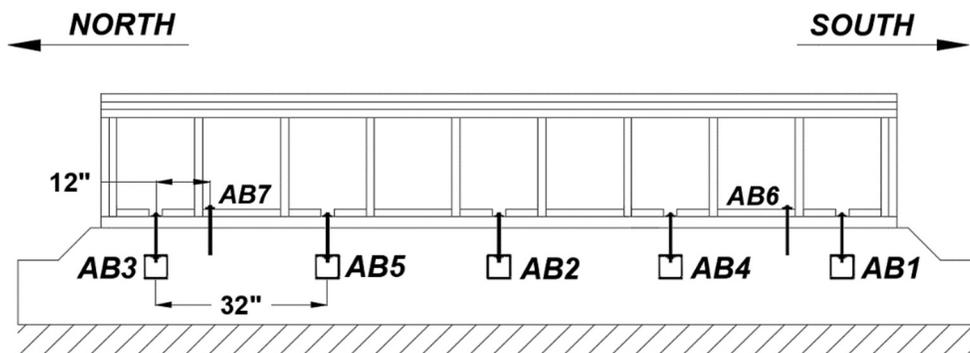
Figure 3.60 Specimen A-10 anchor bolt layout for the retrofitted cripple wall with horizontal siding over diagonal sheathing.

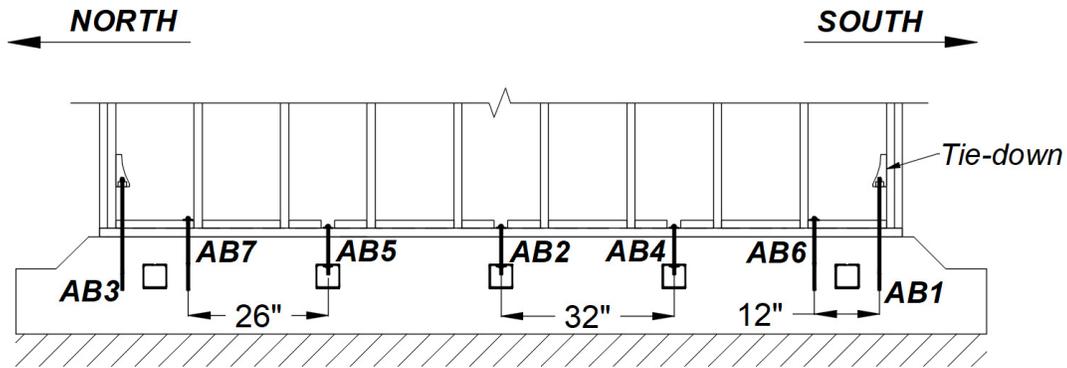
Figure 3.61 Specimen A-14 anchor bolt layout for the retrofitted 6-ft-tall cripple wall with horizontal siding.

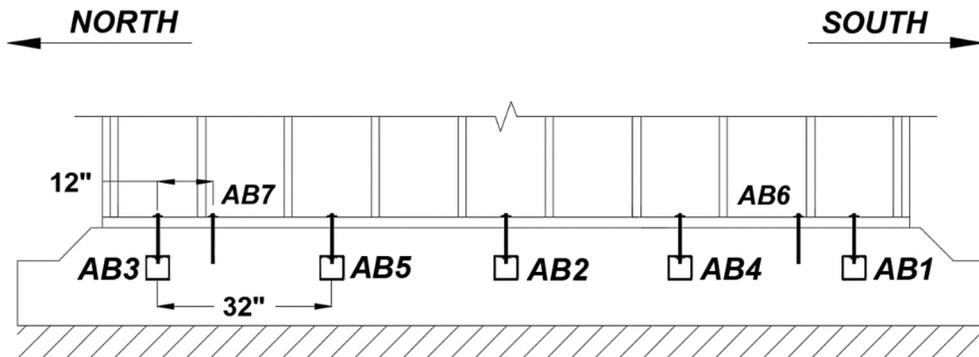
Figure 3.62 Specimen A-24 anchor bolt layout for the retrofitted 6-ft-tall T1-11 cripple wall.

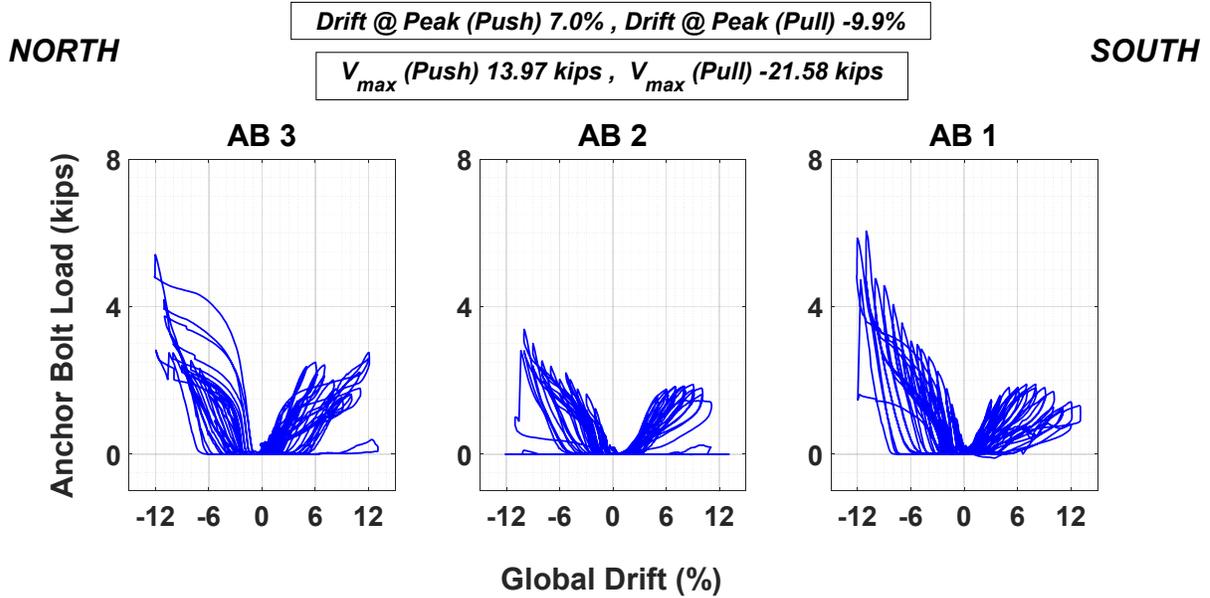
Figure 3.63 Specimen A-9 anchor bolt load versus global drift for the existing cripple wall with horizontal siding over diagonal sheathing.

Figure 3.63 shows the anchor bolt load versus displacement for existing cripple wall Specimen A-9, and Figure 3.66 shows the anchor bolt load versus displacement for retrofitted cripple wall Specimen A-10. In Figures 3.64 and 3.67, the locations of the anchor bolt fractures on the hysteretic response can be seen for the existing and retrofitted cripple walls, respectively. Figures 3.65 and 3.68 provide a reference to the locations of the anchor bolts for the existing and retrofitted cripple walls, respectively. The fractures are a result of both shear and flexural forces acting on the anchor bolts. Once one anchor bolt fracture occurred, the shear and flexural forces would increase on the other anchor bolts, and as the cripple walls continued to gain strength, the anchor bolts could not resist these forces, eventually causing all anchor bolts to fracture. Although the load on Specimen A-14's anchor bolts was the highest of all the specimens, there were no fractures. These anchor bolts were connected to the tie-downs; therefore, they were more in tension from the cripple wall uplifting than flexure and shear from the wall displacing.

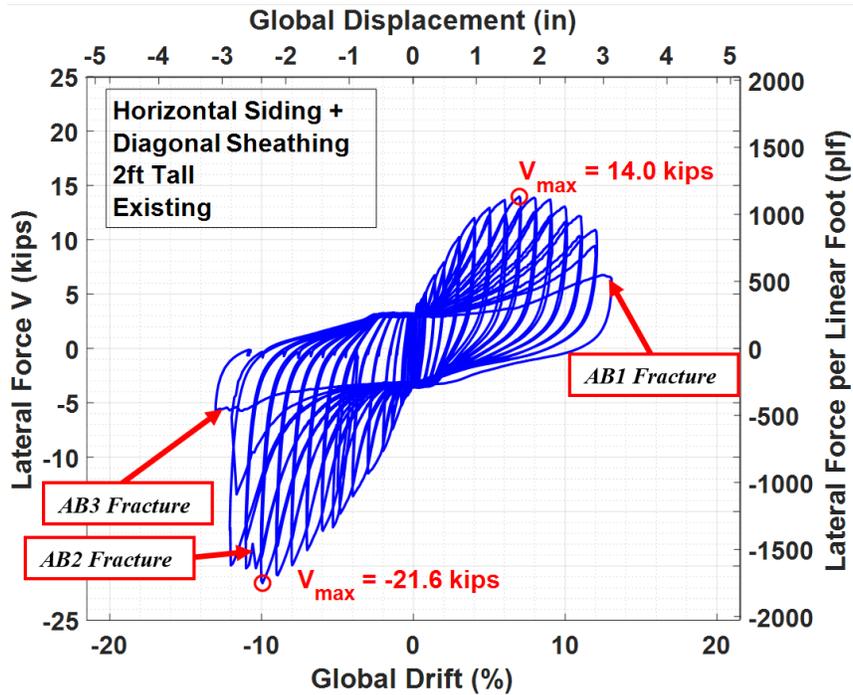
Figure 3.64 Specimen A-9 location of anchor bolt fractures on lateral force versus global lateral drift and displacement hysteresis.

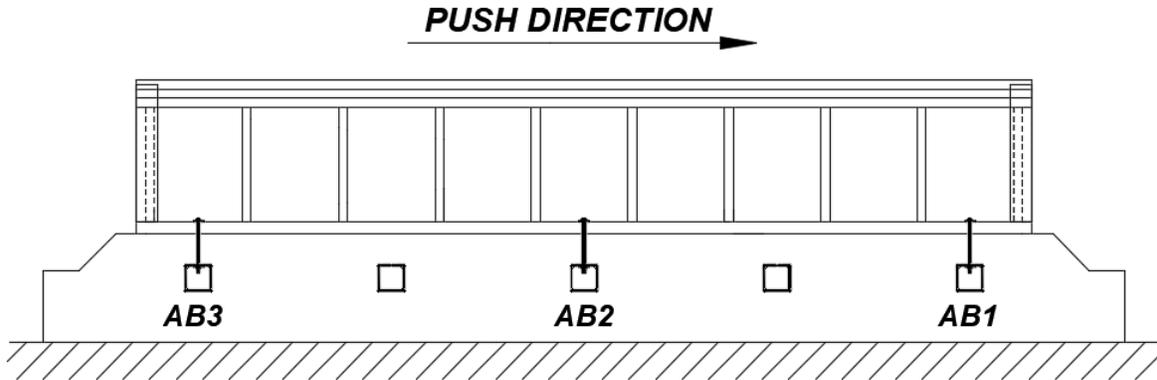
Figure 3.65 Specimen A-9 anchor bolt locations.

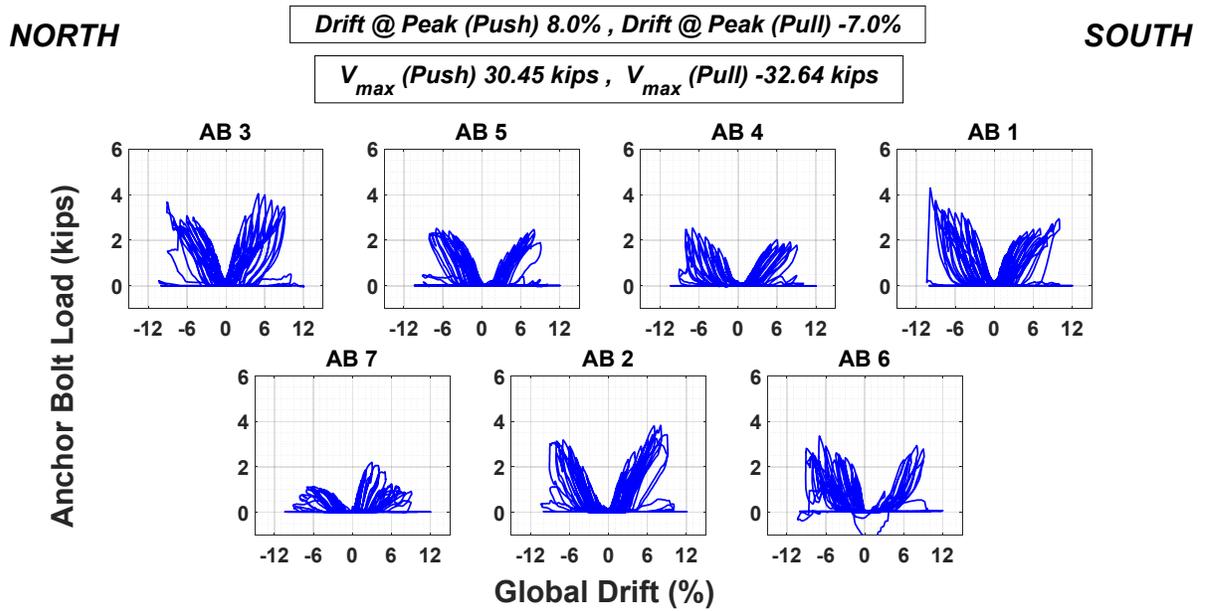
Figure 3.66 Specimen A-10 anchor bolt load versus global drift for the retrofitted cripple wall with horizontal siding over diagonal sheathing.

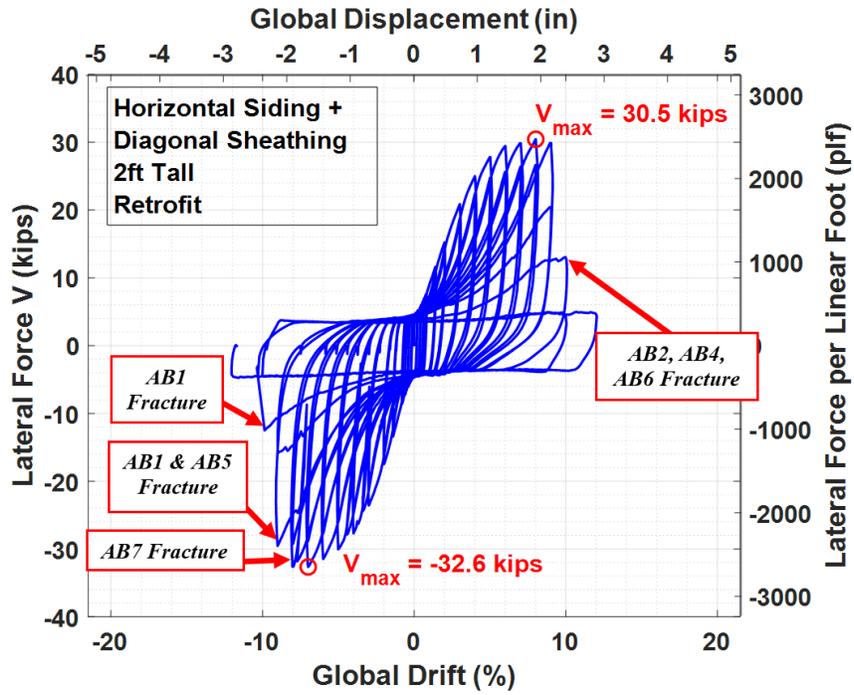
Figure 3.67 Specimen A-10 instances of anchor bolt fractures overlaid with the lateral force versus global lateral drift and displacement hysteresis.

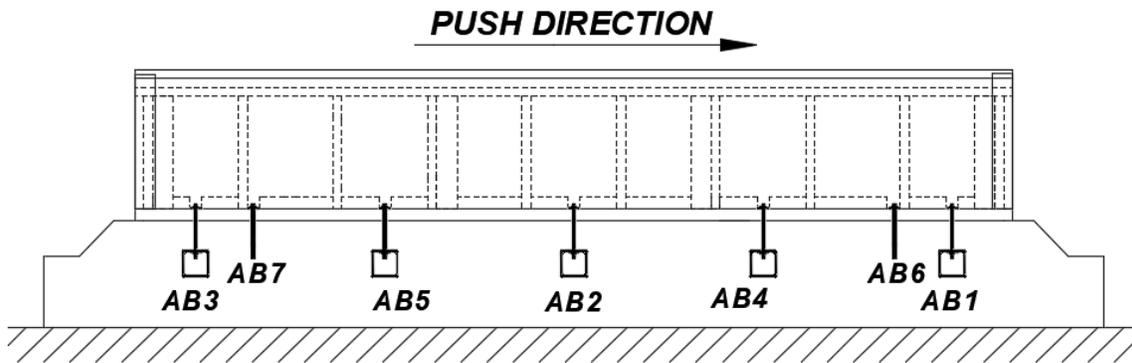
Figure 3.68 Specimen A-10 anchor bolt locations.

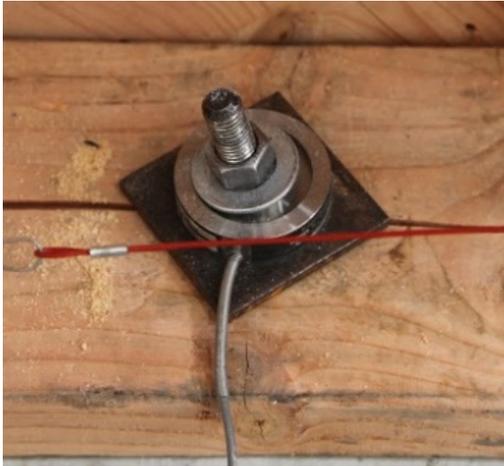
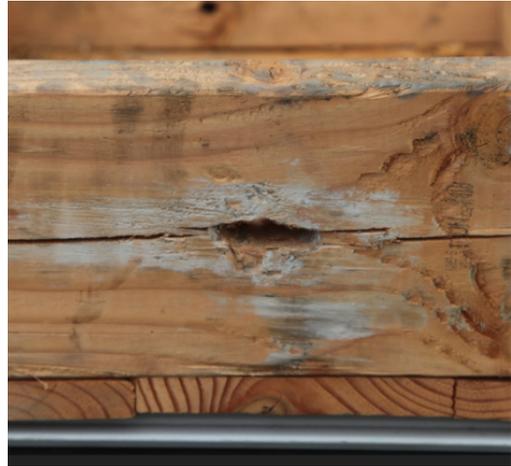
Figure 3.69 Specimen A-9 fractured anchor bolt (left) and damage to the sill plate post-testing (right).

Figures 3.69 and 3.70 show images of the anchor bolt failures for both specimens. During testing of many cripple walls, cross-grain cracks developed in the sill plates. In the case of Specimen A-28, cross-grain cracks propagated across the entire span of the sill plate. This specimen also had a horizontal siding over diagonal sheathing exterior finish, but the applied vertical load was a third of the other cripple walls with this finish (150 plf versus 450 plf). The reduction in vertical load reduced the uplift resistance on the wall. Combined with the diagonal sheathing uplifting during testing, large stresses were developed in the sill plate. Since the sheathing material was only nailed to the exterior of the cripple wall, the sill was subjected to cross-grain bending, and resulted in a full span crack of the sill through all anchor bolt slots. Because there was no resistance from the sill plate, the cripple wall strength dramatically decreased even though there was not significant damage to the finish materials or framing. Photographs of the damage to the sill plate are provided in Figure 3.71. All anchor bolt load versus global drift hysteresis can be found in Appendix C.1.

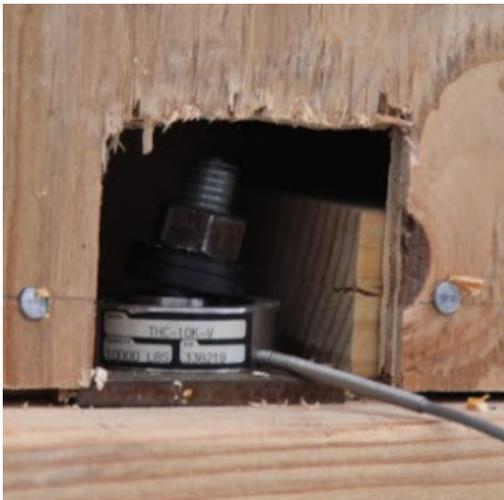
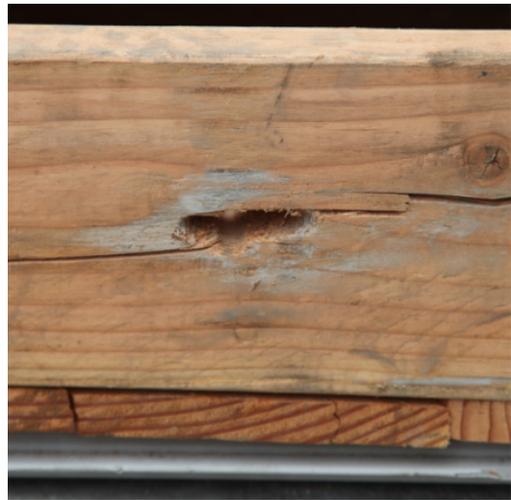
Figure 3.70 Specimen A-10 fractured anchor bolt (left) and damage to the sill plate post-testing (right).

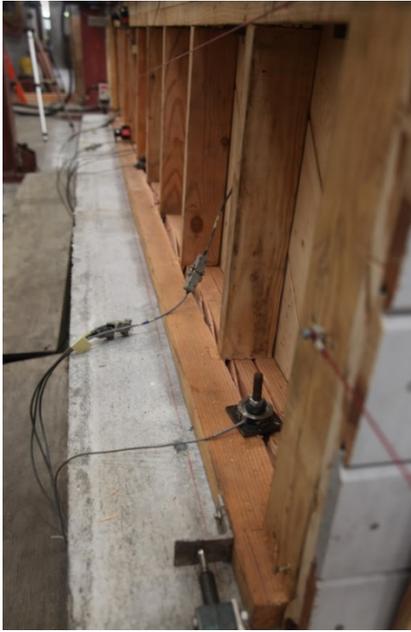
Figure 3.71 Specimen A-28 cross-grain sill plate split.

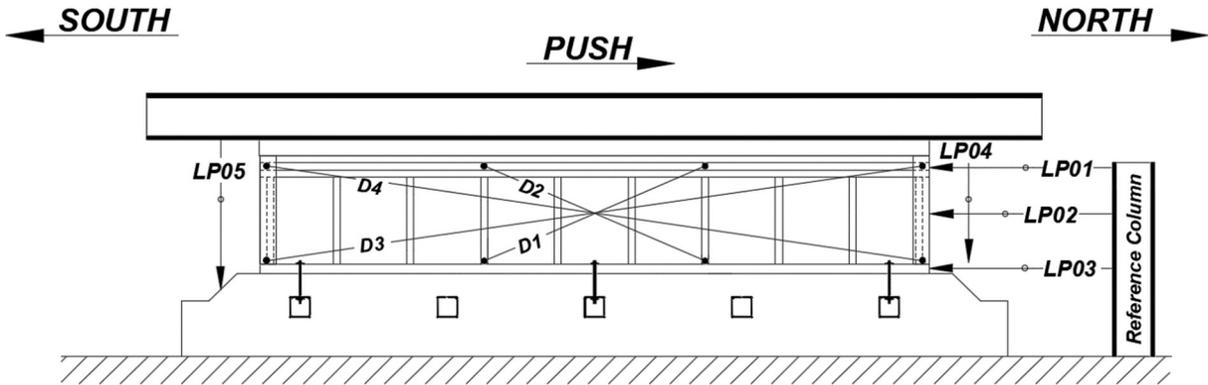
Figure 3.72 Diagonal, end uplift, and lateral displacement potentiometer schematic.

Two sets of potentiometers were used to take measurements of the displacement across the diagonals of the cripple wall. One pair of potentiometers measured the distortion across the entire cripple wall, while the other pair measured the distortion of the middle third of the cripple wall. The purpose of these measurements was to determine the amount of shear distortion within the cripple wall. These measurements were used to determine whether the applied lateral displacement could be resolved using the diagonal and end uplift measurements. Figure 3.72 shows the linear potentiometers used to calculate the resolved lateral displacement of the cripple wall. Figure 3.73 shows the how the resolved lateral displacements from diagonal and uplift measurements were derived.

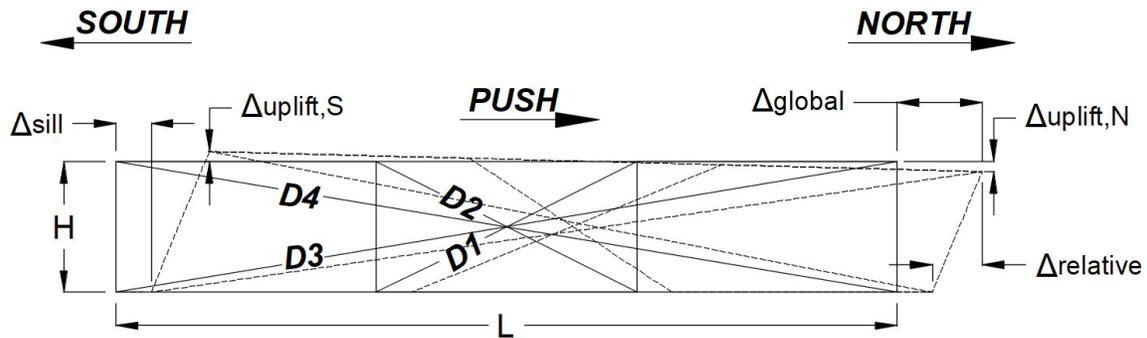
Figure 3.73 Deformed cripple wall with measurements used for resolving lateral displacement from diagonal and uplift measurements.
