Cripple Wall Small-Component Test Program: Dry Specimens

**A Report for the “Quantifying the Performance of
Retrofit of Cripple Walls and Sill Anchorage in Single-
Family Wood-Frame Buildings” Project**

PEER Report 2020/17

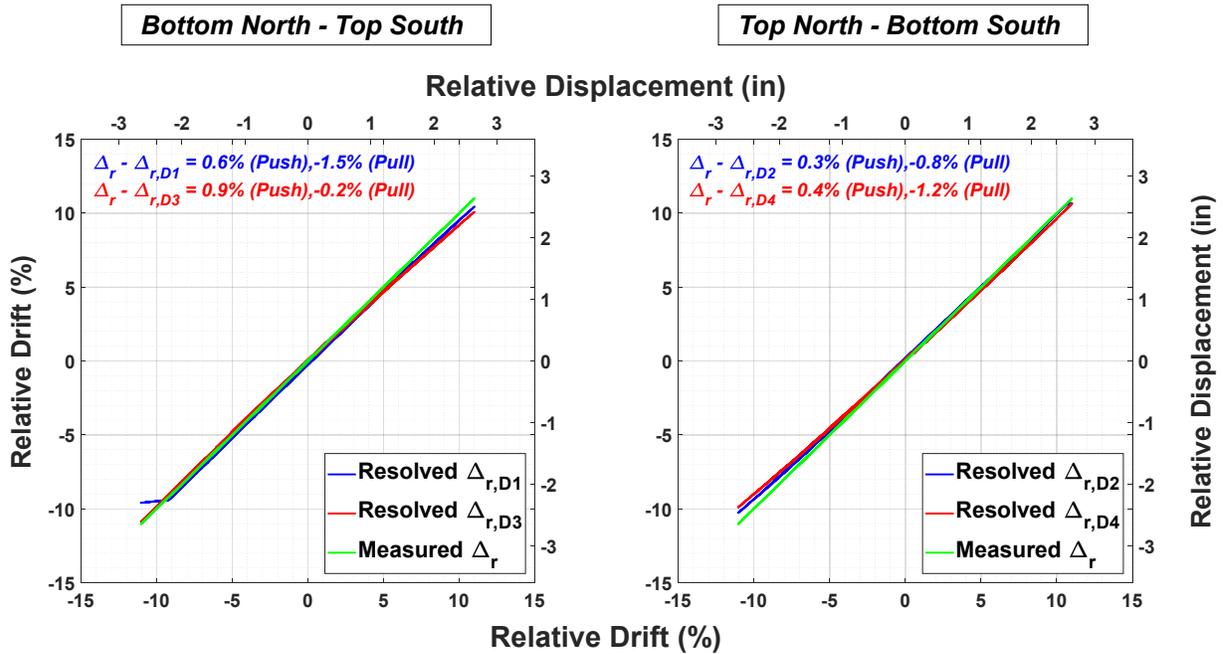
Figure 3.74 Specimen A-13: resolved relative drift from diagonal measurements in one direction versus measured relative drift for the existing 6-ft-tall cripple wall with horizontal siding.

Figures 3.74 through 3.77 show the relative drift versus the relative drift resolved from the diagonal and uplift measurements for Specimen A-13 and A-14. Figures 3.74 and 3.76 overlay the resolved lateral drifts from the inside diagonals on the left and the resolved lateral drifts from the outside diagonals on the right for Specimen A-13 and A-14, respectively. Figures 3.75 and 3.77, overlay the resolved lateral drifts from the diagonals running from the bottom north end of the wall to the top south end of the wall on the left, and the resolved lateral drifts running from the top north end of the wall to the bottom south end of the wall on the left for Specimen A-13 and A-14, respectively. All these figures include a green line, indicating the measured relative drift plotted against itself, as a reference. These cripple walls were chosen because they only differ in their retrofit condition. Specimen A-13, the unretrofitted cripple wall, had resolved relative drift values within 1.5% drift of the measured relative drift. The difference tended to be less than that for most of the test, only diverging at later drift amplitudes. On average between push and pull loading, the relative drift resolved from the inside diagonals differed by 0.8% relative drift and the relative drift resolved from the outside diagonals differed by 0.7% relative drift. These values increased for the differences between the measured relative drift and resolved relative measurements from the inside diagonals for the retrofitted cripple wall with an average difference of 5.0%, while the difference

for the measured relative drift and resolved relative drift of the outside diagonals was 2.1% relative drift. This shows that the addition of the plywood panels for the retrofit reduced the shear distortion through the interior of the cripple wall where the panels are attached. Overall, the pattern was the same for all existing and retrofitted cripple walls. All of the resolved relative drift figures can be found in Appendix C.2.

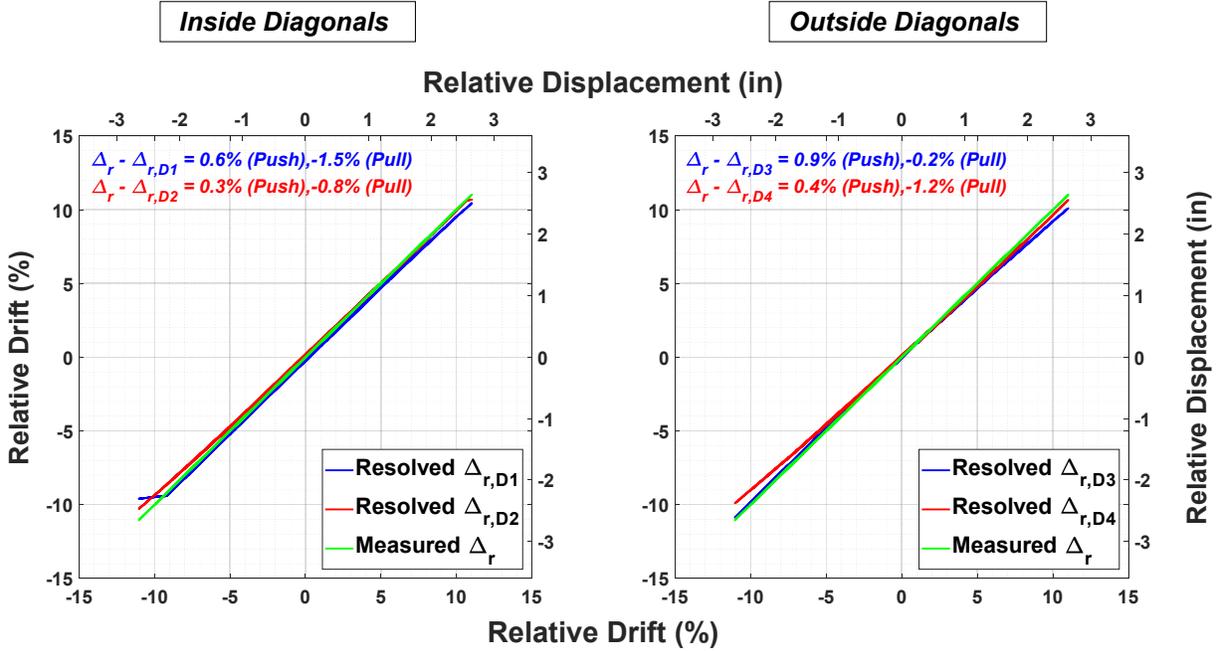
Figure 3.75 Specimen A-13: resolved relative drift from diagonal measurements (outside and inside diagonals) versus measured relative drift for the existing 6-ft-tall cripple wall with horizontal siding.

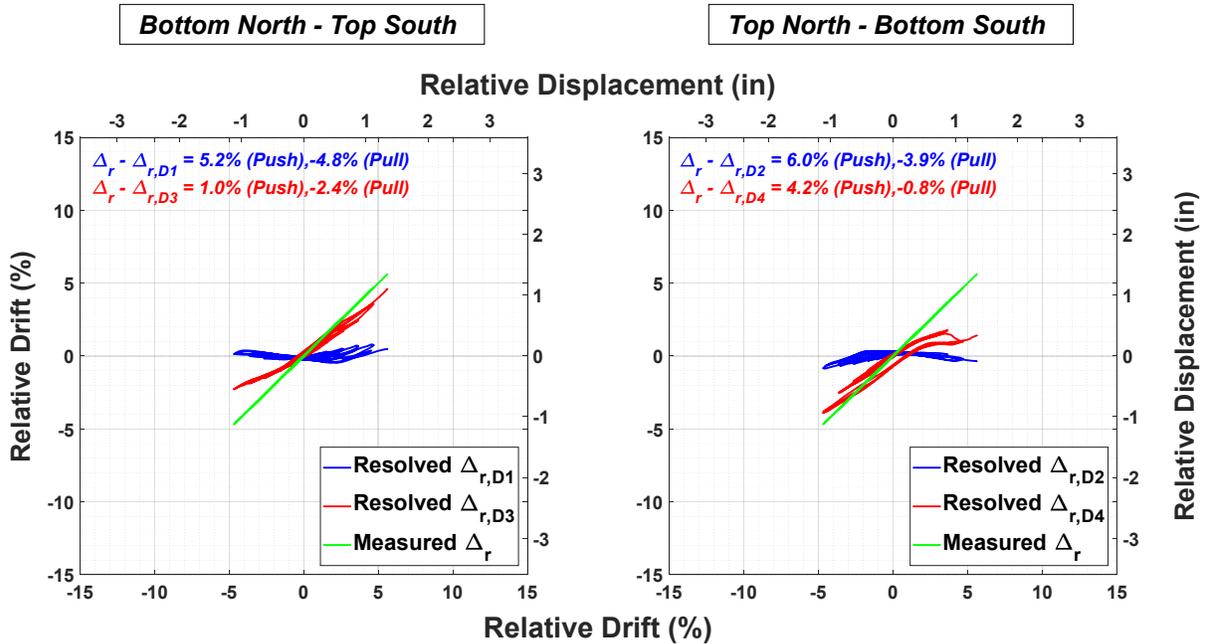
Figure 3.76 Specimen A-14: resolved relative drift from diagonal measurements in one direction versus measured relative drift for retrofitted 6-ft-tall cripple wall with horizontal siding.

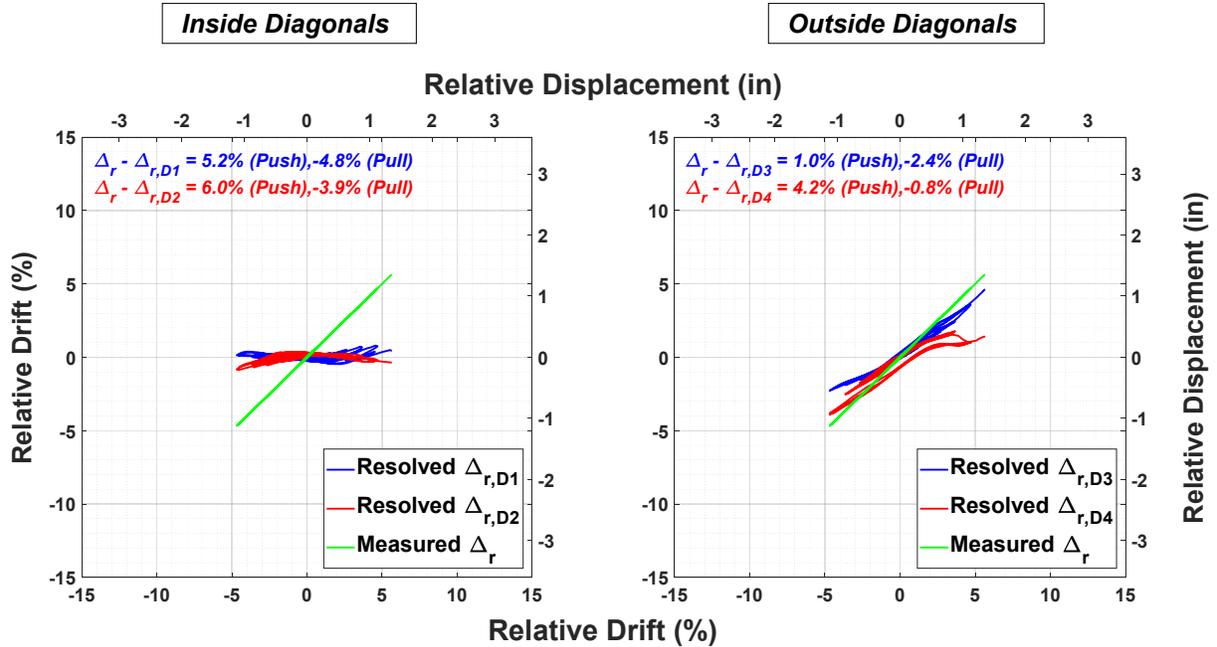
Figure 3.77 Specimen A-14 resolved relative drift from diagonal measurements (outside and inside diagonals) versus measured relative drift for the retrofitted 6-ft-tall cripple wall with horizontal siding.

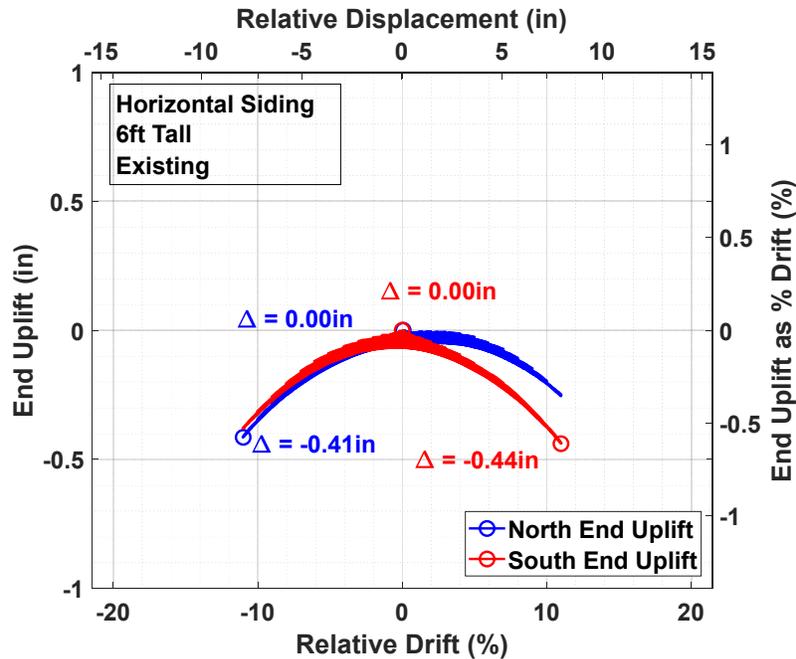
Figure 3.78 Specimen A-13 end uplift versus relative drift for the existing 6-ft-tall cripple wall with horizontal siding.

Figures 3.78 and 3.79 show the end uplift versus relative drift response for the existing and retrofitted 6-ft-tall specimens with horizontal siding finishes, respectively. At each drift ratio level, the existing specimen's height was reduced due to the deformation of the wall and insufficient forces to overcome the uplift resistance. With the added retrofit, deformation still occurred, but the increased strength of the cripple wall caused uplift to occur as it is greater than the uplift resistance provided by the vertical load and weight of the specimen. The addition of the retrofit increased the end of wall uplift for all specimens. For the existing cripple walls with horizontal siding over diagonal sheathing, there was a drastic difference in the uplift at the south end versus the north end of the walls, which is attributed to the orientation of the diagonal sheathing boards. When loaded in the pull direction, the sheathing board moved both laterally and vertically upward, whereas the sheathing boards moved laterally and vertically downward in the opposite direction of loading. This caused the uplift to be strongly governed by the direction of loading. The largest end uplifts were measured for the horizontal siding over diagonal sheathing finished cripple wall with a light

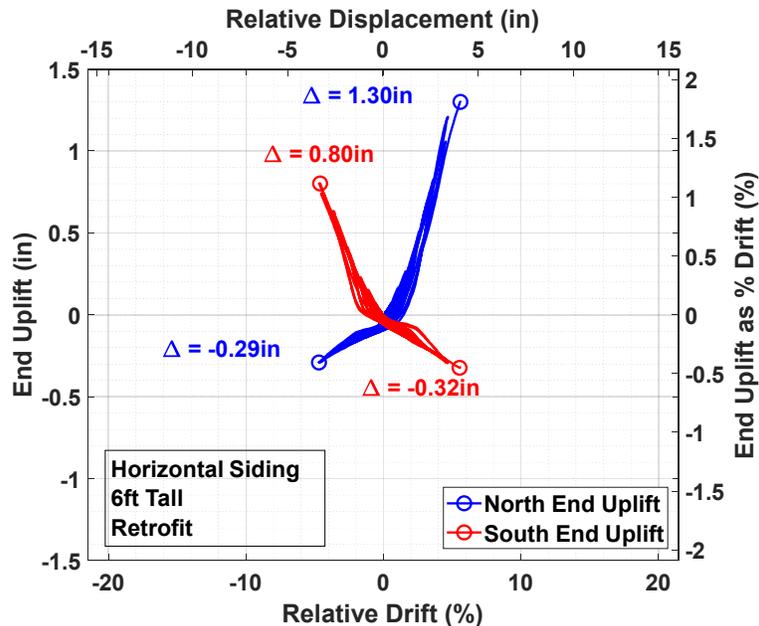
Figure 3.79 Specimen A-14 end uplift versus *relative drift* for the retrofitted 6-ft-tall cripple wall with horizontal siding.

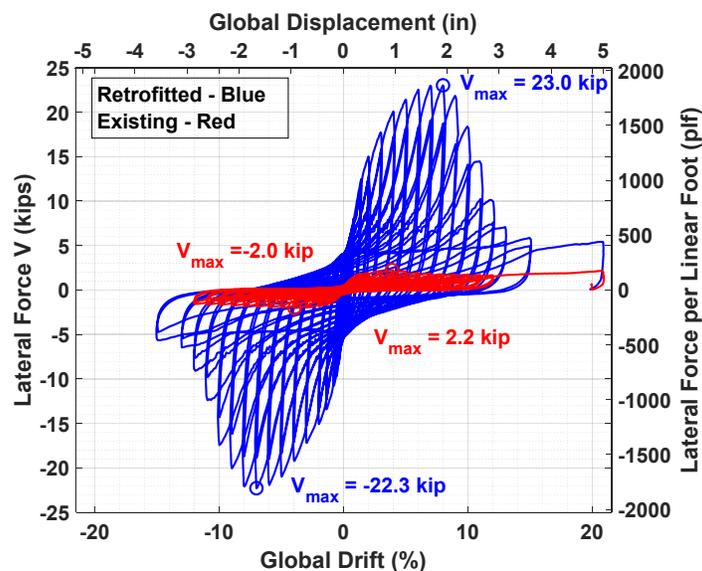
Figure 3.80 Specimens A-7 and A-8: comparison of *global* drift versus lateral load hysteretic response for retrofitted and existing 2-ft-tall cripple walls with horizontal siding.

Overall, the retrofit dramatically increased the lateral strength of the cripple wall, and in some cases, it also increased the drift capacity of the cripple wall. Recall that cripple wall retrofit pairs are identical to each other besides the addition of the retrofit. Figures 3.80 through 3.89 show overlays of the global and relative lateral displacement versus lateral load hysteretic response for specimen pairs. Figure 3.90 shows the lateral strength per linear foot of the five retrofitted cripple walls. Figure 3.91 shows the relative drift (total drift minus the displacement between the sill plate and foundation) at strength for the five retrofitted cripple walls. Lastly, Figure 3.92 shows the percent increase in strength of the retrofitted specimens compared to their existing counterpart. Note that all boundary conditions and vertical load were the same for the specimens.

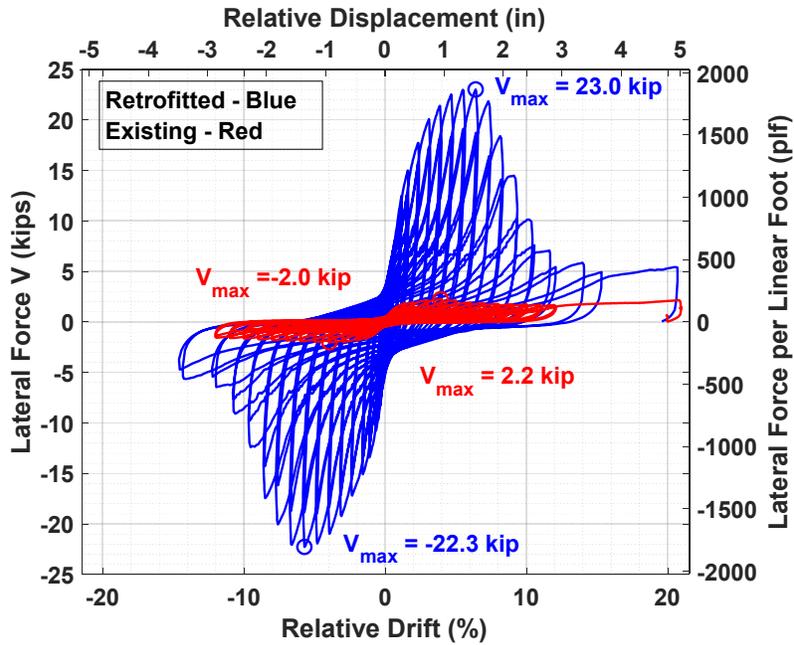
Figure 3.81 Specimens A-7 and A-8: comparison of *relative* drift versus lateral load hysteretic response for retrofitted and existing 2-ft-tall cripple walls with horizontal siding.

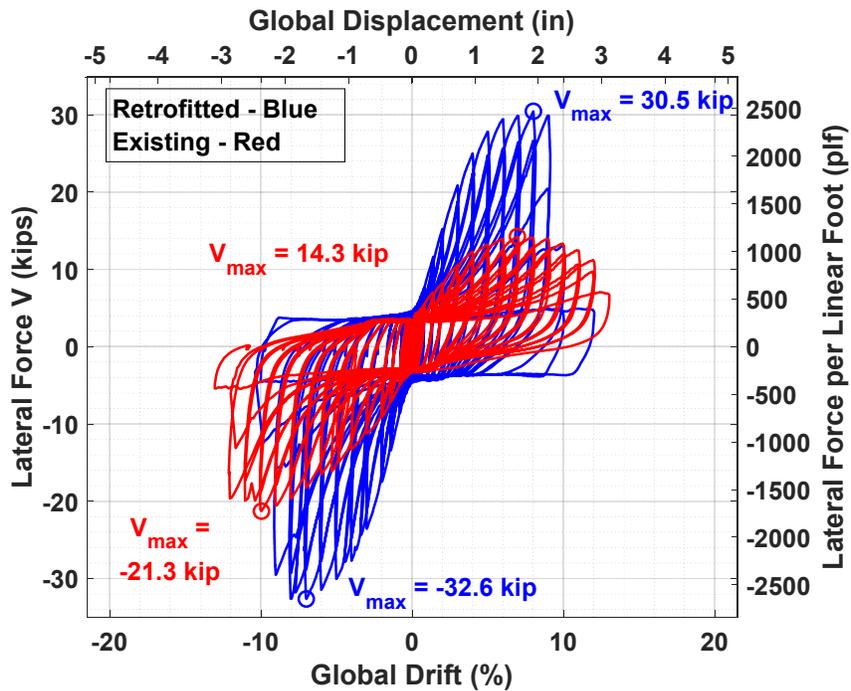
Figure 3.82 Specimens A-9 and A-10: comparison of *global* drift versus lateral load hysteretic response for retrofitted and existing, cripple walls with horizontal siding over diagonal sheathing.

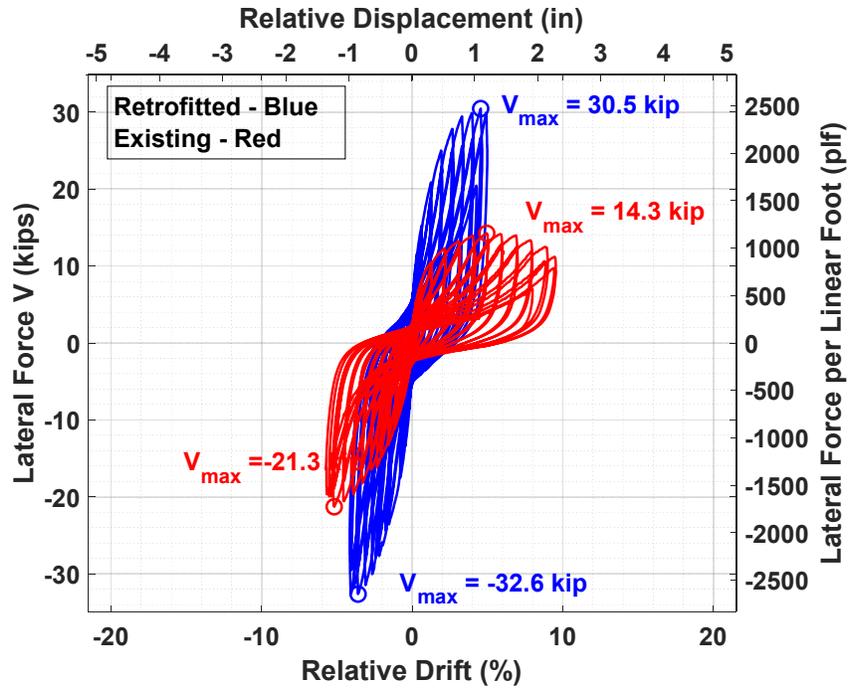
Figure 3.83 Specimens A-9 and A-10: comparison of *relative* drift versus lateral load hysteretic response for retrofitted and existing cripple walls with horizontal siding over diagonal sheathing

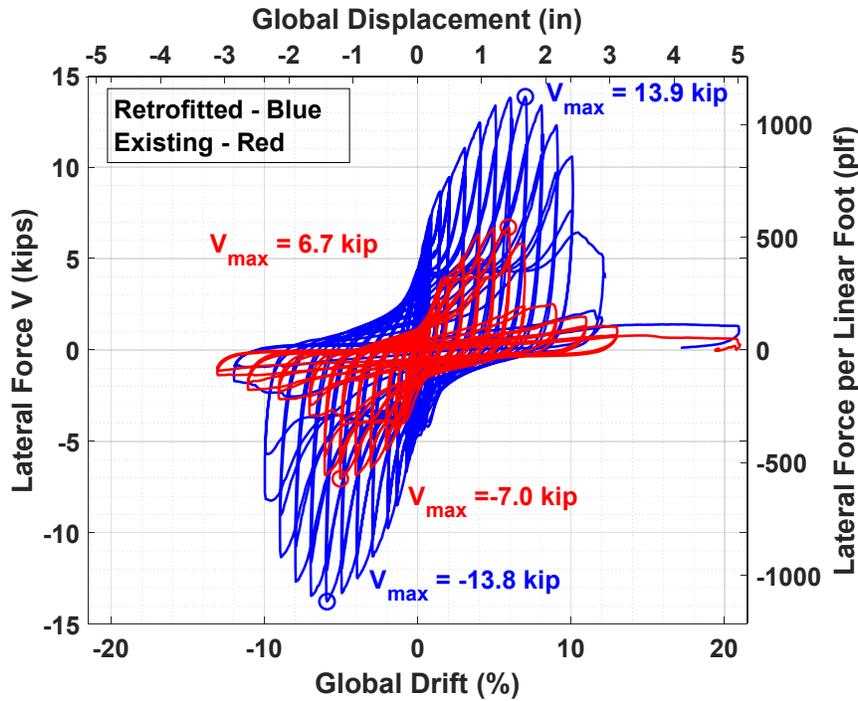
Figure 3.84 Specimens A-11 and A-12: comparison of *global* drift versus lateral load hysteretic response for retrofitted and existing cripple walls with T1-11 plywood.

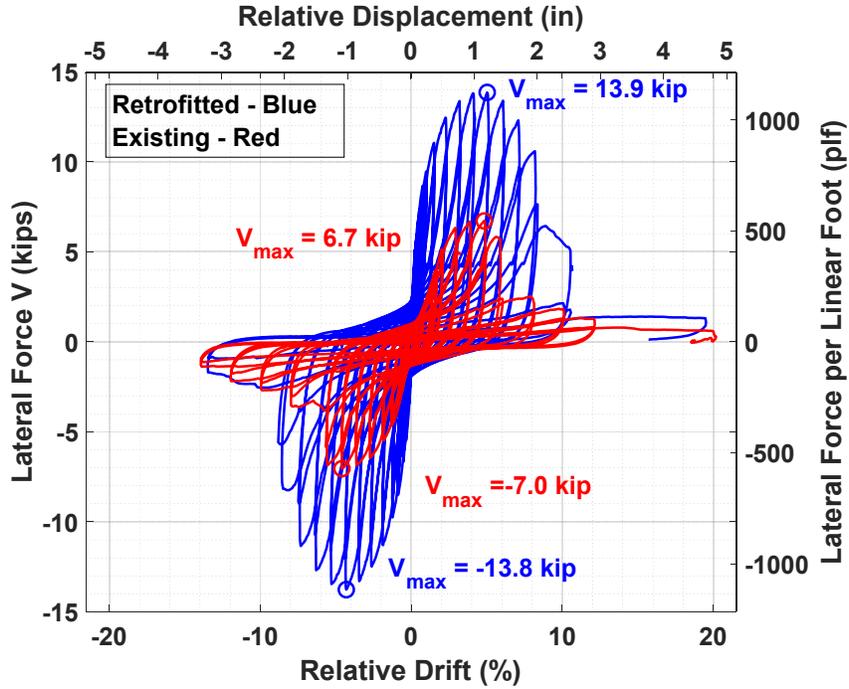
Figure 3.85 Specimens A-11 and A-12: comparison of *relative* drift versus lateral load hysteretic response for retrofitted and existing cripple walls with T1-11 plywood.

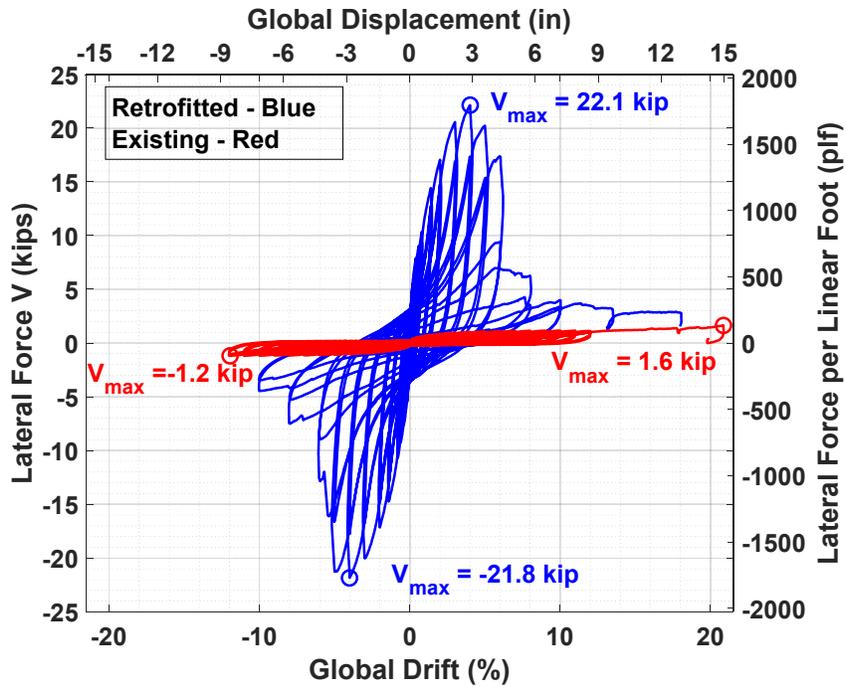
Figure 3.86 Specimens A-13 and A-14: comparison of *global* drift versus lateral load hysteretic response for retrofitted and existing 6-ft-tall cripple walls with horizontal siding.

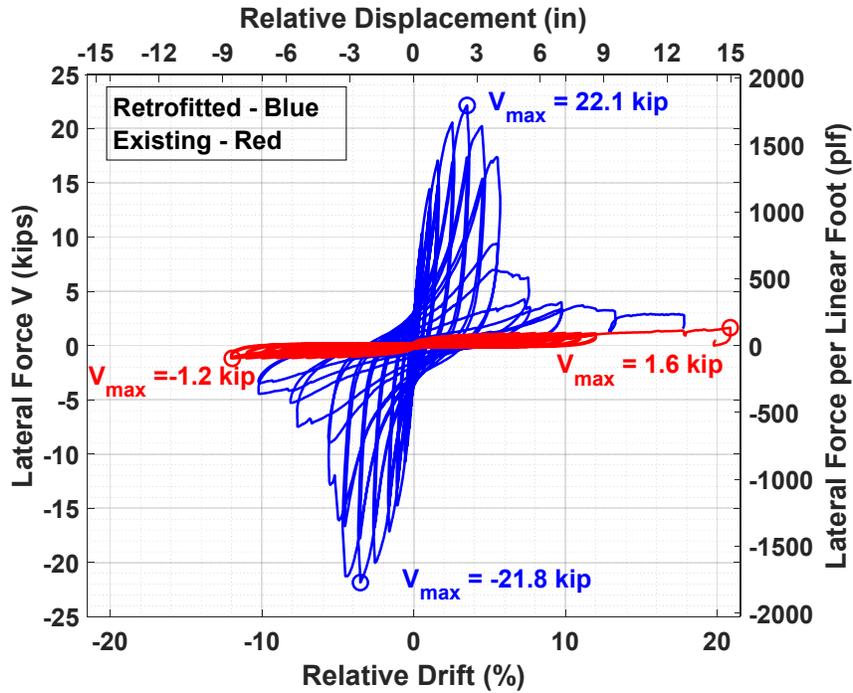
Figure 3.87 Specimens A-13 and A-14: comparison of *relative* drift versus lateral load hysteretic response for retrofitted and existing 6-ft-tall cripple walls with horizontal siding.

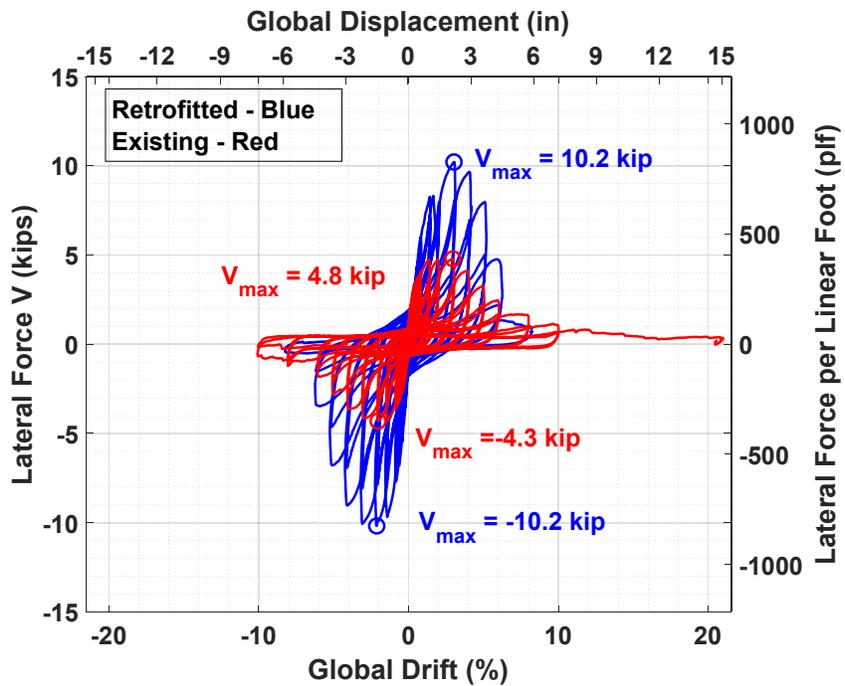
Figure 3.88 Specimens A-23 and A-24: comparison of *global* drift versus lateral load hysteretic response for retrofitted and existing 6-ft-tall cripple walls with T1-11 plywood.

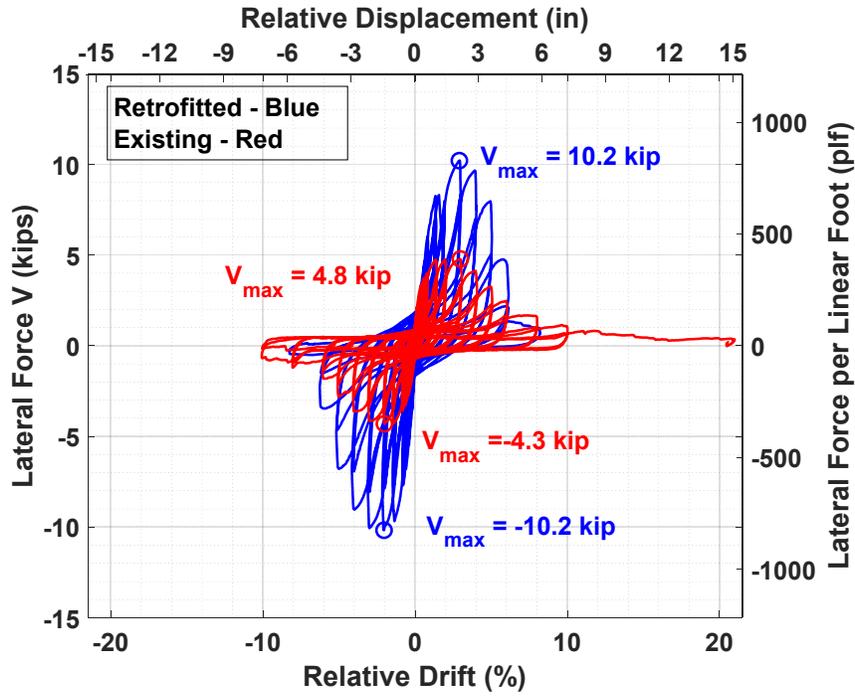
Figure 3.89 Specimens A-23 and A-24: comparison of *relative drift* versus lateral load hysteretic response for retrofitted and existing 6-ft-tall cripple walls with T1-11 plywood.

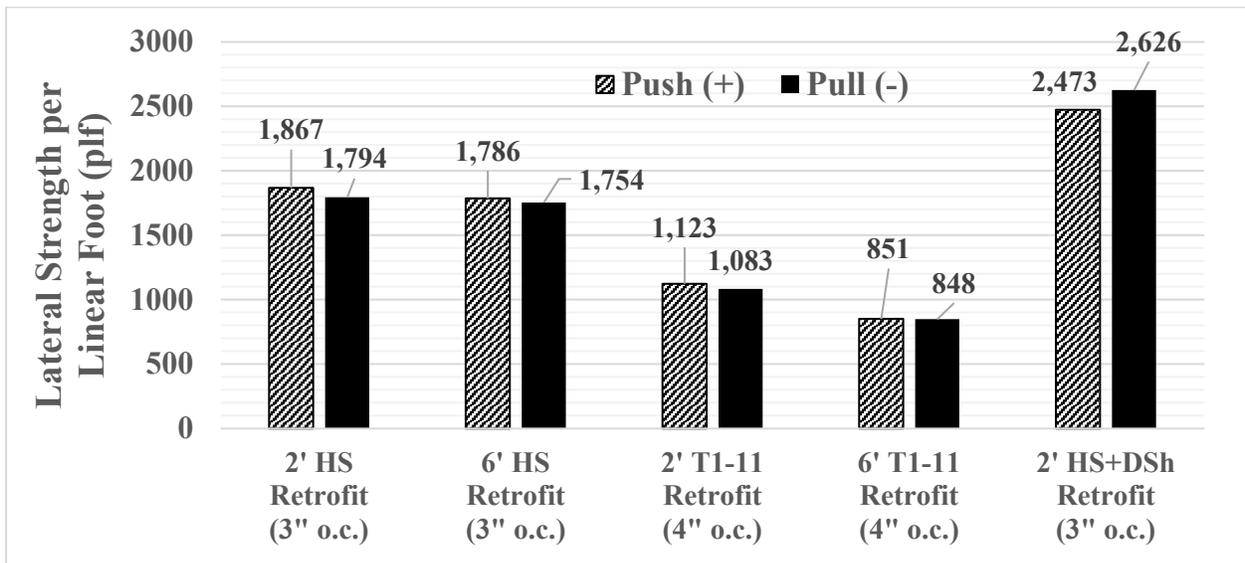
Figure 3.90 Lateral strength per linear foot for retrofitted specimens.

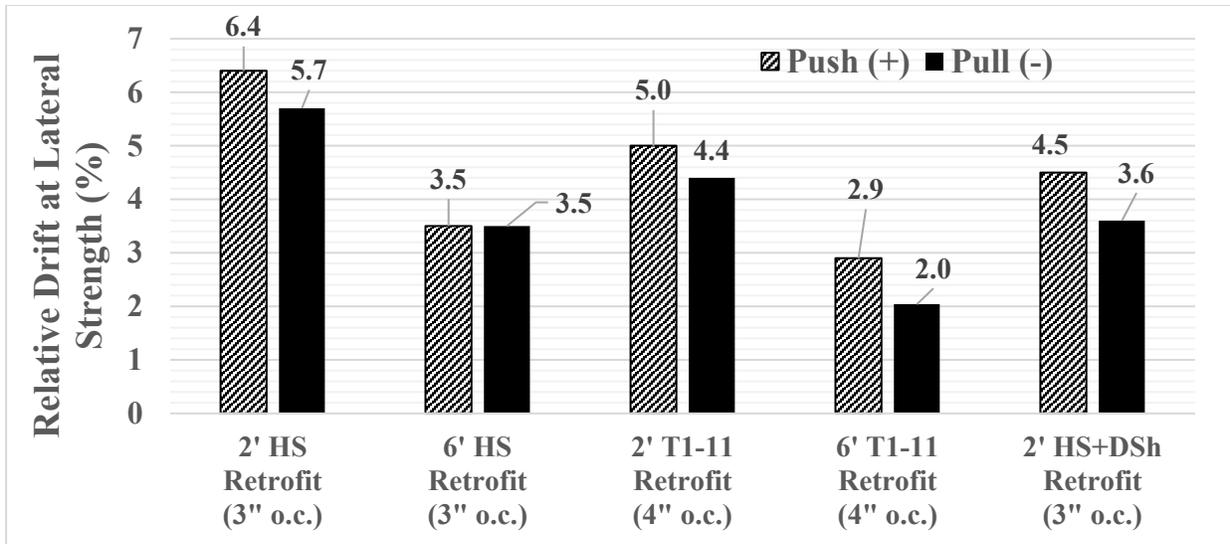
Figure 3.91 Relative drift at lateral strength for retrofitted specimens.

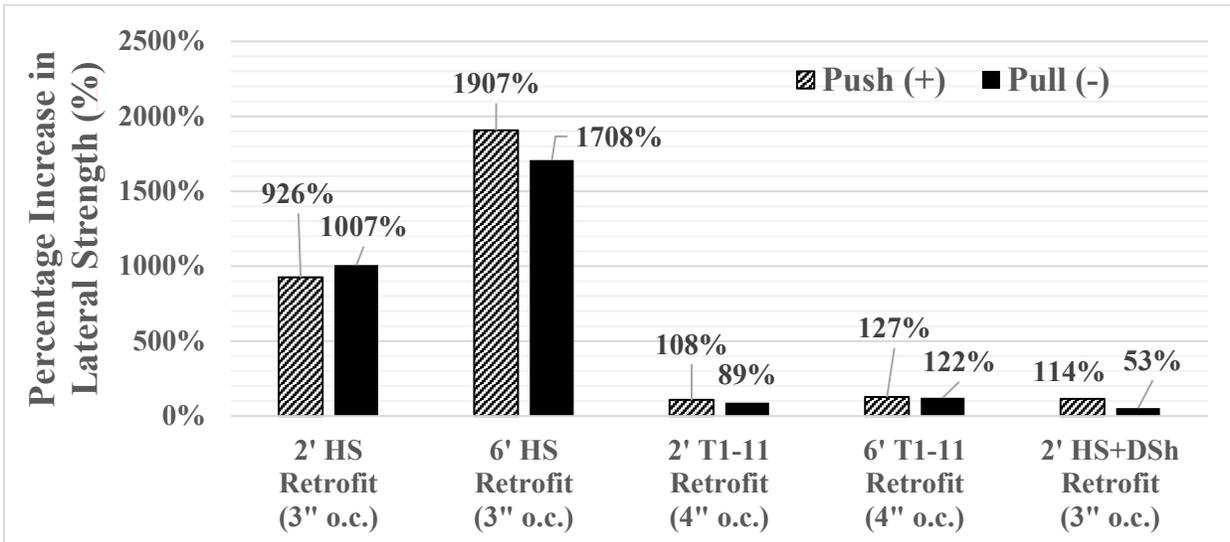
Figure 3.92 Contribution of retrofit to lateral strength for retrofitted specimens.

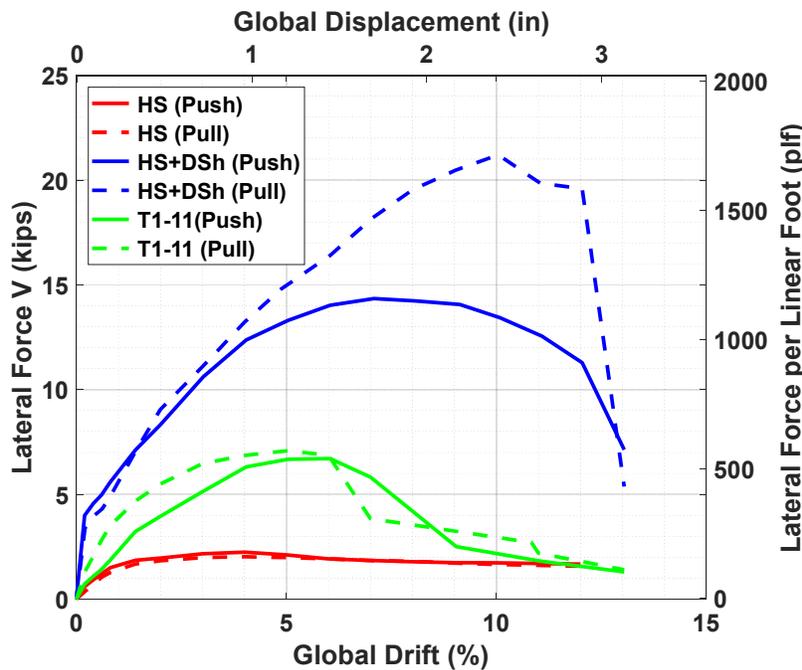
Figure 3.93 Comparison of existing Specimens A-8, A-10, and A-12 finish materials: envelopes of global drift versus lateral strength.

It is useful to compare the response of the cripple walls using overlays of the envelopes extracted from the lateral force–lateral displacement hysteresis. These curves are obtained by extracting the strength at each drift amplitude throughout the loading protocol. It is noted that only the leading cycles of each cycle group were considered in the development of these envelopes. Figures 3.93 through 3.99 show key comparisons of the cripple walls using the envelopes of each specimen’s hysteresis. Both the push and pull loading direction is displayed in the same quadrant for ease of comparison. Figure 3.93 compares existing 2-ft-tall cripple walls with the three dry exterior finishes. The response for the horizontal siding cripple wall was nearly symmetric in the push and pull directions of loading, which is not the case for the horizontal siding over diagonal sheathing.

The orientation of the diagonal sheathing boards largely affected the response of the wall. Initially, the response was nearly symmetric, but at larger displacements in the pull loading direction, the gaps between the sheathing boards closed and the boards began to bear on one another. Once this occurred, the cripple wall continued to gain strength in this loading direction while losing strength in the opposite loading direction. It is evident that the diagonal sheathing boards provided drastic increases in both capacity (734% average increase) and stiffness (132% average increase for secant stiffness associated with relative drift at 80% strength).

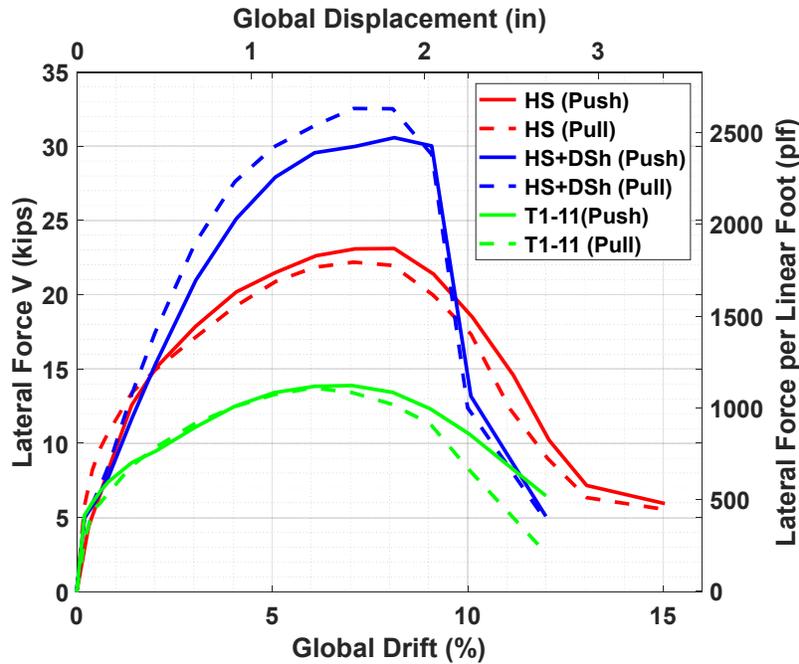
Figure 3.94 Comparison of retrofitted Specimens A-8, A-10, and A-12 finish materials: envelopes of *global* drift versus lateral strength.

In Figure 3.94, the same comparison is shown for the retrofitted counterparts. With the added retrofit, the differences in strength and stiffness were much less pronounced between the horizontal siding and horizontal siding over diagonal sheathing finished cripple walls. This horizontal siding specimen achieved higher strength than the T1-11 wood structural panel cripple wall, which is largely due to the increased number of nails attaching the plywood to the horizontal siding finished wall versus the T1-11 finished wall (3 in. o.c. and 4 in. o.c.). The added retrofit produced a much more symmetric response for the horizontal siding over diagonal sheathing cripple wall, but if the tests had not been terminated by the anchor bolts fracturing, the sheathing boards bearing on each other likely would have produced an asymmetric response at larger displacements.

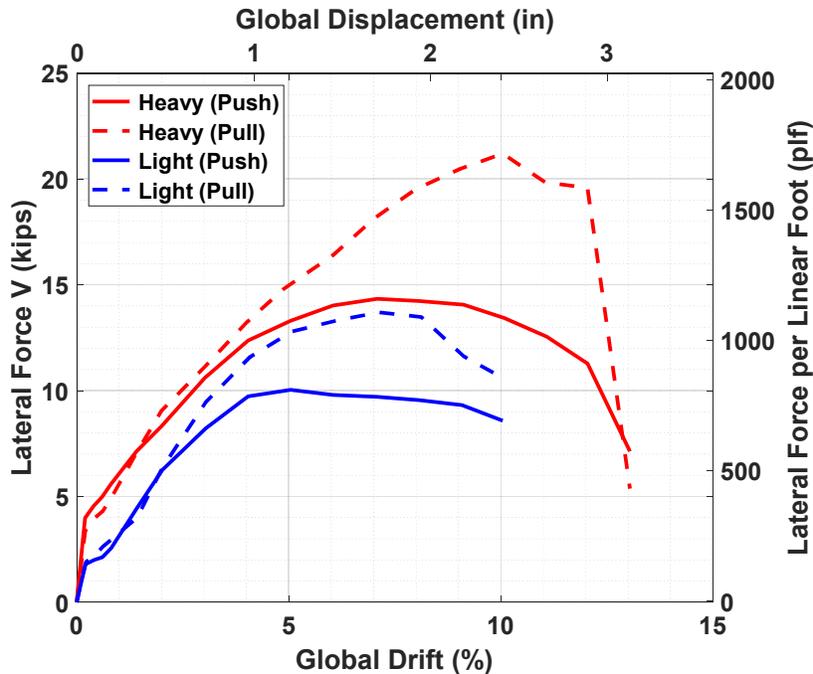
Figure 3.95 Specimen A-9 and A-28 comparison of envelopes of global drift versus lateral strength: varying vertical load.

Figure 3.95 compares the envelopes for the existing cripple walls with horizontal siding over diagonal sheathing finishes. These were the only pair of specimens to have a difference in applied vertical load. Recall that the low vertical load is 150 plf and representative of the gravity load of a single-story dwelling with light construction materials, while the heavy vertical load is 450 plf and mimics the weight of a two-story dwelling with heavy construction materials. The increase in strength regardless of loading directions was similar. Increase of vertical load produced a 47% increase in strength in the push loading direction and 53% increase in the pull loading direction. The secant stiffness associated with relative drift at 80% strength was nearly identical for both specimens, showing that the increased vertical load had little influence on the stiffness of the cripple walls.

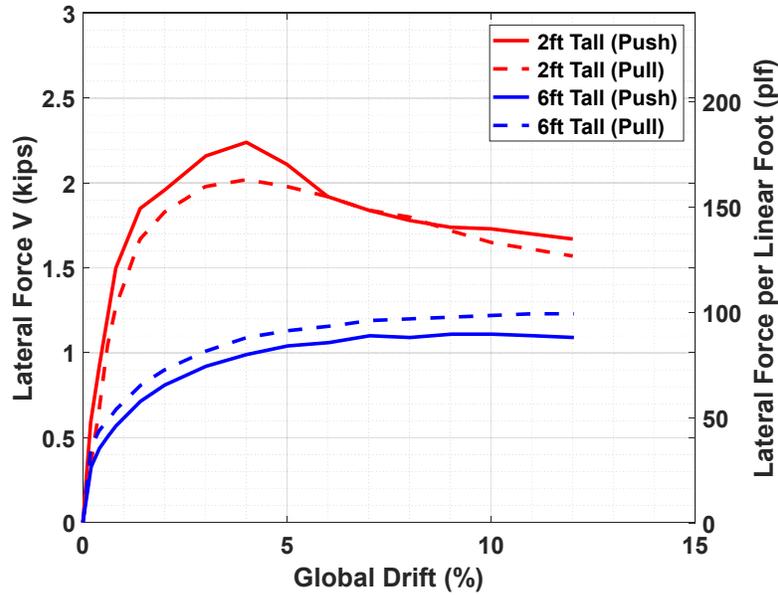
Figure 3.96 Specimen A-7 and A-13 comparison of envelopes of *global drift* versus lateral strength: response for the existing 2-ft-tall and 6-ft-tall cripple walls with horizontal siding.

Comparisons of the envelopes of global drift versus lateral strength for 2-ft-tall and 6-ft-tall cripple walls are given in Figures 3.96 to 3.99. Figure 3.96 shows the existing cripple walls finished with horizontal siding. The strength was twice as much for the 2-ft-tall specimen compared to the 6-ft-tall specimen. The 6-ft-tall cripple wall continued to gain strength throughout the entire test, whereas the 2-ft-tall specimen peaked a 4% drift. There was only a 25% drop in capacity for the 2-ft-tall specimen from 4% to 12% drift. The response of both specimens demonstrates how flexible and weak cripple walls are when finished with horizontal siding. Since the orientation of the sheathing is aligned with the direction of loading, the lateral resistance is primarily achieved through the moment couple between the nails fastening the boards to the studs. The secant stiffness associated with relative drift at 80% strength was 22 times higher for the 2-ft-tall cripple wall than the 6-ft-tall cripple wall. With the added retrofit, the strength for the horizontal siding finished cripple walls was much more similar, as shown in Figure 3.97. The drift at peak for the 2-ft-tall specimen occurred at 8% whereas it was achieved at 4% for the 6-ft-tall specimen. This is largely due to the anchor of the specimens. The 6-ft-tall wall was constructed with two additional anchor bolts as well as tie-downs at both ends, which reduced the amount of relative displacement between the sill plate and the foundation. The secant stiffness associated with relative drift at 80% strength was 94% higher for the 2-ft-tall cripple wall than the 6-ft-tall cripple wall. Because taller walls are expected to be more flexible than shorter walls, it is important to note that the addition of the retrofit drastically reduced gap between the secant stiffnesses of the 2-ft-tall and 6-ft-tall cripple walls. In addition, the relative drift at strength was higher for the 2-ft-tall specimen than the 6-ft-tall specimen due to the added retrofit.

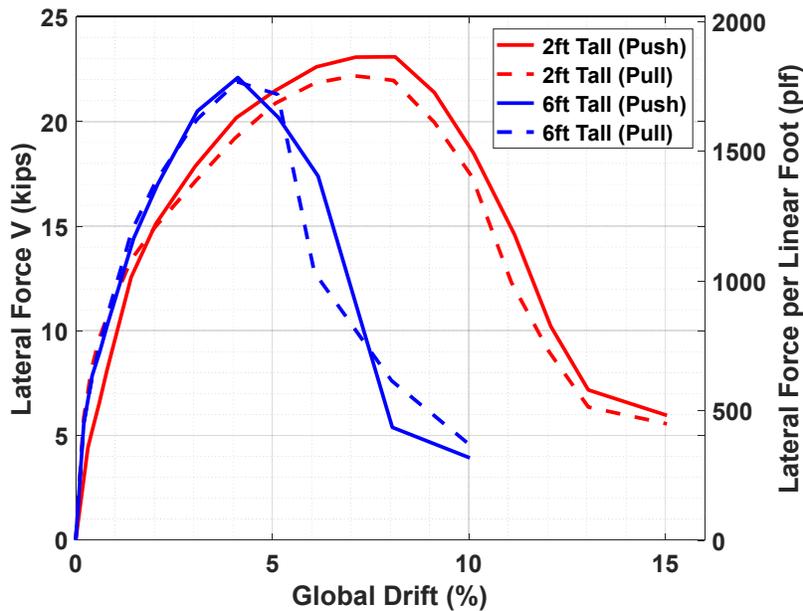
Figure 3.97 Specimen A-8 and A-14 comparison of envelopes of *global drift* versus lateral strength: response for the retrofitted 2-ft-tall and 6-ft-tall horizontal siding finished cripple walls.

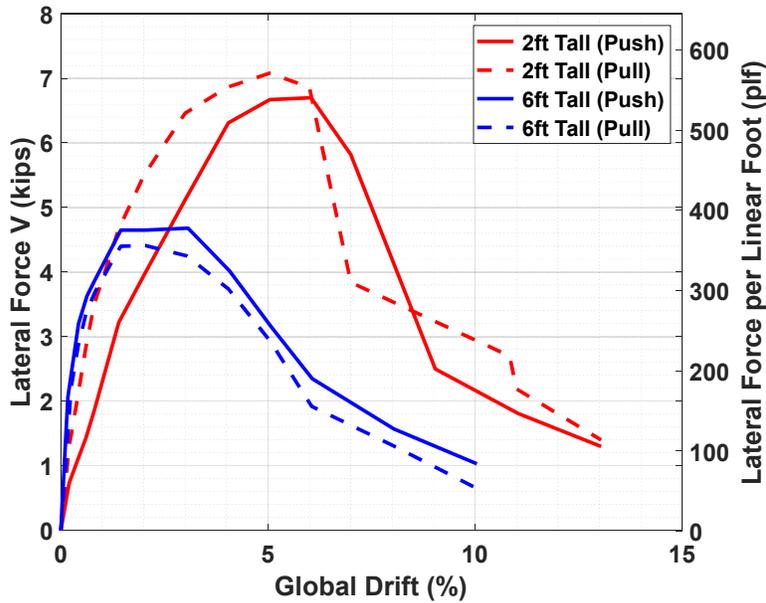
Figure 3.98 Specimen A-11 and A-23 comparison of envelopes of *global* drift versus lateral strength: response for the existing 2-ft- and 6-ft-tall cripple walls finished with T1-11 wood structural panels.

Figure 3.98 shows the envelopes of global drift versus lateral strength hysteretic response for the existing 2-ft- and 6-ft-tall T1-11 wood structural panel finished cripple walls; Figure 3.99 shows the same for the retrofitted specimens. The relative responses regardless of the retrofit condition are strikingly similar. The main difference between the existing and retrofit specimen is

the decrease of nail spacing from 8 in. on center to 4 in. on center. By doubling the amount of edge, the strength is around doubled for both cripple walls, regardless of height. The increase in height reduced the strength by 32% for the existing specimens and 23% for retrofit specimens. The response was more symmetric for the retrofitted specimens due to the row of nails added to the panel overlaps, which was present for the existing specimens.

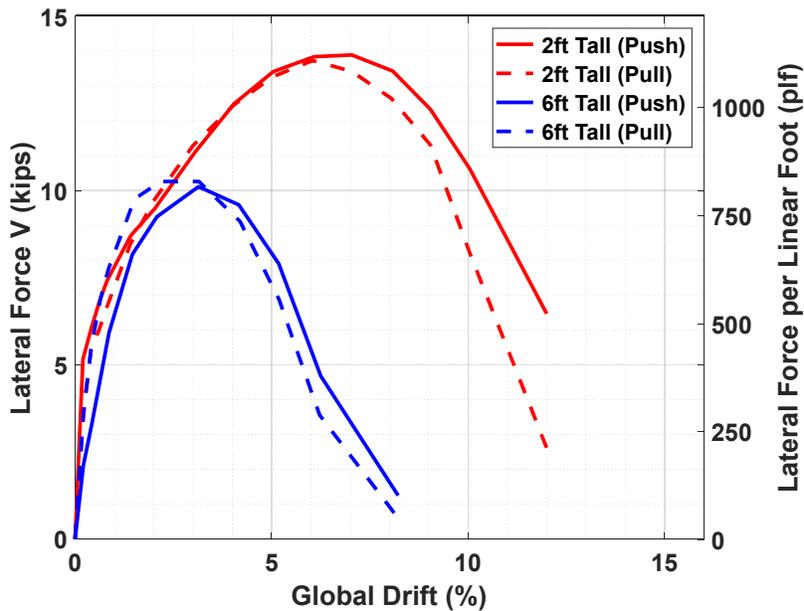
Figure 3.99 Specimen A-12 and A-24 comparison of envelopes of *global* drift versus lateral strength: response for the retrofitted 2-ft- and 6-ft-tall cripple walls finished with T1-11 wood structural panels.

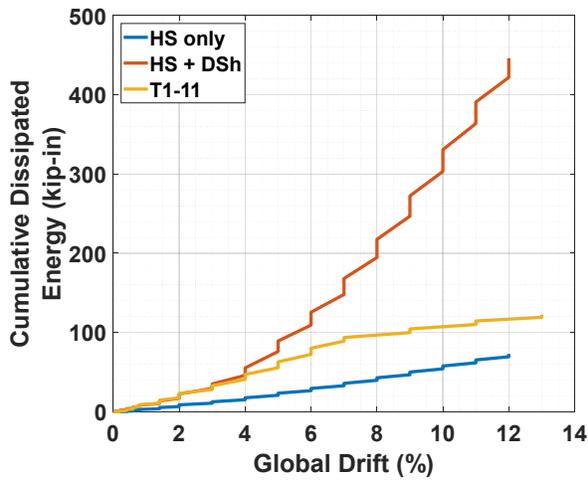
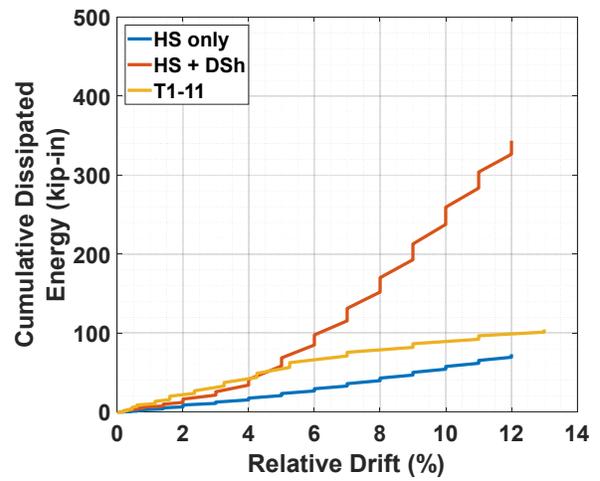
Figure 3.100 The existing 2-ft-tall cripple wall hysteretic energy dissipation comparison: (a) *global* response; (b) *relative* response.

Figure 3.100 compares the cumulative energy dissipated for existing, 2-ft-tall cripple walls tested. The three walls varied in their exterior finishes: shiplap horizontal lumber siding, shiplap horizontal lumber siding over diagonal lumber sheathing, and T1-11 wood structural panels. The cripple wall with horizontal siding over diagonal sheathing dissipated almost 250% more energy than the T1-11 cripple wall and over 500% more energy than the horizontal siding cripple wall. Considering the relative drift response, the horizontal siding over diagonal sheathing cripple wall dissipated over 230% more energy than the T1-11 cripple wall and almost 350% more energy than the horizontal siding cripple wall. It should be noted that the horizontal siding over diagonal sheathing cripple wall failed due to fracturing of all the anchor bolts; therefore, the amount of energy dissipated would have been expected to continue to increase in later displacement cycles.

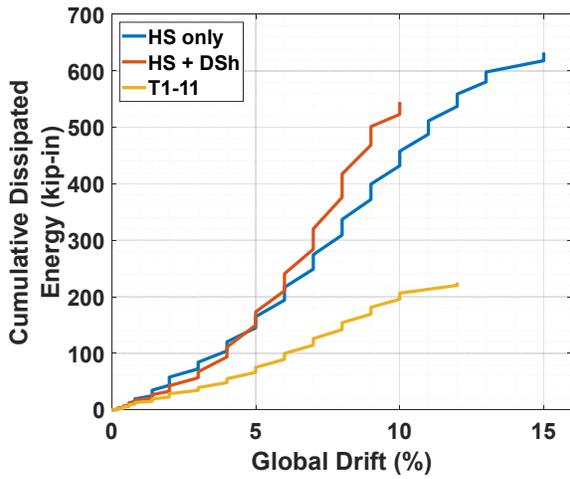
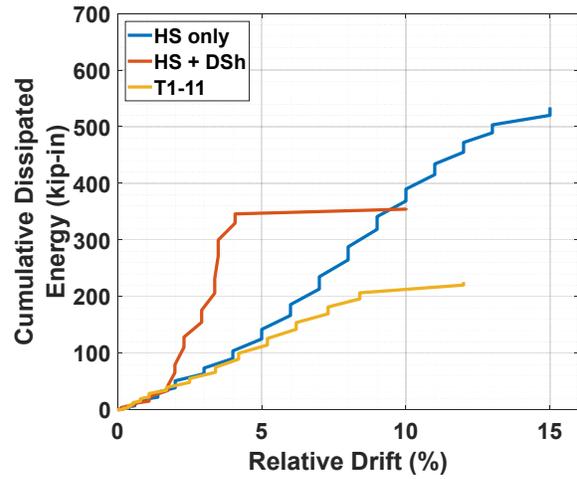
Figure 3.101 The retrofitted 2-ft-tall cripple wall hysteretic energy dissipation comparison: (a) *global* response; and (b) *relative* response.

Figure 3.101 compared the retrofitted, 2-ft-tall cripple walls with the same exterior finishes discussed in the previous figure. By the end of the test, the horizontal siding cripple wall dissipated the most energy, but the horizontal siding over diagonal sheathing cripple wall had dissipated over 250% more energy than either of the other cripple walls by 4% relative drift. The horizontal siding over diagonal sheathing had the largest displacement of the sill plate relative to the foundation of any of the retrofitted 2-ft-tall cripple walls. If considering the global response by 10% global drift, the horizontal siding over diagonal sheathing cripple wall had dissipated around 20% more energy than the horizontal siding cripple wall and 170% more energy than the T1-11 cripple wall. Like the existing cripple wall, the retrofitted horizontal siding over diagonal sheathing cripple wall failed due to fracturing of the anchor bolts; therefore, it is expected that the energy dissipation would have significantly increased if the anchor bolts had stayed intact.

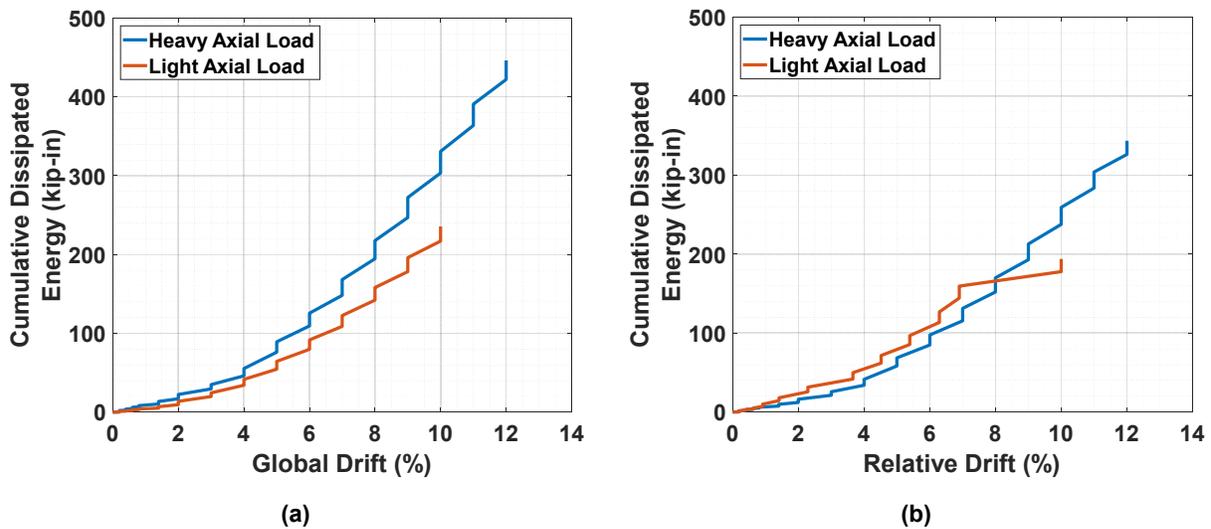
Figure 3.102 Horizontal siding over diagonal sheathing vertical load hysteretic energy dissipation comparison: (a) global response; and (b) relative response.

Figure 3.102 compares the energy dissipated by the existing 2-ft-tall cripple walls with horizontal siding over diagonal sheathing. The two cripple walls differed in the vertical load applied on the wall. The heavy vertical load was 450 plf, and the light vertical load was 150 plf. From the global response, the heavy vertical load wall dissipated around 35% more energy by 10% drift. The light vertical wall was trending to dissipate more energy than the light vertical load cripple wall through a comparison of the relative drift response. Because the light vertical load cripple wall failed prematurely due to the sill plate splitting across its entire span, it is difficult to tell how much energy both cripple walls would have dissipated had it not been for failures of the sill plate or the anchor bolts.
