Cripple Wall Small-Component Test Program: Dry Specimens

**A Report for the “Quantifying the Performance of
Retrofit of Cripple Walls and Sill Anchorage in Single-
Family Wood-Frame Buildings” Project**

PEER Report 2020/17

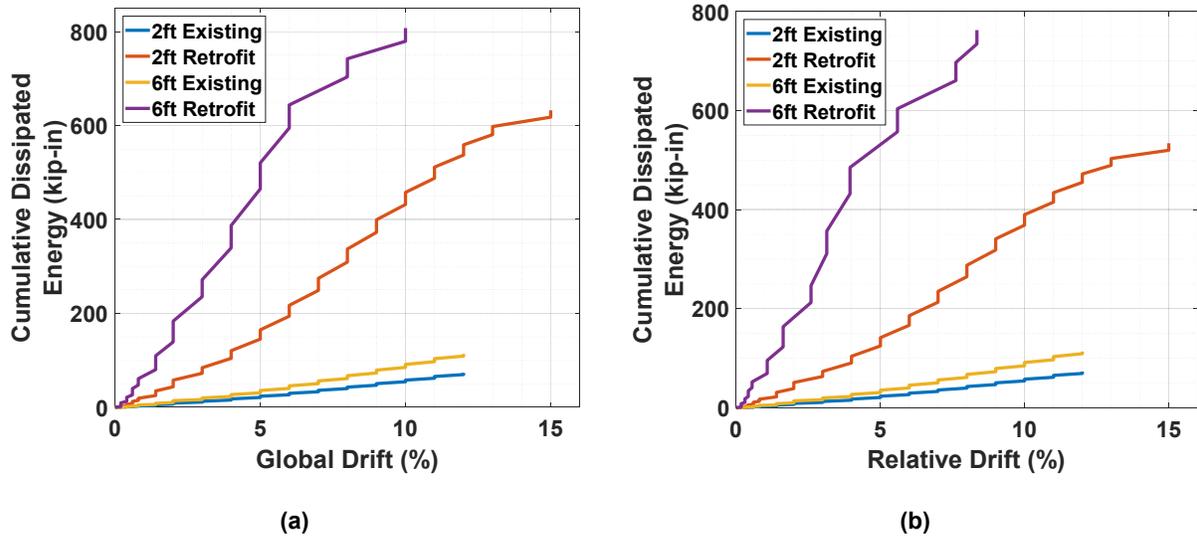
Figure 3.103 Horizontal siding hysteretic energy dissipation comparison: (a) *global* response; and (b) *relative* response.

Figure 3.103 compares the energy dissipated of the existing and retrofitted, 2-ft-tall and 6-ft-tall cripple walls with horizontal siding. For both the existing and retrofitted cases, the 6-ft-tall cripple walls dissipated more energy than their 2-ft-tall counterparts even though both walls had lower peak strengths. In terms of both the global and the relative response, the existing 2-ft-tall specimen dissipated nearly 50% energy more than its counterpart. For the 6-ft-tall specimens, the loading protocols diverged at 6% global drift (4.9% relative drift); at this point the retrofitted specimen dissipated nearly 200% more energy in the global response (240% more energy in the relative response) than existing specimen. The increased energy dissipation is largely due to the amount of displacement imposed on the 6-ft-tall specimens being three times as much as the 2-ft-tall specimens, as well as the increased number of fasteners attaching the horizontal siding and plywood doing work. The added retrofit accounted for a nearly a 700% increase in the energy dissipated by 10% global drift for the 2-ft-tall cripple walls and over an 850% increase for the 6-ft-tall cripple walls. Horizontal siding had by far the lowest capacity of any of the dry exterior finishes; therefore, the added retrofit would naturally provide large increases in the amount of energy dissipated.

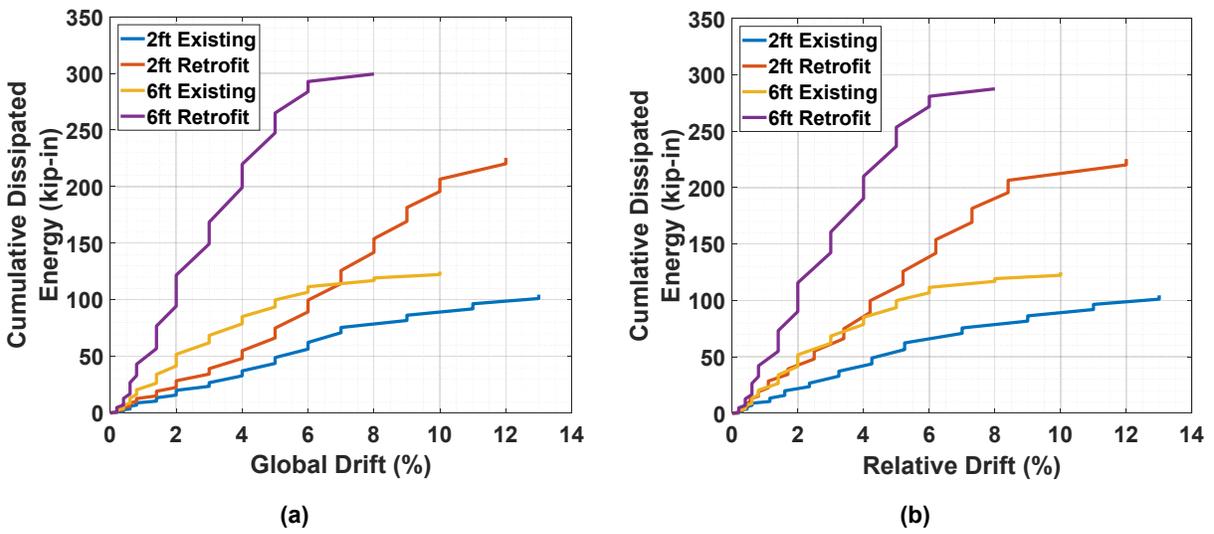
Figure 3.104 T1-11 wood structural panel hysteretic energy dissipation comparison: (a) *global* response; and (b) *relative* response.

Figure 3.104 shows the hysteretic energy dissipation of the global and relative response for the 2-ft- and 6-ft-tall specimens finished with T1-11 wood structural panels for both the existing and retrofitted condition. The loading protocols for each of the specimens were the same up to the 6% global drift ratio level. At this point, the retrofitted, 2-ft-tall cripple wall dissipated nearly 50% more than its existing counterpart, and the retrofitted, 6-ft-tall specimen dissipated over 110% more energy than the existing specimen. There was a 70% increase in the energy dissipation at this point from the existing to retrofitted 2-ft-tall specimens, and a 150% increase from the existing to retrofitted 6-ft-tall specimens. As with the horizontal siding finished specimens, the increased dissipation was due to the increased number of fasteners in the taller walls as well as the imposed displacements being three times as large.

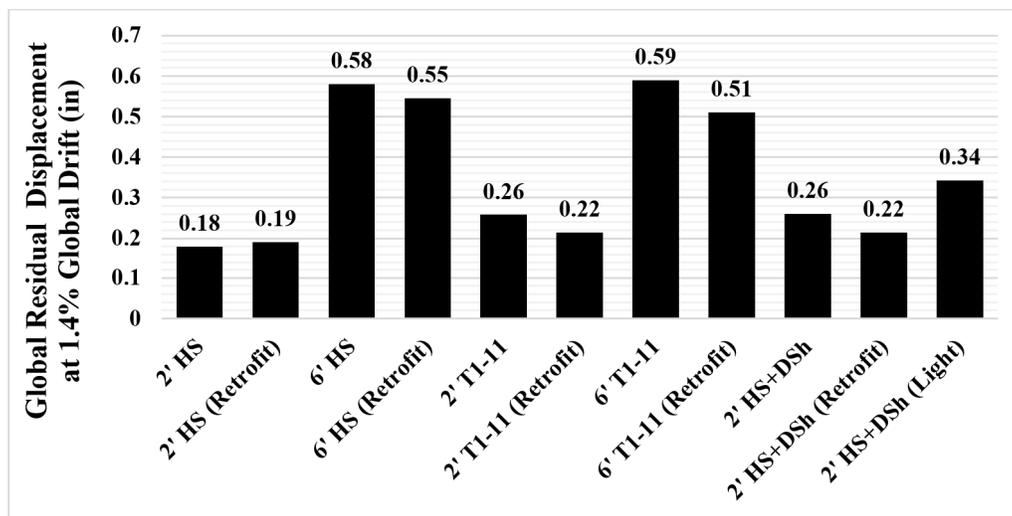
Figure 3.105 *Global* residual displacement of cripple walls at the end of the 1.4% global drift cycle group.

displacement in the cripple wall measured when there is no lateral force being imposed on the cripple wall. As the amplitude of the displacement increased, the residual displacement increased to the point where it became visible, even prior to the cripple walls' achieving full strength. Figure 3.105 shows the global residual displacement of the cripple walls after the 1.4% drift cycle group. Global residual displacement refers to not only the residual displacement of the cripple wall itself but also to the residual displacement of the sill plate relative to the foundation. Figure 3.109 shows the relative residual displacement of the cripple walls after the 1.4% drift cycle group. The relative residual displacement accounts for only the deformation sustained in the cripple wall, excluding any deformation of the sill plate relative to the foundation. For convenience, the relative residual displacement will be referred to as residual displacement. This measurement is a better indicator of the structural performance of the cripple wall as it only accounts for the cripple wall's residual deformation. There were variations in the alignment of the sill plate connection to the foundation as the anchor bolt holes were oversized $\frac{1}{4}$ in. It should be noted that the residual displacements are not normalized by any height metric within Figures 3.105 through 3.109. Naturally, the 6 ft-tall-cripple walls would have more residual displacement than their 2-ft-tall counterparts due to the imposed displacement being three times as much for the 6-ft-tall cripple walls than the 2-ft-tall cripple walls.

For 2-ft-tall cripple walls, the global residual displacement was 0.18 to 0.34 in. or 0.8%–1.4% drift; see Figure 3.105. The largest global residual displacement was for Specimen A-28, which had a horizontal siding over diagonal sheathing finish and a light vertical load. There was little difference between the global residual displacement for the existing and retrofitted cripple walls. For the 6-ft-tall cripple walls, the ranges in global residual displacement were from 0.51 to 0.59 in. or 0.7% to 0.8% drift. In terms of global residual displacement as a percentage drift, the height of the cripple wall had little effect on the residual displacement. When looking at the residual displacement at 1.4% global drift (Figure 3.106), the cripple walls with horizontal siding remained fairly consistent, except for the retrofitted 6-ft-tall specimen. The cripple walls with horizontal siding over diagonal sheathing had dramatic differences between the global residual displacement and the residual displacement, decreasing from 0.22–0.34 in. to 0.03–0.06 in. This was caused by the large amounts of displacement that accrued between the sill plate and the foundation as the cripple wall slid along the foundation instead of the wall itself deforming. This figure also indicates the relative drift of the cripple walls at 1.4% global drift.

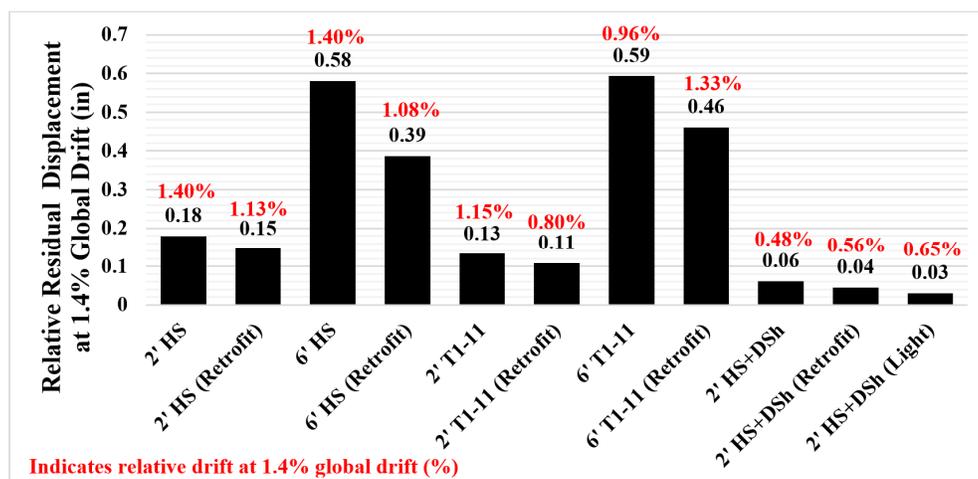
Figure 3.106 *Relative* residual displacement of cripple walls at the end of the 1.4% global drift cycle group.

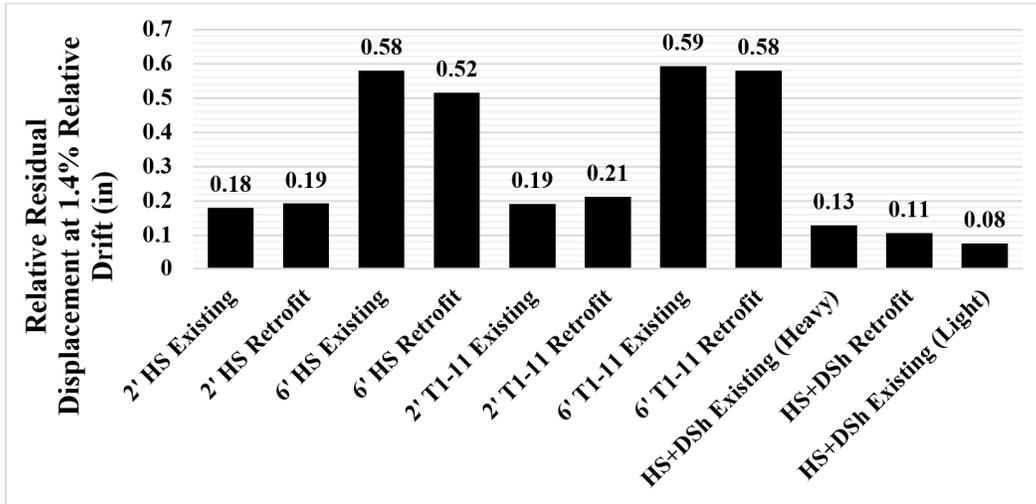
Figure 3.107 *Relative residual displacement of cripple walls at the end of the 1.4% relative drift cycle, linearly interpolated.*

It is more useful to compare the residual displacements in the cripple walls at the same relative drift amplitude. If a linear interpolation is made to determine the residual displacement at 1.4% relative drift, the residual displacements are much more consistent, as shown in Figure 3.107. For the cripple walls with horizontal siding, the residual displacement is fairly consistent, regardless of retrofit condition and height, e.g., between 0.18 and 0.19 in. (0.7–0.8% drift) for the 2-ft-tall specimens and between 0.52 and 0.58 in. (0.7–0.8% drift) for the 6-ft-tall specimens. The same trend is exhibited for the T1-11 finished cripple walls. The residual displacement is between 0.19 and 0.21 in. (~0.8% drift) for the 2-ft-tall specimens and between 0.58 and 0.59 in. (~0.8% drift) for the 6-ft-tall specimens. These results are fairly consistent with the horizontal siding cripple walls. The cripple walls with horizontal siding over diagonal sheathing have significantly less residual displacement at 1.4% relative drift, in the range of 0.08 to 0.13 in. (0.3–0.5% drift). The cripple wall with the light vertical load is on the lower end of that range, which is due to the decreased amount of weight on top of the cripple wall keeping it from returning to its undeformed position. Overall, the horizontal siding over diagonal sheathing finish combination is more elastic

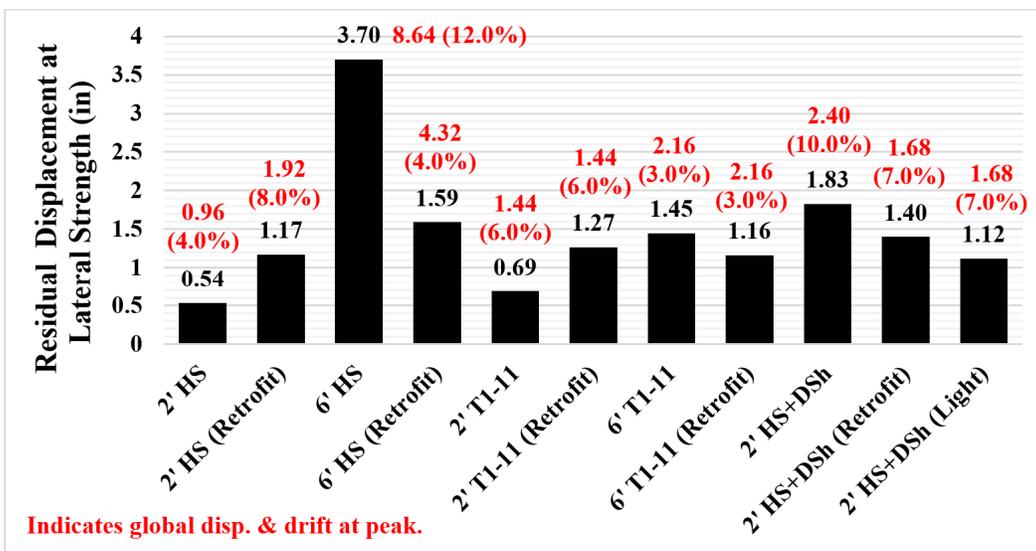
Figure 3.108 *Global residual displacement of cripple walls at the end of the peak strength drift cycle group.*

Figure 3.109 shows the global residual displacement at strength. Since the strengths occurred over a wide range of drifts and the amount of sill plate to foundation displacement varies drastically between specimens, there are not as many decipherable trends between the walls. Figure 3.108 shows the residual displacement at lateral strength; it is evident that the T1-11 and horizontal siding finishes have comparable residual displacement between the existing cripple walls and the retrofitted cripple walls for the 2-ft-tall specimens. This is as much the same for the case of the 6-ft-tall walls, where the existing cripple wall with horizontal siding has a residual displacement of 3.7 in. This is by far the most flexible cripple wall tested. The retrofitted cripple wall with horizontal siding over diagonal sheathing had the lowest residual displacement, 0.26 in. This is less than half the residual displacement at peak strength of any of the other cripple walls.

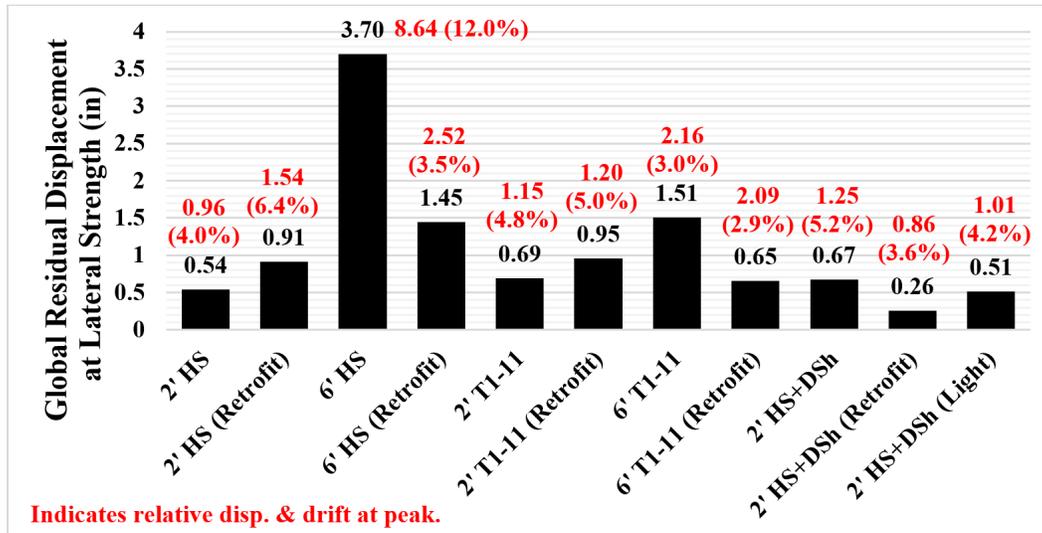
Figure 3.109 Relative residual displacement of cripple walls at the end of the peak strength drift cycle group.

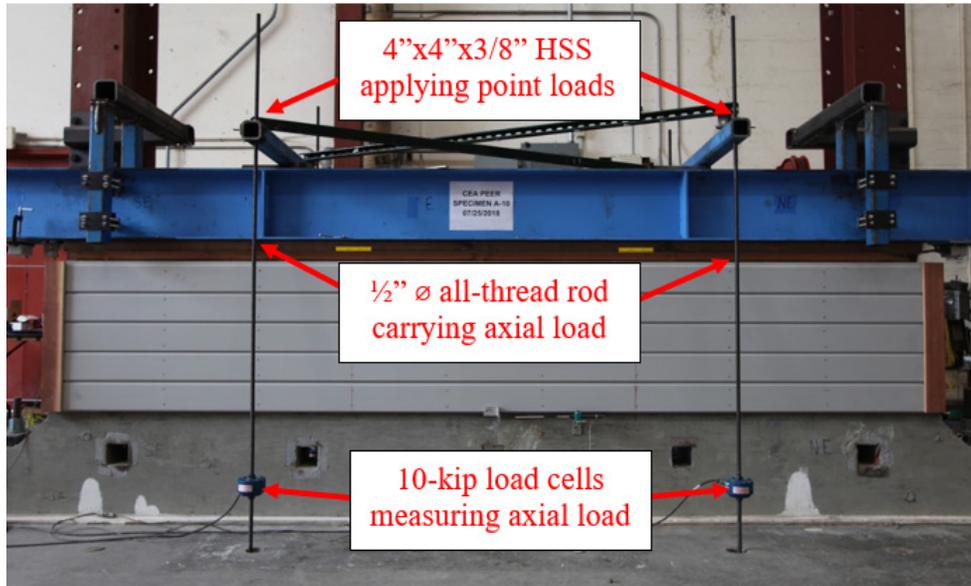
Figure 3.110 Axial load set up.

Figure 3.110 shows the set up for the application of the vertical load, and Figure 3.111 shows the geometry of the vertical load and lateral load as the cripple wall displaces. Overall, the correction for the lateral load was a reduction in the range of 0–3% for all cycles for the 2-ft-tall cripple walls and 0–6% for 6-ft-tall cripple walls. During the monotonic push, the correction would have a maximum reduction of around 5% for 2-ft-tall cripple walls and 10% for 6-ft-tall cripple walls. Note that all results presented have accounted for these corrections. The only exception to the aforementioned vertical load application was for Specimen A-28, which had a lighter vertical load. For this specimen, the vertical load came from steel plates spanning the top of the horizontal steel transfer beam. The same system of applying the load was not used due to the lack of accuracy and precision in the hydraulic system at such low loads. The equation for the corrected lateral load and corrected vertical load are as follows:

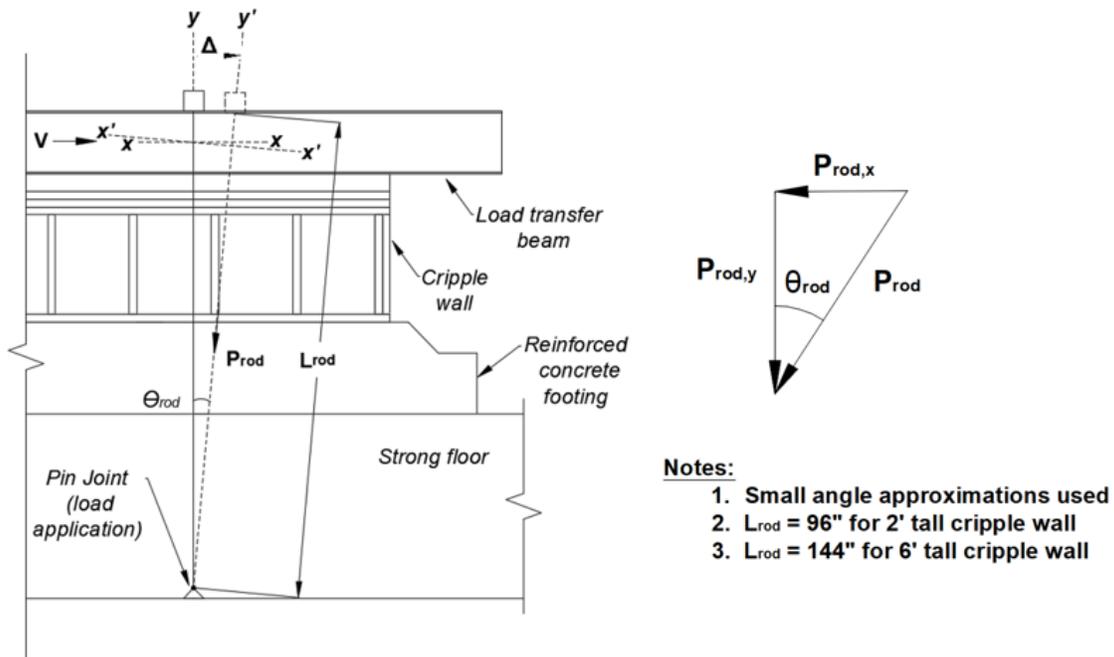
Figure 3.111 Schematic of displaced geometry for lateral load correction.

$$V_{actual} = V_{measured} - P_{rod} \sin(\theta_{rod}),$$

$$P_{actual} = P_{rod} \cos(\theta_{rod}), \text{ where } \theta_{rod} = \sin^{-1} \frac{\Delta}{L_{rod}}$$

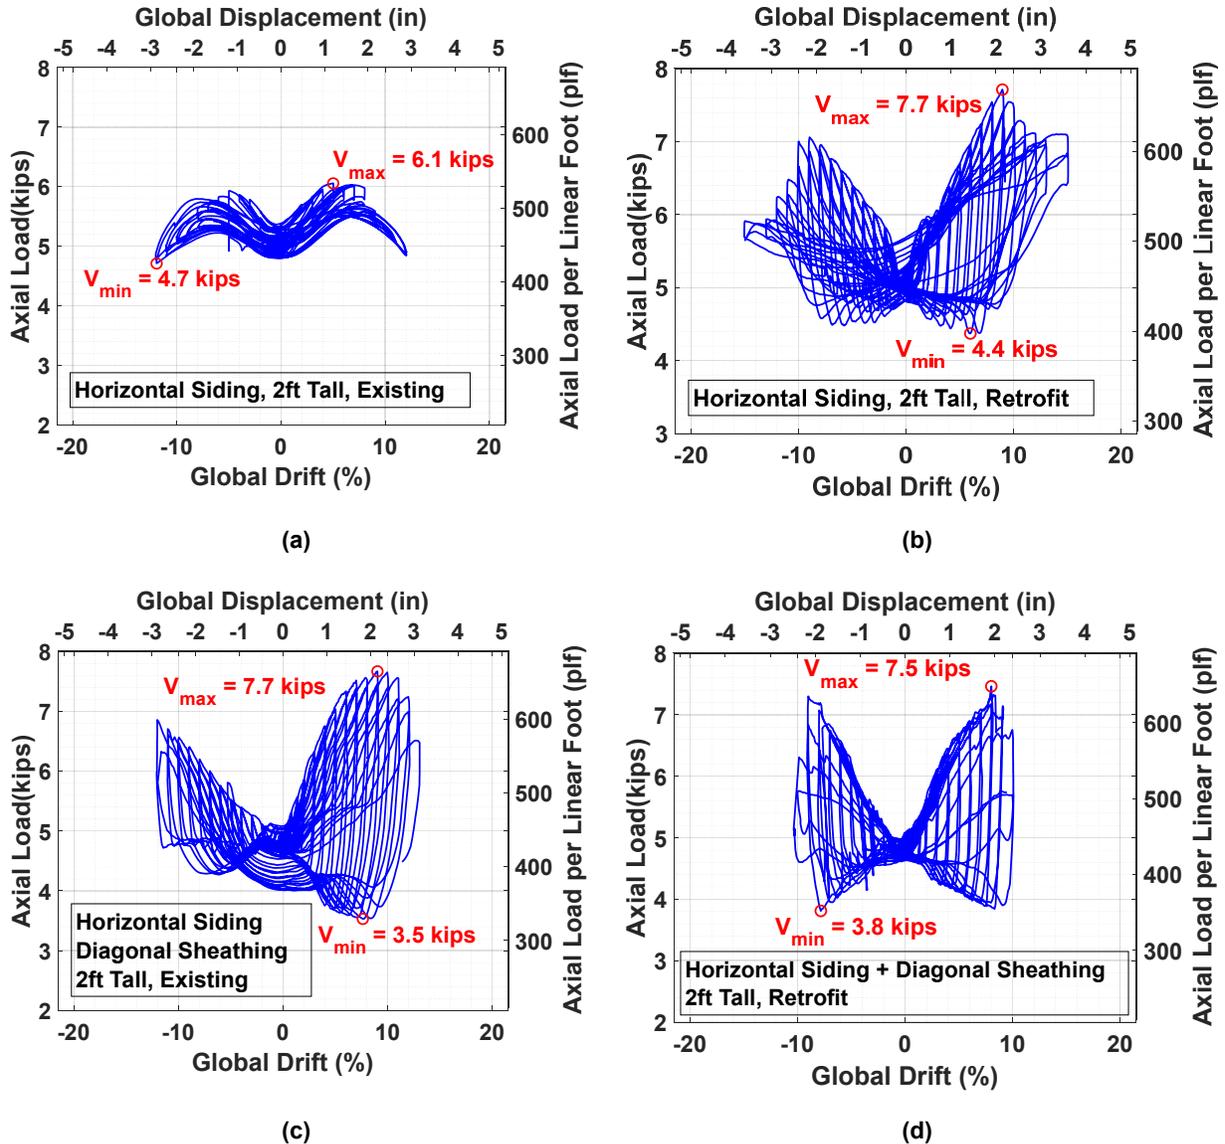
Figure 3.112 Axial (vertical) load versus global drift for specimens: (a) Specimen A-7; (b) Specimen A-8; (c) Specimen A-9; (d) Specimen A-10; (e) Specimen A-11; (f) Specimen A-12; (g) Specimen A-13; (h) Specimen A-14; (i) Specimen A-23; and (j) Specimen A-24.

with light building materials. In order to achieve 450 plf of vertical load, 5 kips were applied between the four hydraulic jacks after the weight of the horizontal load transfer beam, laminated wood beam, and HSS sections had been accounted for. Throughout the displacement cycles, the vertical load applied by the jacks would oscillate. These oscillations are shown in Figure 3.112. For all cripple walls, the vertical loads fluctuated from by a range of 1.3 to 3.7 kips over their entire loading protocol. The maximum vertical load experienced was 7.7 kips by Specimen A-8, and the lowest vertical load was 3.2 kips by Specimen A-14.

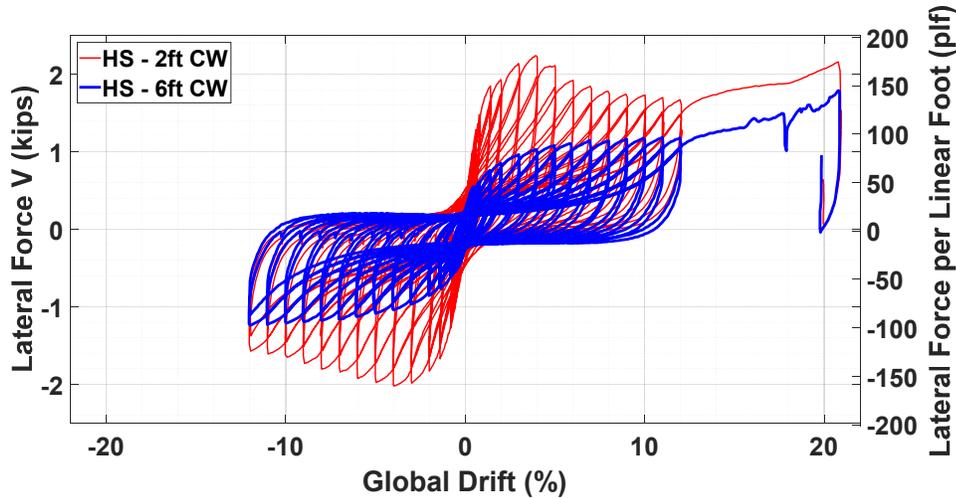
Figure 3.113 Specimens A-7 and A-13 lateral force versus *global* lateral drift and displacement hysteresis overlay.

As stated in Section 3.2, horizontal siding is the weakest exterior finish of those tested. The lateral strength per linear foot for the existing 2-ft-tall cripple wall with horizontal siding had an average of 174 plf between the push and pull directions, whereas the 6-ft-tall counterpart had an average of 97 plf between both directions of loading. Figure 3.113 shows an overlay of the hysteresis for these two cripple walls, while Figure 3.114 shows an overlay of their envelopes of their hysteretic response.

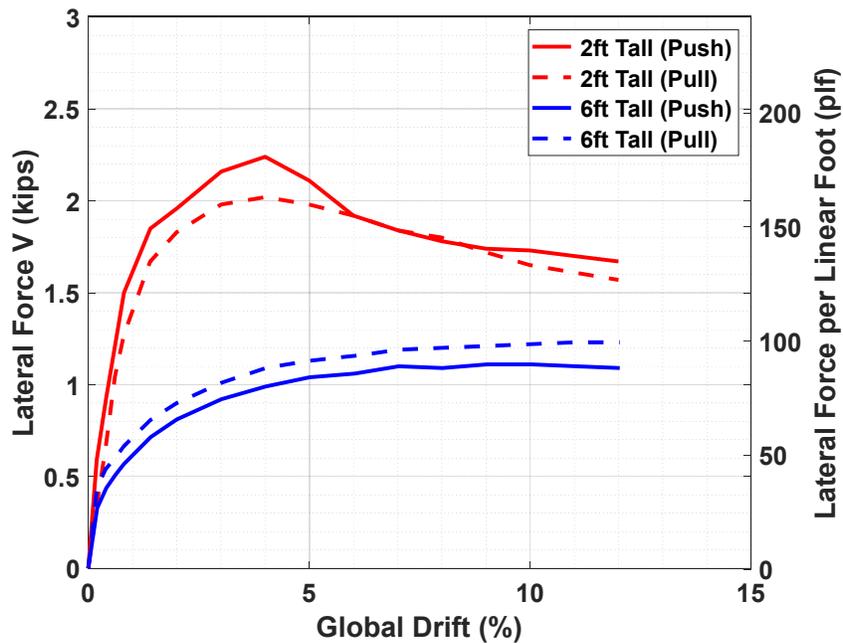
Figure 3.114 Specimens A-7 and A-13 lateral force versus *global* lateral drift and displacement envelope of hysteretic response overlay.

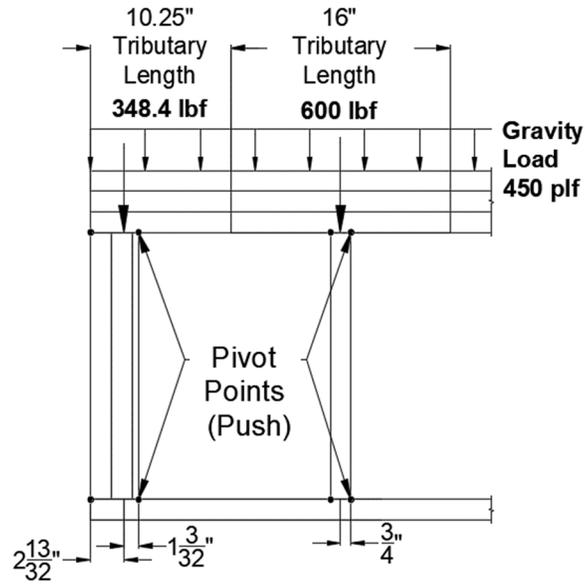
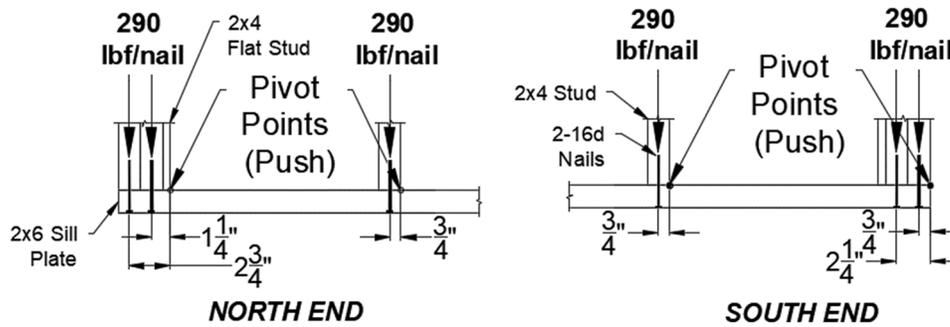
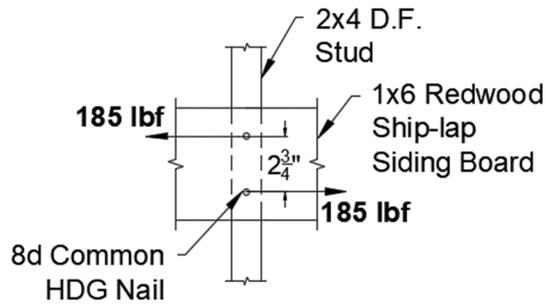
Figure 3.115 Force diagram for moment capacities for cripple walls with horizontal siding exterior finish: (a) overturning; (b) framing nailing; and (c) siding nailing.

By taking the moment about the pivot points on the framing that are at each of the 8 interior studs and the two end-flat stud (shown in Figure 3.118), the moment capacity of the framing from the nail withdrawal strength is found as:

Finally, the applied vertical load resists overturning of the cripple wall. This resistance is the same for both the 2-ft-tall cripple wall and the 6-ft-tall cripple wall as the framing details were identical except for length of the stud; the applied vertical load was the same for the two cripple walls. By calculating the tributary area of the applied load, the amount of compressive load each interior stud and corner can be determined. The overturning moment resistance is taken by multiplying the compressive load by the distance from the center-of-mass of the studs/corner to the pivot points on which the interior studs and corners will rotate on when laterally displaced. Note that both the top and bottom of the studs and corners resist overturning. The compressive loads and distance to the pivot points can be seen in Figure 3.115.

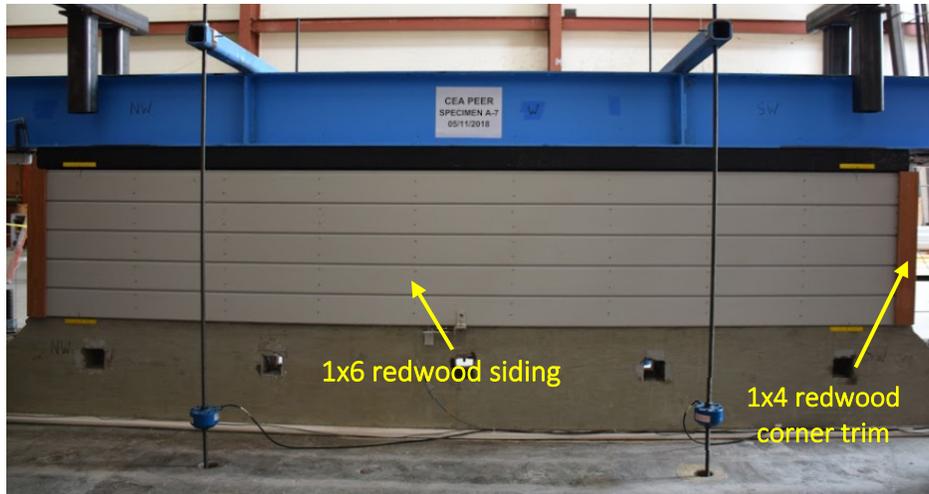
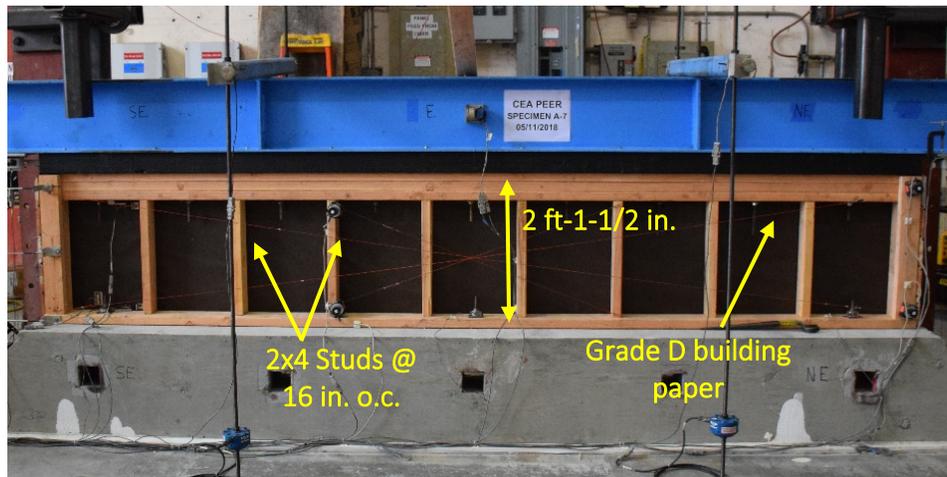
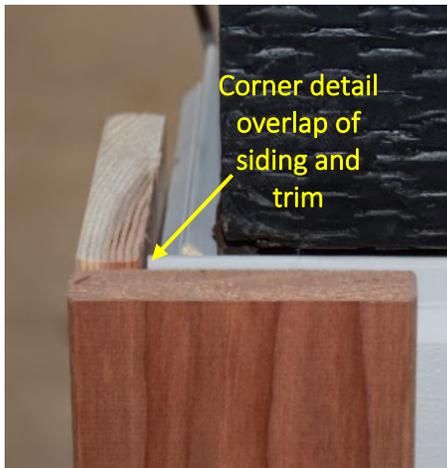
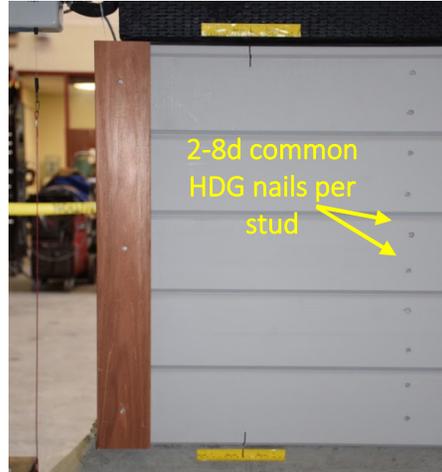
Figure 4.1 Specimen A-7 pre-test photographs of the existing 2-ft-tall cripple wall finished with horizontal siding: (a) exterior elevation; (b) interior elevation; (c) top of north exterior of wall corner view; and (d) north-end of exterior of wall view.

The photographs in Figure 4.1 show the initial state of Specimen A-7. Specimen A-7 is a 2-ft-tall cripple wall with horizontal siding exterior finish in an existing condition. The siding is 1 × 6

redwood fastened with two 8d common hot-dipped galvanized nails per stud. There was no notable pre-existing damage on the cripple wall prior to testing. The actual height of the cripple wall is 2 ft-1-1/2 in. due to the addition of a third top plate as part of top boundary condition B; the actual length of the cripple wall is 12 ft-4-1/2 in. due to the addition of built-up corners as part of bottom boundary condition c. Details of the siding nailing and corner are given in Figure 4.1(c) and (d), respectively.

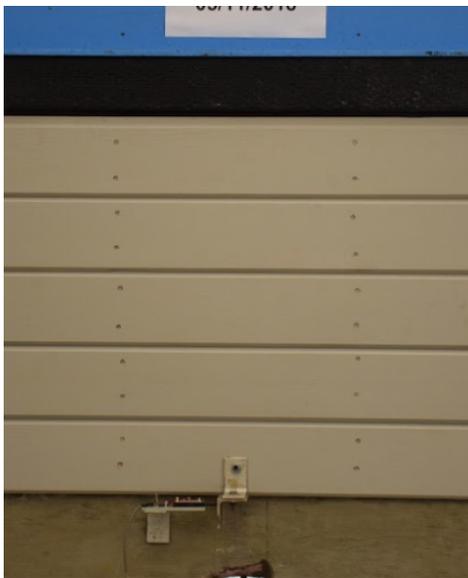
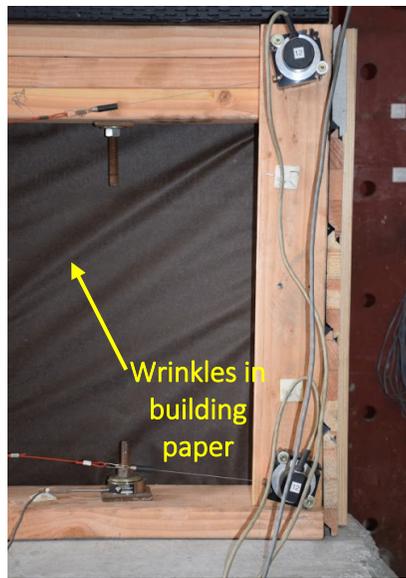
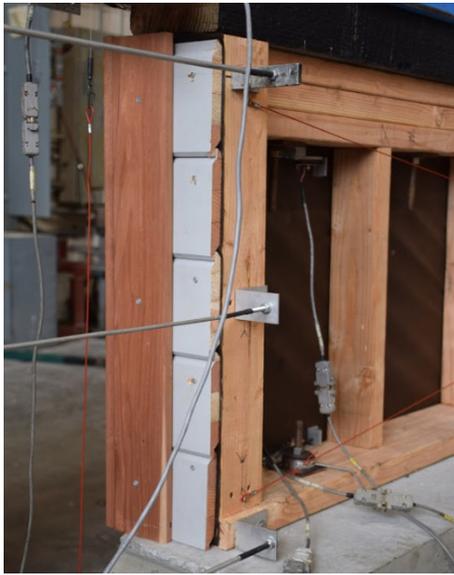
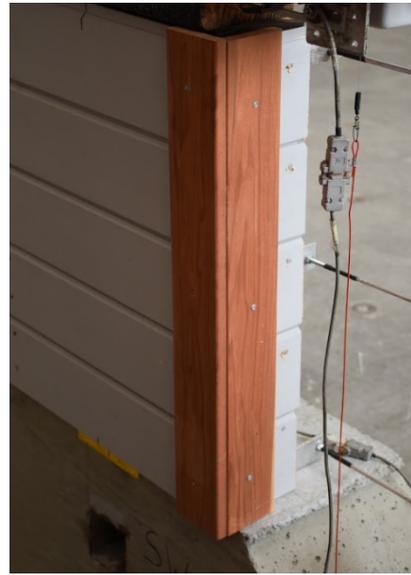
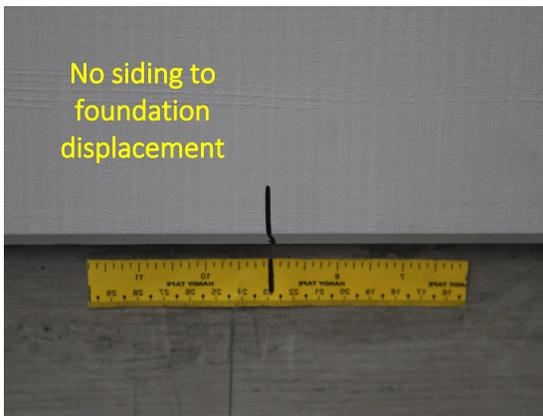
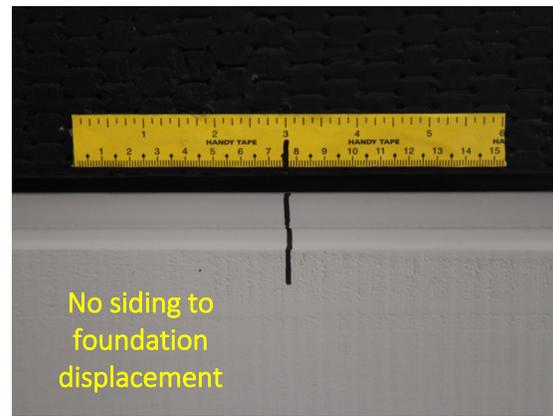
Figure 4.2 Cripple wall details at -1.4% drift ratio level @ $\Delta = -0.336$ in.: (a) middle exterior of wall view; (b) north interior of wall corner view; (c) south interior of wall corner view; (d) south exterior of wall corner view; (e) bottom of wall exterior view; and (f) top exterior of wall view.

From the 0.0% drift ratio level to the 0.6% drift ratio level, no visible damage was present on the cripple wall. The only notable change was the formation of wrinkles on the building paper. From 0.6% to 1.4% drift, there was again no noticeable damage to the specimen. Figure 4.2 shows the state of the cripple wall at -1.4% drift. The only significant change to the wall was more profound wrinkling in the building paper. The wrinkles originated from the studs where the building paper was stapled. Figures 4.2 (e) and (f) show the displacement of the siding relative to the foundation and the top plate, respectively. At this displacement level, there were no significant displacements at these two interfaces. Lastly, as shown in Figure 4.2(a), a stepping pattern is beginning to show between the siding boards. This shows that the imposed displacement on the cripple wall was being carried by the cripple wall itself, i.e., sliding of the sill plate on the foundation did not occur.

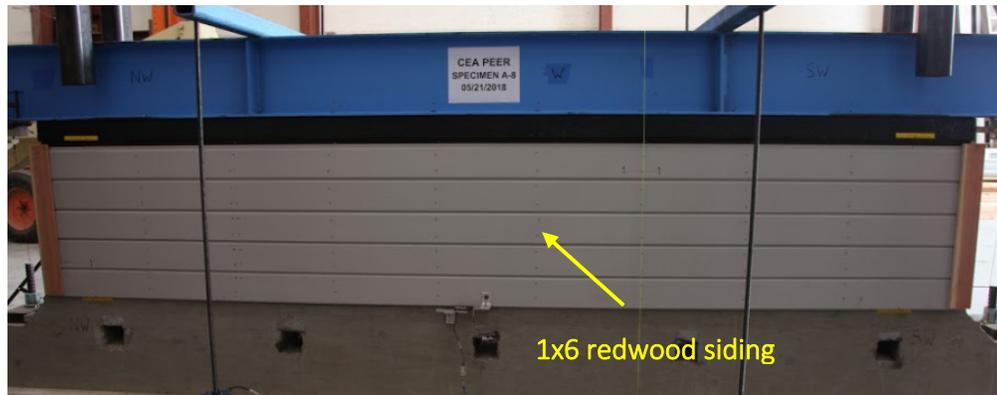
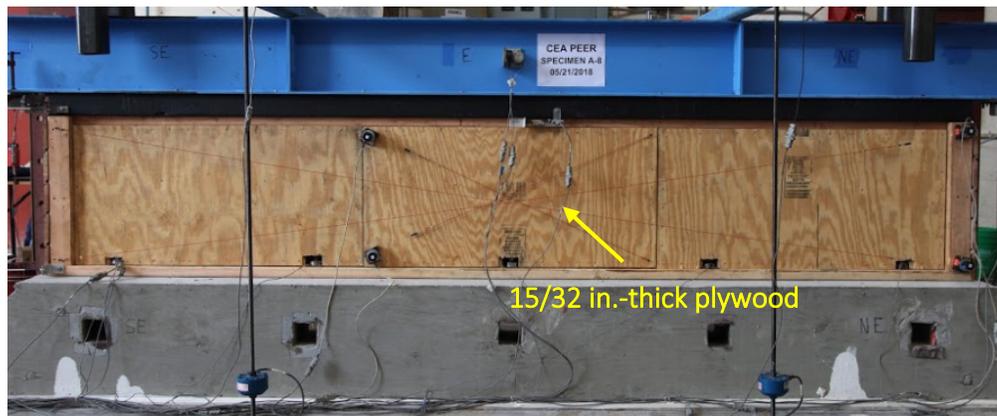
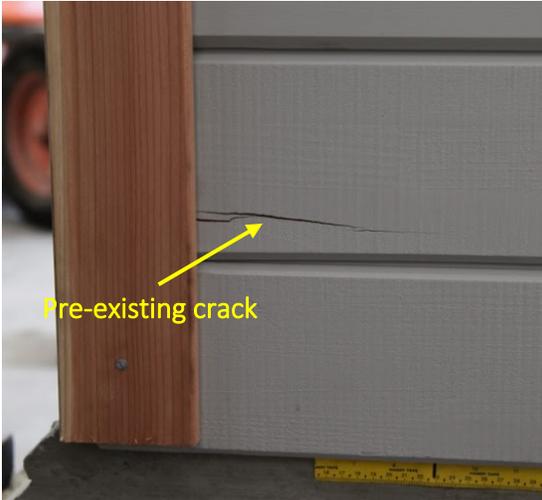
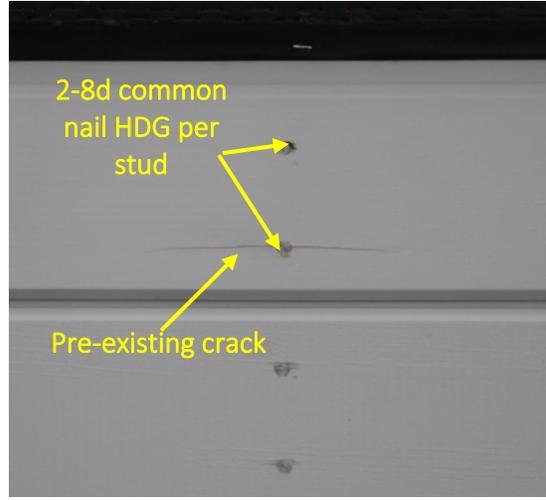
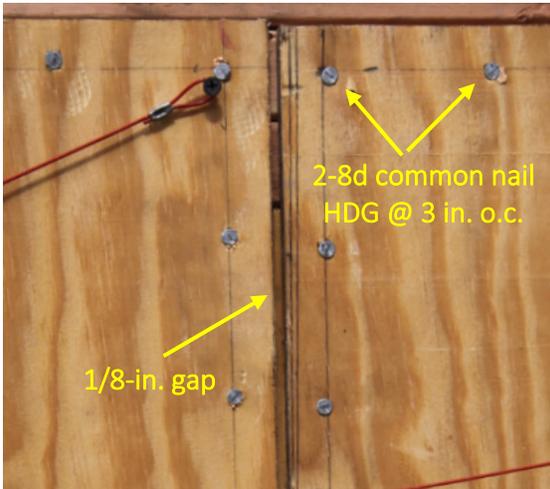
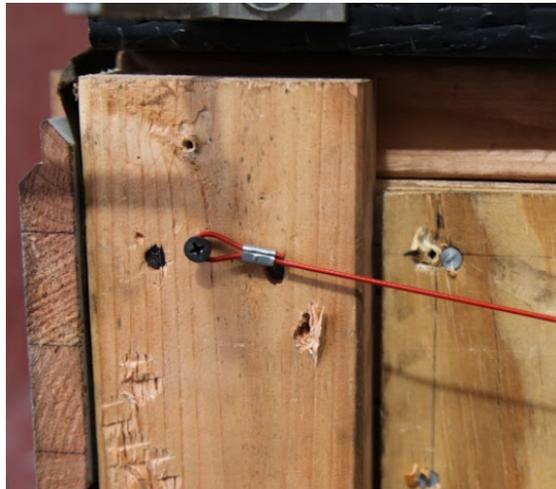
Figure 4.3 Specimen A-8 pre-test photographs of the retrofitted 2-ft-tall cripple wall finished with horizontal siding: (a) exterior elevation; (b) interior elevation; (c) bottom of north exterior of wall corner view; (d) top middle exterior of wall view; (e) top middle interior of wall view; and (f) top of interior of wall south corner view.

The photographs in Figure 4.3 show the initial state of Specimen A-8 prior to testing. Specimen A-8 is a retrofitted 2-ft-tall cripple wall with horizontal siding exterior finish. The siding is 1 × 6 redwood fastened with two 8d common hot-dipped galvanized nails per stud. The retrofit included the addition of three sections of 15/32-in.-thick plywood fastened with 8d common hot-dipped galvanized nails spaced at 3 in. on center around the edge of the panels and 12 in. on center in the field of the panels. A 1/8-in. gap is present between the plywood panels. In addition, two extra anchor bolts were added to reduce the anchor bolt spacing from 64 in. on center to 32 in. on center. The dimensions of the cripple wall are identical to Specimen A-8. In Figures 4.3 (c) and (d), pre-existing cracks in the siding can be seen. These cracks originated from over-driven nails at the two locations.

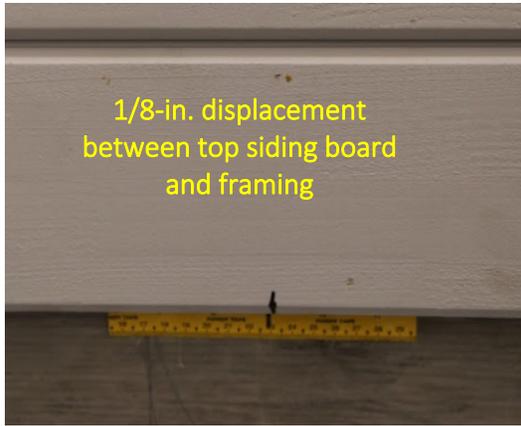
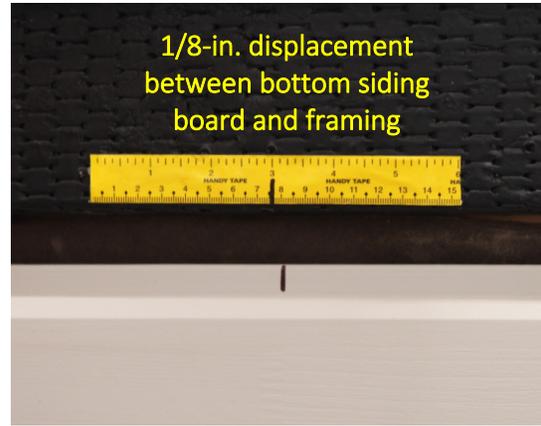
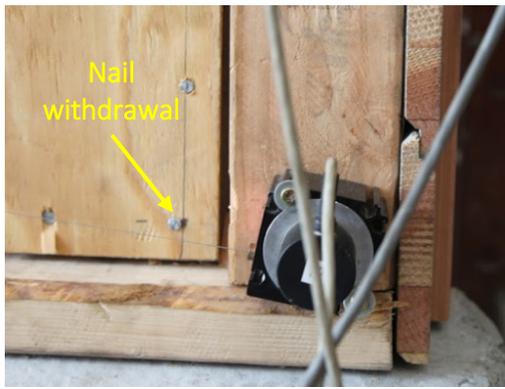
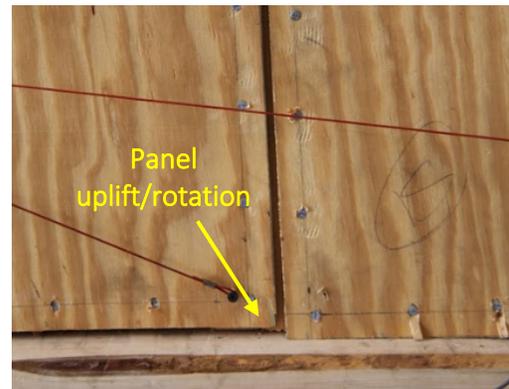
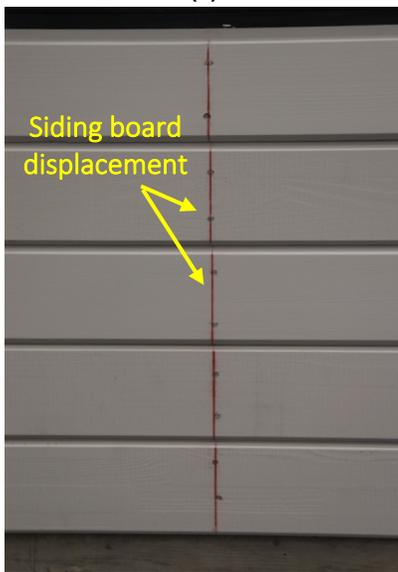
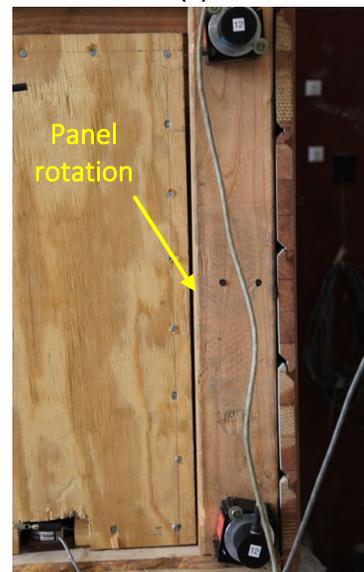
Figure 4.4 Specimen A-8 damage state details at -1.4% drift ratio level @ $\Delta = -0.336$ in.: (a) top middle of exterior wall view; (b) bottom middle of exterior wall view; (c) bottom of north interior corner view; (d) bottom interior of wall (middle and south panels); (e) middle exterior of wall view; and (f) north-end interior of wall view.

Details of the damage characteristics at -1.4% drift are shown in Figure 4.4. At the top of the wall the top siding board has displaced 1/8 in. relative to the framing [Figure 4.4(a)], and at bottom of the wall the displacement of the bottom siding board is 1/8 in. relative to the foundation. Panel rotation and nail withdrawal has become visible; see Figure 4.4 (c) and (d). At this point, the displacements between the siding boards have begun to increase. A red line was added down a row of nails on the siding to better track these displacements as shown in Figure 4.4(e).

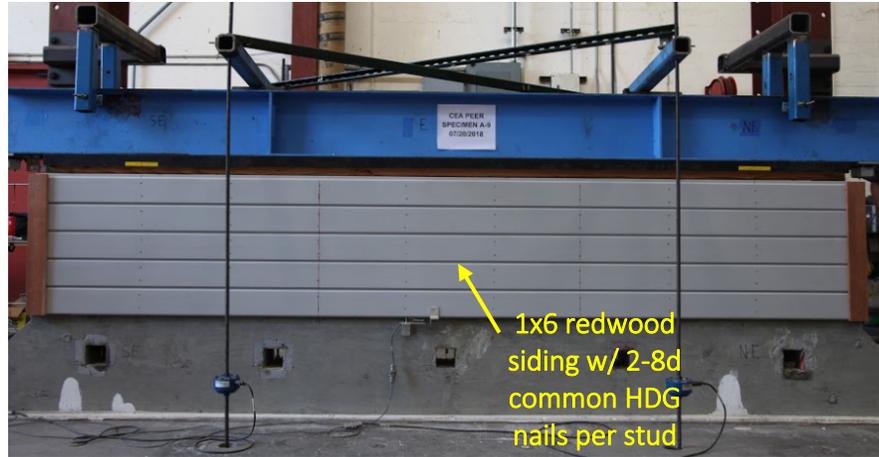
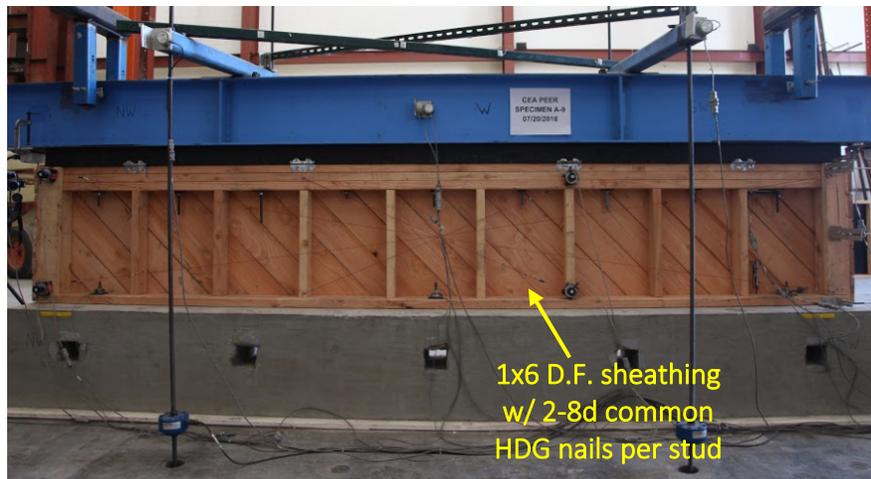
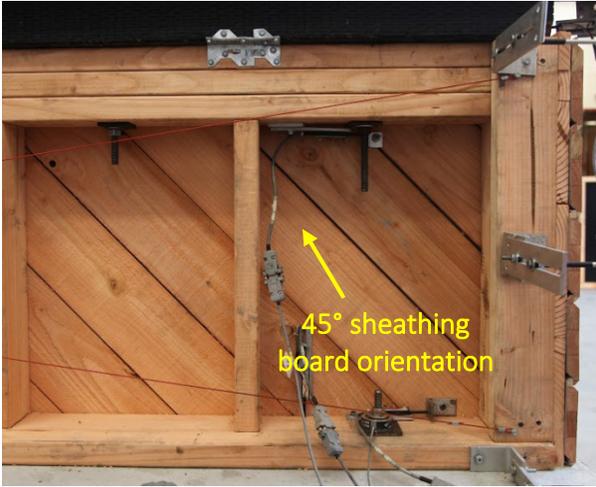
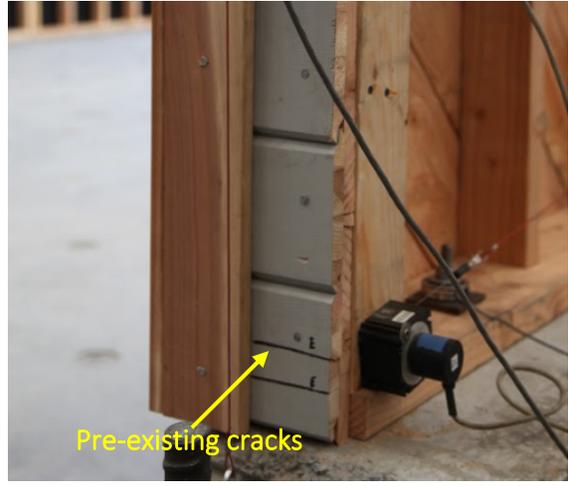
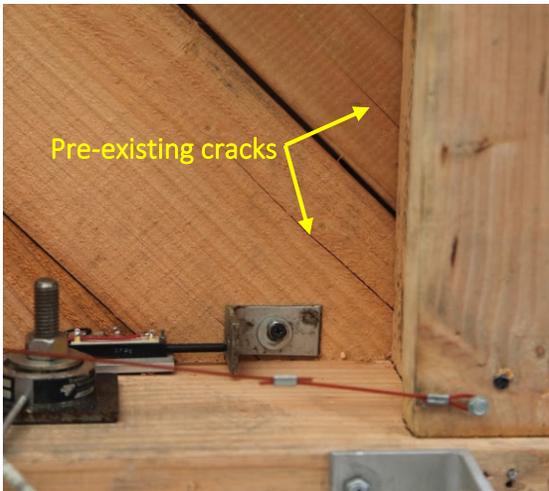
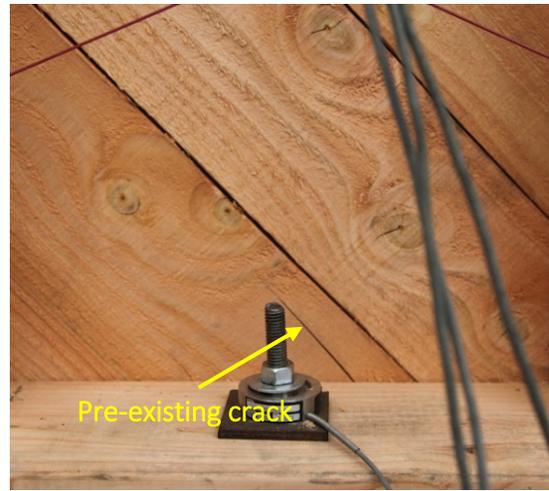
Figure 4.5 Specimen A-9 pre-test photographs of the existing 2-ft-tall cripple wall finished with horizontal siding over diagonal sheathing, heavy vertical load: (a) exterior elevation; (b) interior elevation; (c) south-end interior of wall corner view; (d) bottom of north-end interior of wall view; (e) bottom of south-end interior of wall corner view; and (f) bottom of middle interior of wall view.

The photographs in Figure 4.5 show the initial state of Specimen A-9 prior to testing. Specimen A-9 is an existing 2-ft-tall cripple wall with horizontal siding over diagonal sheathing exterior finish. The siding is 1 × 6 redwood fastened with two 8d common hot-dipped galvanized nails per stud. The diagonal sheathing boards 1 × 6 construction grade Douglas Fir were oriented at a 45° angle from southwest to northeast; see Figure 4.5(c). The dimensions of the cripple wall were the same as Specimen A-7 and Specimen A-8. Figure 4.5 (d), (e), and (f) show pre-existing cracks in the corner siding as well as the sheathing boards. These cracks occurred during construction. The cracks in the sheathing boards originated when the siding boards were being installed. The cracks in the corner siding board originated from when the corner trim was being installed.
