Cripple Wall Small-Component Test Program: Dry Specimens

**A Report for the “Quantifying the Performance of
Retrofit of Cripple Walls and Sill Anchorage in Single-
Family Wood-Frame Buildings” Project**

PEER Report 2020/17

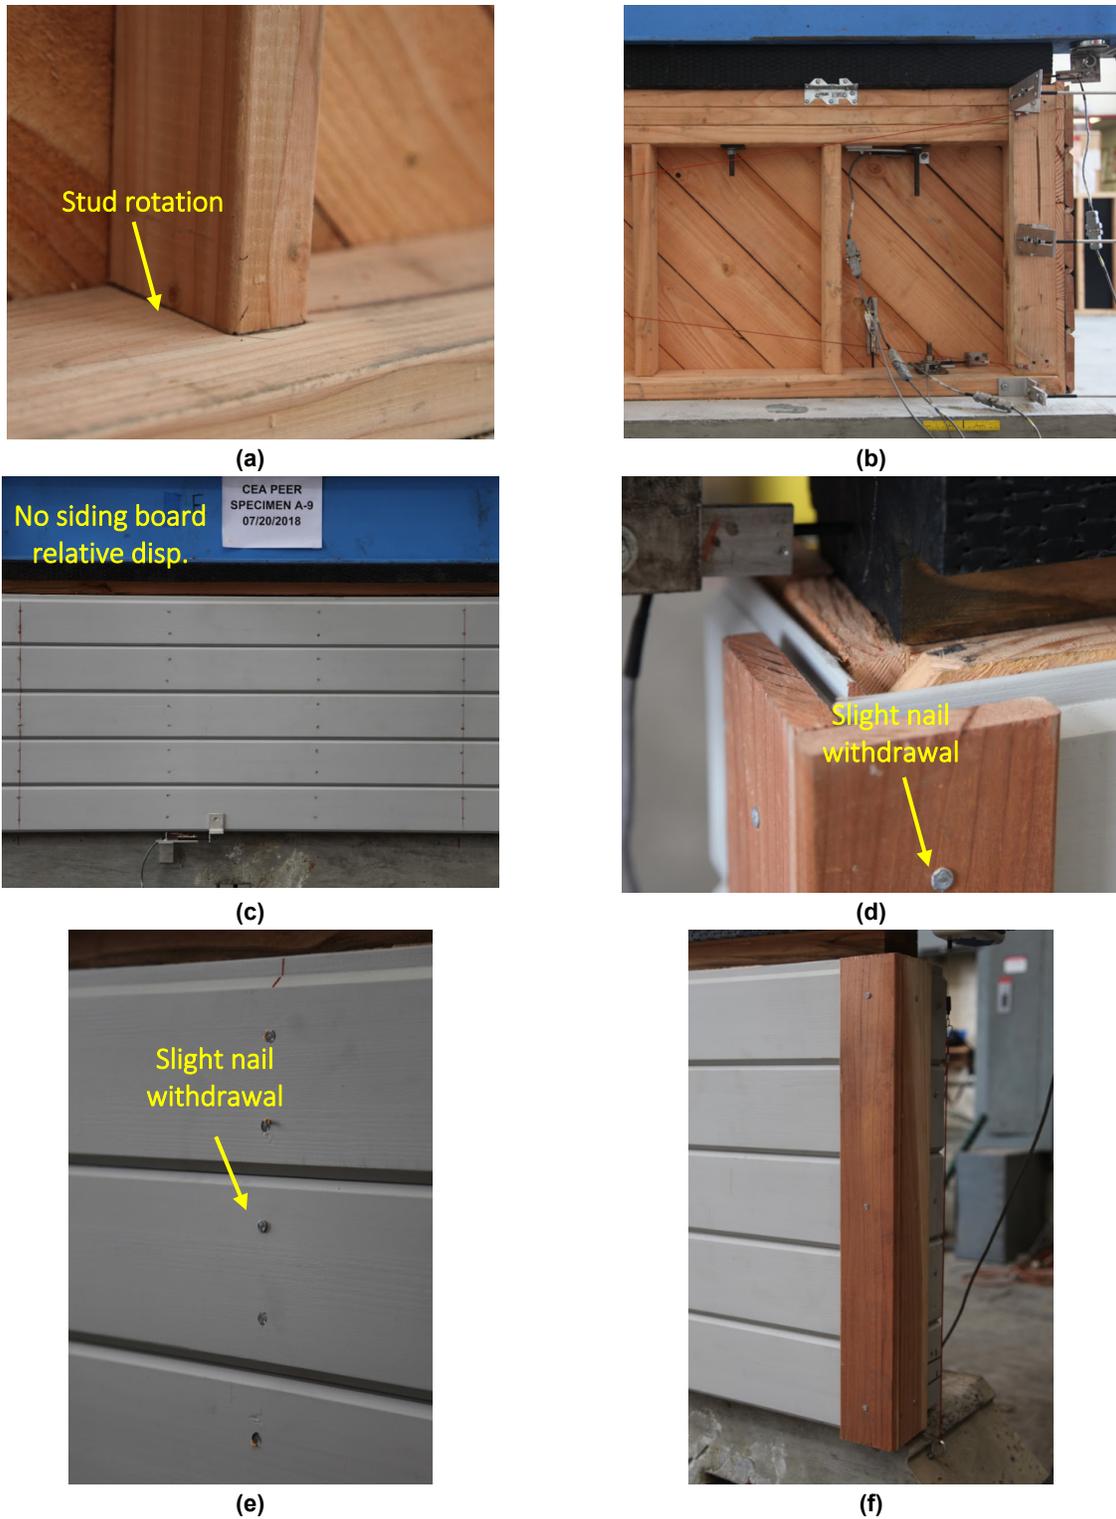
Figure 4.6 Specimen A-9 damage state details at -1.4% drift ratio level @ $\Delta = -0.336$ in.: (a) bottom interior of wall view; (b) south-end interior of wall view; (c) middle of wall corner view; (d) top of north-end exterior of wall corner view; (e) top middle exterior of wall view; and (f) south-end exterior of wall view.

No visible changes or damages occurred to the specimen from 0.0% to 1.4% drift. Figure 4.6 shows details of the cripple wall at -1.4% drift. No visible damage was apparent on the specimen besides a small rotation of the studs [Figure 4.12(a)], and slight nail withdrawal on the siding [Figure 4.6(e)] and the corner trim [Figure 4.6(d)].

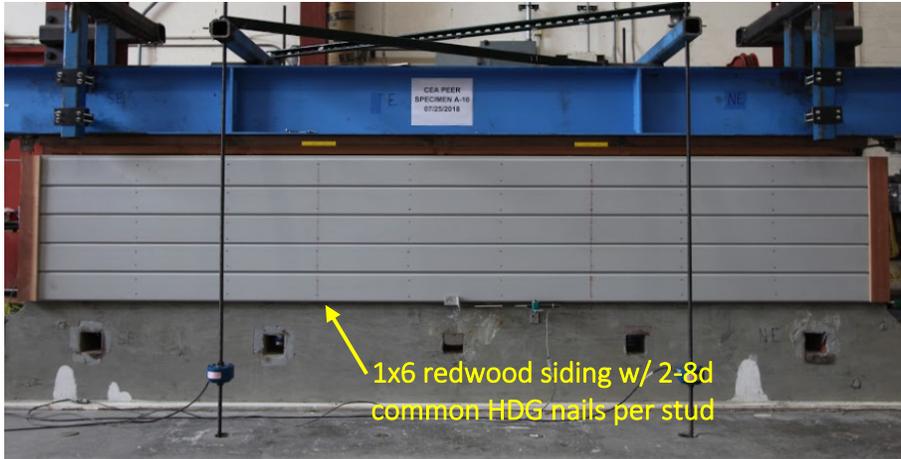
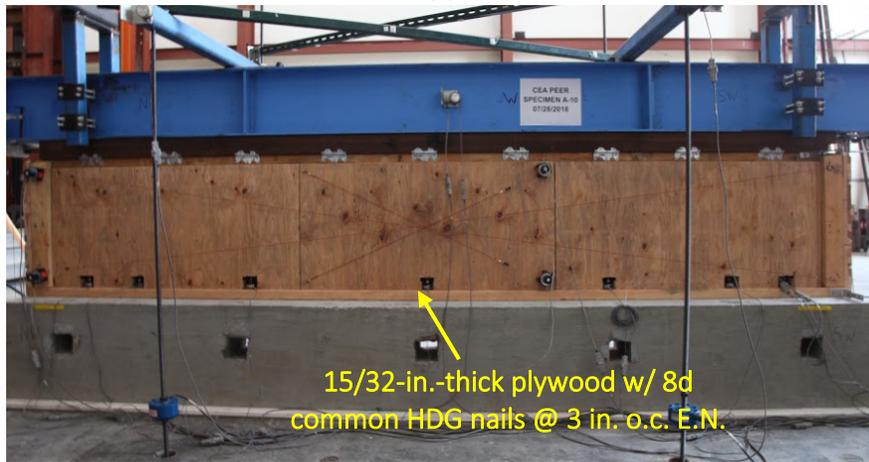
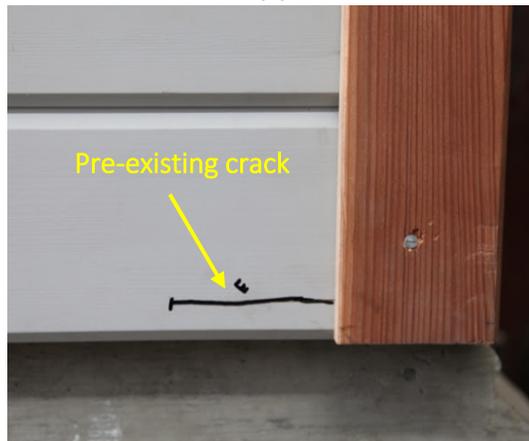
Figure 4.7 Specimen A-10 pre-test photographs of the retrofitted 2-ft-tall cripple wall finished with horizontal siding over diagonal sheathing: (a) exterior elevation; (b) interior elevation; and (c) bottom of south-end exterior of wall corner view.

The photographs in Figure 4.7 show the initial state of Specimen A-9 prior to testing. Specimen A-9 is a retrofitted 2-ft-tall cripple wall with horizontal siding over diagonal sheathing exterior finish. The siding is 1 × 6 redwood fastened with two 8d common hot-dipped galvanized nails per stud. The diagonal sheathing boards 1 × 6 construction grade Douglas Fir were oriented at a 45° angle from southwest to northeast. The retrofit included the addition of three sections of 15/32-in.-thick plywood fastened with 8d common hot-dipped galvanized nails spaced at 3 in. on center around the edge of the panels and 12 in. on center in the field of the panels. A 1/8 in. gap is present between the plywood panels. In addition, four extra anchor bolts were added. Two anchor bolts were placed in the existing slots of the foundation, reducing the anchor bolt spacing from 64 in. on center to 32 in. on center, and two additional anchor bolts were epoxied 12 in. in from the outermost anchor bolts. The dimensions of the cripple wall are identical to Specimen A-9. Figure 4.7(c) shows a pre-existing crack on the siding board that was present before the installation of the siding.

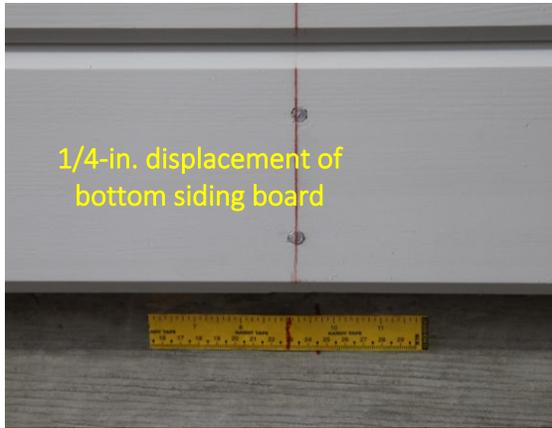
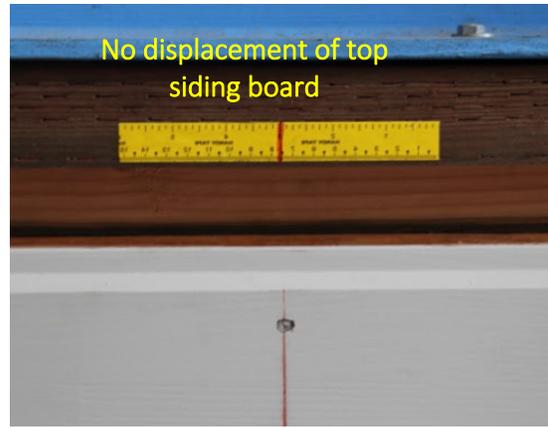
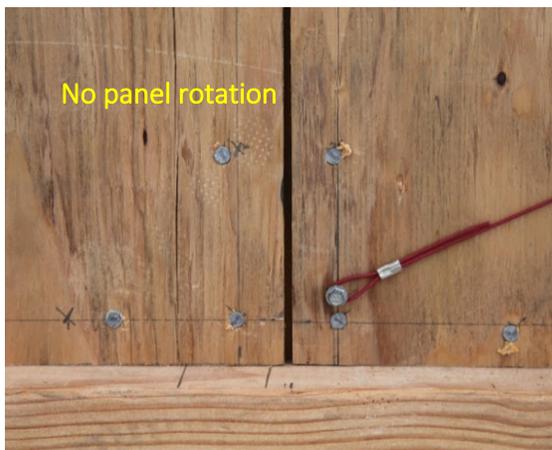
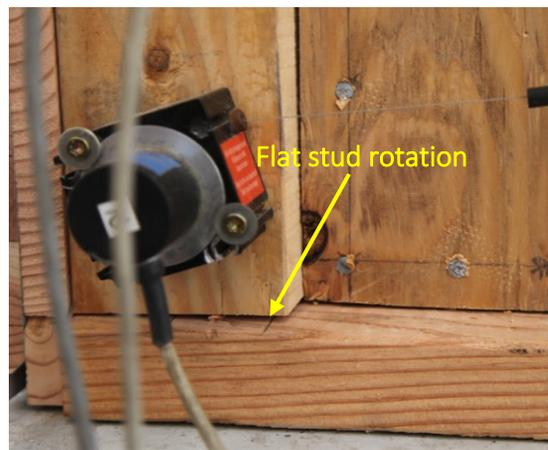
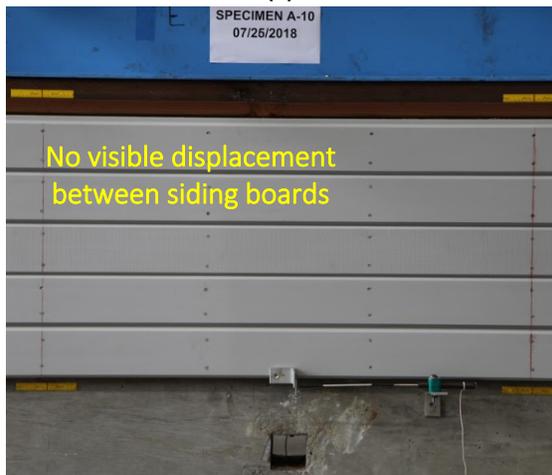
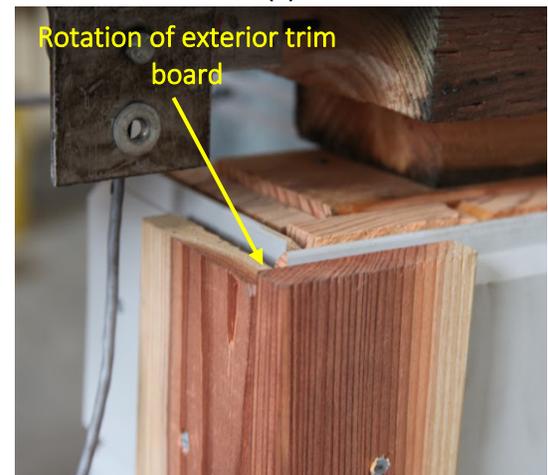
Figure 4.8 Specimen A-10 damage state details at -1.4% drift ratio level @ $\Delta = -0.336$ in.: (a) bottom middle exterior of wall view; (b) top middle exterior of wall view; (c) bottom middle interior of wall view (north and middle panels); (d) bottom of north-end interior of wall corner view; (e) middle exterior of wall view; and (f) top of south-end exterior of wall corner view.

Figure 4.8 shows details of the damage at -1.4% drift. shows the interior and exterior faces of the cripple wall at the 1.4% drift ratio level. As with Specimen A-9, there were not many changes to state of the cripple wall from the start of the test. The only noticeable differences were a slight uplift of the corners and the start of the plywood panel crushing against the corner flat stud [Figure 4.8(d)] as well as a 1/4-in. displacement of the bottom siding board relative to the foundation; see Figure 4.8(a). This shows that the cripple wall had begun to slide on the foundation. Rotations in the plywood panels [Figure 4.8(c)] were not as significant in Specimen A-10 as they were in Specimen A-8 at -1.4% drift.

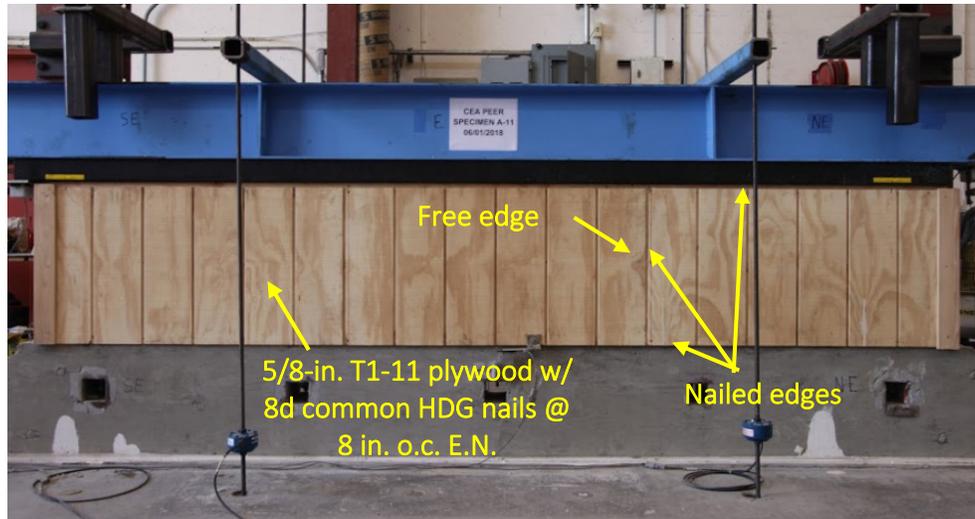
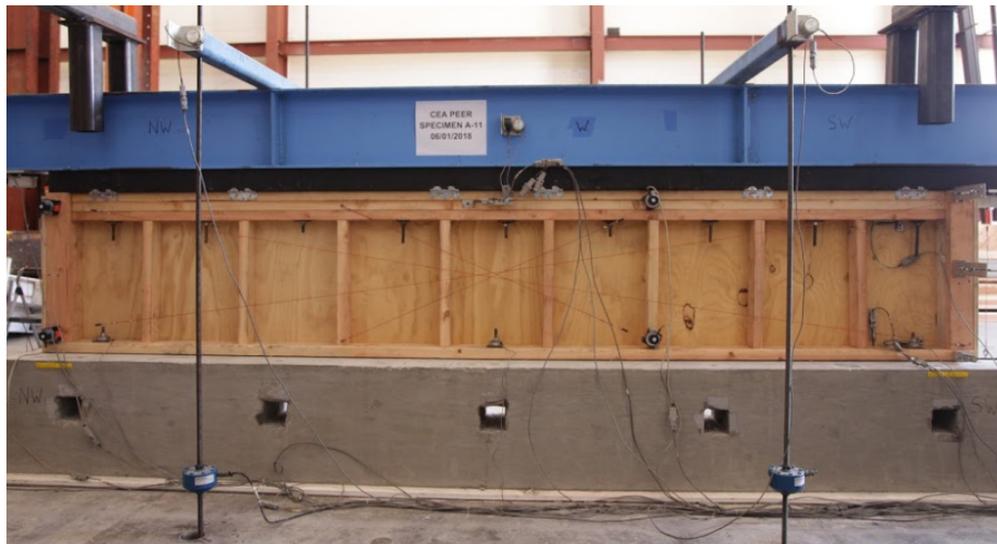
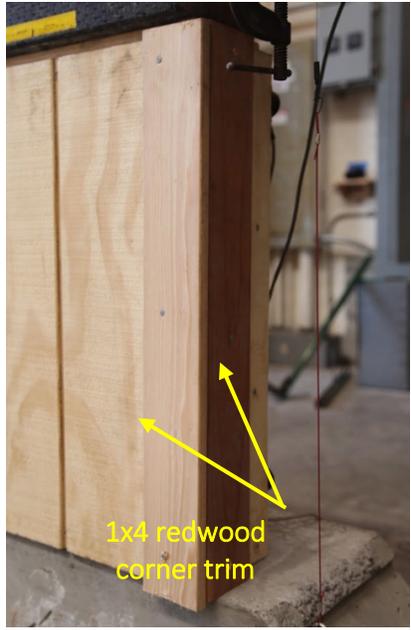
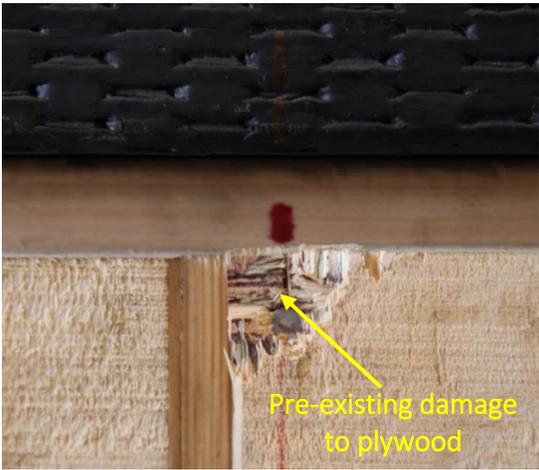
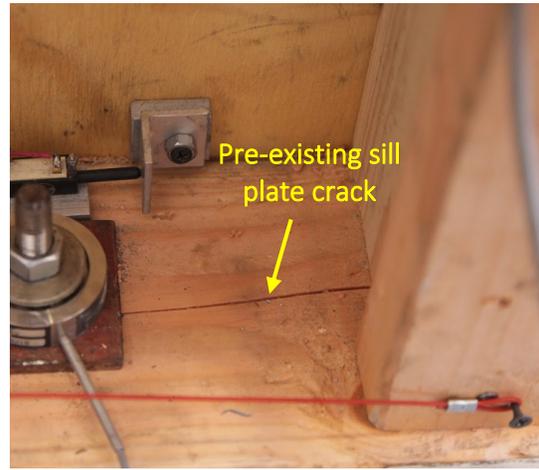
Figure 4.9 Specimen A-11 pre-test photographs of the existing 2-ft-tall cripple wall finished with T1-11 wood structural panels: (a) exterior elevation; (b) interior elevation; (c) north-end exterior of wall corner view; (d) top middle exterior of wall view (middle and north panels); and (e) bottom of south-end interior of wall view.

The photographs in Figure 4.9 show the initial state of Specimen A-11 prior to testing. Specimen A-11 is an existing 2-ft-tall cripple wall with a 5/8-in.-thick T1-11 plywood exterior finish. Recall that the T1-11 panels were fastened on three edges and relied on the overlapping -panel to hold the underlying T1-11 panel in place. An 1/8 in. gap is left between panels. The height of the cripple wall is the same as the previous specimens, but the length of the cripple wall is 12 ft instead of 12 ft-4-1/2 in. The length was shortened in order to accommodate three 4-ft sections of T1-11 plywood. The T1-11 panels came in 4-ft × 8-ft sections, so no partial widths of the panels were used. The panels were fastened with 8d common hot-dipped galvanized nails at 8 in. on center around the edges of the panels and 12 in. on center throughout the field of the panels. Figure 4.9(d) shows pre-existing damage to the corner of one of the T1-11 panels where a nail was overdriven. Figure 4.9(e) shows a pre-existing crack in the sill plate at the south end of the wall.

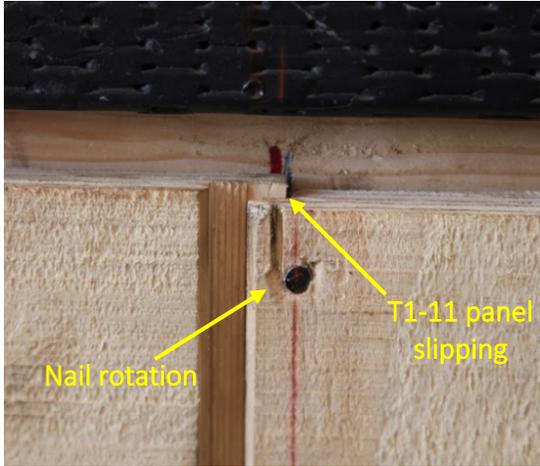
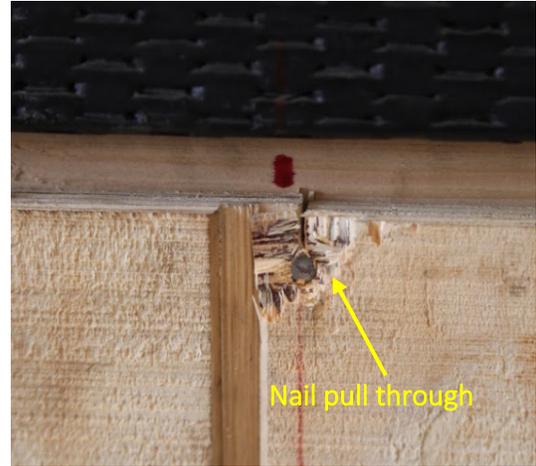
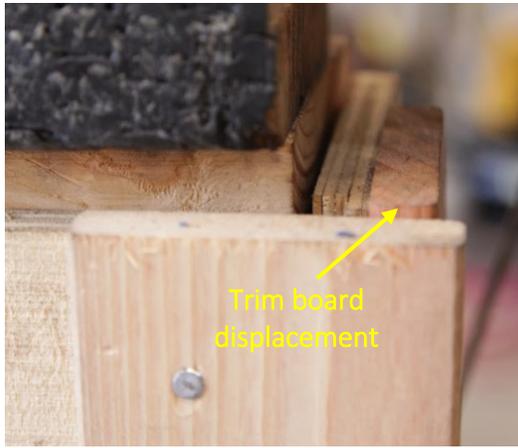
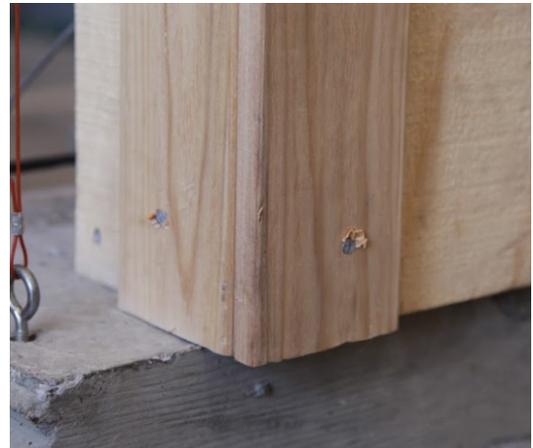
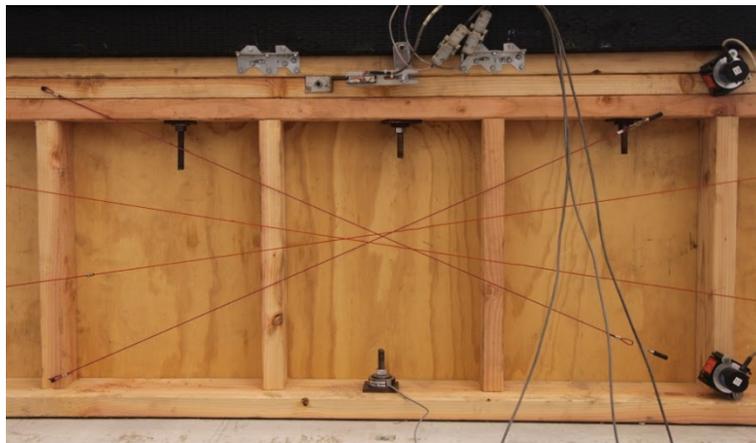
Figure 4.10 Specimen A-11 damage state details at +1.4% drift ratio level @ $\Delta = +0.336$ in. unless otherwise noted: (a) top middle interior of wall view (south and middle panels); (b) top middle interior of wall view (north and middle panels); (c) top of north exterior of wall corner view at -1.4% drift; (d) bottom of south-end exterior of wall corner view; and (e) middle interior of wall view.

Details of the damage at -1.4% drift are shown in Figure 4.10. Panel rotation at the top of the wall is visible in Figure 4.10(a). Figure 4.10(a) and (b) show the slip of the underlying T1-11 panels at the top of both overlap locations. Since the underlying panel was not fastened, it began to slip from the overlying panel at low drift amplitudes. In Figure 4.10(c), the corner trim on the top of the exterior face had displaced around a 1/4 in. from the corner trim on the corner face. This same displacement is not evident at the bottom of the corners; see Figure 4.10(d).

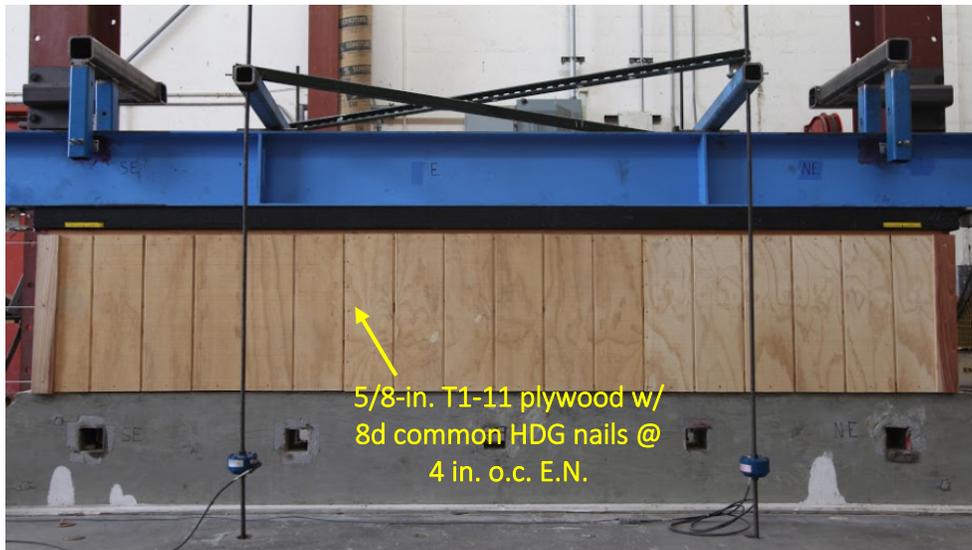
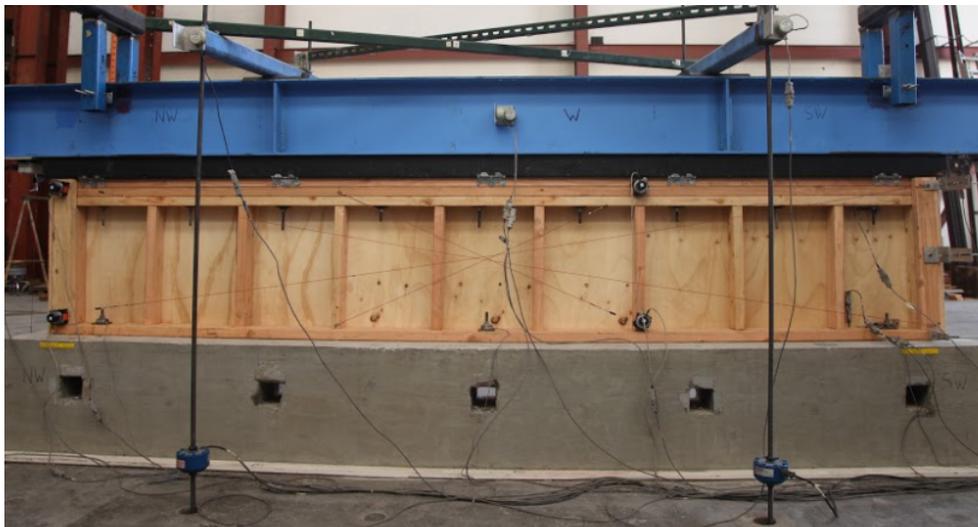
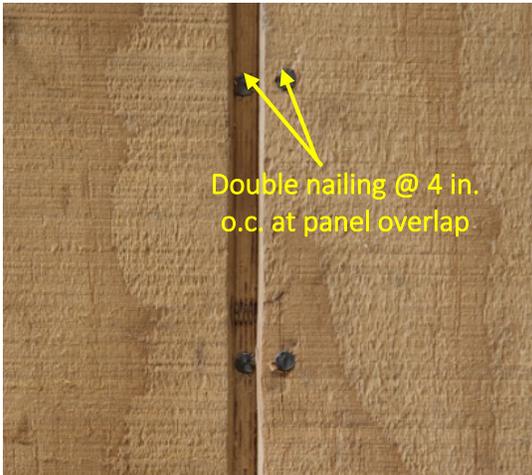
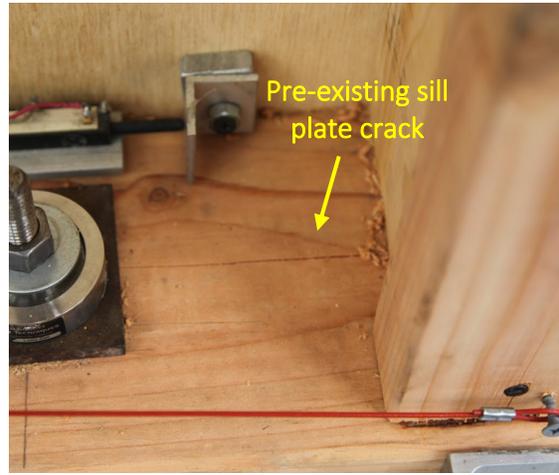
Figure 4.11 Specimen A-12 pre-test photographs of the retrofitted 2-ft-tall cripple wall finished with T1-11 wood structural panels: (a) exterior elevation; (b) interior elevation; (c) top middle exterior of wall view (middle and north panels); and (d) bottom of south-end interior of wall view.

The photographs in Figure 4.11 show the initial state of Specimen A-12 prior to testing. Specimen A-12 is a retrofitted 2-ft-tall cripple wall with 5/8-in.-thick T1-11 plywood exterior finish. Recall that the retrofit for T1-11 cripple walls requires that the T1-11 panels be fastened on all edges. This requires an extra row of nails as shown in Figure 4.11(c). In addition, nail spacing was reduced from 8 in. on center around the edges to 4 in. on center around the edges. The panels were fastened with 8d common hot-dipped galvanized nails at 4 in. on center around the edges of the panels and 12 in. on center throughout the field of the panels. An 1/8-in. gap was left between panels. Unlike all other retrofitted specimens, no additional anchor bolts were added to this cripple wall. The reasoning for this is discussed in Section 3.5. The dimensions of the cripple wall are the same as the existing counterpart, Specimen A-11. Figure 4.11(d) shows a pre-existing crack in the sill plate at the south end of the cripple wall.

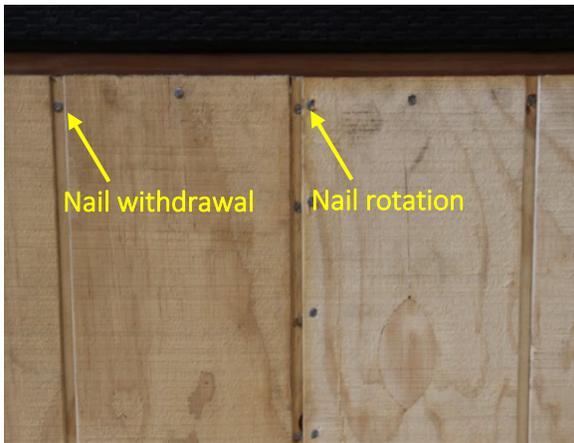
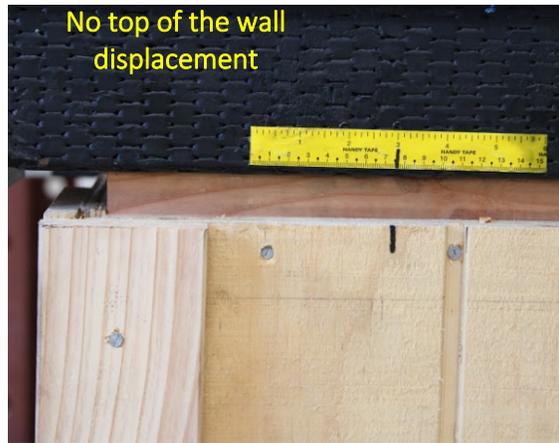
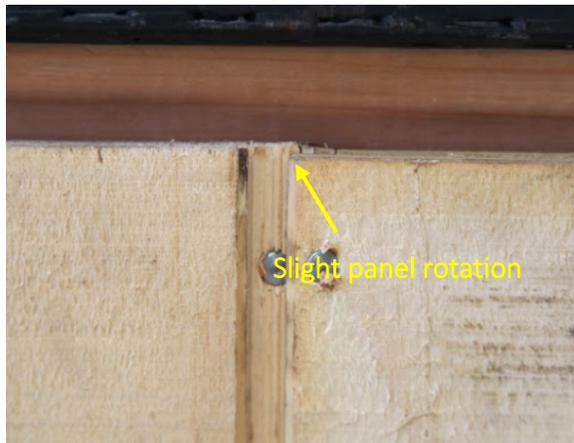
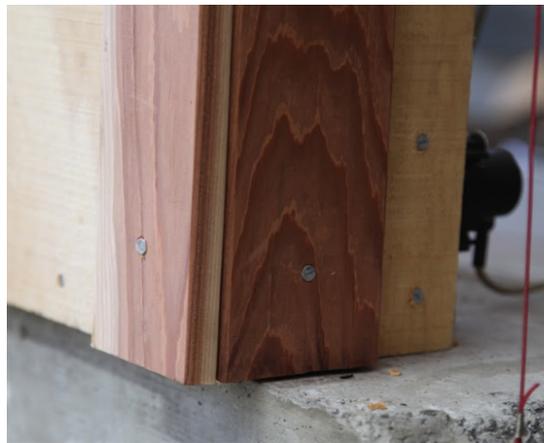
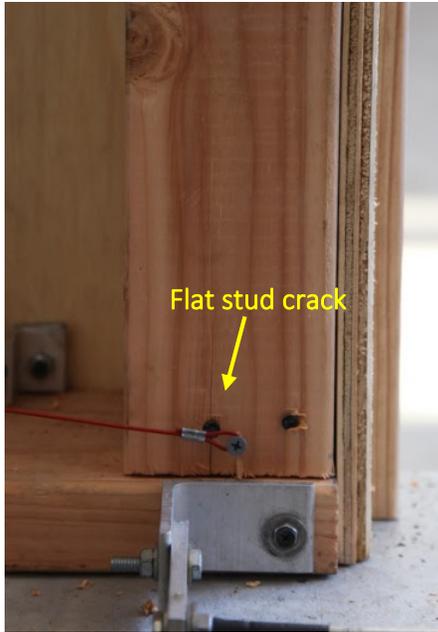
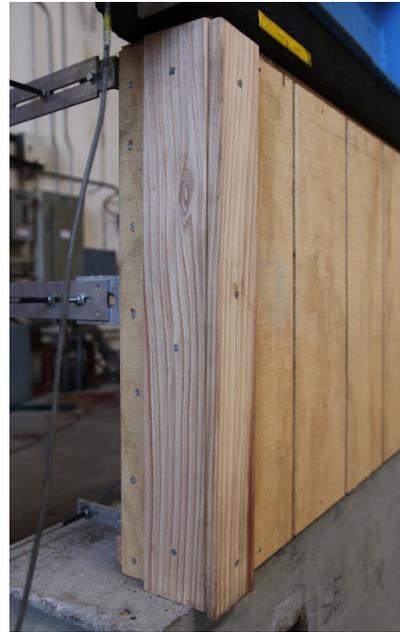
Figure 4.12 Specimen A-12 damage state detail at +1.4% drift ratio level @ $\Delta = +0.336$ in.: (a) top middle interior of wall view (north and middle panels); (b) top south-end exterior of wall view; (c) top middle interior of wall view (south and middle panels); (d) bottom of north-end exterior of wall corner view; (e) bottom of south-end interior of wall corner view; and (f) south-end exterior of wall corner view.

Details of damage at -1.4% drift are shown in Figure 4.12. At this point, rotation of the T1-11 panels had begun to accrue, but it was much less significant than the existing specimen; see Figure 4.12(c). This can be attributed to the addition of the added nailing at the panel joints. In the grooves of the T1-11 panels, the nails have begun to pull through and outside of the grooves, the nails have begun to rotate; see Figure 4.12(a). Since the thickness of the panel is decreased in the grooves, the nails are prone to pull through the panel and stay attached to the framing. Lastly, a small crack had formed at the bottom of the south end, flat stud; see Figure 4.12(e).

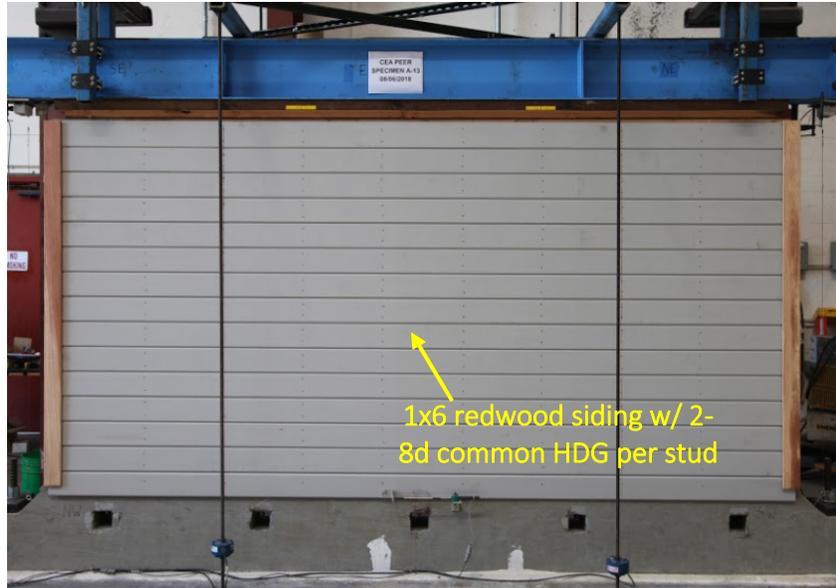
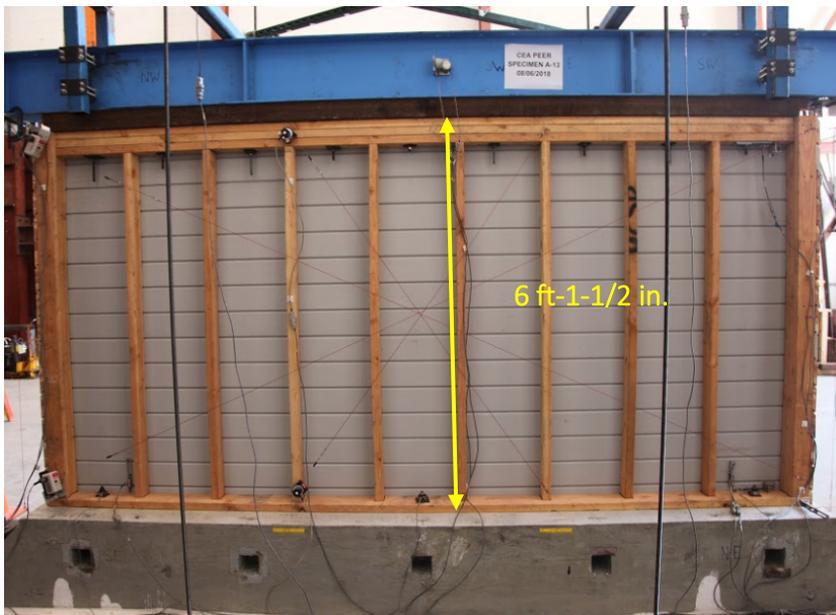
Figure 4.13 Specimen A-13 pre-test photographs of the existing 6-ft-tall cripple wall finished with horizontal siding: (a) exterior elevation; and (b) interior elevation.

The photographs in Figure 4.13 show the initial state of Specimen A-13. Specimen A-13 is an existing 6-ft-tall cripple wall with horizontal siding exterior finish. The siding is 1 × 6 redwood fastened with two 8d common hot-dipped galvanized nails per stud. There was no notable pre-existing damage on the cripple wall prior to testing. The actual height of the cripple wall is 6 ft-1-1/2 in., and the length of the cripple wall is the same as Specimen A-7, the 2-ft-tall counterpart.

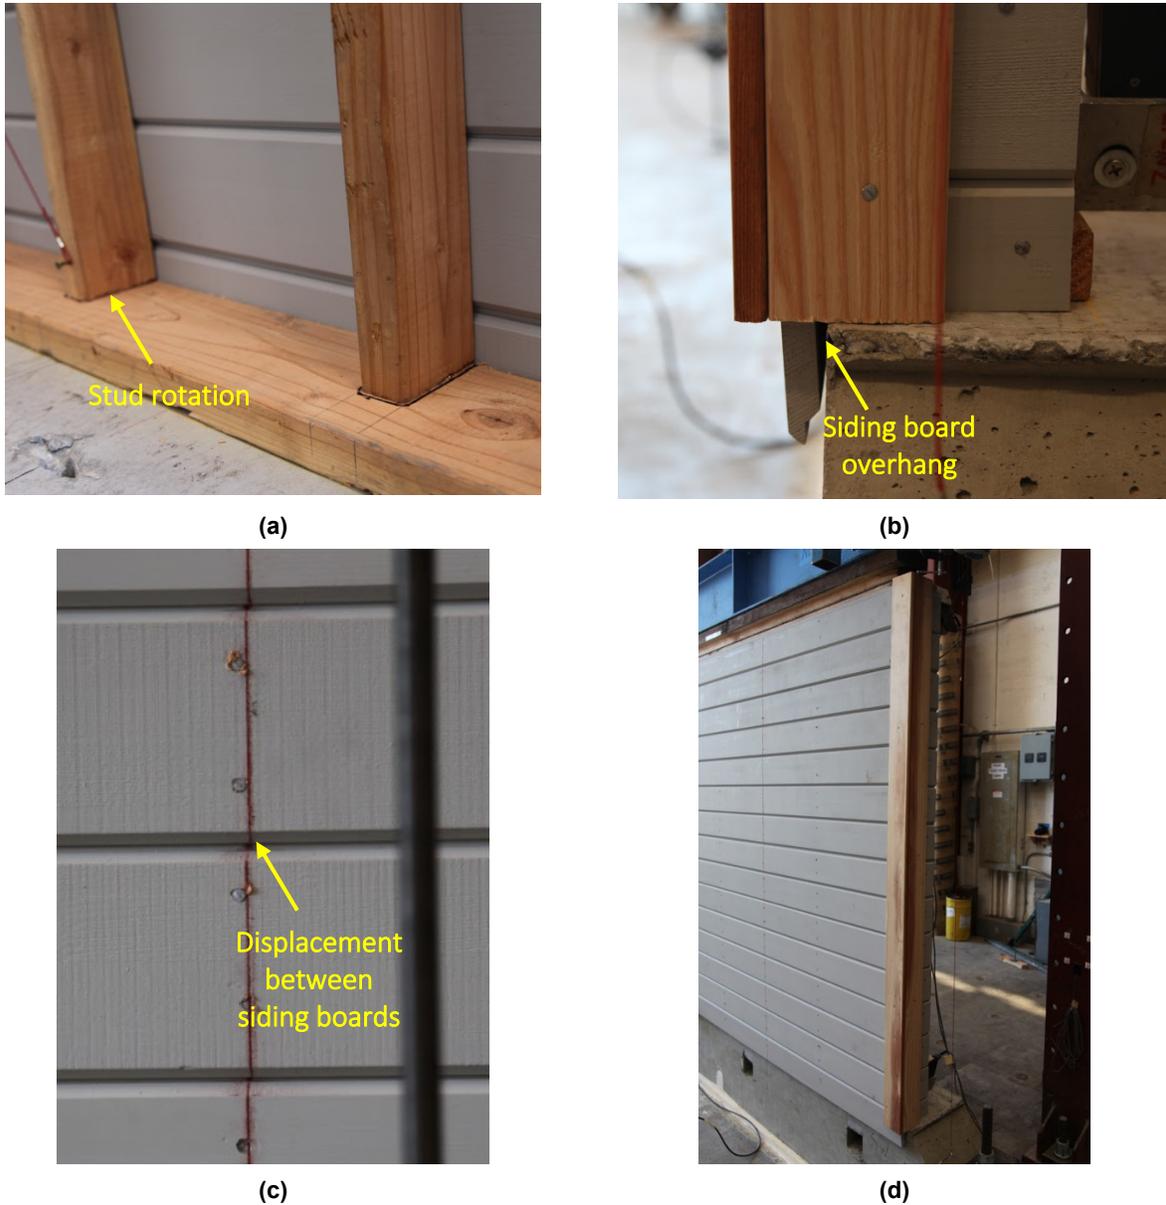
Figure 4.14 Details of damage for Specimen A-13 at +1.4% drift ratio level @ $\Delta = +1.008$ in.: (a) bottom middle interior of wall view; (b) bottom north-end of wall corner view; (c) middle exterior of wall view; and (d) north-end exterior of wall corner view.

From the start of the test to the 0.8% drift ratio level, a cracked formed in a corner siding board at the top of the north corner of the cripple wall. In addition, uplifting of the corner studs at the north corner of the specimen became apparent at 0.8% drift. Figure 4.14 shows close-up images at some key locations on the specimen at 1.4% drift. In Figure 4.14(a), the rotations of the studs are shown. At this point, displacements between siding boards have started to become visible; see Figure 4.14(c).

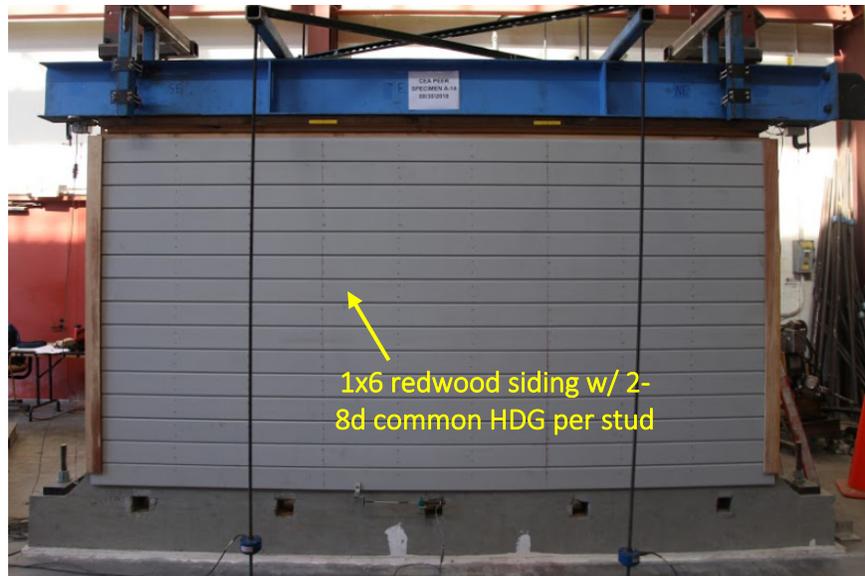
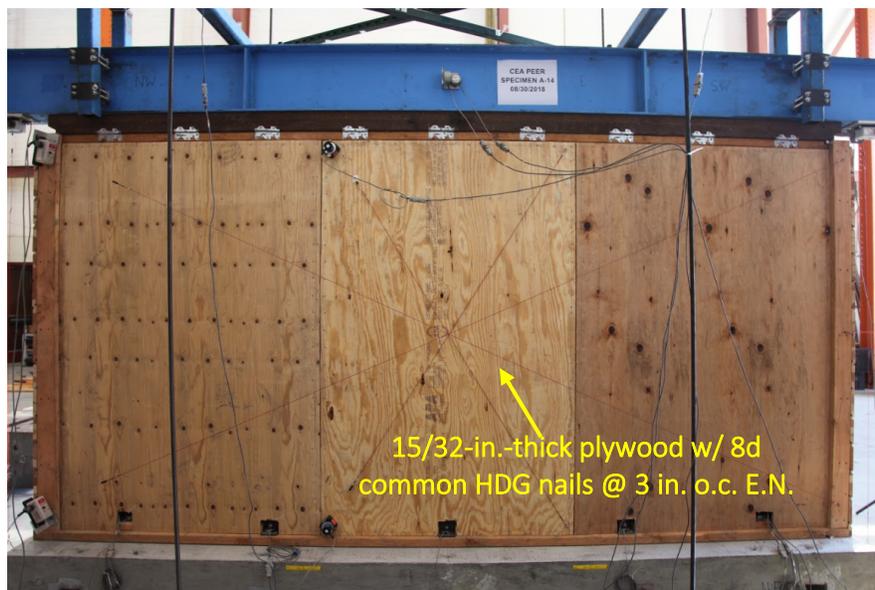
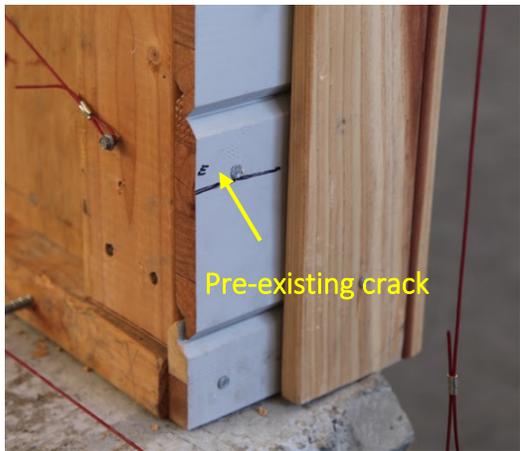
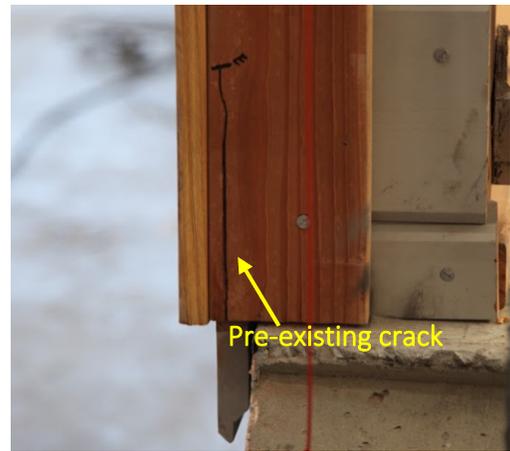
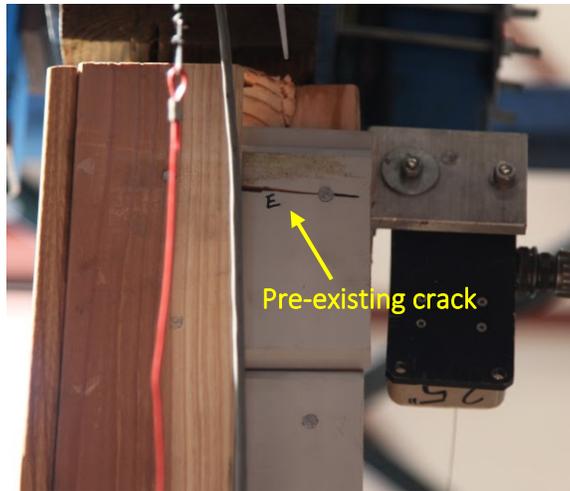
Figure 4.15 Specimen A-14 pre-test photographs for the retrofitted 6-ft-tall cripple wall finished with horizontal siding: (a) exterior elevation; (b) interior elevation; (c) bottom of south-end interior of wall corner view; (d) bottom of north-end of wall corner view; and (e) top of north-end of wall corner view.

The photographs in Figure 4.15 show the initial state of Specimen A-14 prior to testing. Specimen A-14 is a retrofitted 6-ft-tall cripple wall with horizontal siding exterior finish. The siding is 1 × 6 redwood fastened with two 8d common hot-dipped galvanized nails per stud. The retrofit included the addition of three sections of 15/32 in.-thick plywood fastened with 8d common hot-dipped galvanized nails spaced at 3 in. on center around the edge of the panels and 12 in. on center in the field of the panels. A 1/8-in. gap was present between the plywood panels. In addition, four extra

anchor bolts were added. Two anchor bolts were placed in at the corners of the cripple wall. These anchor bolts were epoxied into place and were part of the hold-downs used to resist uplift of the cripple wall. Two additional anchor bolts were epoxied 12 in. in from the location of the hold-downs. The dimensions of the cripple wall were identical to Specimen A-13. Figure 4.15(c), (d), and (e) shows pre-existing cracks in the bottom corner siding board, bottom corner trim board, and top corner trim board, respectively. These cracks formed during the installation of the siding and trim boards.

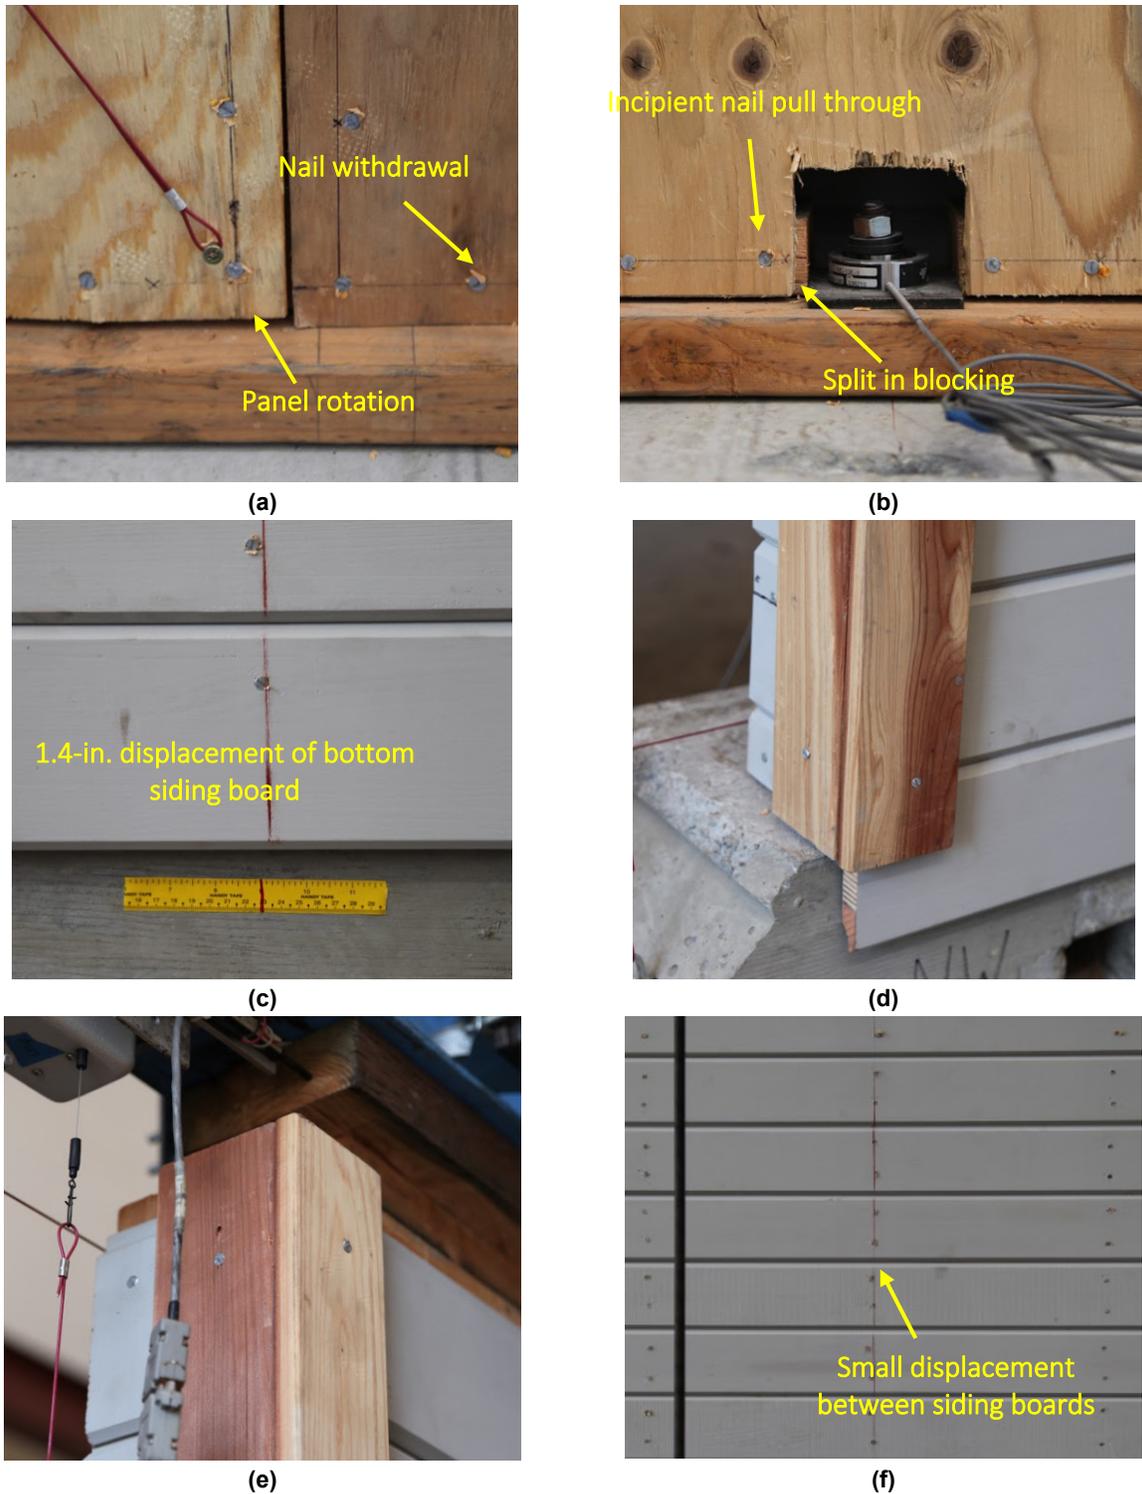
Figure 4.16 Specimen A-14 damage state details of damage at -1.4% drift ratio level @ $\Delta = -1.008$ in.: (a) bottom middle interior of wall view (north and middle panels); (b) bottom of north-end interior of wall view; (c) bottom middle of exterior of wall view; (d) bottom of south-end exterior of wall corner view; (e) top of south-end interior of wall corner view; and (f) middle exterior of wall view.

Figure 4.16 shows close-up images of the state of the specimen at -1.4% drift. The most notable damage is a split in the blocking just north of the middle anchor bolt; see Figure 4.16(b). From this photograph and Figure 4.16(a), uplift and rotation of the plywood panels is apparent. Sliding of the sill plate over the foundation had also begun, shown by the 1/4-in. displacement between the bottom siding plate and foundation in Figure 4.16(c). The nails had begun to withdrawal at some locations and show incipient pull through at other locations.

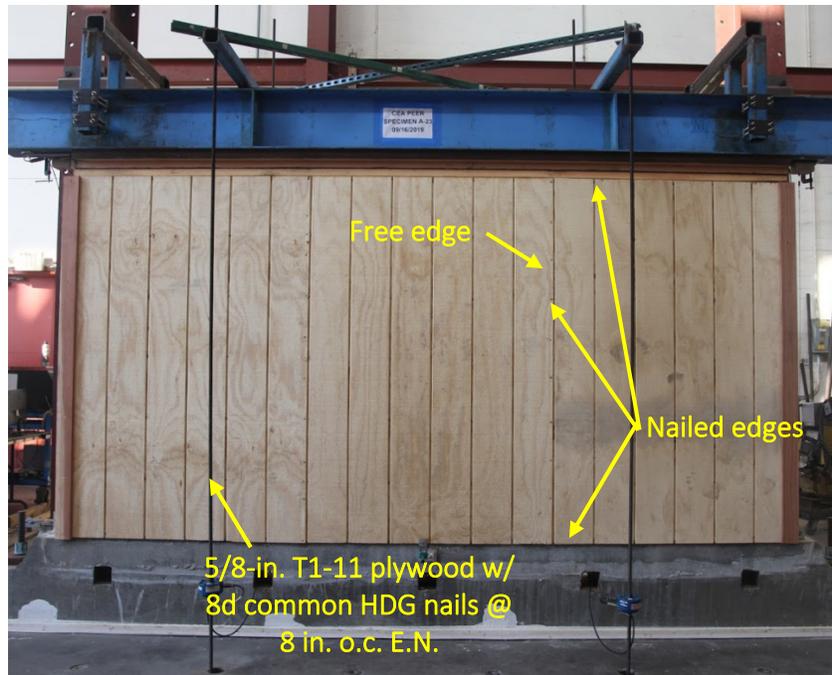
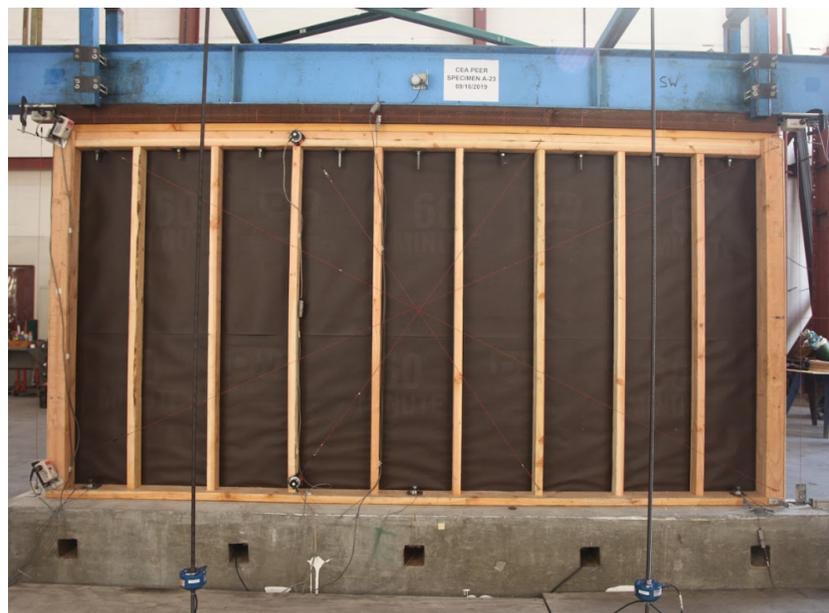
Figure 4.17 Specimen A-23 pre-test photographs of the existing 6-ft-tall cripple wall finished with T1-11 wood structural panels: (a) exterior elevation; (b) interior elevation; (c) south-end exterior of wall corner view; and (d) top of south-end of wall corner view.

The photographs in Figure 4.17 show the initial state of Specimen A-23 prior to testing. Specimen A-23 is an existing 6-ft-tall cripple wall with 5/8-in.-thick T1-11 wood structural panels. Recall that the T1-11 panels were fastened on three edges and relied on the overlapping T1-11 panel to hold the underlying T1-11 panel in place. A 1/8-in. gap was left between panels. The height of the cripple wall was the same as the previous 6-ft-tall specimens (6 ft-1-1/2 in.), but the length of the cripple wall was 12 ft instead of 12 ft-4-1/2 in. The length was shortened in order to accommodate three 4-ft sections of T1-11 plywood. The T1-11 panels came in 4-ft × 8-ft sections so no partial widths of the panels were used. The panels were fastened with 8d common hot-dipped galvanized nails at 8 in. on center around the edges of the panels and 12 in. on center throughout the field of the panels. Figure 4.17(d) shows pre-existing cracks at the top of the south end flat stud. These cracks occurred during framing of the cripple wall. The largest crack does not contain a fastener (removed), instead a fastener was driven 1/2 in. from the crack location.

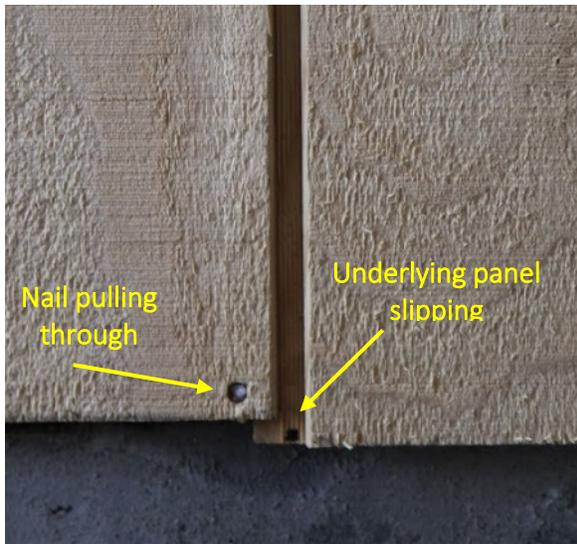
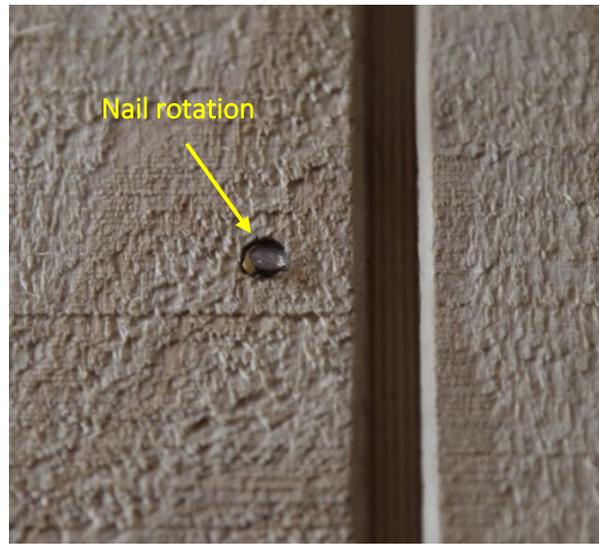
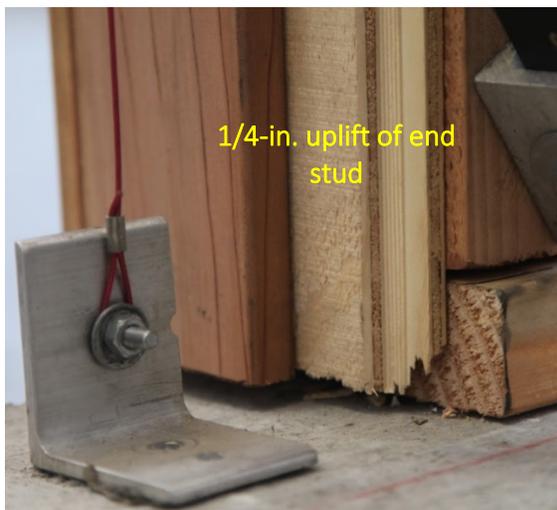
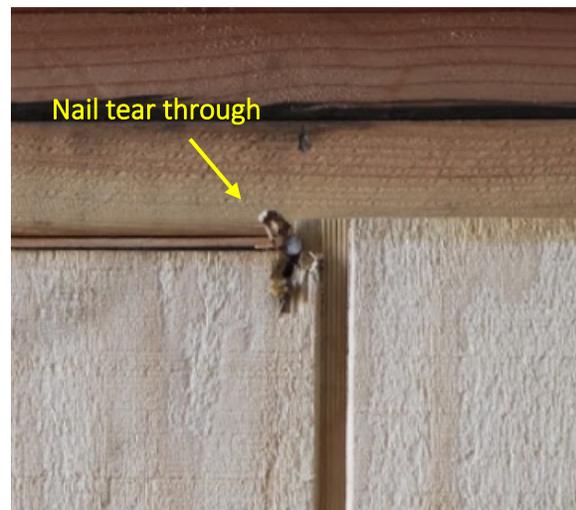
Figure 4.18 Specimen A-23 damage state details at -1.4% drift ratio level @ $\Delta = -1.008$ in.: (a) bottom middle exterior of wall view (south and middle panels); (b) middle exterior of wall view; (c) bottom of south-end interior of wall corner view; and (d) top middle exterior of wall view (south and middle panels).

At the 0.8% drift ratio level, the T1-11 panels show visible rotation, as the underlying panel had little resistance to rotate due to the lack of nailing on the panel edge. Figure 4.18 show details of the damage at -1.4% drift. Along with panel rotation, the nails connecting the panels show visible rotation; see Figure 4.18(b). There is even tearing of nails through the edges of the panels at the corners; see Figure 4.18(d). The cripple wall also began to exhibit uplift of the corner trim and the corner studs. The sill plate remained in contact with the foundation. As with the 2-ft-tall counterpart Specimen A-11, the underlying panel had begun to slip away from the overlying panel due to the lack of fasteners keeping it in place; see Figure 4.18(a).
